KSC Ice/Frost/Debris Assessment For Space Shuttle Mission STS-30R

May 1989

KSC
ICE/FROST/DEBRIS ASSESSMENT
FOR
SPACE SHUTTLE MISSION
STS-30R
MAY 4, 1989

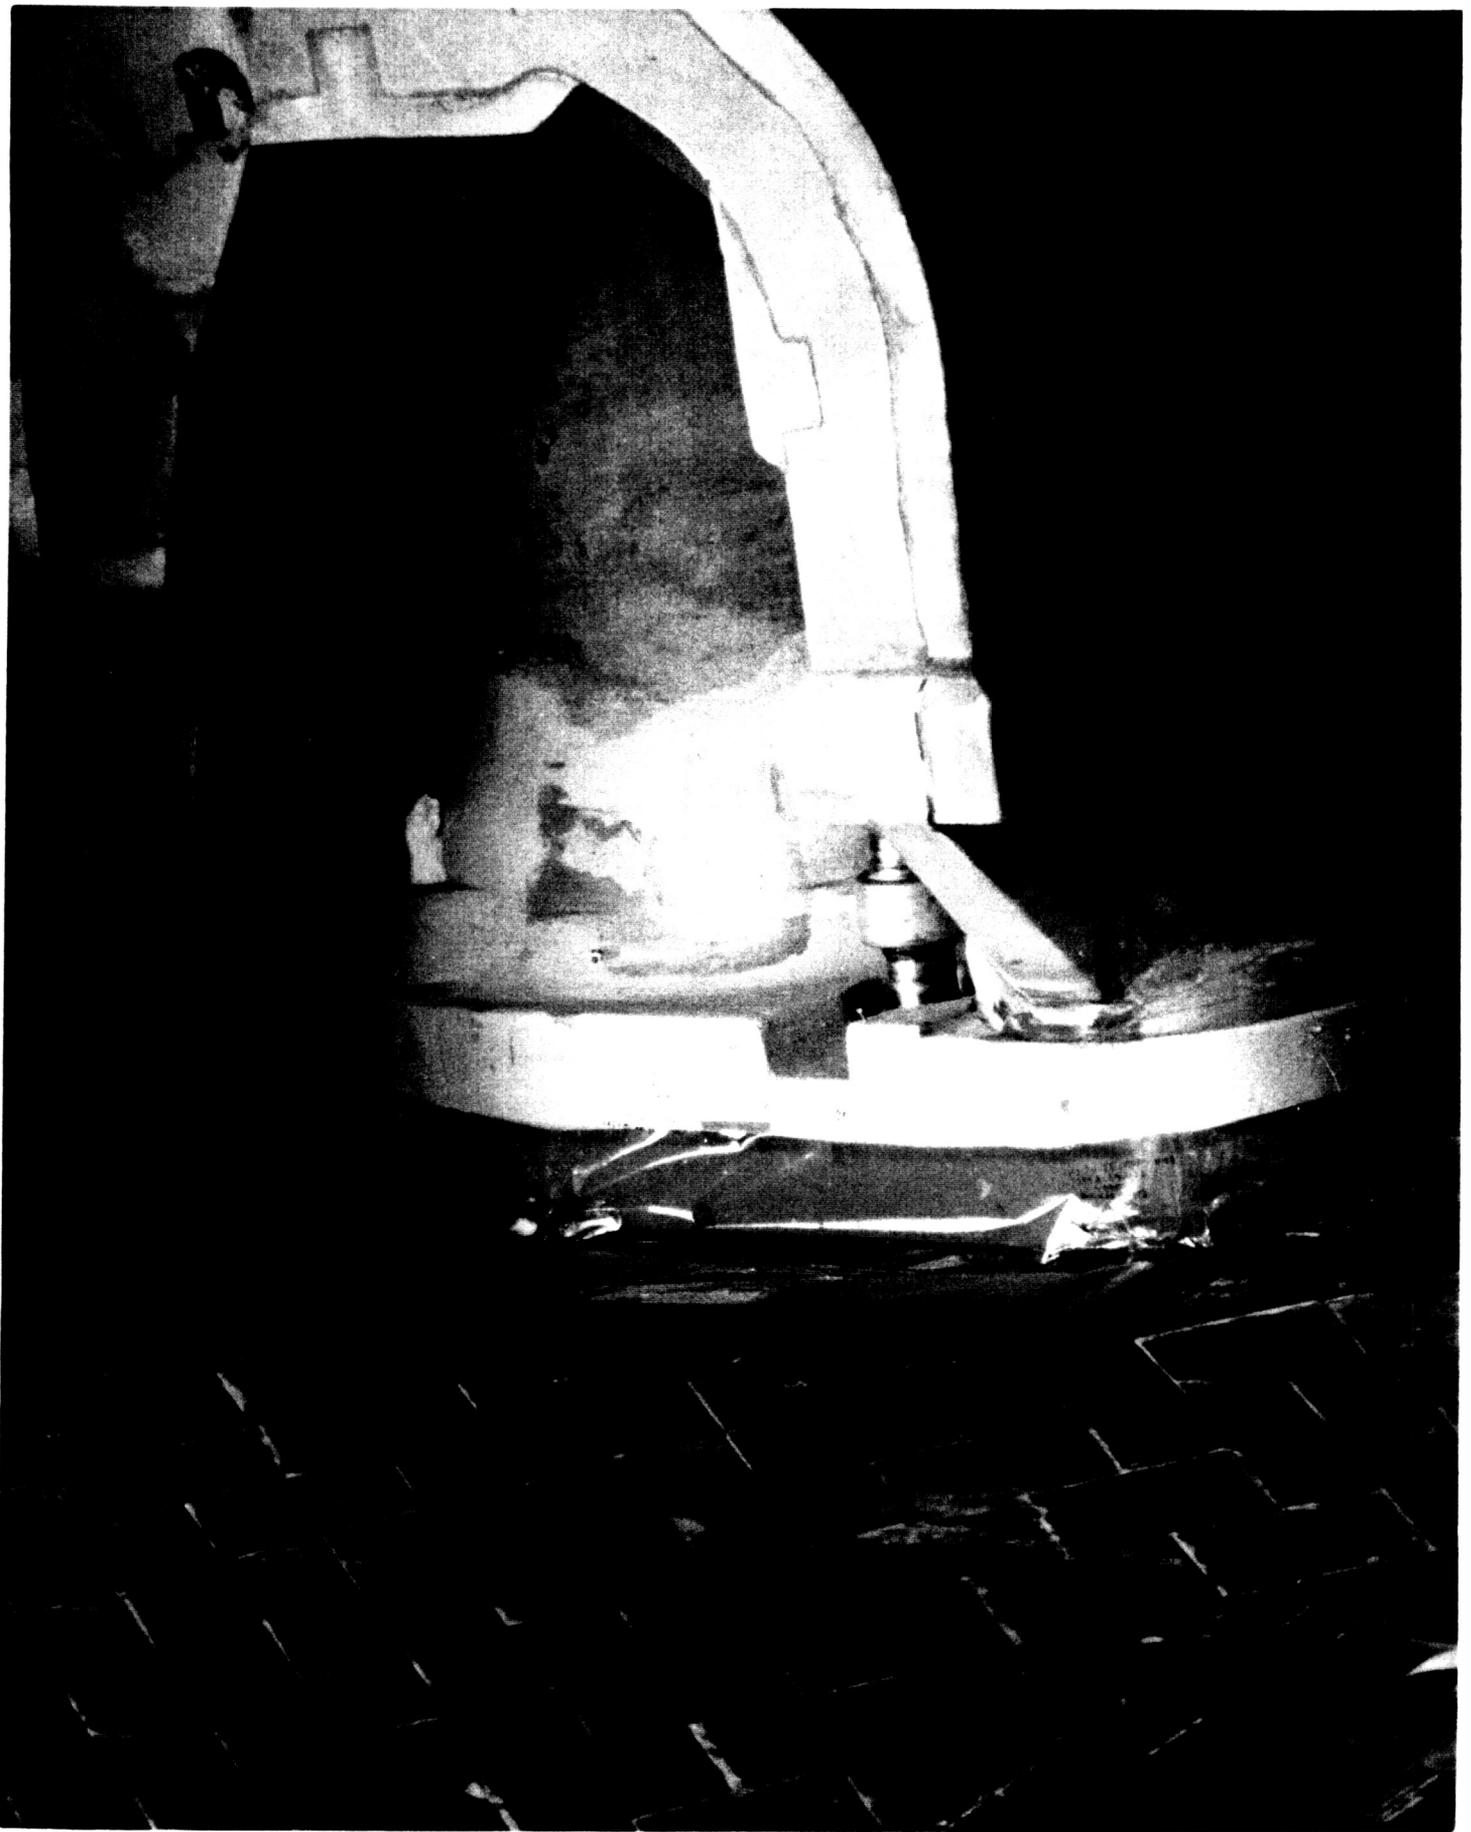
FROST FINGER ON ET/ORB LO2 UMBILICAL PURGE VENT

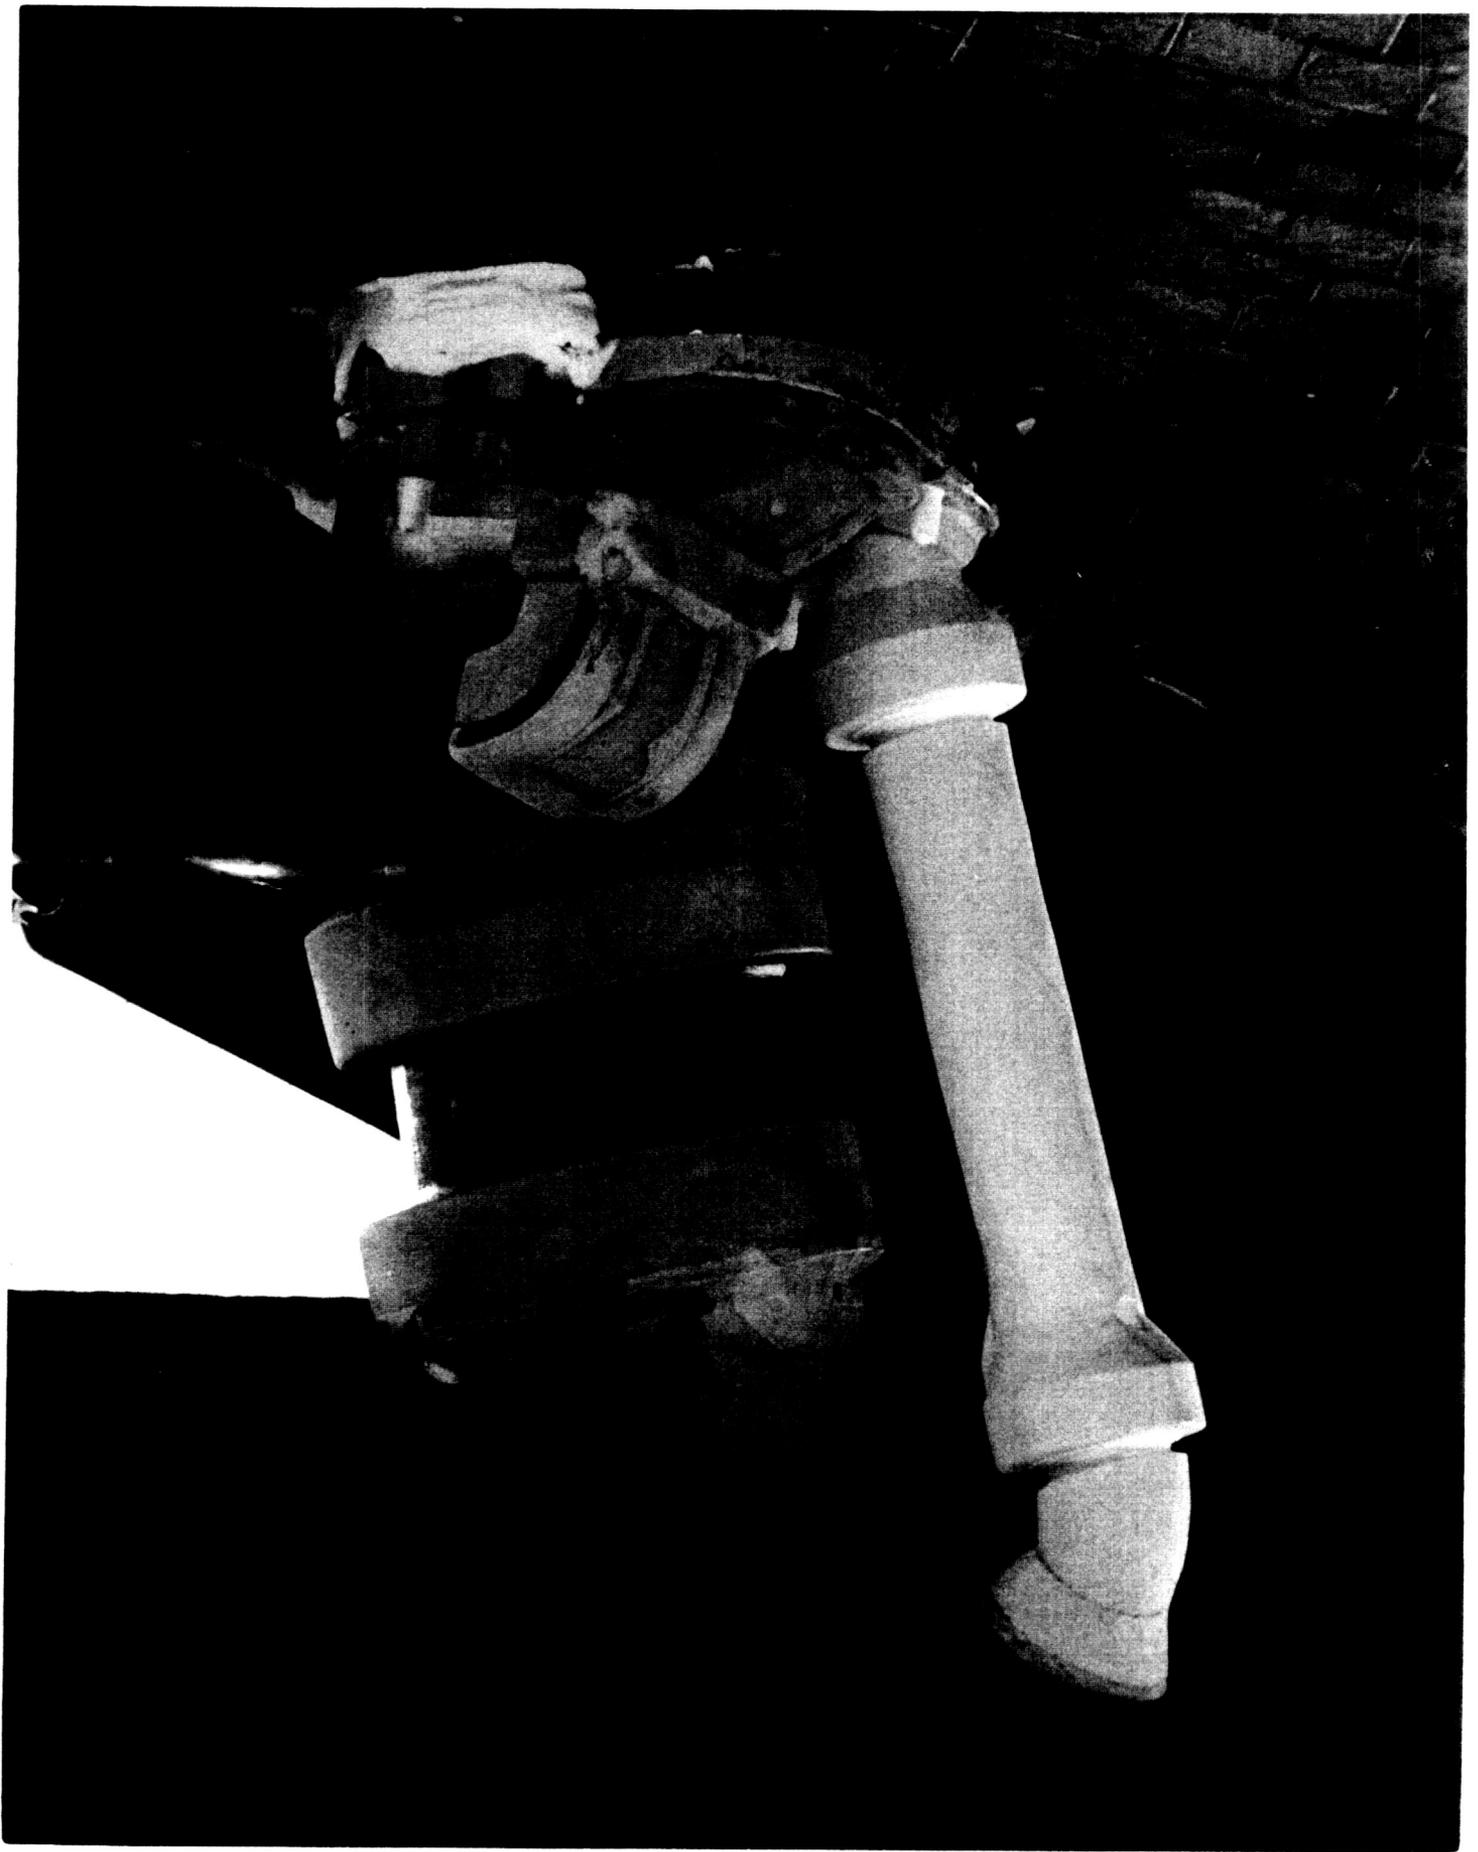
TYPICAL ICE/FROST ACCUMULATION ON OUTBOARD SIDE OF ET/ORB
LH2 UMBILICAL BAGGIE, ON PURGE VENTS, AND IN BELLOWS ;

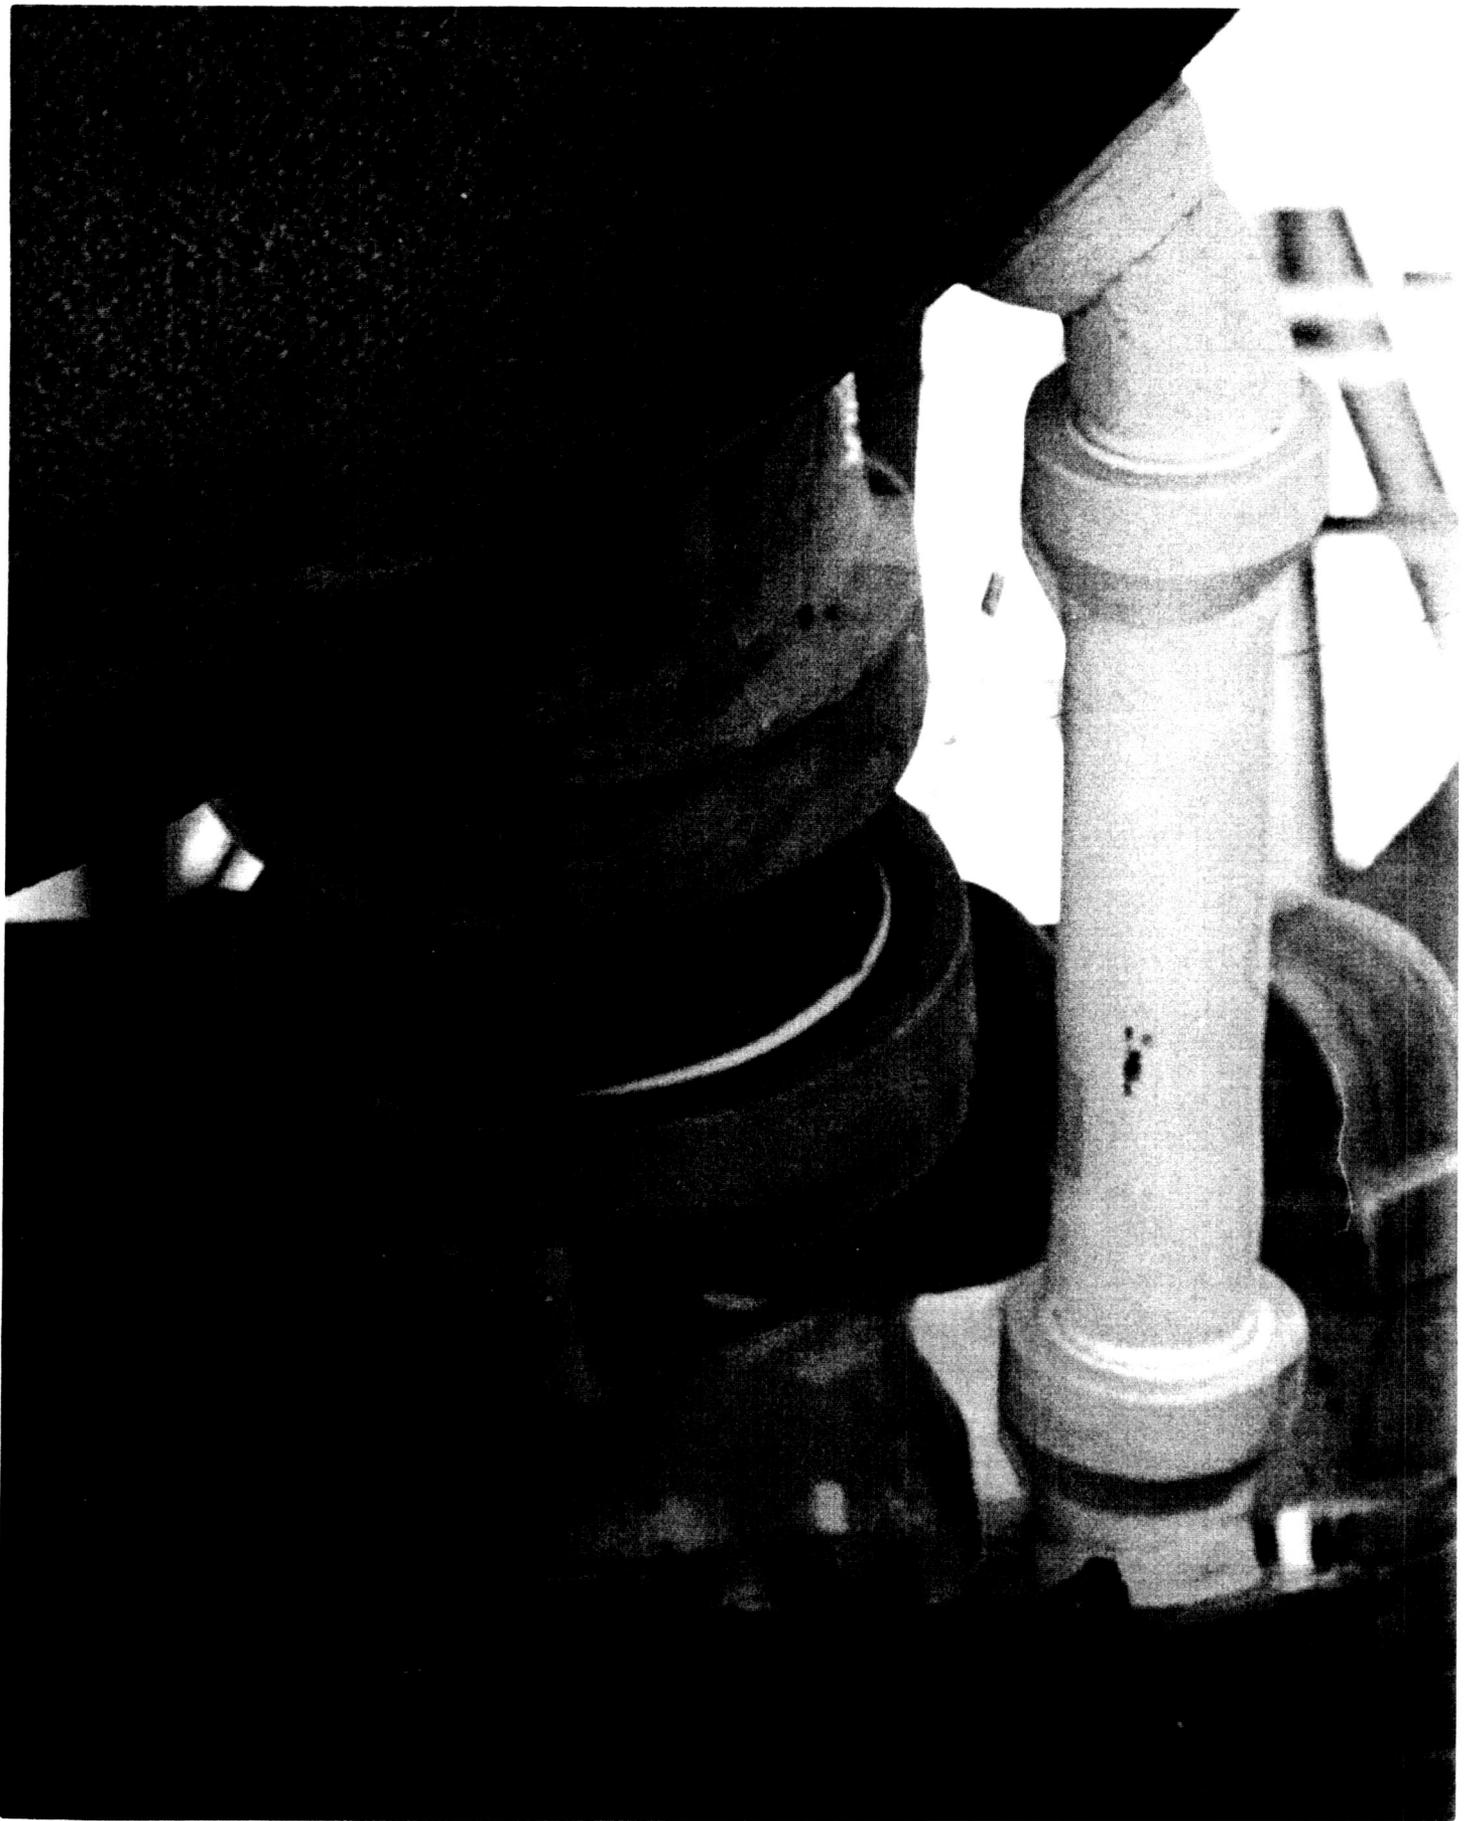
TYPICAL FROST ACCUMULATION IN LH2 FEEDLINE
AND RECIRCULATION LINE BELLOWS

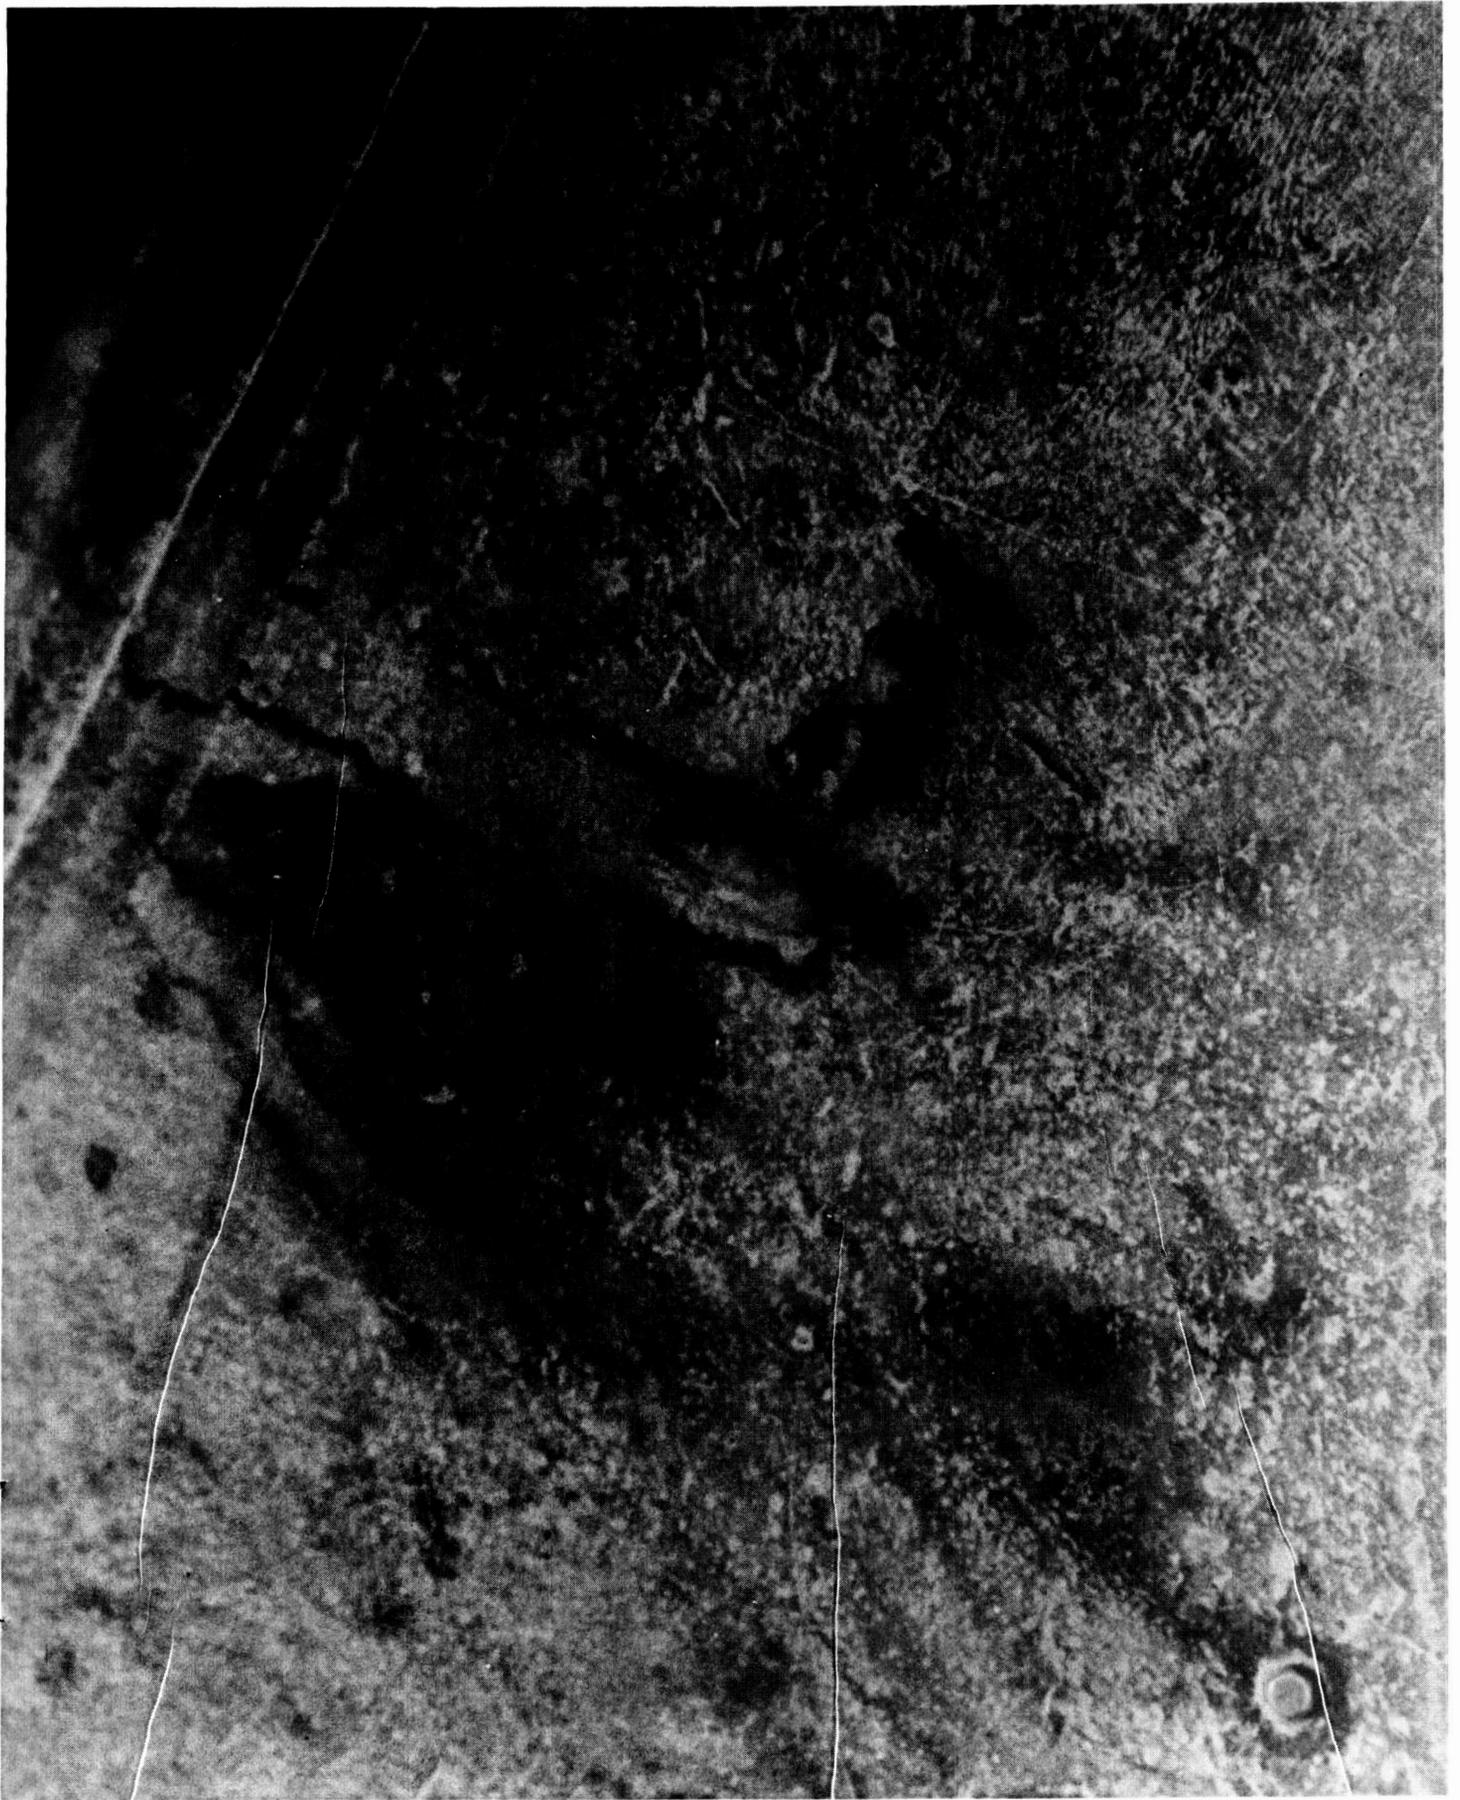
FRANGIBLE NUT AND NSI FRAGMENTS FOUND IN HDP #5 STUD HOLE

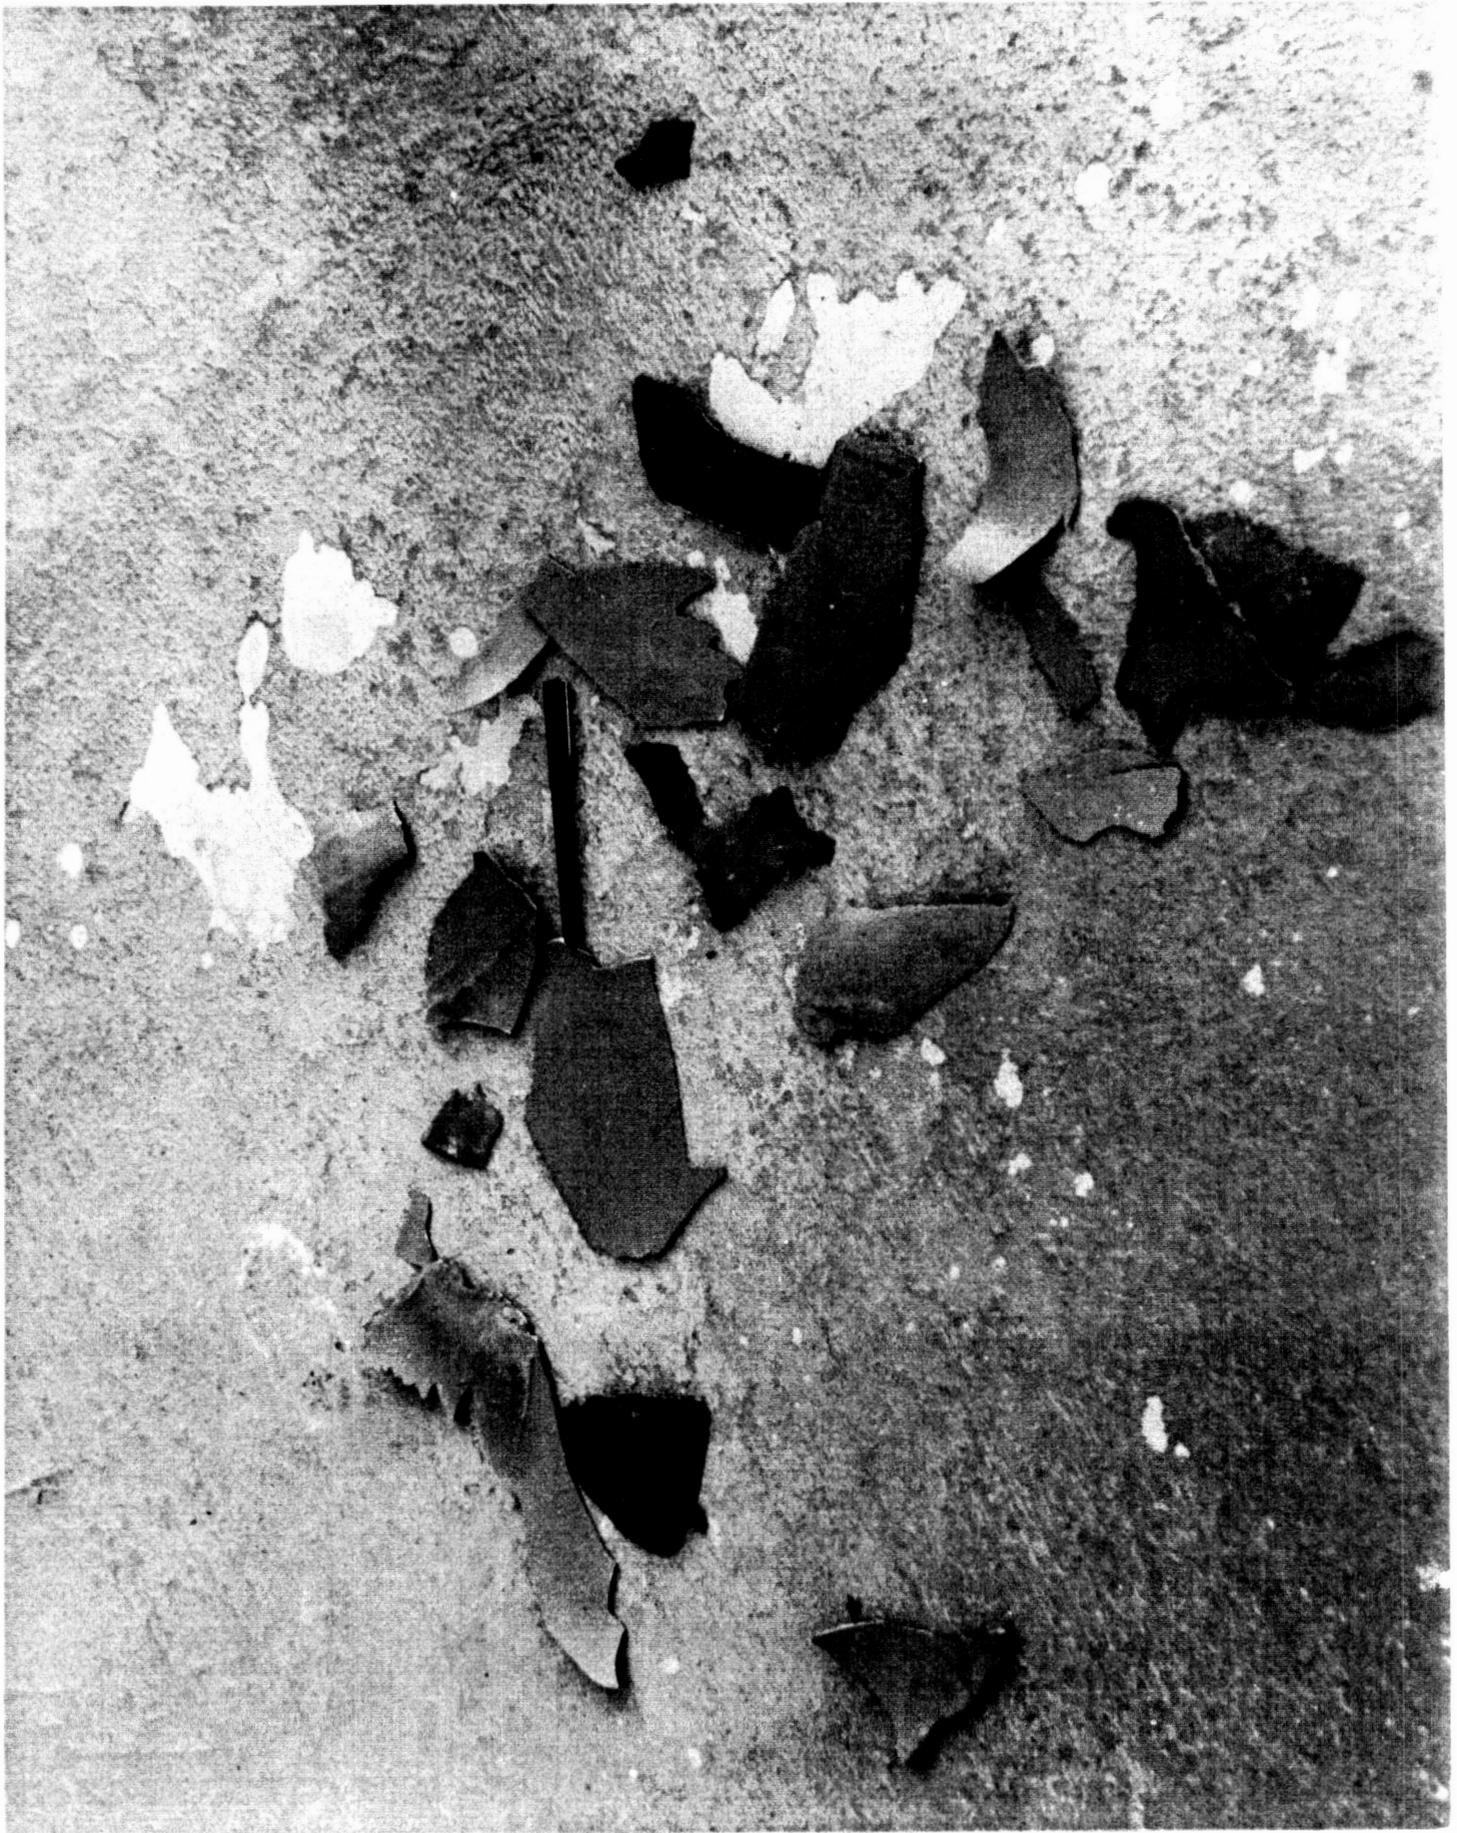
ORIGIN OF MATERIAL FOUND ON MLP DECK
IS UNKNOWN BUT IS NOT DECK COATING

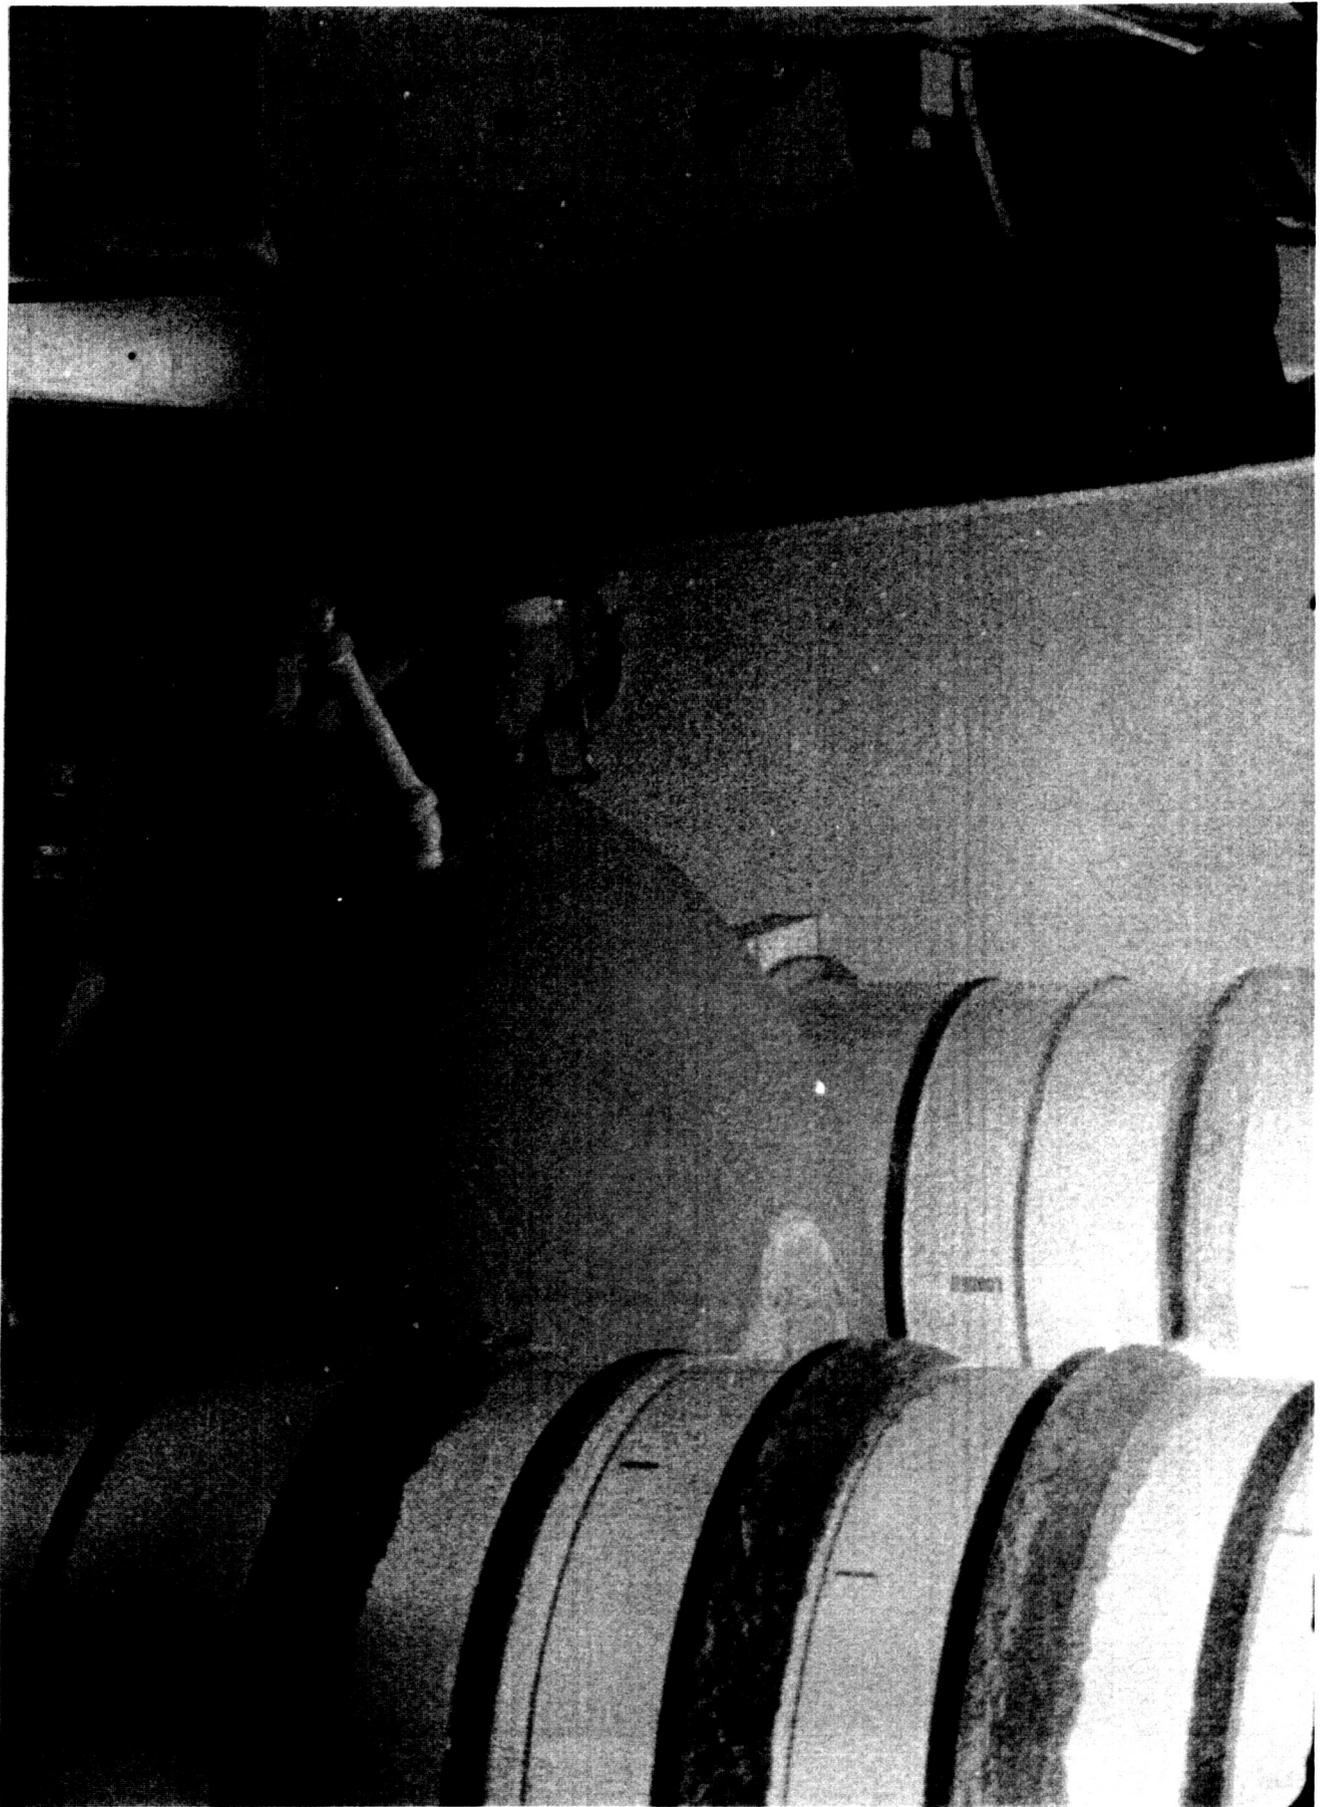
ICE/FROST FALLS FROM ET/ORBITER UMBILICALS.
NO UNUSUAL VAPORS EMANATE FROM LH2 UMBILICAL.

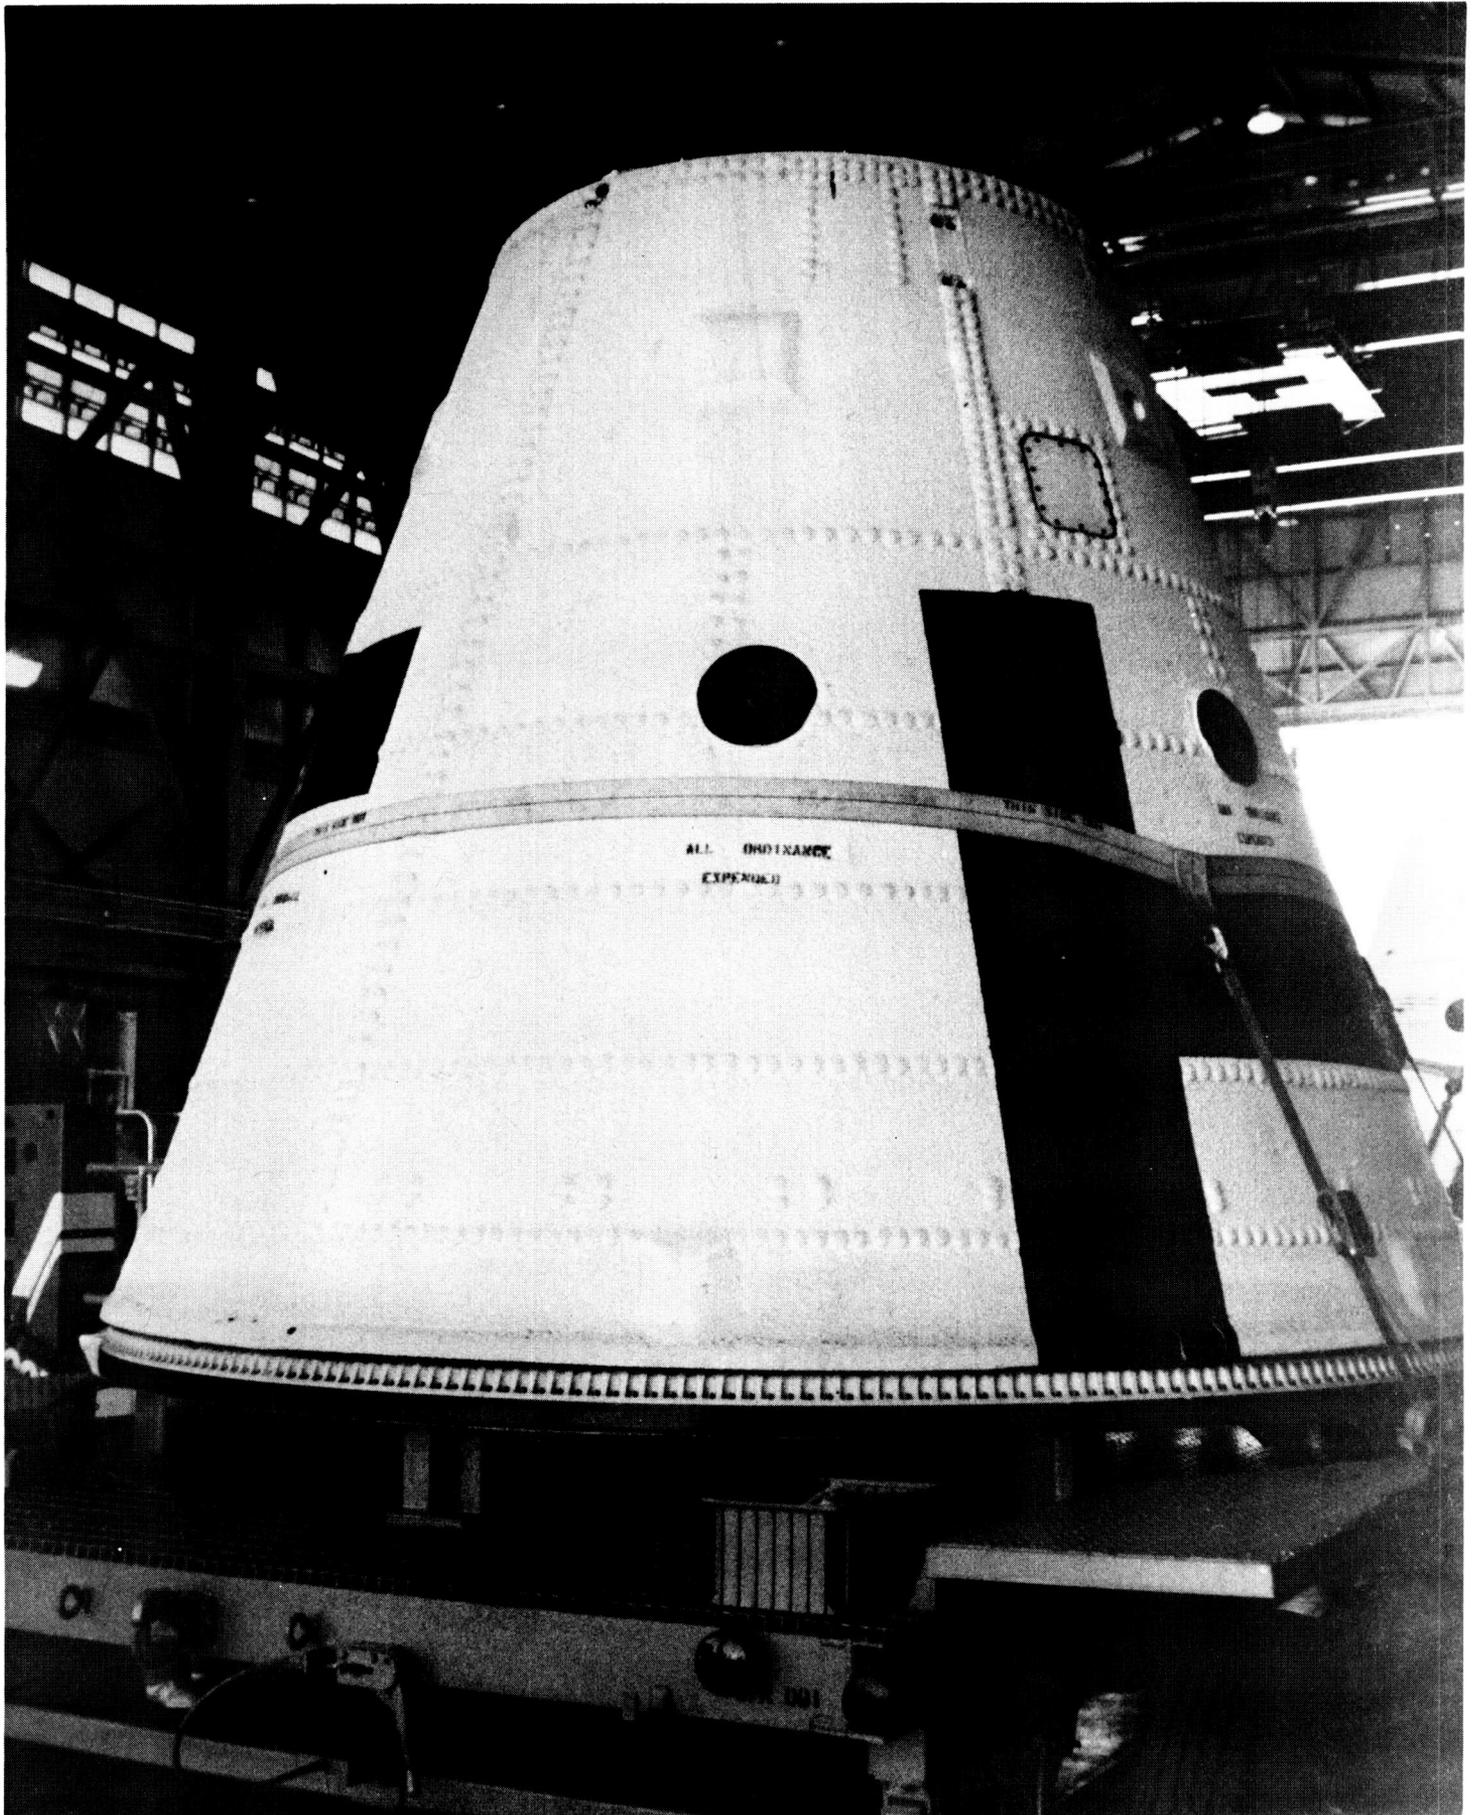
LH SRB FRUSTUM EXHIBITING NO MISSING TPS
AND MINIMAL HYPALON PAINT BLISTERING
145

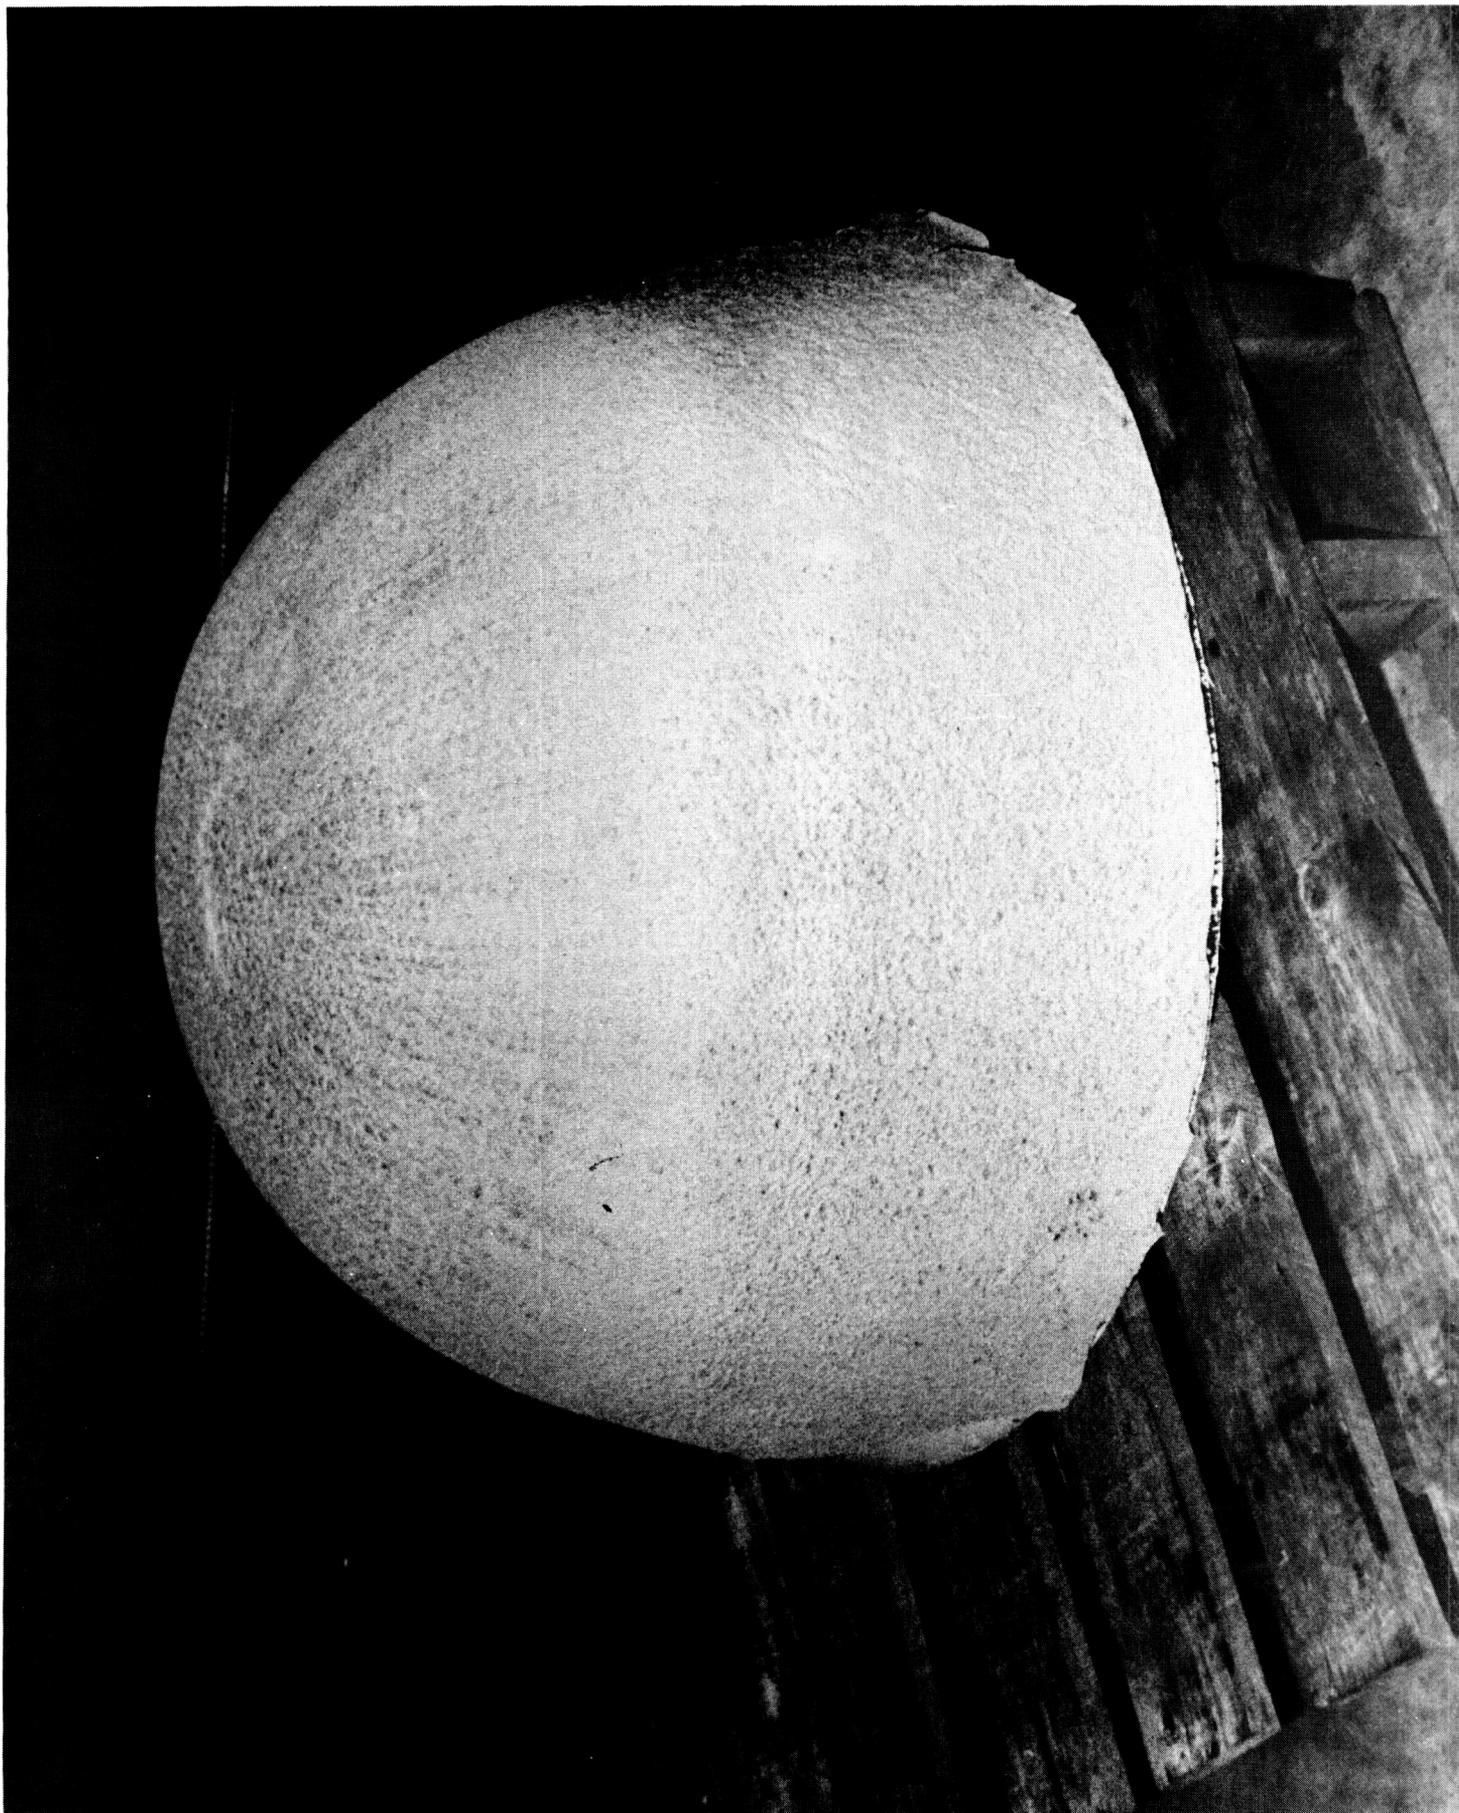
RH SRB NOSECAP DOME SHOWING NO ABLATOR ADHESION PROBLEMS
