KSC Ice/Frost/Debris Assessment For Space Shuttle Mission STS-30R

May 1989

KSC
ICE/FROST/DEBRIS ASSESSMENT
FOR
SPACE SHUTTLE MISSION
STS-30R
MAY 4, 1989

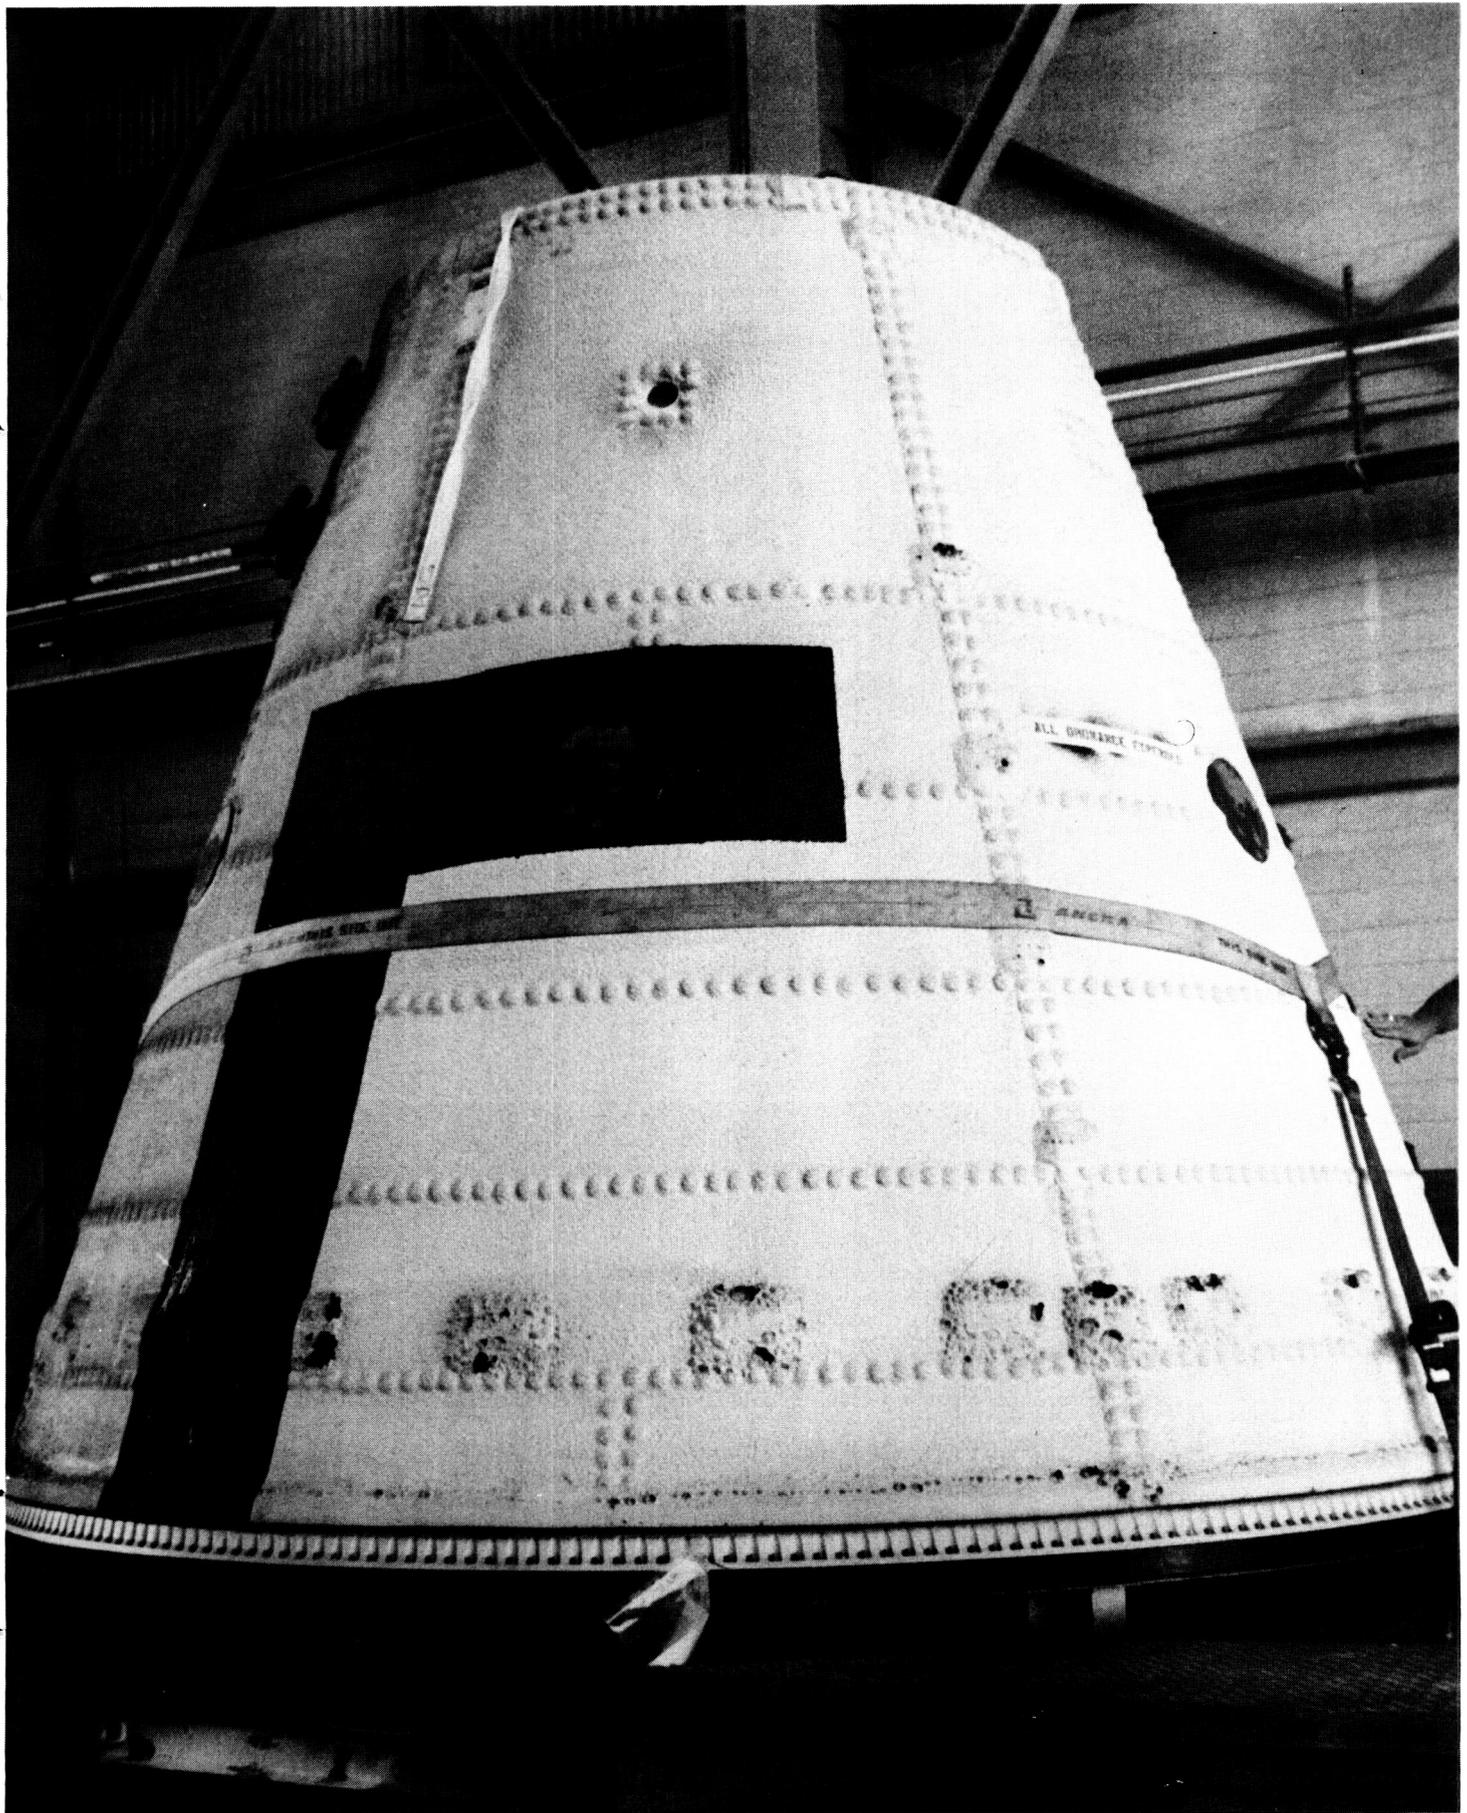
**RH SRB FRUSTUM EXHIBITS NO MISSING TPS, BUT
PROBLEM WITH HYPALON PAINT BLISTERING CONTINUES**

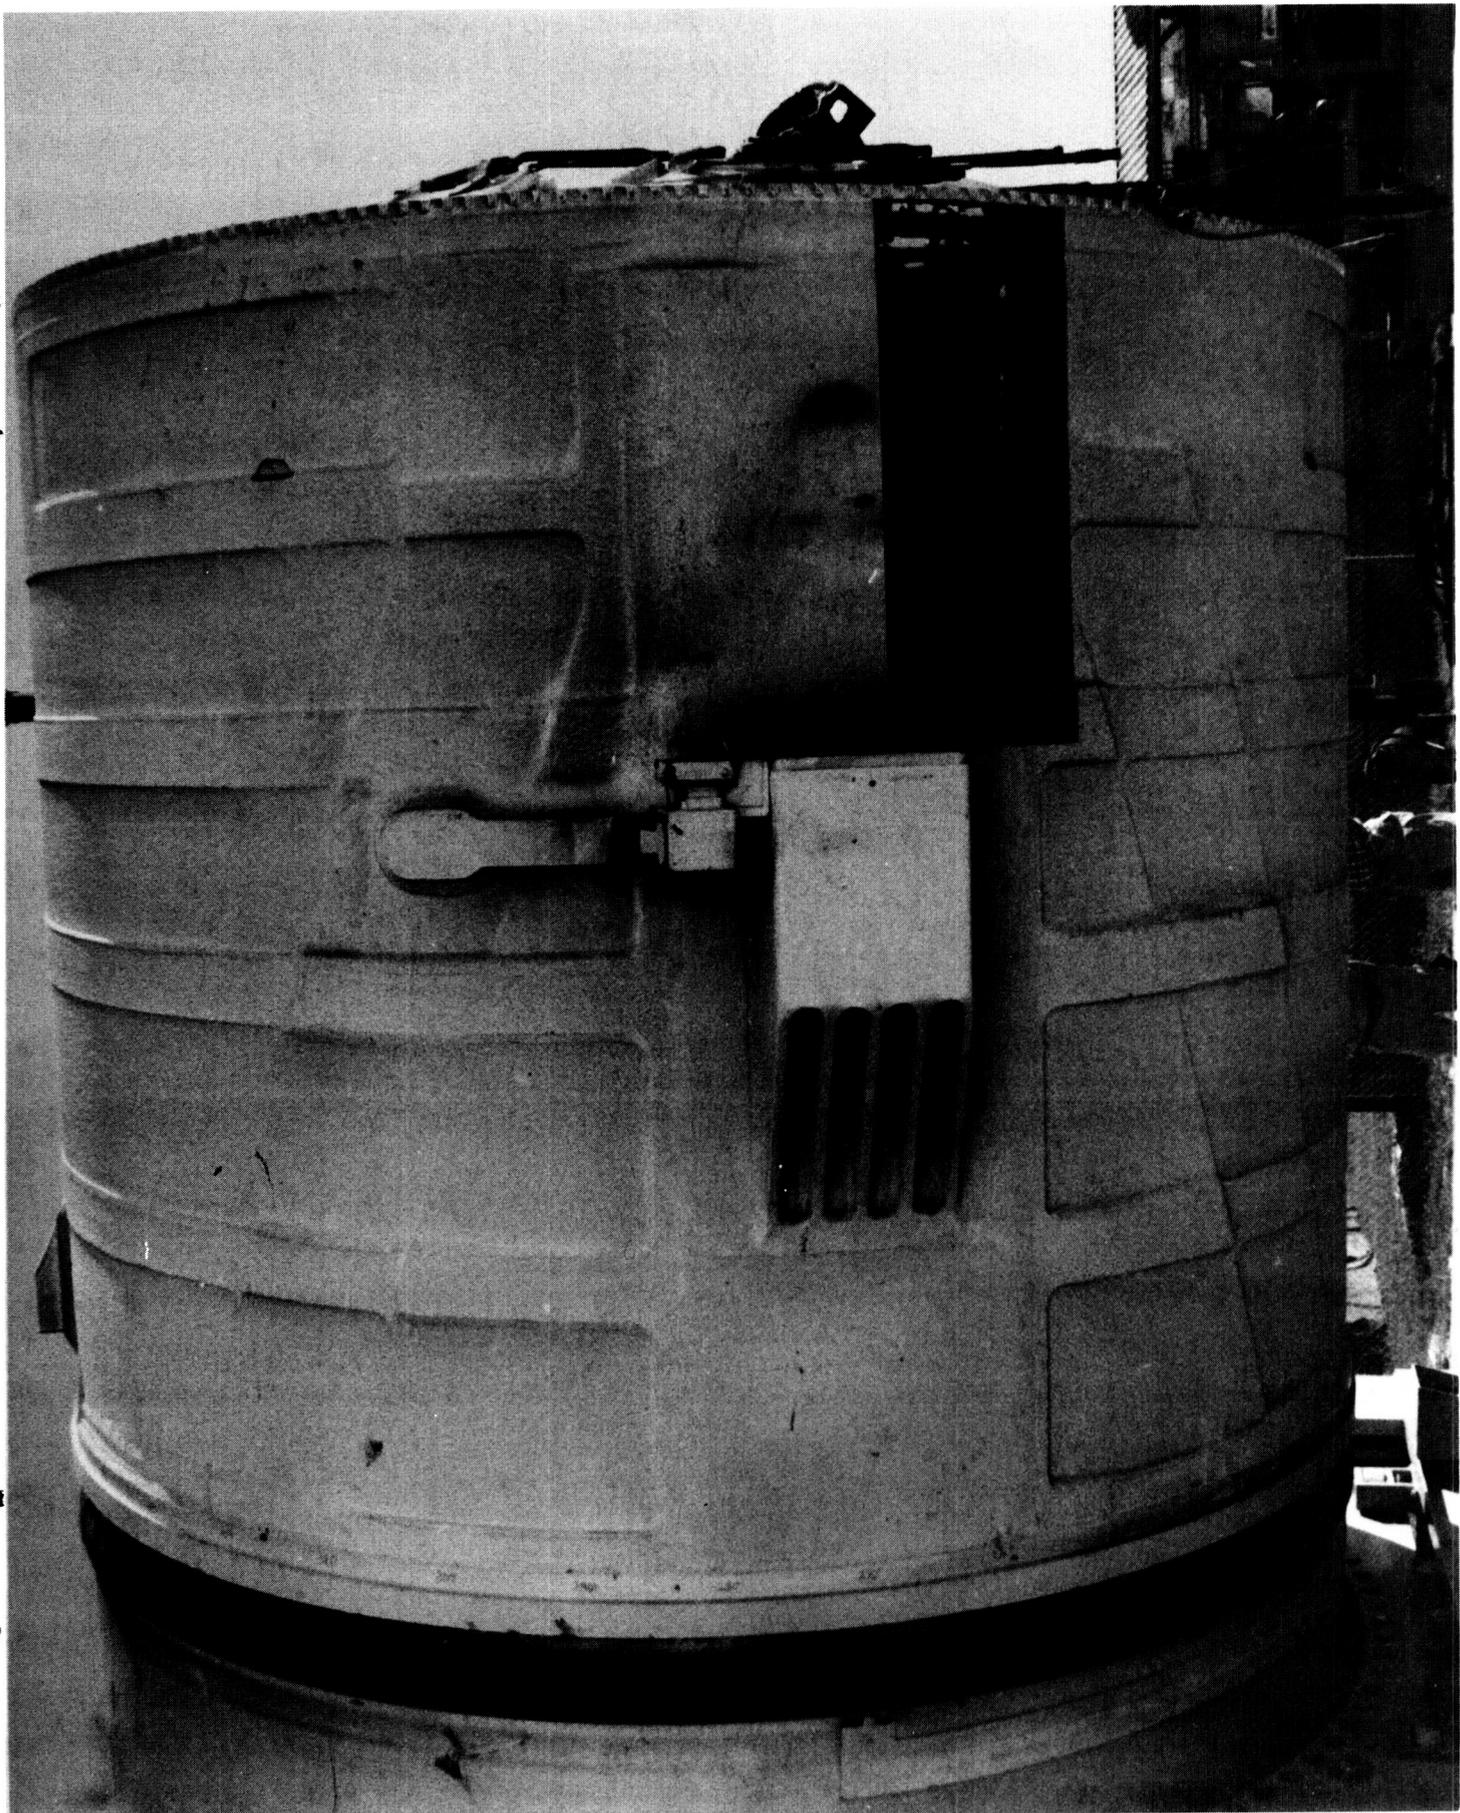
RH SRB FORWARD SKIRT EXHIBITING MINIMAL TPS DAMAGE

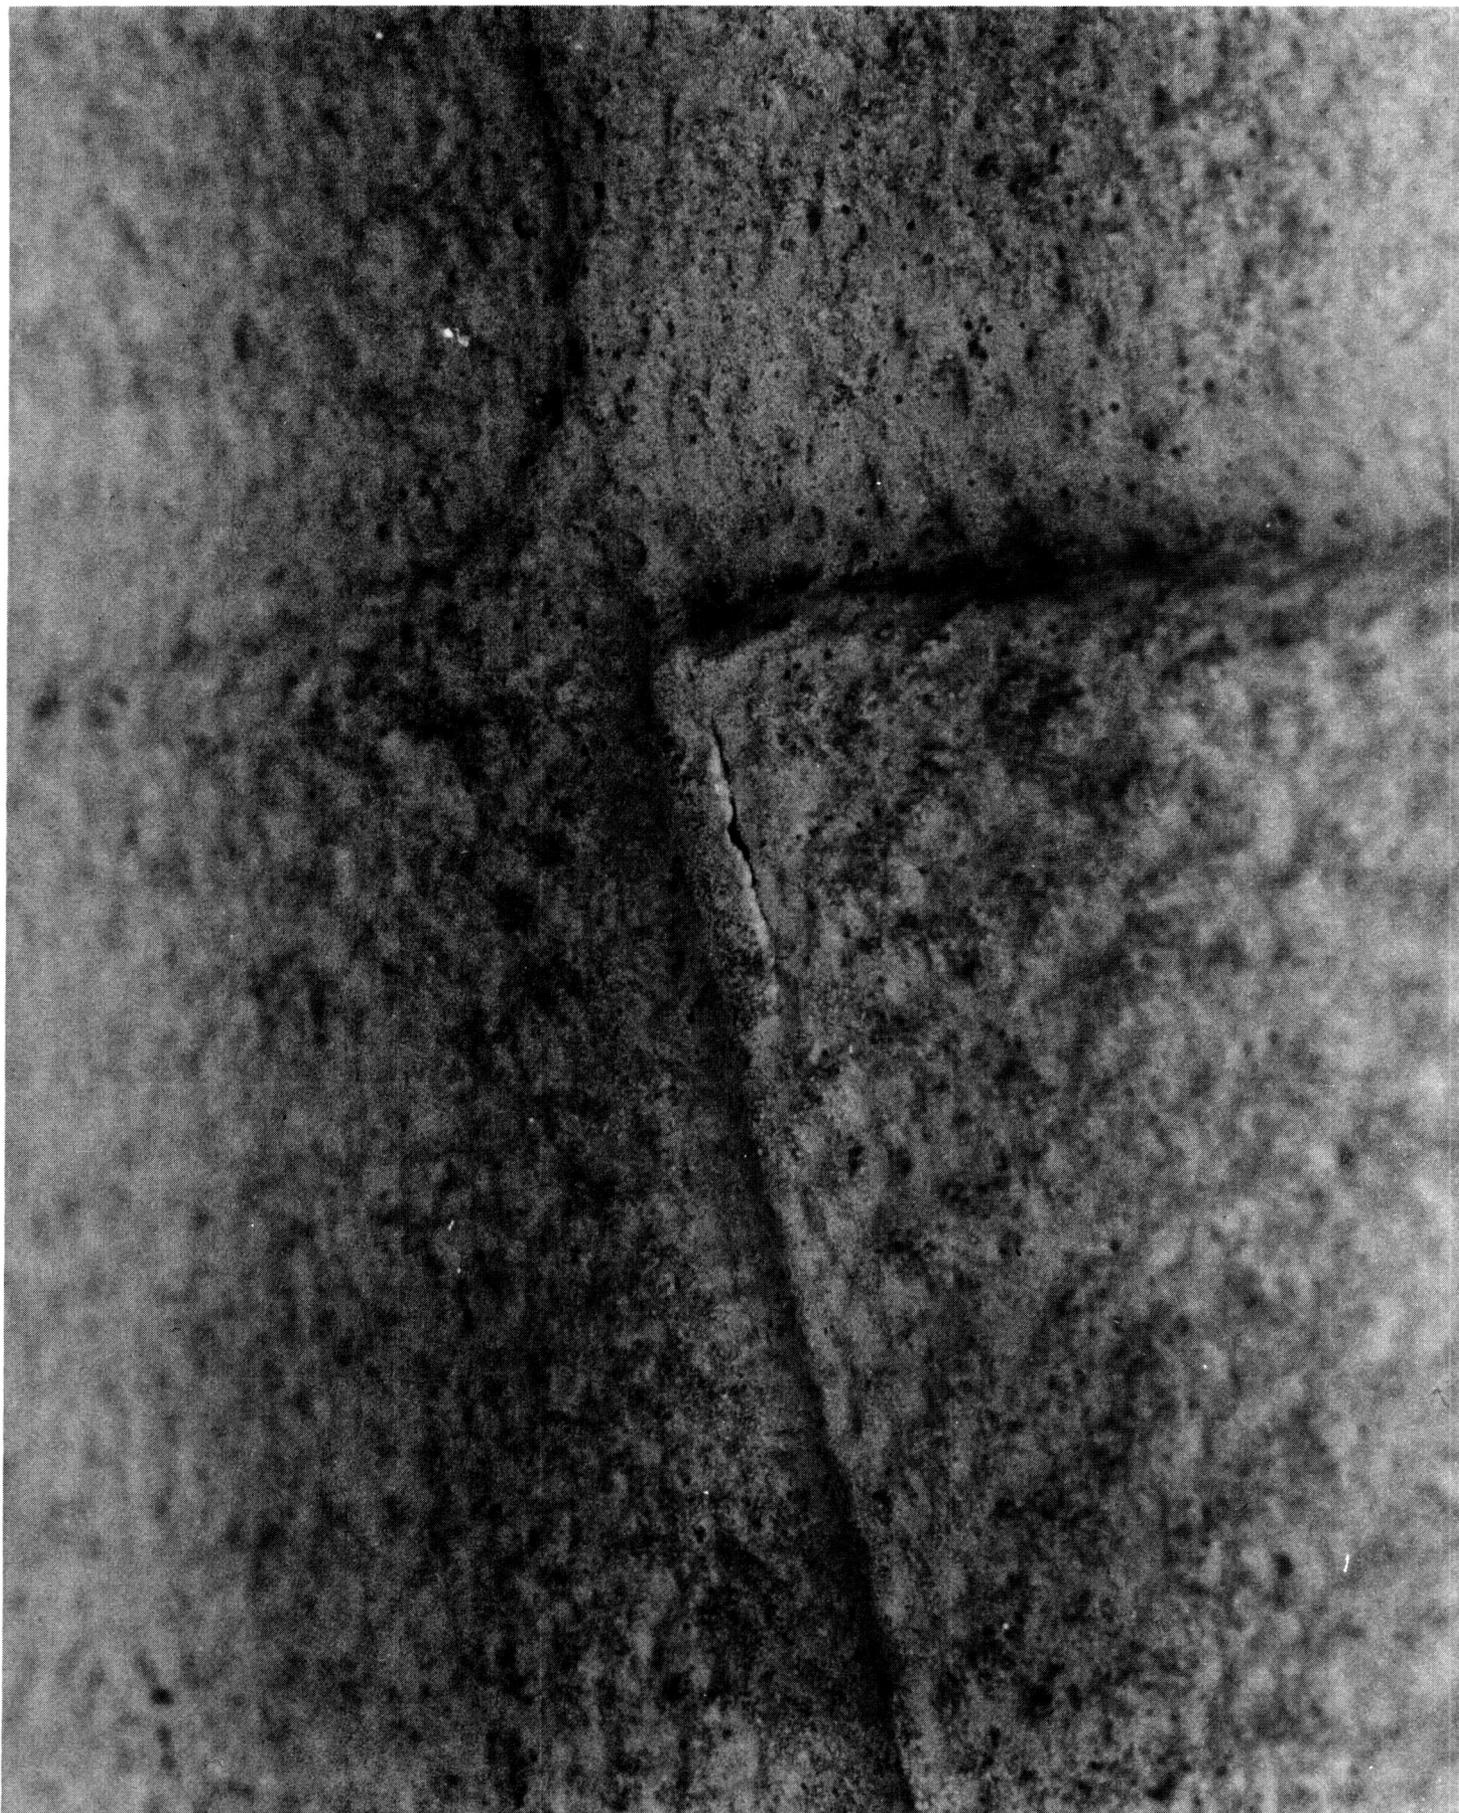
TWO AND ONE HALF INCH CRACK ON RH SRB FORWARD SKIRT ABLATOR

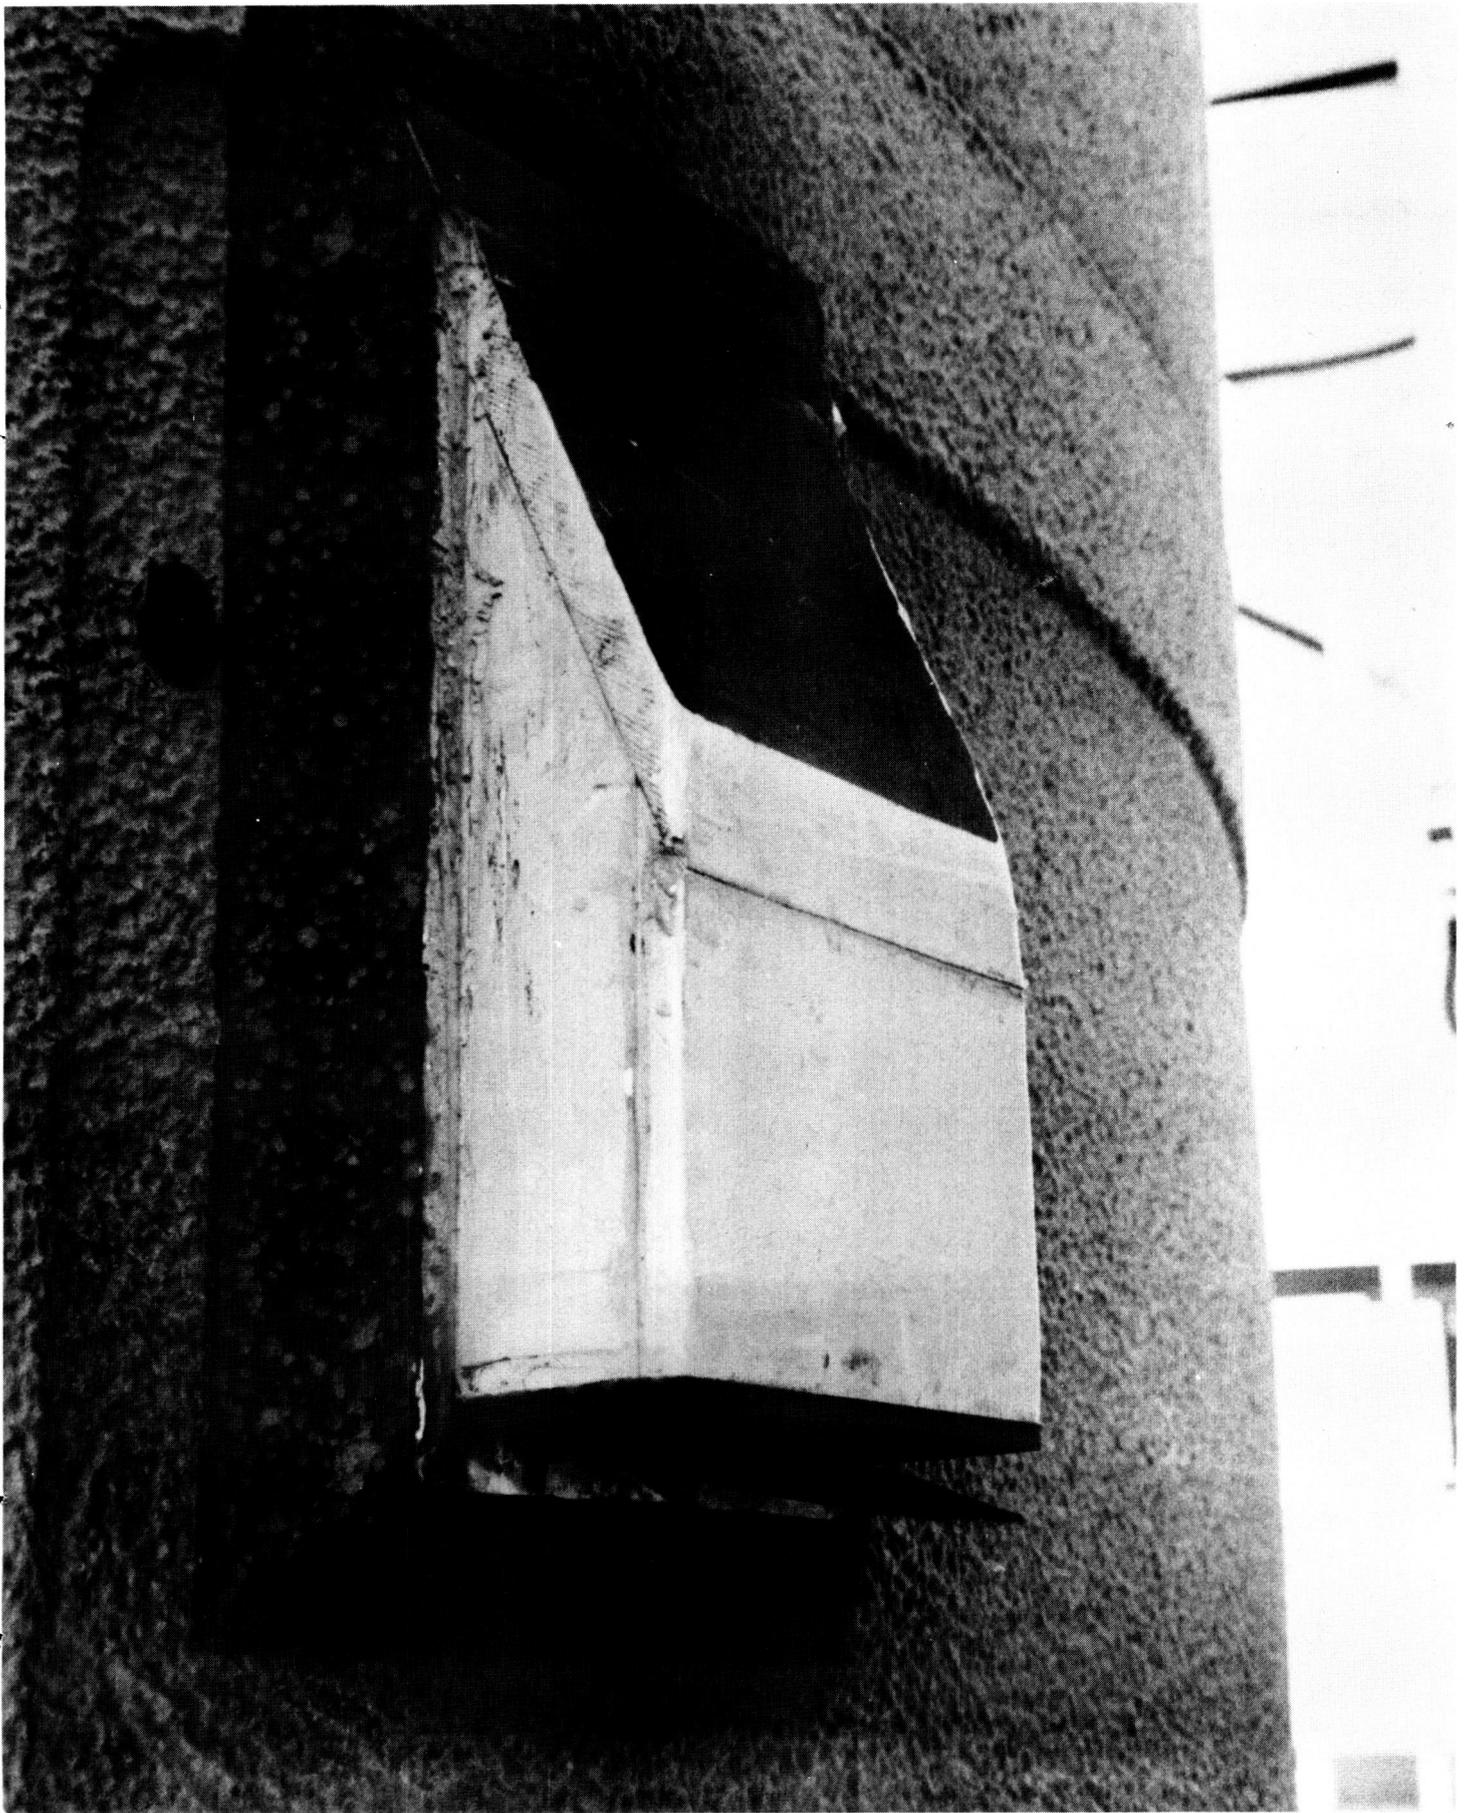
DELAMINATED RSS ANTENNA PHENOLIC PLATE ON LH SRB FORWARD SKIRT

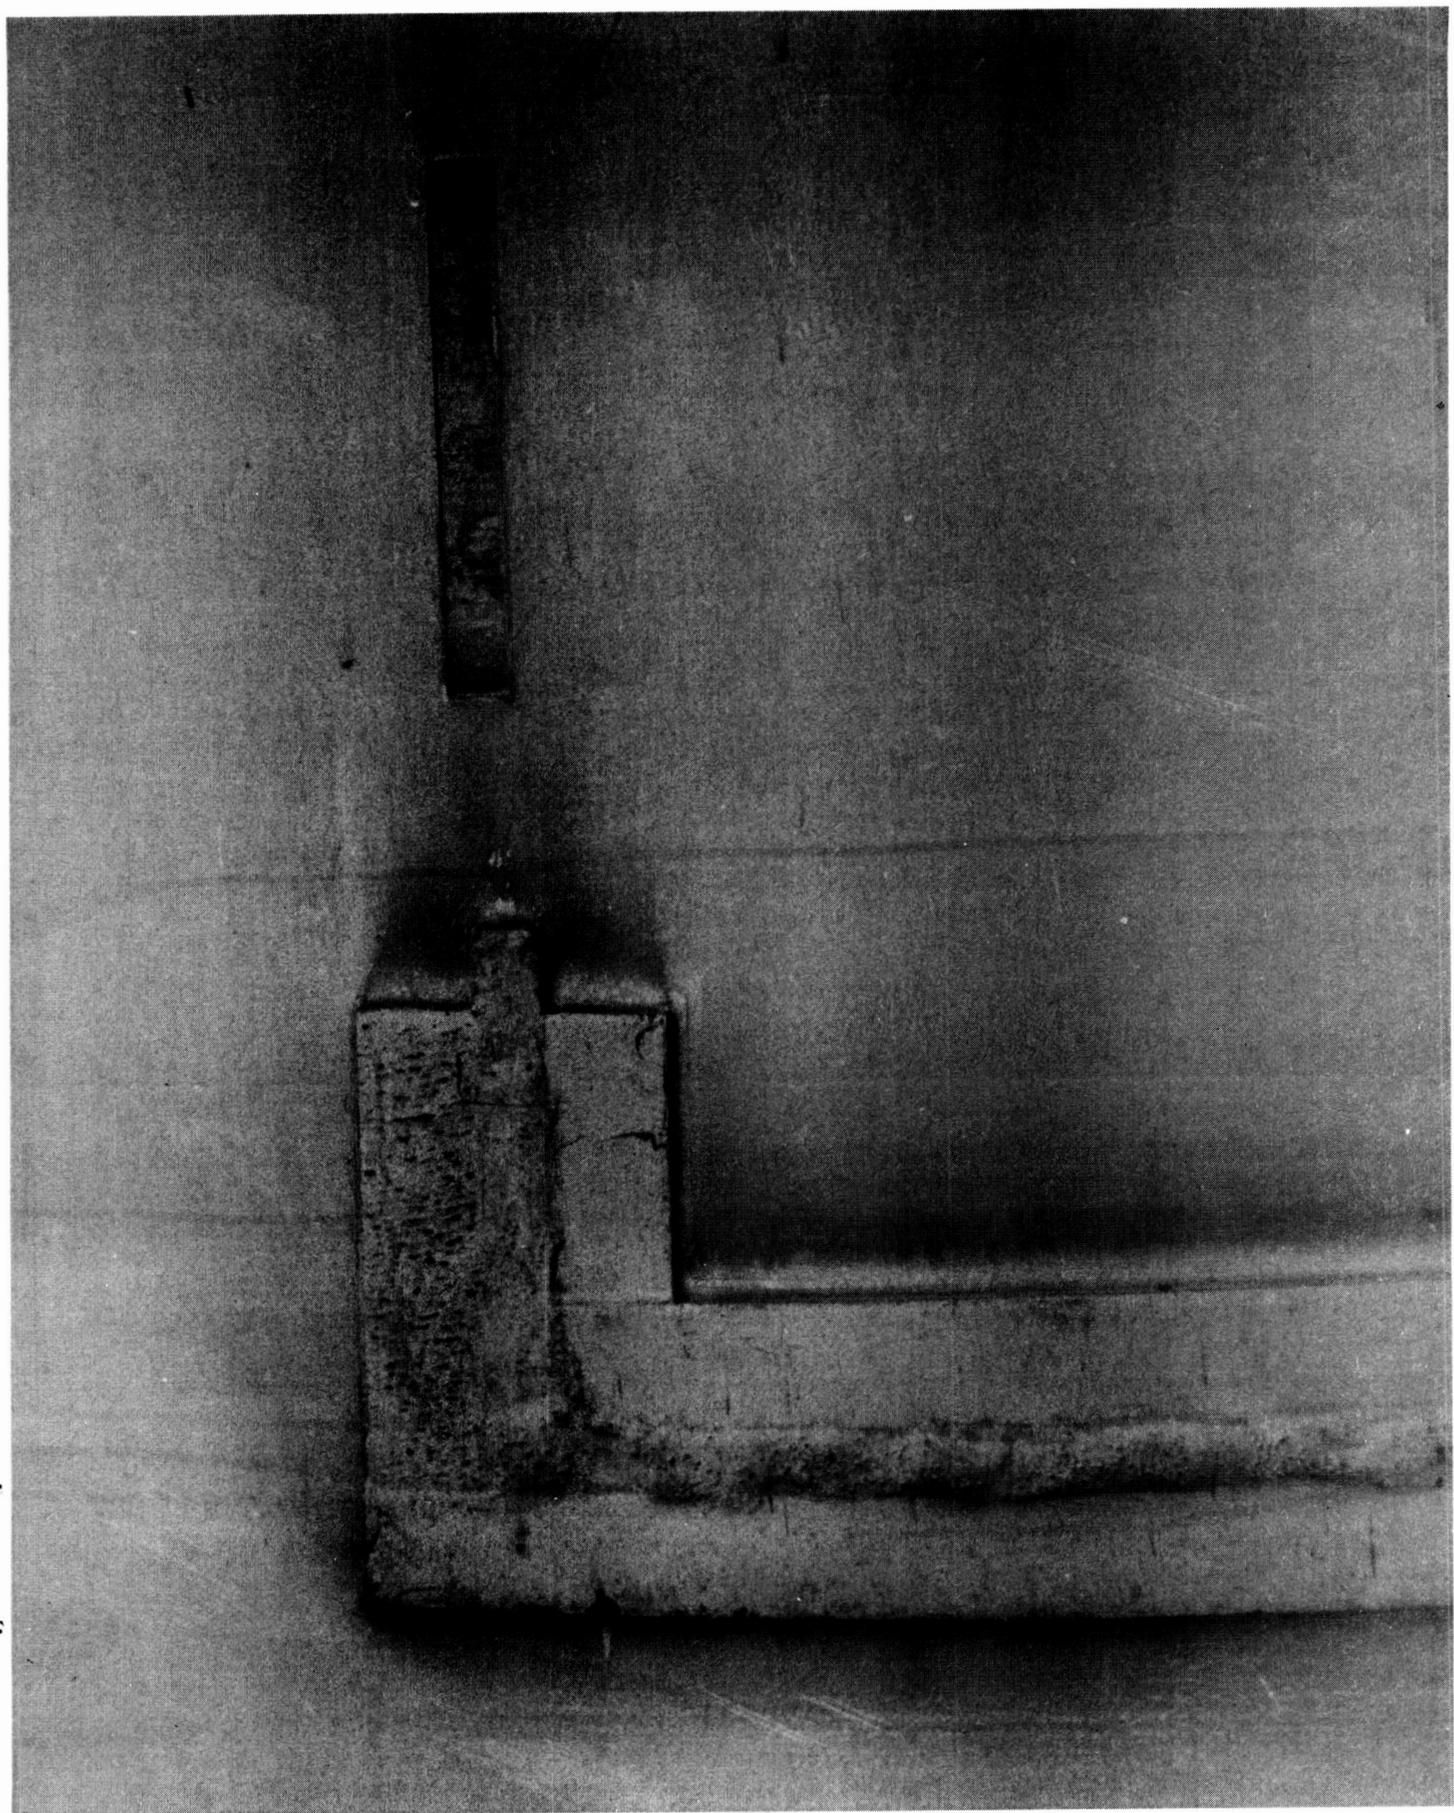
MISSING (TYPICAL) EPOXY COVERED GEI ID LABEL FROM SRB CASE

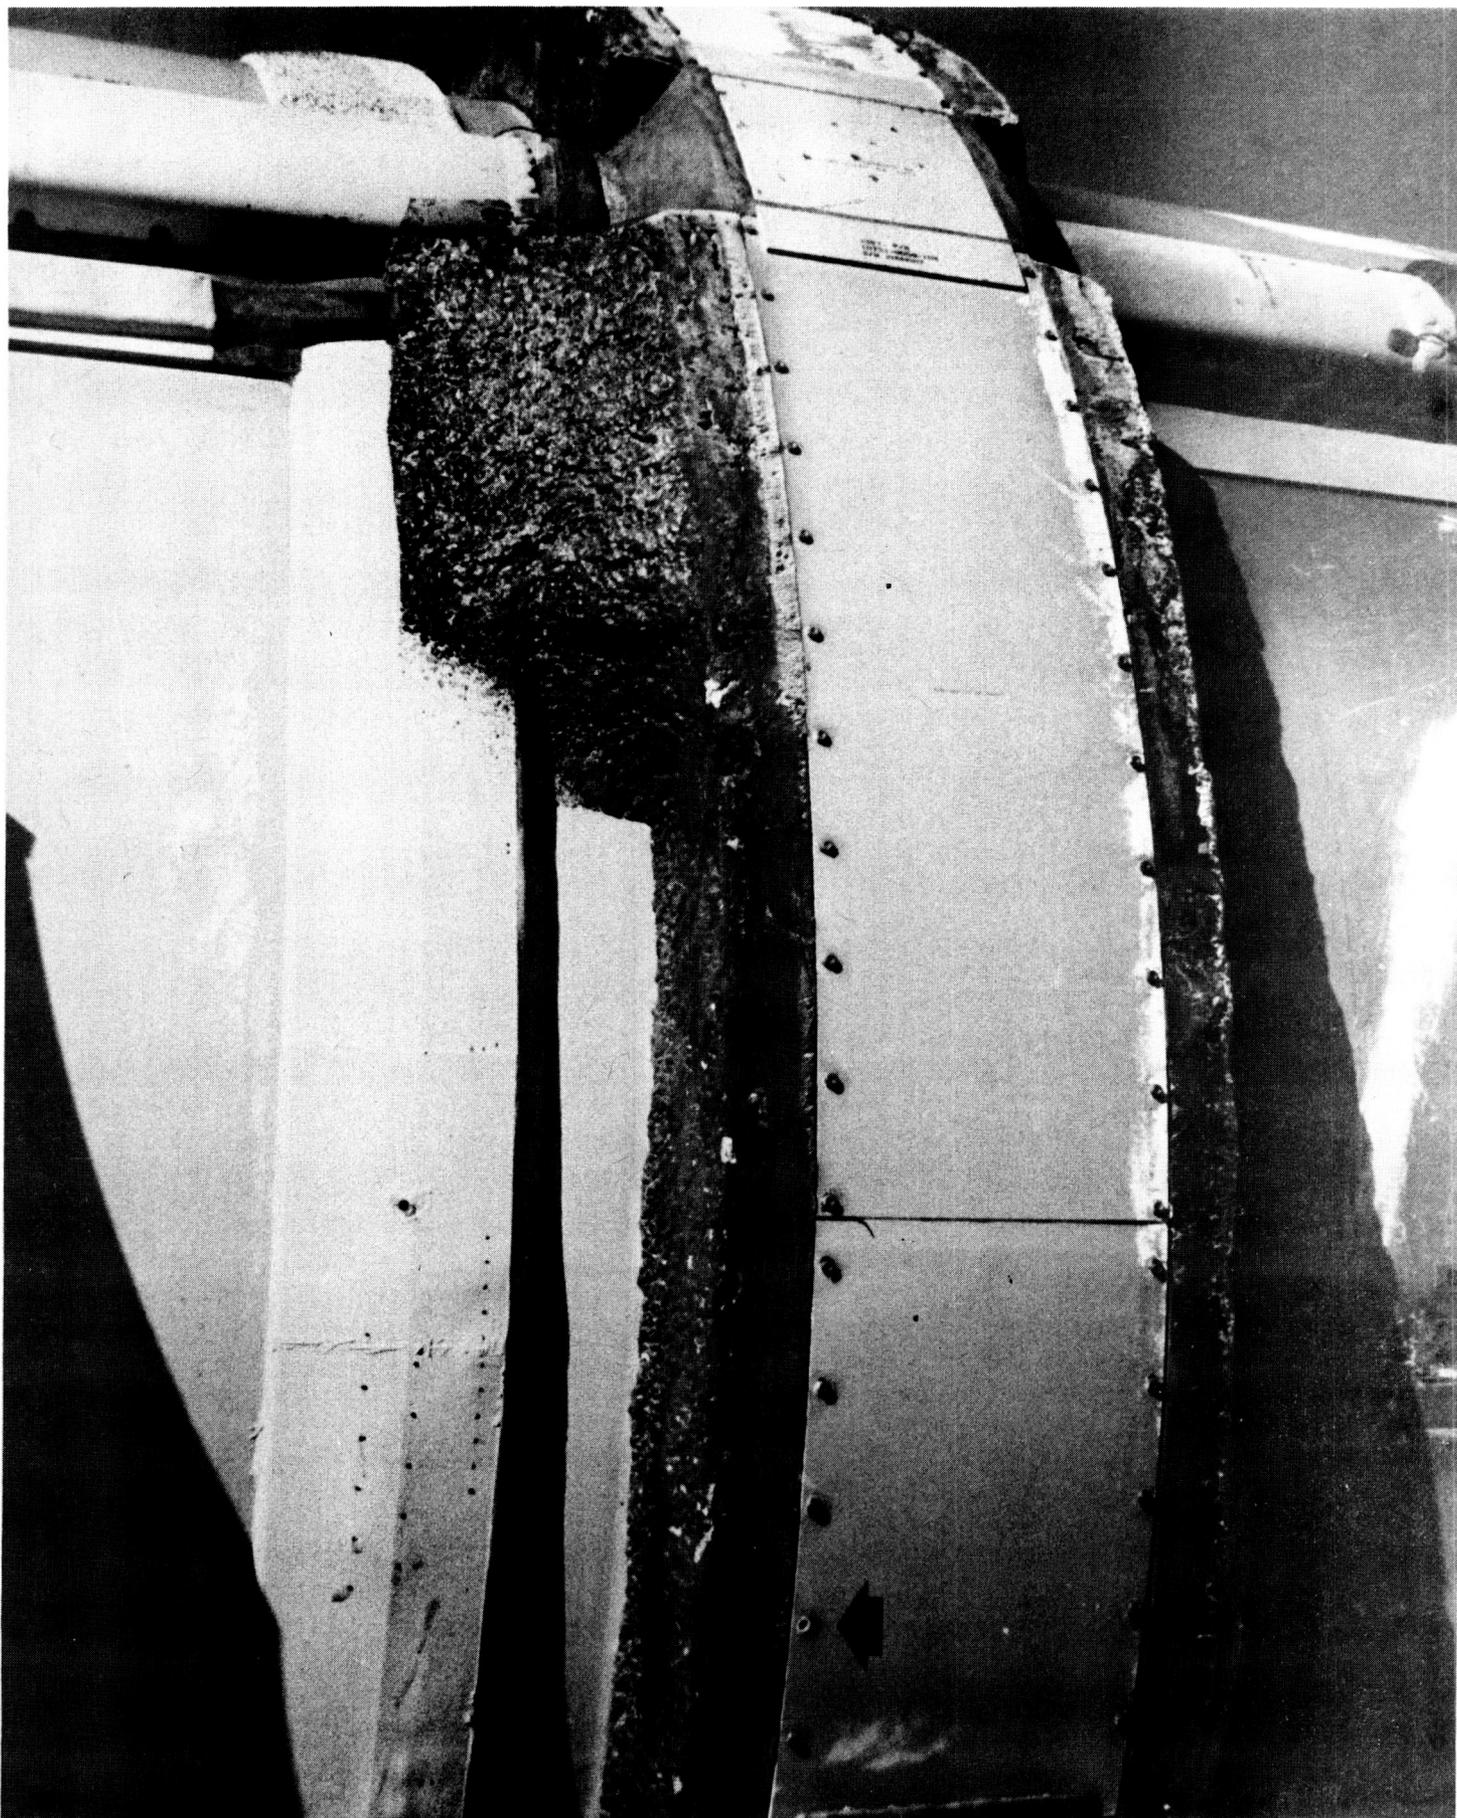
MISSING BOLT FROM ETA RING COVER

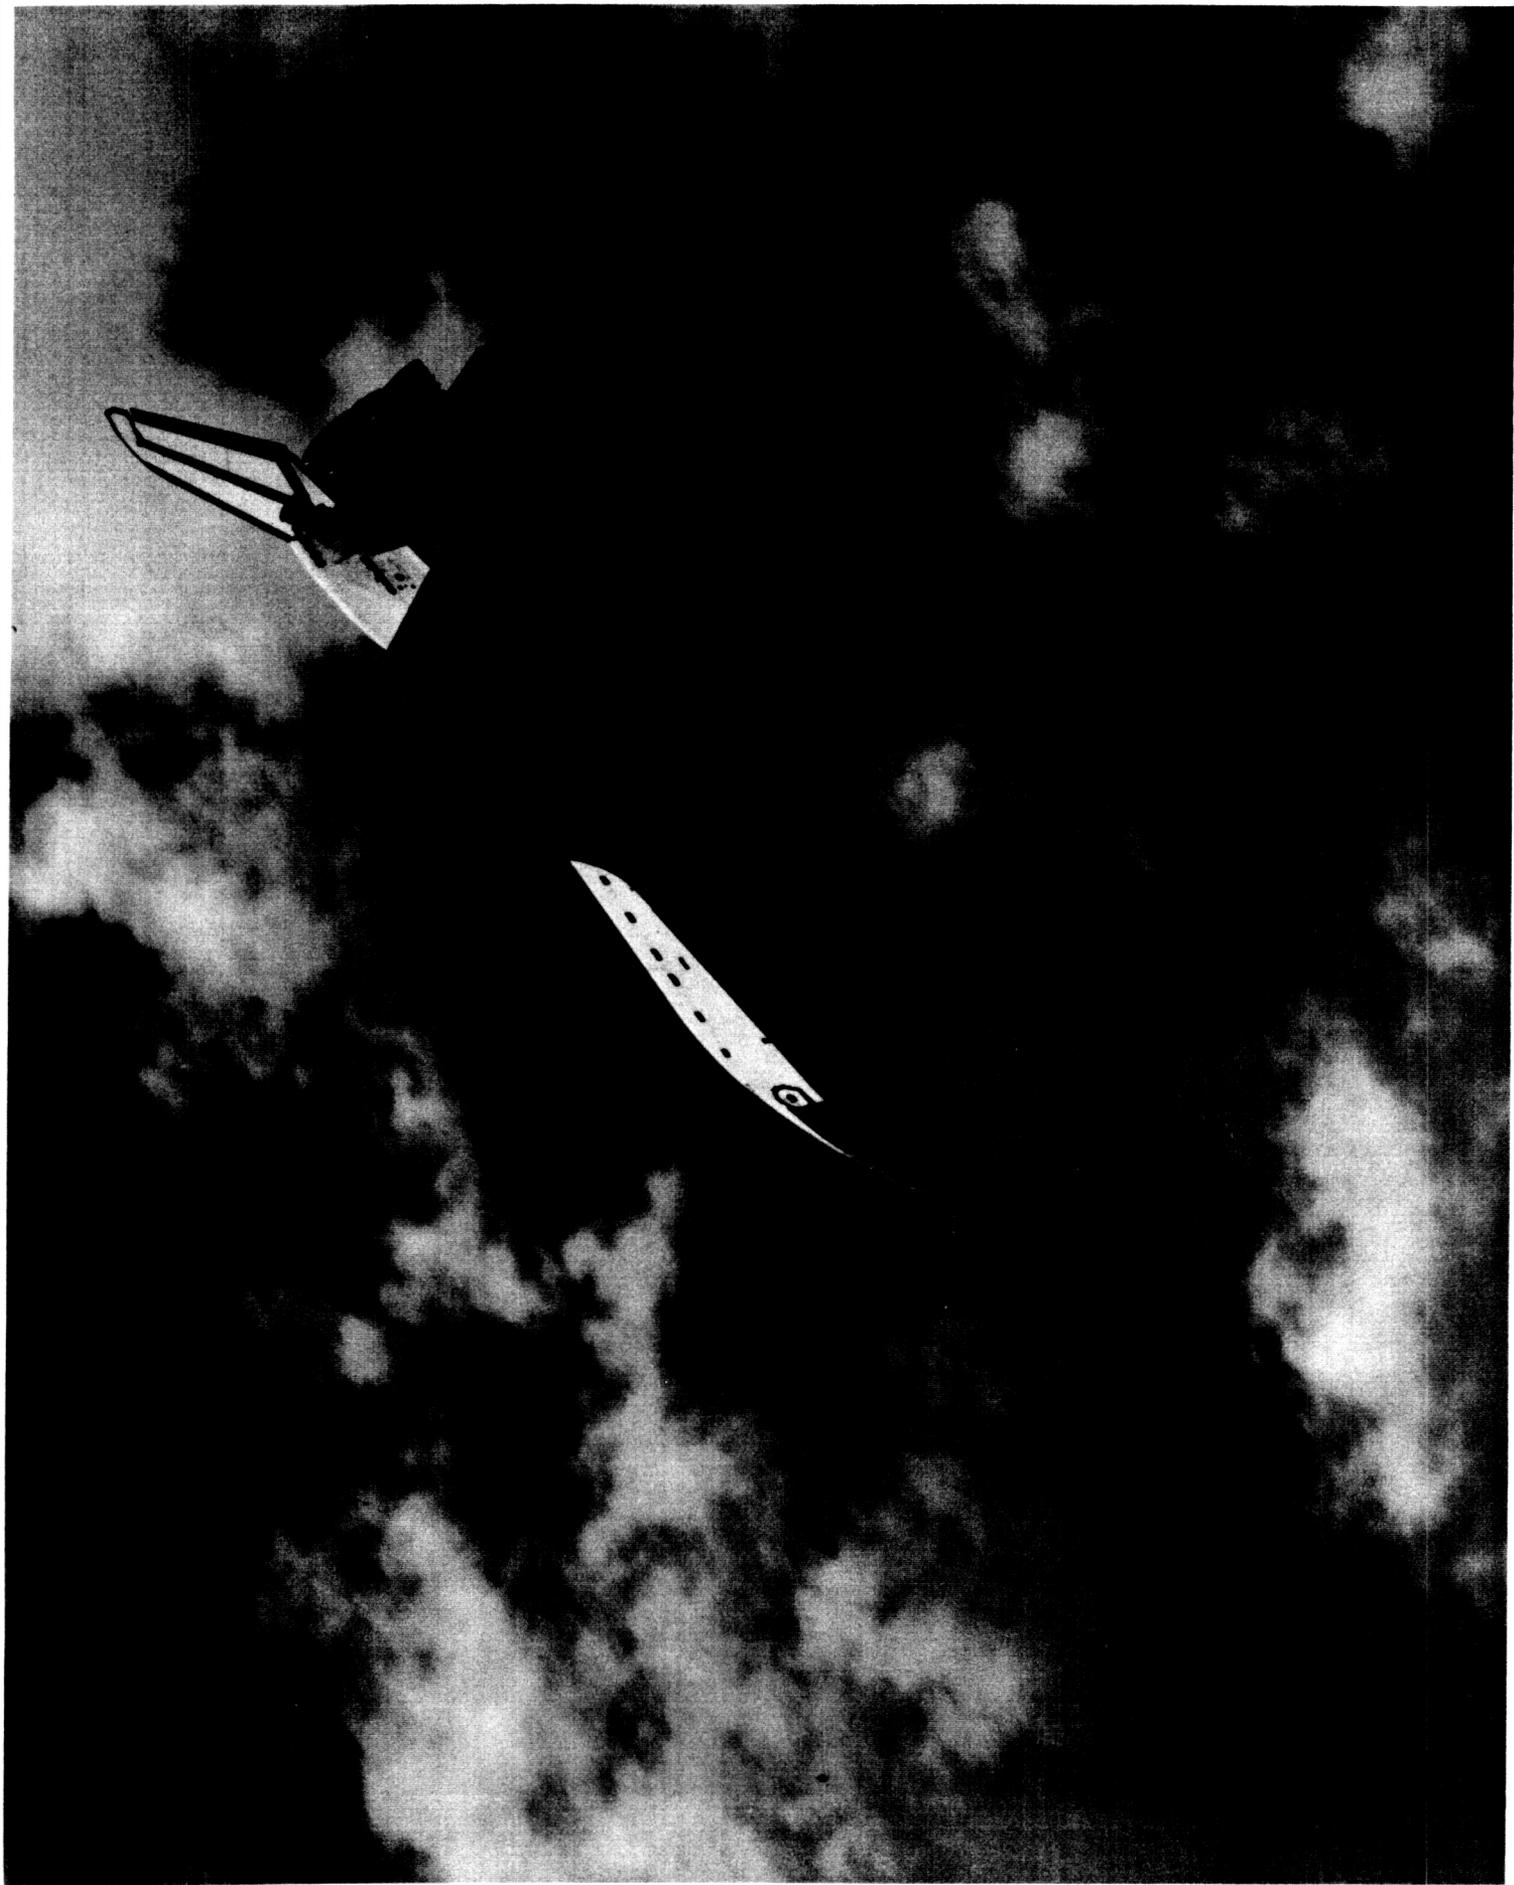
MINIMAL ORBITER TILE DAMAGE VISIBLE PRIOR TO LANDING

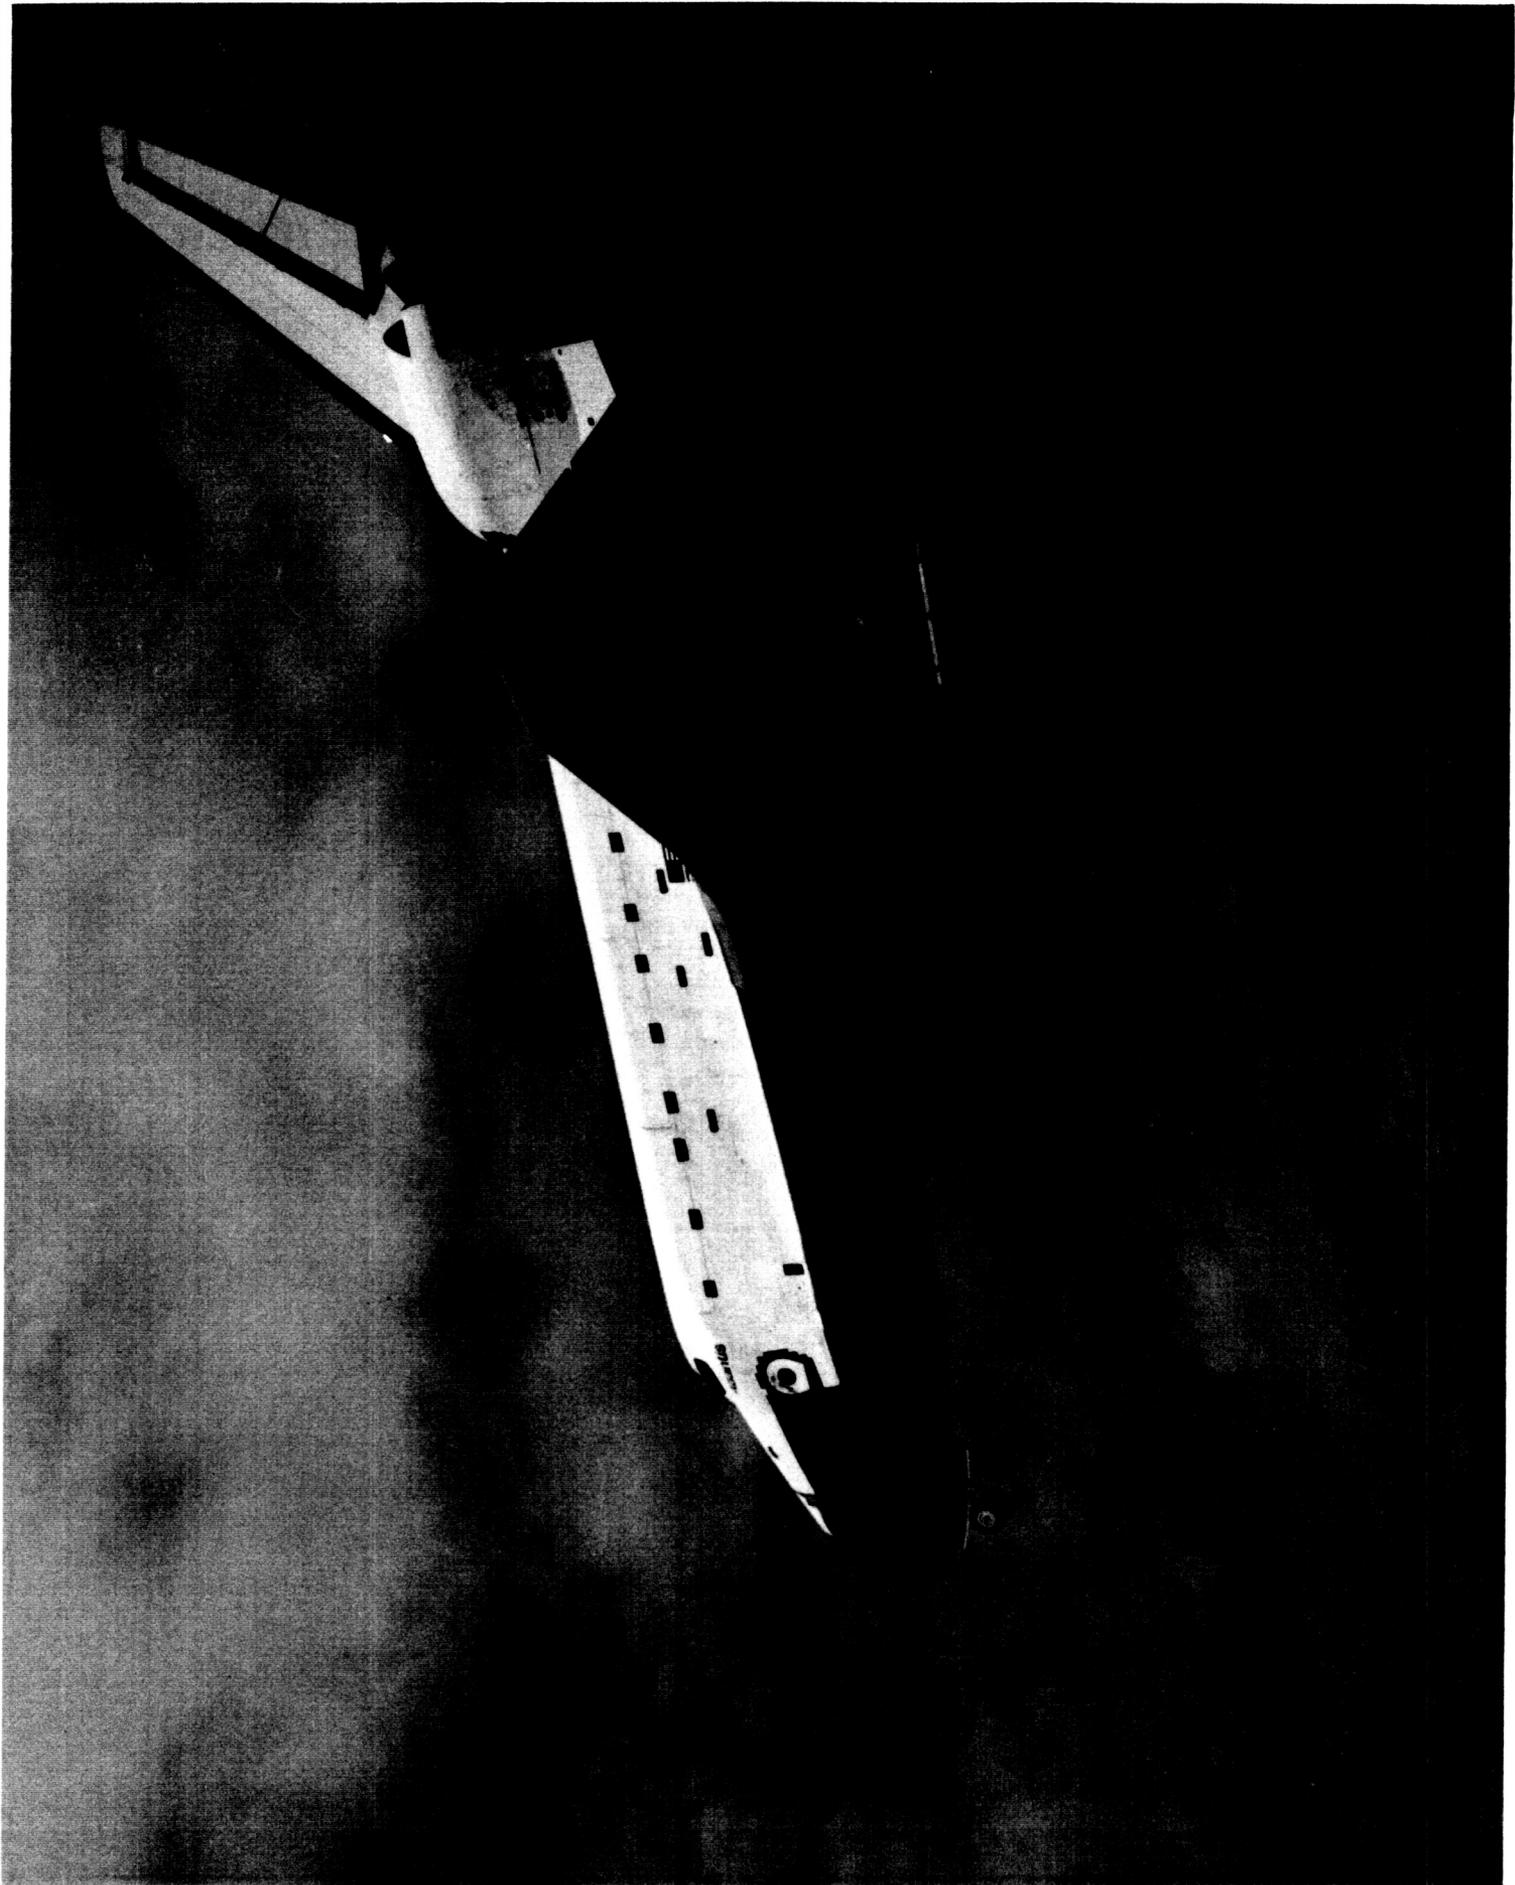
NO LANDING GEAR DOOR CORNER TILE PIECES LOST
