KSC Ice/Frost/Debris Assessment For Space Shuttle Mission STS-30R

May 1989

KSC
ICE/FROST/DEBRIS ASSESSMENT
FOR
SPACE SHUTTLE MISSION
STS-30R
MAY 4, 1989

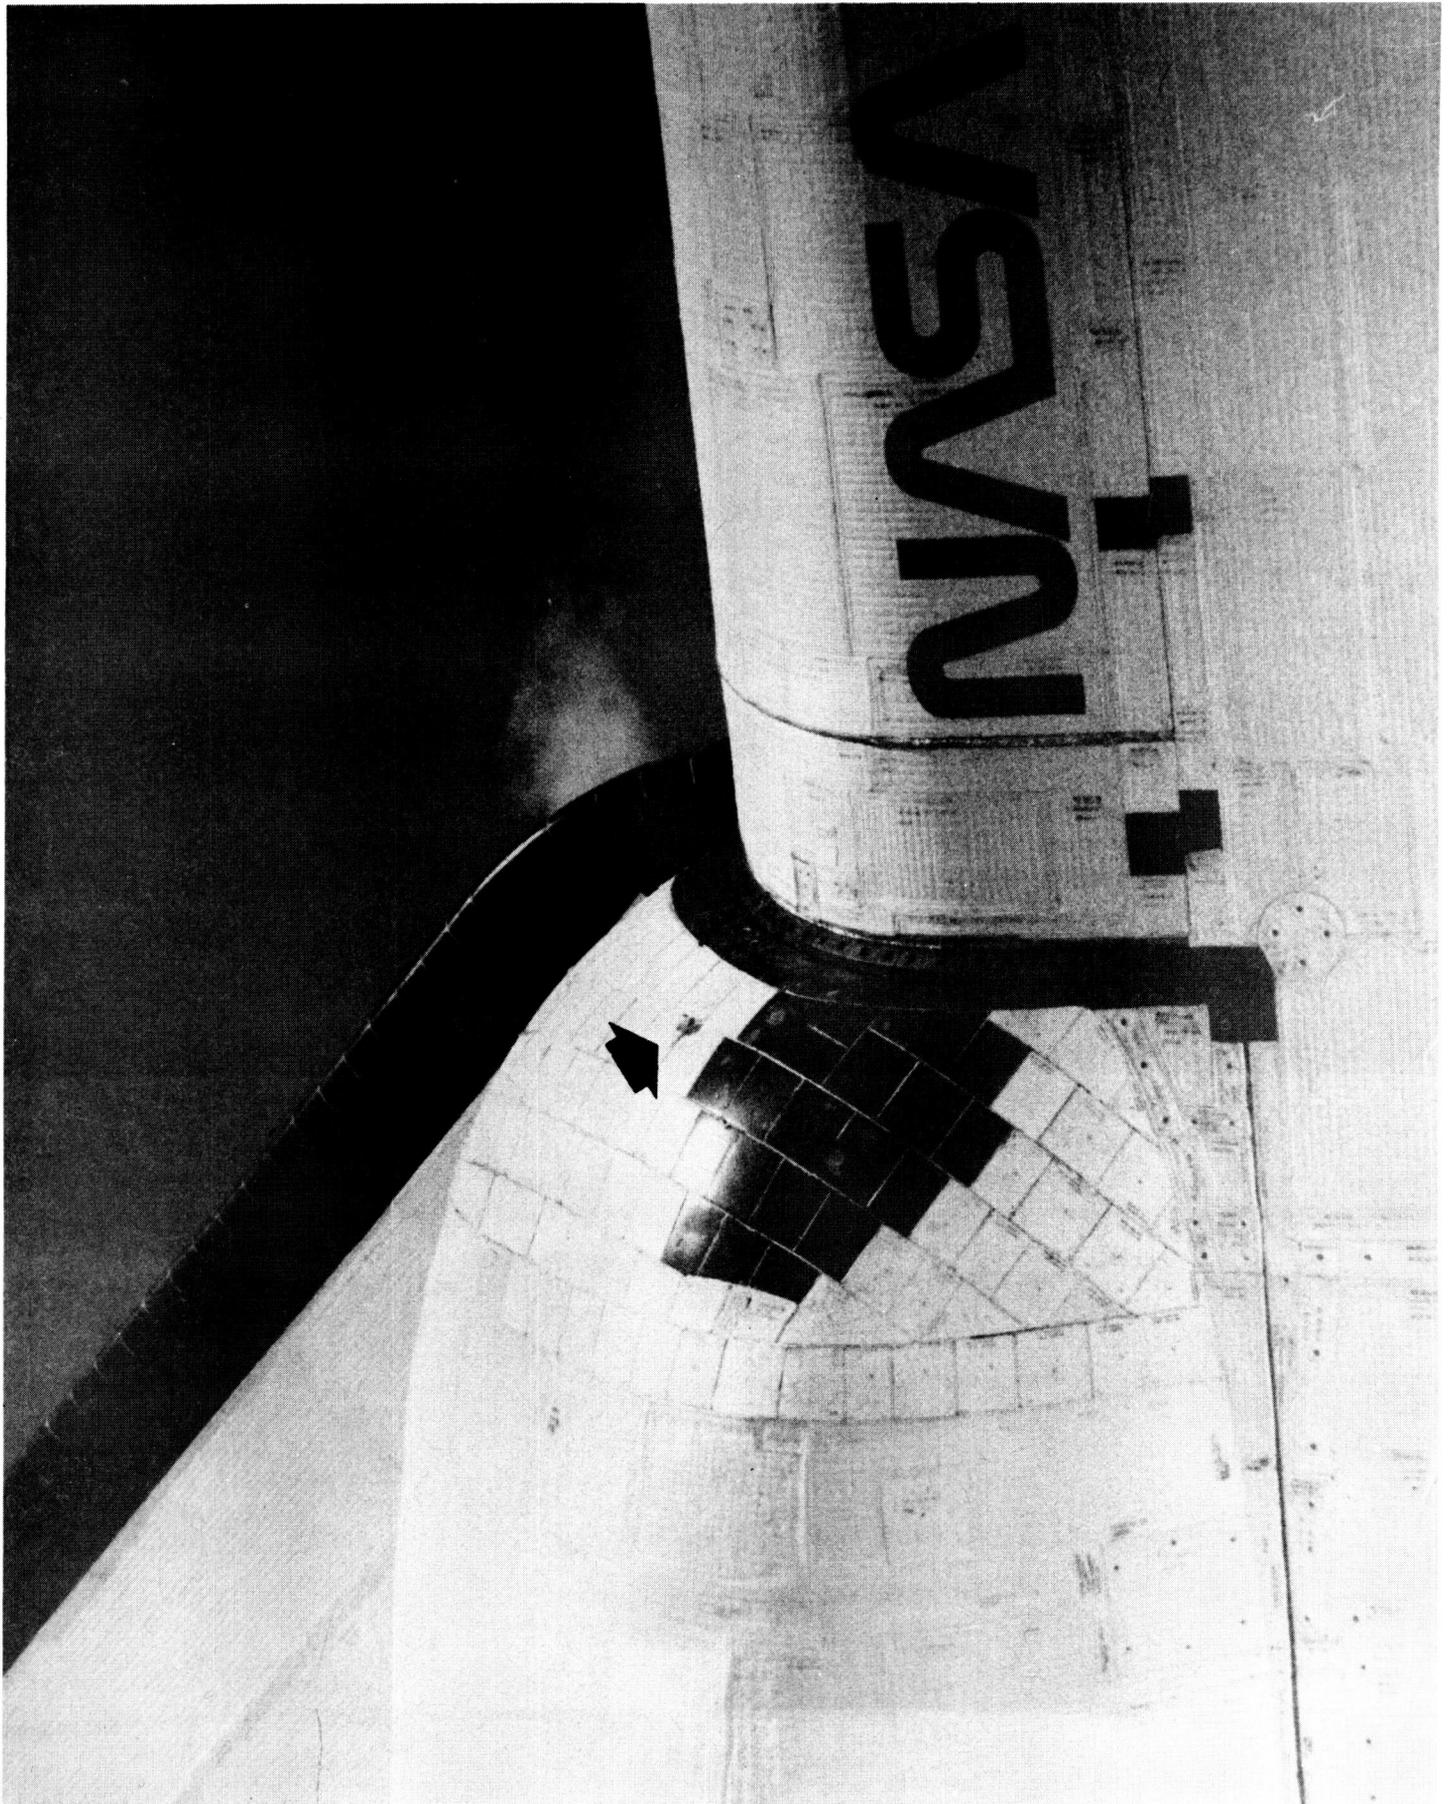
Loose sleeving material on the forward area of the RH OMS pod caused damage to one white tile.

LOOSE SLEEVING MATERIAL ON THE FORWARD
AREA OF THE RH OMS' POD DAMAGED ONE TILE

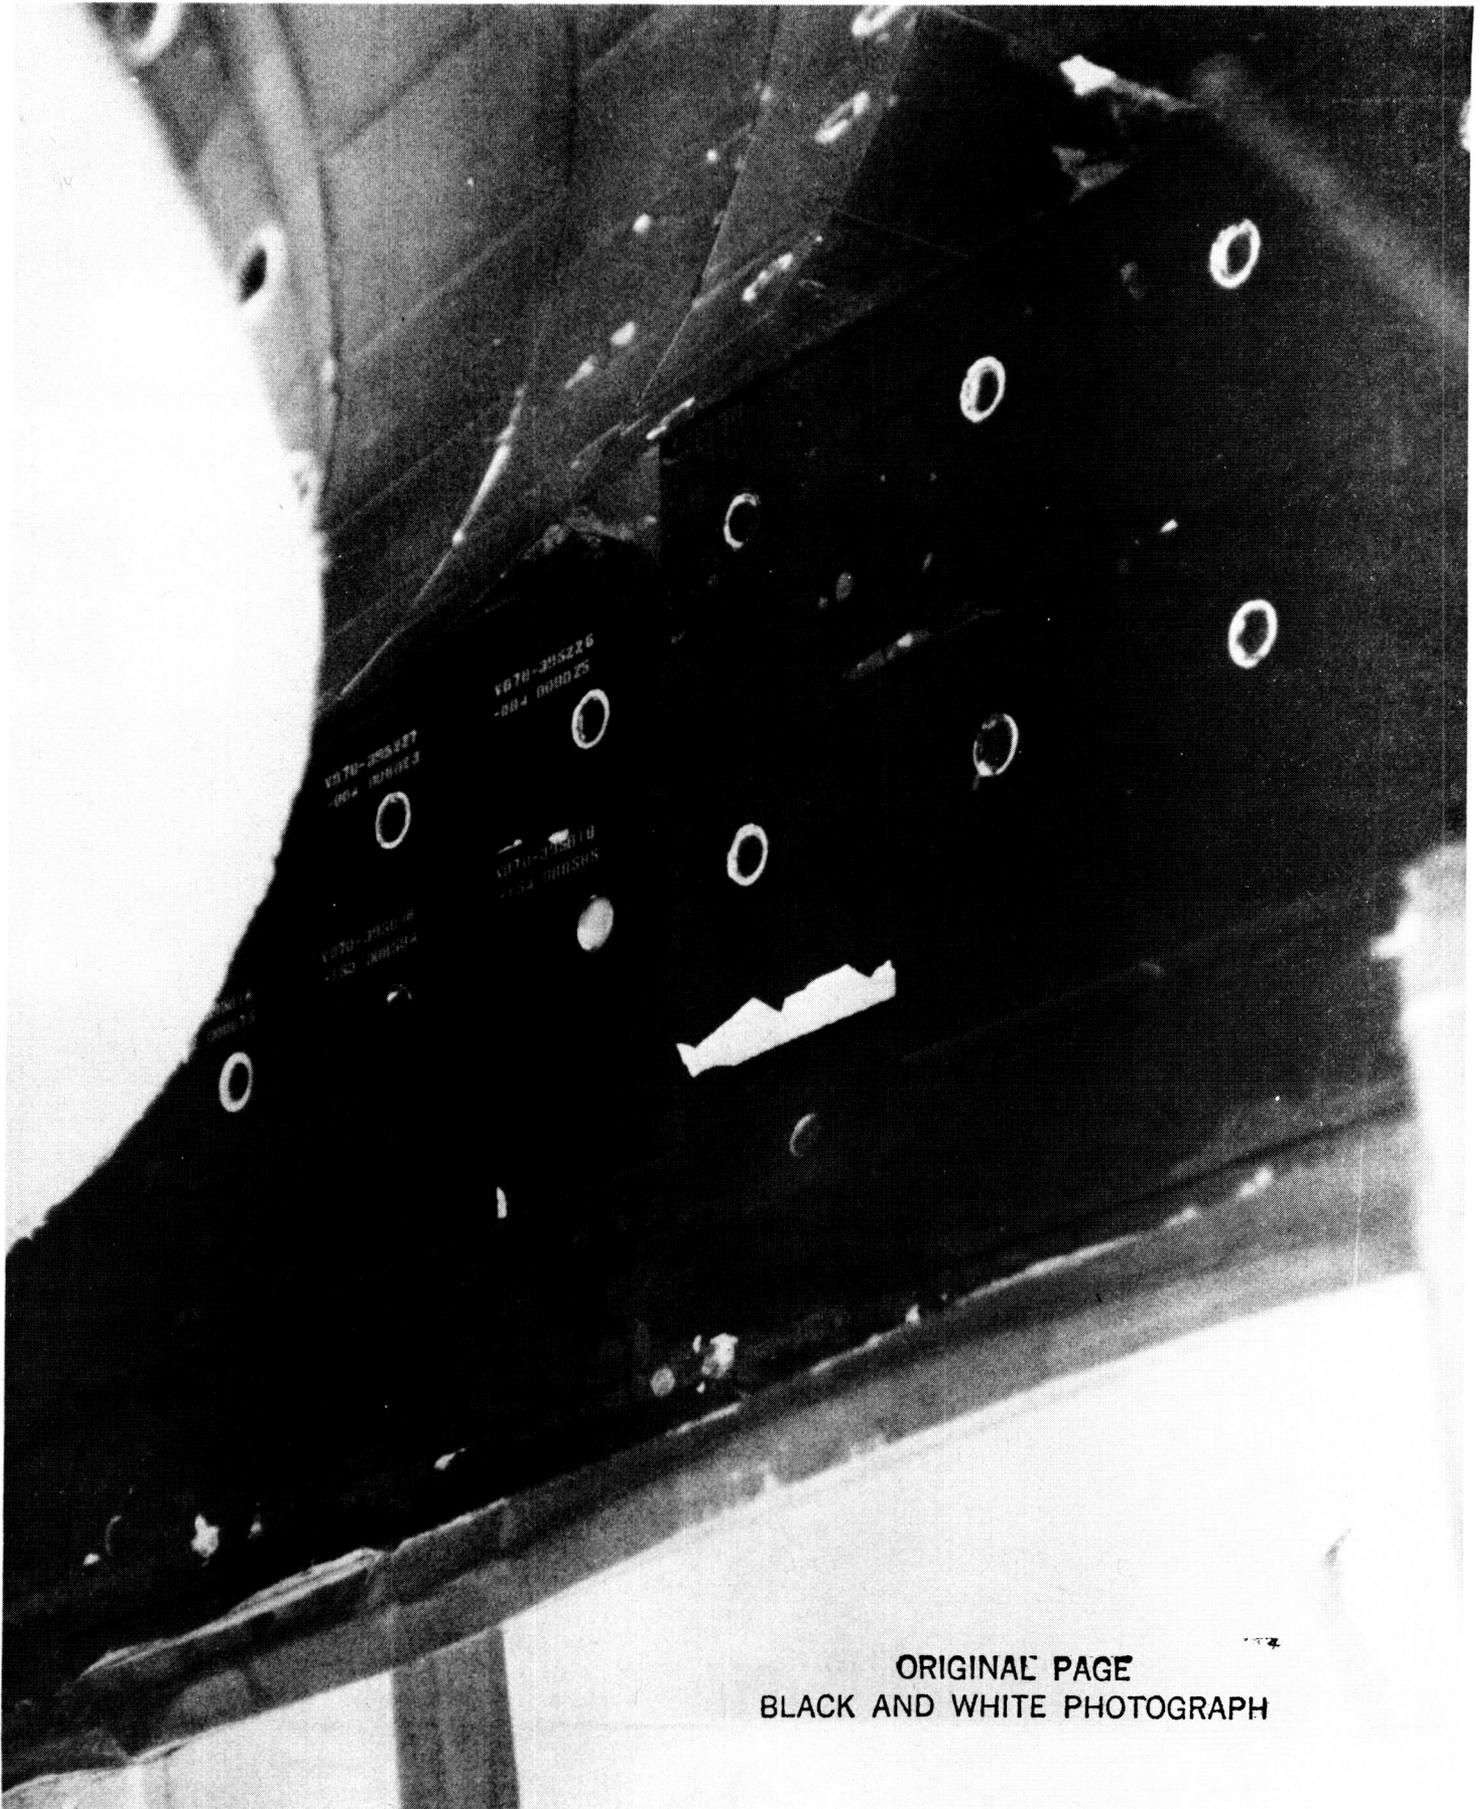
MISSING TILE PIECE FROM THE UPPER SURFACE OF THE BODY
FLAP HINGE AREA THAT WAS OBSERVED IN LAUNCH FILMS

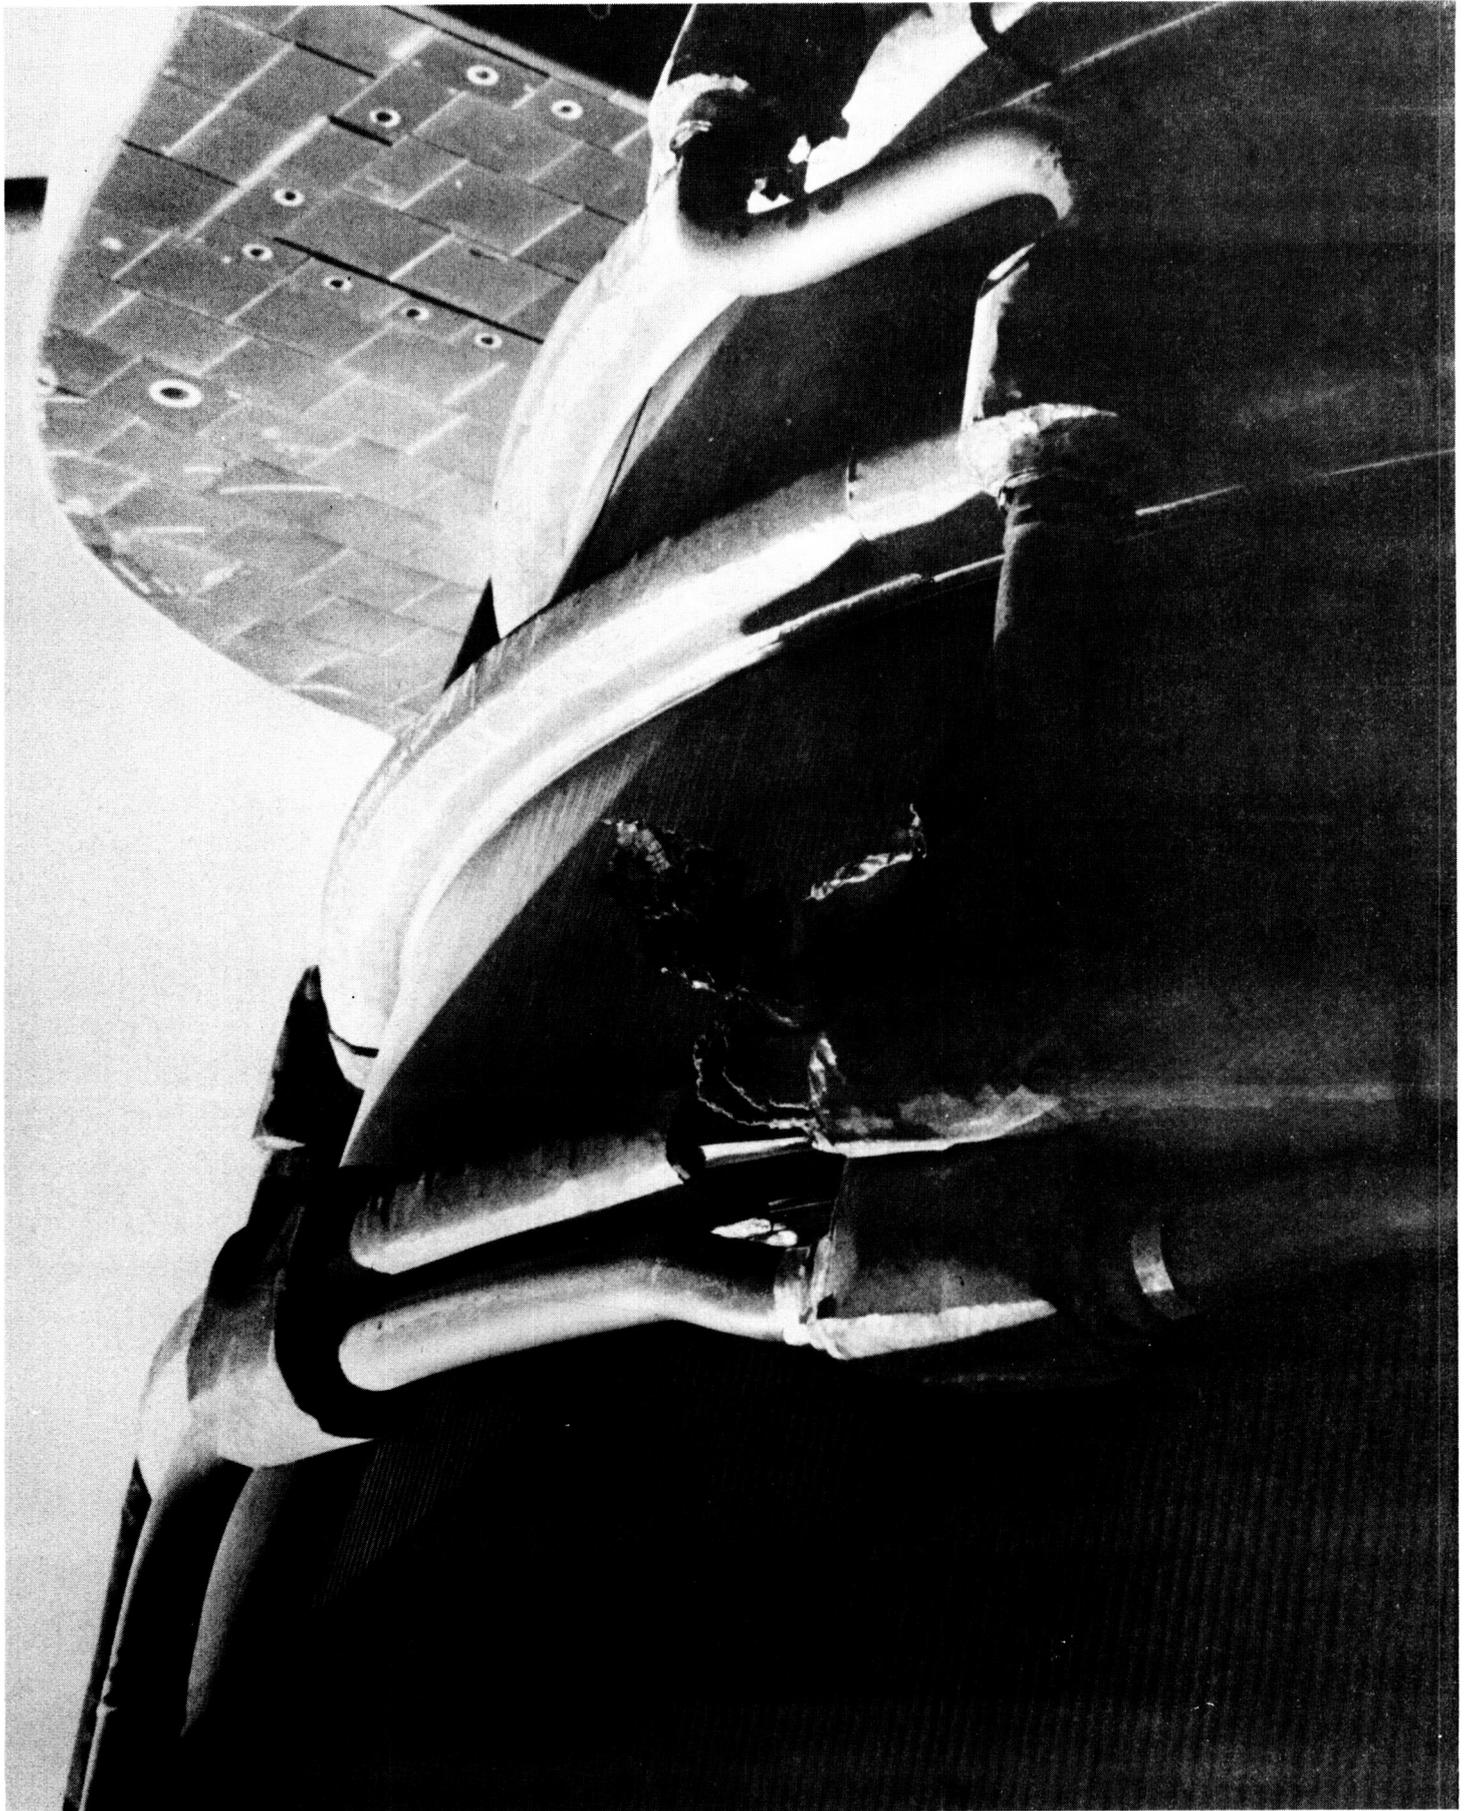
DAMAGED AND LOOSE THERMAL BLANKET ON SSME #1 NOZZLE

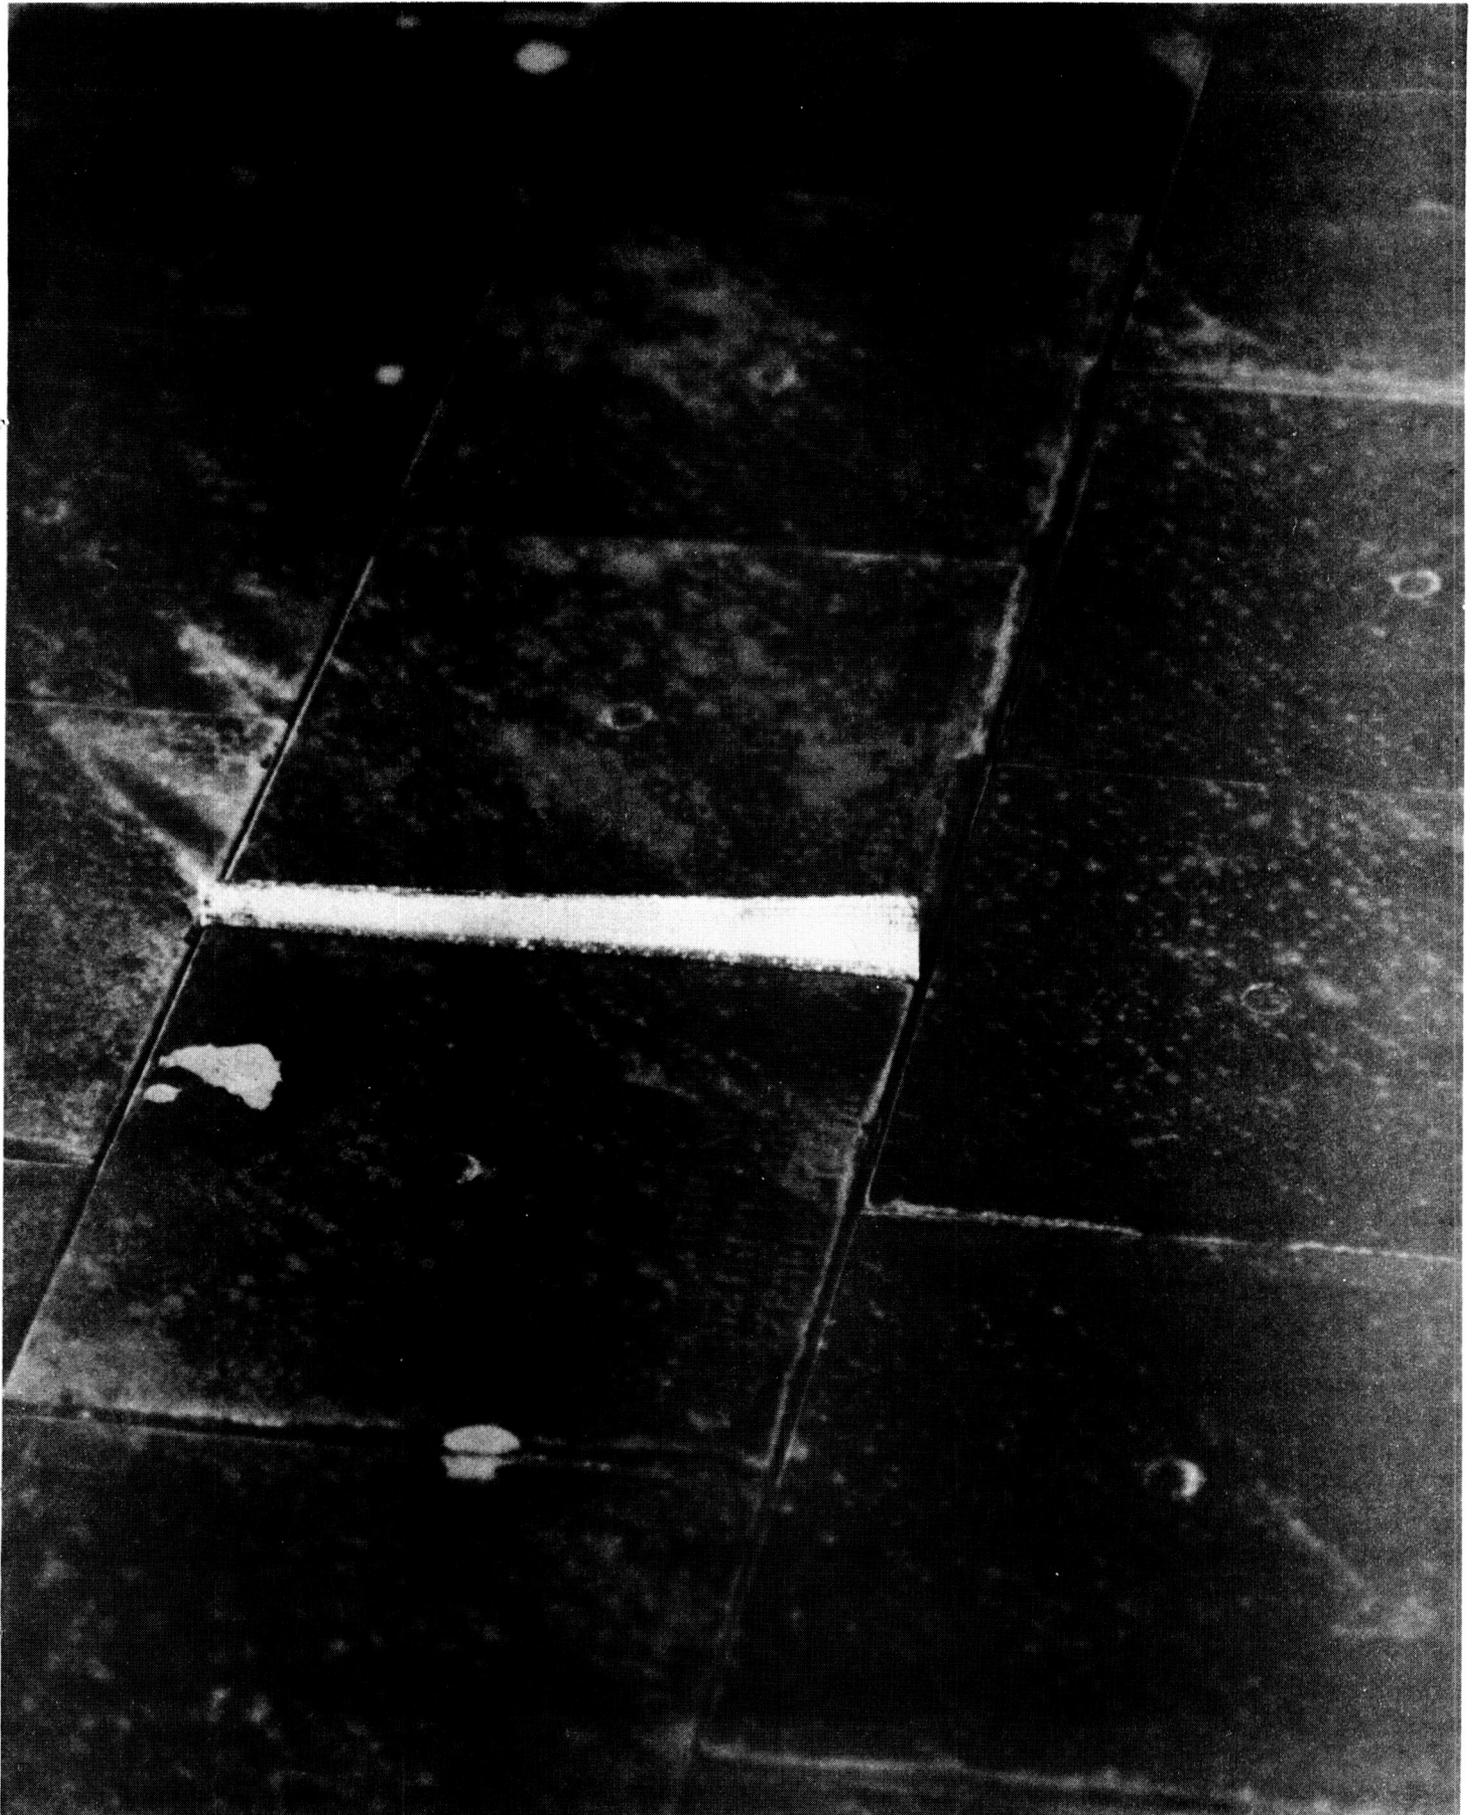
LOOSE AND PROTRUDING TILE GAP FILLER

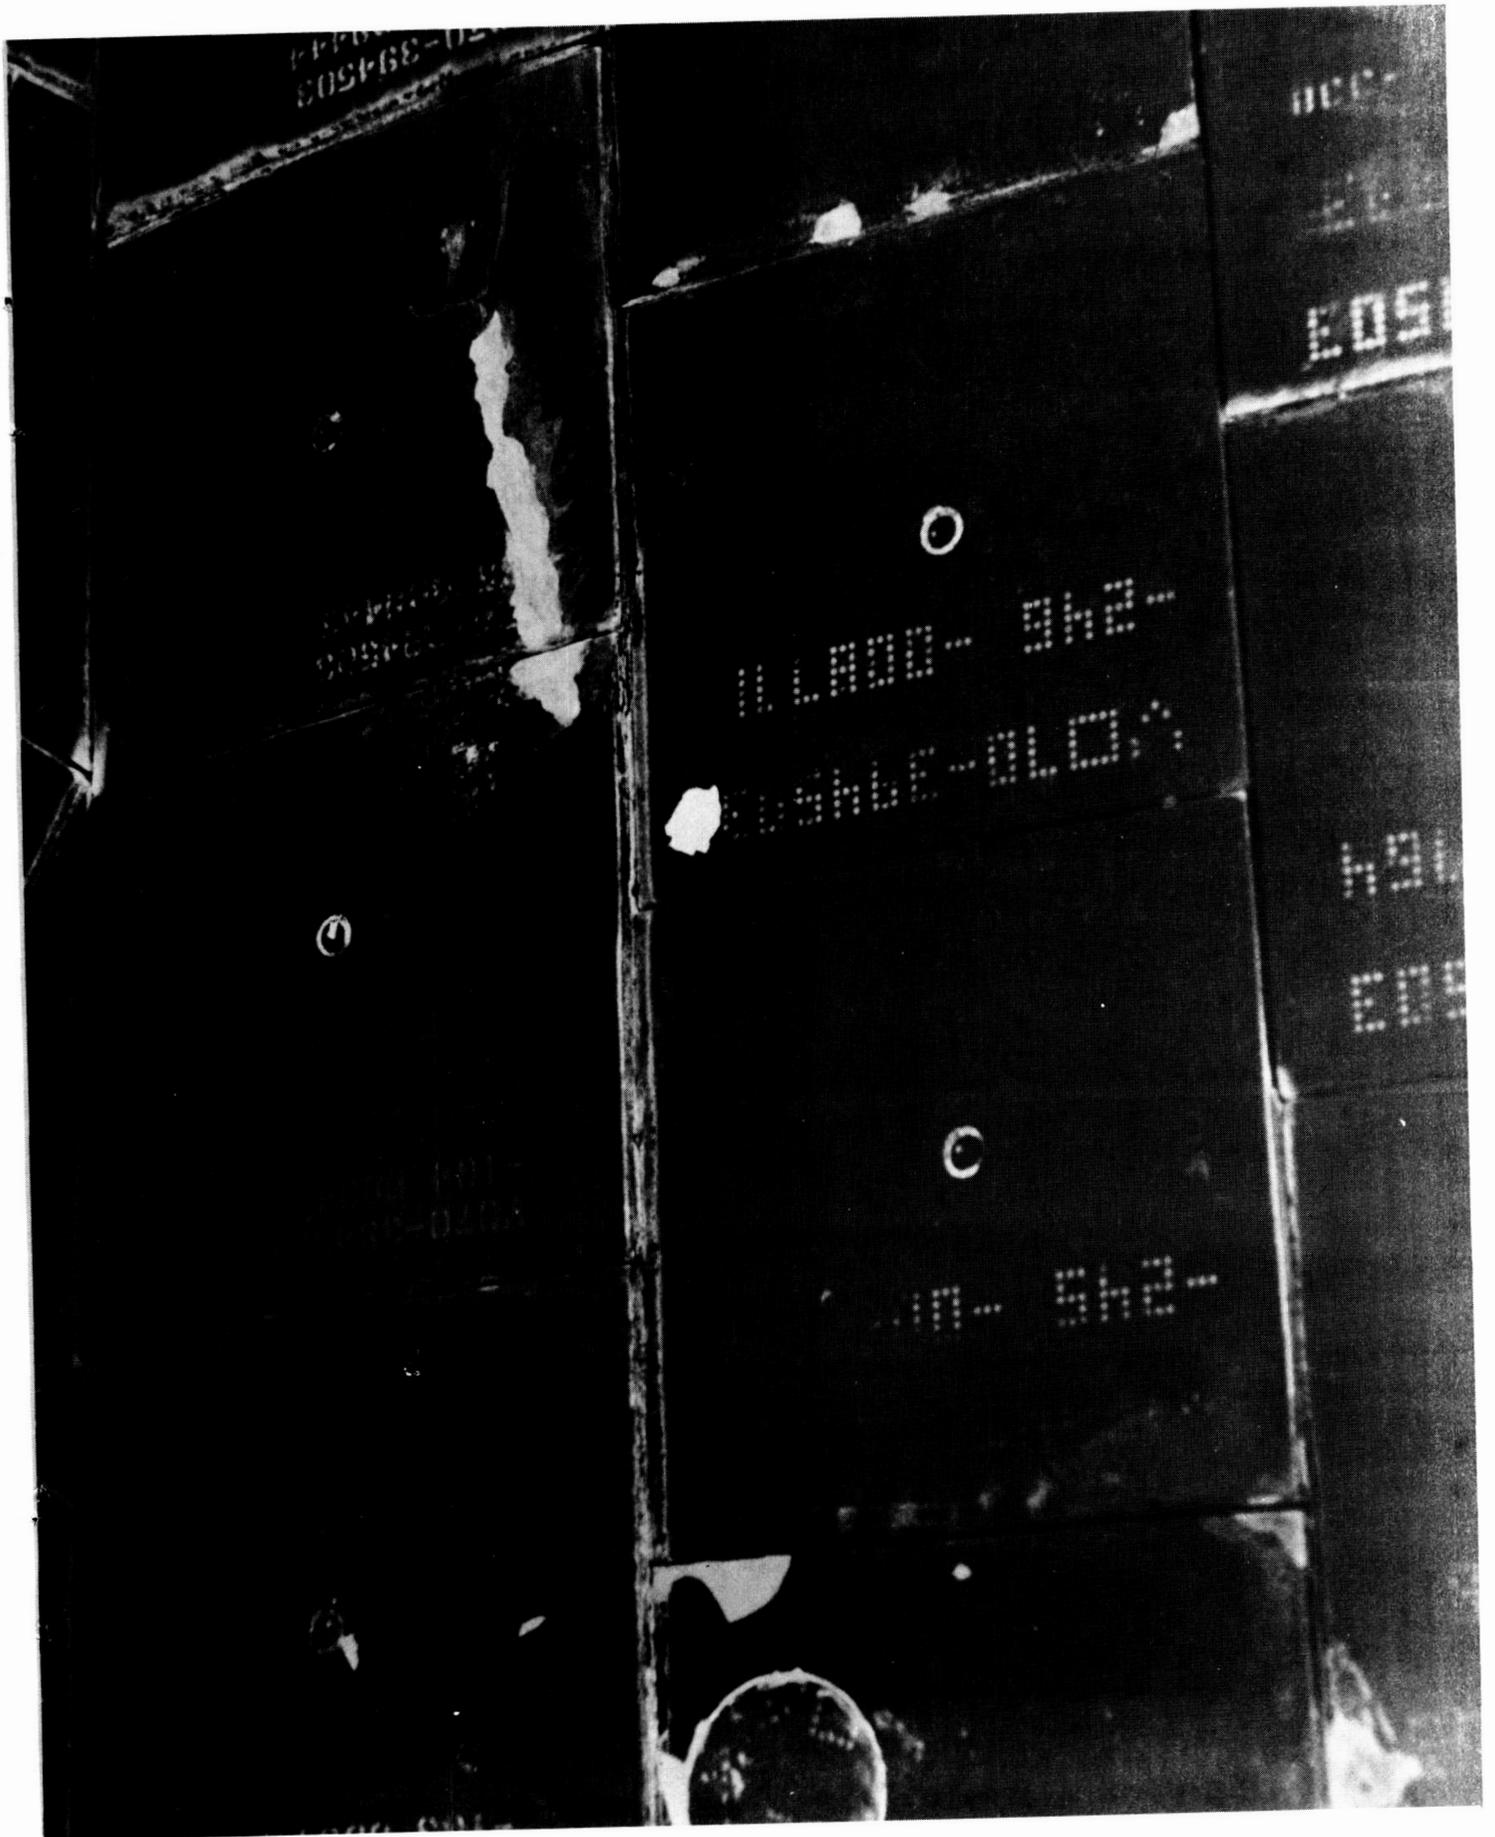
FOREIGN SUBSTANCE ADHERING TO TILE

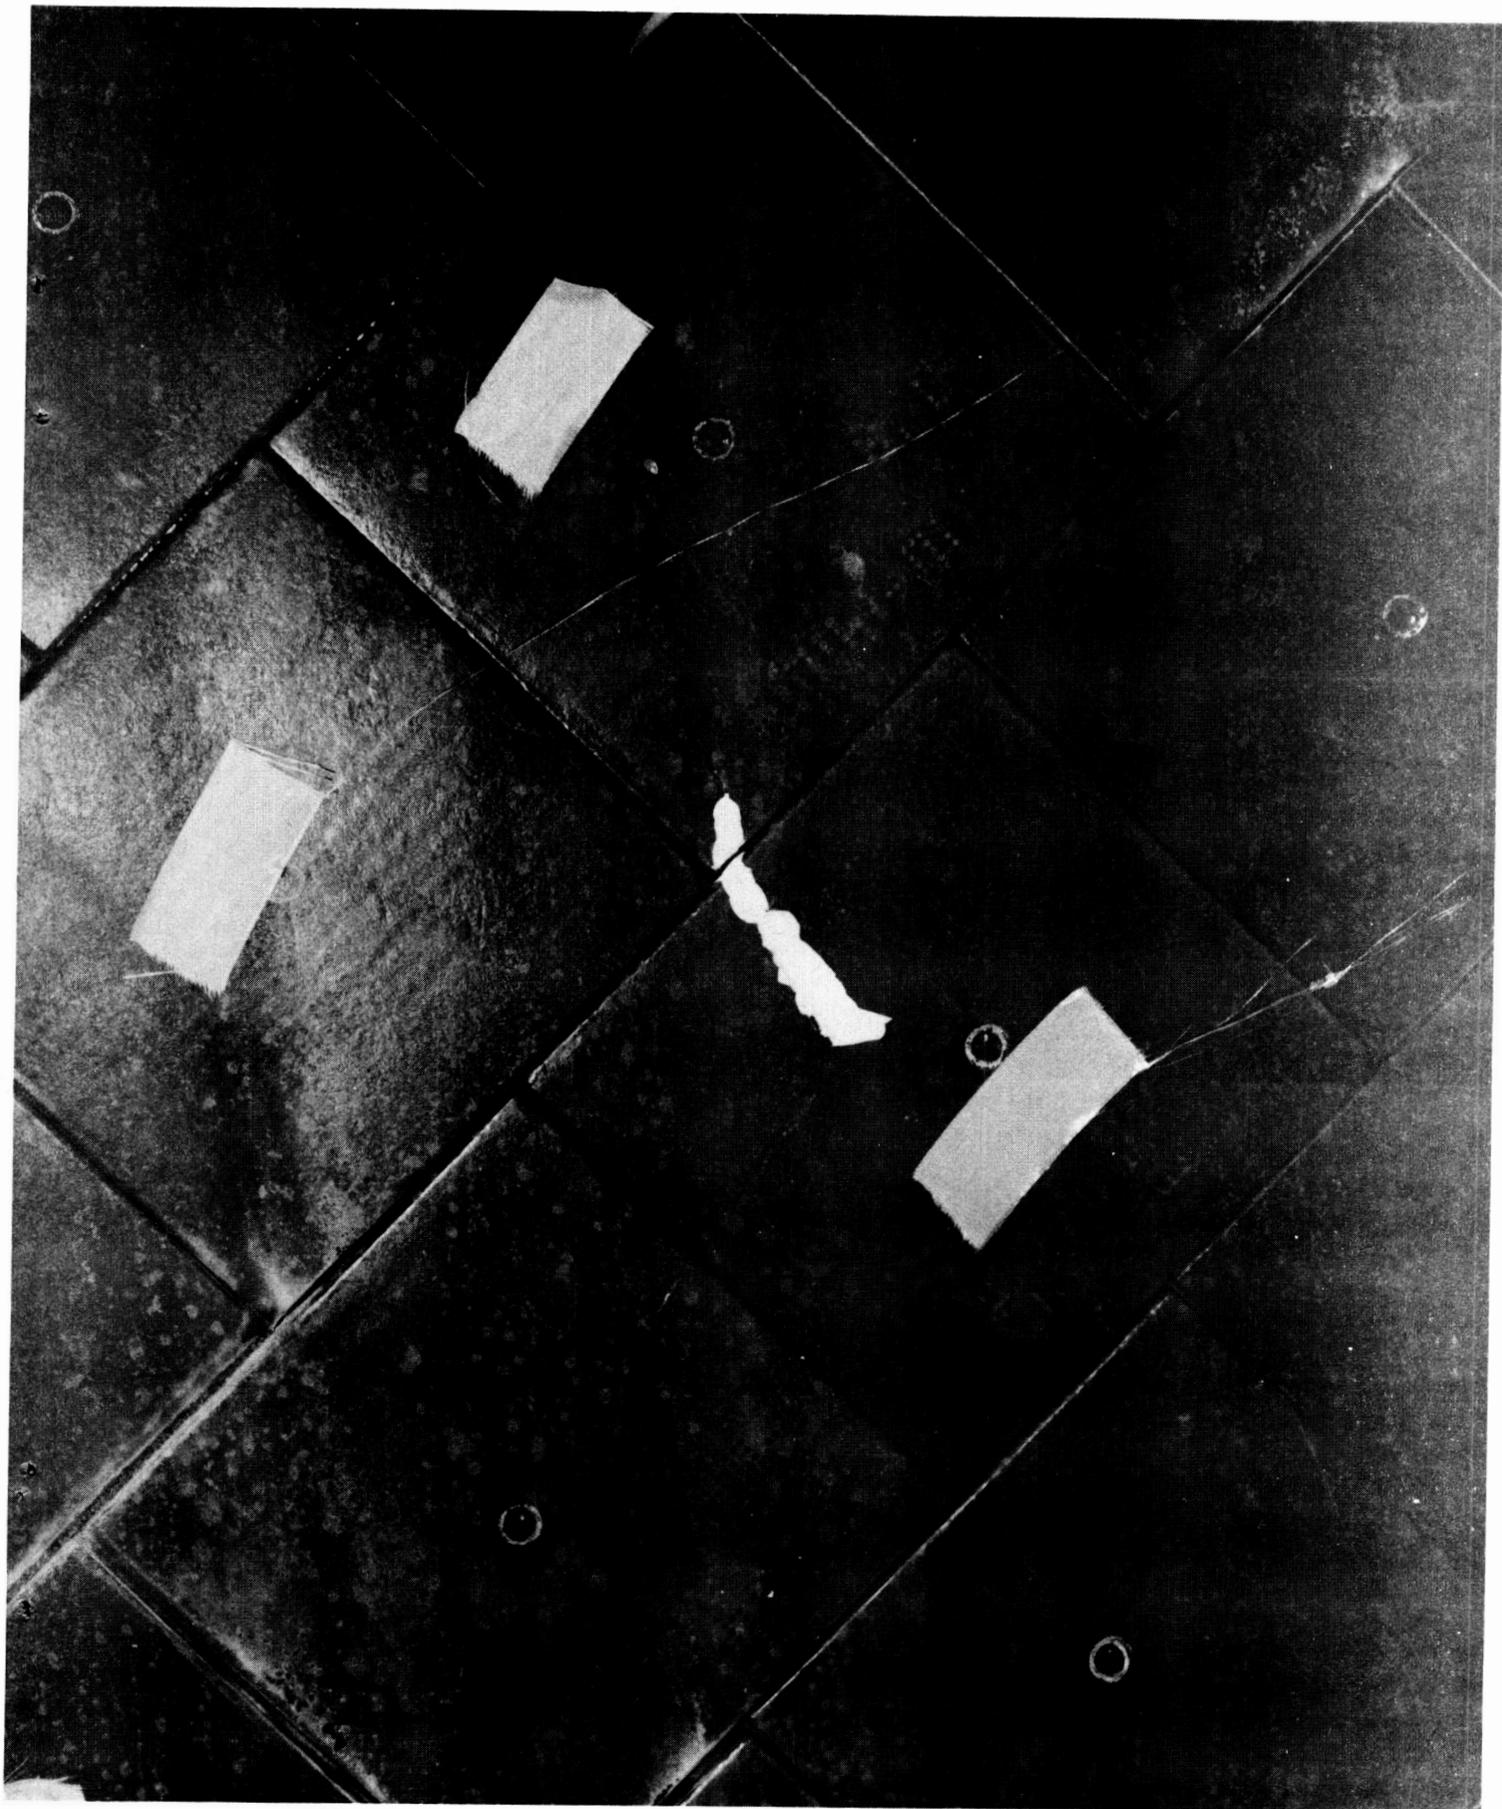
TYPICAL DEBRIS IMPACT DAMAGE

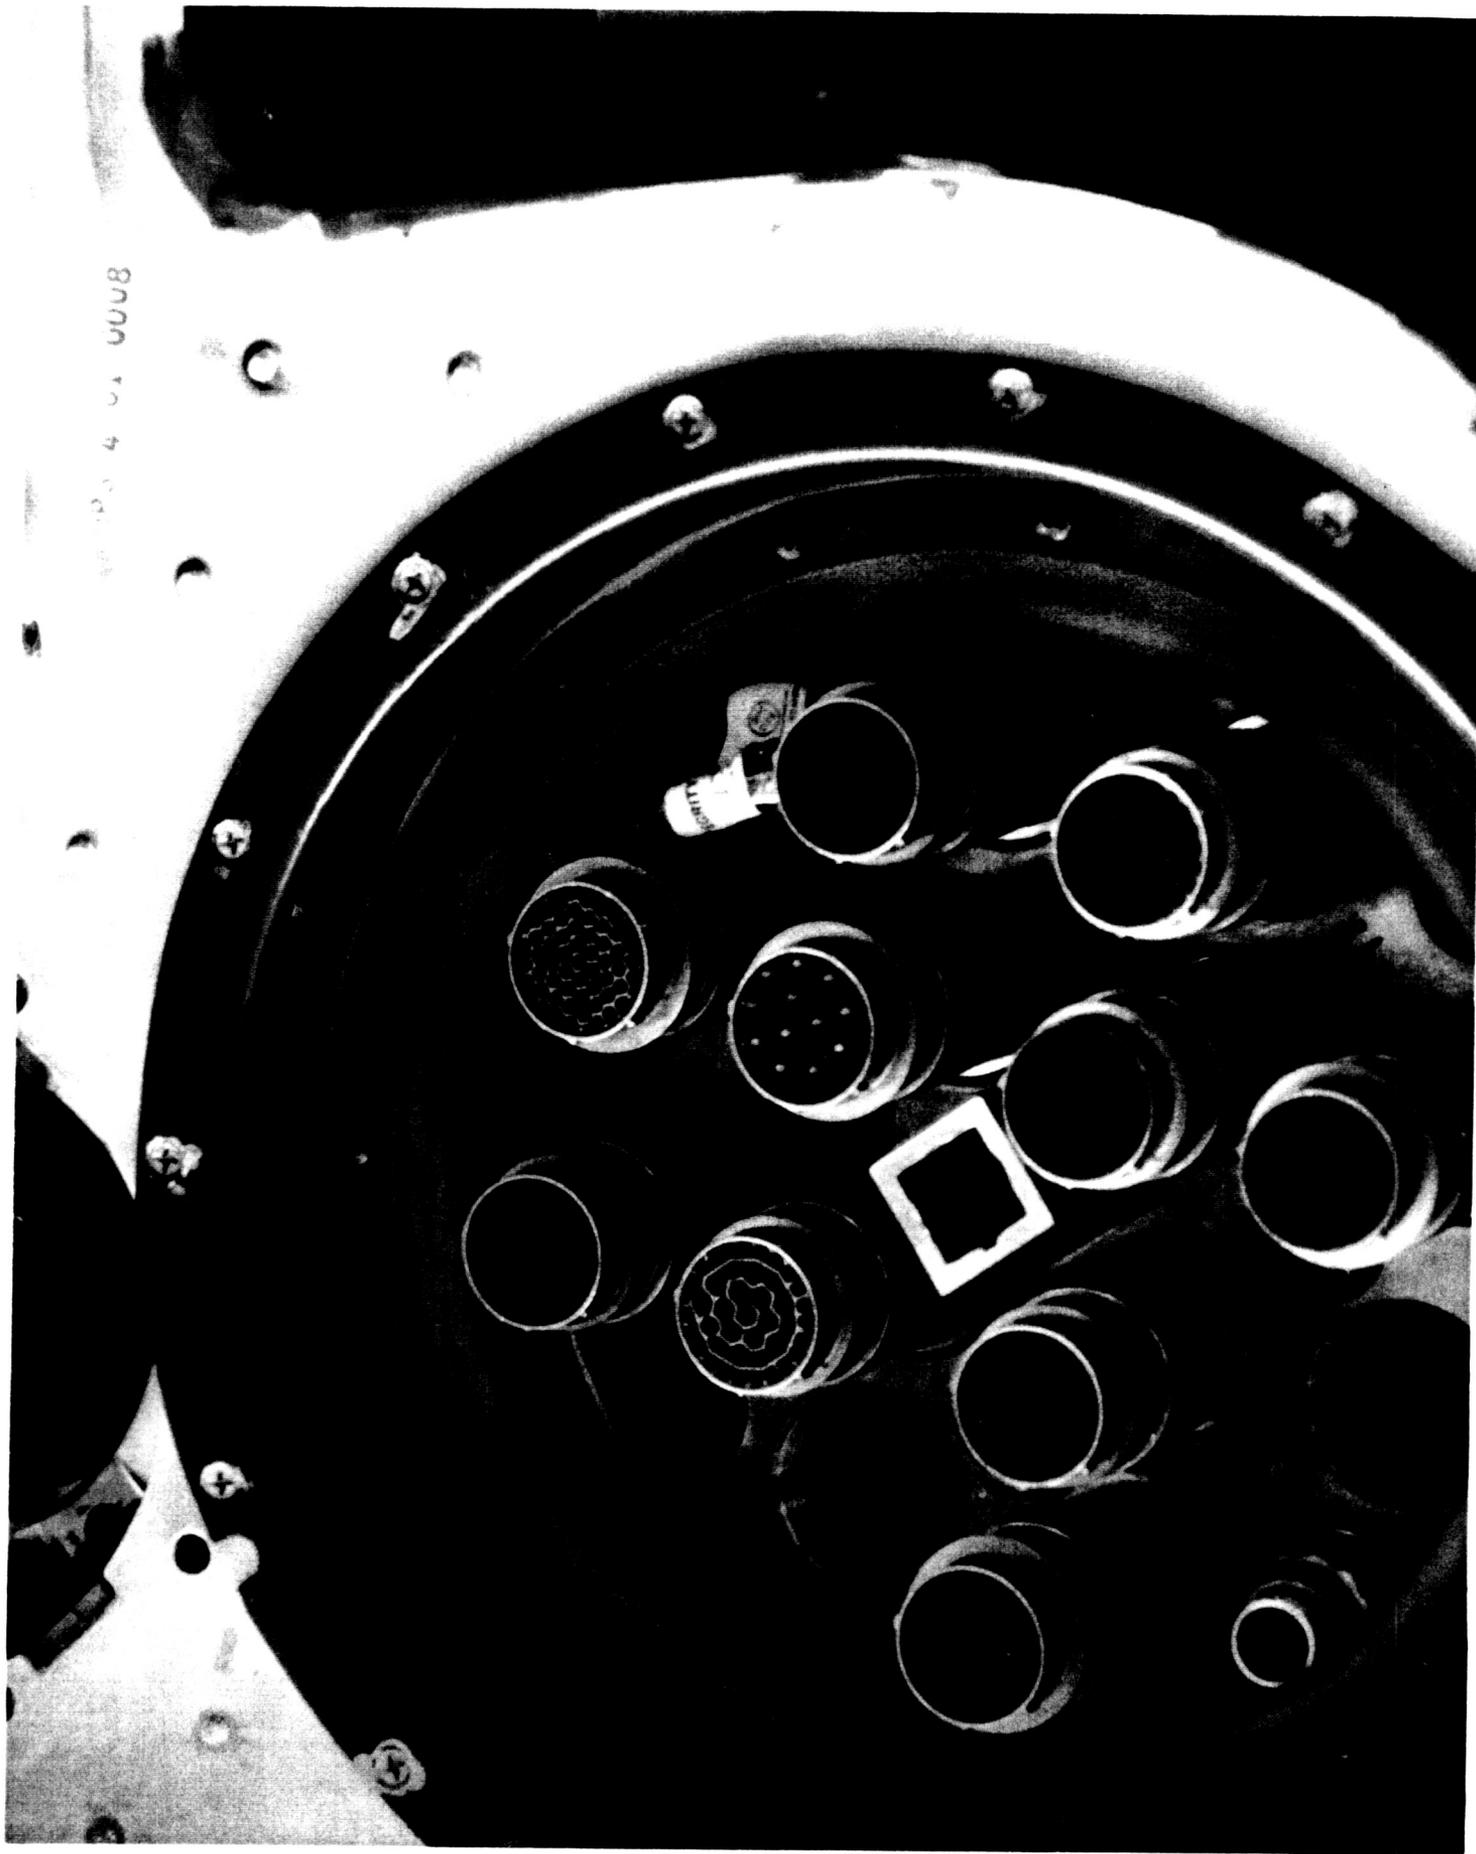
PURGE LINE TAPED CLOSED IN LO2 UMBILICAL ELECTRICAL CONNECTION
