FULL SCALE TECHNOLOGY DEMONSTRATION OF A MODERN COUNTERROTATING UNDUCTED FAN ENGINE CONCEPT

ENGINE TEST

December 1987

by
GE Aircraft Engines
GE36 Project Department
Cincinnati, Ohio 45215

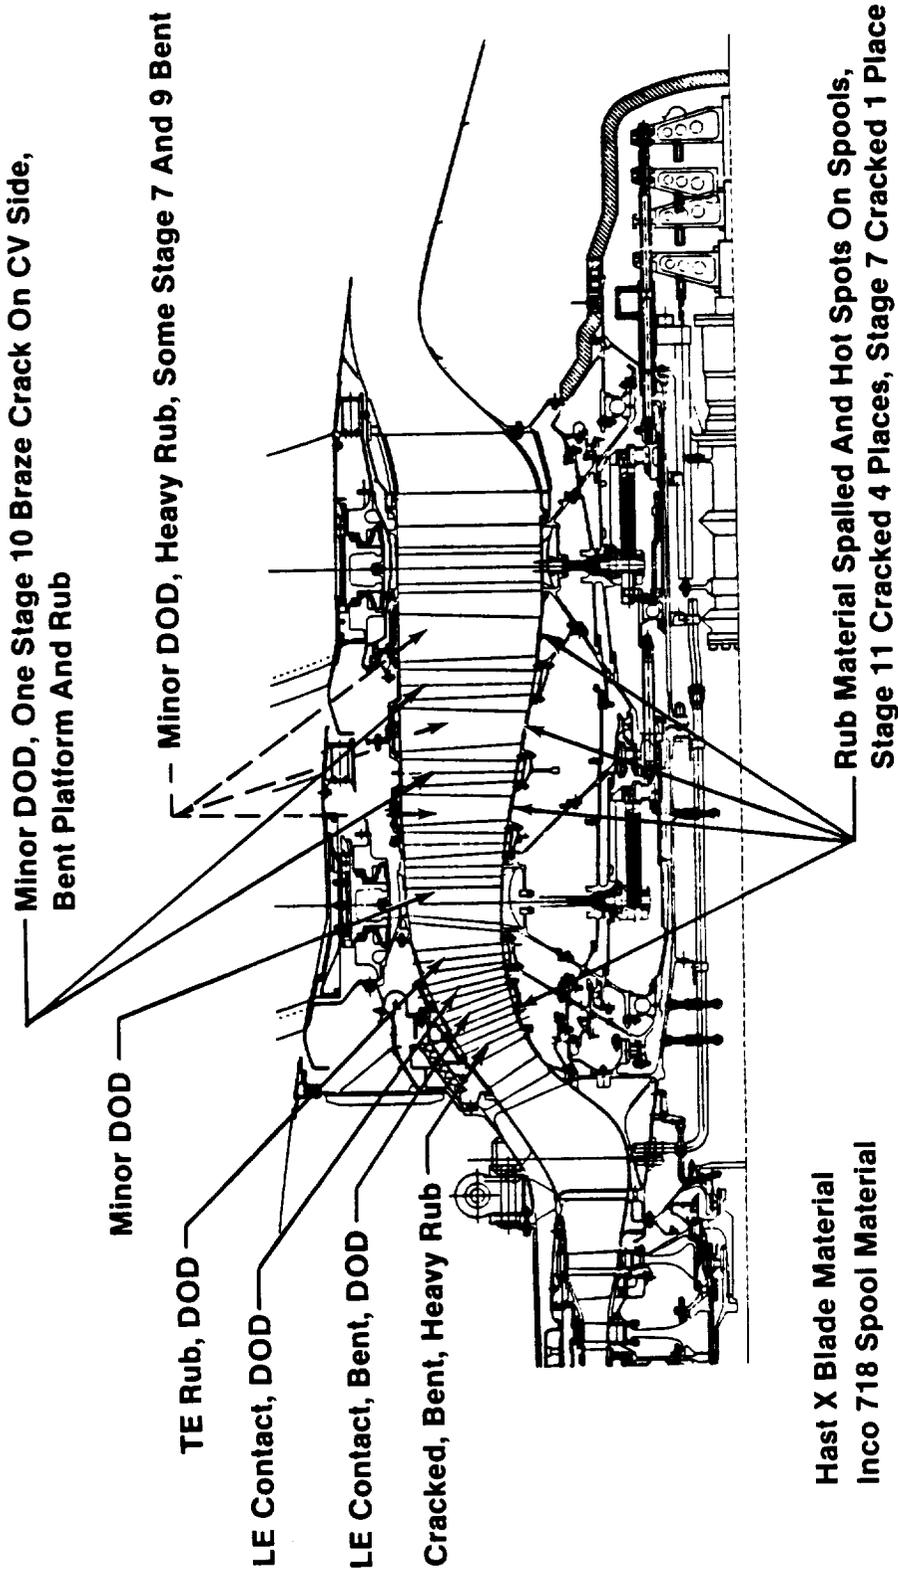
Figure 3-11. Summary of Hardware Damage.

- Engine operating on point at takeoff power (24,000 lbf), 1,350 rpm propulsor fan speed for 4 minutes
- Stage 1 turbine blade failure: high cycle fatigue (first flex) cracking at blade root resulting in aft lean of blades
- Contact of Stage 1 blades with Stage 2
- Reduction of Stages 1 and 2 flow area
- IPC stall
- Engine stopcocked about 1.5 seconds after stall initiation
- Rotor axial excursion
- Secondary damage to remaining stages resulting from failure of Stage 1
- Additional rubs experienced by Stages 7, 9, and 11
- Fast coast-down
- Rotor-to-rotor lockup.

During testing, prior to the stall, significant first flexural vibratory response had been observed on all stages of power turbine blading (Figures 3-12 and 3-13). Teardown revealed significant damage to Stage 1. Several blades had large leading edge root cracks and were leaning aft toward Stage 2. One local segment of blades was buckled aft into Stage 2. All Stage 2 leading and trailing edges, as well as all Stage 3 leading edges, were bent circumferentially and severely rubbed. Stages 1, 7, 9, and 11 exhibited severe tip rub. While Stages 7, 9, and 11 had rubbed previously during Build No. 1 due to oil leakage past a broken carbon seal, the poststall rubs were more severe. Stage 4 had very light tip rub only at the trailing edge. Stages 2, 3, 6, and 8 exhibited no tip rub. Stage 10 rubbed only one blade, which was bent at the platform. Stages 7, 9, and 11 had several bent airfoils. The rotor inner

spools exhibited local burn spots at Stages 1, 7, 9, and 11 rub locations, with cracking evident at Stages 7 and 11. Domestic object debris damage was confined to the power turbine flowpath. Nicks and dents were significant only on the forward turbine blade stages. The power frame and OGV (outlet guide vanes) airfoils exhibited only minor debris damage.

Metallurgical evaluation of the Stage 1 blades found root leading edge cracks on 117 of 124 airfoils. However, none of the airfoils were completely separated. Crack lengths varied from approximately 0.02 to 1.2 inch. SEM (scanning electron microscopy) revealed evidence of high cycle fatigue along the entire fracture surface. Evidence of root fatigue cracking was also found on Stages 2, 4, 6, and 11. Stages 7 and 9, and the one bent Stage 10 blade, were found to have tensile cracks at the root braze joints and tensile tears in some of the platform braze joints. Local burn spots on the spools showed evidence of severe overtemperature of the Inco 718 substrate. Four locations at Stage 11 and one at Stage 7 were confirmed cracked.

Based on the responsiveness of all stages of power turbine blading at first flexural frequency, it is concluded that the blade and spool design configuration did not provide effective dovetail Coulomb damping as anticipated. Hardware condition indicates that the Stage 1 blades were cracked to varying degrees prior to stall and that these cracks propagated in high cycle fatigue while sitting on point on October 2, 1985. As the cracks grew, the blades leaned further aft until one or more contacted Stage 2, causing the slow drop-off in propulsor rotor speed prior to the stall. Contact with Stage 2 rolled the leading edge, resulting in a sudden reduction in power turbine flow function. The reduction in flow function caused the F404 gas generator to stall. The remainder of the damage was secondary during the rapid shutdown.

All power turbine blades were replaced for Build 2. Spanning across adjacent blades, coulomb dampers (in the form of René 41 pins) were designed for all stages of blading as illustrated in Figure 3-14. Effectiveness of the damper design has been substantiated by component rig spin ("whirligig") and bench wear tests. Although no evidence of fatigue was indicated for the power frames, dampers were also added to Stage 12 as a precaution due to a predicted first flexural response with the outlet guide vane passing frequency. Strain gages have also been added to the Stages 5 and 12 power frame airfoils for Build 2.

Low cycle fatigue and crack growth analyses of the spools indicate that they have sufficient life capability for the remainder of planned testing. The spools have been weld repaired and the rub coats stripped and reapplied to provide additional margin.

Because of the severity of rub during Build 1 when oil leaked past the forward intershaft carbon seal and during the Build 1A stall, power turbine blade tip clearances have been increased an additional 0.050-inch on the outer attached blades and 0.030-inch on the inner attached blades, and all tips have been tapered to 0.005 to 0.015-inch thickness as a precautionary measure.

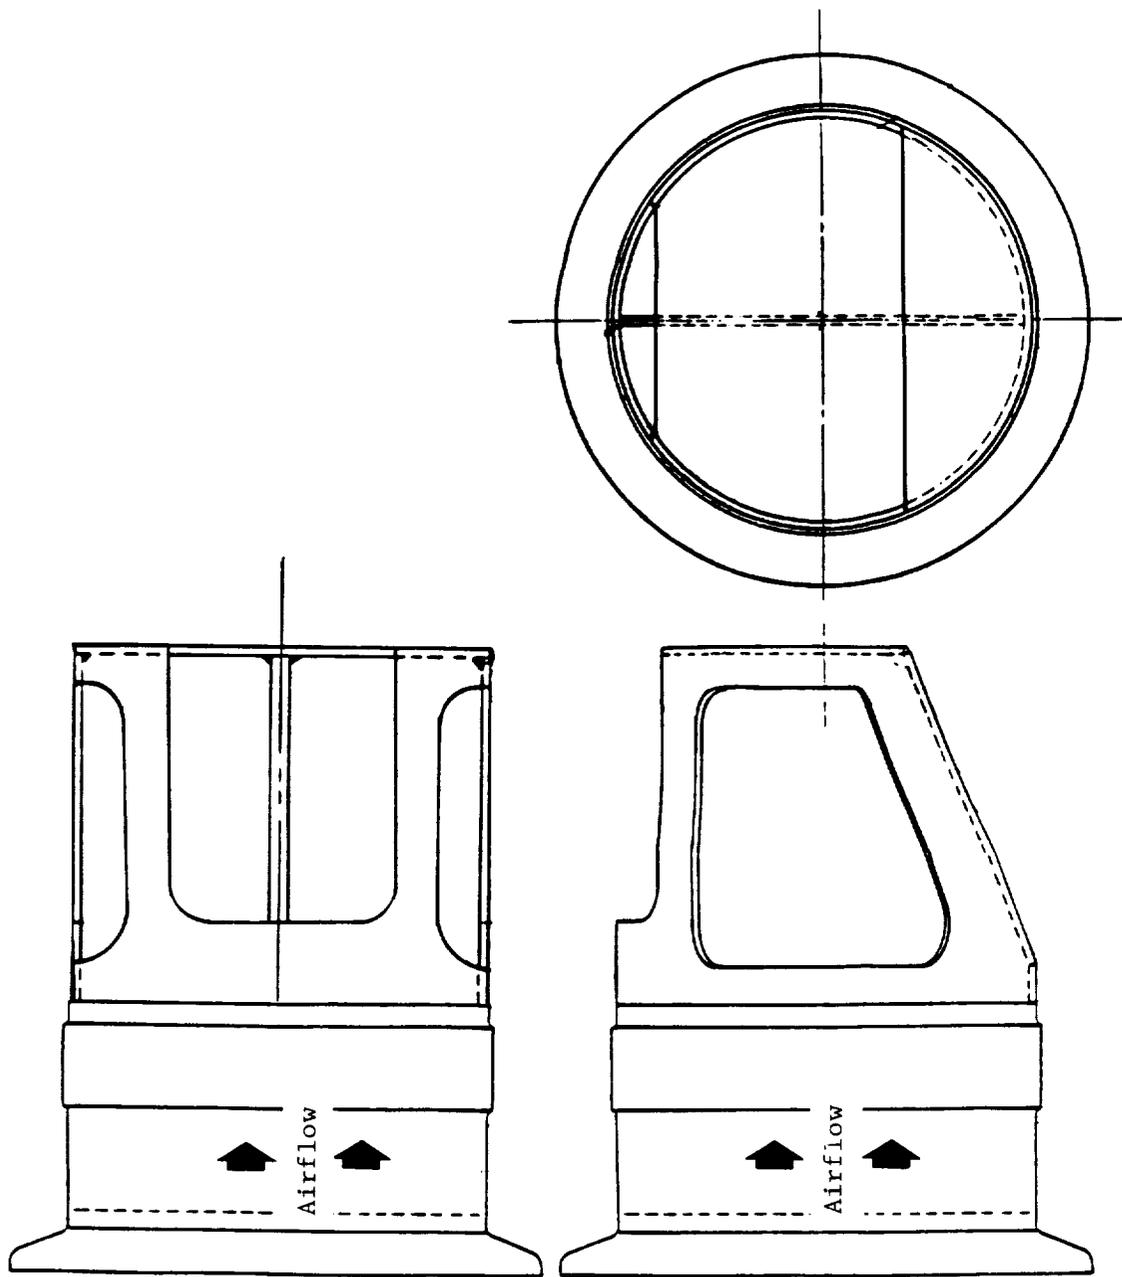
Figure 3-30. Redesigned Bypass Bleed Valve Diffuser.

During Build 2, the fan bypass bleed valve diffuser failed in high cycle fatigue (Figure 3-29). Until a redesigned diffuser (Figure 3-30) could be

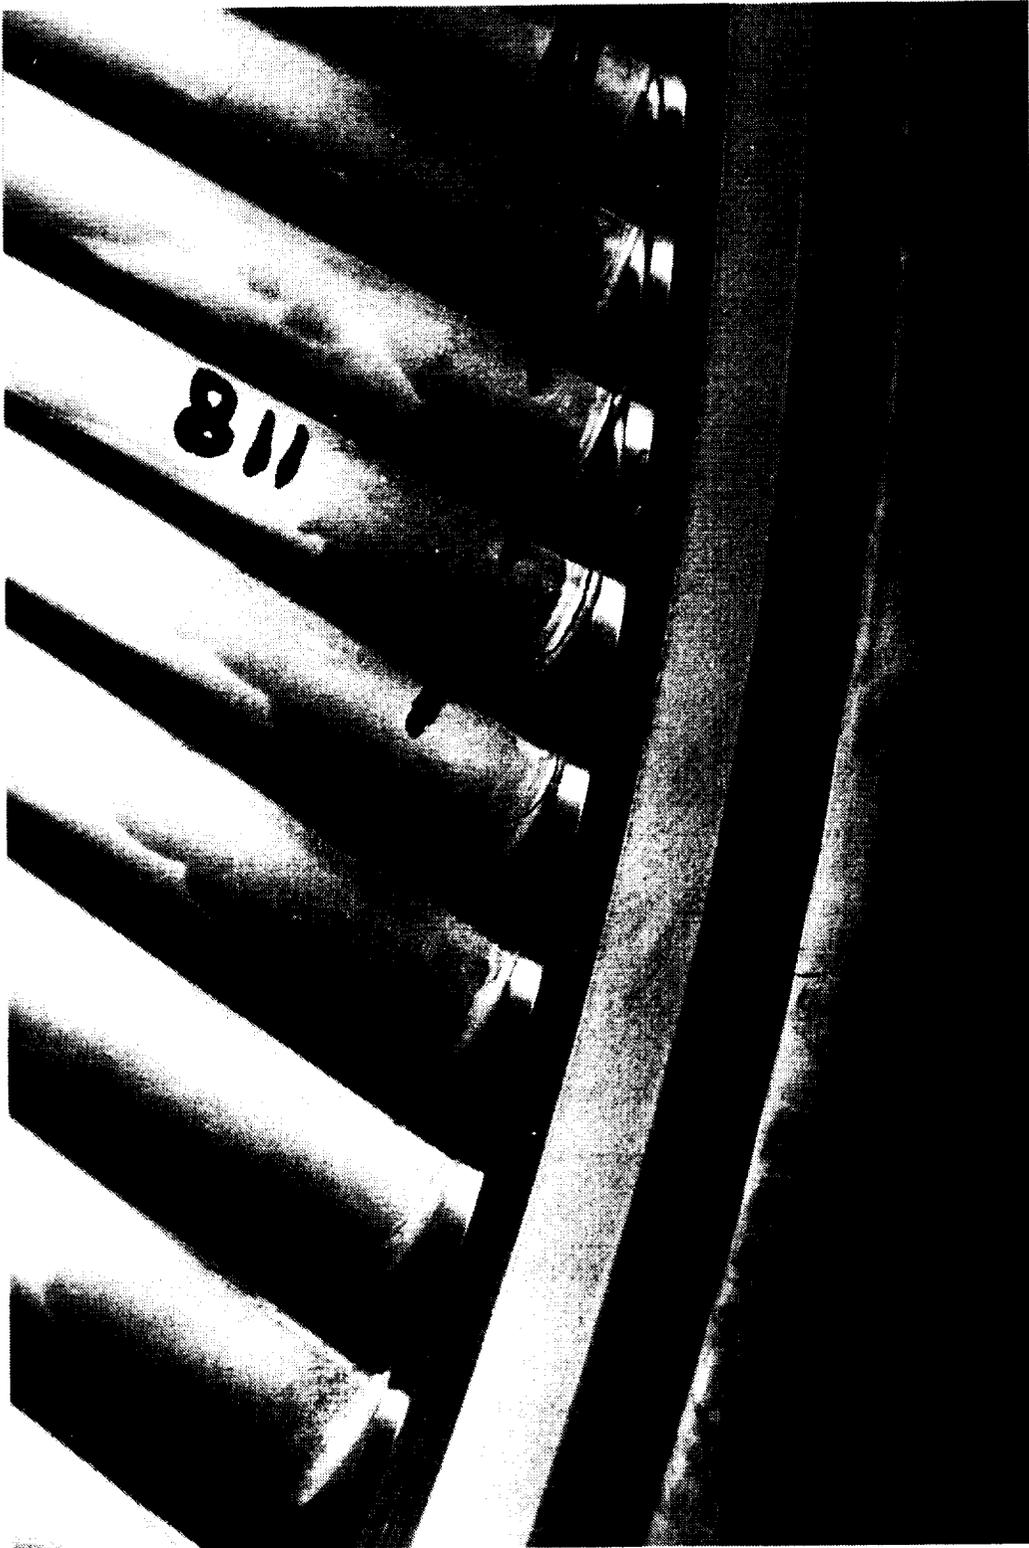
Figure 3-59. Stage One Blade Cracks at Leading Edge Root.

The Stage 1 blades were found to have HCF cracks that initiated at the leading edge root. The blades with the most visible cracks are illustrated in Figure 3-59. There is a total of 124 Stage 1 blades; of these, 19 blades had

Stage	1	2	3	4	6	7	8	9	10	11
No. of Blades	124	118	120	94	90	72	84	54	82	56
No. Cracked (1× Visual)	19	0	0	0	0	-	-	-	-	0
Additional No. Cracked (Borescope)	0	0	0	0	-	0*	0*	0*	0	3
Additional No. Cracked (10× Visual)	0	0	-	-	-	-	-	-	-	-
Additional No. Cracked (40× Visual)	34	-	-	-	-	-	-	-	-	-
Total Cracked	53 (42.7%)	0	0	0	0	0	0	0	0	3 (5.4%)
* Approximately 25% Sample; Others Inspected 100%

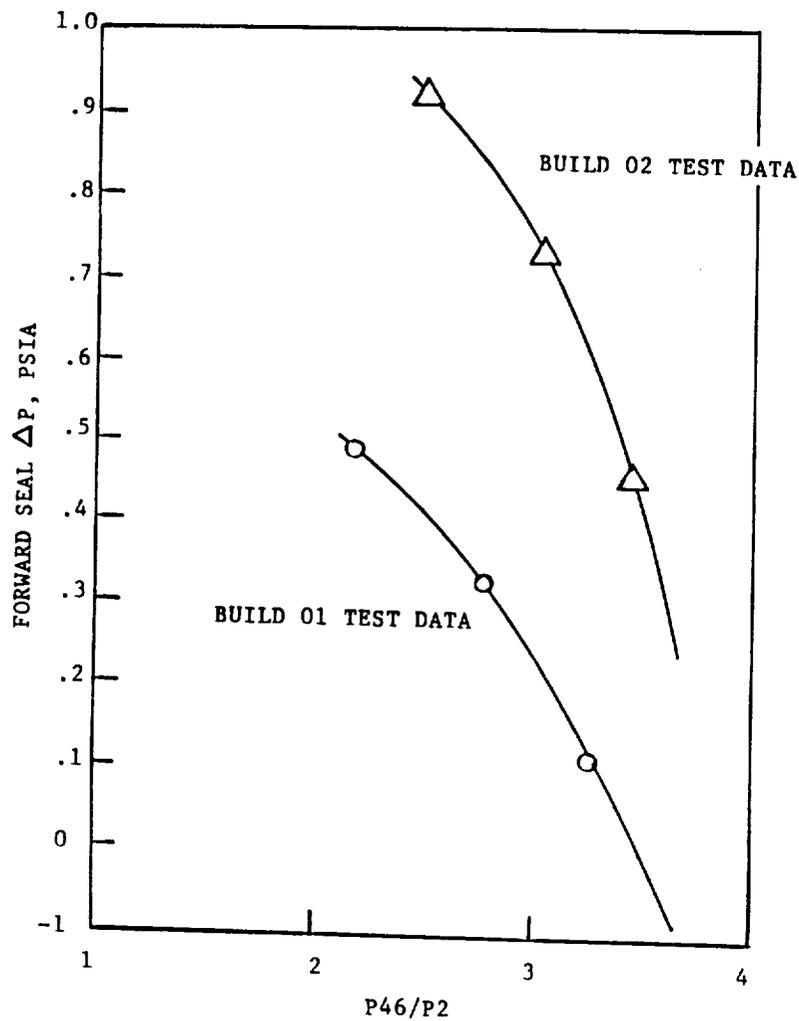
Figure 4-8. Potential Forward Seal Problem.

- PROBLEM: EXTRAPOLATION OF TEST DATA INDICATES THAT FORWARD SEAL COULD BACKFLOW AT MAX POWER.
- CAUSE: UNDERSIZED SUPPLY HOLE AND OVERSIZED ANNULUS HOLES REDUCE THE SEAL SUPPLY PRESSURE.
- SOLUTION: INCREASE SUPPLY HOLE AREA.

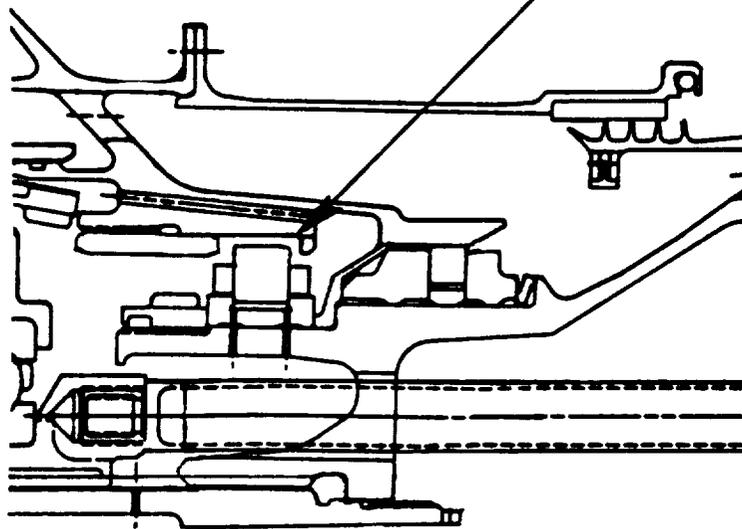
Figure 6-3. Disassembly Problem and Roller Corner Damage.

Rollers Having Moved Radially
Outward Contact Shaft Shoulder
