Debris/Ice/TPS Assessment And Photographic Analysis For Shuttle Mission STS-36

April 1990

DEBRIS/ICE/TPS ASSESSMENT
AND
PHOTOGRAPHIC ANALYSIS
OF
SHUTTLE MISSION STS-36

February 28, 1990

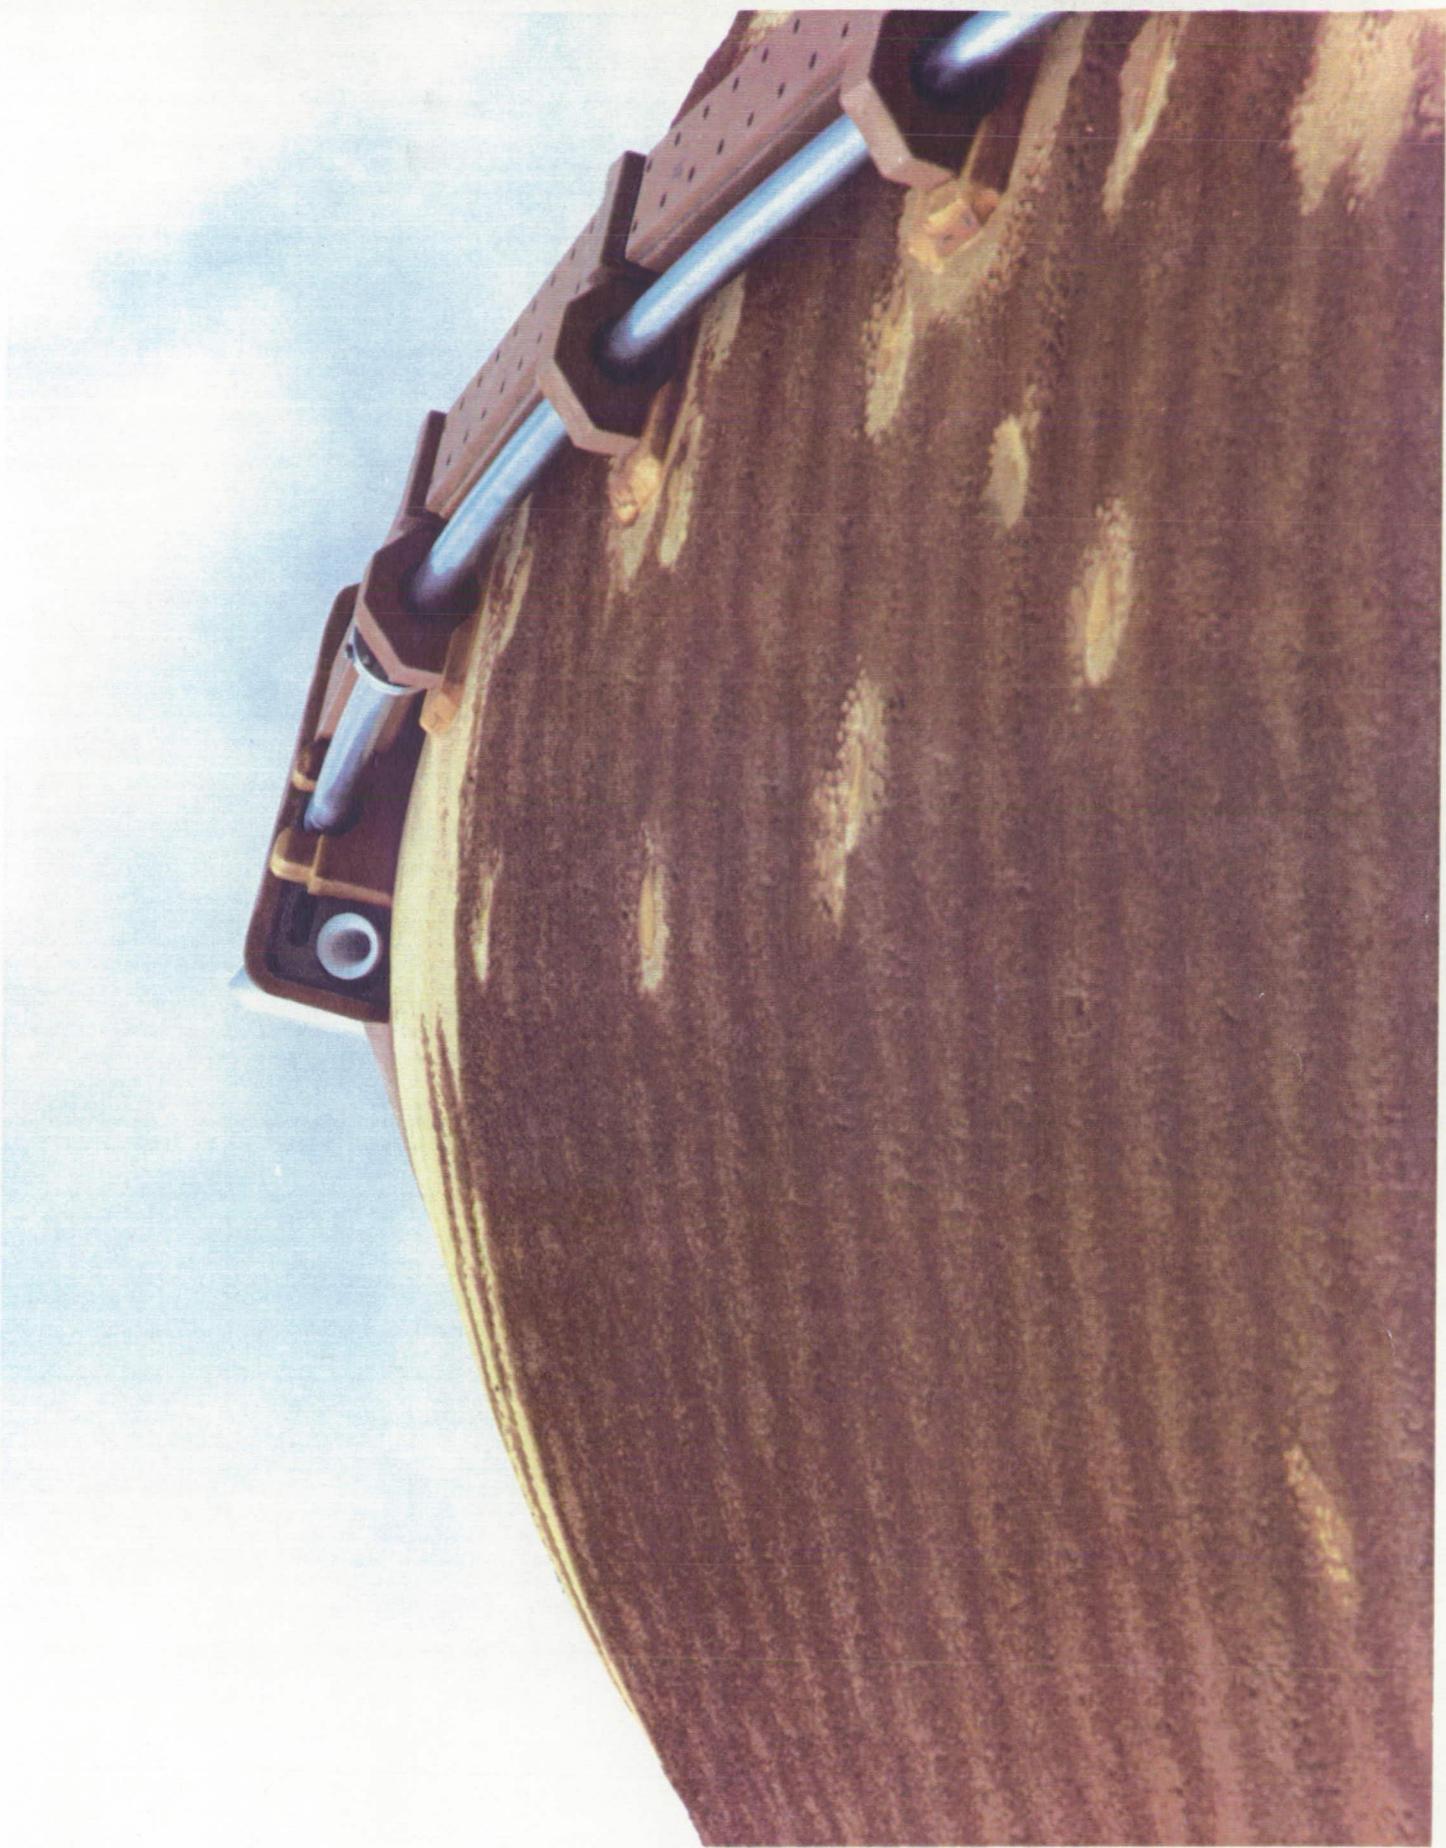
New design of ET tumble valve cover was installed for launch

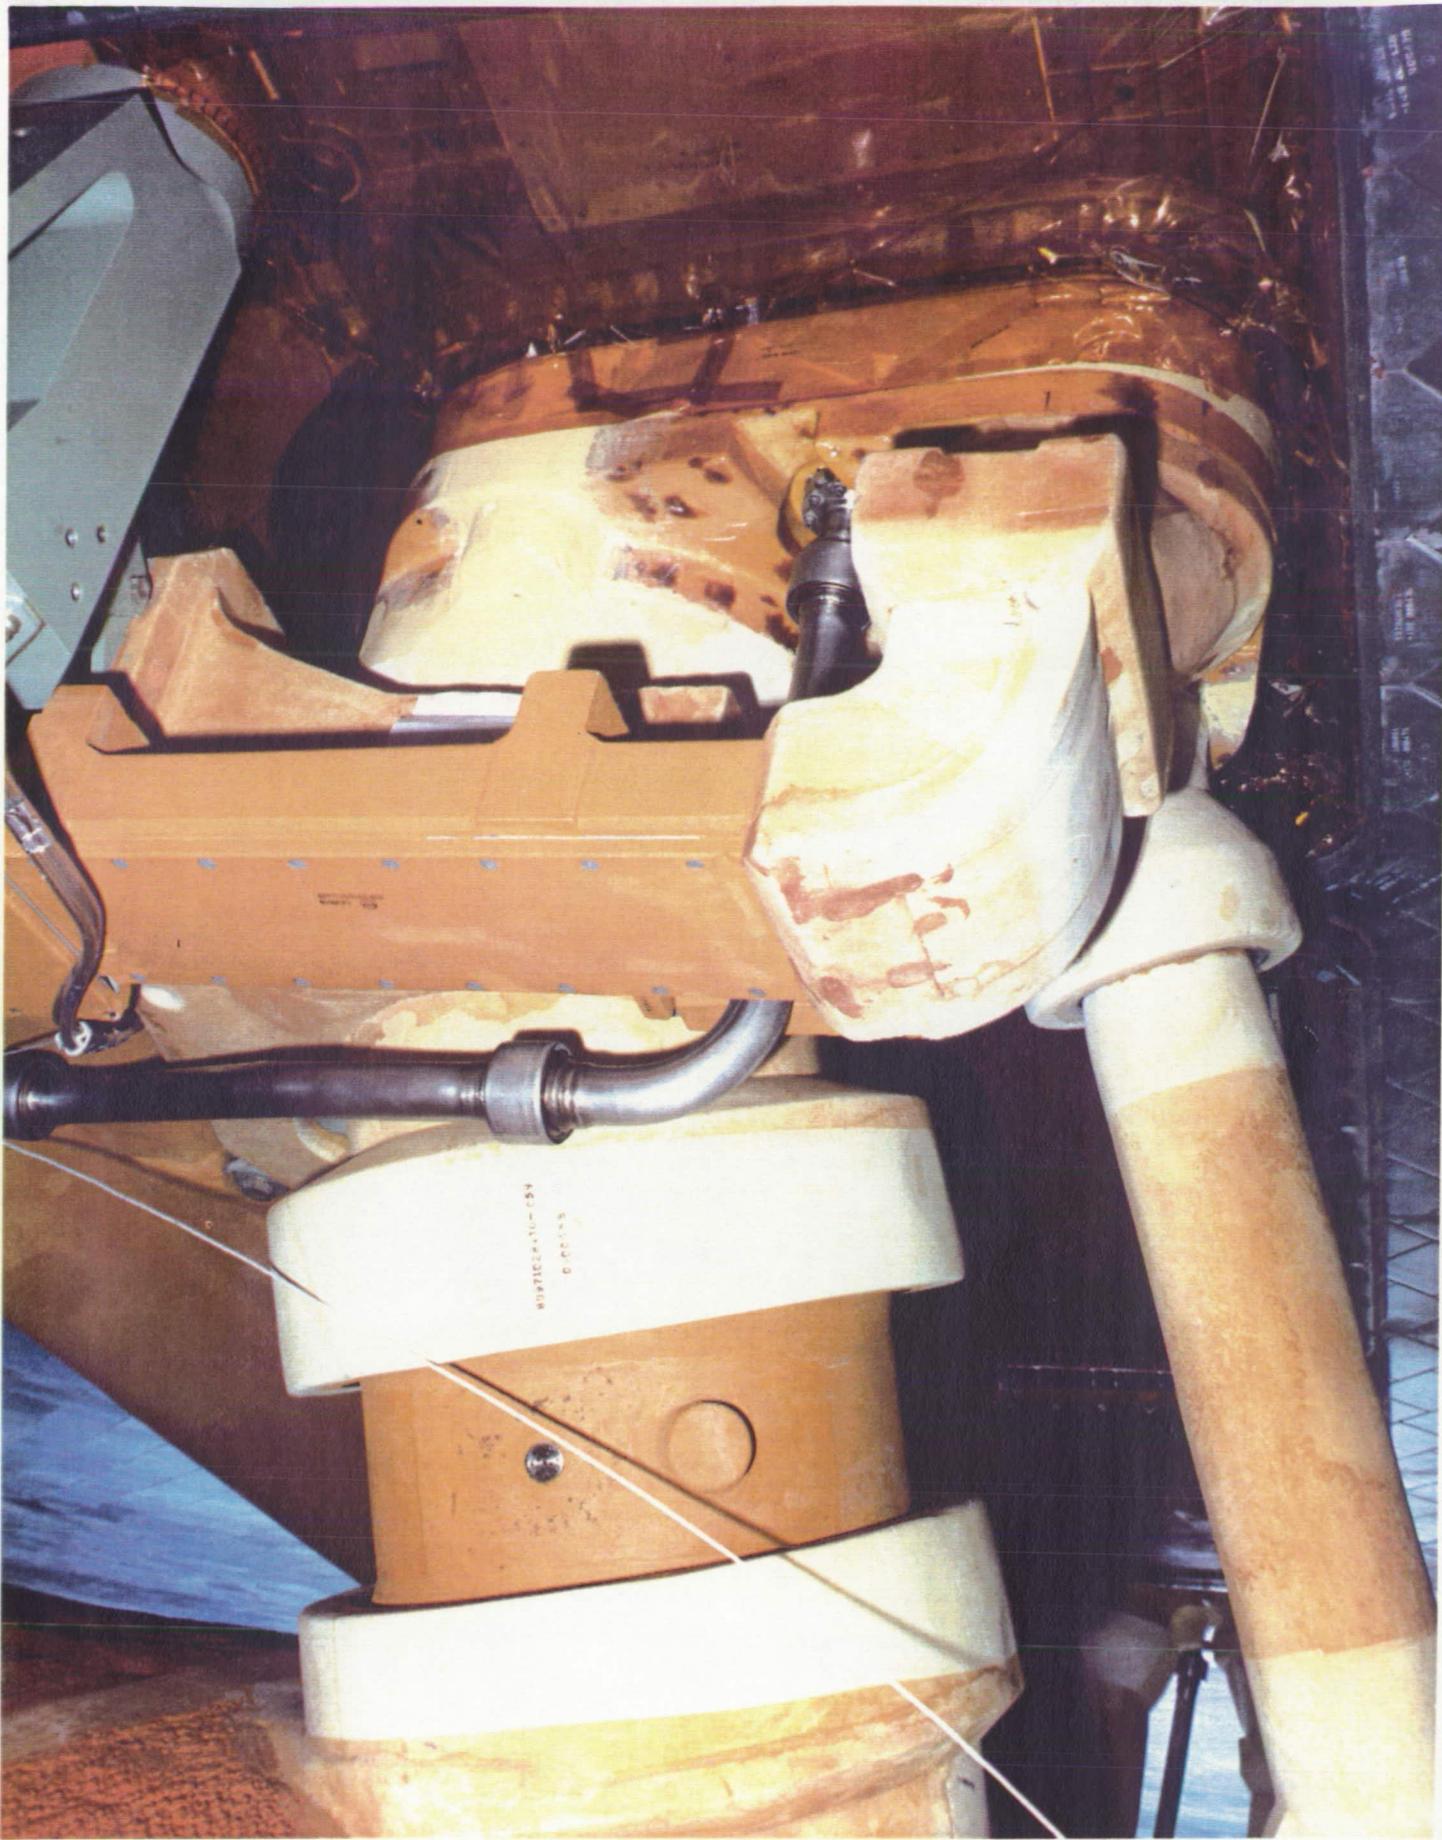
Pre-launch view of LH2 ET/ORB umbilical baggie material, which subsequently was found torn during the second vehicle cryo load

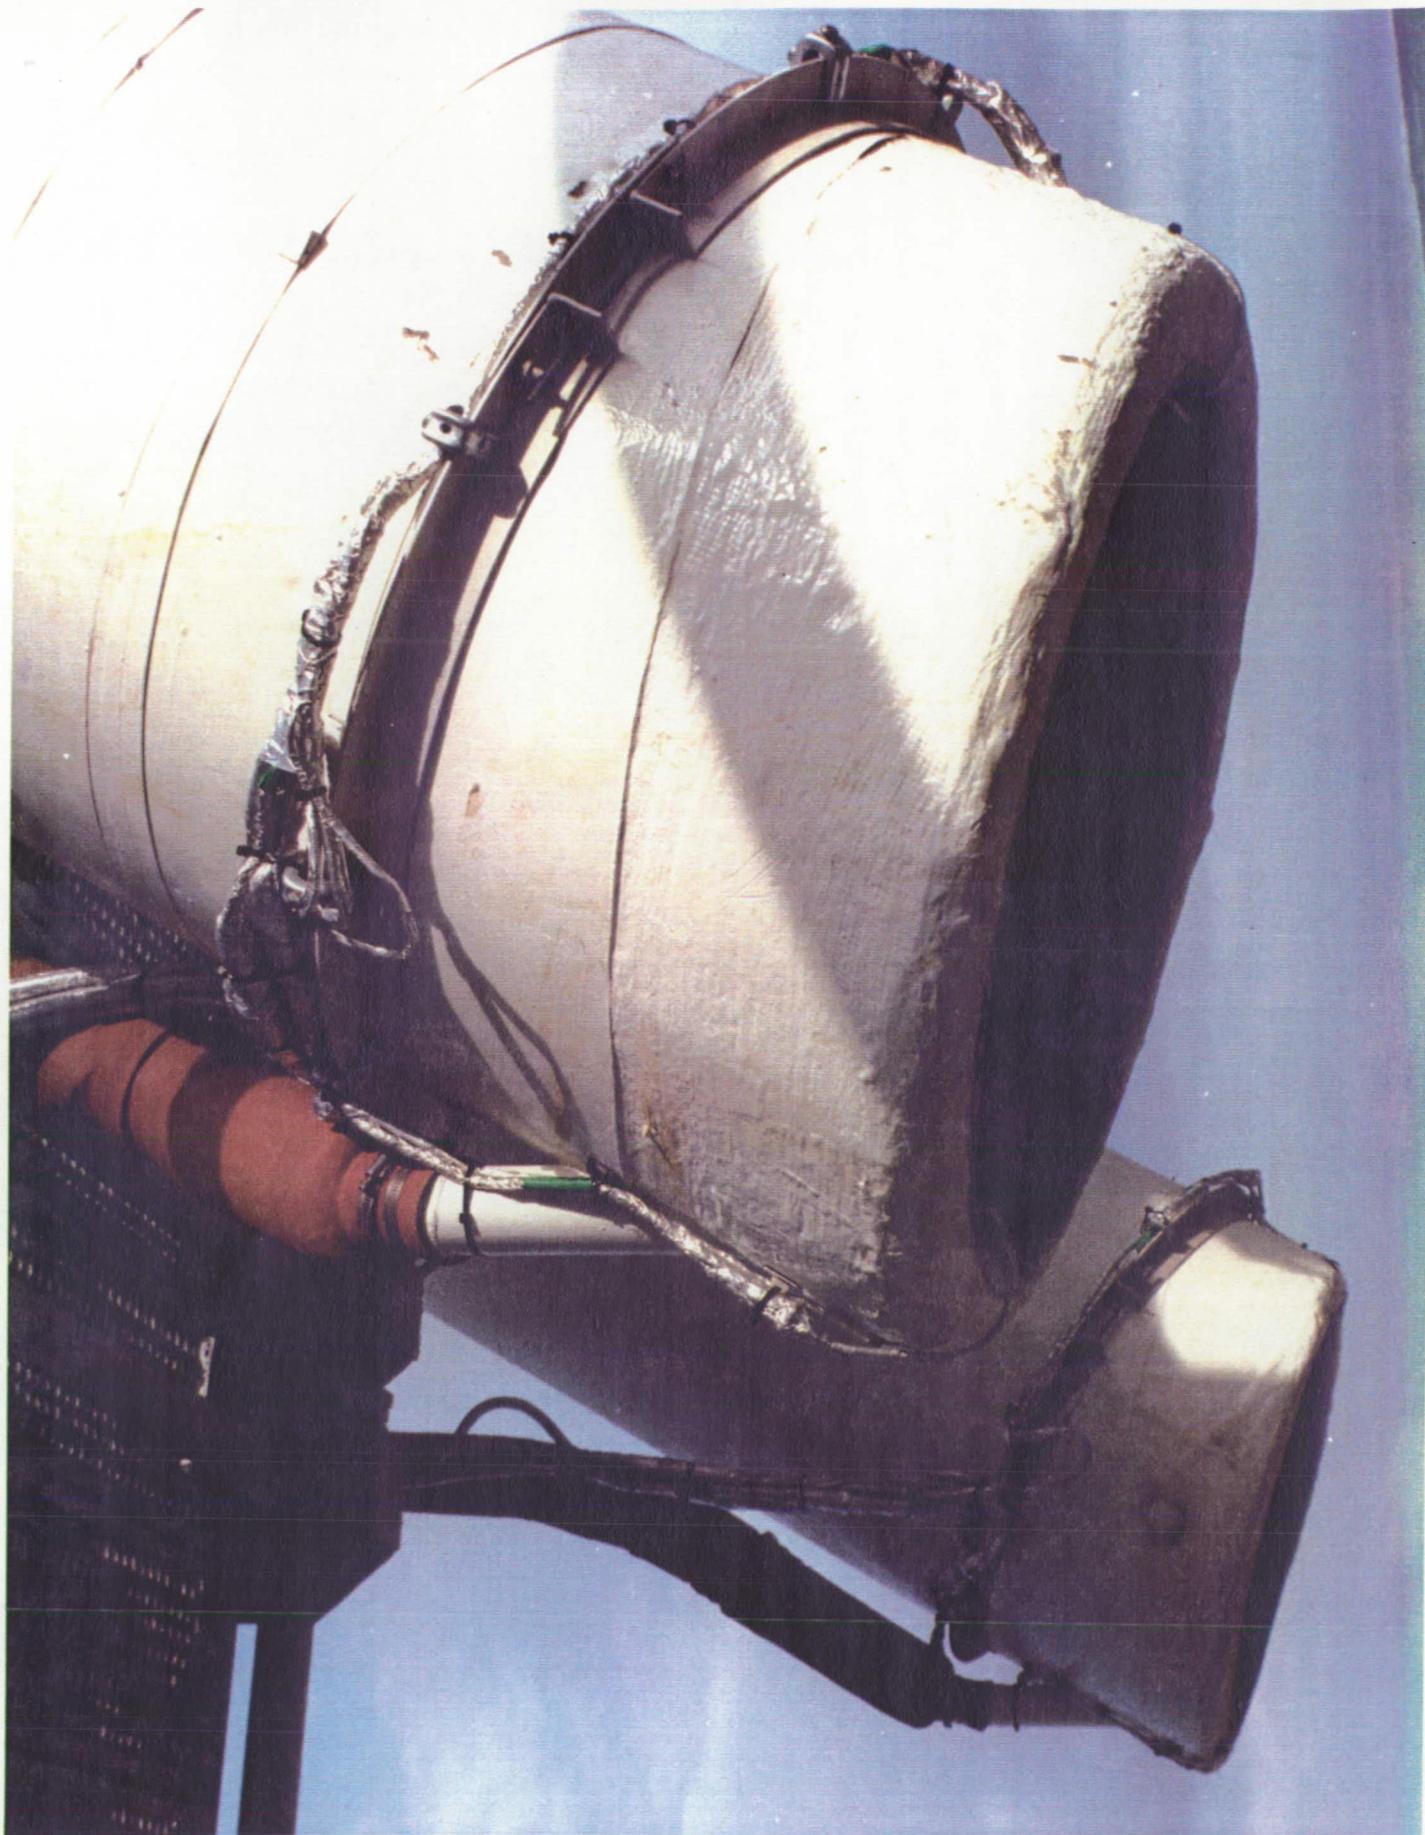
Condensate hydro diverters on the ends of the GOX vent ducts
Frost usually covers the temp sensor wiring inside the ducts

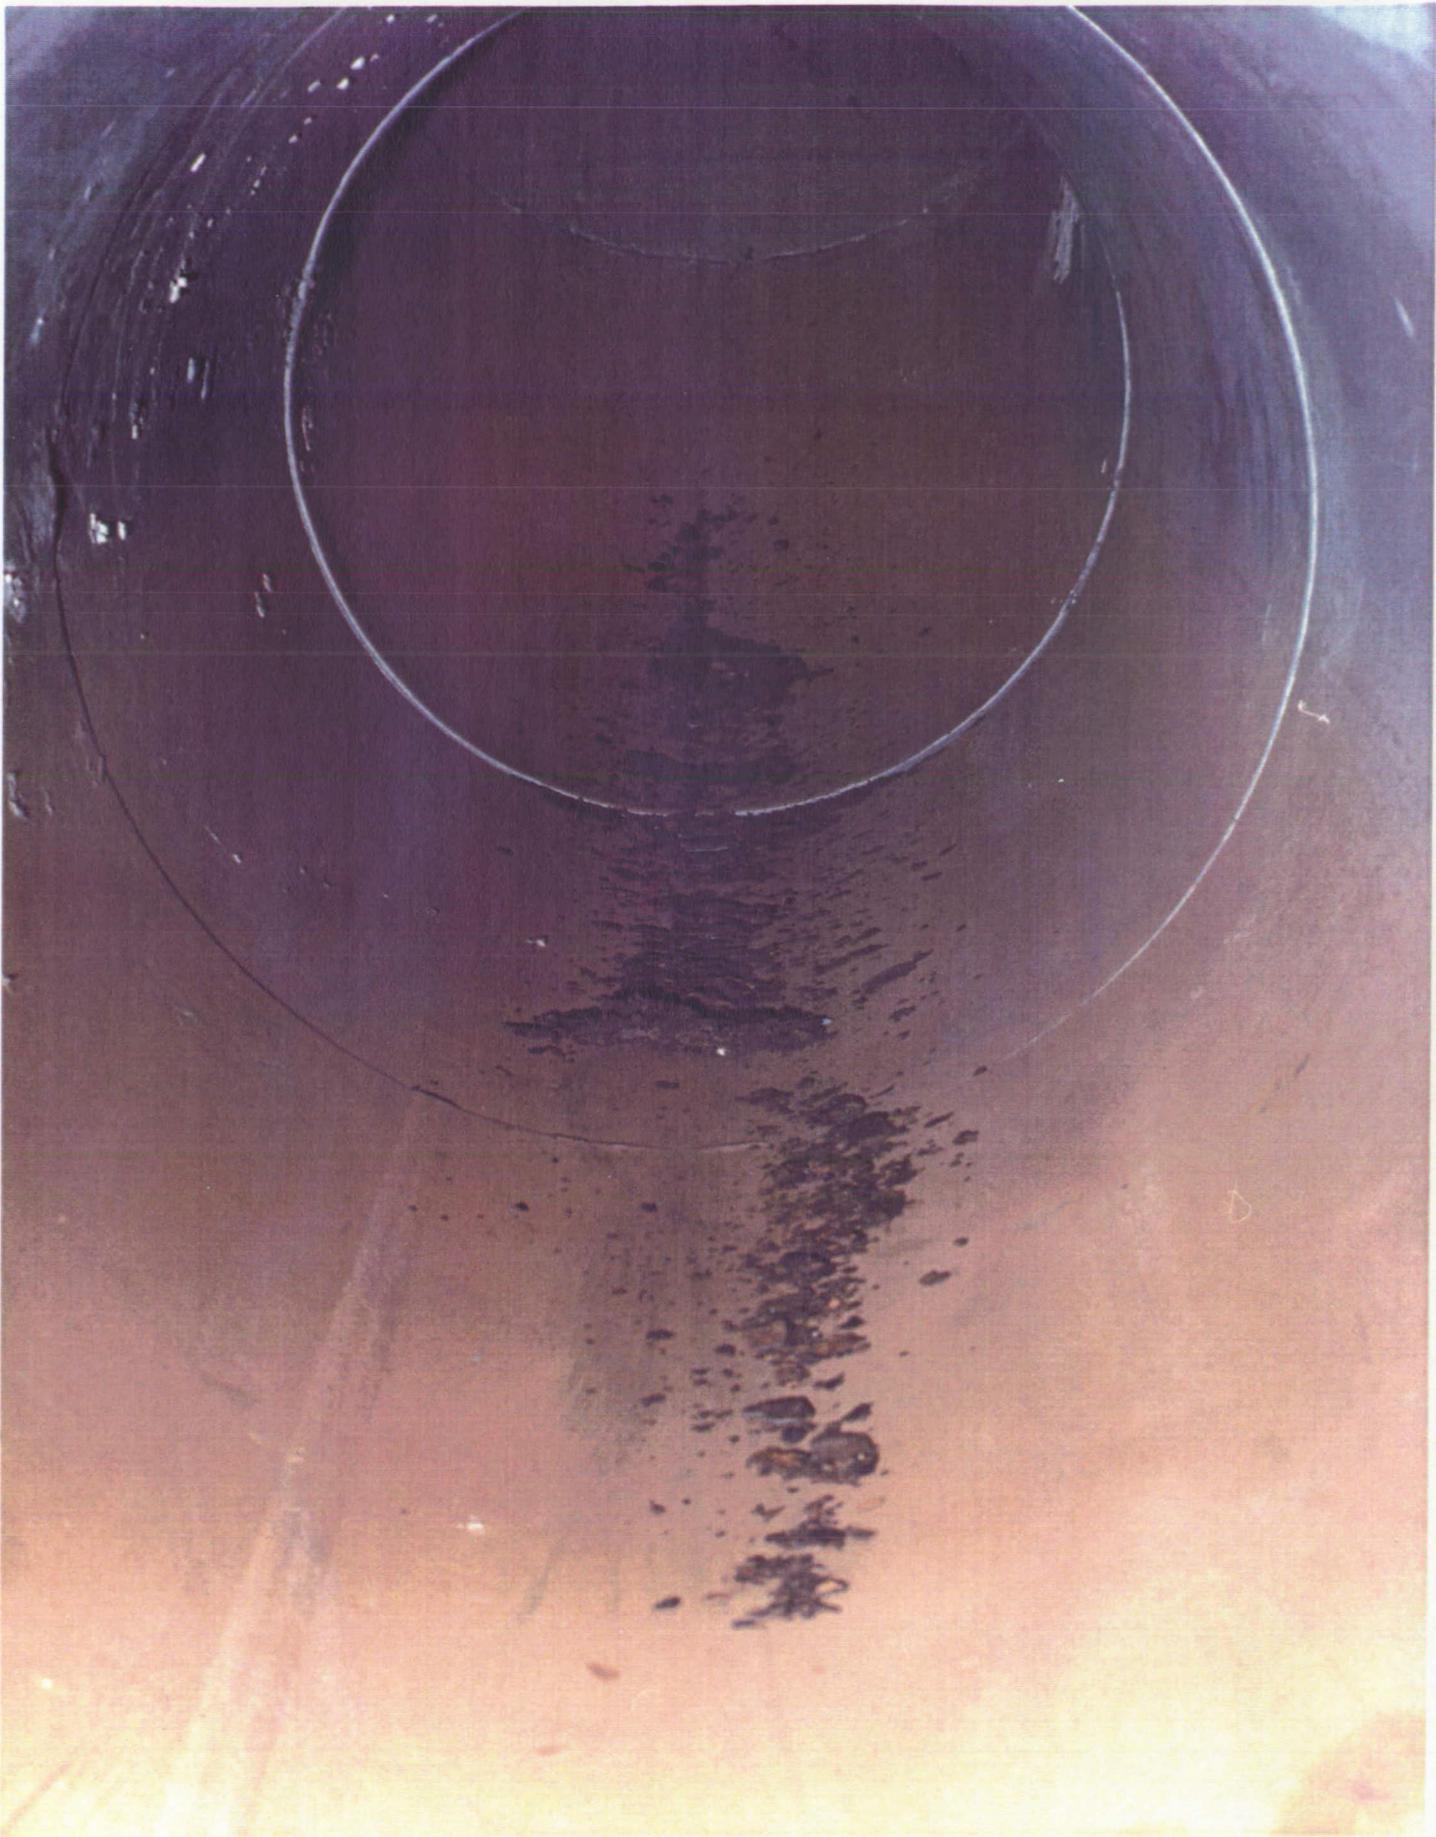
Trash and debris was visible in several areas including all south holddown post haunches. Rust flakes lay in an open sound suppression water pipe west of the SRB exhaust hole.

Rust flakes lay in an MLP deck sound suppression water pipe

Cleanup of the MLP deck and pad surface was almost complete at the time of the inspection. The facility discrepancies were worked real-time or transferred to the pad leader for resolution prior to vehicle tanking.

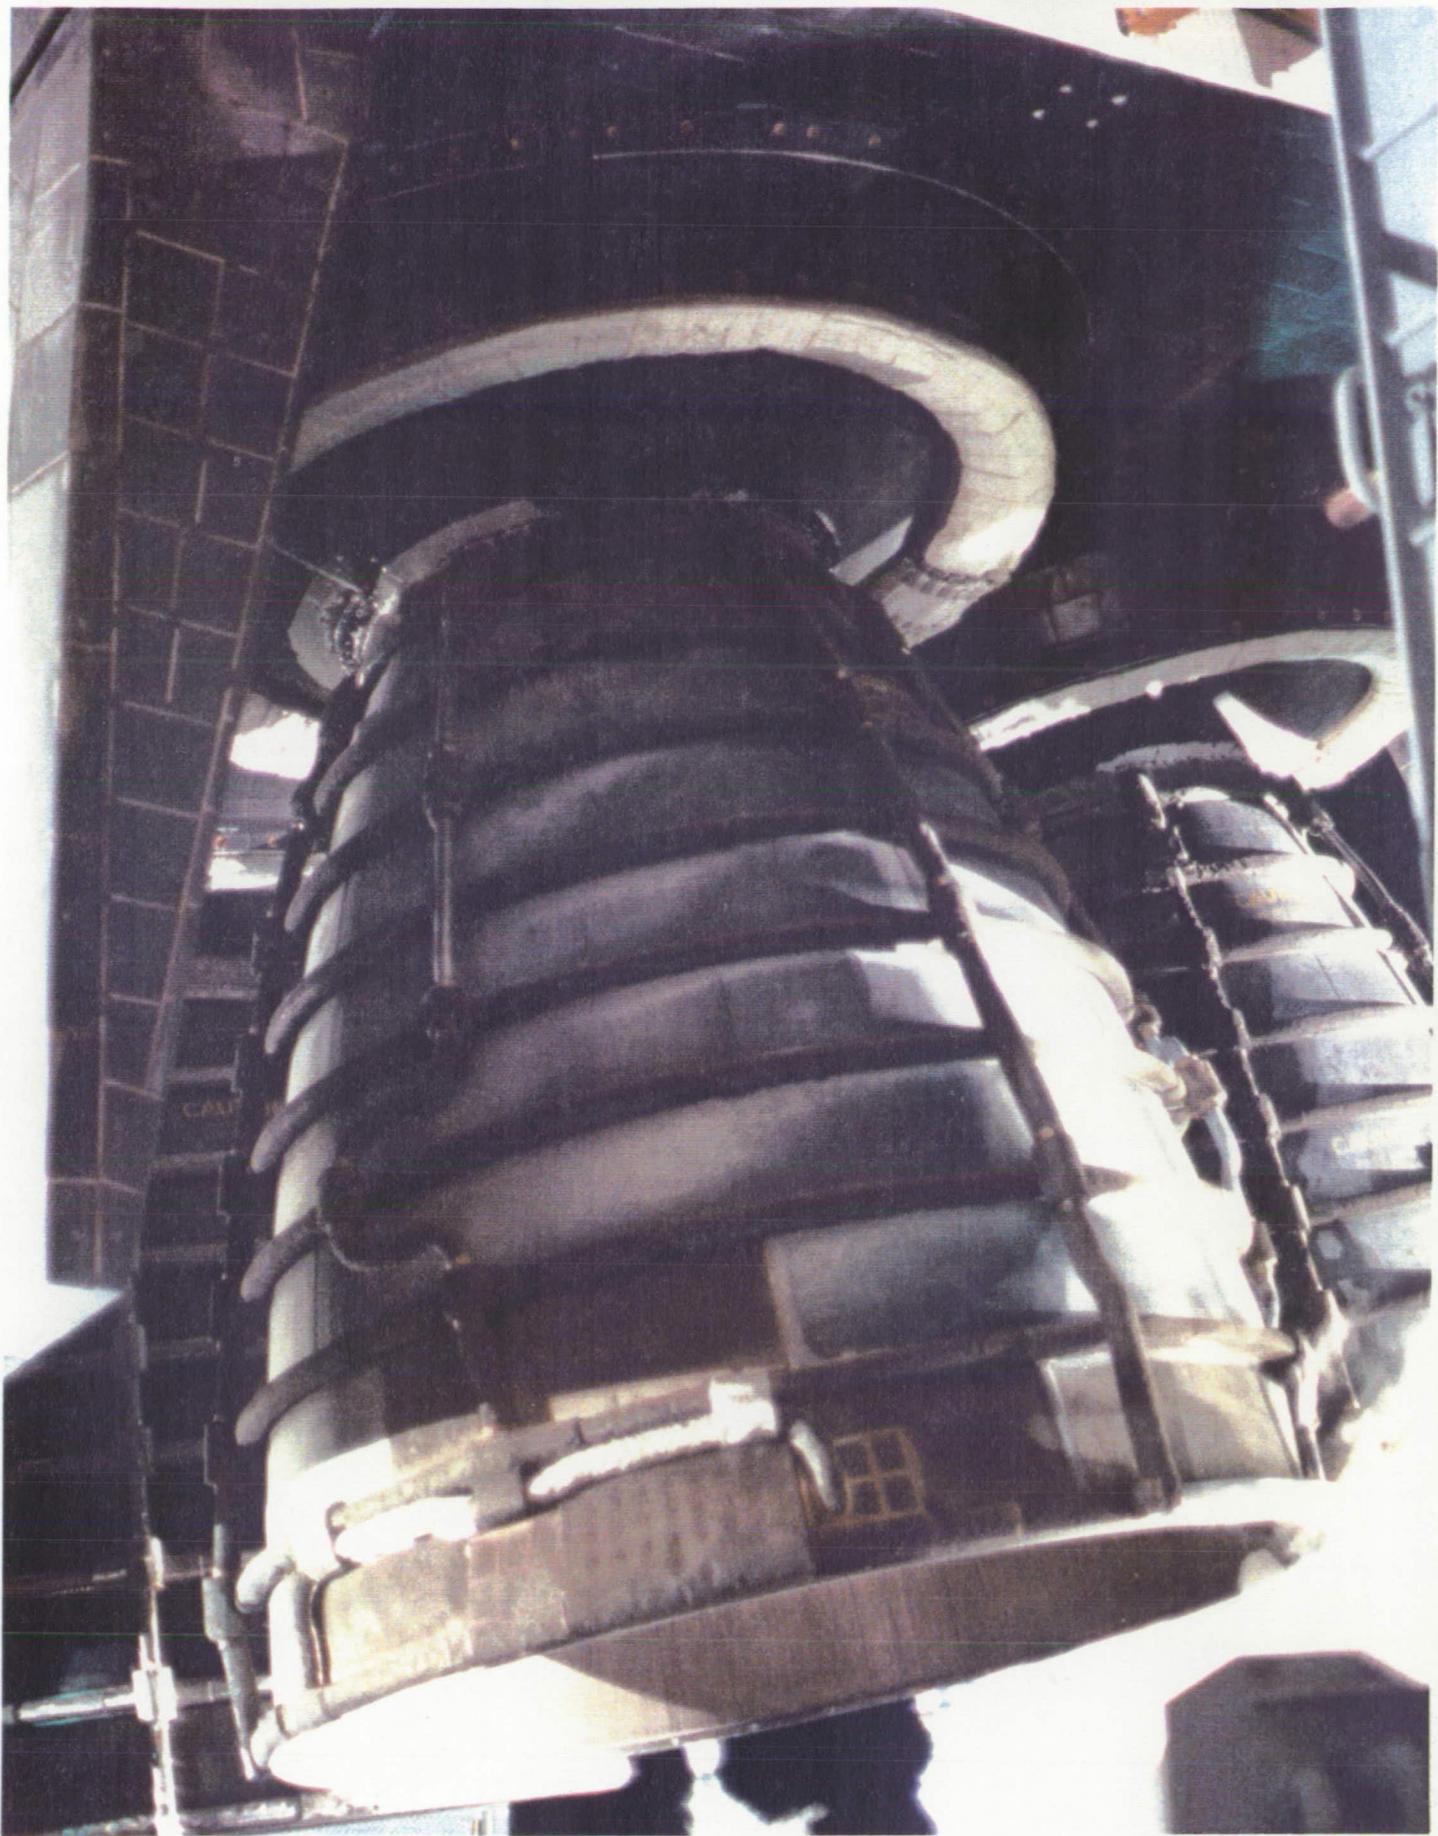
Ice/frost accumulation on SSME #1 and #2 engine mounted
heat shield-to-nozzle interface

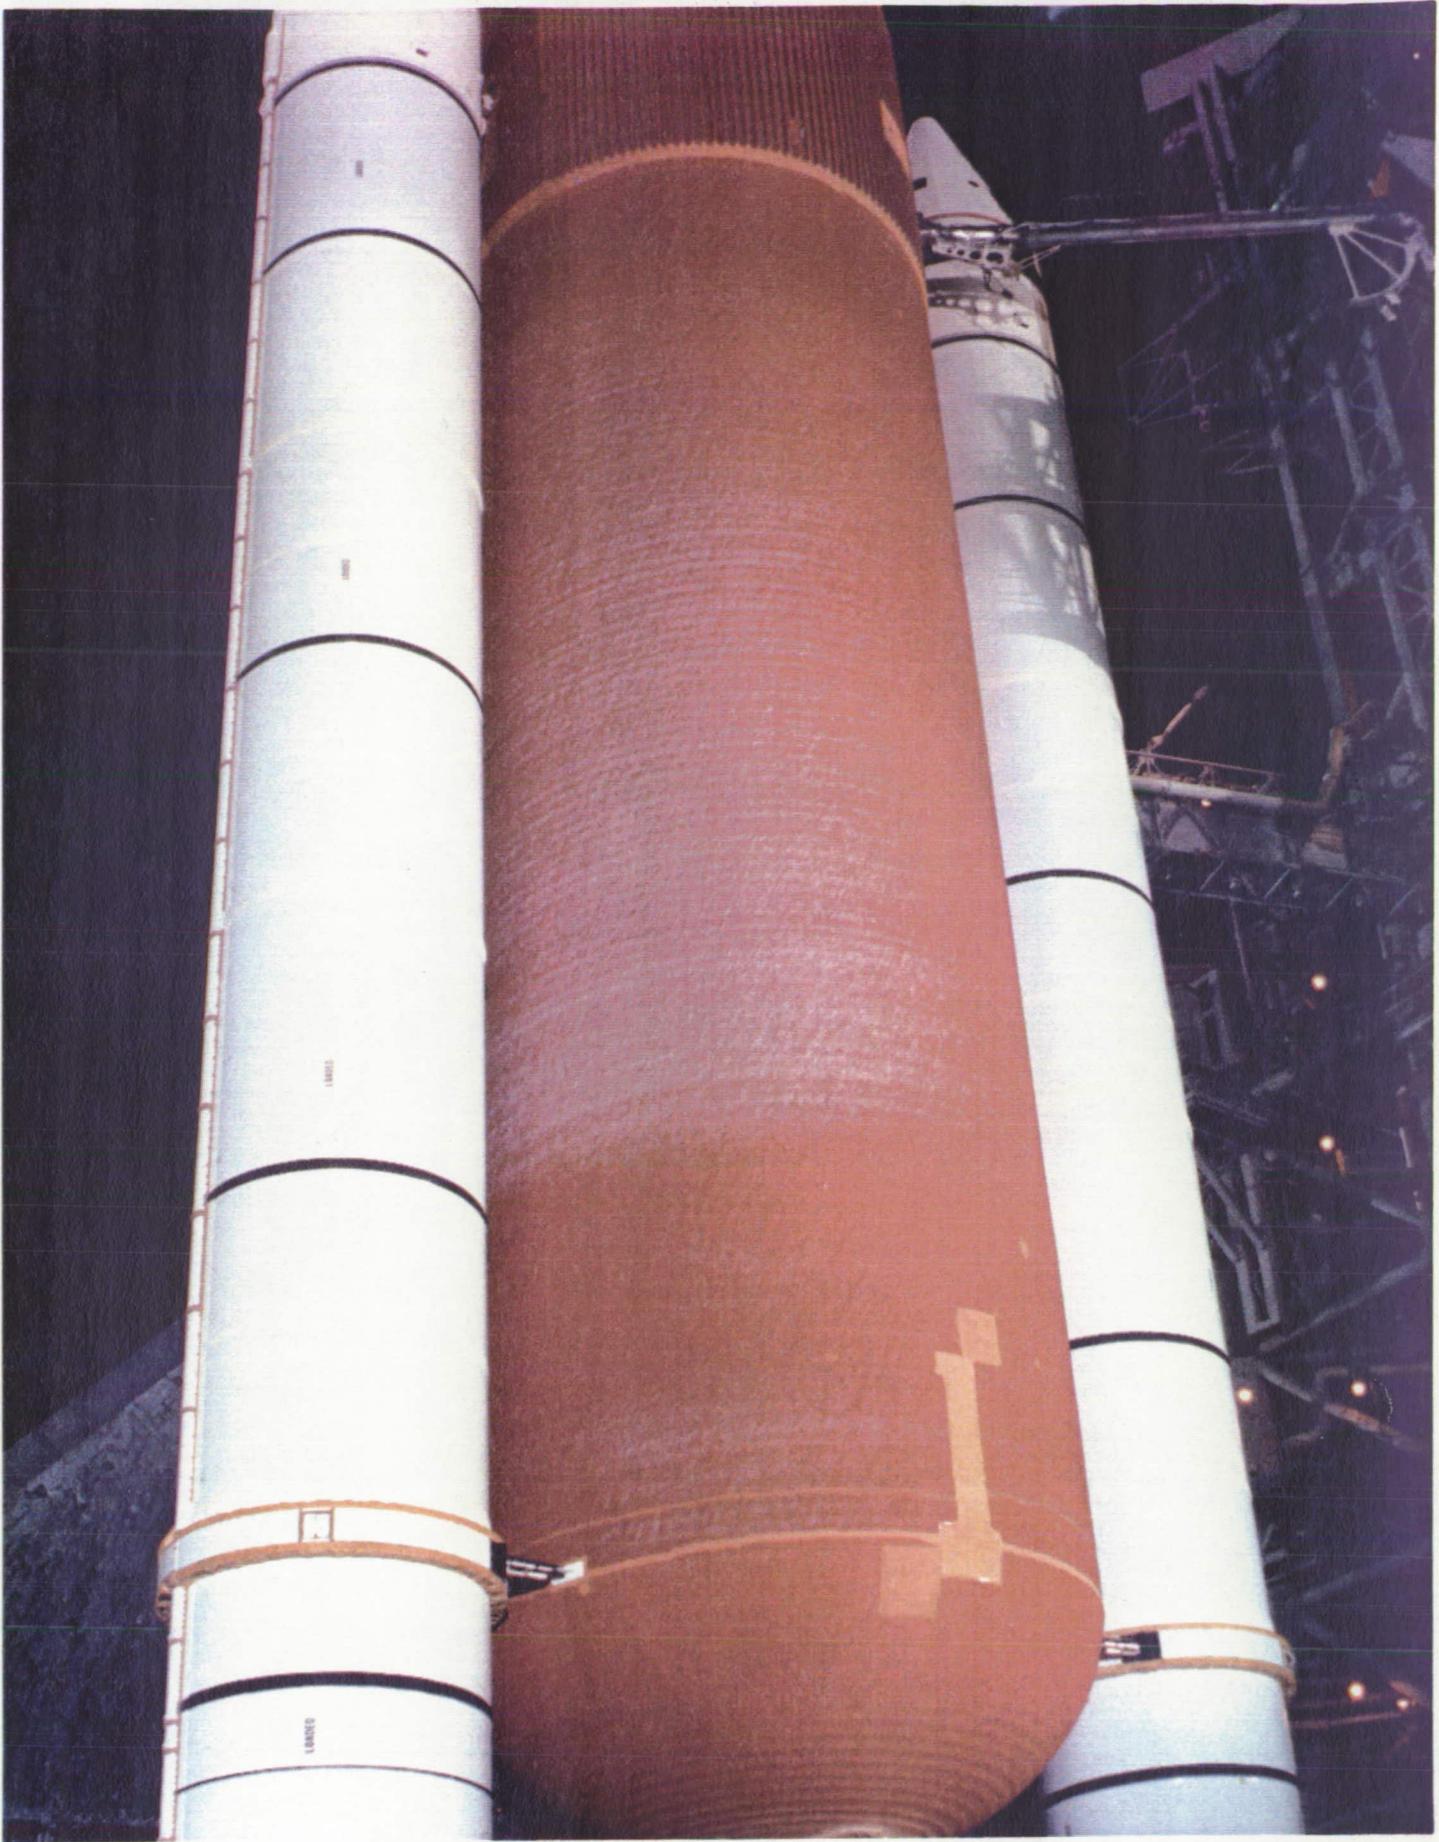
Frost accumulation on the LH2 tank acreeage -Z side at the time
of the Ice Team inspection at T-3 hours

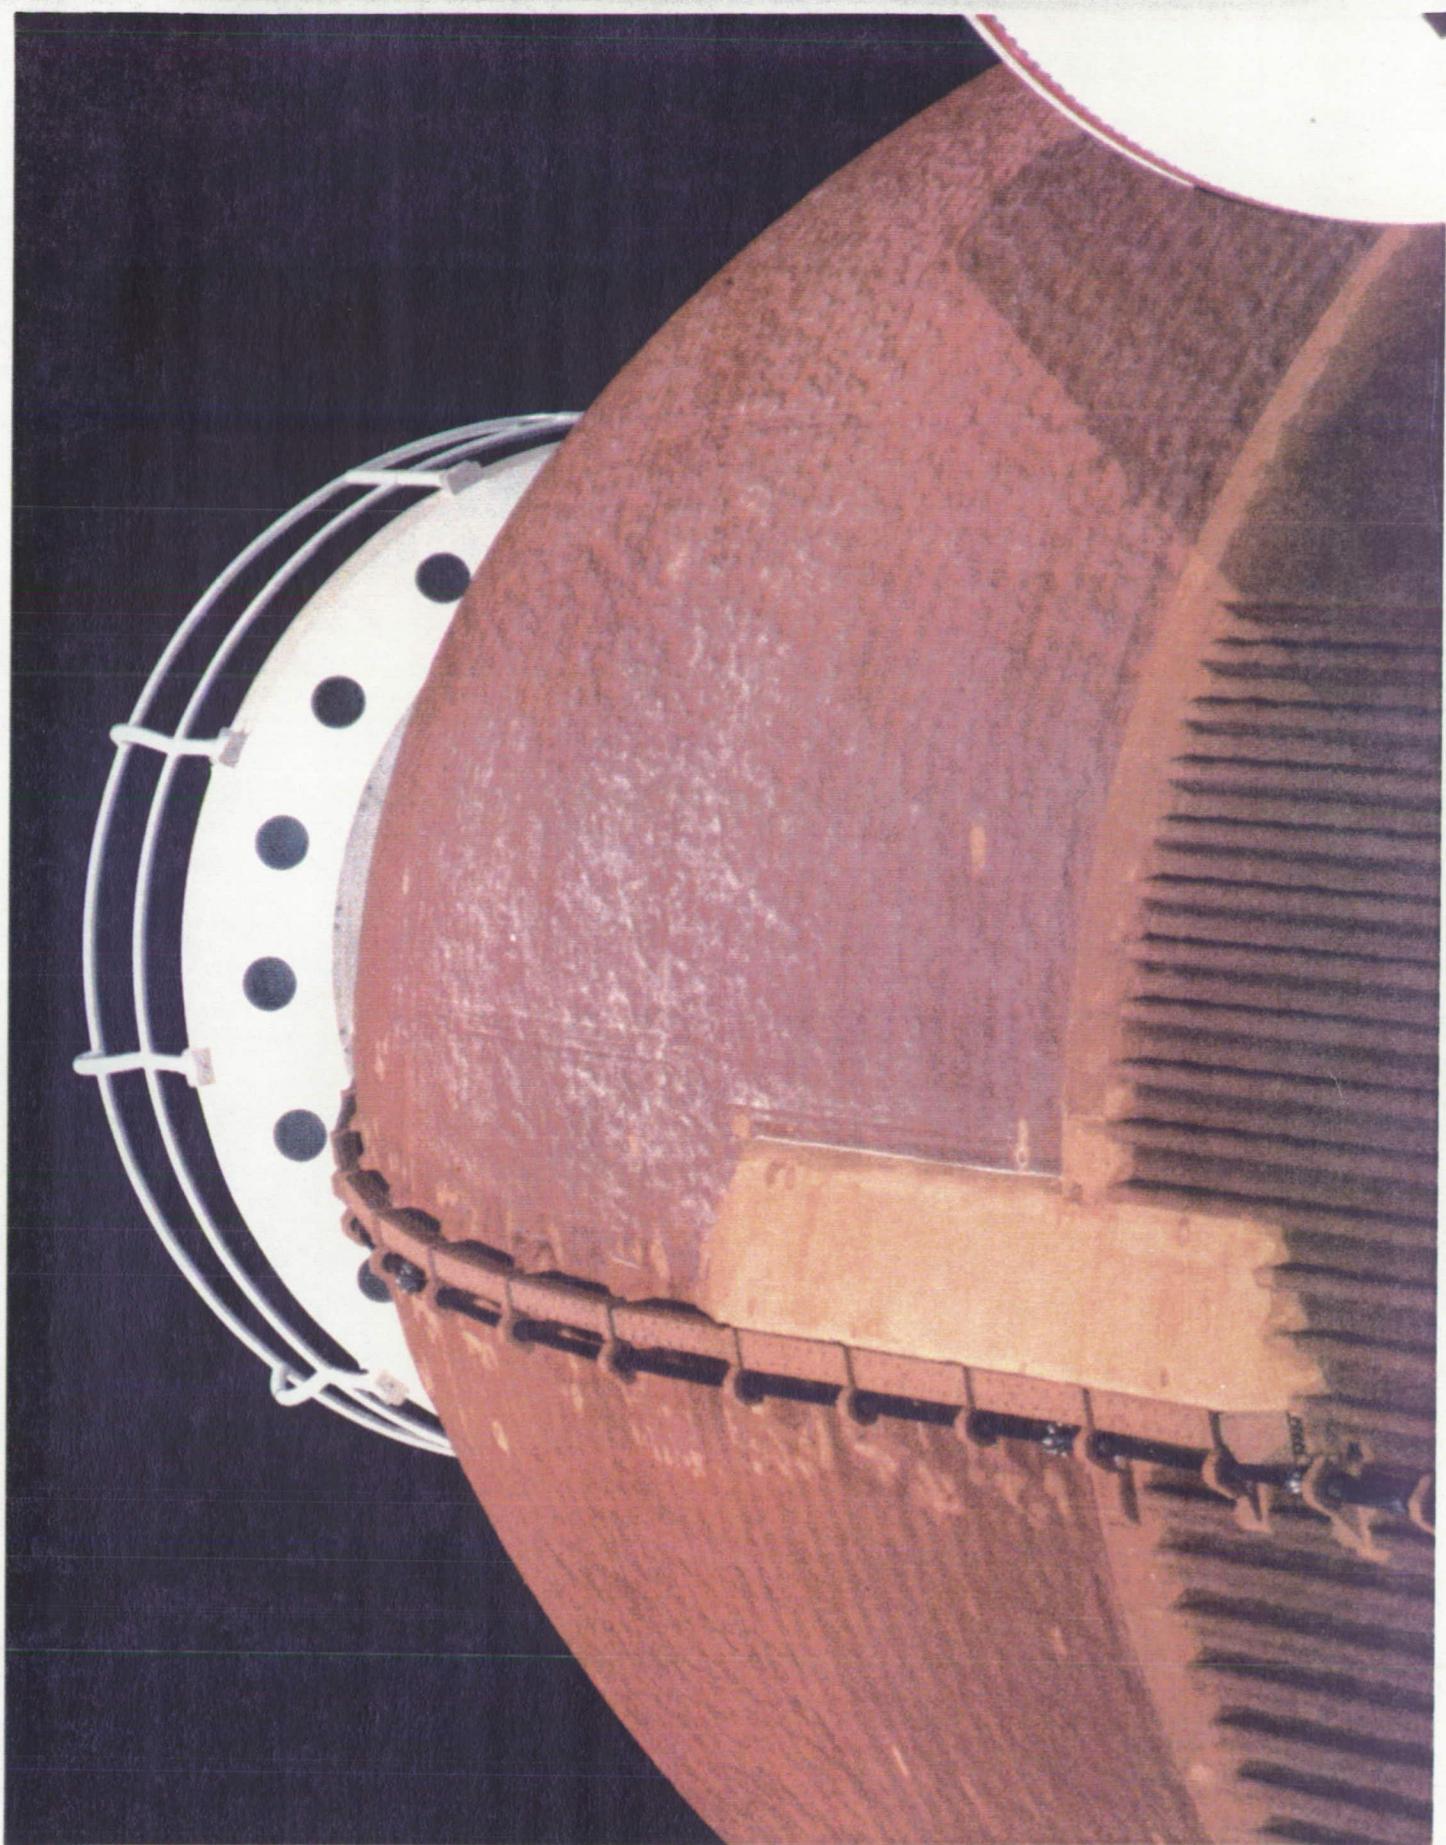
Frost accumulation on the L02 tank barrel section acreage
+Z side at T-3 hours in the countdown

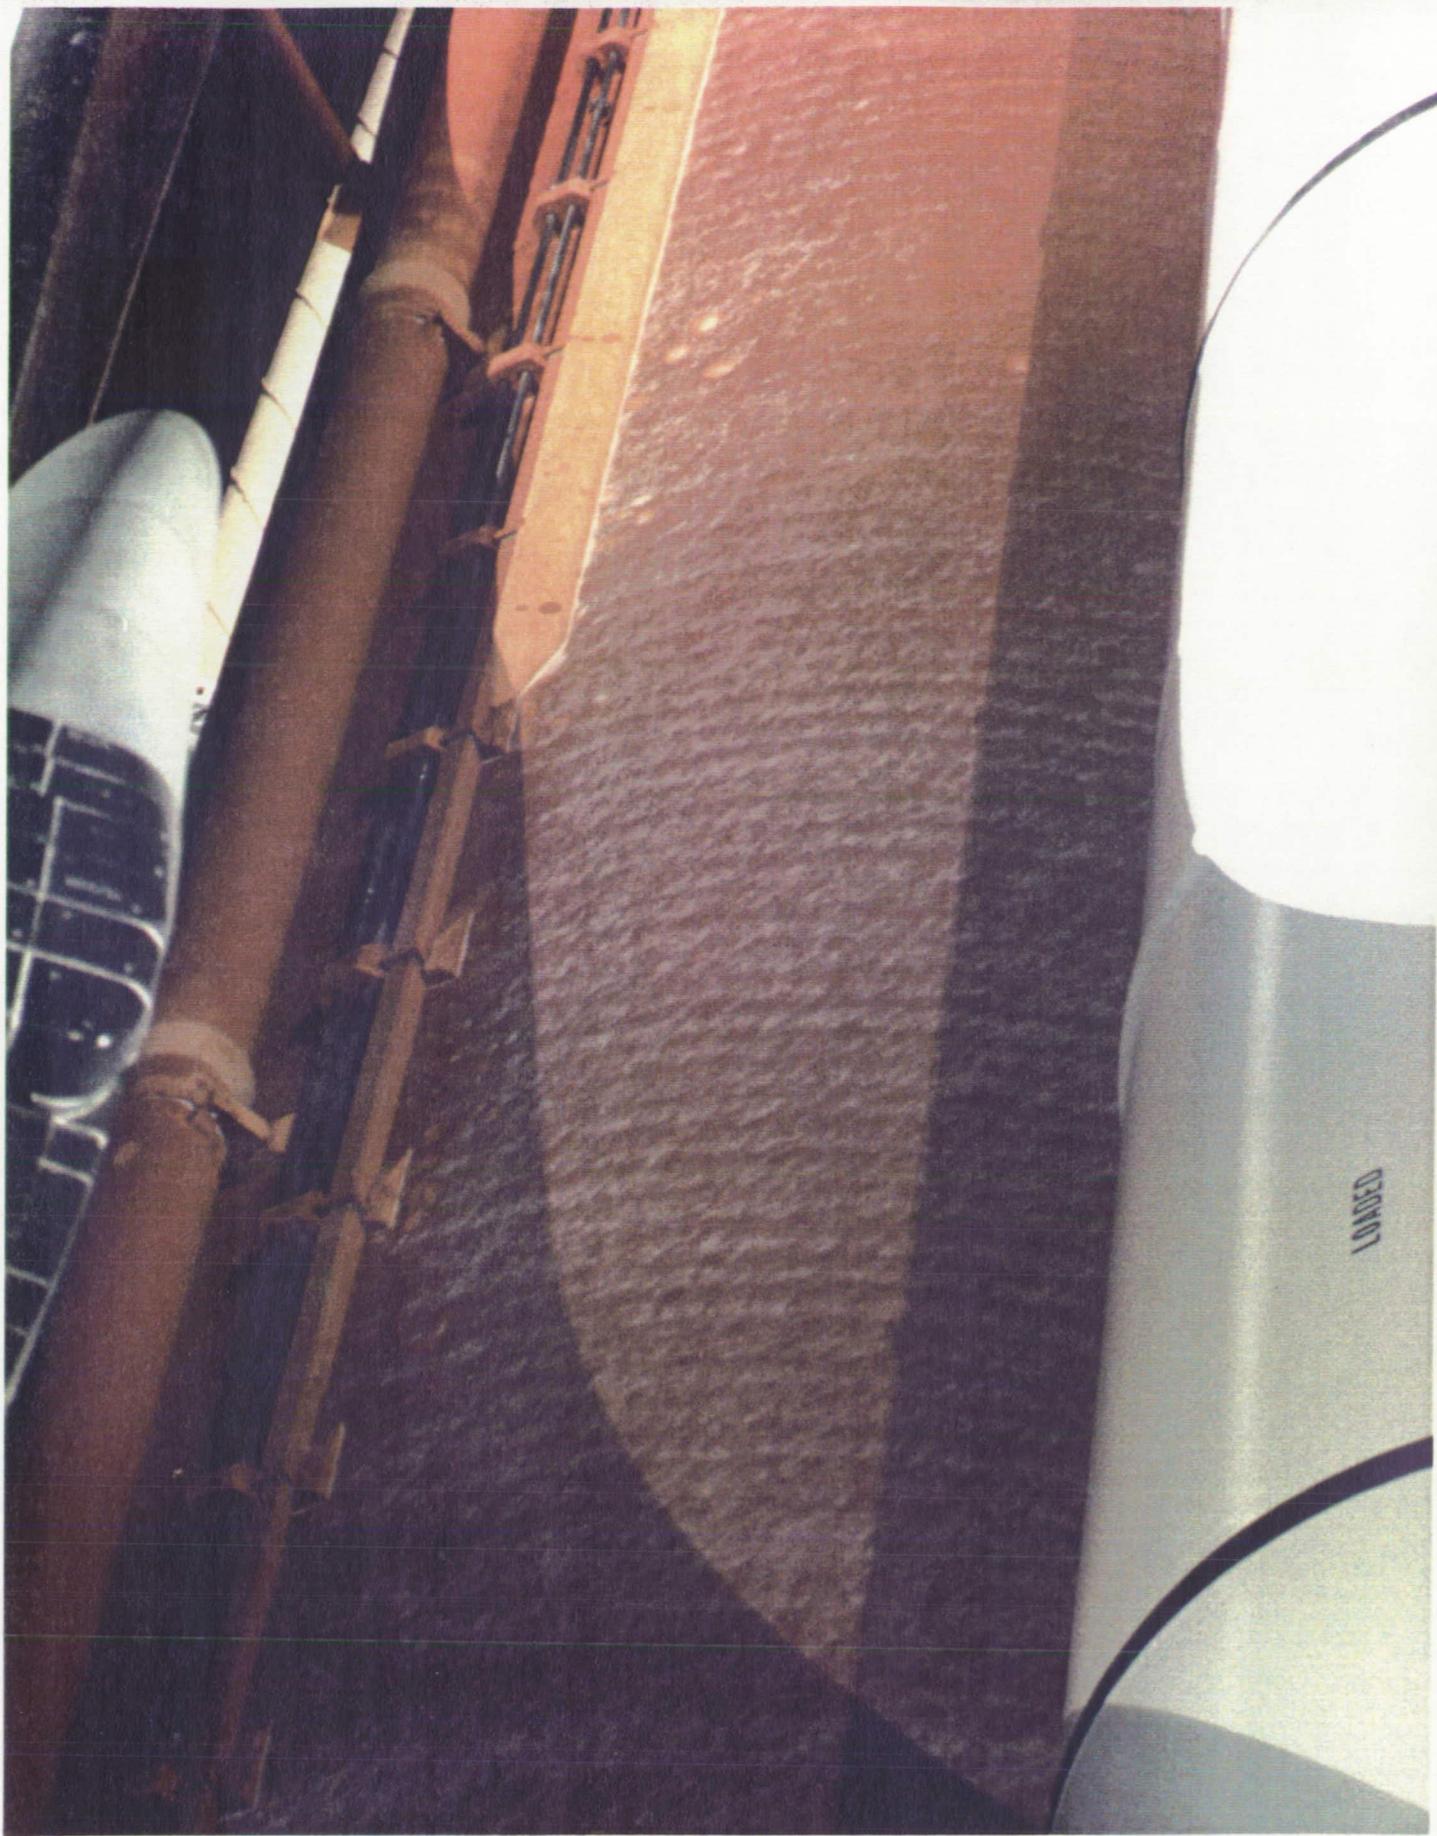
Frost accumulation on the LH2 tank acreage +Y+Z quadrant
visible during the Ice Team inspection
