Debris/Ice/TPS Assessment And Photographic Analysis For Shuttle Mission STS-36

April 1990

DEBRIS/ICE/TPS ASSESSMENT
AND
PHOTOGRAPHIC ANALYSIS
OF
SHUTTLE MISSION STS-36

February 28, 1990

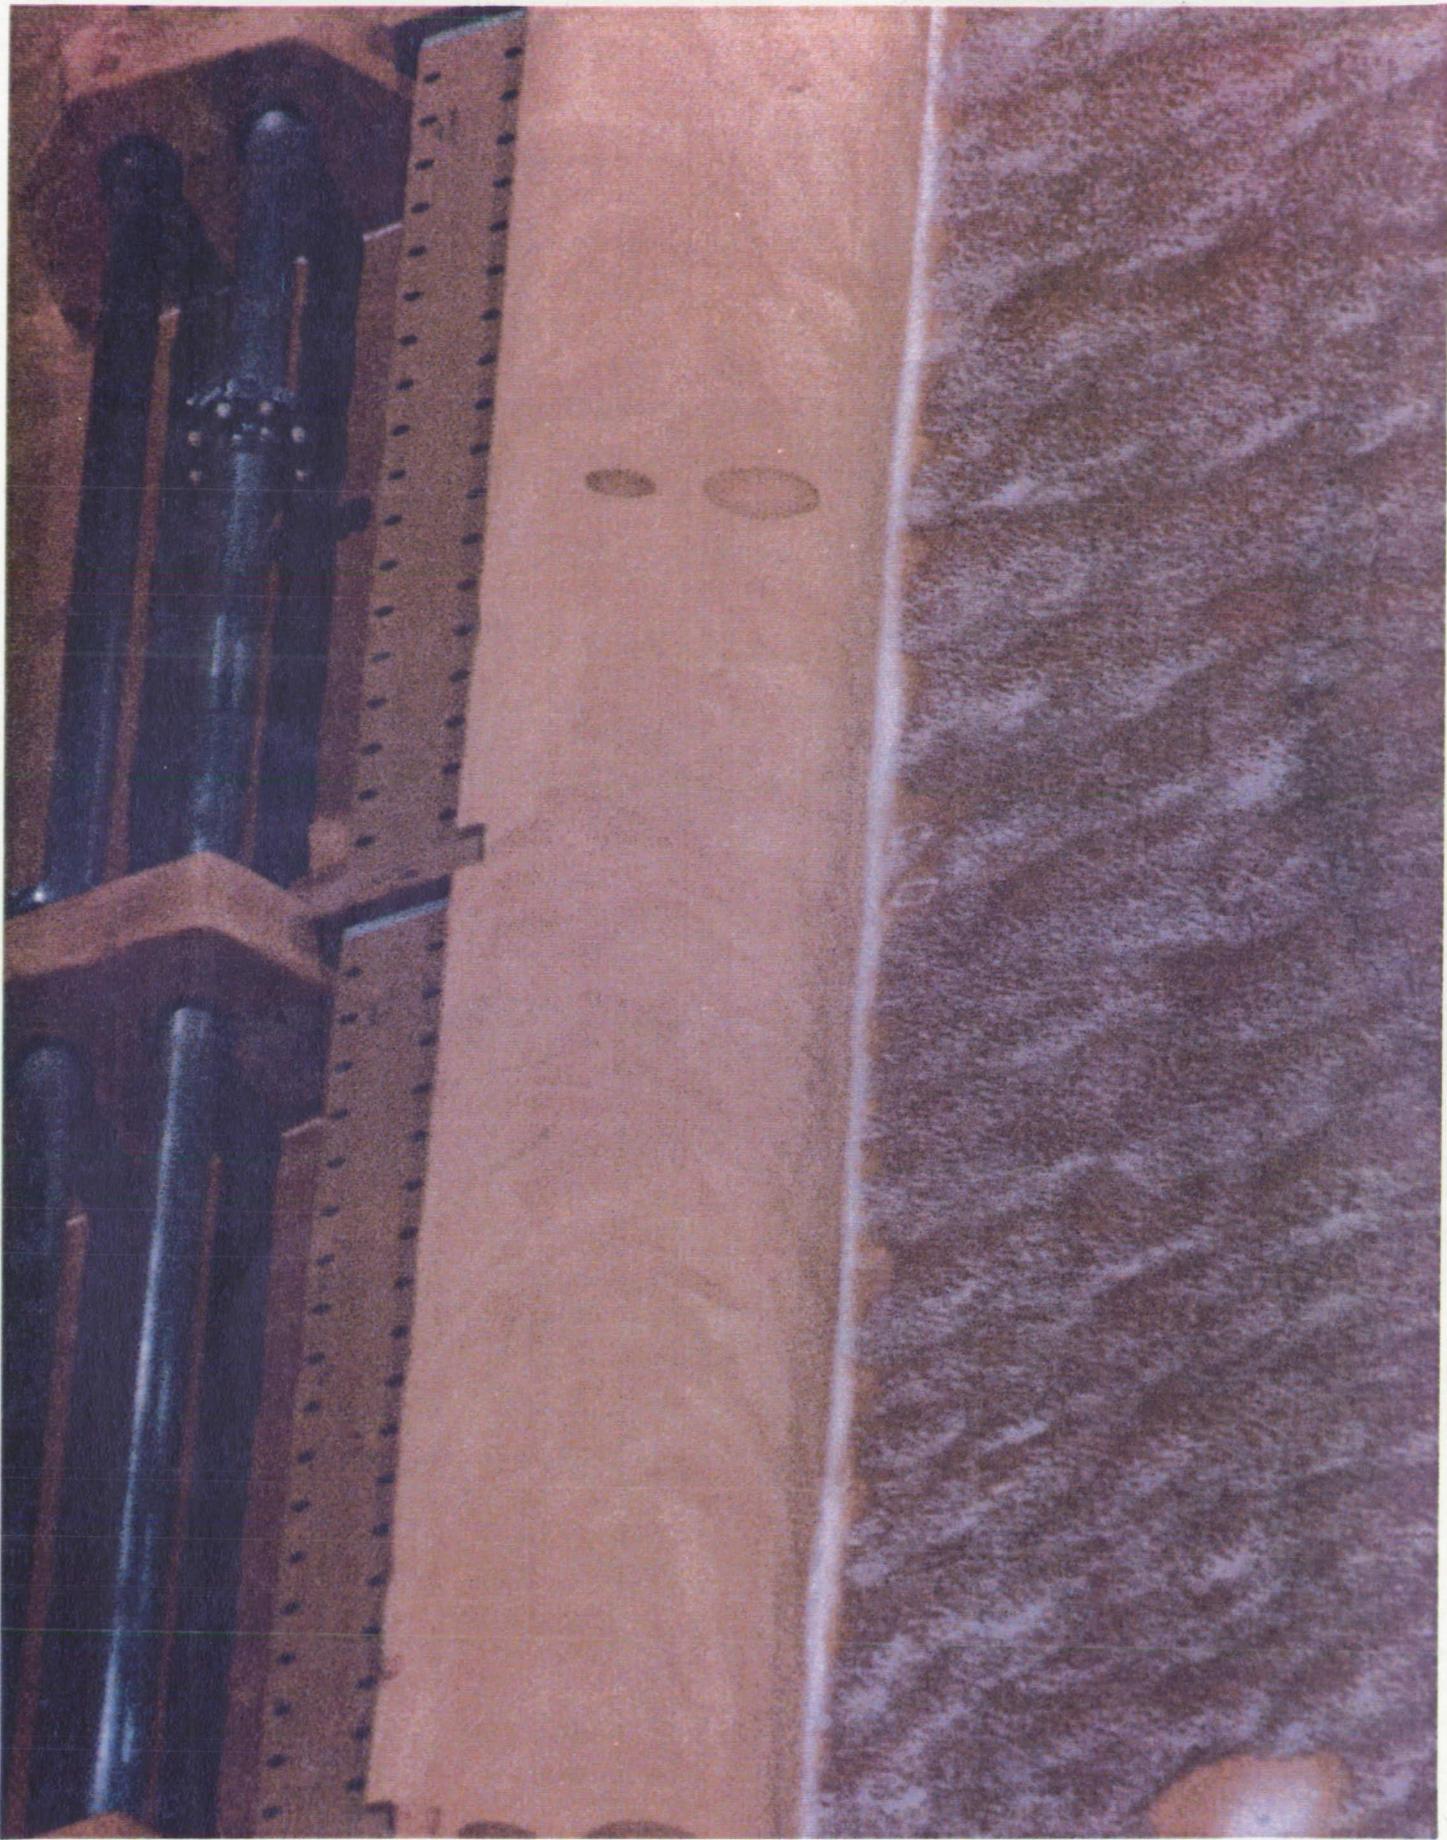
Frost accumulation along the PAL ramp-to-LH2 tank acreage interface

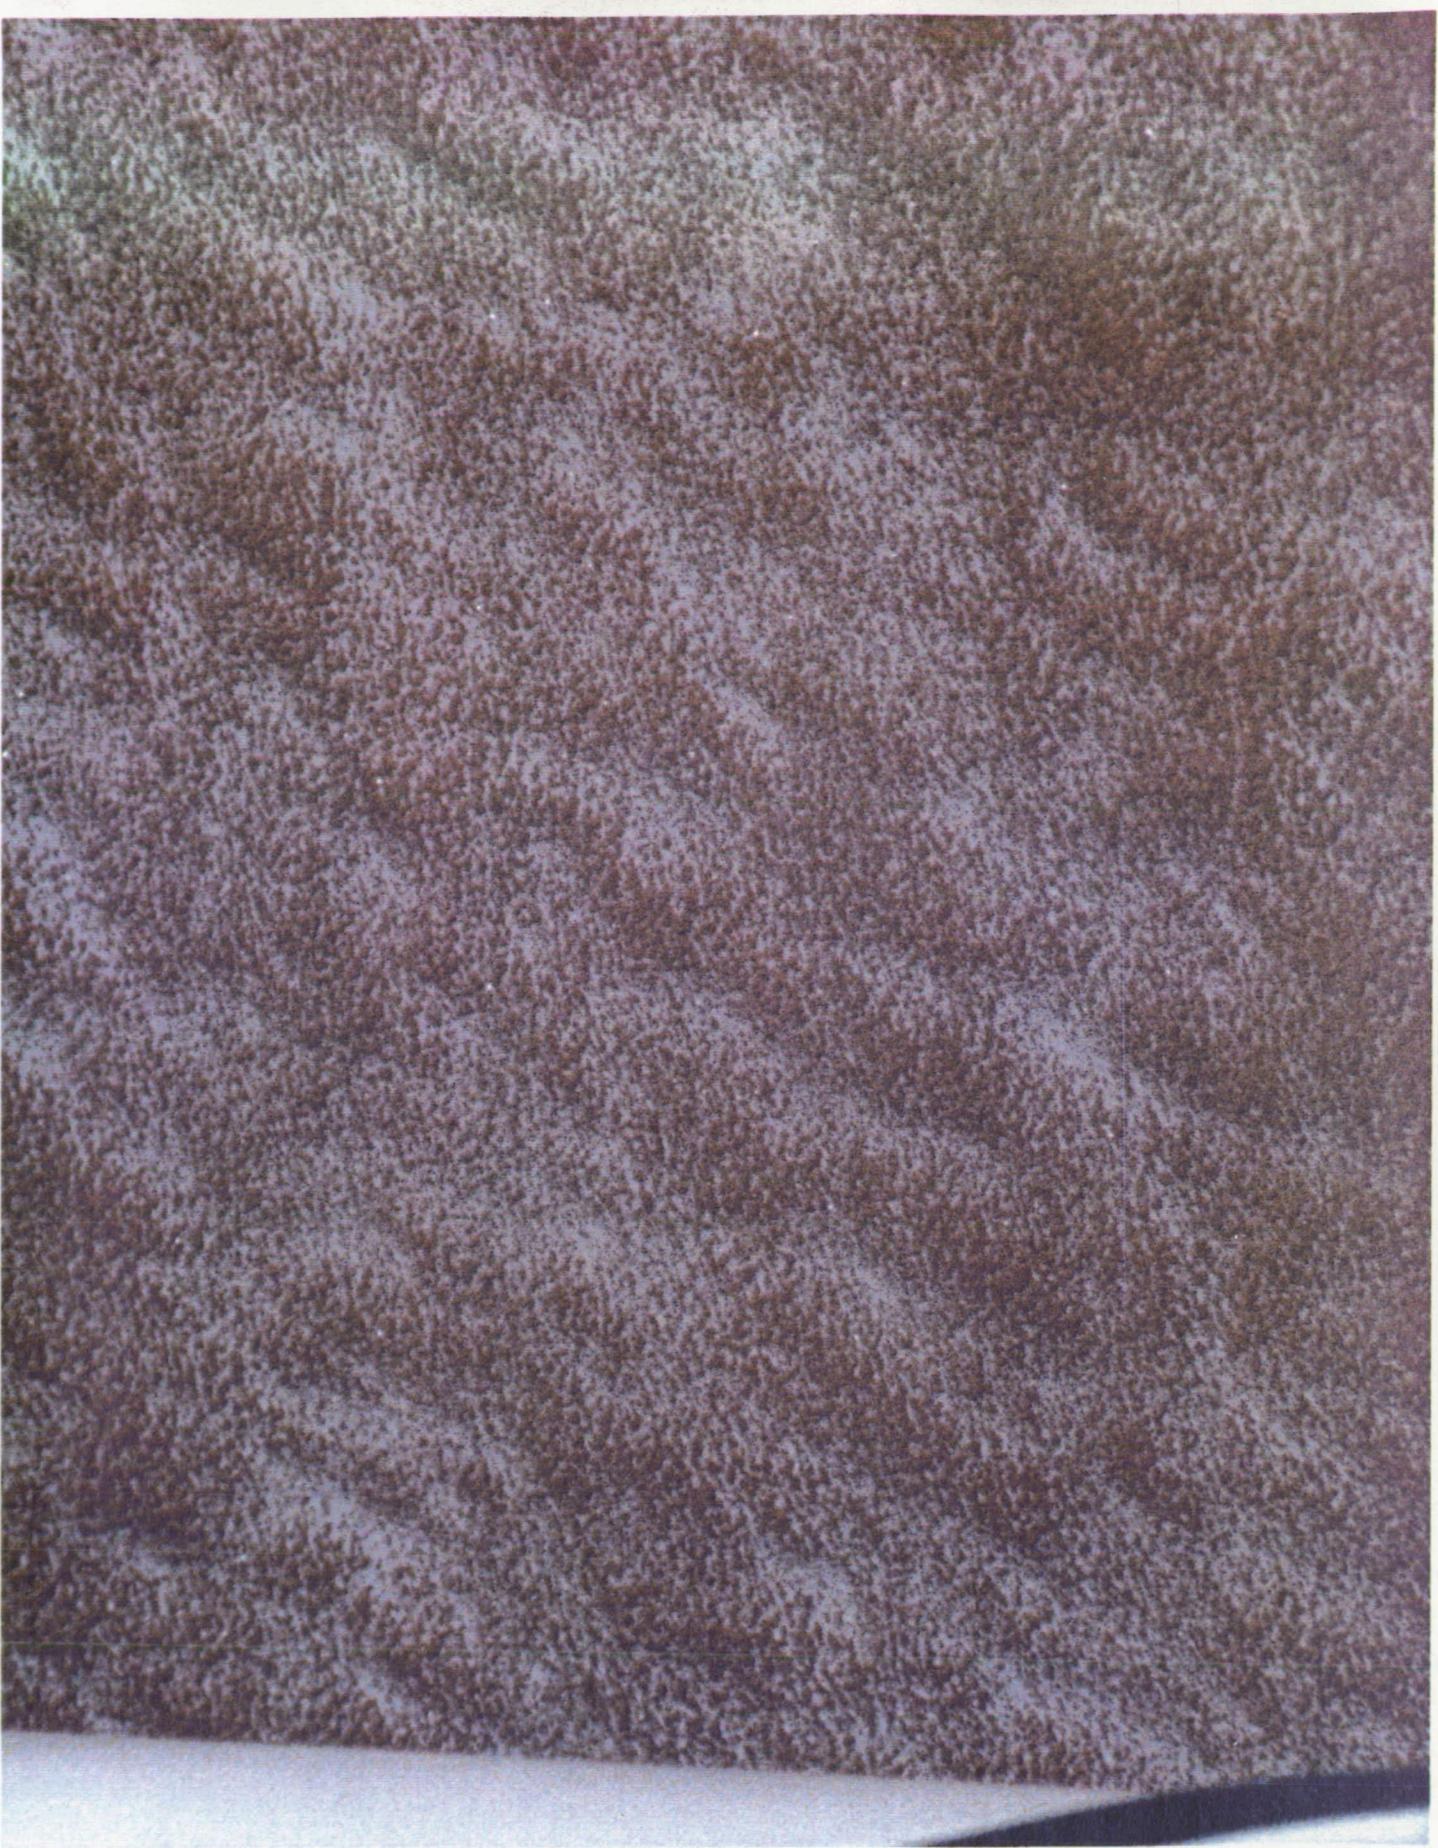
Close-in view of frost accumulation on the LH2 tank acreage

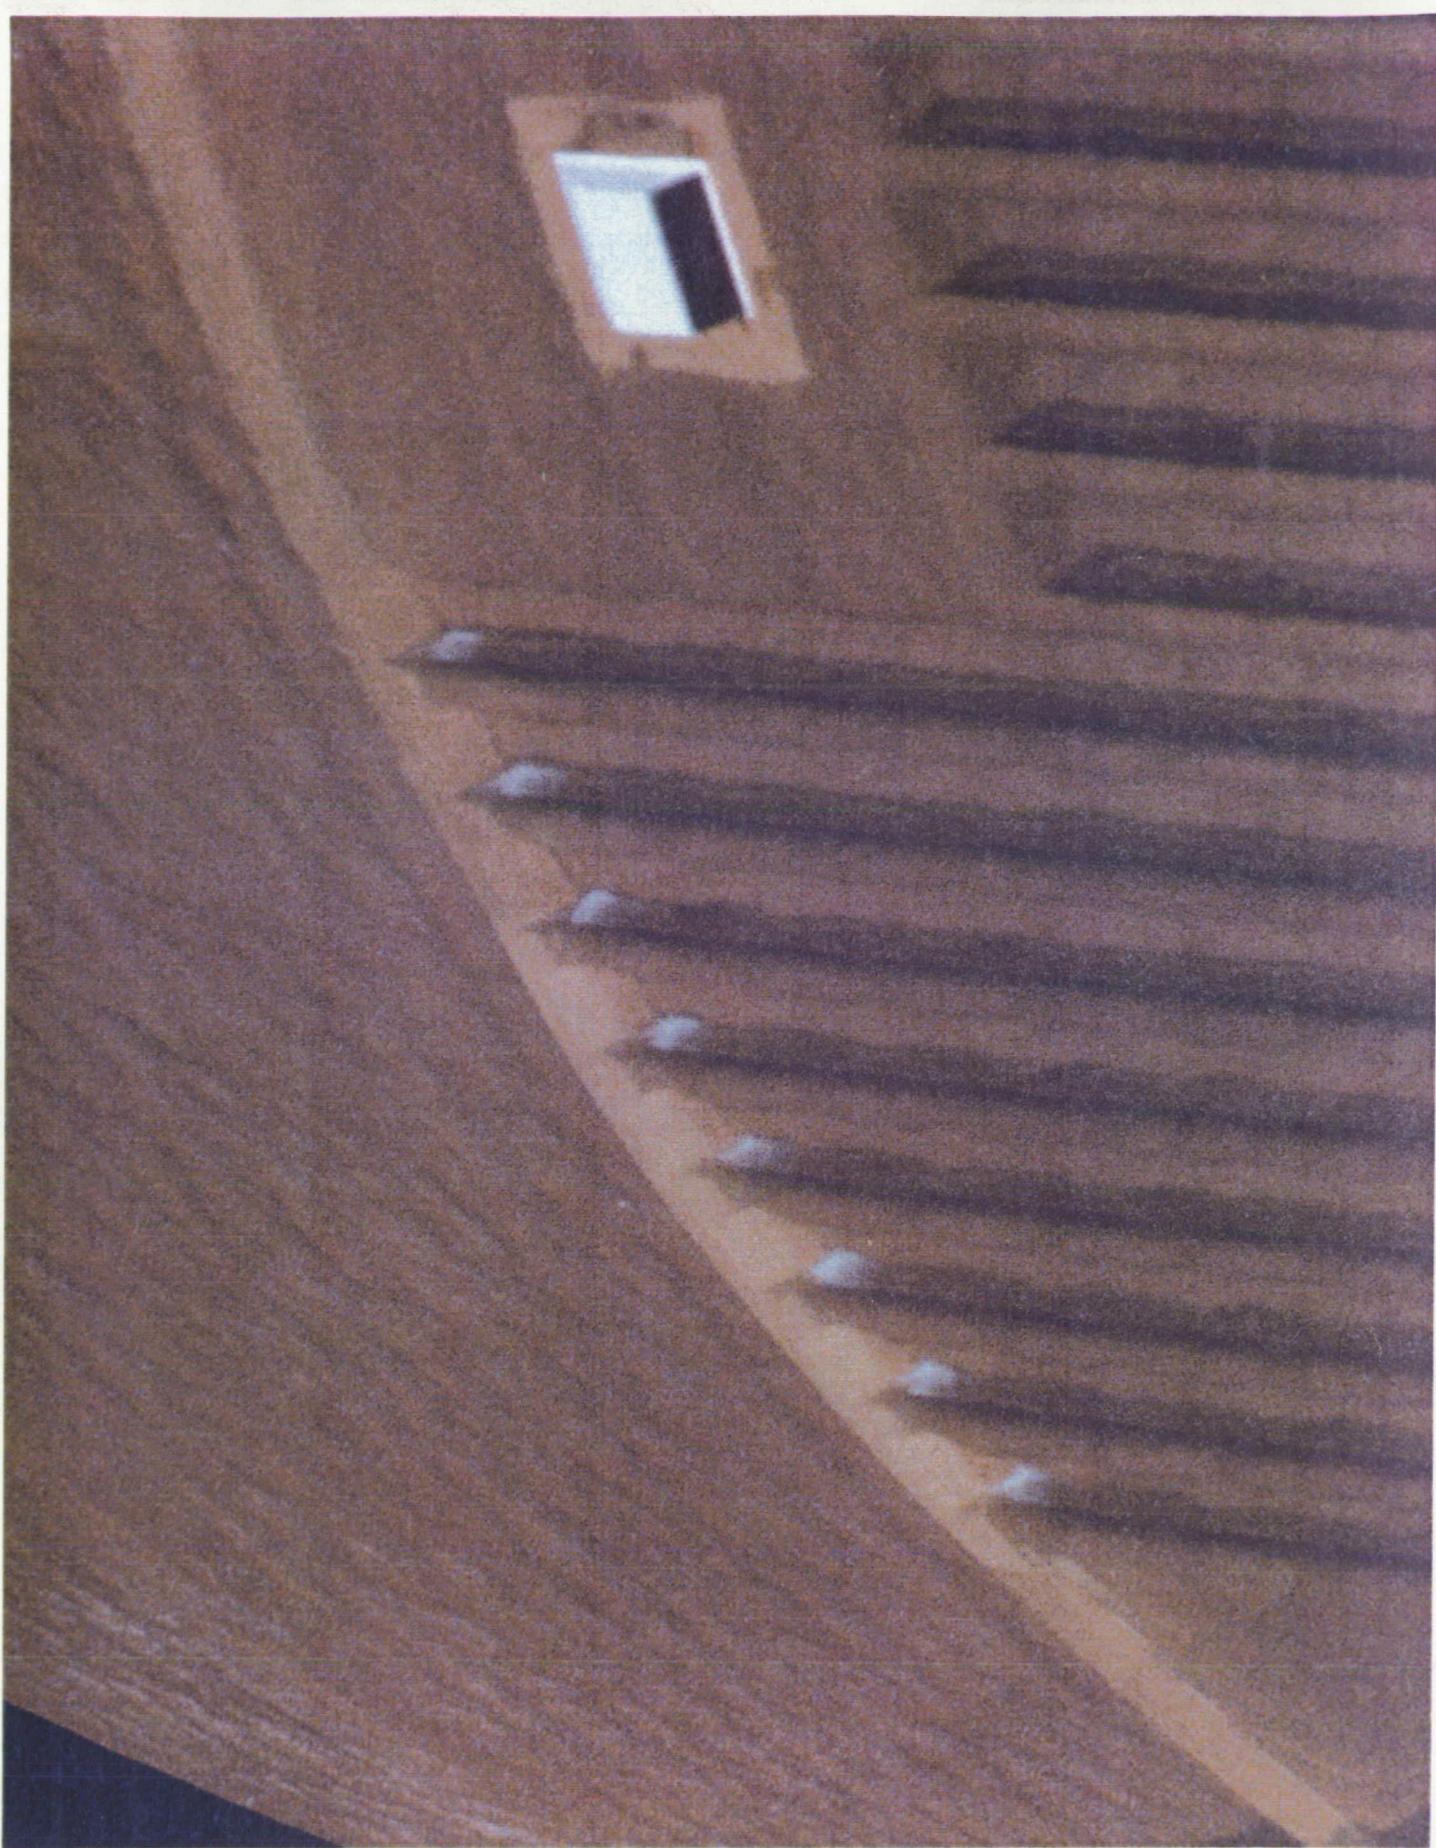
Ice/frost had formed in the intertank -Z side stringer valleys
at the LO2 tank flange

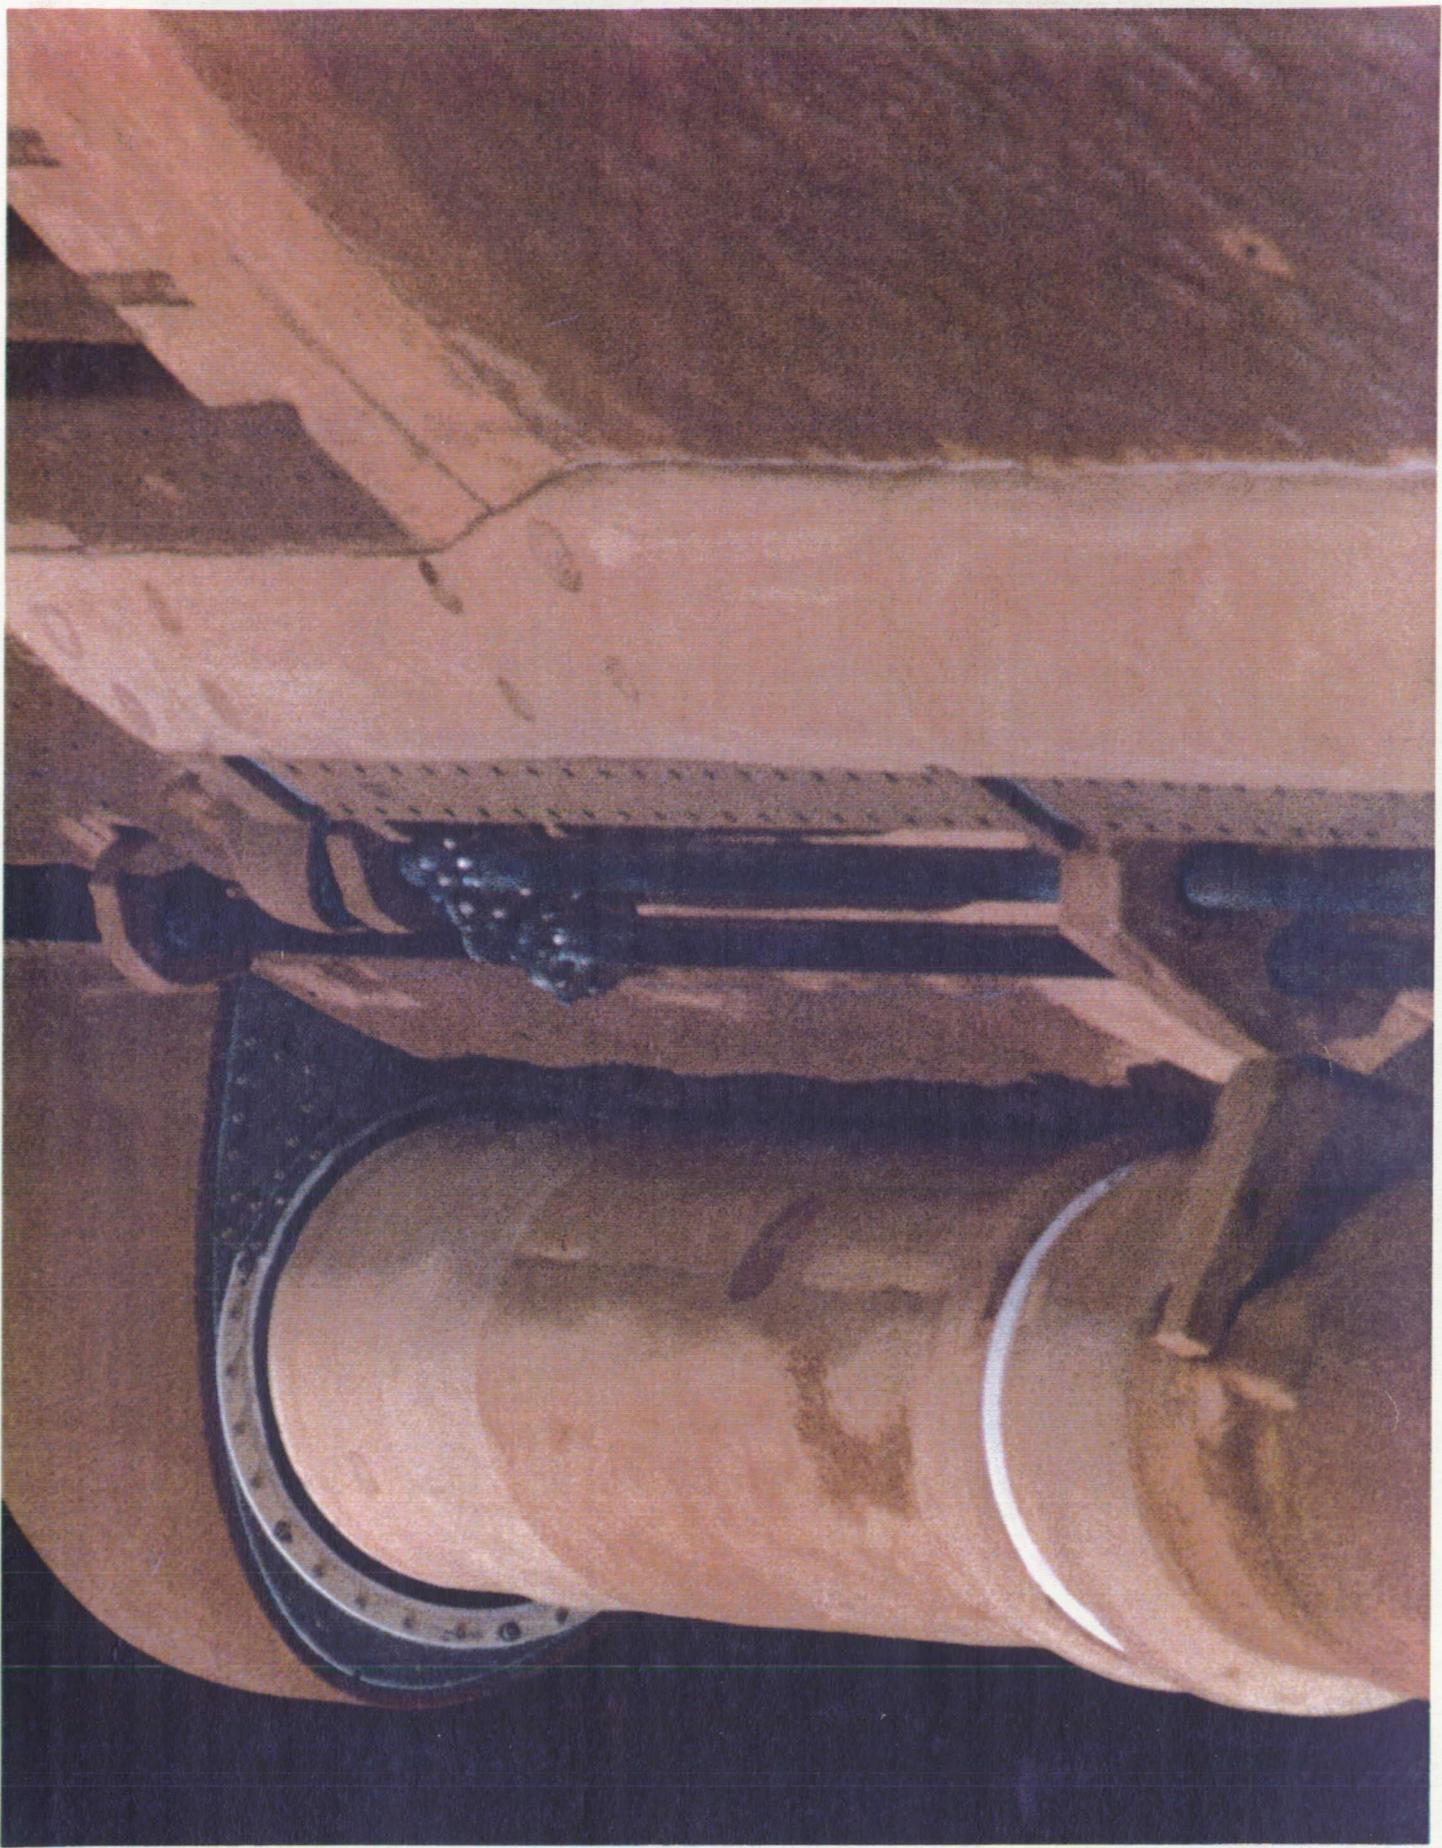
Typical ice/frost formation in the L02 feedline upper bellows

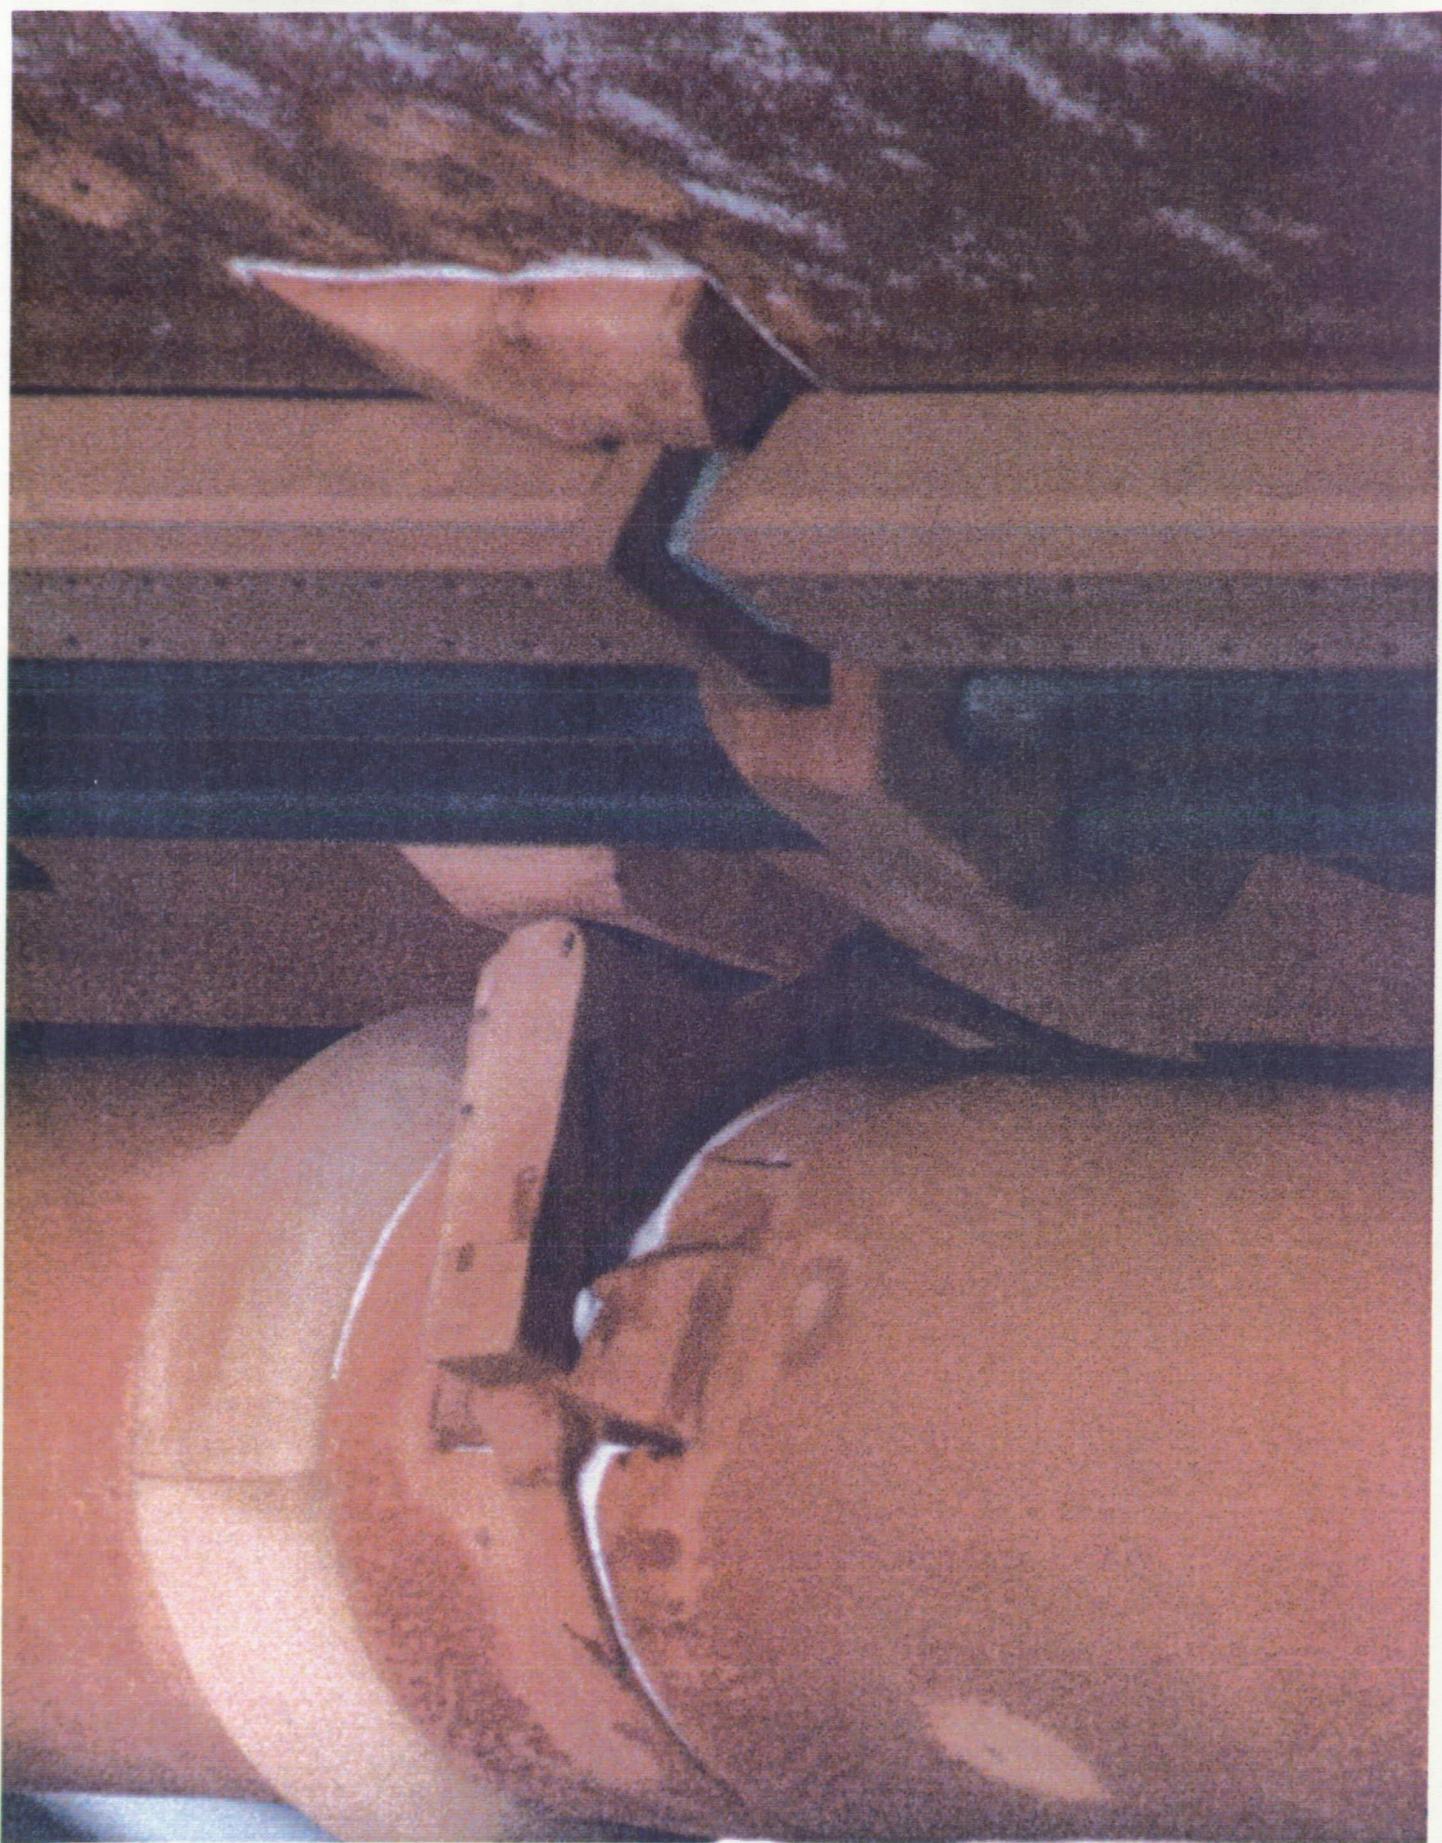
Ice/frost formed along the cable tray ramps and in the L02
feedline support brackets

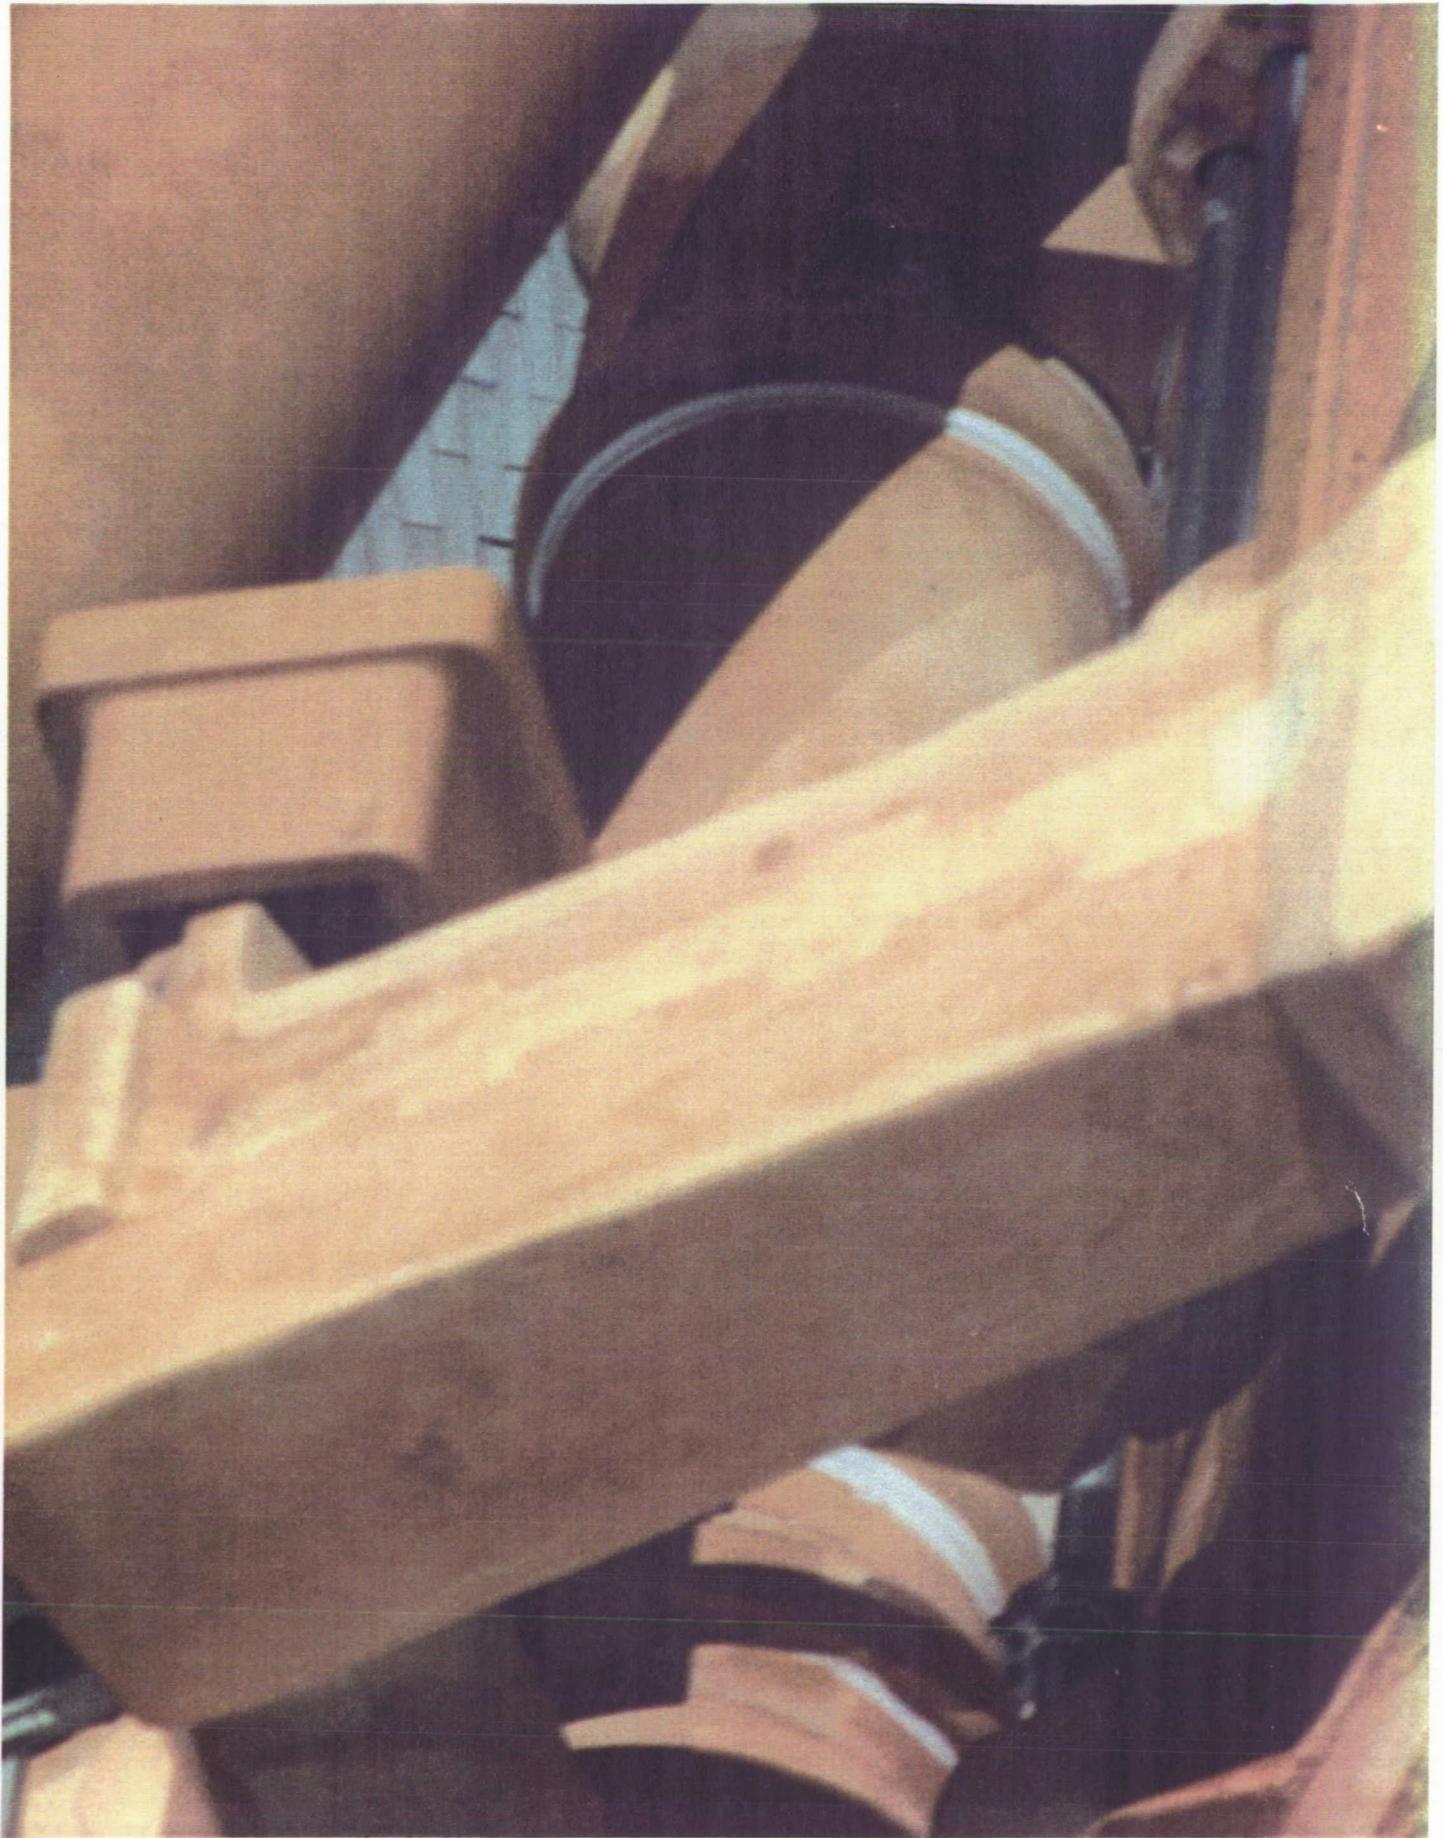
Ice/frost accumulations in the L02 feedline lower bellows
and support brackets

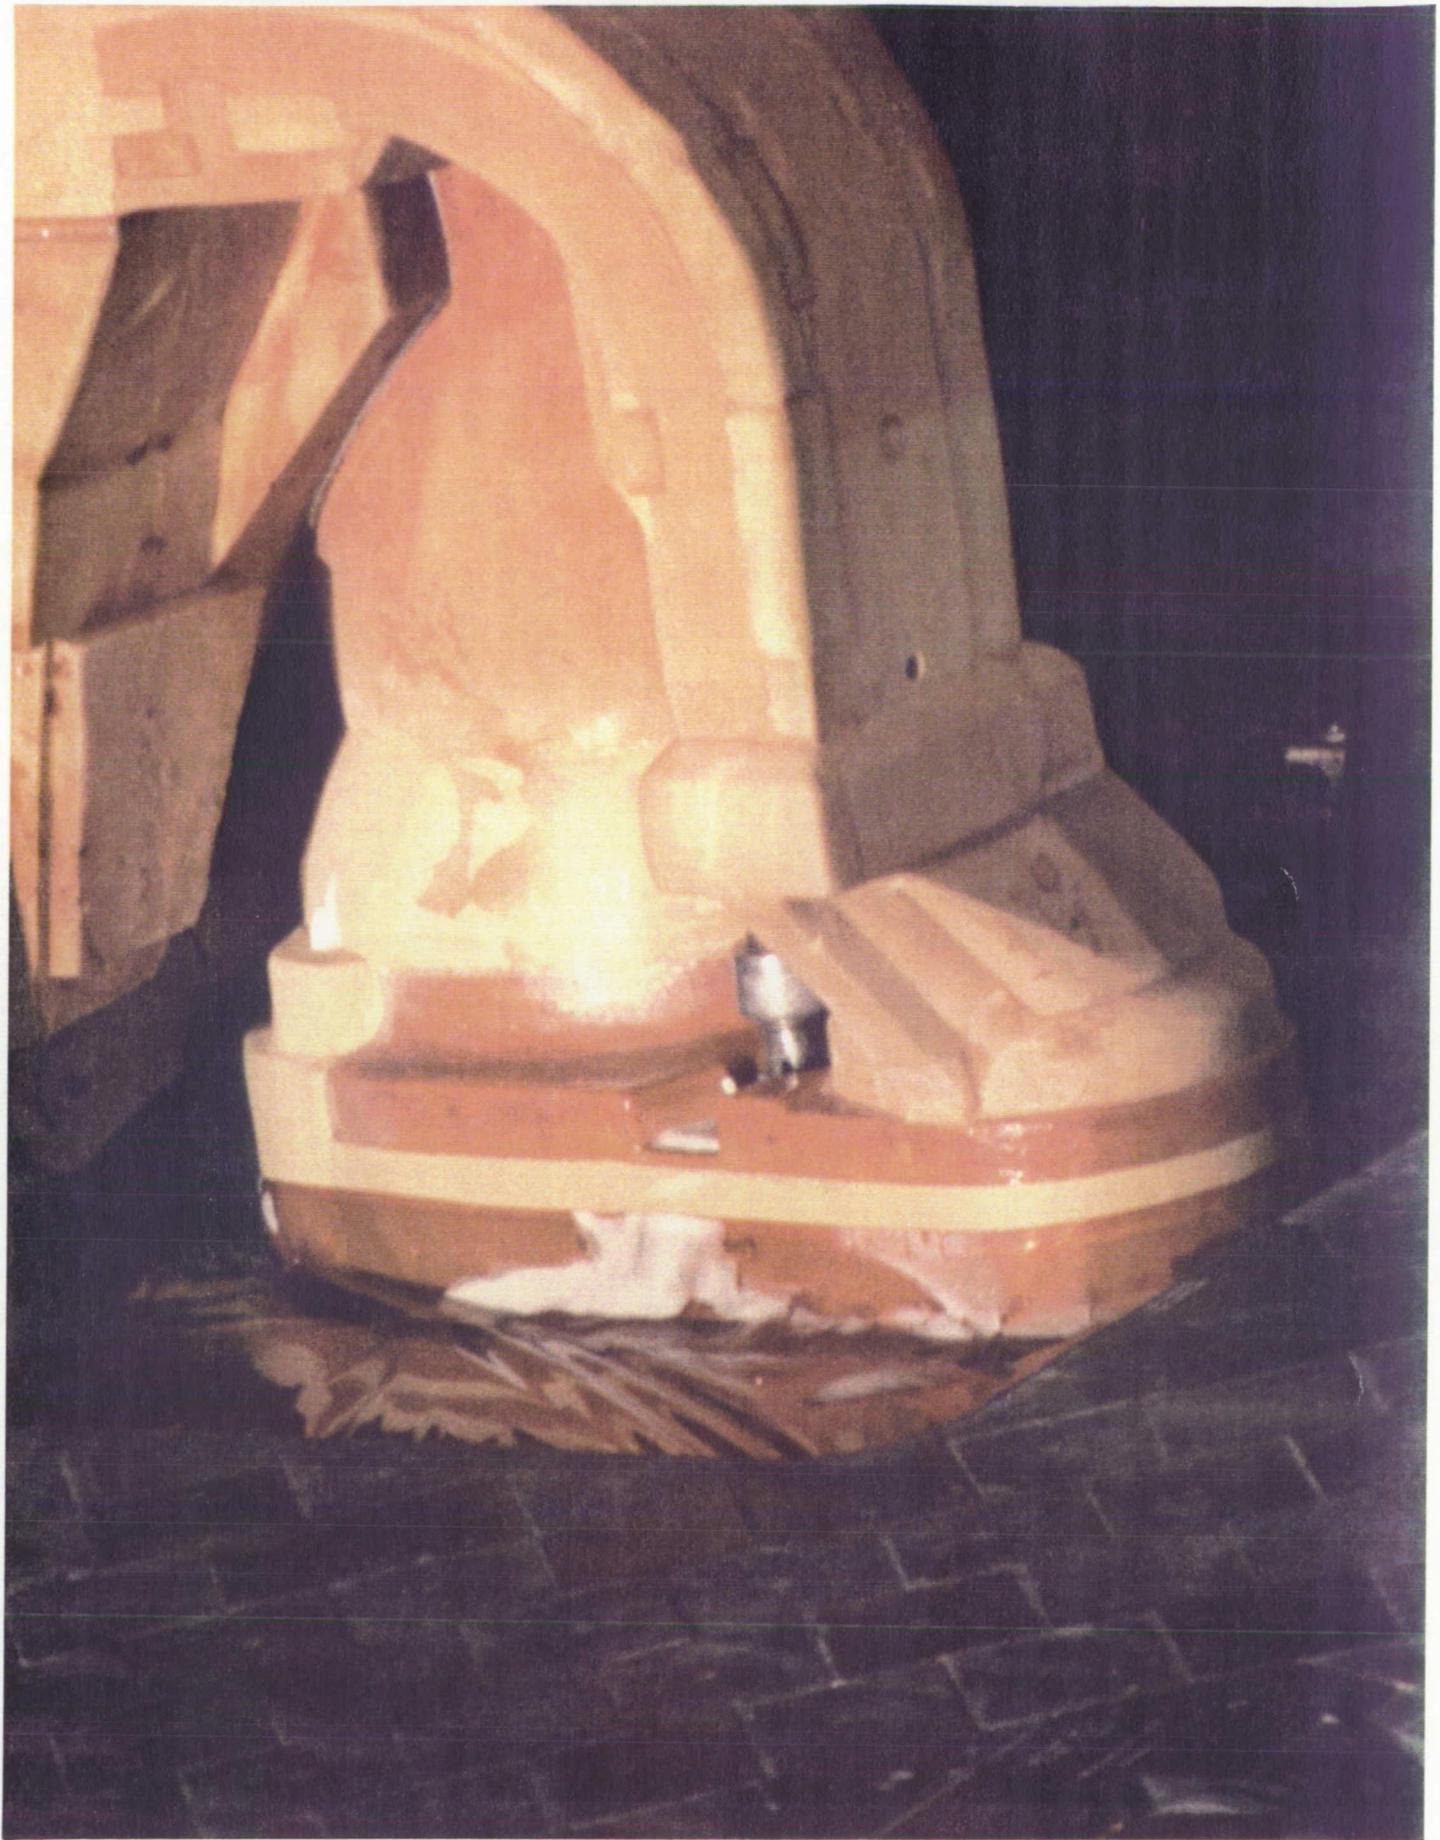
Light formation of ice/frost on the L02 ET/ORB umbilical
cavities, baggie material, and purge vents

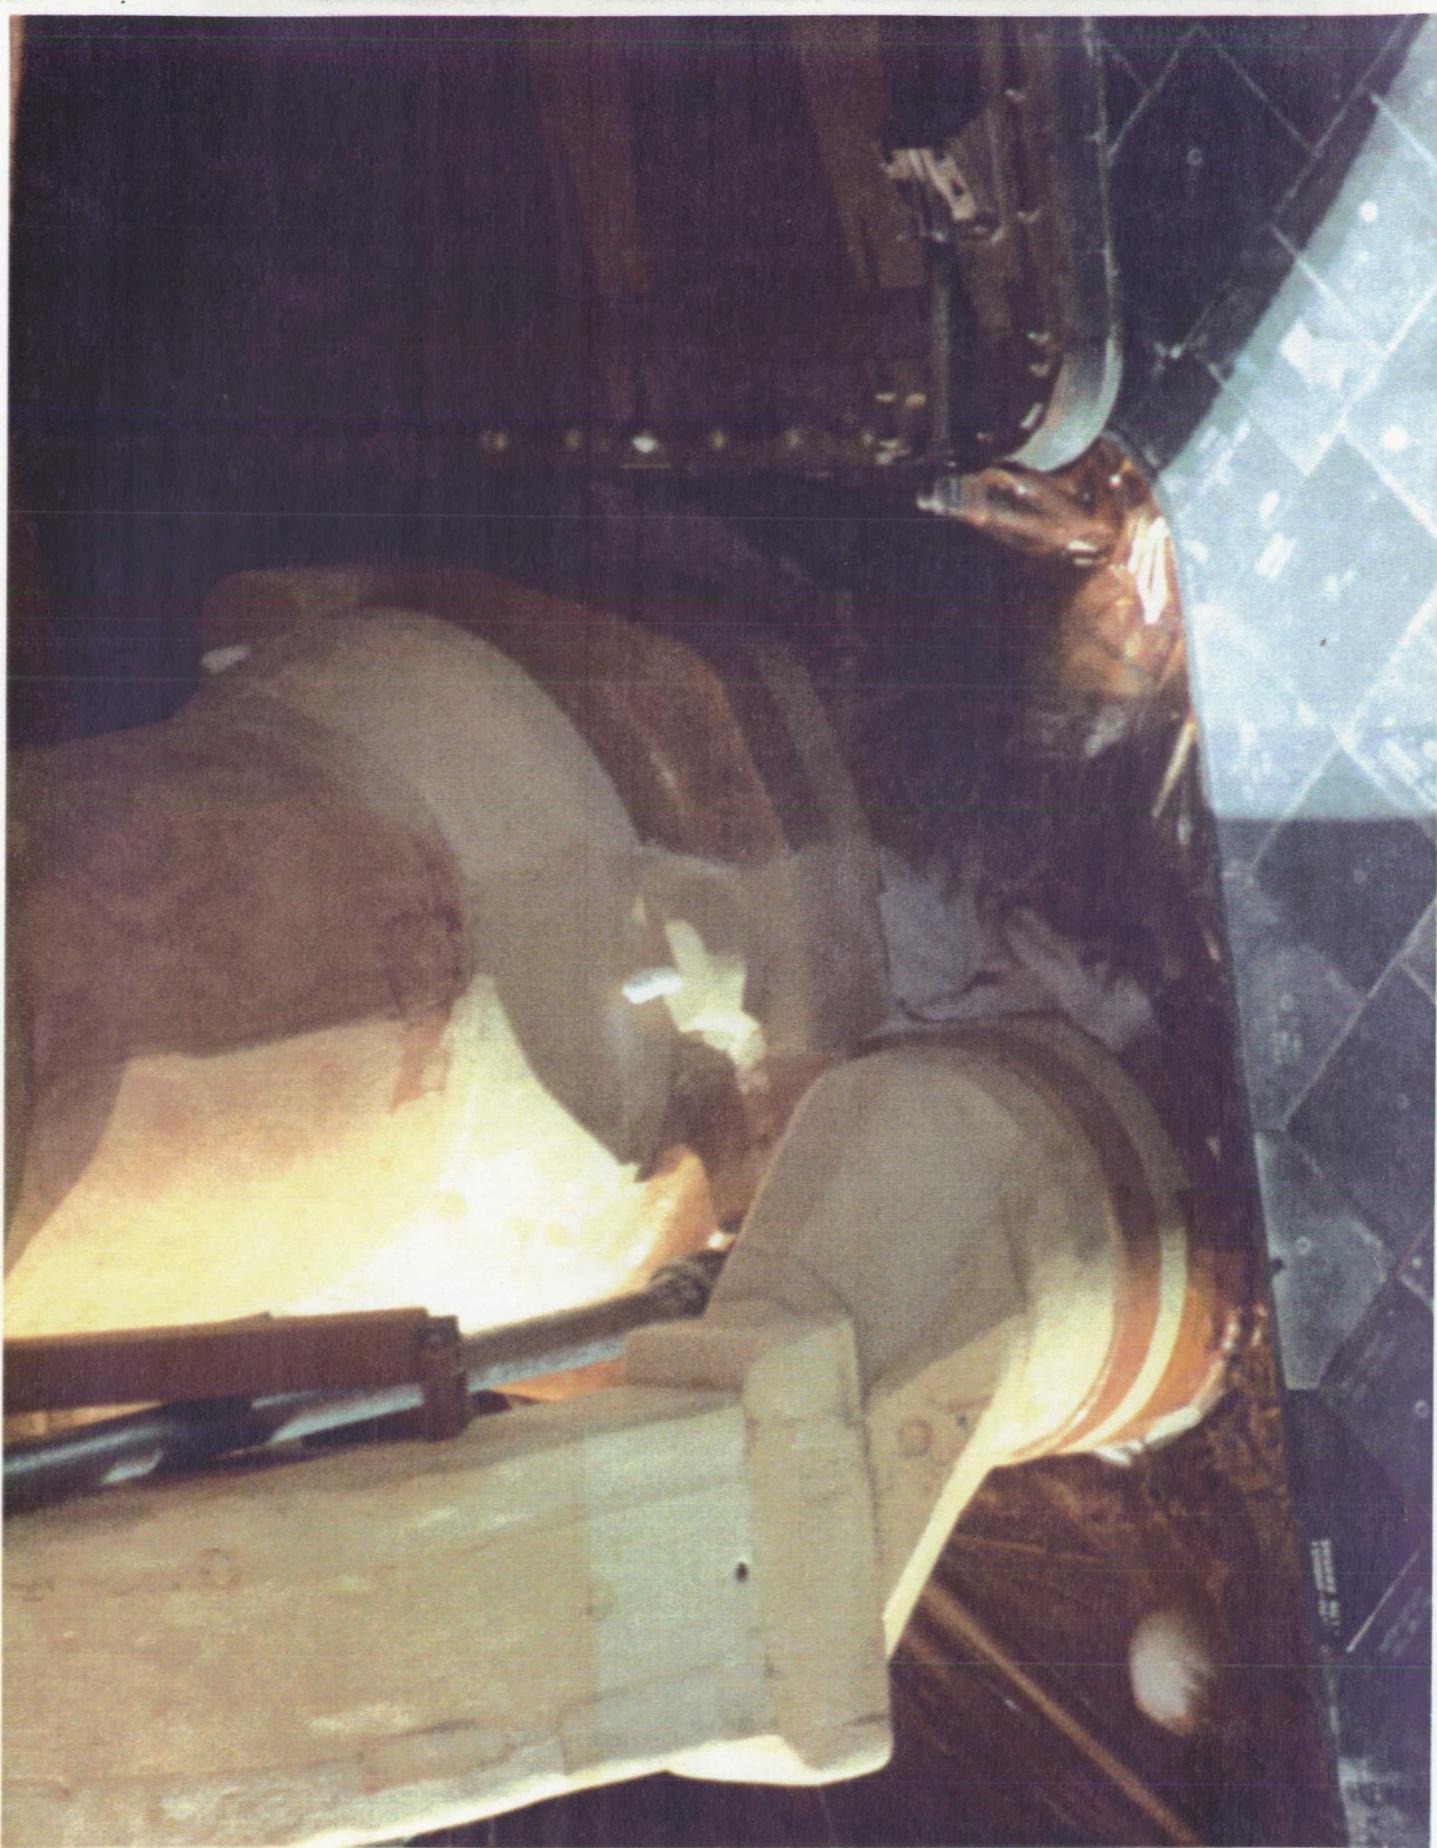
Ice/frost accumulation on the L02 ET/ORB umbilical aft and inboard sides. Note frost finger on aft purge vent.
