Debris/Ice/TPS Assessment And Photographic Analysis For Shuttle Mission STS-36

April 1990

DEBRIS/ICE/TPS ASSESSMENT
AND
PHOTOGRAPHIC ANALYSIS
OF
SHUTTLE MISSION STS-36

February 28, 1990

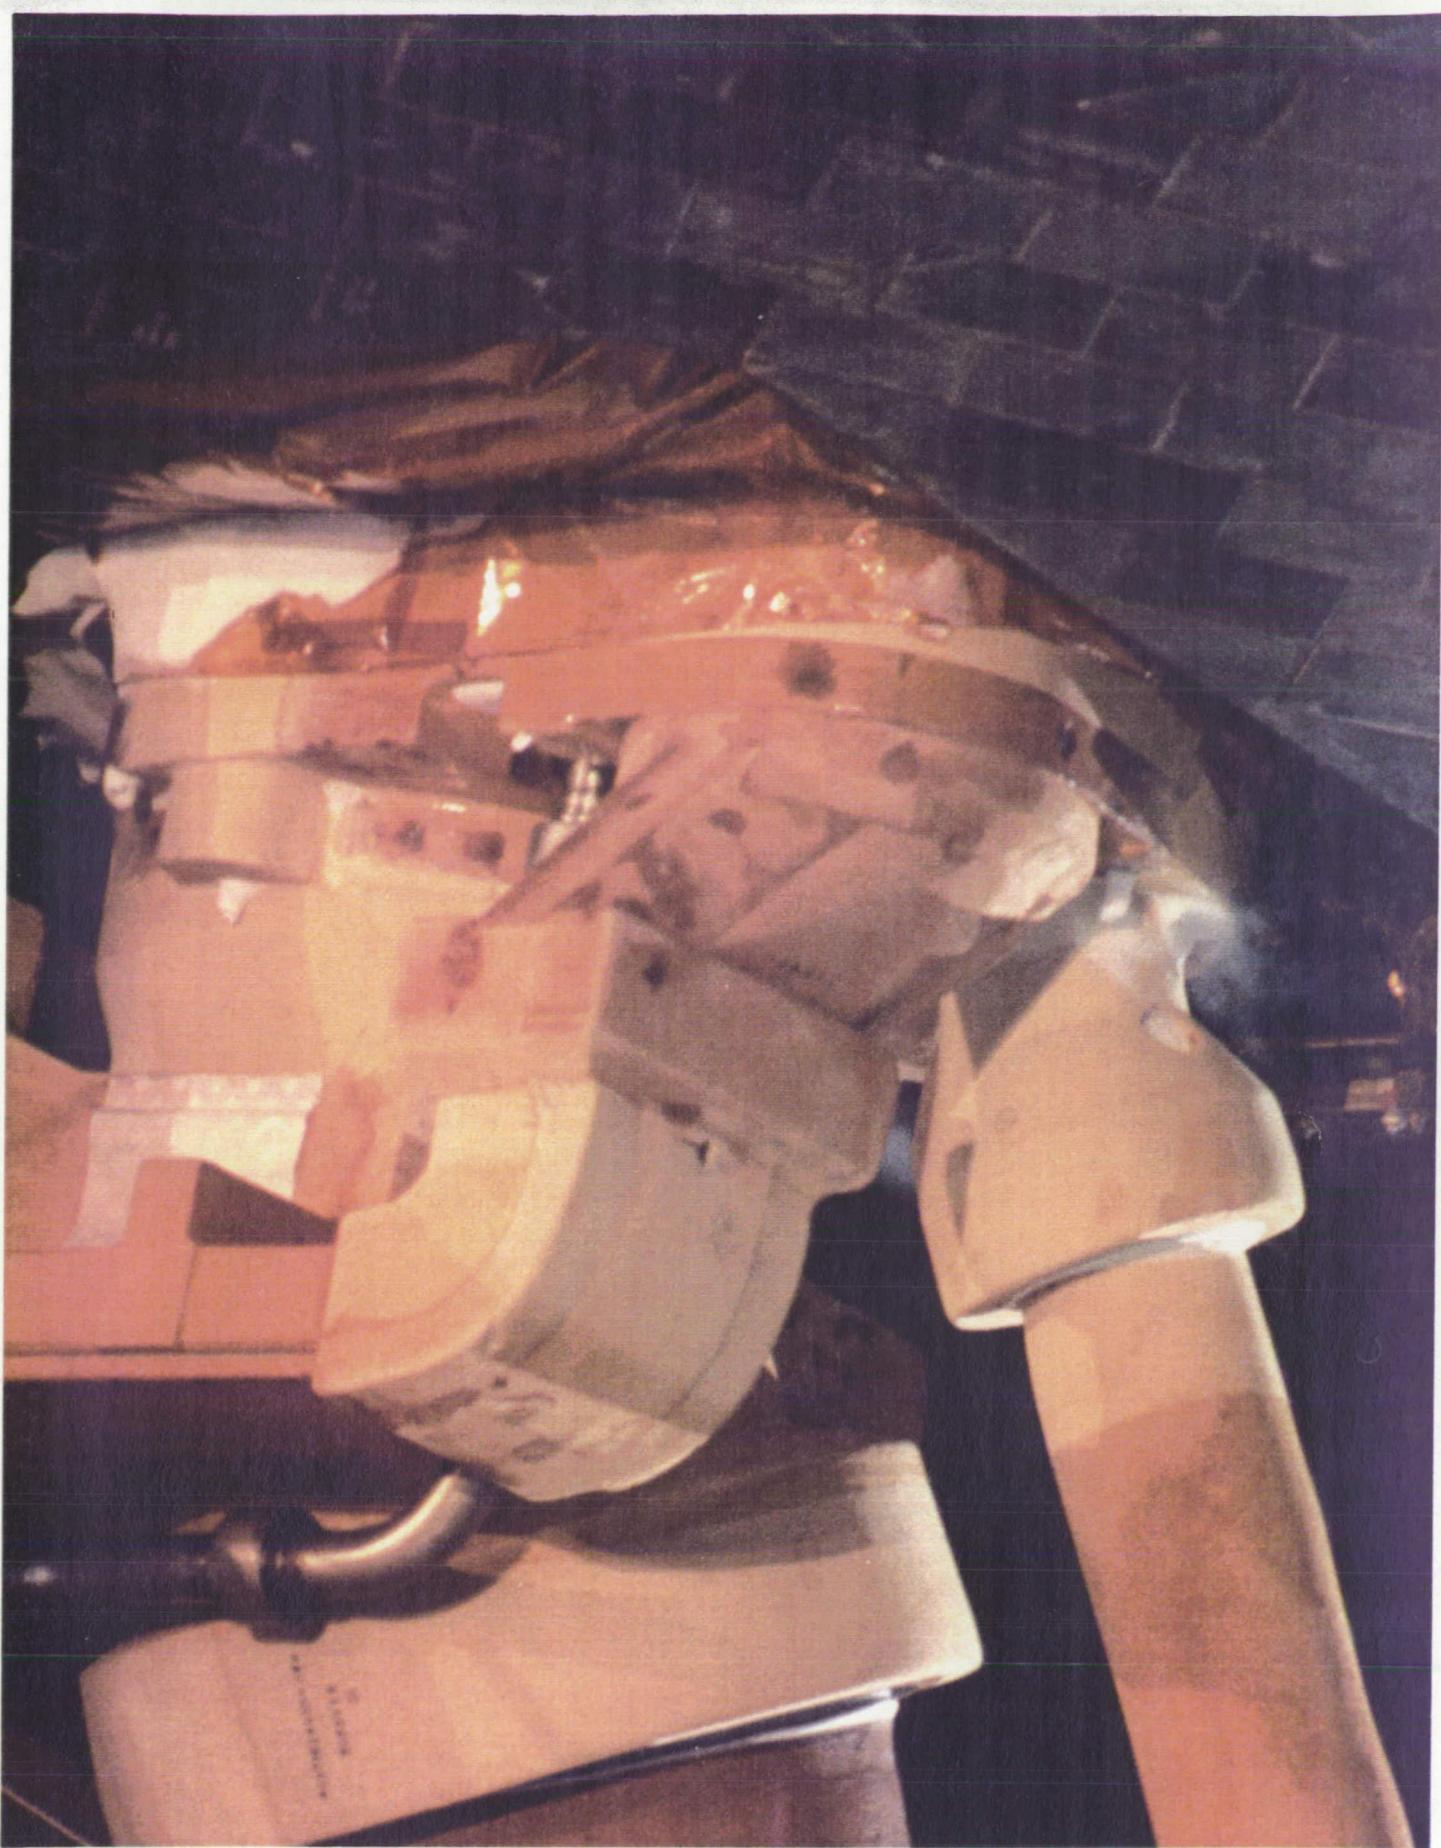
Ice/frost had formed on LH2 ET/ORB umbilical top and outboard sides. Frost fingers on purge vents are typical.

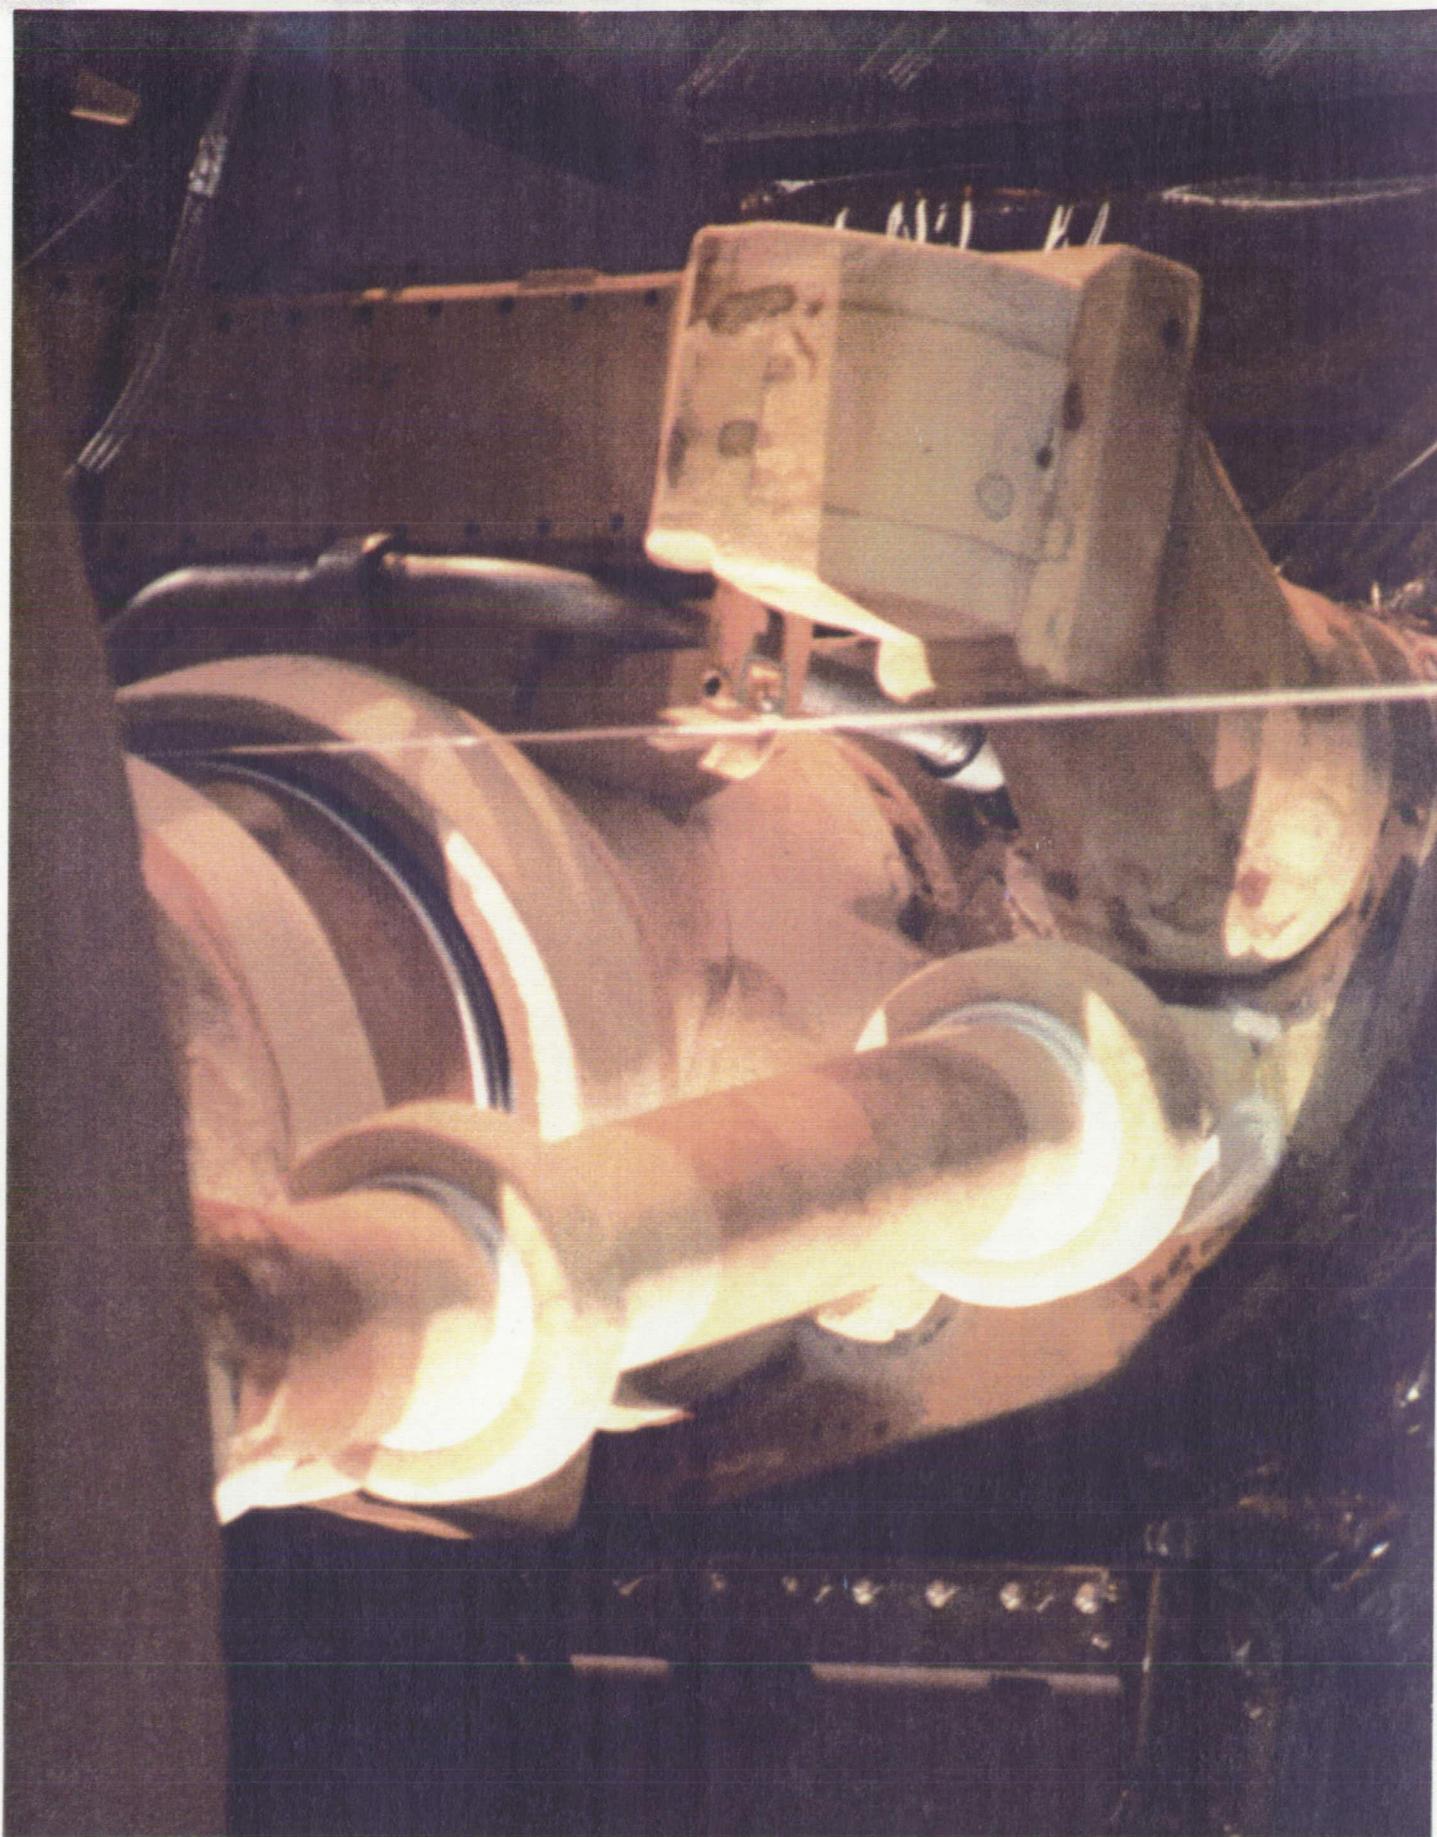
Both LH2 recirculation line bellows were filled with ice and frost, but the LH2 feedline bellows was clear

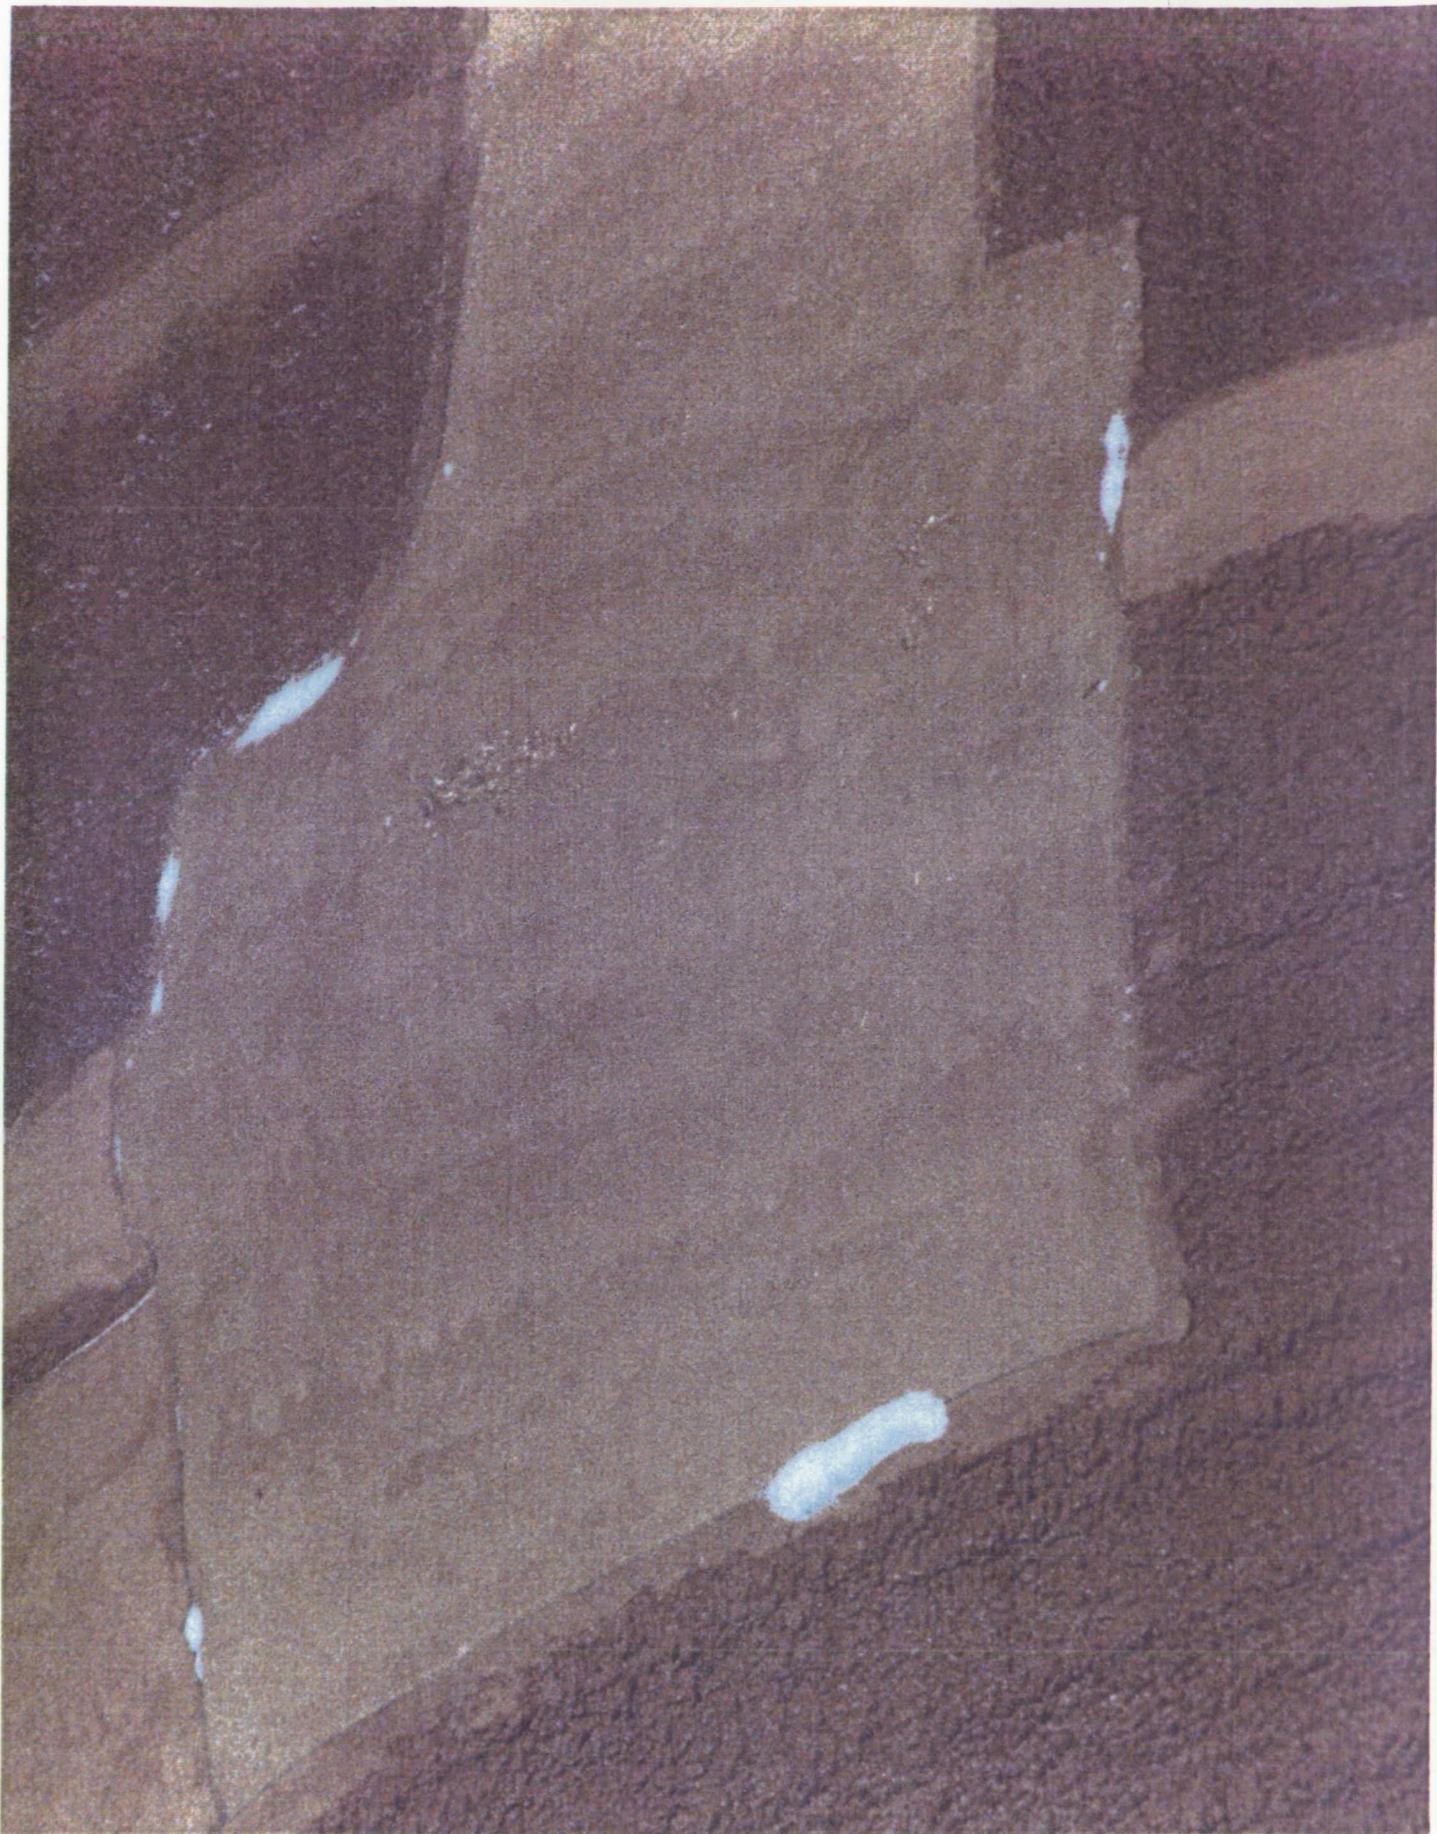
Small areas of ice/frost outline the ET third hardpoint

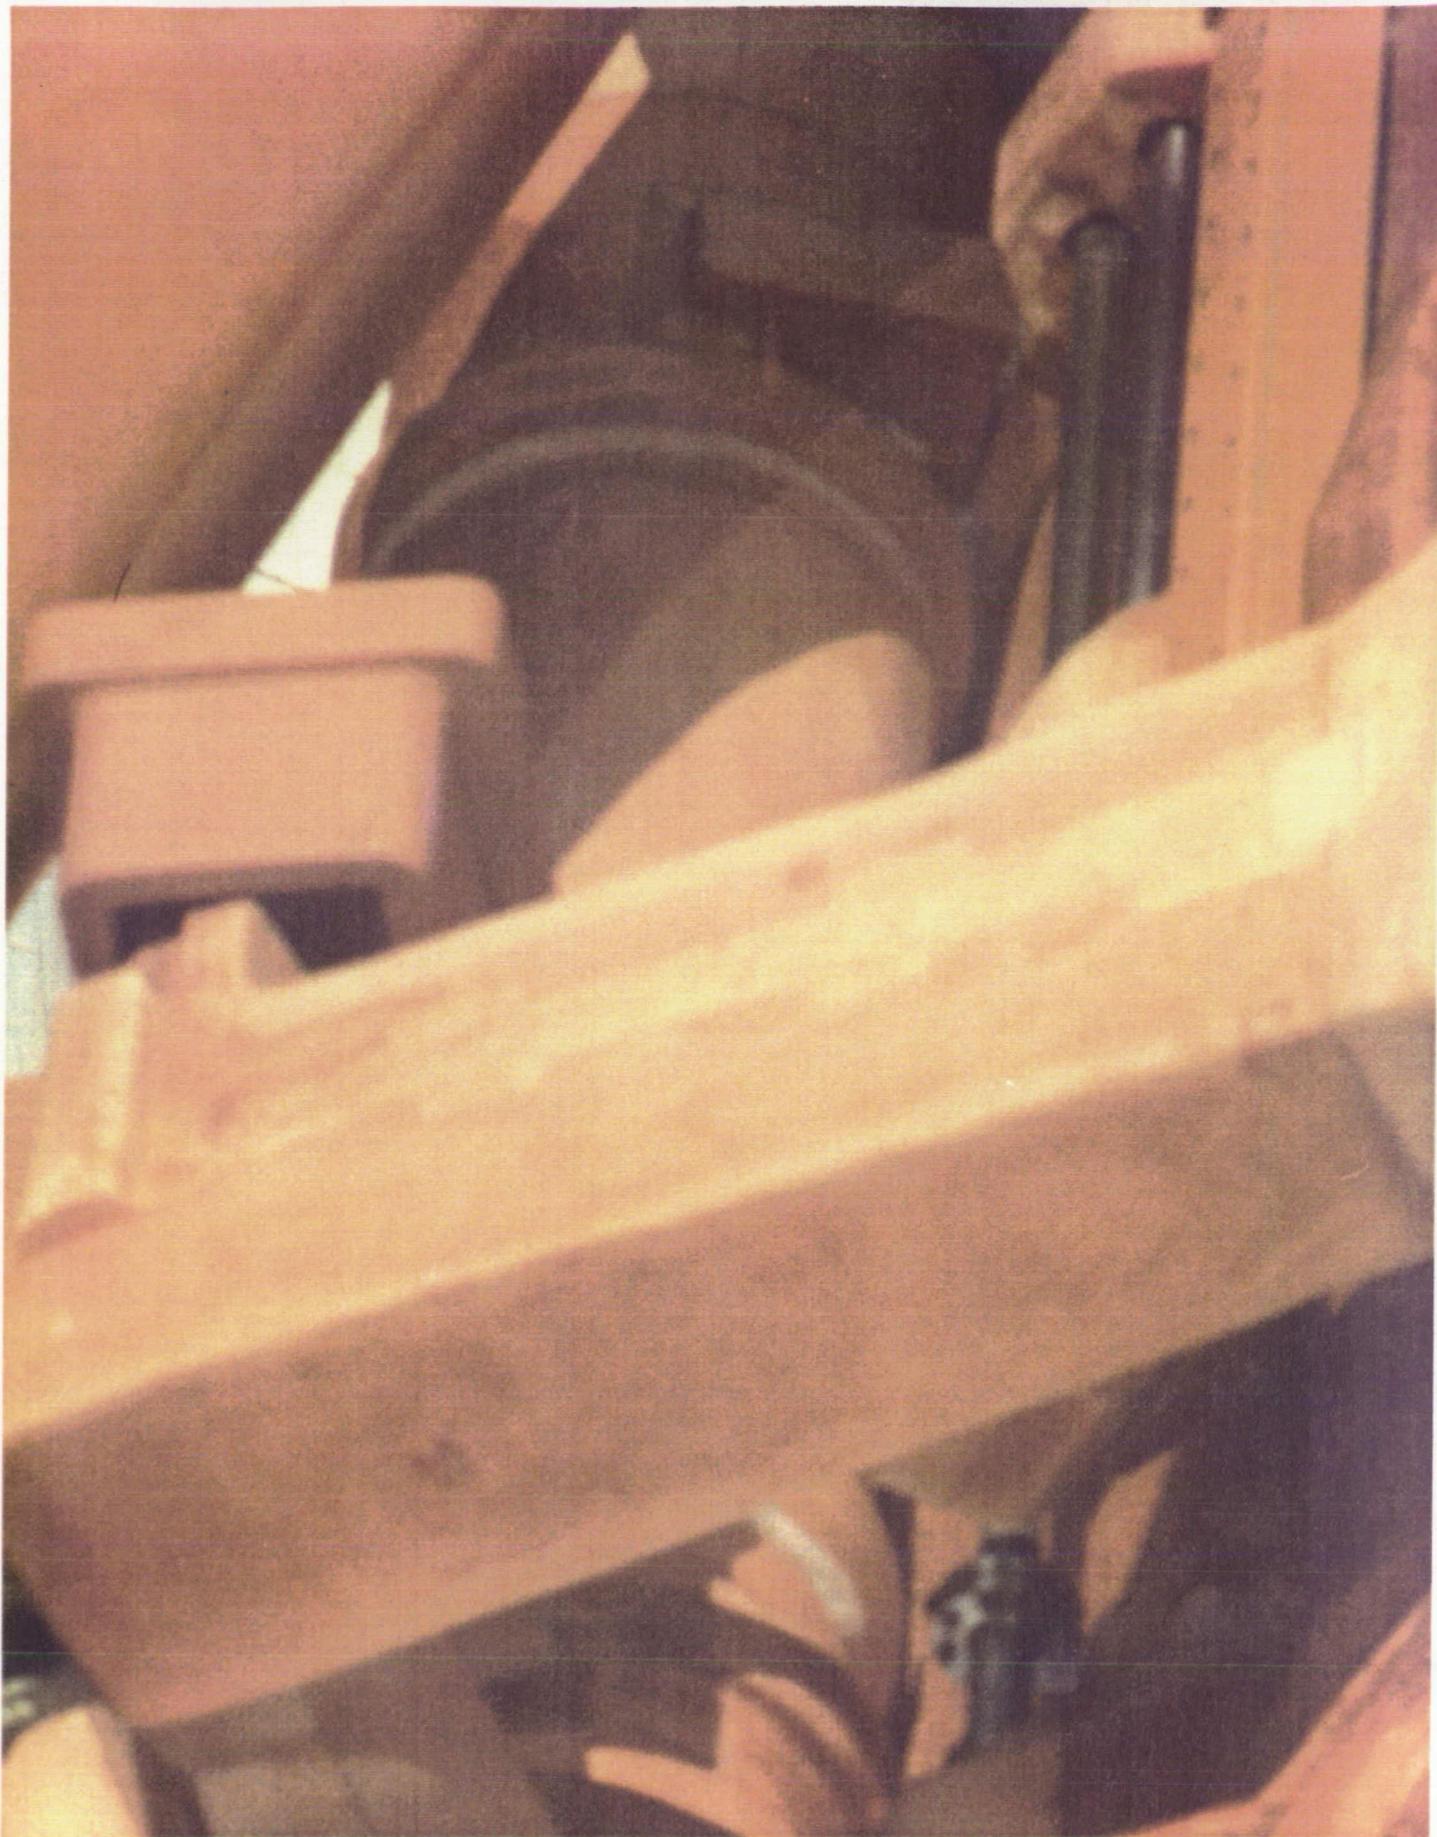
Hard ice still remained in the L02 feedline lower bellows
and support brackets during the post drain inspection

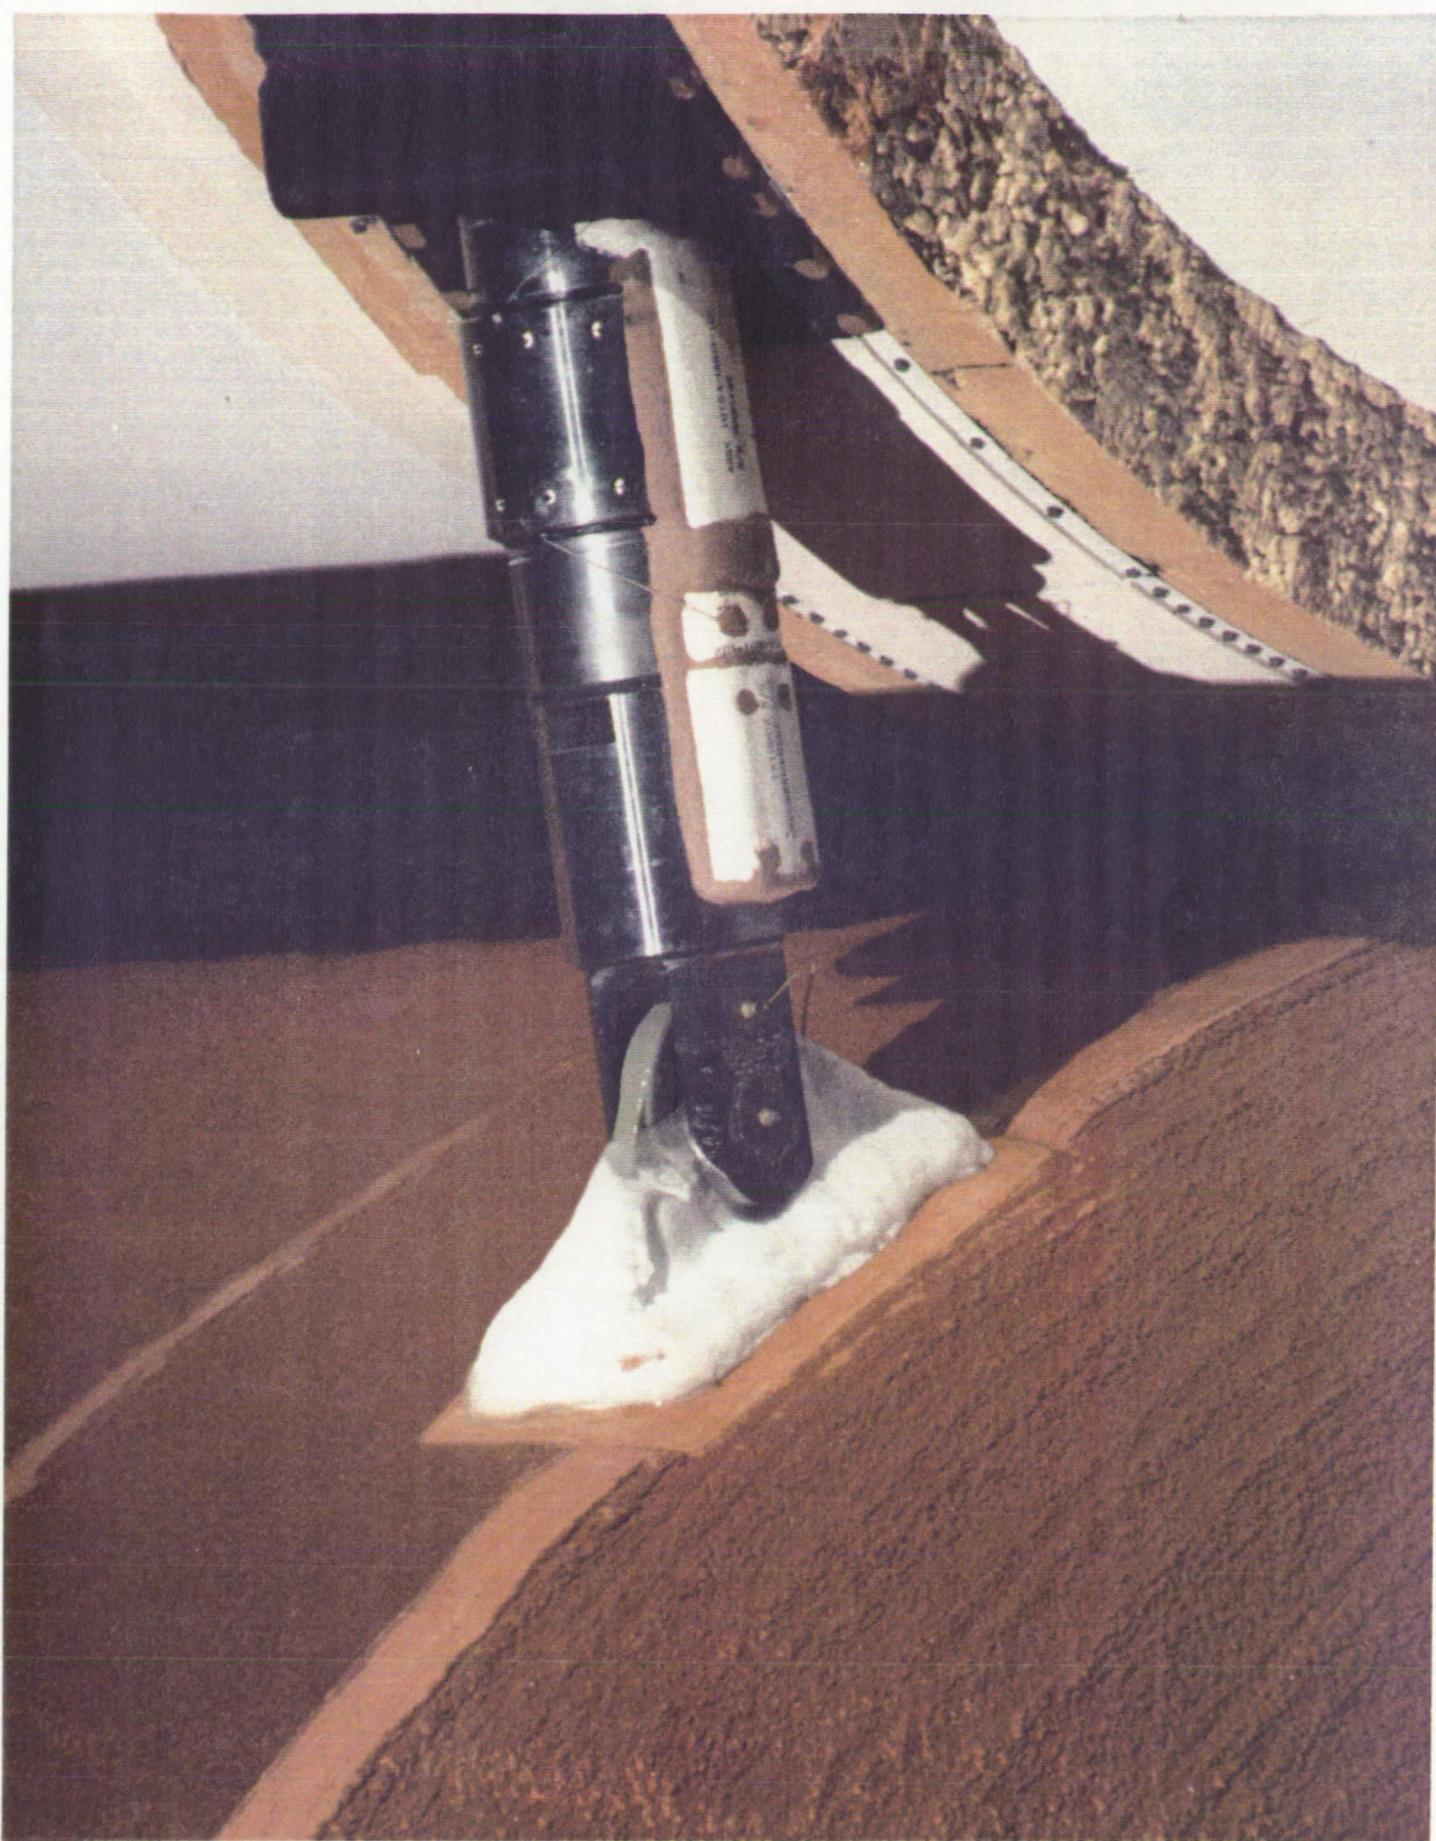
Ice/frost covered the EB-7 and EB-8 fittings to the
ET/SRB lower strut pin holes

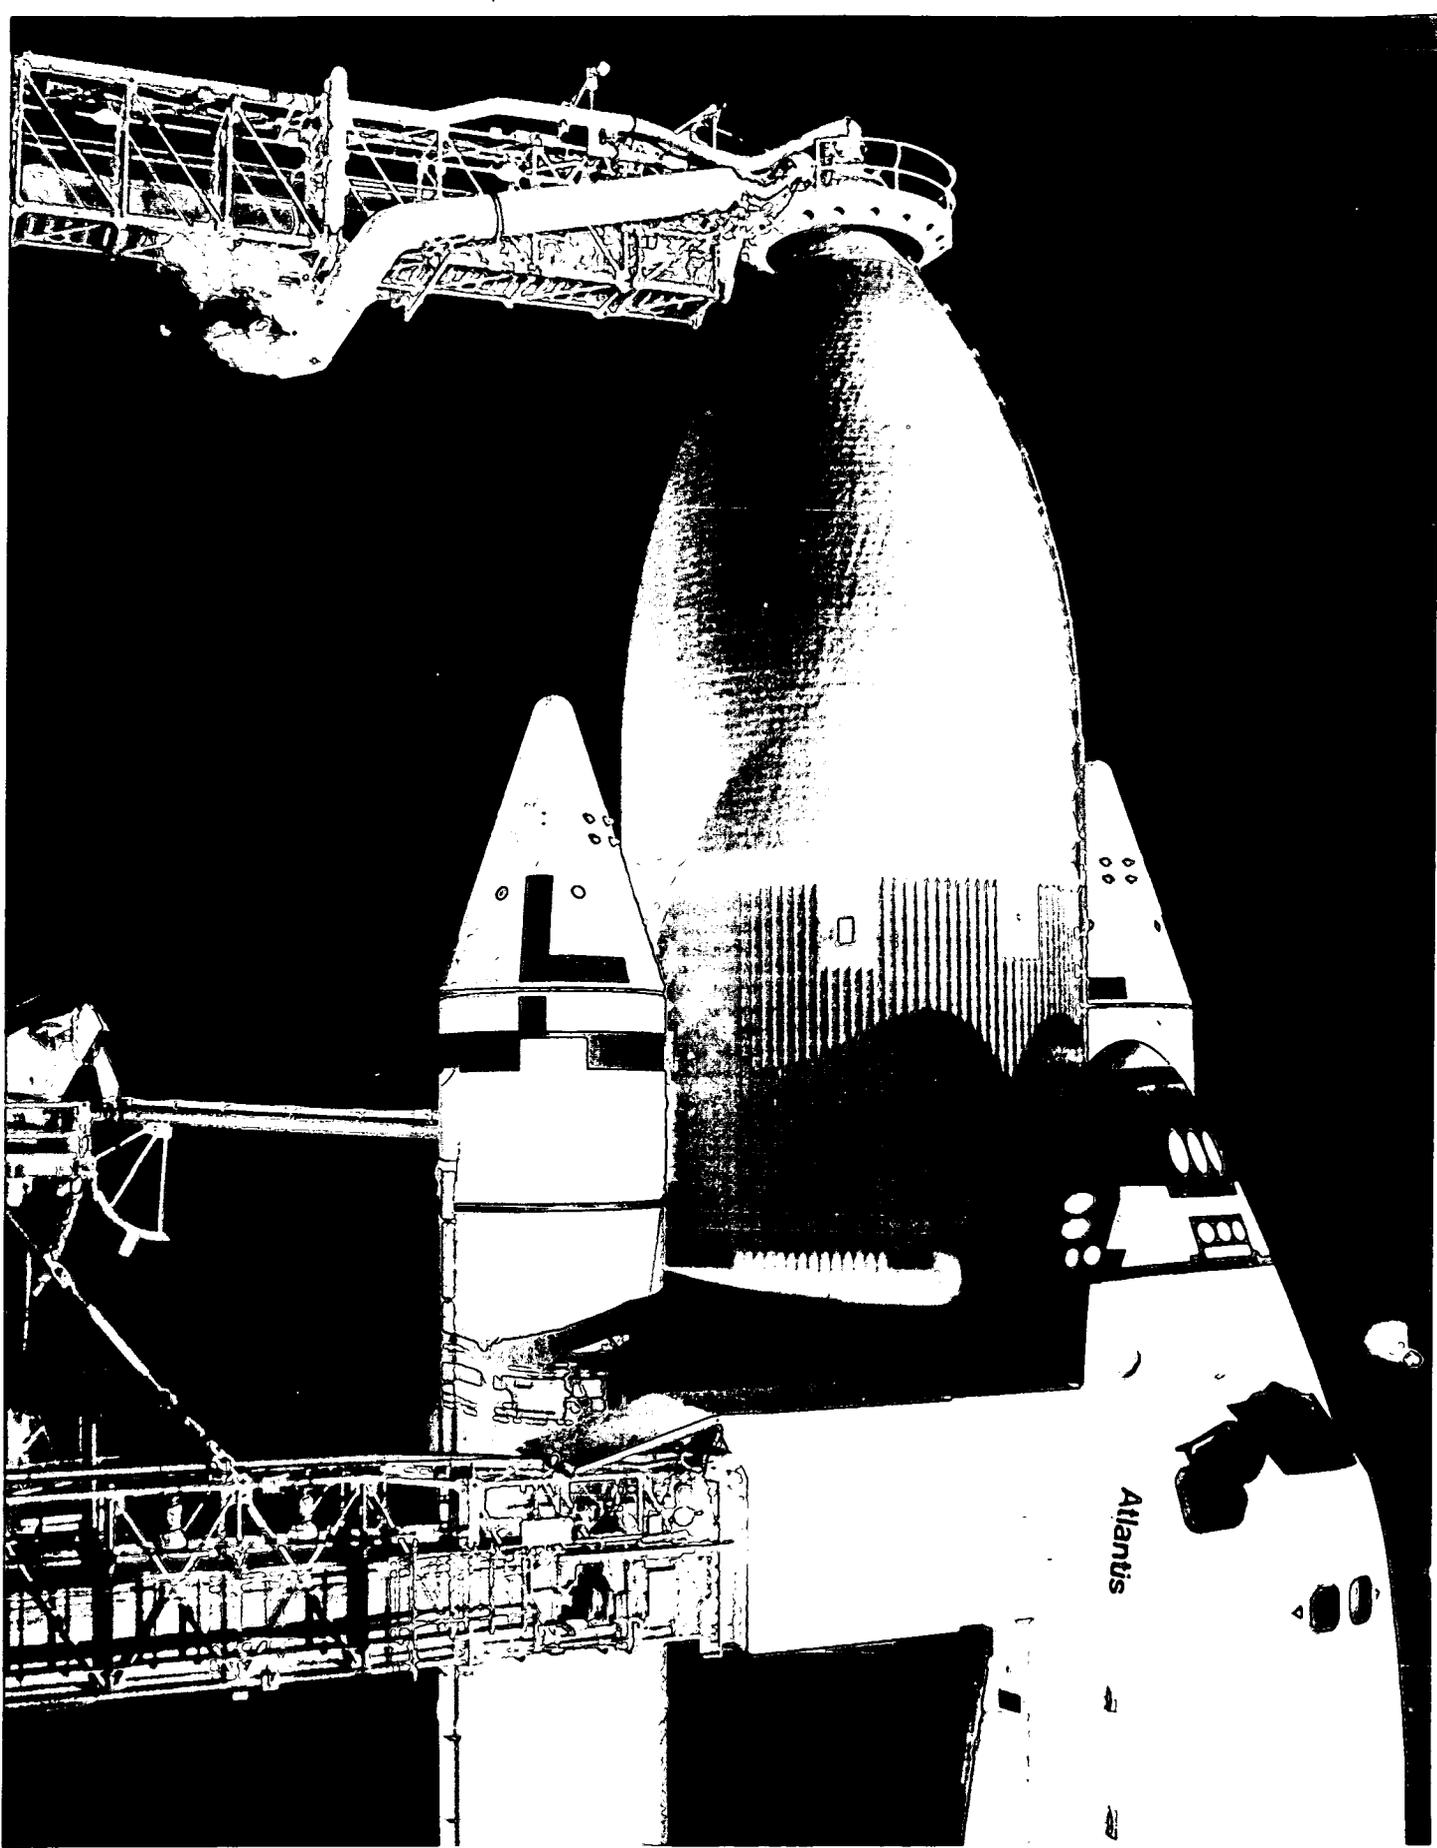
Weather conditions during the second cryo loading of the vehicle precluded the formation of acreage frost

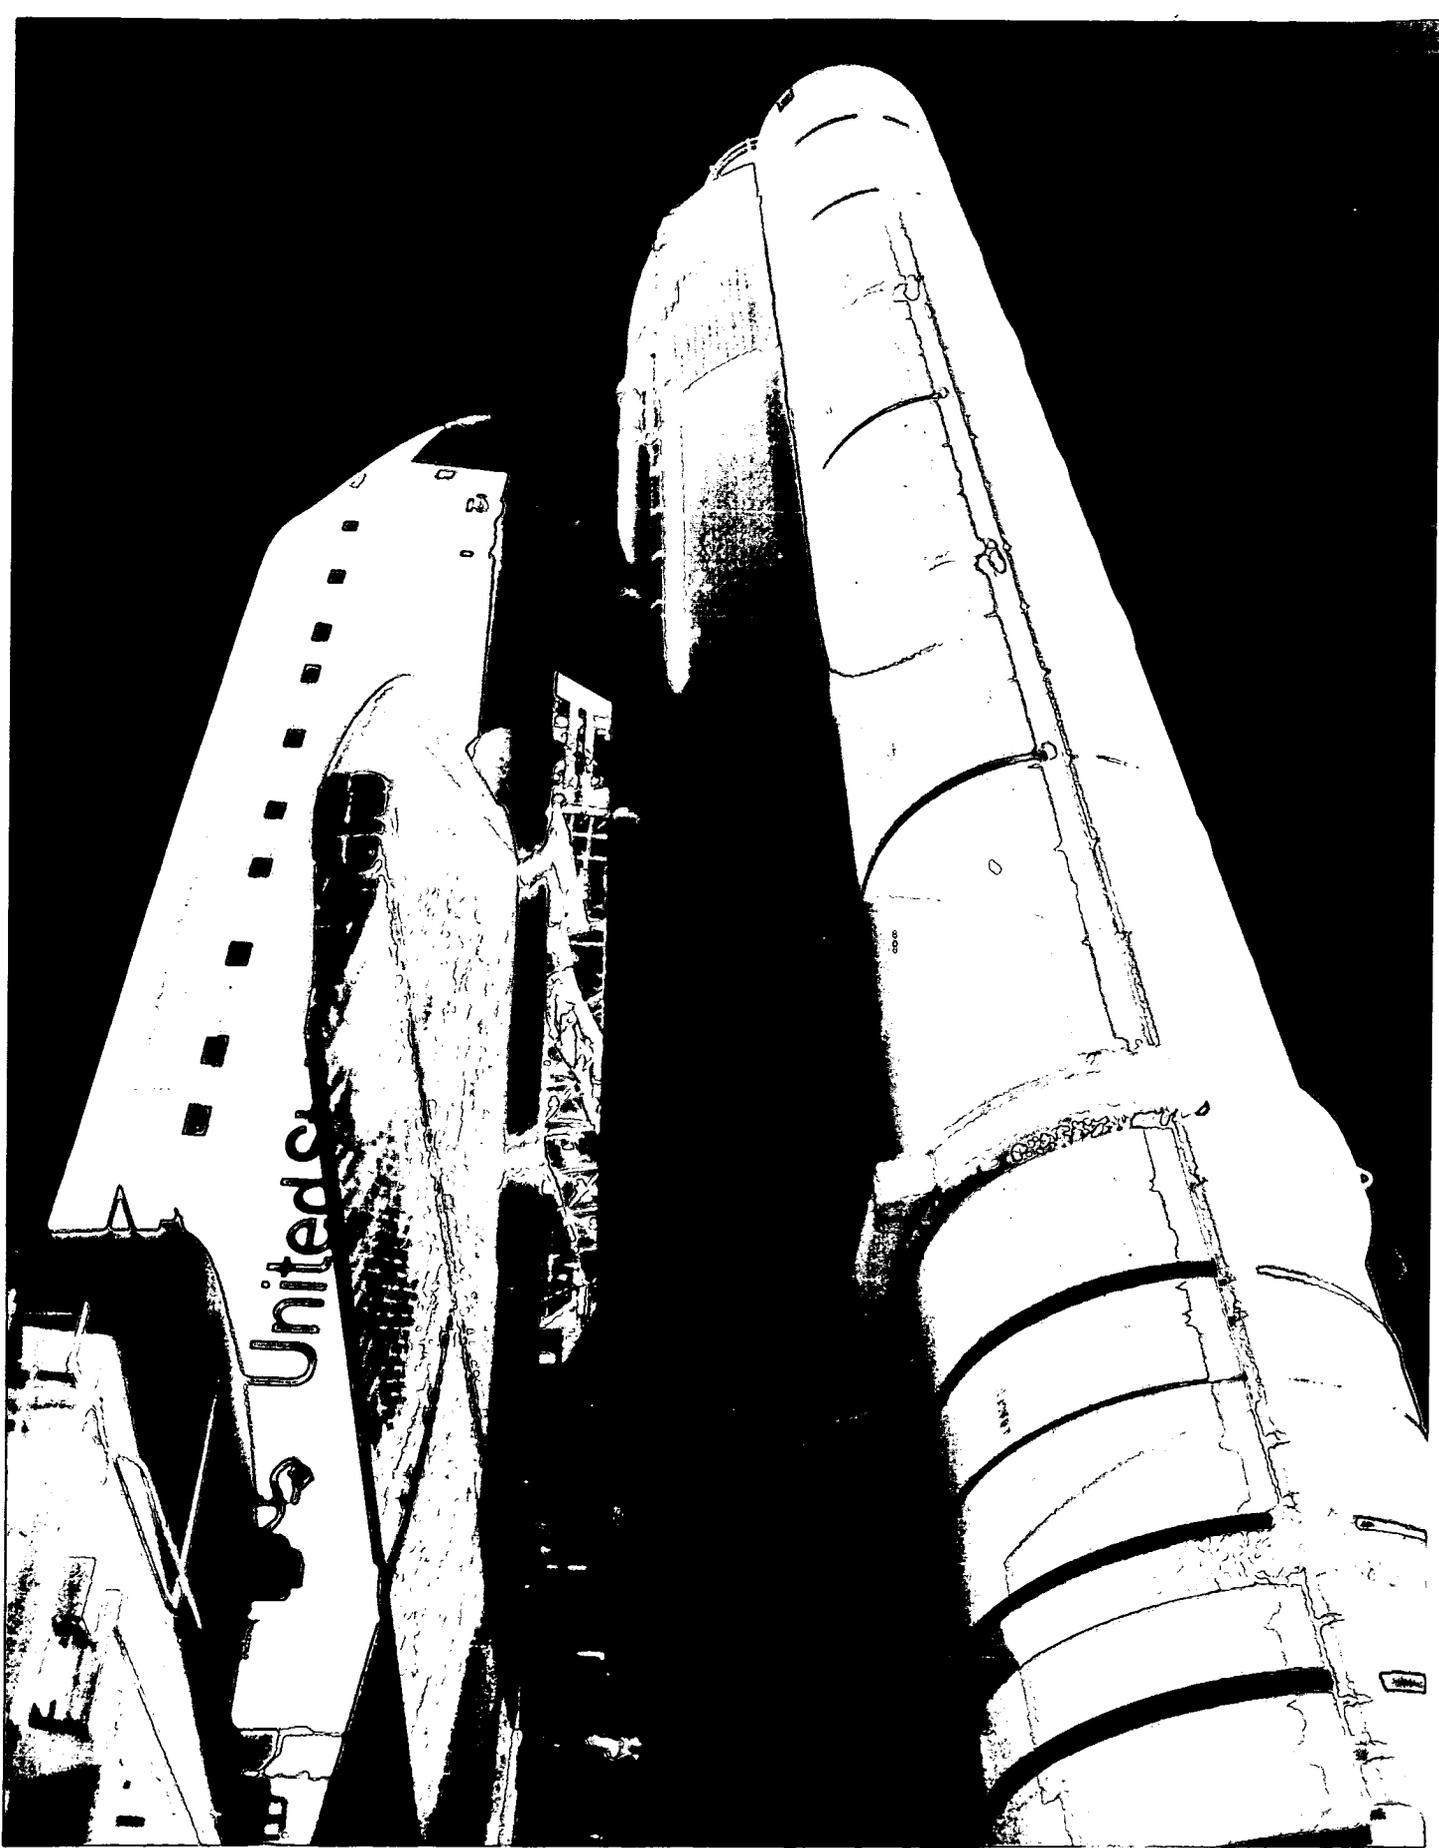
No acreage frost accumulated on the ET L02 and LH2 tank +Y+Z
quadrant acreage during the second cryo loading

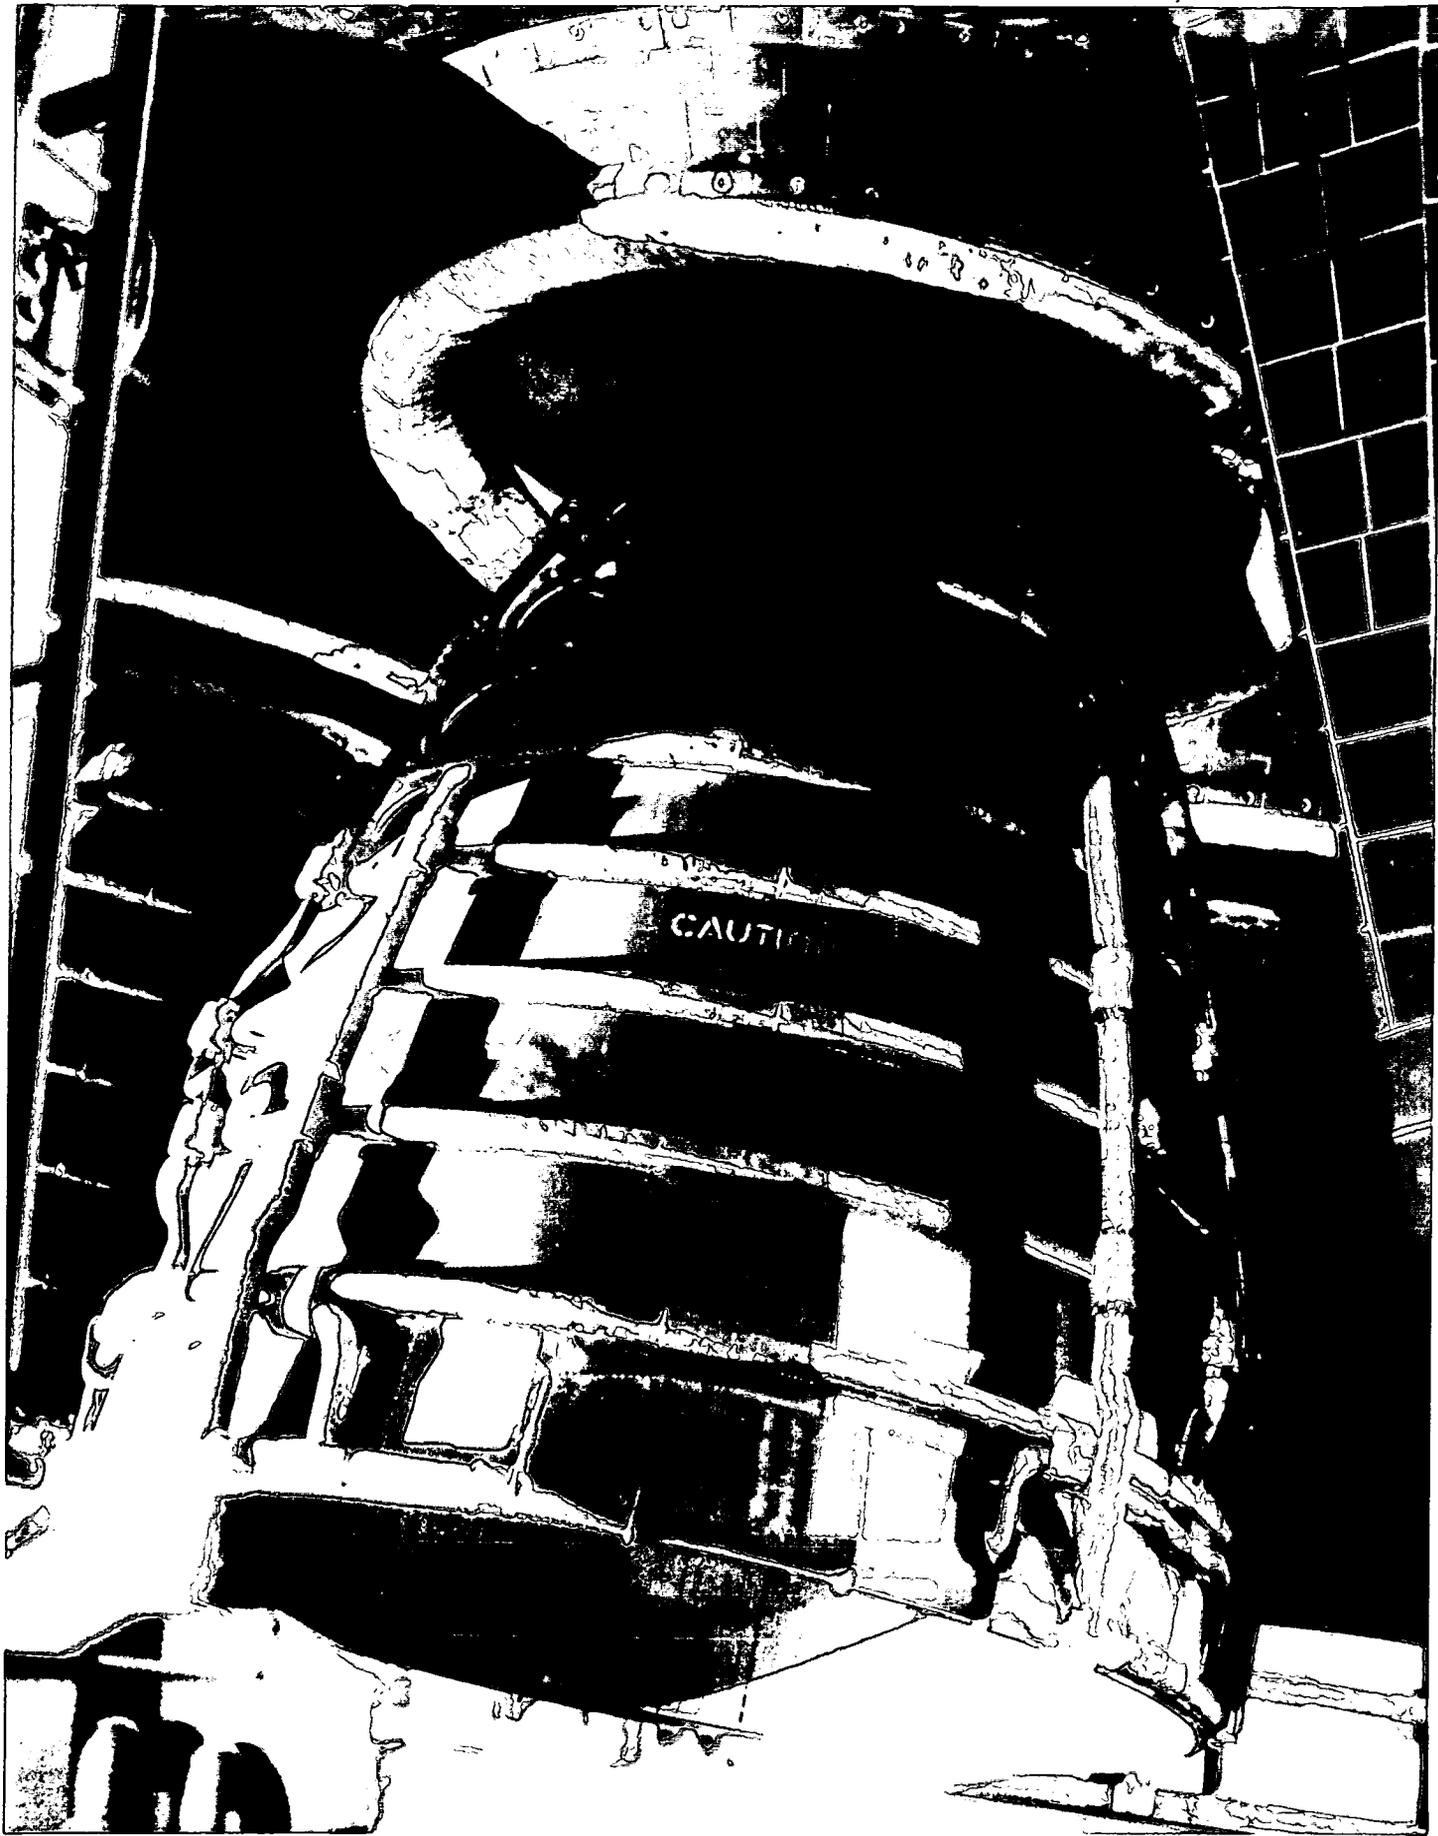
Ice/frost has formed along the SSME #1 and #2 engine mounted heat shield-to-nozzle interfaces
