Debris/Ice/TPS Assessment And Photographic Analysis For Shuttle Mission STS-36

April 1990

DEBRIS/ICE/TPS ASSESSMENT
AND
PHOTOGRAPHIC ANALYSIS
OF
SHUTTLE MISSION STS-36

February 28, 1990

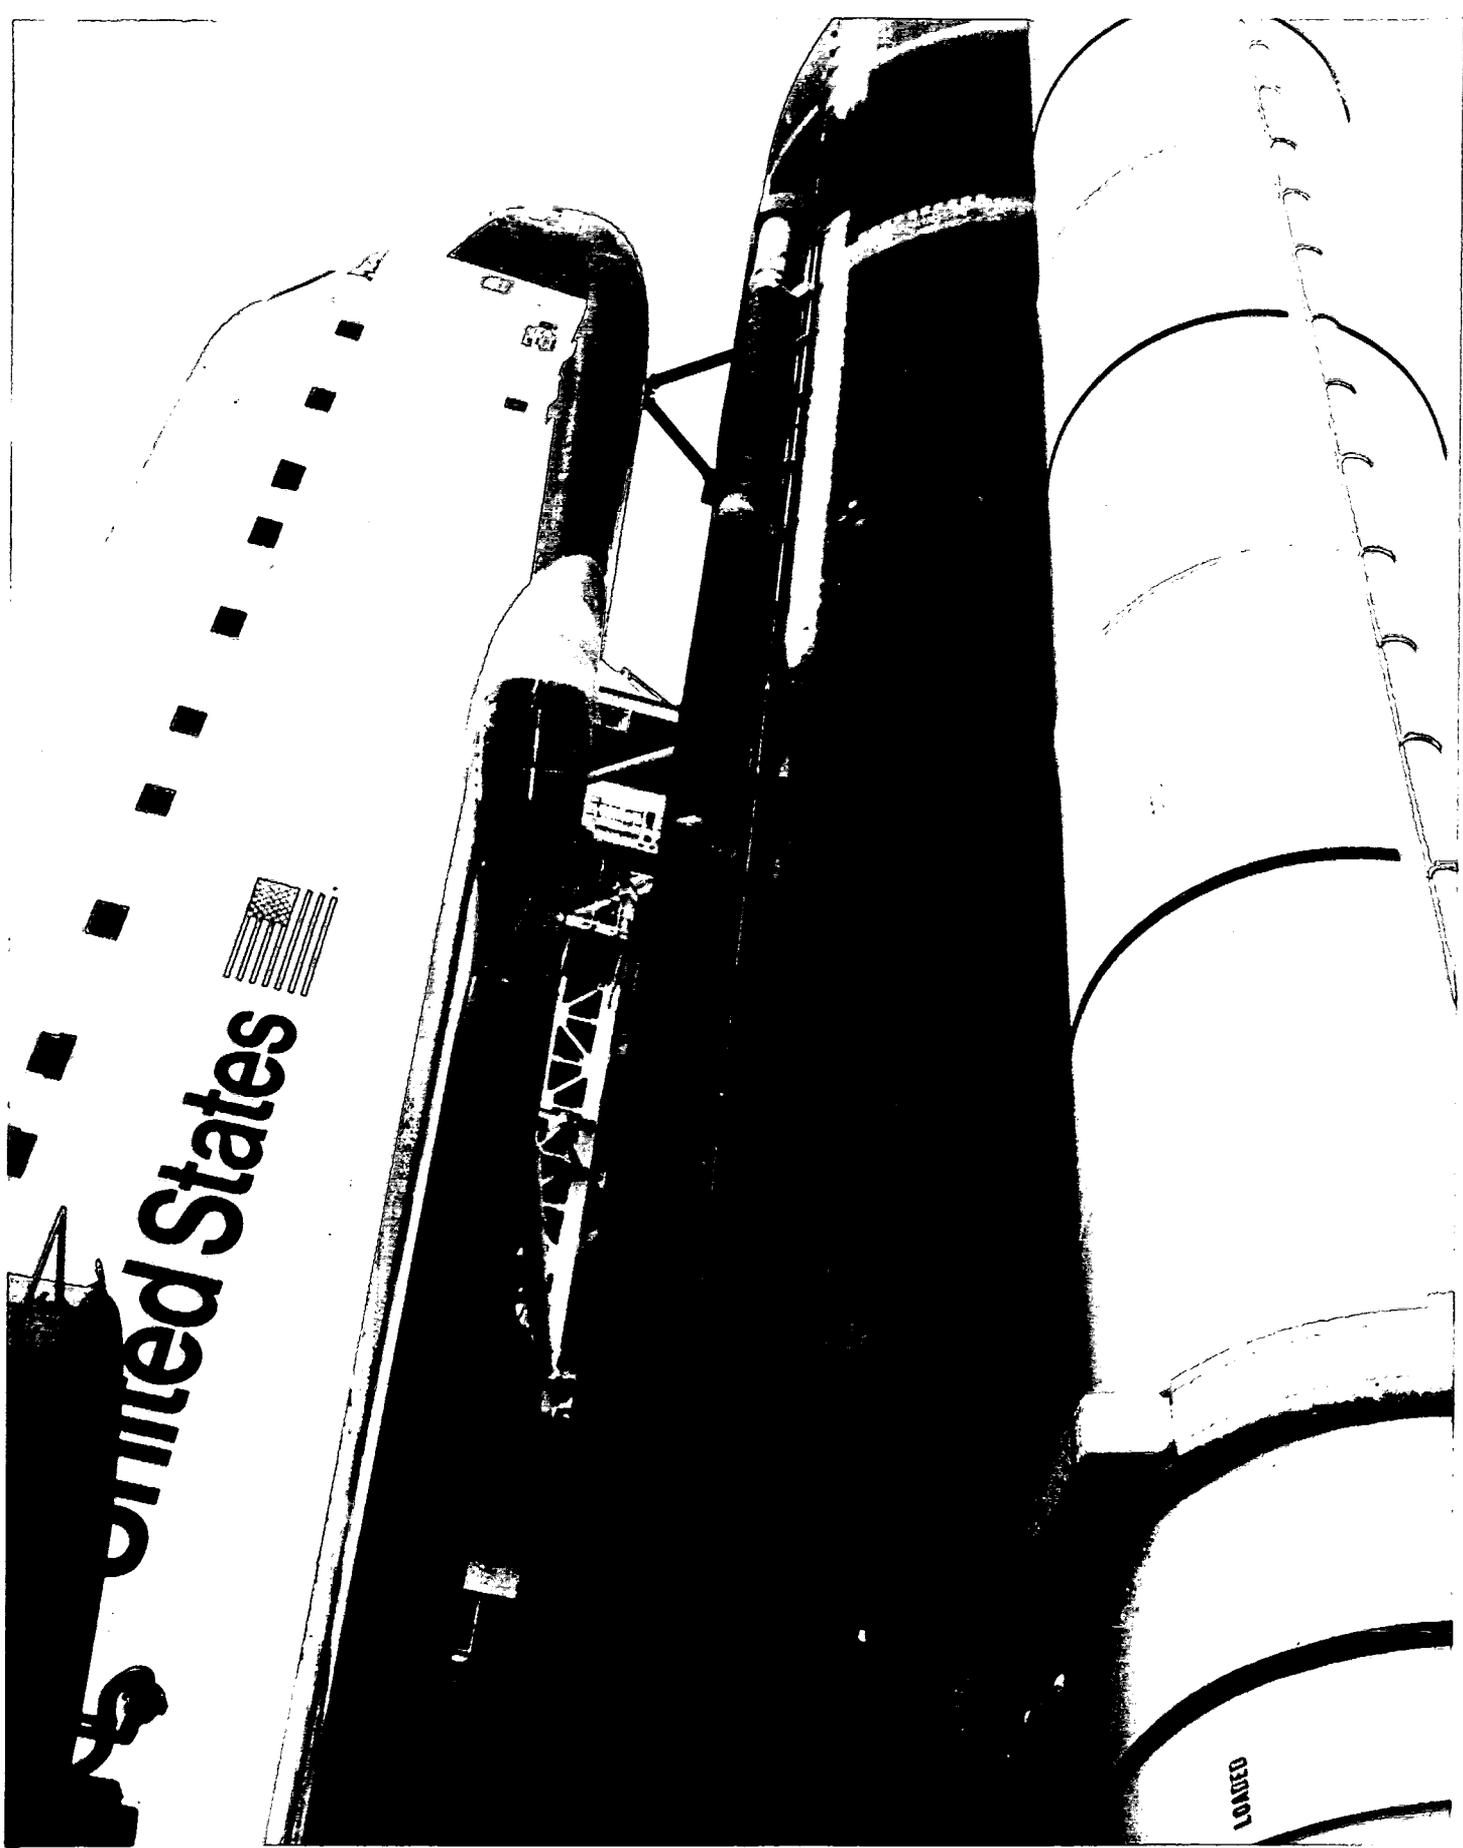
Overall view of the ET LH2 tank +Y+Z TPS acreage during
the second post drain inspection

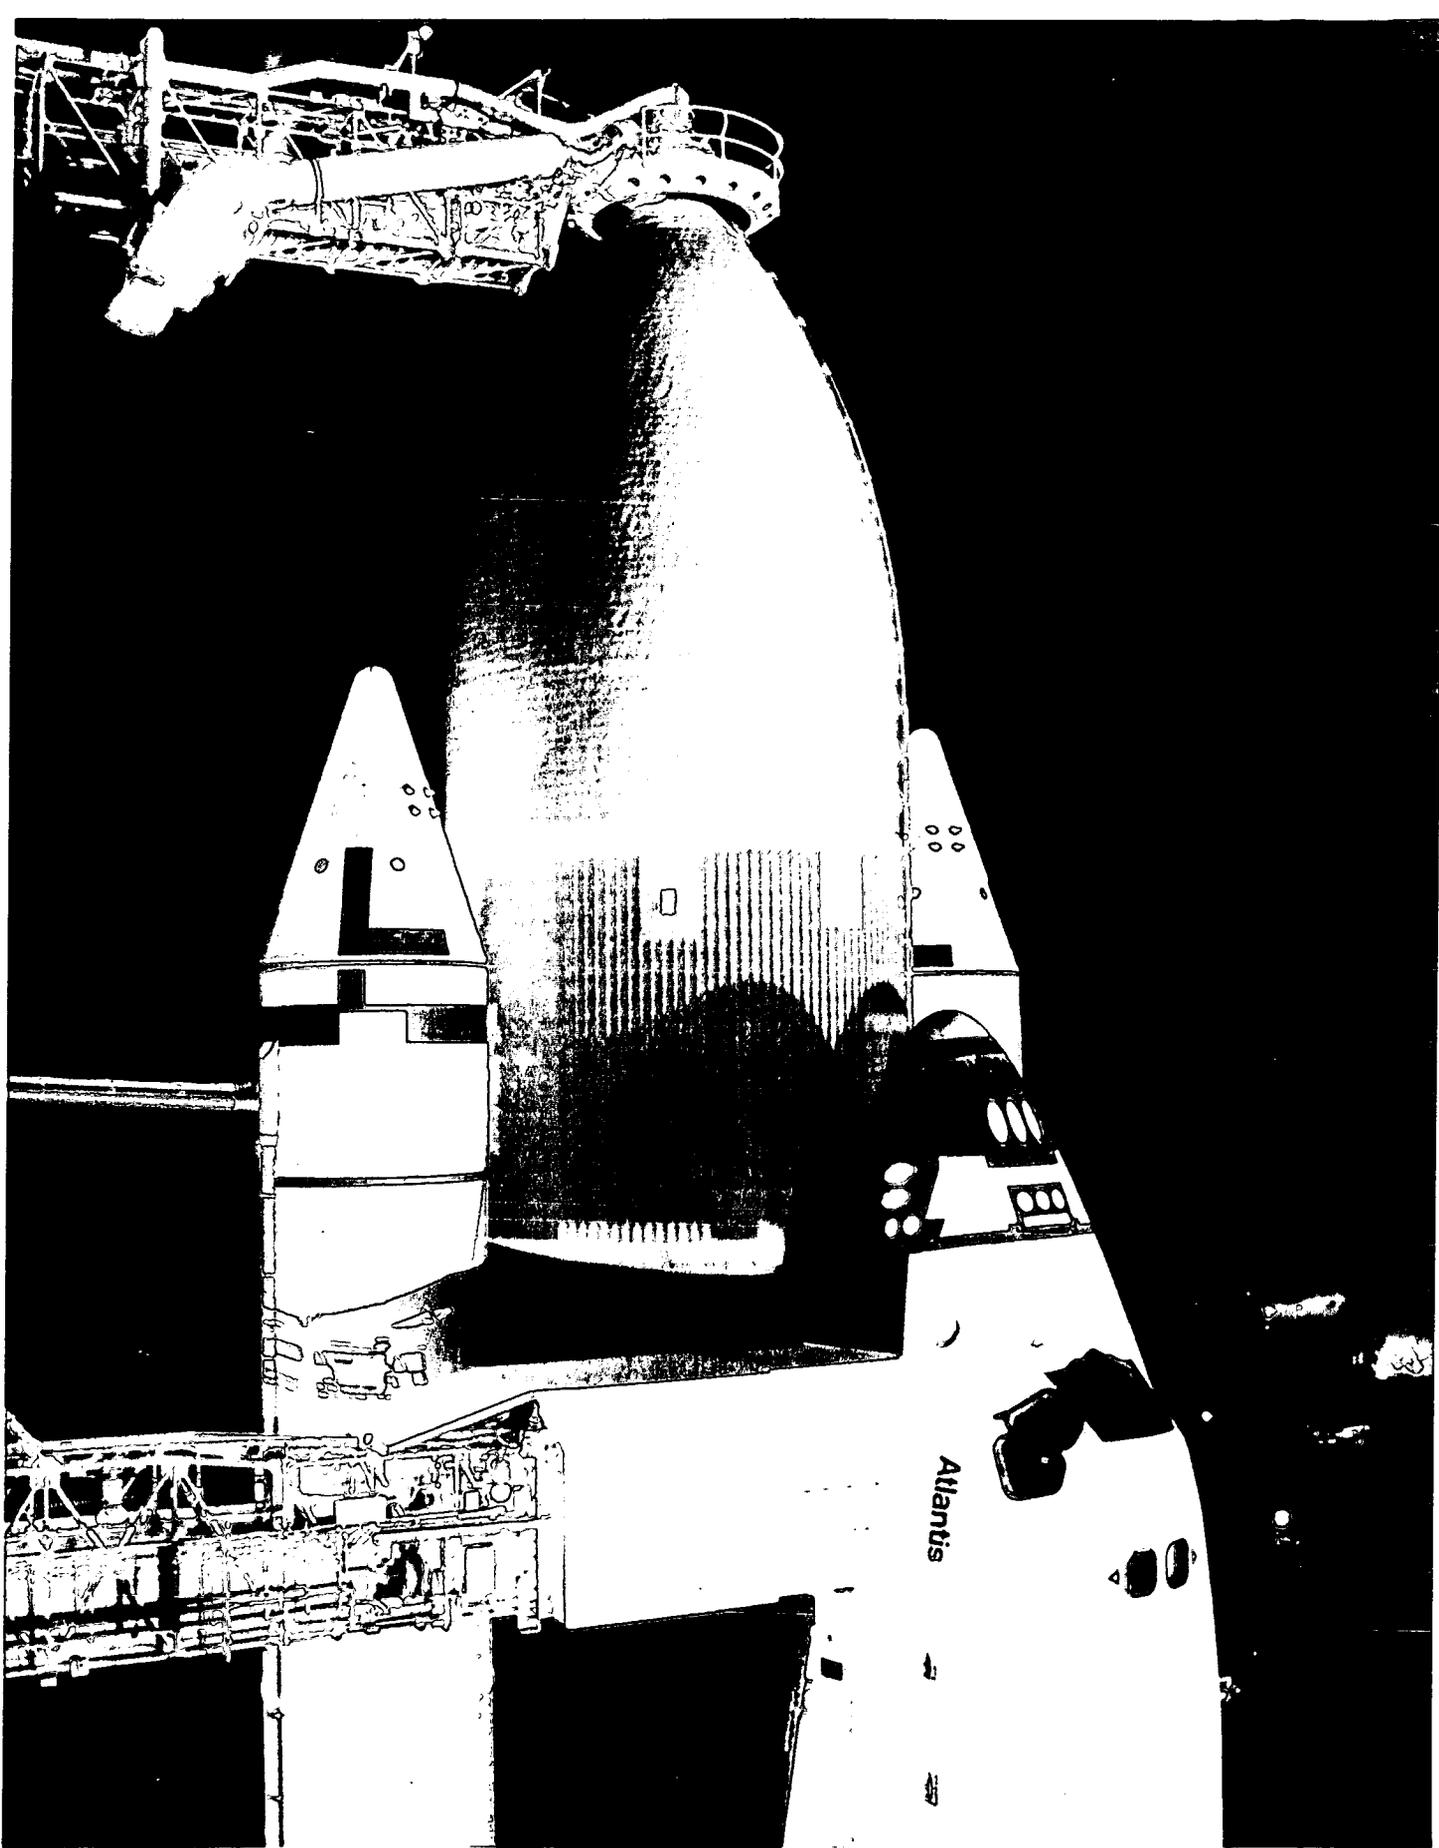
Weather conditions during the third cryo loading of the vehicle precluded the formation of acreage frost

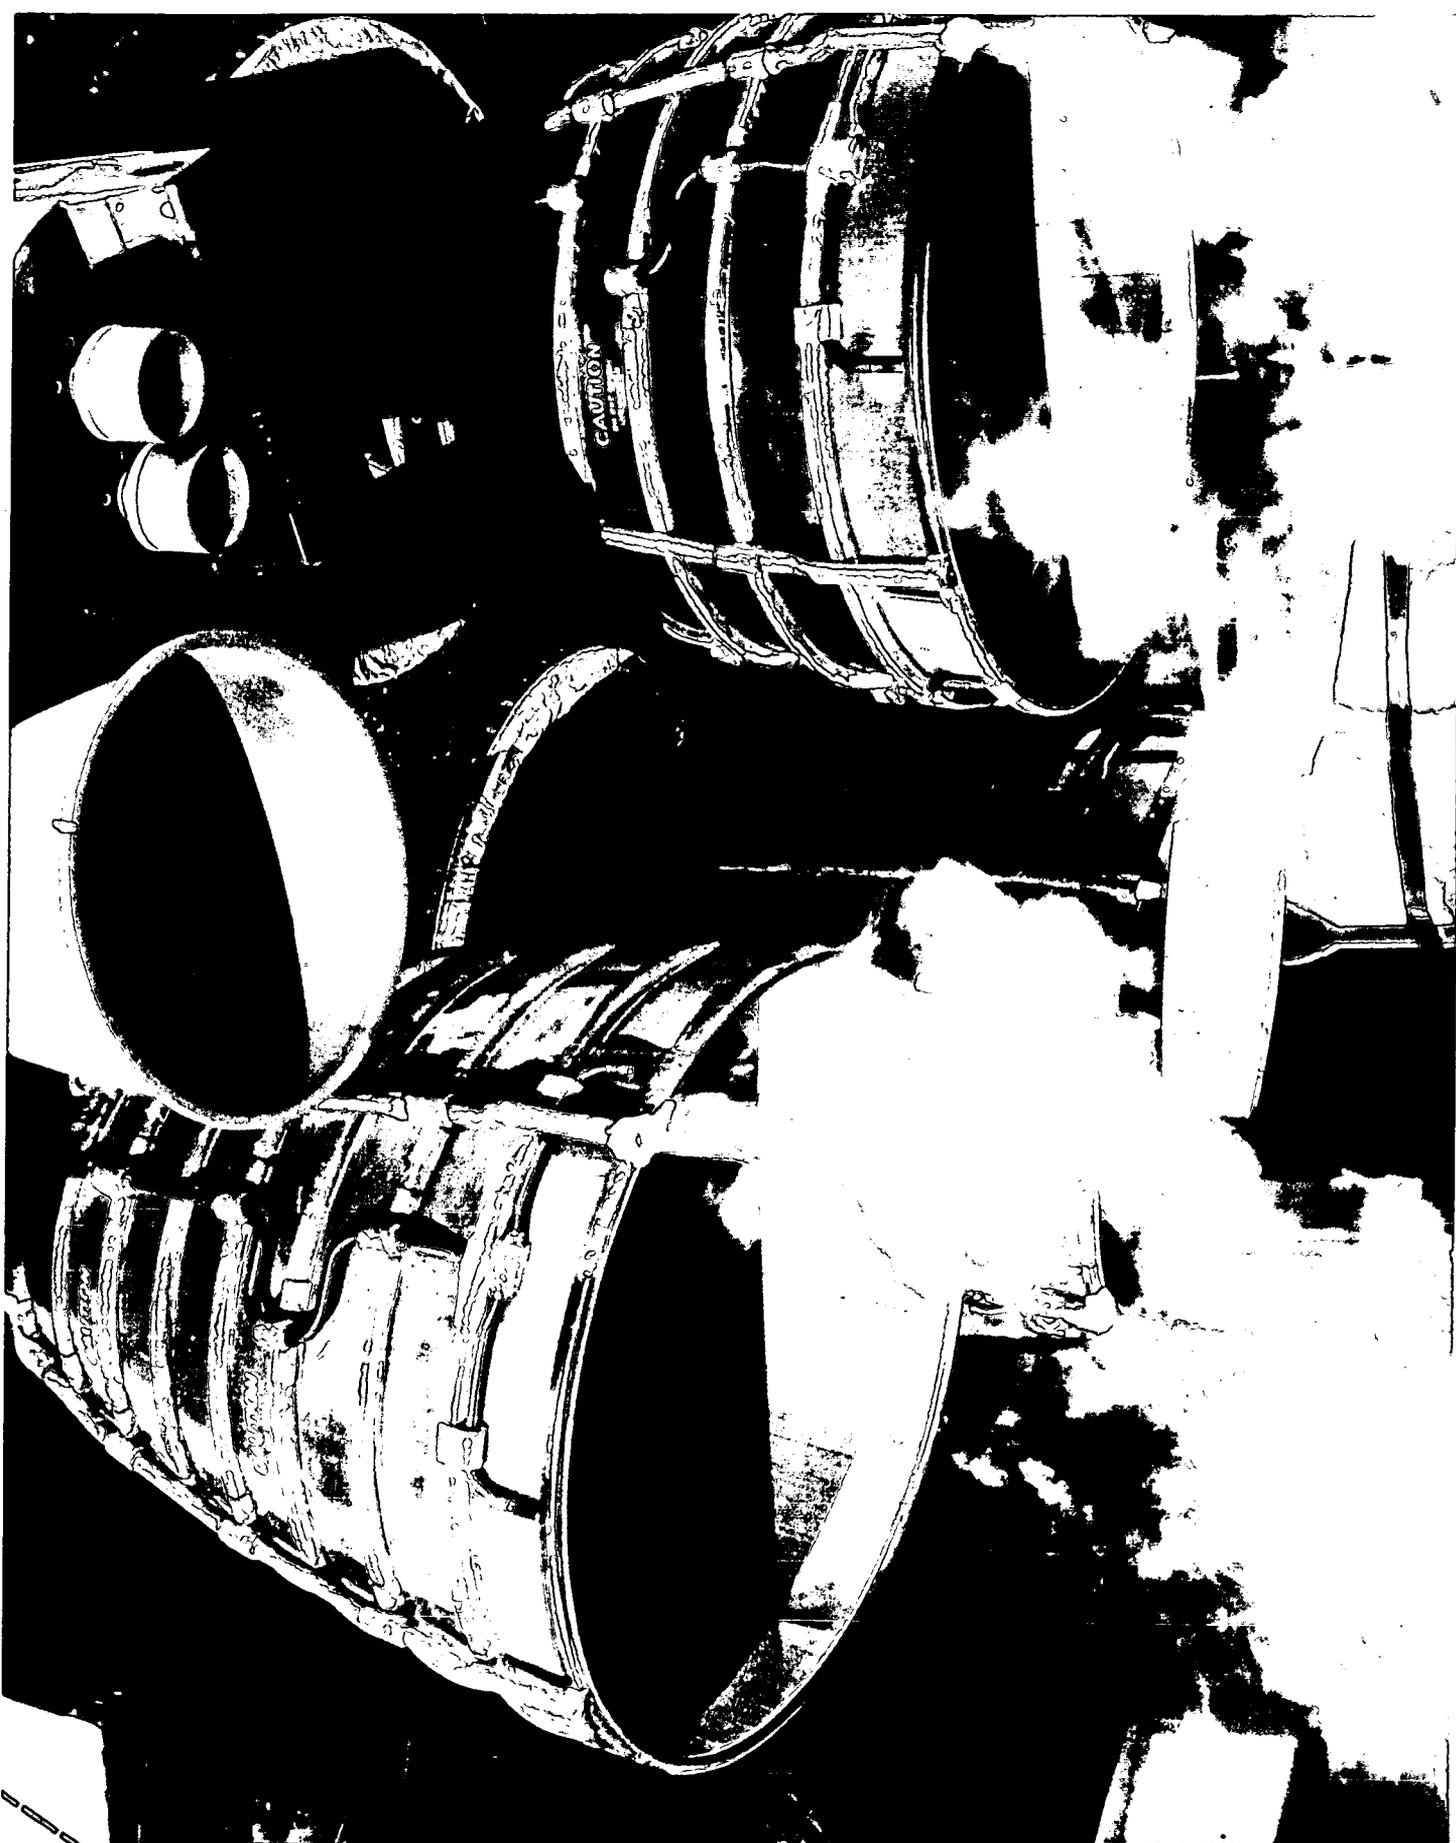
Overall view of Shuttle Main Engines shows frost along the SSME #2 engine heat shield-to-nozzle interface

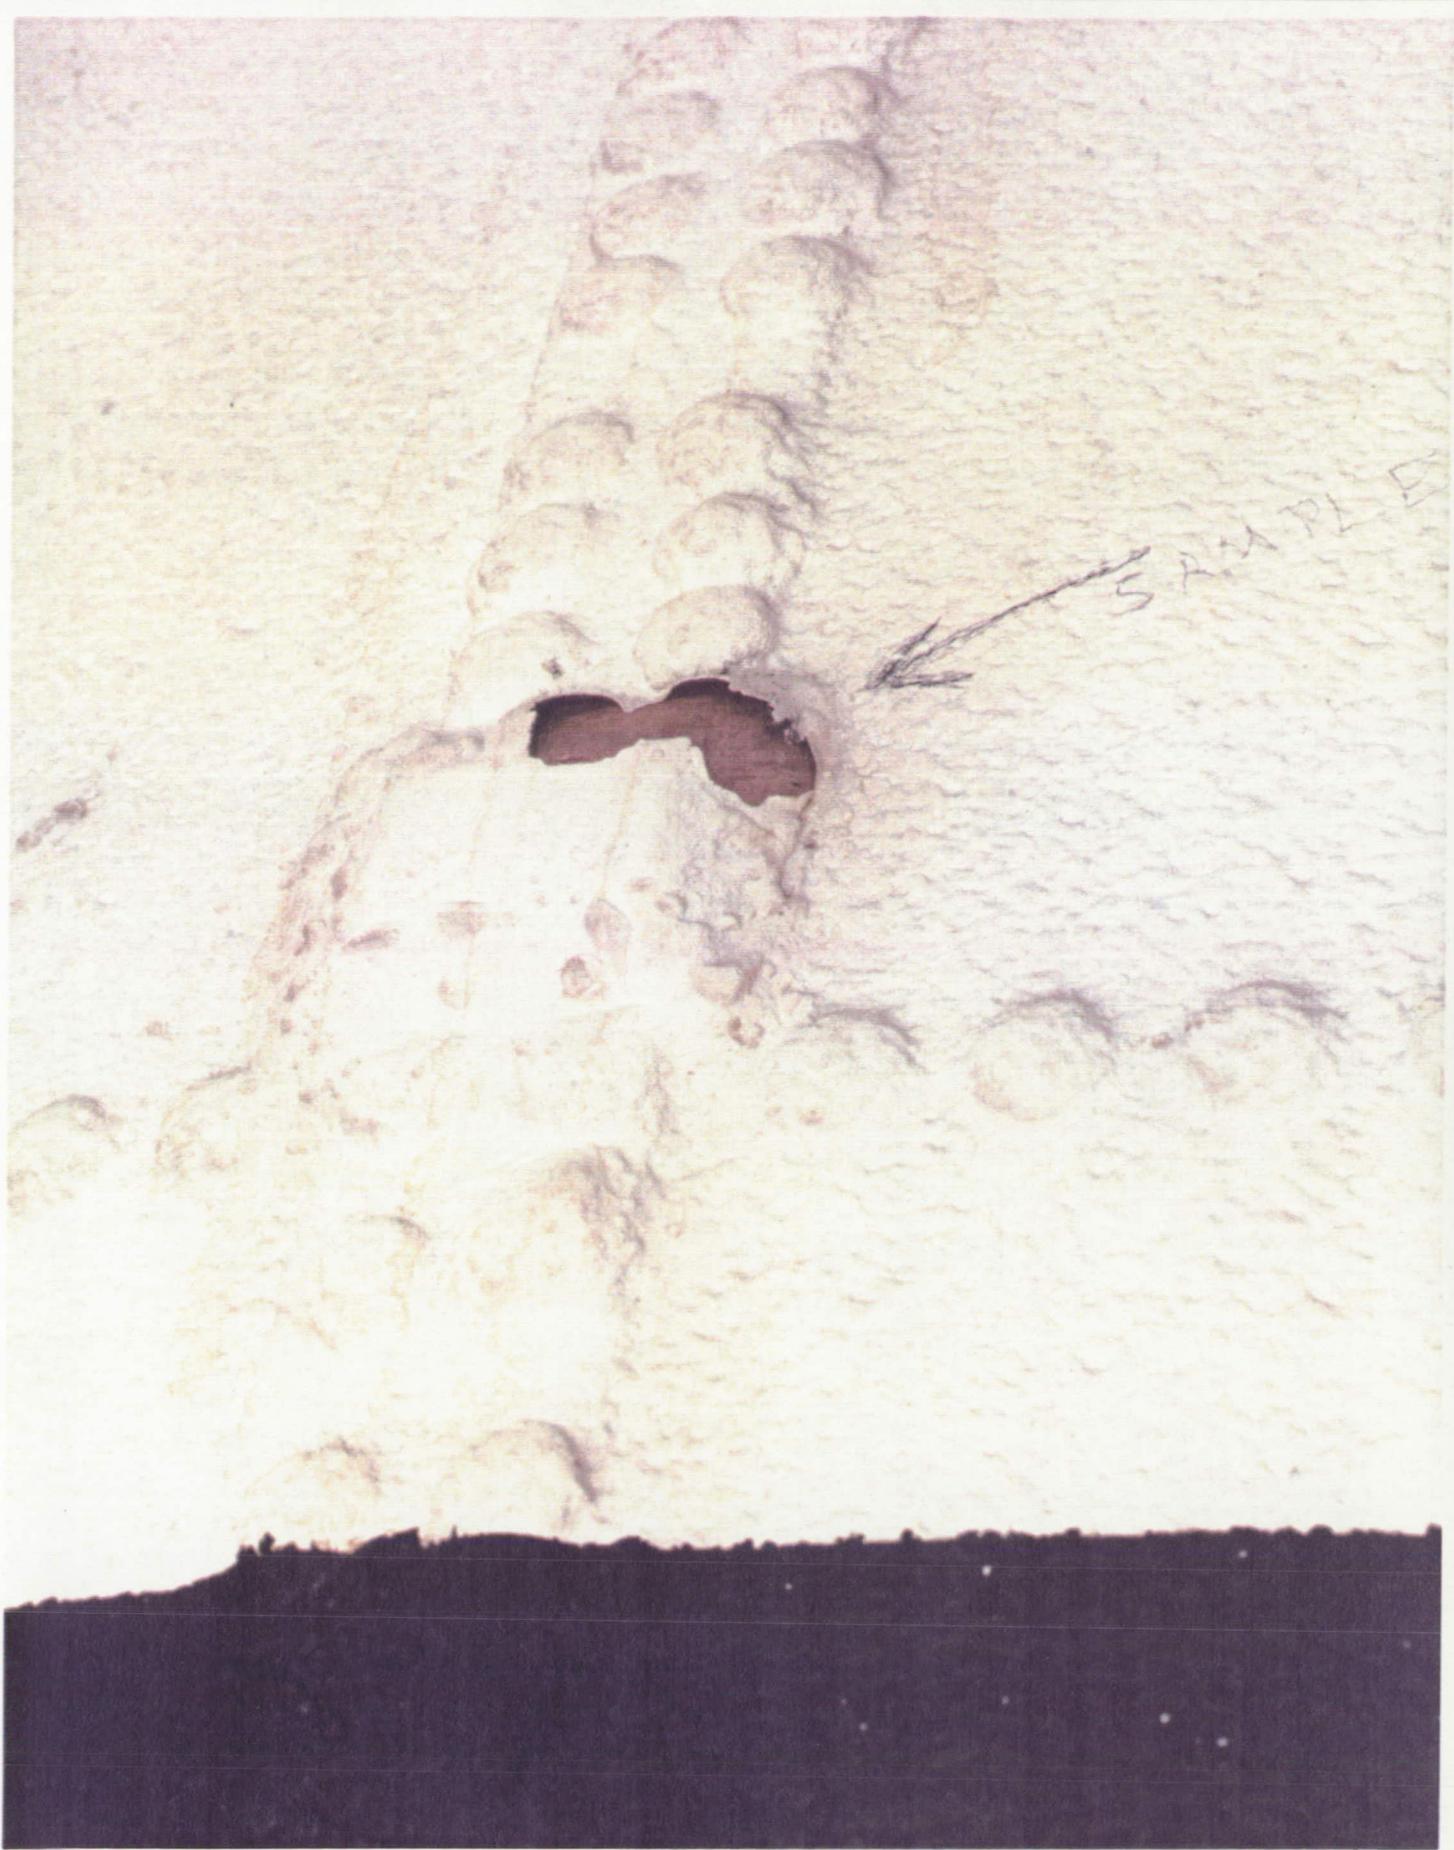
Missing Hypalon paint with some layers of MSA-2 attached was located just above the 318 ring near the -Y axis

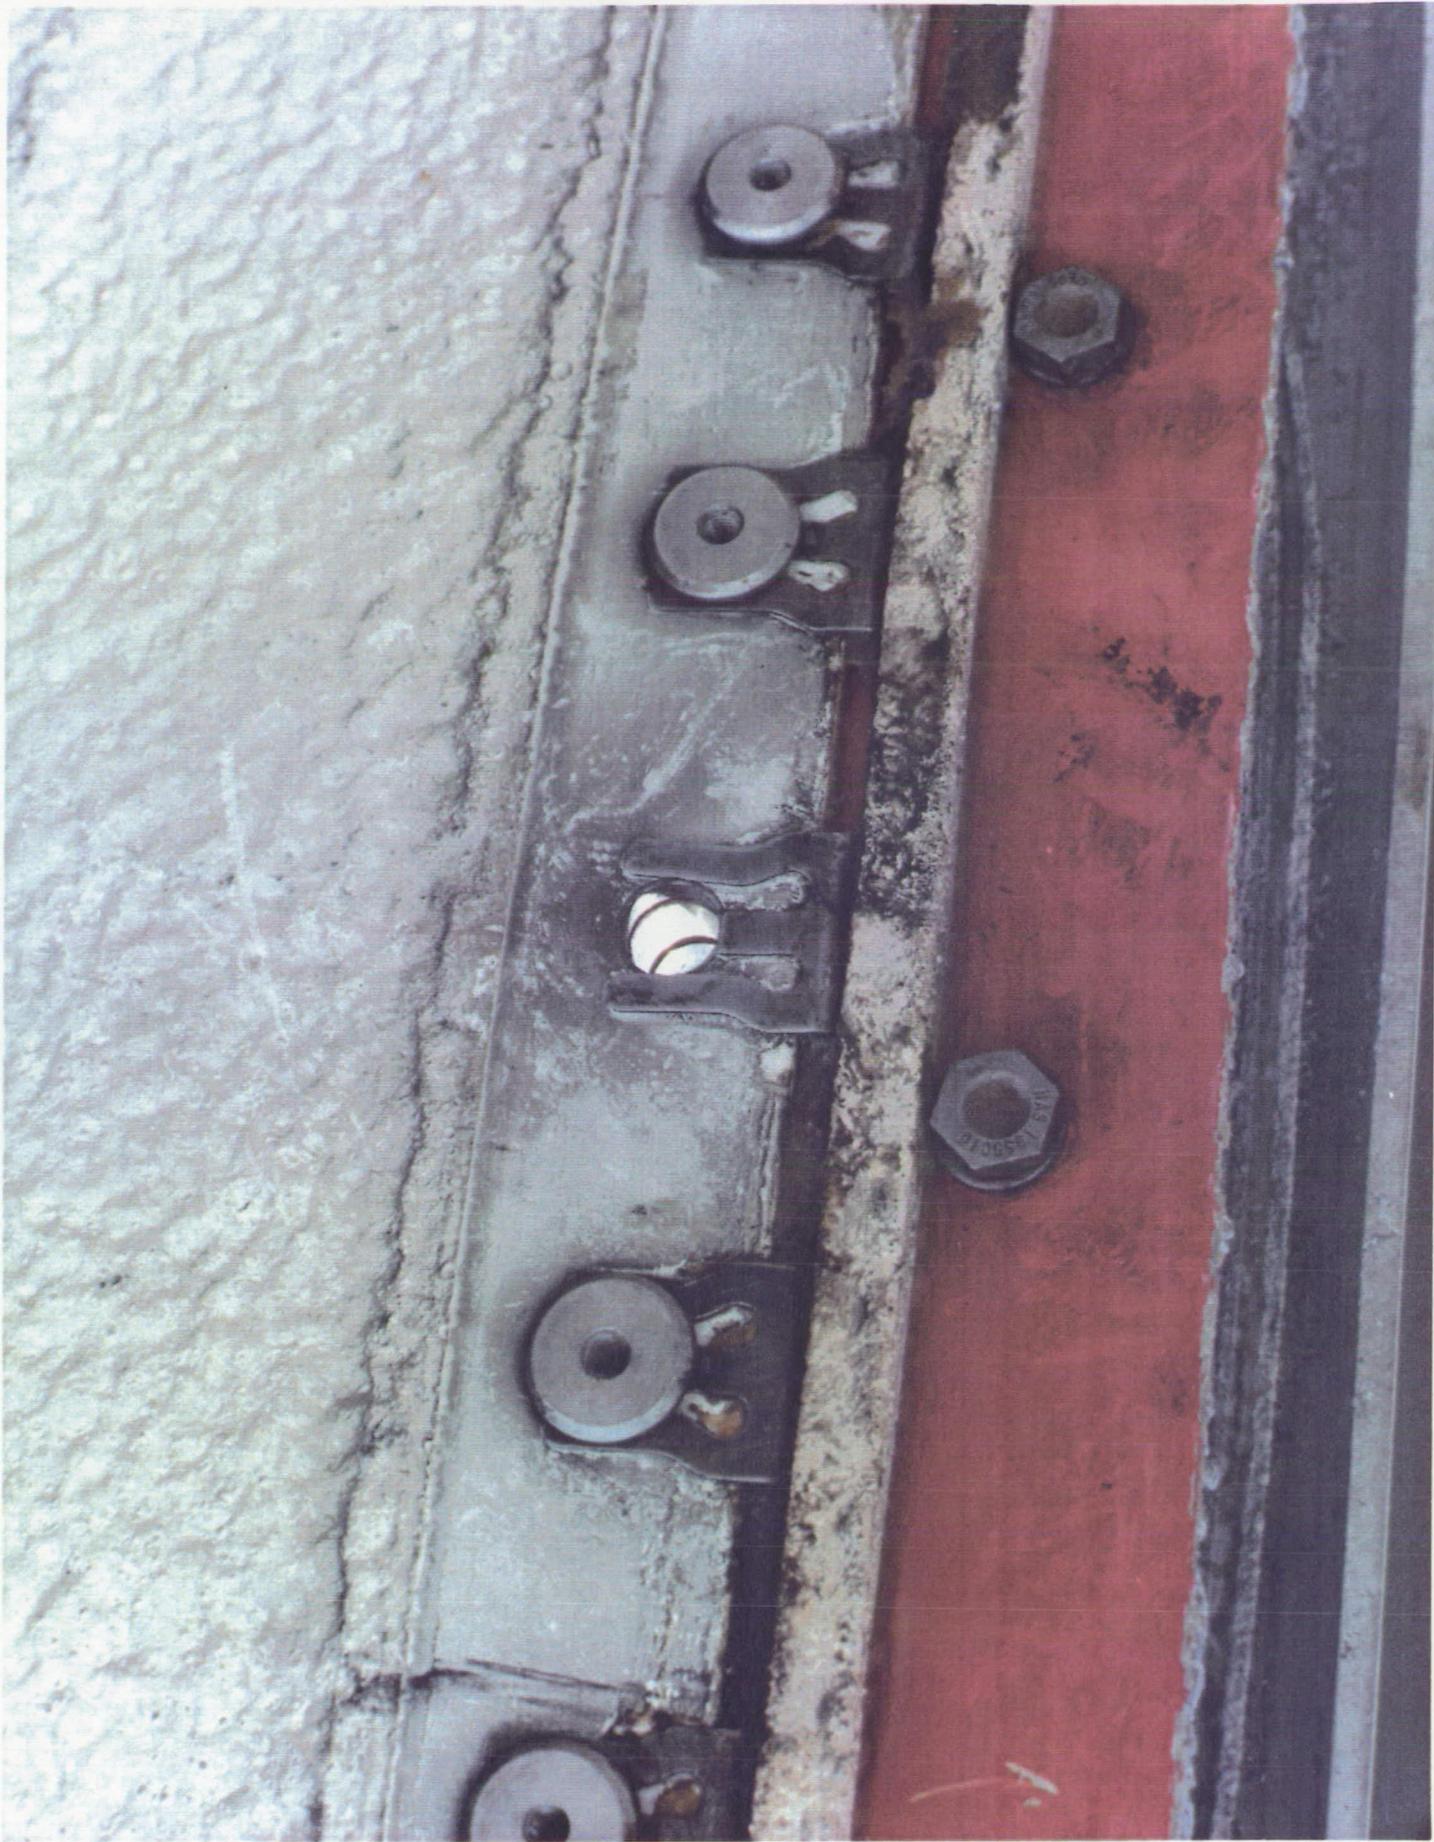
The Solid Rocket Boosters were inspected at Hanger AF after retrieval. Both forward skirts and frustums exhibited a total of 16 debonds and 3 areas of TPS. Three pins from the LH frustum severance ring at approximately 100, 120, and 240 degrees were missing. One of the pins was found embedded 0.75

Three pins were missing and 29 pins were backed out on the LH frustum/forward skirt severance ring

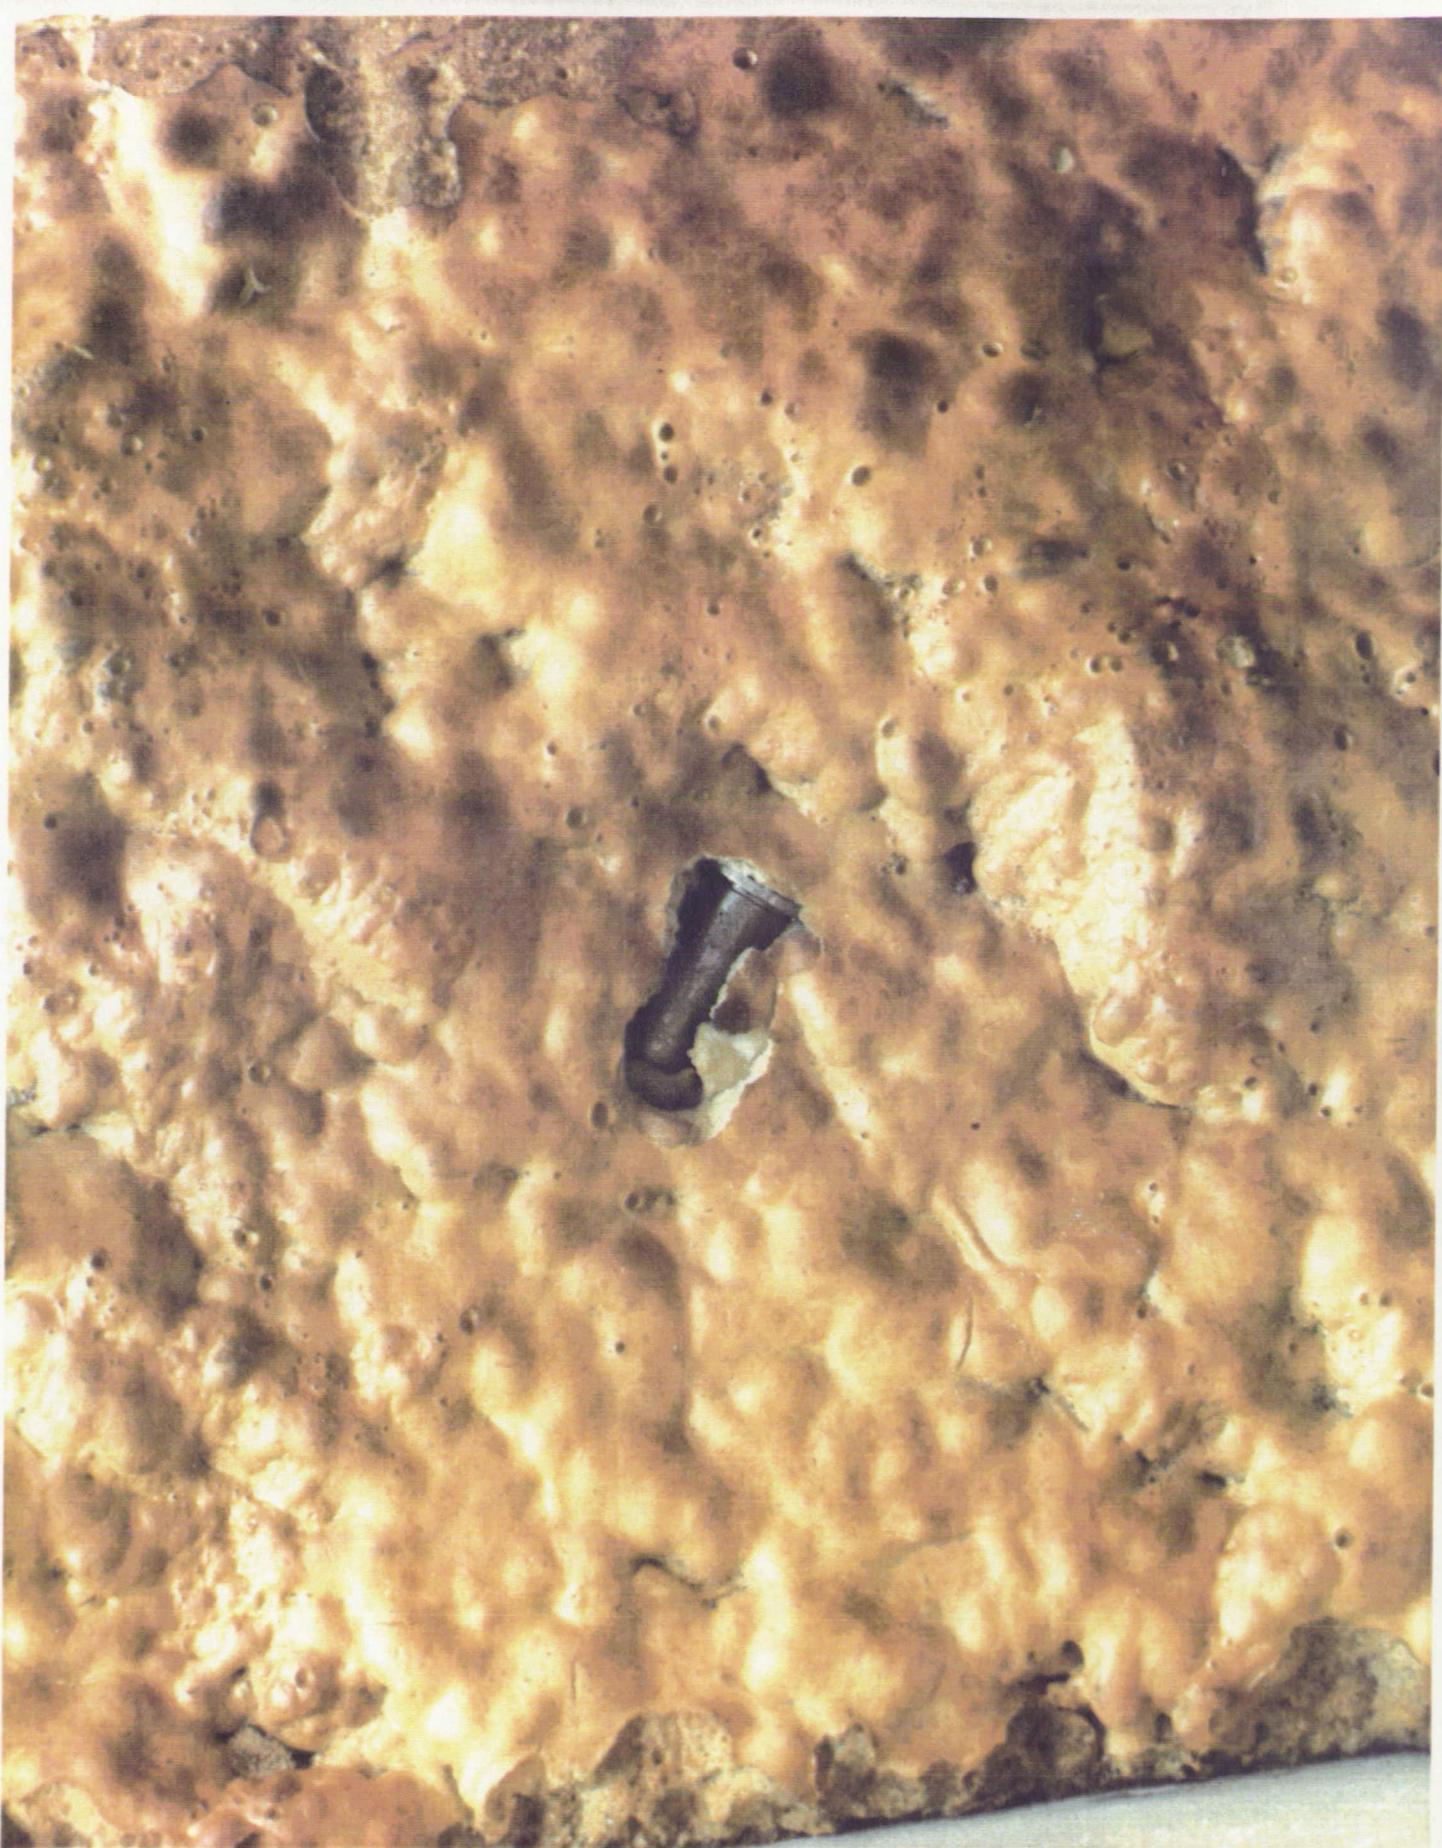
inches into the TPS on the forward edge of the ETA ring at 175 degrees. Analysis of this pin and the adjacent TPS indicated that the impact occurred during ascent (Ref MSFC presentation on 3/9/90). All field joint closeouts were undamaged. The LH aft center segment factory joint EPDM moisture seal was unbonded at 4 locations along the trailing edge and exhibited Chemlok 205 to case failure. K5NA was missing from numerous bolt heads on the aft side of both kick rings and from all eight aft BSM nozzles. The plungers on holddown posts #1, #6, and #7 were seated but offset from their spherical washers. Three small pieces of shim material were wedged in the bore against the HDP #4 plunger. Half of a frangible nut was wedged between the HDP #8 plunger and spherical washer. HDP #2 experienced a skewed firing. Overall, the SRBs were in good condition.

One of the missing pins from the LH frustum/forward skirt
severance ring was found embedded in the ETA ring foam

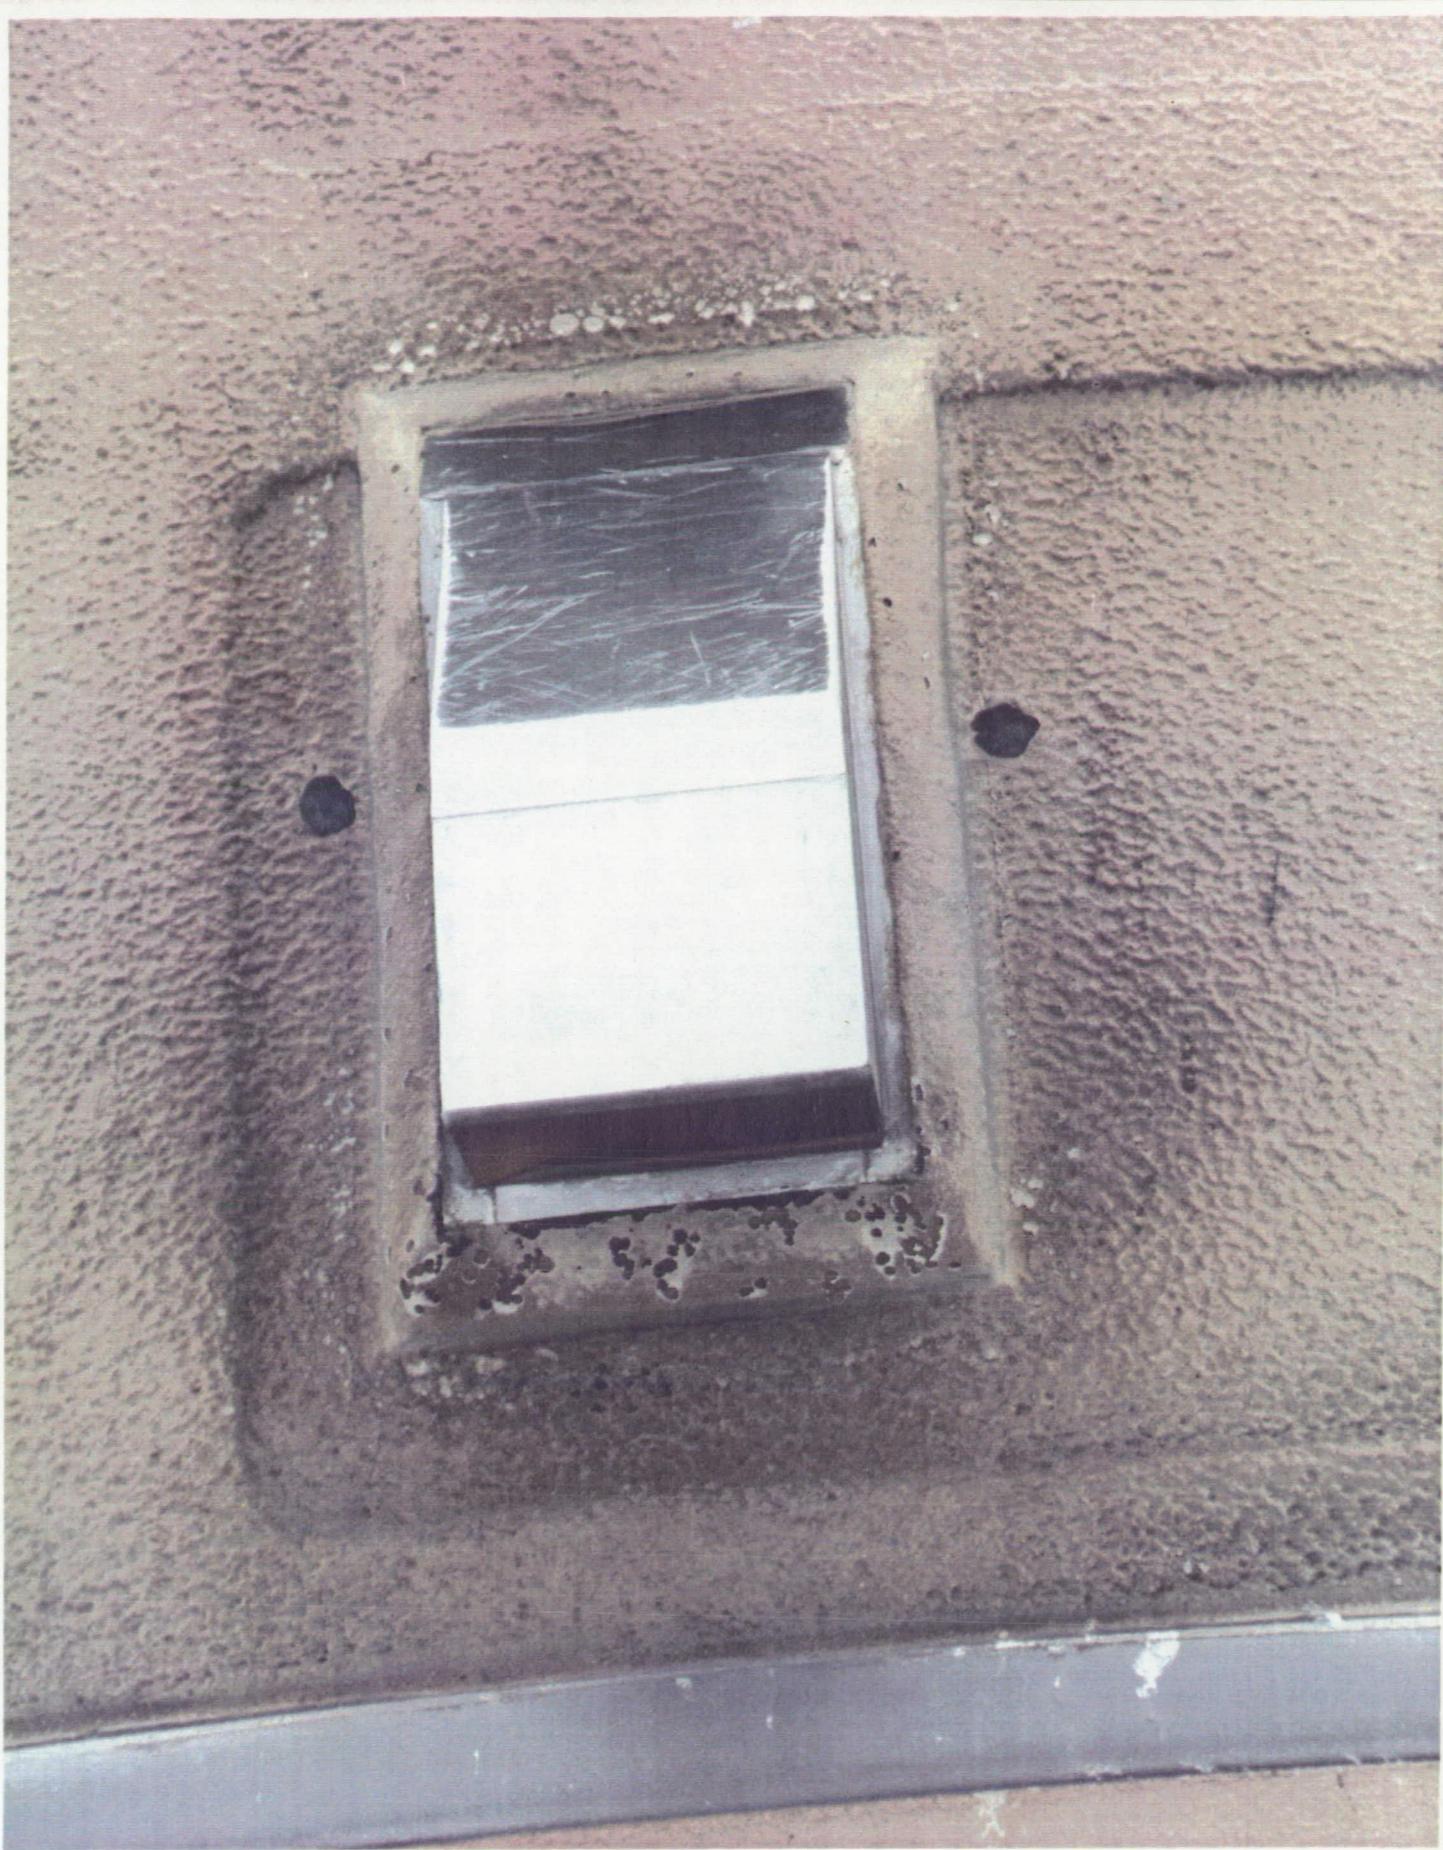
The phenolic plate on the LH forward skirt +Z RSS antenna was delaminated and some of the material was missing

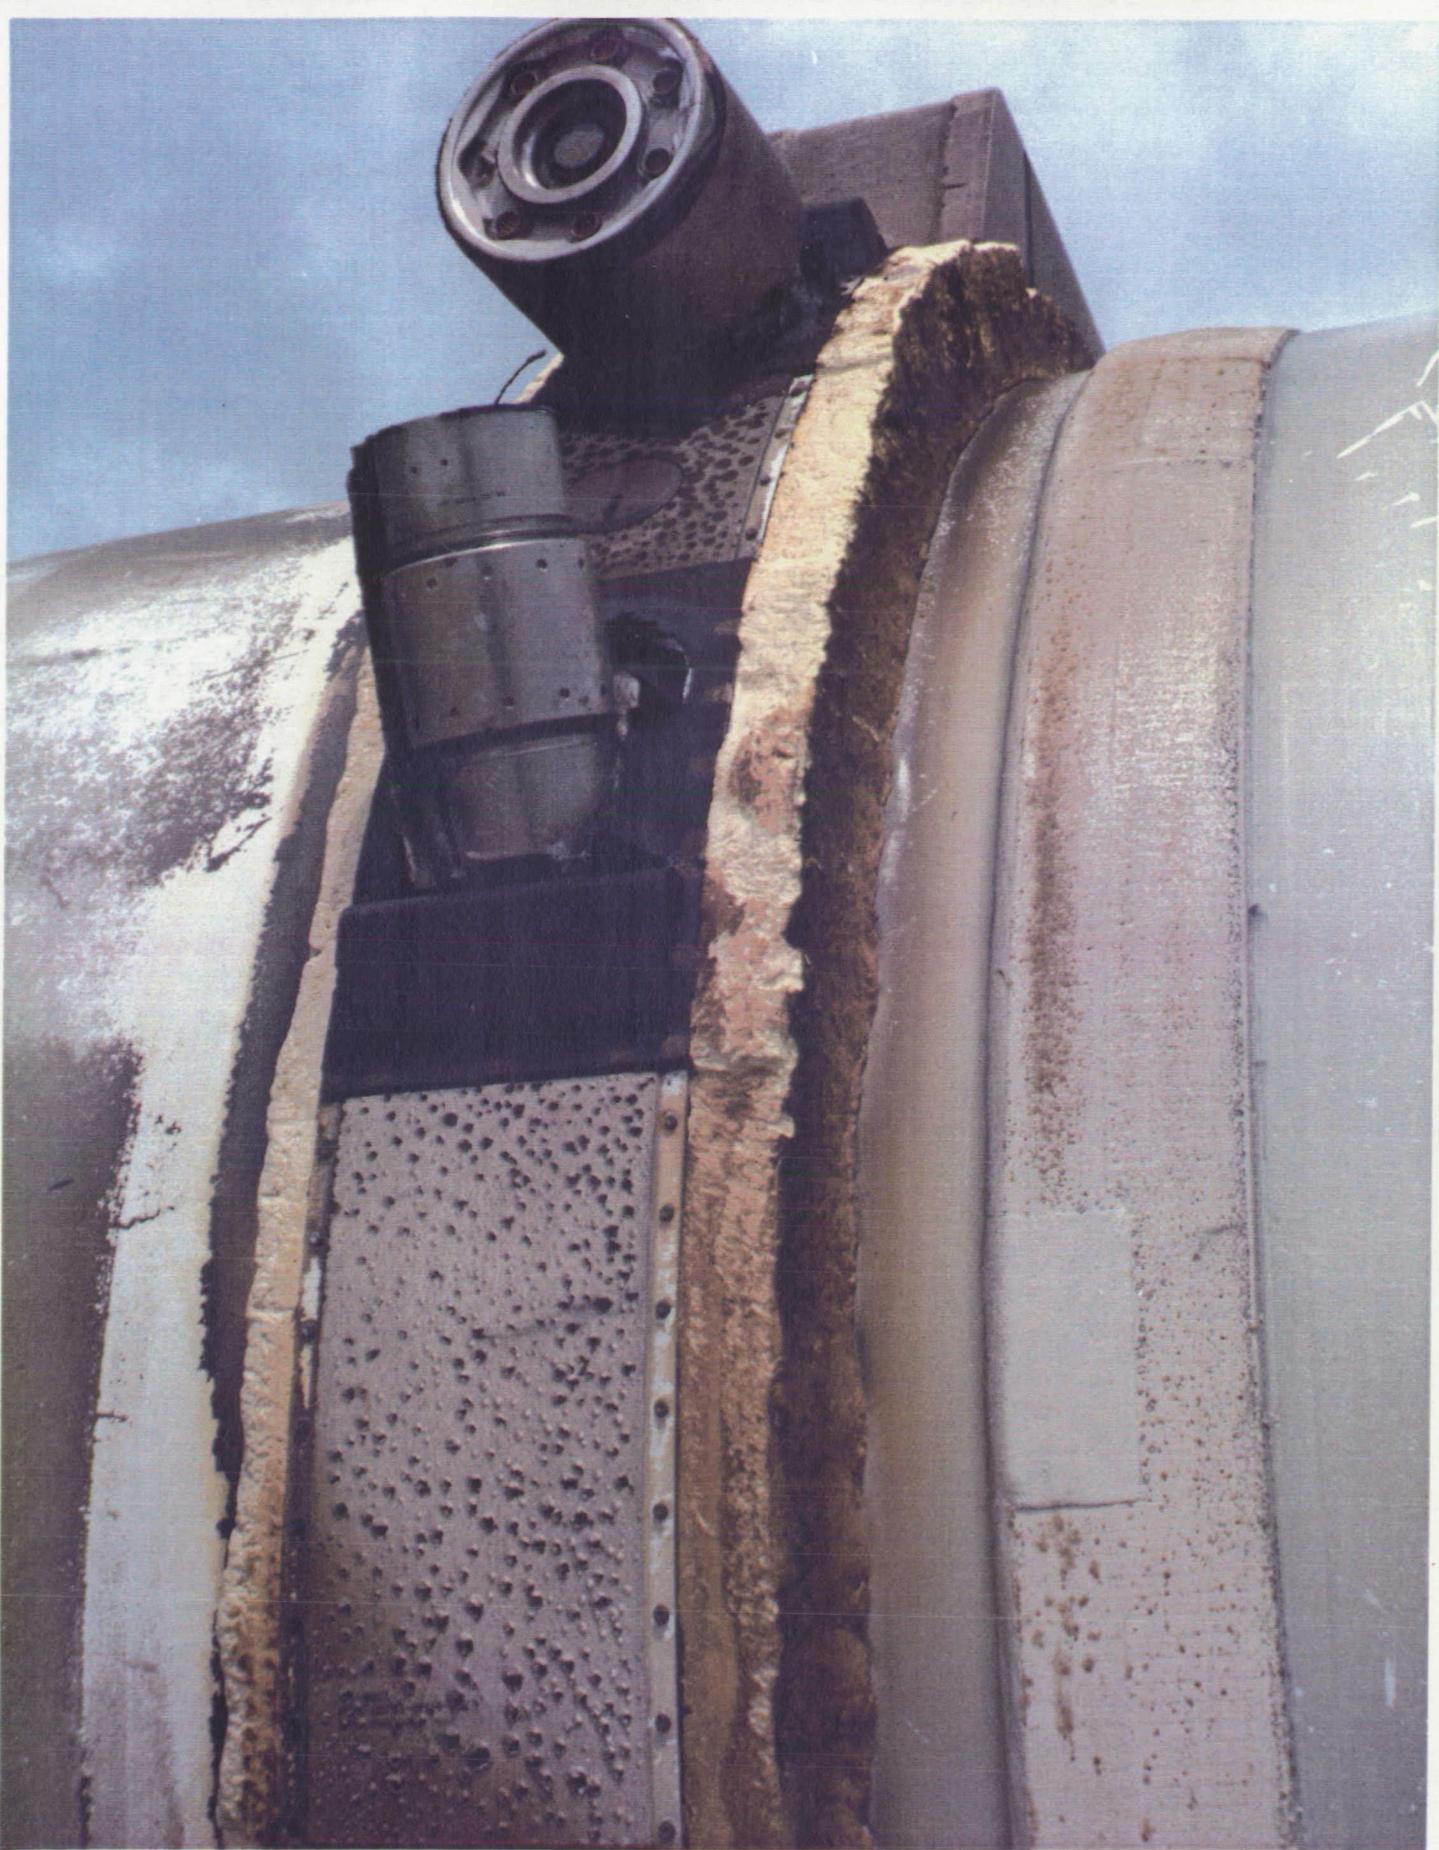
EPDM seal around the ET/SRB struts was torn and the Hypalon
paint on the ETA ring covers was blistered
