Debris/Ice/TPS Assessment And Photographic Analysis For Shuttle Mission STS-36

April 1990

DEBRIS/ICE/TPS ASSESSMENT
AND
PHOTOGRAPHIC ANALYSIS
OF
SHUTTLE MISSION STS-36

February 28, 1990

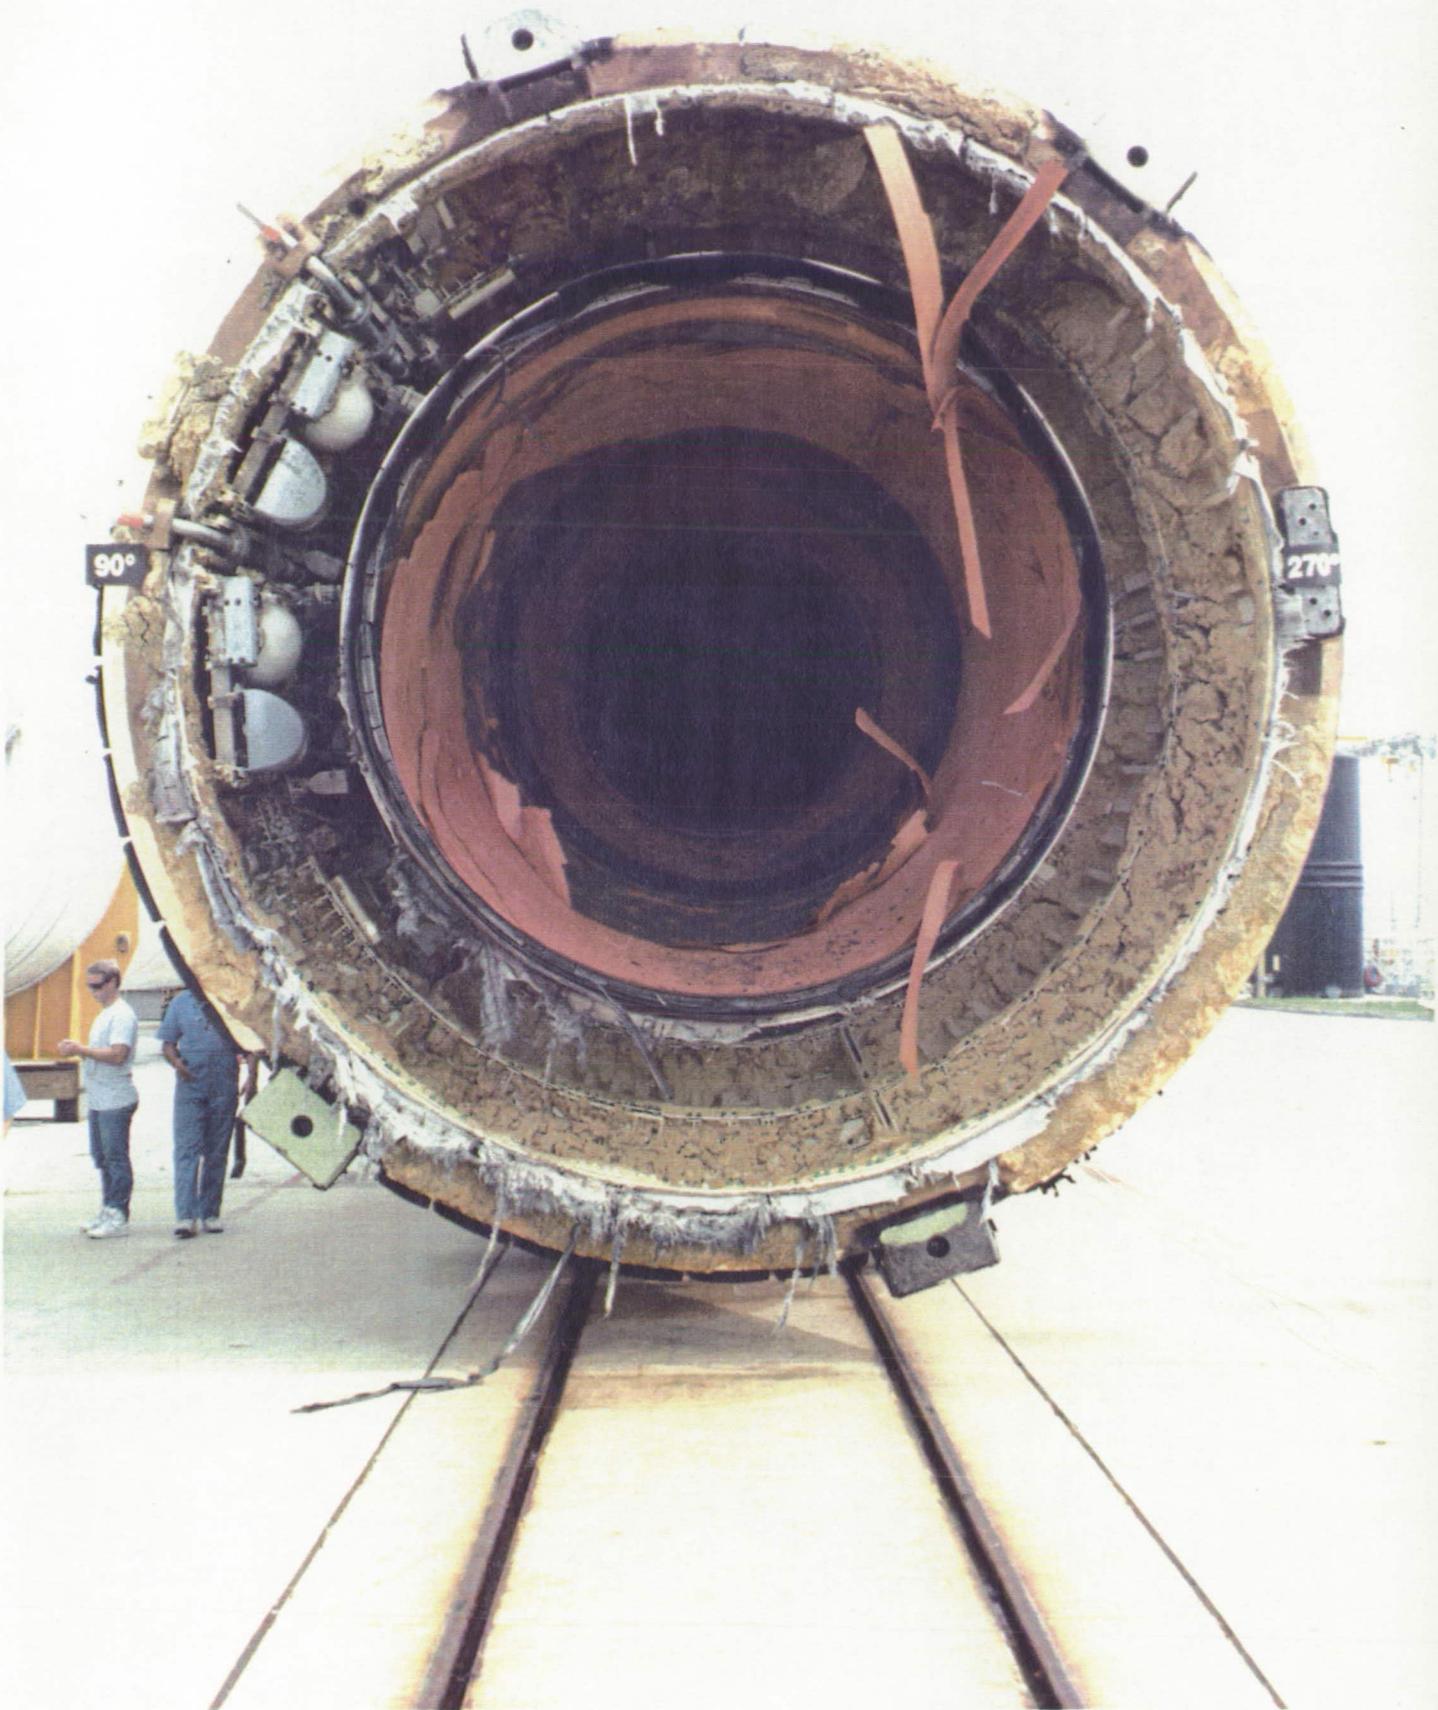
Post flight condition of LH aft skirt shows some loss of foam around aft ring prior to water impact

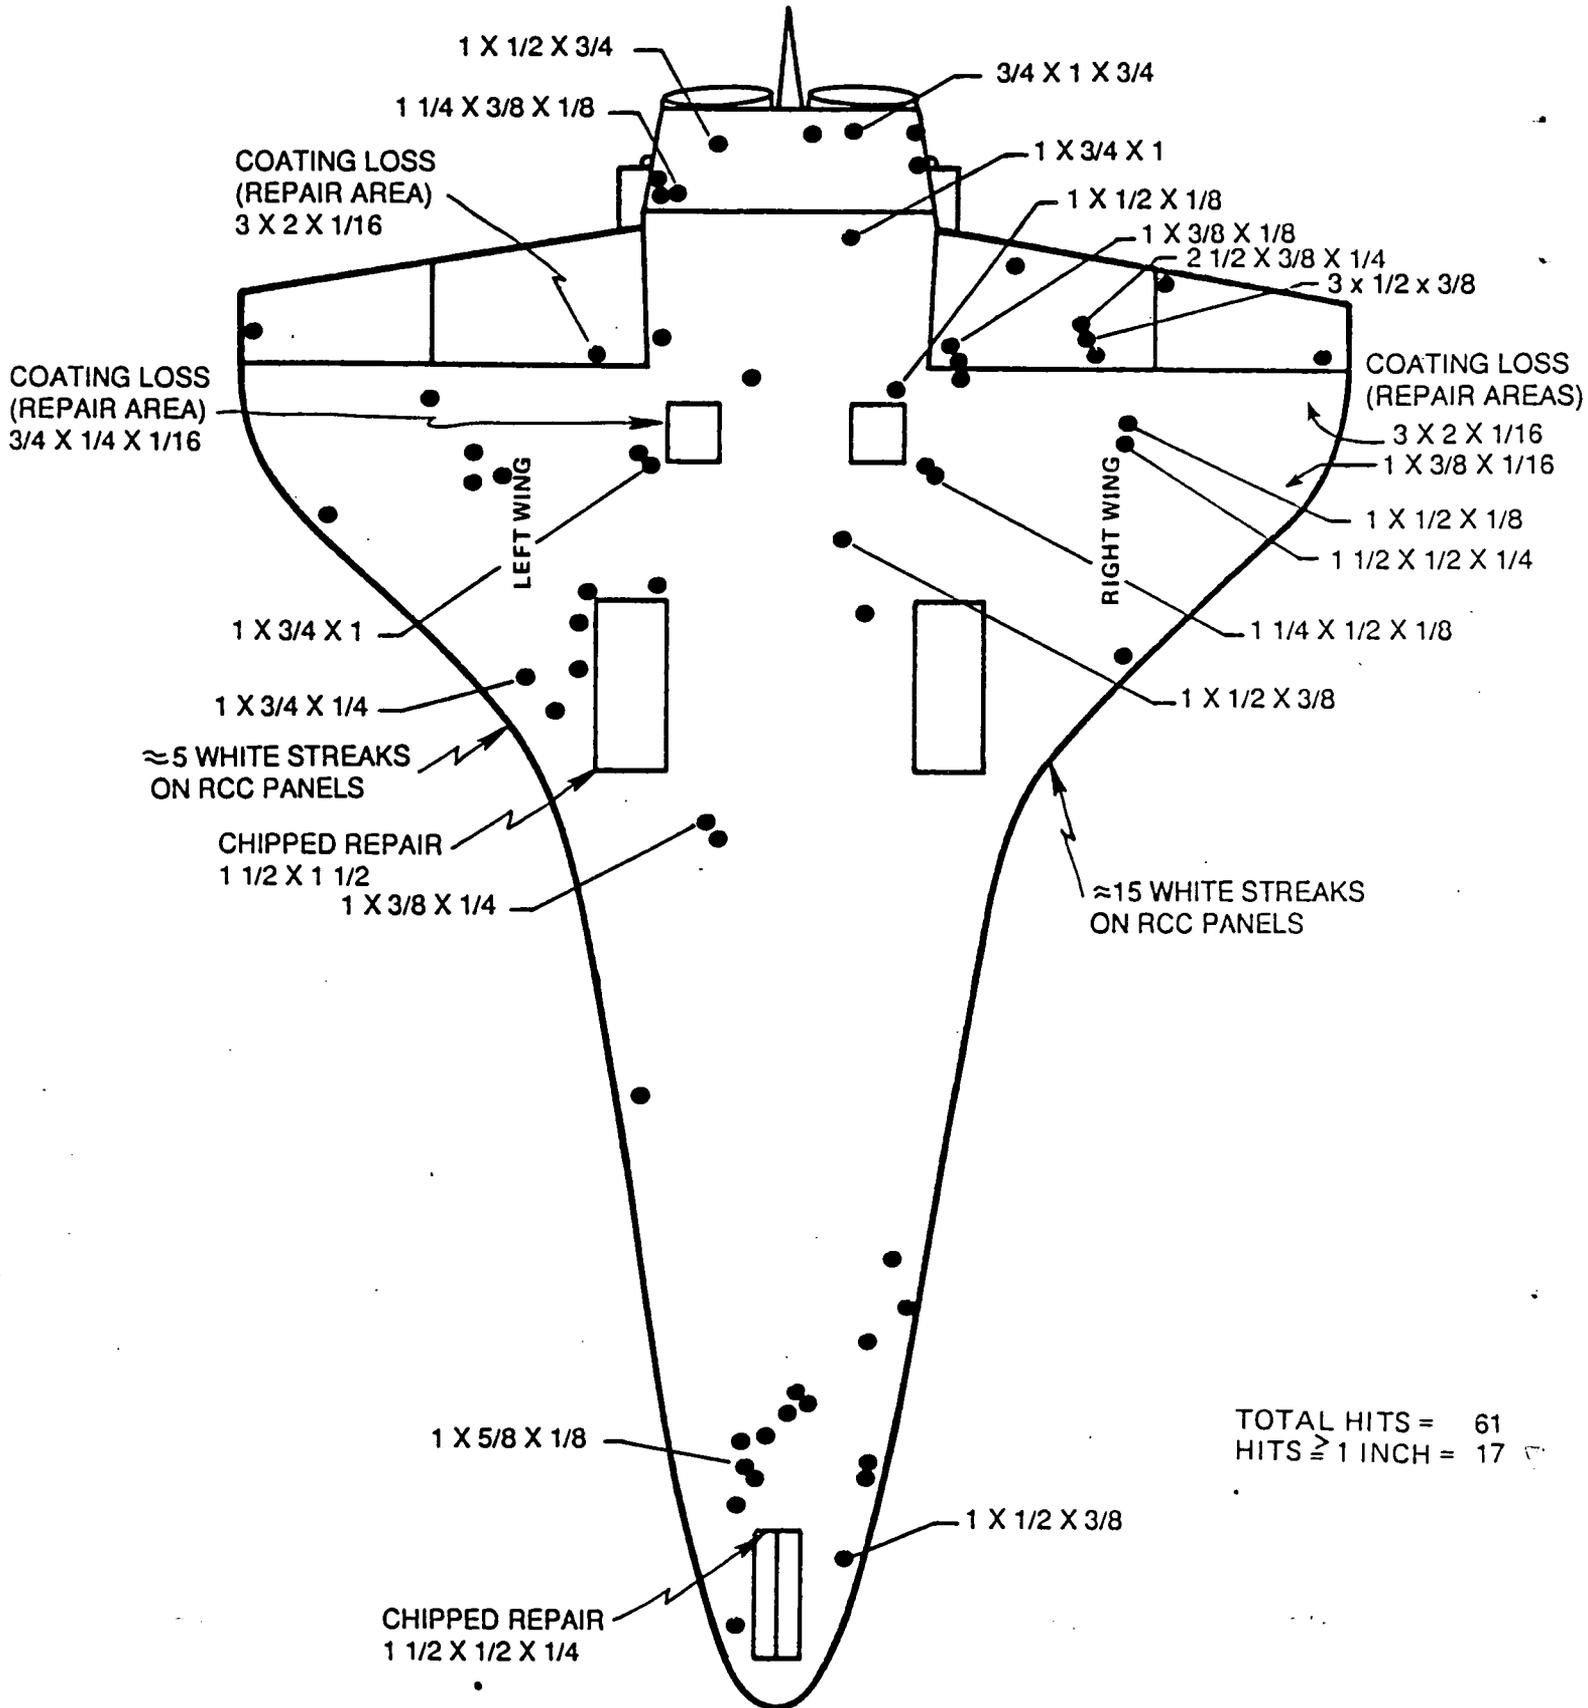
FIGURE 33. DEBRIS DAMAGE LOCATIONS

TOTAL HITS = 61
HITS ≥ 1 INCH = 17

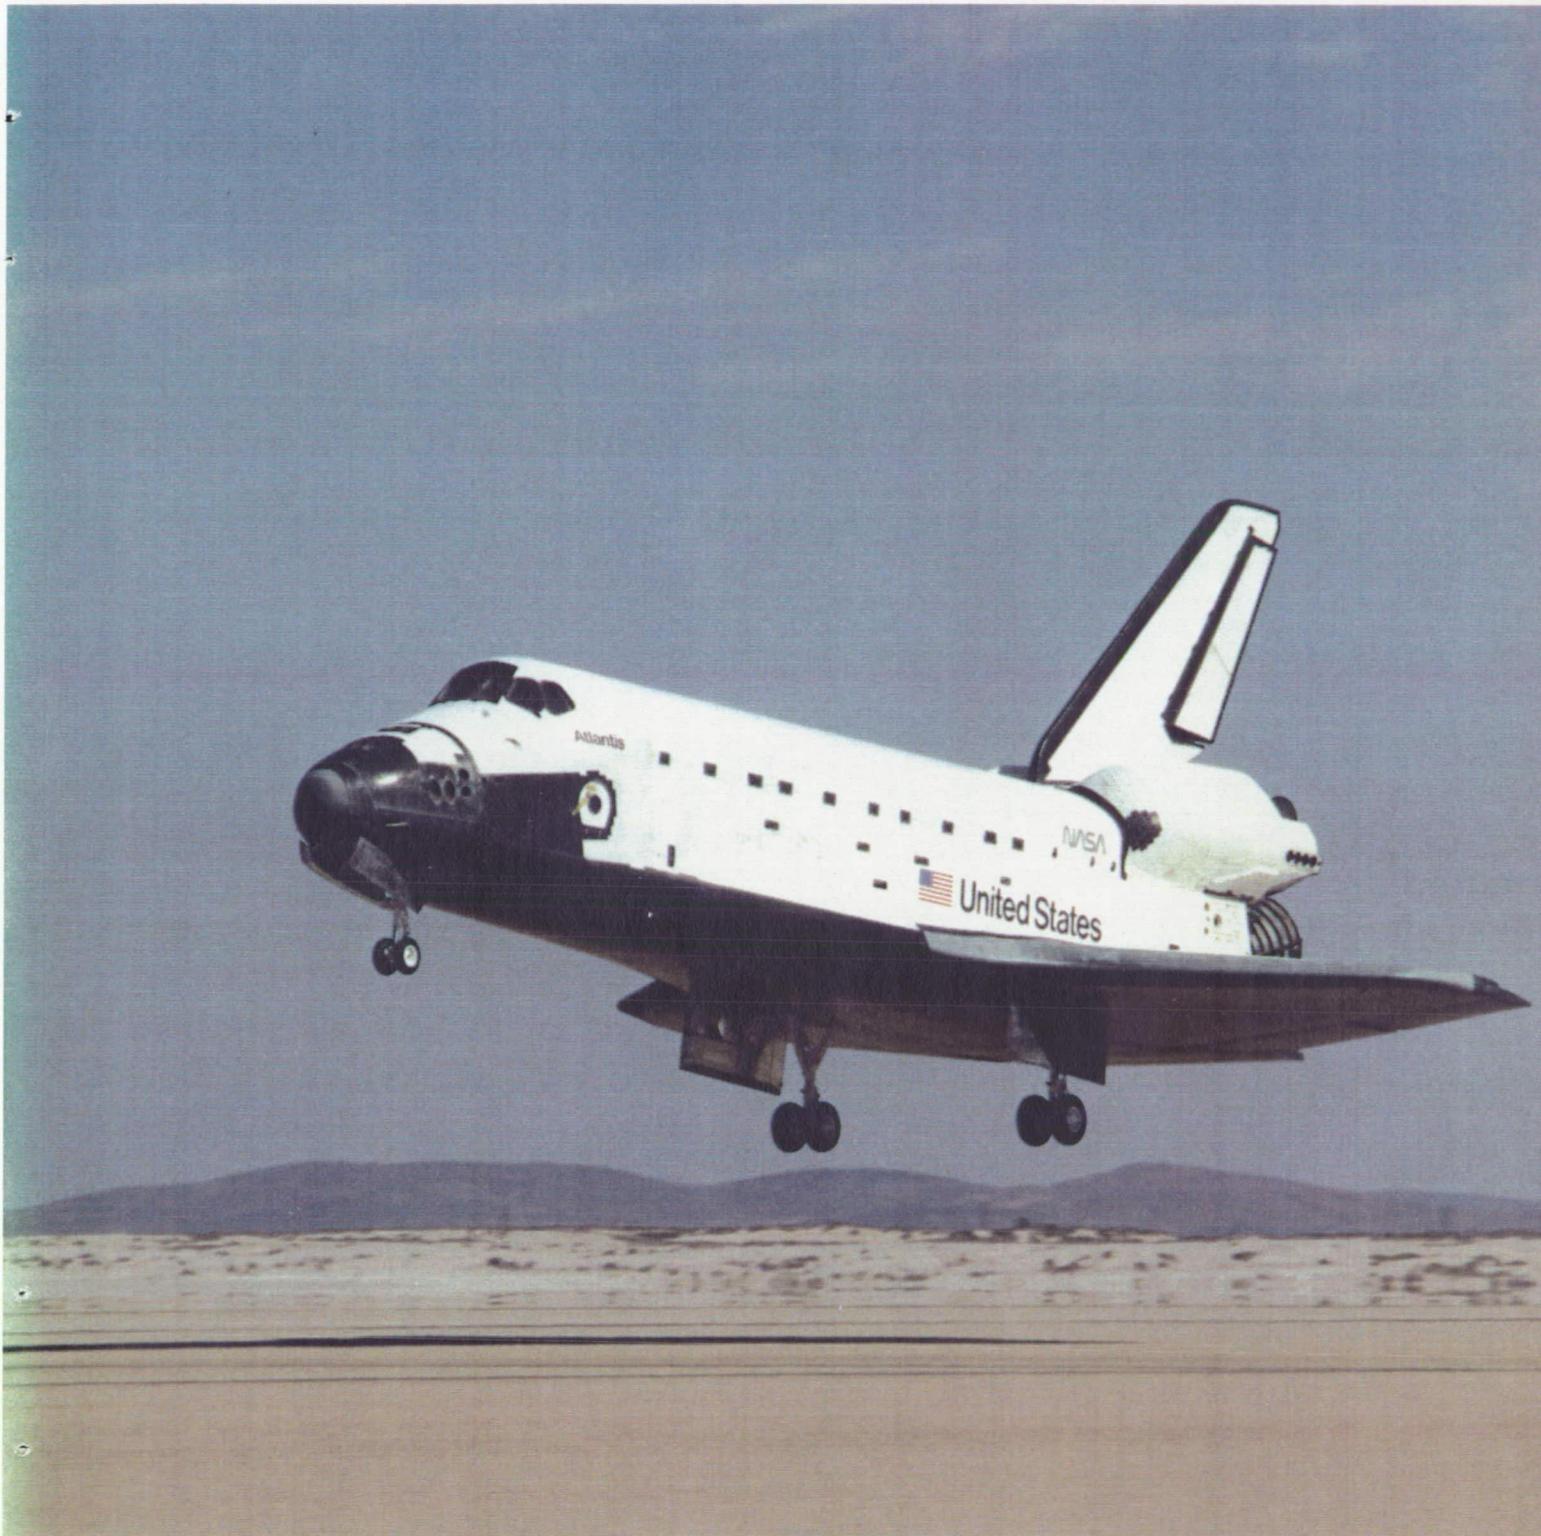
No major TPS damage was visible on OV-104 Atlantis just prior
to touchdown at Ames-Dryden/Edwards AFB

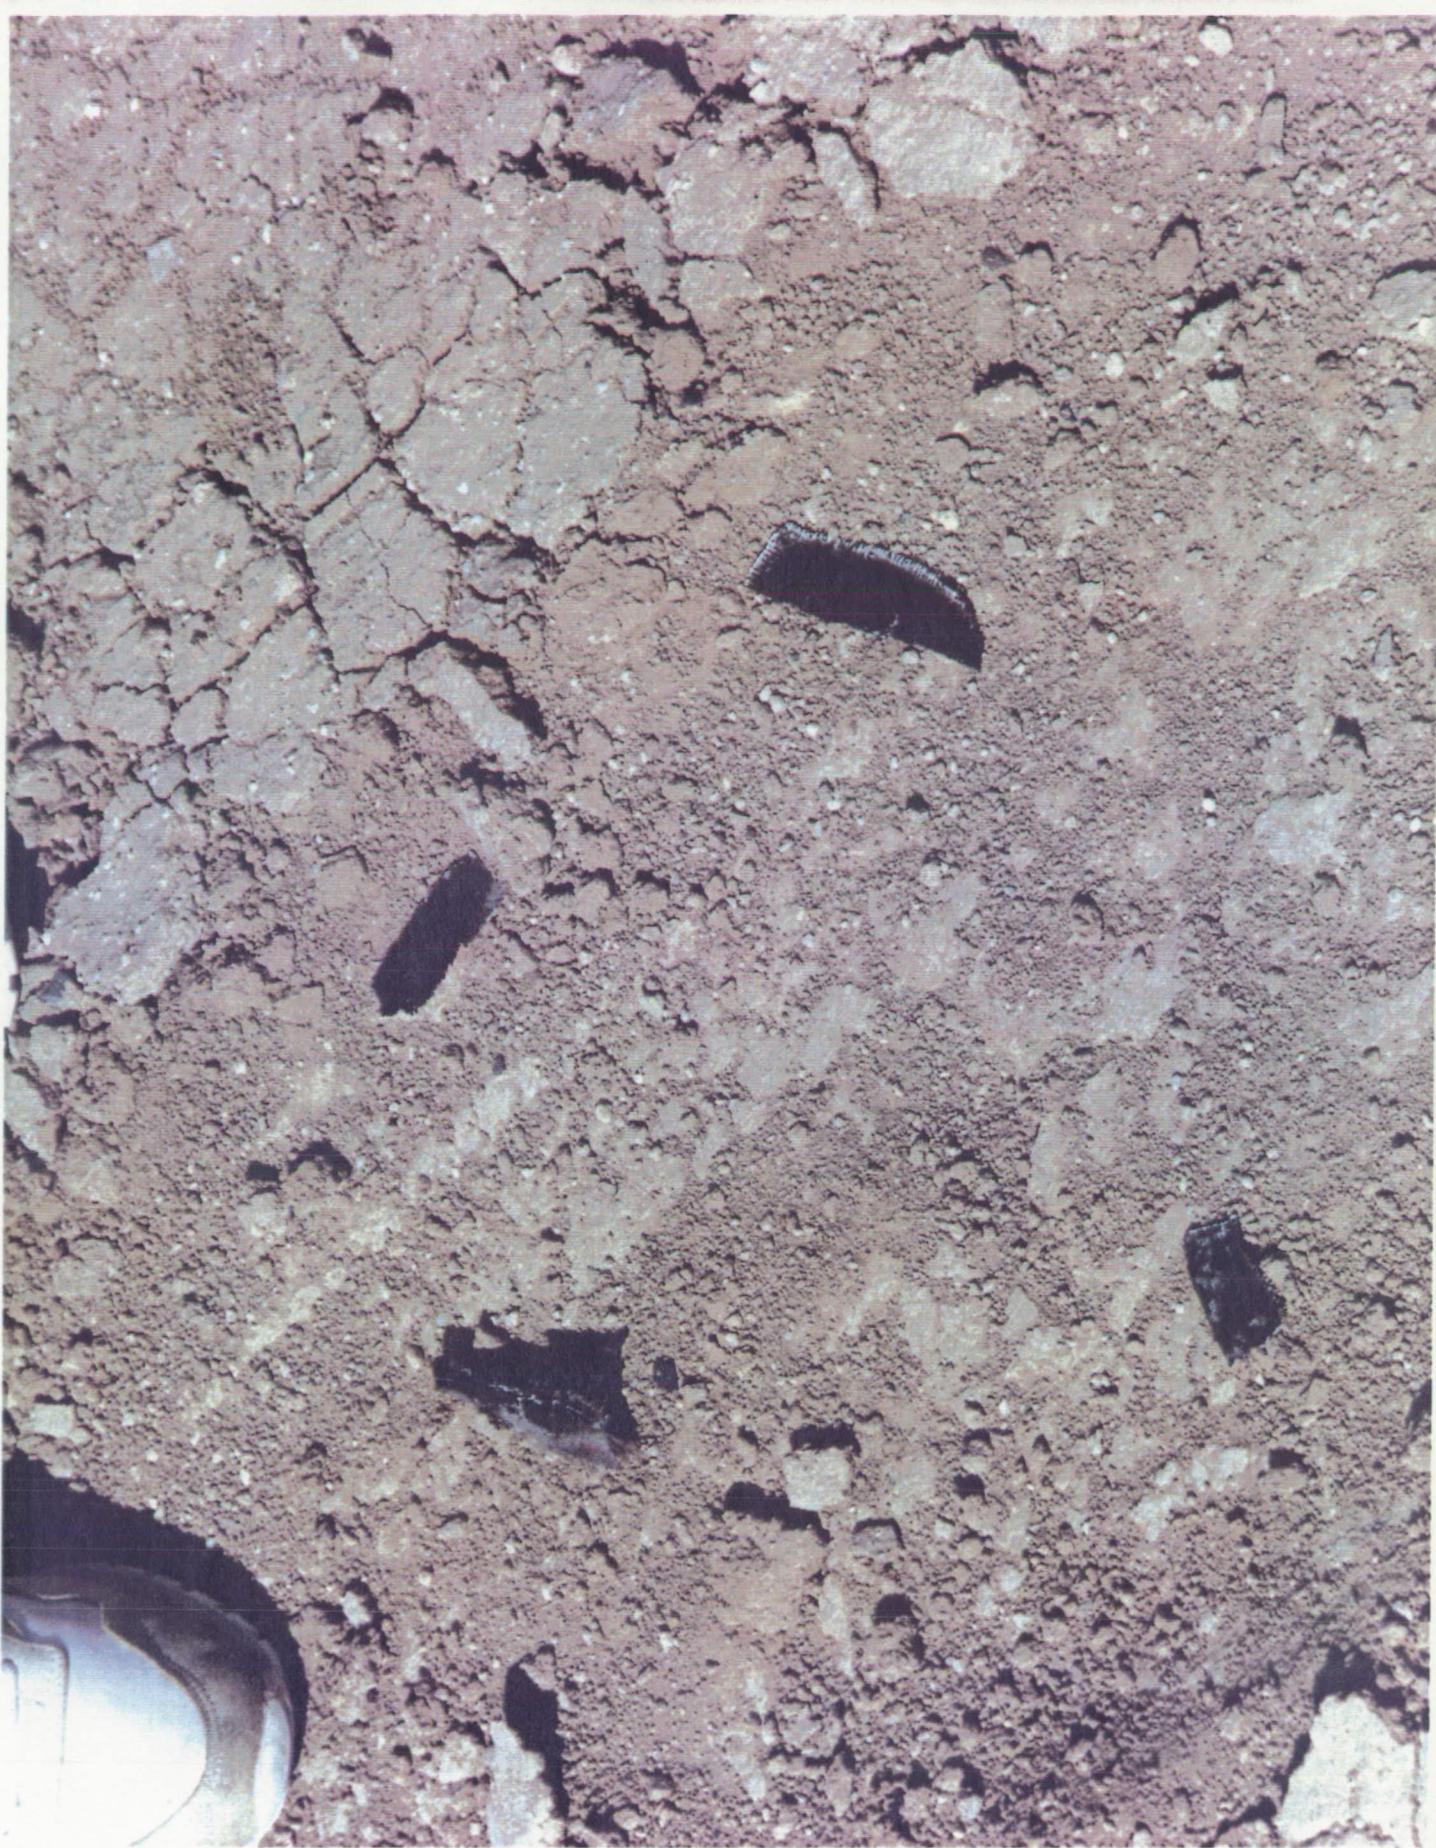
Four pieces of nose landing gear door Ames gap filler were found on the runway at the approx NLG touchdown point

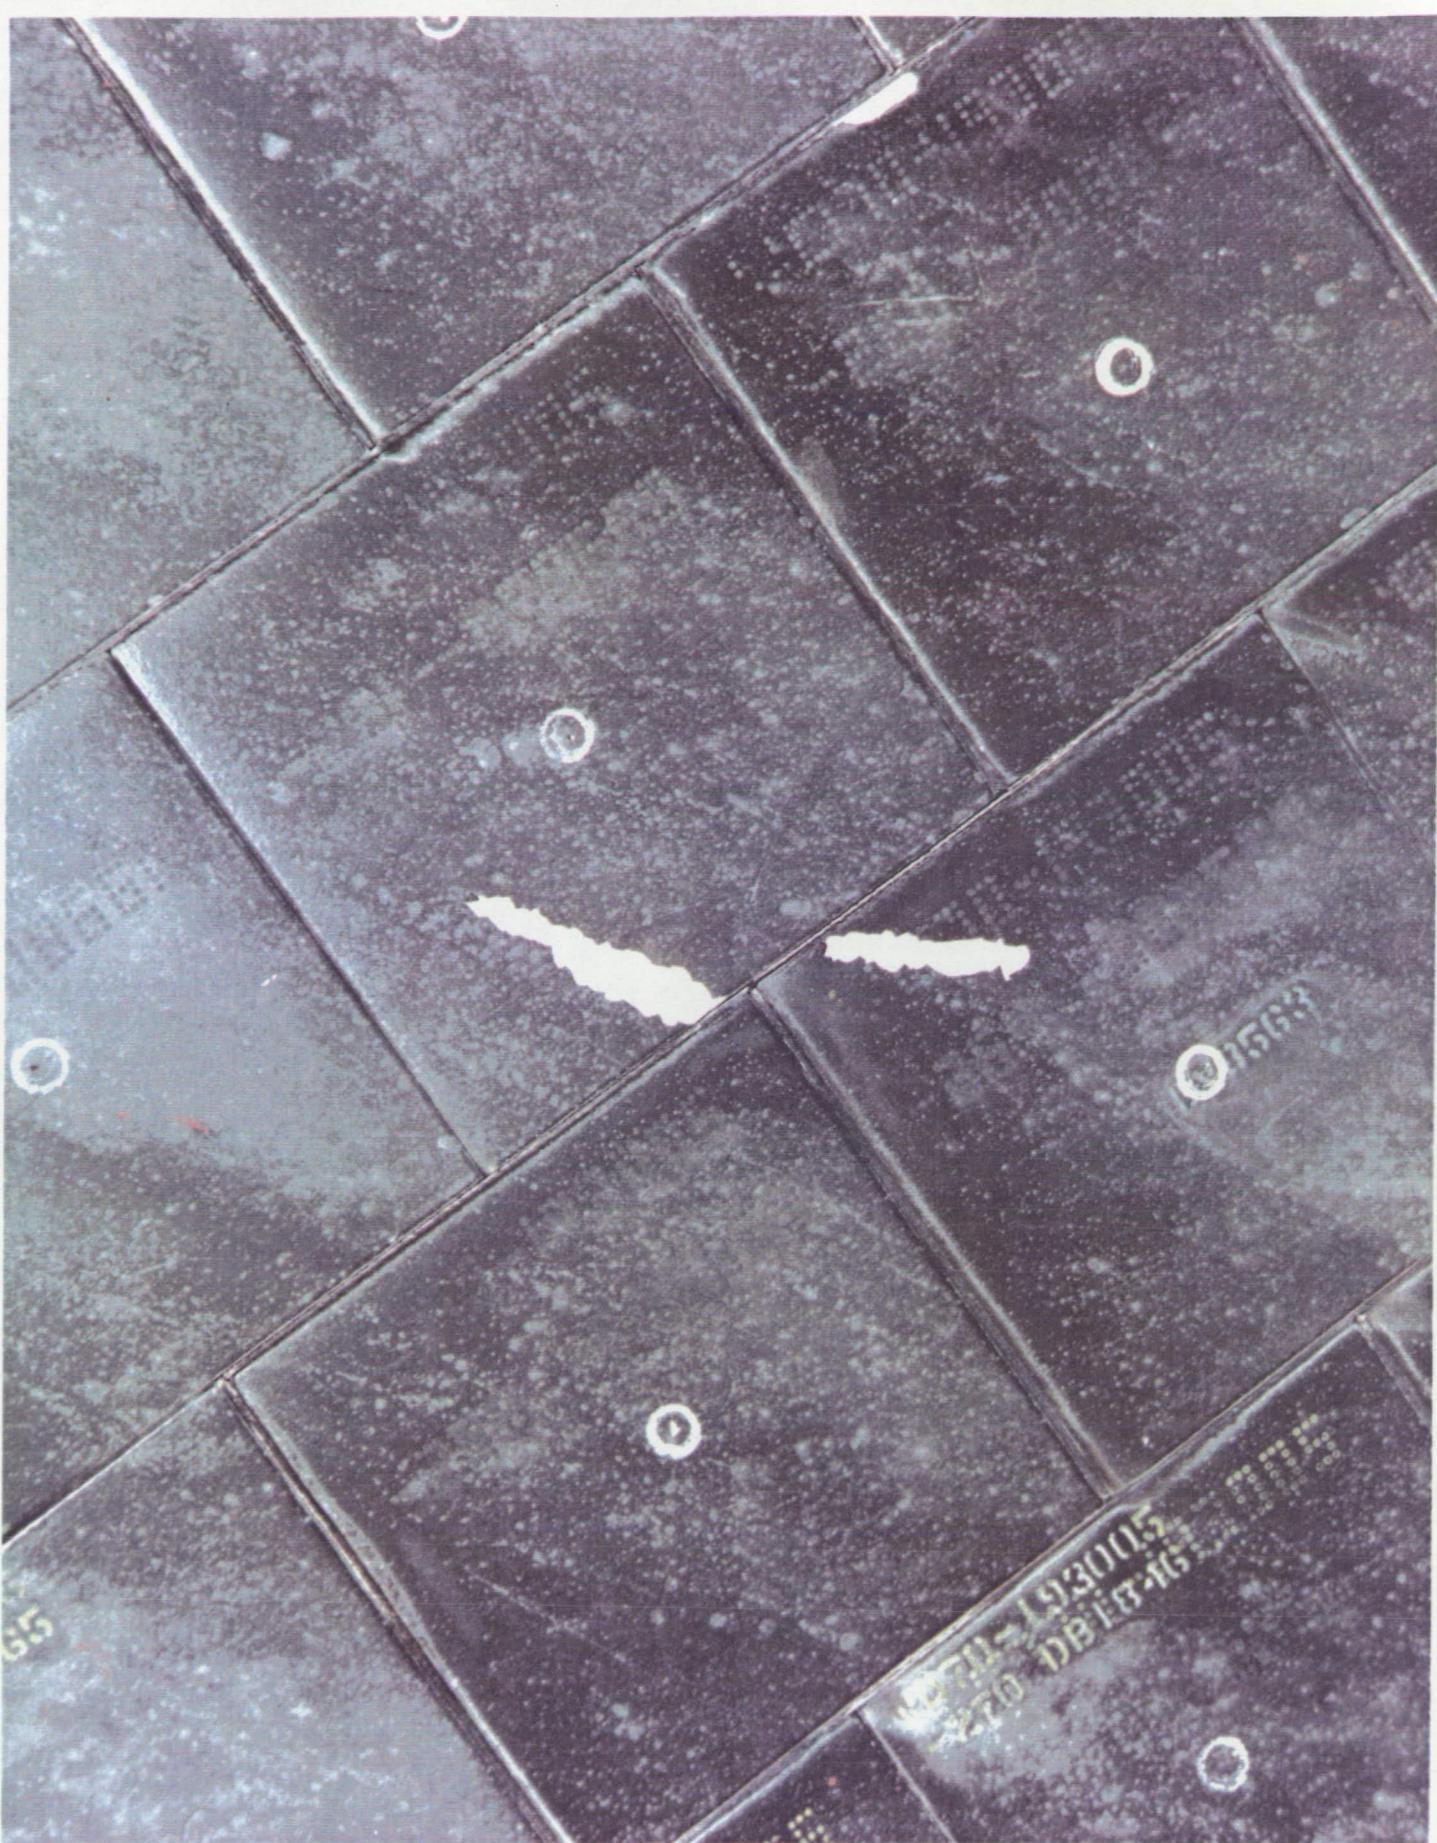
Typical tile surface coating shallow impact damage from
low density debris

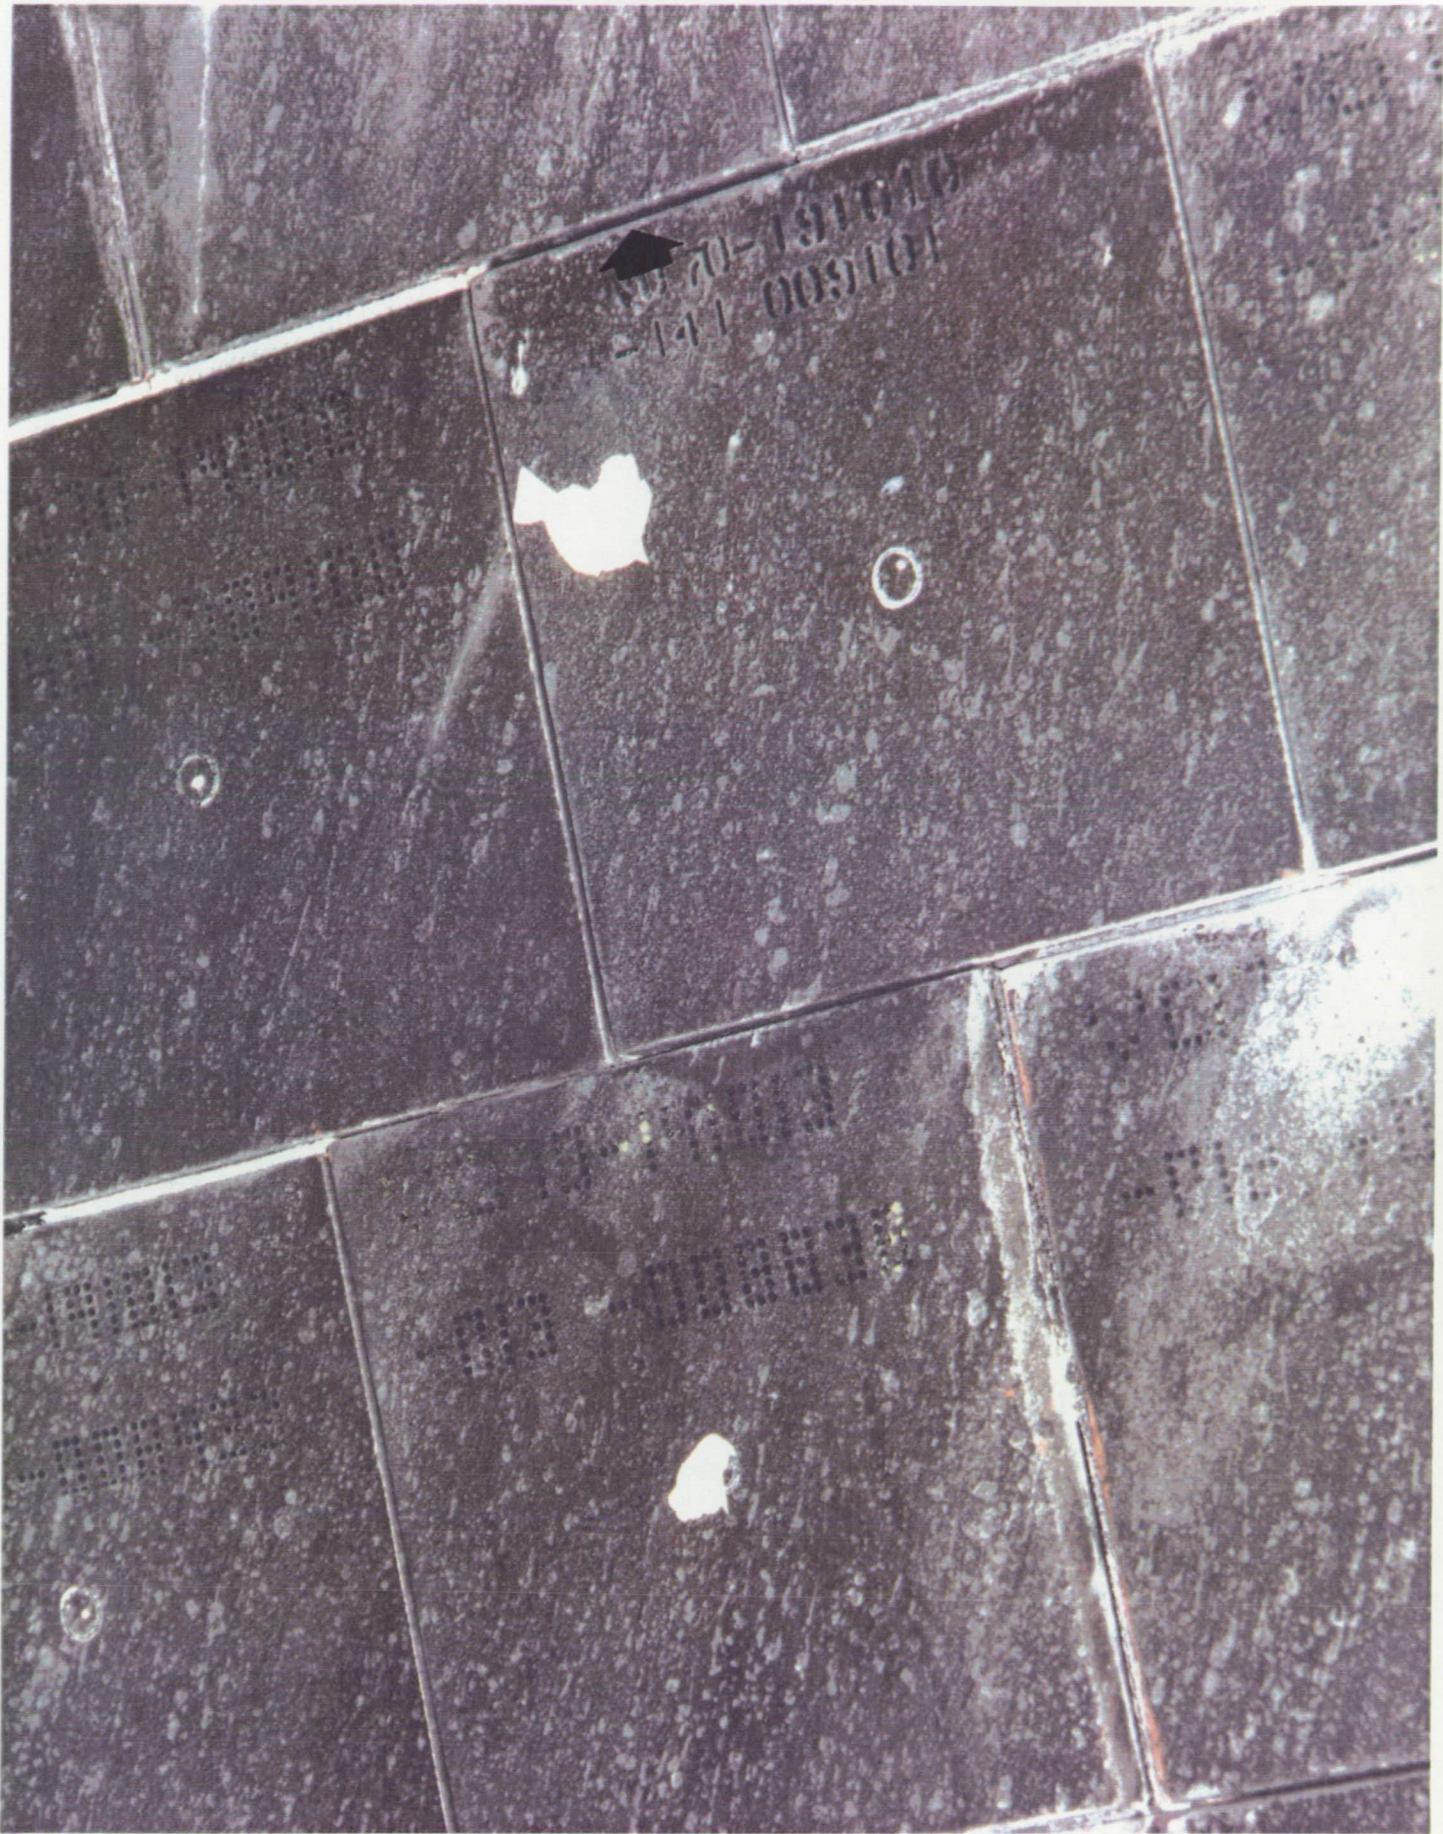
Typical tile surface coating impact damage from debris.
Note missing tile gap filler (arrow).

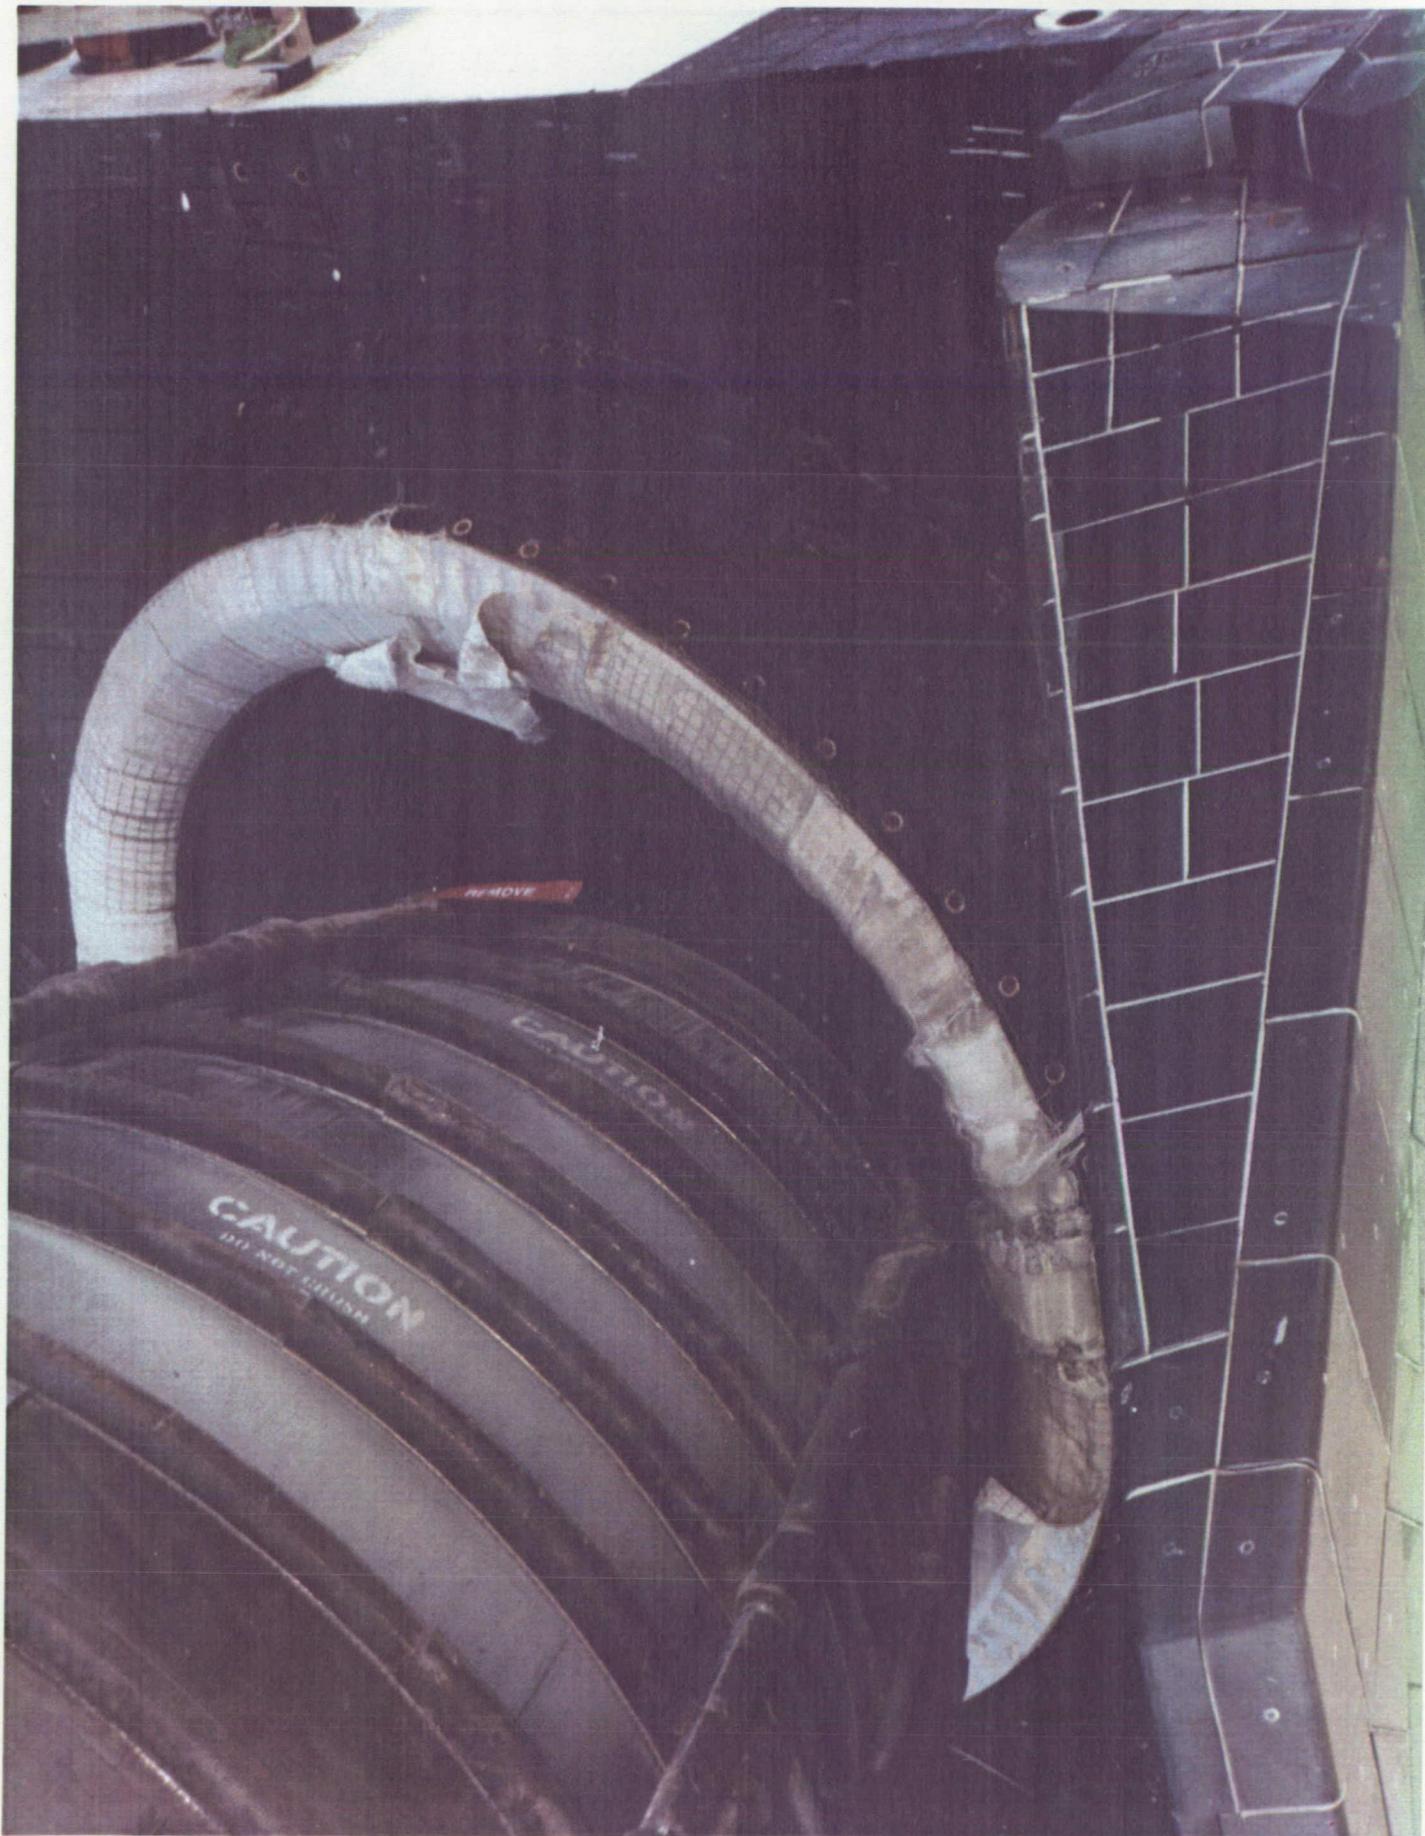
Top layer of SSME #3 blanket was loose at 3 o'clock, frayed at 6 o'clock, and missing from the 6:30 to 10 o'clock position

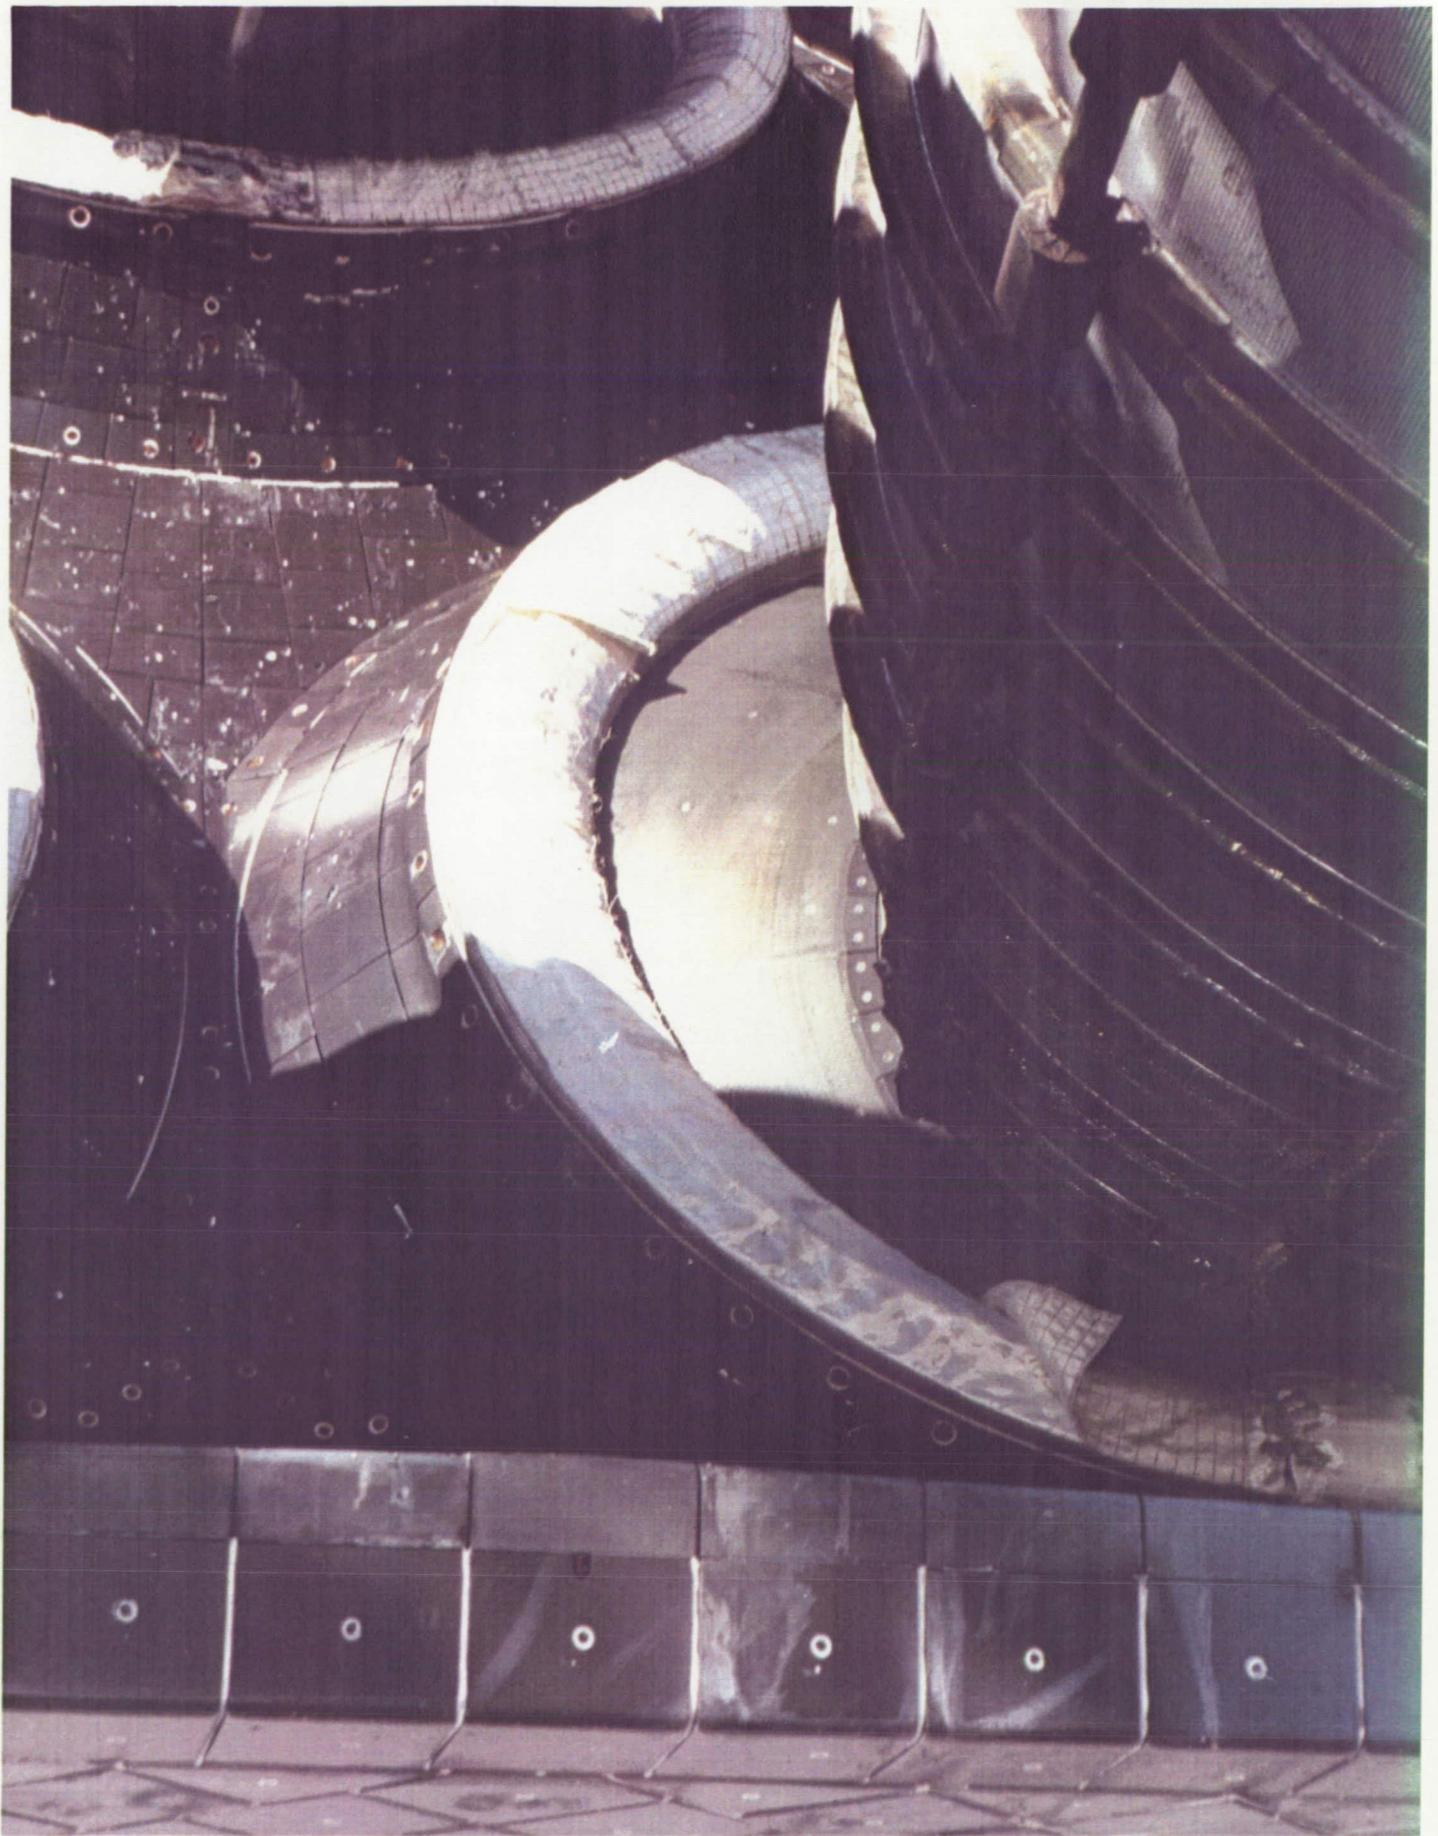
Top layer of SSME #3 beta blanket was missing from the
6:30 to 10 o'clock position

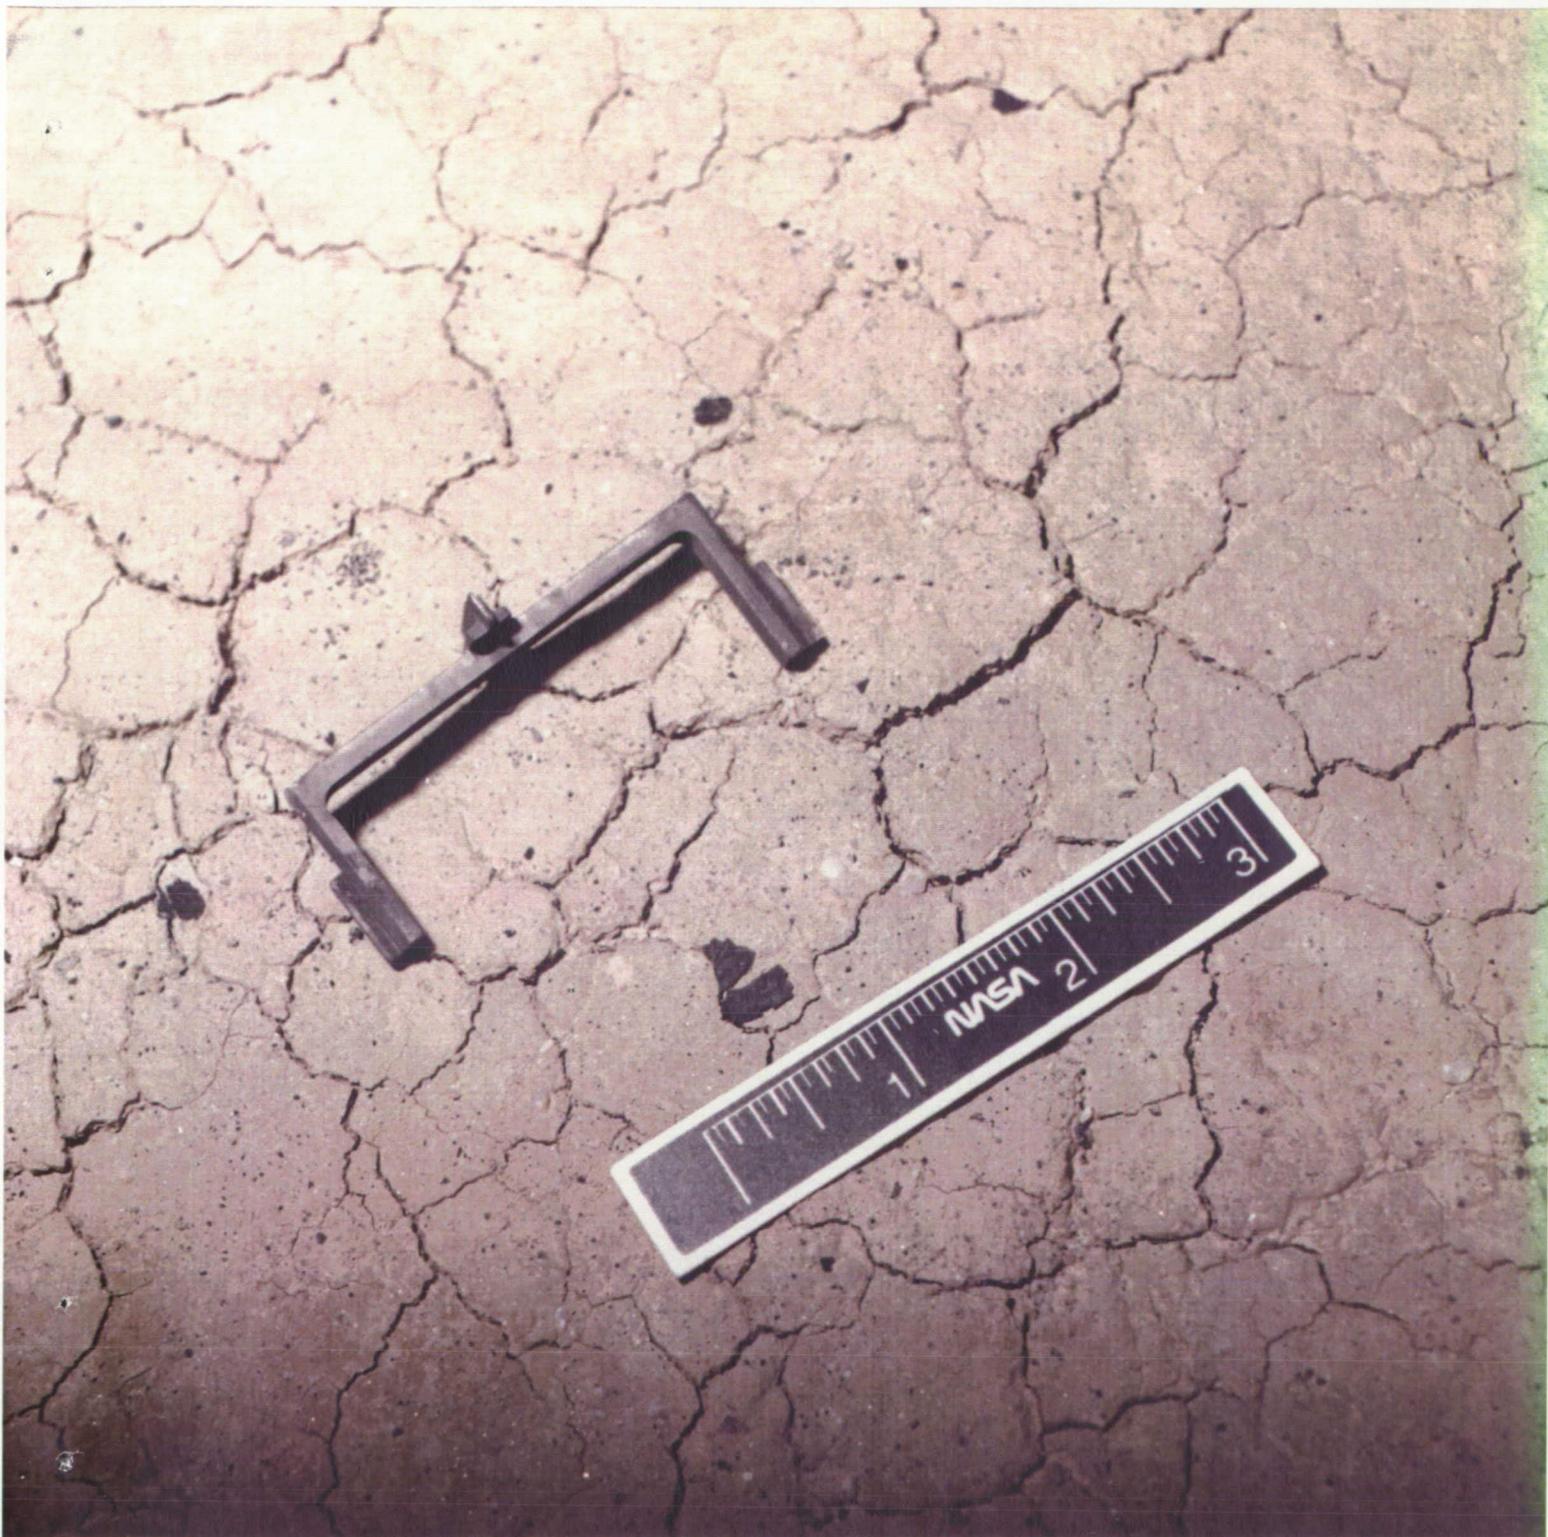
One pyro retention yoke on the LH2 side was loose in the umbilical cavity and fell onto the runway when the door opened
