Debris/Ice/TPS Assessment And Photographic Analysis For Shuttle Mission STS-36

April 1990

DEBRIS/ICE/TPS ASSESSMENT
AND
PHOTOGRAPHIC ANALYSIS
OF
SHUTTLE MISSION STS-36

February 28, 1990

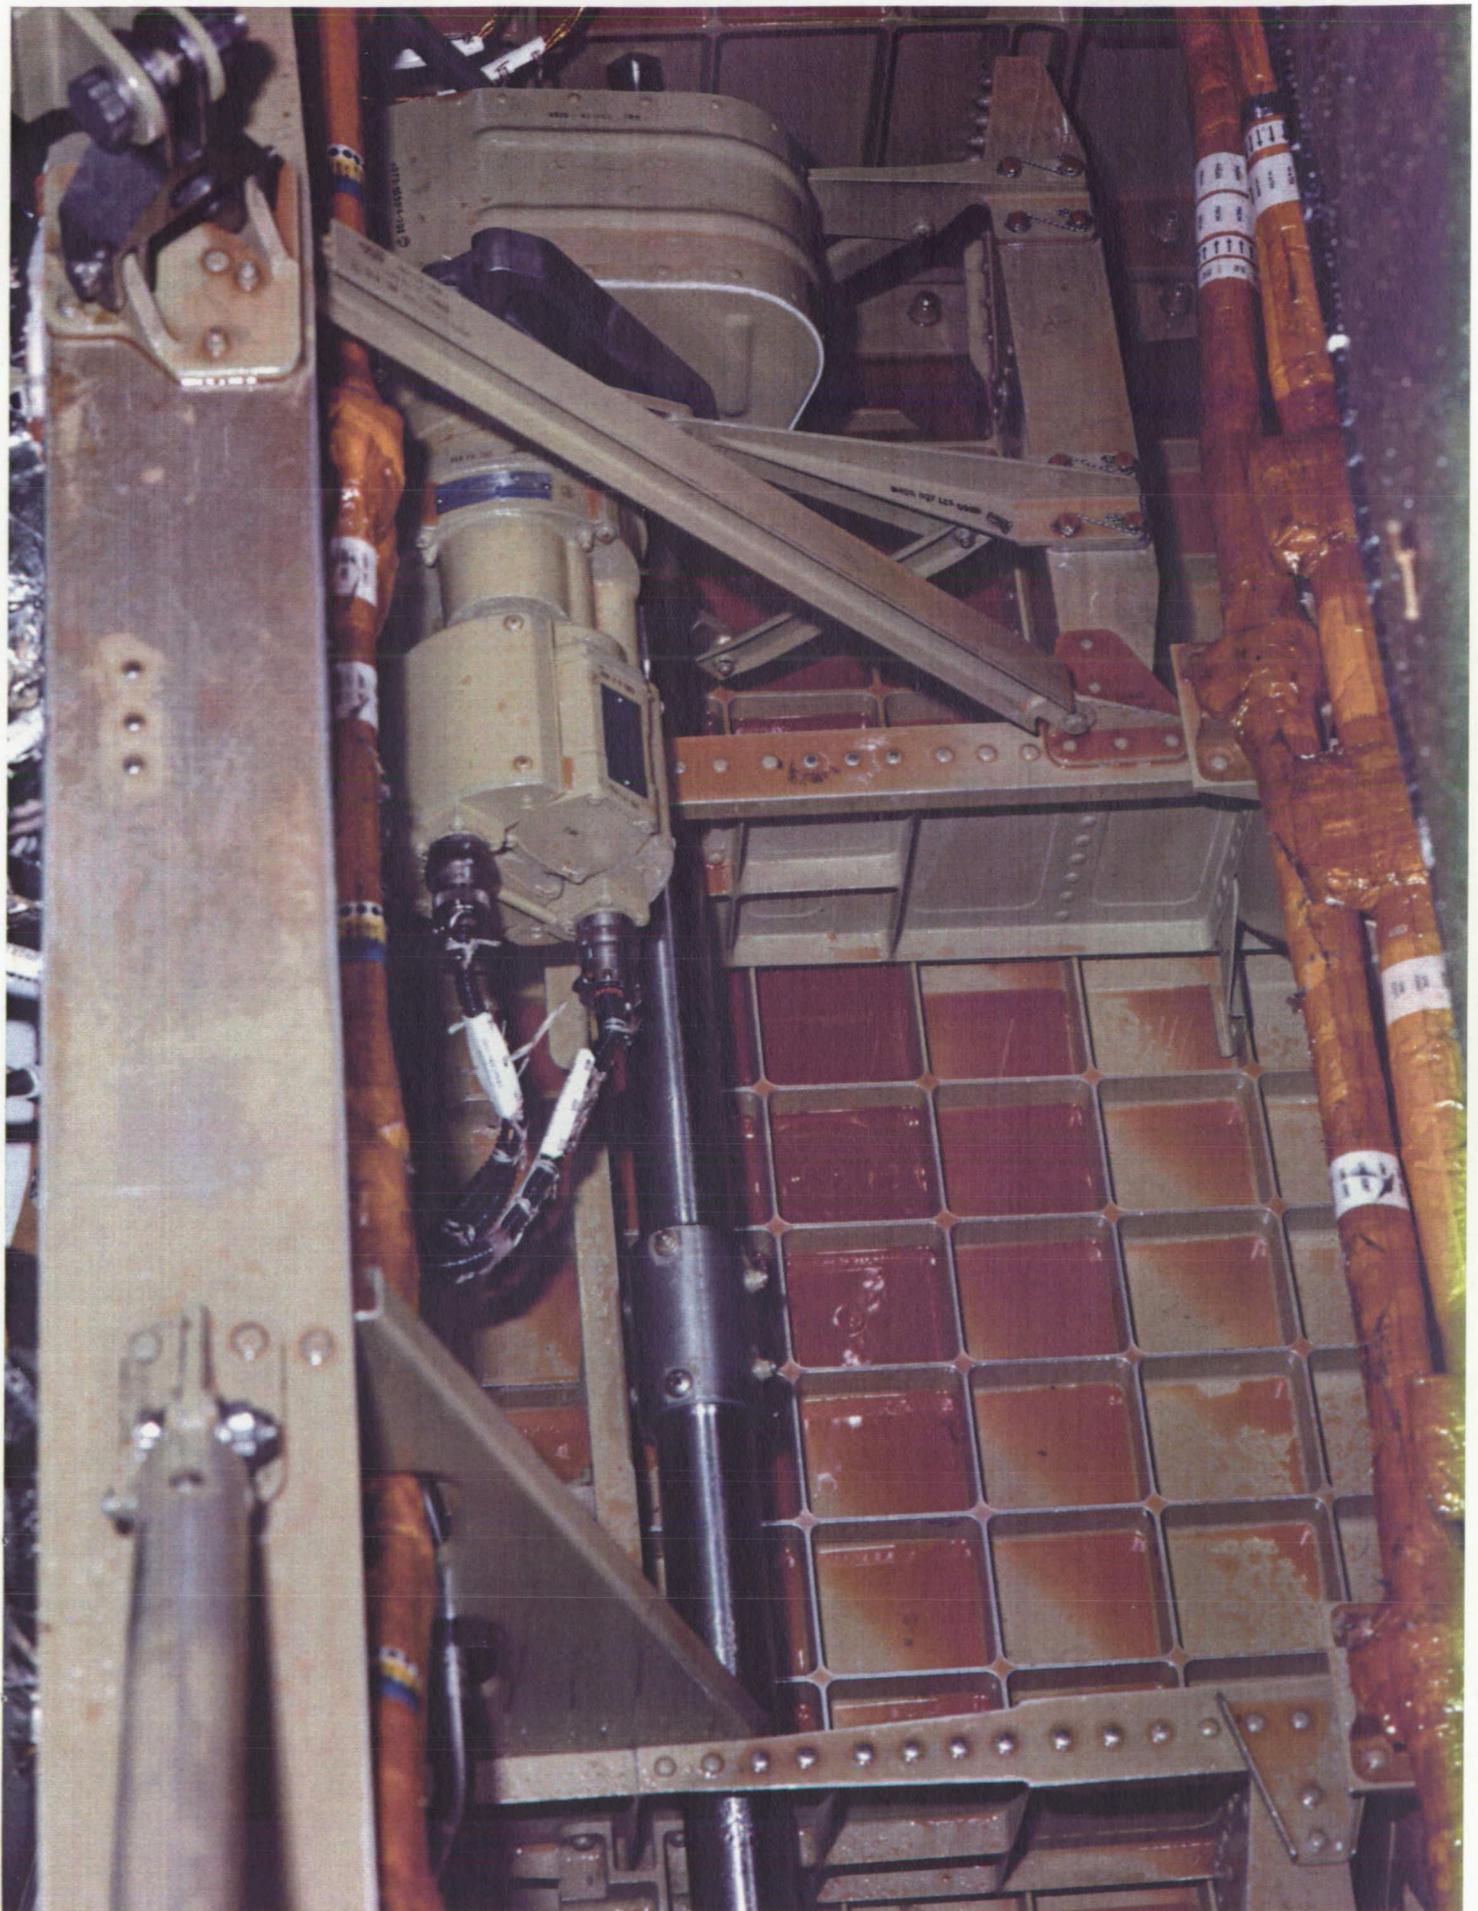
Leaking APU hydraulic fluid collected in low areas in the
Orbiter aft compartment

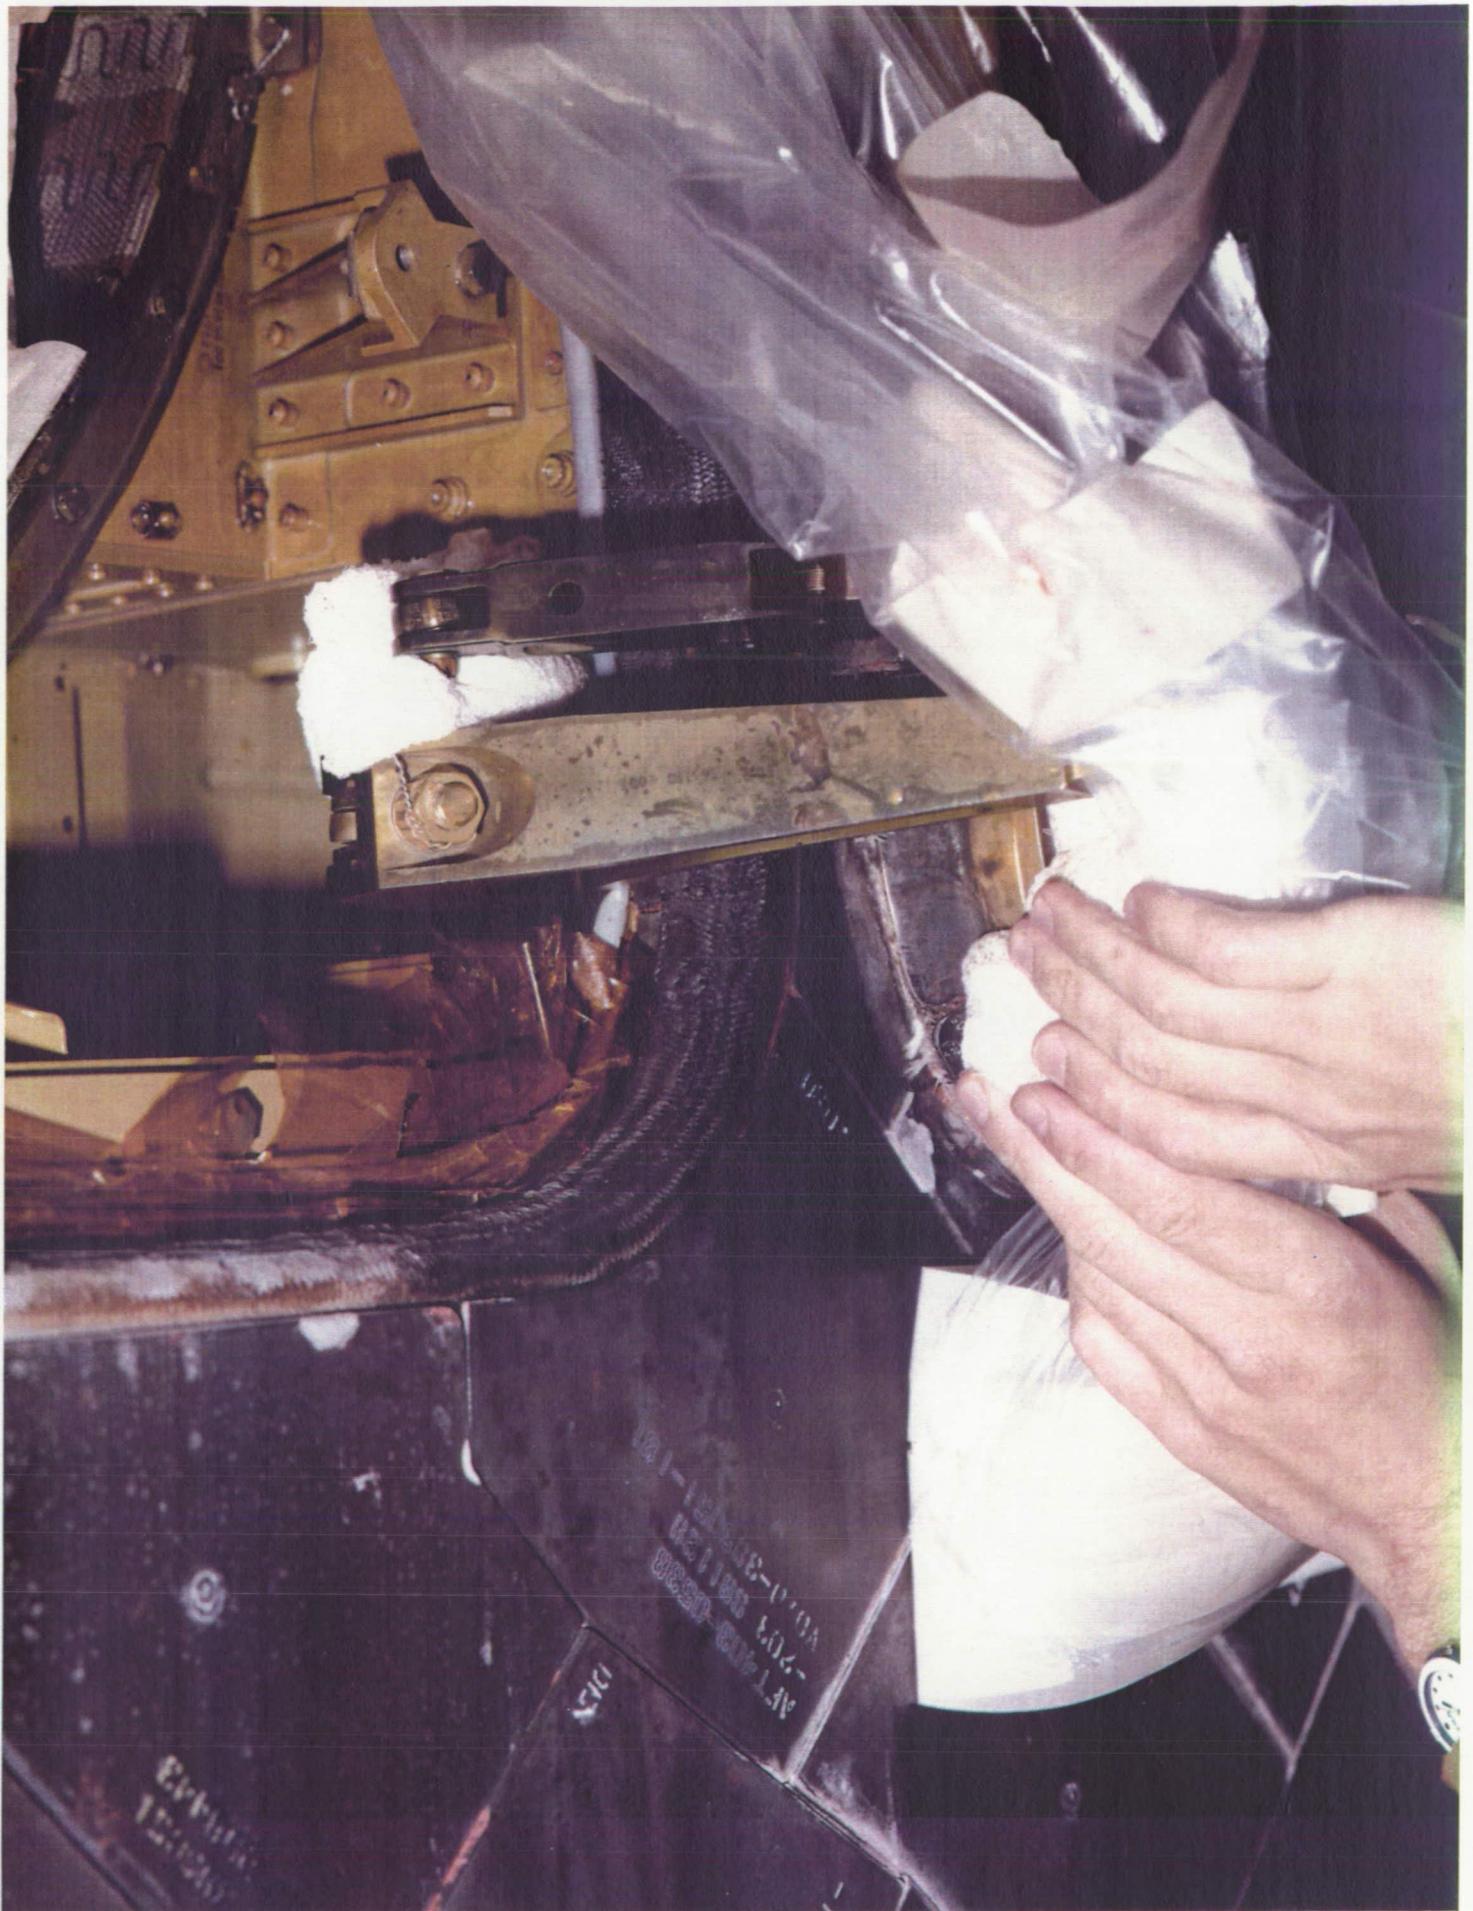
Leaking APU hydraulic fluid was visible around the ET/ORB umbilicals. Some fluid was present on lower surface tiles.

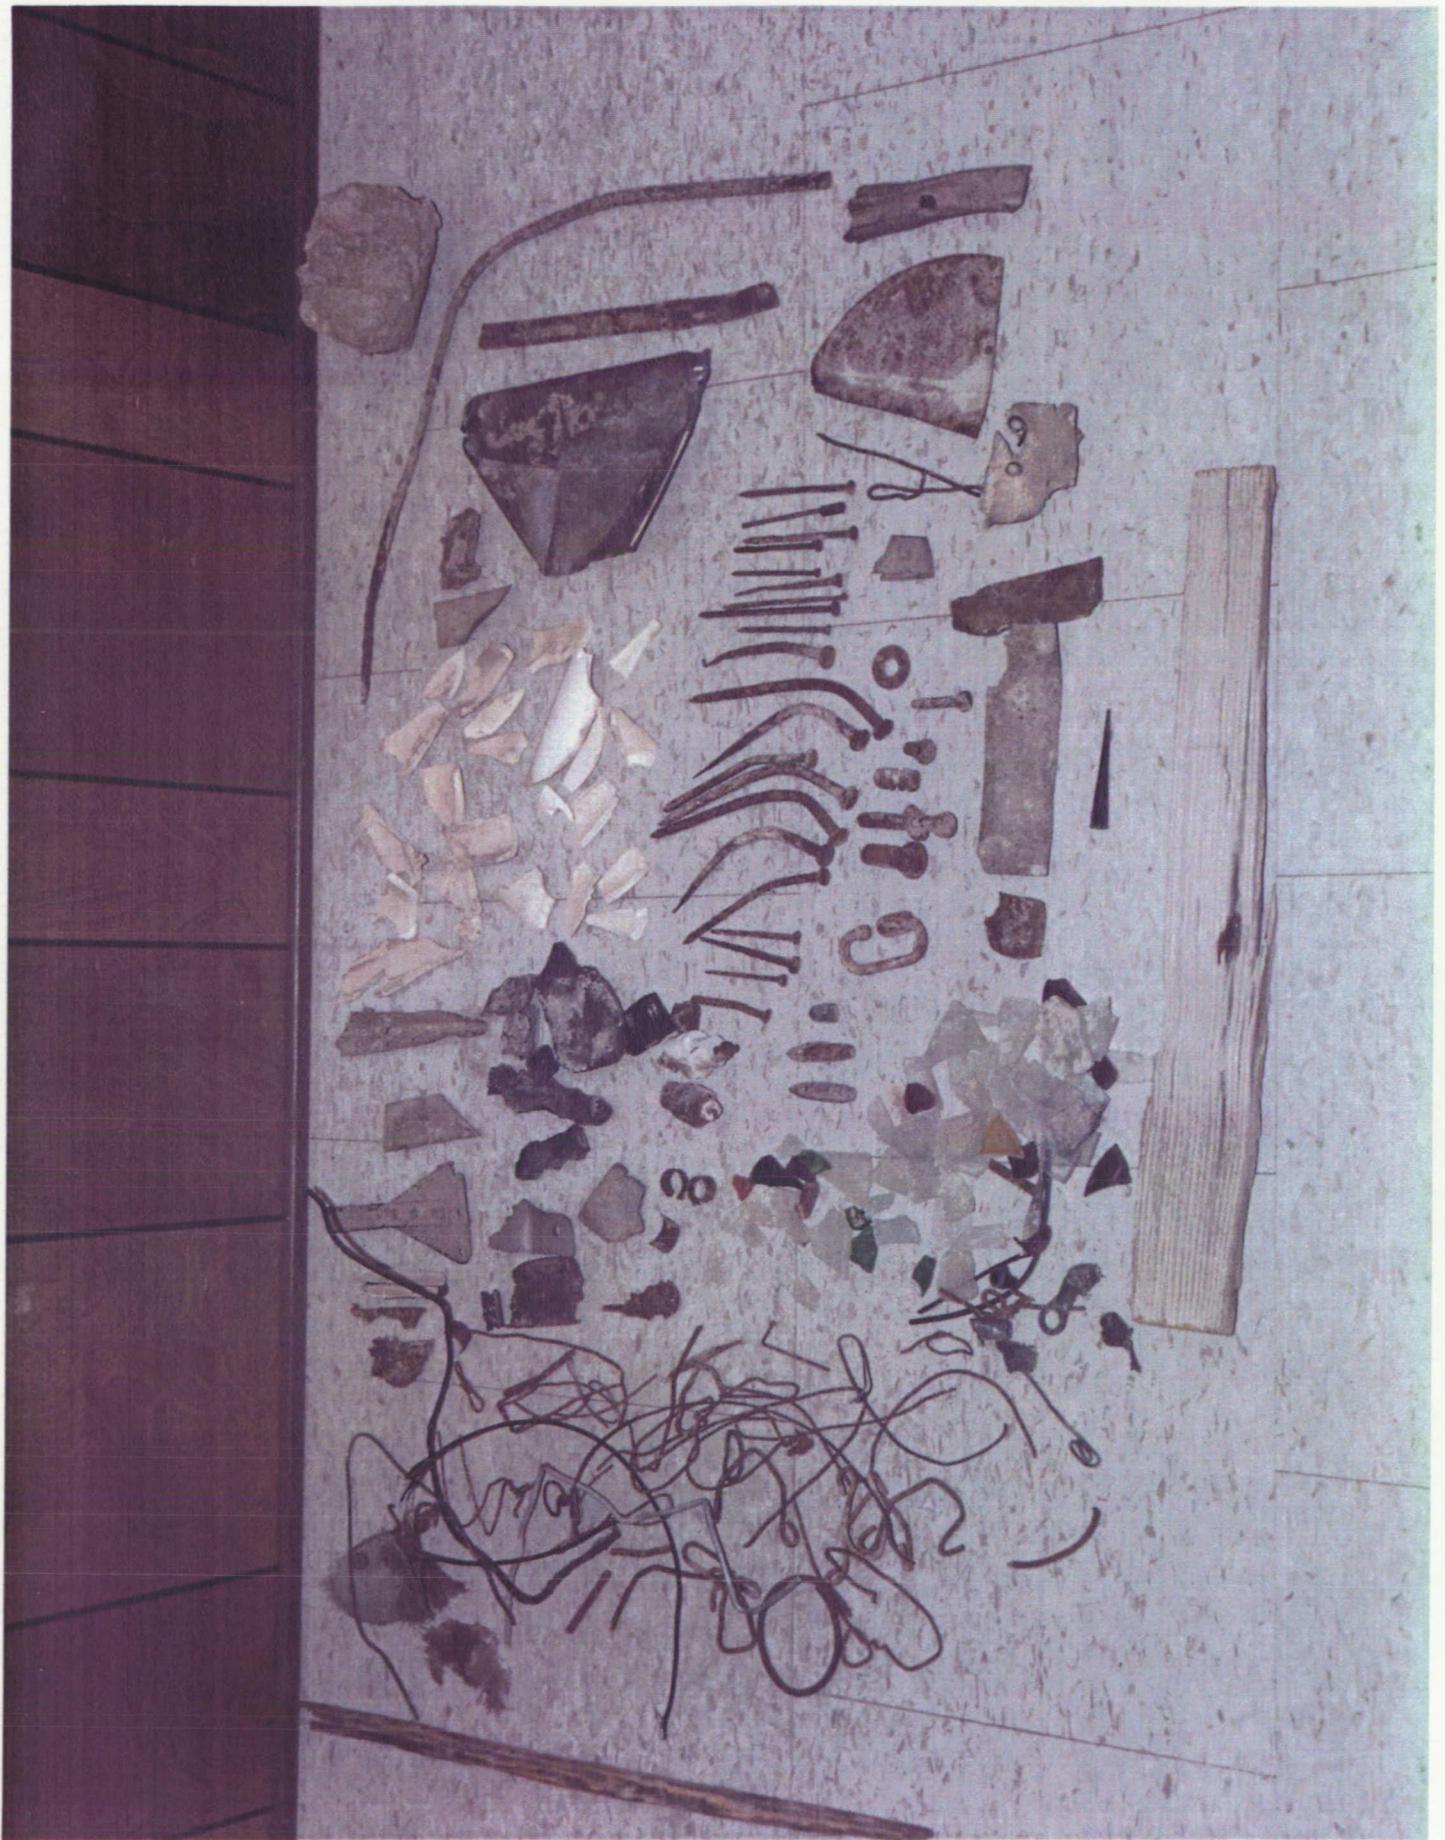
Typical debris collected from the pre-landing debris
walkdowns on runways 17L and 23L
