NASA-CR-183904

TWR-17544 Vol IV

FLIGHT SET 360H005 (STS-28)  
SEALS FINAL REPORT

February 1990

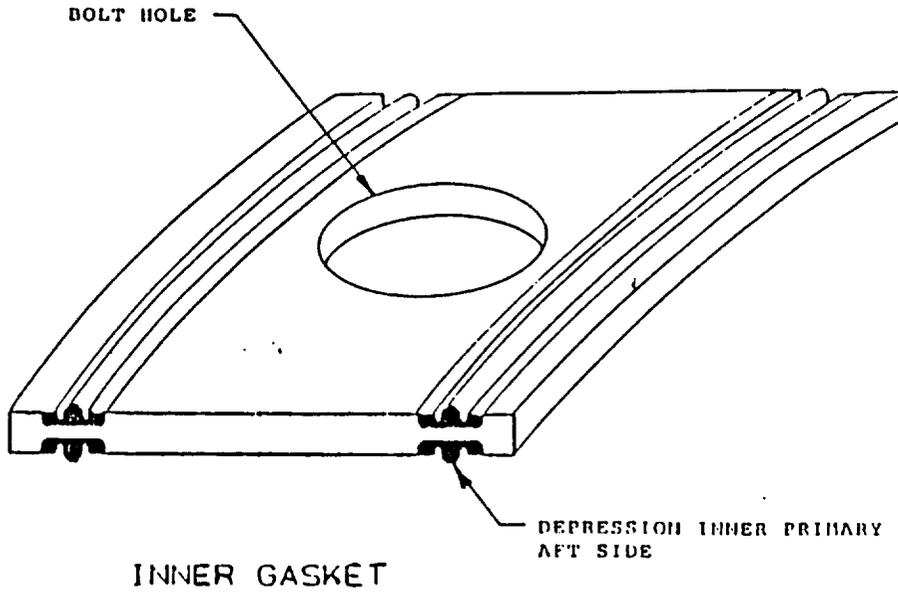
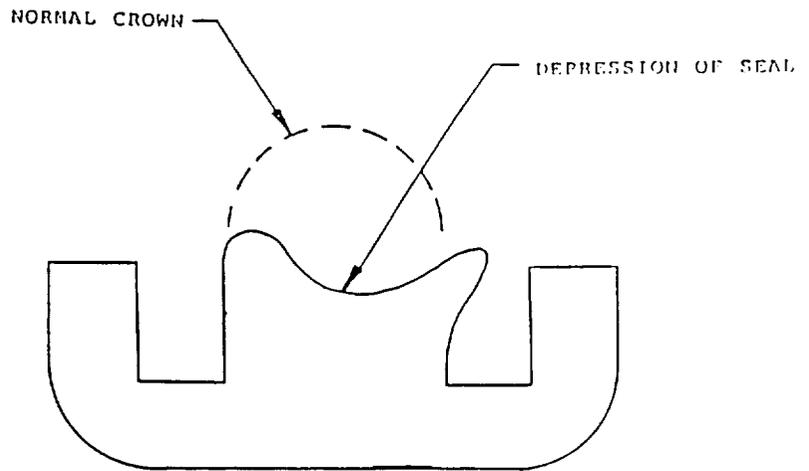
Figure 11  
Indentation on Right Hand Inner Igniter Gasket

The post-flight inspection of both motors showed the seal components to be in excellent condition except for the indentation found on the inner primary seal of the right hand inner igniter gasket, aft face (see Figure 11). Detailed inspection results, and inspections performed by the O-ring Inspection Team can be found in Section 5.0 of this report.

the inner gasket outer retainer edge at 270 degrees. An indentation was observed in the crown of the inner primary seal at 220 degrees on the aft face. The indentation was approximately 0.10 inch long by 0.025 inch wide. The indentation slowly rebounded after disassembly. Dissection of the area revealed two small subsurface voids. Additional inspection criteria was implemented to find these type of voids prior to assembly in the joint. All stat-o-seals from the inner joint bolts were damaged during disassembly.
