Flight Set 360L007 (STS-33R) Field Joint Protection System, Thermal Protection System, and Systems Tunnel Components Final Report—Volume VII

September 1990

Thiokol CORPORATION
SPACE OPERATIONS

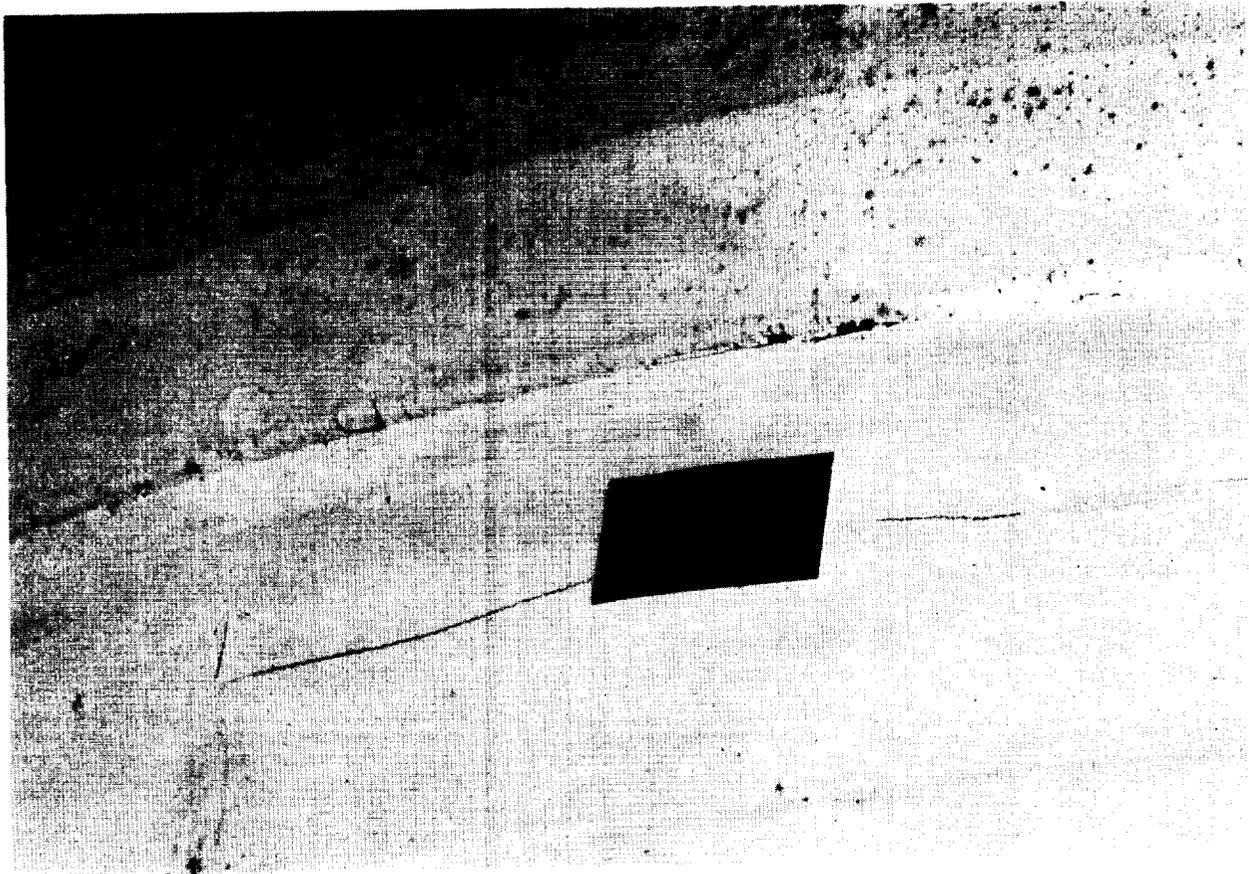
**Figure 3. Impact Marks on FJPS Cork
(LH forward field joint)**

Numerous small cracks were observed on the forward edge of the LH forward FJPS cork between 240 and 260 deg (Figure 3). Impact marks were noted on each side of the affected area approximately 3 ft apart. Problem Report PV-6-146407 was written against these cracks (Appendix A). The cracks measured approximately 0.50 in. axially by less than 0.10 in. radially and were within the current material acceptance requirements. The impact marks were most likely caused by a parachute float line. A limit was added to the PEEL stating that cracks in the FJPS that meet current acceptance criteria are acceptable and should not be reported.

1. NUMEROUS SMALL CRACKS ON FWD EDGE OF JPS CORK.
TWO IMPACT MARKS (POSSIBLE PARACHUTE FLAT LINE) ON EACH SIDE OF AFFECTED AREA

16. ITEM	17. PROBLEM DESCRIPTION <p>The left hand forward field joint forward edge from 240° to 260° exhibited two possible impact marks approximately 3 feet apart. Numerous small surface cracks were on the forward facing edge between the marks.</p>
----------	-----------------------------------------------------------------------------------------------------------------------------------------------------------------------------------------------------------------------------------------------------

19. DESCRIPTION (ATTACH PFORS, FIGURES, PHOTOGRAPHS, ETC.) Numerous small cracks were observed on the forward edge of the forward field joint FJPS cork from 240 to 260 degrees. Impact marks were noted on each side of the affected area approximately 3 feet apart. The cracks measured approximately 0.50 inch axially by less than 0.10 inch radially.

20. HISTORY None. This is the first time that cracks of this type have been reported.			
21. CAUSE Cracks of this size meet the current material acceptance requirements. The impact marks were most likely caused by a parachute float line.

22. CORRECTIVE ACTION Add a limit to the PEEL stating that cracks in the FJPS that meet current acceptance criteria are acceptable and should not be reported.

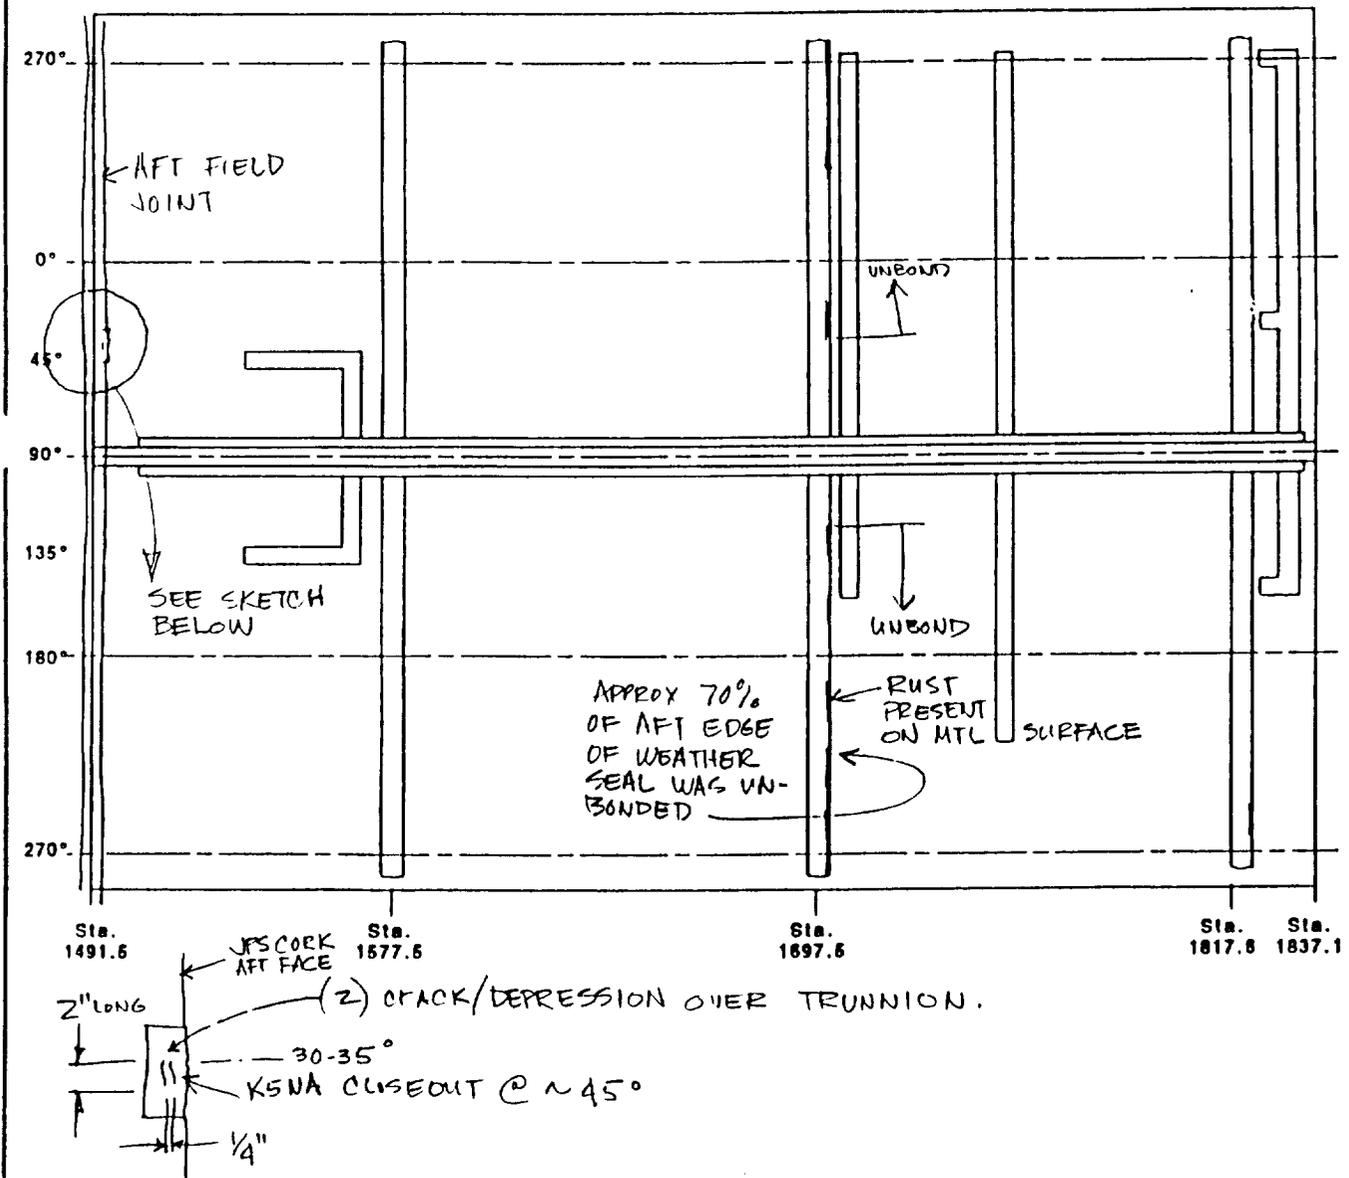
Clarification Number: A-4B

1. CRACKS IN KENA CLOSEOUT OVER TRUNNION

16. ITEM	17. PROBLEM DESCRIPTION
	<p>The left-hand aft field joint transition location at 45° which was potted in with K5NA had two cracks. The cracks were parallel (0.25 inches apart) and extended 2 inches circumferentially. The cracks were opened approximately 0.1 inches. The material between the cracks could be depressed by moderate thumb pressure.</p>
