TWR-17548 - Vol - 1

Flight Motor Set 360L009 (STS-36) Final Report

Volume I - System Overview
September 1990

Thiokol CORPORATION
SPACE OPERATIONS

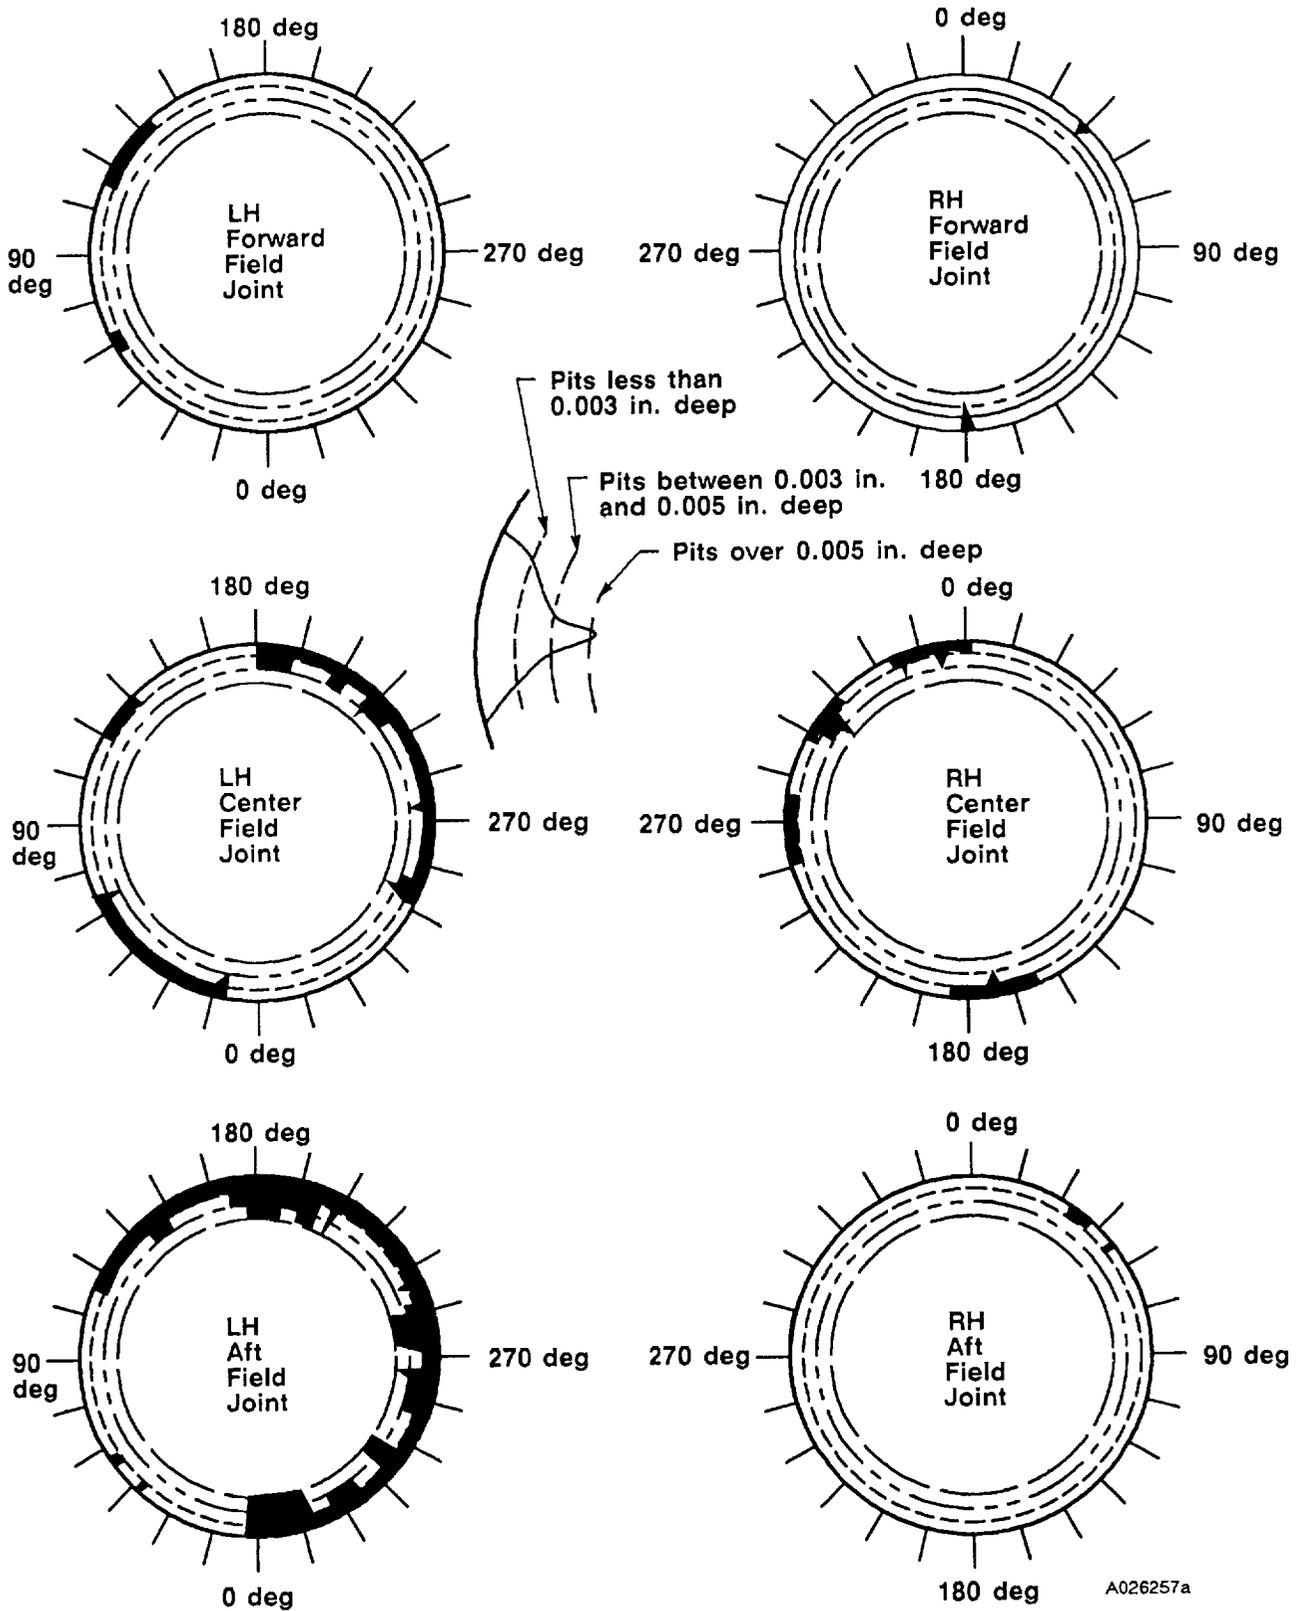
Figure 4.11-1. Flight Motor Set 360L009 Field Joint Fretting

3.1.9.2 Case. The case field joint surface conditions were as expected. Field joint fretting on this flight ranged from light to heavy. All joints had some fretting. The left center and aft field joints had the worst fretting (0.008 to 0.011 in. deep); the right center field joint had a 0.009 in. deep fret. New fretting was interspersed between the old fret repairs.
