**NASA**  
**Reference**  
**Publication**  
**1239**

# Failure Behavior of Generic Metallic and Composite Aircraft Structural Components Under Crash Loads

Huey D. Carden  
and Martha P. Robinson

Huey D. Carden  
and Martha P. Robinson  
*Langley Research Center  
Hampton, Virginia*

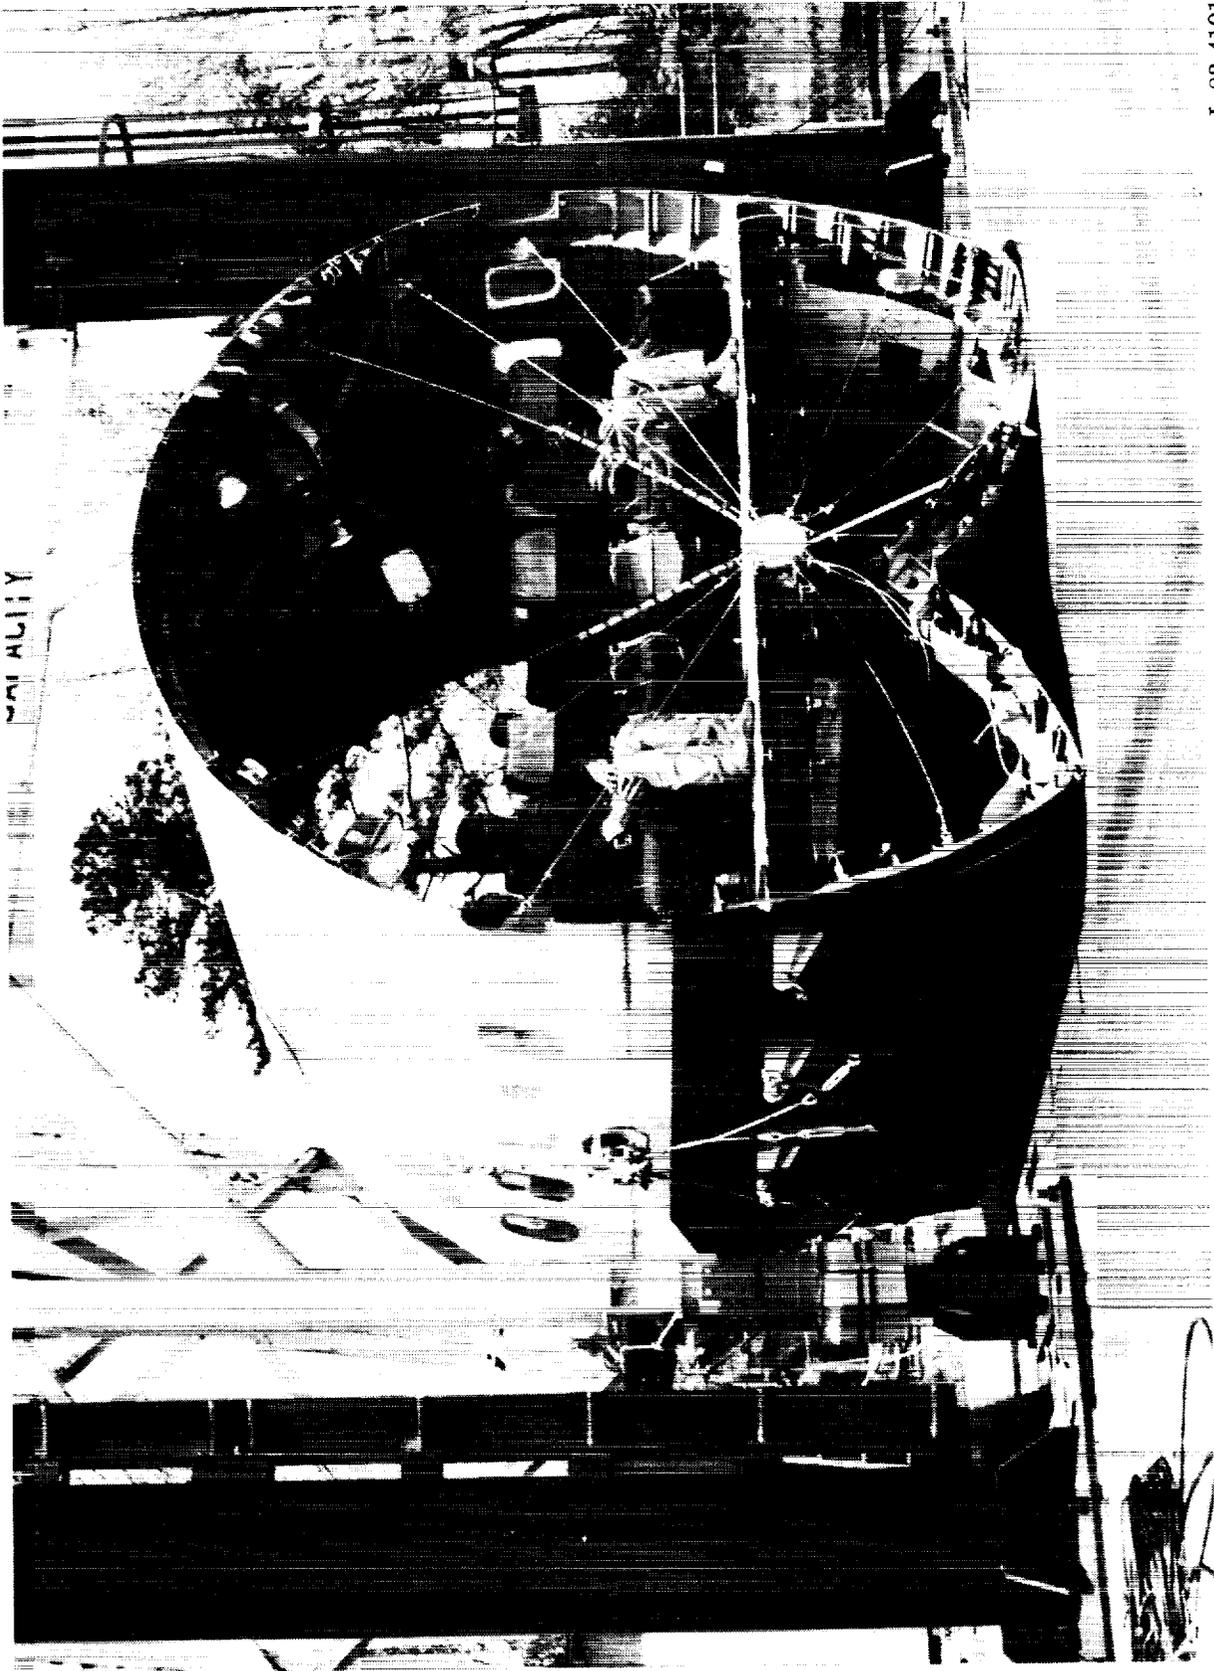
(a) Section from forward of wing.

**Dynamic tests.** The resulting structural damage to the transport aircraft structures from the 20 ft/sec vertical drop tests is shown in figures 11(a) and (b). The damage to the transport sections was confined to the lower fuselage below the floor. All seven frames ruptured near the bottom impact point. Plastic hinges formed in each frame along both sides of the fuselage approximately  $50^\circ$  up the circumference from the bottom contact point (see fig. 11(c)).

The crushing of the lower fuselage was approximately 22-23 in. at the front end and 18-19 in. at the rear for the section forward of the wing (fig. 11(a)). For the aft section (fig. 11(b)), the crushing was about 14 in. at front and 18 in. at the rear. Although the aircraft structures are metal and the failures discussed above involve plastic deformations with some tearing of the metal rather than brittle fracturing, the general observed failure pattern and failure locations for the transport fuselage sections will be shown to be quite similar to those of the composite frames and subfloors discussed later.

Figure 11. Structural damage to metal transport aircraft structures resulting from impact tests.

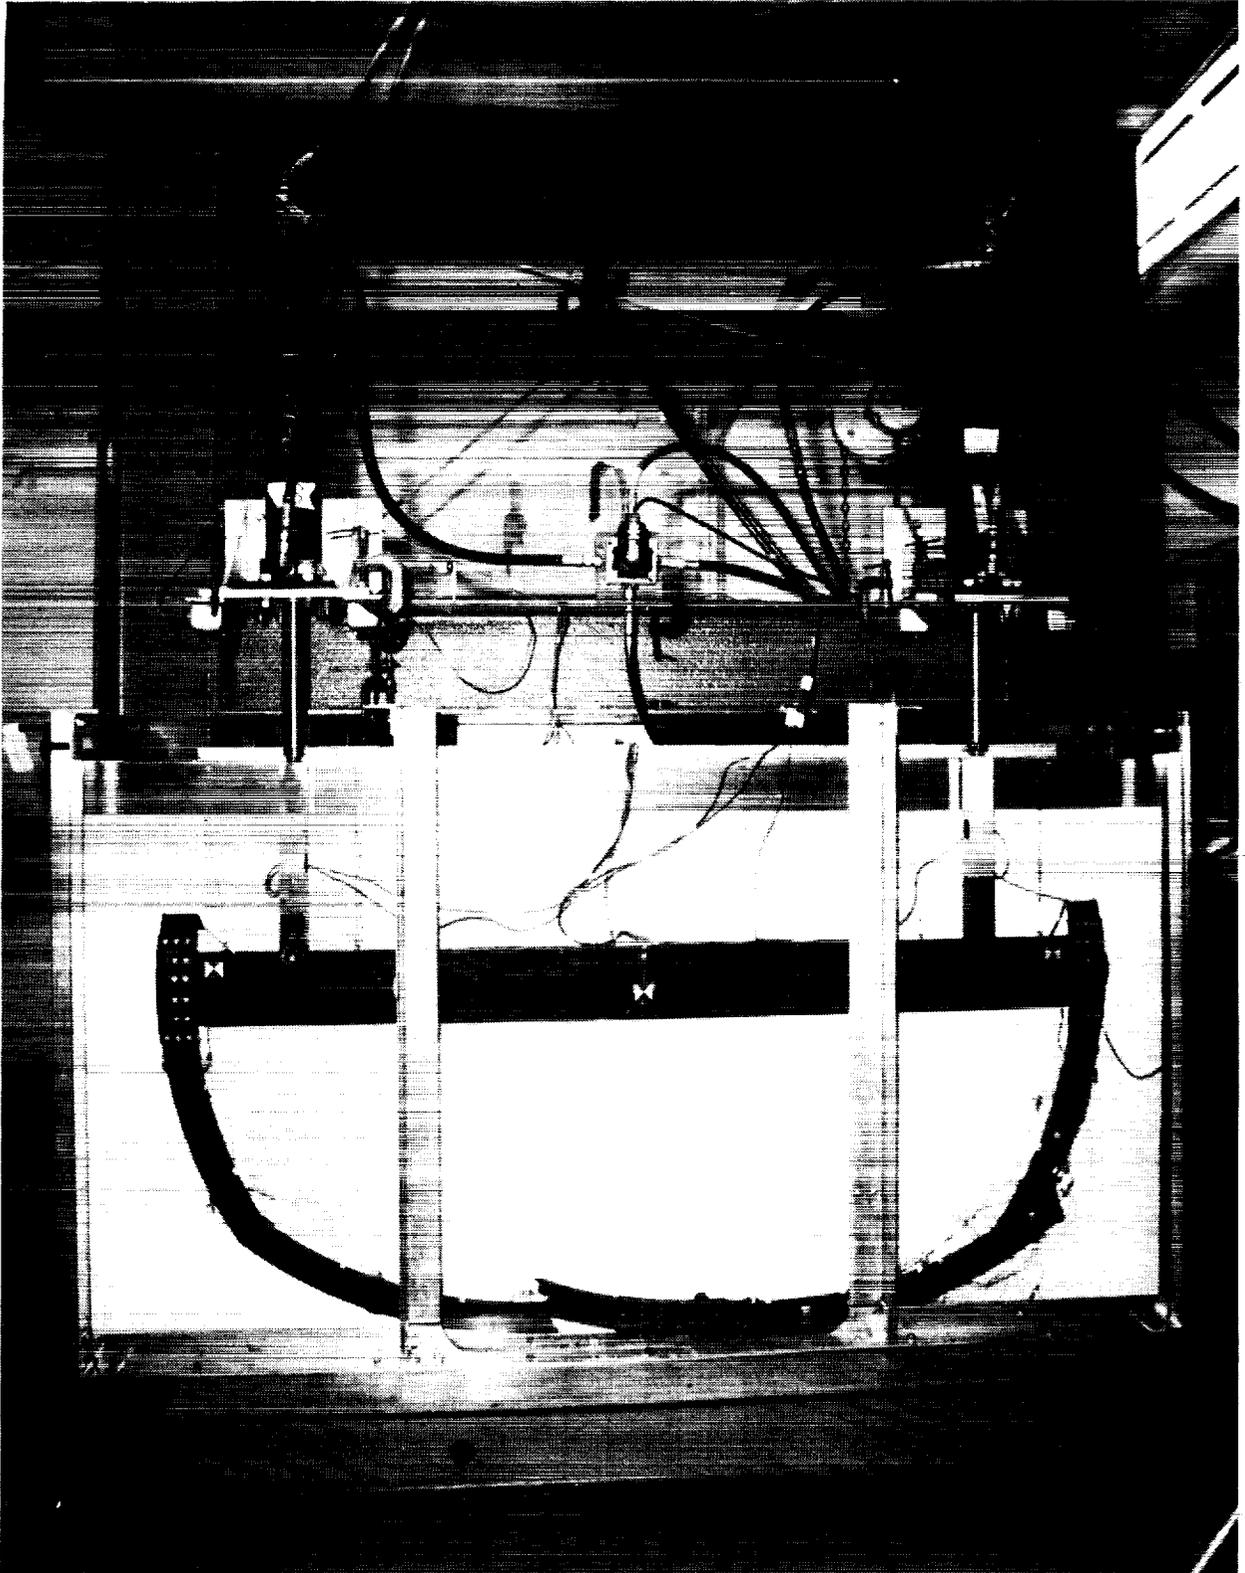
(a) Static test apparatus.

**Static tests.** Results from the static test of a composite semicircular frame (ref. 31) with a Z-cross section are presented in figure 16. A photograph of the static test apparatus in figure 16(a) shows that the splice plate was at the load point. Consequently, the frame failed just outside the doubler splice plate area by a complete fracture across the Z-section. Load deflection data and the failure locations are shown in figure 16(b). The load deflection data show a saw-toothed behavior of loading and unloading. The load increased linearly until initial failure, then fell off to under 600 lb force. Subsequent loading of the frame after initial failure is at a new, reduced stiffness. Second and third fractures occurred up the side again at approximately  $54^\circ$  and  $58^\circ$  under continued loading, as may be noted in the sketch at the right of figure 16(b). Photographic data in figure 16(c) show that the initial failure was induced by a local buckling of the frame, which occurred at about  $18^\circ$  from the bottom loading point outside the splice plate area.

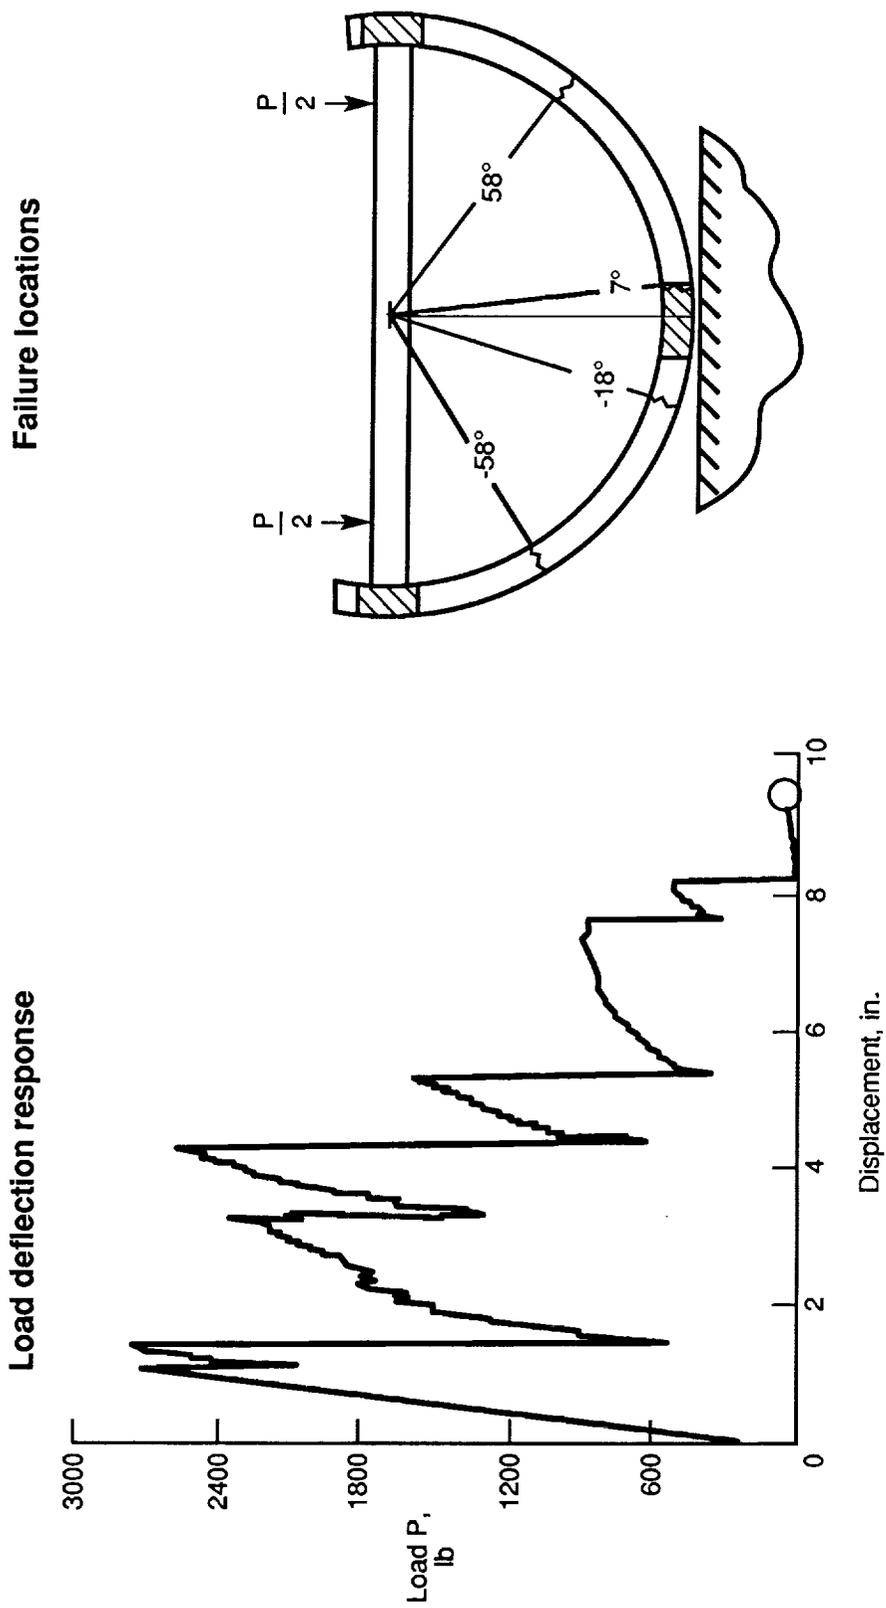
(b) Load displacement and failure locations.

Furthermore, a comparison of the analytical cases (fig. 17(a)) with the actual static load deflection of the Z-section (fig. 16(b)) indicates very similar load deflection behavior patterns, as discussed above. Although the Z-frame had no skin, if the ends jam together (as they did in several cases), the boundary is effectively between the skin-stiffened case and a guided boundary. Thus, the predicted failure in the simple beam-frame model at about  $50^\circ$ – $55^\circ$  agrees

well with the 54° and 58° failure locations in the experiment with the Z-section frame.

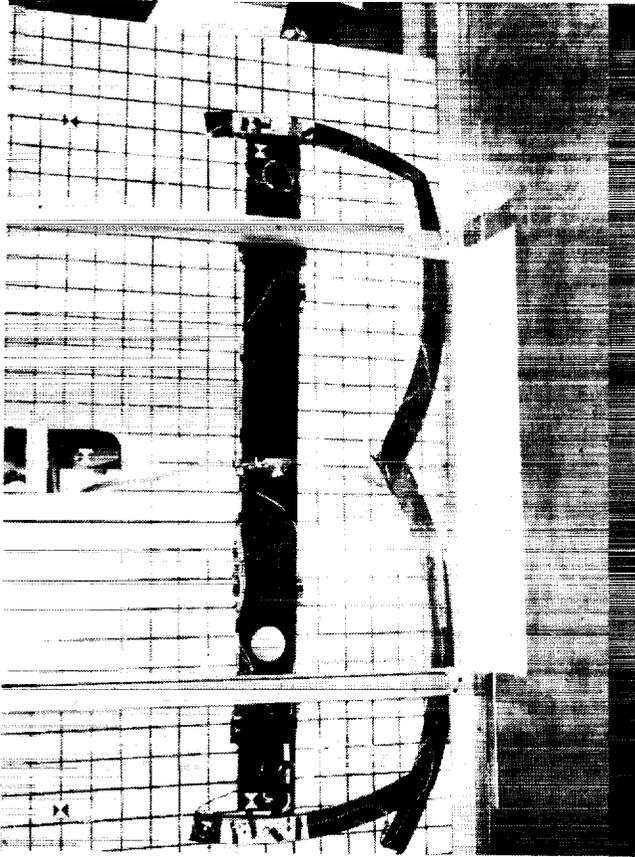
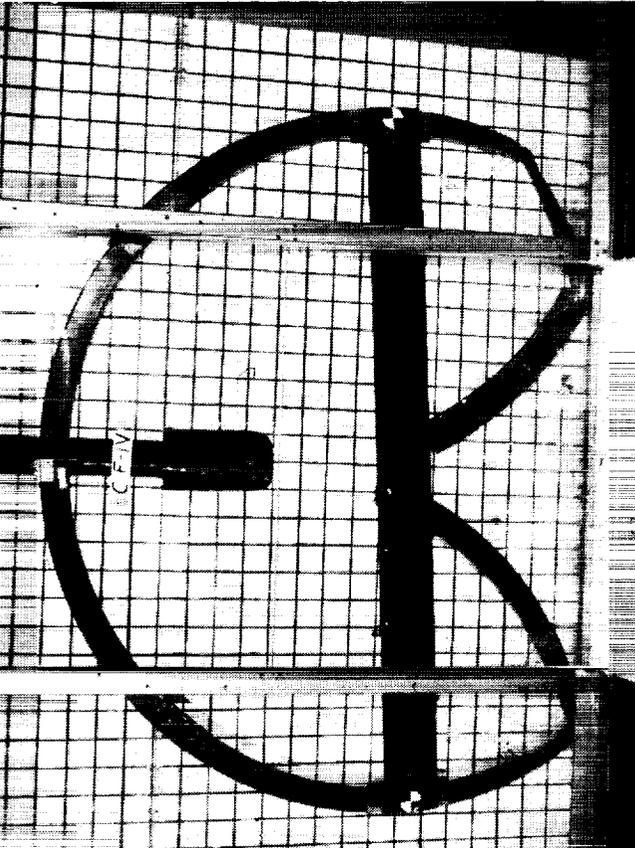
(a) Photographs of failed frames.

**Dynamic tests.** Information from reference 33 on the dynamic studies of the response of composite frames is shown in figure 18. As shown in figure 18(a), the splice plates joining the segments of the frame are 45° up the circumference from the point of impact. As noted in figure 18(b), complete failures (fractures) of the Z-section frames occurred at the bottom and approximately 60° from the bottom. It appears that the presence of the splice plates moved the top failure points up a few degrees (to about the 60° locations).

Figure 18. Behavior of composite Z-frames under dynamic loading.

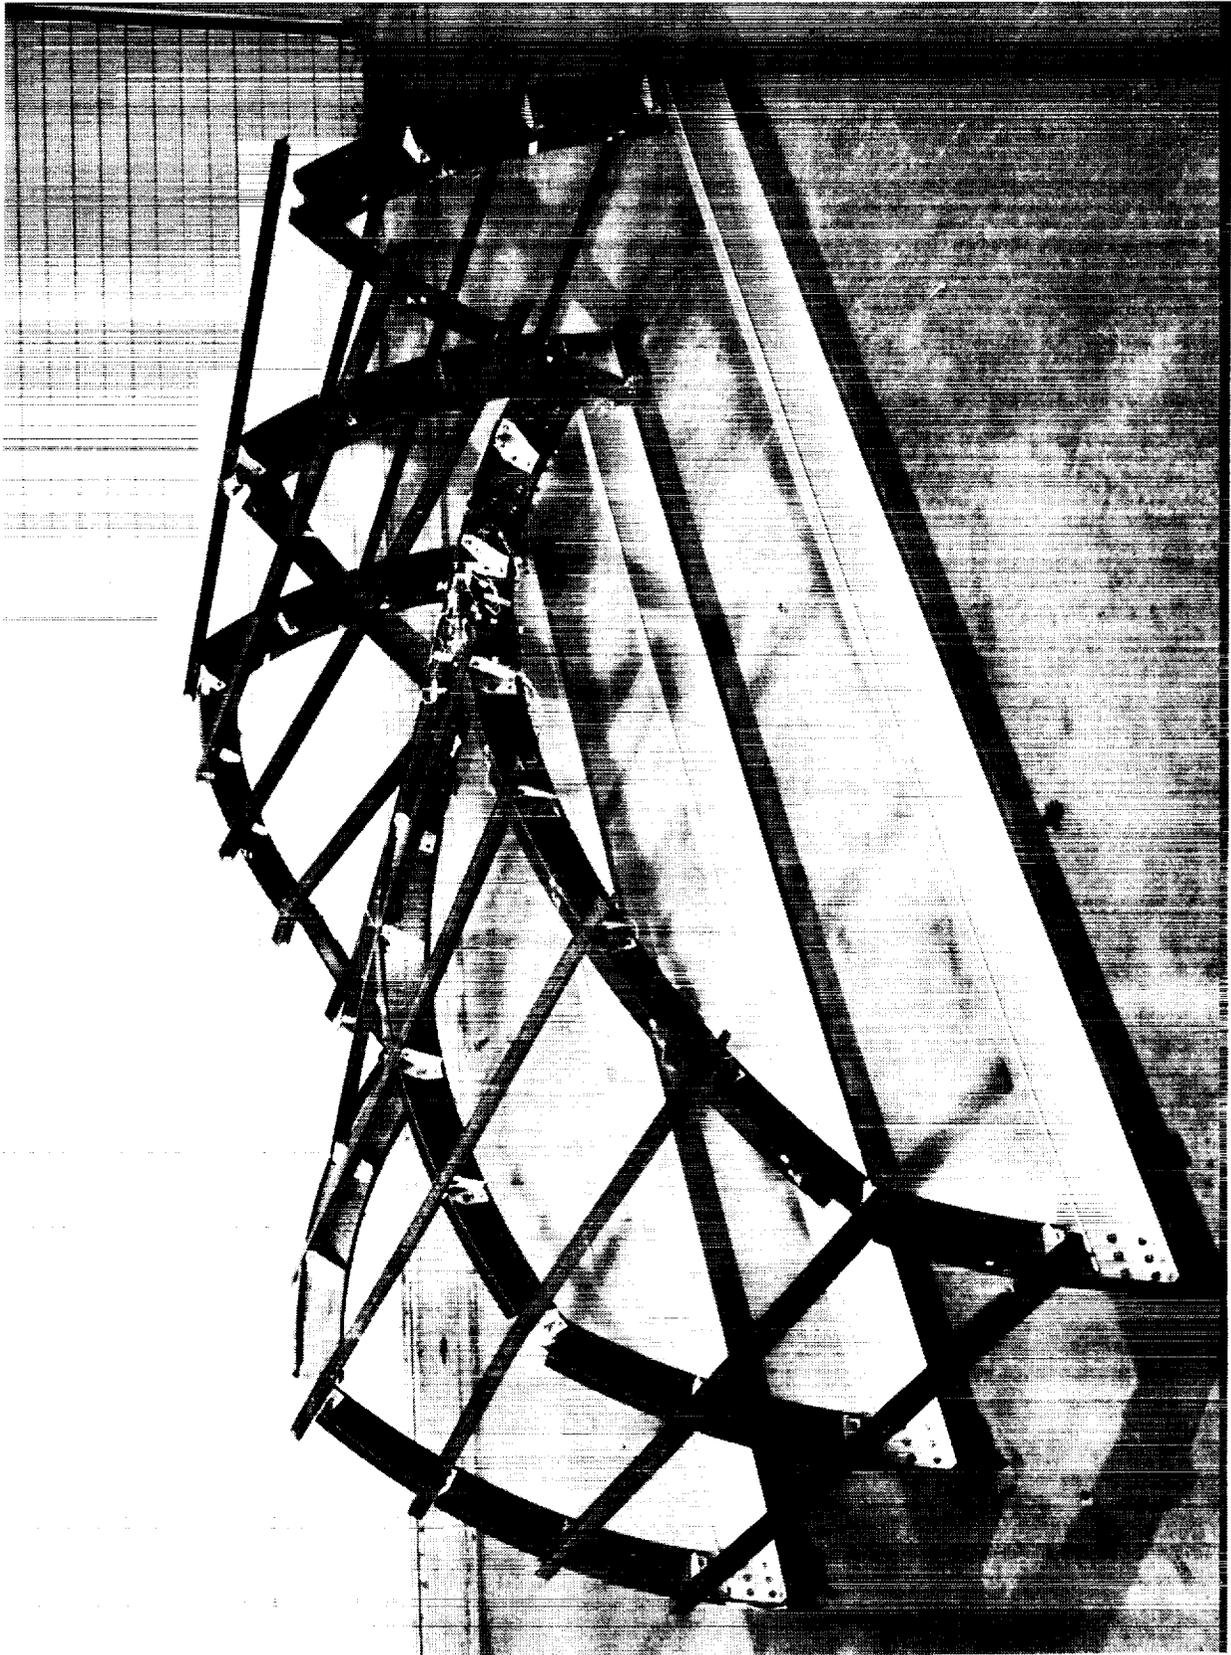
(a) Failed skeleton subfloor after static test.

**Static tests.** Experimental results (ref. 34) for the skeleton subfloor specimen following a static test are shown in figure 20. As shown in figure 20(a), failures on the 3 Z-section frames occurred at 15 discrete locations. Unlike the unnotched single Z-frame, the failures in this specimen occurred at notches (which served as stress risers) in the frame, through which the stringer passed. However, as shown in figure 20(b), the failures were still near the point of load application (approximately 12°-14°) and at other circumferential locations of approximately 55°. In the absence of skin material, twisting and out-of-plane bending occurred with the frames. The stringers had minimal effect on the subfloor response, with the exception of maintaining the lateral spacing of the three Z-frames.

Figure 20. Behavior of composite skeleton subfloor under static loading tests.

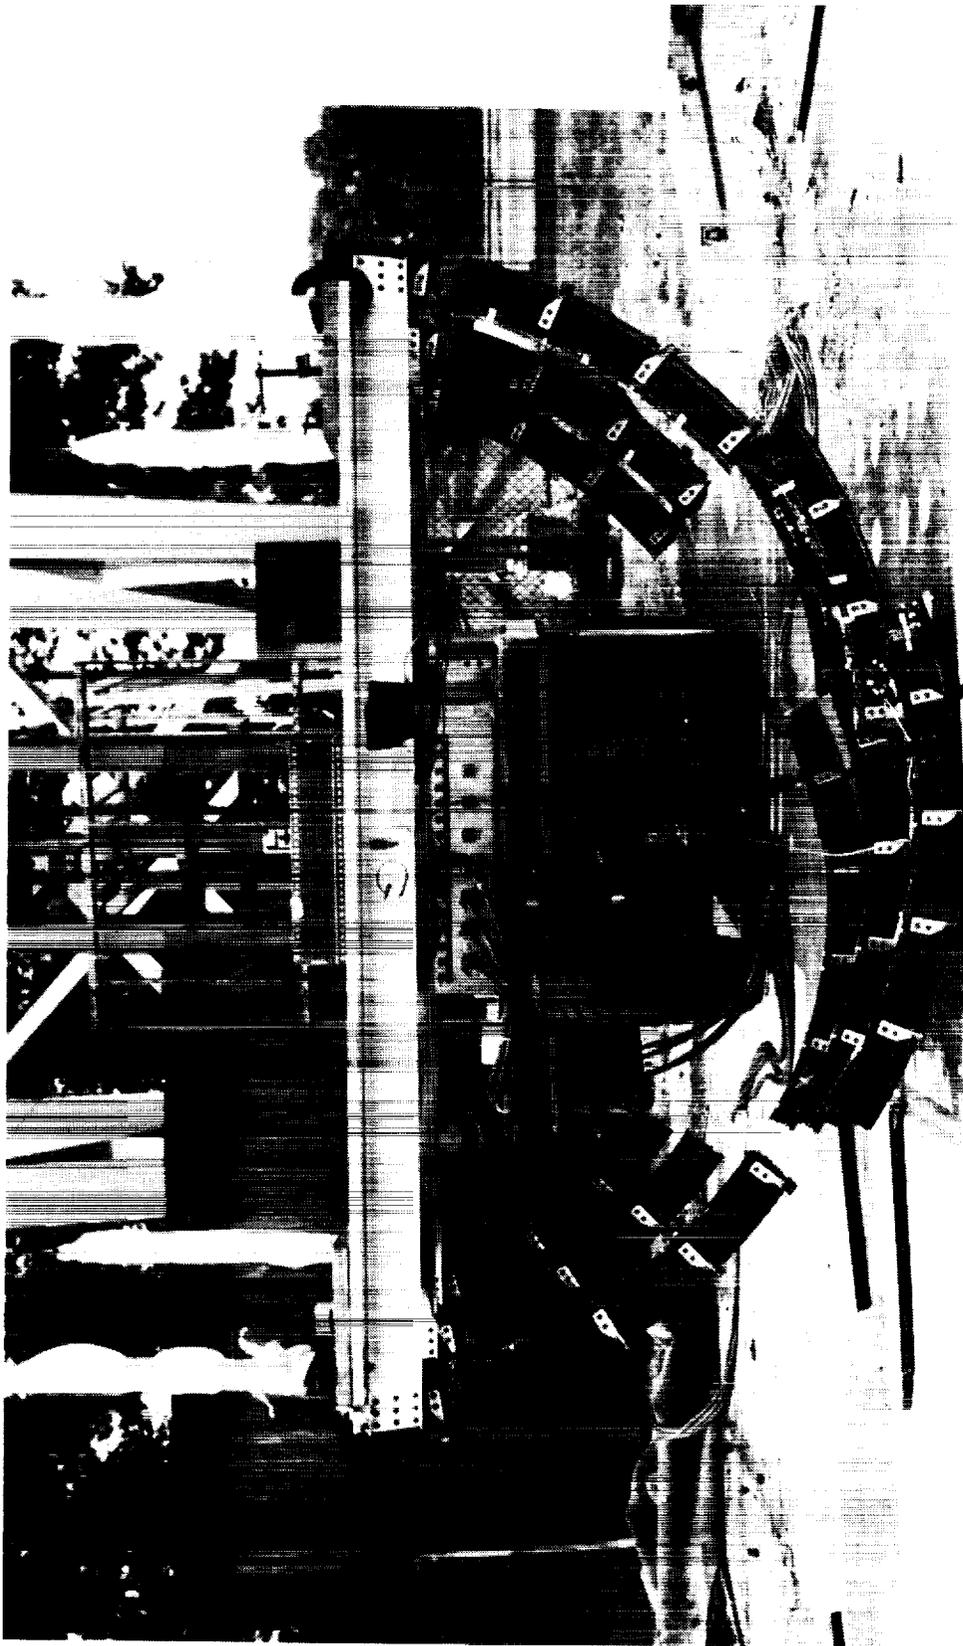
(a) Failed skeleton subfloor after dynamic test.

**Dynamic tests.** A photograph of a skeleton subfloor after impact onto a concrete surface at 20 ft/sec is shown in figure 21. In the dynamic test of the skeleton subfloor, fractures were produced at notches in the frames (fig. 21(a)) and, as shown in figure 21(b), also near the point of impact (about 14° because of the splice plate) and at 2 other locations up the circumference of the frames (45° and 78°), totaling 15 fractures for all 3 frames. The impact energy exceeded the energy absorbed by the local fractures, and the floor bottomed out in the impact. Figure 21(c) shows normalized circumferential strain distribution measured on the flange of the first (end) frame during the dynamic test just before first failure. A comparison of the distribution to the moment distribution of figures 17(b) and (c) shows essentially identical shape between the single frame and skeleton frame distributions. Maximum values at 0° and at approximately 50° to 55° agree well with the analytically predicted locations on the frame.

Figure 21. Behavior of composite skeleton subfloor under dynamic loading tests.

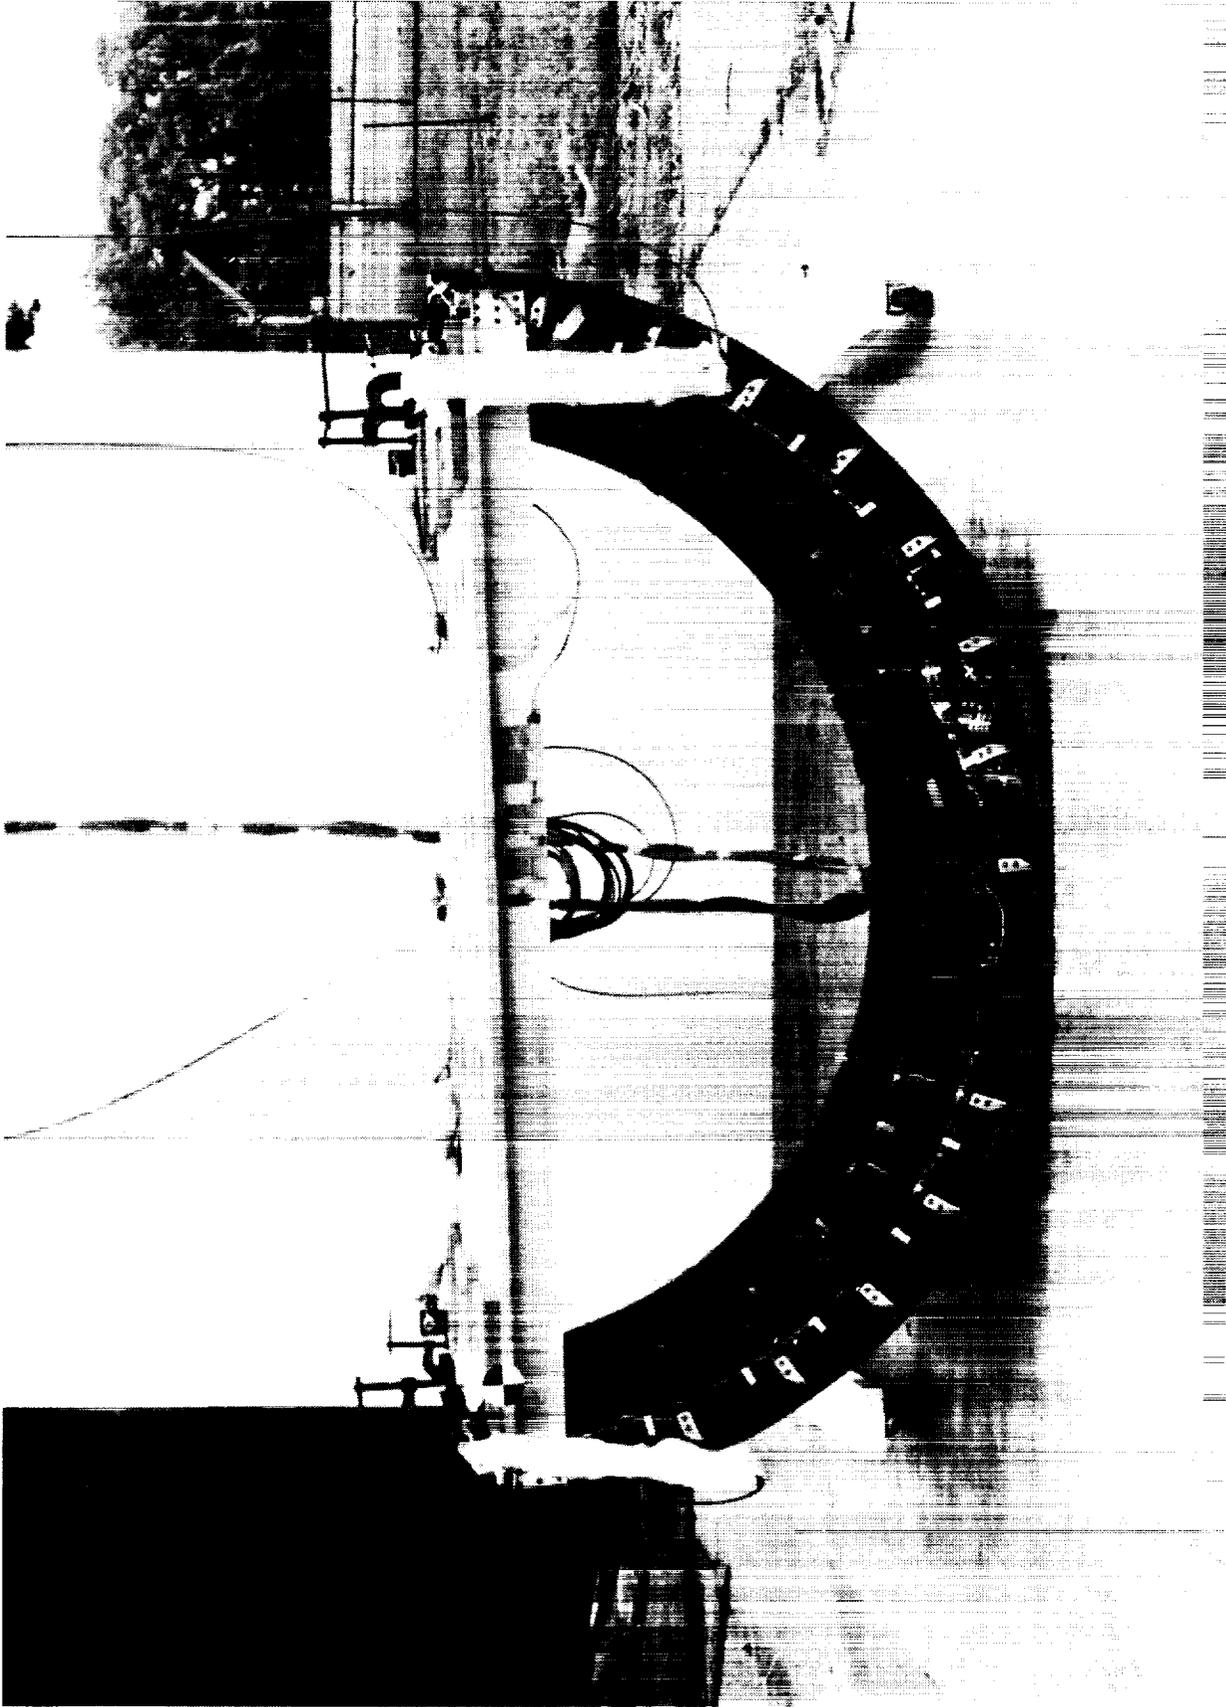
(a) Failed skinned subfloor after drop test.

Impact results for the subfloor with skin after an impact of 20 ft/sec are shown in figure 22. A photograph of the subfloor specimen after the test is shown in figure 22(a). Points of failure of the frames in this specimen are indicated in figure 22(b). Again the points of failure are near the impact point (within 12°) and circumferentially at about 56° up both sides of the middle and rear frames and at 45°, 11.3°, and 22.5° on the front frame. It was observed that the subfloor impacted first on the front area, possibly explaining the 11.3° and 22.5° fractures being different from those at the other locations. Again all three frames were involved in the failures. Some delamination of the frames from the skin was evident, but the skin remained intact. A normalized circumferential strain distribution (just prior to first failure) measured on the skin at the first (end) frame during the dynamic test is shown in

Figure 22. Behavior of skinned subfloor under dynamic loading tests.

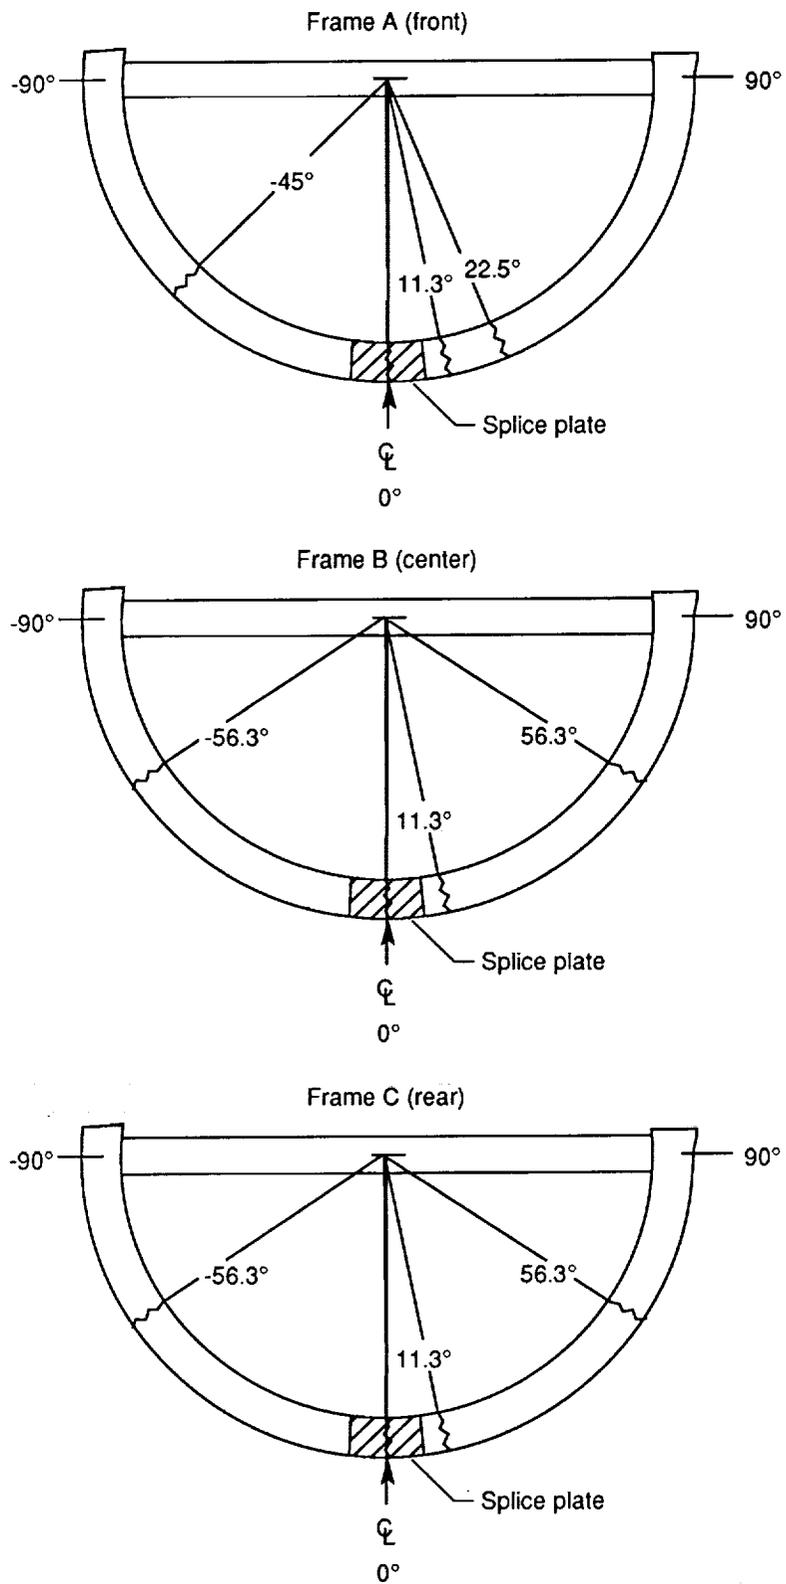
(b) Location of failures.

figure 22(c). A comparison of the distribution with the moment distributions of figures 17(b) and (c) and the strain distribution in figure 21(c) shows essentially identical shape as the single frame and skeleton frame distributions. As was the case for the skeleton subfloor, maximum values at  $0^\circ$  and at approximately  $50^\circ$  to  $55^\circ$  agree well with the analytically predicted locations on the frame.
