TWR-50143-2

The Full-Scale Process and Design Changes for Elimination of Insulation Edge Separations and Voids in Tang Flap Area Final Report

January 1991

Thiokol CORPORATION
SPACE OPERATIONS

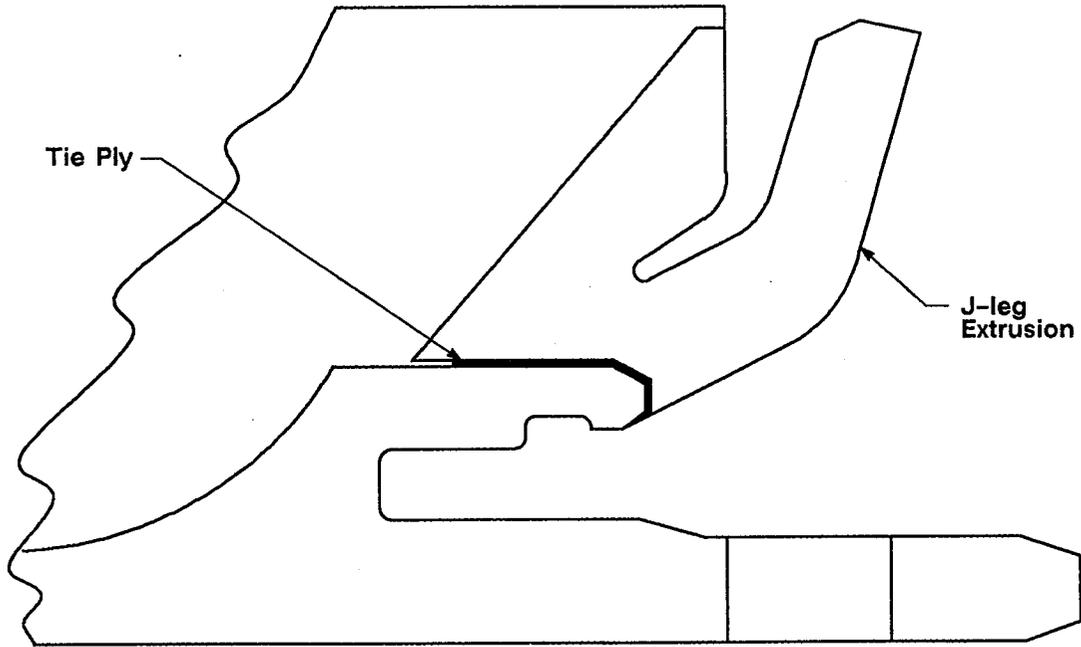
Figure 1a. Tang End Tie Ply Layups

Insulation layup was conducted per Drawing 5U77147-101. The cylinder was processed per normal manufacturing planning, except for the items listed below. The tang tie ply was used as outlined in the Table 1 test matrix. This included applying the tang tie ply to the capture feature (Figure 1a) for 270 deg shortly after the segment was placed in the assembly stand prior to mold ring installation. The cylinder was then moved to the M-111 Annex for insulation layup. Rubber layup was accomplished in the standard horizontal position using the layup platform up to the debulk operation. Changes to the standard flight layup incorporated into this configuration are detailed below.

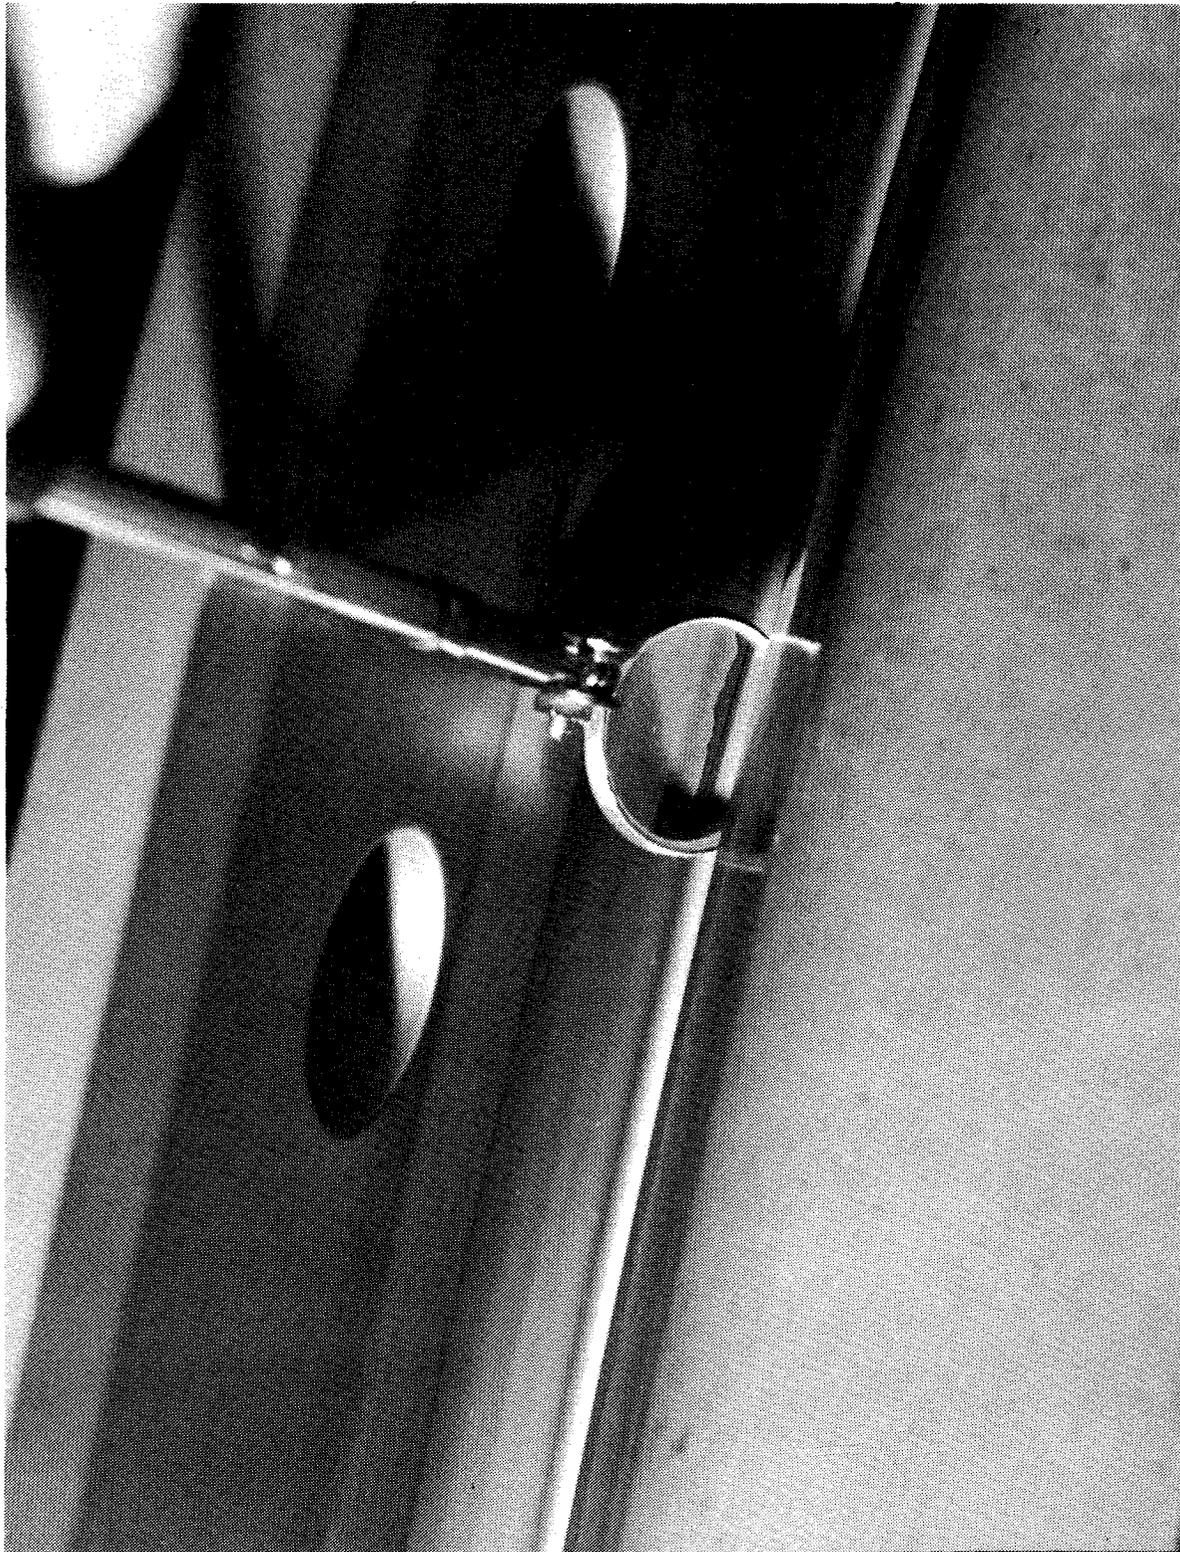
Figure 2. Non-tie Ply Region of Segment

All trimming, probing, and visual inspections were conducted per normal flight hardware processing. Postcure visual inspection determined there was normal flashing in the 90-deg area where the tie ply was not used (Figure 2) and exceptionally good flow (even into the O-ring groove) in the 270-deg area where the tie ply was used (Figure 3). The transition between the interface of the tie ply to the normal layup (no tie ply) demonstrates the difference in the insulation flow between the two test areas and the obvious advantage of using the tie ply (Figure 4). Probe inspections conducted by Manufacturing and Quality Assurance, after trim and after one month of aging, detected 17 unbonds in the 90-deg area where normal layup occurred and only one defect in the 270-deg area with the tie ply (Appendixes A and B). This one defect was an obvious tear caused during the probing operation. Since this testing showed no layup-related defects in the 270-deg area, the new layup process has been qualified.

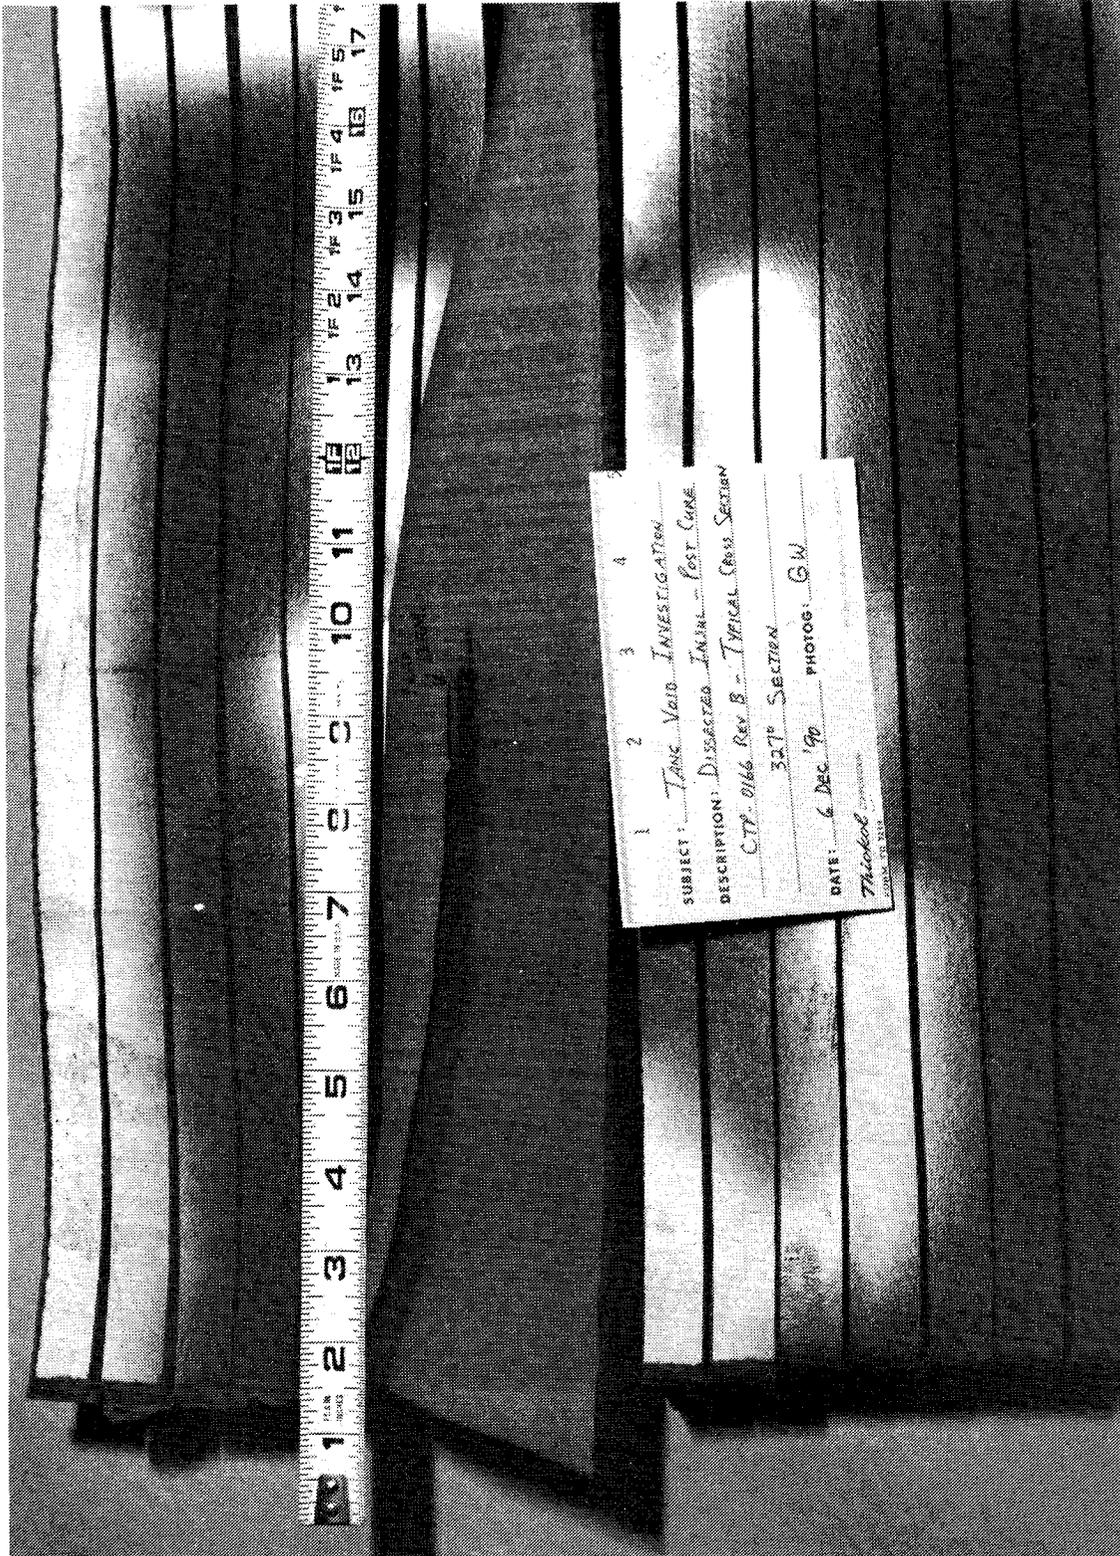
Figure 5. Typical Dissected Section of Tang Flap Region

that this area is where most defects occur. The dissected areas started approximately 8.5 in. aft of the tang and extended approximately 19 in. (Figures 5 and 6). The insulation aft of the dissected regions was removed and used in the resiliency testing conducted per WTP-0232.

The dissected areas were chosen to provide good comparisons between TCA and MEK and between perforated and nonperforated separator film. No defects were found in any of the sections including the section centered at 327 deg (LDI location). Since the TCA and MEK-activated regions contained no defects, MEK is qualified for use as an activator in the tang flap region. It was impossible to determine the effects of normal, perforated, and prepunched holes in the flap separator film since no defects were found in any of the areas.

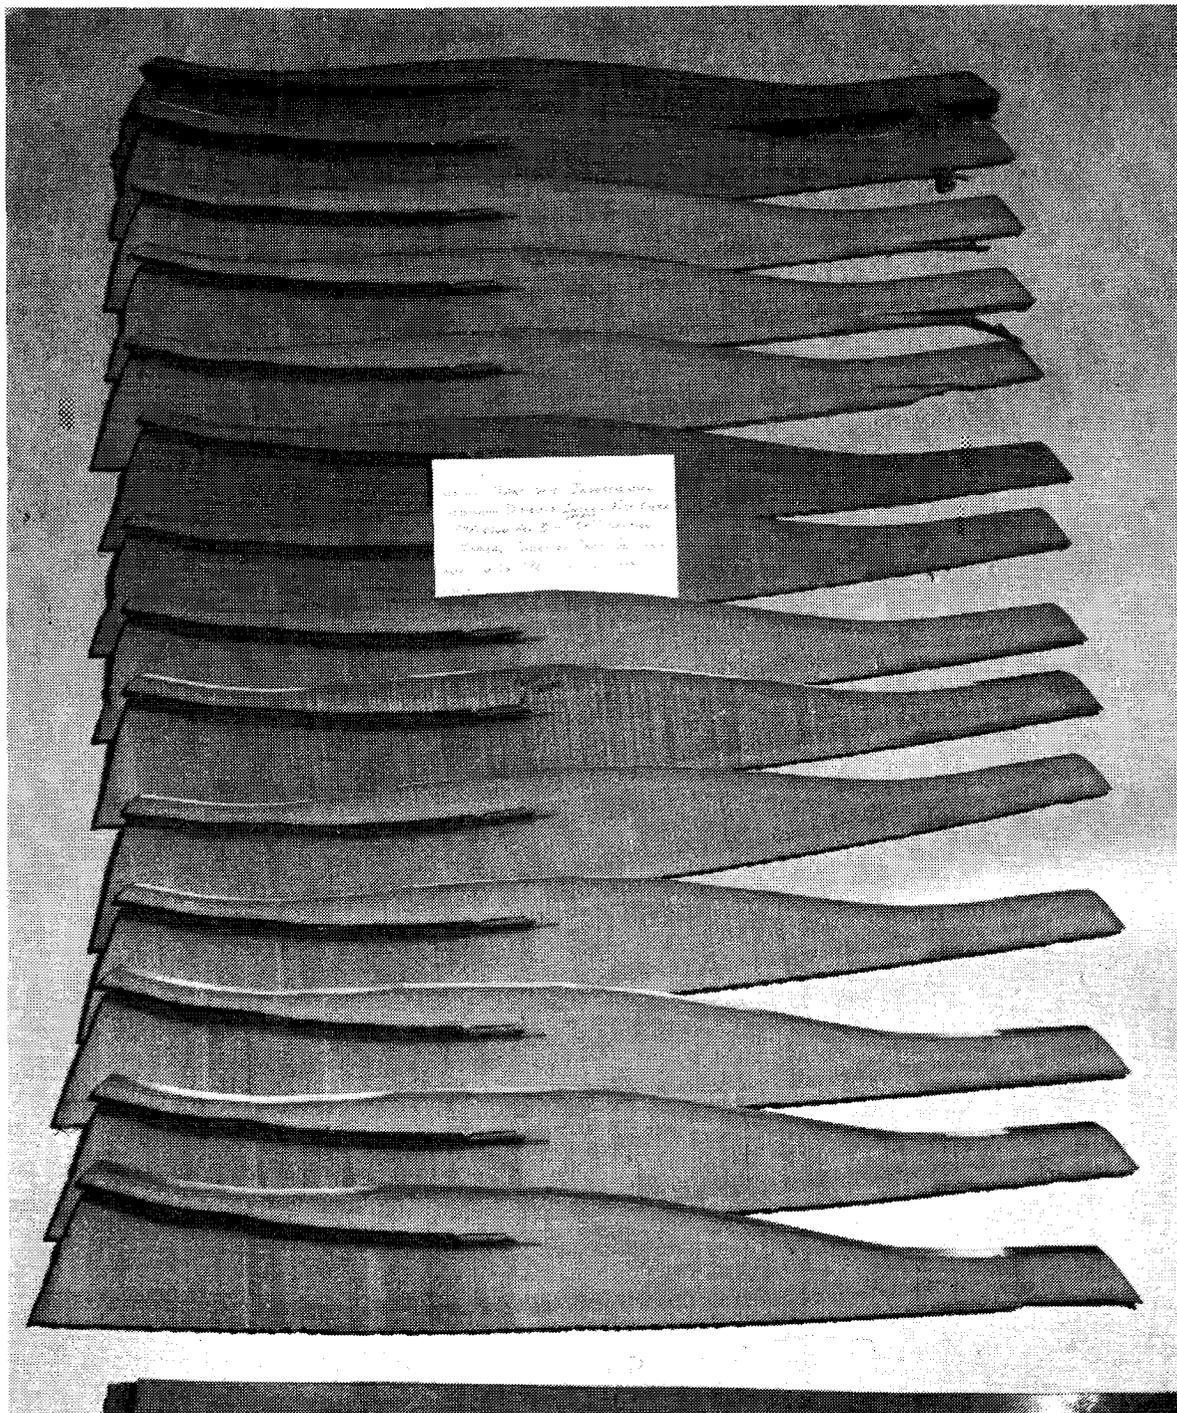
Figure 6. Dissected Strips From the 327-deg Area
of the Tang Flap

X-ray inspection was performed on the tang flap and flap bulb regions. This inspection revealed one low density indication (LDI) which may have been a case-to-insulation unbond. The LDI was seen rising to tangent position from 318 to 327 deg. Measurements were taken at 327 deg and showed that the LDI was located 7.530 in. forward of the tang end. The LDI had a length of 1.540 in. and a depth of 0.126 inch. The LDI was seen coming off tangent at 336 deg. Due to scatter caused by the outer case diameter, the LDI was lost from view between 330 and 333 deg (Appendix C).
