NASA Technical Memorandum 101698

Flow Visualization Study of a 1/48-Scale AFTI/F111 Model to Investigate Horizontal Tail Flow Disturbances

Lisa J. Bjarke
Ames Research Center, Dryden Flight Research Facility, Edwards, California

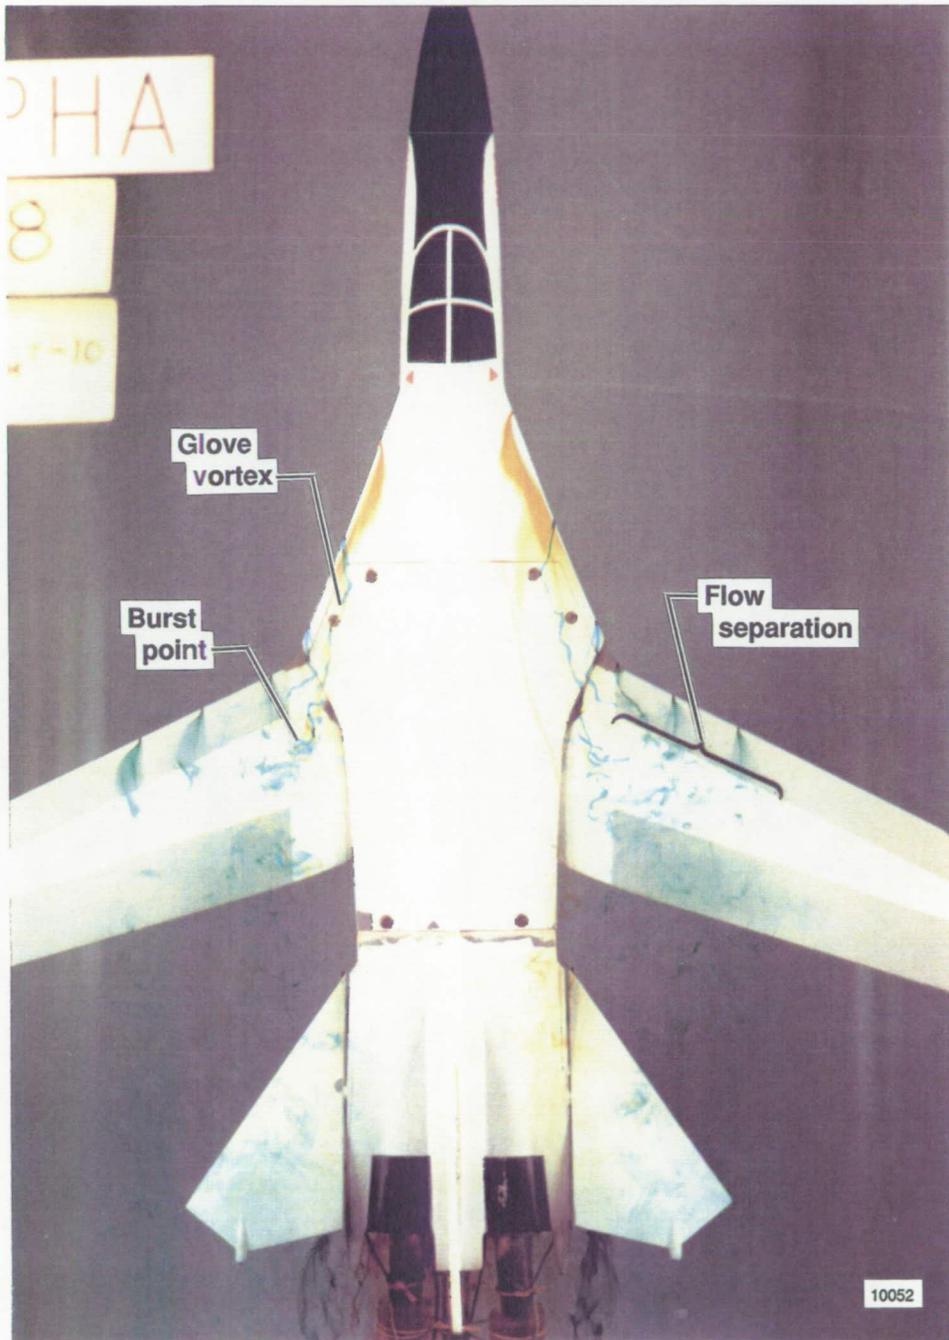
(a) Plan view.

At $\alpha = 8^\circ$, the plan view (fig. 4(a)) shows that wing flow separation occurs just behind the leading-edge devices. The glove vortex burst point is near the wing root at approximately mid-chord. (It should be noted that the path of this vortex and its effect on the flow over the wing agreed with wind-tunnel tuft flow visualization results from a Boeing study summarized by Nelson (1982)). The side view (fig. 4(b)) shows that the wing separation and glove vortex flow goes above the horizontal tail while the lower surface of the horizontal tail experiences a different flow field. This type of flow field on the horizontal tail could be the cause of the slight horizontal tail buffet experienced in flight at similar test conditions as discussed by Friend (1989). Also visible in the side view is a weak vortex that begins at the engine inlet lip-fuselage juncture, travels aft along the fuselage and causes a flow disturbance both above and below the horizontal tail root.

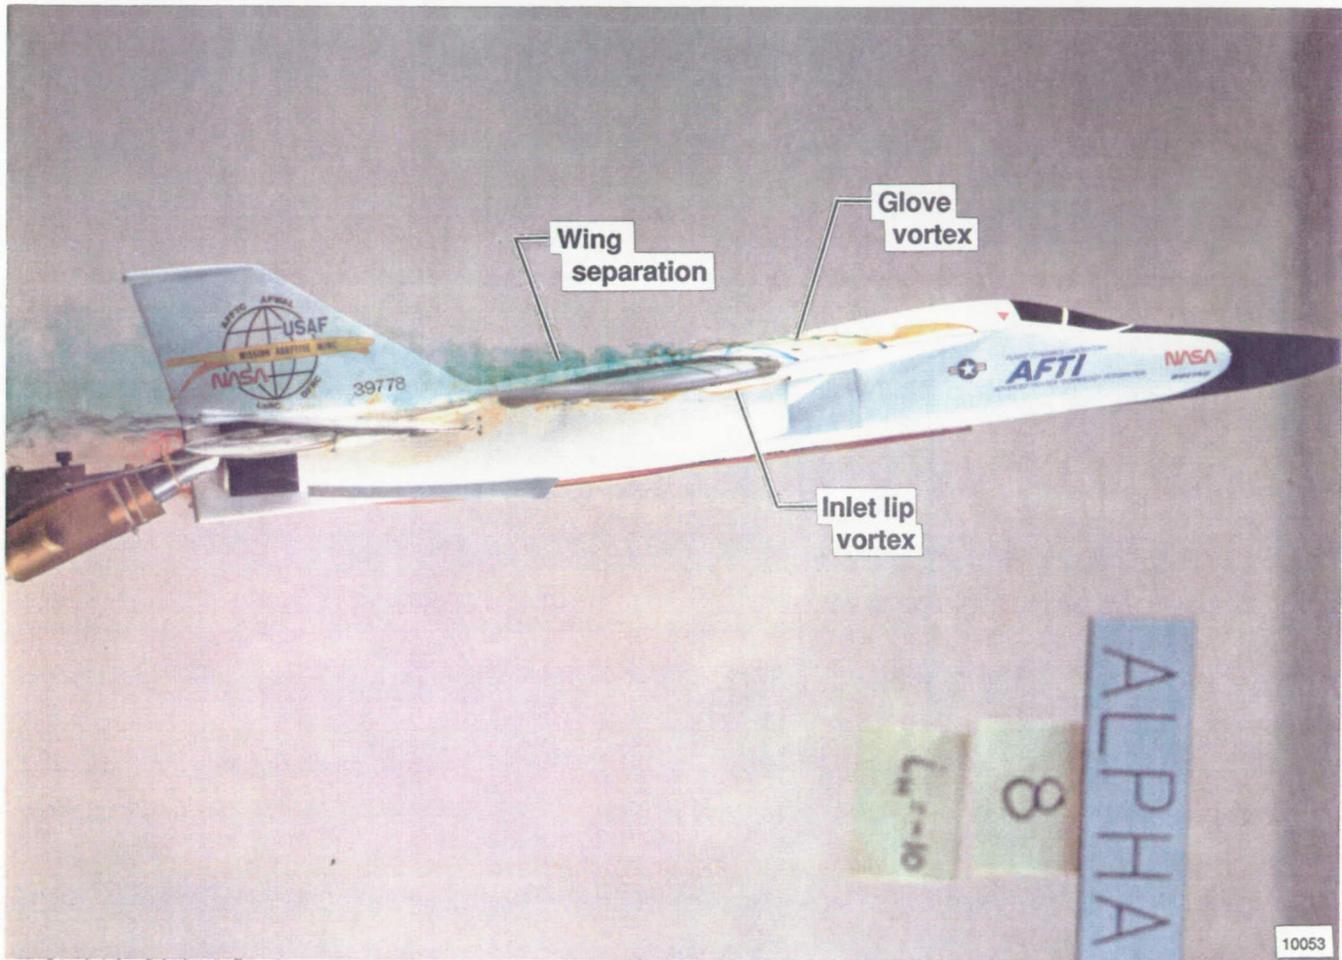
(b) Side view.

Figure 5 presents the flow visualization results at $\alpha = 10^\circ$ for this configuration. With the increase in angle of attack, flow separation on the wing moved slightly forward (fig. 5(a)). In addition, there is now both a primary and secondary glove vortex, both of which burst slightly further forward on the wing than at $\alpha = 8^\circ$ (fig. 4(a)). In the side view (fig. 5(b)), the separated and vortex flow field from the wing can again be seen traveling above the horizontal tail. However, at this angle of attack, more of the inlet lip vortex goes beneath the horizontal tail than at $\alpha = 8^\circ$ (fig. 4(b)).

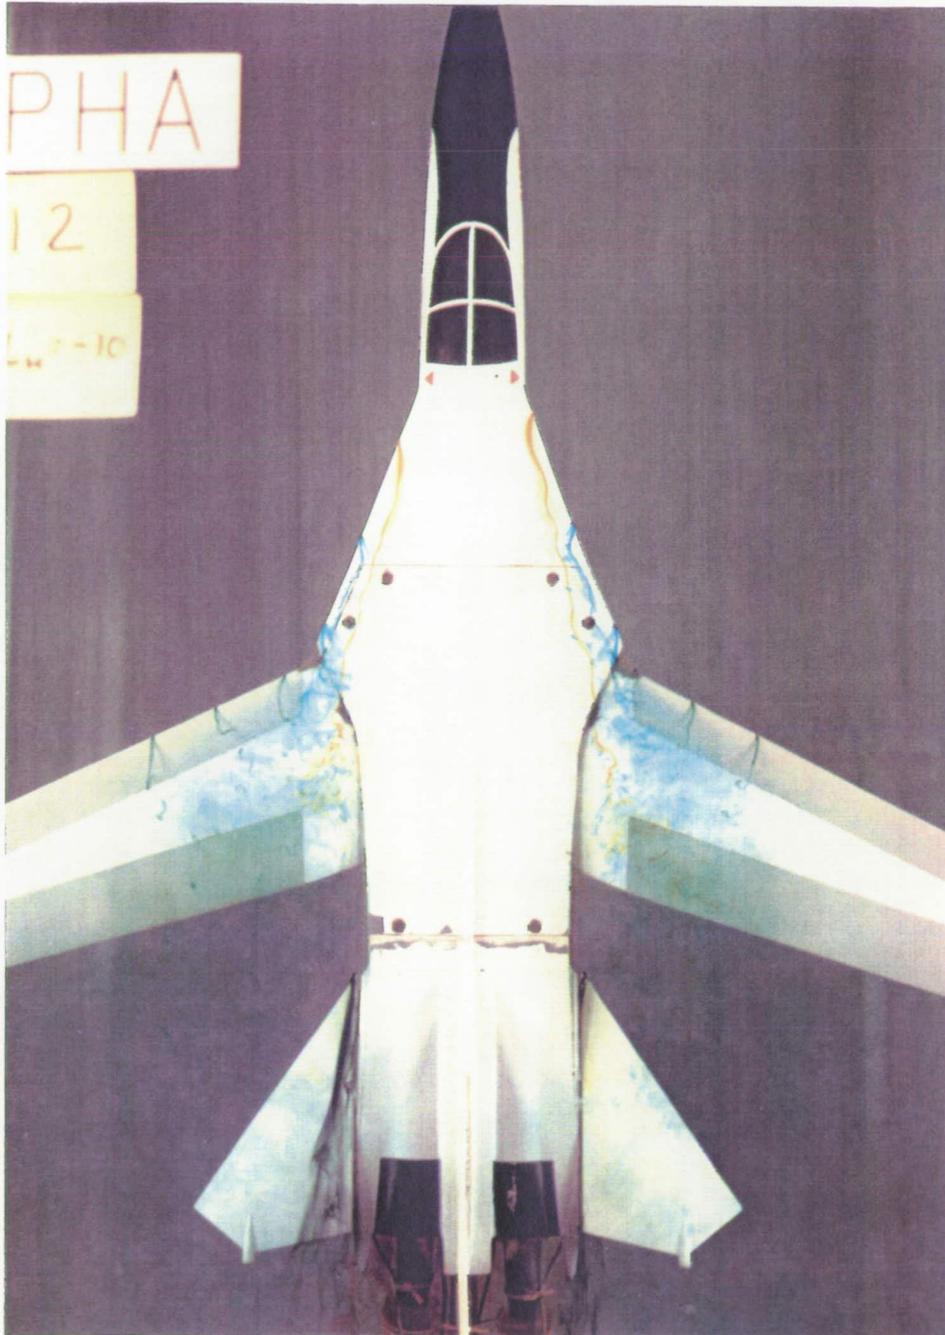
(a) Plan view.

At $\alpha = 12^\circ$, (fig. 6(a)), more of the wing is separated, especially inboard. This is because the burst point of the secondary glove vortex has moved forward to the wing-glove juncture. The primary vortex is stronger but its burst point is at approximately the same place as it was at $\alpha = 10^\circ$ (fig. 5(a)). Most of the inlet lip vortex curves down away from the wing as it travels aft and goes under the horizontal tail (fig. 6(b)).

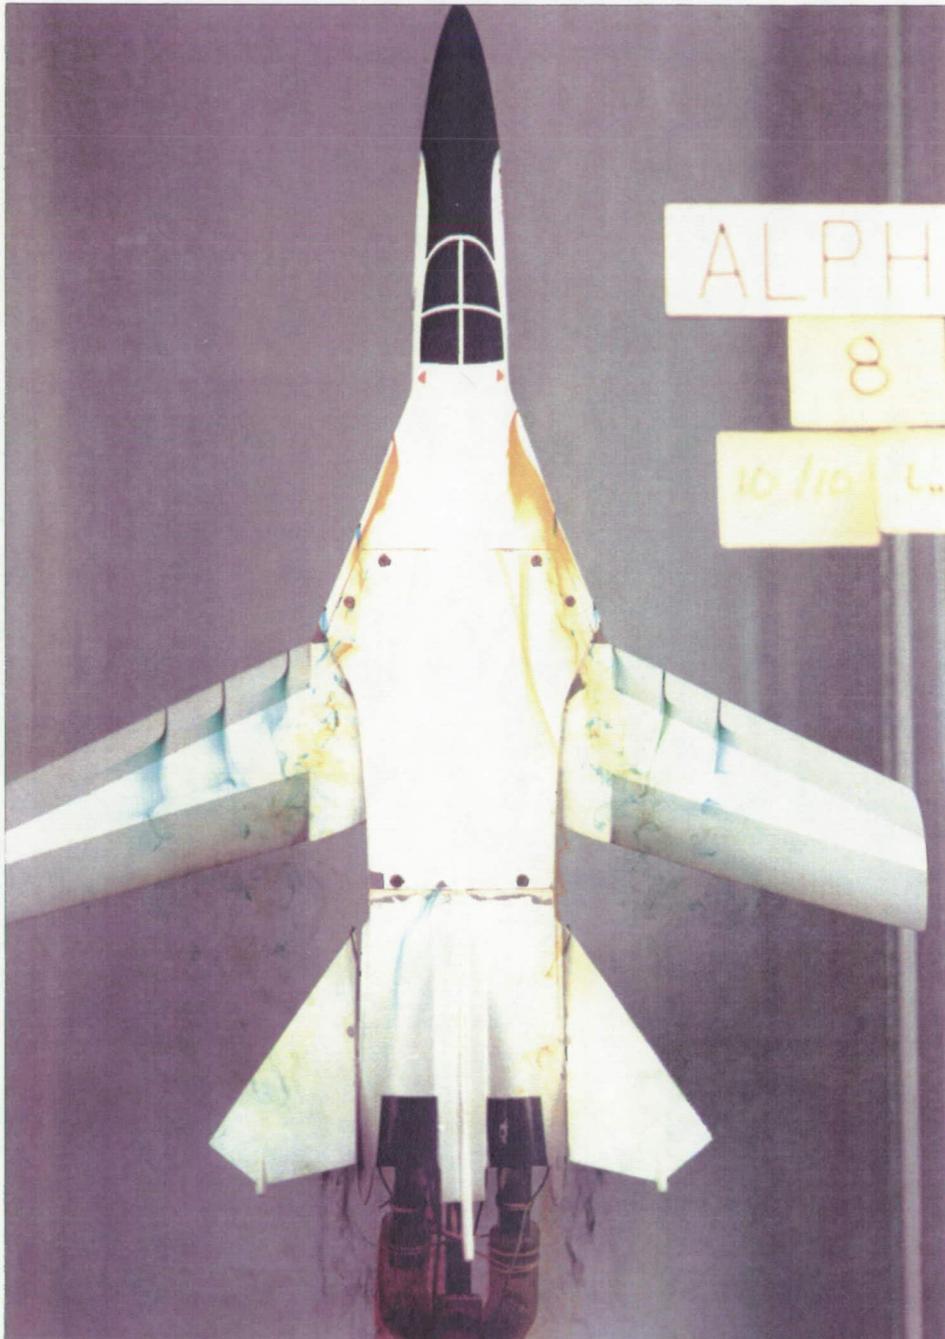
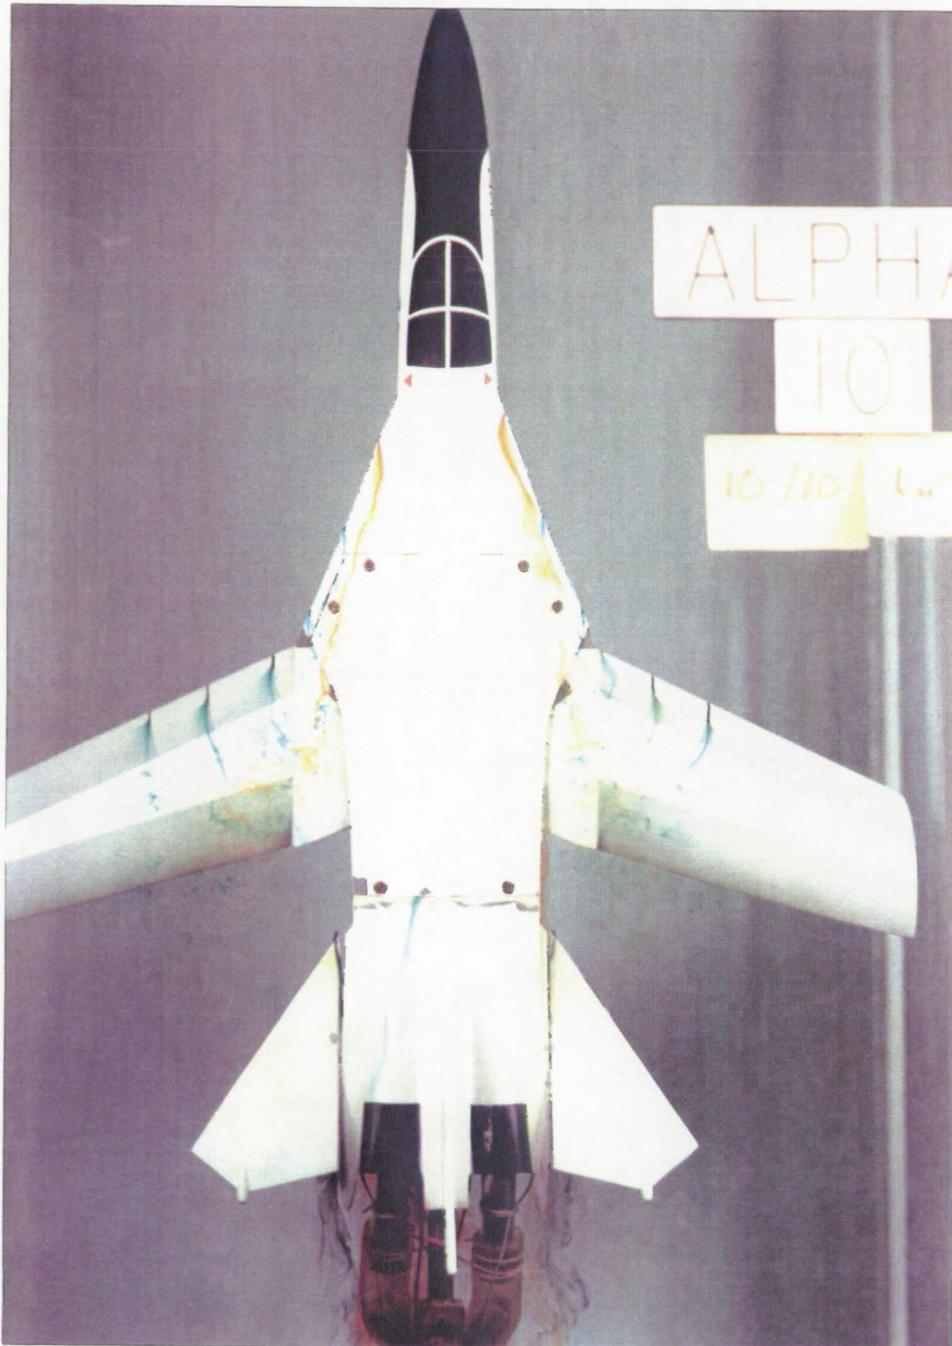
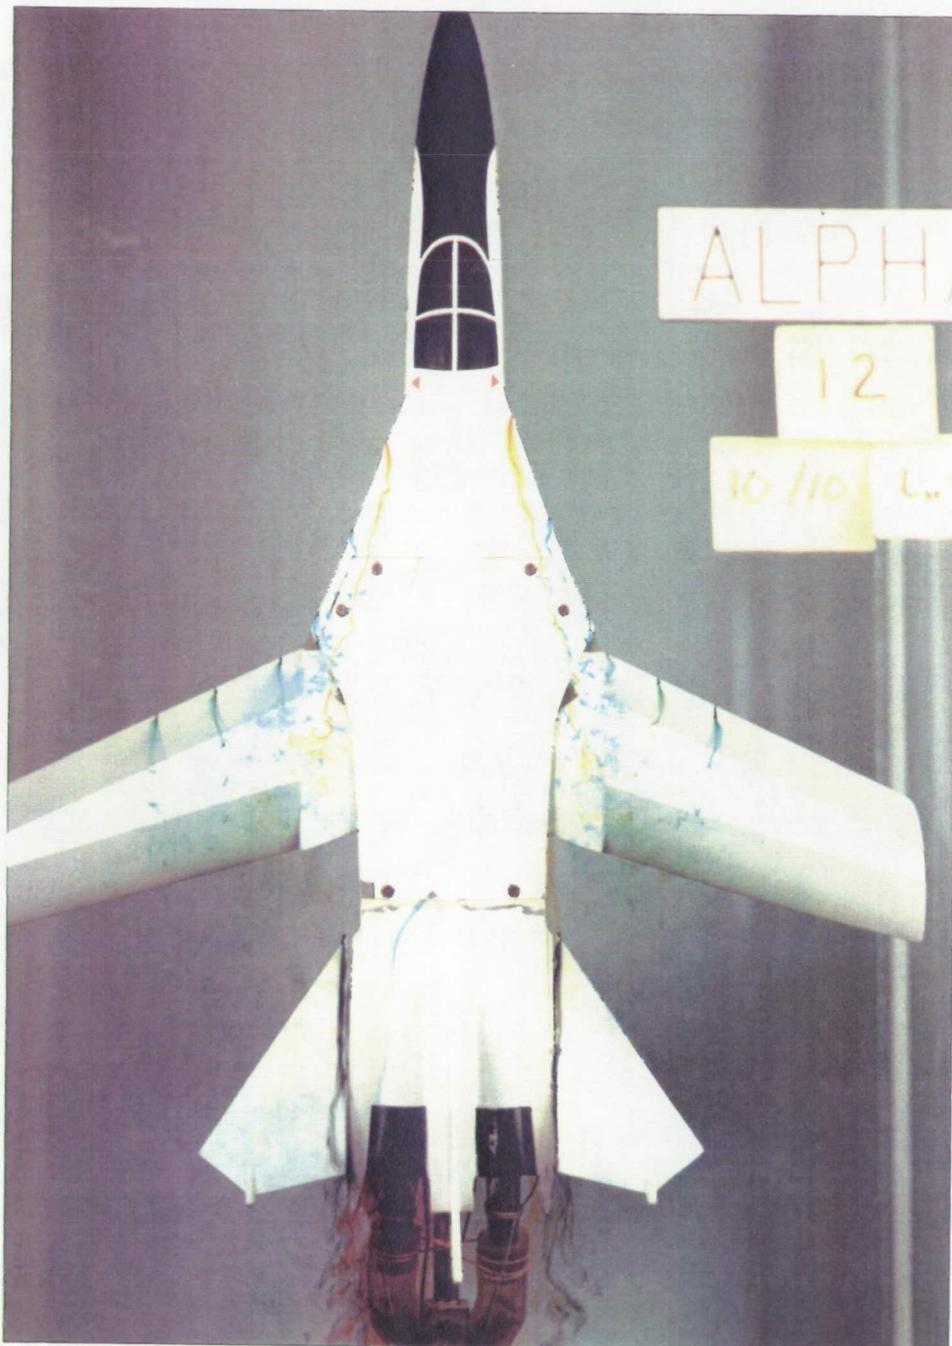
wing flow separation is further aft for this configuration (figs. 7(a), 8(a), and 9(a)), it still moves forward with increasing angle of attack as was discussed previously. The glove vortex follows similar behavior for this configuration as for the $\delta_{LE/TE} = 0/2$ configuration.

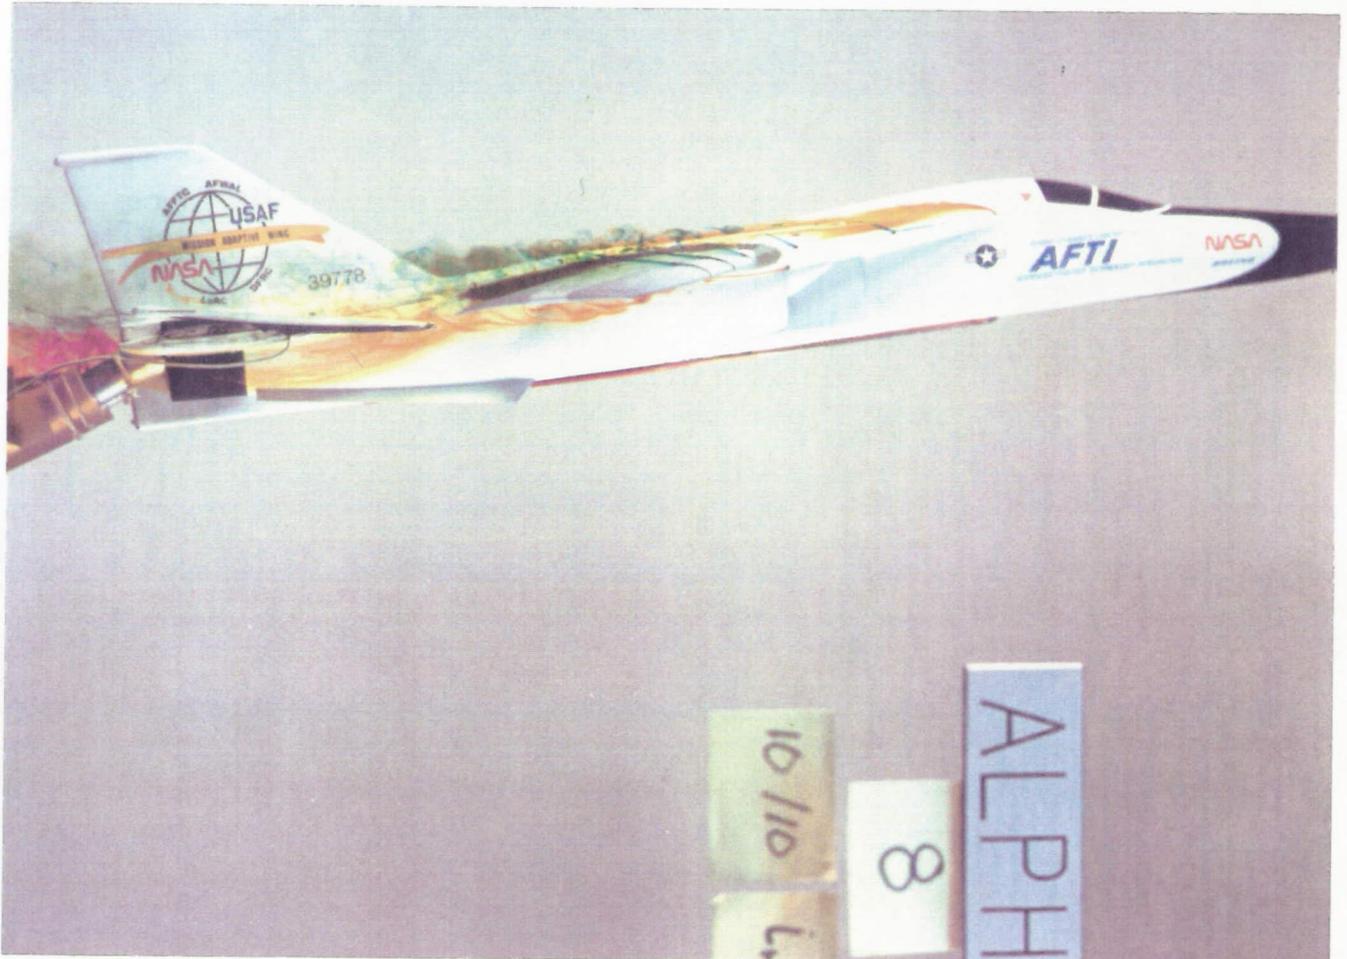
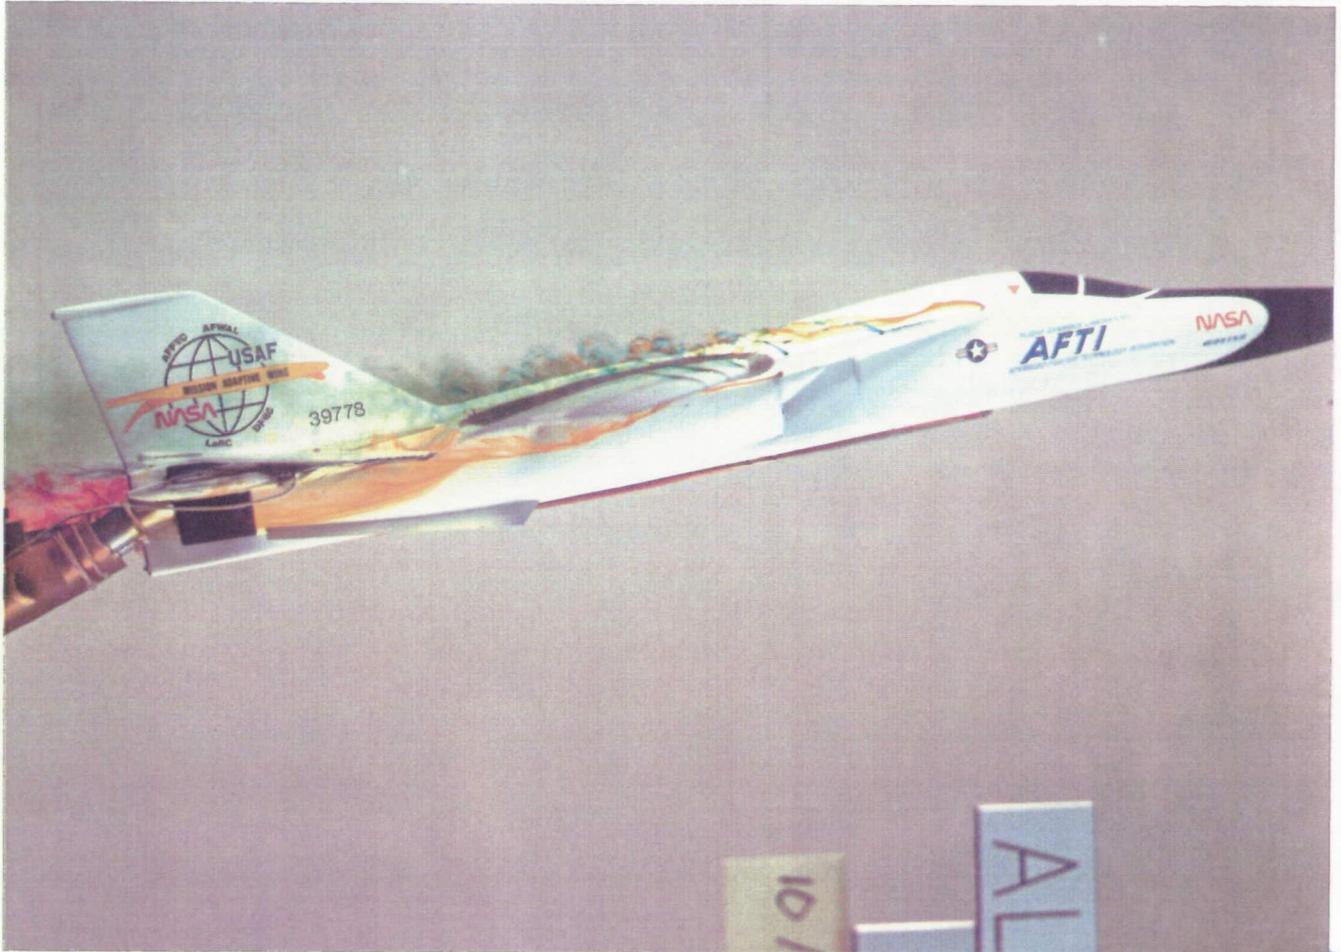
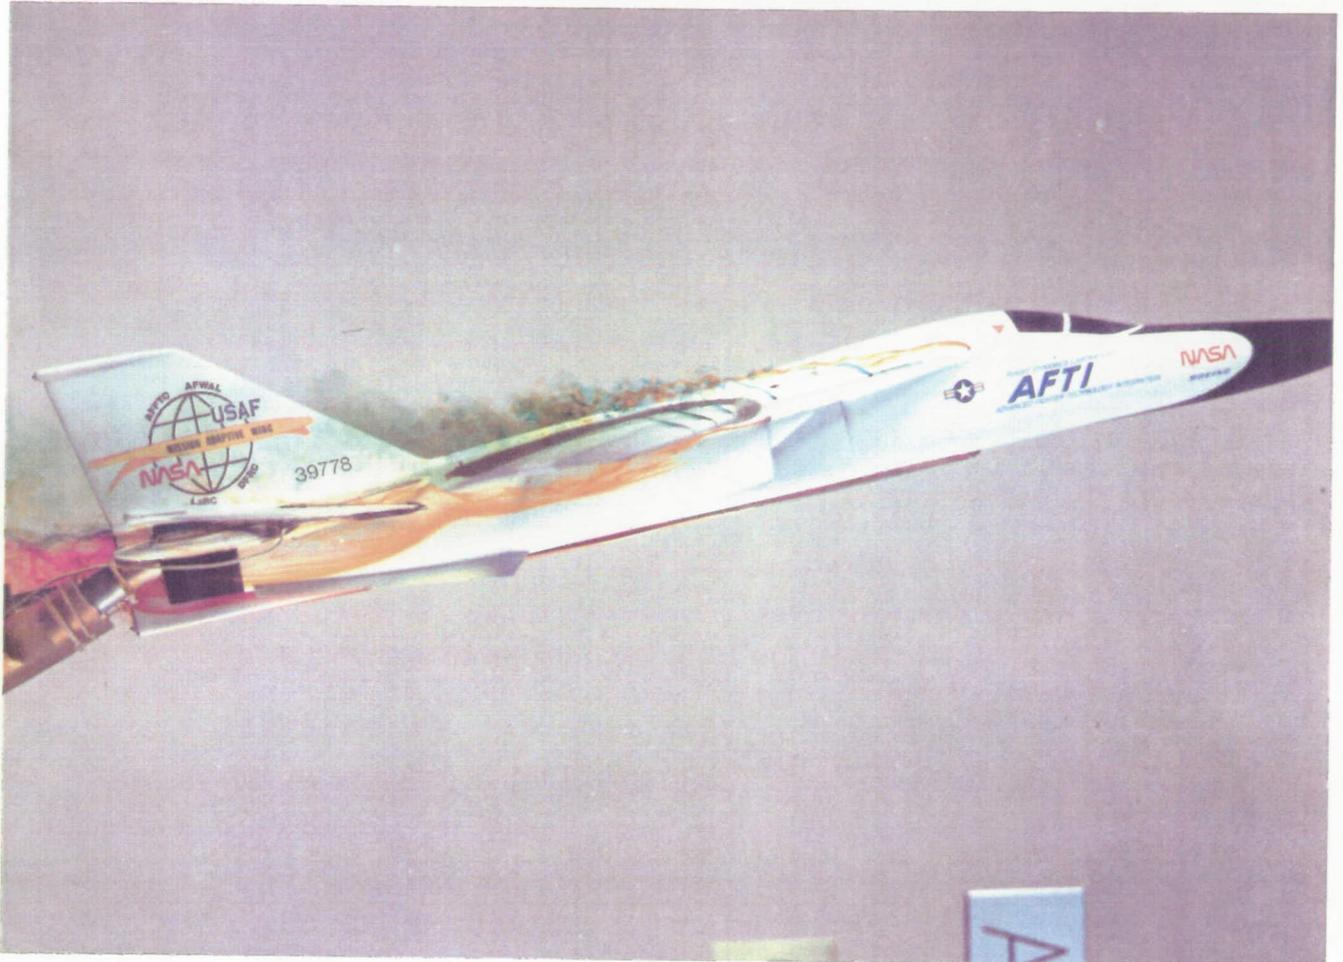
The side views (figs. 7(b), 8(b), and 9(b)) show that the separated and glove vortex flow from the wing still travel above the horizontal tail but turns downward near the trailing-edge device and interact more directly with the horizontal tail upper surface. The inlet lip vortex appears more circulatory (stronger) in nature and interacts directly with the horizontal tail at the root leading edge. This difference is most dramatic at $\alpha = 10^\circ$ and 12° (figs. 8(b) and 9(b)) where the inlet lip vortex engulfs the horizontal tail rather than traveling on one side or the other as was the case when $\delta_{LE/TE} = 0/2$ (figs. 5(b) and 6(b)). With the changes in the direction and placement of both the flow from the wing and the inlet lip, the horizontal tail is in a more disturbed flow field at $\delta_{LE/TE} = 10/10$ than at $\delta_{LE/TE} = 0/2$. These results are consistent with the findings of Friend (1989) which show increased horizontal tail buffet experienced in flight for similar test conditions.

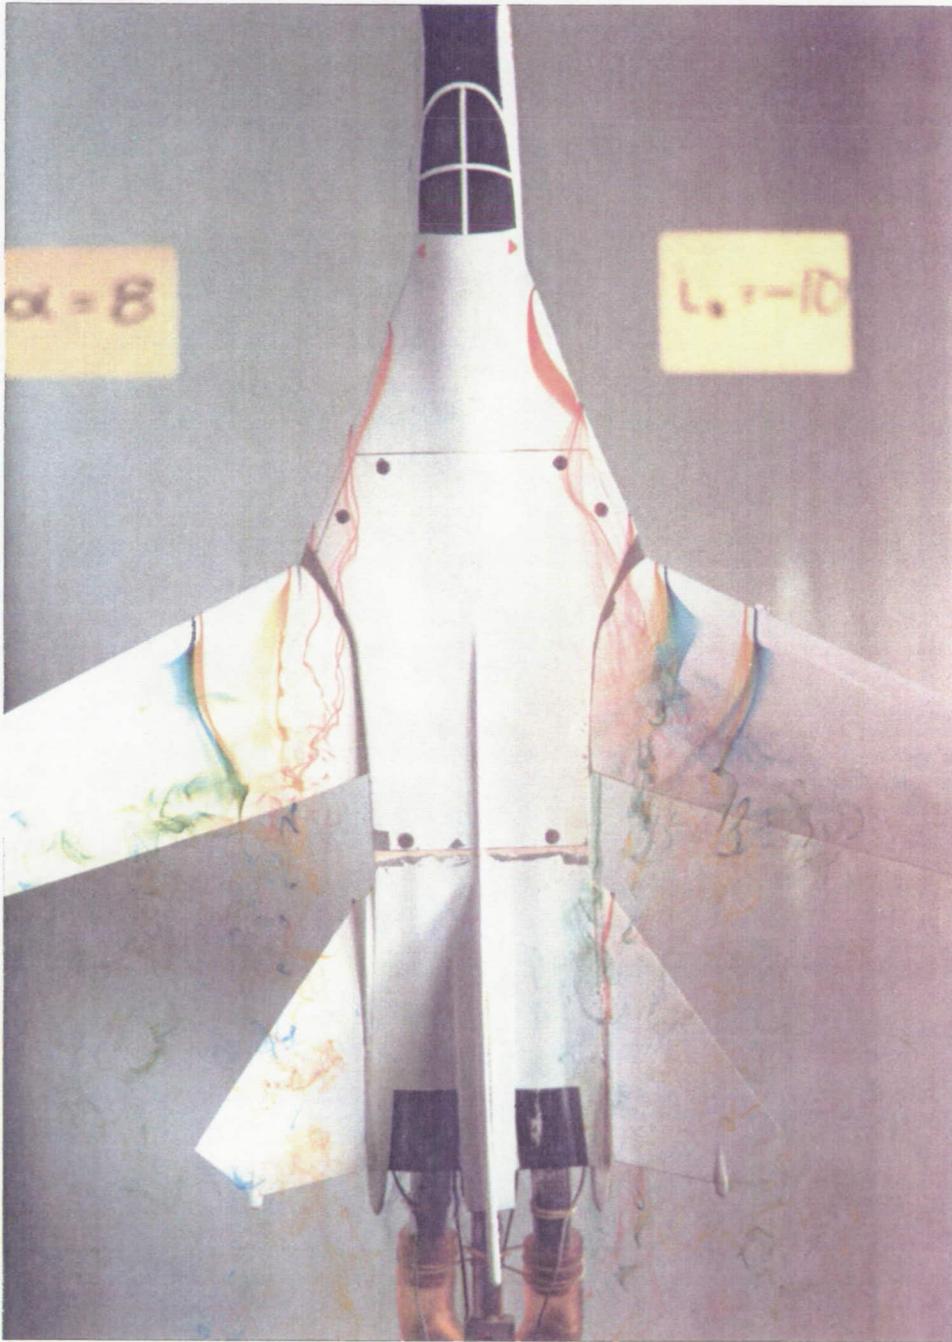
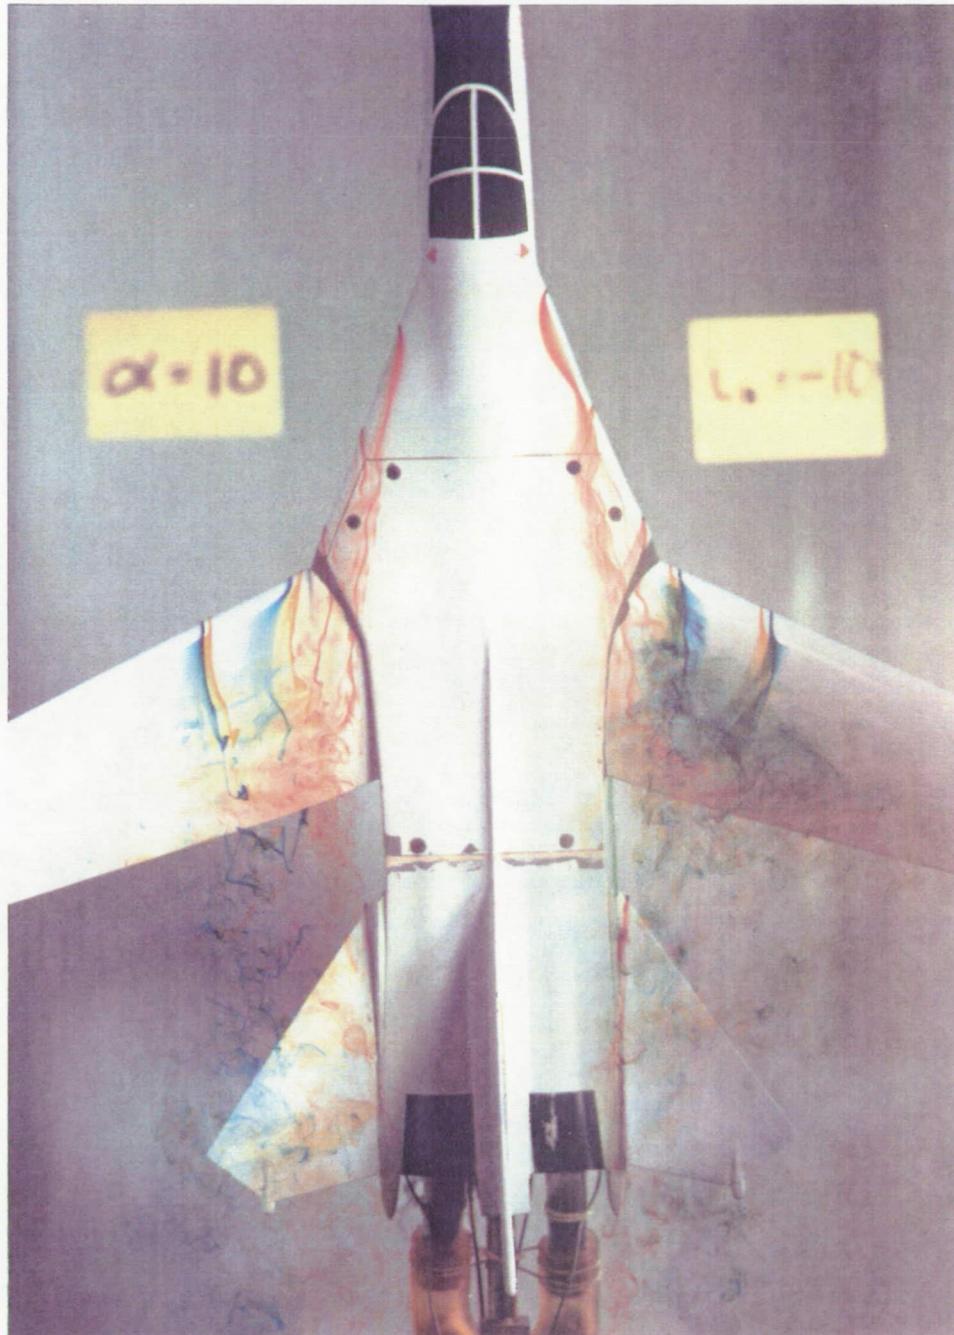
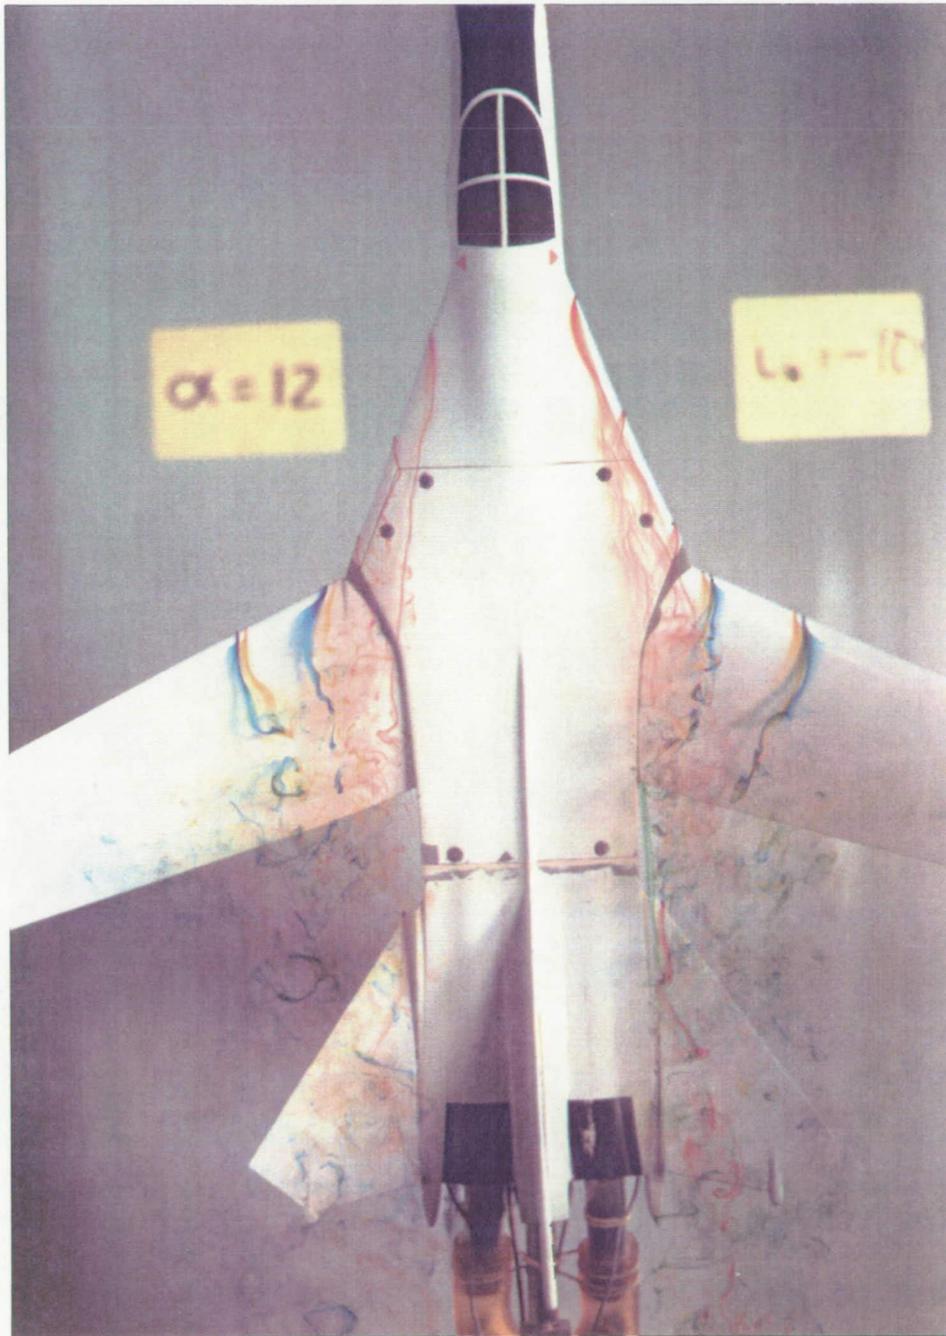
Generally, in comparing this configuration to the previous two configurations discussed, the wing separation and glove vortex burst location (figs. 10(a), 11(a), and 12(a)) behaved similarly to that of $\delta_{LE/TE} = 10/10$ (figs. 7(a), 8(a), and 9(a)). However, the side views (figs. 10(b), 11(b), and 12(b)) indicate that the direction of the separated and glove vortex flow are more similar to that of the $\delta_{LE/TE} = 0/2$ configuration (figs. 4(b), 5(b), and 6(b)). From these results it appears that the horizontal tail is subject to similar flow fields at both $\delta_{LE/TE} = 0/2$ and $10/2$.

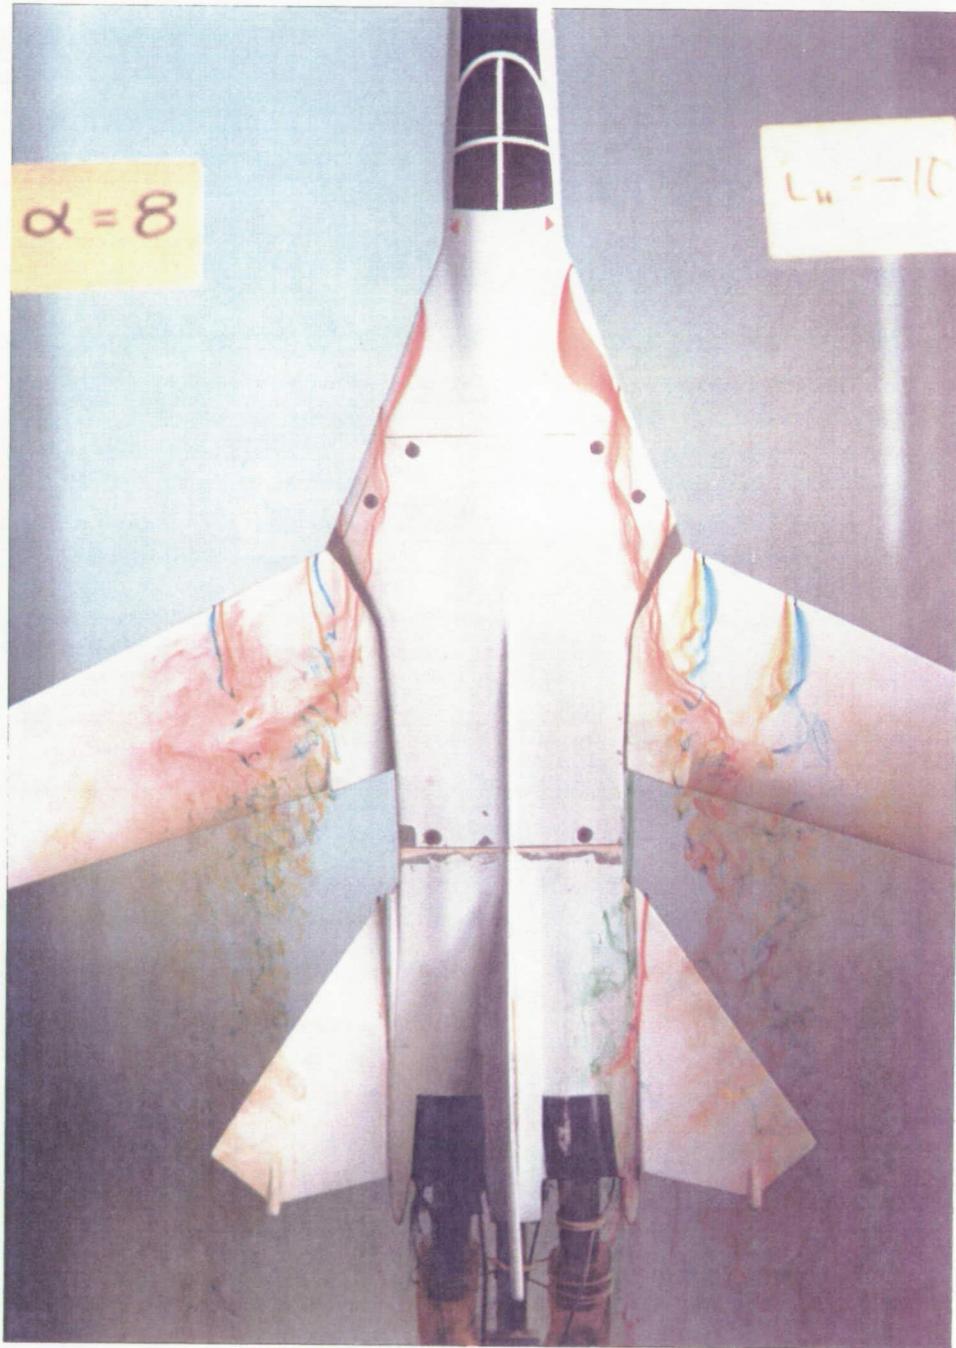
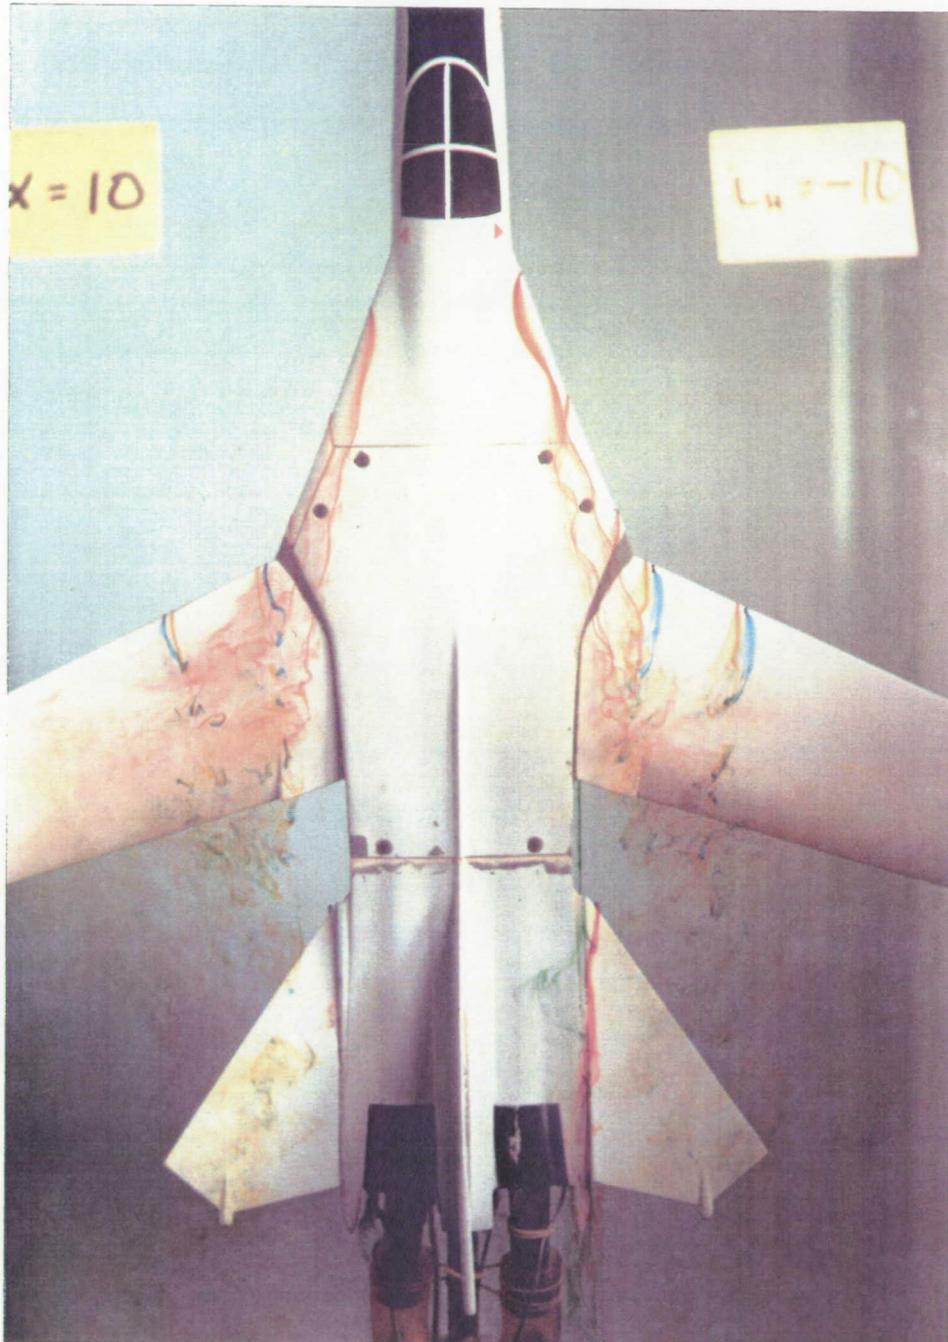
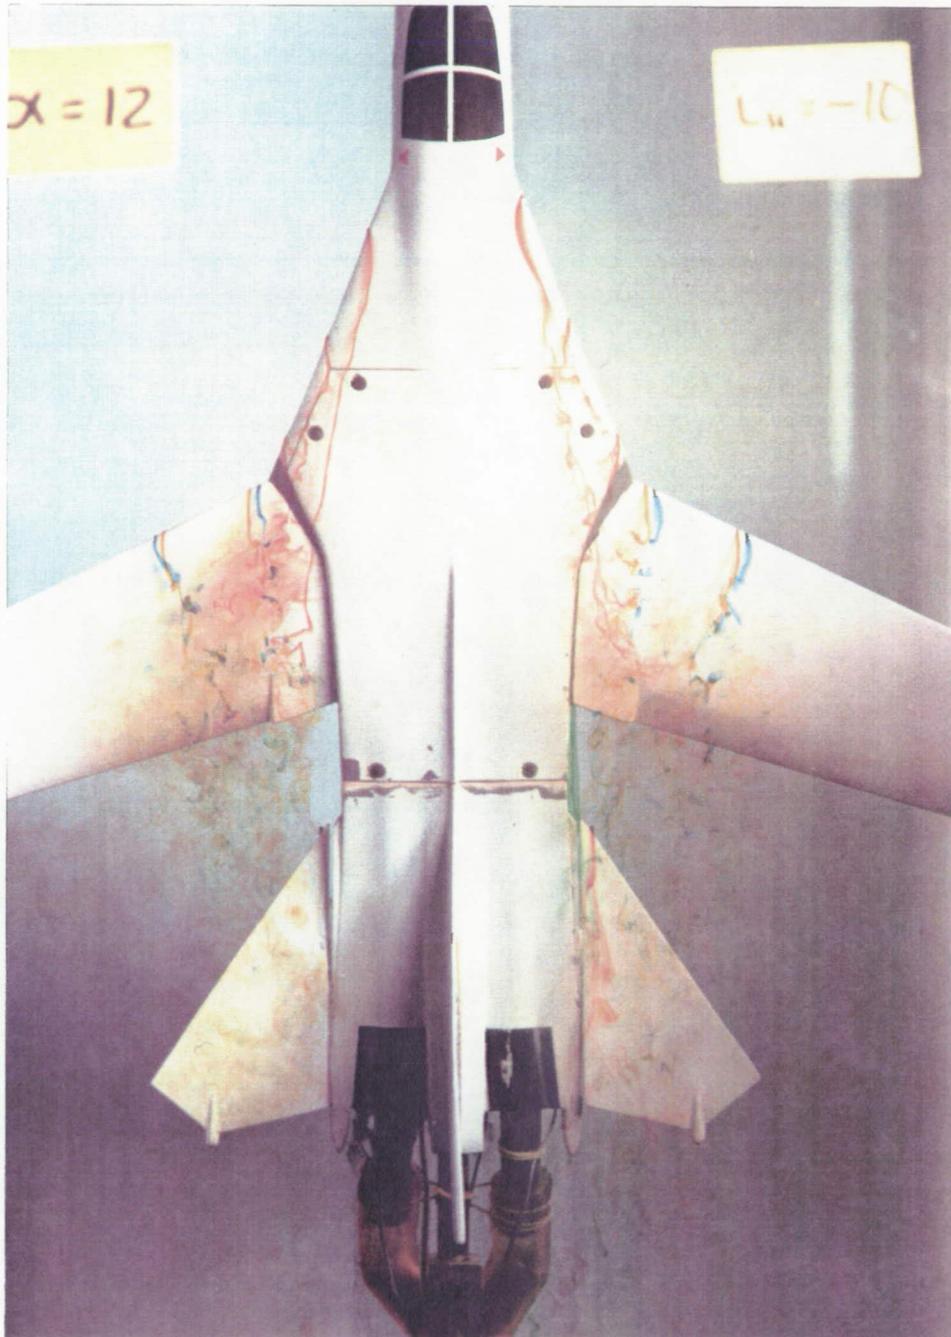
Figures 13 through 15 show the results for the $\delta_{LE/TE} = 0/10$ camber configuration. The behavior of the location of flow separation and glove vortex burst point (figs. 13(a), 14(a), and 15(a)) follow similar trends like those discussed for all the previous cases.
