NASA Technical Memorandum 101698

Flow Visualization Study of a 1/48-Scale AFTI/F111 Model to Investigate Horizontal Tail Flow Disturbances

Lisa J. Bjarke
Ames Research Center, Dryden Flight Research Facility, Edwards, California

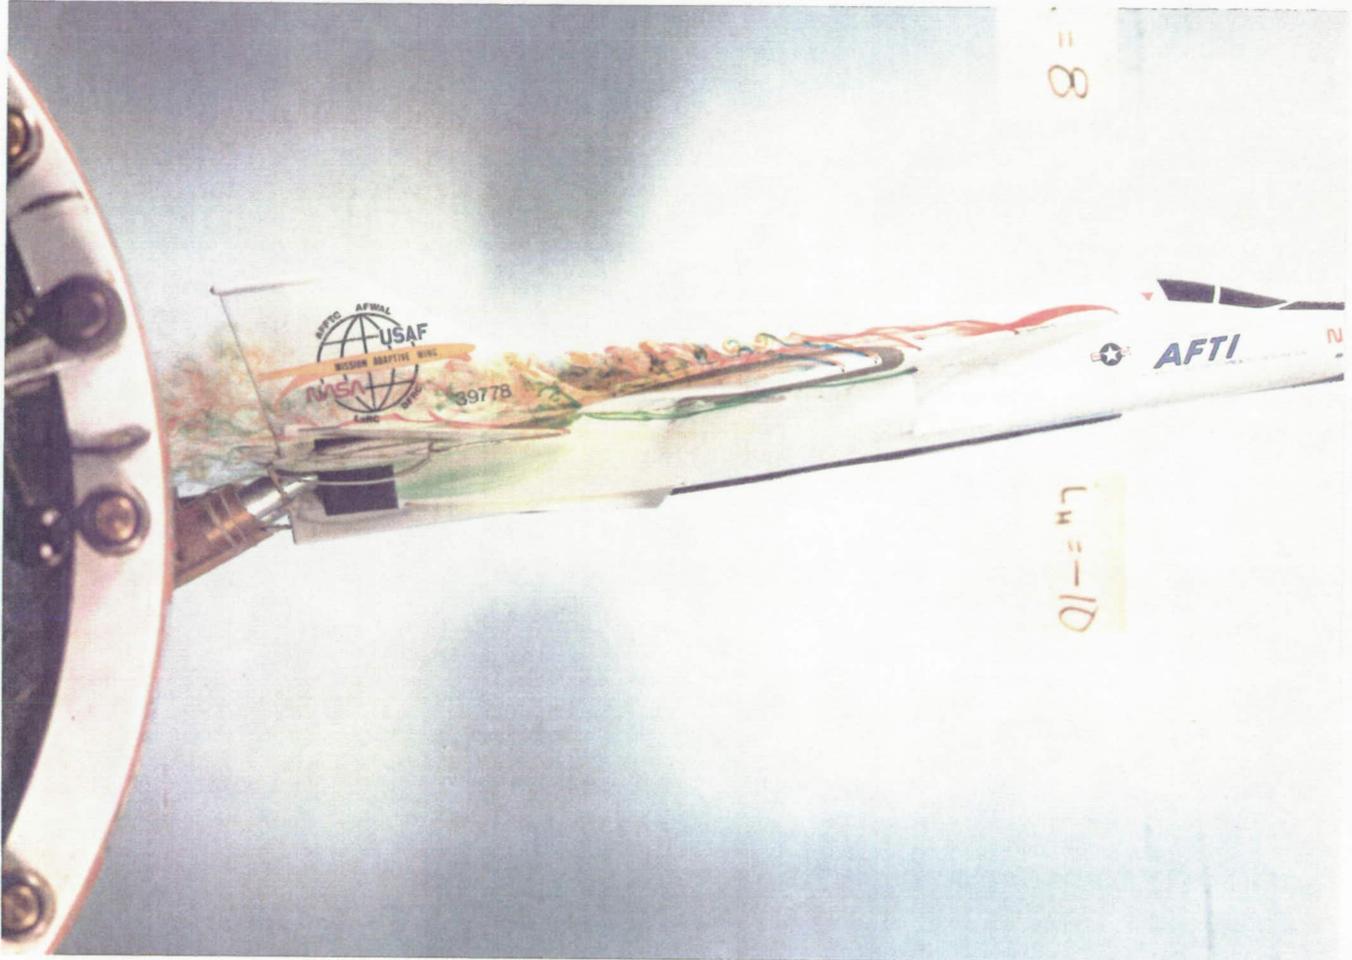
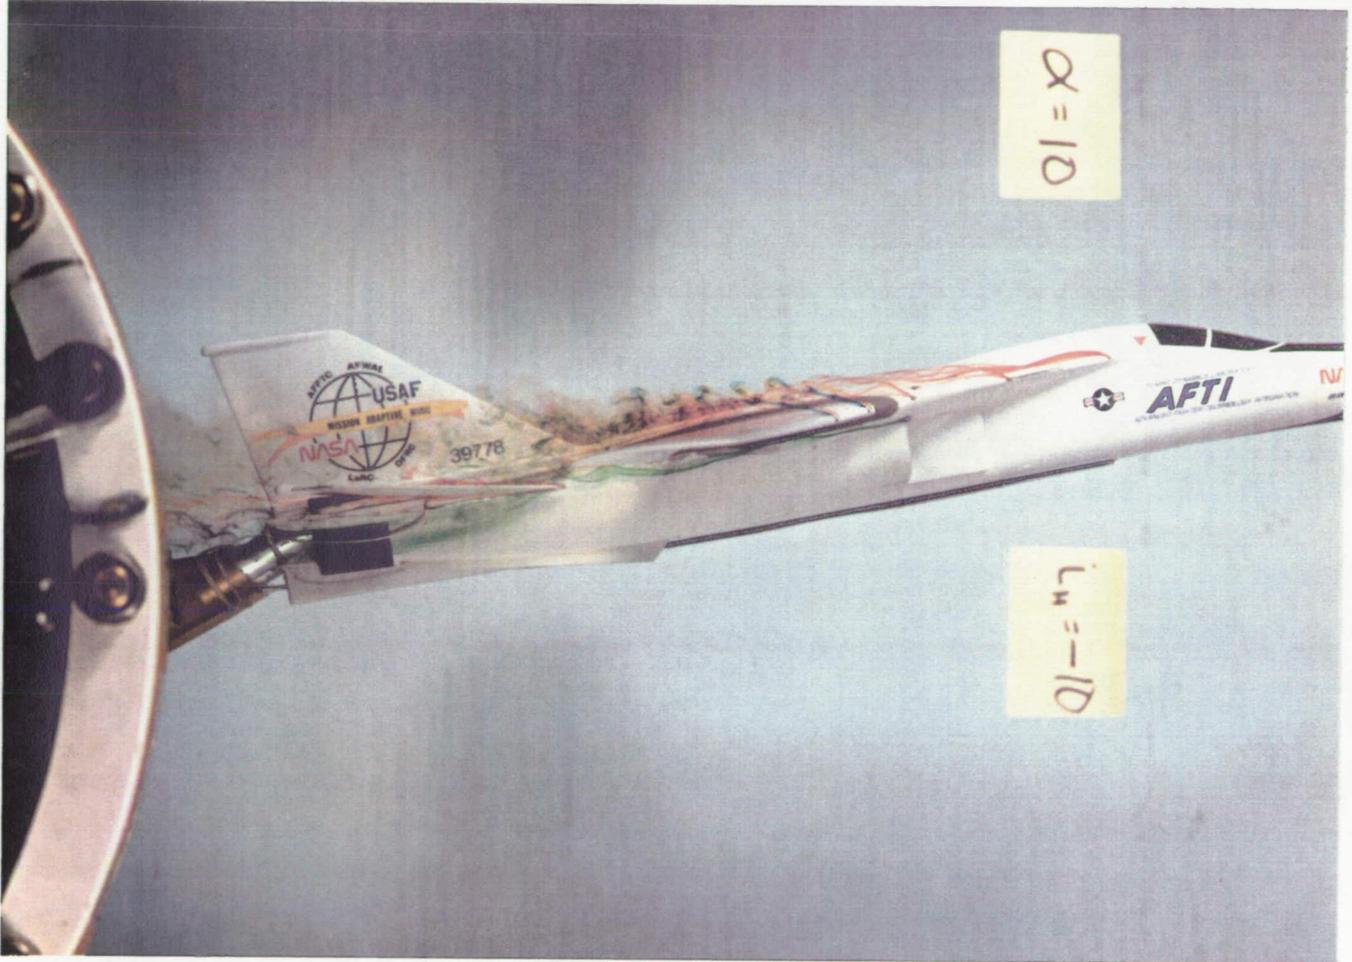
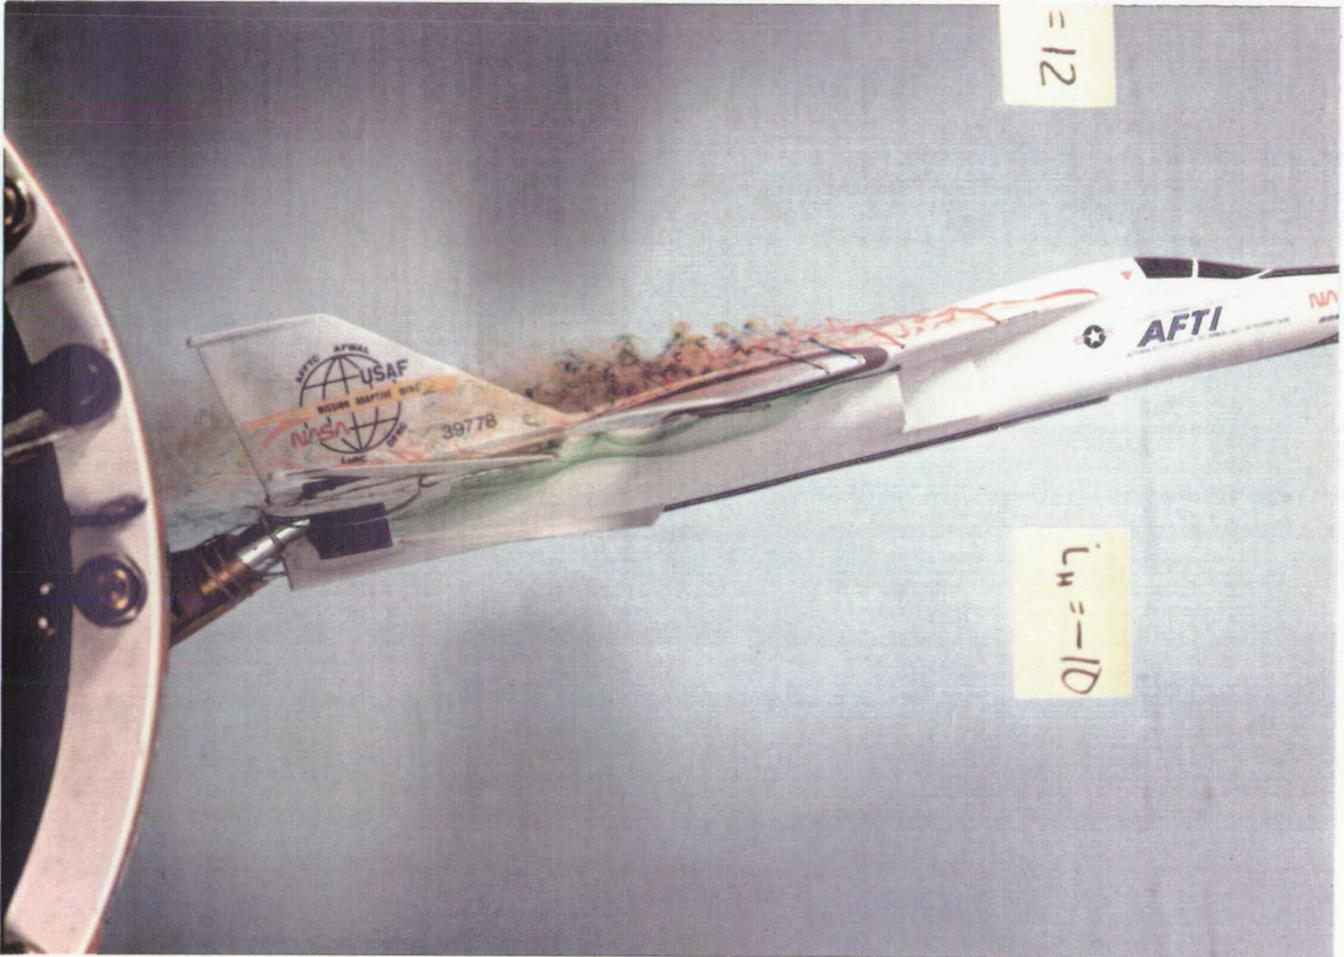
By looking at the side views for this configuration (figs. 13(b), 14(b), and 15(b)), it is noted that the path that the separated and glove vortex flow takes is most similar to that of the $\delta_{LE/TE} = 10/10$ camber configuration (figs. 7(b), 8(b), and 9(b)); that is, a downward turn near the trailing edge causing a more direct interaction with the horizontal tail. The inlet lip vortex also has direct interaction with the horizontal tail, especially at $\alpha = 12^\circ$ (fig. 15(b)).
