Debris/Ice/TPS Assessment And Photographic Analysis For Shuttle Mission STS-37

April 1991

Gregory N. Katnik
NASA/Kennedy Space Center

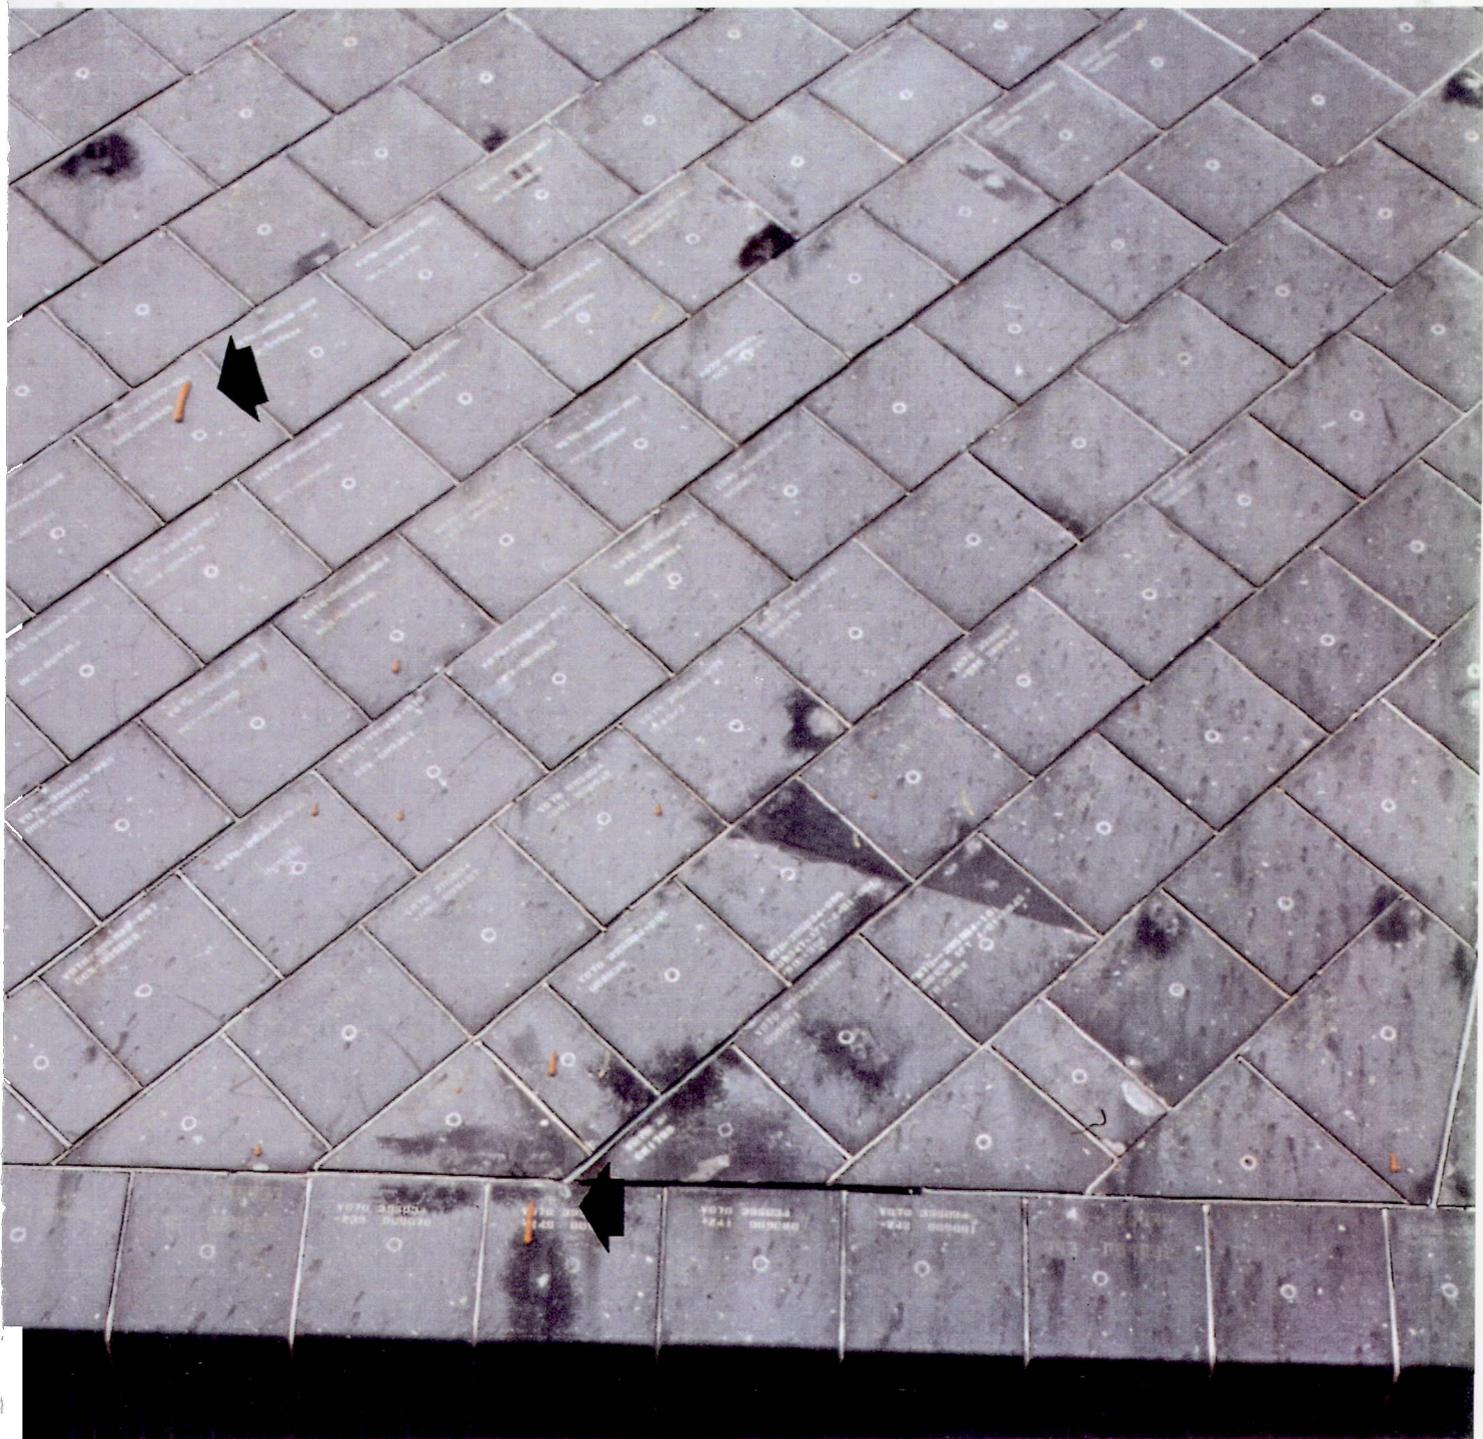
Foam, in the liquid state, dripped from the LH2 ET/ORB umbilical onto body flap tiles during closeout operations

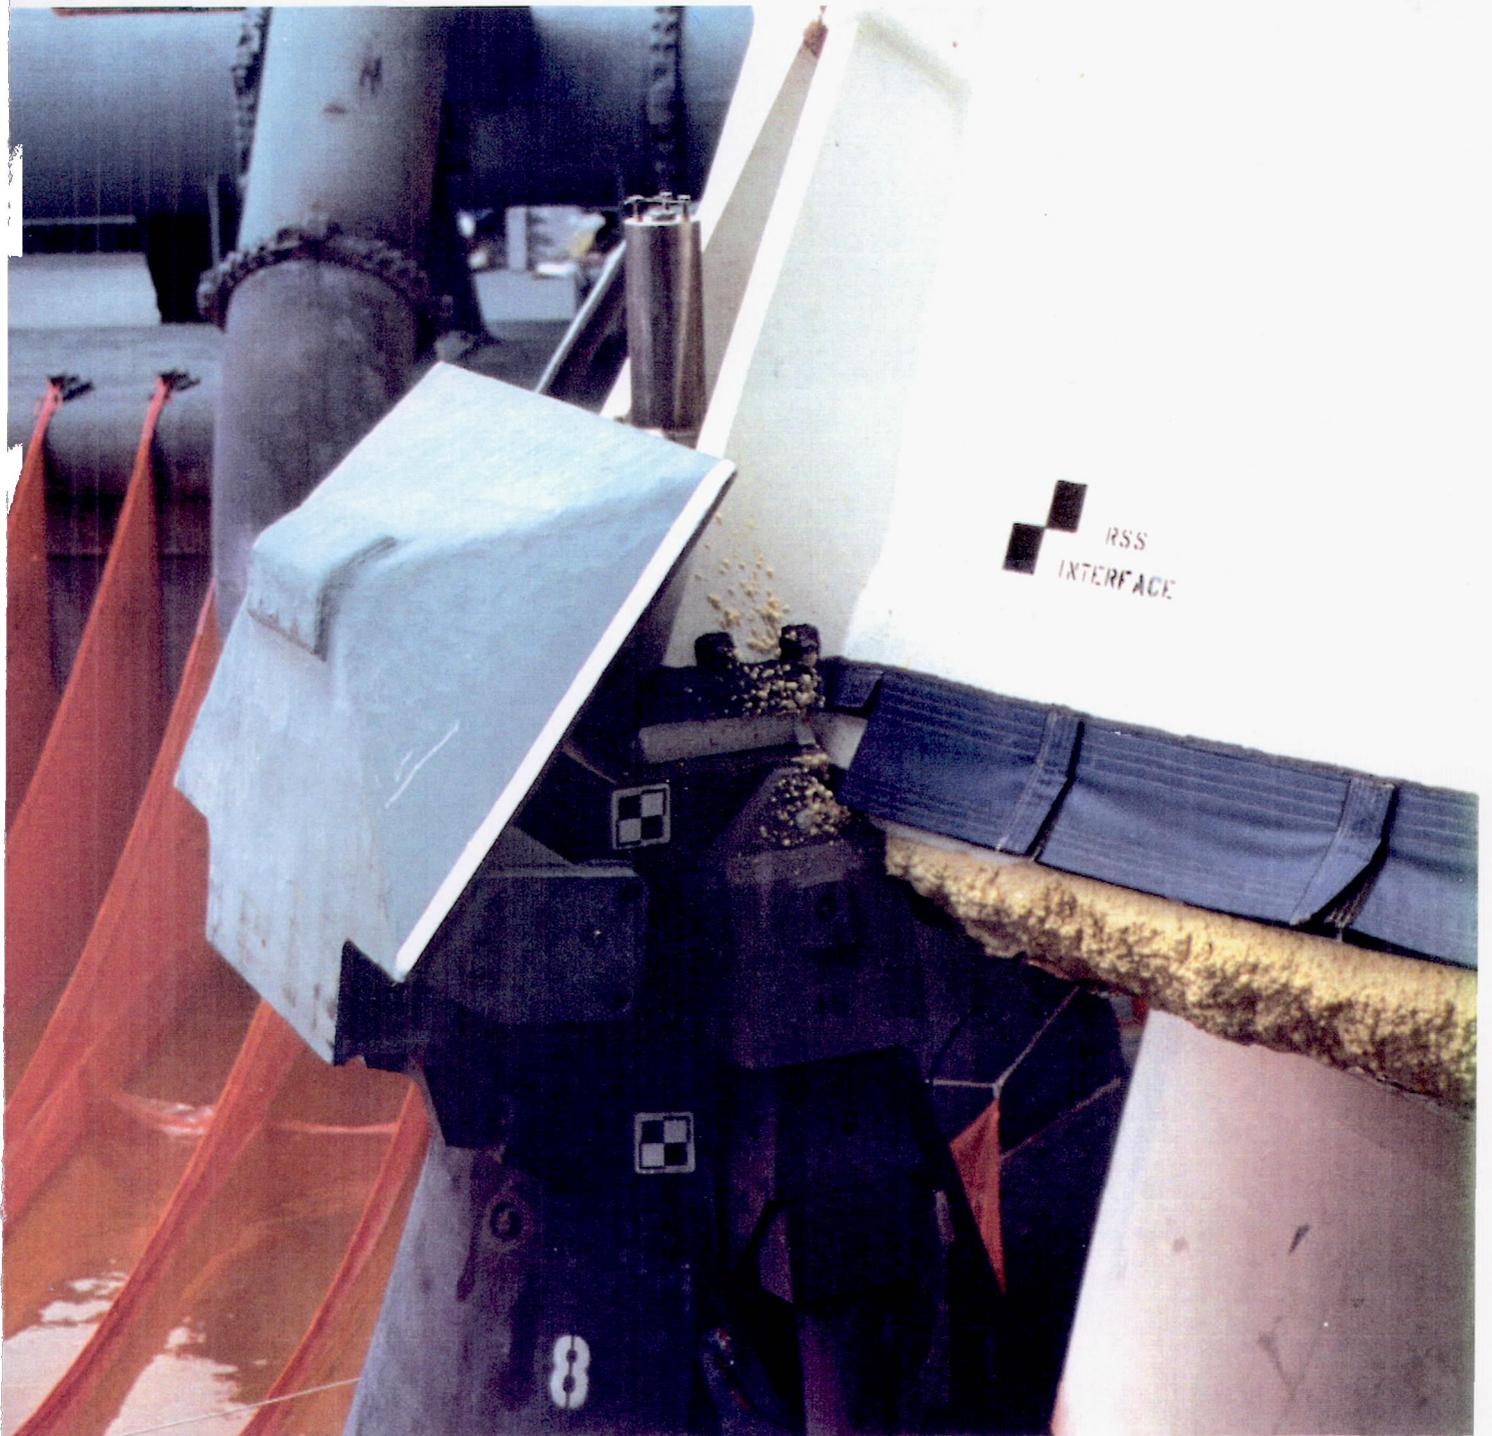
Instafoam overspray adhered to the aft skirt foot and holddown post. Note two optical targets for measuring HDP shoe rotation.

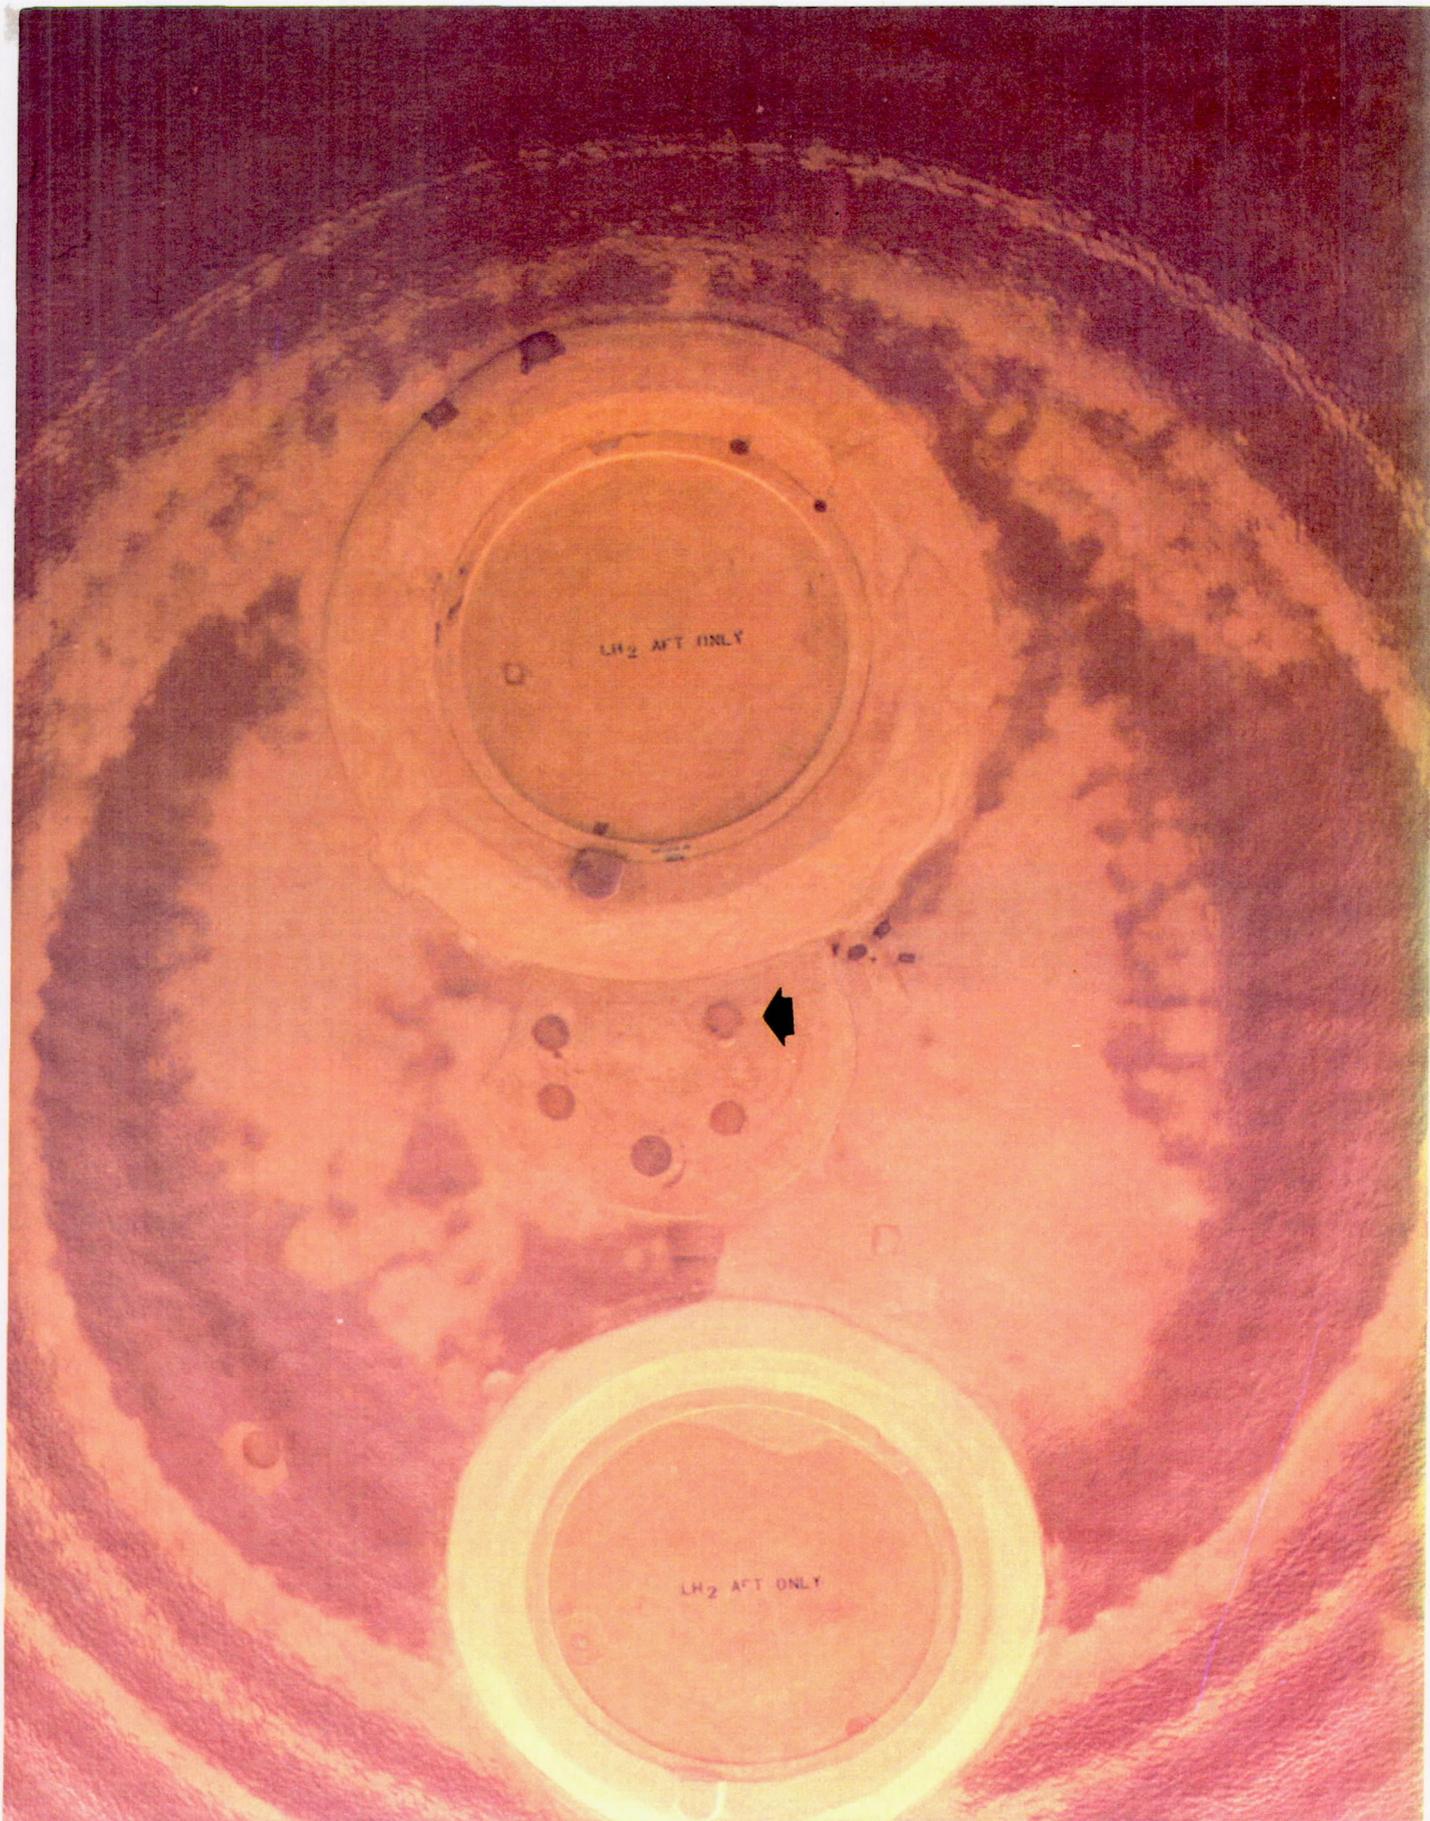
Top right plug repair on the LH2 tank aft dome apex protruded 1/4-inch after the tank was loaded with cryogenic propellant

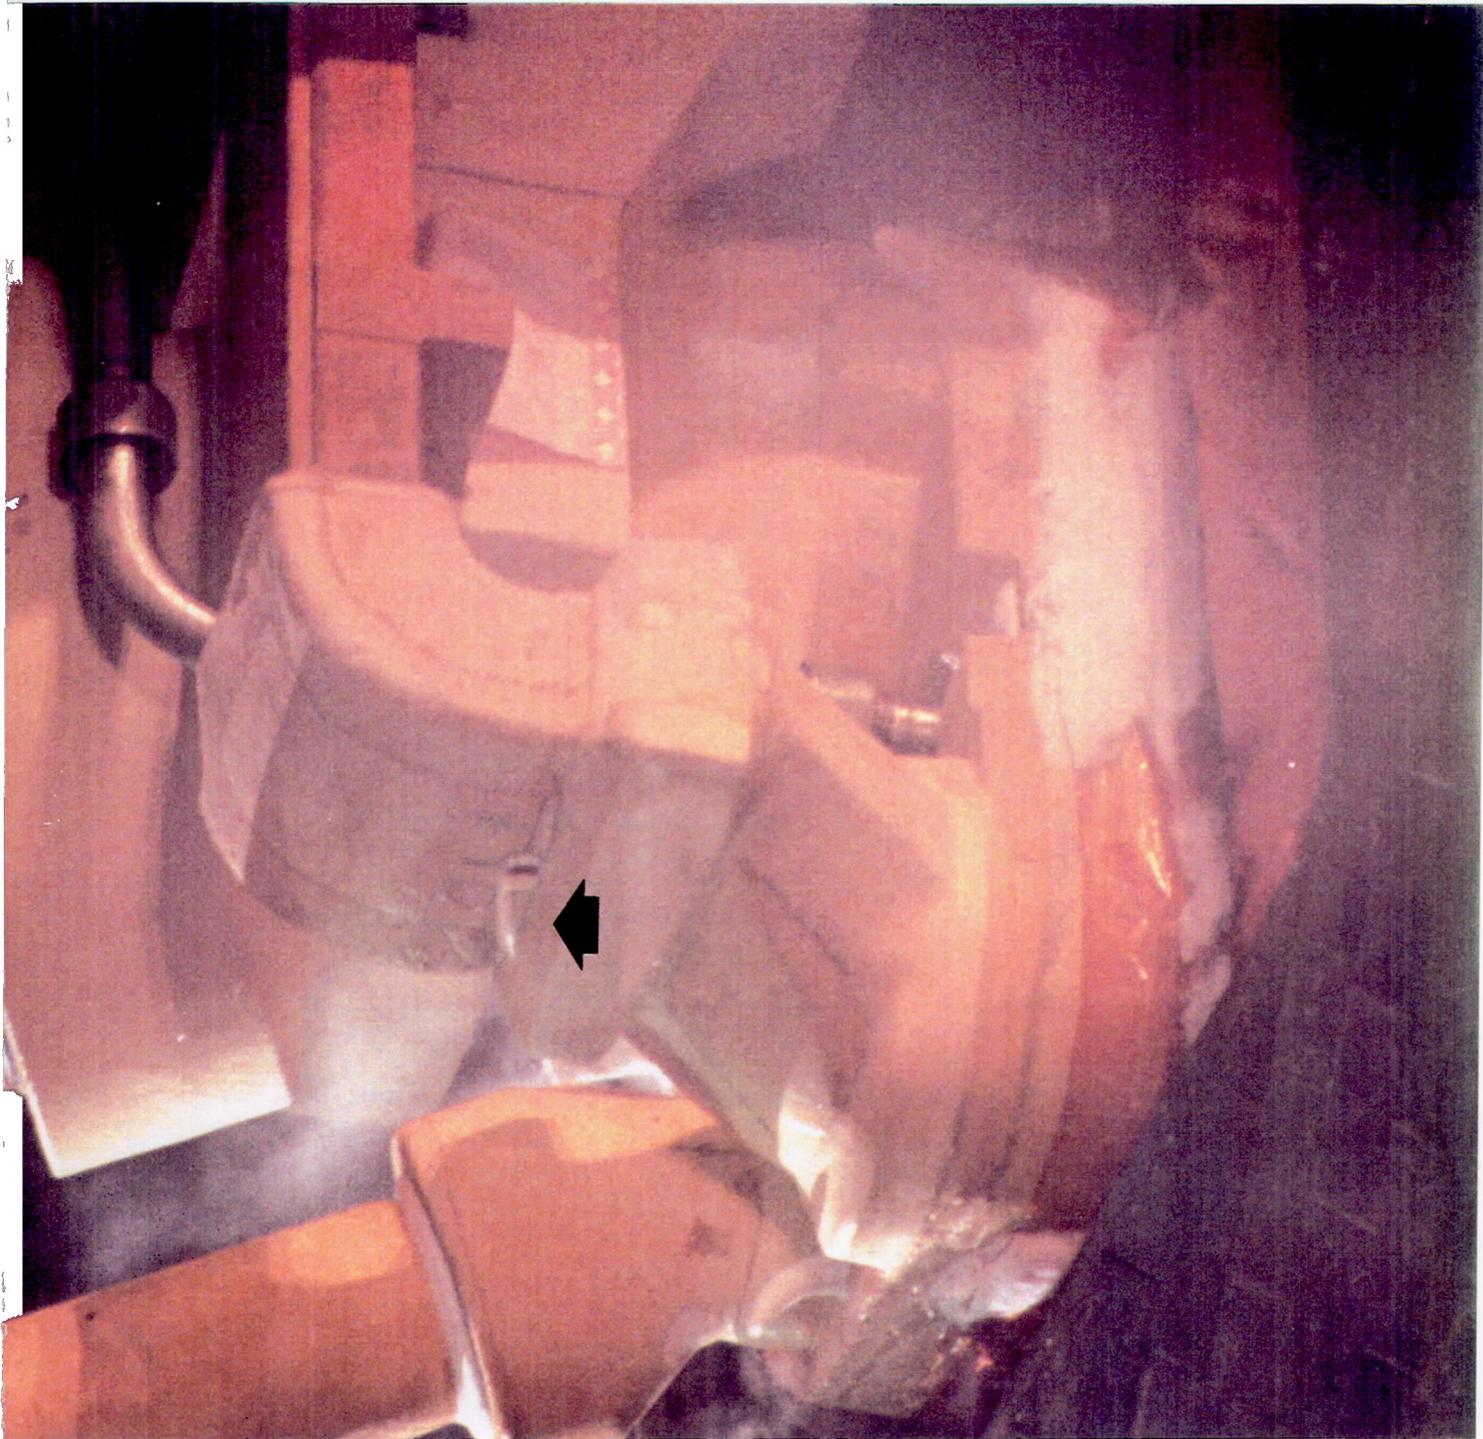
Clear 3"x0.25" icicle had formed on the LH2 umbilical cable tray vent hole due to additional water on the cable tray from recent rainfall. Typical ice/frost had formed on the purge vents and purge barrier. There were no cryogenic drips or unusual vapors during cryogenic loading, stable replenish, and launch.

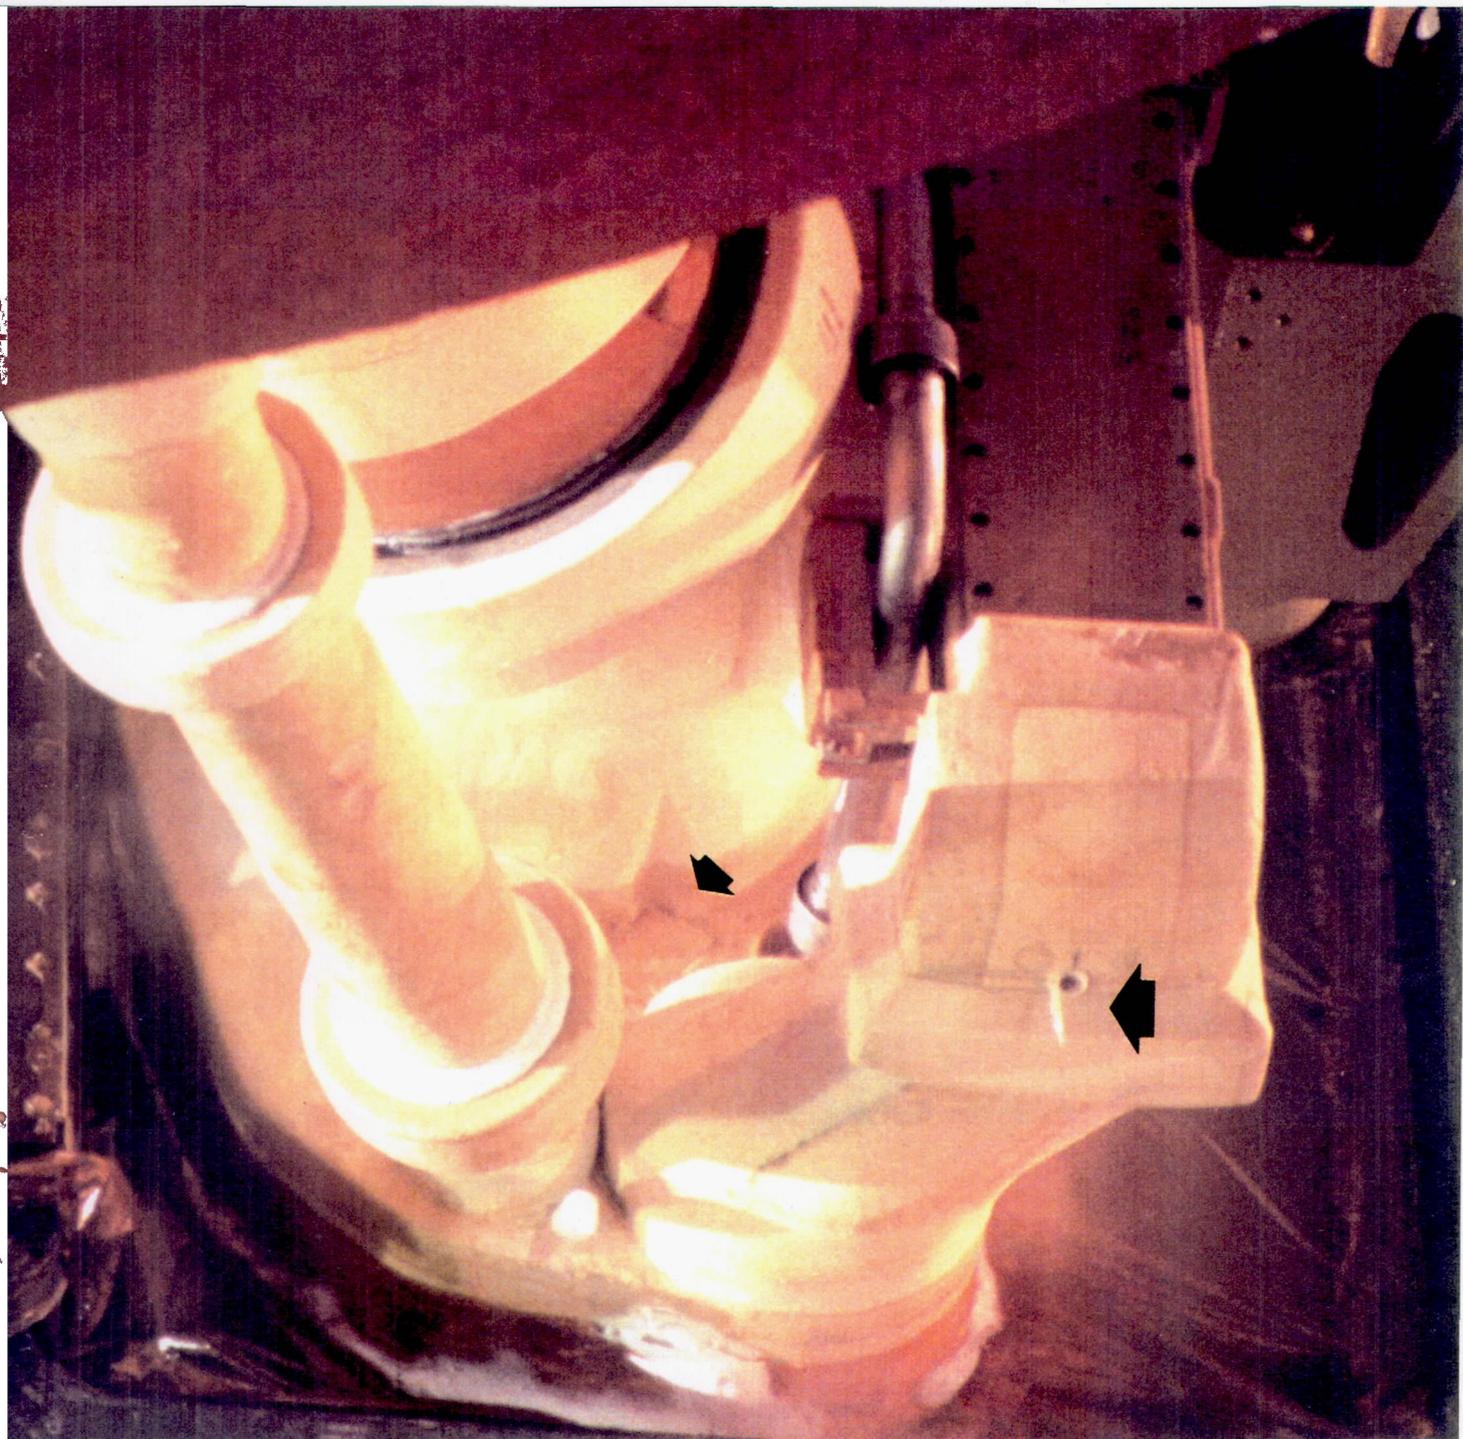
Ice/frost had accumulated in the LH2 recirculation line upper and lower bellows, but only condensate was present in the LH2 feedline bellows. Clear 3"x0.25" icicle had formed on the LH2 umbilical cable tray vent hole due to additional water on the cable tray from recent rainfall. No ice/frost was present on the bondline of the 17-inch flapper valve actuator access port TPS plug closeout.

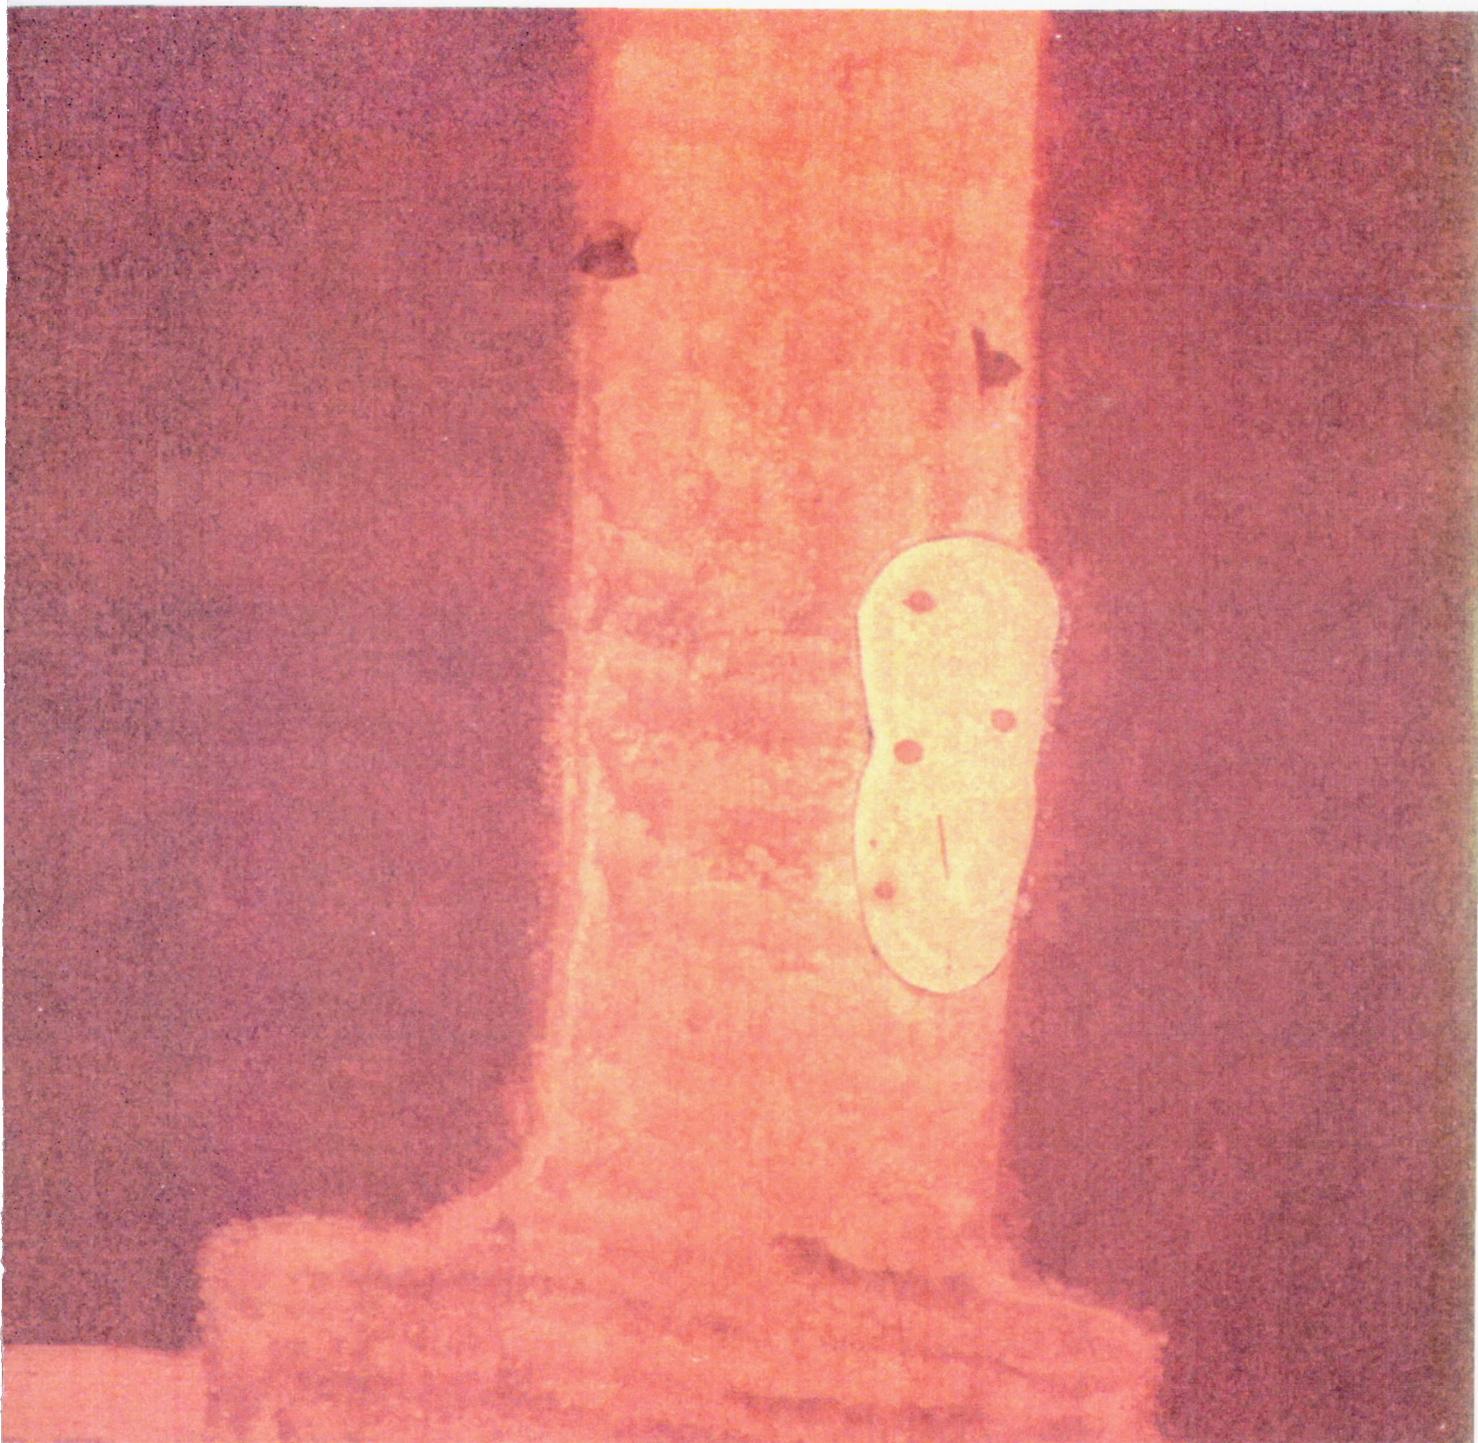
ET aft hard point closeout, part of which had debonded during the previous cryogenic loading, was intact. No ice/frost had formed on the bondline of the repair area.

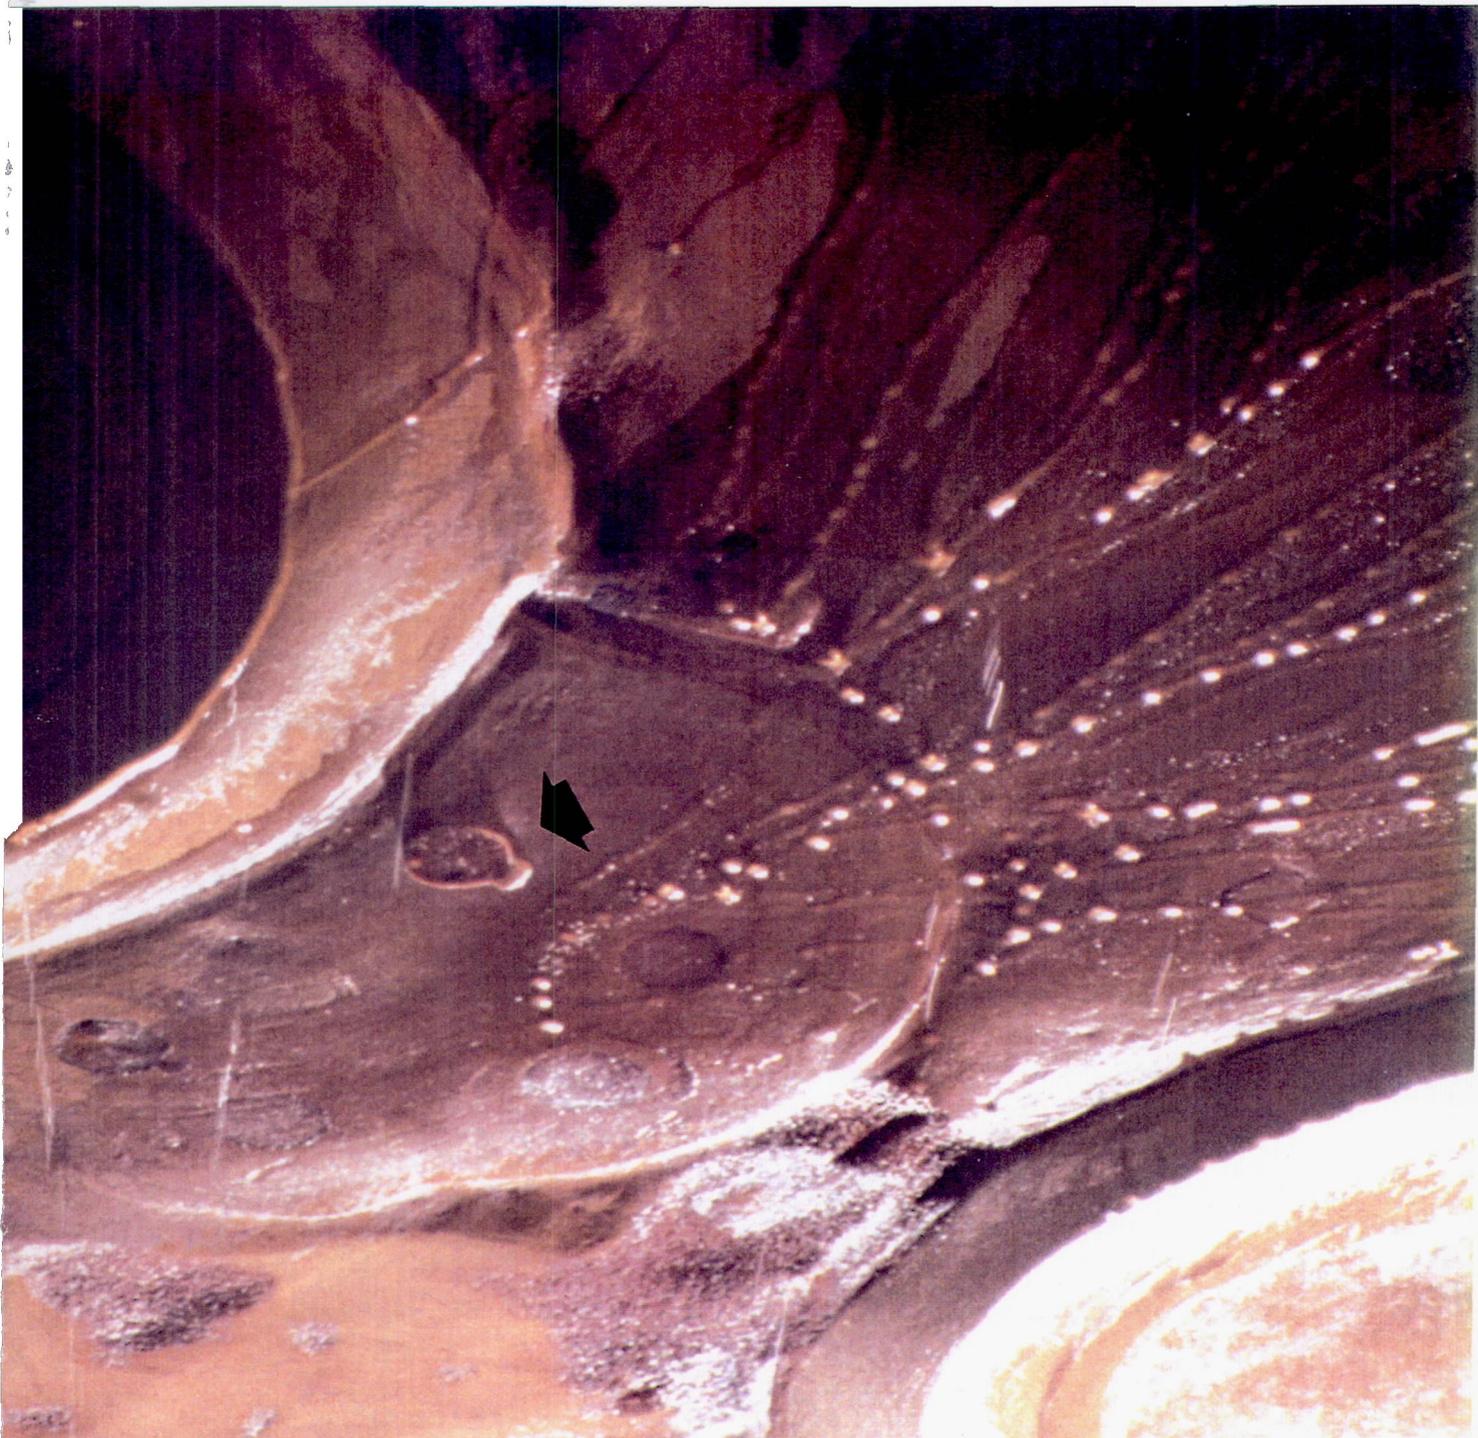
ET LH2 tank aft dome was wet from rain runoff. Plug pull repair on the apex protruded 1/4-inch.

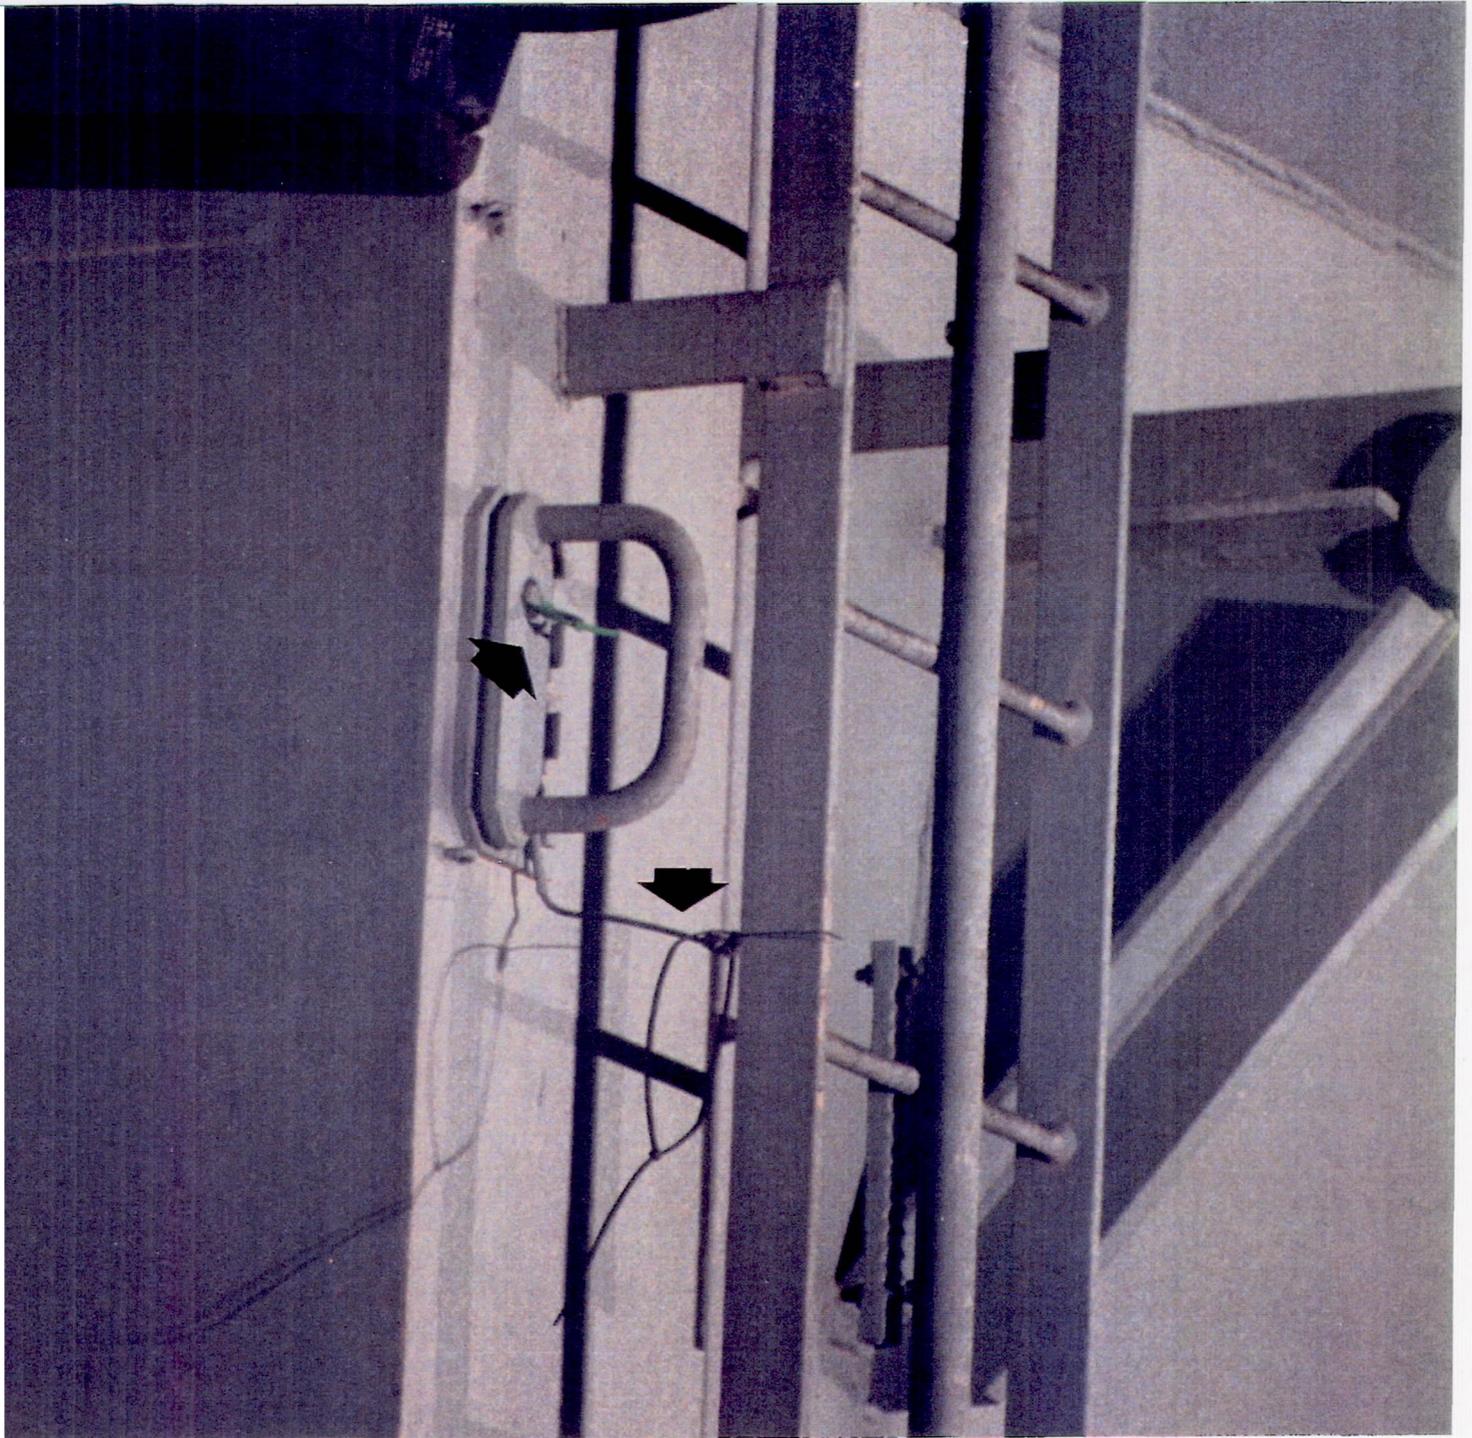
The vehicle was cryoloaded for flight on 5 April 1991. There were no Launch Commit Criteria, OMRS, or NSTS-08303 violations. A facility IPR was taken against tie-wraps attached to the LO2 TSM near the Orbiter RH aft RCS stinger. (The tie-wraps remained attached to the TSM during launch). There were no ET anomalies. The ET TPS was wet from rainfall, but there was no ice/frost on the acreage. Seven Ice/Frost console observation anomalies were documented and found acceptable for launch per the LCC and NSTS-08303. The LH2 umbilical leak sensor detected no significant hydrogen during the cryo load. At launch, the ET ice condition was well within the data base for ice formation.

Three tie-wraps, 2 black and 1 green, were attached to L02 TSM platform pin tethers. The tie-wraps remained in place through liftoff and caused no damage to flight hardware.

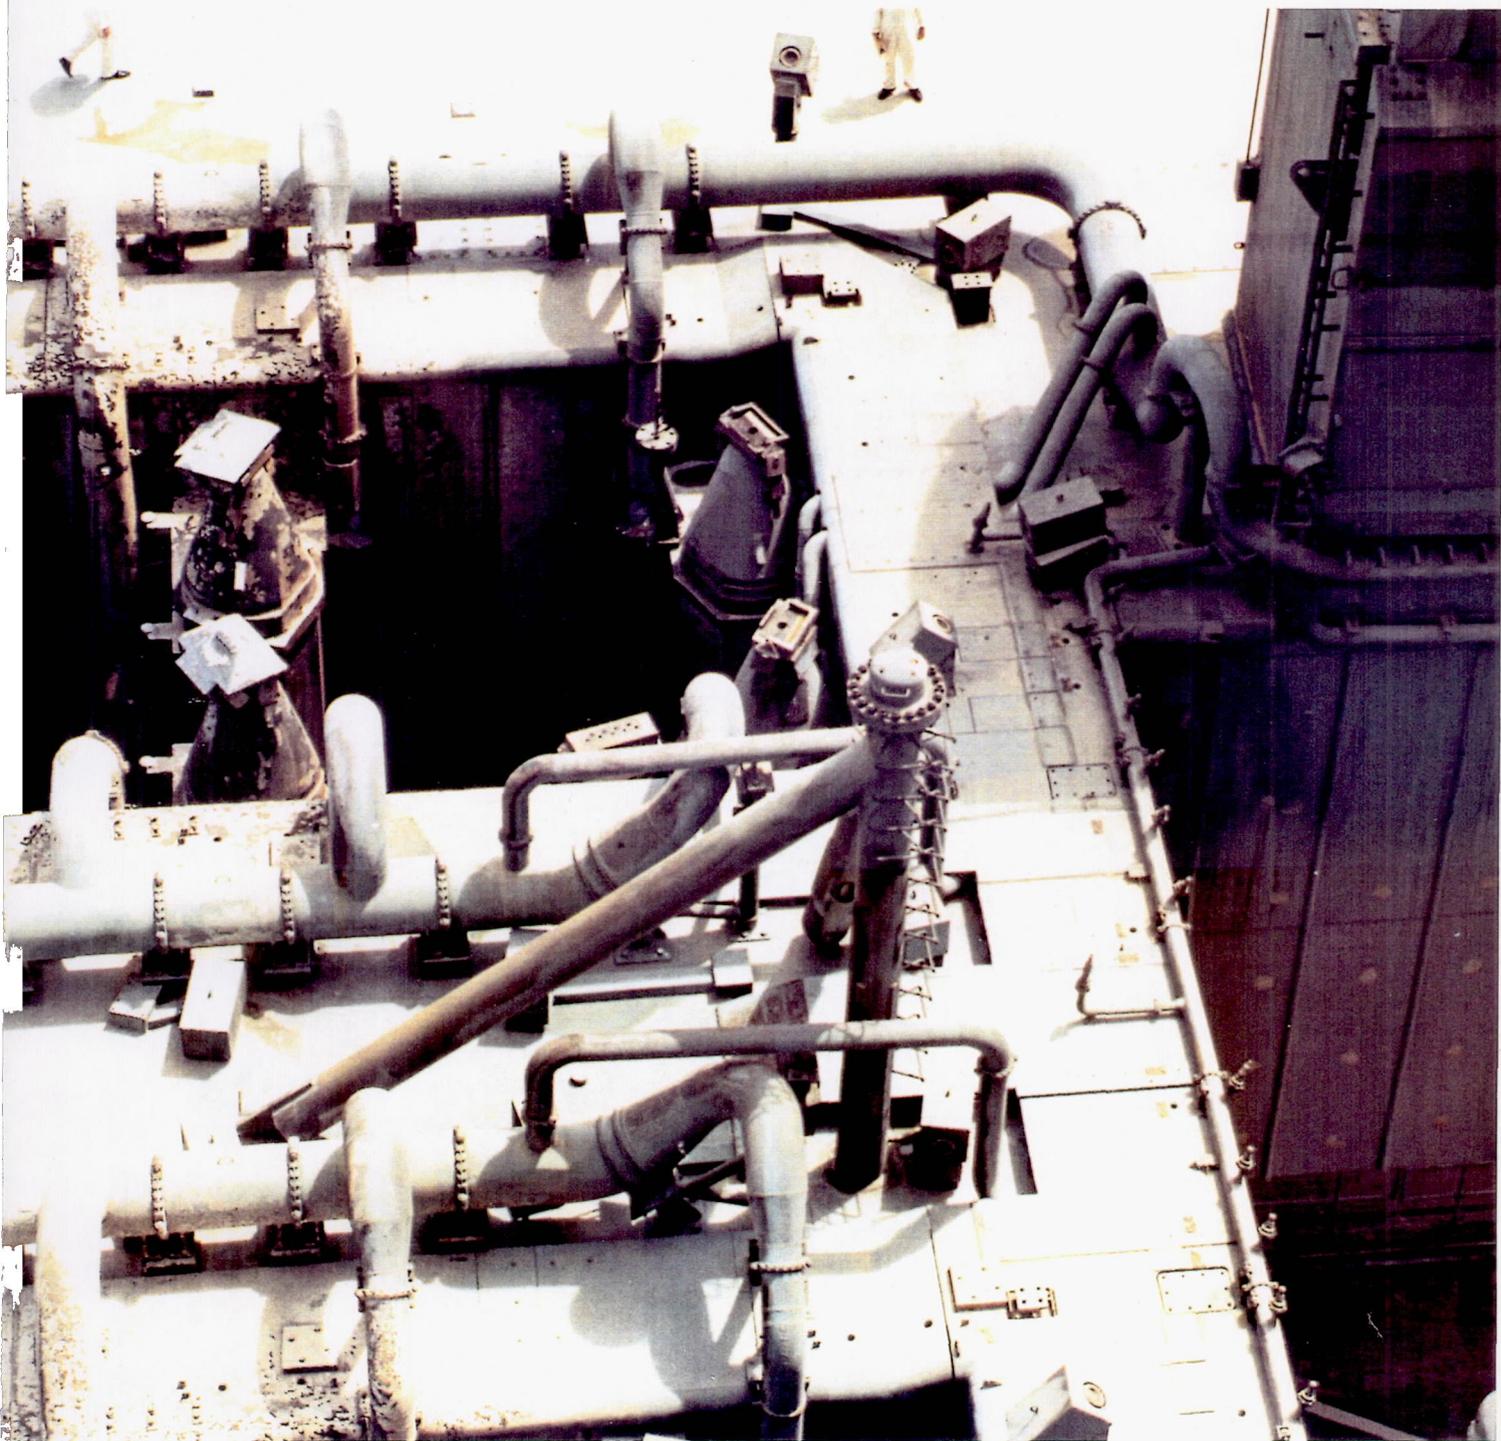
Post launch condition of MLP-1. The new hydrogen dispersal system sustained only minor damage from plume impingement.

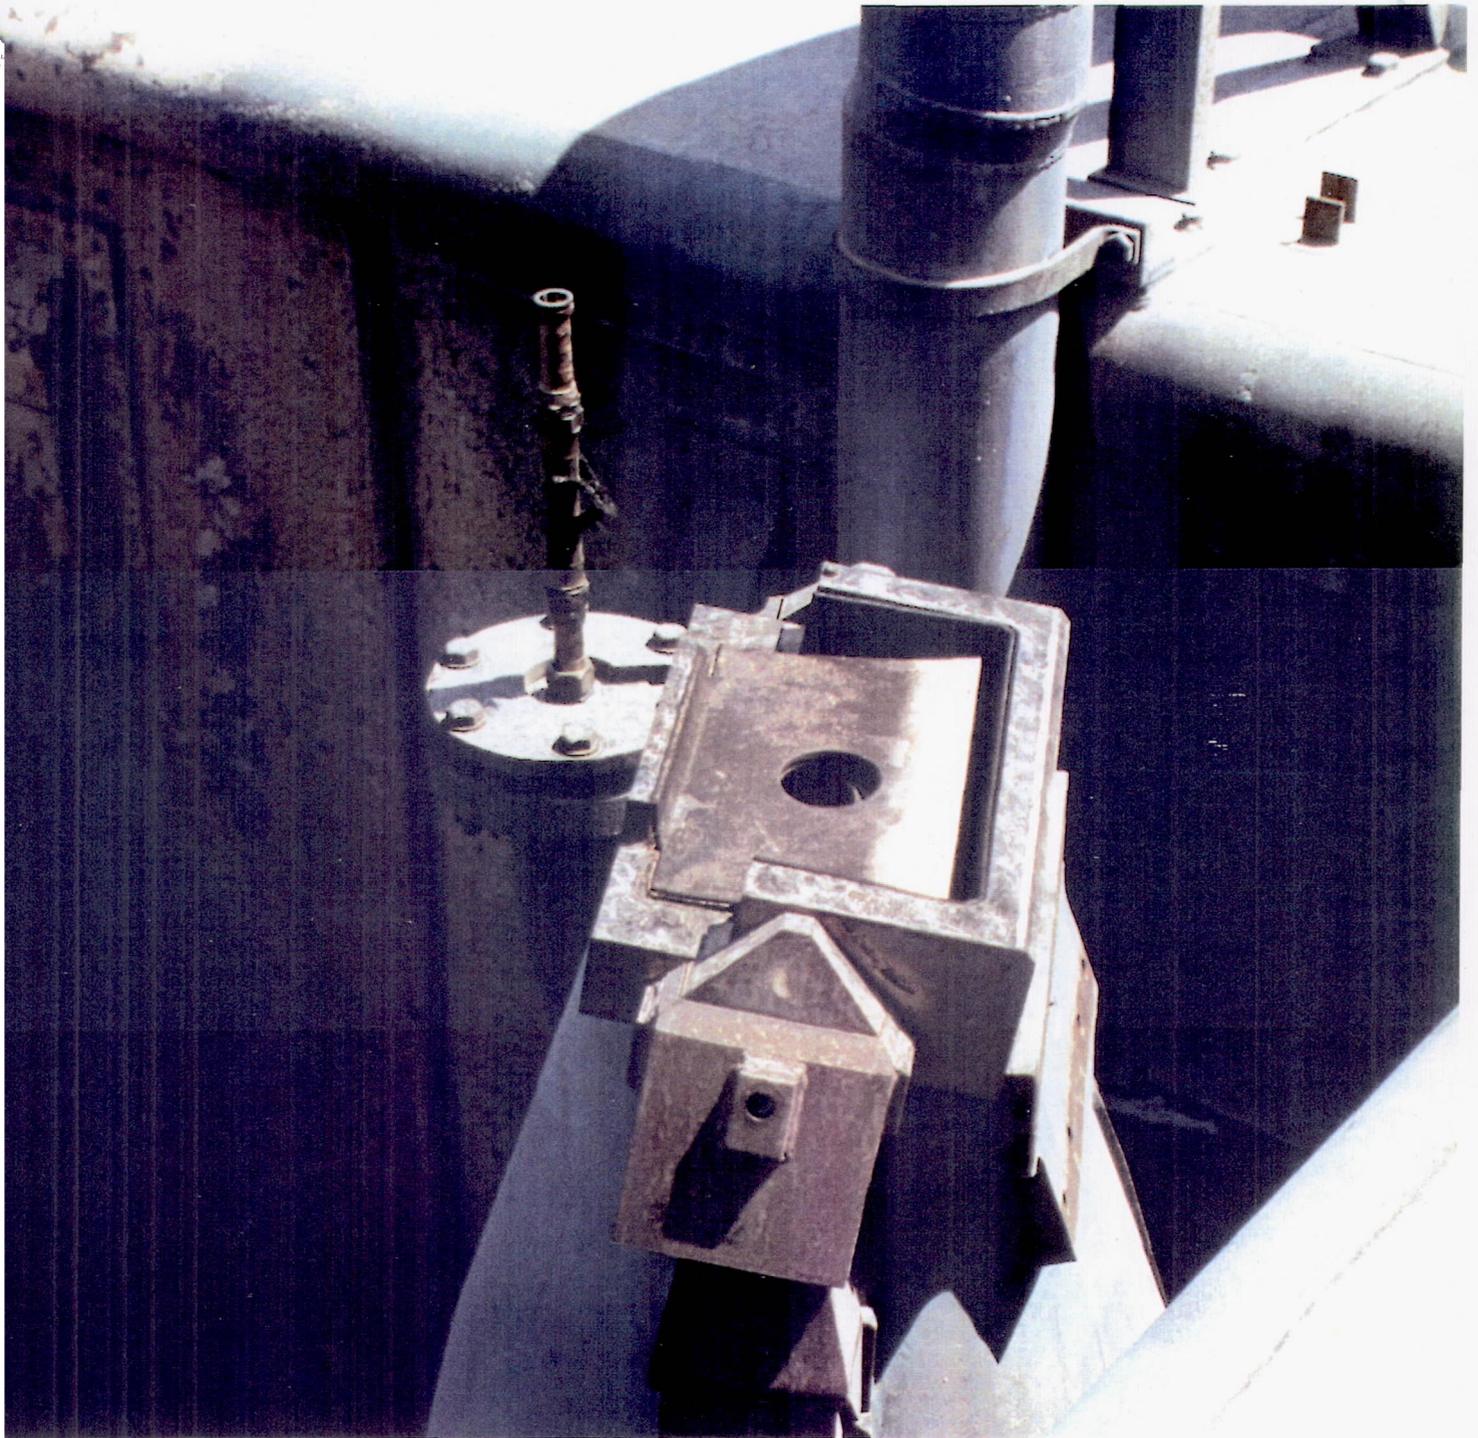
EPON shim material on the south holddown posts was intact
but debonded to various degrees
