Debris/Ice/TPS Assessment And Photographic Analysis For Shuttle Mission STS-37

April 1991

Gregory N. Katnik
NASA/Kennedy Space Center

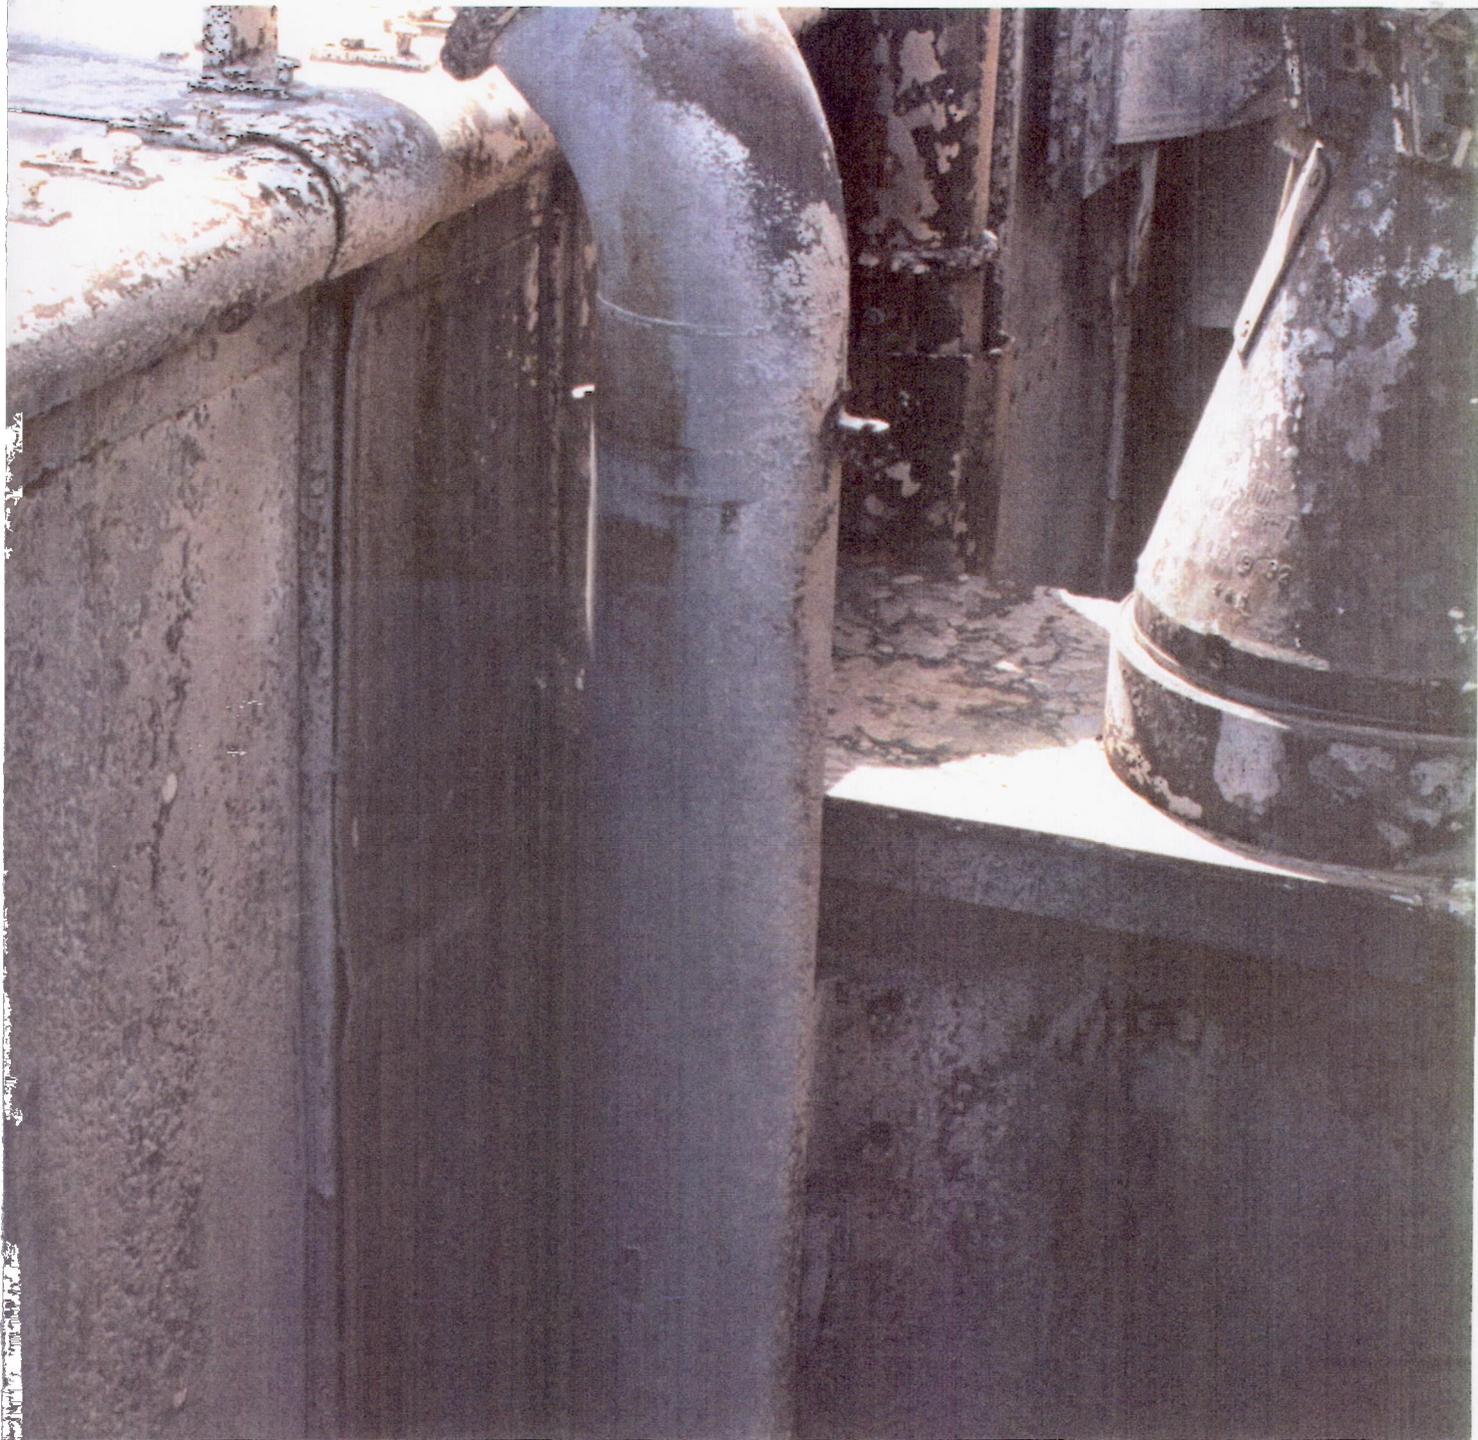
SRB exhaust hole sacrificial plates had buckled in 2 places

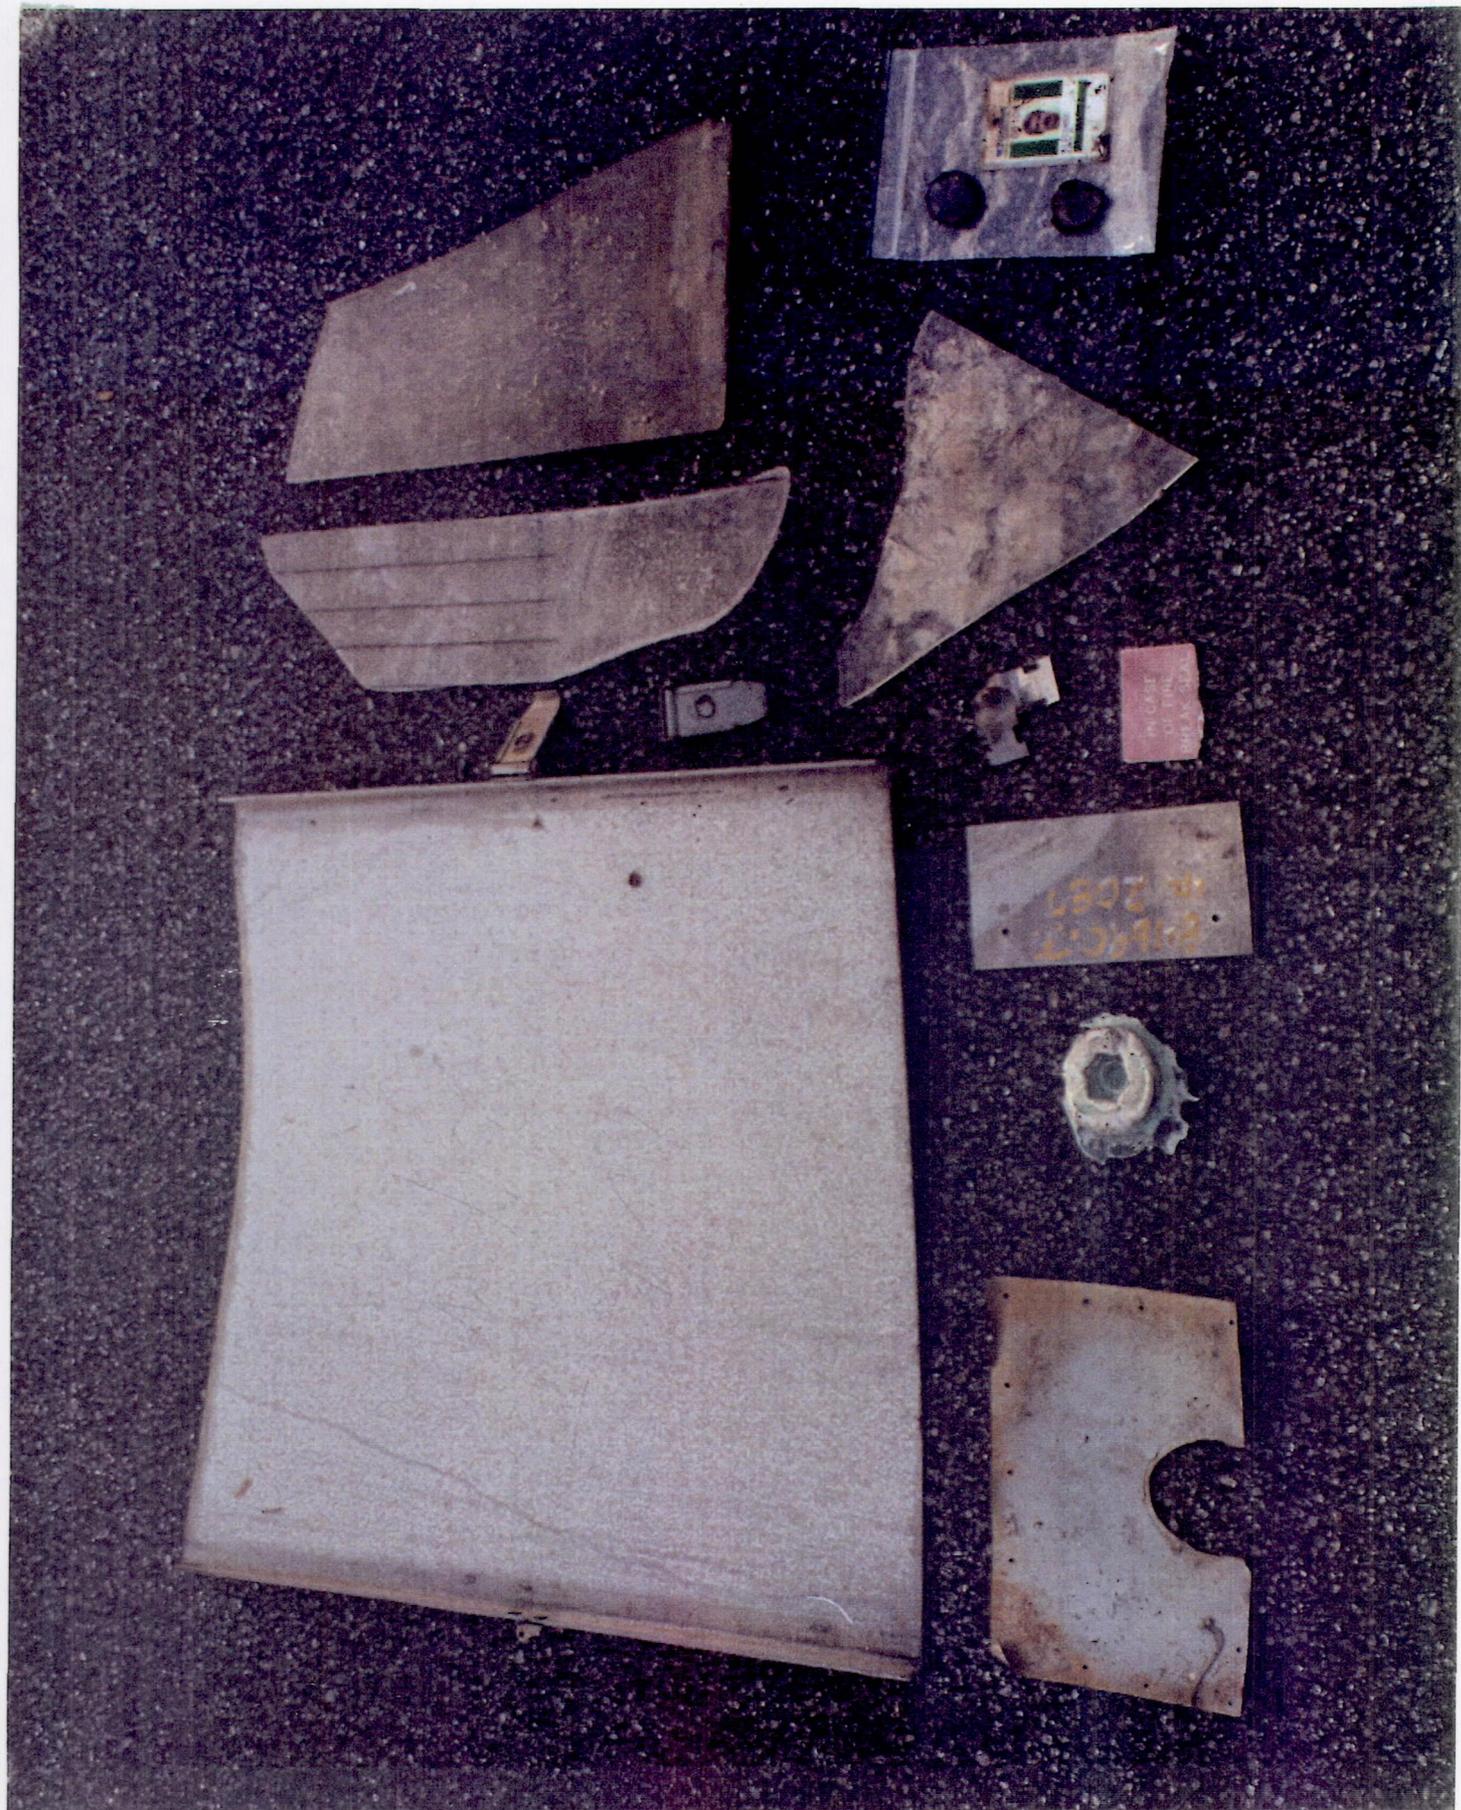
A cable tray cover was loose on the RSS 207 foot level adjacent to the FSS crossover. An adjacent cable tray cover exhibited loose flanges due to broken spot welds.

Typical post launch pad debris included a cable tray cover and pieces of glass from the GOX vent hood

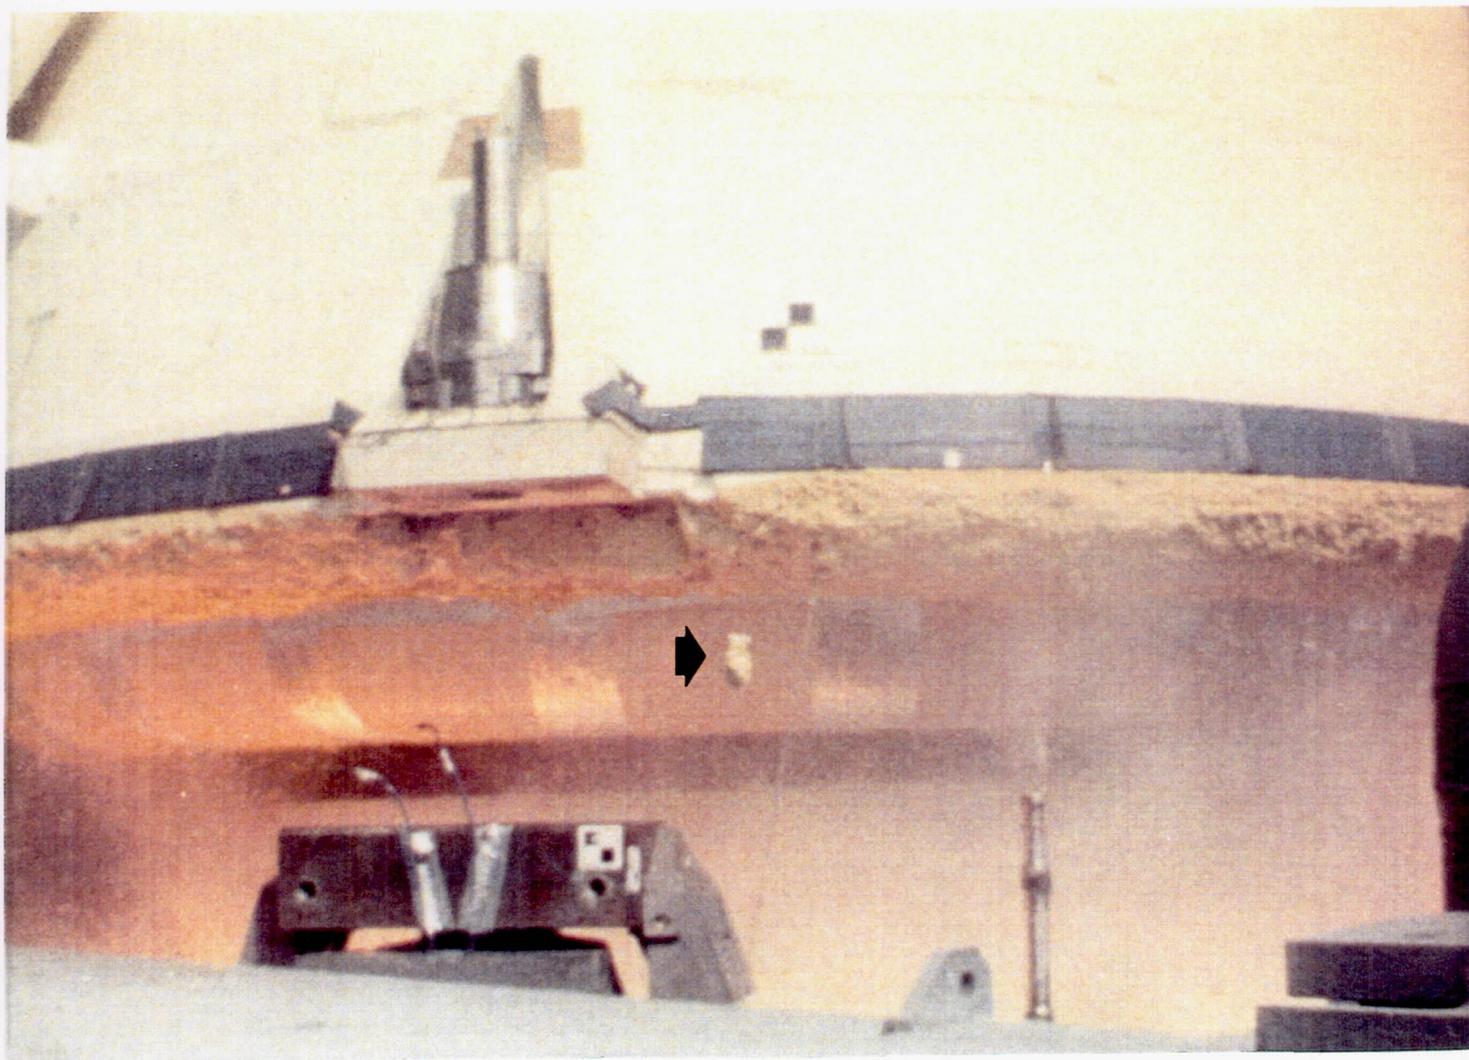
Piece of RH SRB aft skirt instafoam, which originated near the GN2 purge line, broke loose shortly after liftoff. Range Safety System (RSS) GSE coax cable attached to aft skirt has not yet separated.

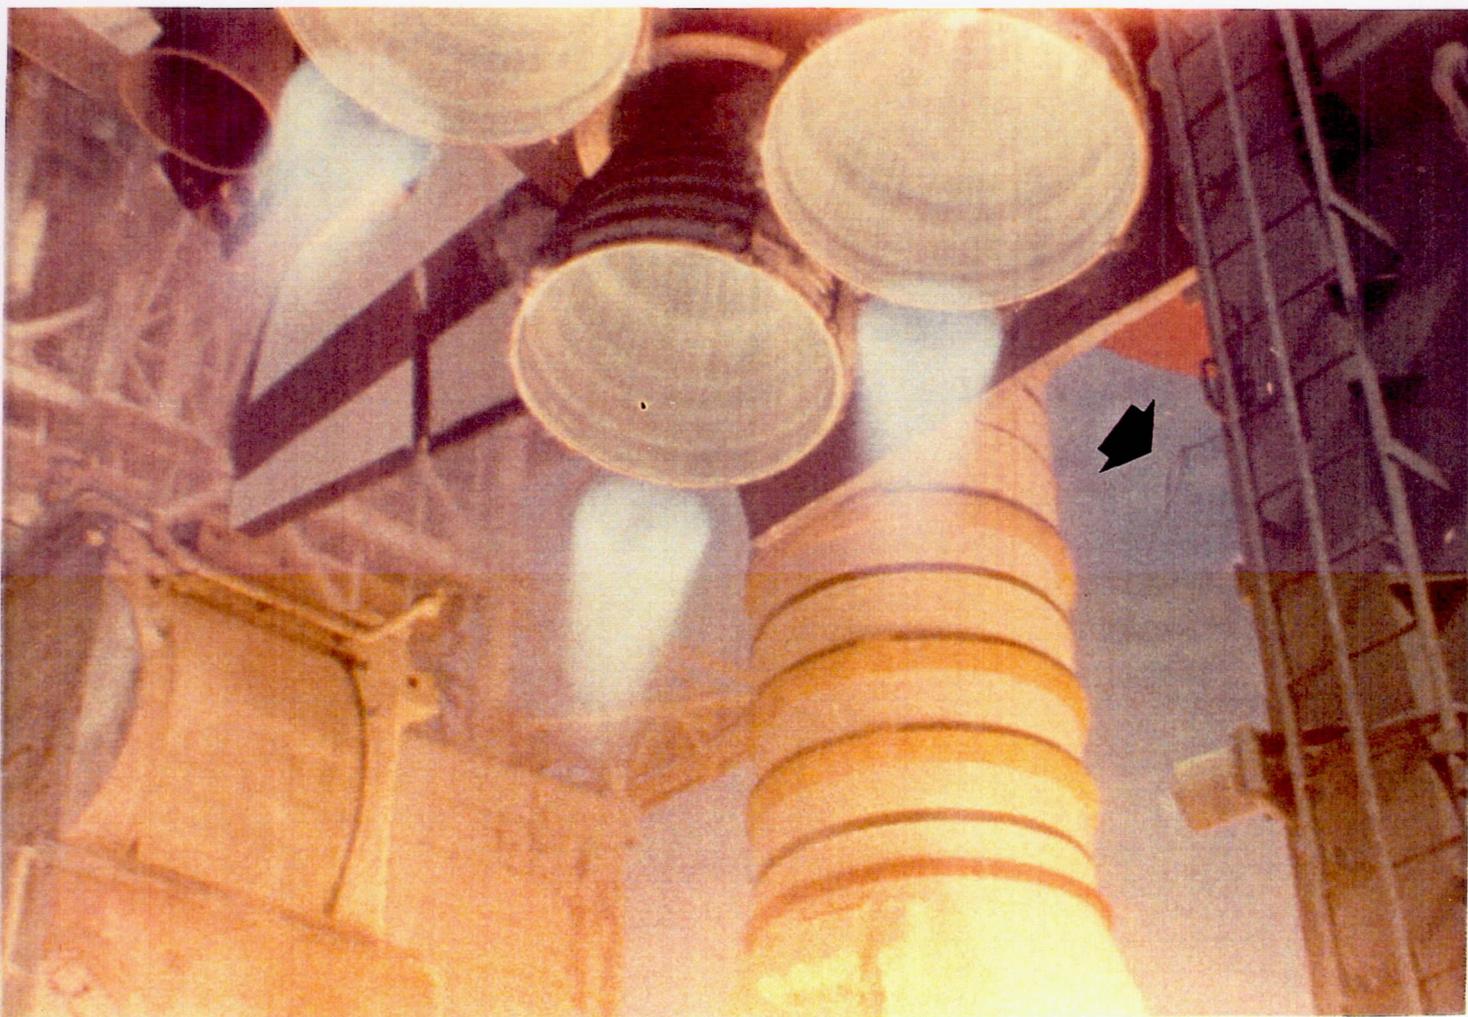
Black tie-wraps, which were attached to a L02 TSM platform pin tether, remained in place through liftoff and caused no damage to flight hardware.

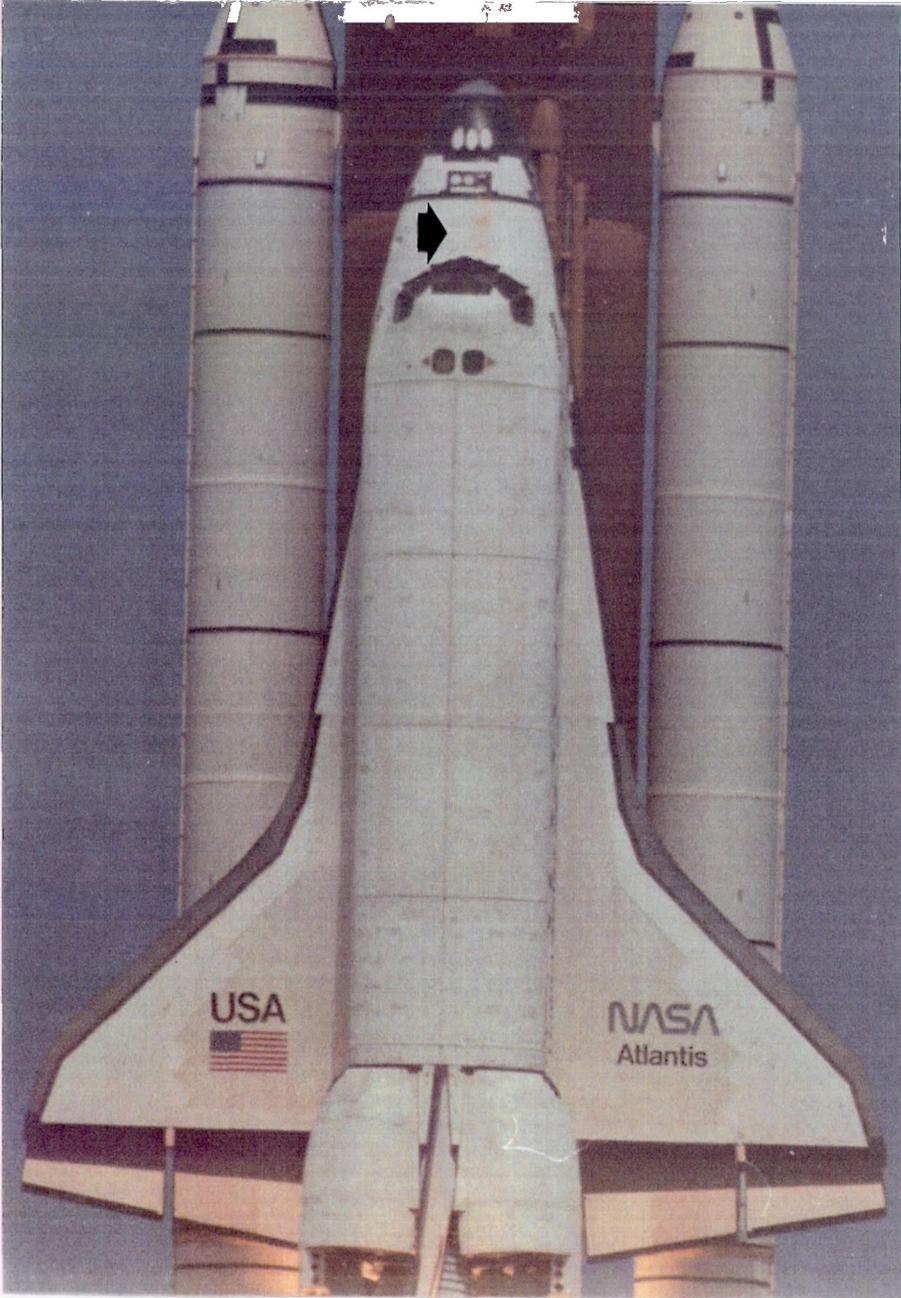
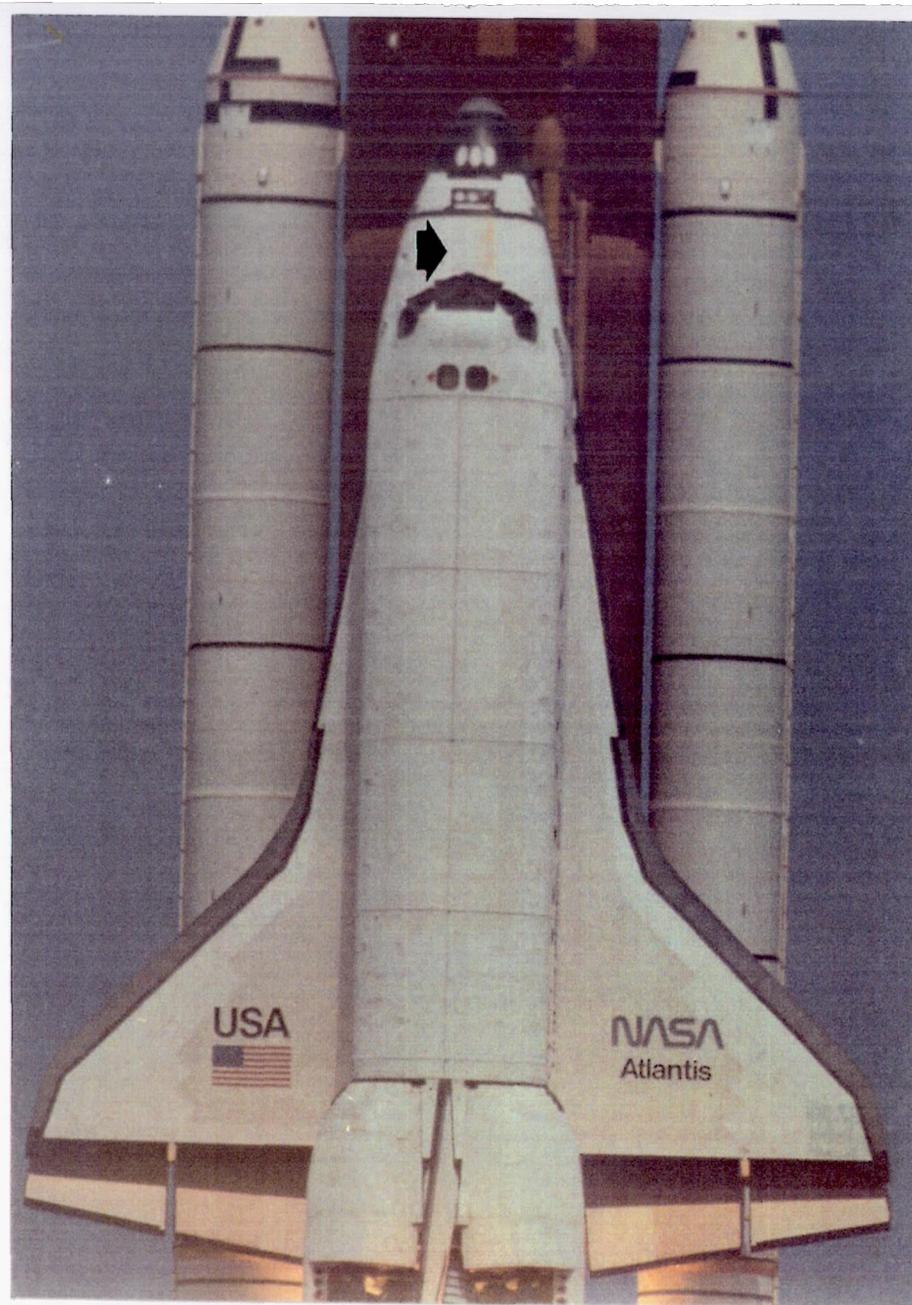
Just after initiation of the roll maneuver, the F2U FWD RCS paper cover detached from the thruster and released a puff of oxidizer vapor. This thruster had been leaking slightly during ground operations.

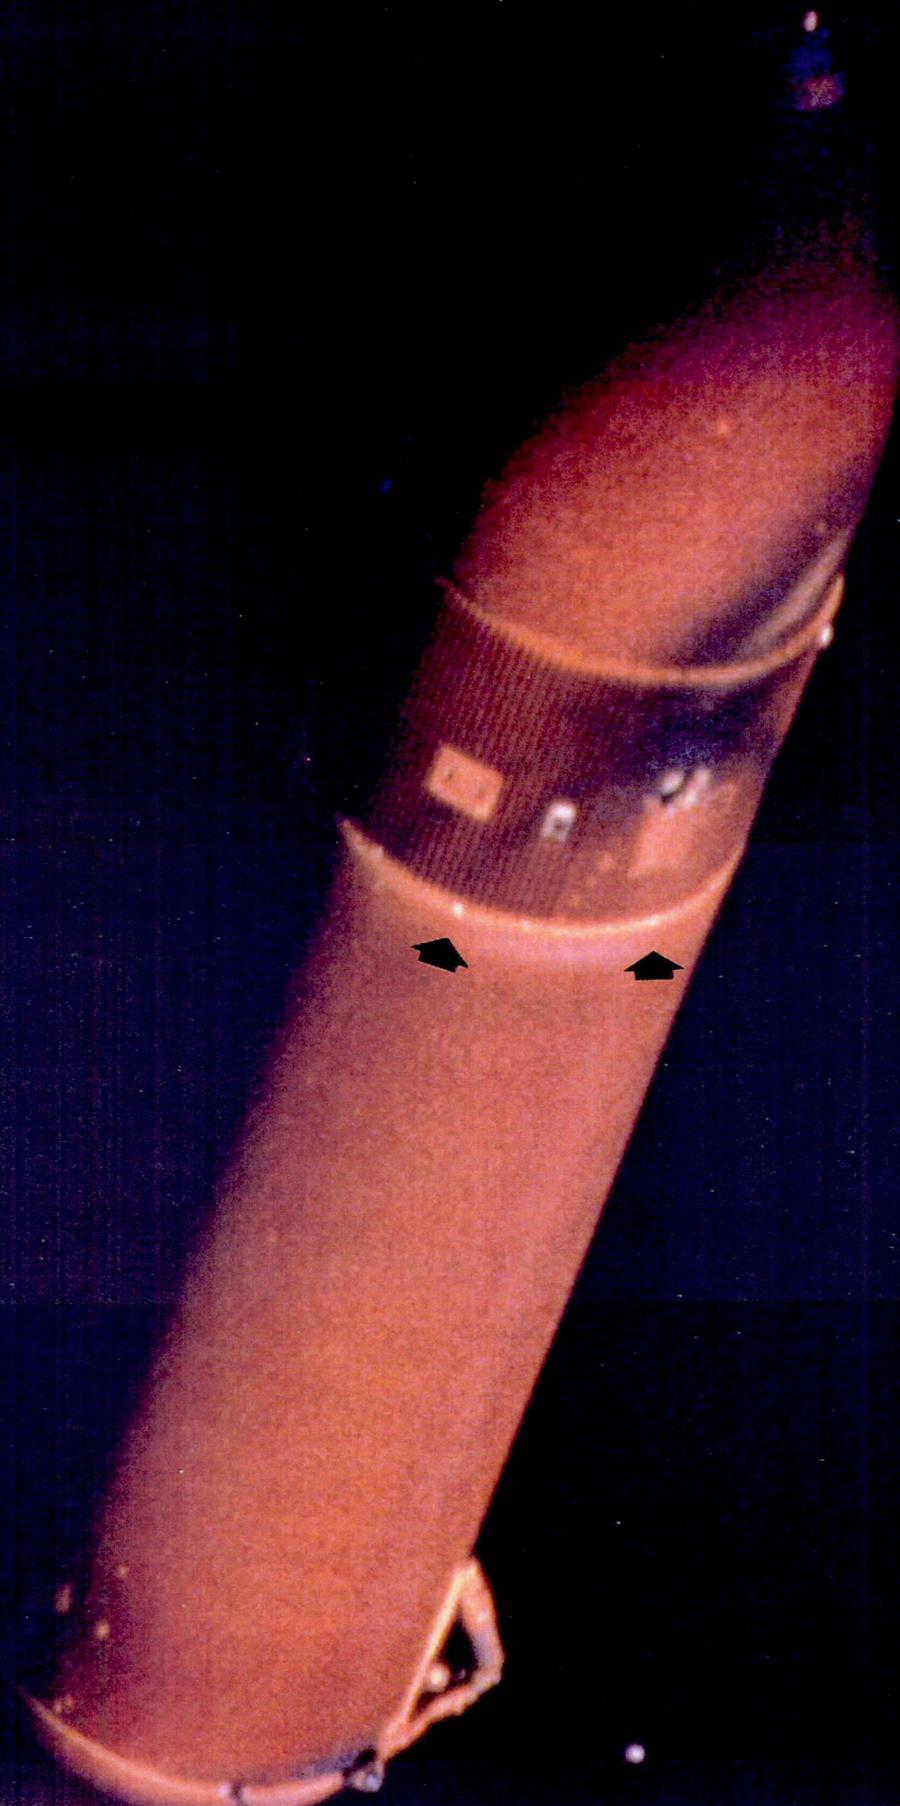
On-orbit view of the External Tank shortly after separation from the Orbiter. Other than 6 divots on the intertank-to-LH2 tank flange closeout, there were no other apparent anomalies.

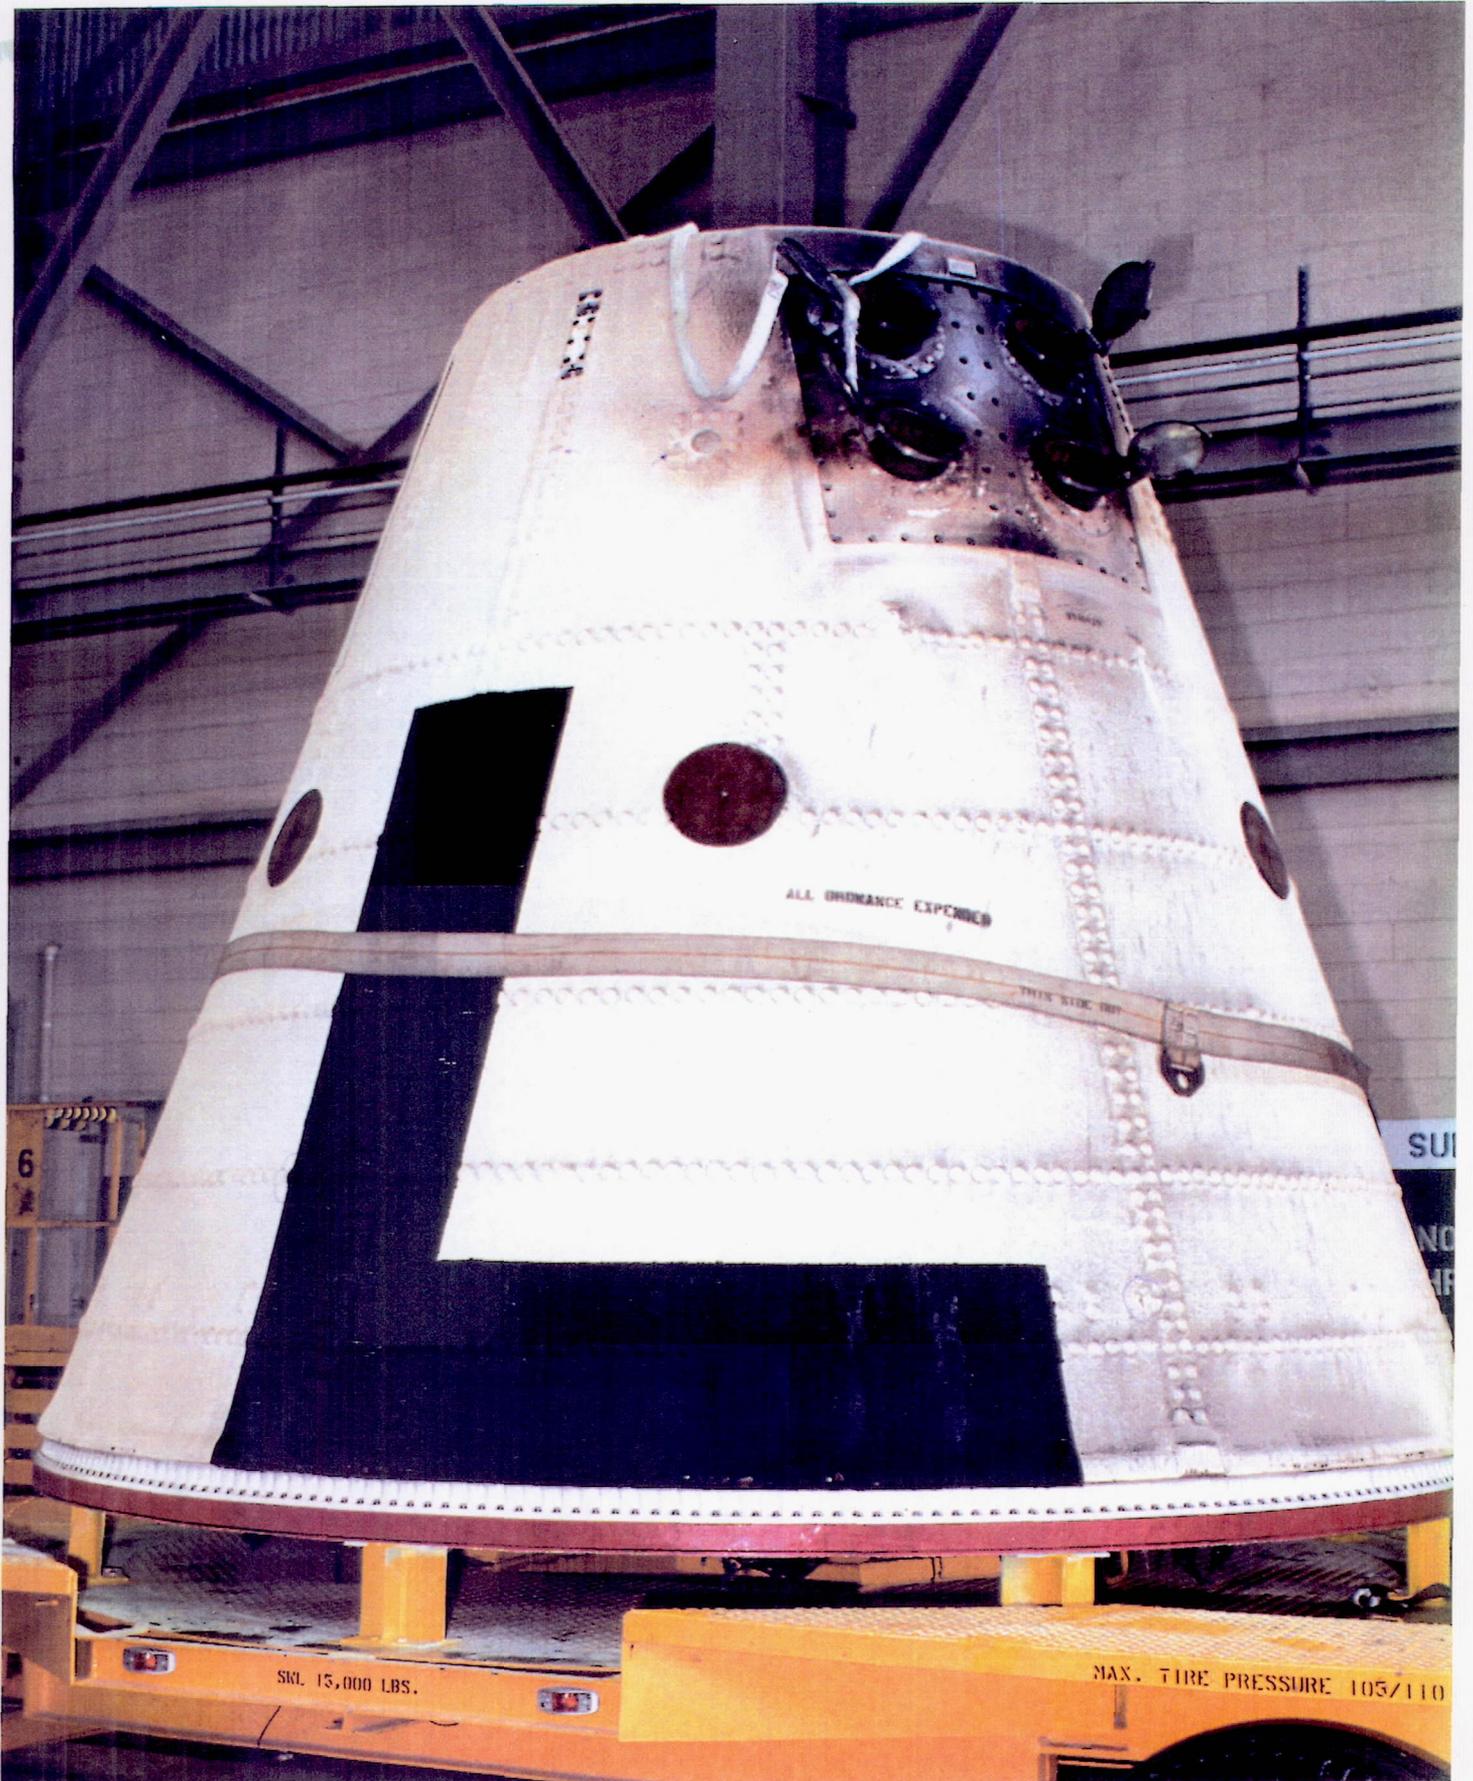
Post flight condition of the RH SRB frustum. There were 26 MSA-2 debonds over fasteners, but no missing material. BSM covers were bent by entanglement with the parachute risers.

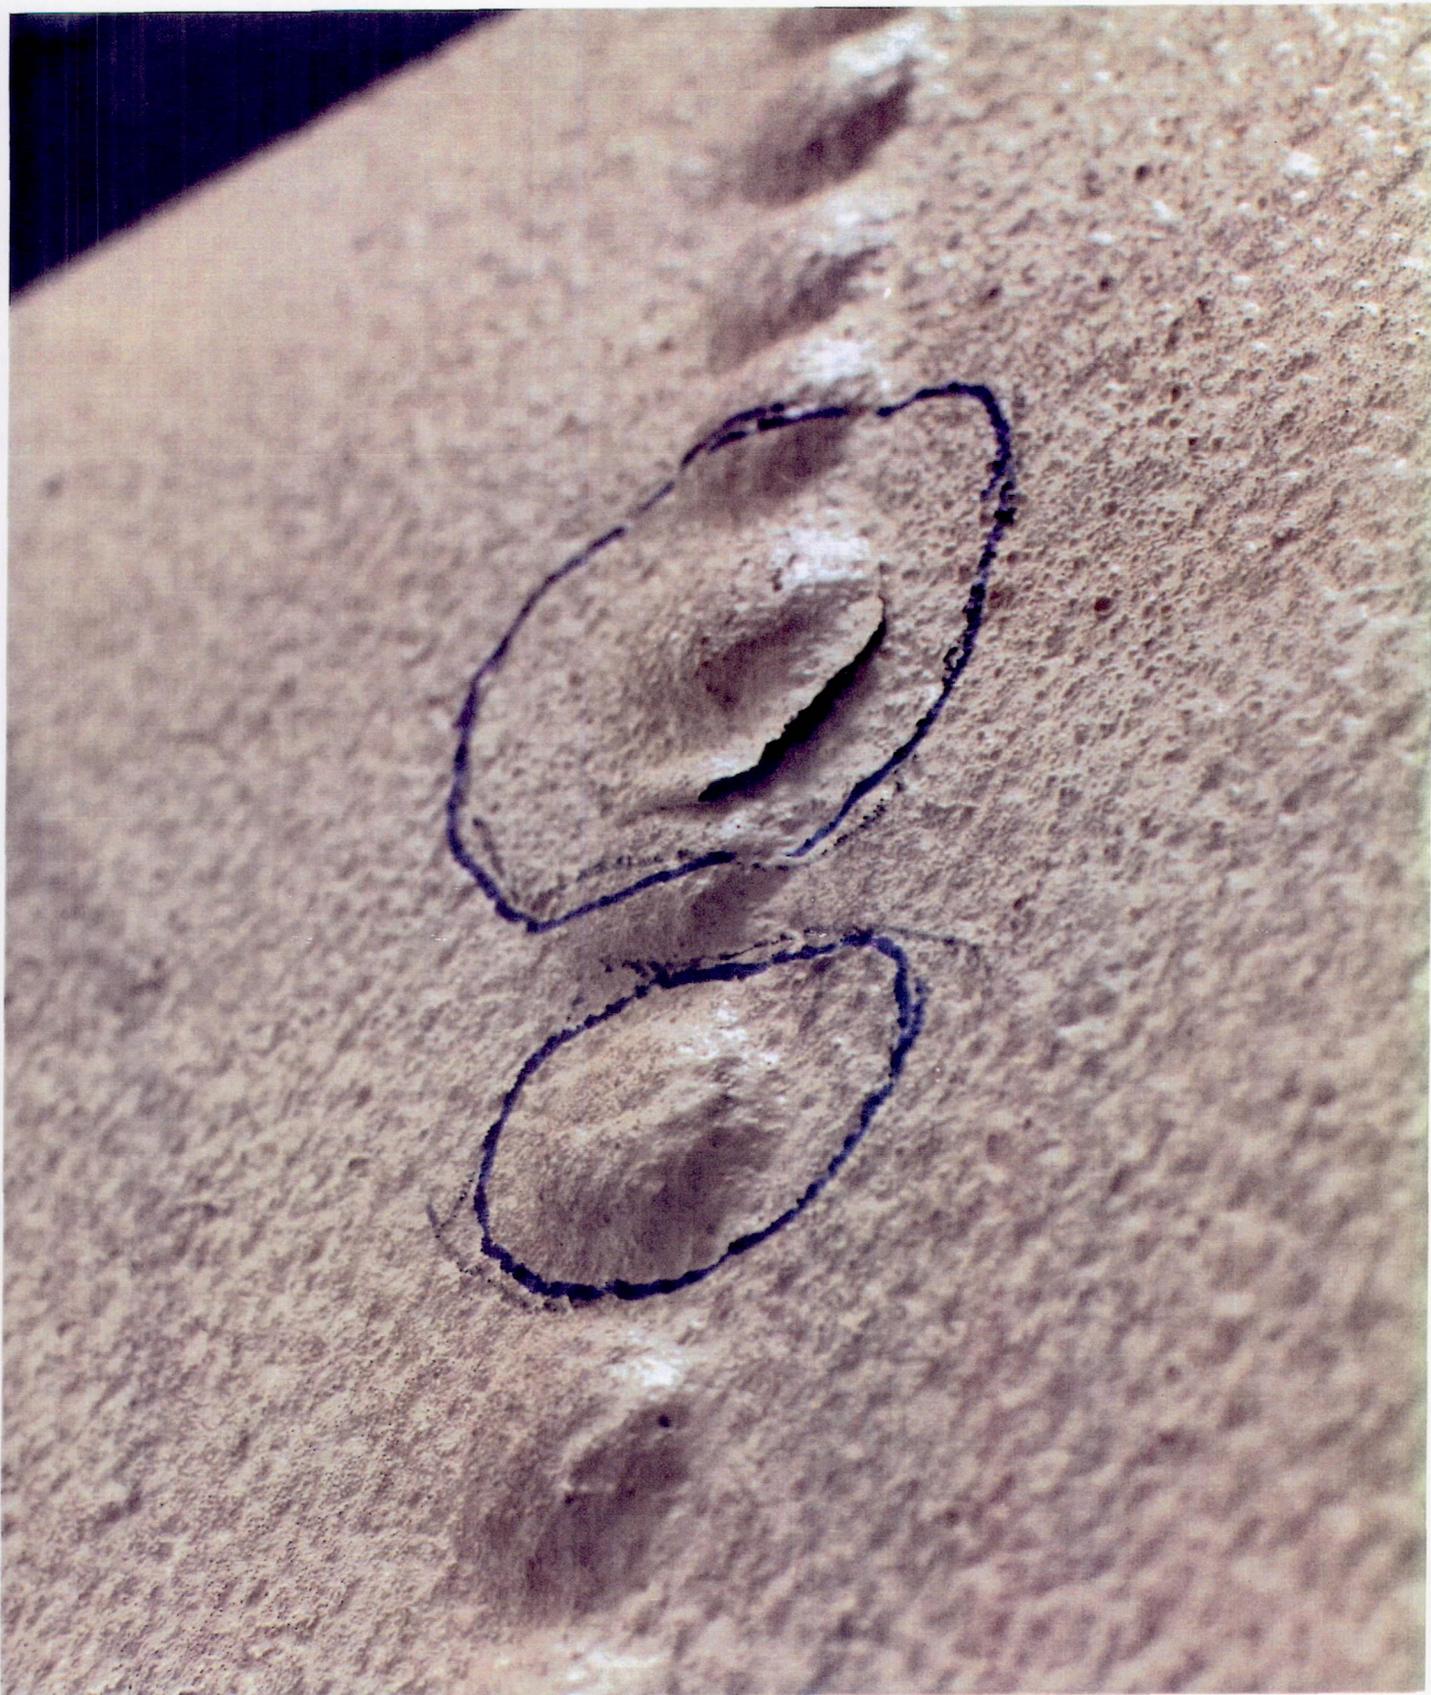
MSA-2 debonds have typically occurred over frustum fasteners. Loss of Hypalon paint with layers of MSA attached can damage tiles during ascent.

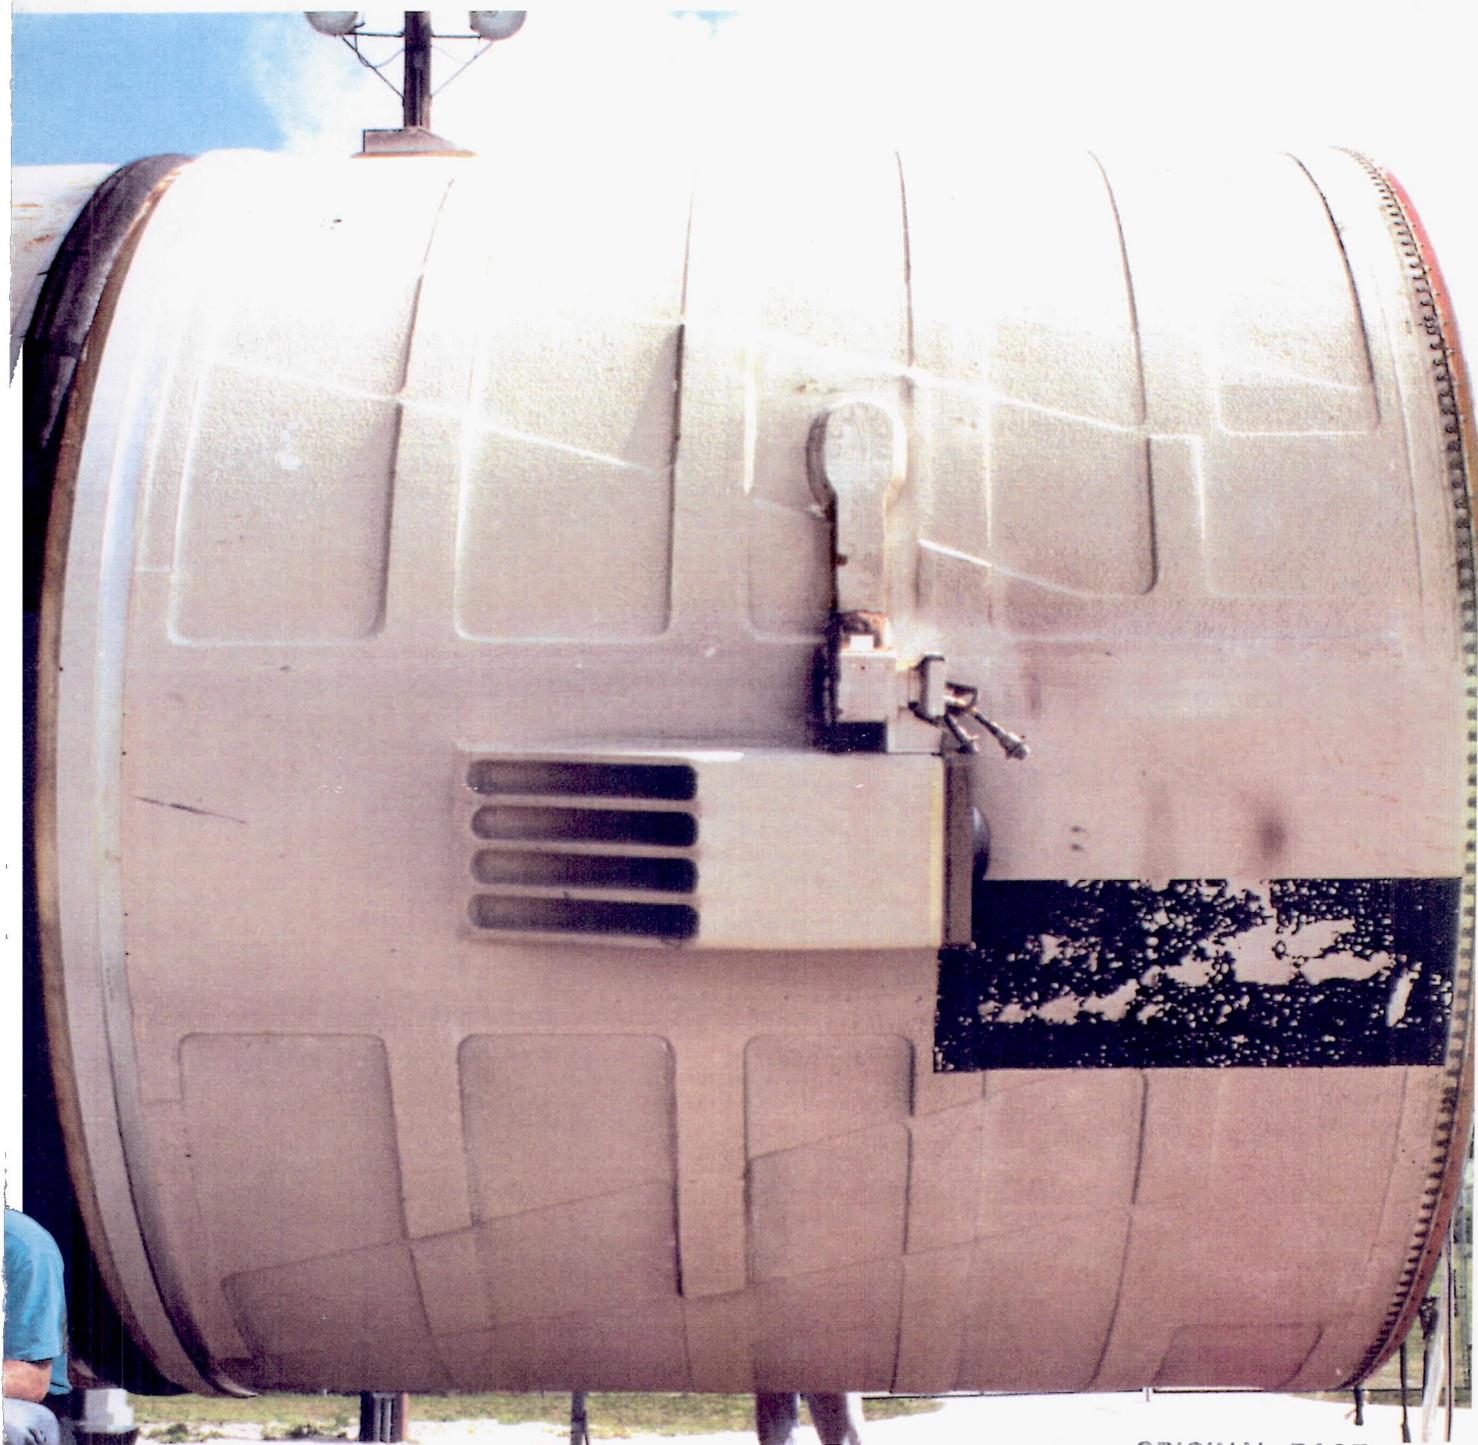
Post flight condition of the RH forward skirt. There were no debonds or missing TPS. Localized blistering of the Hypalon paint occurred forward of the ET/SRB attach fitting.

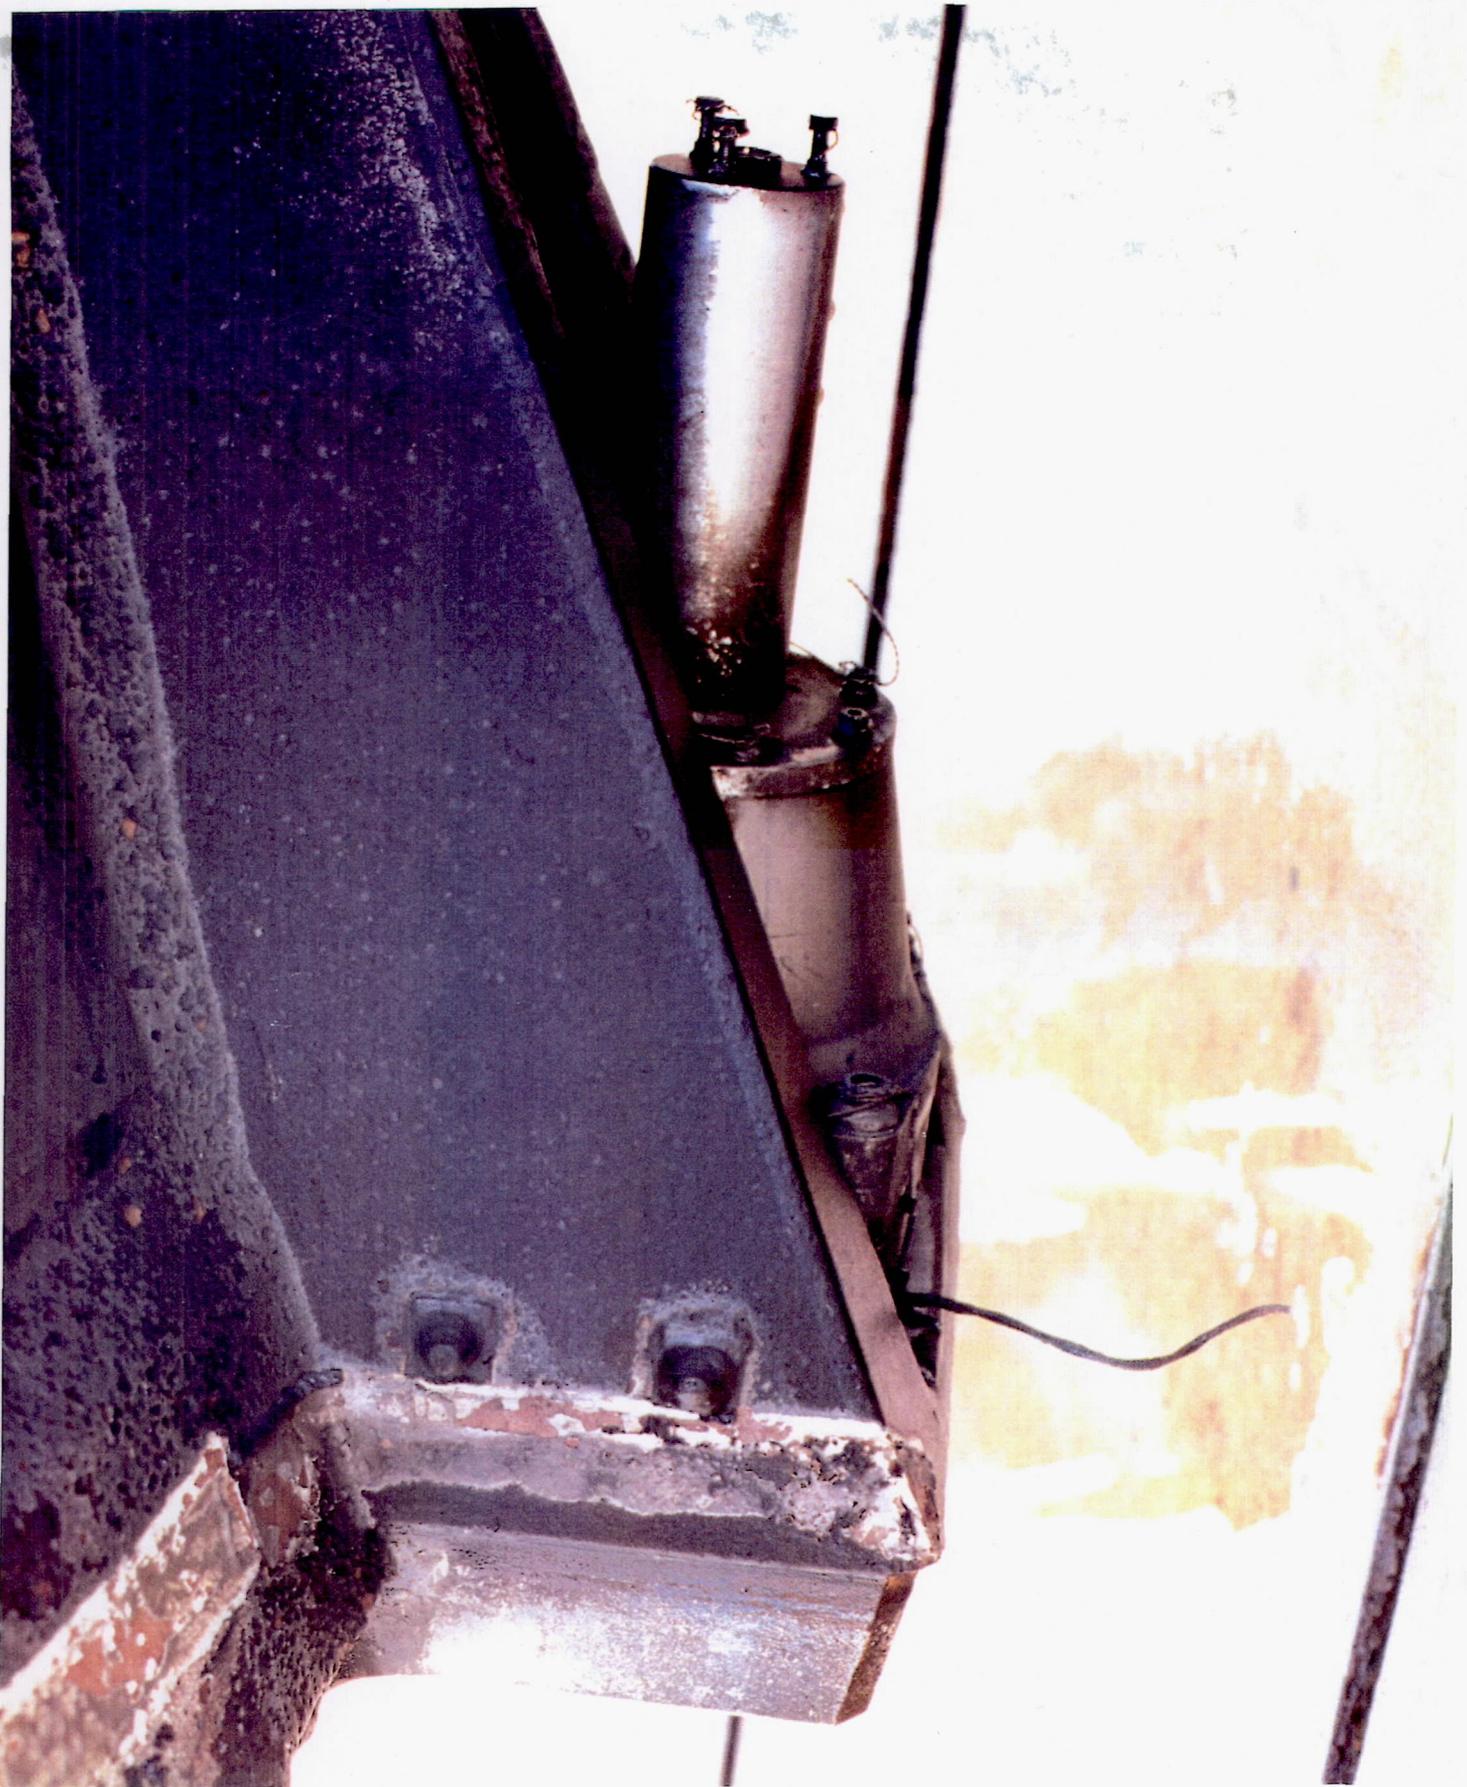
Approximately 10 inches of pyrotechnic cable was still attached to the HDP #1 DCS. Three to four feet of the cable had flown with the vehicle at liftoff.
