Debris/Ice/TPS Assessment And Photographic Analysis For Shuttle Mission STS-37

April 1991

Gregory N. Katnik
NASA/Kennedy Space Center

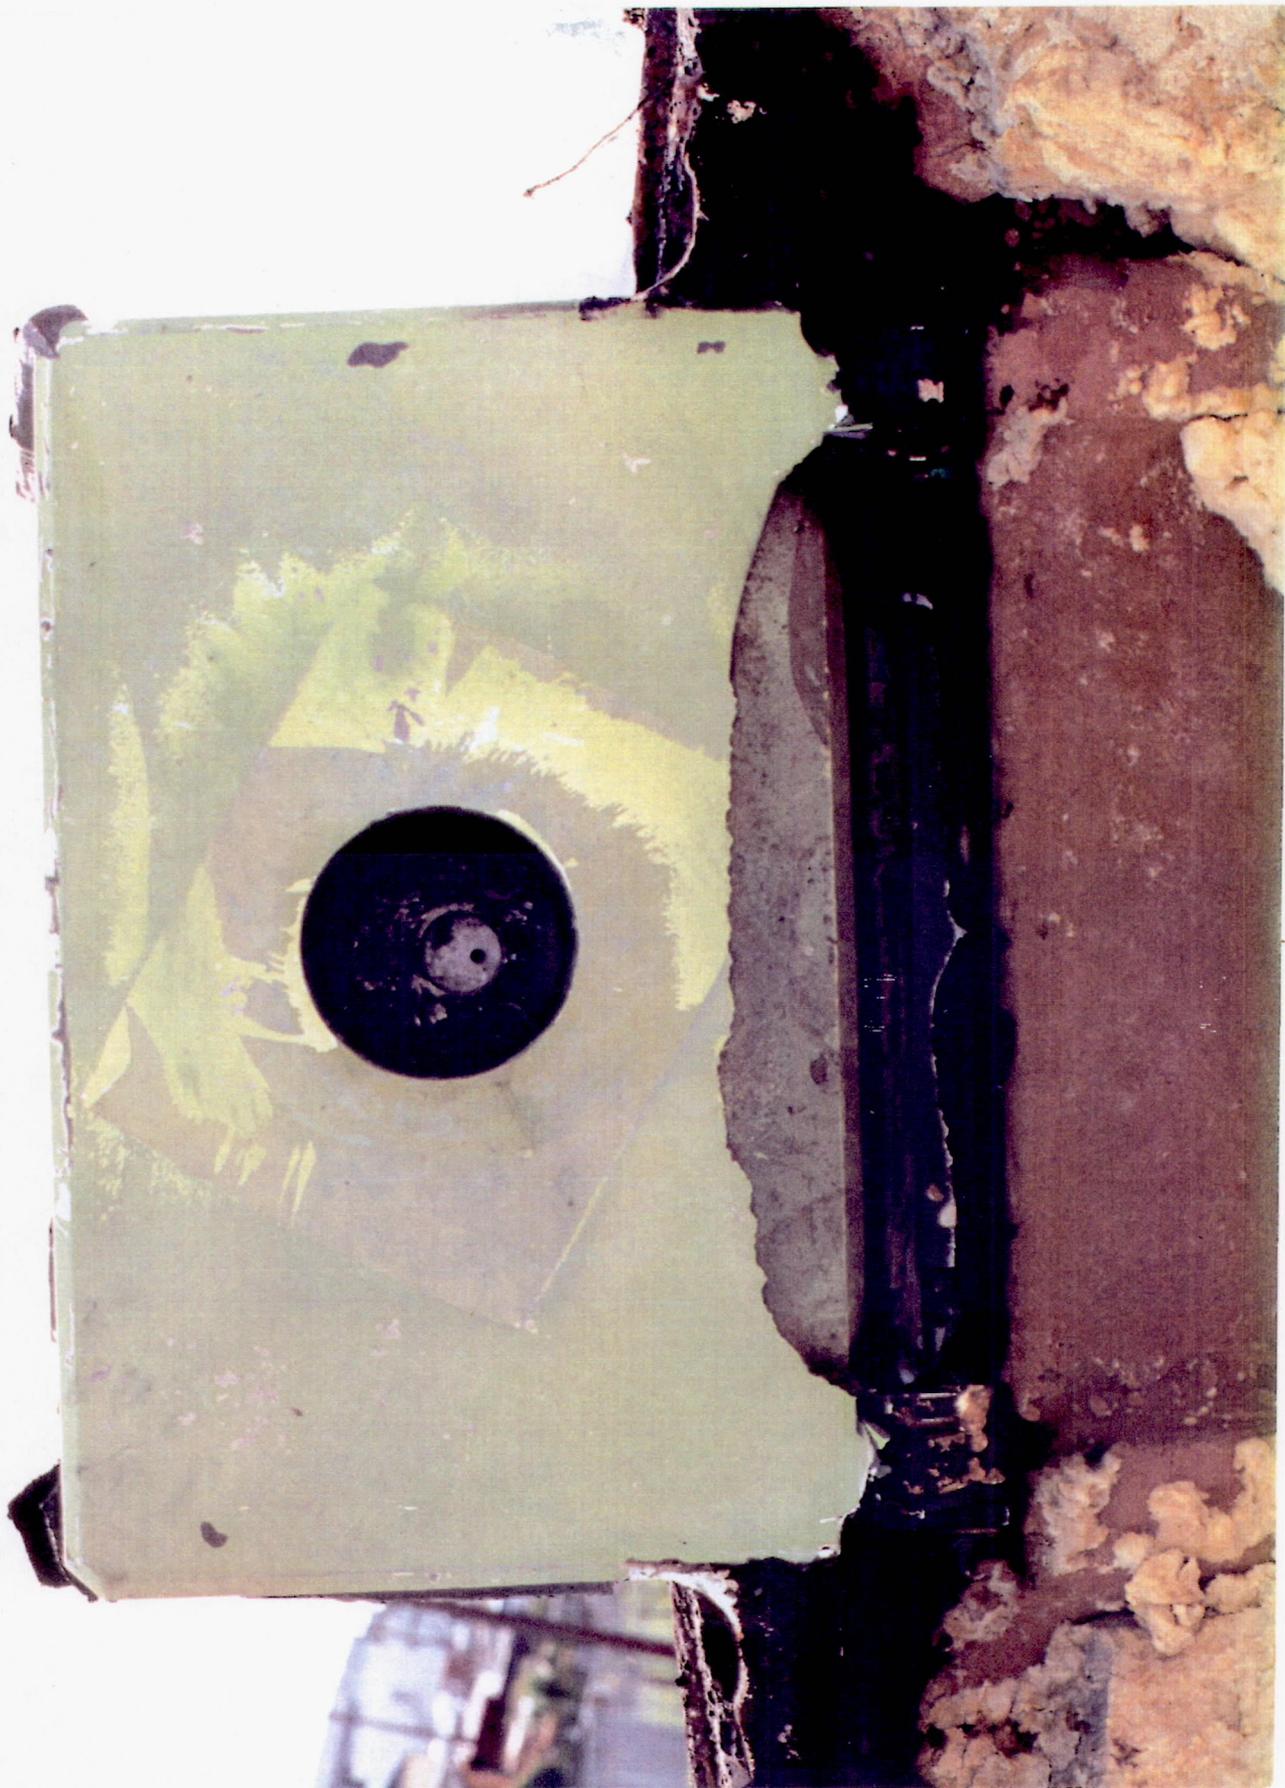
The HDP #4 DCS plunger was properly seated. A 10"x1.5" piece of EPON shim material was missing prior to water impact.

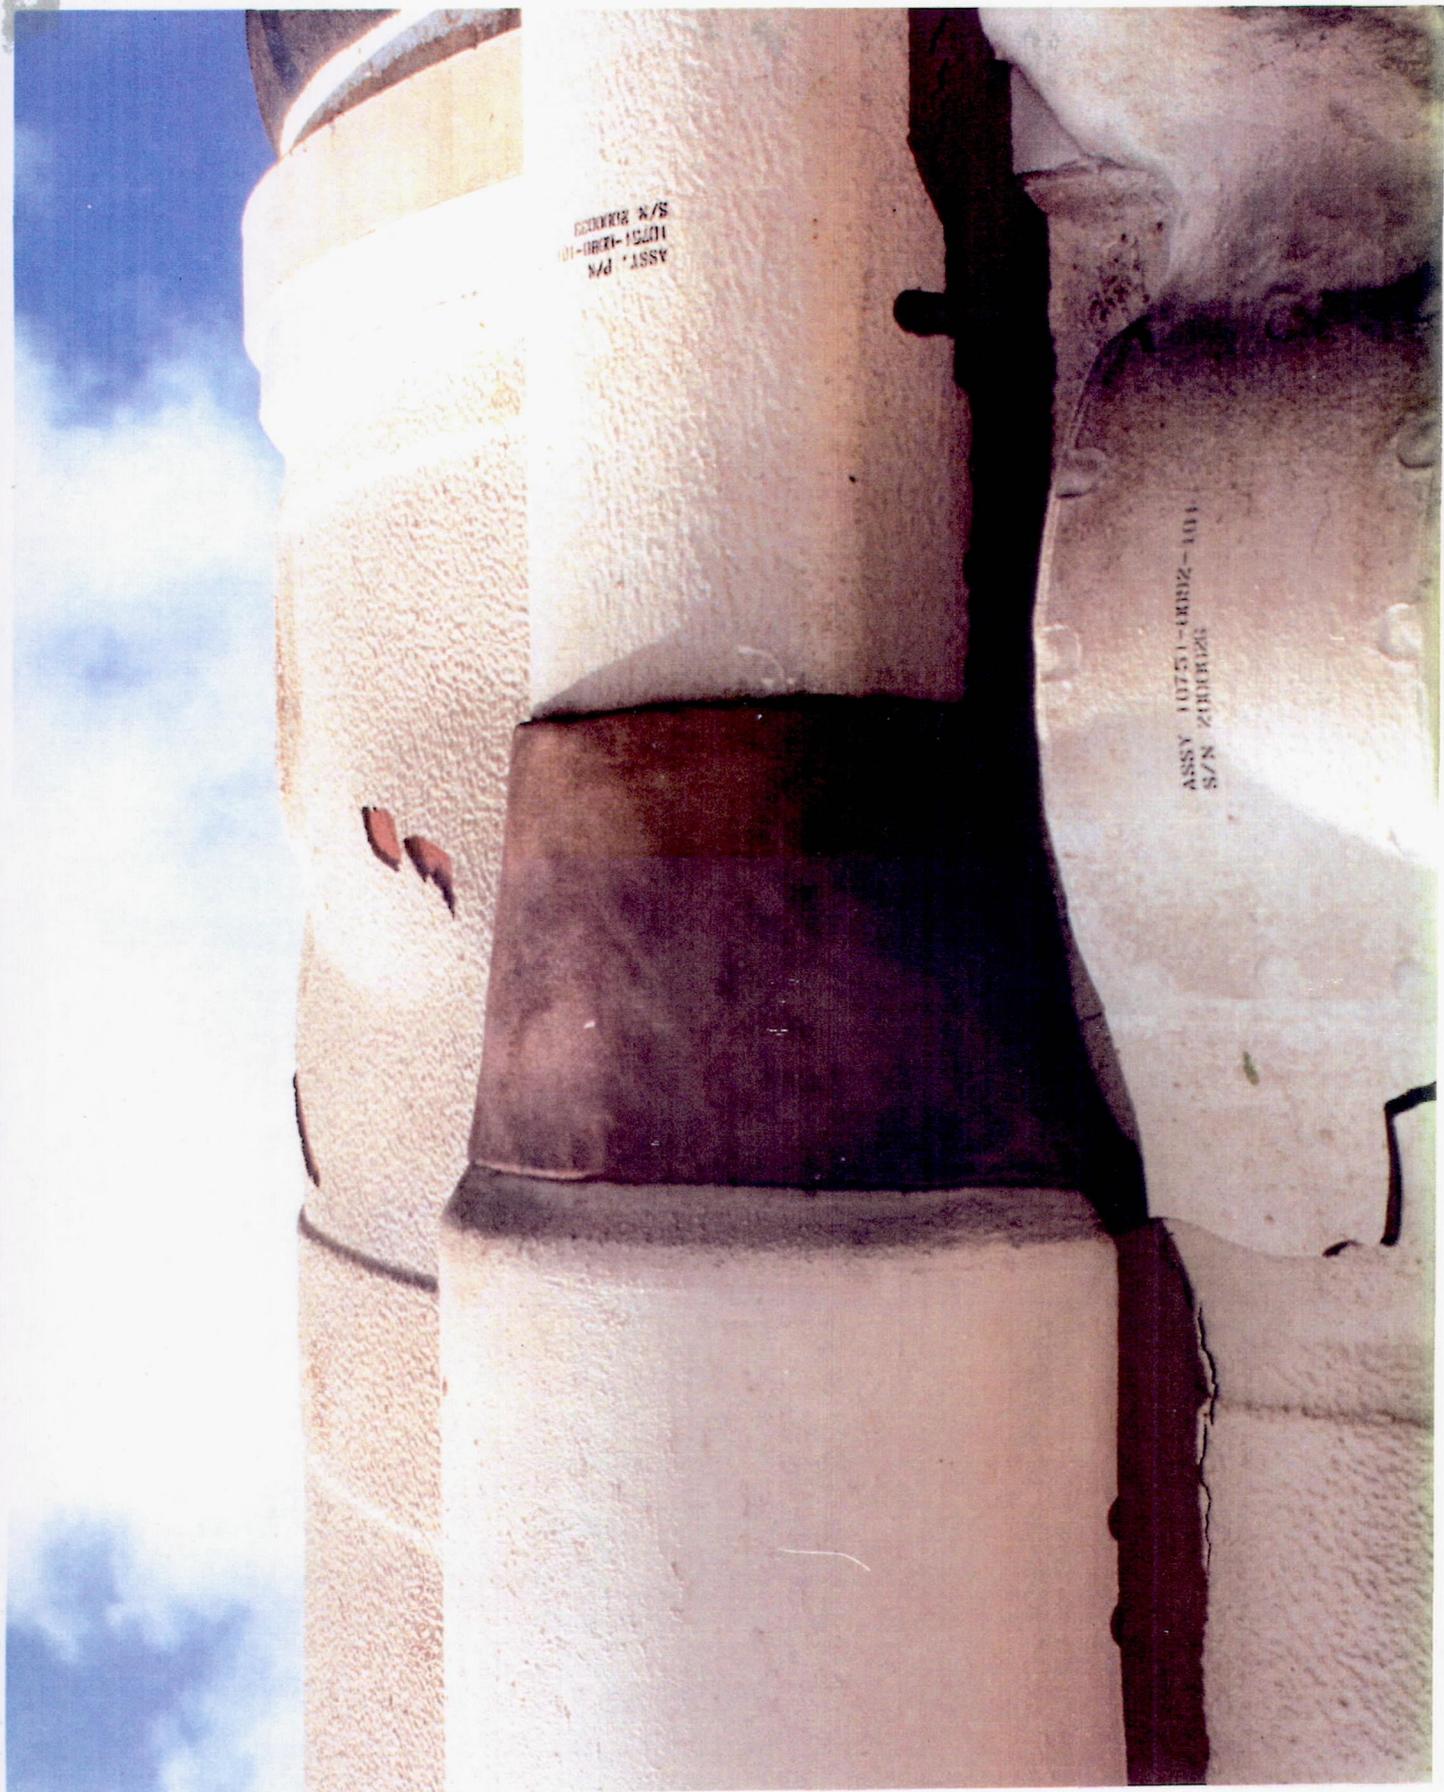
The LH SRB forward skirt sustained damage in the area of the system tunnel. TPS (K5NA and MSA) was cracked and the metal substrate was buckled on both sides of the systems tunnel. Some of the Hypalon topcoat was missing. Debris Team assessment indicates the forward skirt damage was not a source of debris nor was caused by a debris problem. The most likely causes, according to MSFC, were unusual loads induced by water slapdown or parachute deployment.

The LH SRB FWD skirt sustained buckling damage (circumferential wrinkles) approximately 2 feet forward of the field joint. Initial assessment indicated the damage was not a source of debris nor was caused by a debris problem.

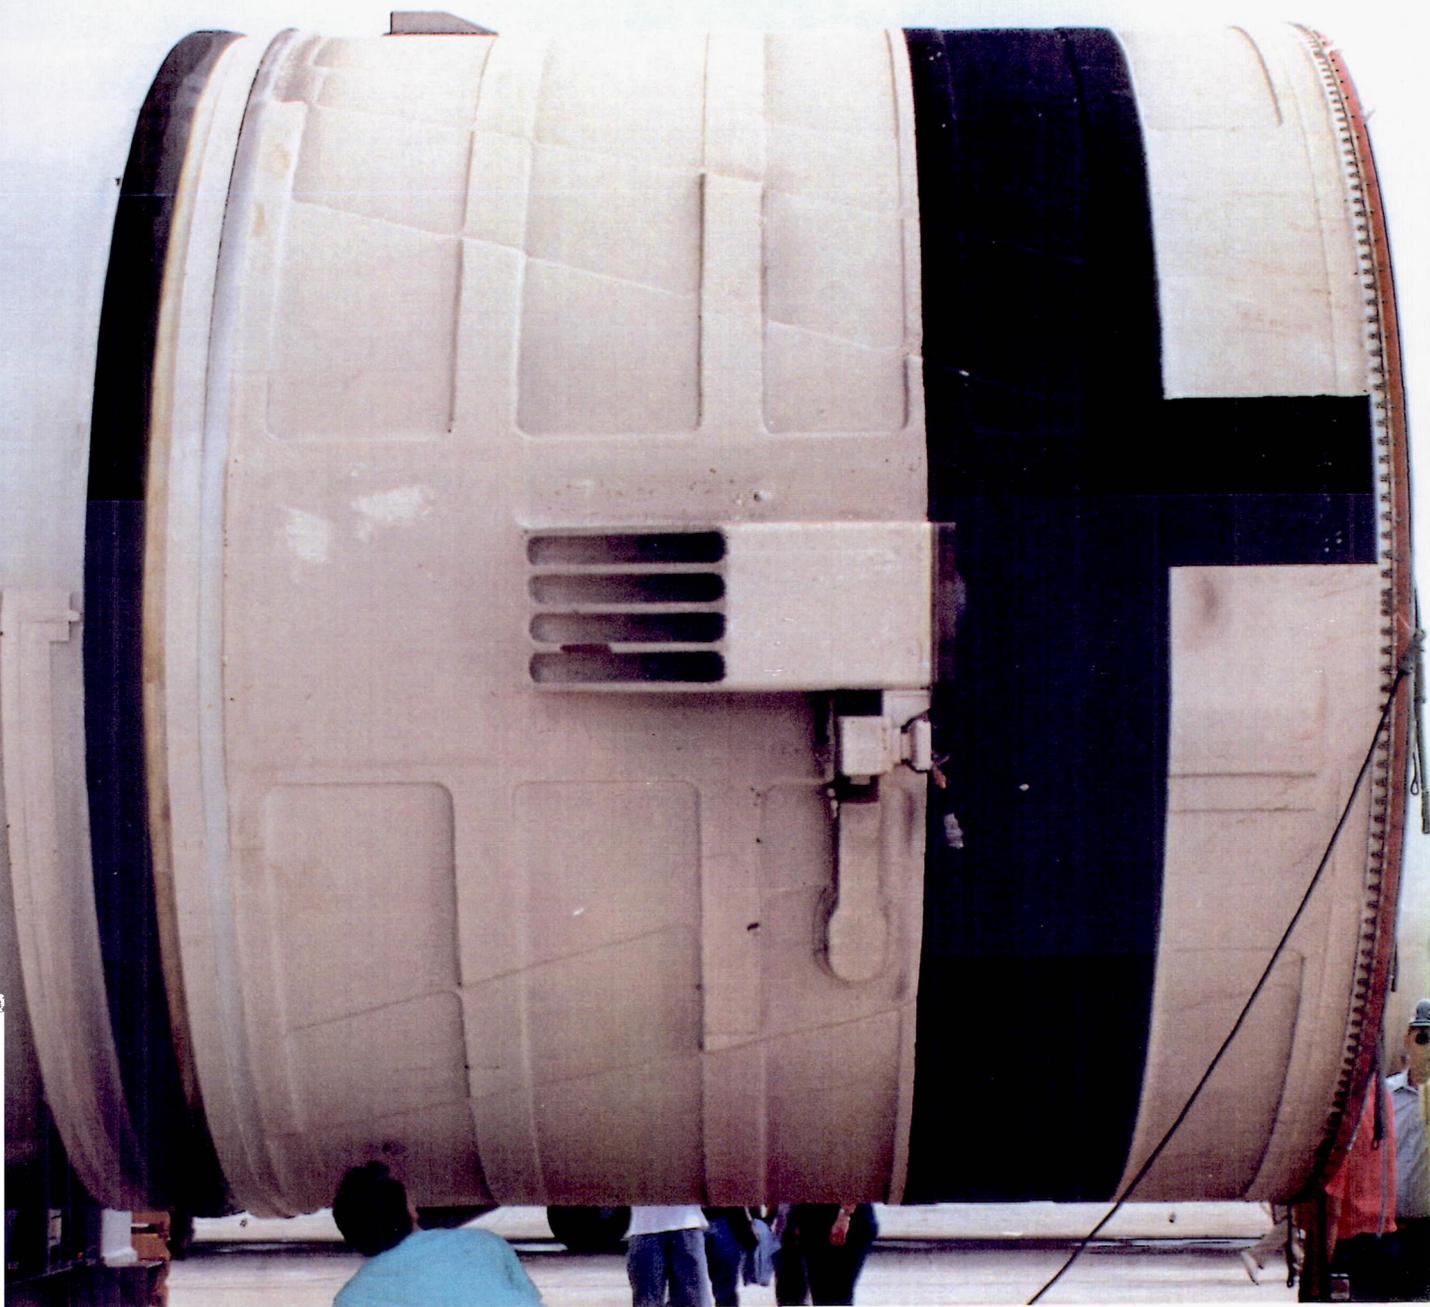
Cracks in the K5NA and MSA showed no signs of sooting or charring. The most likely causes of the damage are unusual loads induced by water impact 'slapdown' or parachute deployment side loads.

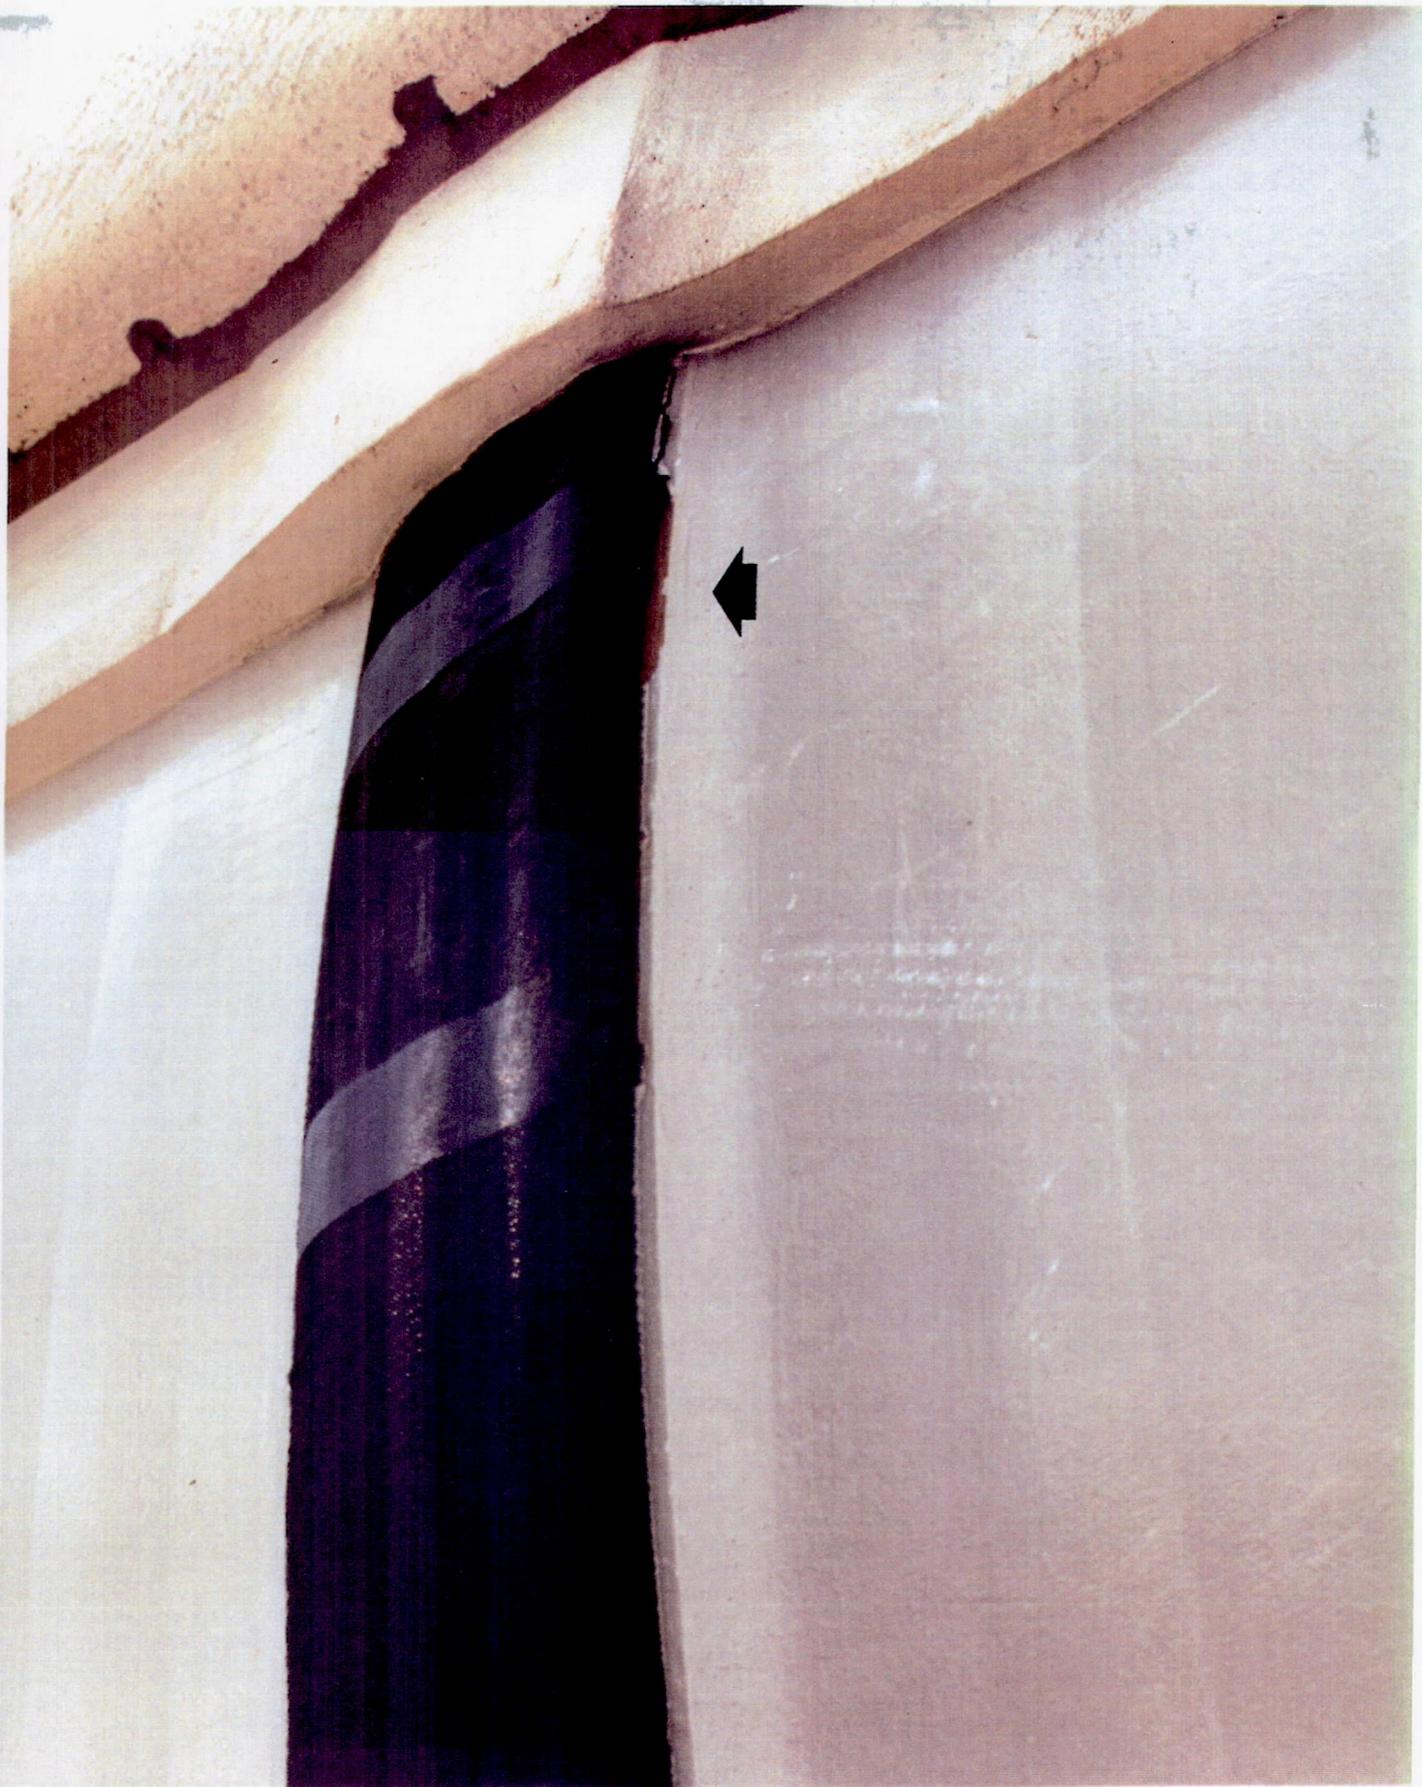
A 12-inch debond occurred along the aft edge of the LH aft center factory joint adjacent to the systems tunnel

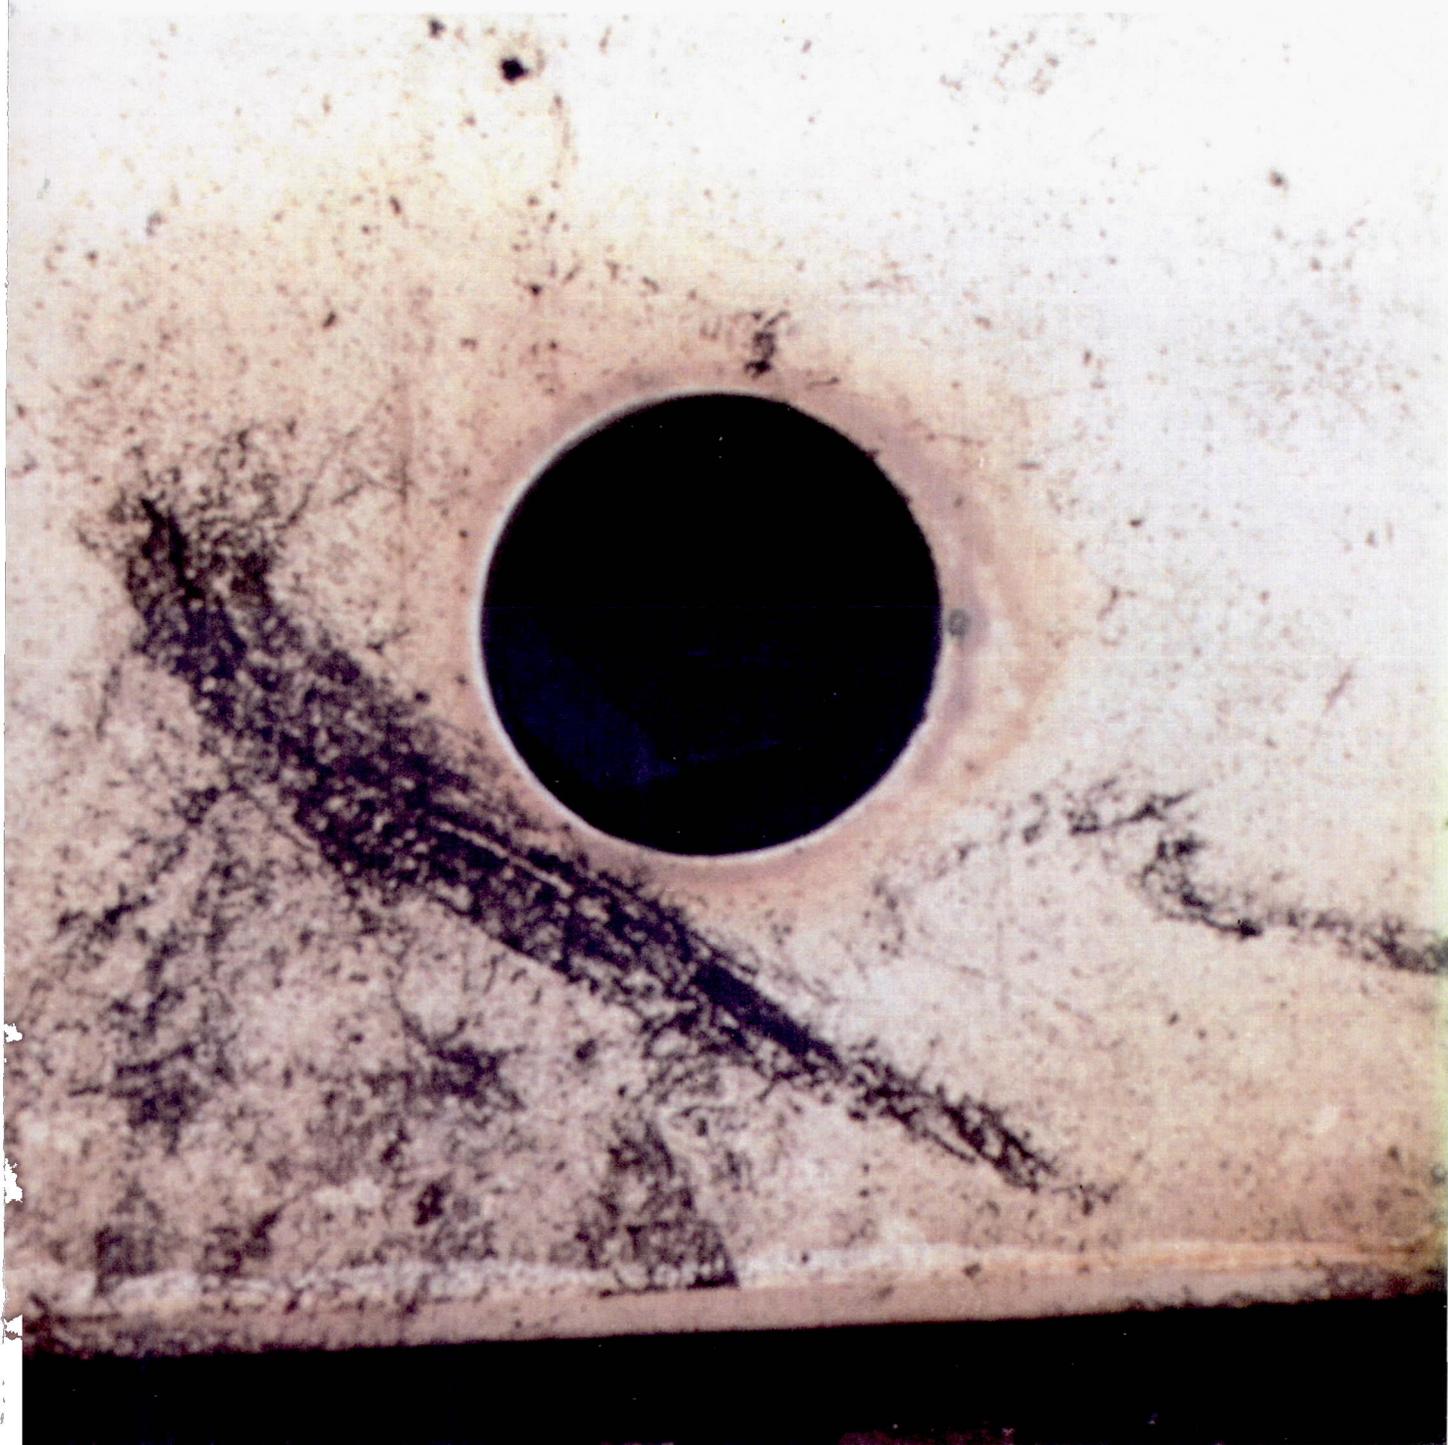
The HDP #6 Debris Containment System (DCS) plunger was
obstructed by a frangible nut half

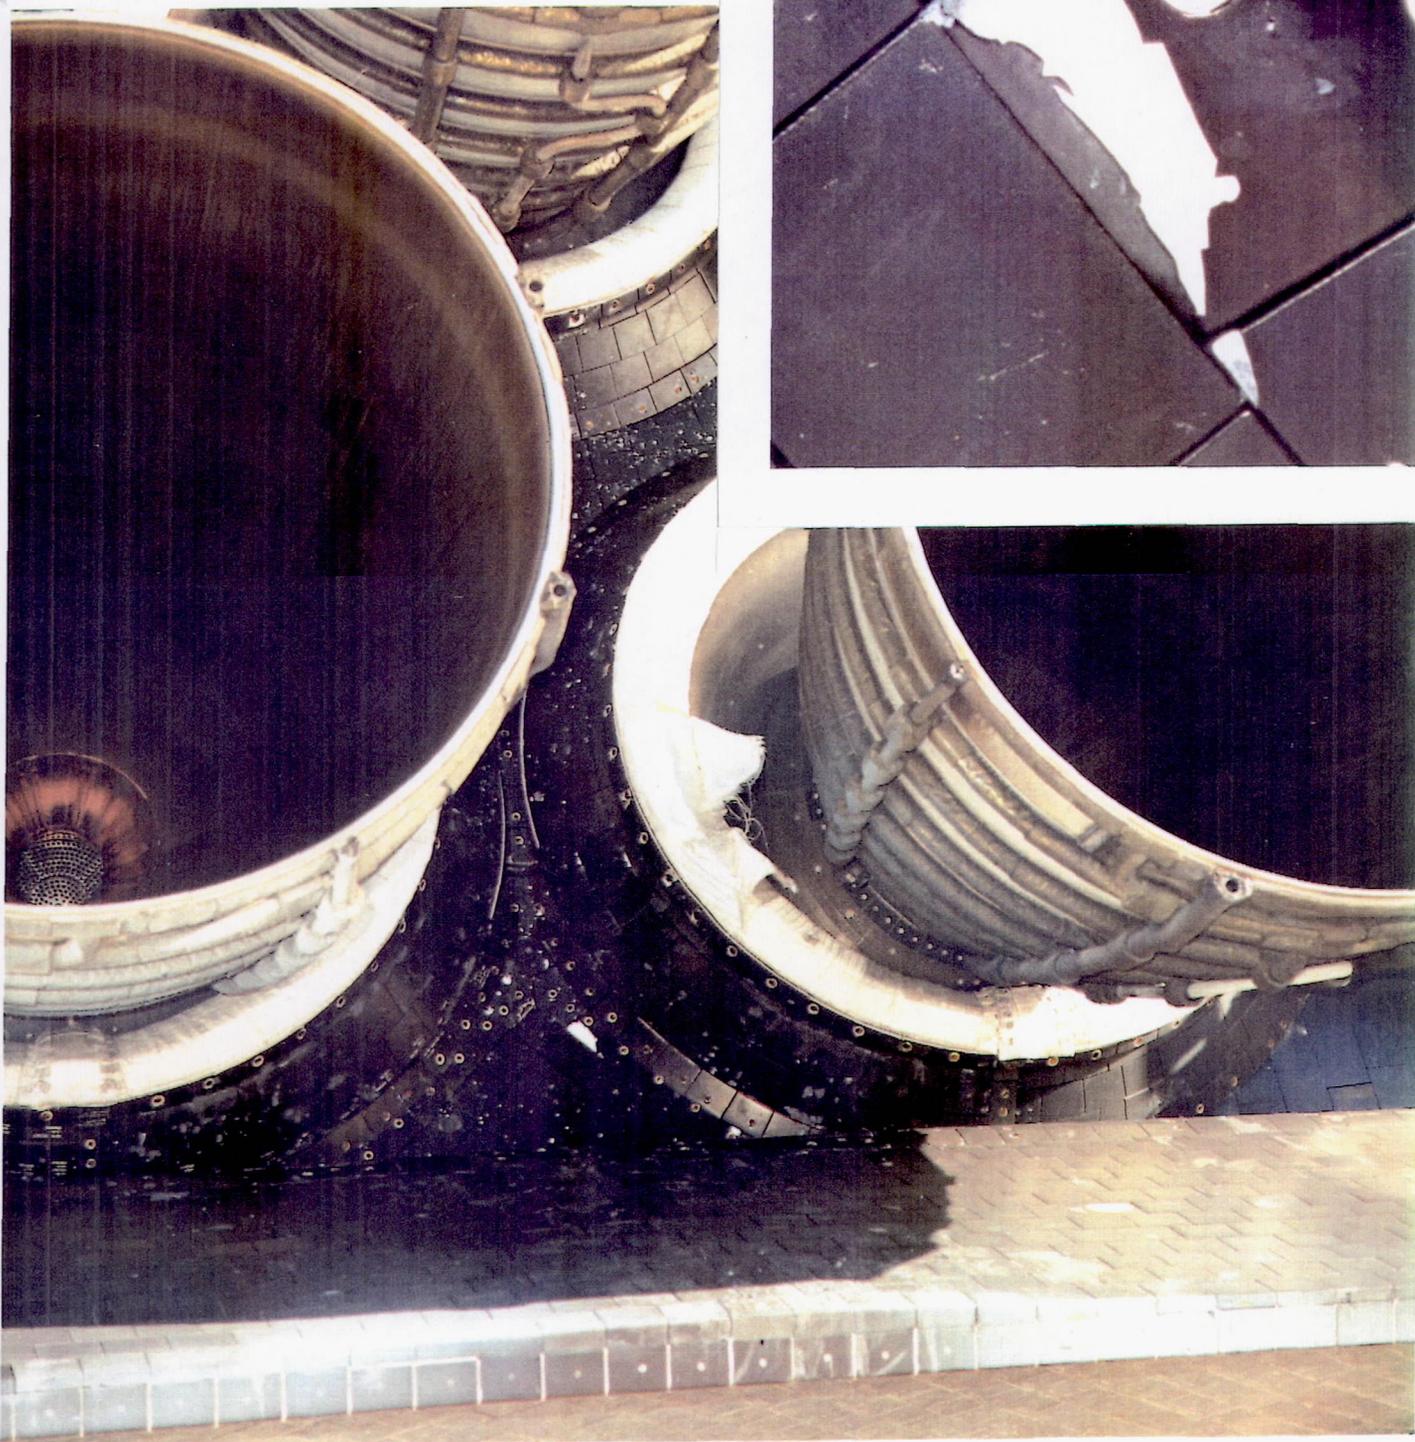
A 5"x2"x1.5" piece of tile was missing between SSME #2 and #3. Inset shows close-up view of the damage. SSME #3 closeout blanket was frayed from 7-9:00 o'clock.

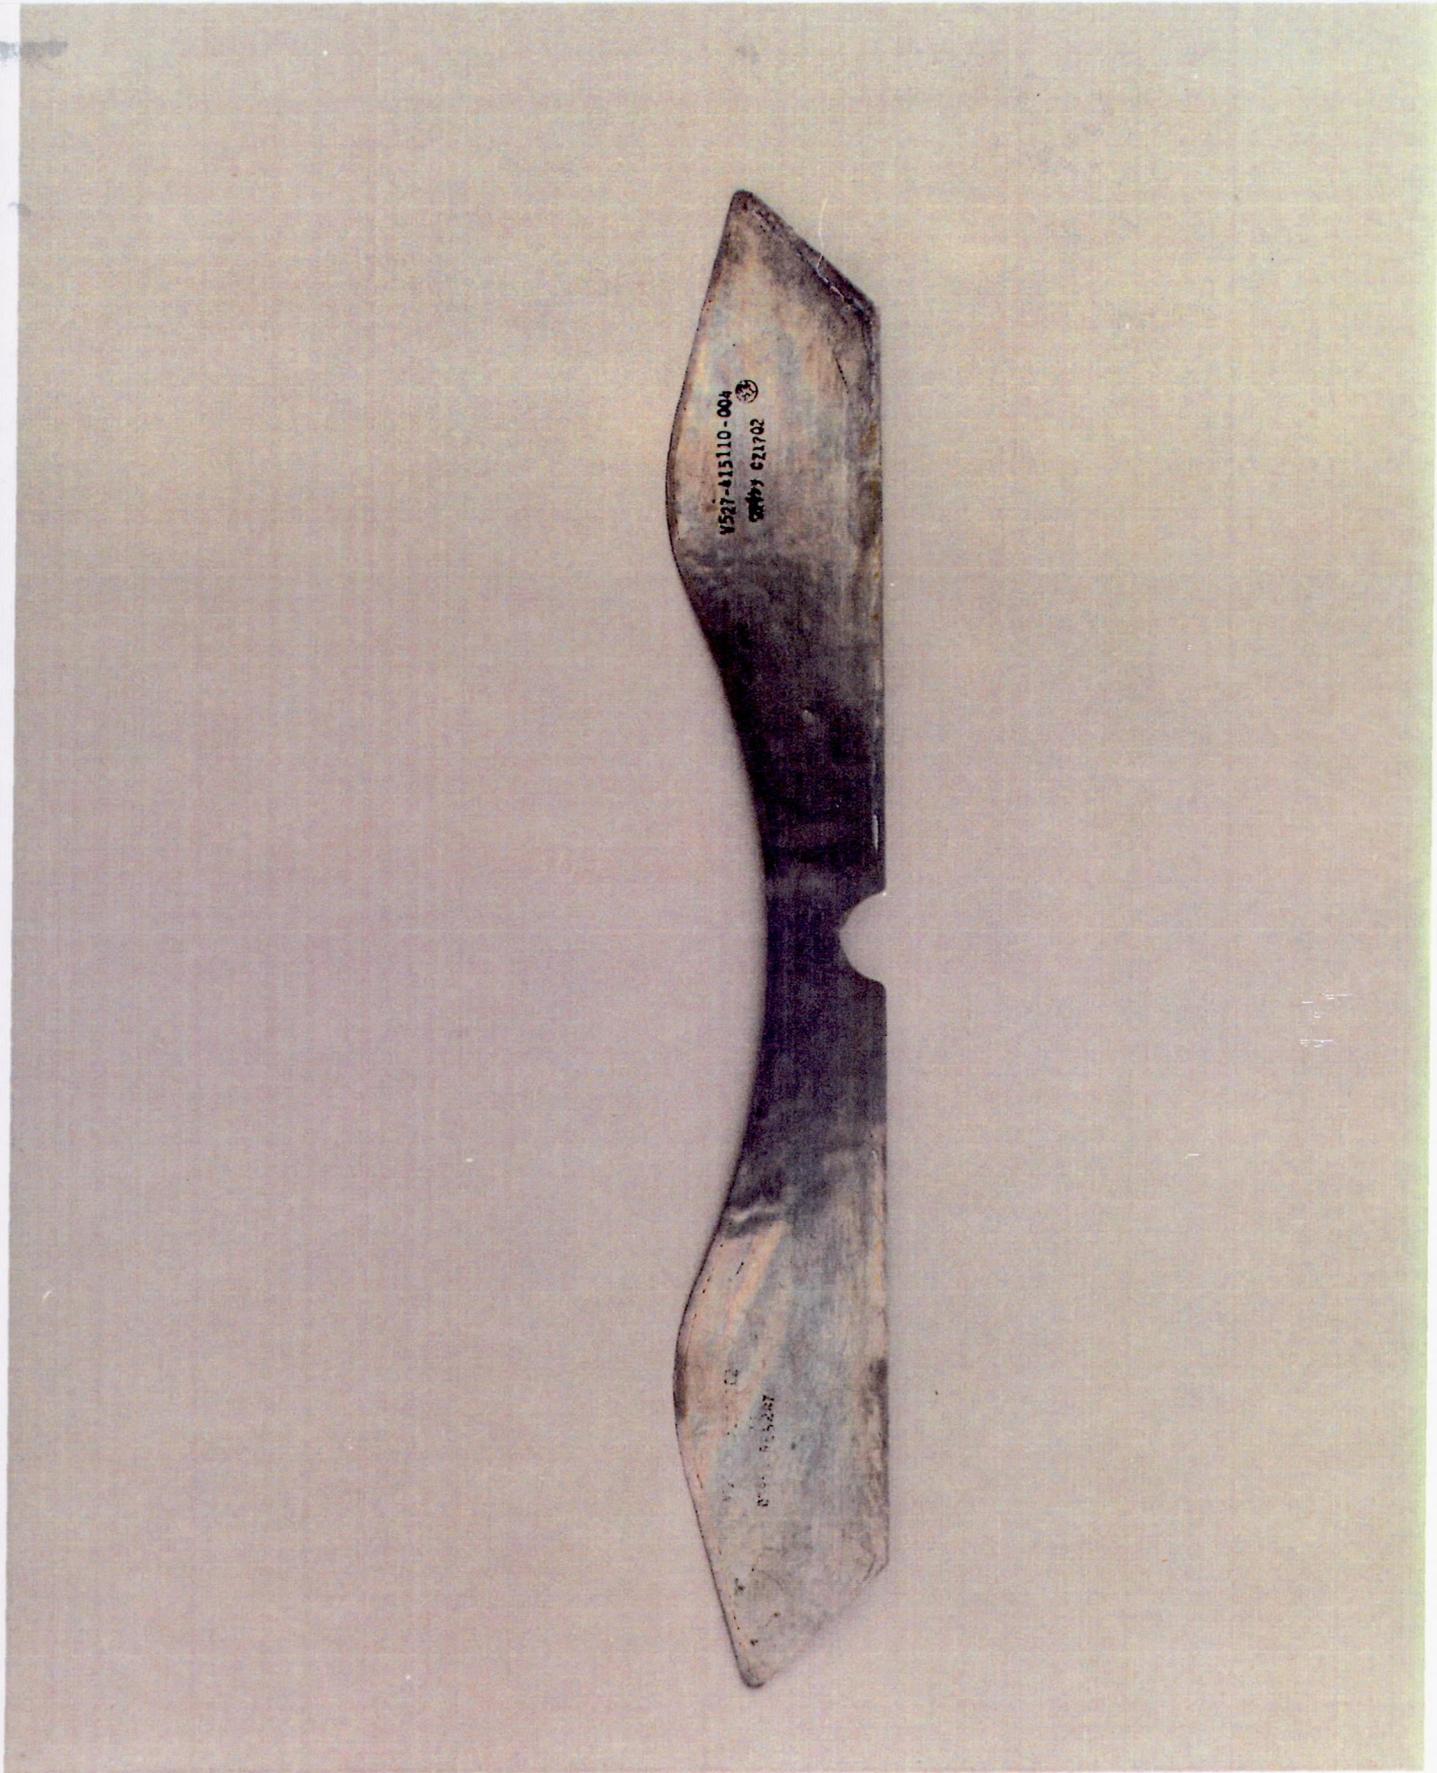
A lightning protection contact fell onto the runway when the LH2 ET/Orbiter umbilical door was opened. This contact, which is approximately 17.5" long by 2.5" wide, is normally bonded to the ET half of the LH2 umbilical and should have stayed with the ET after separation. Subsequent laboratory analysis revealed adhesive failure with very little adhesive present on the inner surface (bonding side of the part to the umbilical). There was no evidence of foam material or contaminants. The

polyurethane adhesive had been poorly cured. The cause of the bonding problem is unknown, but the use of self tapping screws to secure the lightning contact is under review. The new 14 inch disconnects were designed with fastened lightning protection contacts.

Lightning protection contact that fell onto the runway when the LH2 ET/ORB umbilical ET door was opened. The contact is normally bonded to the ET half of the umbilical and should have stayed with the ET after separation.

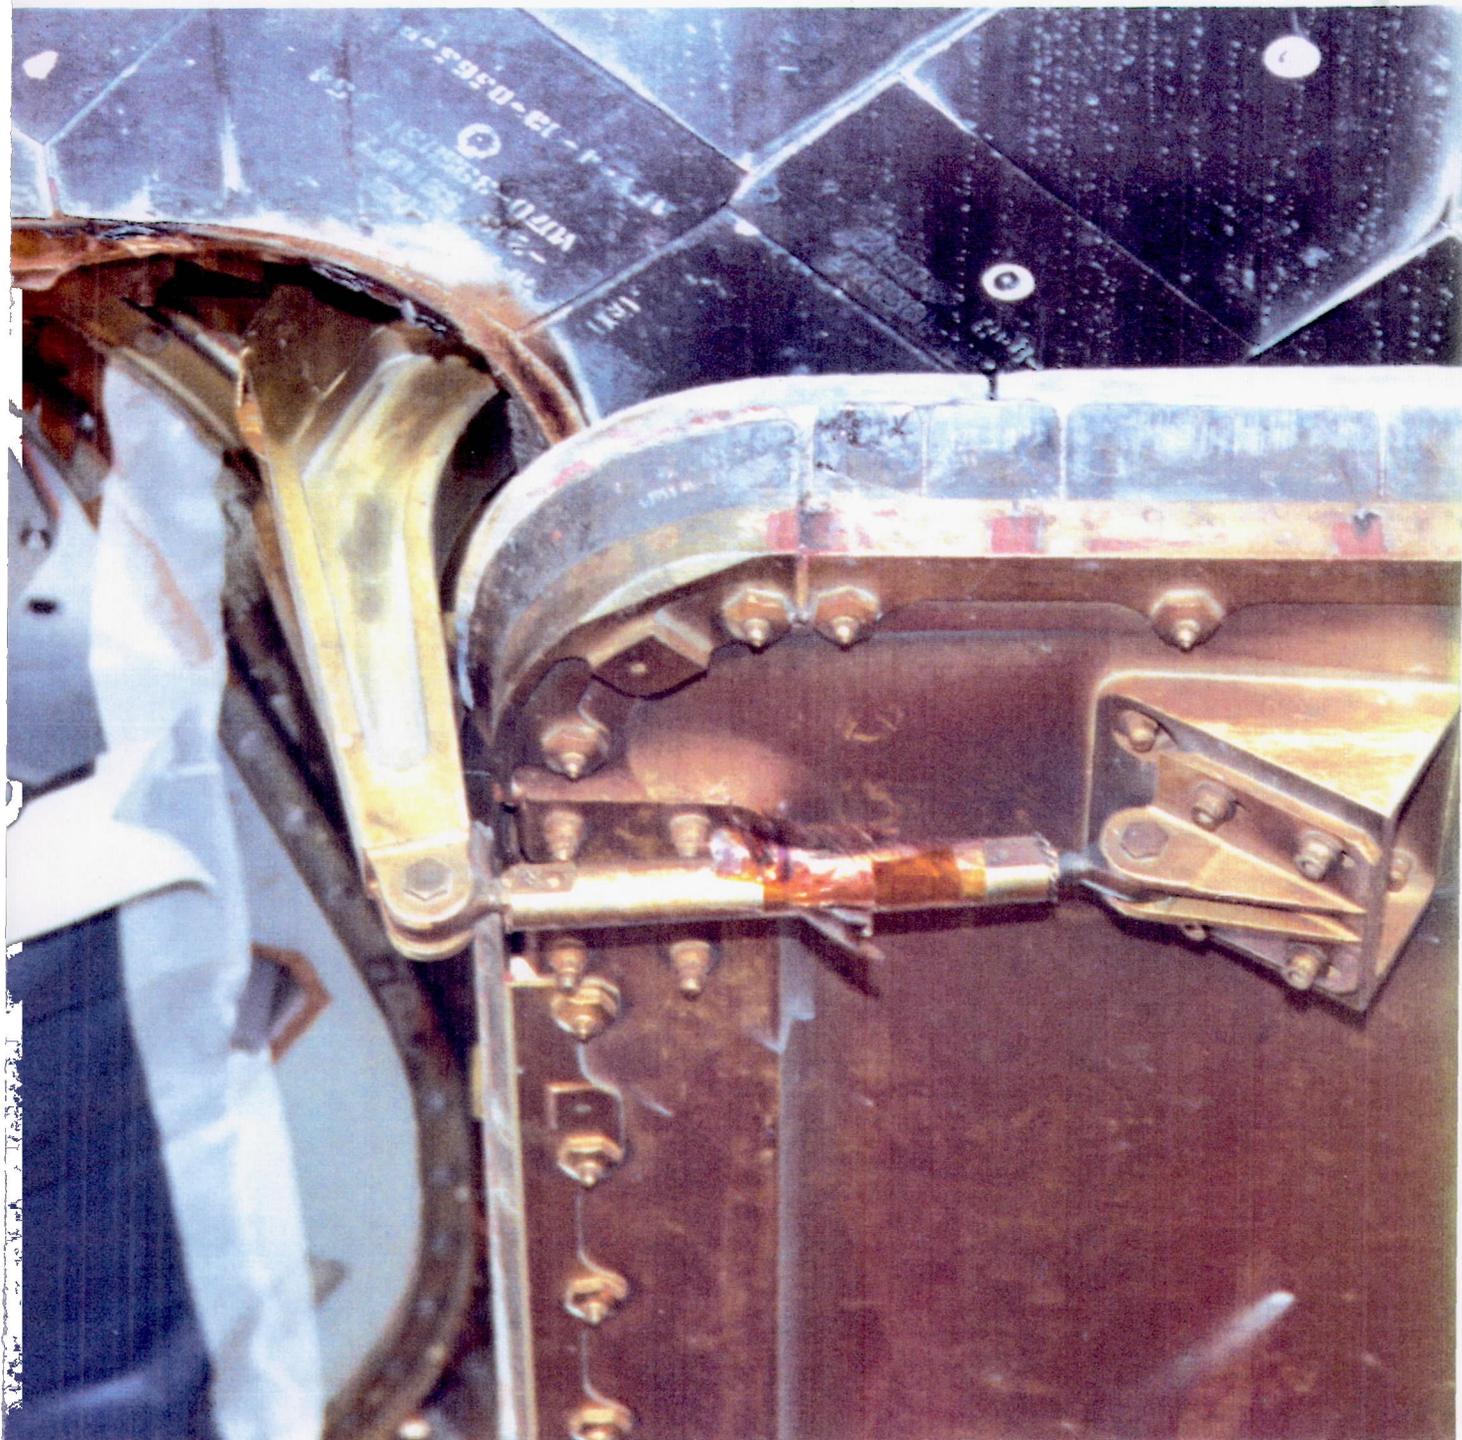
ET/ORB umbilical purge barrier (baggie) was attached to the ET door struts outside of the umbilical cavity and may have contributed to the tile damage aft of that location.

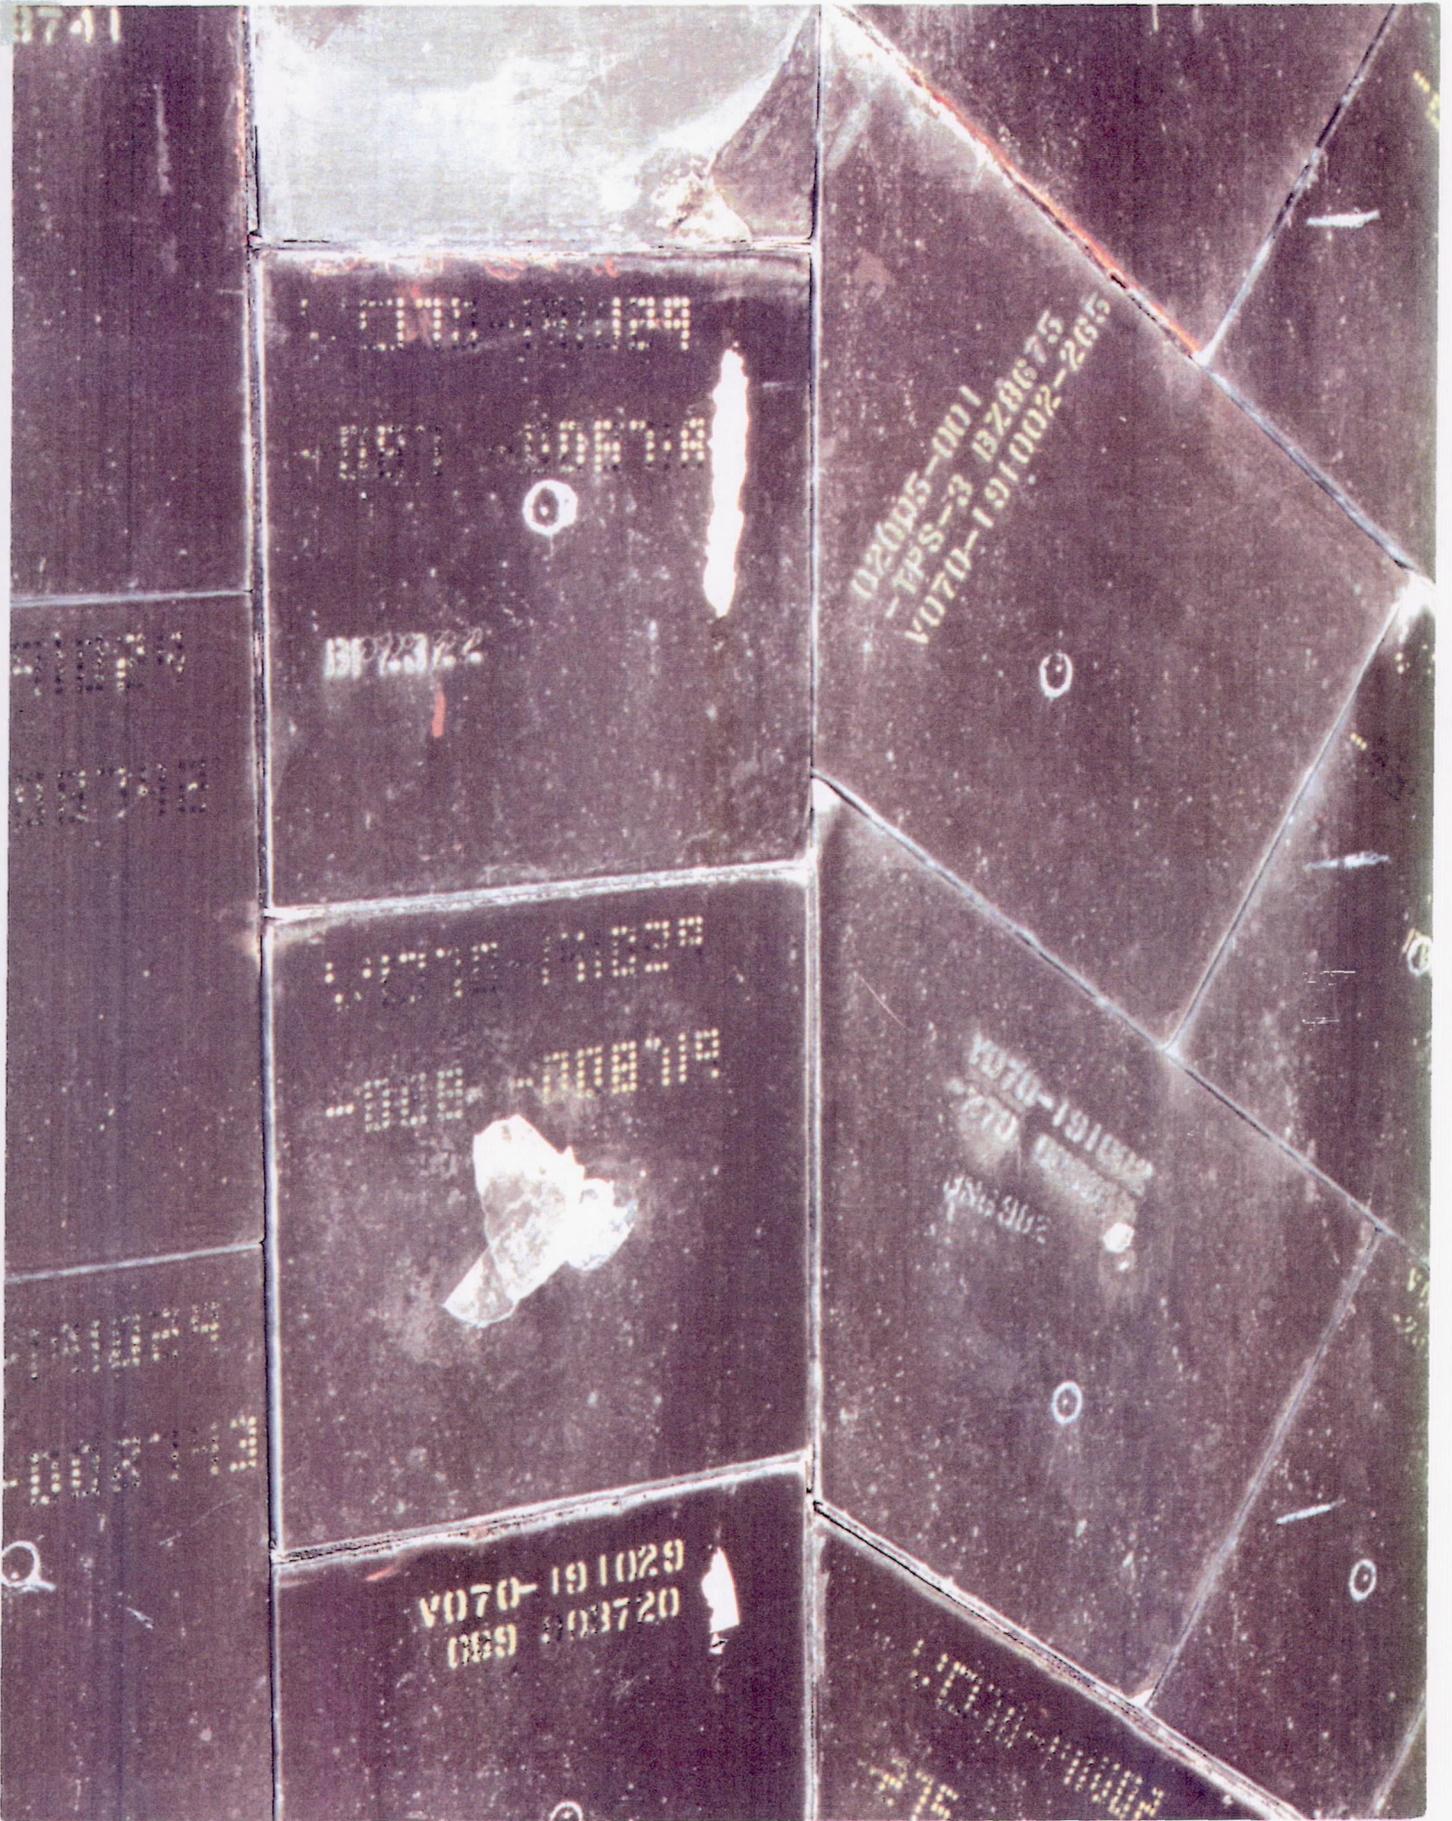
Typical tile damage from debris impacts
