Debris/Ice/TPS Assessment And Photographic Analysis For Shuttle Mission STS-37

April 1991

Gregory N. Katnik
NASA/Kennedy Space Center

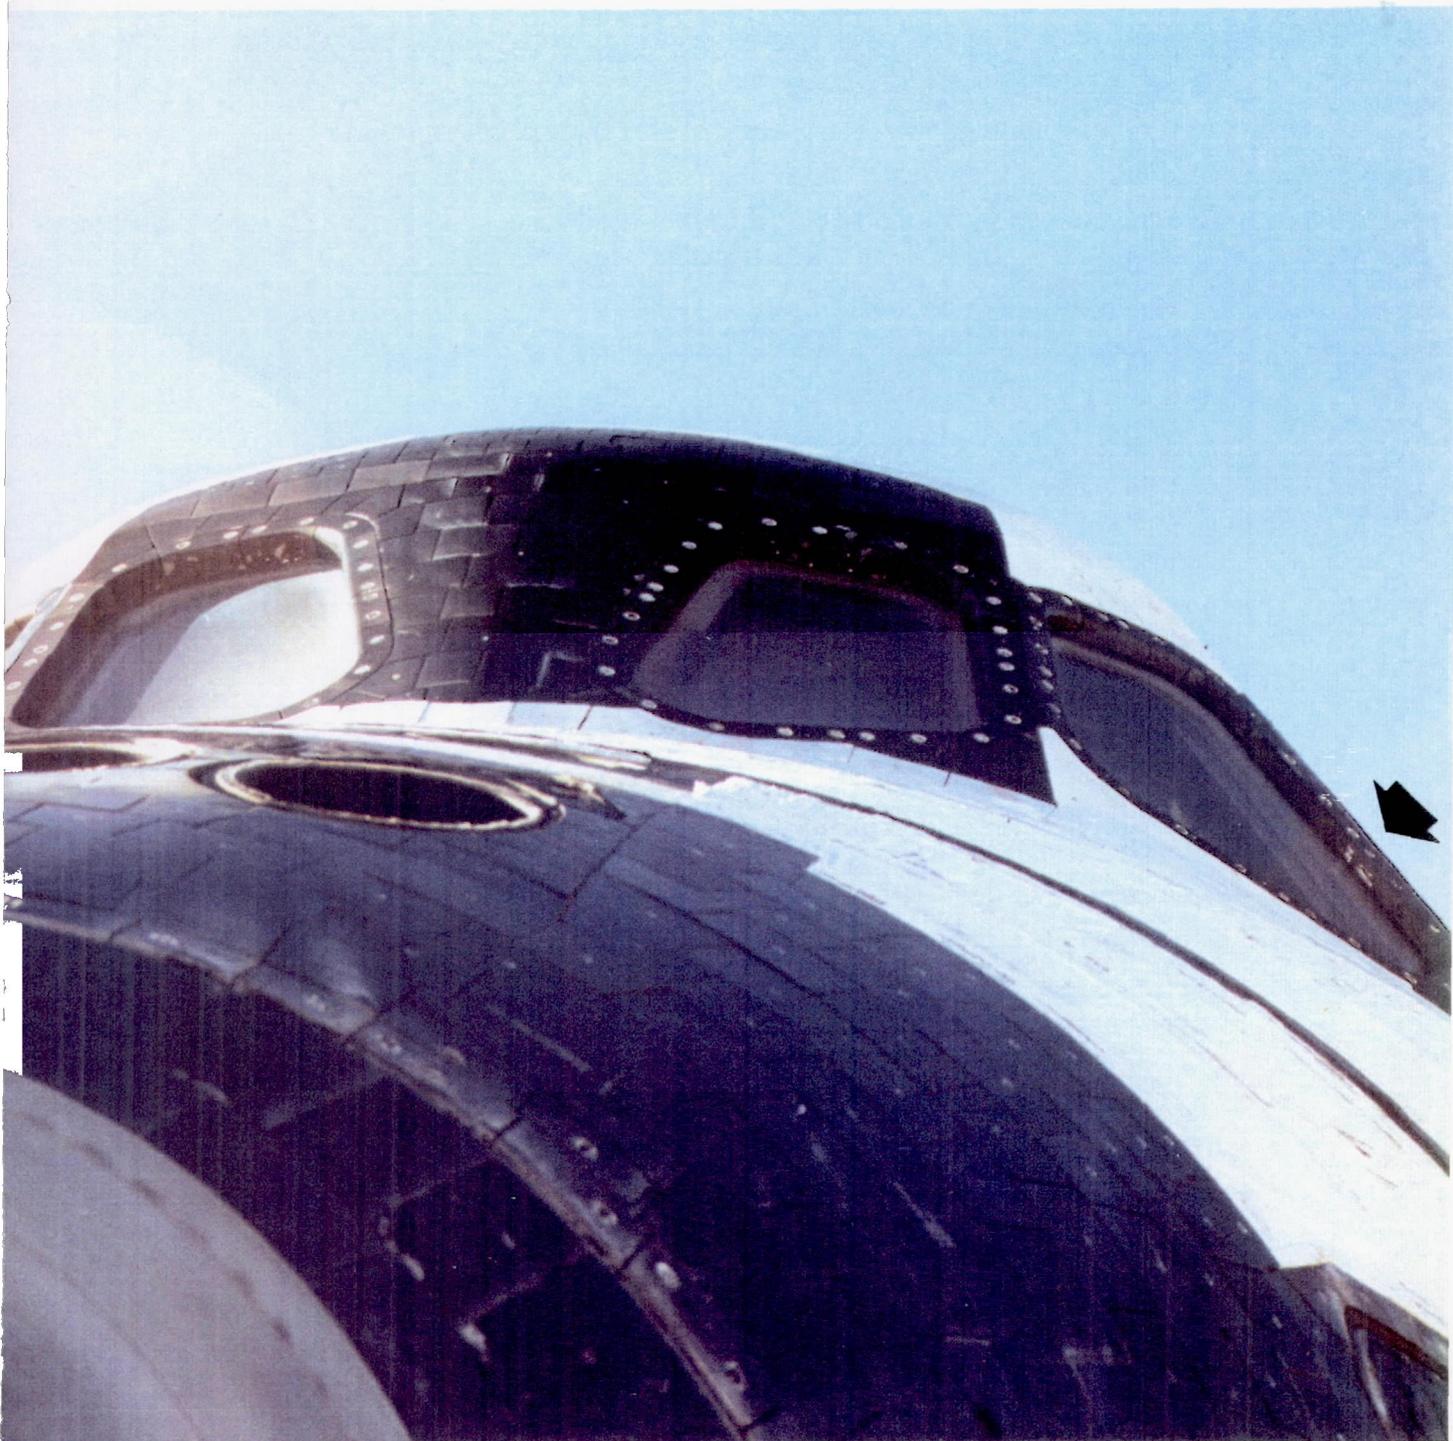
Orbiter windows #3 and #4 were moderately hazed with a few small streaks. Windows #2 and #5 were lightly hazed. Two tile hits greater than 1-inch in size occurred aft of window #1.

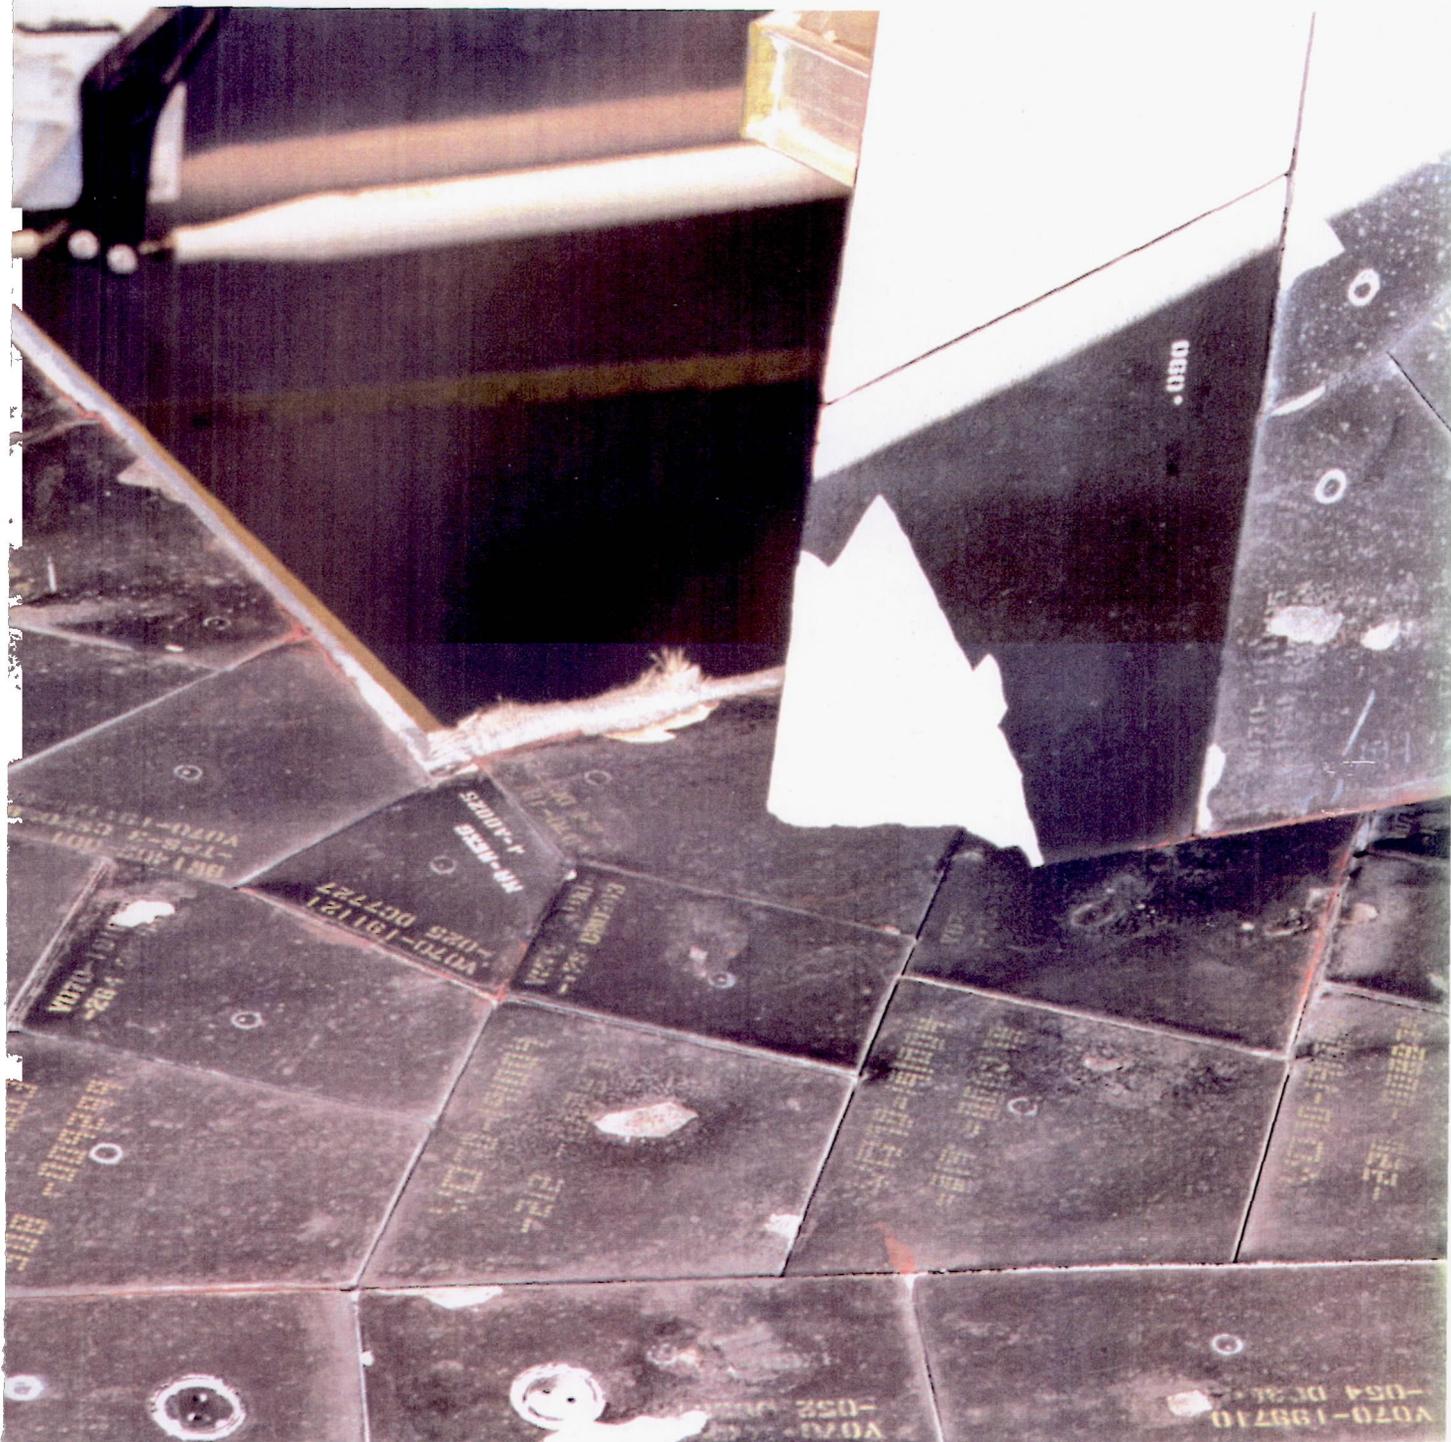
Damage to corner tile on the RH MLG door occurred when the
door was opened for landing

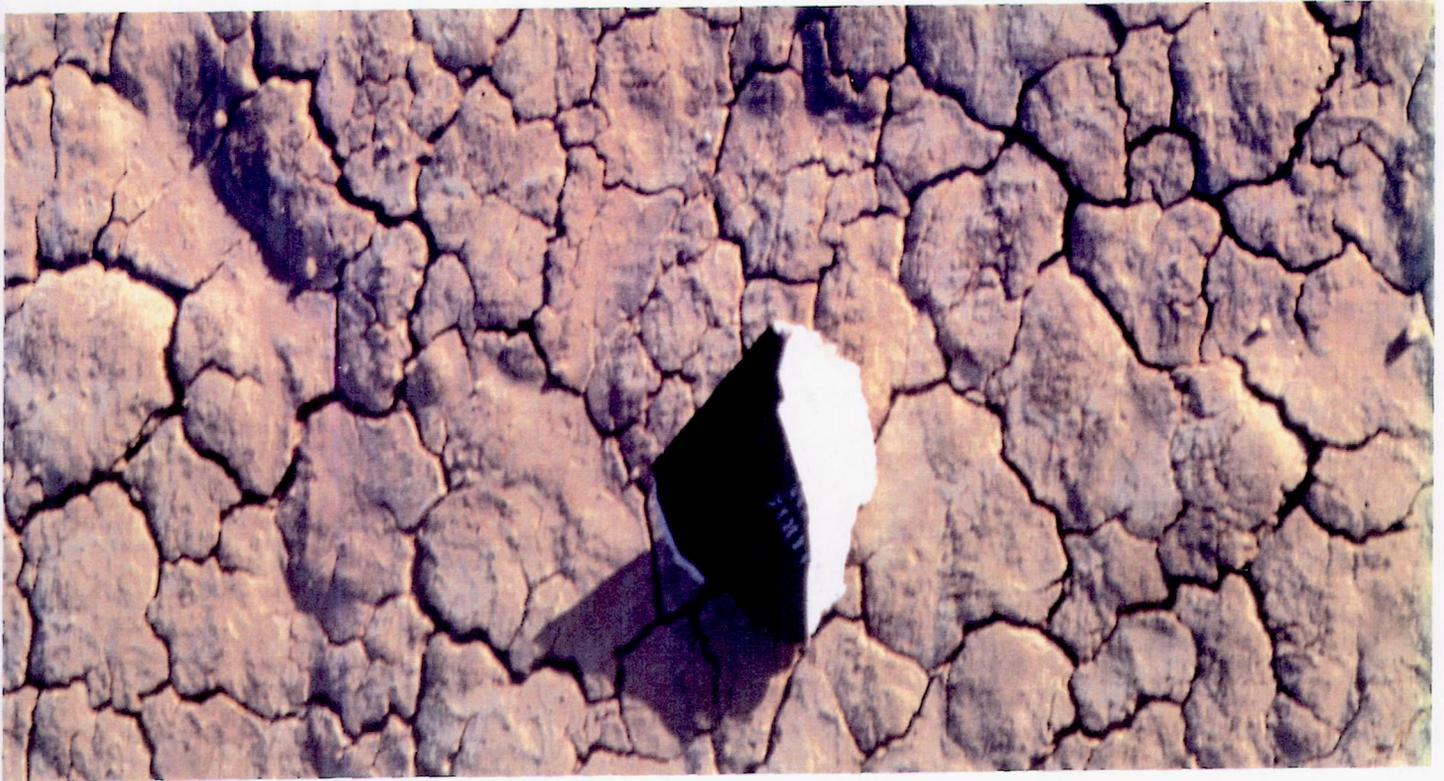
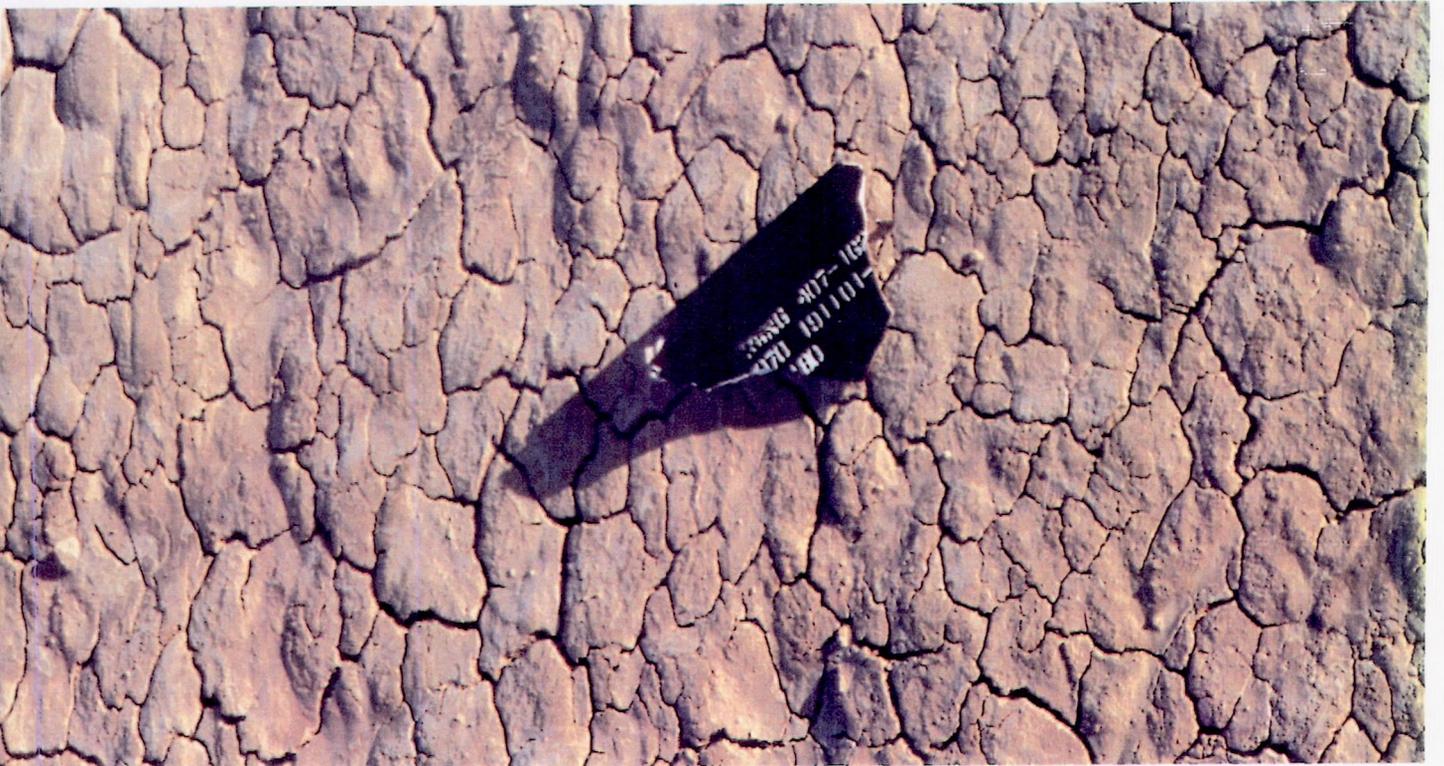
The only flight hardware found on the runway were pieces of the broken tile from the RH main landing gear door
