# Debris/Ice/TPS Assessment And Photographic Analysis For Shuttle Mission STS-40

DEBRIS/ICE/TPS ASSESSMENT  
AND  
PHOTOGRAPHIC ANALYSIS  
OF  
SHUTTLE MISSION STS-40

June 5, 1991.

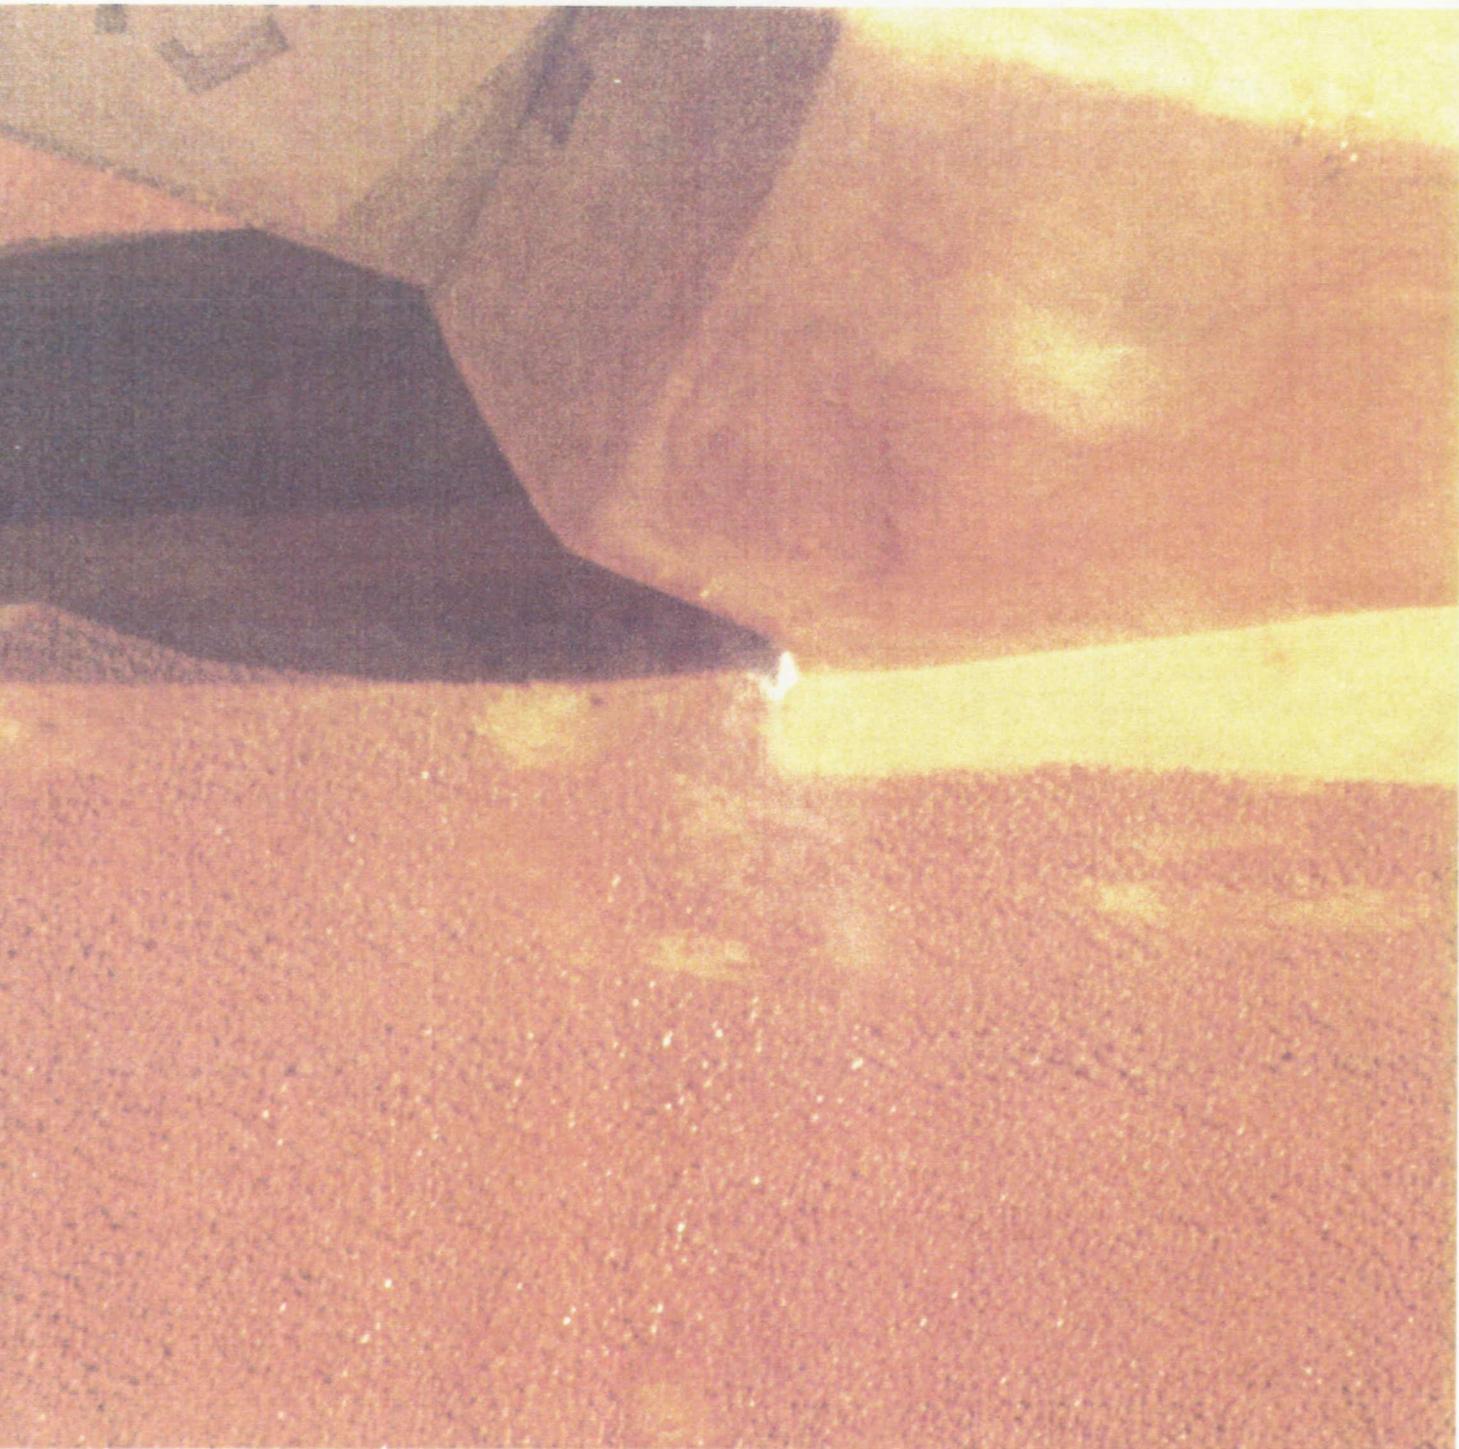
A small ice/frost spot with venting vapors formed at the  
+Y ET/SRB cable tray-to-LH2 tank closeout bondline

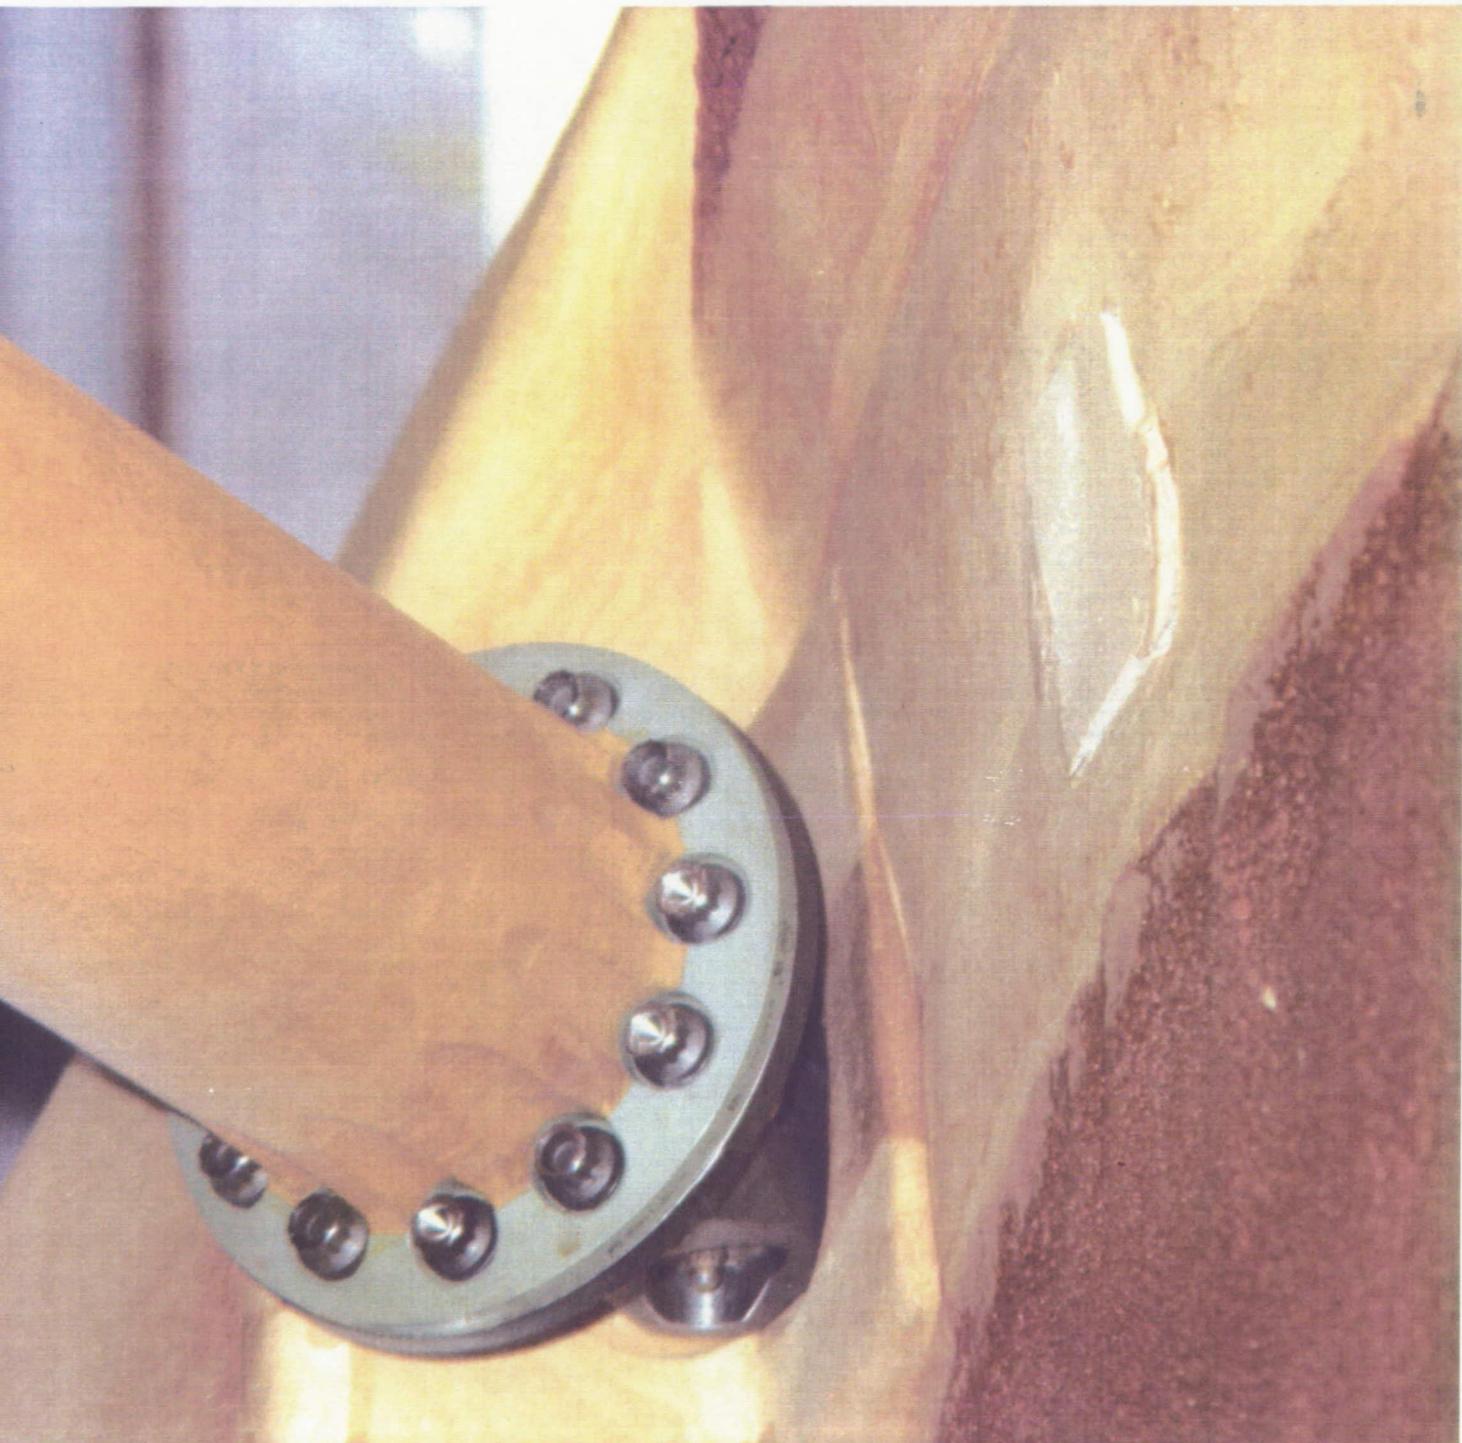
View of the External Tank forward attach point bipods, +Z side of the intertank and upper LH2 tank. Pre-launch inspection revealed a debond of the -Y bipod jack pad closeout, though the debond was not visible from this side of the vehicle.

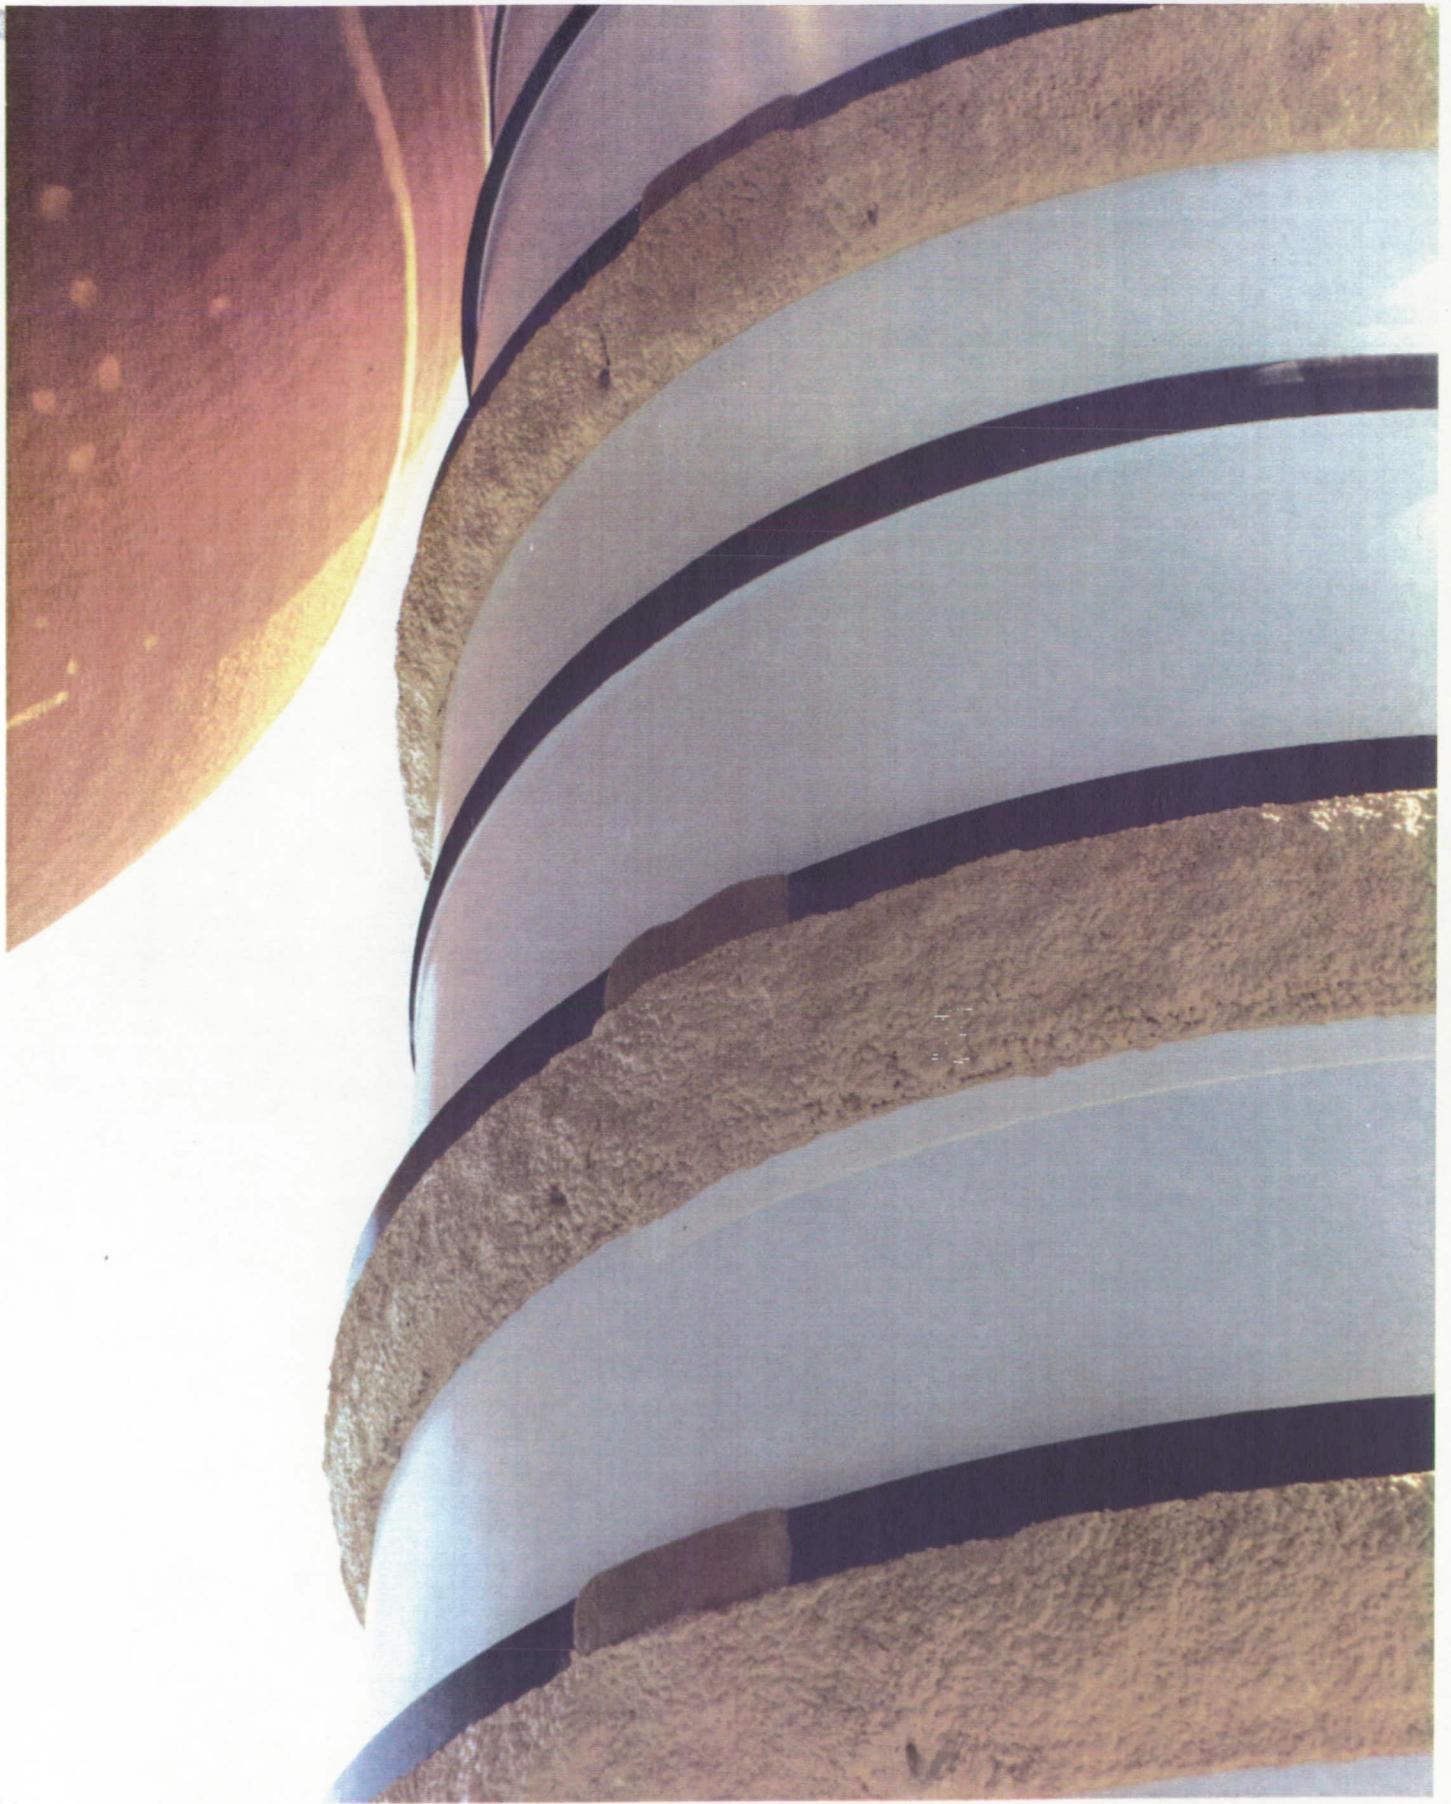
The ET -Y bipod jack pad closeout debonded and was protruding 1/4-inch above the adjacent foam surface. The discrepant closeout was removed and repaired with PDL prior to the second cryoload.

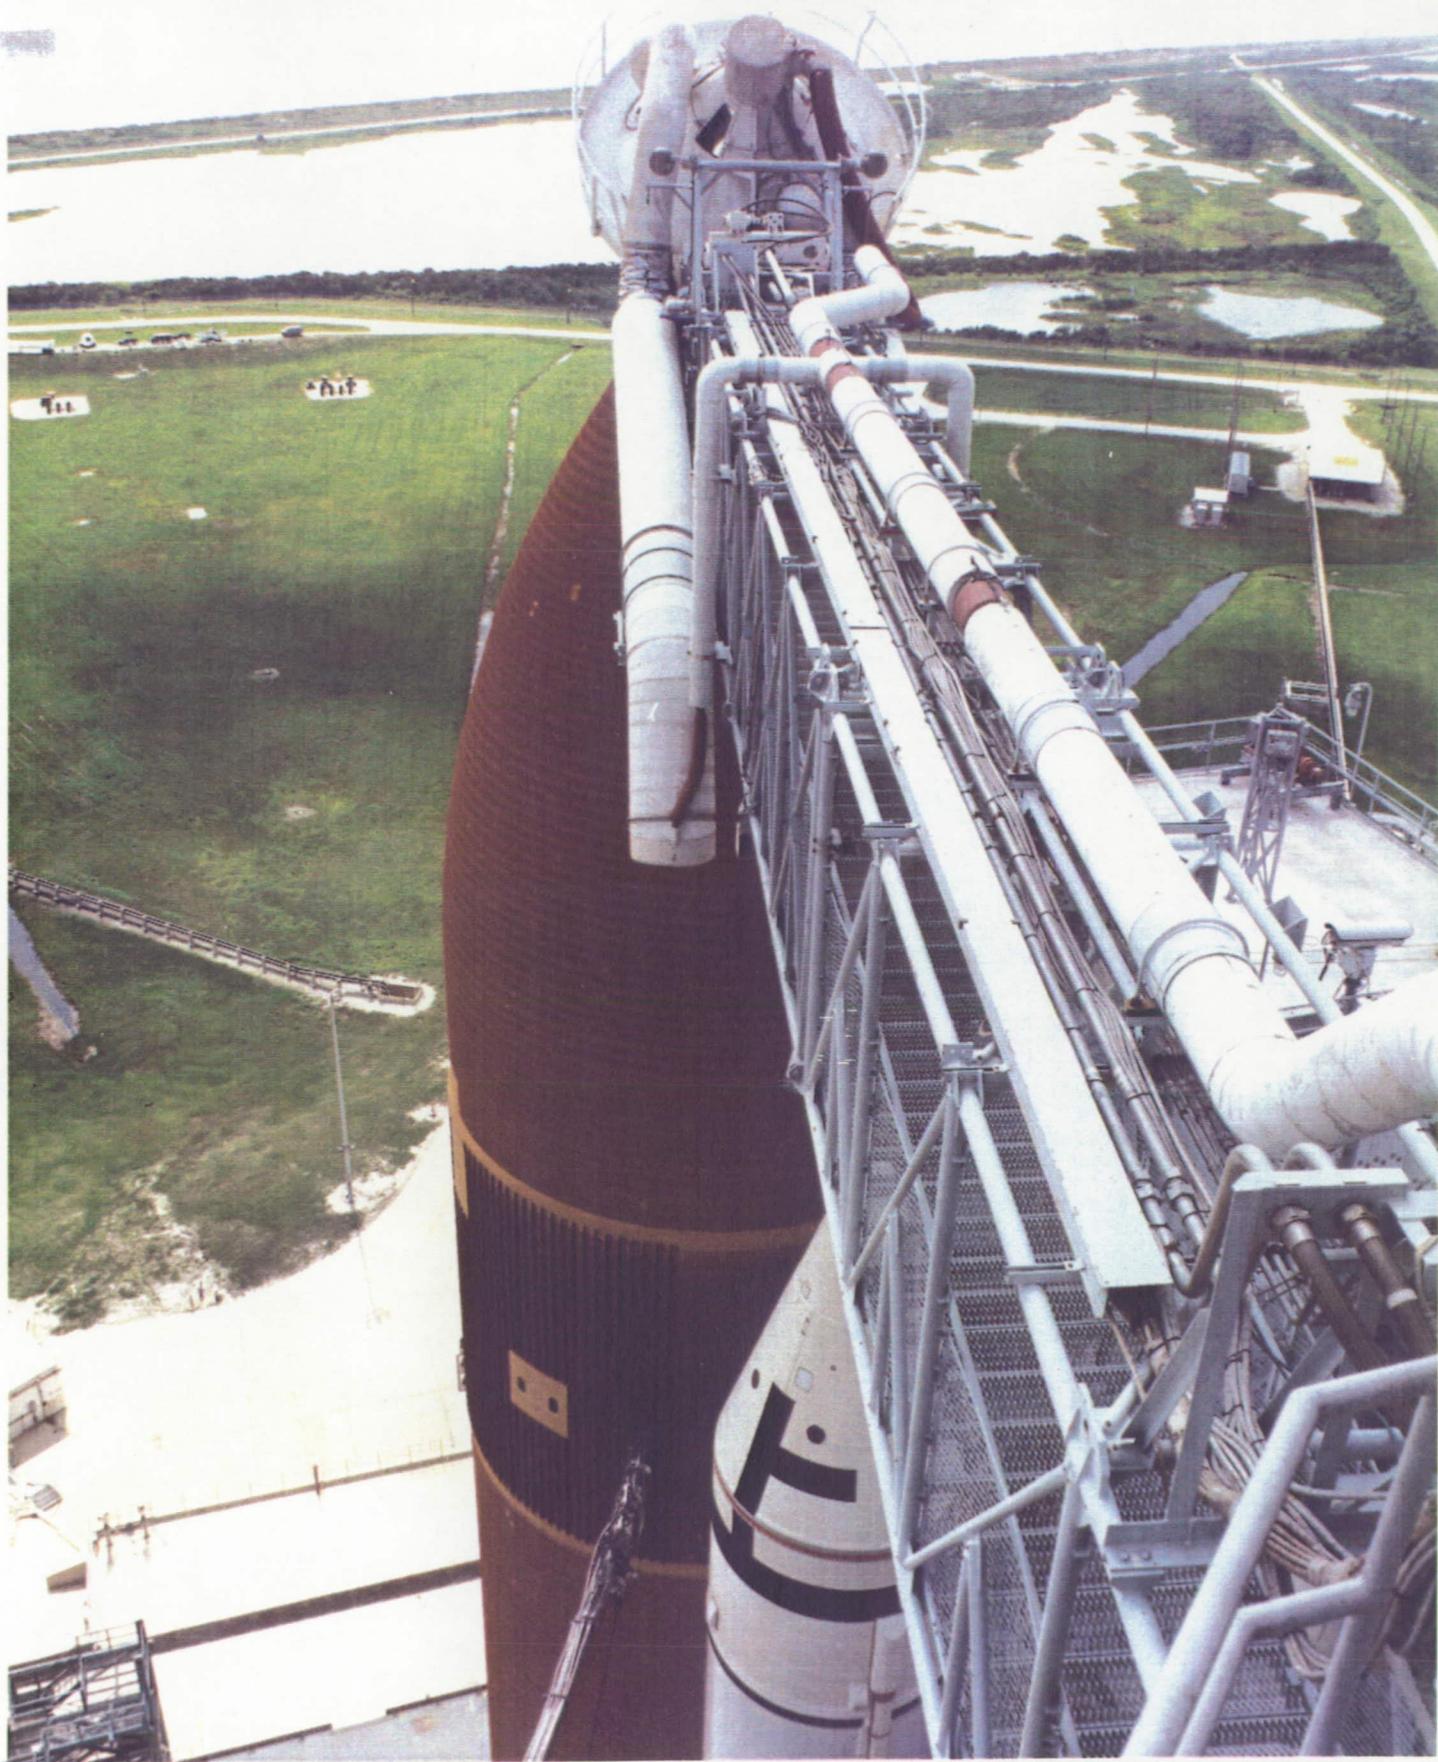
Three of nine aft booster stiffener ring splice plate K5NA closeouts are located on the Orbiter side of the RH Solid Rocket Booster

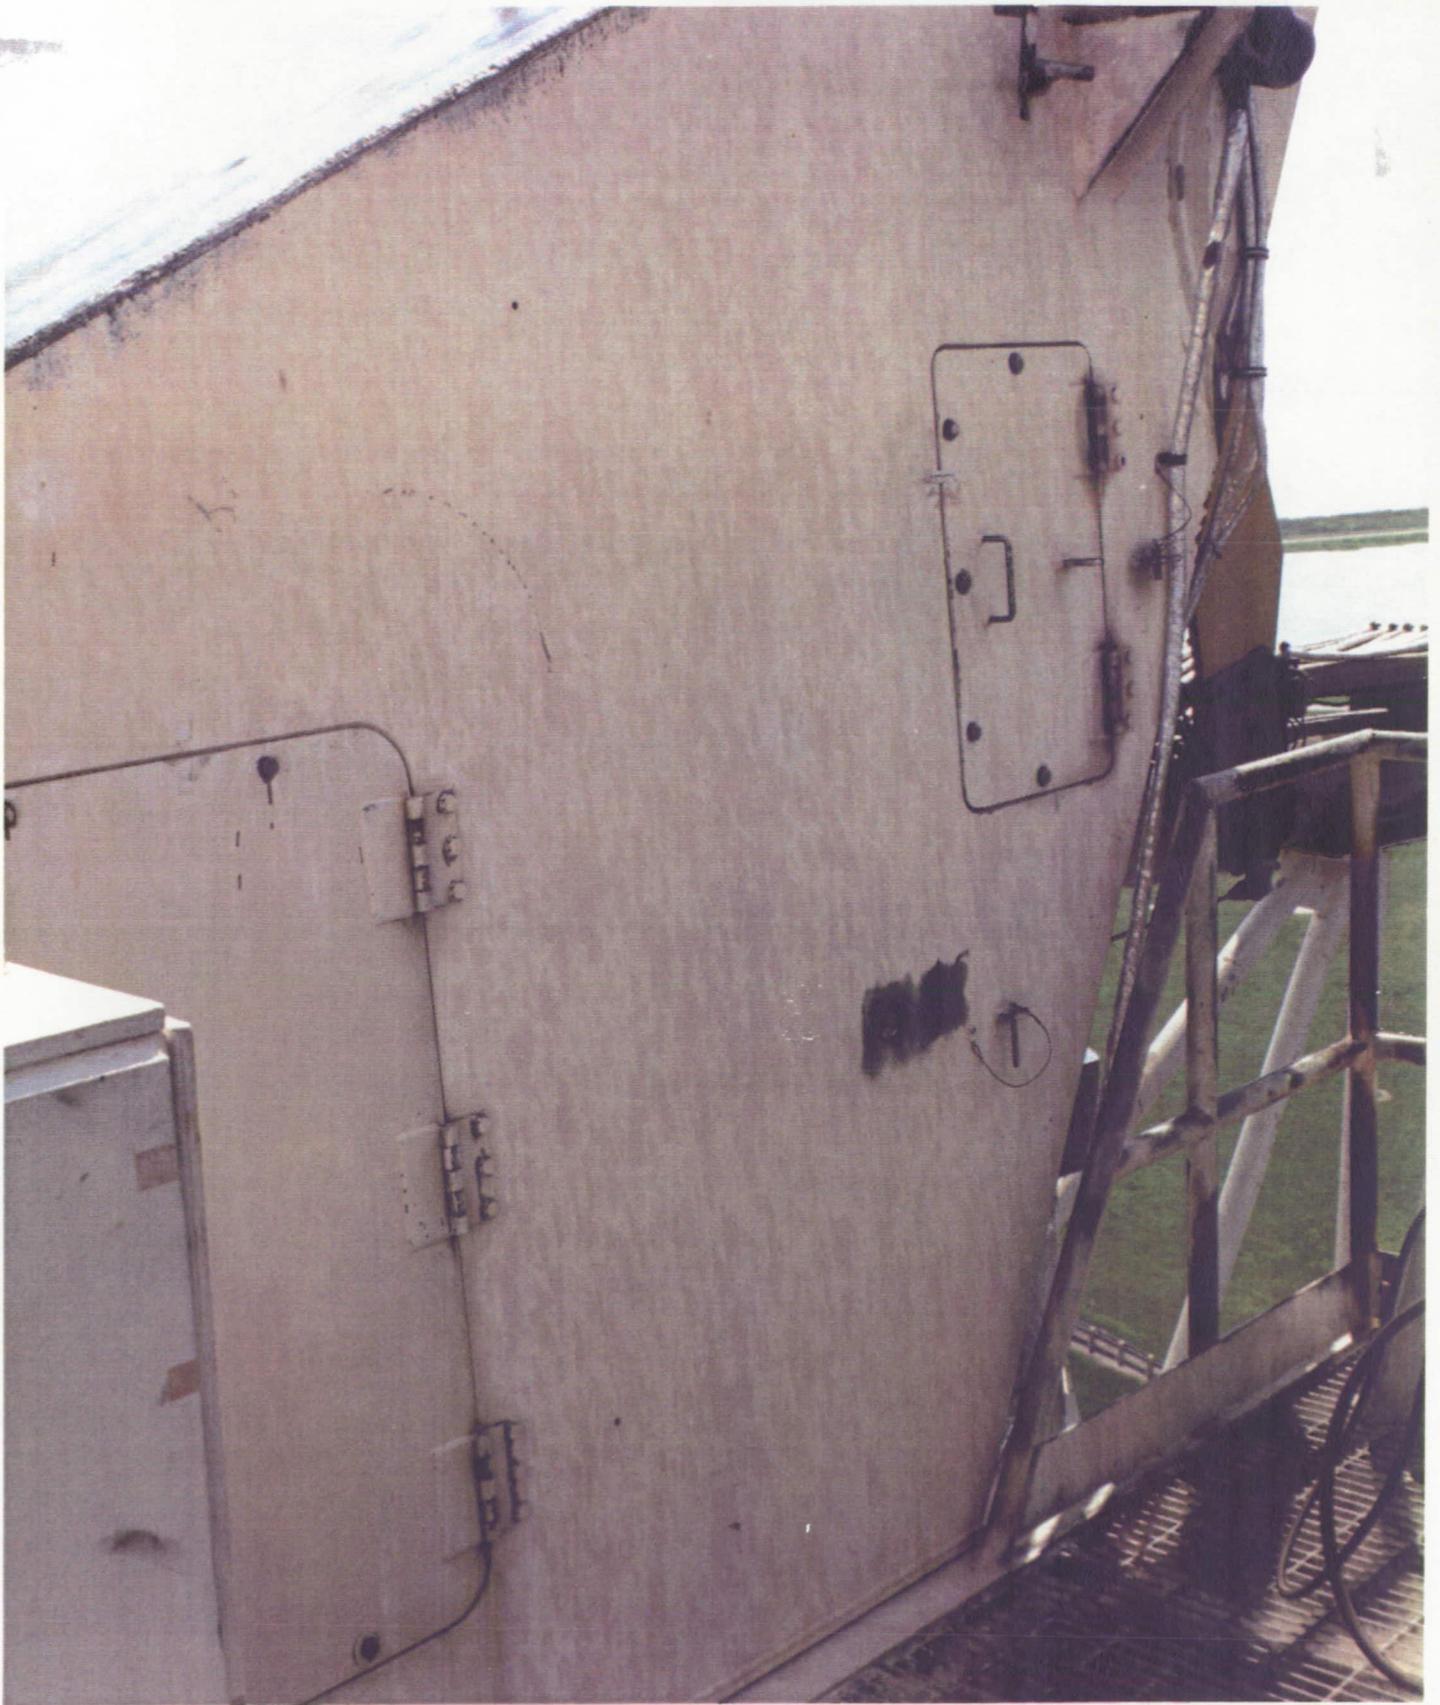
Hydraulic fluid leaked from the GOX vent arm hinge area and was blown toward the vehicle by prevailing winds. Hydraulic fluid drops were present on the -Y-Z quadrant of the External Tank and on the LH SRB. The Orbiter was sheltered by the RSS/OWP.

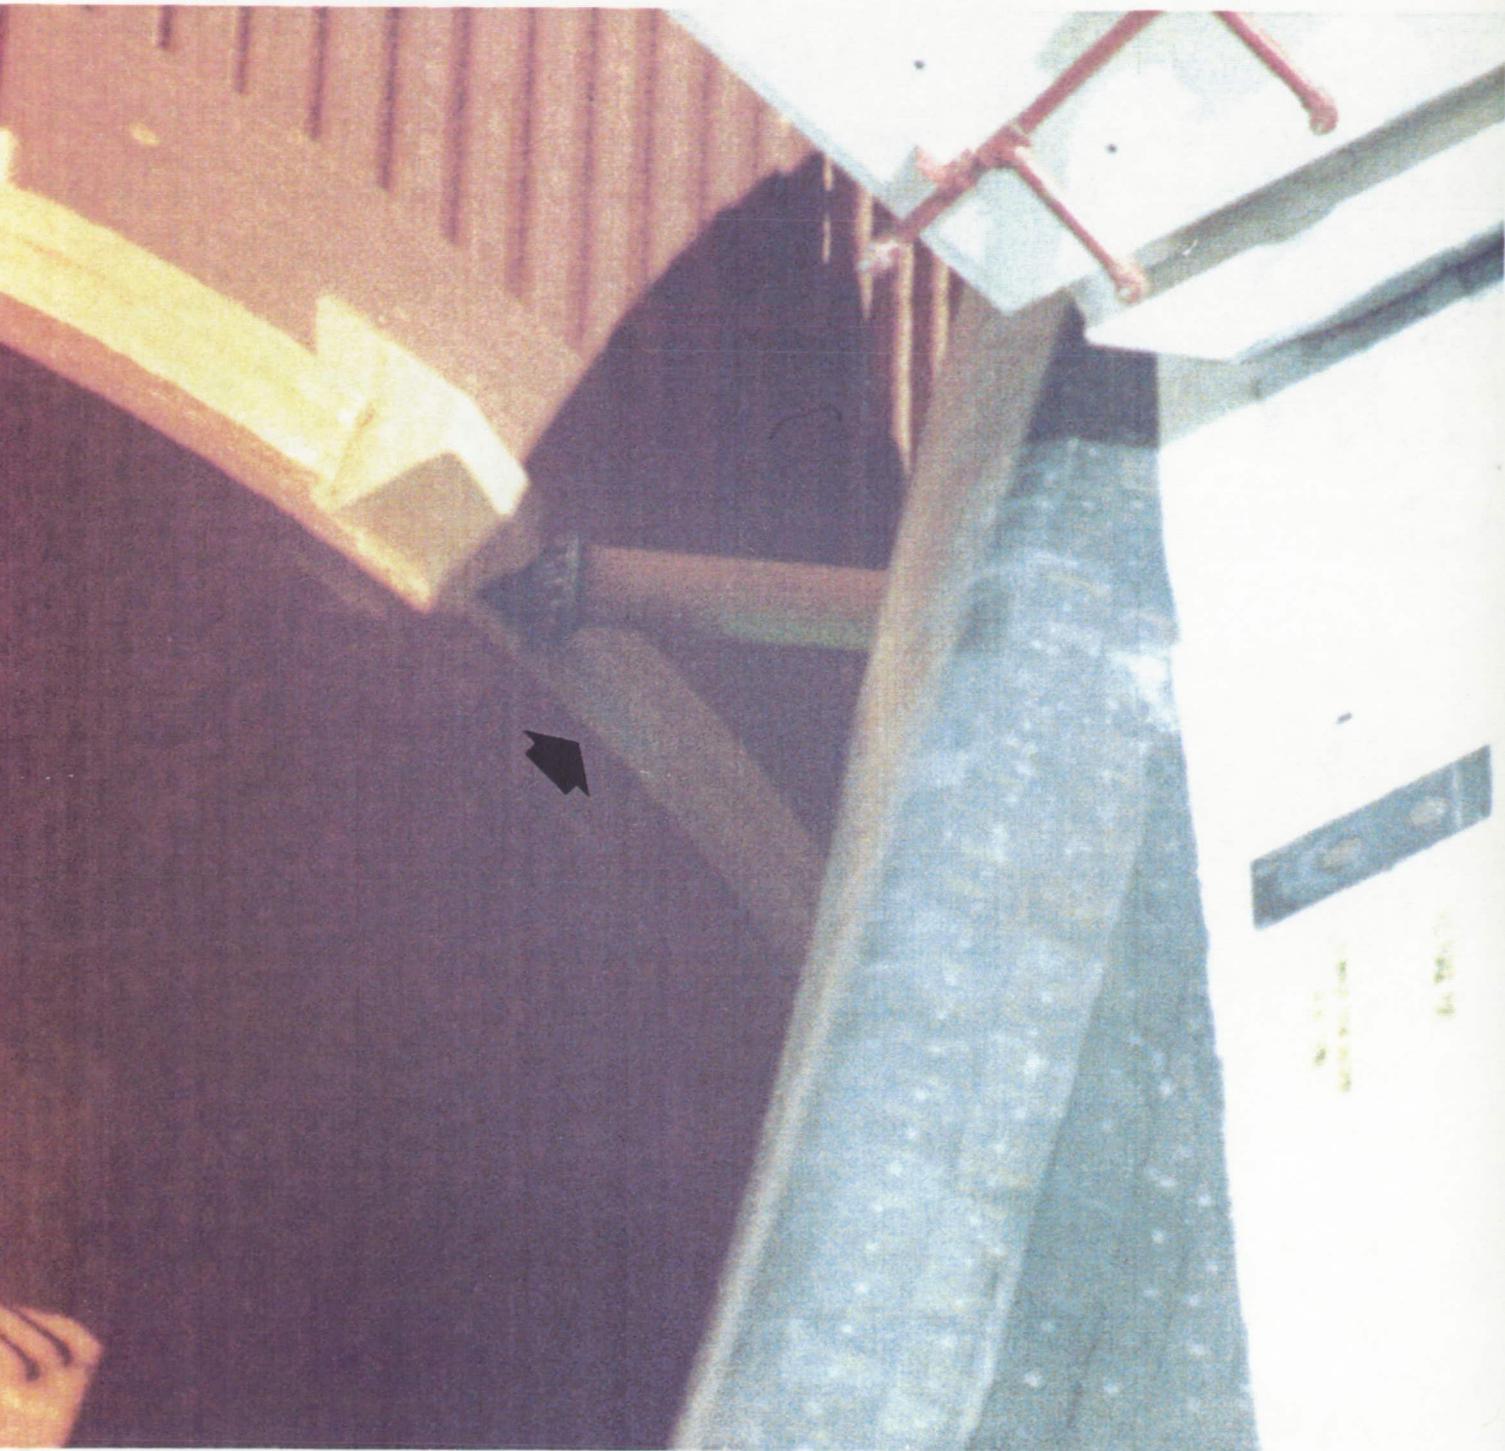
The PDL repair to the ET -Y jack pad closeout was intact after cryogenic loading. The repair was flush with the surrounding foam. No ice or frost was present on the TPS or adhesive bond line. There was no venting of vapor.

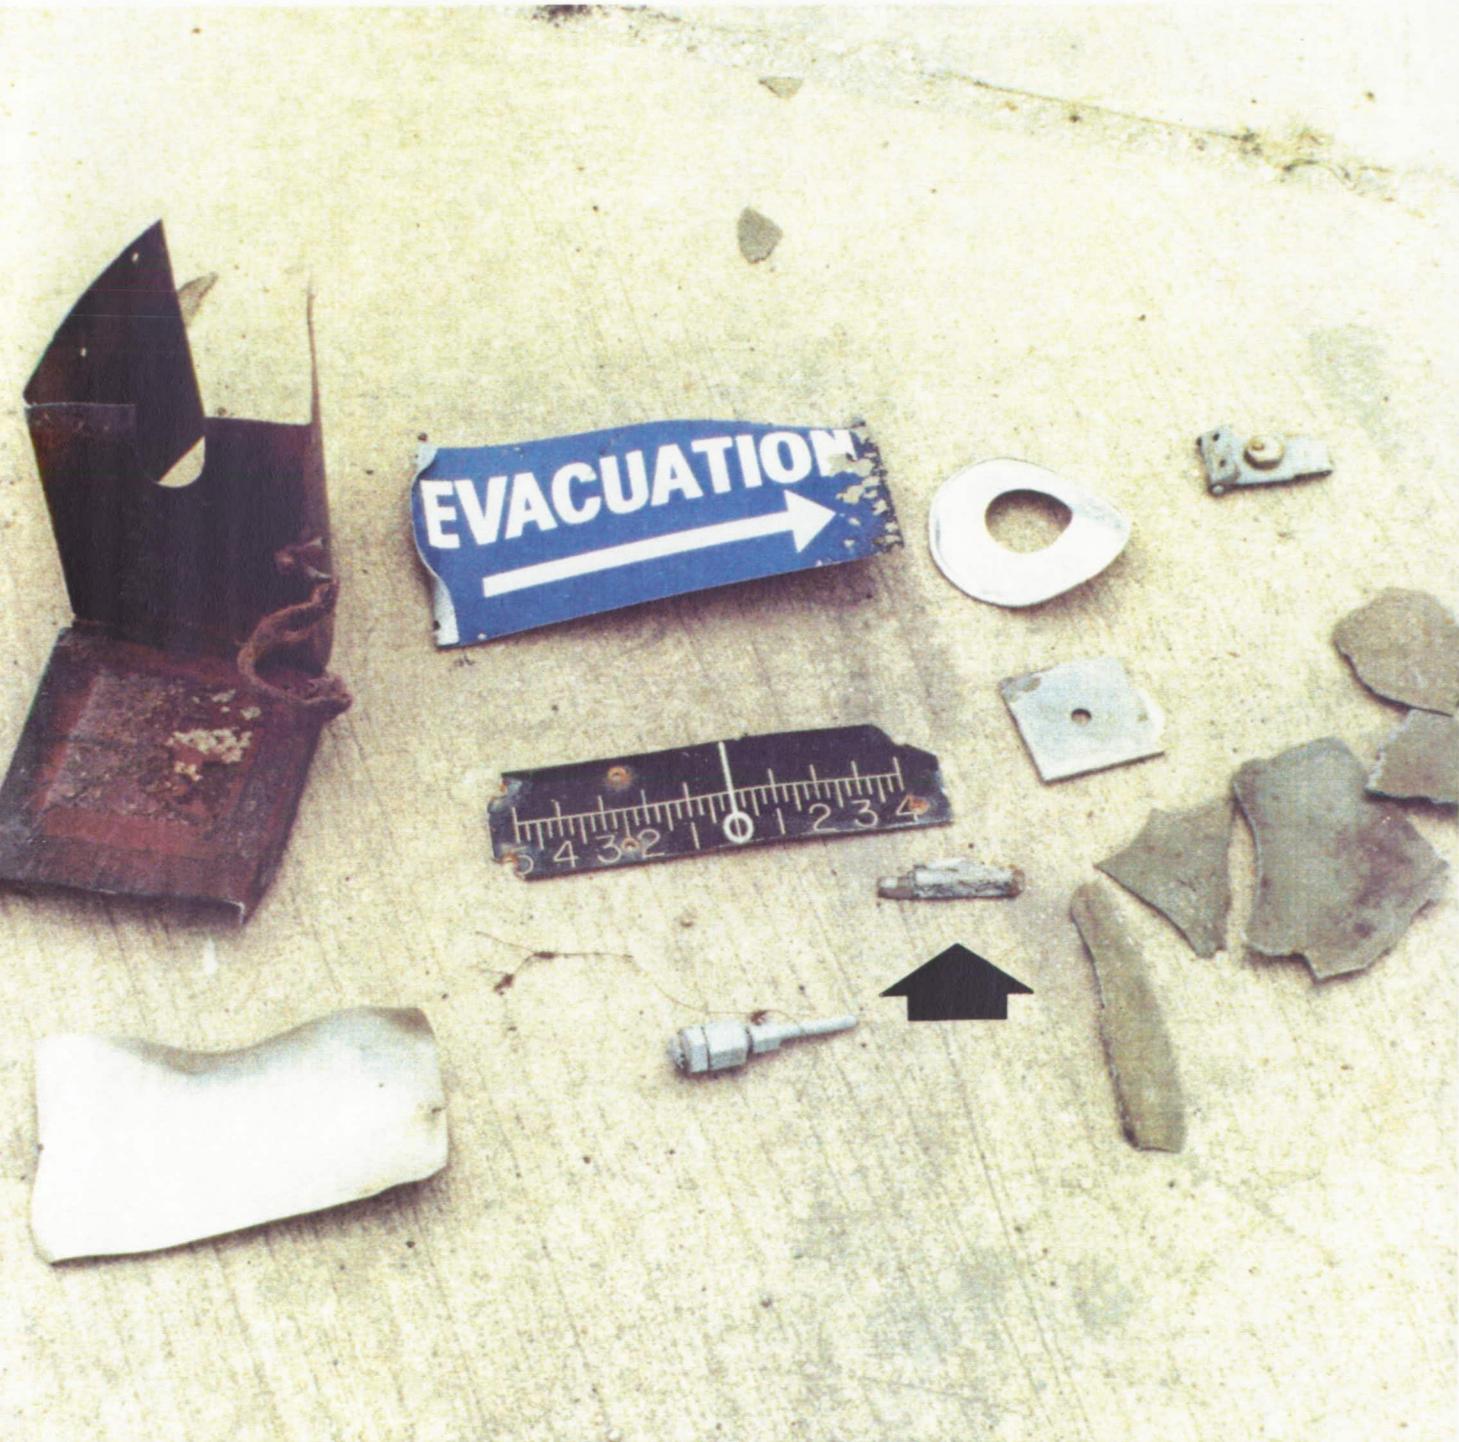
Typical facility debris was found on the pad after launch. A frangible nut fragment 3.25" x 1" x 0.5" from holddown post #5 (arrow) lay on the MLP deck under a sound suppression water pipe just east of the HDP #5 haunch. No flight hardware or TPS materials were found.

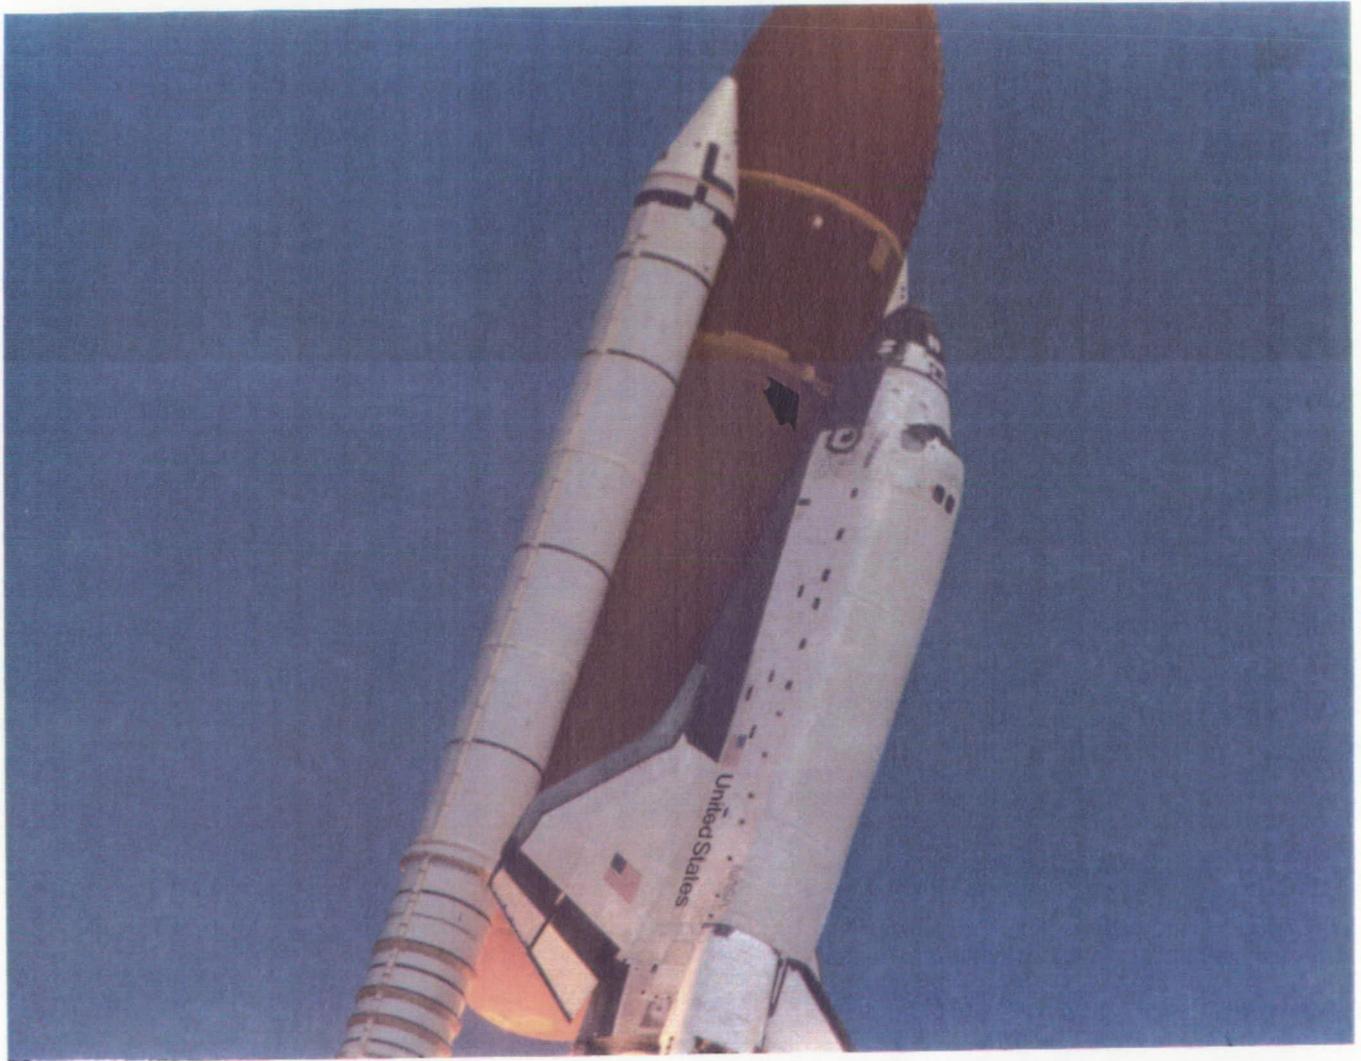
PDL repair to the ET -Y jack pad closeout was intact through the roll maneuver and early ascent. Although resolution of this area decreased as the vehicle gained altitude, no material fell aft from this location while the area was in view.

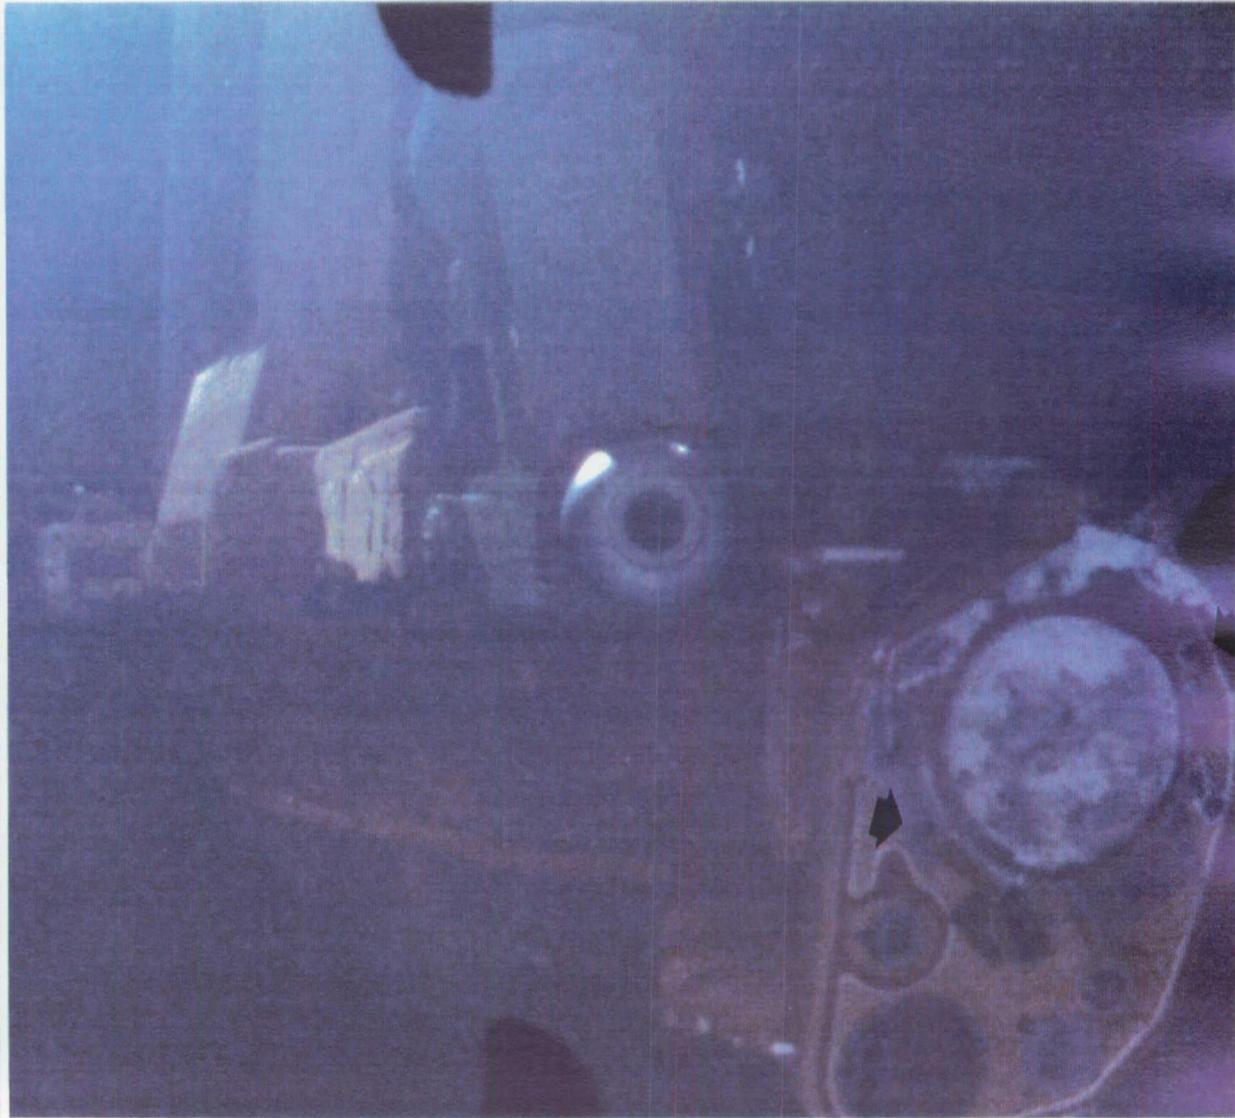
The shear pin bushing was missing from the outboard location of the LH2 ET/ORB umbilical shear pin hole. Note the difference in sheen between the outboard and inboard locations

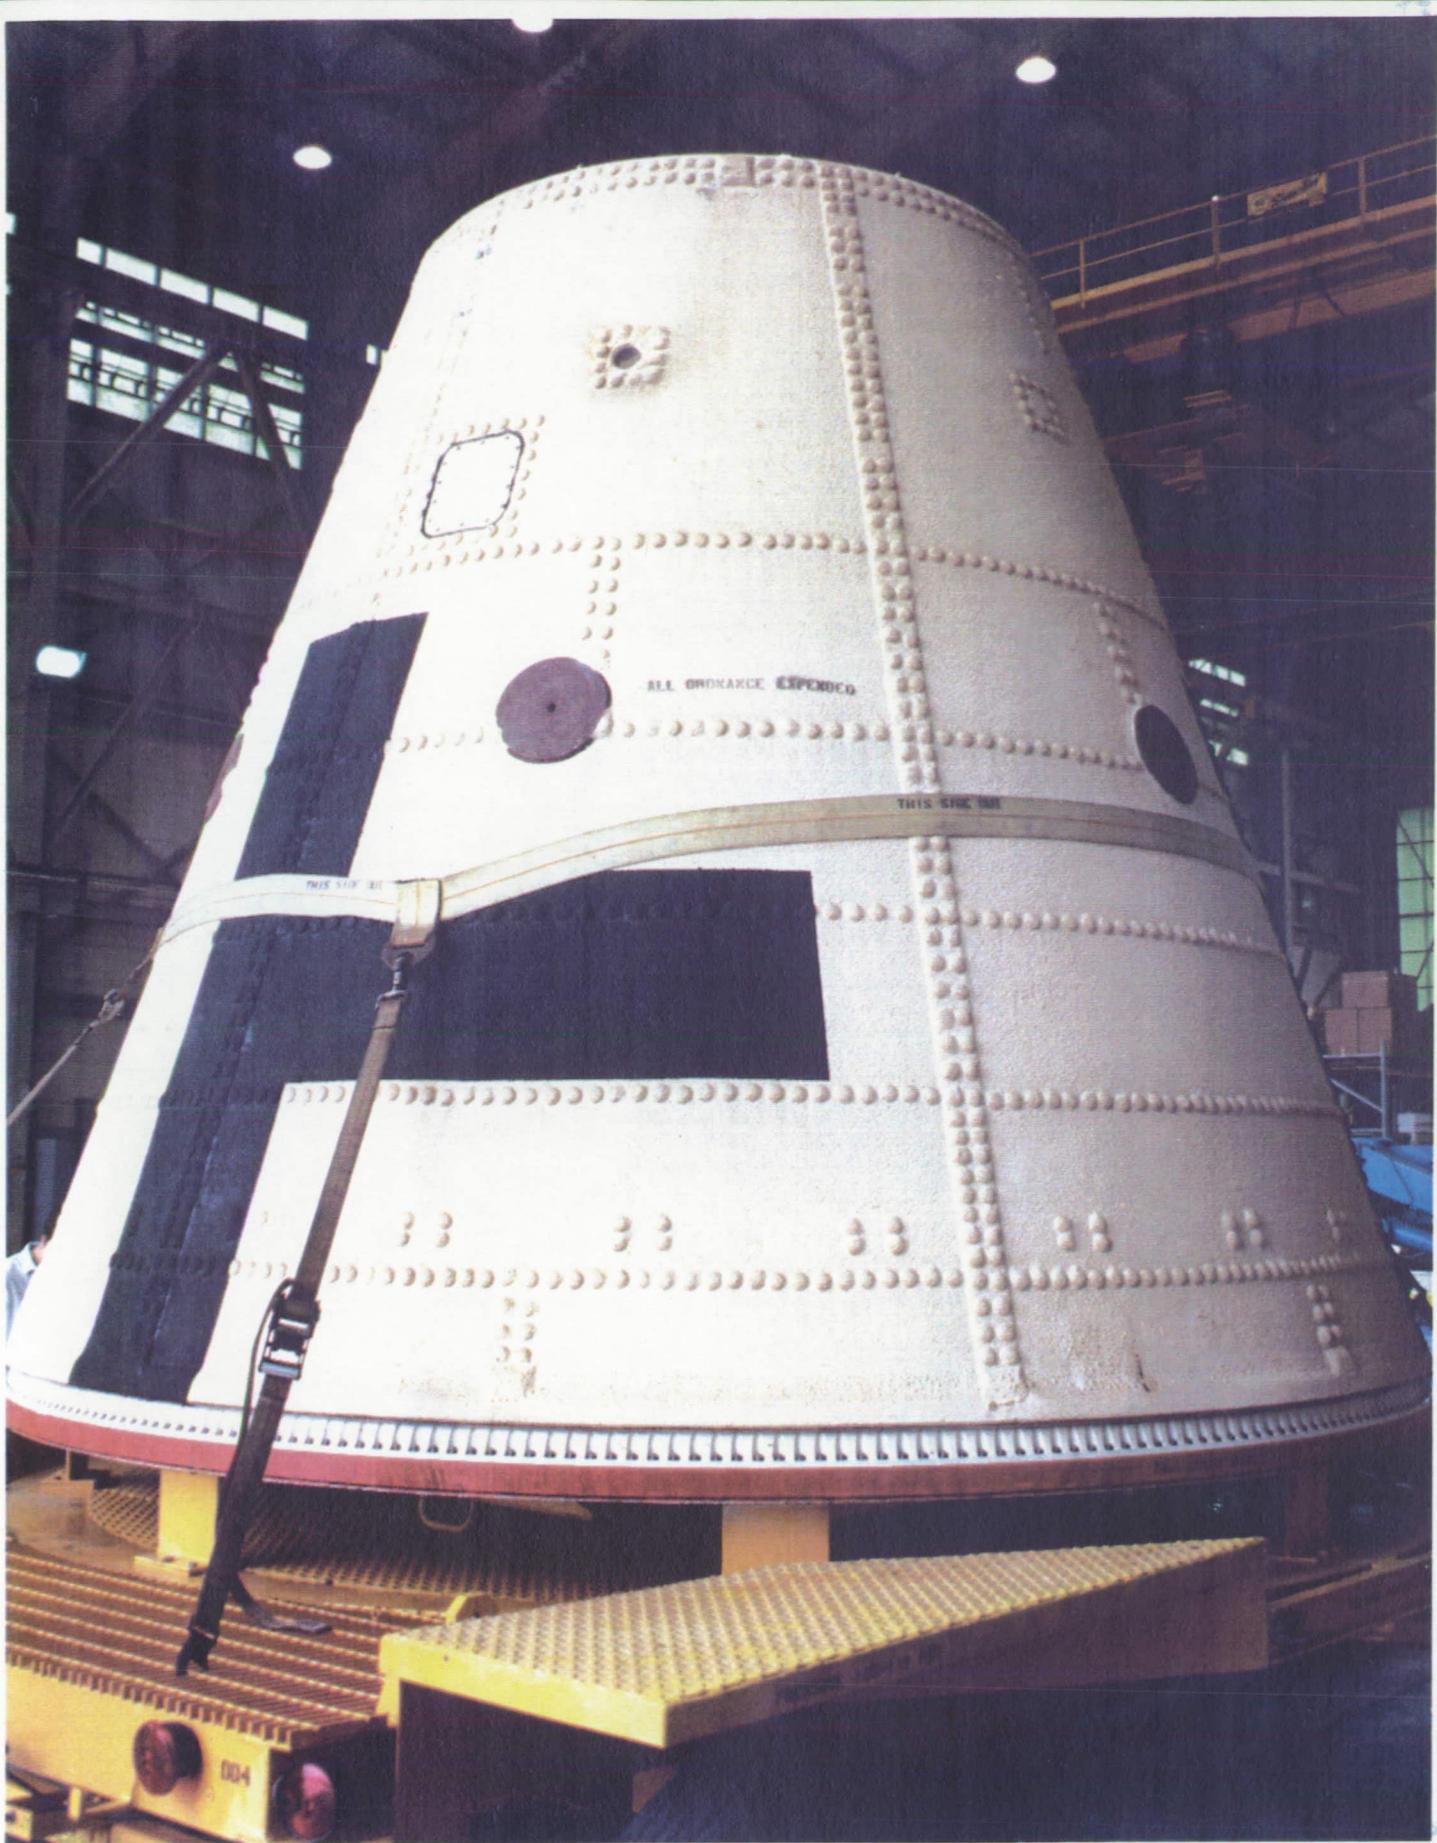
The RH frustum was not missing any TPS but had 32 MSA-2 debonds over fasteners.
