# Debris/Ice/TPS Assessment And Photographic Analysis For Shuttle Mission STS-40

DEBRIS/ICE/TPS ASSESSMENT  
AND  
PHOTOGRAPHIC ANALYSIS  
OF  
SHUTTLE MISSION STS-40

June 5, 1991.

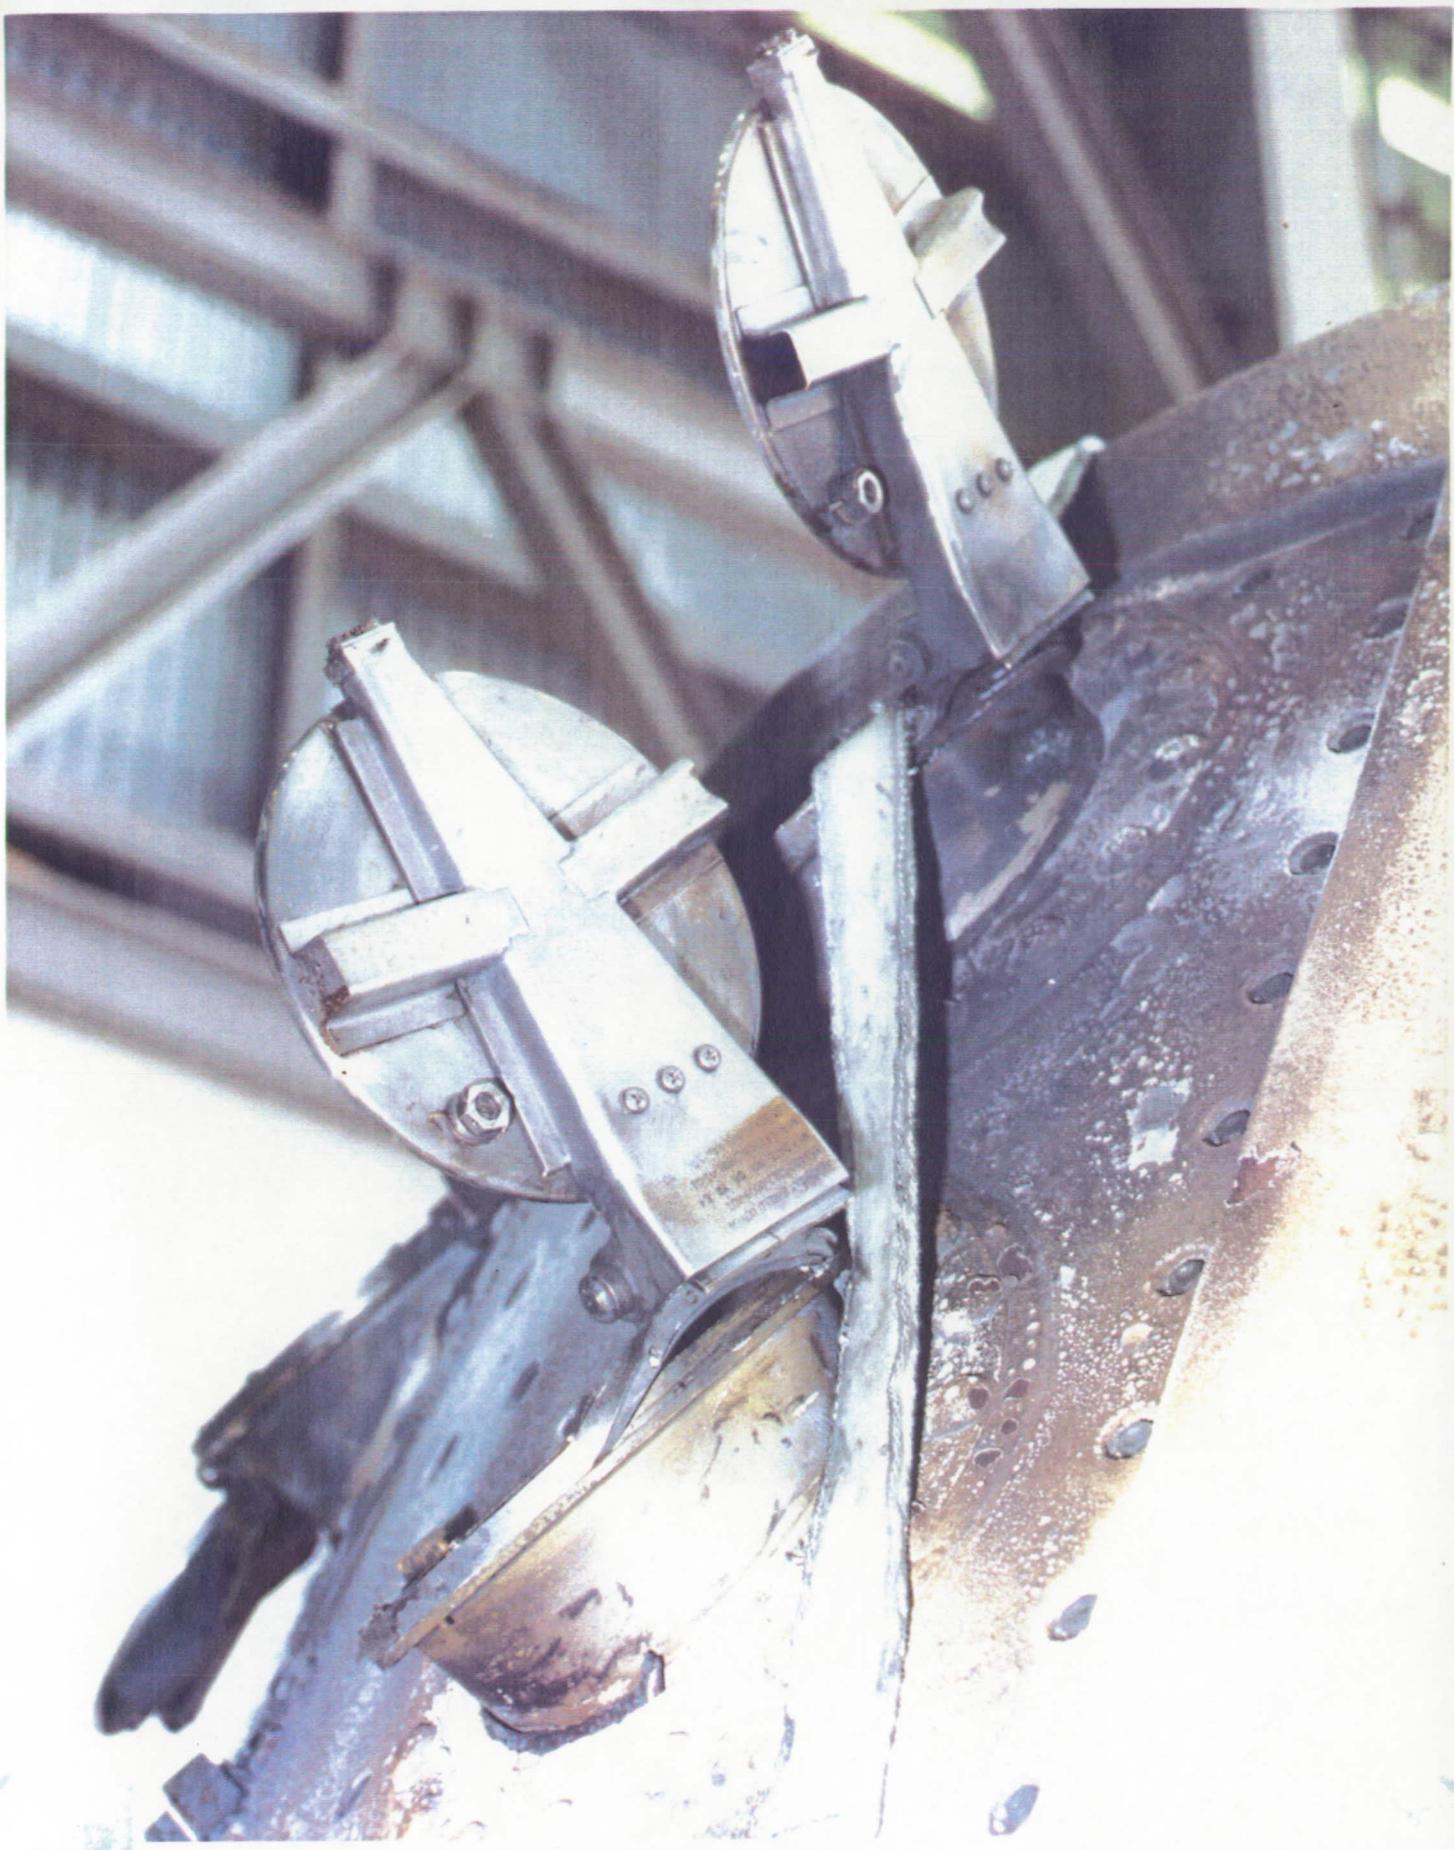
The BSM covers were locked in the open position, but two covers were bent upward by parachute riser entanglement.

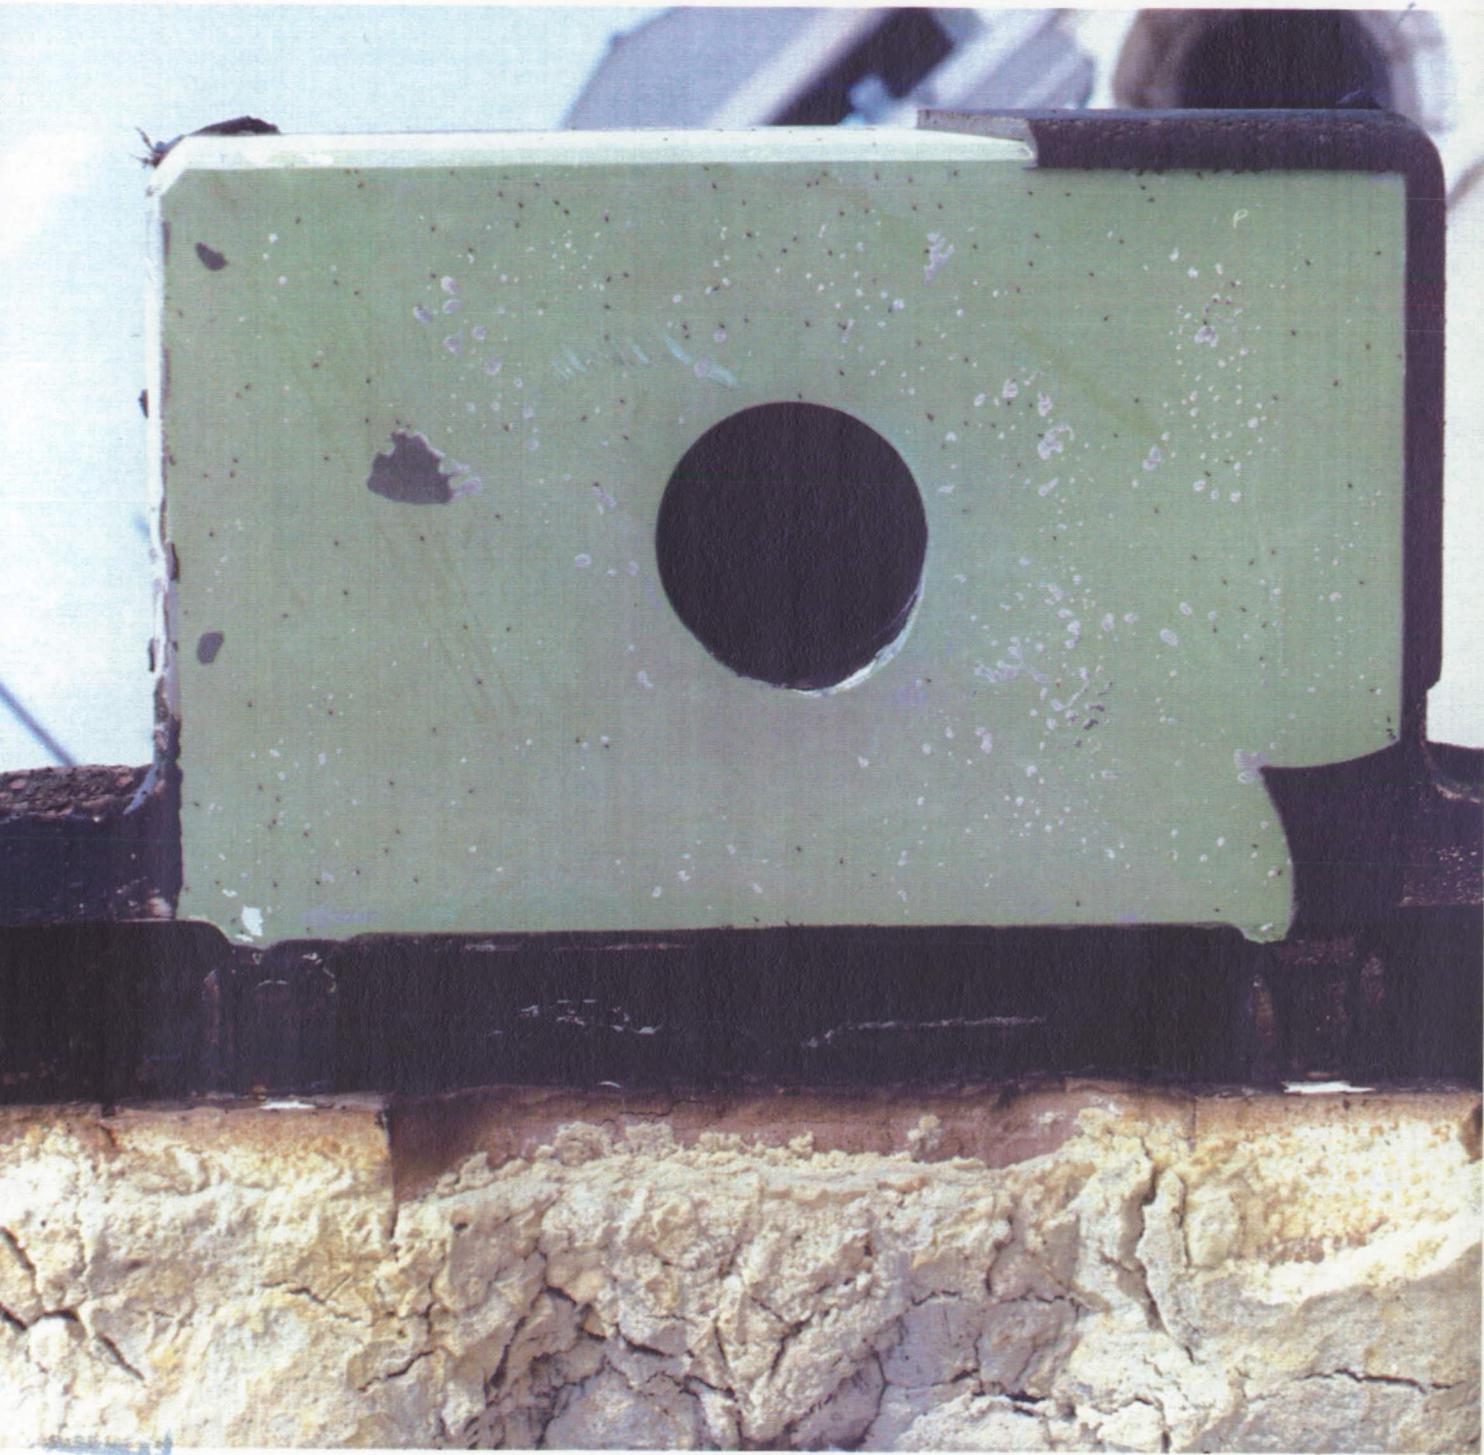
All four HDP Debris Containment System plungers were seated. Most of the EPON shim material was missing from the aft skirt after water impact, but none of the substrate was charred.

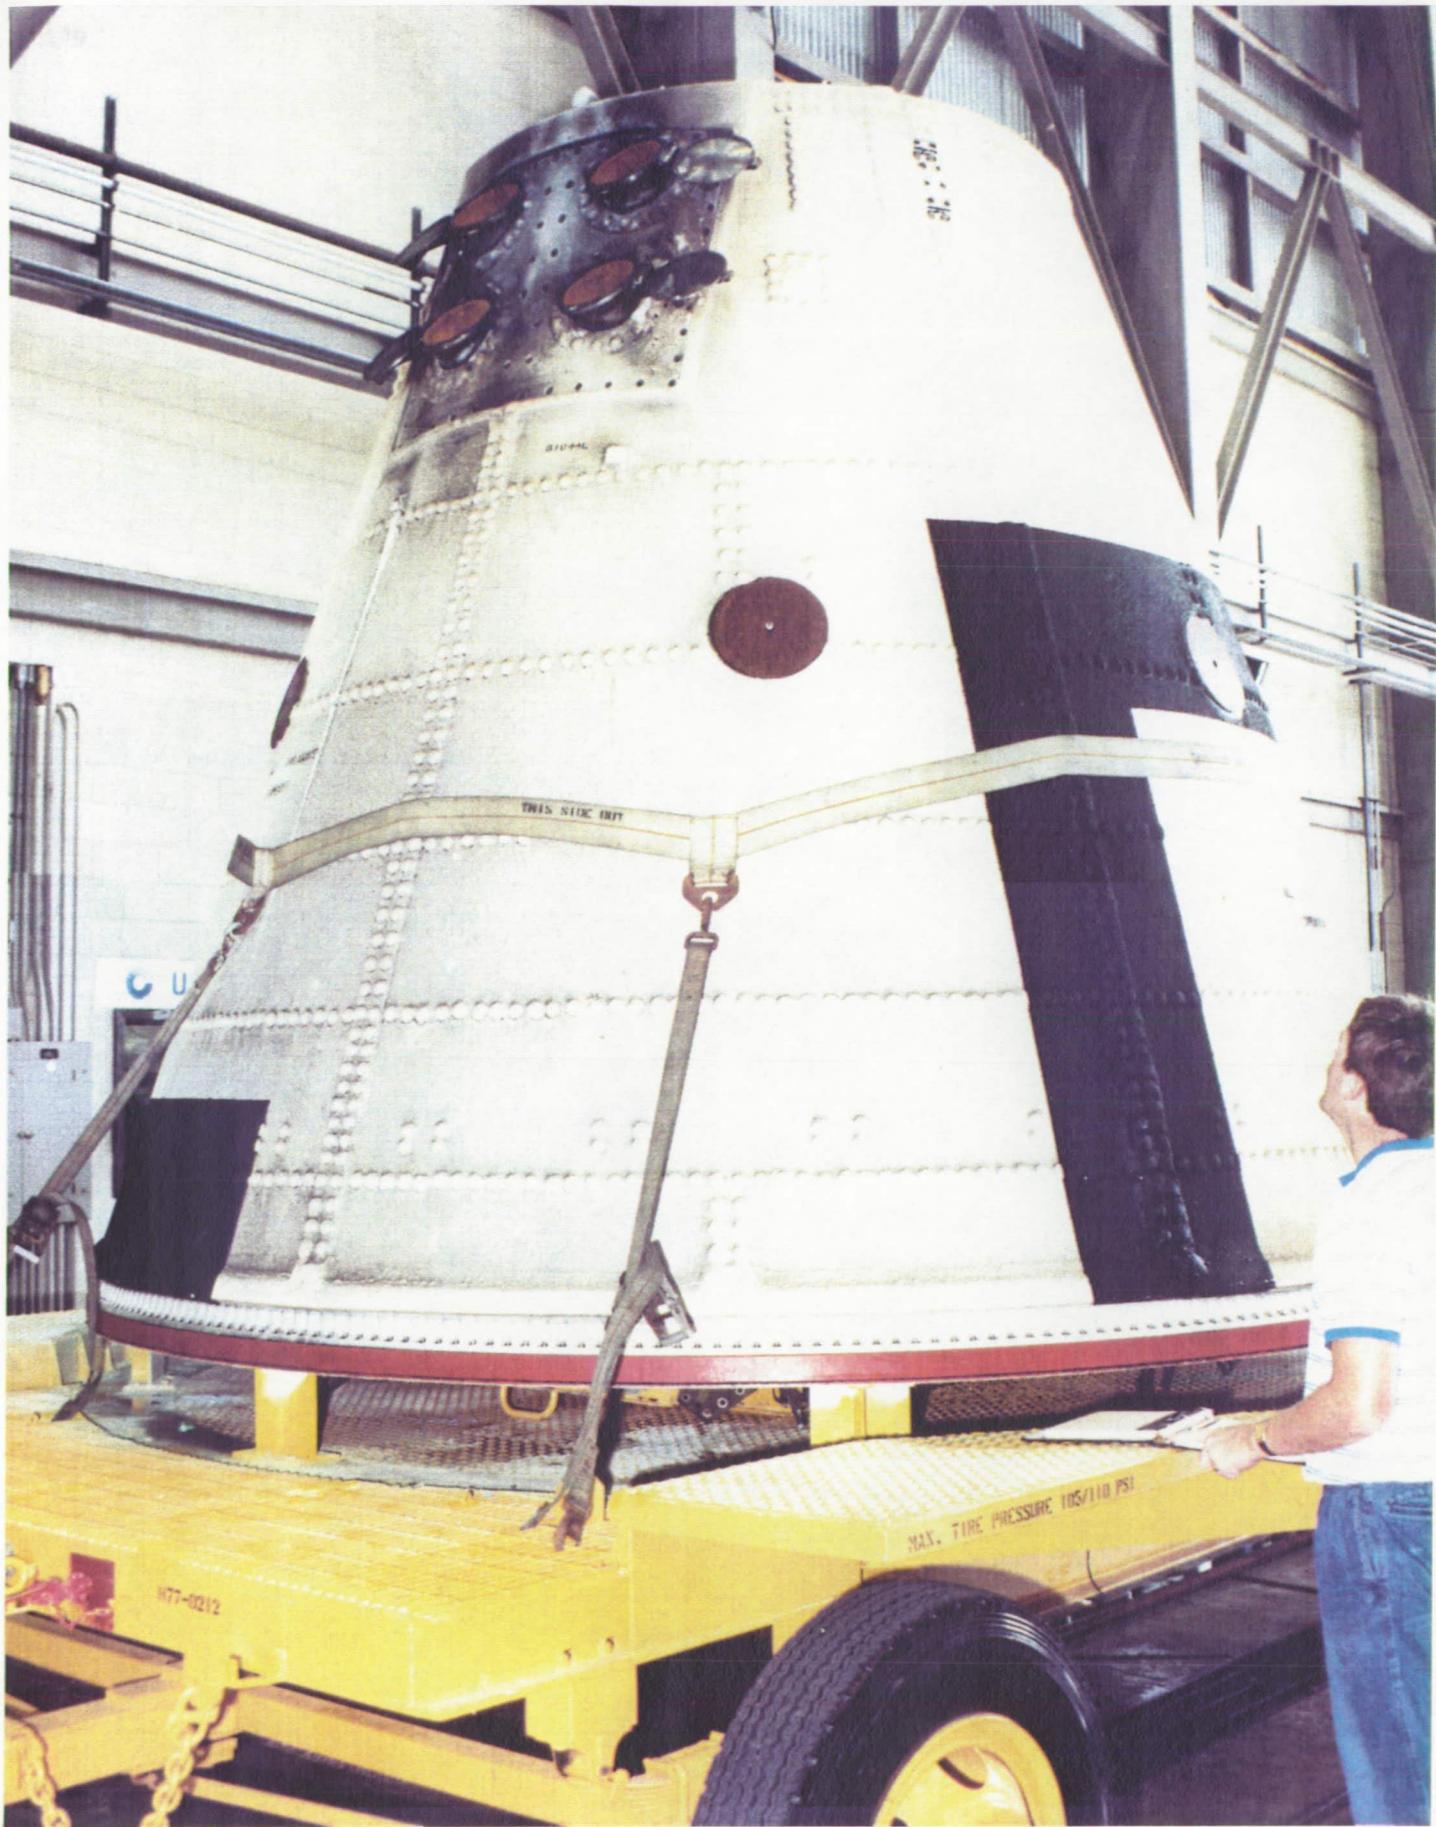
The LH frustum was not missing any TPS but had 30 MSA-2 debonds over fasteners

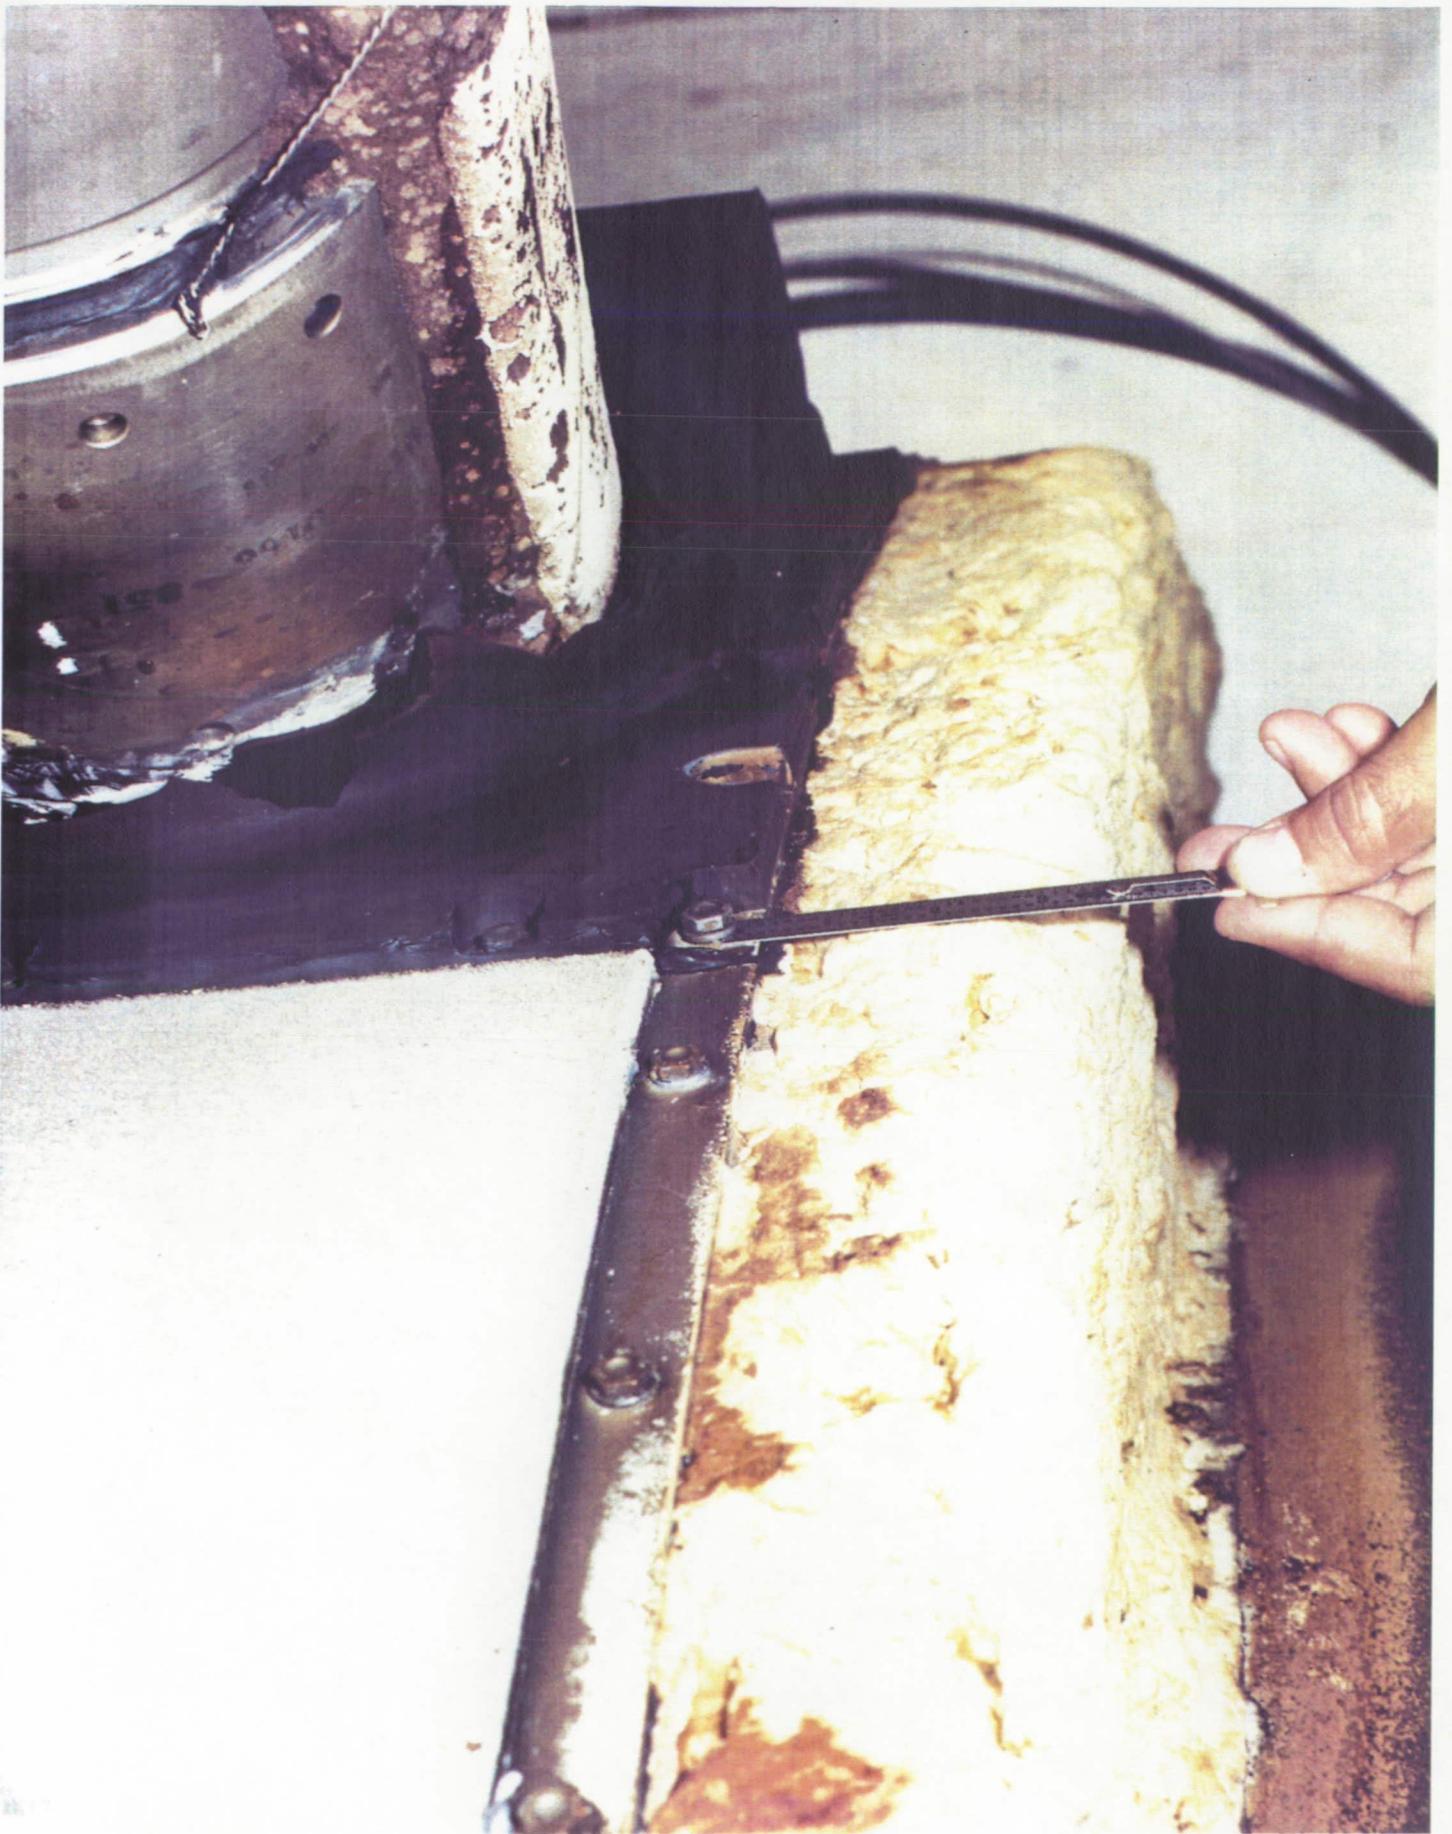
Three IEA cover bolts near the lower ET/SRB strut were bottomed out and the washers under the bolt heads could be rotated

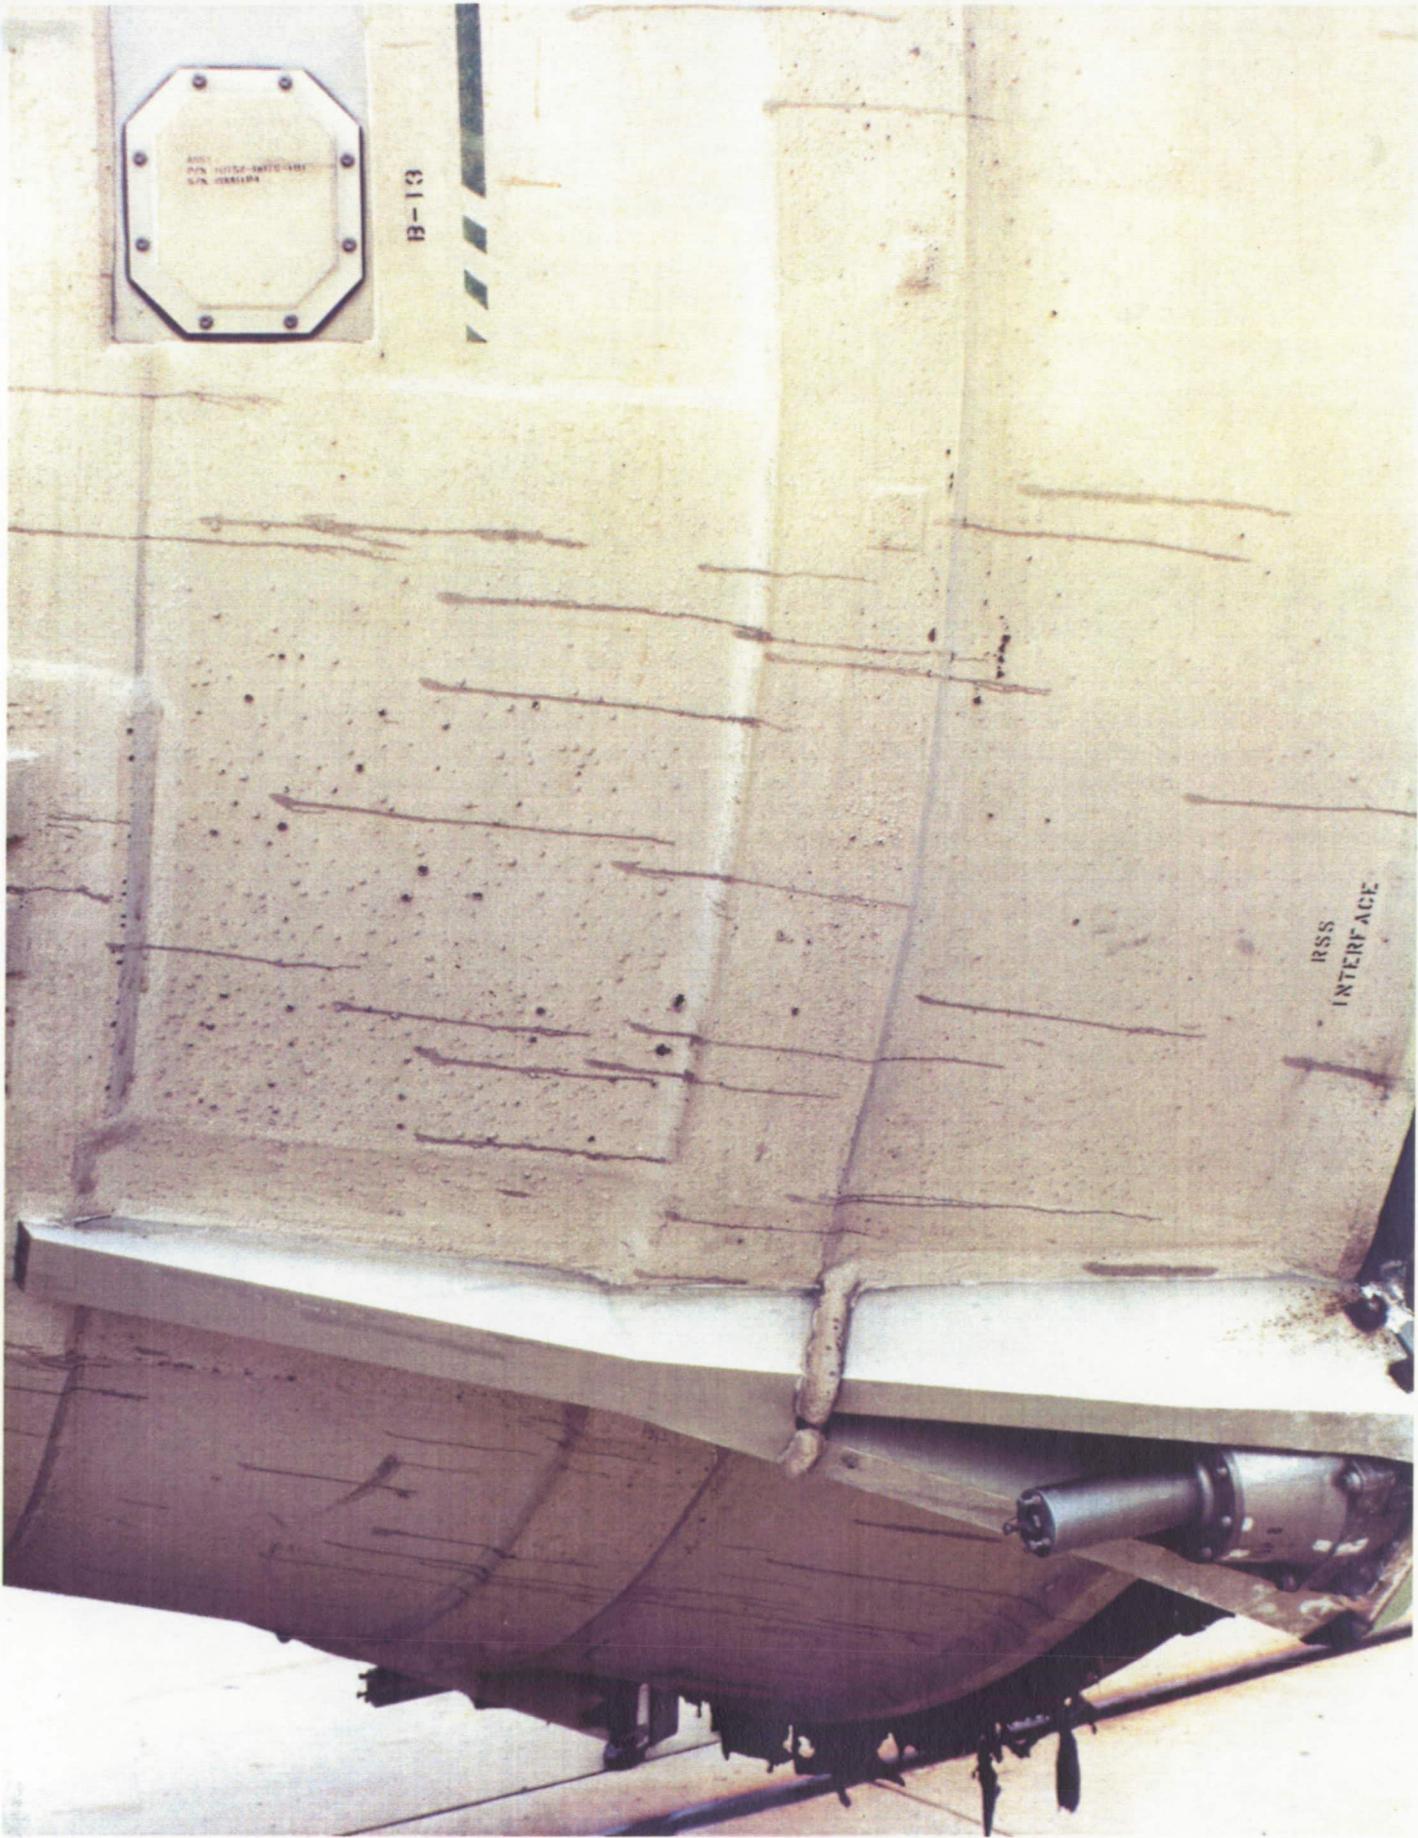
Post flight condition of the LH aft skirt where hydraulic fluid had dripped from a leak at the GOX vent arm hinge before launch

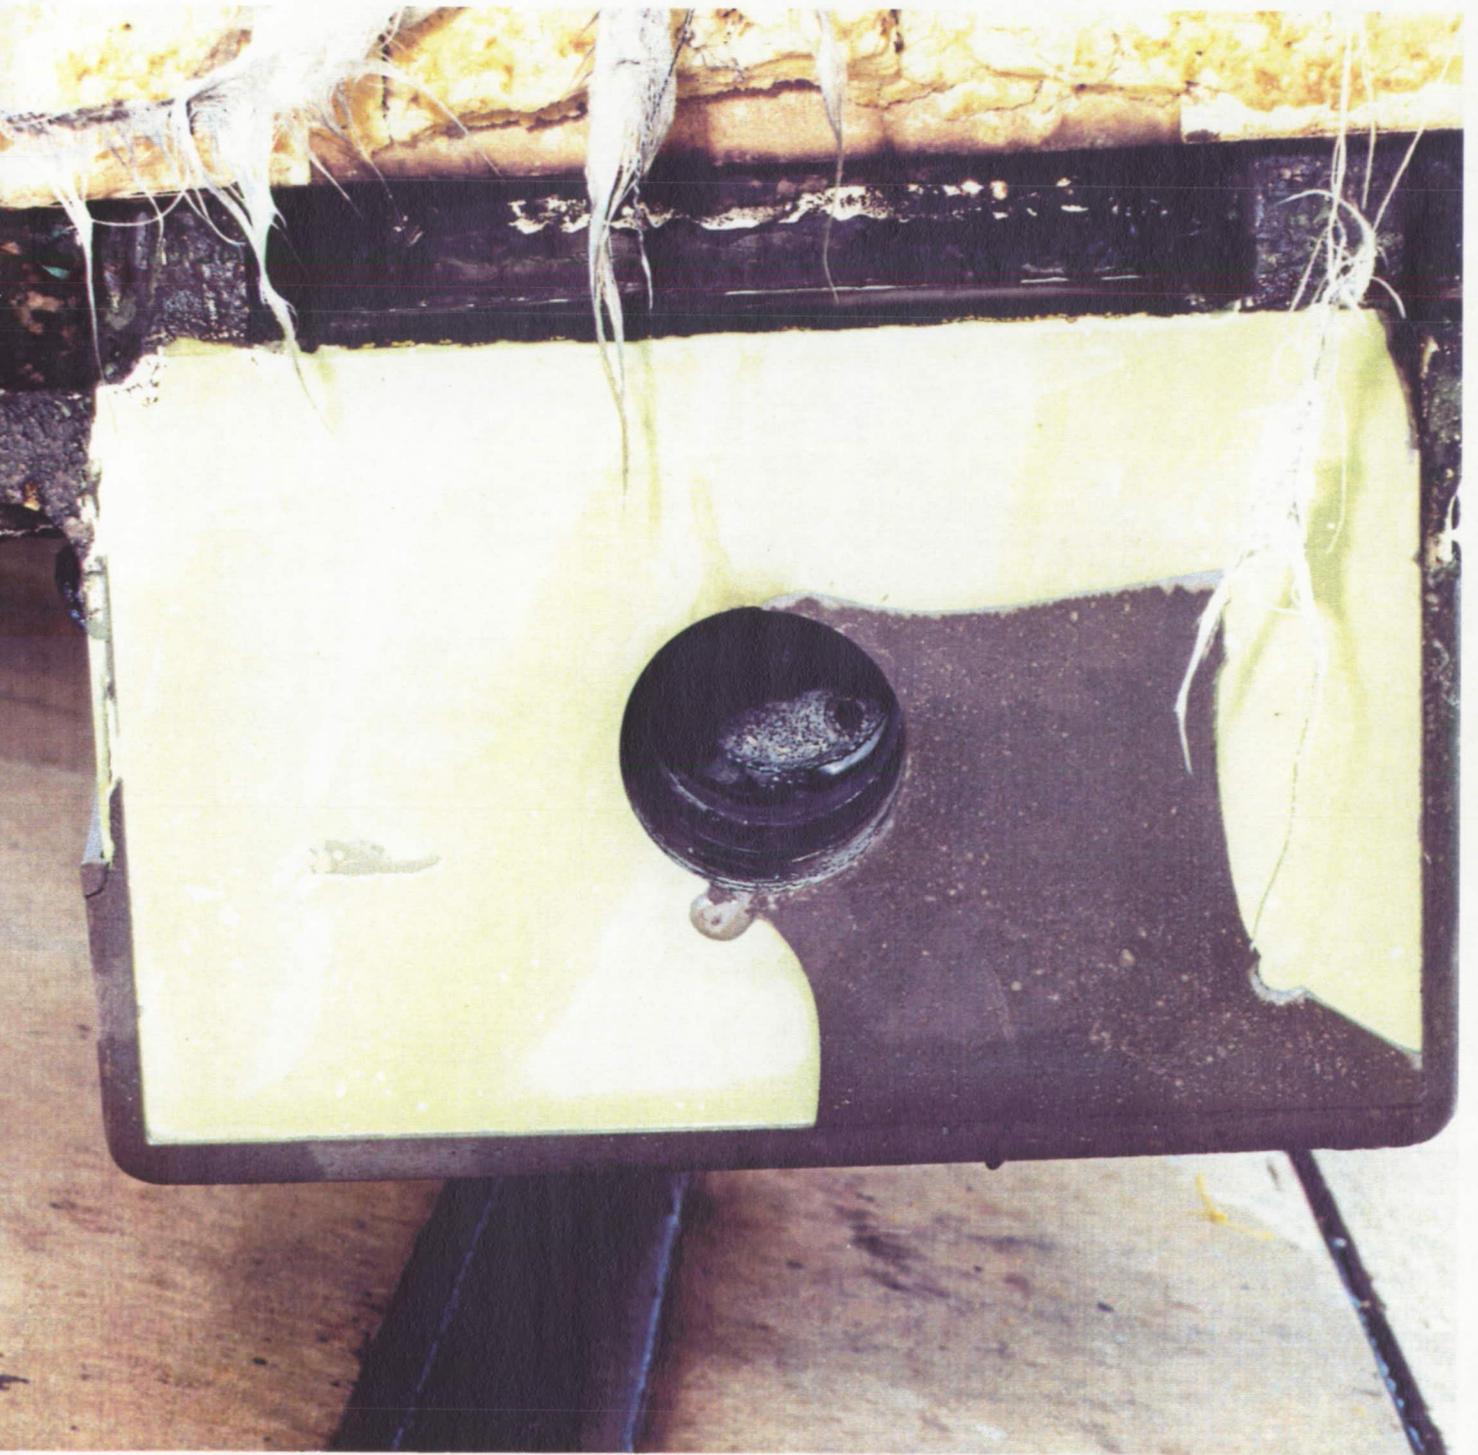
The HDP #7 DCS plunger was obstructed by frangible nut halves

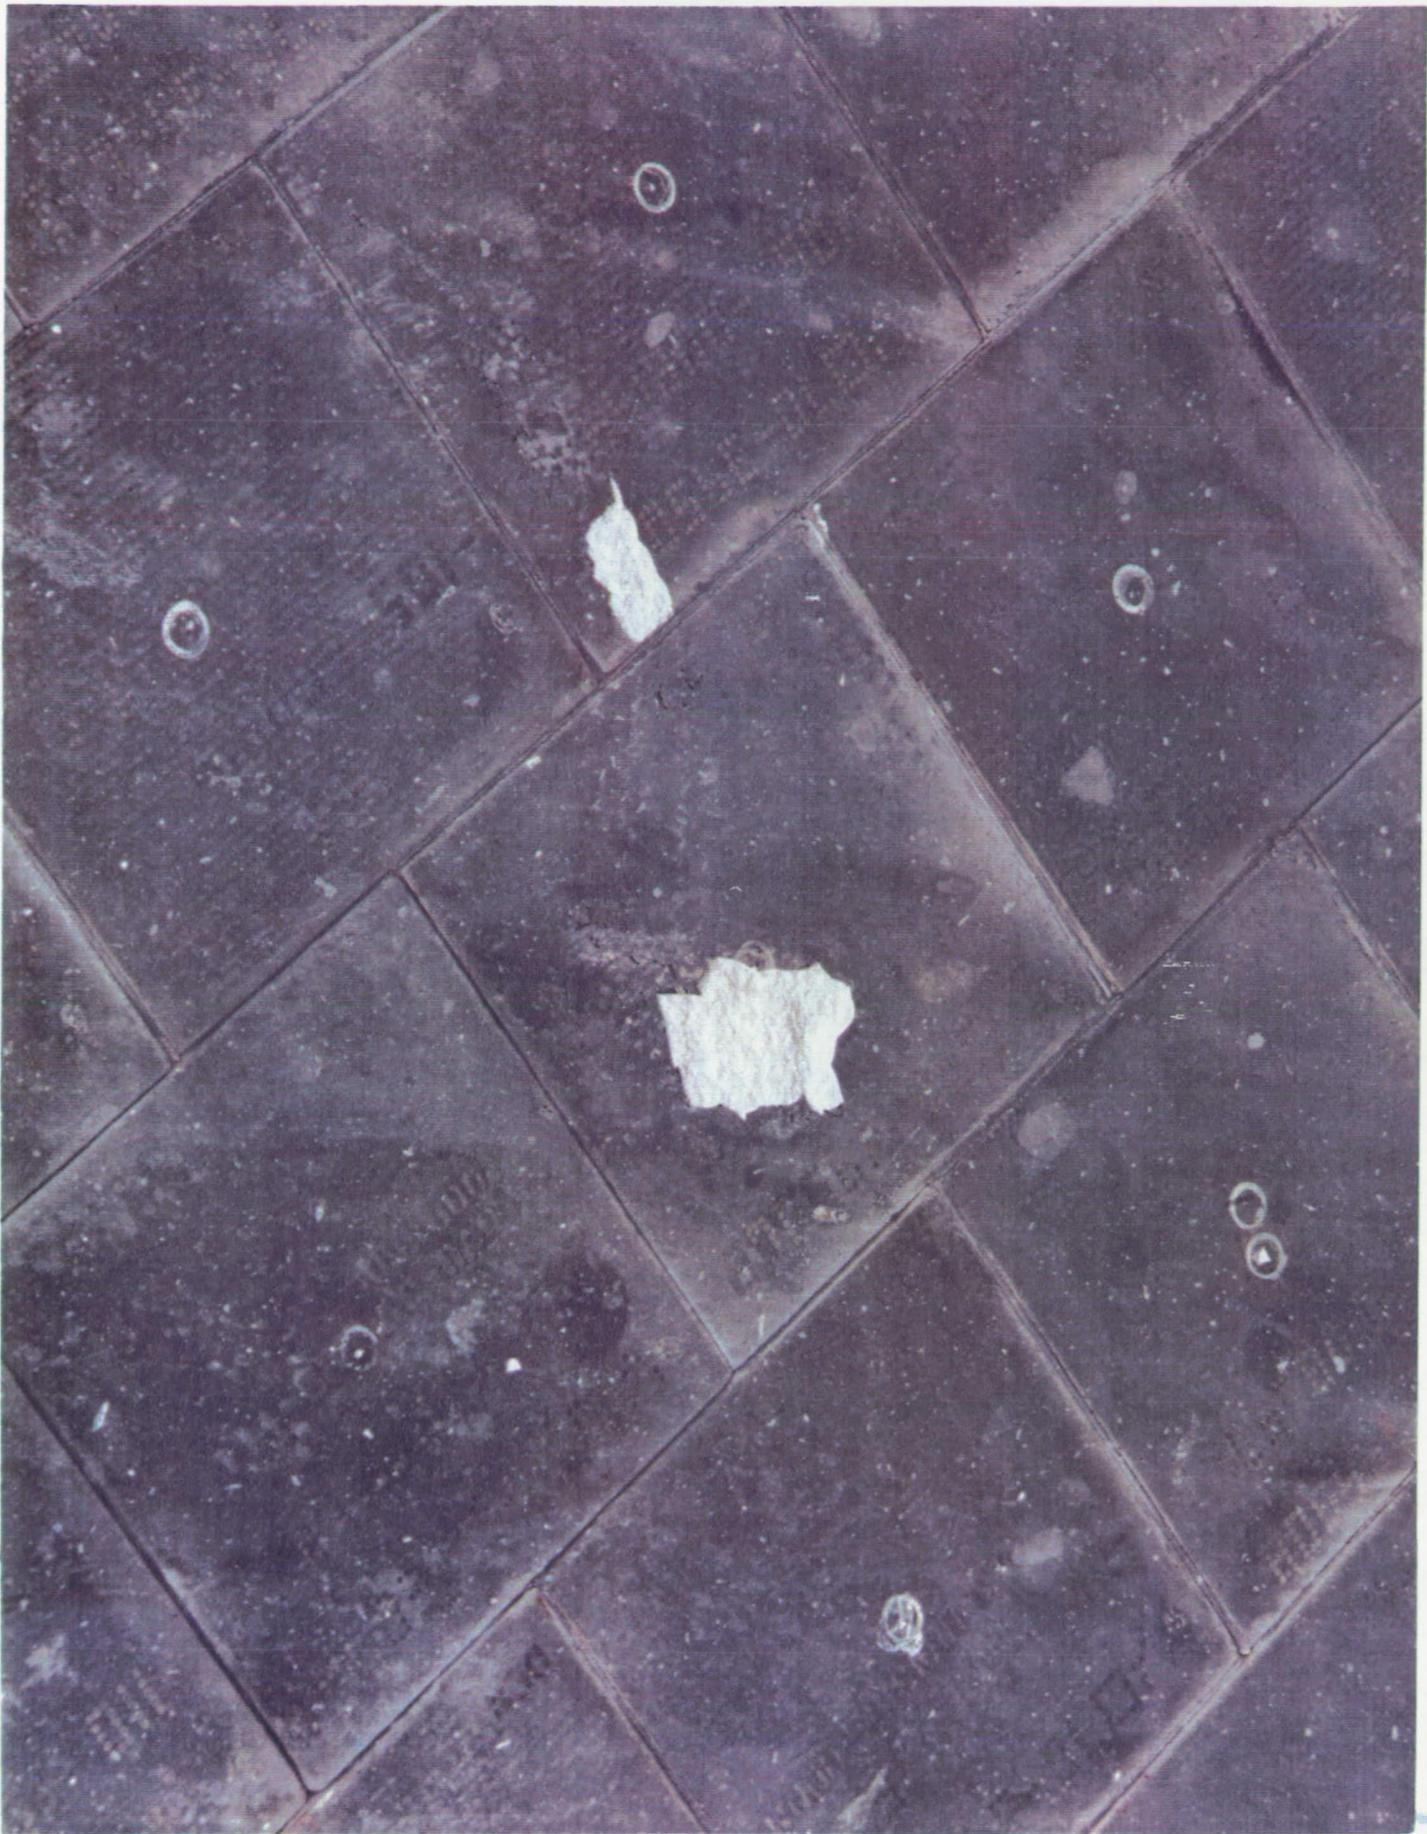
Typical tile debris impact damage on the lower surface

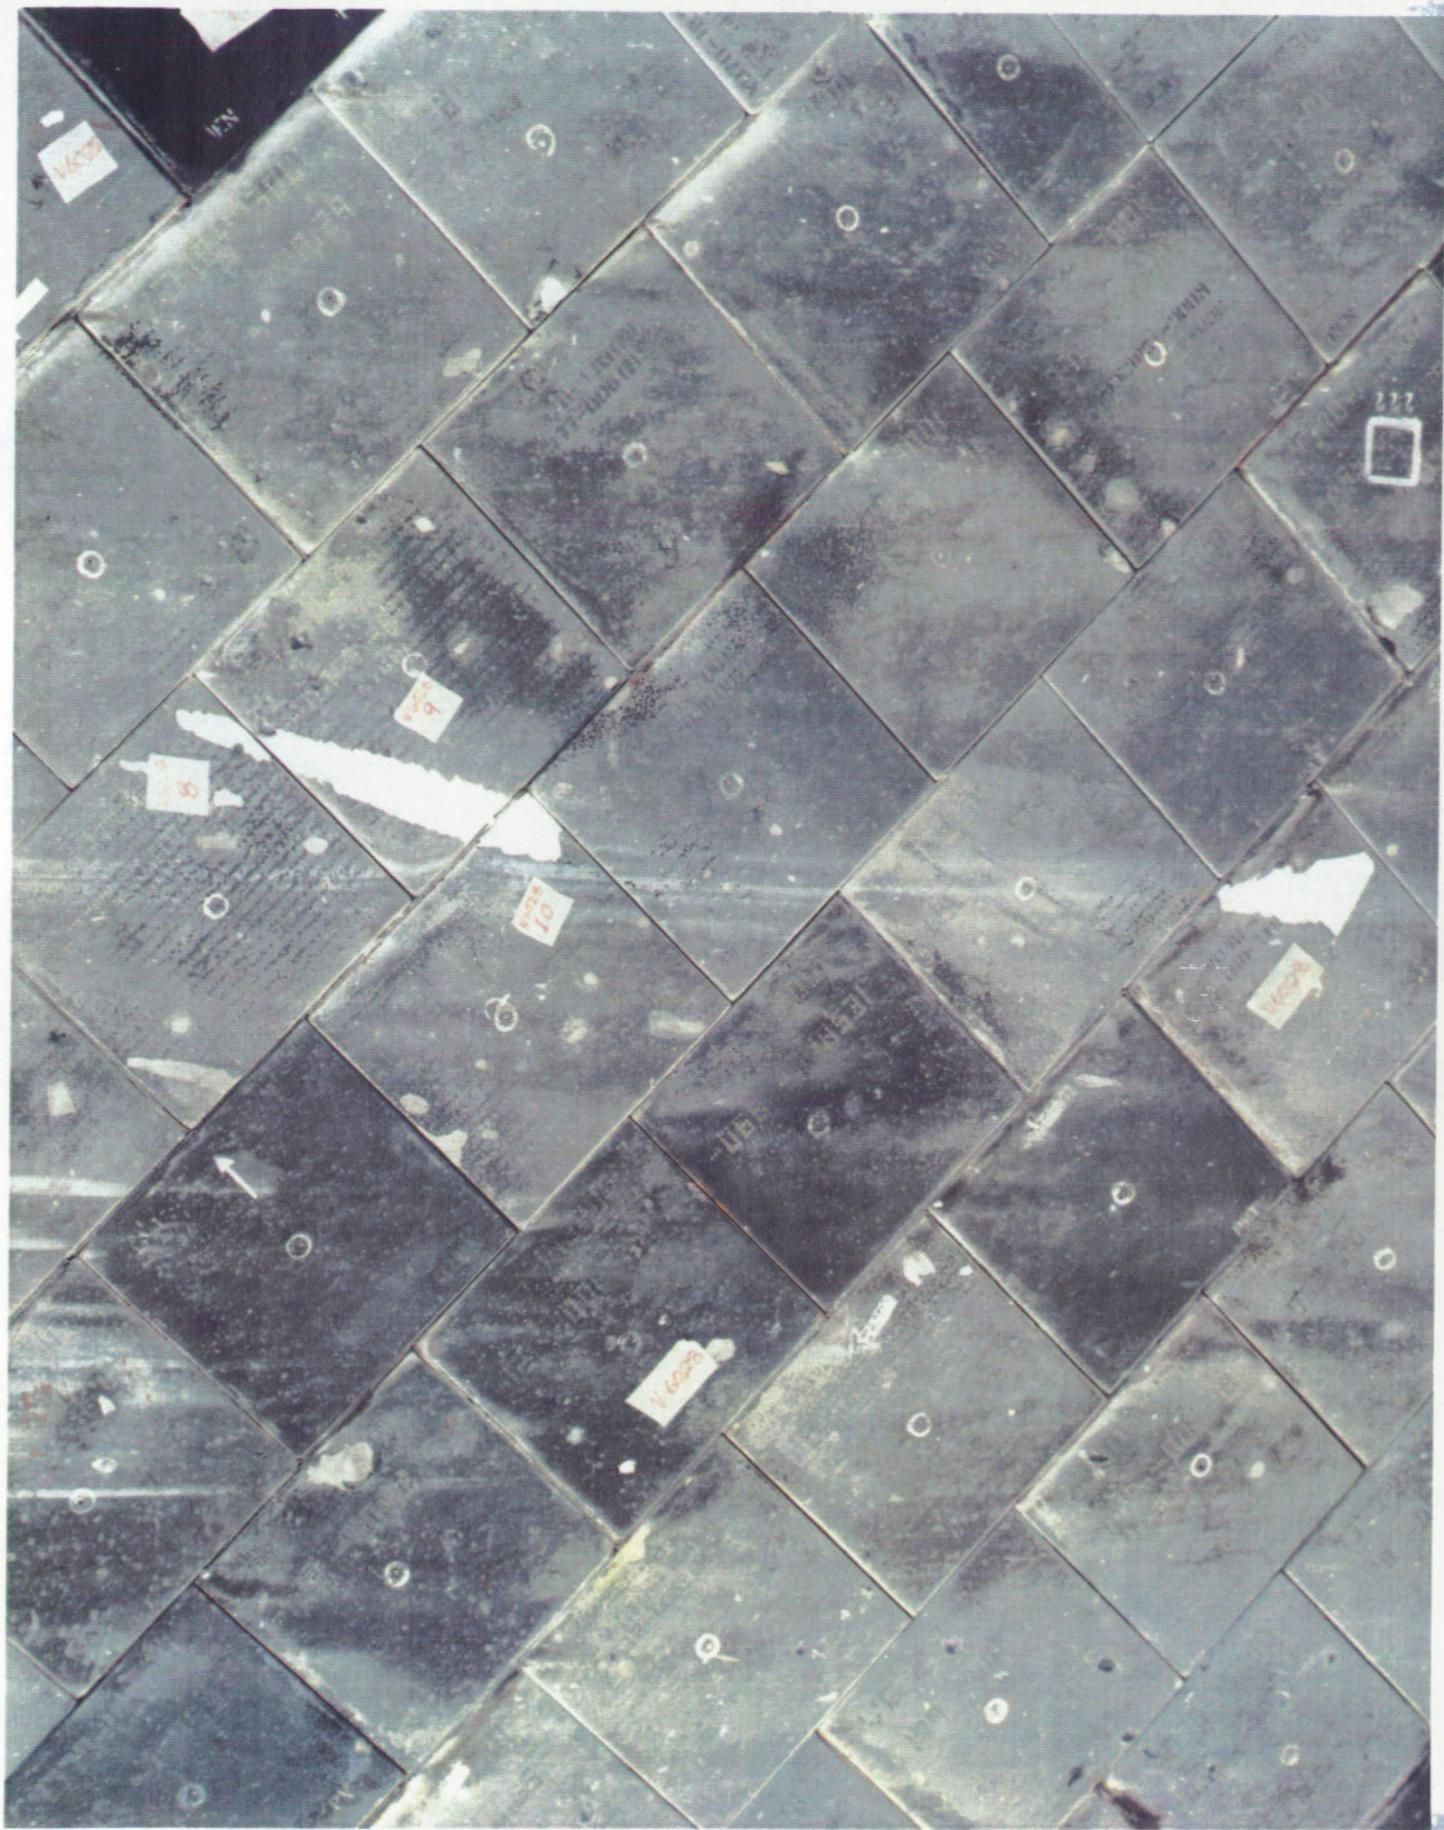
Typical tile debris impact damage on the lower surface

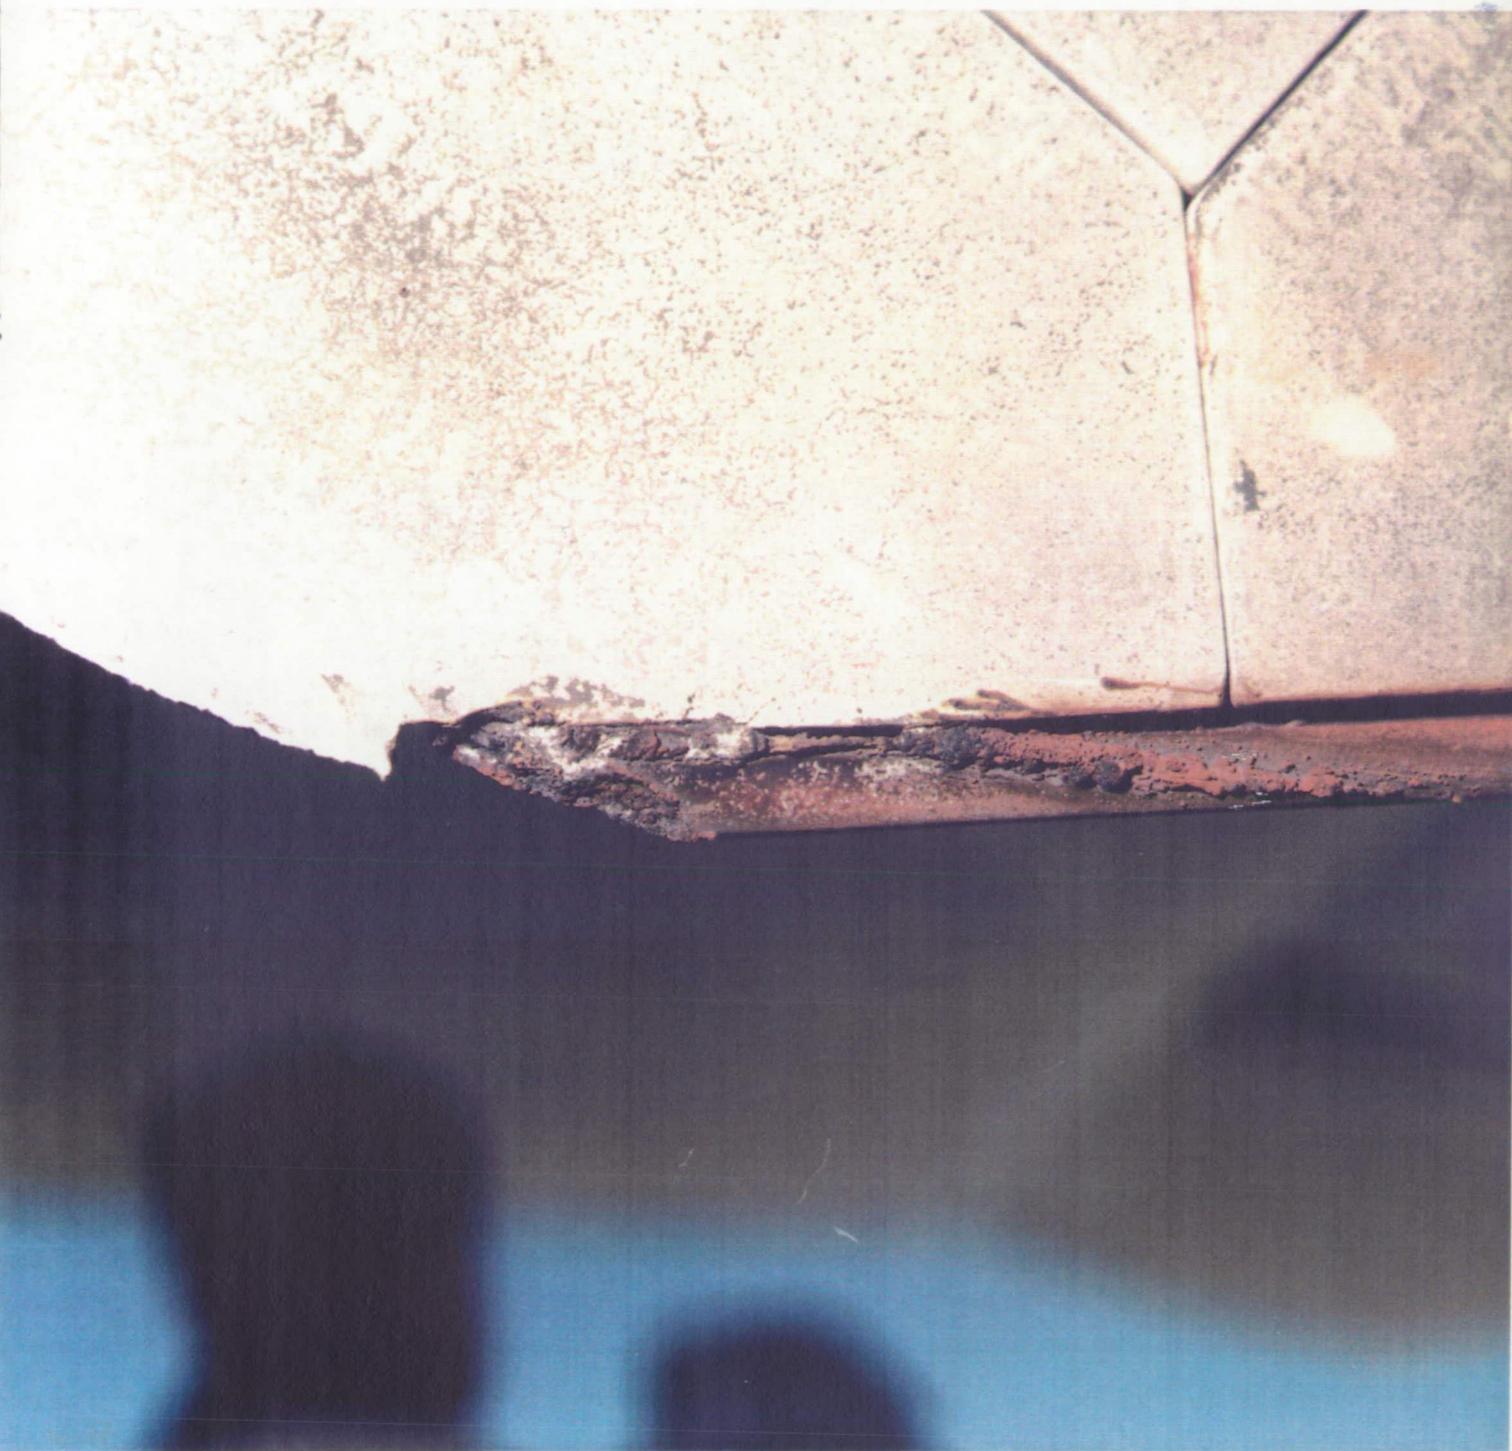
The RH ET/Orbiter (LO2) umbilical door centerline forward outboard latch fitting and adjacent tile sustained hot gas intrusion and exhibited significant melting/erosion due to the lack of or degradation of the RTV seal.
