# Debris/Ice/TPS Assessment And Photographic Analysis For Shuttle Mission STS-40

DEBRIS/ICE/TPS ASSESSMENT  
AND  
PHOTOGRAPHIC ANALYSIS  
OF  
SHUTTLE MISSION STS-40

June 5, 1991.

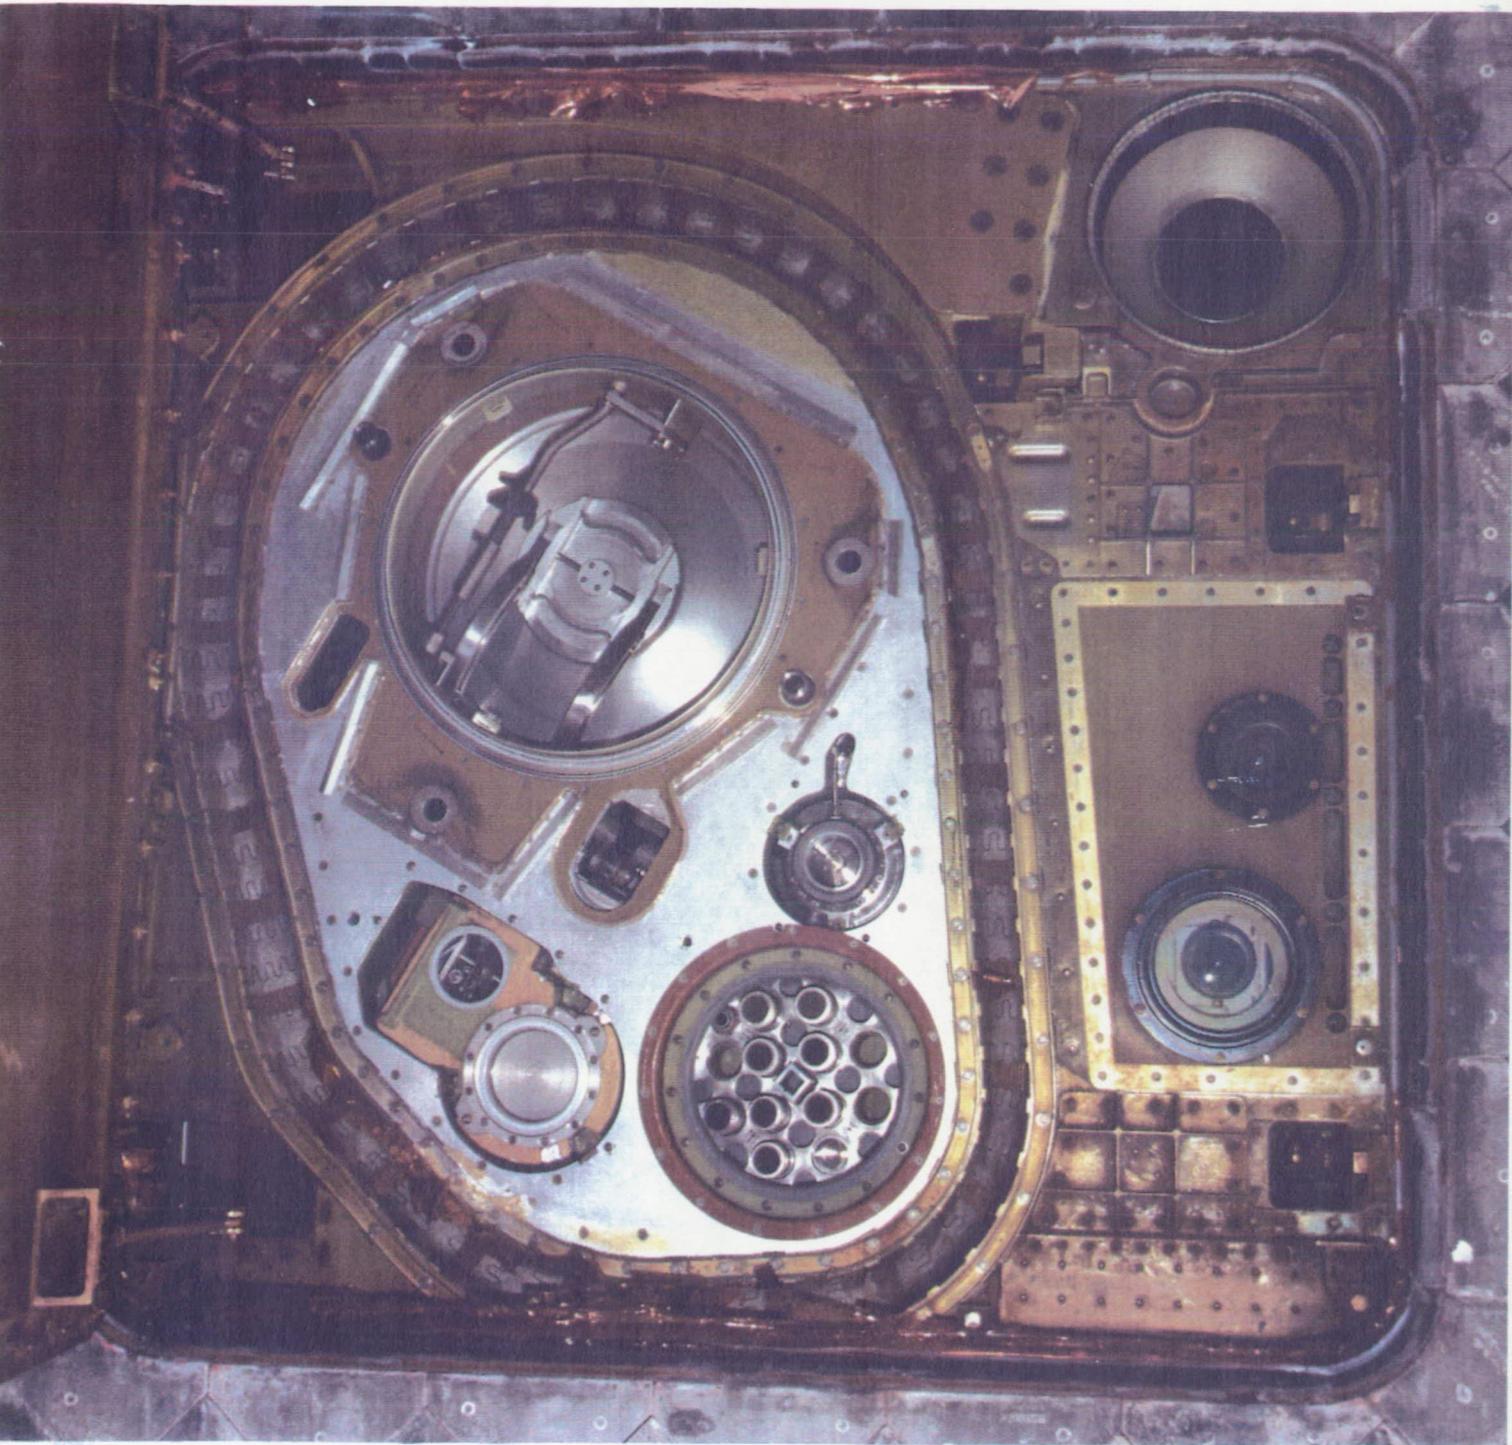
Overall view of the LH2 ET/ORB umbilical cavity. No hardware was missing. There was no galling or raised metal on the shear pins that could be associated with the loss of the LH2 ET/ORB shear pin bushing during ET separation.

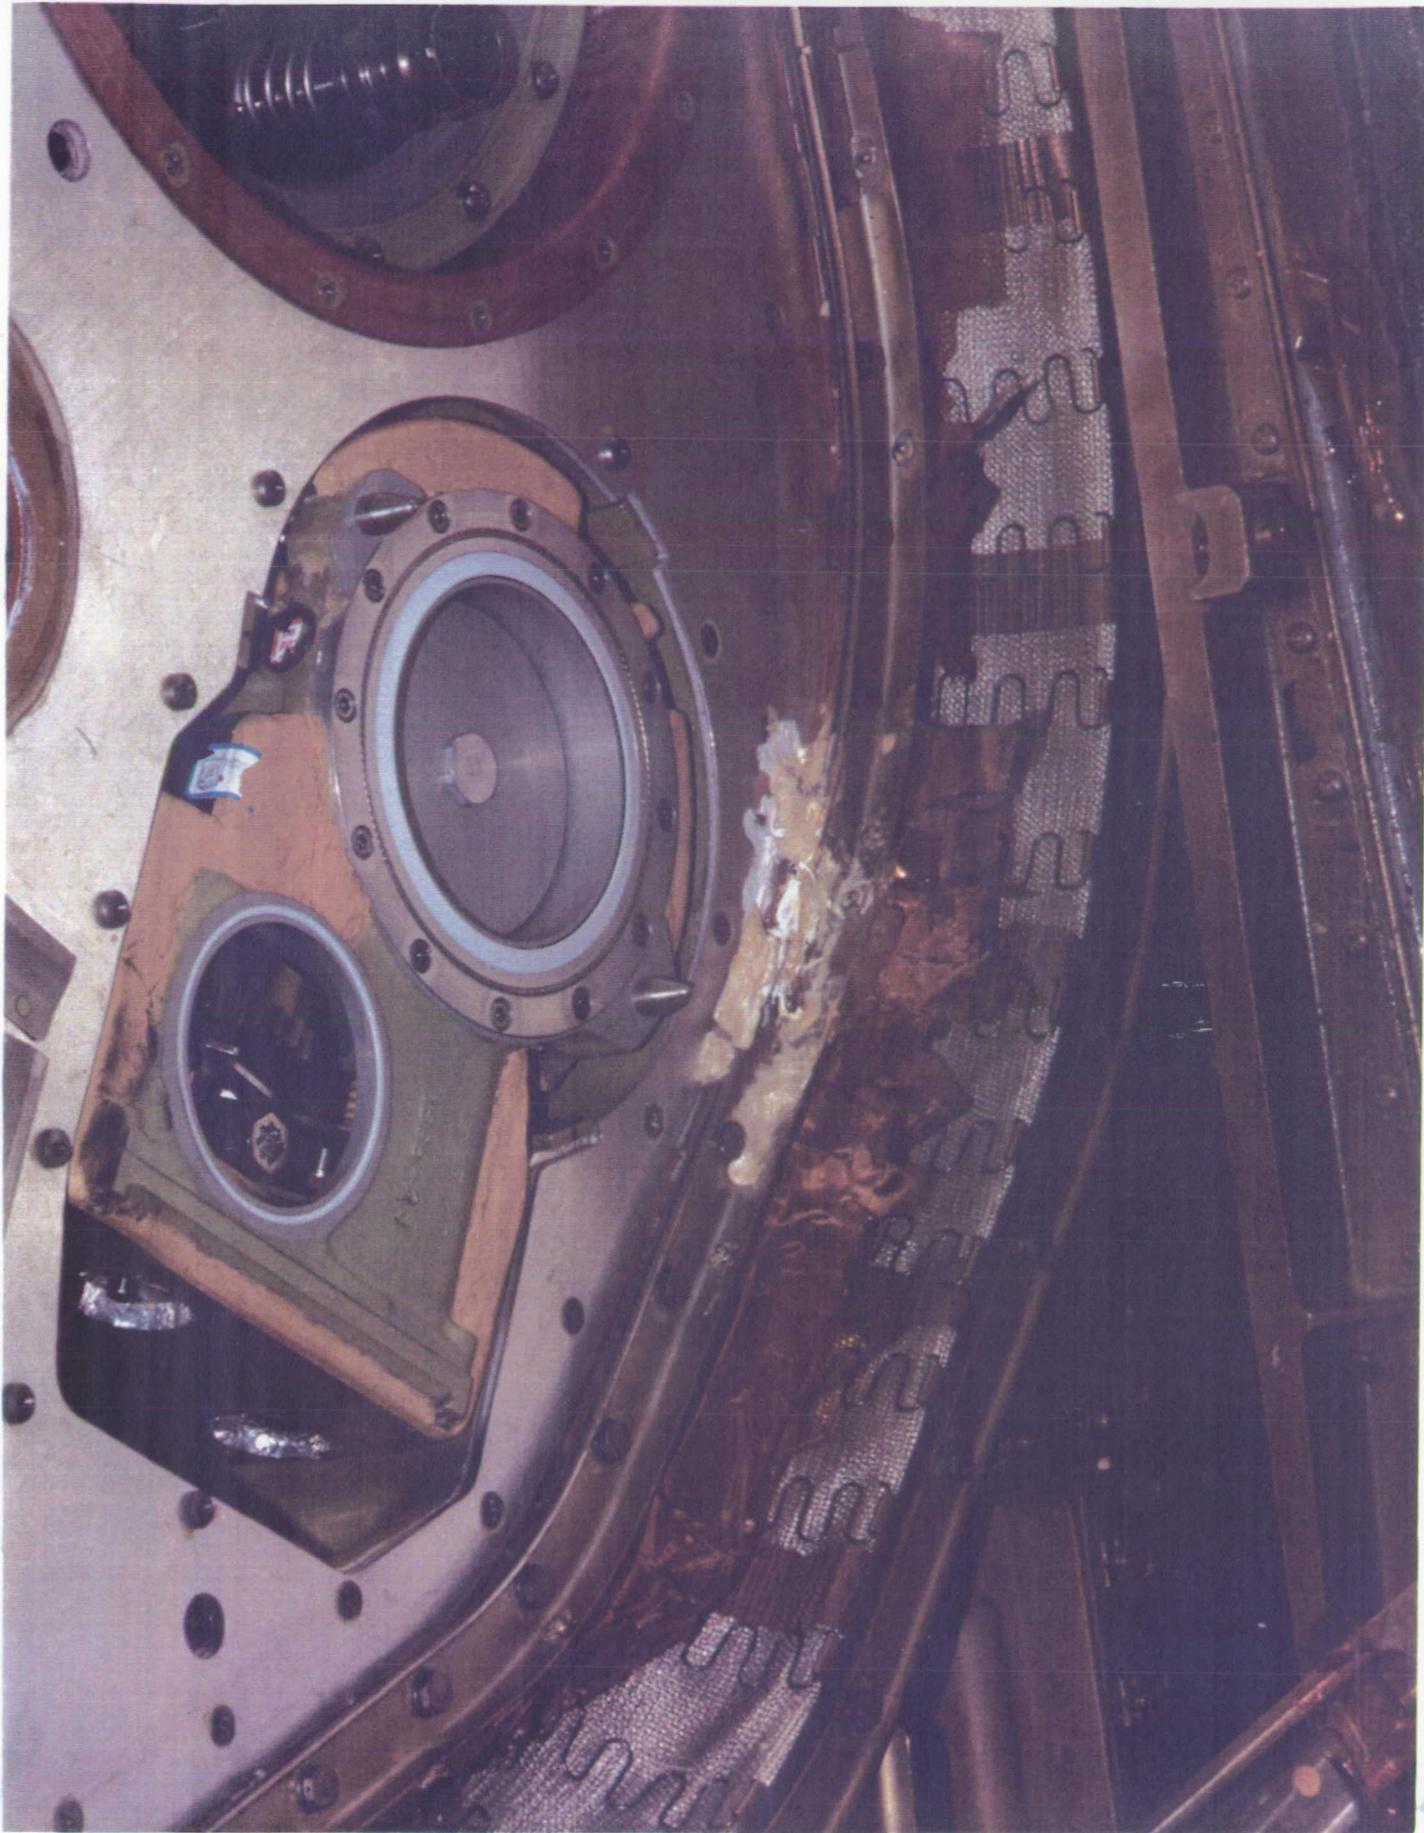
Closeout foam intrusion along the purge barrier seal

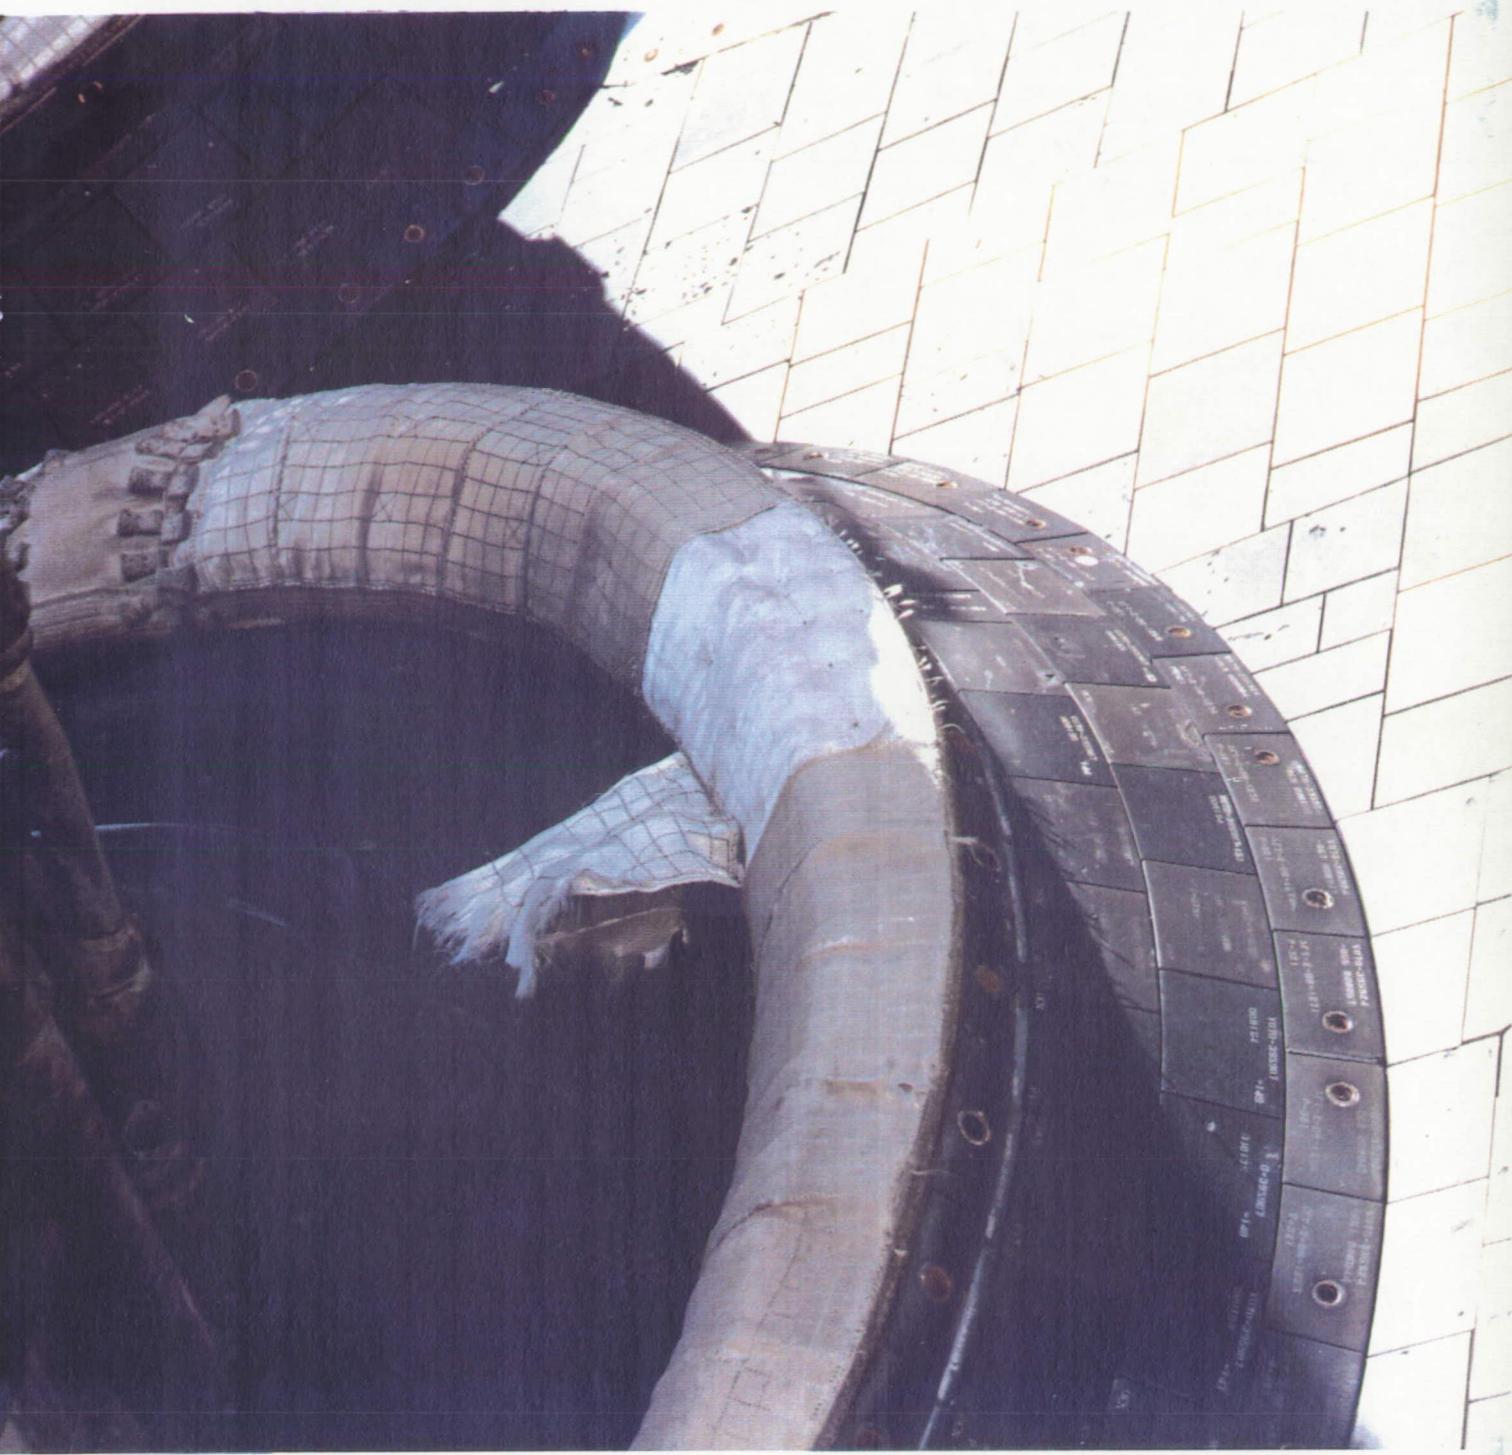
Typical damage to the outer layer of the SSME closeout blanket

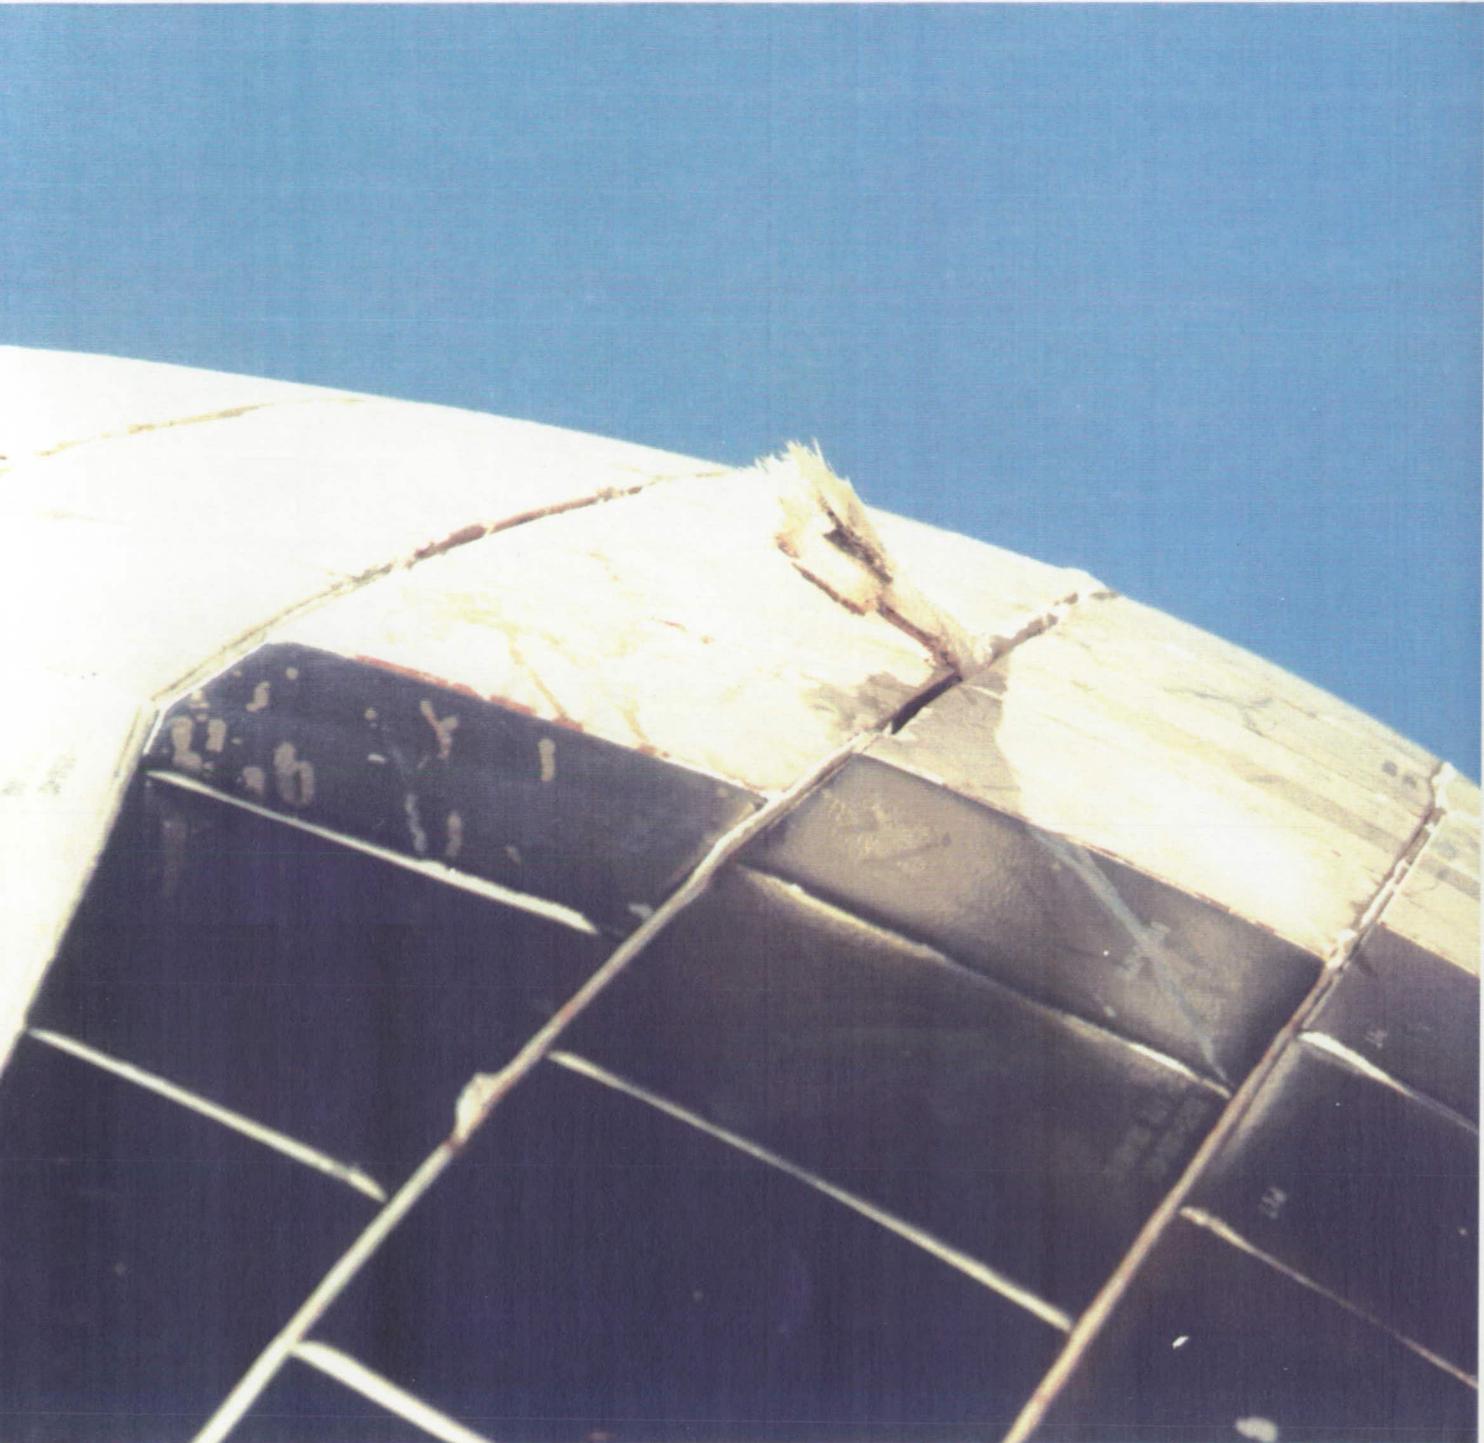
Eight inch long piece of gap filler sleeving material protruded from the RH OMS pod leading edge and caused significant damage to two adjacent white tiles

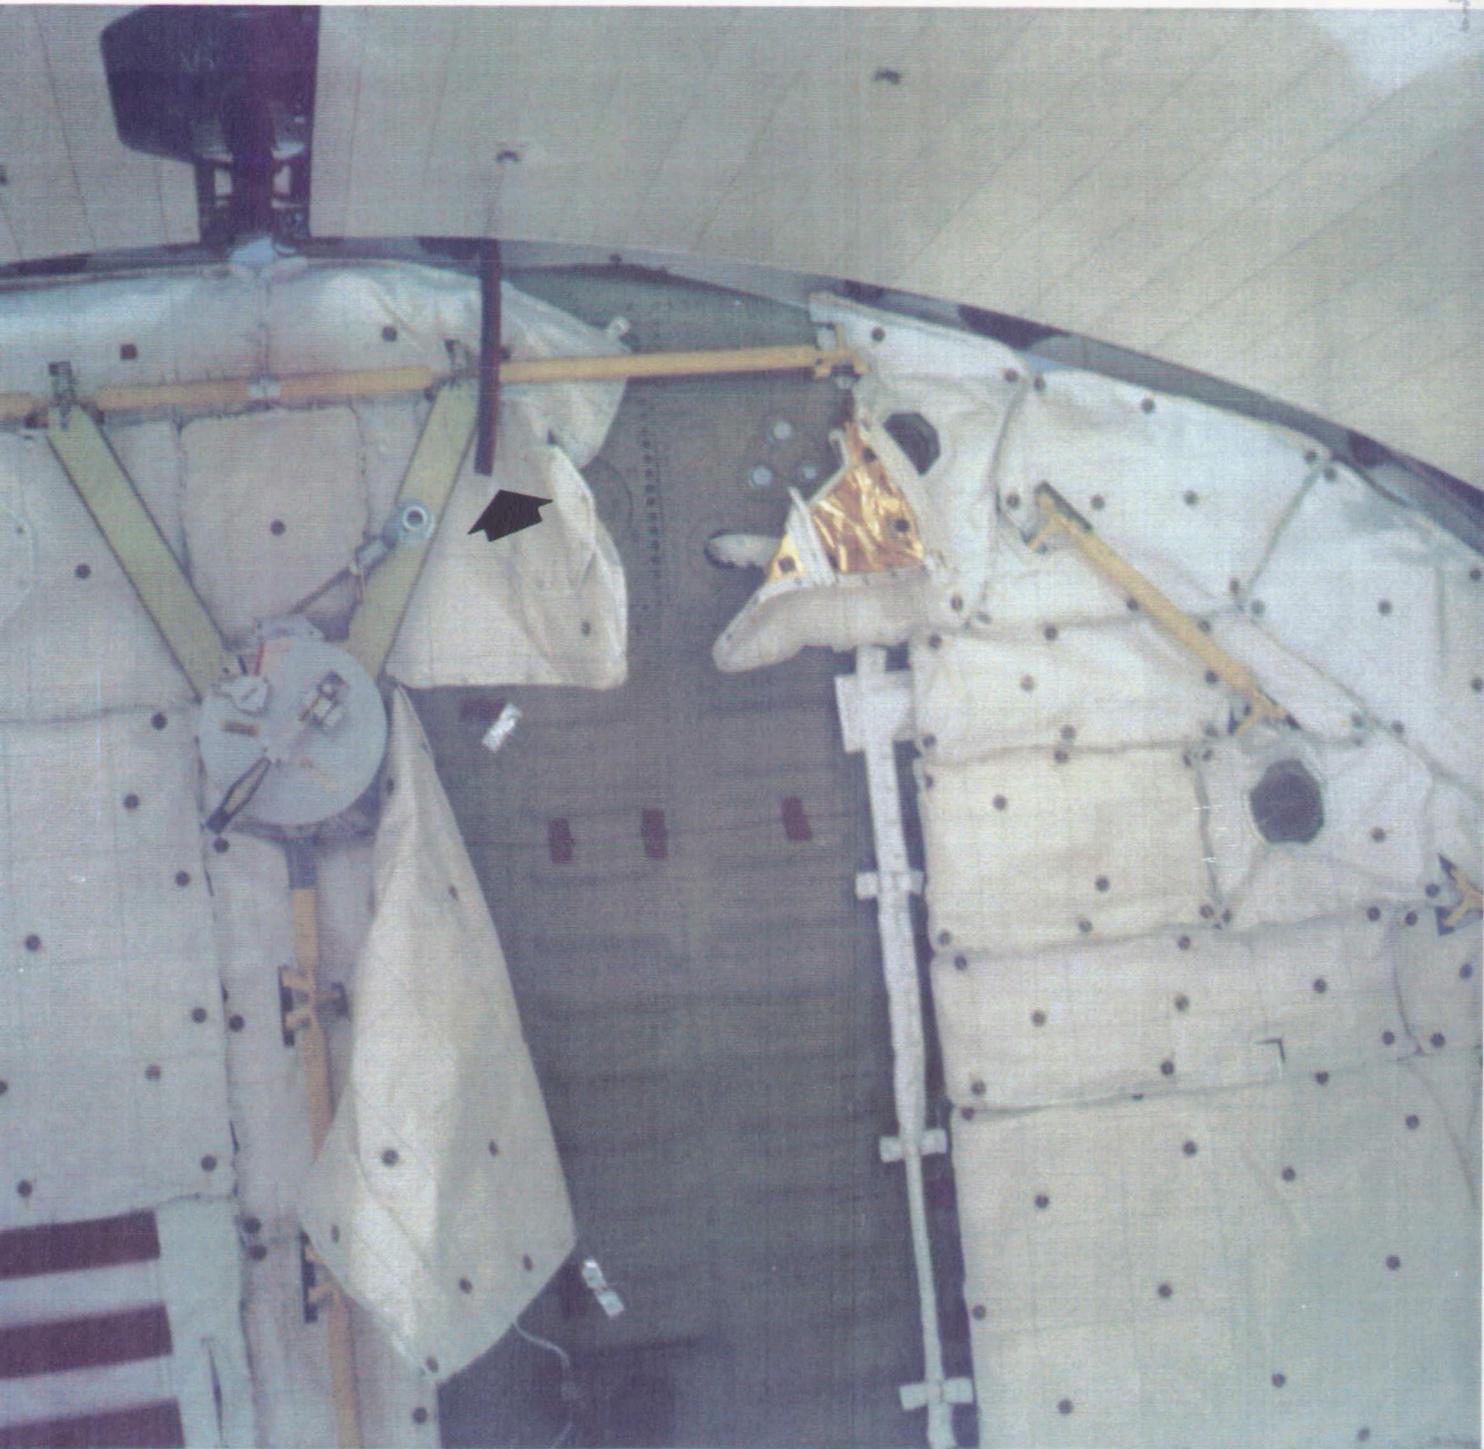
The payload bay door environmental seal debonded at the splice point and protruded from the retainer while on-orbit. The door was successfully closed prior to re-entry when the seal was compressed between the guide hook on the LH aft bulkhead roller assembly housing #4 and the fore-aft PLBD load roller. The LH aft bulkhead latching mechanism was then able to cycle.

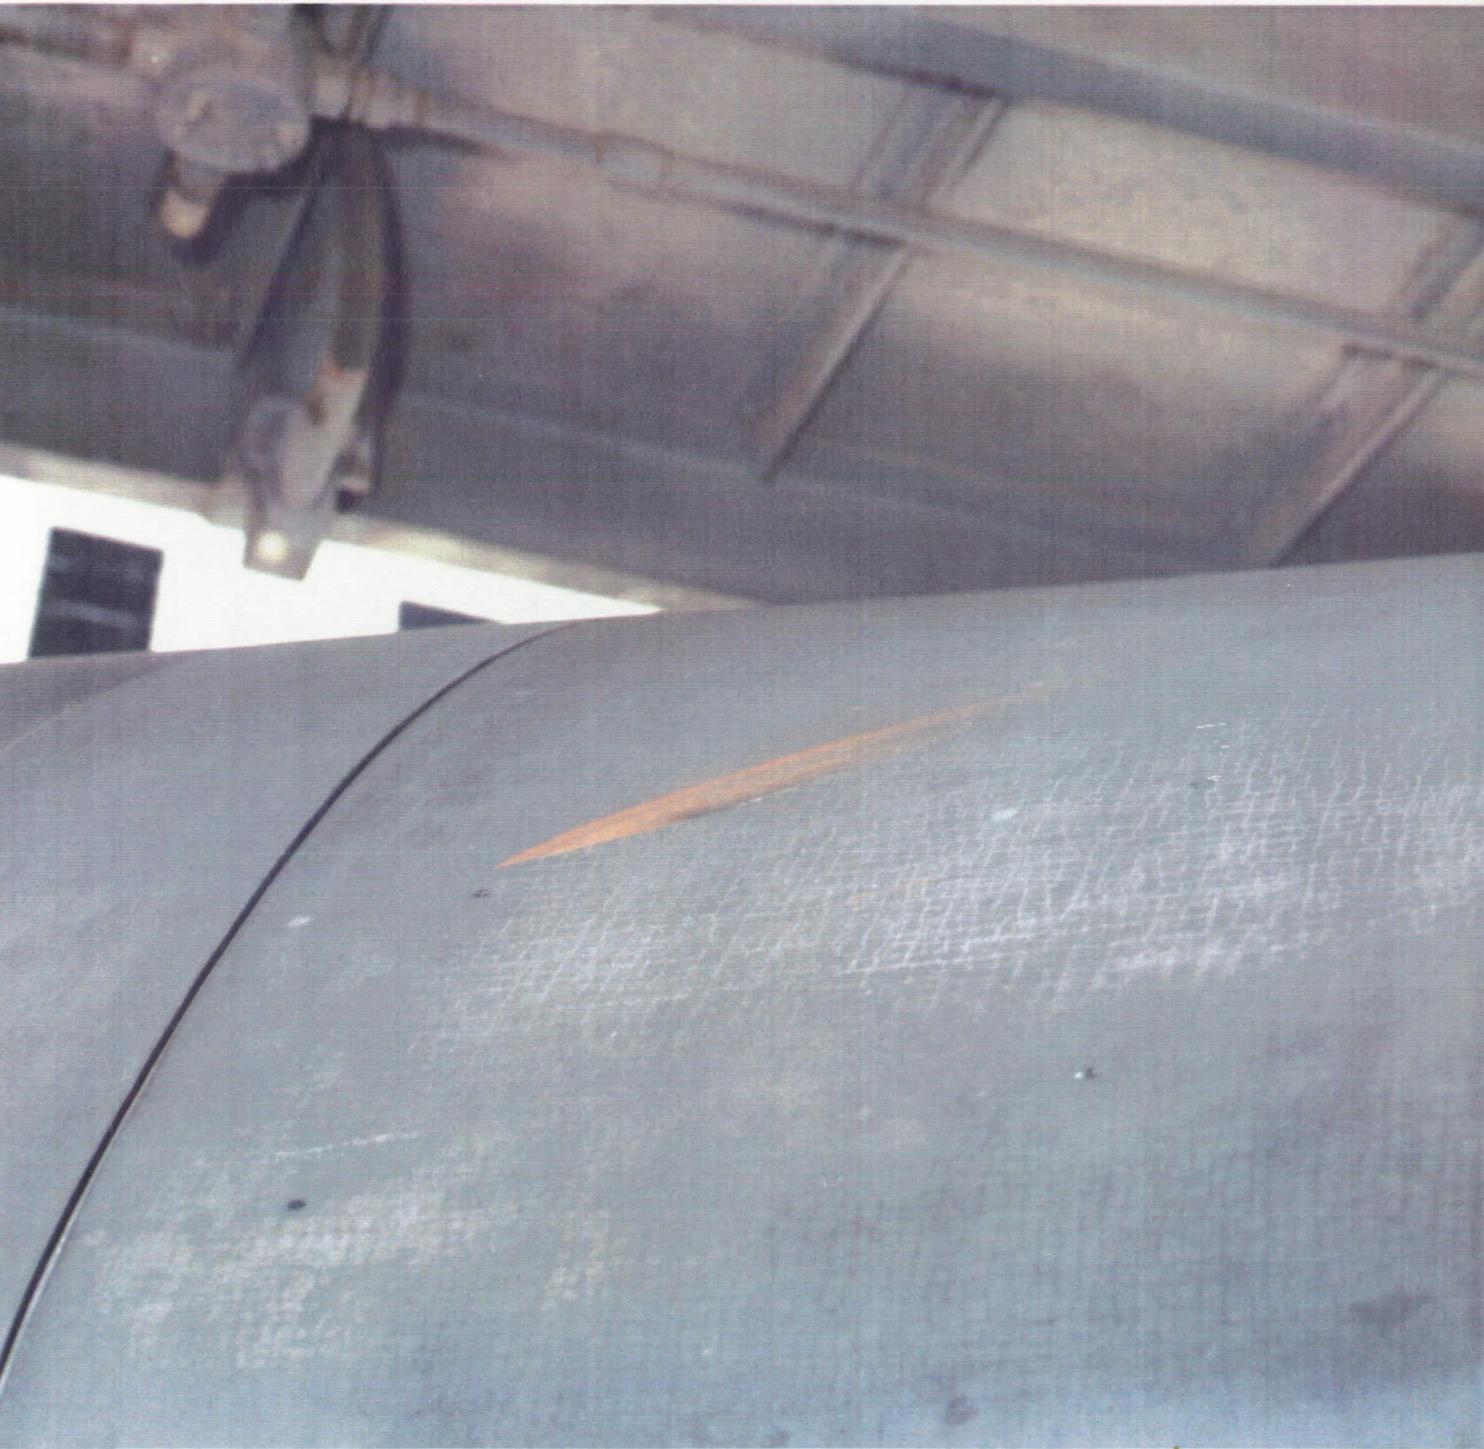
Orbiter RTV caused a reddish-brown streak on the LH wing  
leading edge RCC panel #8
