TWR-61241

AFT SEGMENT DOME-TO-STIFFENER FACTORY JOINT
INSULATION VOID ELIMINATION

FINAL REPORT

MARCH 1991

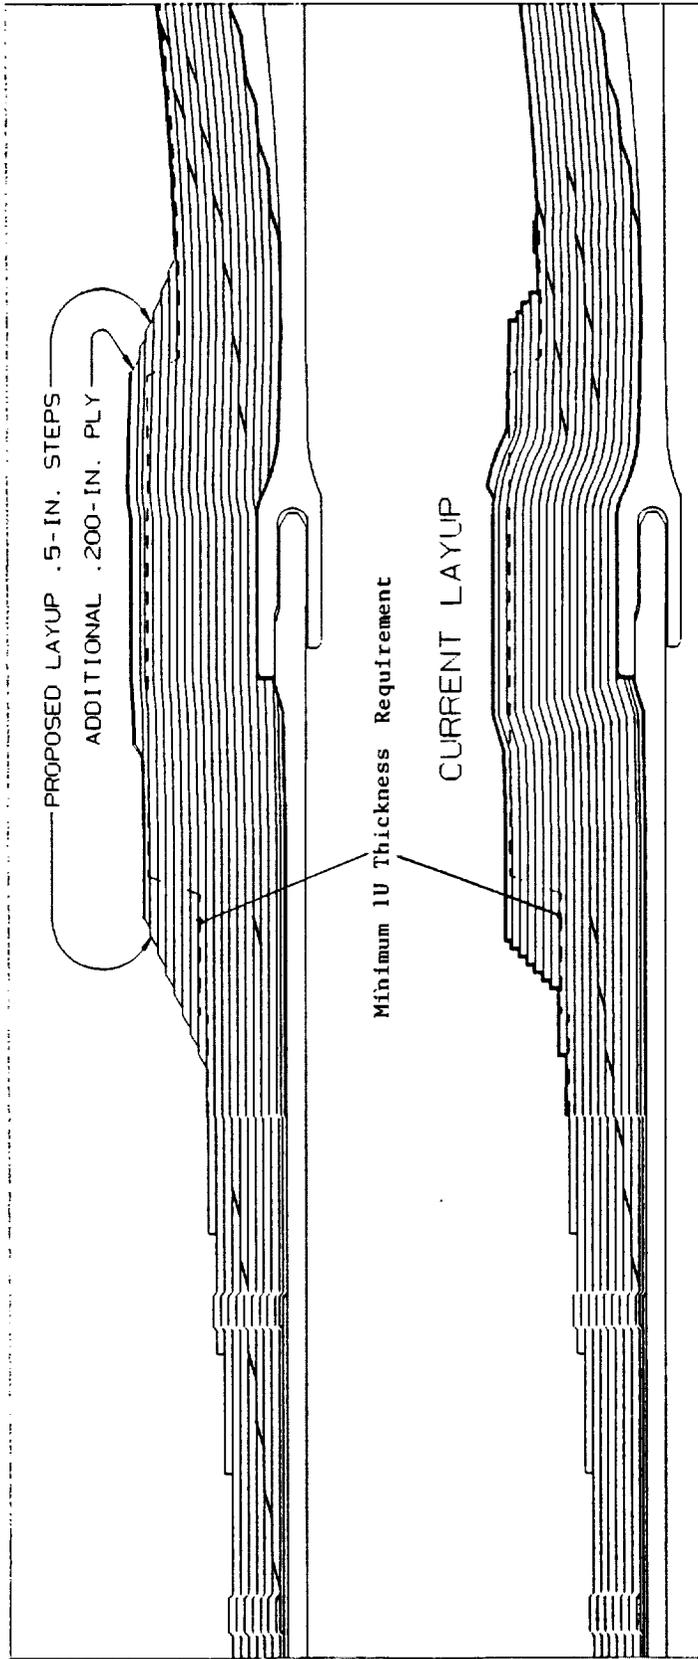
Figure 1. Current And Proposed Layup Configuration

1. Skive the 0.200-in. thick circumferential ends of the pattern strips laid in the dome-to-stiffener joint region to reduce potential air entrapment.
2. Create a smoother layup at the case clevis transition area by ending and skiving the plies at the aft edge of the clevis leg to prevent bridging or lifting within the rubber plies during rubber layup and autoclave cure.
3. Lengthen the angle of the ramp over the factory joint to reduce the chance of vacuum bag bridging by increasing the pattern step length from the current 0.25-in. to 0.5-in. steps.
4. Terminate the 0.050-in. cap ply over the factory joint insulation before the ramps to allow entrapped air in the layup an easier escape route.
5. An additional 0.200-in. ply was laid over the clevis leg for 180 degrees to assure that insulation thicknesses were met.

1. The changes demonstrated in the PSA-8 aft segment be implemented into production aft segments.
2. When 20-oz breather is used, it should be removed in conjunction with the patterning cloth.

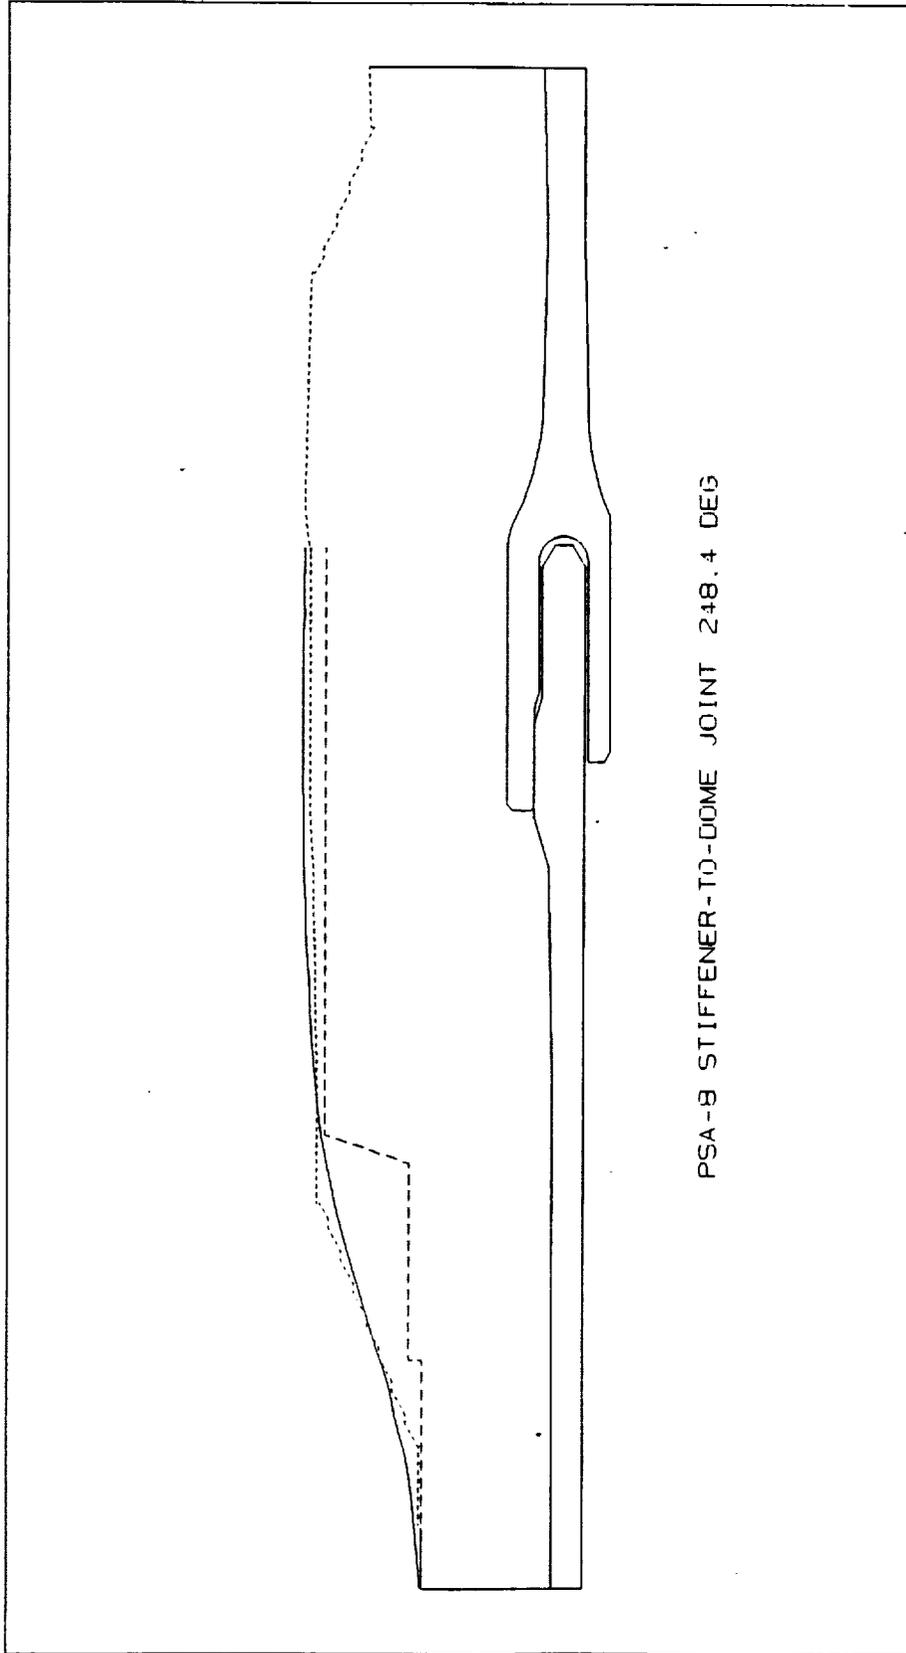
PSA-8 STIFFENER-TO-DOME JOINT 248.4 DEG

Radiographic inspection, conducted at the standard production frequency of every three degrees, detected one void in the aft dome-to-stiffener factory insulation joint. This void was located at 246 to 249 degrees, 10.58-inches aft of the tip of the inner clevis leg. The X-ray Supplement Data Sheet is provided as Appendix C.

X-ray inspection of the insulation in the dome-to-stiffener factory joint was conducted every three degrees. One void was detected in the insulation from 246 to 249 degrees. This void was reported to have a circumferential length of 7.36 inches, an longitudinal length of 1.42 inches, a radial depth of 0.026 inches and was located 10.58-inches aft of the inner clevis leg tip (Appendix C).
