METEOROID AND DEBRIS IMPACT FEATURES DOCUMENTED ON THE LONG DURATION EXPOSURE FACILITY

A Preliminary Report

Compiled by Members
of the LDEF Meteoroid
and Debris Special
Investigation Group

August 1990

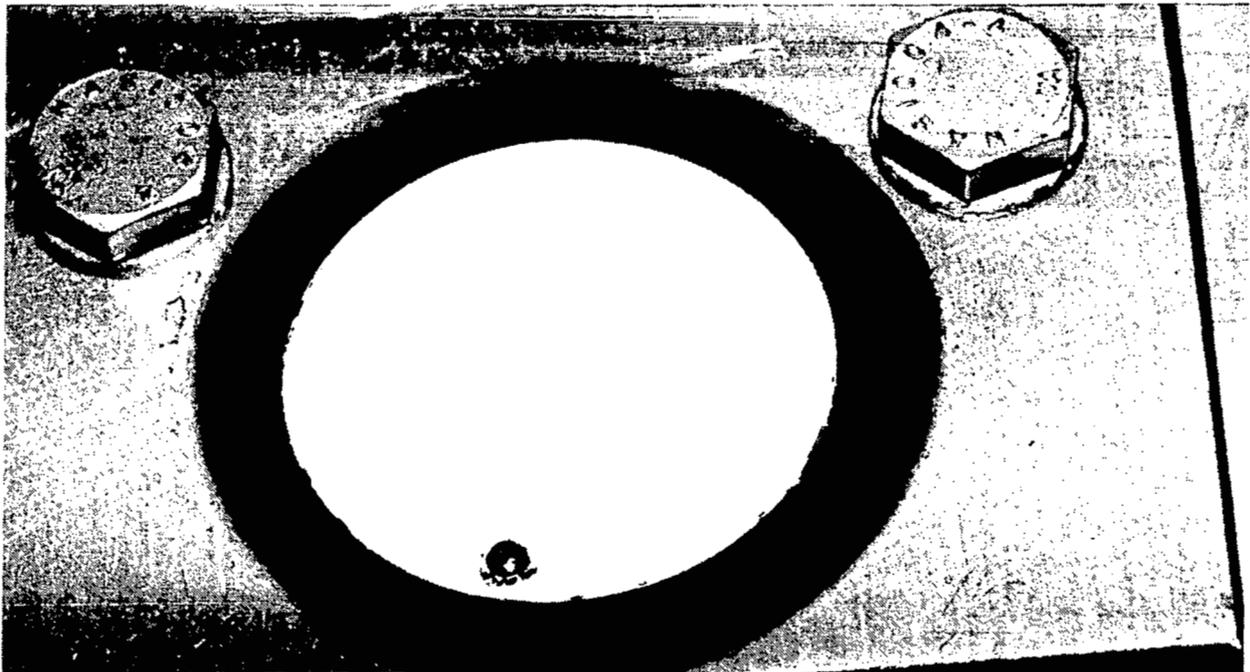
Figure 9. Impact into one of the paint specimens on an experiment-tray clamp. This particular feature was the largest impact feature found on the numerous tray clamps. View measures approximately ~6.5 cm across.
