EVALUATION OF RSRM
CASE HARDWARE FRETTING
CONCERNS

11 October 1990

Thiokol CORPORATION
SPACE OPERATIONS

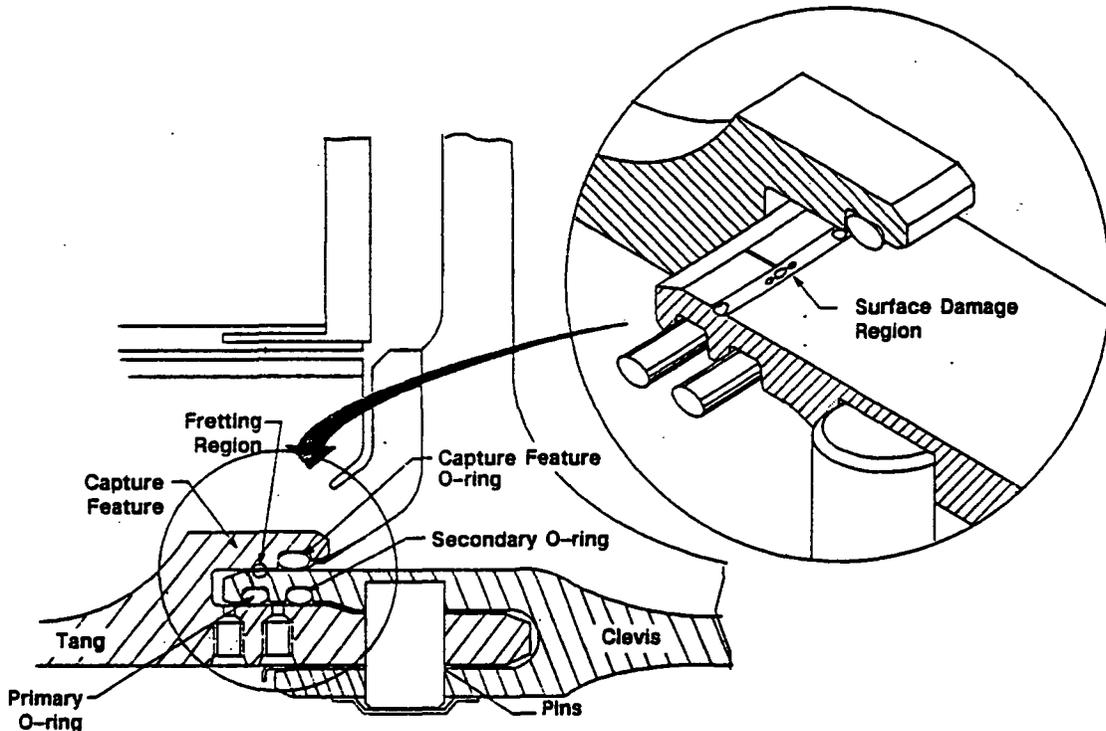
Figure 1: Field Joint Fretting Location

The field joint fretting occurs at the capture feature/inner clevis leg interface, see Figure 1 below.

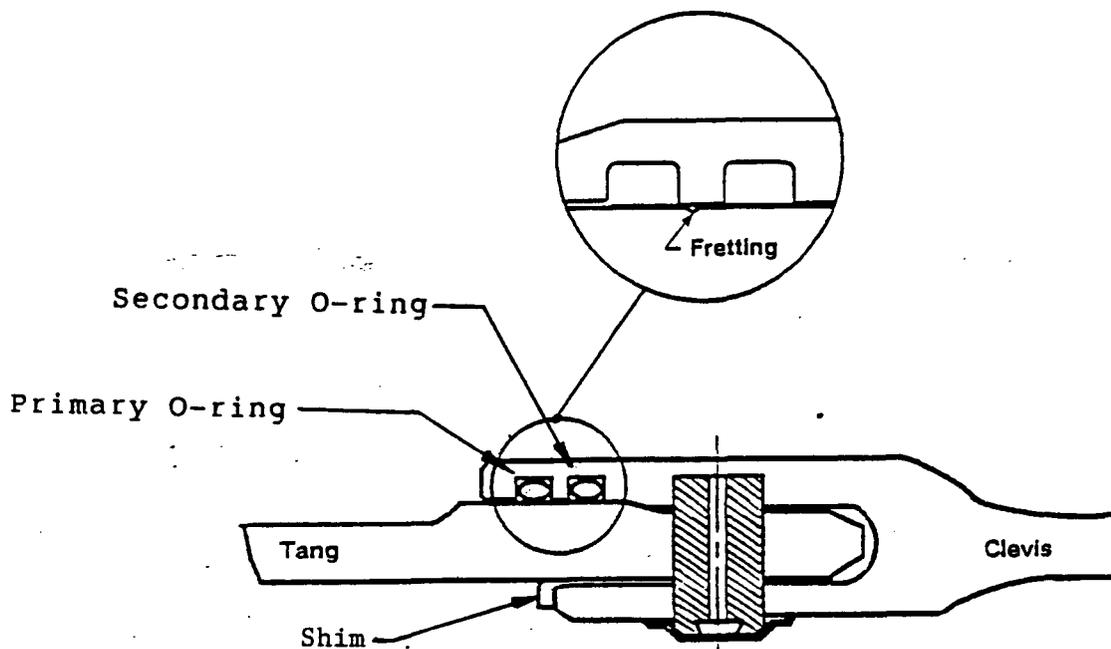
Figure 2: Factory Joint Fretting Location

The factory joint fretting occurs at the interface between the inner clevis leg and the tang surface at the area of the land between the primary and secondary O-ring grooves. See Figure 2, which illustrates this location. Factory joint fretting is much

smaller in both magnitude and number than the fretting at the field joint. The presence and/or awareness of the factory joint fretting can be attributed to two factors:

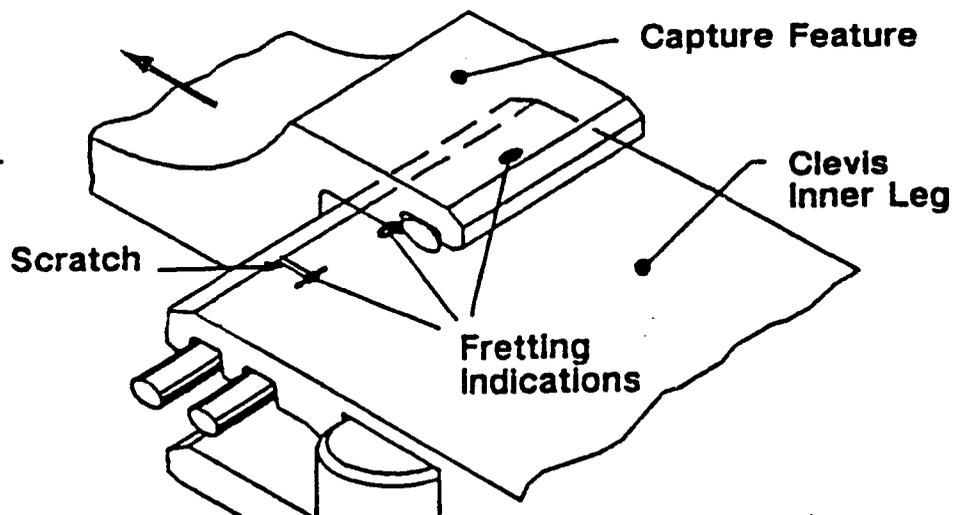
Figure 3: Field Joint Fret Indication with Associated Scratch

The fretting which is occurring at the capture feature of the field joint has very defined characteristics. A typical fret on the clevis leg side of the interface is a small pit approximately .004 to .005 inch deep and approximately .020 to .060 inch wide. The most severe pit was .017 inch deep (STS-29) which is a great deal larger than any other occurrence. The capture feature side of the interface is characterized by very light pitting and the presence of slightly raised material. During disassembly of the field joint, the raised metal present on the capture feature leaves a small scratch trailing from the pit on the clevis. This scratch is typically .0015 inch or less deep, and less than .020 inch wide. Figure 3 below illustrates typical field joint fretting as described.

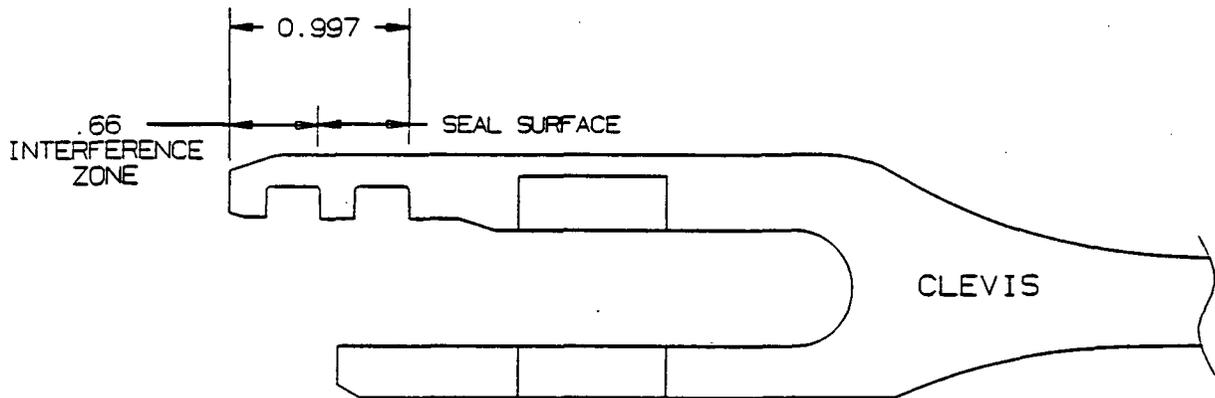
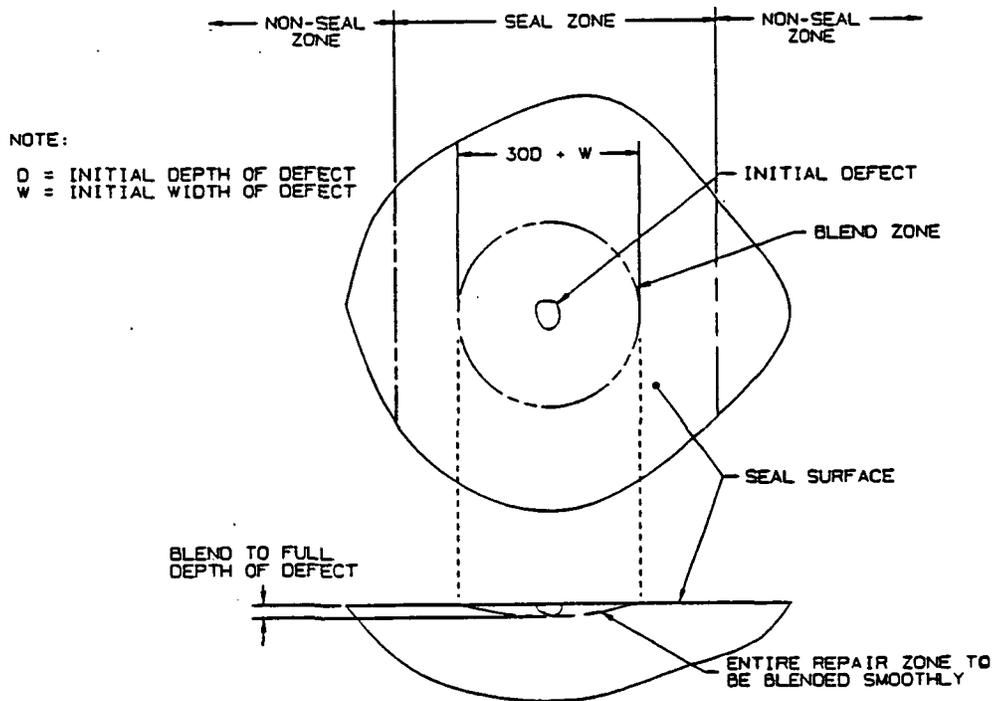
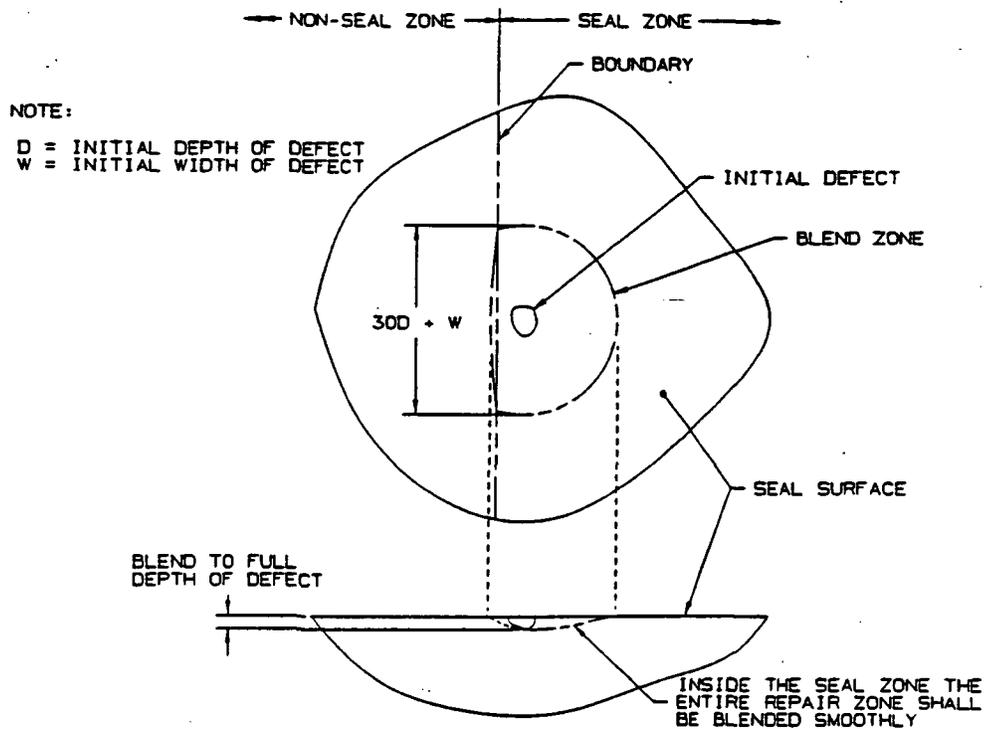
Fretting pits which occur in the seal zone but so near the interference zone that the projected blend zone would cross into the interference zone are feathered out in the axial direction at the seal/interference zone boundary. By not allowing the blend to extend into the interference zone the interference fit is not compromised. Those pits which are entirely in the interference zone are repaired by only breaking sharp edges and removing raised metal. The entire capture feature tang fretting region falls into this category of surface. Figures 4 thru 6 identify the seal and non-seal zones as well as illustrate the required rework for the various situations we have described above.

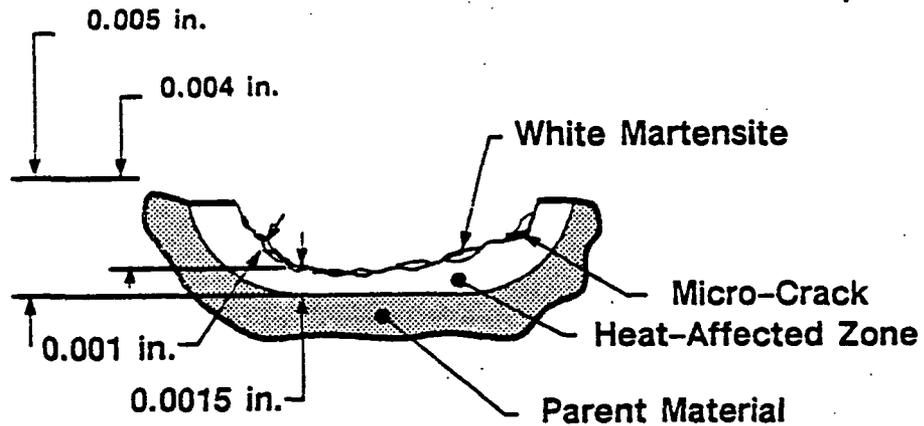
Figure 7: Fret Cross Section

In an effort to understand the micro-structure of the fret, an actual piece of fretted flight hardware from mission STS-27 was sectioned to perform a metallurgical study (Reference TWR-19666). The cross section of the fretting pit was examined using high magnification and x-ray diffraction. It was determined that a residue of metal oxides was present on the surface at the region of the fret. This presence of oxides is evidence that fretting is really a form of corrosion. The pits also showed a thin (.001 inch or less) discontinuous layer of white martensite at the surface of the pits. The total depth of the heat affected zone, excluding the white martensite, was approximately .0015 inch deep. The heat affected zone is caused by the very localized hot spots generated by the fretting action. Also observed, was the presence of small micro-cracks at the surface of the pitted region. These micro-cracks were shown to be .001 inch or less deep and did not extend into the parent material. The cracks are approximately .003 inch long and run parallel to the contour of the pit at the approximate boundary between the martensite and the heat affected regions. A typical cross section of a fret pit is shown in Figure 7 which illustrates some of the details described above. Figure A2 in Appendix A shows a 500X photo of one of the sectioned frets.
