MOLECULAR FILMS ASSOCIATED WITH LDEF*

E. R. Crutcher and K. J. Warner
Boeing Defense and Space Group
Seattle, WA 98124-2499
Phone: 206/773-7002, Fax: 206/773-1473

SUMMARY

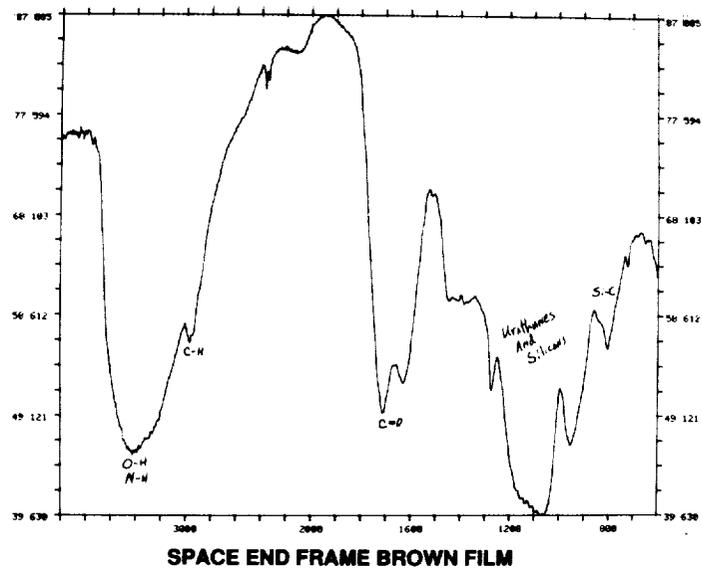
Figure 1: Brown film from longeron exposure at tray G-12 facing ram direction.

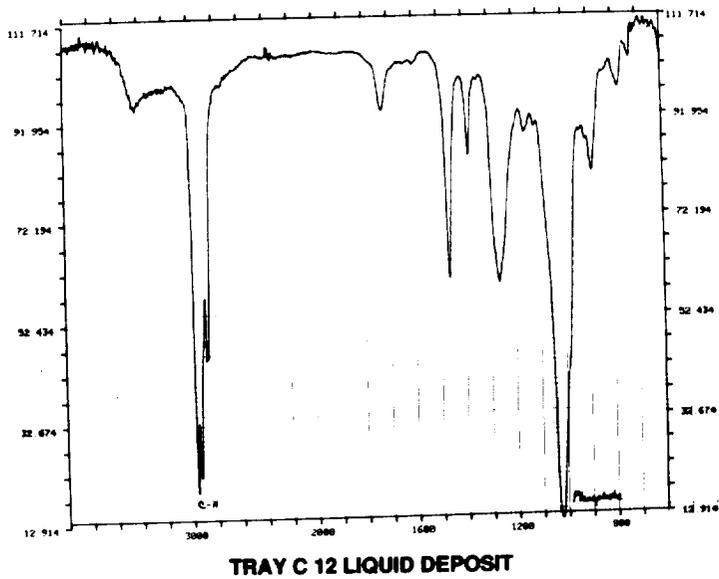
Tray C-12 was a special case. When LDEF was first rotated in SAEF-2 a liquid began running from this tray. The spectrum of the liquid (Figure 7) essentially matched that of the triocyl phosphate used as a fire retardant material in the plastic insulation around the fiber optic bundles on that tray (Figure 6). The brown film around tray C-12 contained very little silicones as is indicated by the absence of the peak near 800 wave numbers in this spectrum (Figure 8).

Figure 7: Tray C-12, liquid collected on glass fiber paper during deintegration.

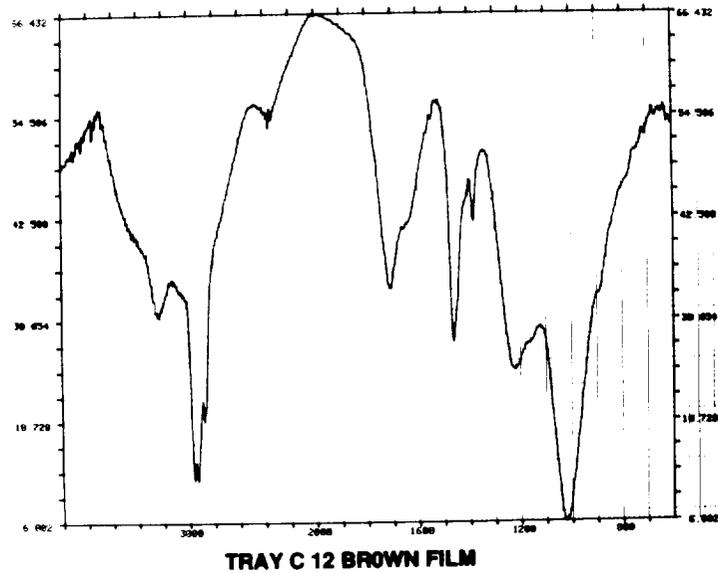
Figure 8: Tray C-12, brown film from corner vent.

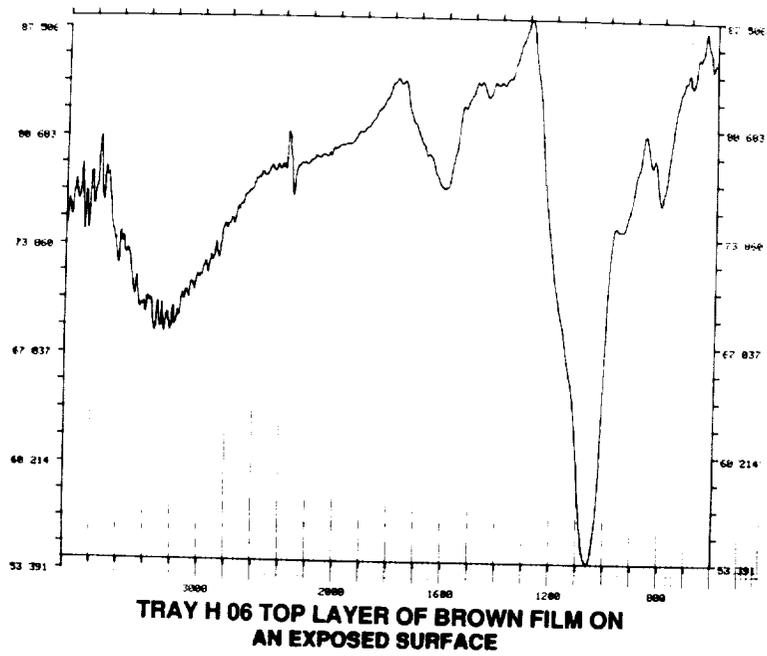
Figure 9: Tray H-06, top layer of AO exposed brown film.

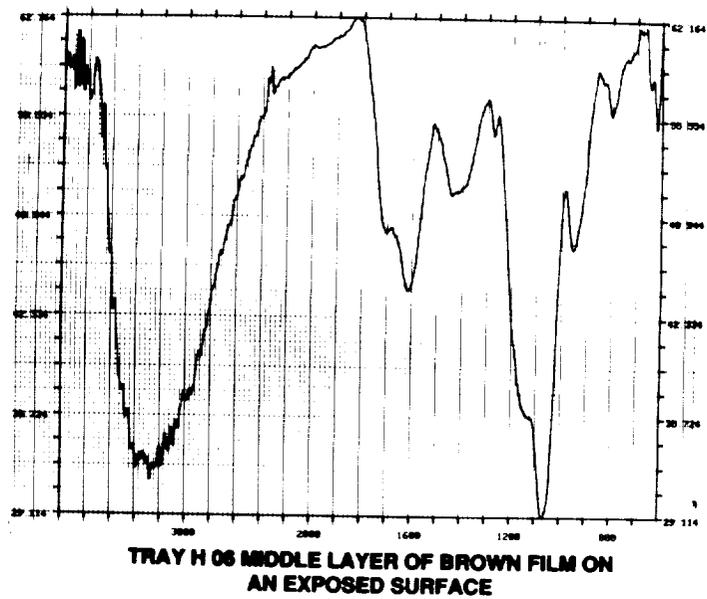
Figure 10: Tray H-06, middle layer of AO exposed brown film.

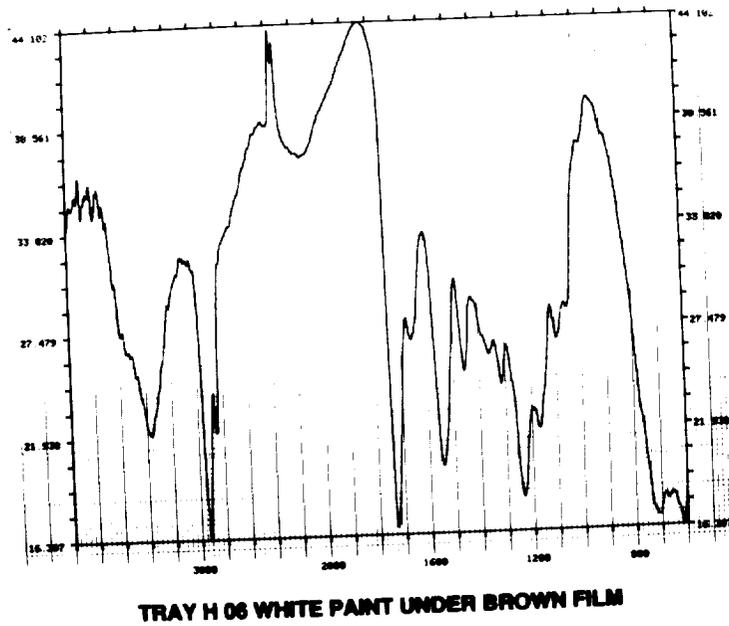
Figure 11: Tray H-06, bottom deposit (paint surface) of AO exposed brown film.

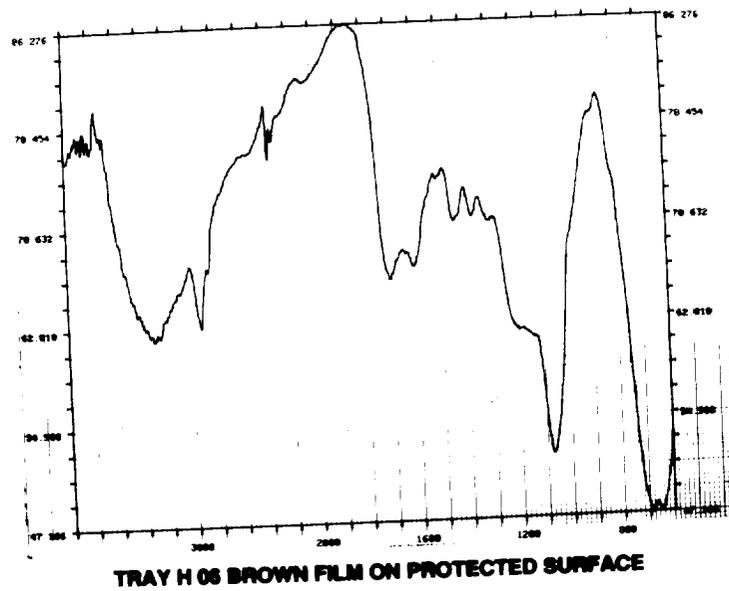
Figure 12: Tray H-06, brown deposit on trailing exposure.

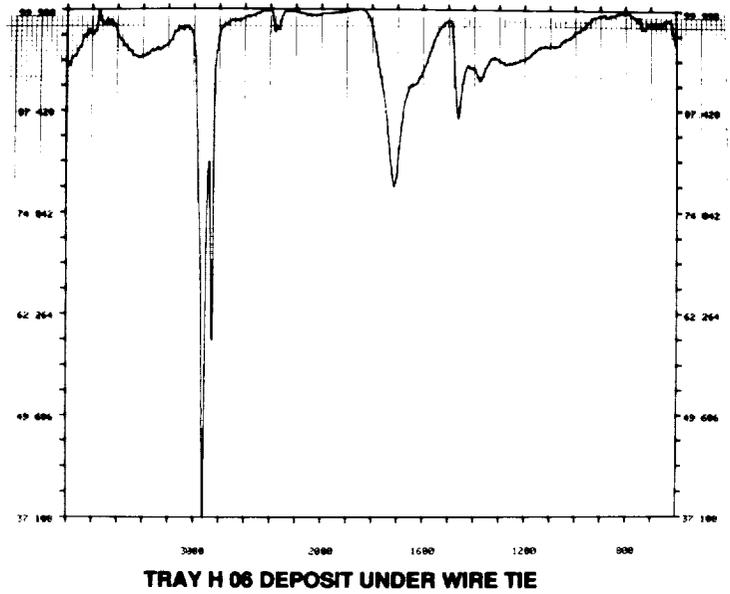
Figure 14: Tray H-06, deposit beneath wire tie wrap.

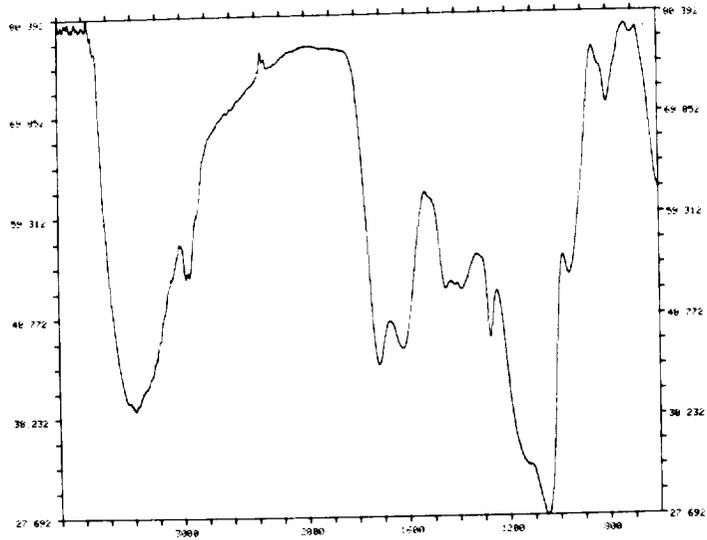
The thickest brown films always formed on vents from the interior on the side facing into the ram direction. Figure 15 is an example from tray F-06. Notice that this spectrum is very similar to that in Figures 1 and 2. A yellow deposit on the front of tray E-02, clamp 6 had a pattern that was quite different than the typical brown film (Figure 16). No precursor of this deposit has been found at this time.

TRAY E 06 CORNER VENT FACING RAM DIRECTION

Figure 15: Tray F-06, corner vent deposit facing ram exposure.

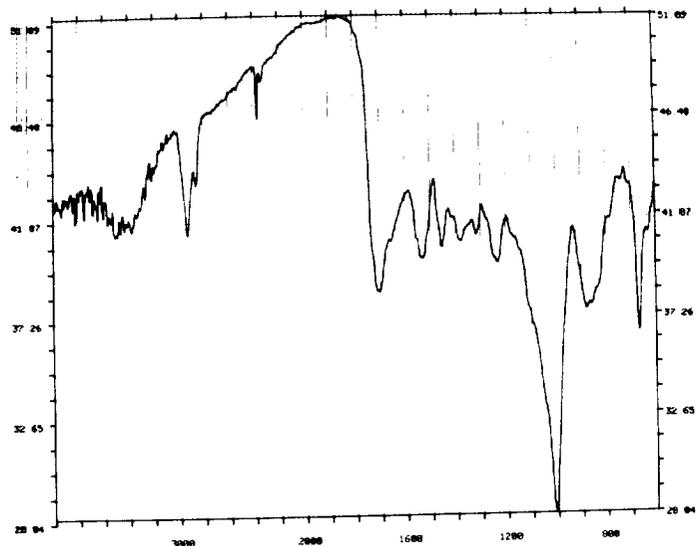
TRAY CLAMP E 02 6 YELLOW DEPOSIT ON FRONT SURFACE

Figure 16: Tray E-02, clamp 3, yellow deposit.

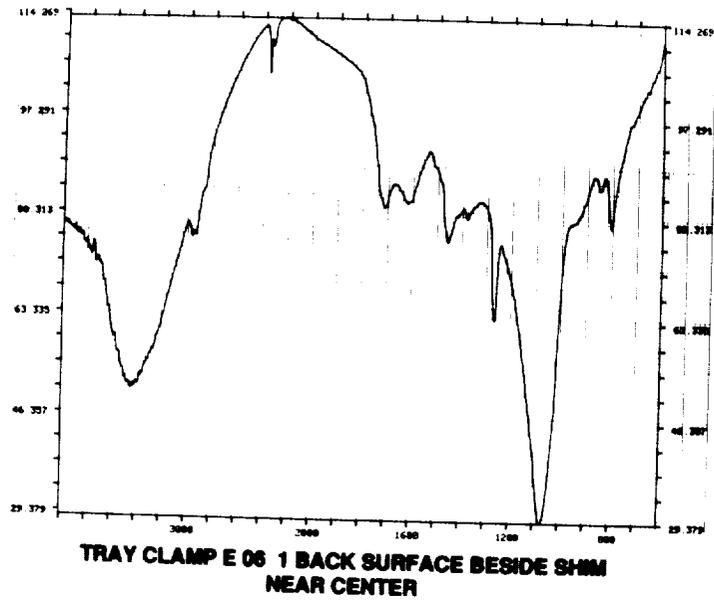
The backs of the tray clamps and shims were examined to evaluate the types of molecular film contaminants that were launched with LDEF. The material on the back surface of tray E-06, clamp 1 had a large silicone component (Figure 17). Closer to the edge of the clamp the hydrocarbon component increased (Figure 18) until at the edge of the clamp the pattern had become very similar to the typical brown film pattern (Figure 19).

Figure 17: Tray E-06, clamp 1, deposit between clamp and shim at center.

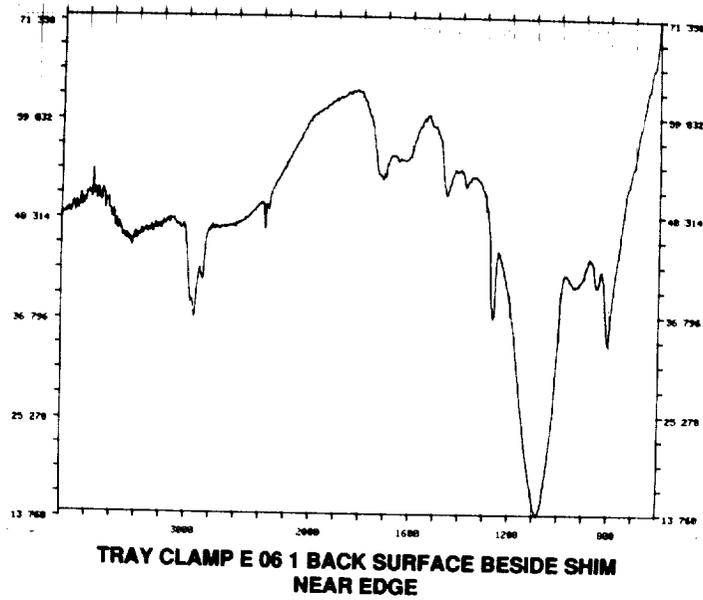
Figure 18: Tray E-06, clamp 1, deposit between clamp and shim near edge of clamp.

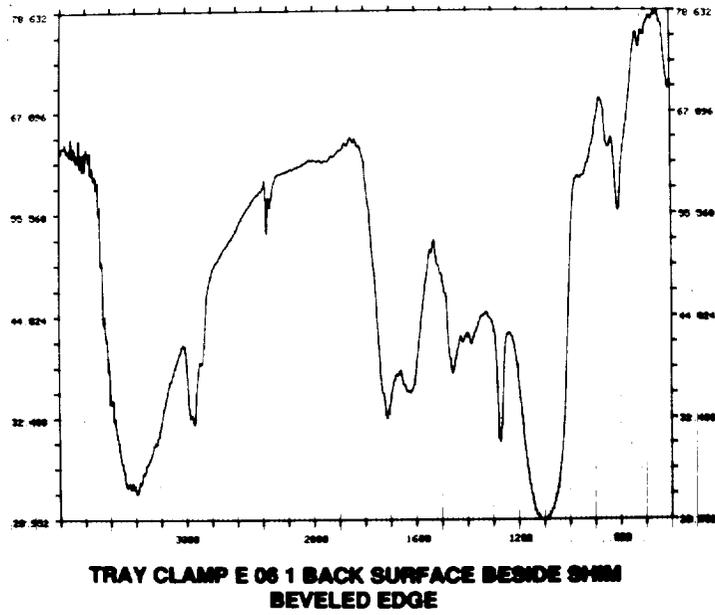
Figure 19: Tray E-06, clamp 1, deposit on beveled edge of clamp.

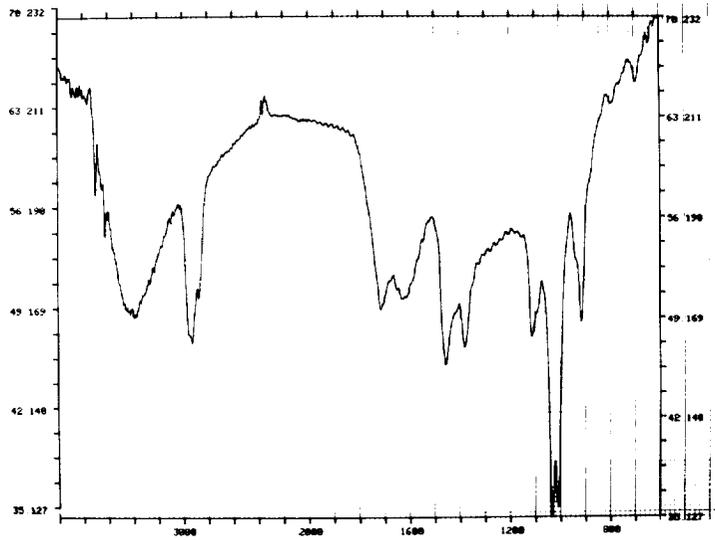
Another interesting spectrum was shown by brown spots found on a number of surfaces (Figure 20). These brown spots were often associated with a variety of particulate matter, paint spheres, wear metals, fibers, and other debris (Photograph 5) and a significant concentration of sodium chloride, potassium chloride, and other water soluble salts. These materials were also found on leading edge trays indicating they were not present during the nearly six years LDEF was in orbit. These may be the residue of waste dumps made after the retrieval of LDEF by the shuttle.

Figure 20: Tray F-09, clamp 8, brown spot.

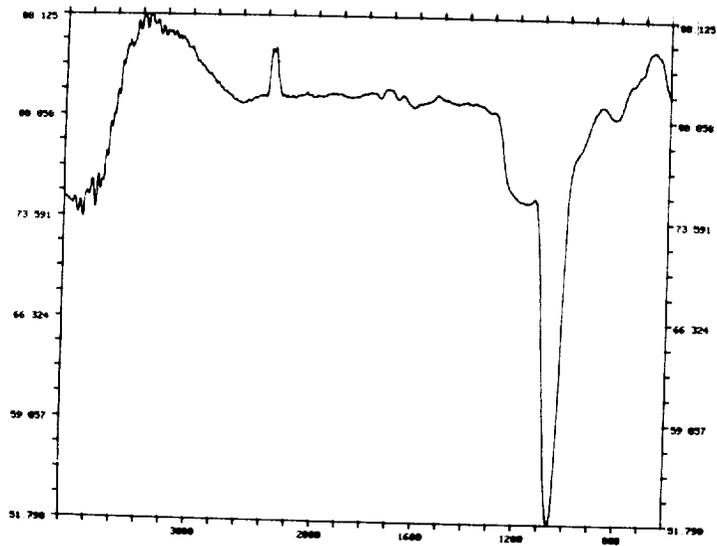
On the leading edge trays there was often little evidence of deposition by discoloration. Elemental analysis of the surface in many areas did indicate silicate films, presumably the remnant of the hydrocarbon/silicone film after reacting with atomic oxygen. Figure 21 is the infrared spectrum of one of these films on clamp 4 of tray F-09. Figure 22 shows the elemental mapping of this "shadow" seen next to bolt A of clamp 4 on tray F-09. The aluminum map shows the bare aluminum exposed under the washer and the aluminum in the anodized surface of the clamp. The oxygen map illustrates the distribution of oxides. In the area of the weaker aluminum signal the silicon map illustrates a concentration of silicon. This is a silicon dioxide film over the anodized aluminum. Photograph 8 shows the LDEF structure with the trays removed and a slight discoloration in the exposed area of the structure associated with the presence of the silica film compared to the areas covered by the tray edges and tray clamps. This is in contrast to the obvious dark film seen on the trailing structure clearly delineating the position of the tray edges and clamps (Photograph 9).

Figure 21: Tray F-09, clamp 4, surface with change in interference color.

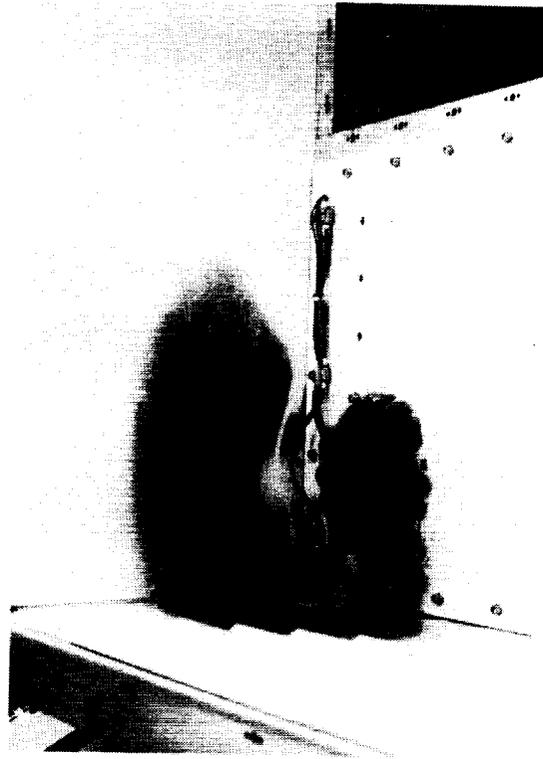
Photograph 1: Tray H-06, brown deposit in AO exposed corner.
(See color photograph, p.599.)

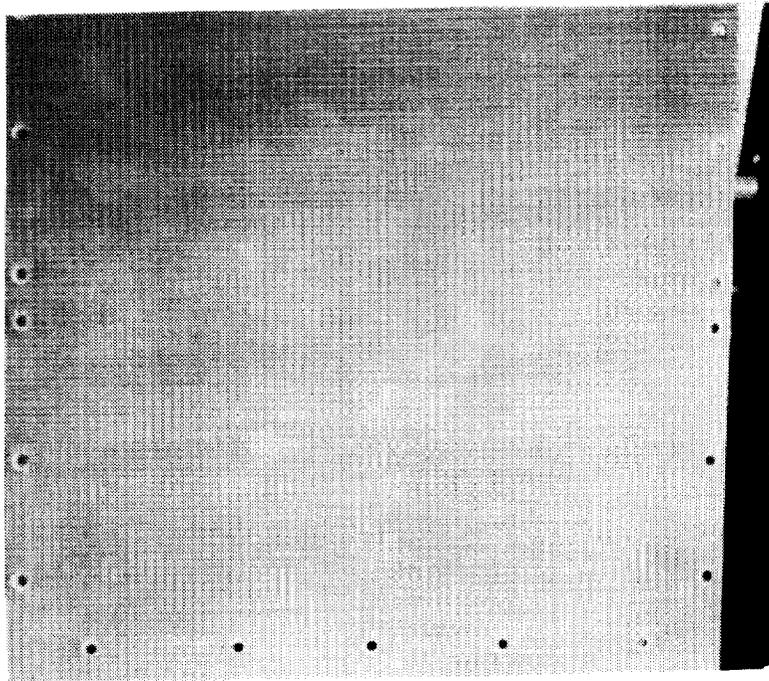
Photograph 6 shows a handprint in the bottom of tray F-06. The handprint is lighter than the surrounding area indicating the print acted as an ultraviolet light filter or as a sacrificial surface layer reducing the effect on the paint vehicle underneath or it represented an area of positive pressure preventing the deposition of brown molecular film. Fingerprints in other areas were seen to become dark brown or black but this was always on metal surfaces rather than paint. Similar "lightening" effects were seen on other trays such as the pre-flight scuff patterns seen in the brown deposits in Photographs 1 and 2.

Photograph 6: Tray F-06, handprint on bottom panel.

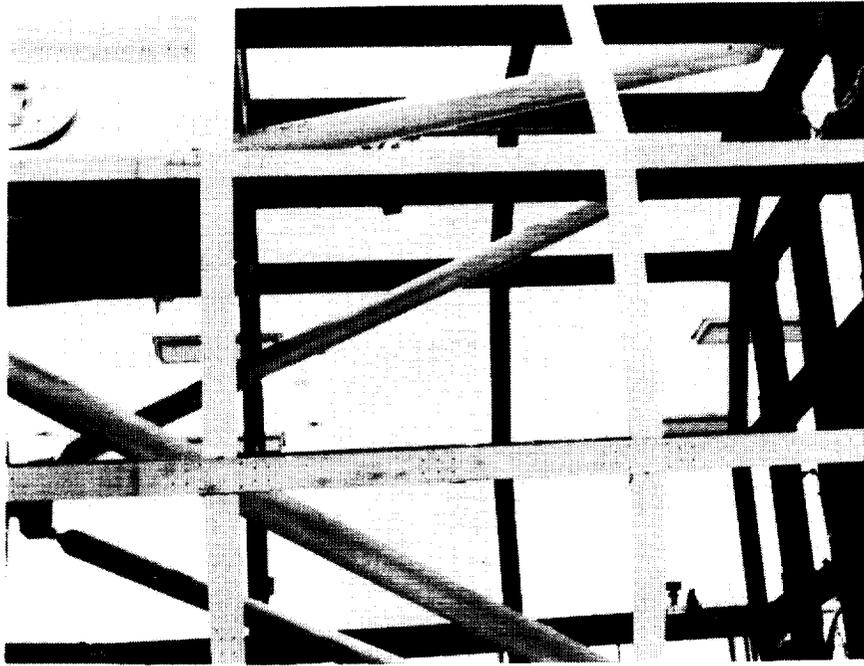
LDEF Leading edge (ram direction)

Photograph 8: Leading edge view of LDEF structure.

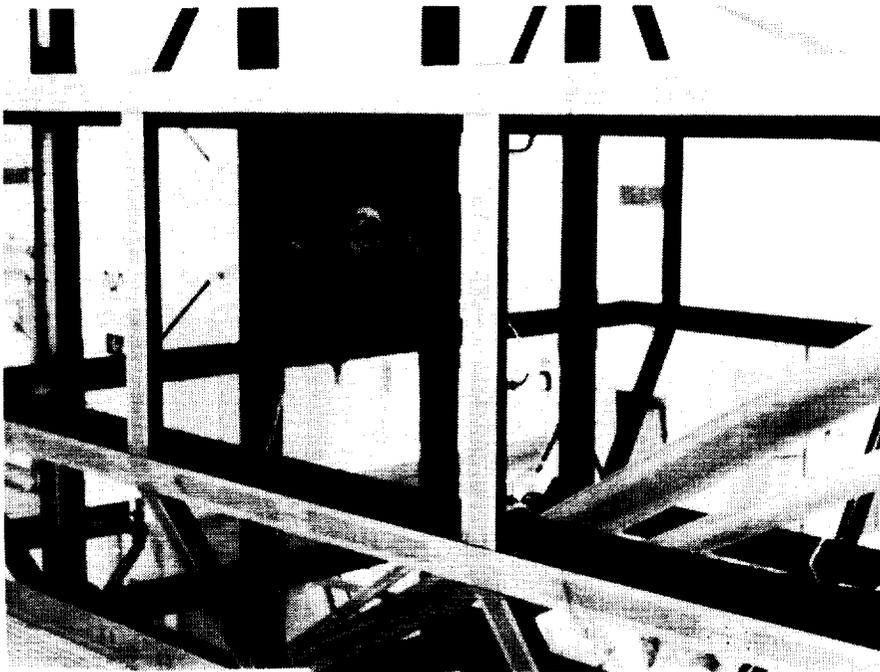
NVR stain LDEF trailing edge Earth end

Photograph 9: Trailing edge view of LDEF structure.
