# Debris/Ice/TPS Assessment And Integrated Photographic Analysis For Shuttle Mission STS-47

November 1992

**Gregory N. Katnik**  
**NASA/Kennedy Space Center**

DEBRIS/ICE/TPS ASSESSMENT  
AND  
PHOTOGRAPHIC ANALYSIS  
OF  
SHUTTLE MISSION STS-47

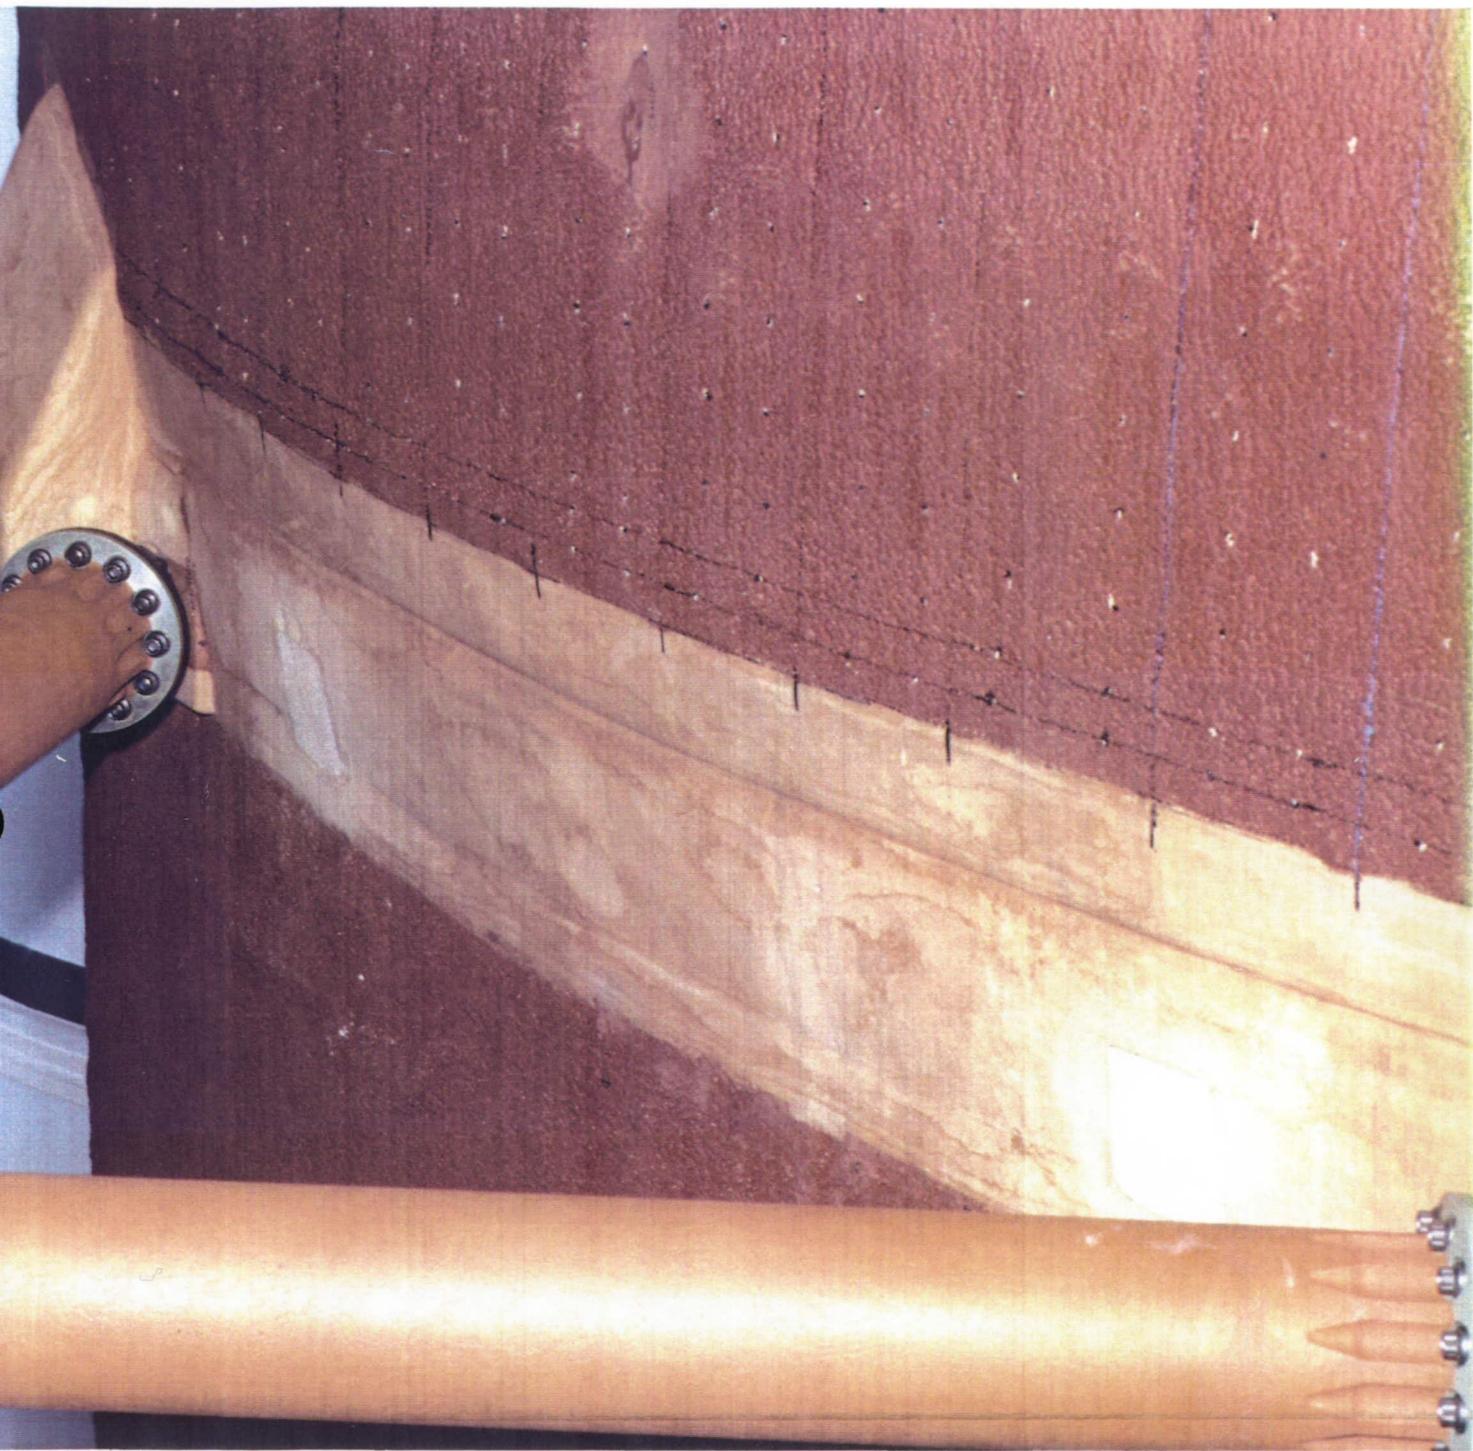
Pre-flight configuration of the bipod jack pad closeouts, the intertank TPS acreage, and the LH2 tank flange closeout. Post ET separation photography would reveal the loss of TPS from the intertank acreage and the LH2 tank flange closeout.

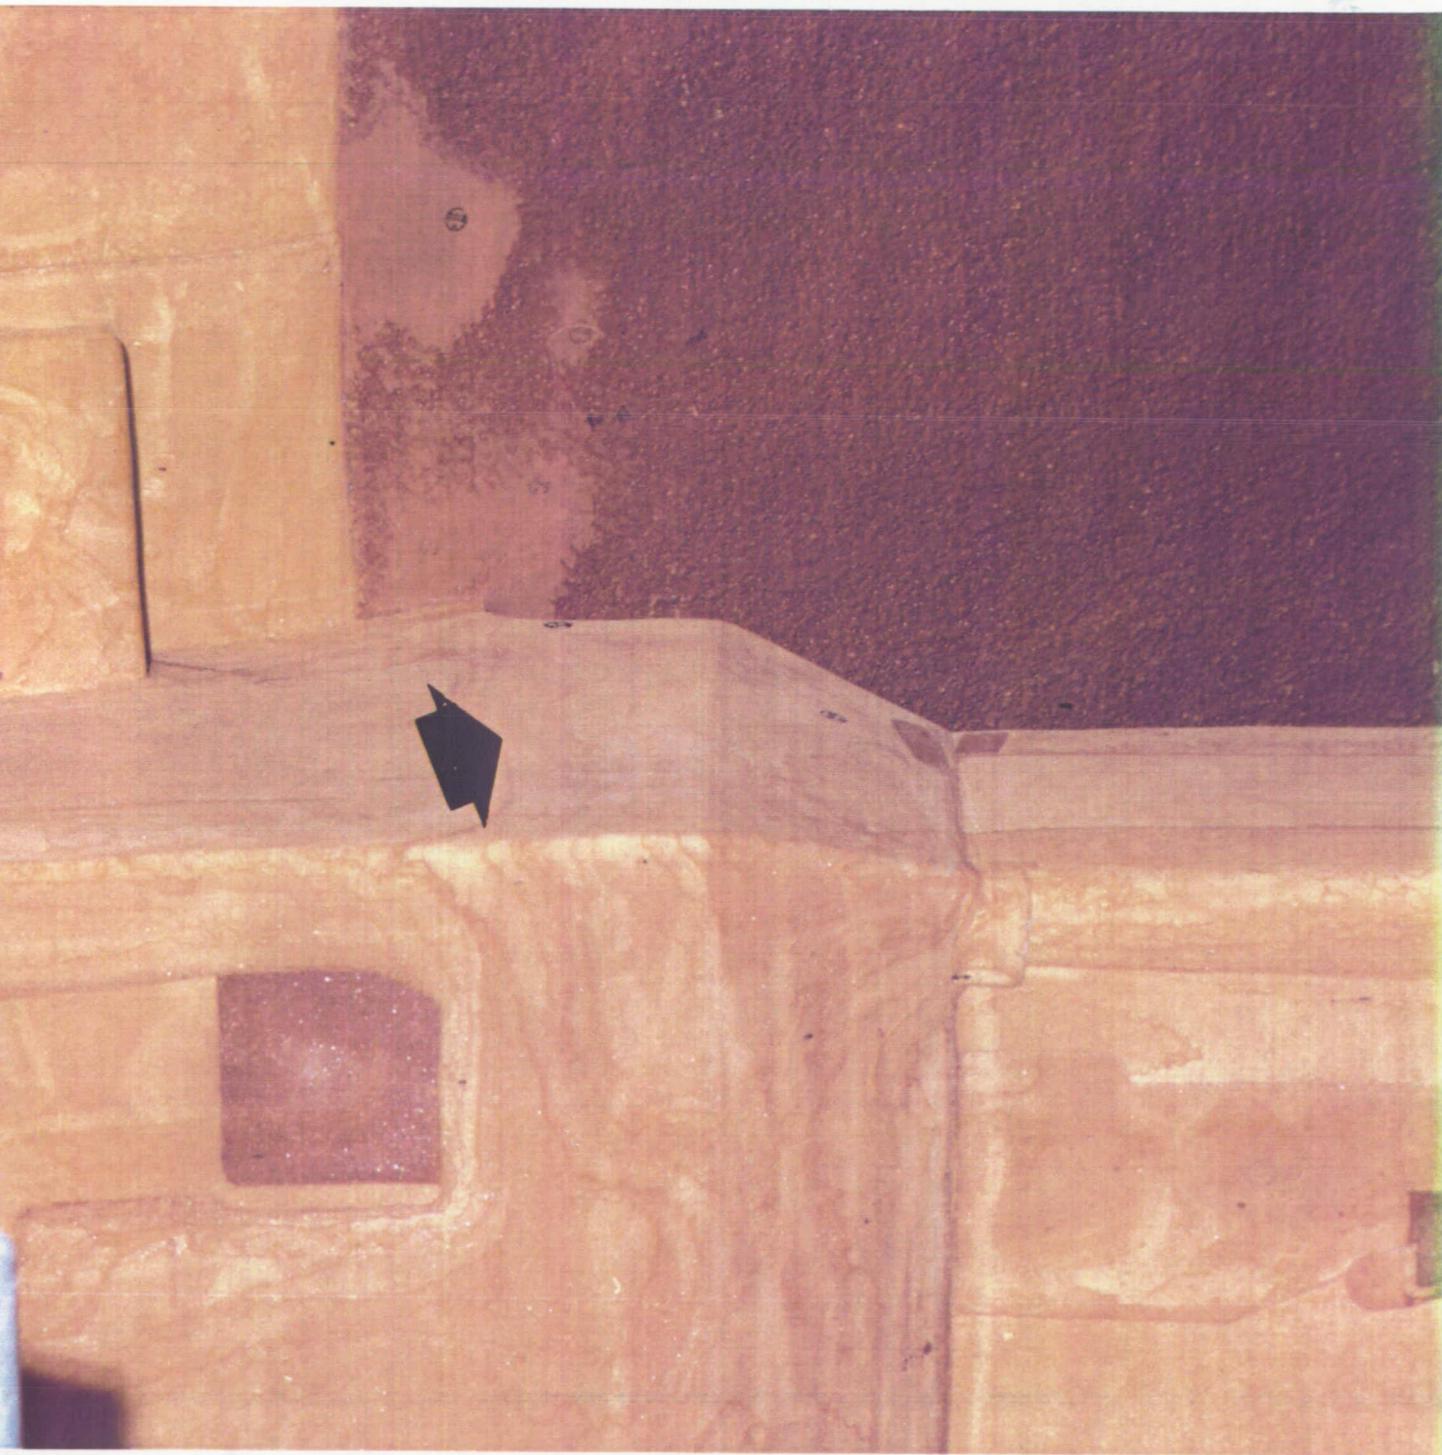
LH (-Y) vertical strut/cable tray TPS covering prior to cryogenic fuel loading. Cracks have appeared in this general area after cryoload due to the elimination of a stress relief gap as part of a manufacturing process enhancement change.

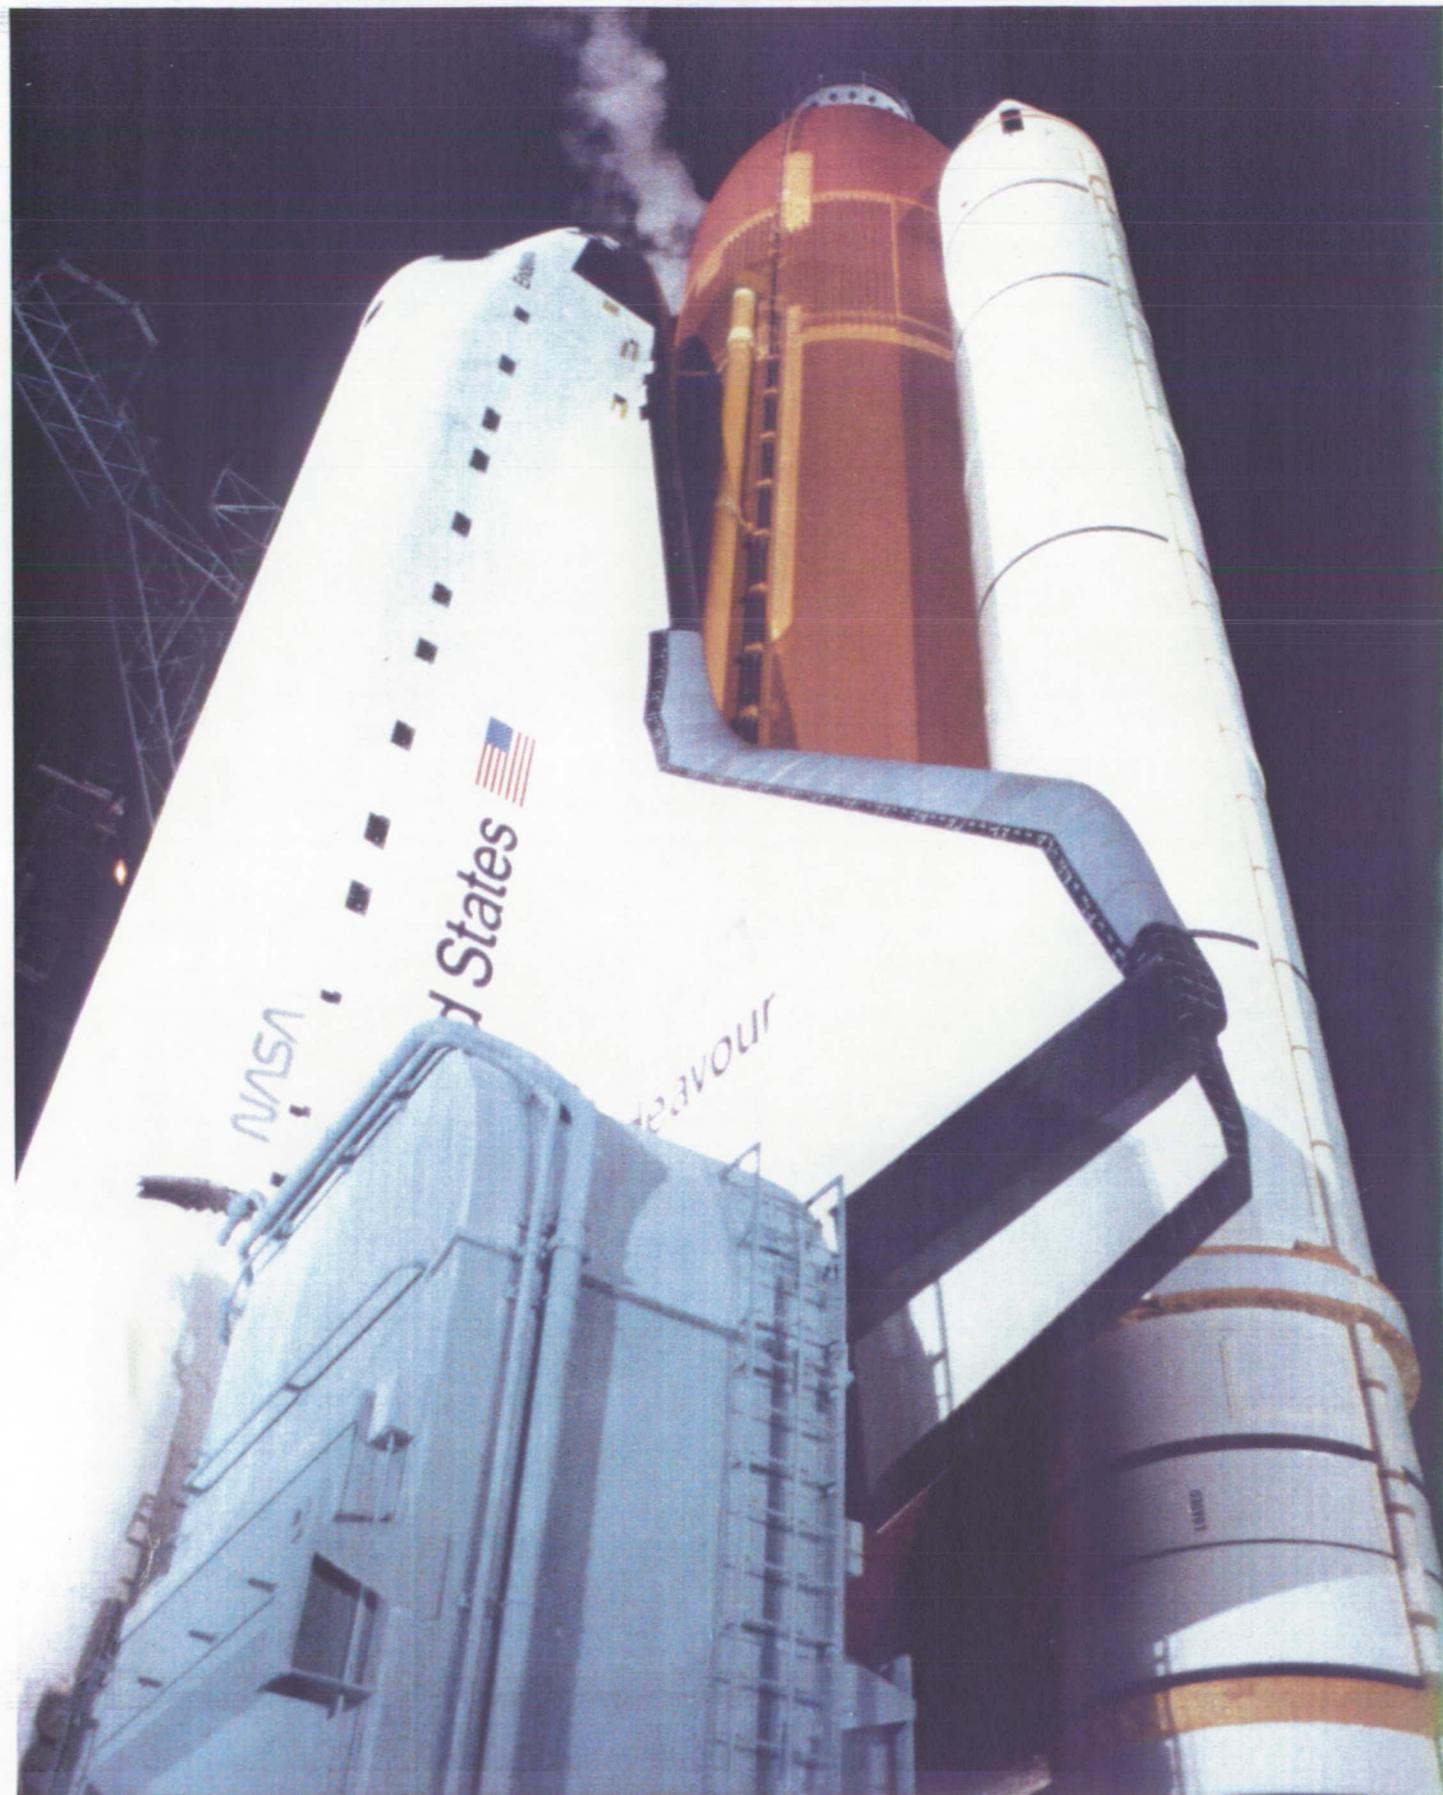
Light condensate, but no ice or frost accumulation, was present on the ET LO2 and LH2 tank TPS acreage

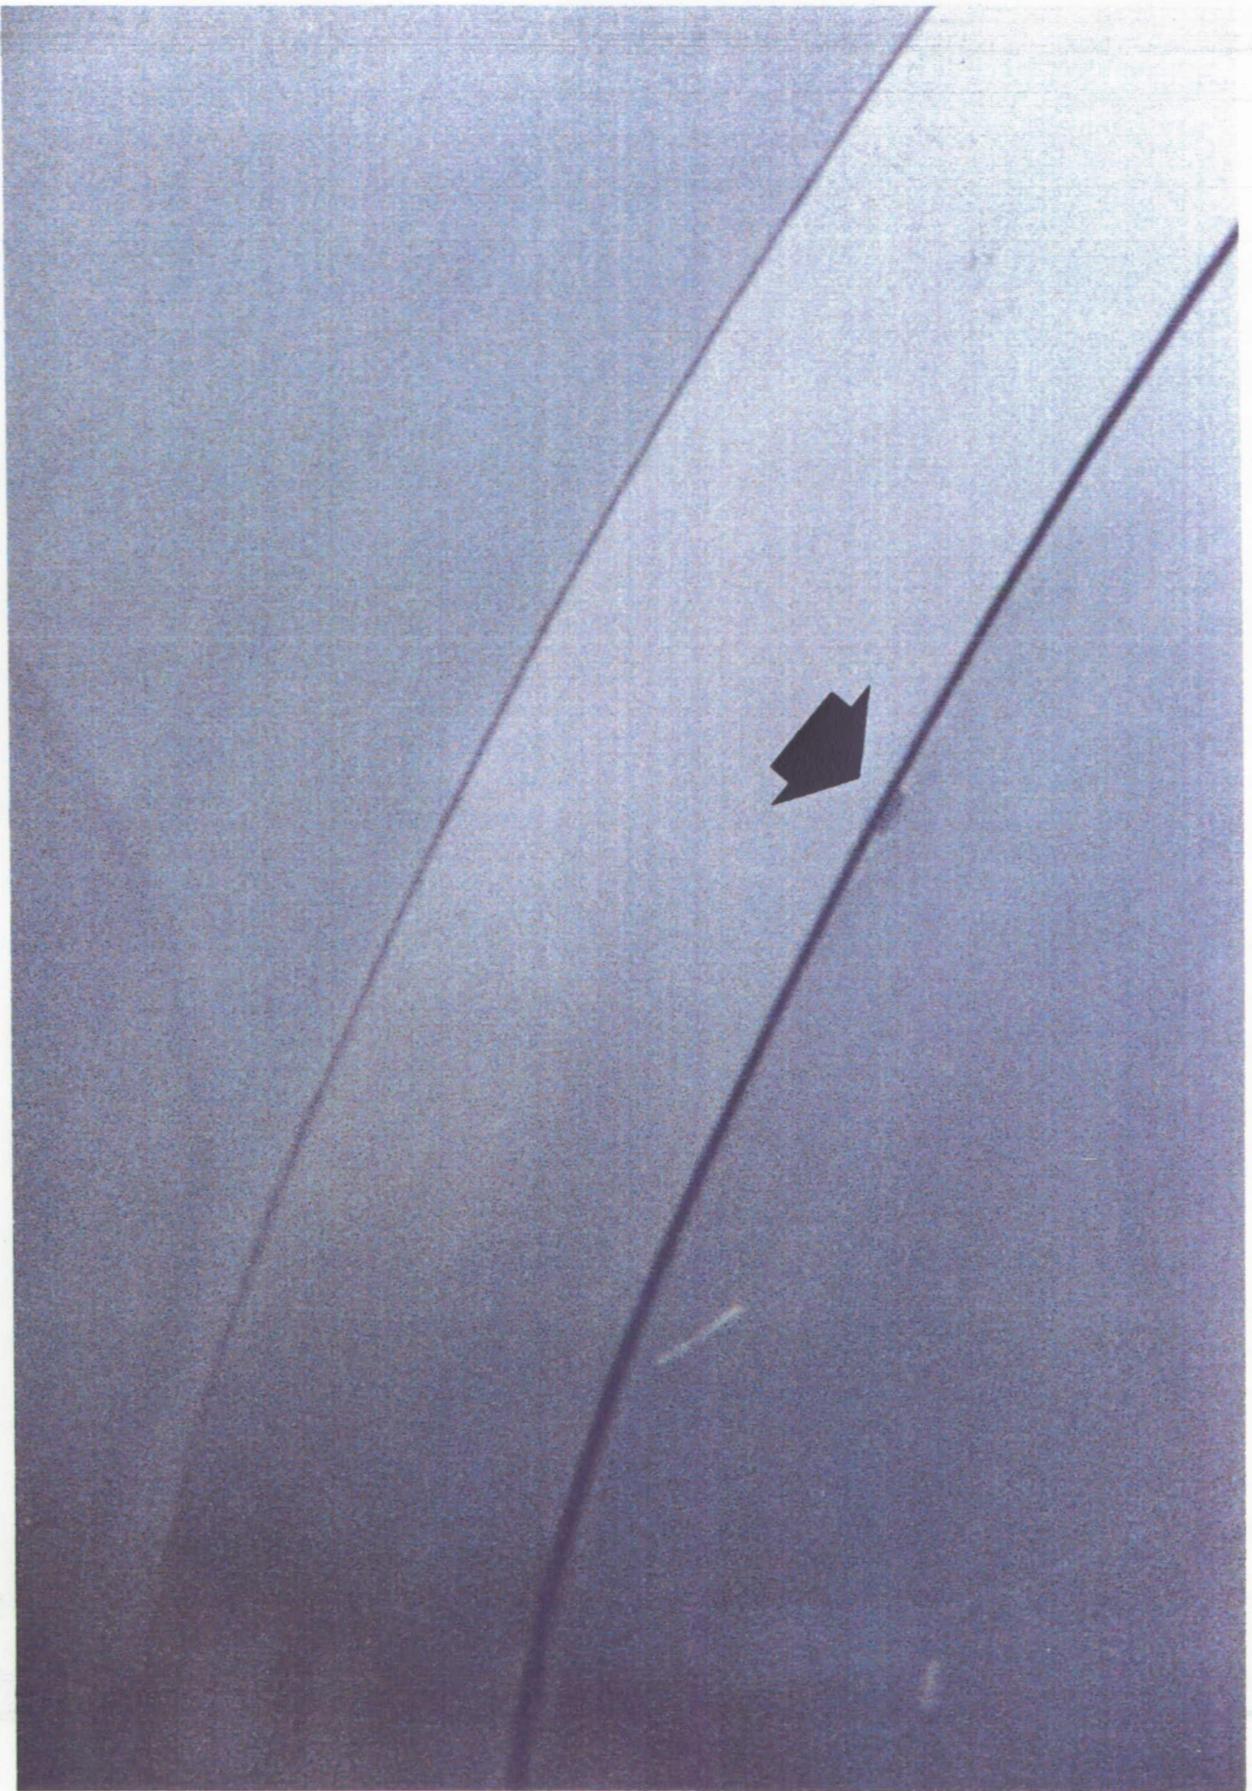
No Orbiter tile anomalies were observed. An IPR was taken against a .40L x .15W x .0625D-inch dent, or cavity, on the inboard edge of the LH RCC panel #9. The IPR was dispositioned to fly as-is. All RCS thruster paper covers and water spray boiler plugs were intact. Less than usual ice/frost was present at the SSME heat shield-to-nozzle interfaces. Condensate was present on all SSME heat shields and on base heat shield tiles. An infrared scan revealed no unusual temperature gradients on the base heat shield or engine mounted heat shields. No unusual vapors originated from inside the SSME nozzles.

An IPR was taken against an apparent dent, or cavity, on the left wing RCC panel #9 adjacent to the T-seal. The IPR was dispositioned to fly as-is.

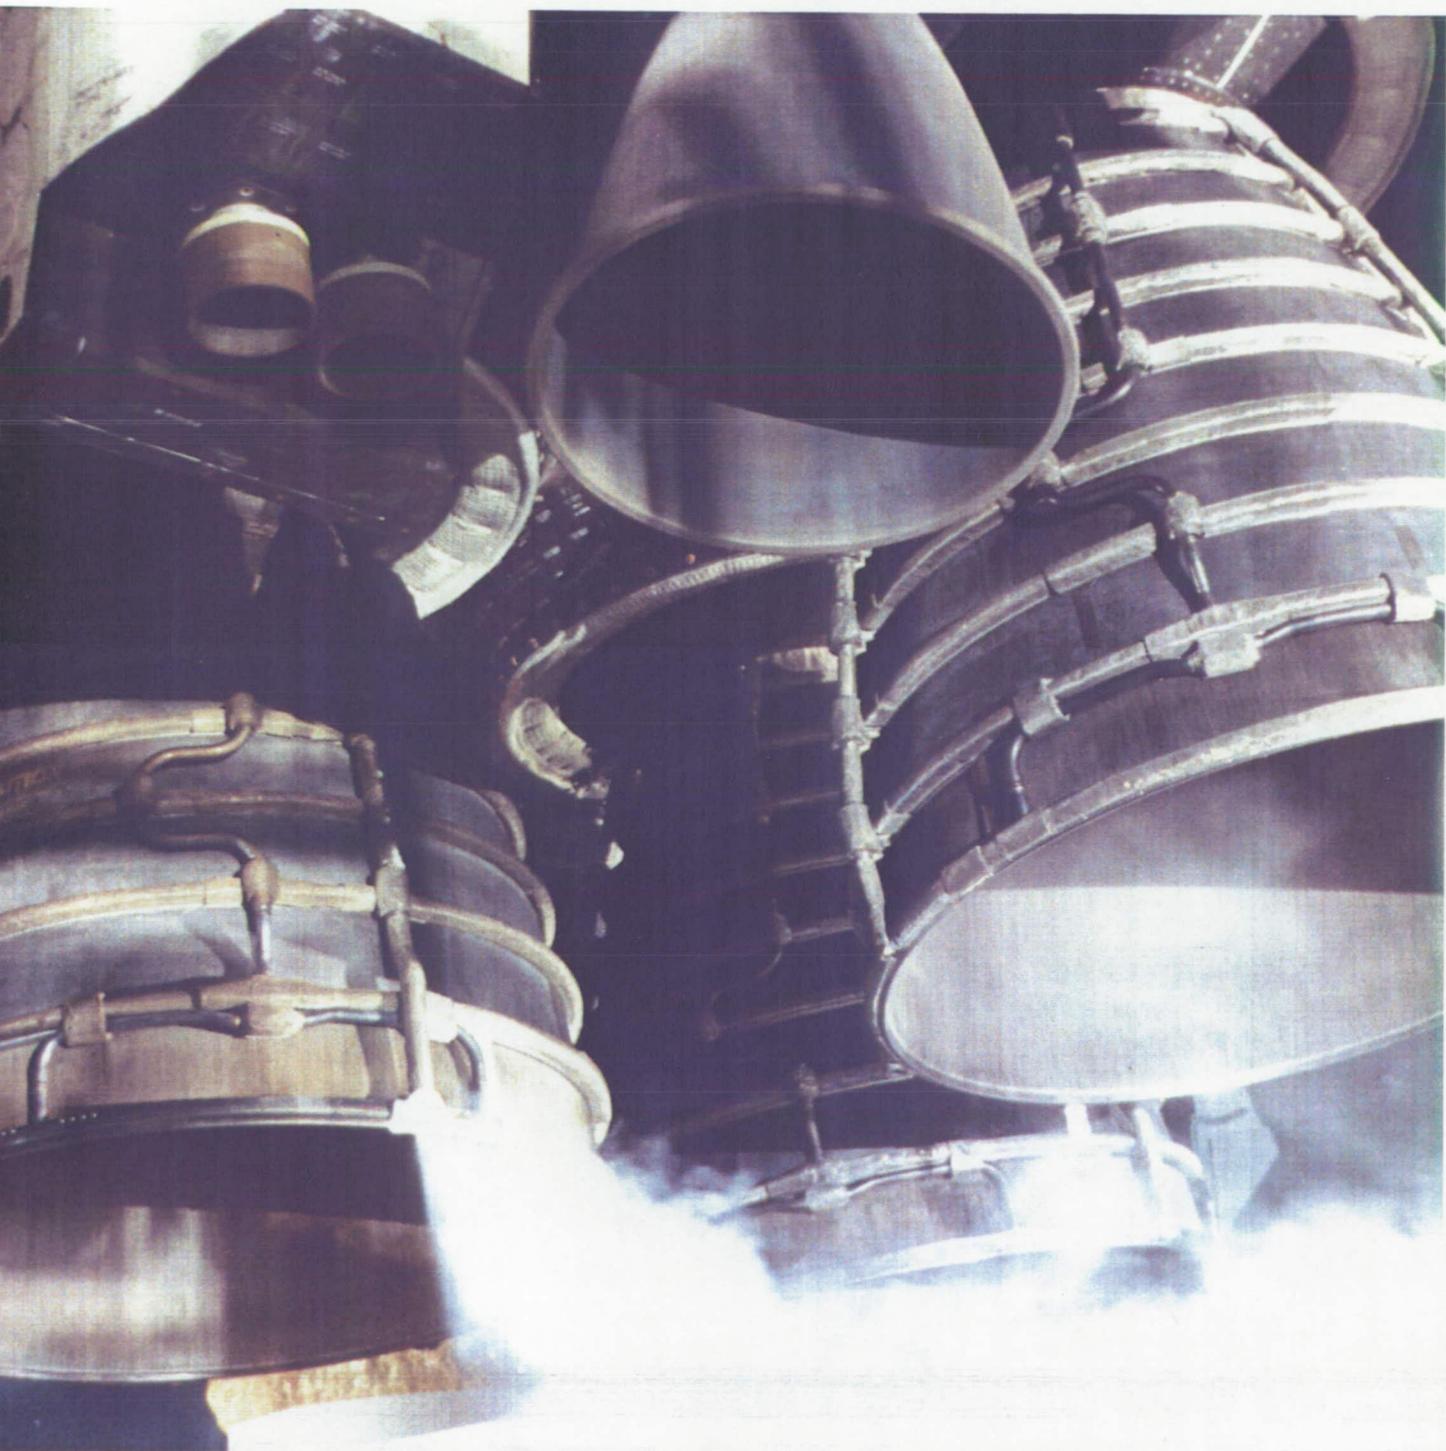
Less than usual ice/frost had formed at the SSME heat shield-to-nozzle interfaces. An infrared scan revealed no unusual temperature gradients on the base heat shield or engine mounted heat shields.

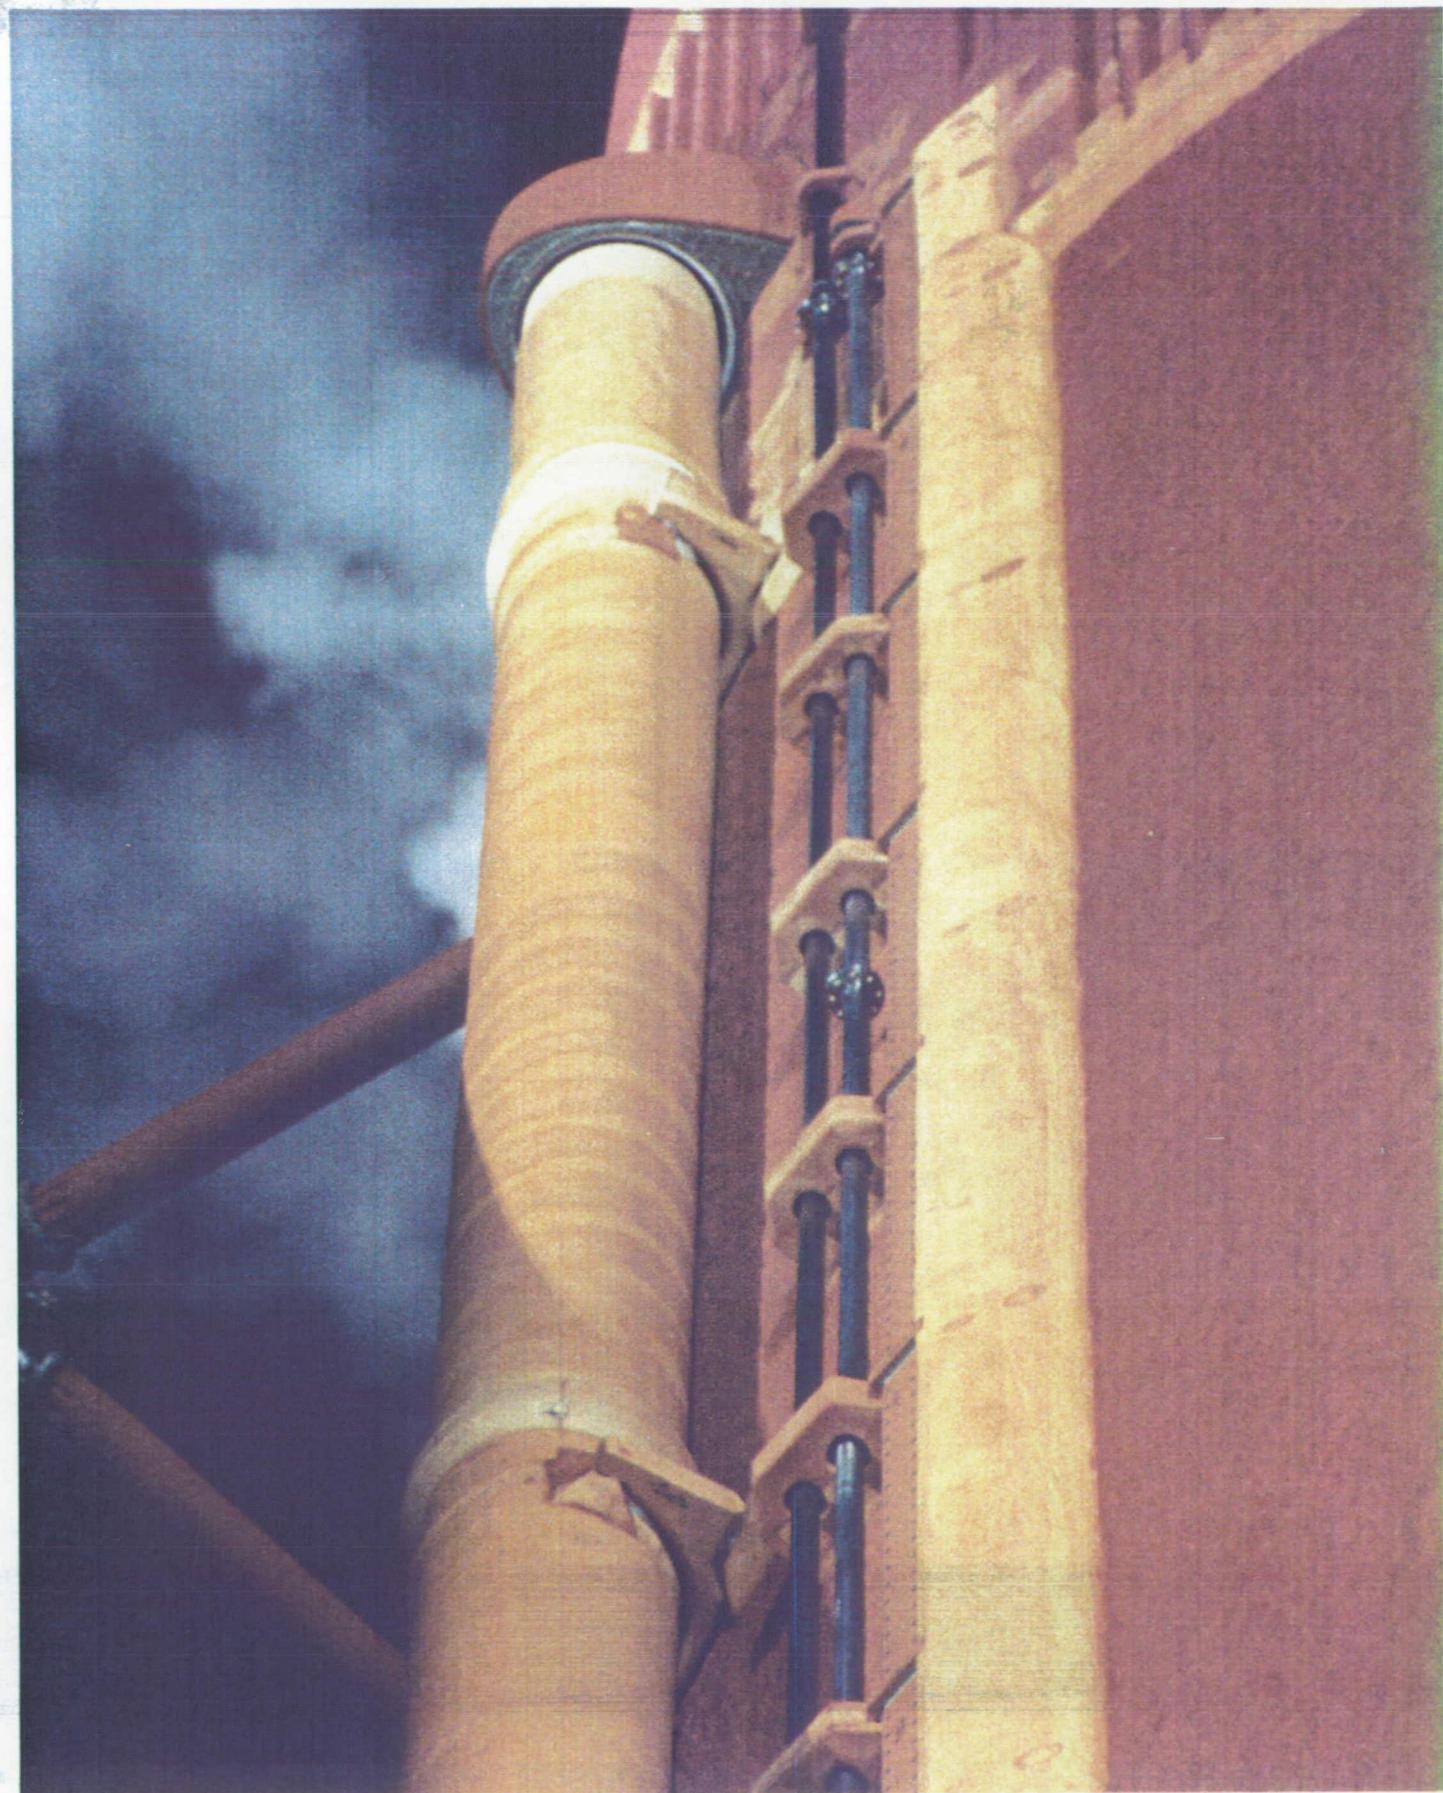
Anomaly 005 (documentation only) recorded ice/frost formations in the LO2 feedline bellows and support brackets. These ice and frost formations were acceptable per NSTS-08303.

Typical amounts of ice/frost had formed in the L02 feedline support bracket and upper bellows

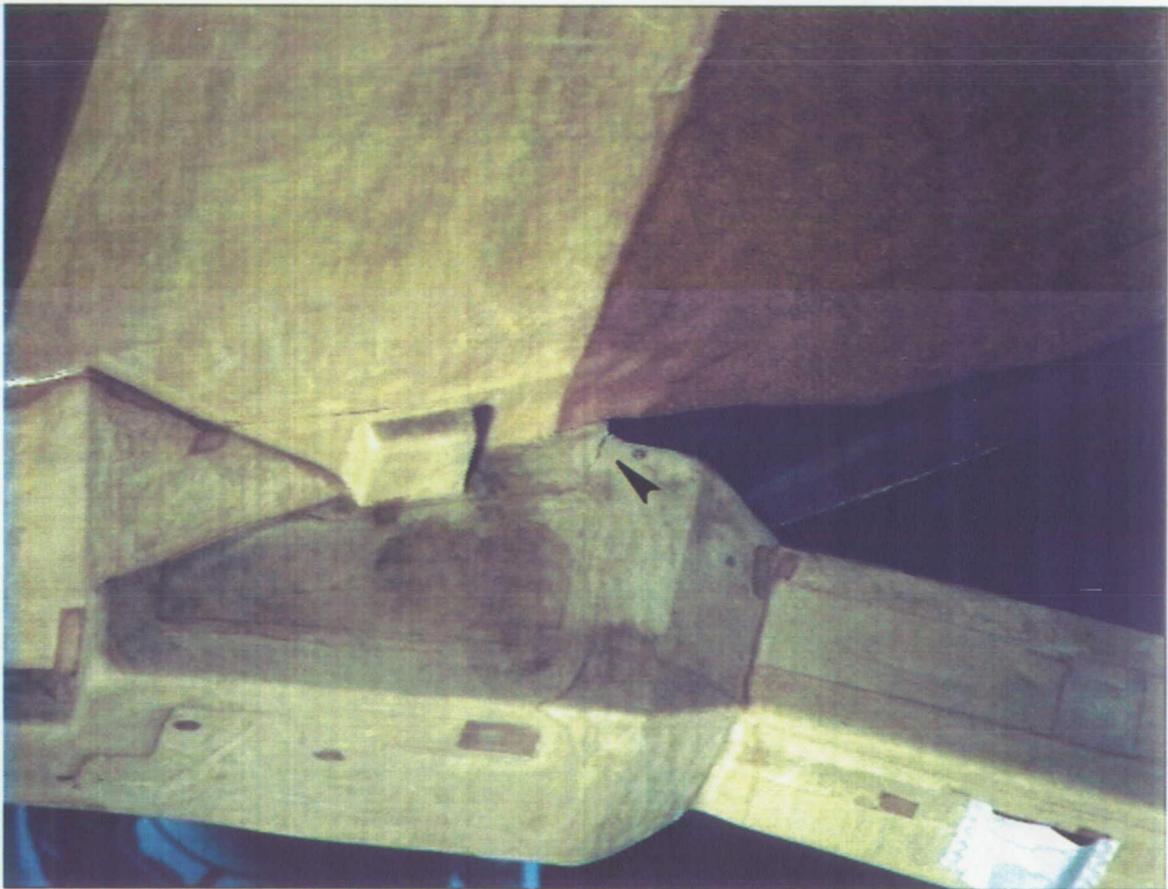
Anomaly 002 documented a 4-inch crack in the forward surface TPS covering of the -Y vertical strut cable tray near the longeron closeout interface. The crack exhibited no offset and were not filled with ice or frost. The condition was acceptable for launch per NSTS-08303 and CR S041254C.

One crack, approximately 6 inches long, appeared in the LH (-Y) vertical strut/cable tray forward facing TPS covering near the longeron closeout interface. A stress relief cut in the TPS to allow for structural movement had been deleted by design. This condition was acceptable for flight per the NSTS-08303 criteria

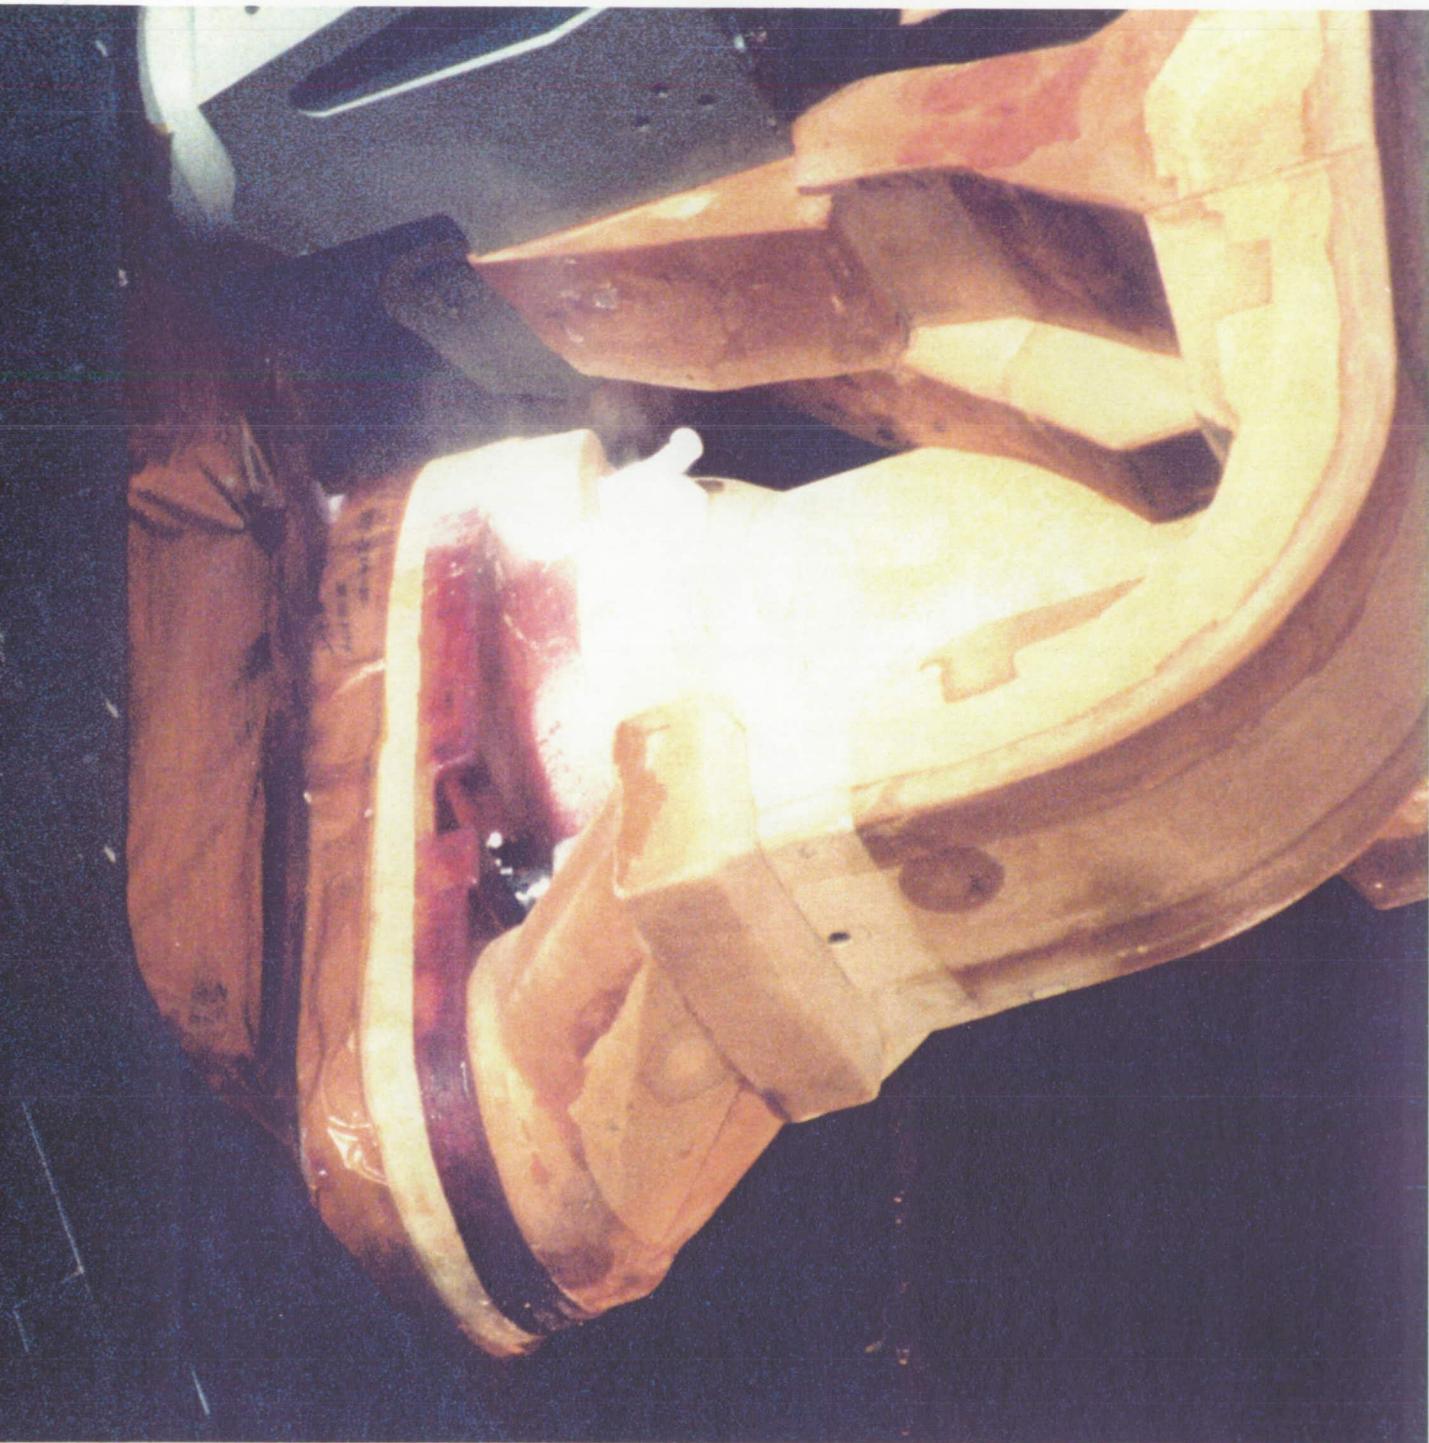
Overall view of the LO2 ET/ORB umbilical. There were no TPS anomalies or unusual ice/frost formations.

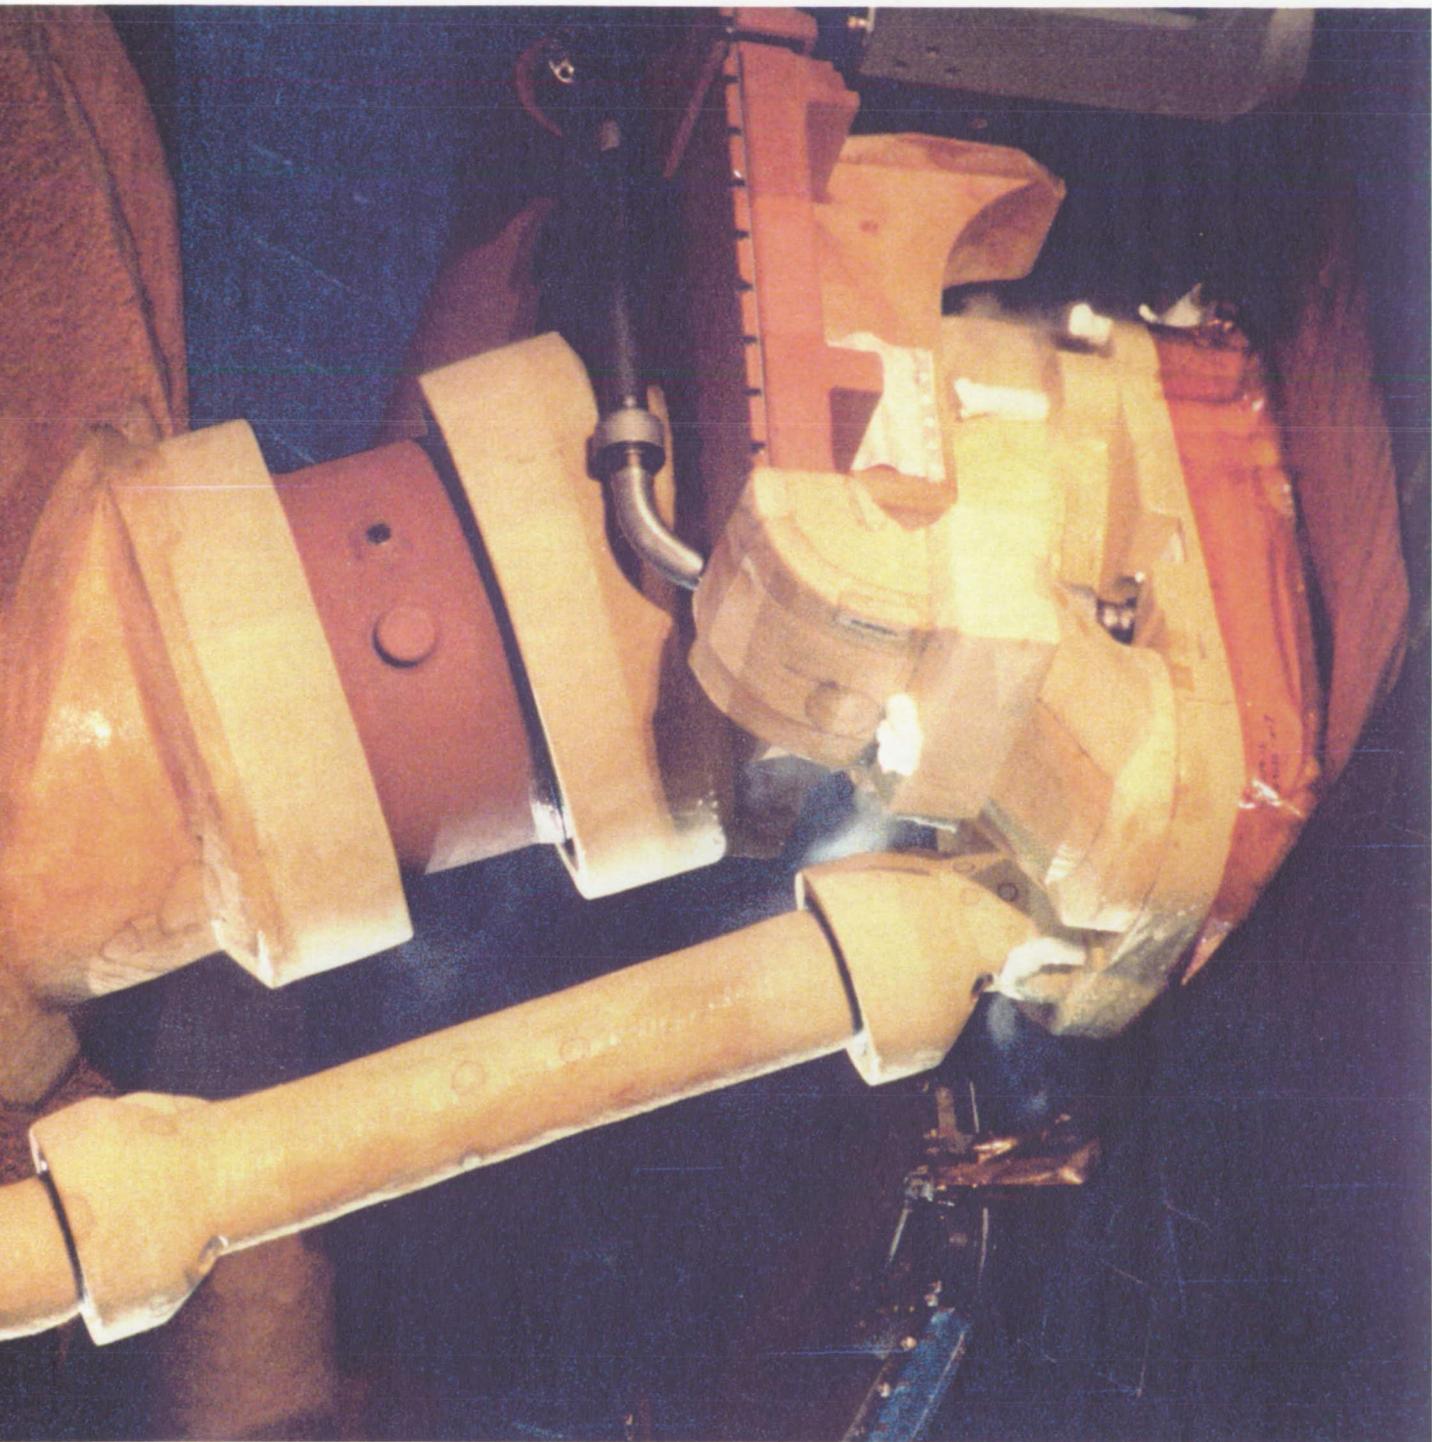
Less than usual ice/frost had formed on the outboard and top sides of the LH2 ET/ORB umbilical/purge barrier. Typical amounts of ice had accumulated on the plate gap and pyrotechnic canister purge vents, and in the LH2 recirculation line bellows

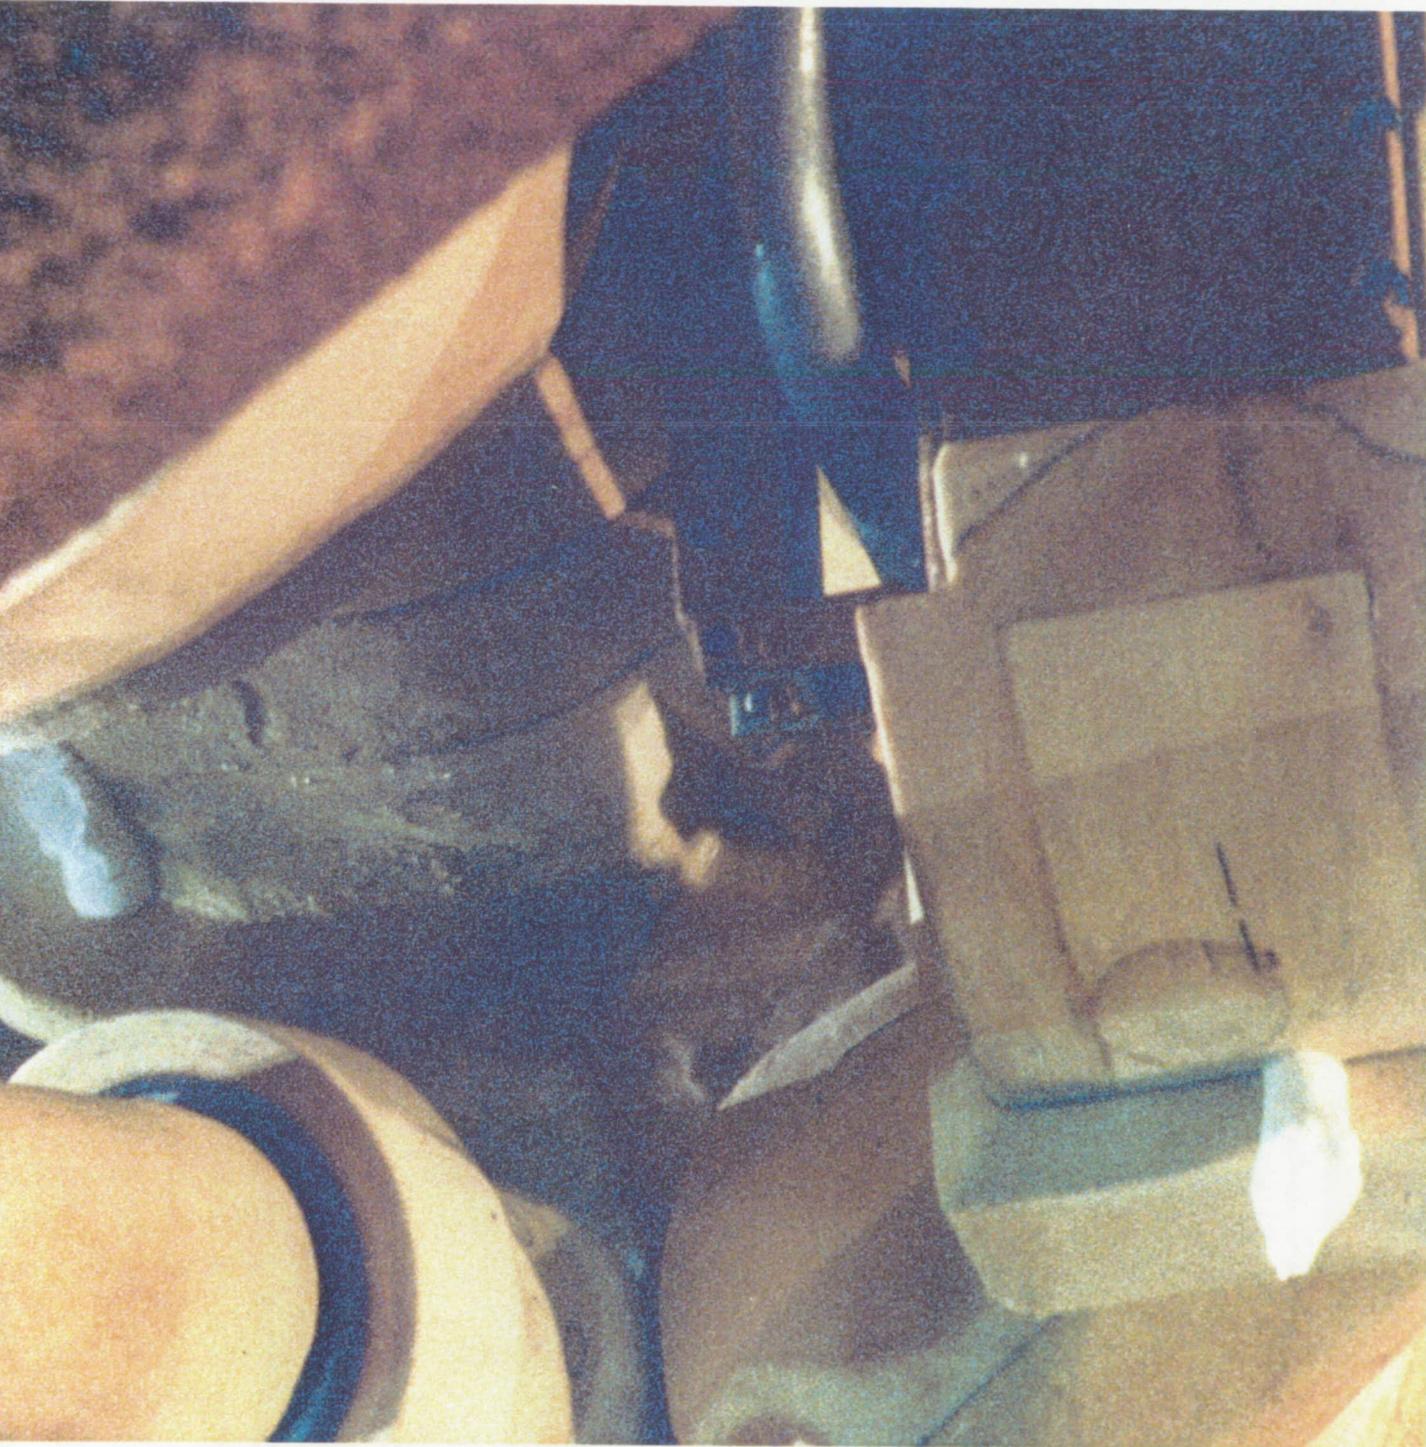
Typical in size, ice/frost fingers had formed on the aft pyro canister purge vent and LH2 umbilical cable tray vent hole. No ice or frost had accumulated on the 17-inch flapper valve actuator access port foam plug closeout.
