# Debris/Ice/TPS Assessment And Integrated Photographic Analysis For Shuttle Mission STS-47

November 1992

**Gregory N. Katnik**  
**NASA/Kennedy Space Center**

DEBRIS/ICE/TPS ASSESSMENT  
AND  
PHOTOGRAPHIC ANALYSIS  
OF  
SHUTTLE MISSION STS-47

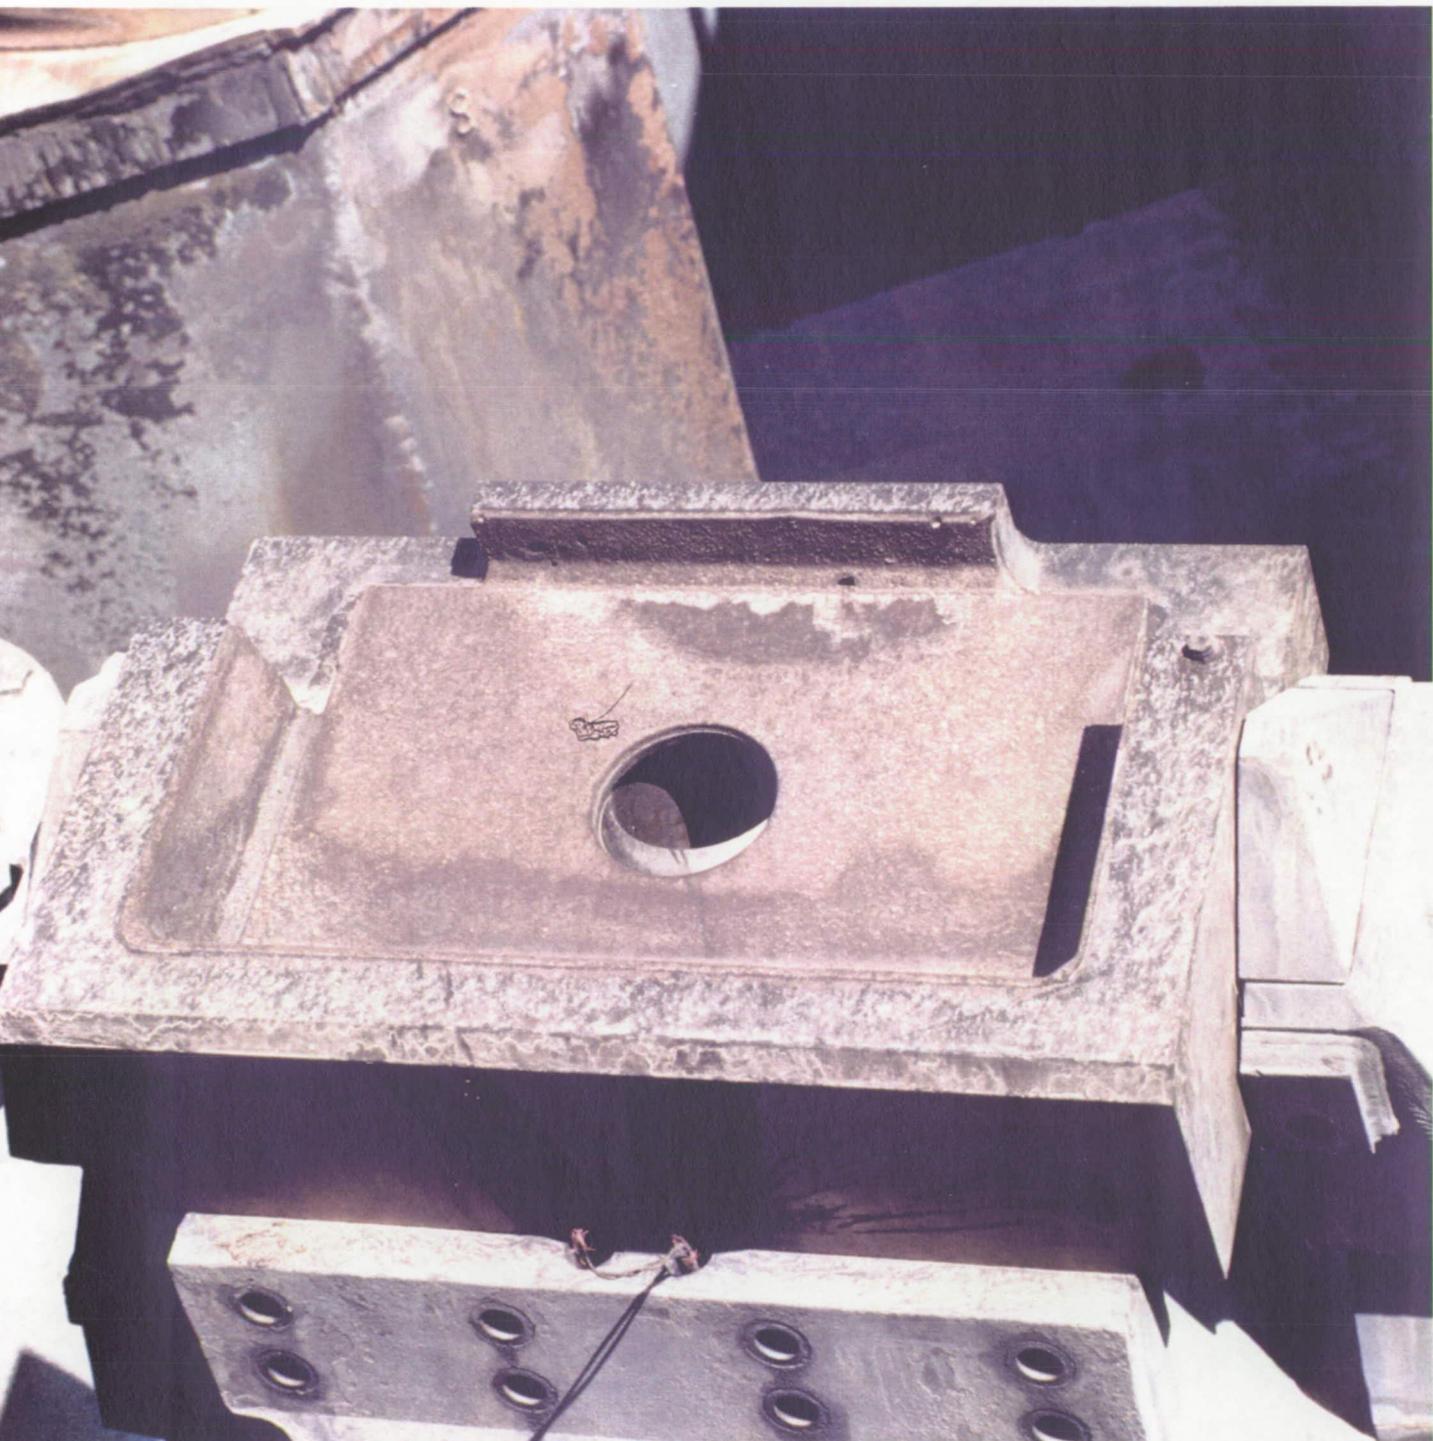
Plume erosion of the south SRB holddown posts was typical. EPON shim material was intact and bonded to the holddown post shoes.

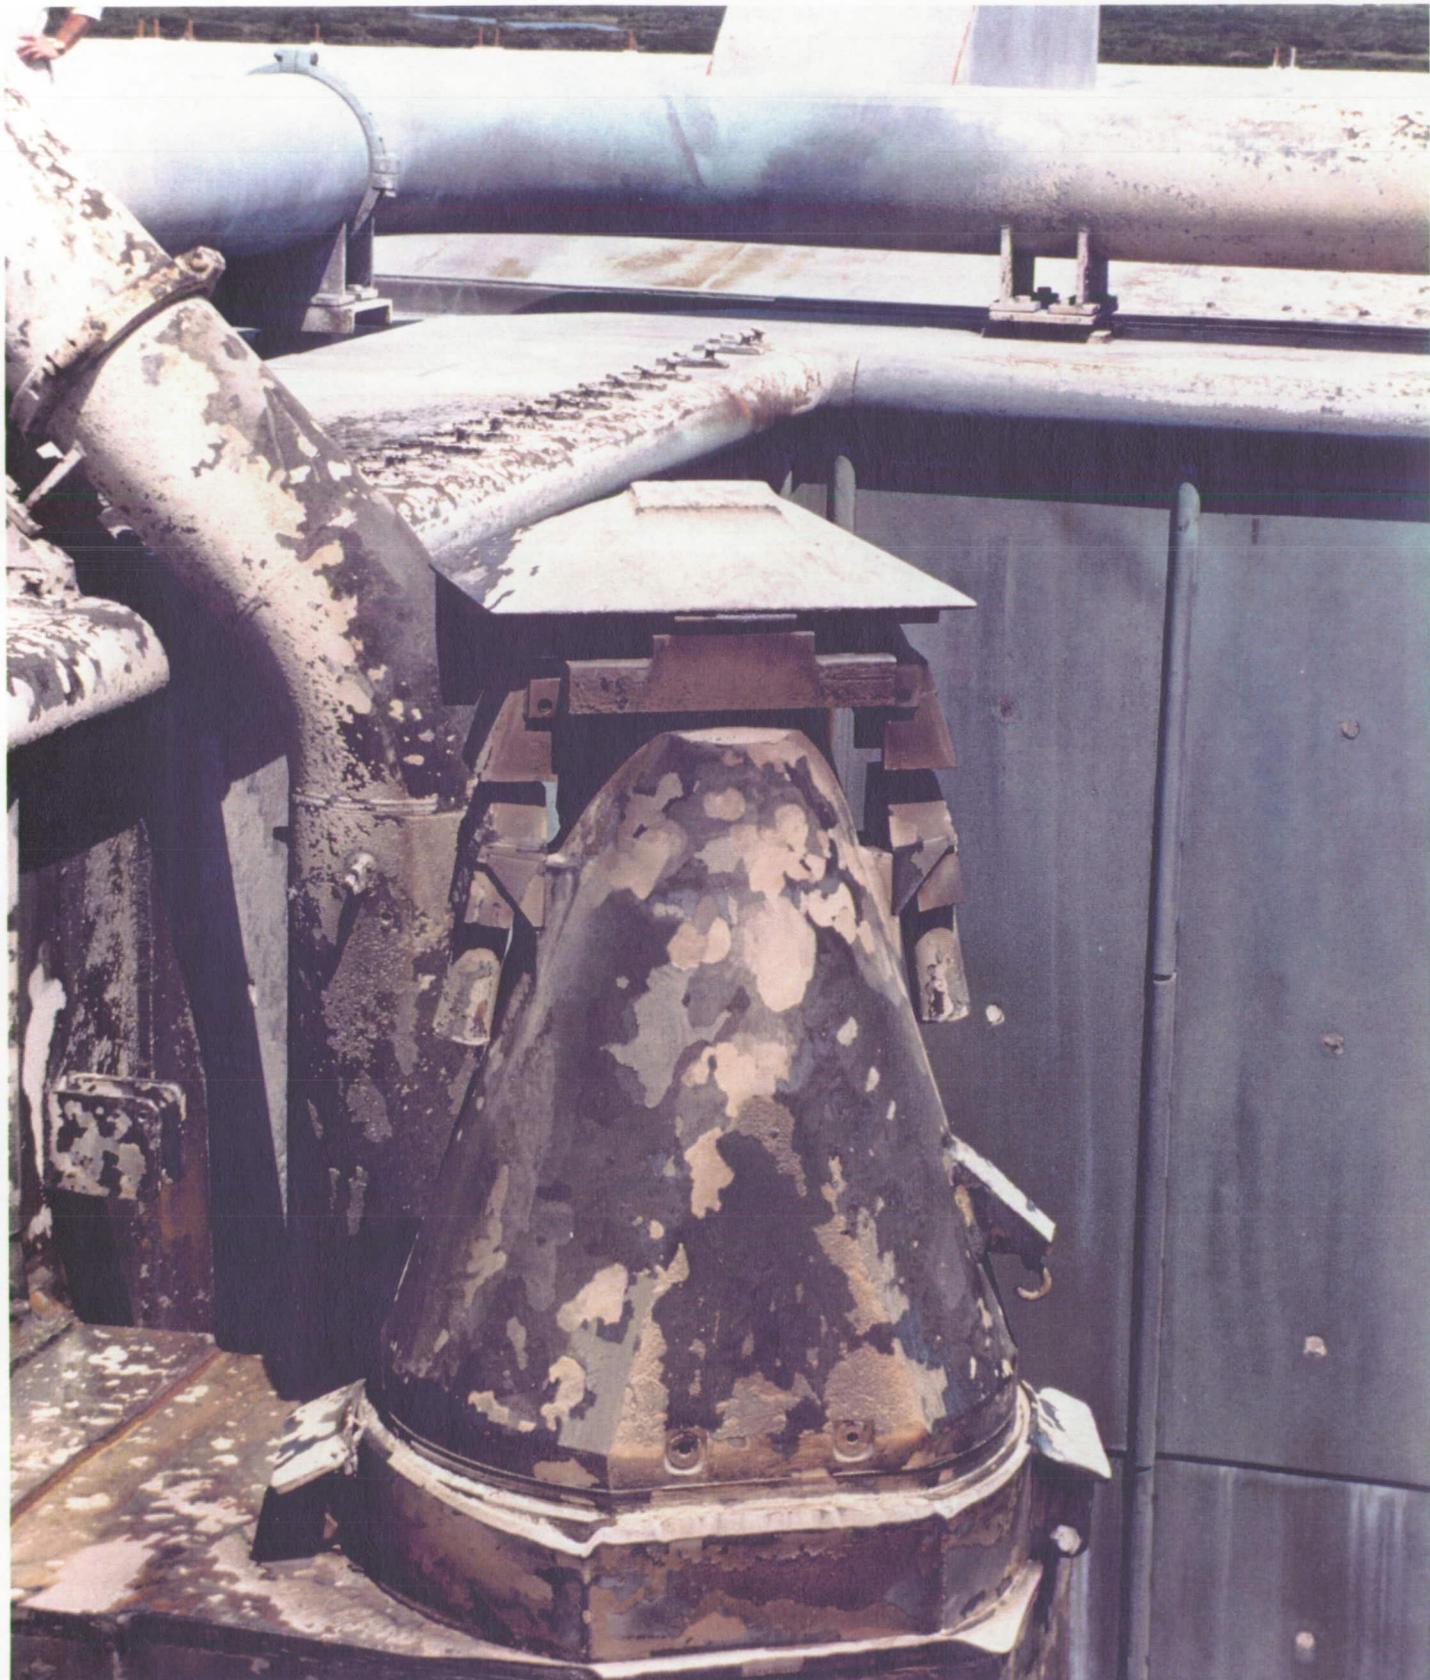
All of the north holddown post doghouse blast covers were in the closed position and showed less than usual erosion

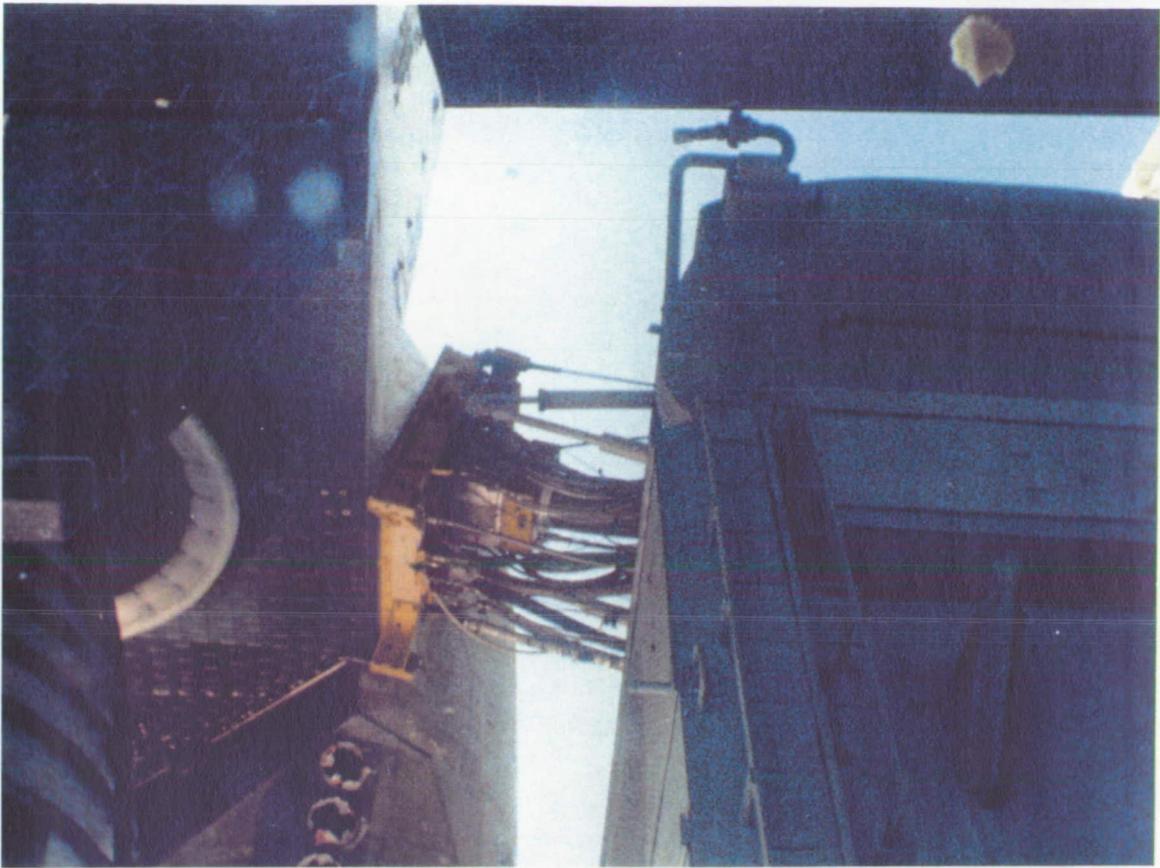
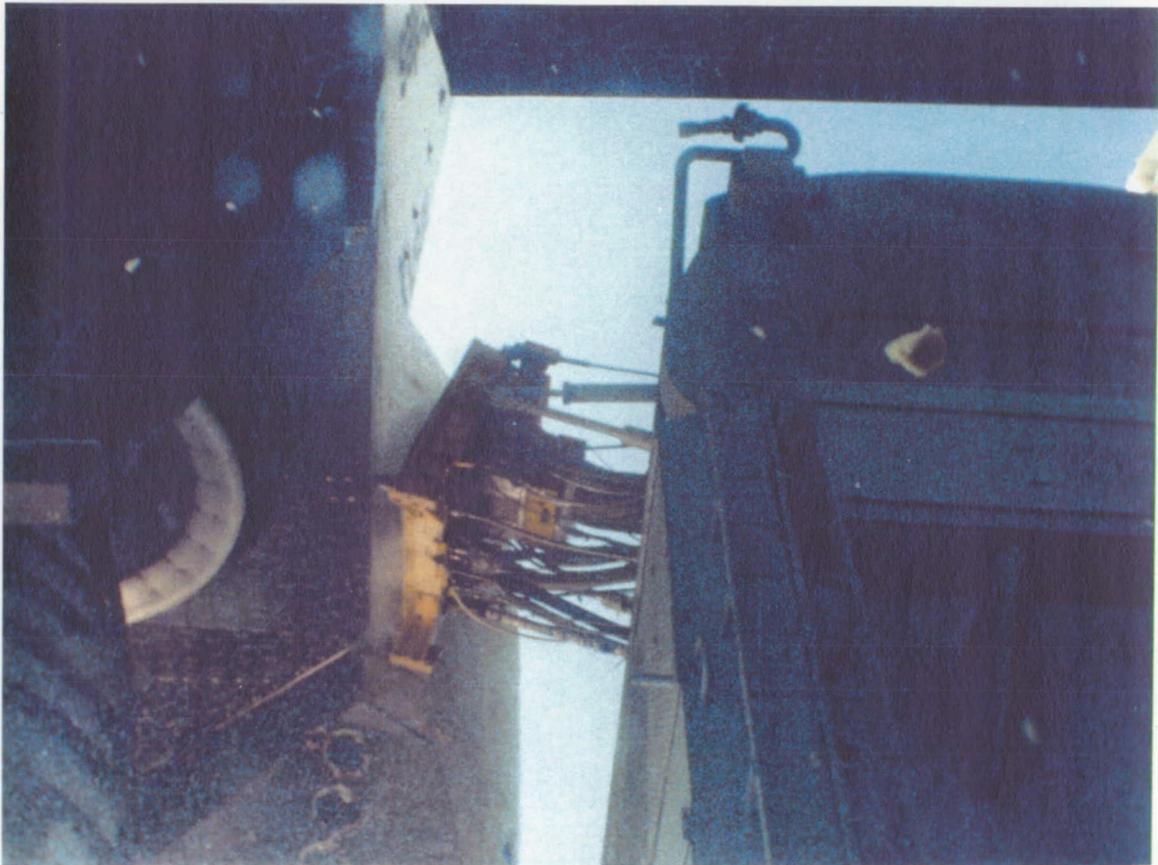
A piece of the magnesium button from the hydrogen burn ignitor on the L02 TSM southwest corner did not contact any of the flight hardware. Although normally consumed before exiting the ignitor, the appearance of the magnesium was not anomalous.

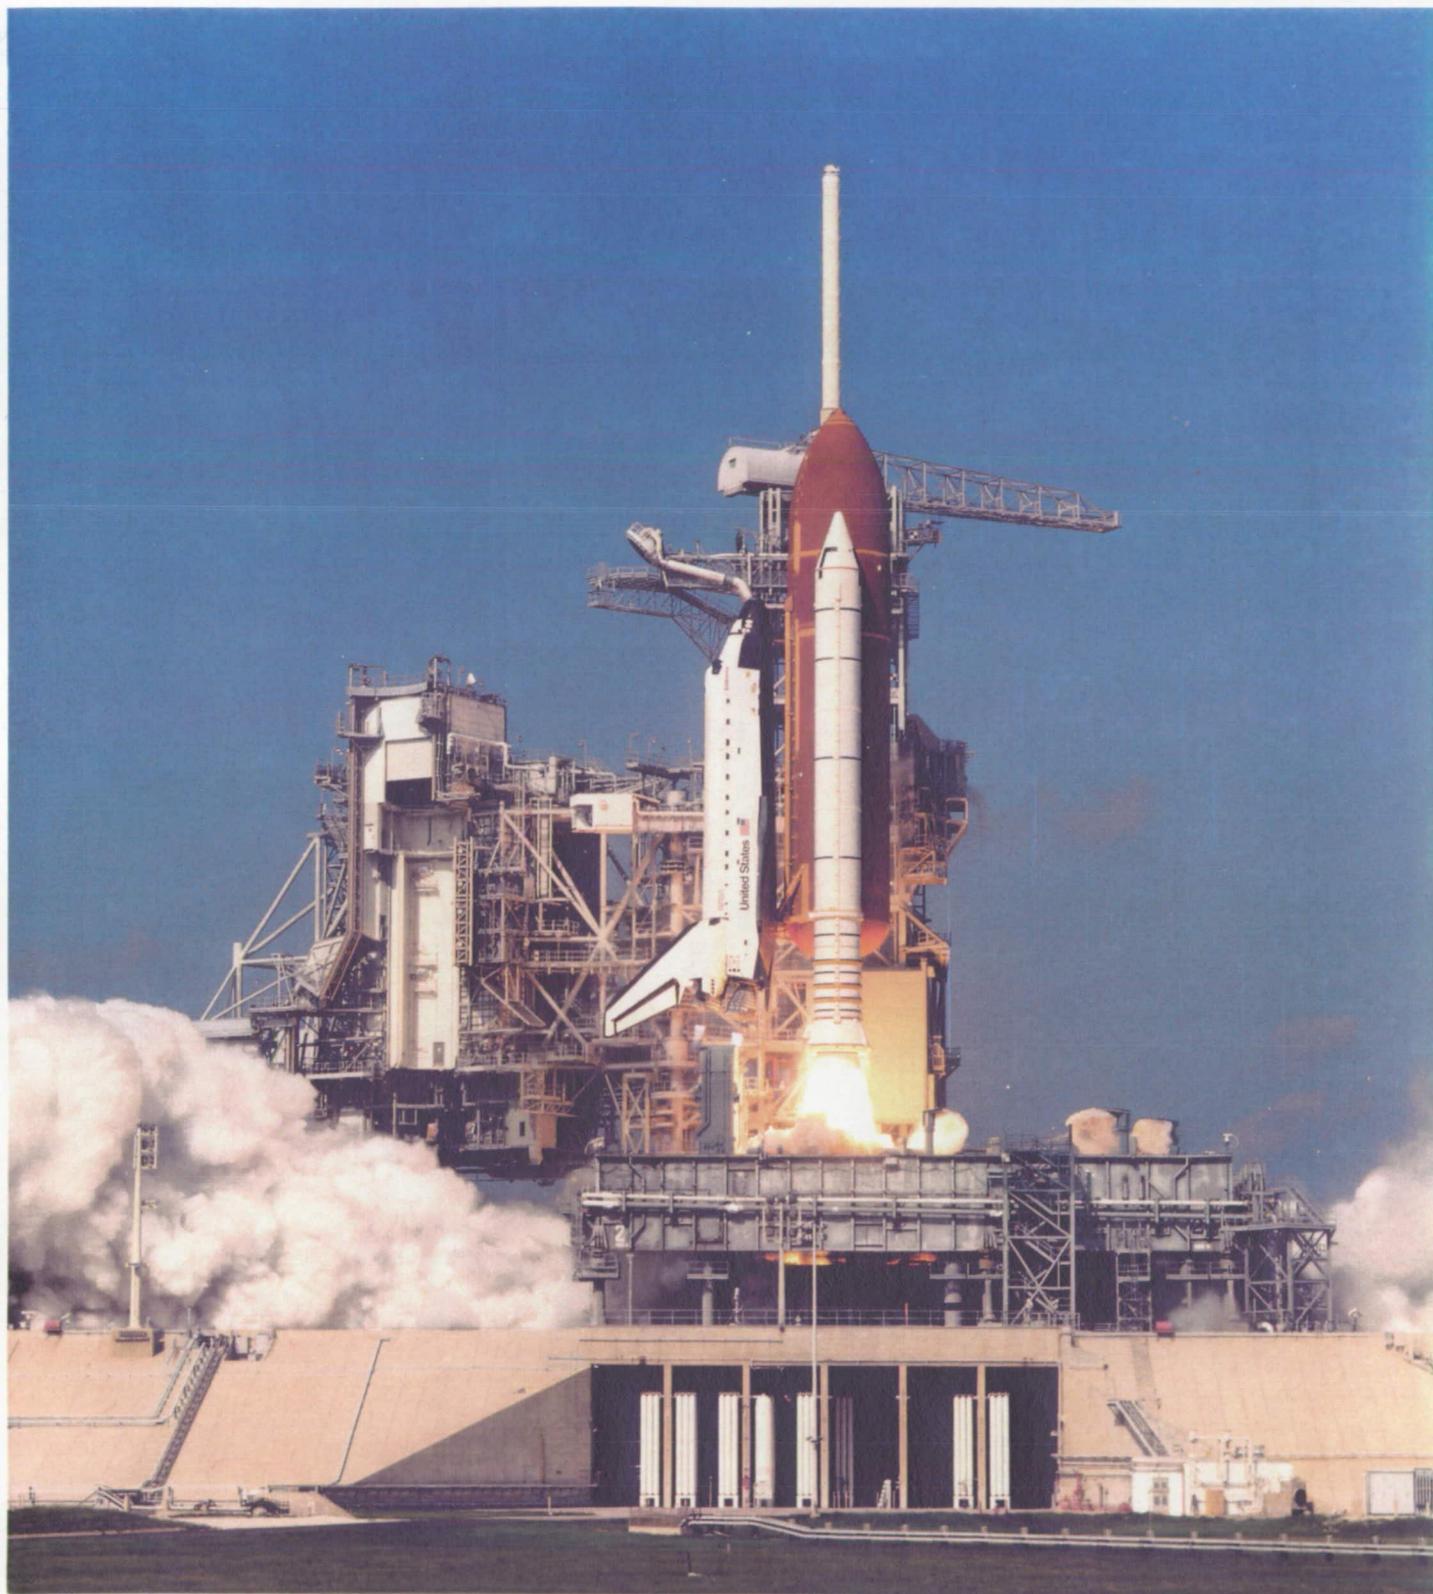
Disconnect and separation of the LH2 T-0 umbilical from the Orbiter was nominal. A large piece of SRB throat plug material was ejected upward out of the exhaust hole, but did not contact any flight hardware.

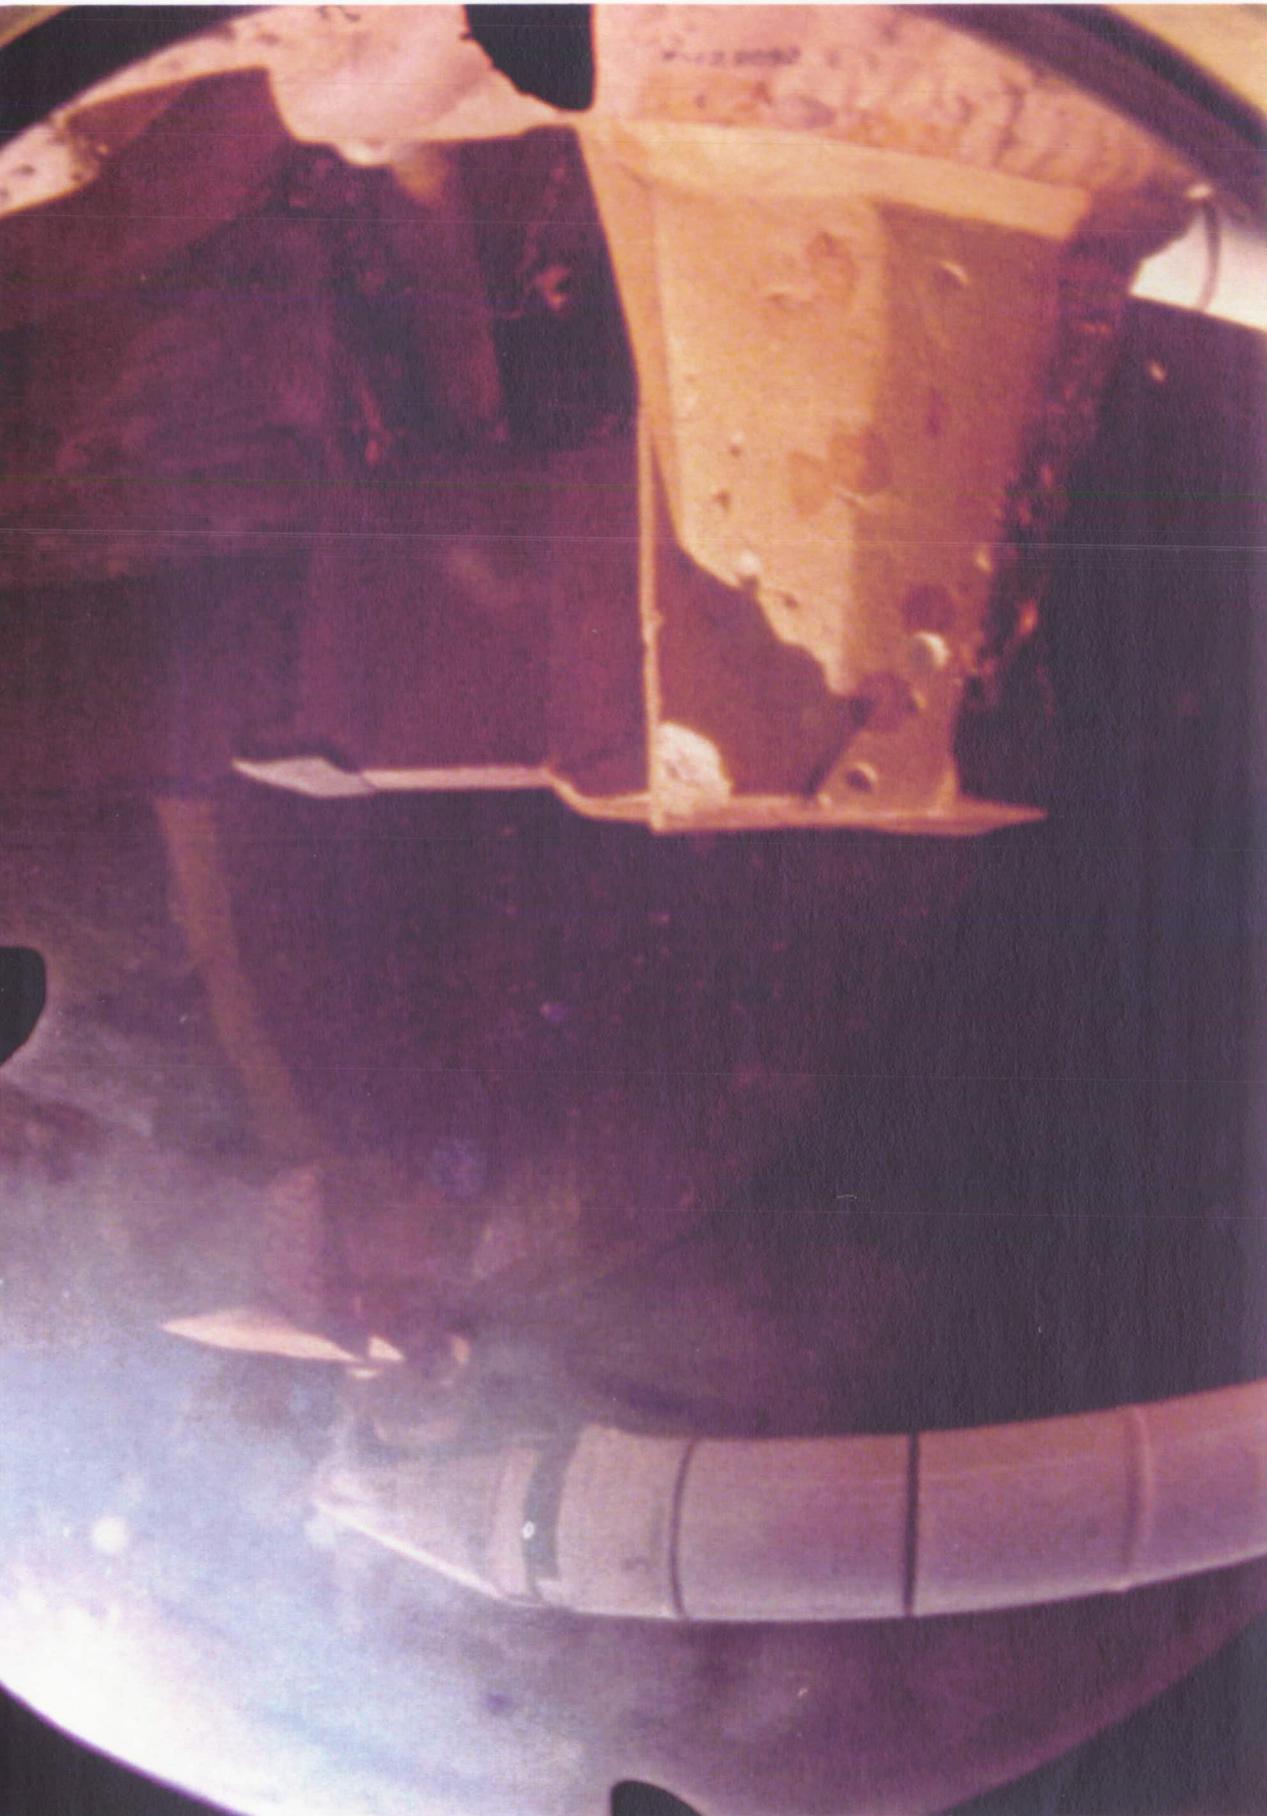
A 6-8 inch divot was present behind the LH bipod just forward of the jack pad closeout. The divot is located in the LH2 tank-to-intertank flange closeout.

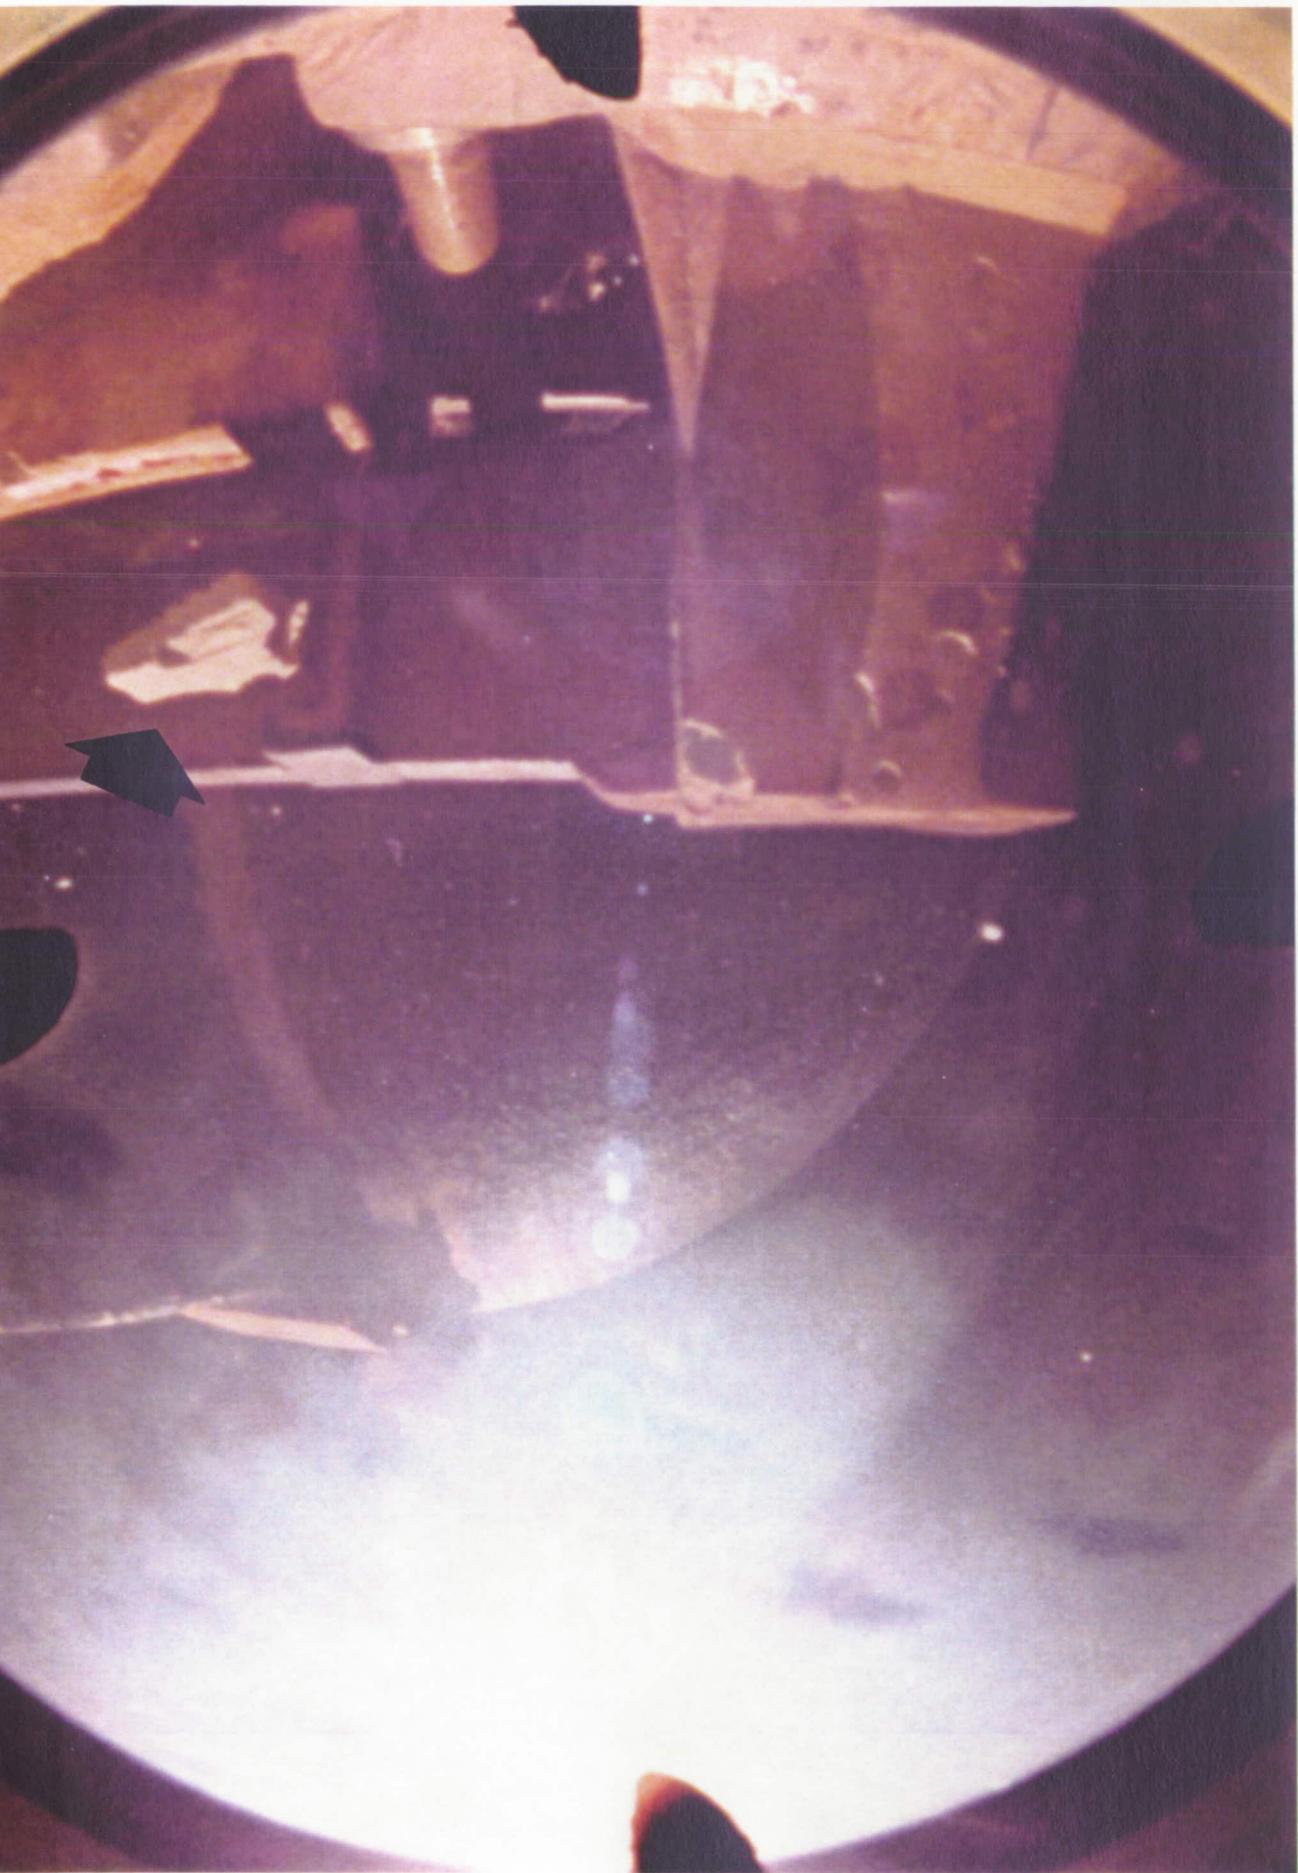
Wide angle view from a camera in the LH2 ET/ORB umbilical showed nominal separation of the LH SRB from the External Tank. Note erosion/loss of material from the TPS on the vertical strut/cable tray aft surface and the umbilical cable tray outboard side.

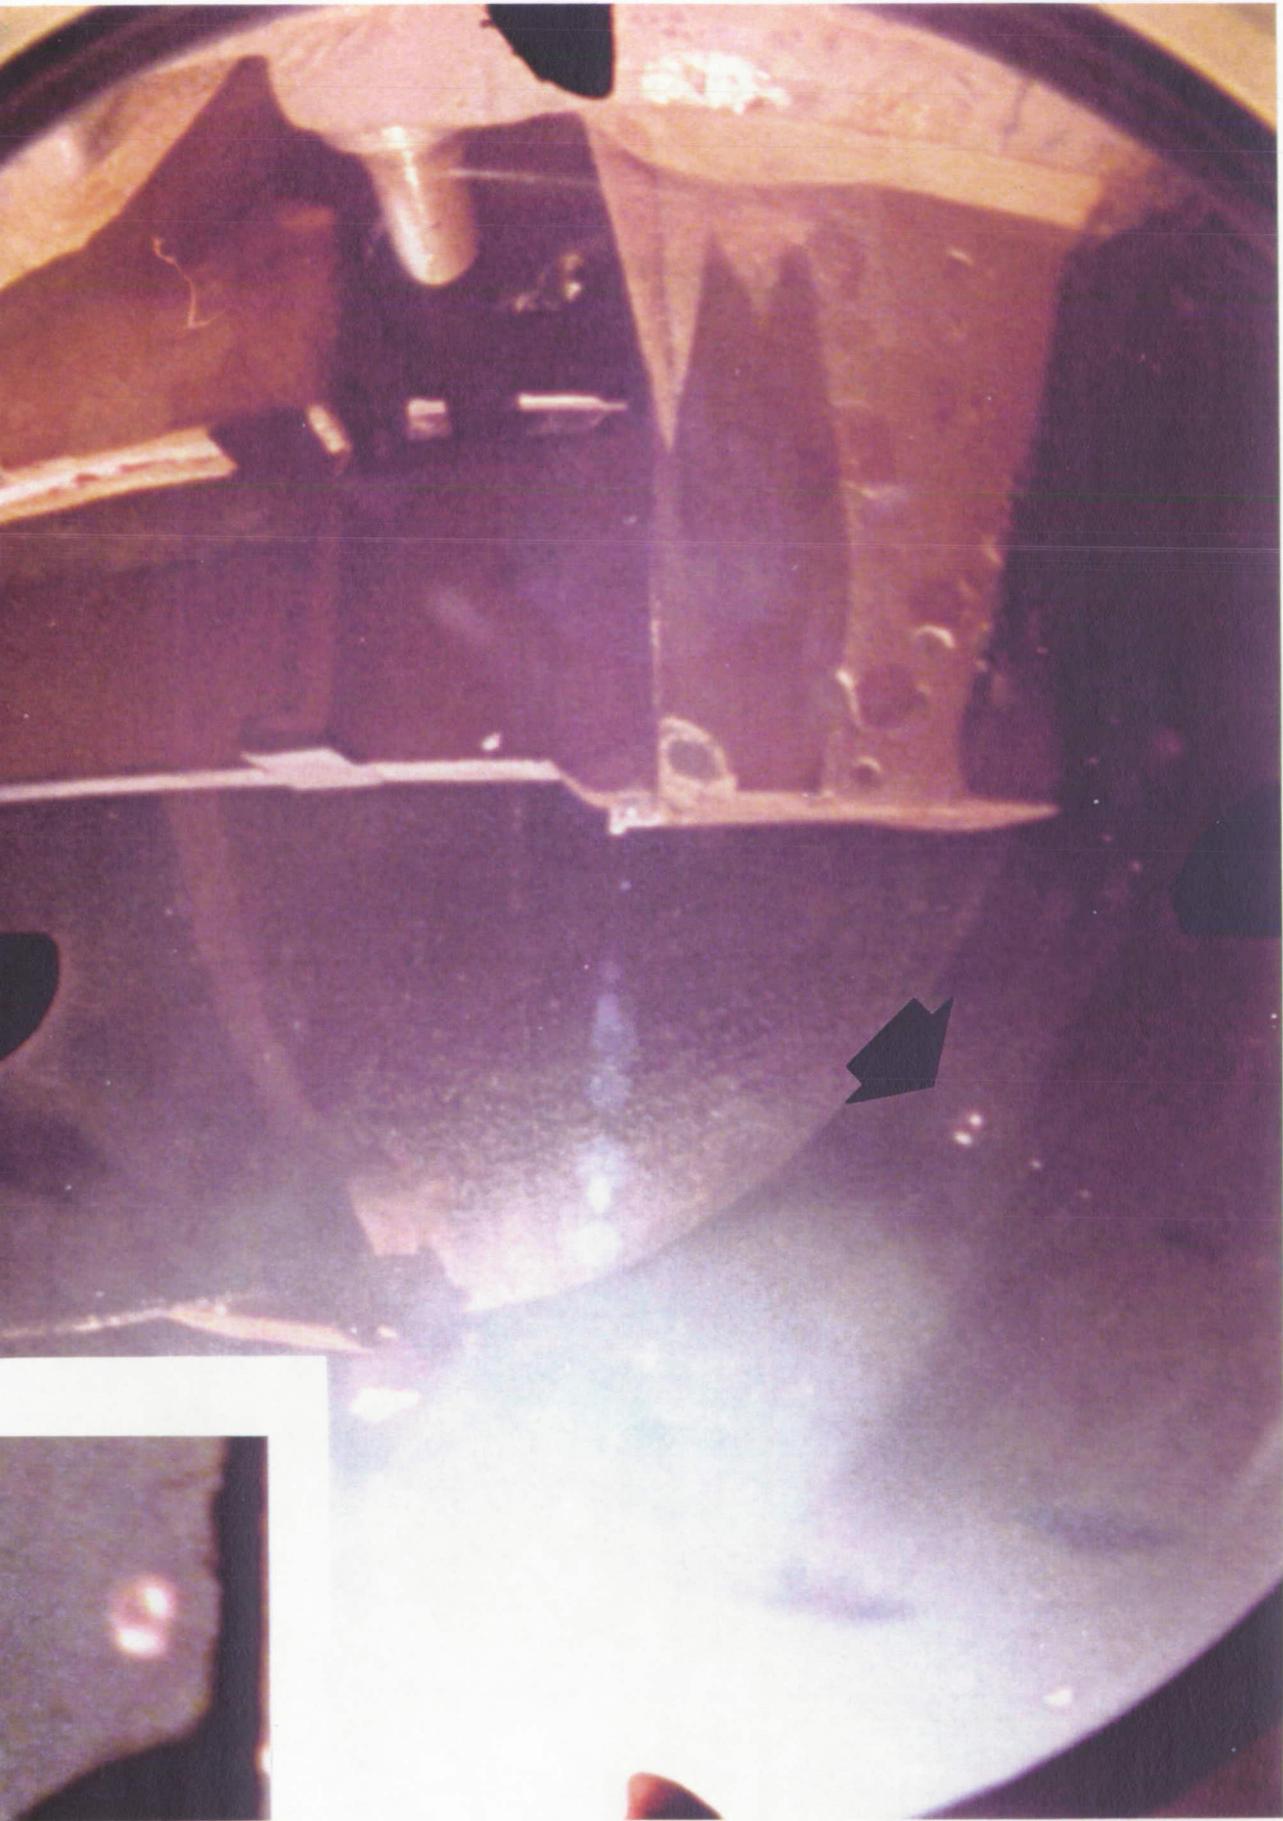
Piece of TPS falling aft past the LH2 ET/ORB umbilical cable tray vertical section (arrow) features an indentation similar to an intertank stringer and may indicate the foam piece originated from the intertank acreage divot.

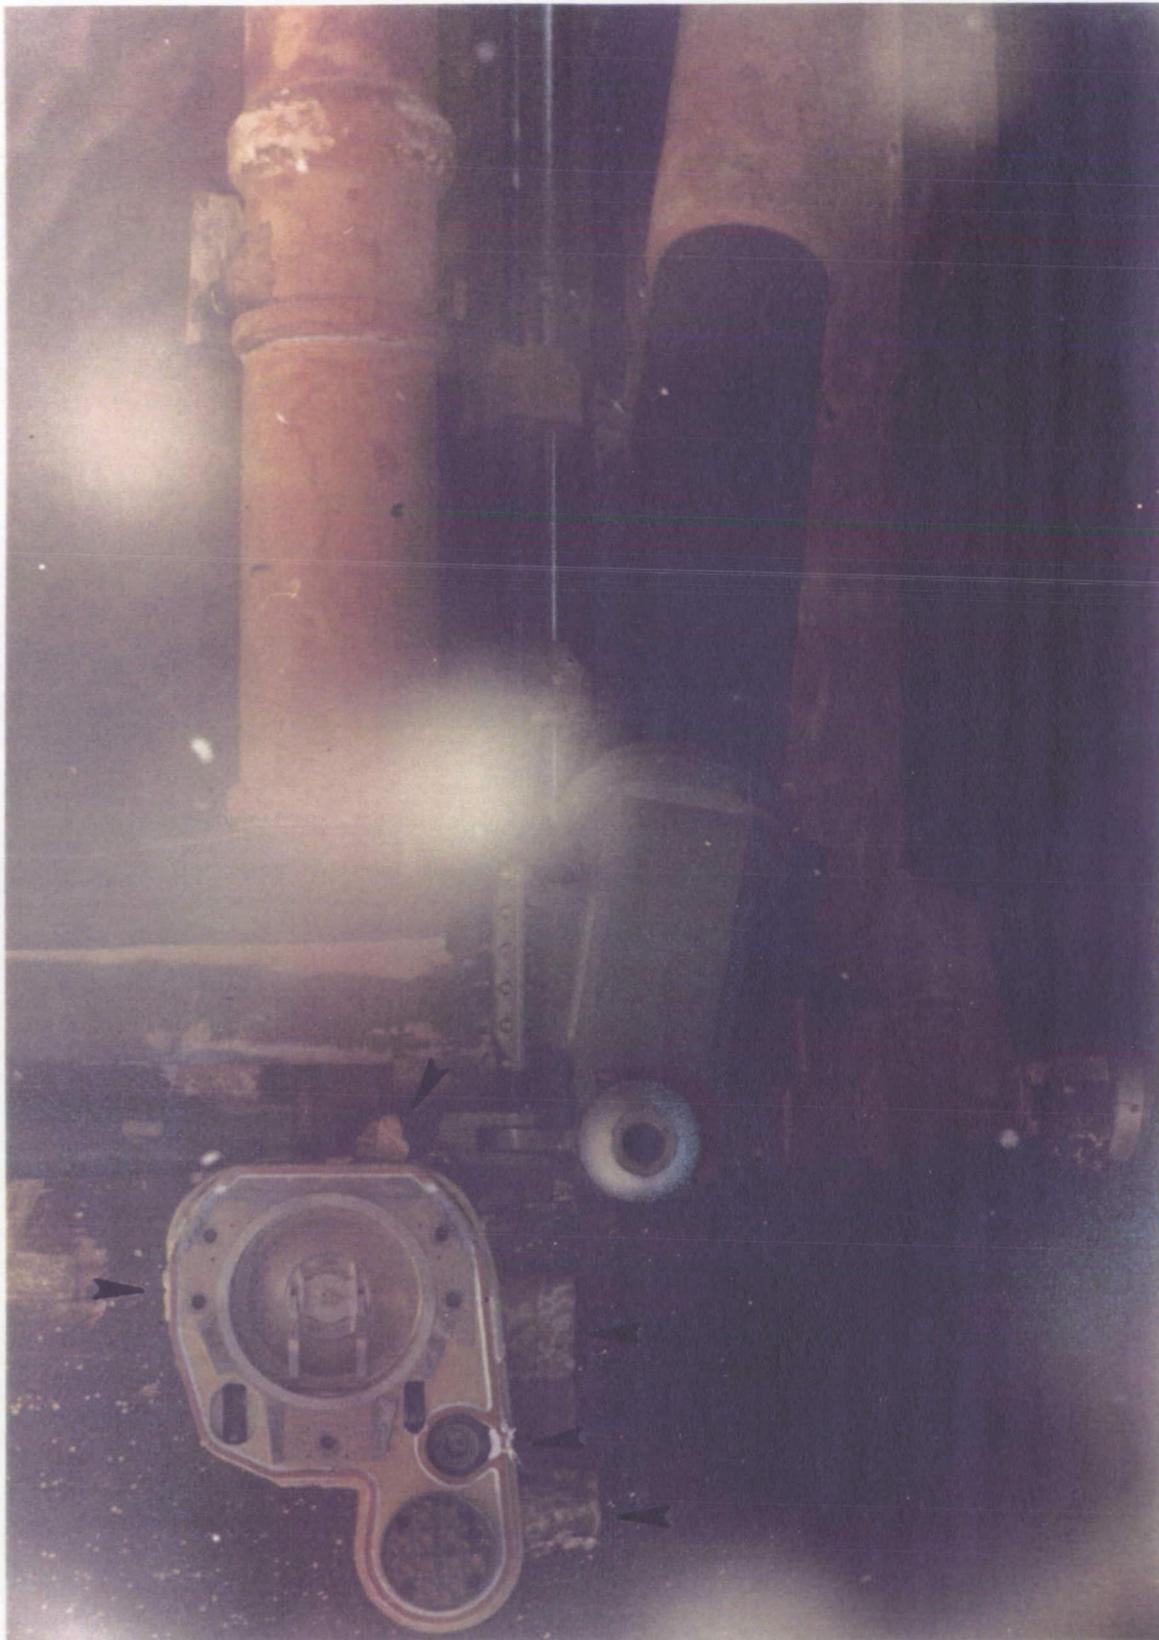
A brass- or copper-colored object drifted away from the LH2 ET/ORB umbilical area during separation of the External Tank from the Orbiter. The identification and origin of the object, believed to be a nut or spacer (inset), has not been determined yet.

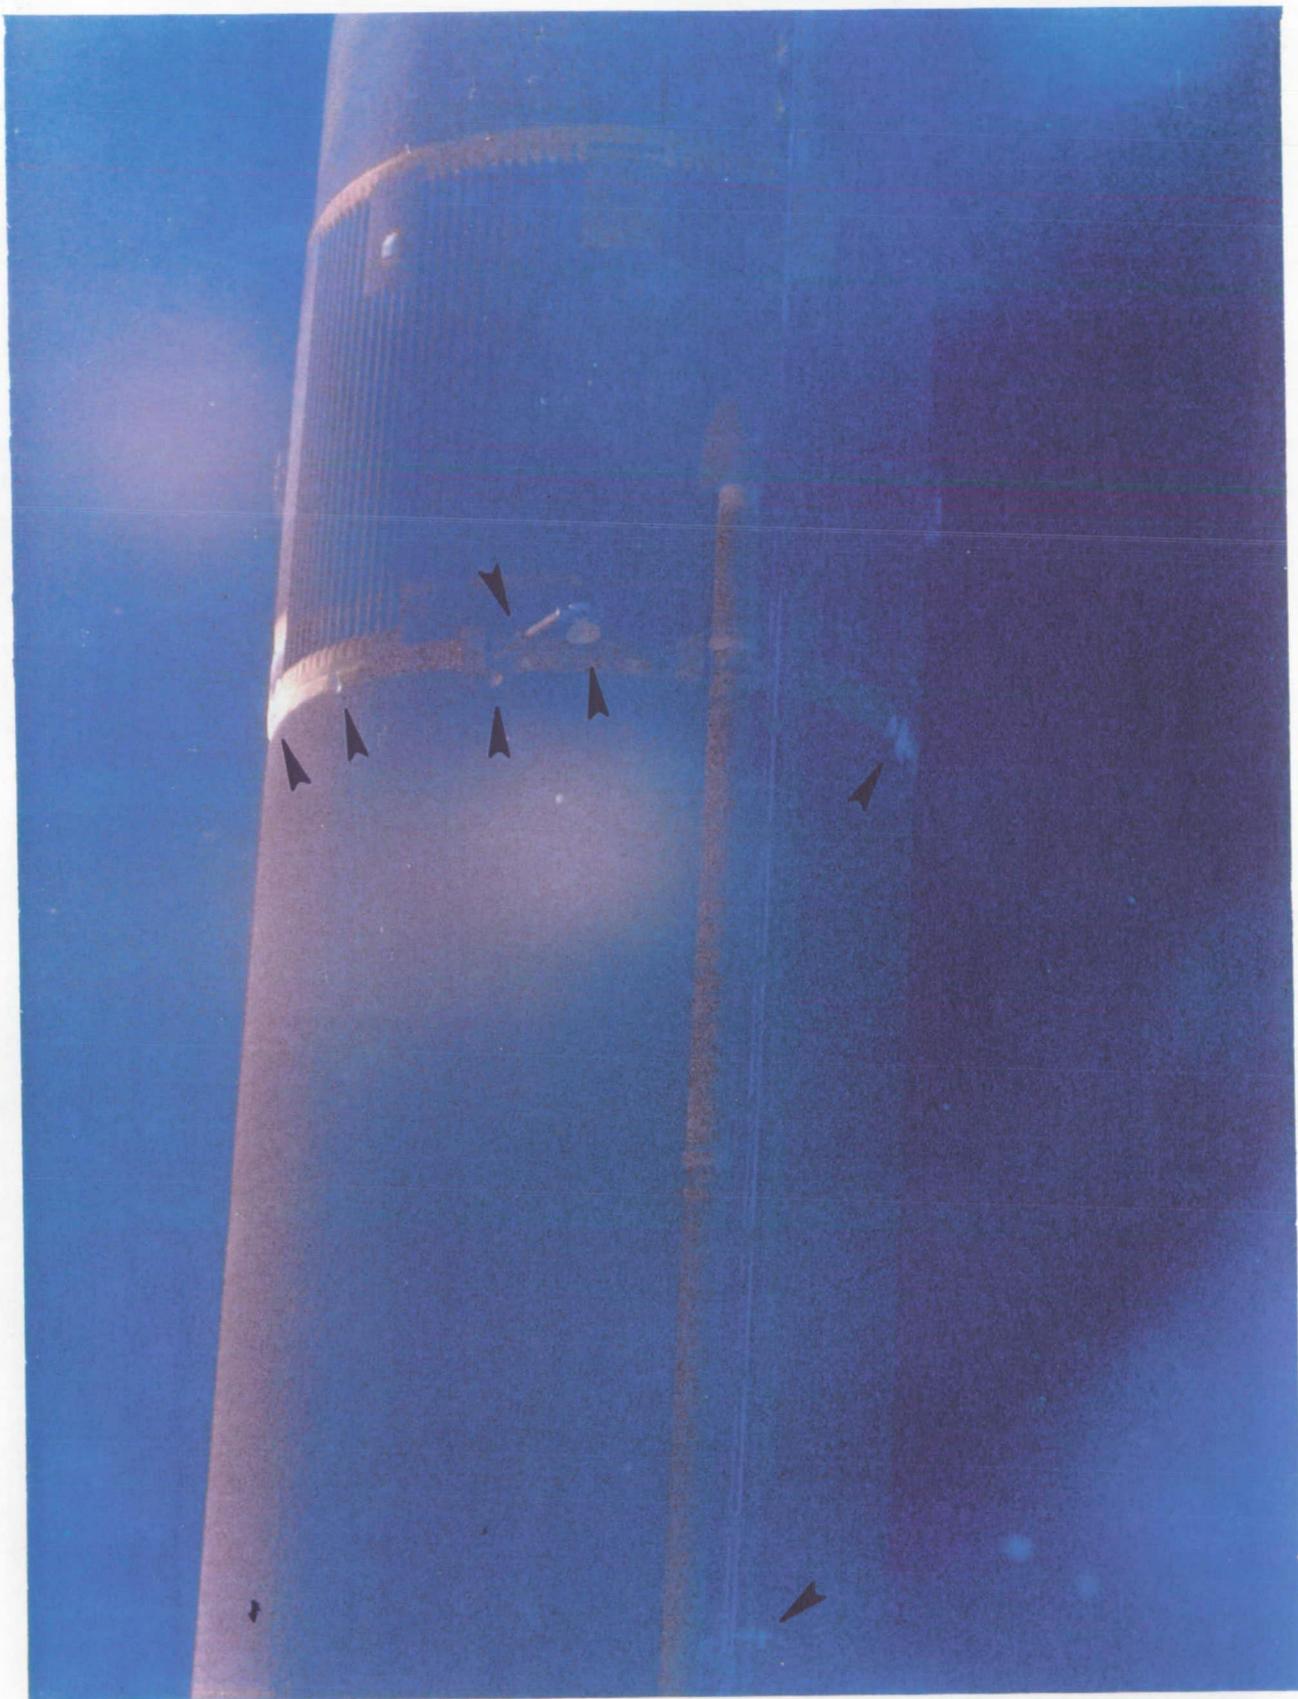
View from the LO2 ET/ORB umbilical separation camera showed a layer of TPS had rolled back on the forward surface of the umbilical and possible foam damage appeared on the inboard side. Foam was also lost from the vertical and horizontal sections of the umbilical cable tray. The 2-inch press line red seal/white RTV looked "blown out", but was actually the result of the overpressure test/closeout work at the pad.

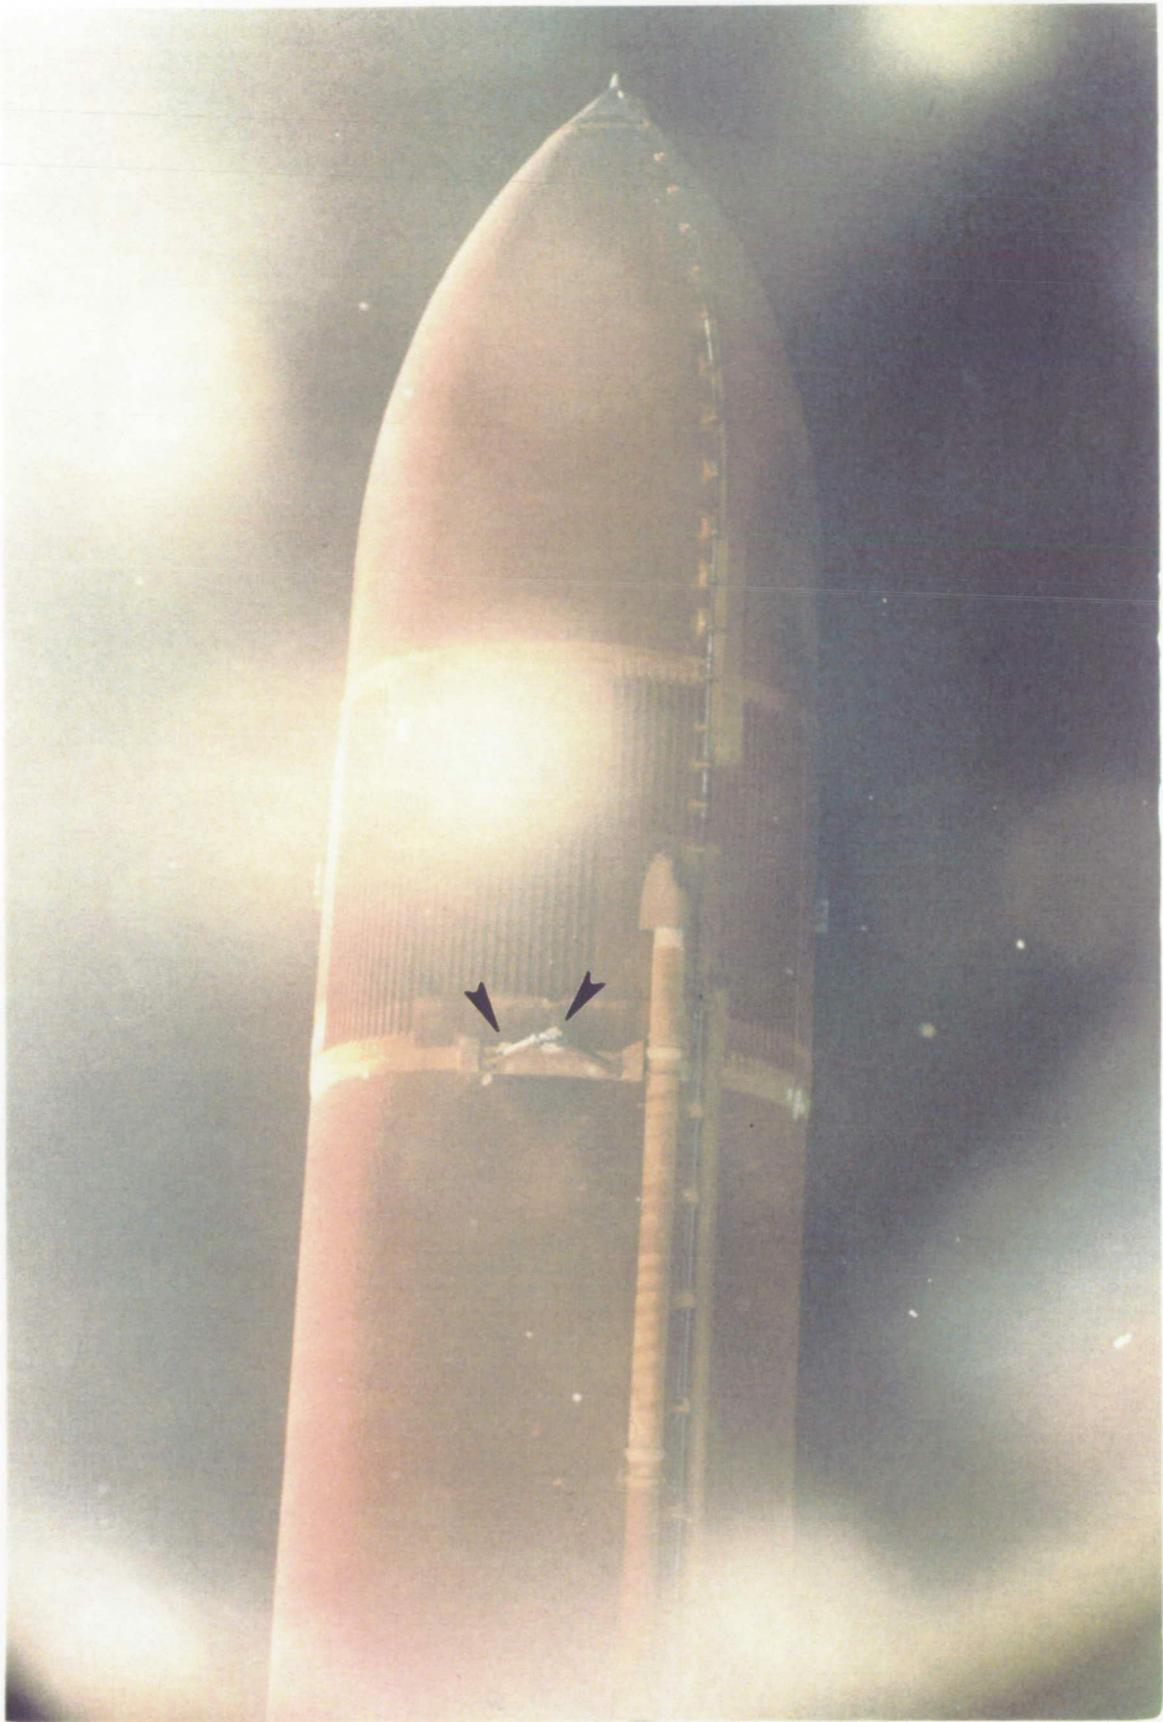
Divots were visible in the LH2 tank acreage aft of the PAL ramp and LH bipod spindle, in the LH2 tank-to-intertank flange closeout, and in the intertank acreage TPS between the bipods.
