# Debris/Ice/TPS Assessment And Integrated Photographic Analysis For Shuttle Mission STS-47

November 1992

**Gregory N. Katnik**  
**NASA/Kennedy Space Center**

DEBRIS/ICE/TPS ASSESSMENT  
AND  
PHOTOGRAPHIC ANALYSIS  
OF  
SHUTTLE MISSION STS-47

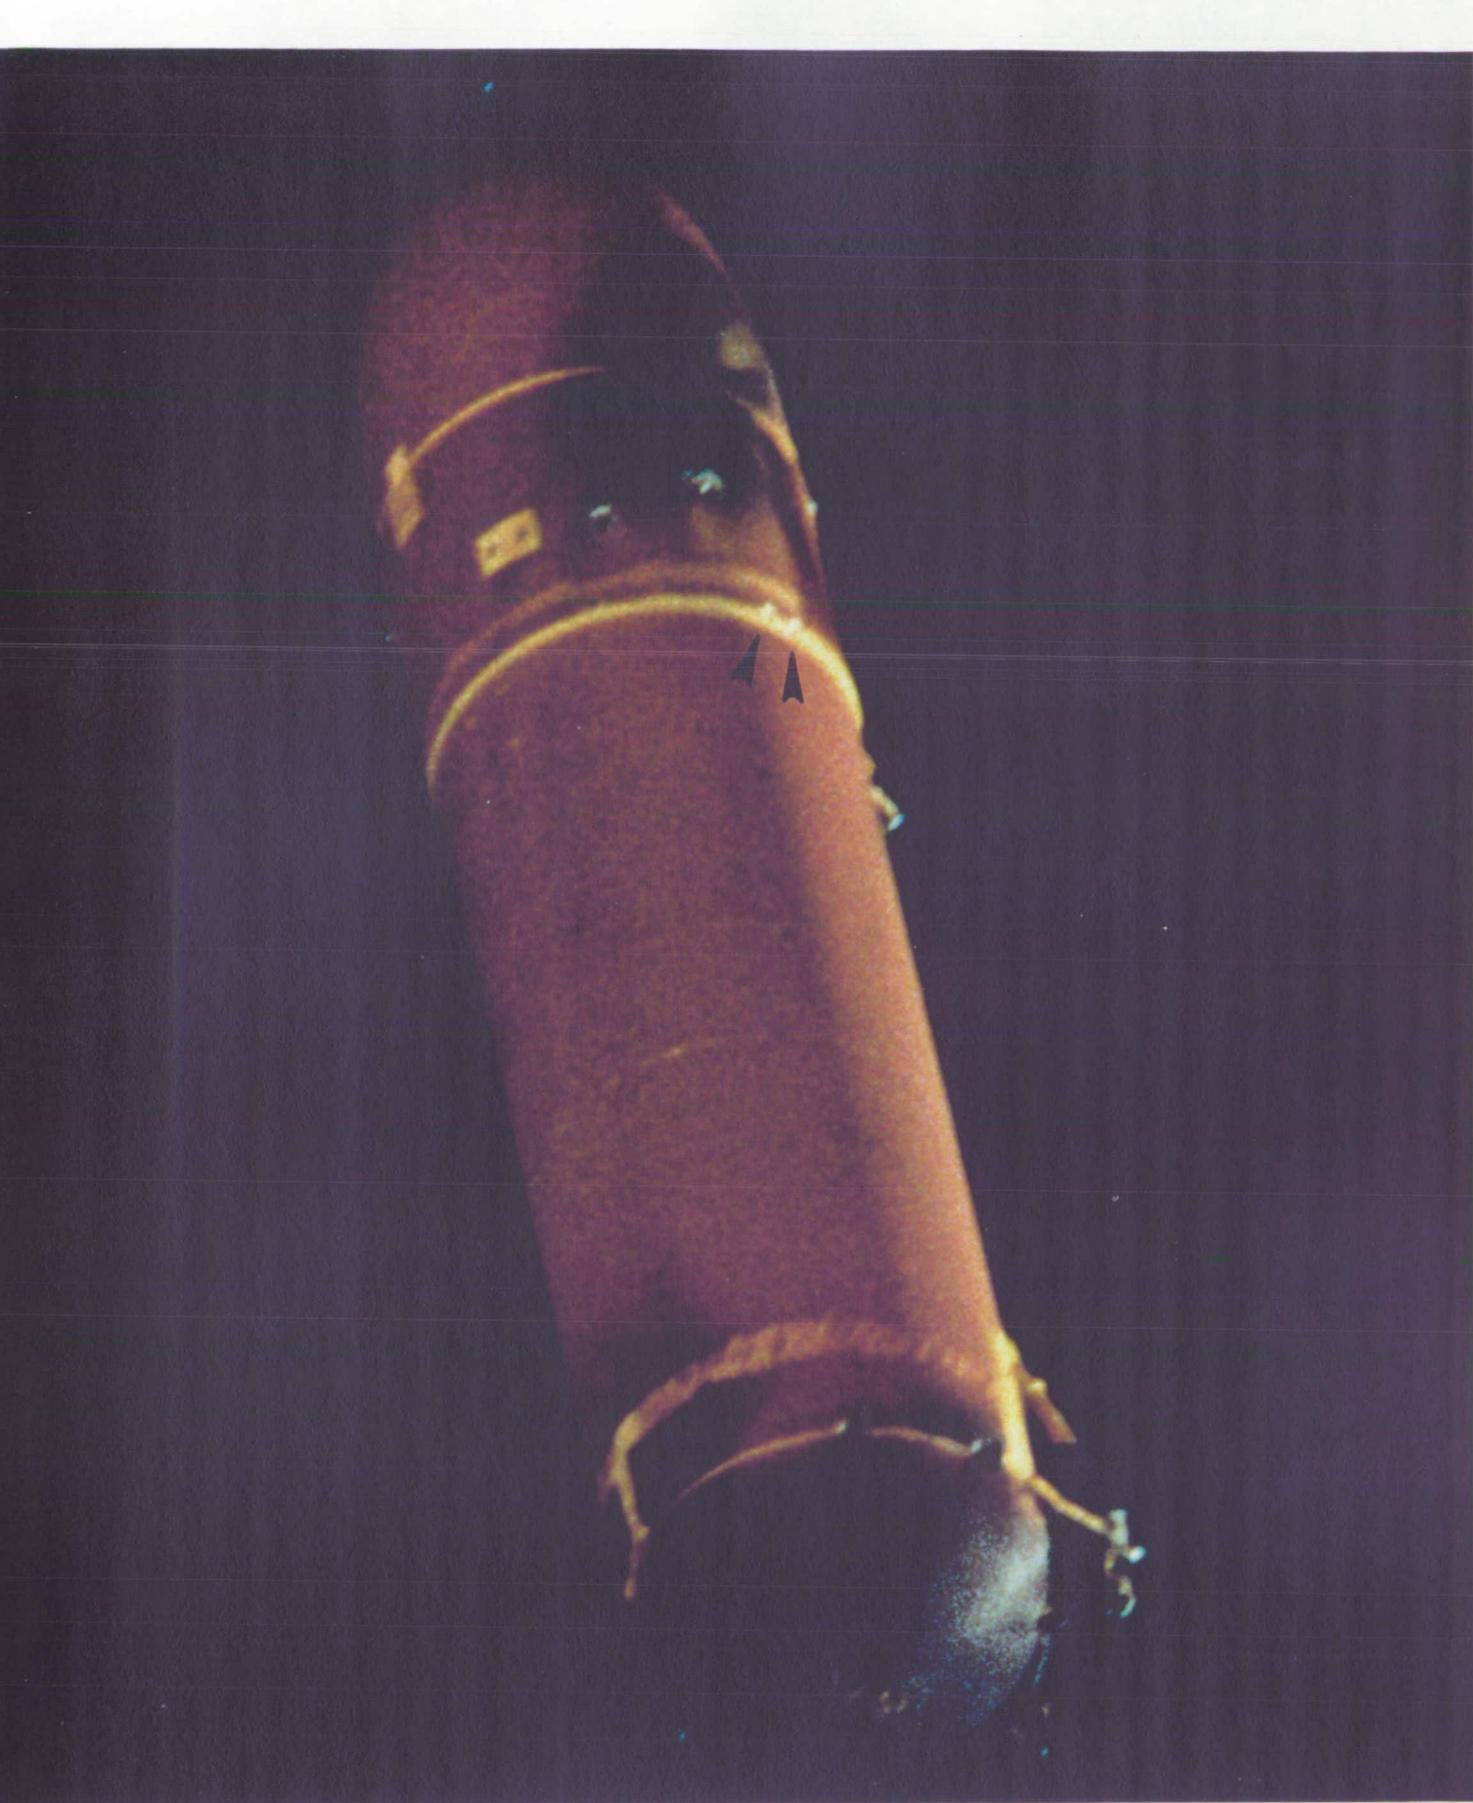
An IFA was taken against the 14-16 inch diameter divot in the intertank acreage TPS between the bipods. No anomalies/divots were apparent on the L02 tank or nosecone.

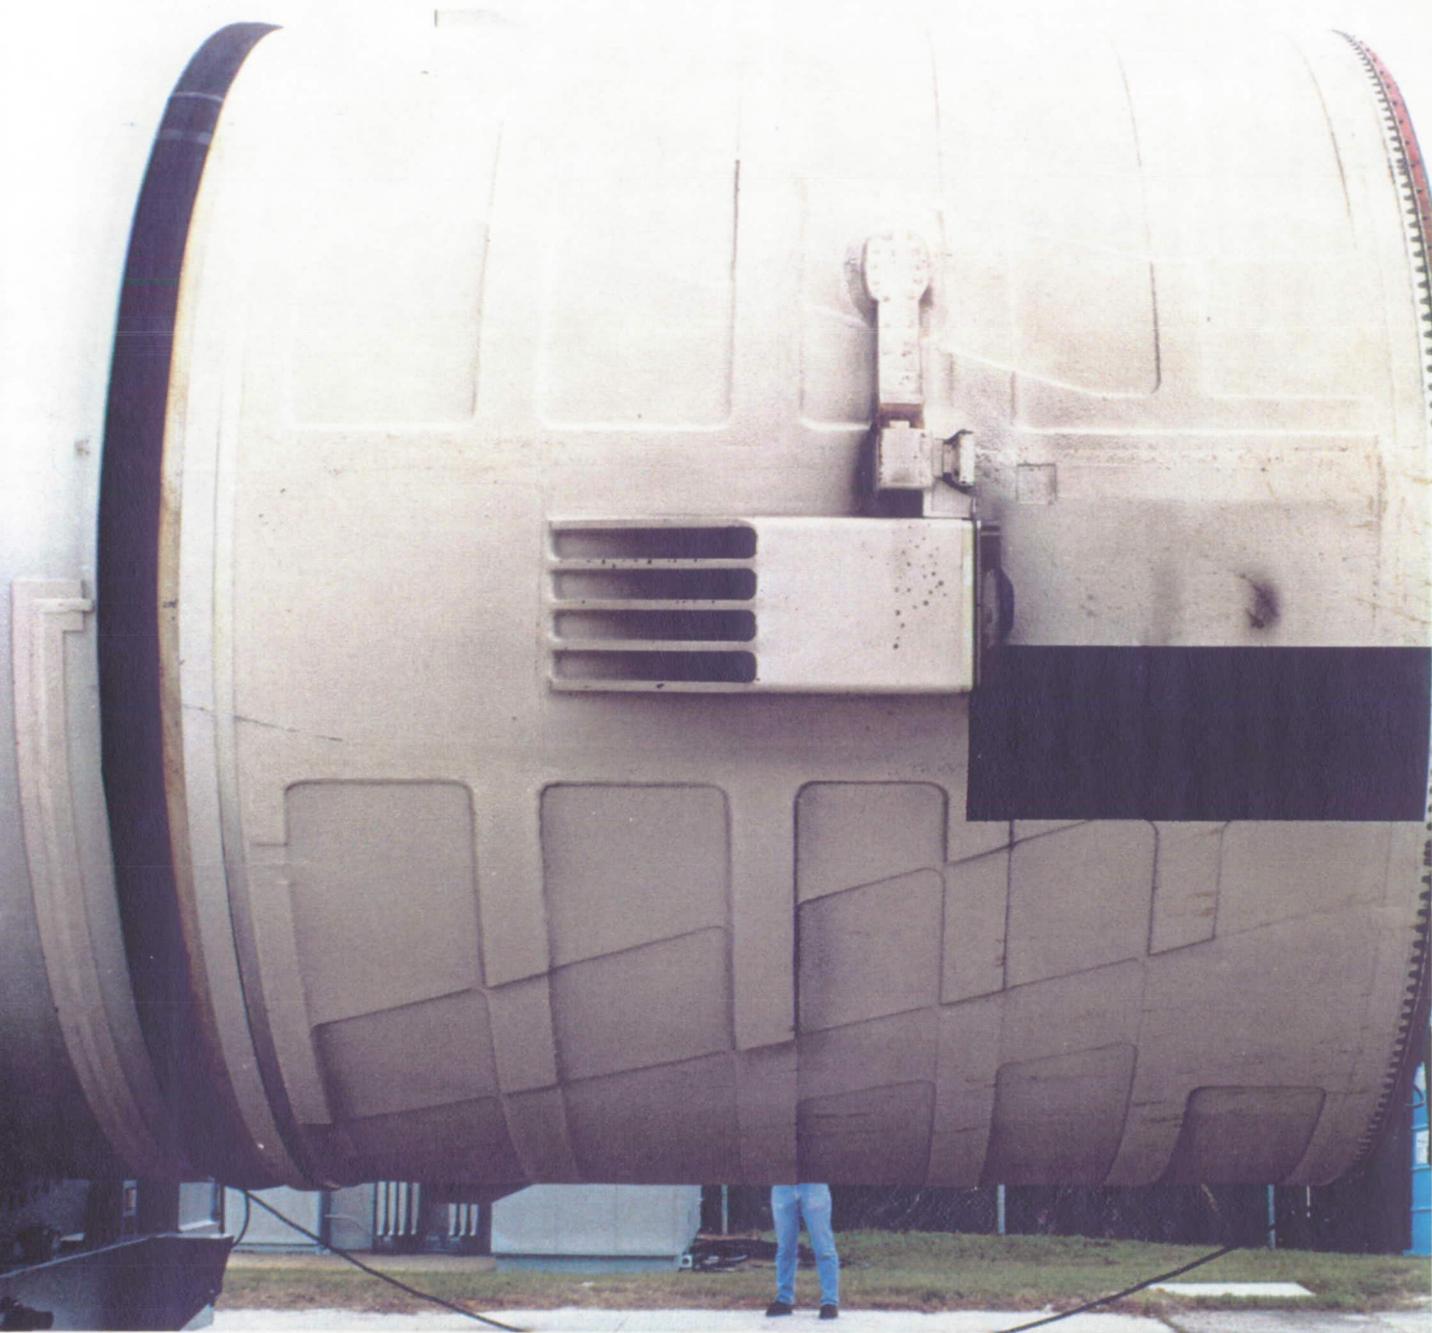
The RH forward skirt exhibited no debonds or missing TPS. Minor blistering of the Hypalon paint occurred in localized areas. Both RSS antenna covers/TPS were intact though the +Z antenna phenolic plate was delaminated.

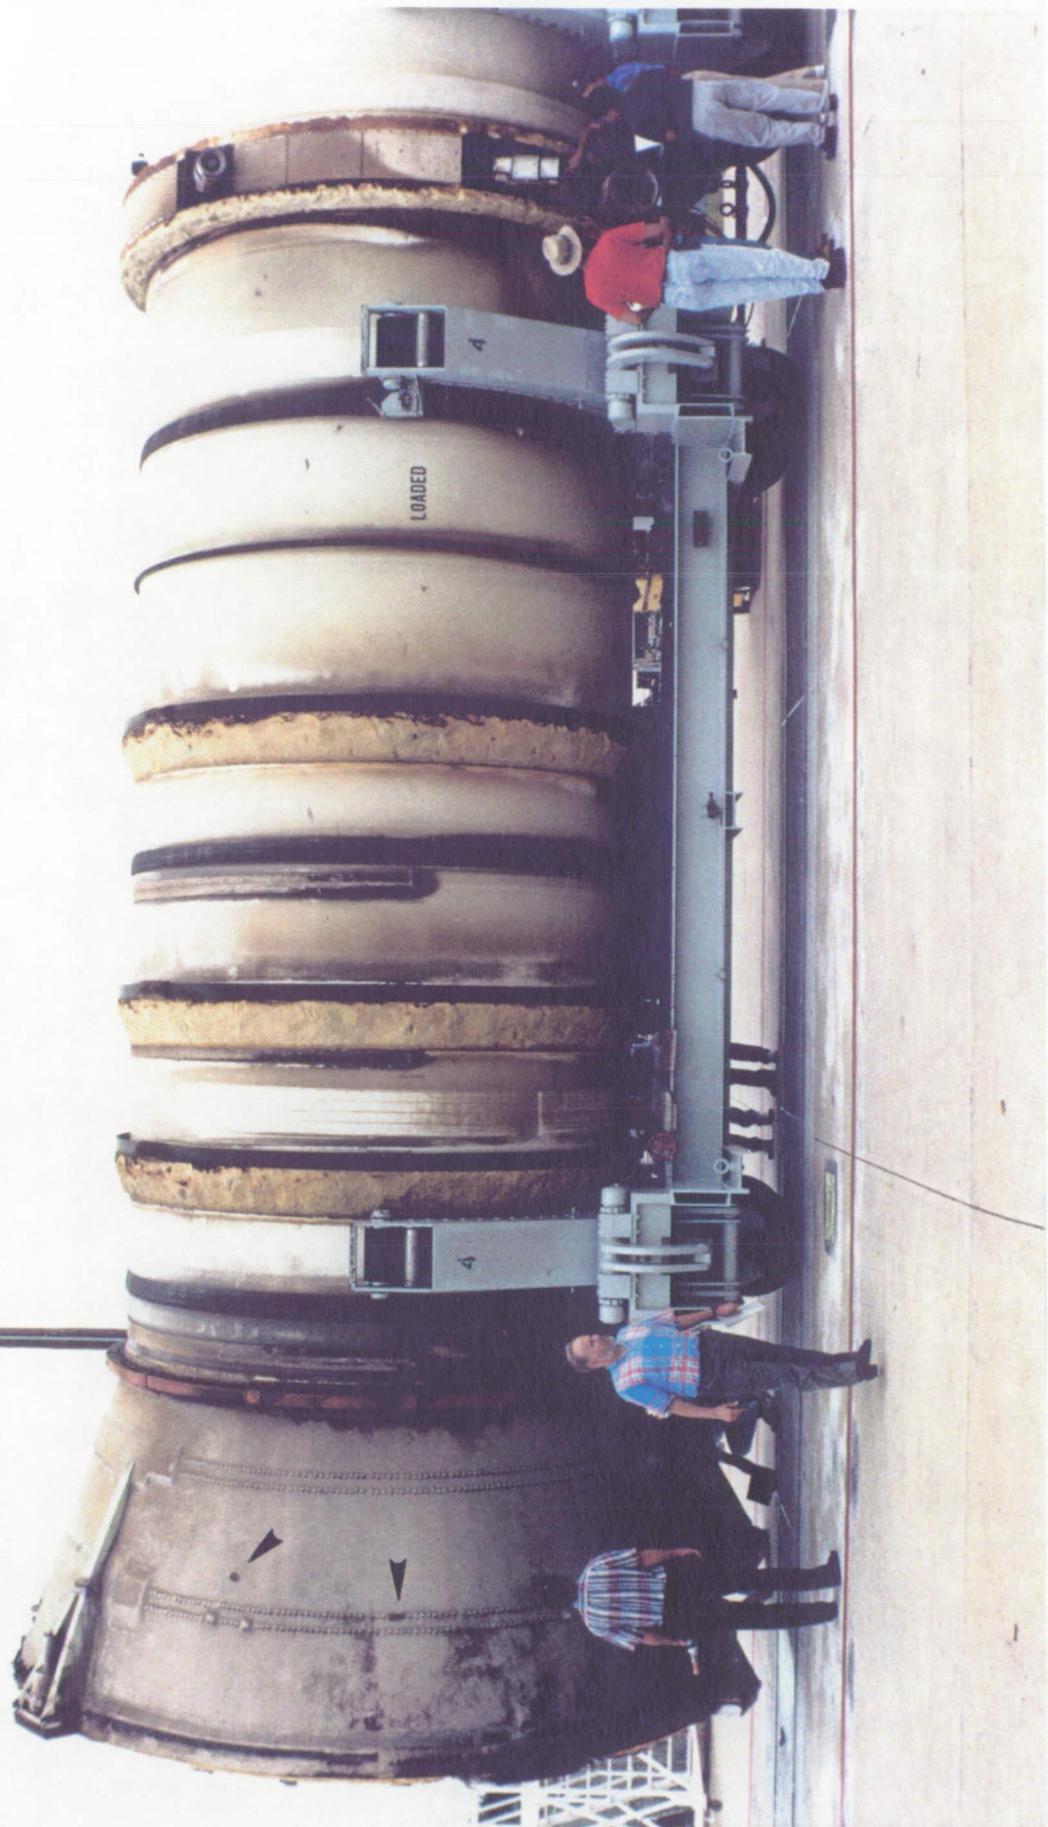
Post flight condition of the RH aft booster. MSA-2 TPS was missing from three areas on the aft skirt acreage. The ET/SPB aft struts, ETA ring, and IEA appeared undamaged. All three aft booster stiffener rings sustained water impact damage.

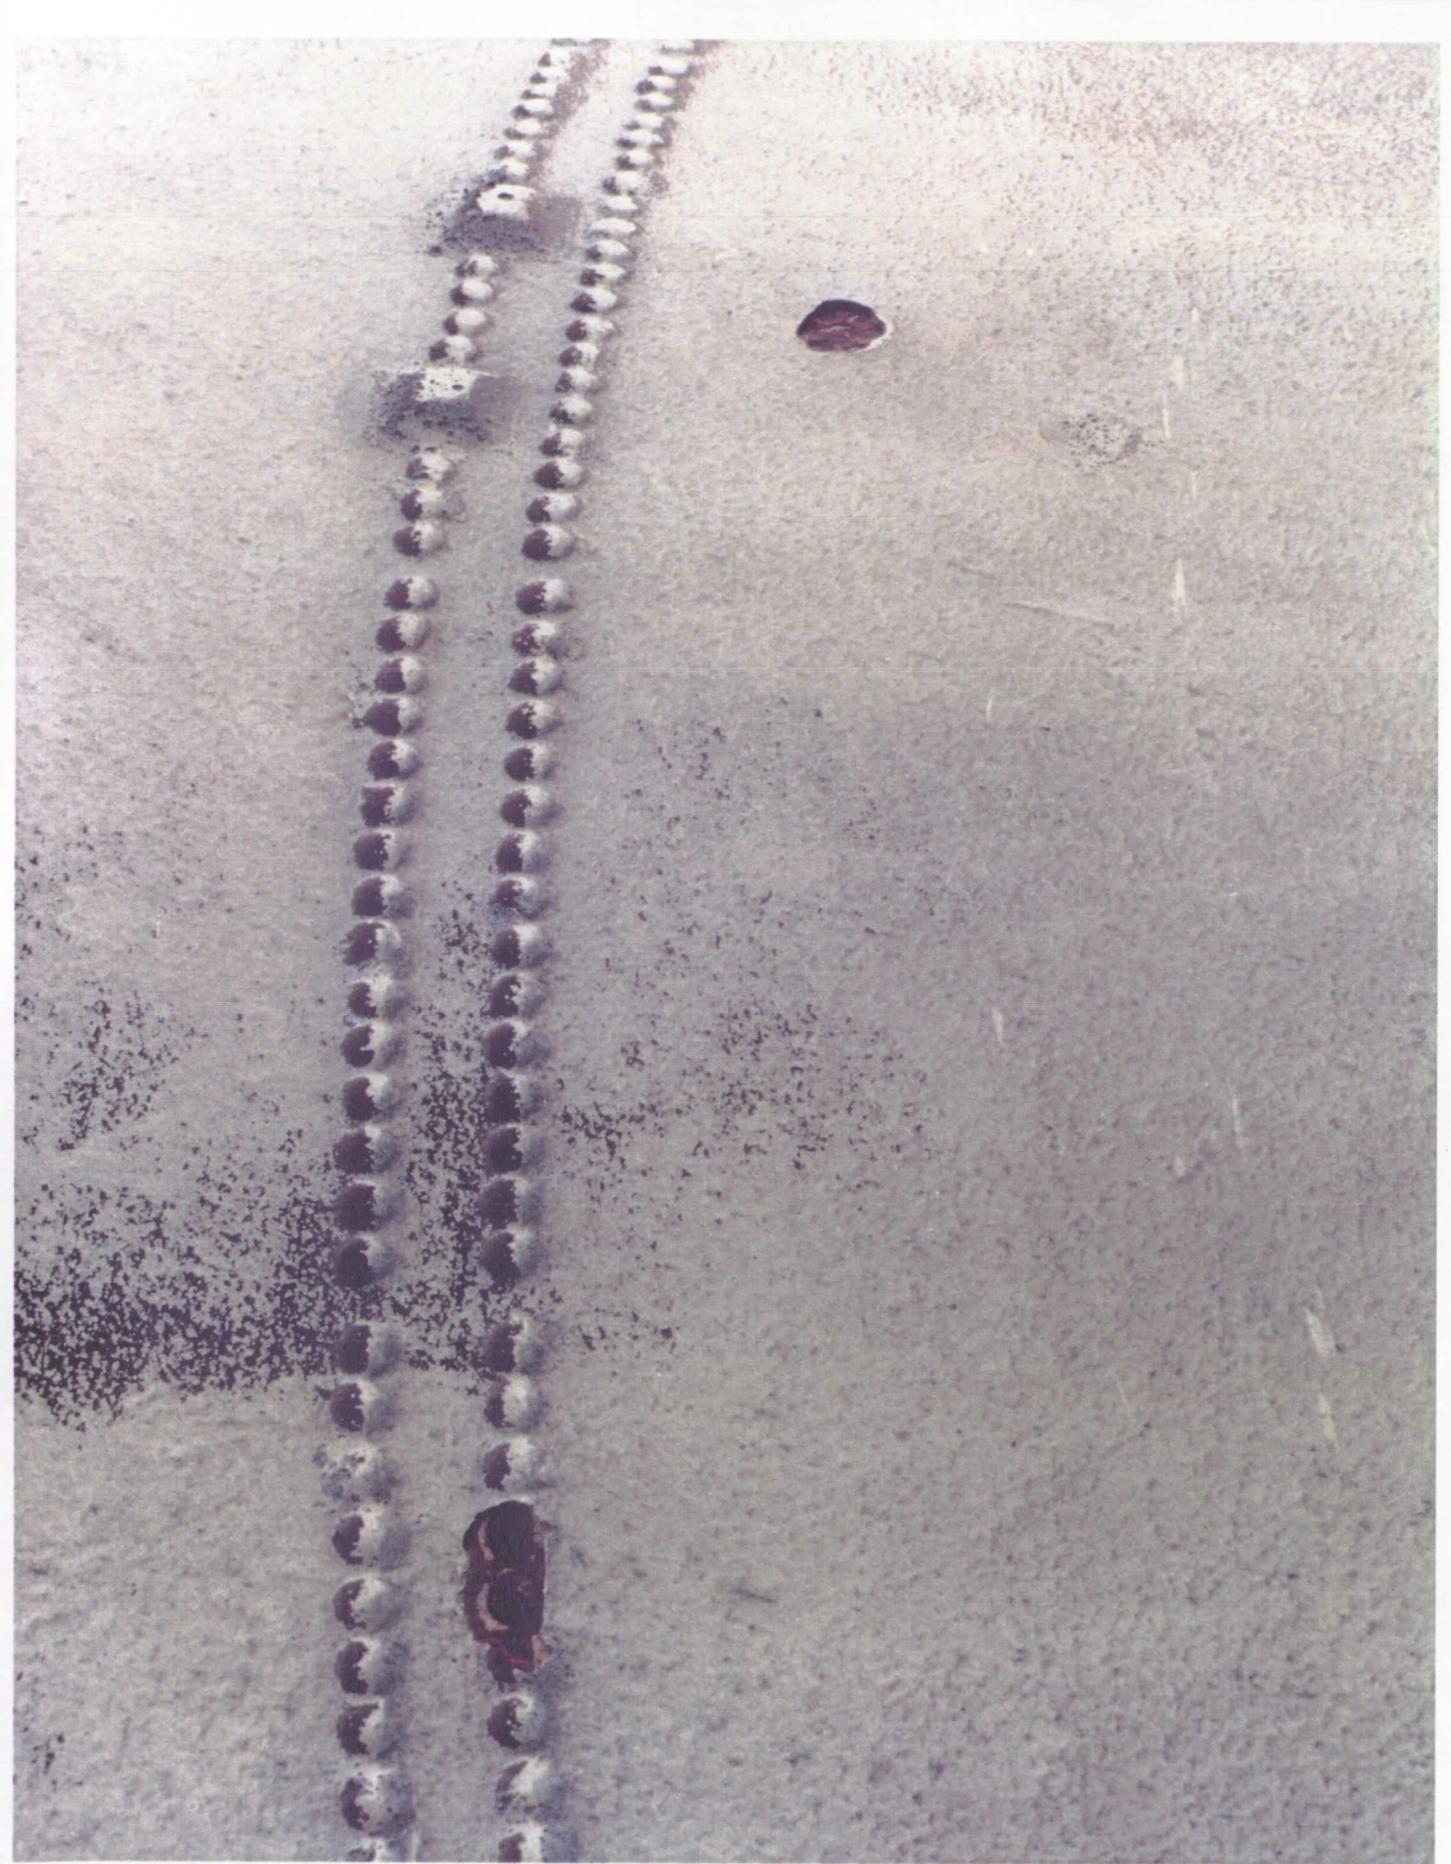
MSA-2 TPS was missing from two areas over aft skirt fasteners

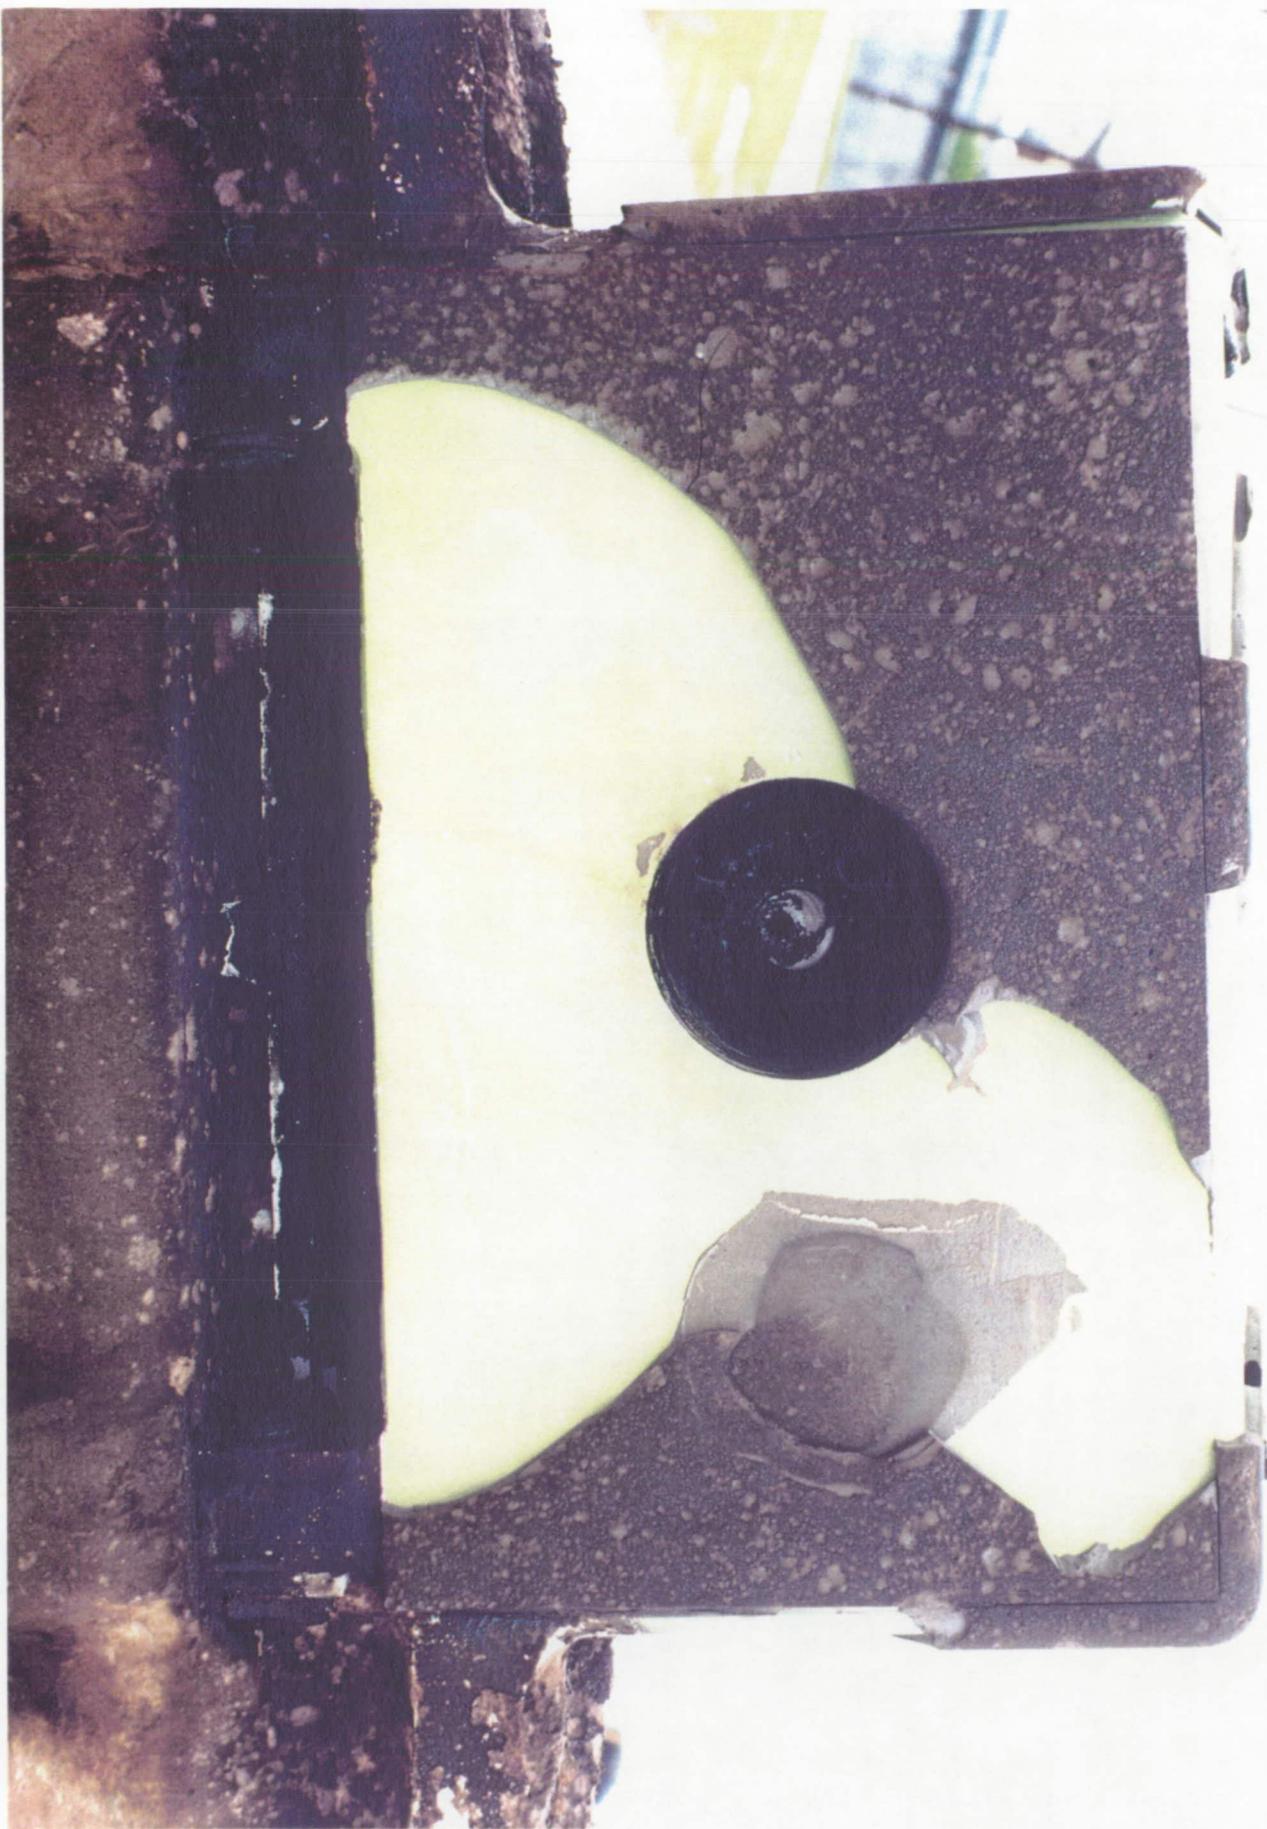
A 3-inch diameter piece of the HDP #4 EPON shim was missing prior to water impact (sooted/charred substrate).

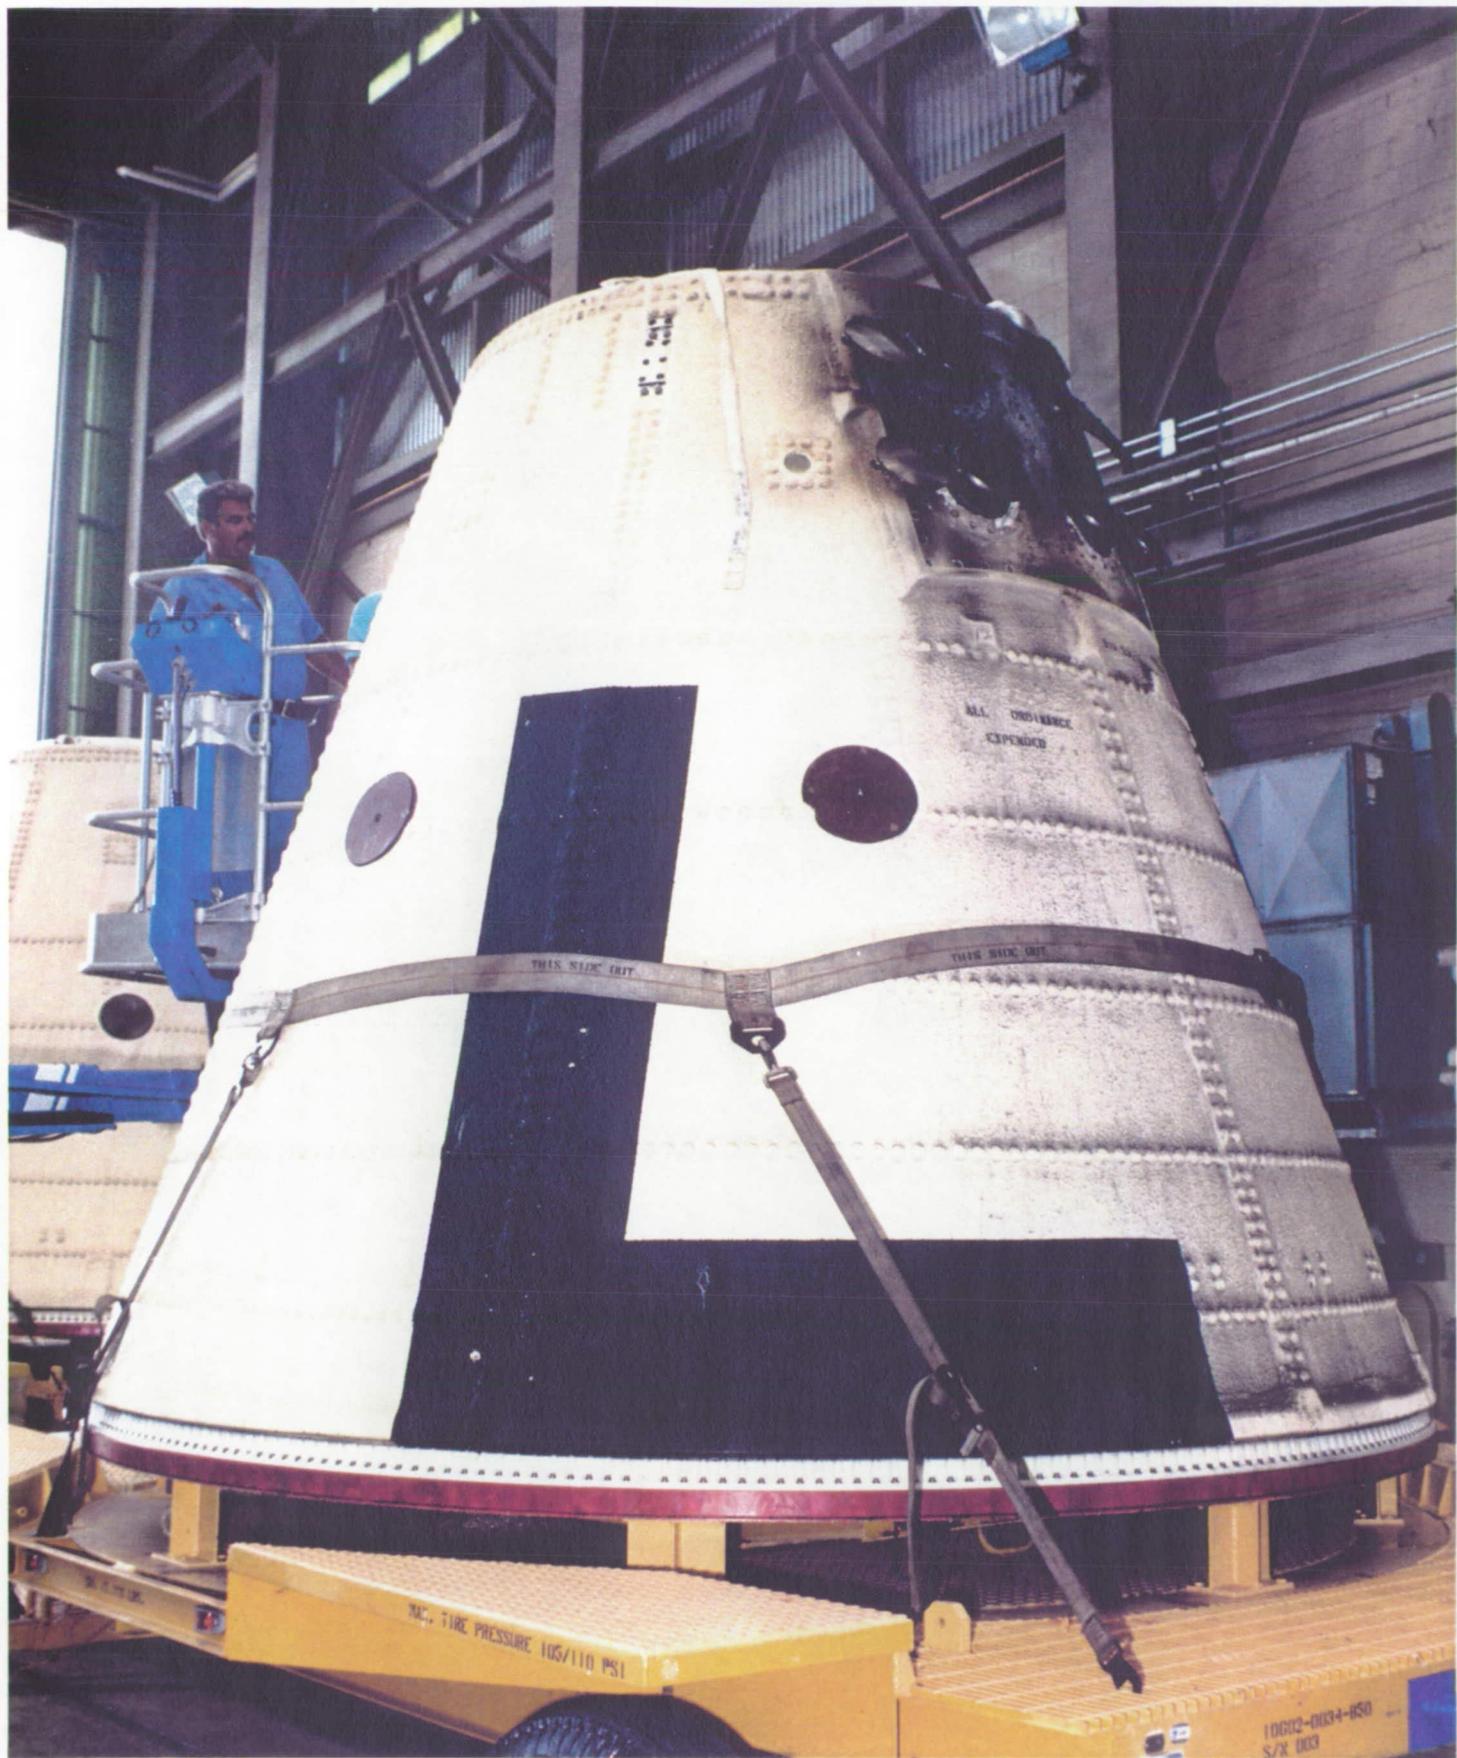
The LH frustum had 25 MSA-2 debonds over fasteners and was missing MSA-2 from one location between the +Y and +Z axes on the 381 ring frame. The BSM aero heat shield covers were locked in the fully opened position.

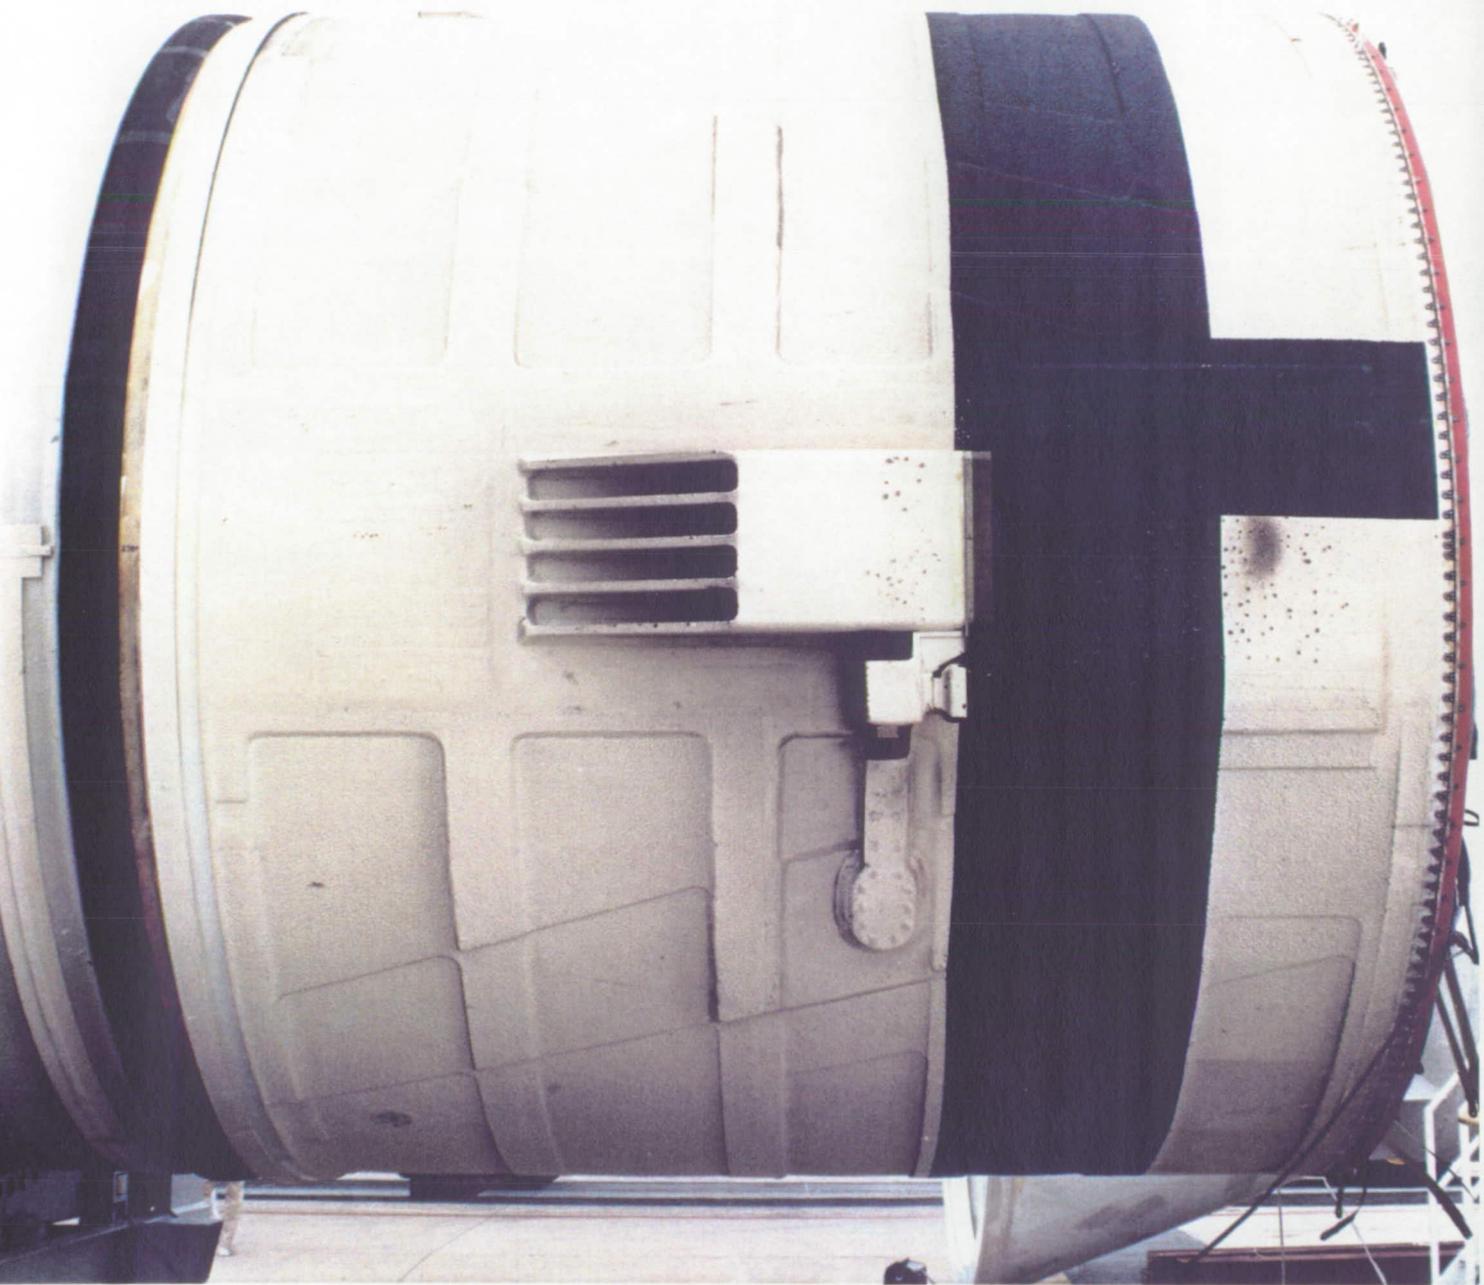
The LH forward skirt exhibited no debonds or missing TPS. Minor blistering of the Hypalon paint occurred in localized areas. Both RSS antenna covers/TPS were intact and undamaged.

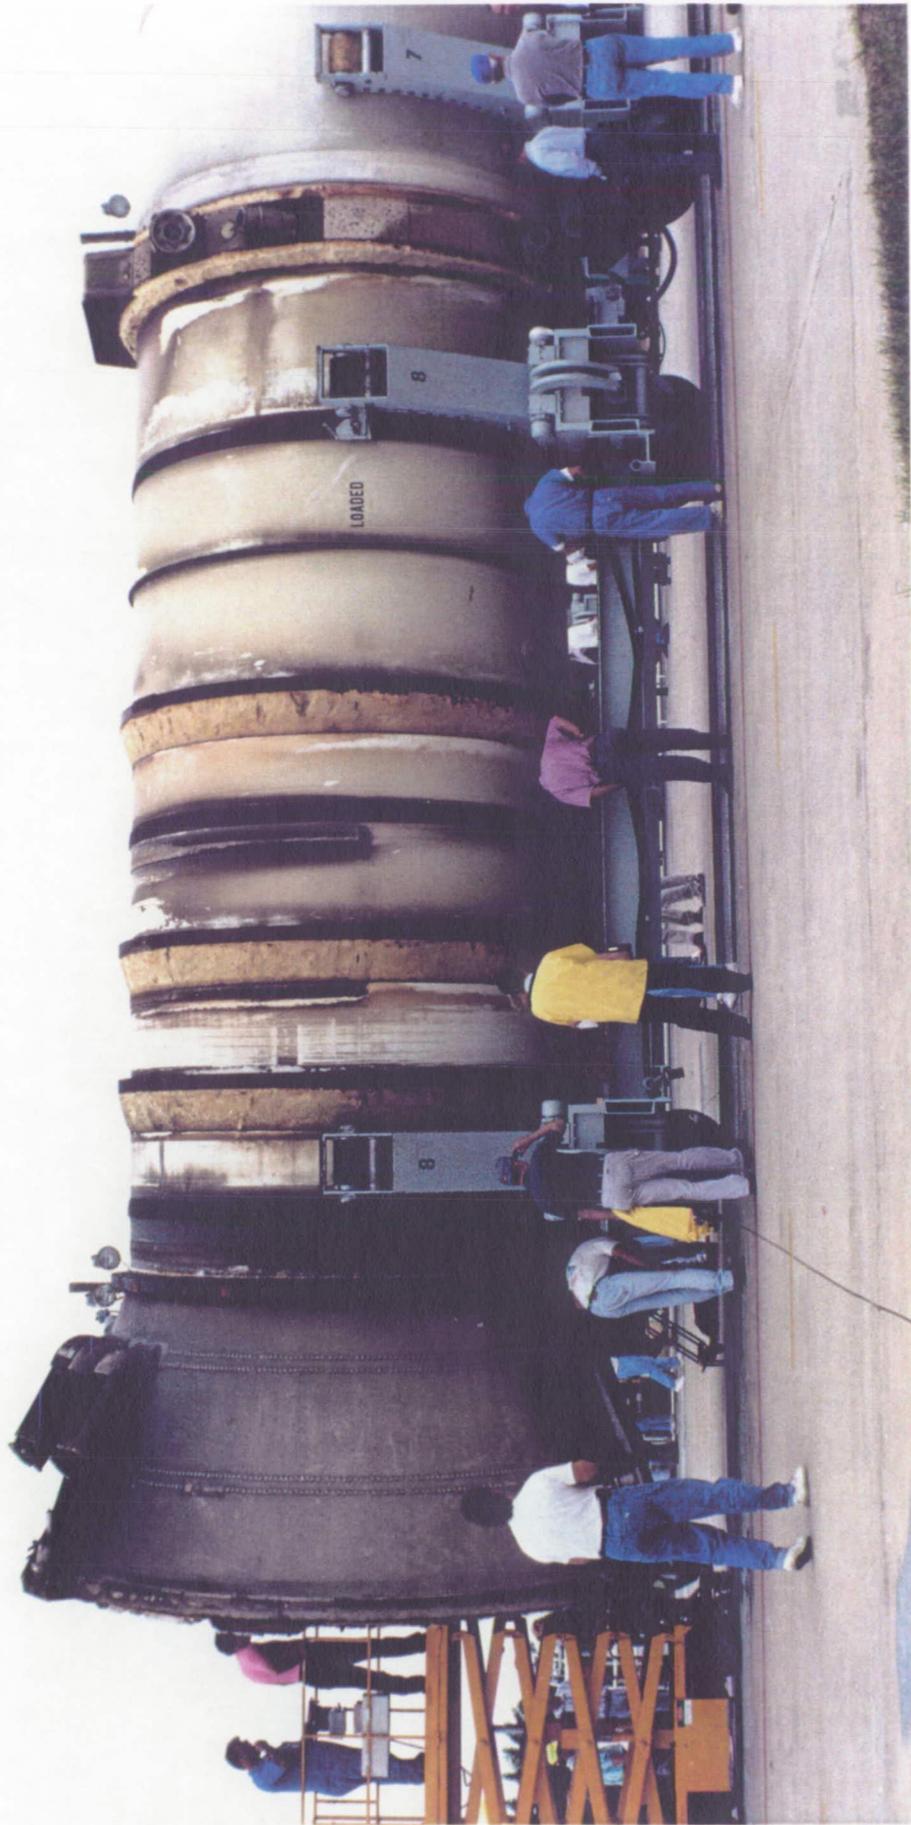
Post flight condition of the LH aft booster. Three MSA-2 divots were present on the aft skirt acreage. The ET/SRB aft struts, ETA ring, and IEA appeared undamaged. All three aft booster stiffener rings sustained water impact damage.

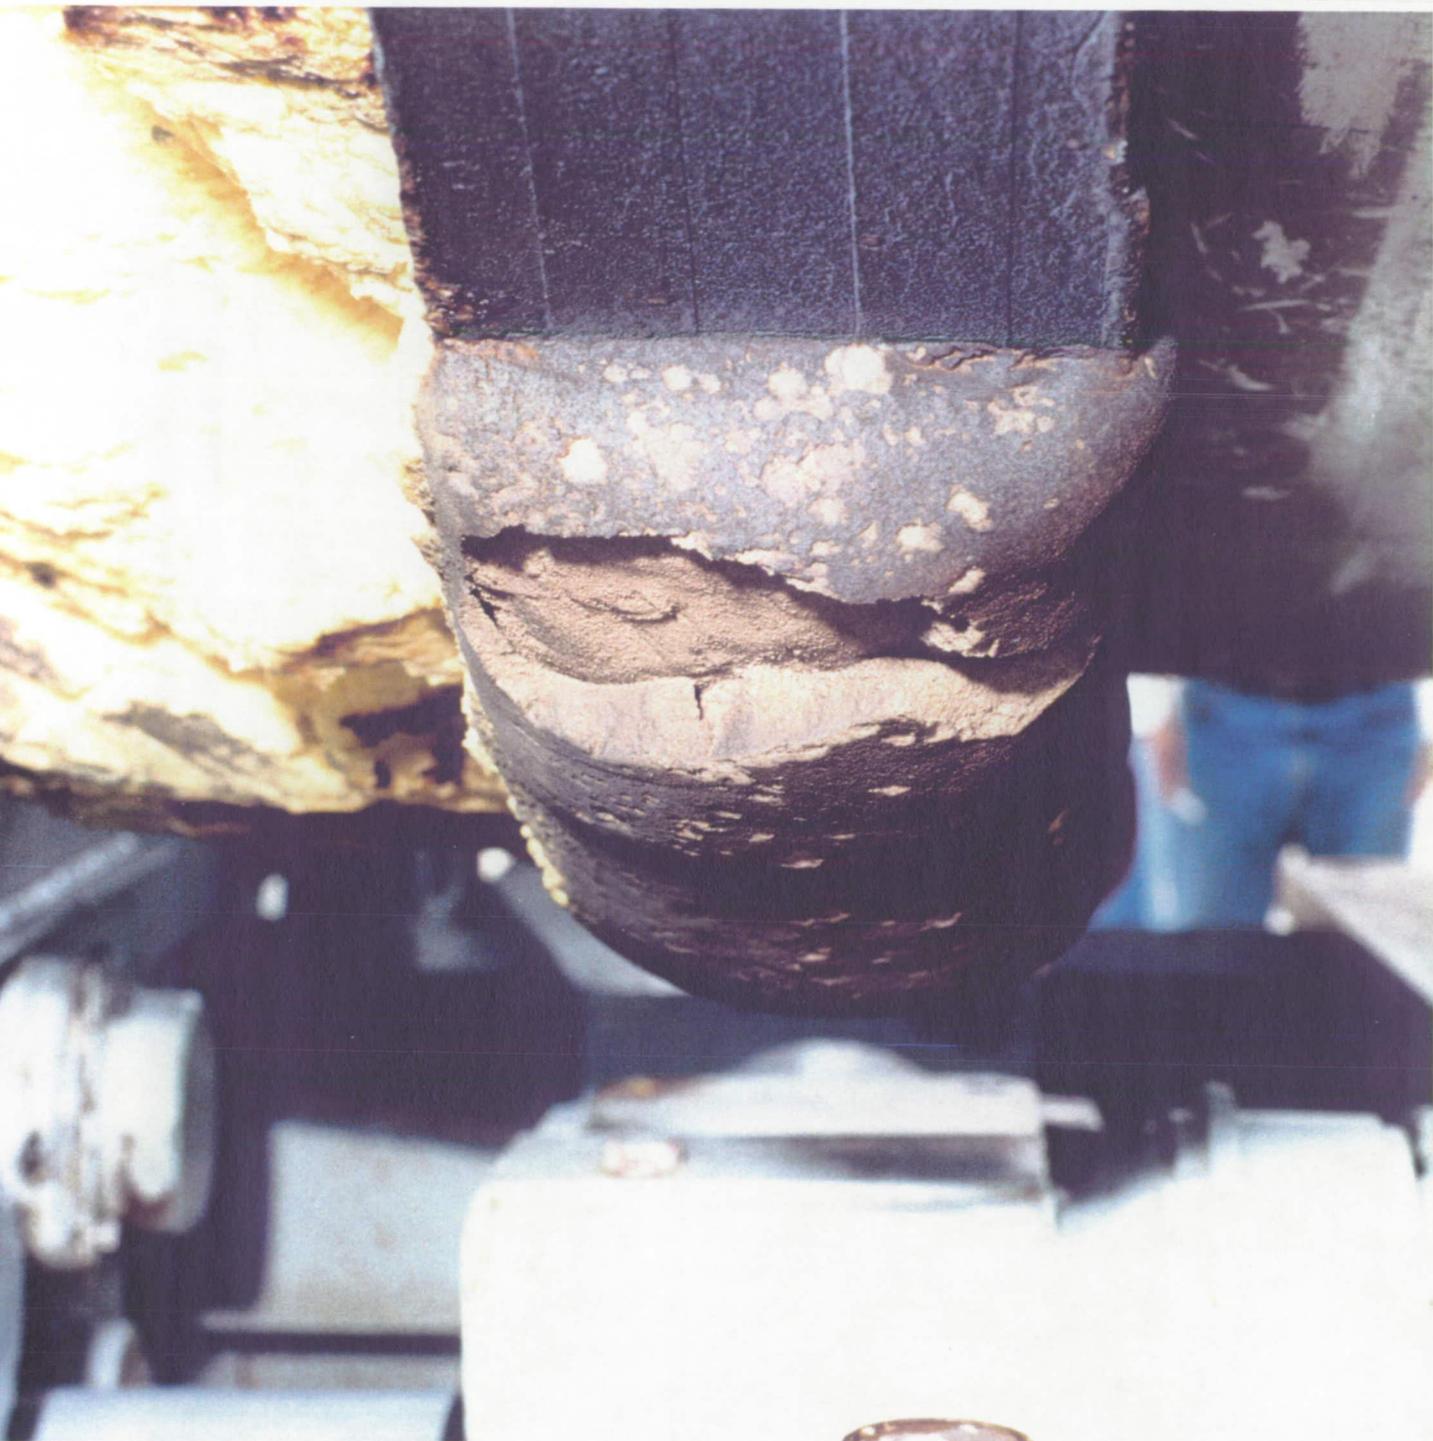
A 6"x3" piece of K5NA was missing from the aft stiffener ring. Though the remaining material showed signs of delamination, the surfaces were not sooted indicating the material was most likely lost at water impact.

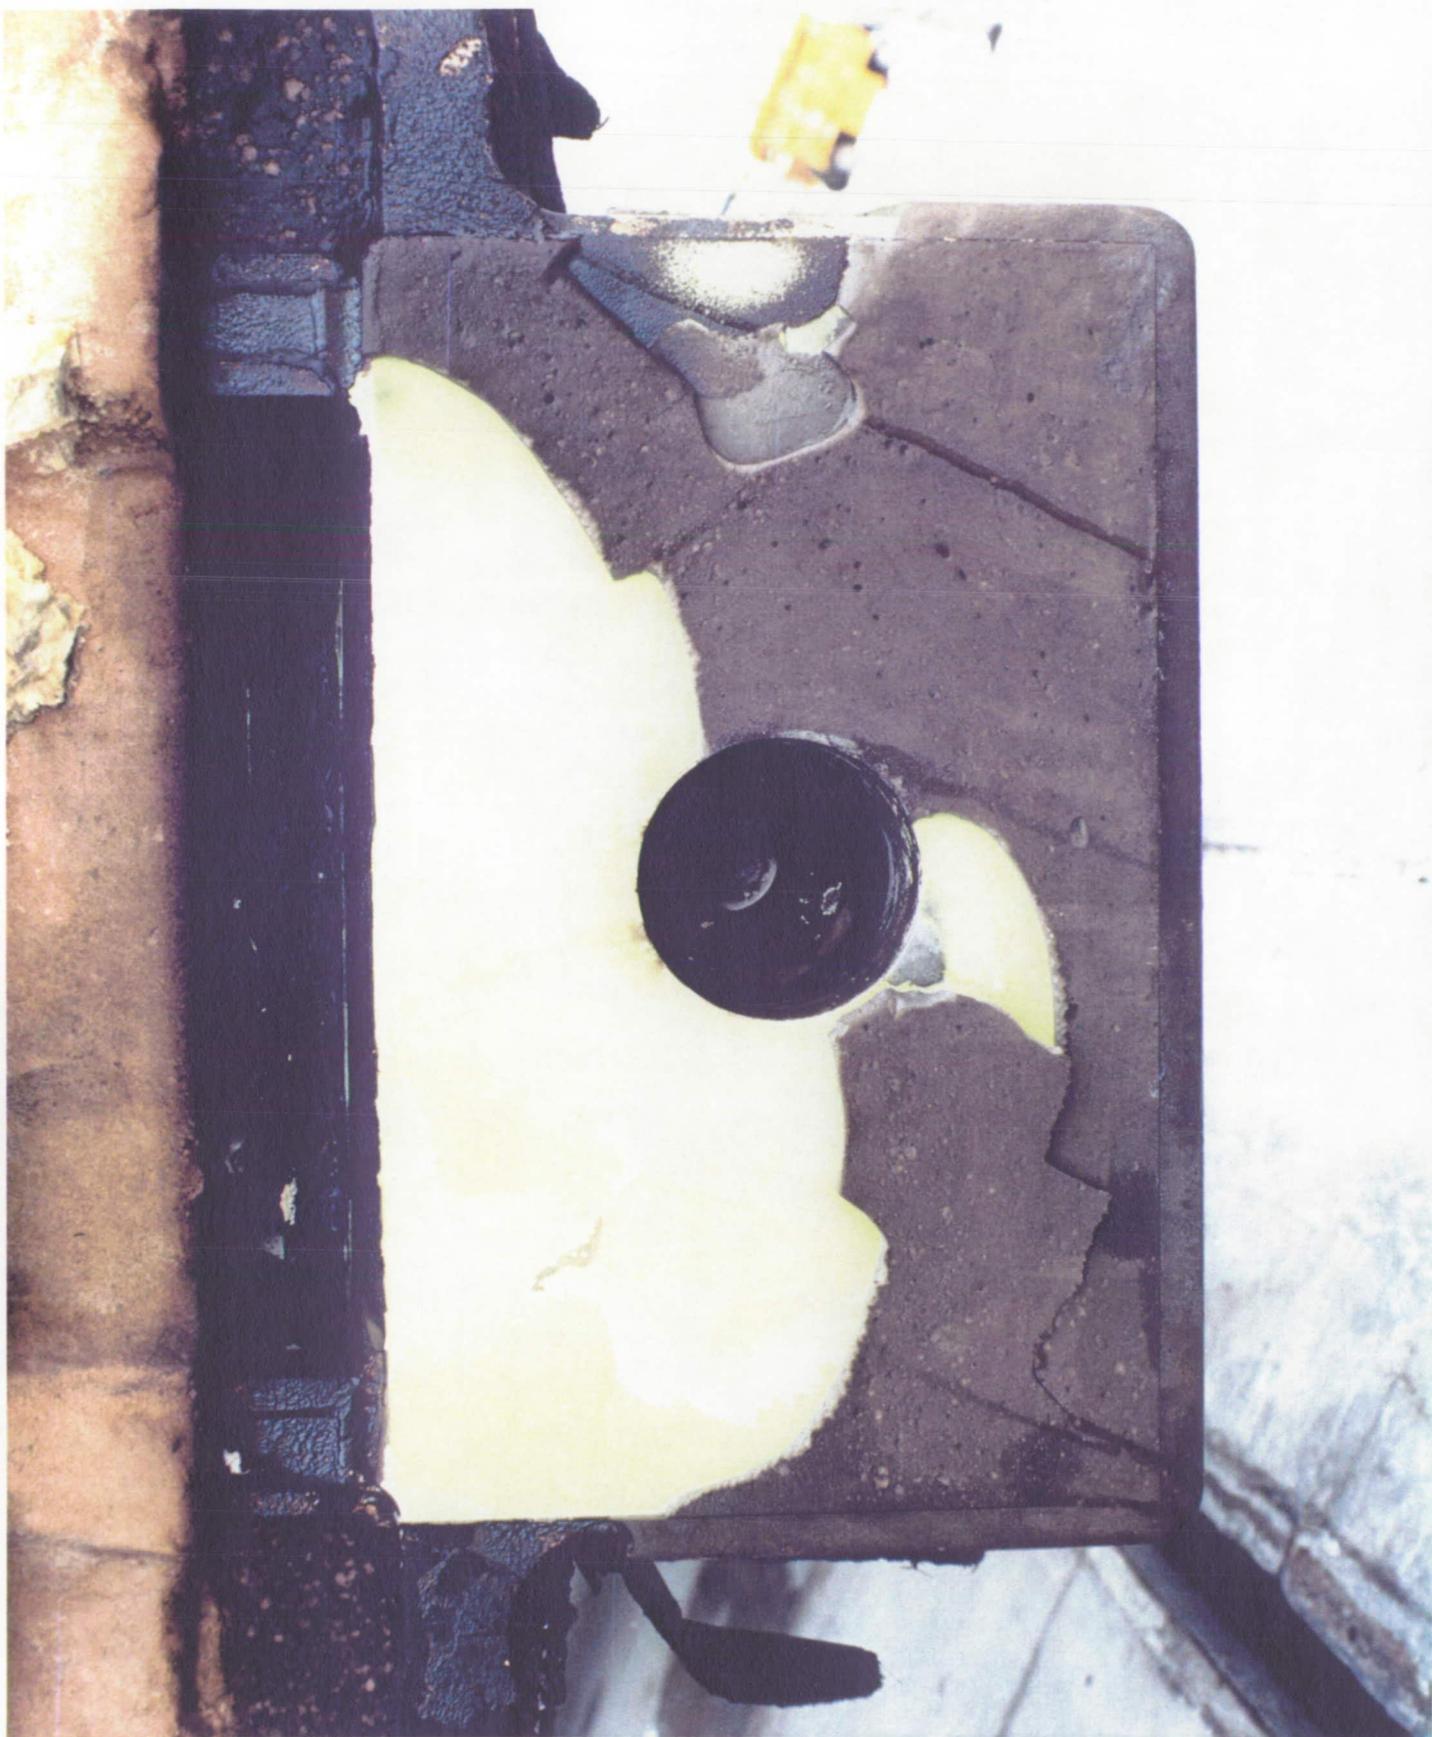
Pieces of the HDP #7 EPON shim were missing prior to water impact (sooted/charred substrate).
