# Debris/Ice/TPS Assessment And Integrated Photographic Analysis For Shuttle Mission STS-47

November 1992

**Gregory N. Katnik**  
**NASA/Kennedy Space Center**

DEBRIS/ICE/TPS ASSESSMENT  
AND  
PHOTOGRAPHIC ANALYSIS  
OF  
SHUTTLE MISSION STS-47

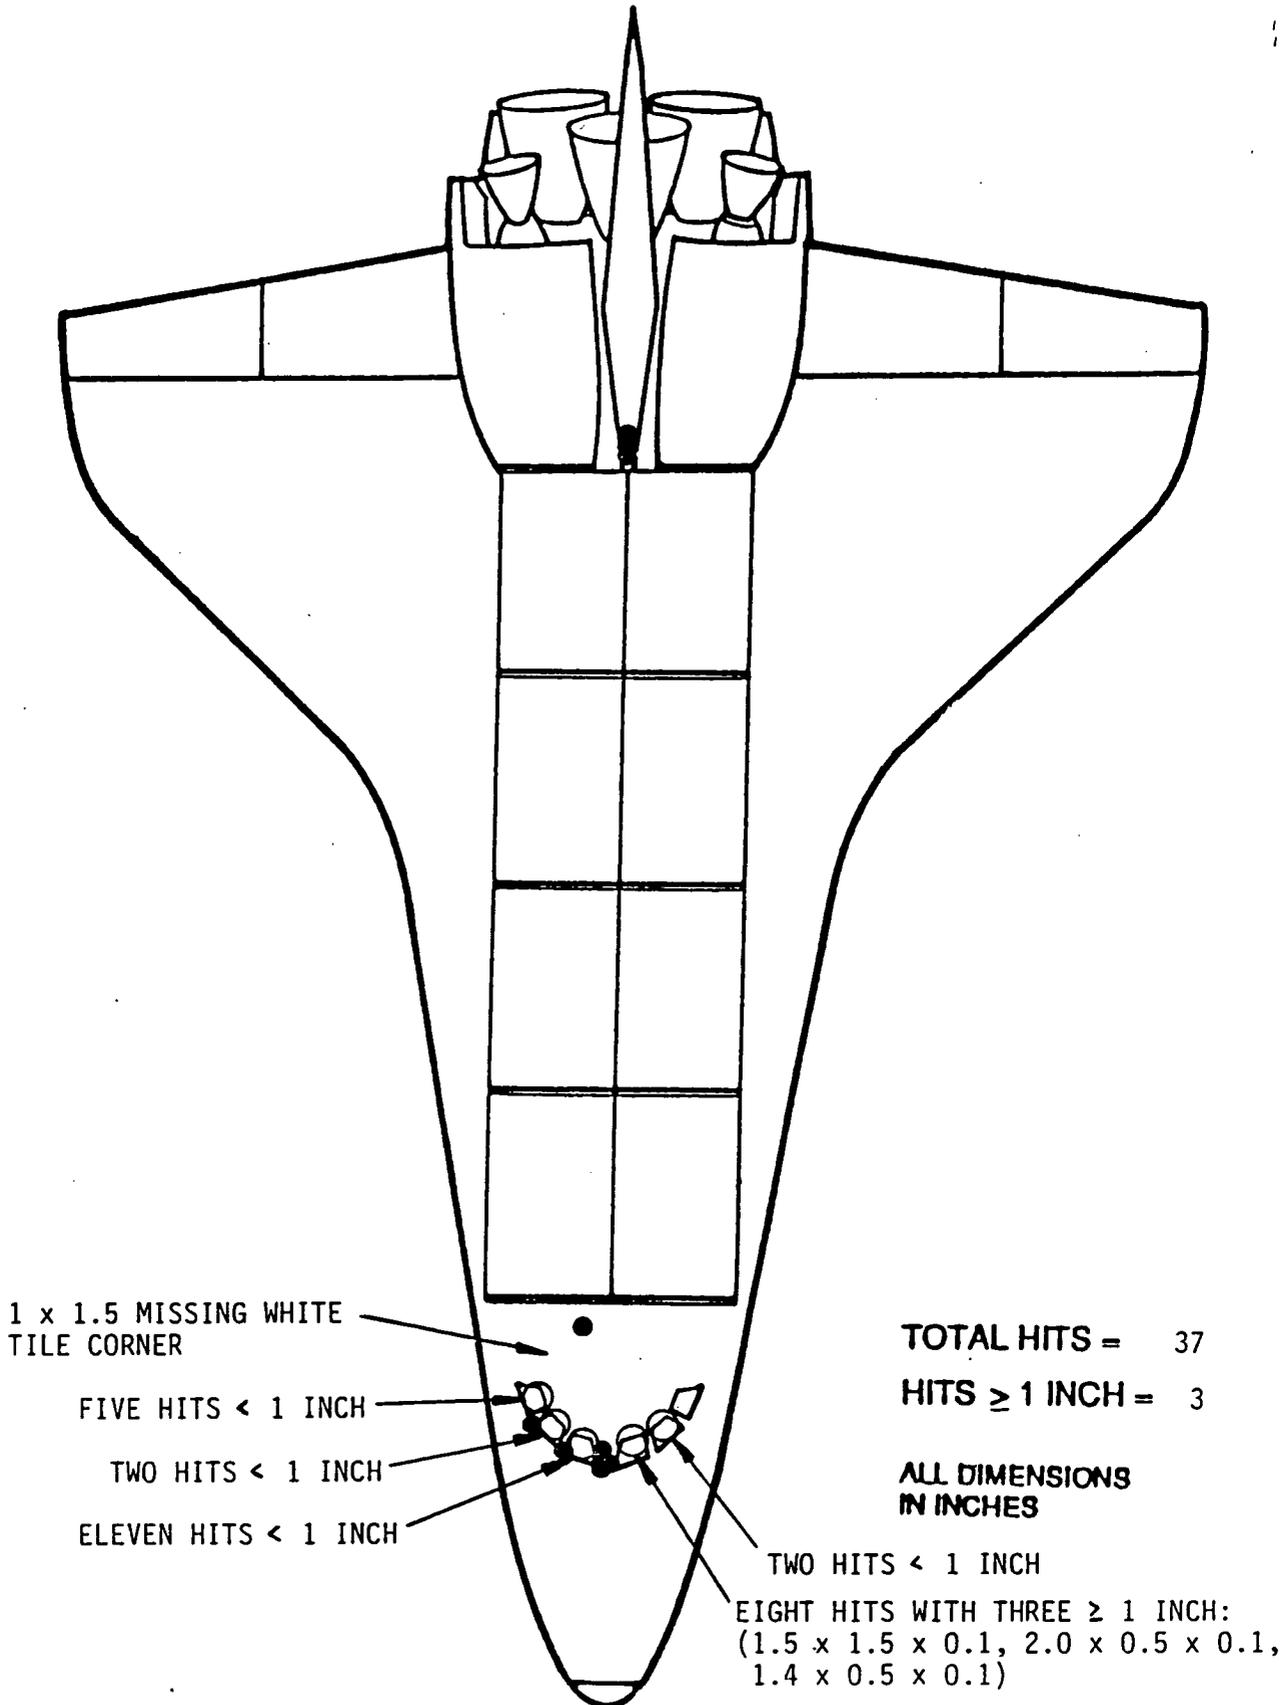
Damage to the base heat shield tiles was less than average. The SSME #1 Dome Mounted Heat Shield (DMHS) closeout blanket splice at the 6:00 o'clock position exhibited minor fraying. All of the remaining DMHS blankets were in excellent condition.

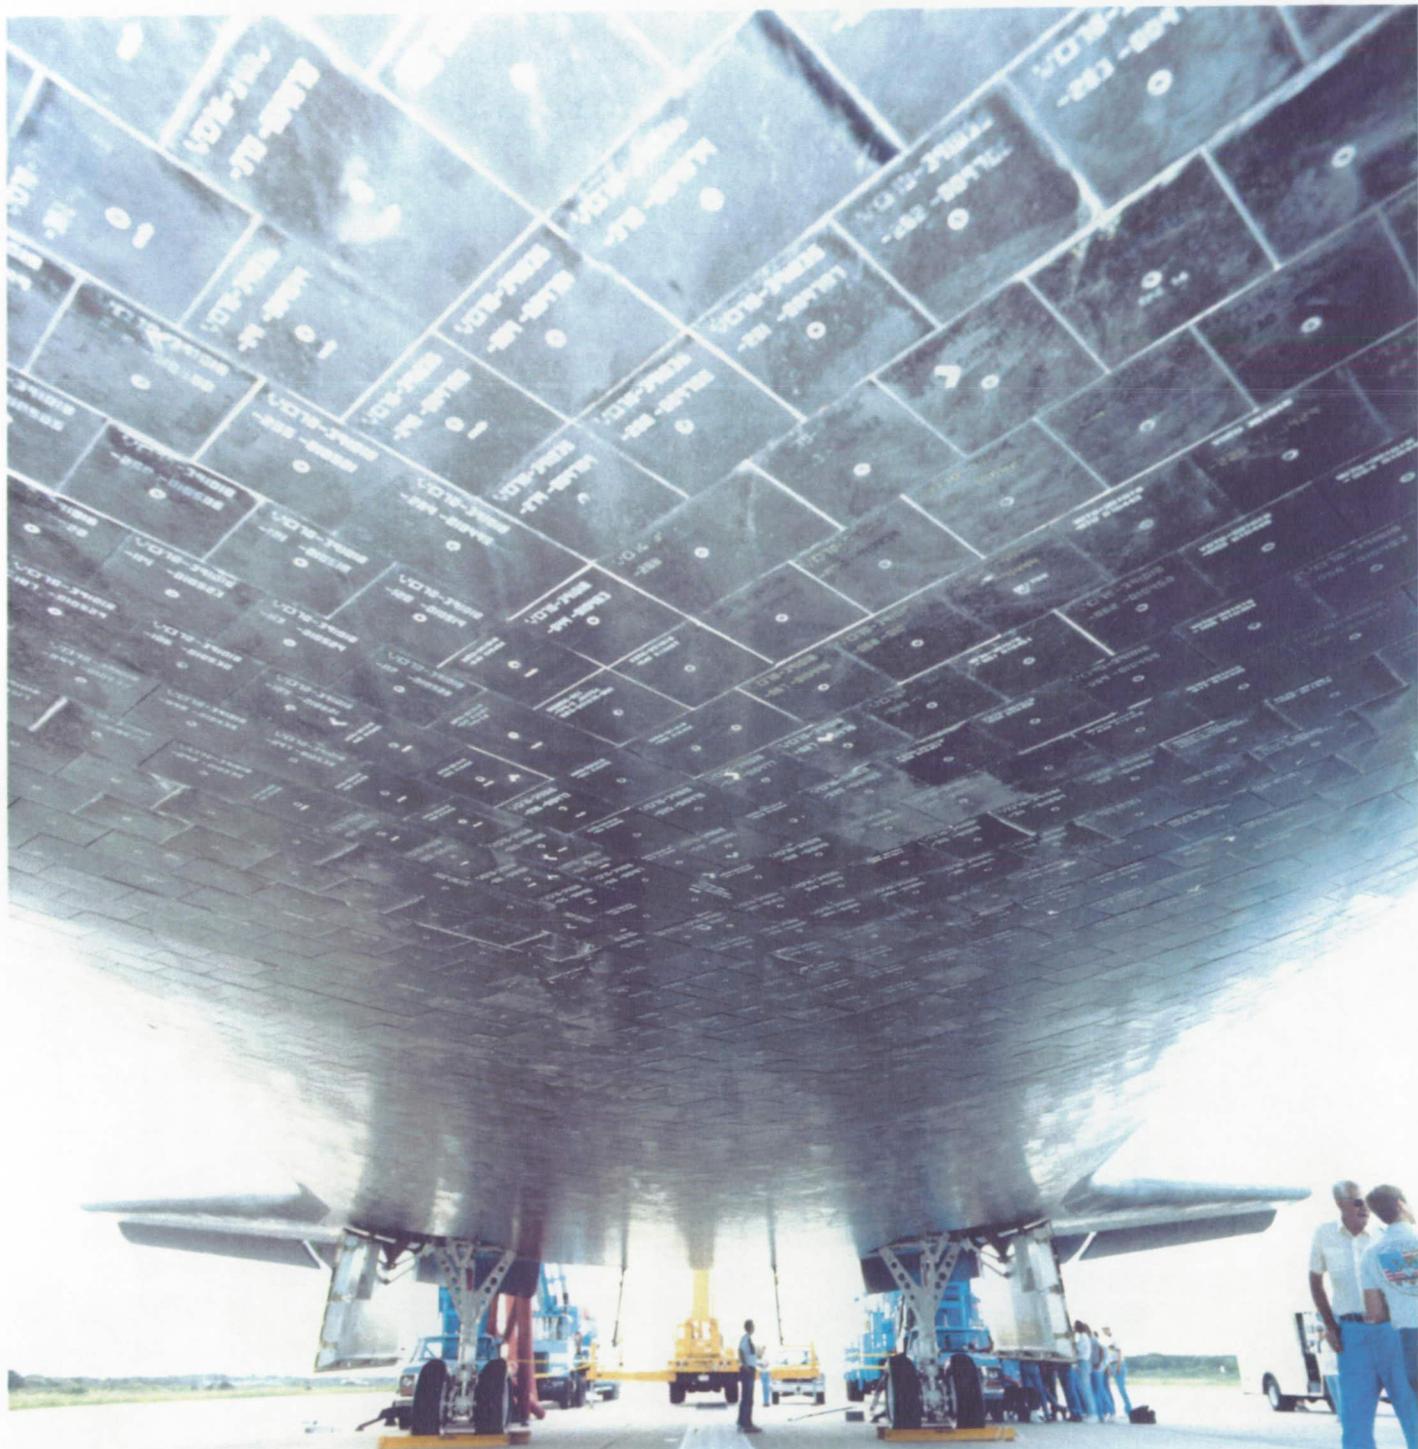
The Orbiter lower surface tiles sustained a total of 47 hits, of which three had a major dimension of 1-inch or greater. These numbers are much less than average.

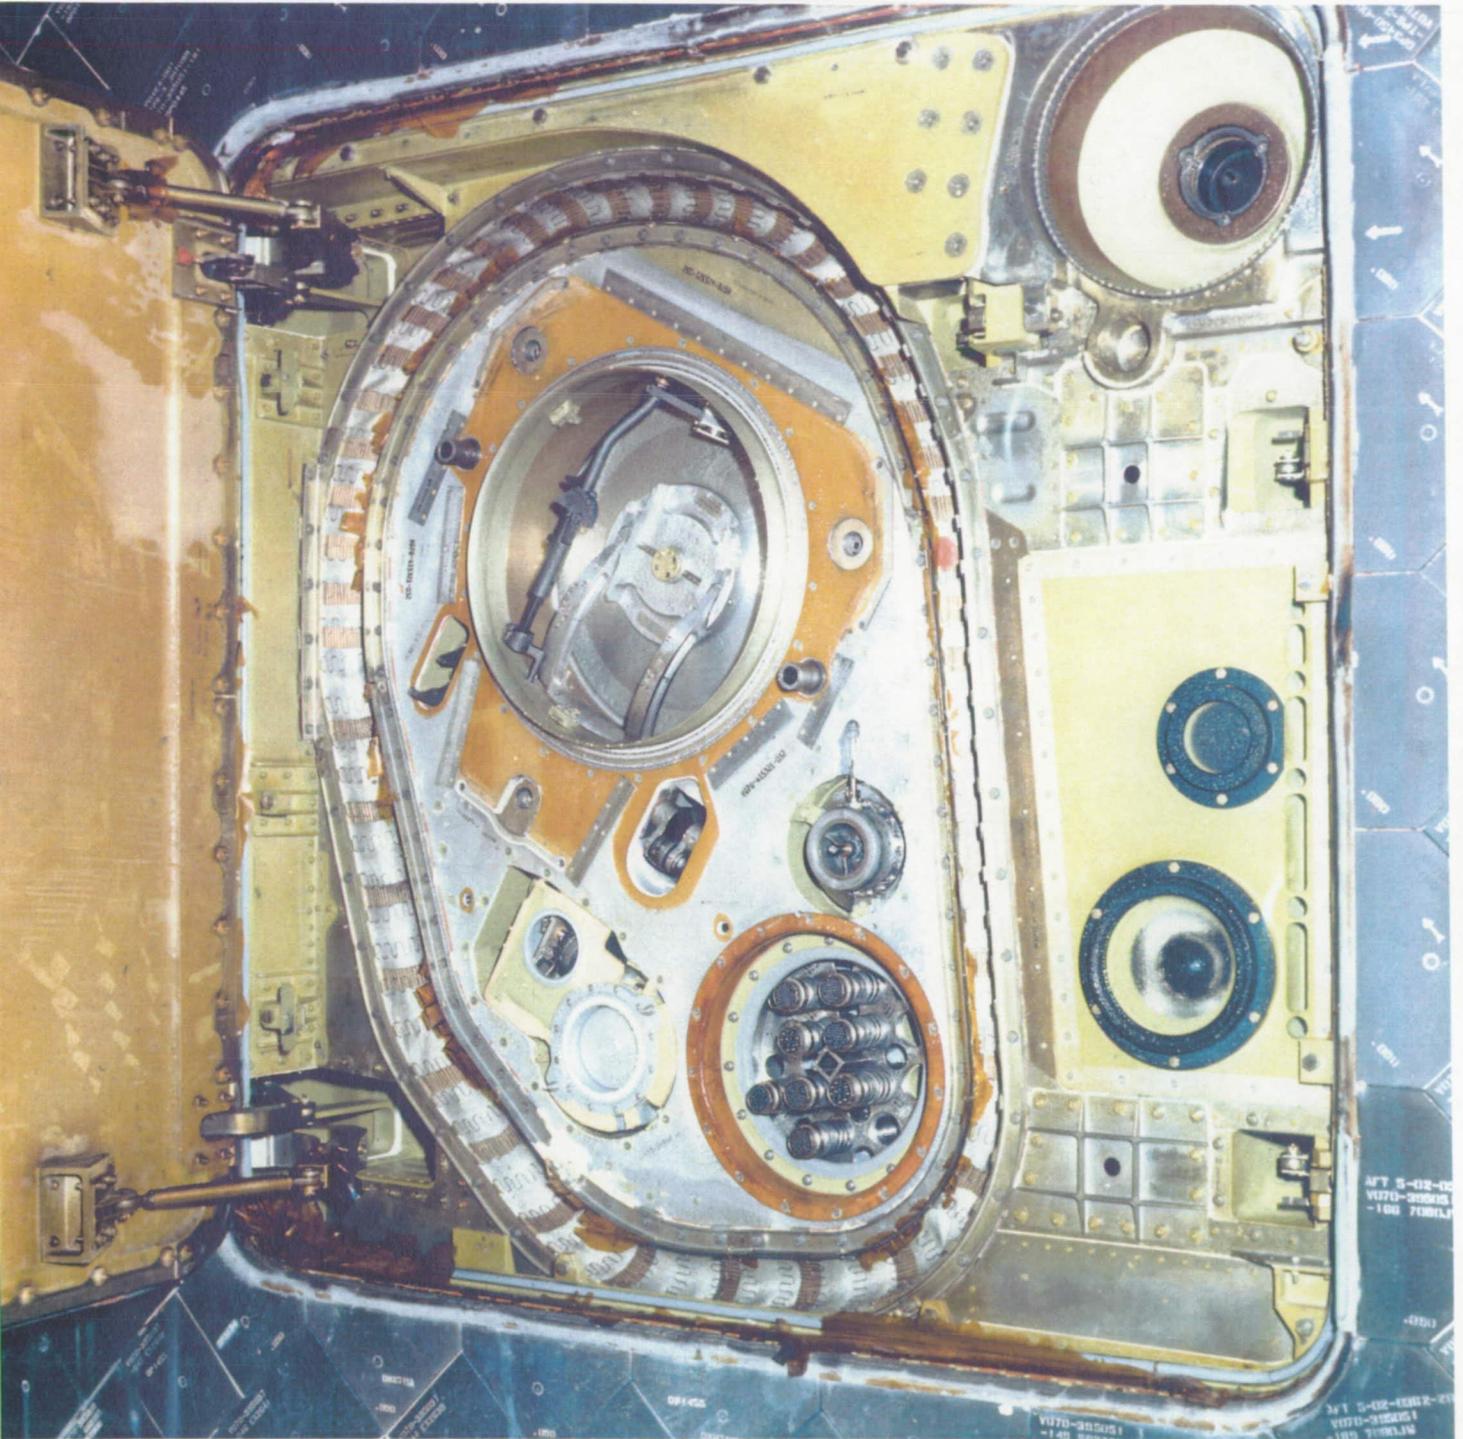
Overall view of the LH2 ET/ORB umbilical. All separation ordnance devices appeared to have functioned properly. No flight hardware was found on the runway below the umbilical when the ET door was opened.

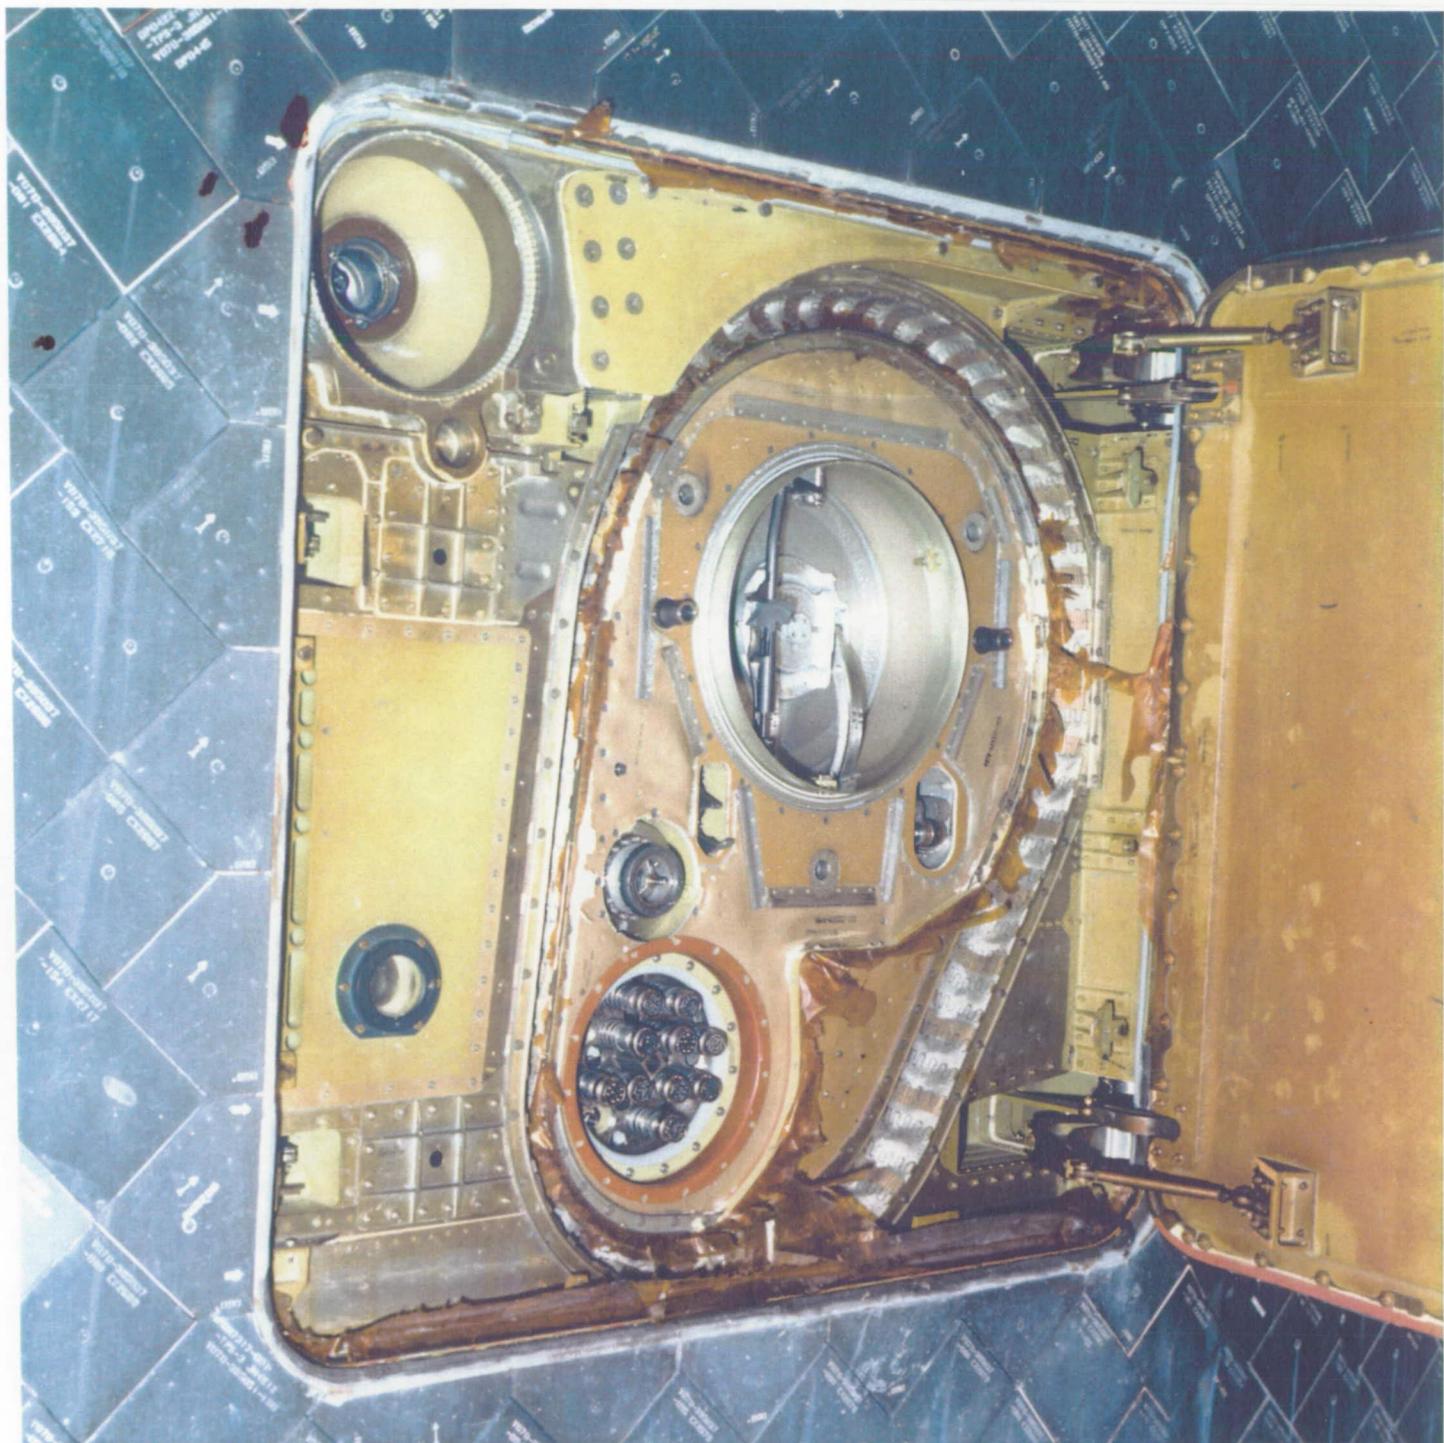
Overall view of the L02 ET/ORB umbilical. No flight hardware was found on the runway below the umbilical when the ET door was opened.

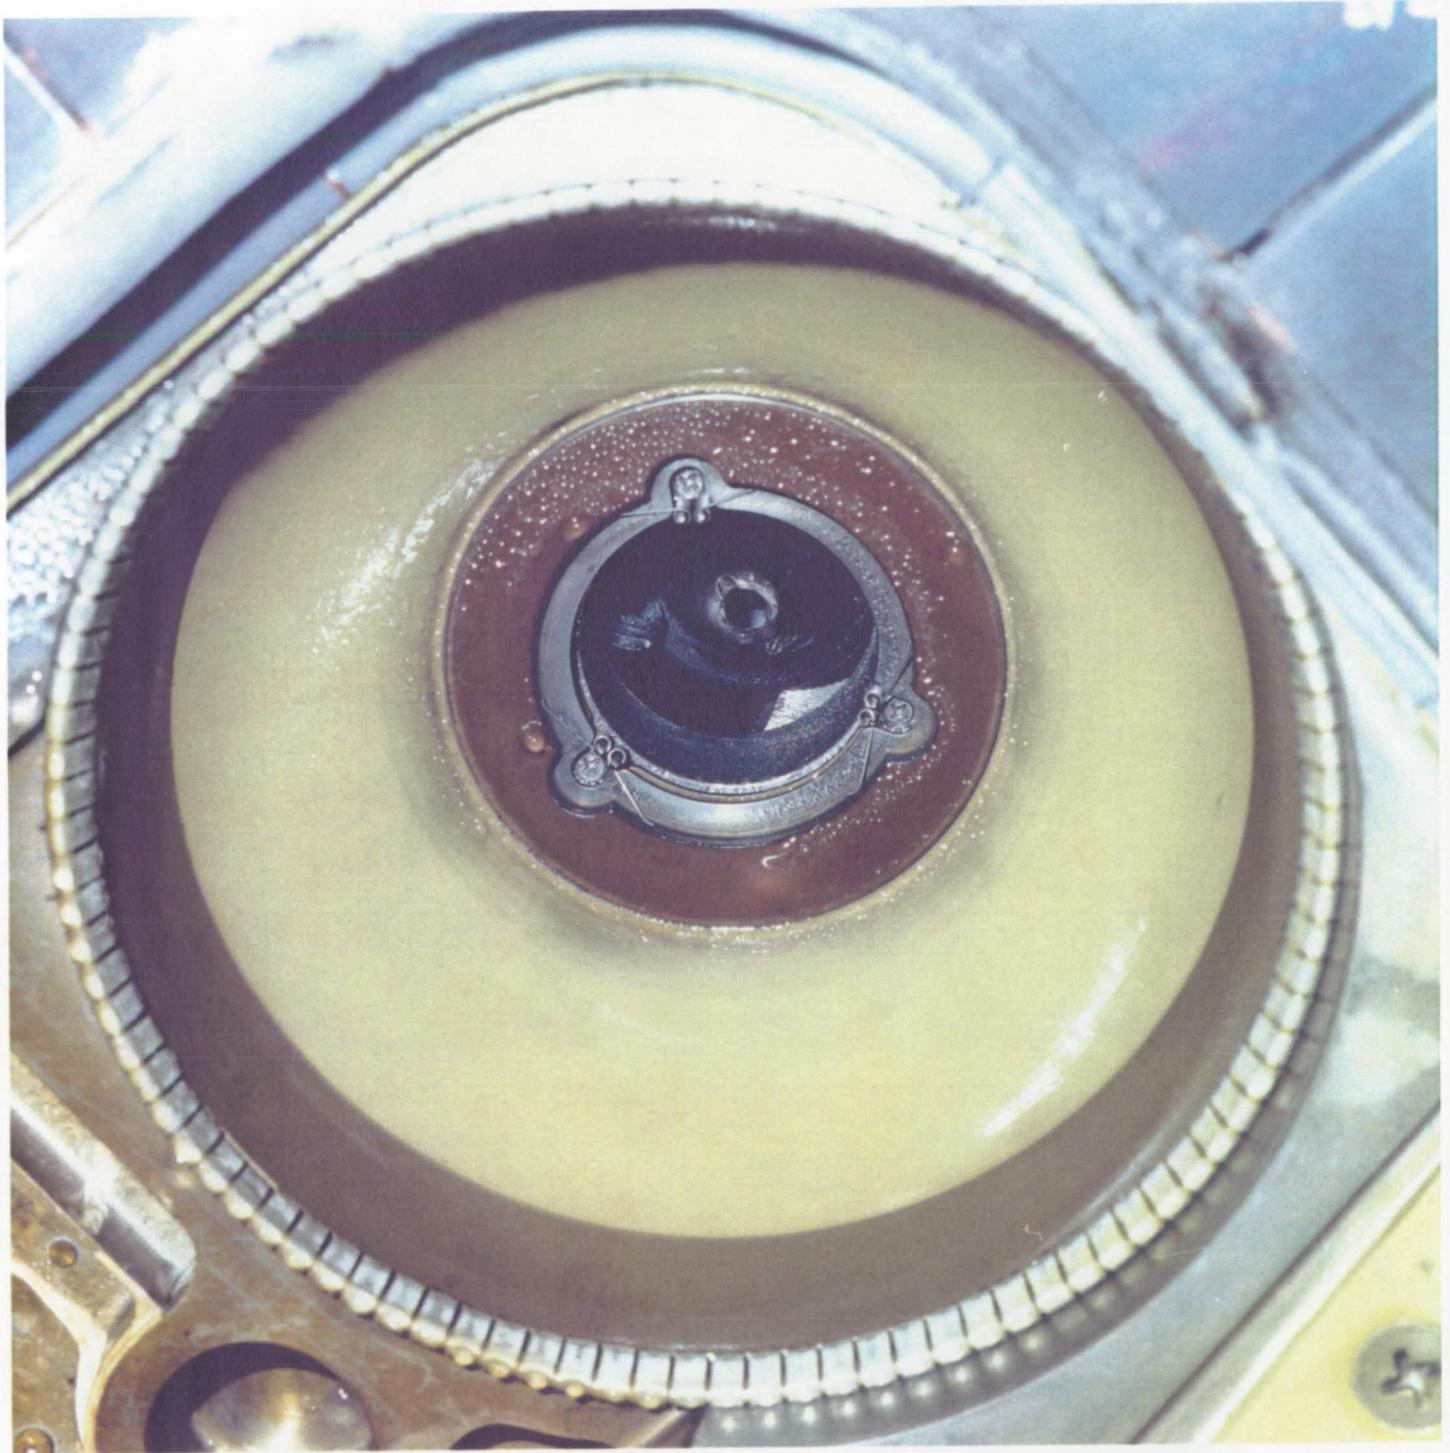
The EO-3 (LO2) separation device debris plunger was obstructed by two ordnance fragments and was prevented from seating

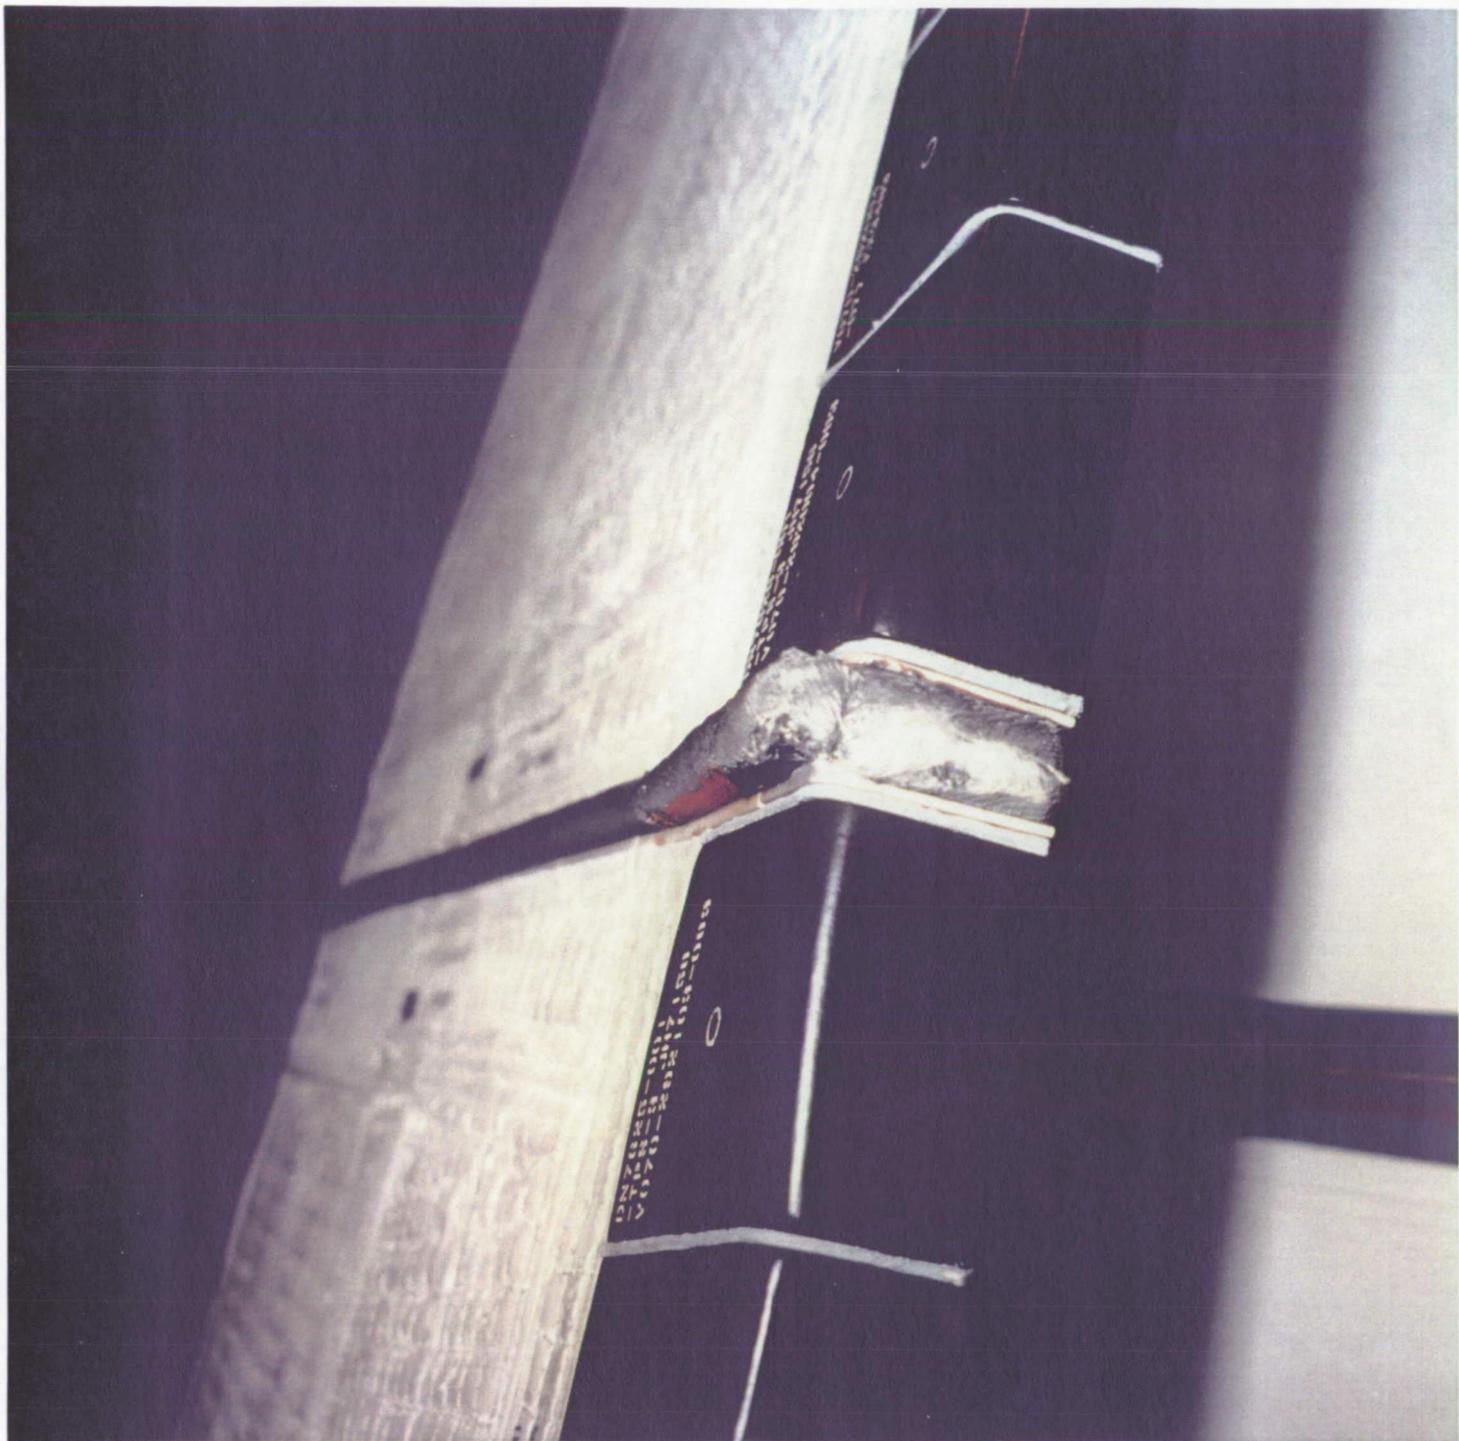
The LH rudder/speed brake split-line thermal barrier was protruding slightly and exhibited minor fraying, but did not appear significantly damaged or deformed.

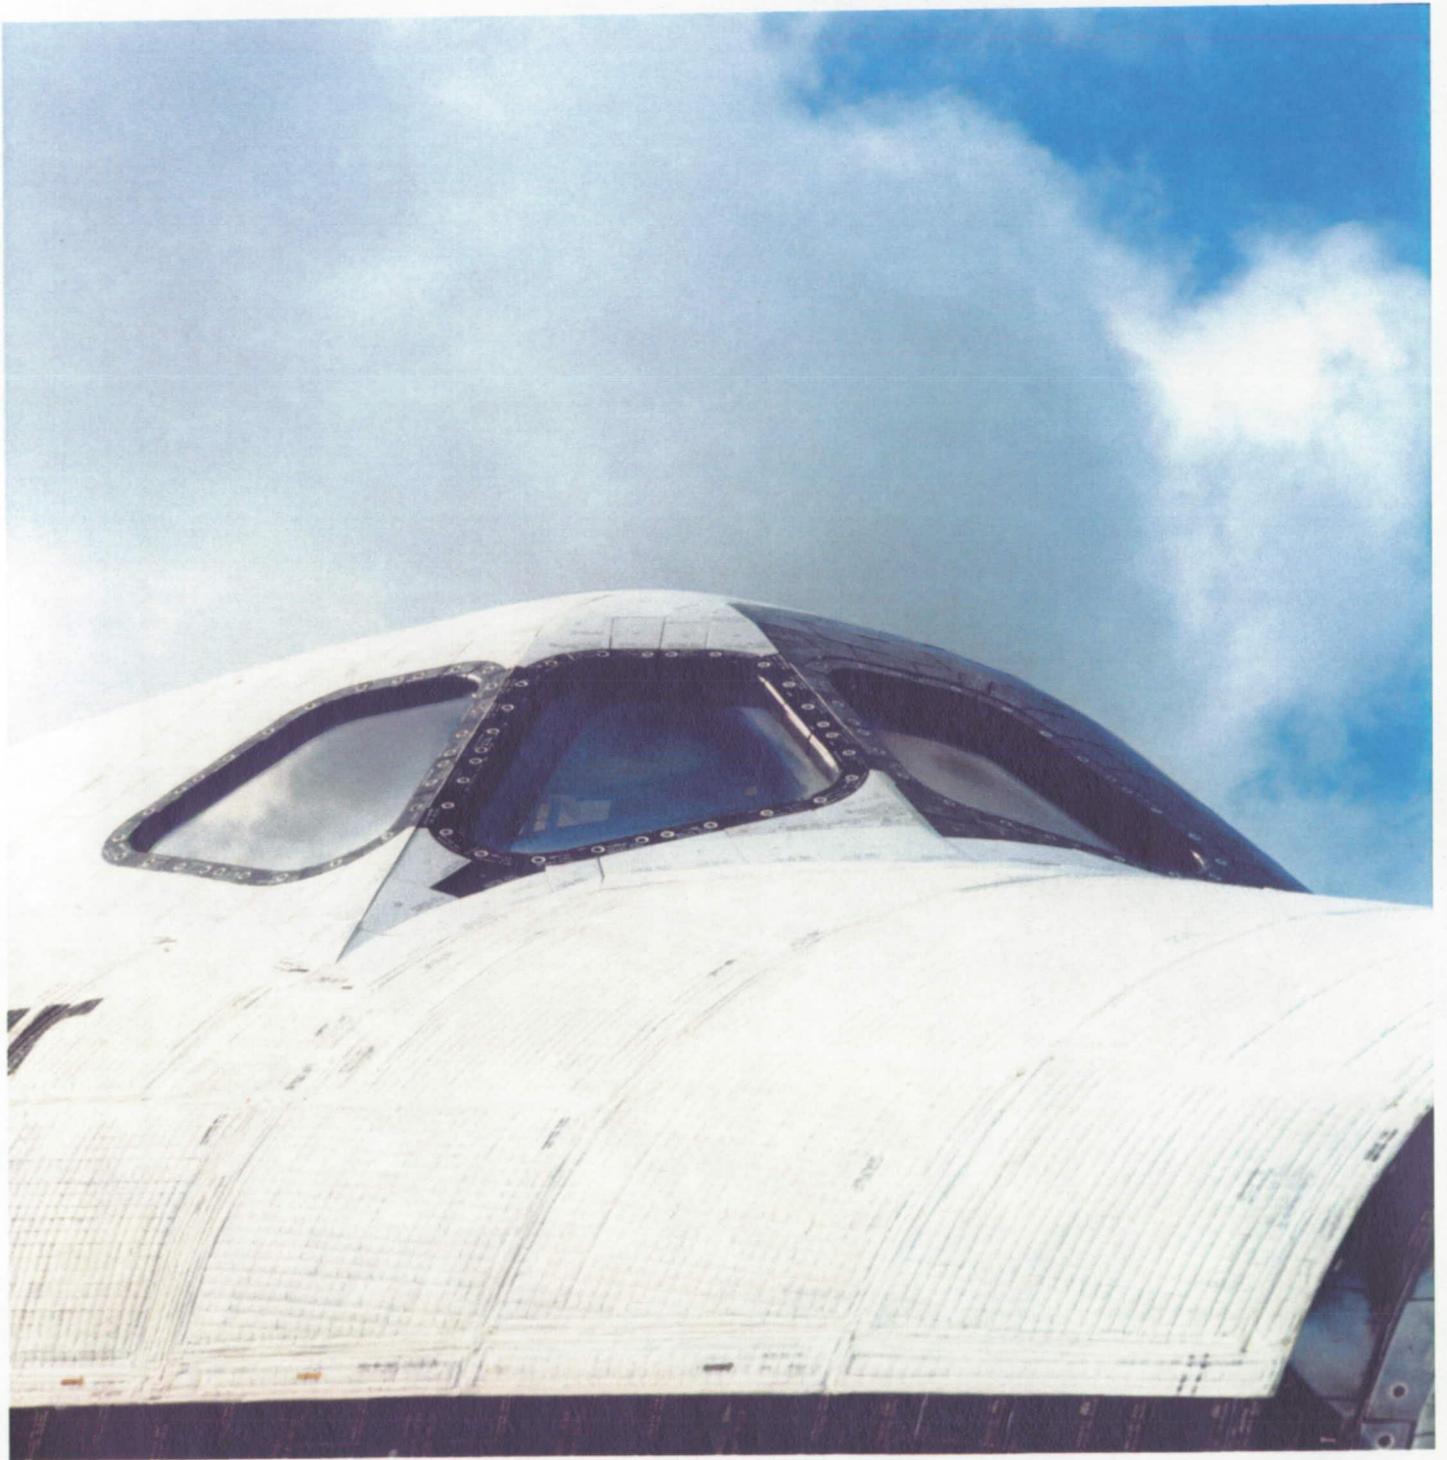
Orbiter windows #3 and #4 exhibited light hazing with a few streaks. Hazing on the other windows was less than usual.

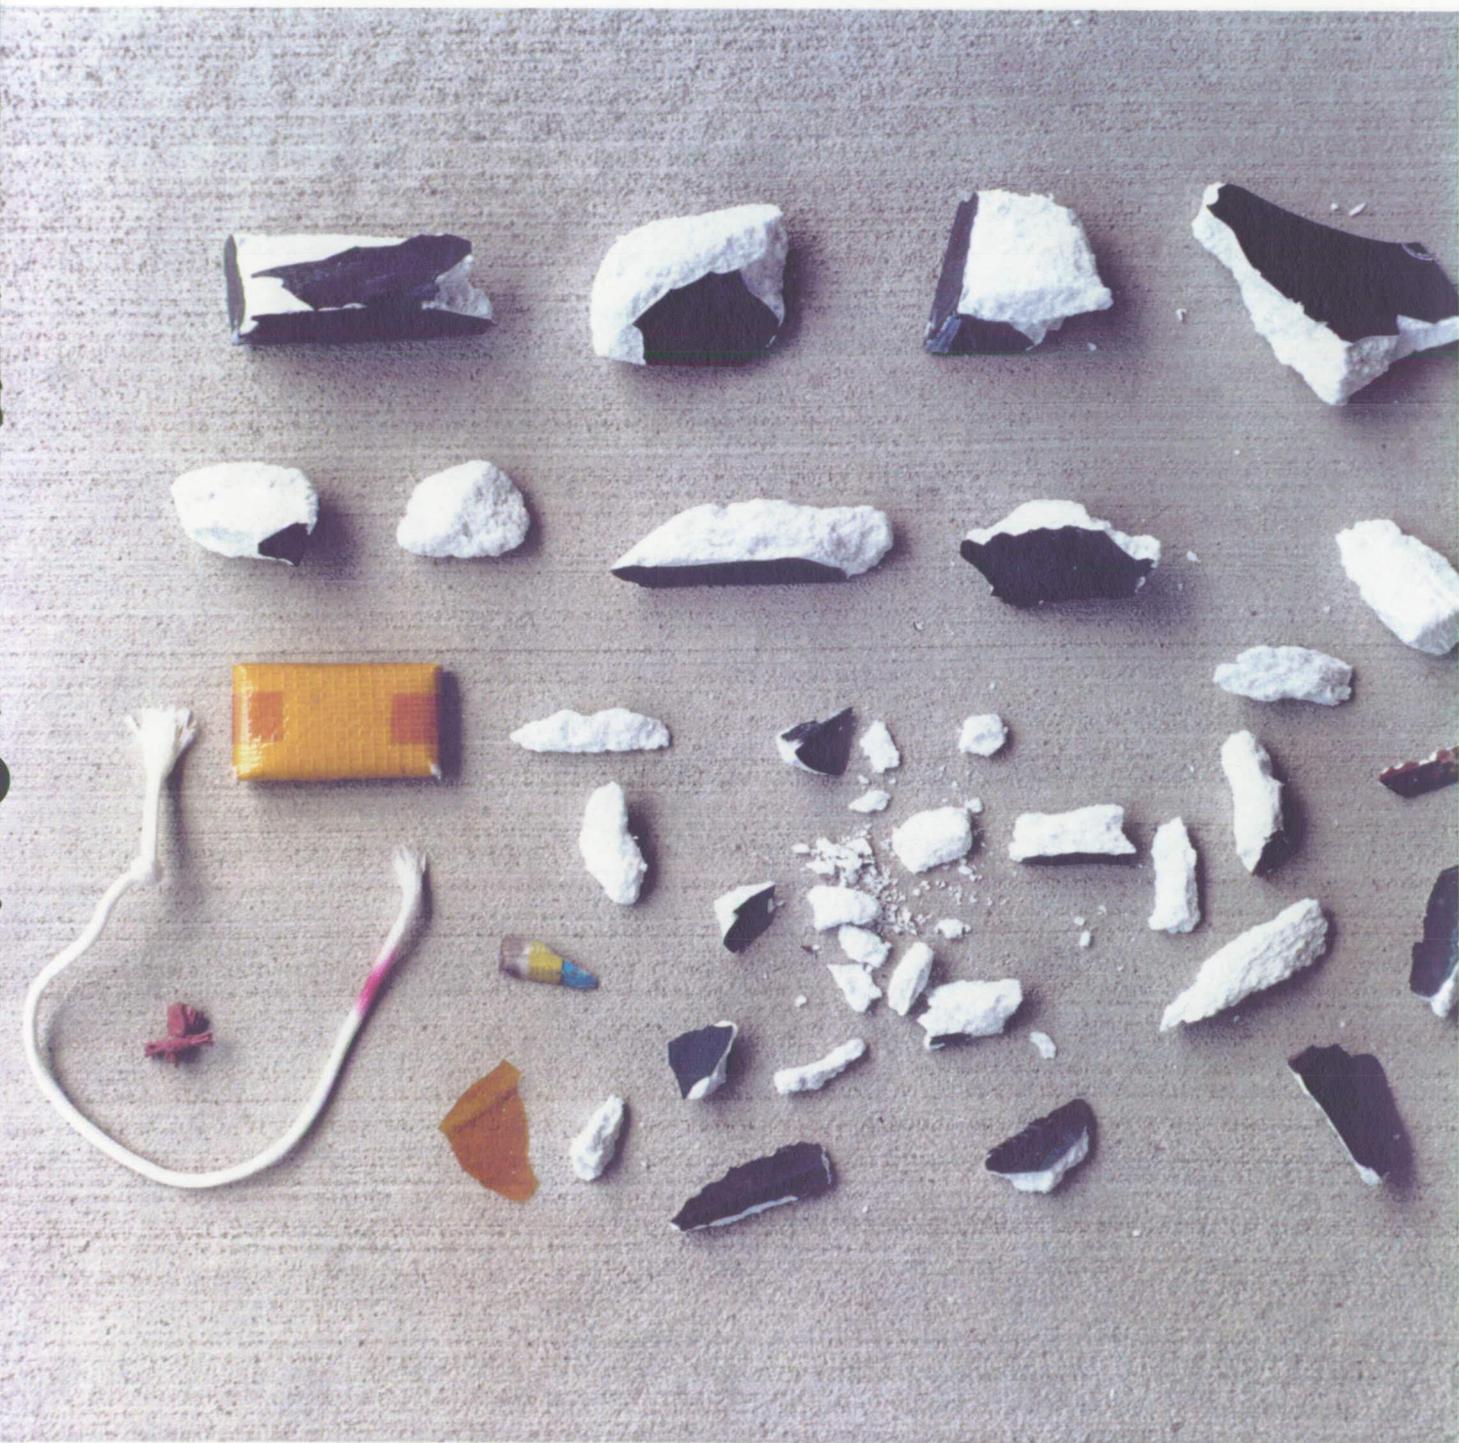
Inspection of Runway 33 immediately after landing revealed numerous pieces of tile material from the vertical stabilizer "stinger" and a piece of red RTV material from the RH outboard main landing gear tire pressure instrumentation cable.

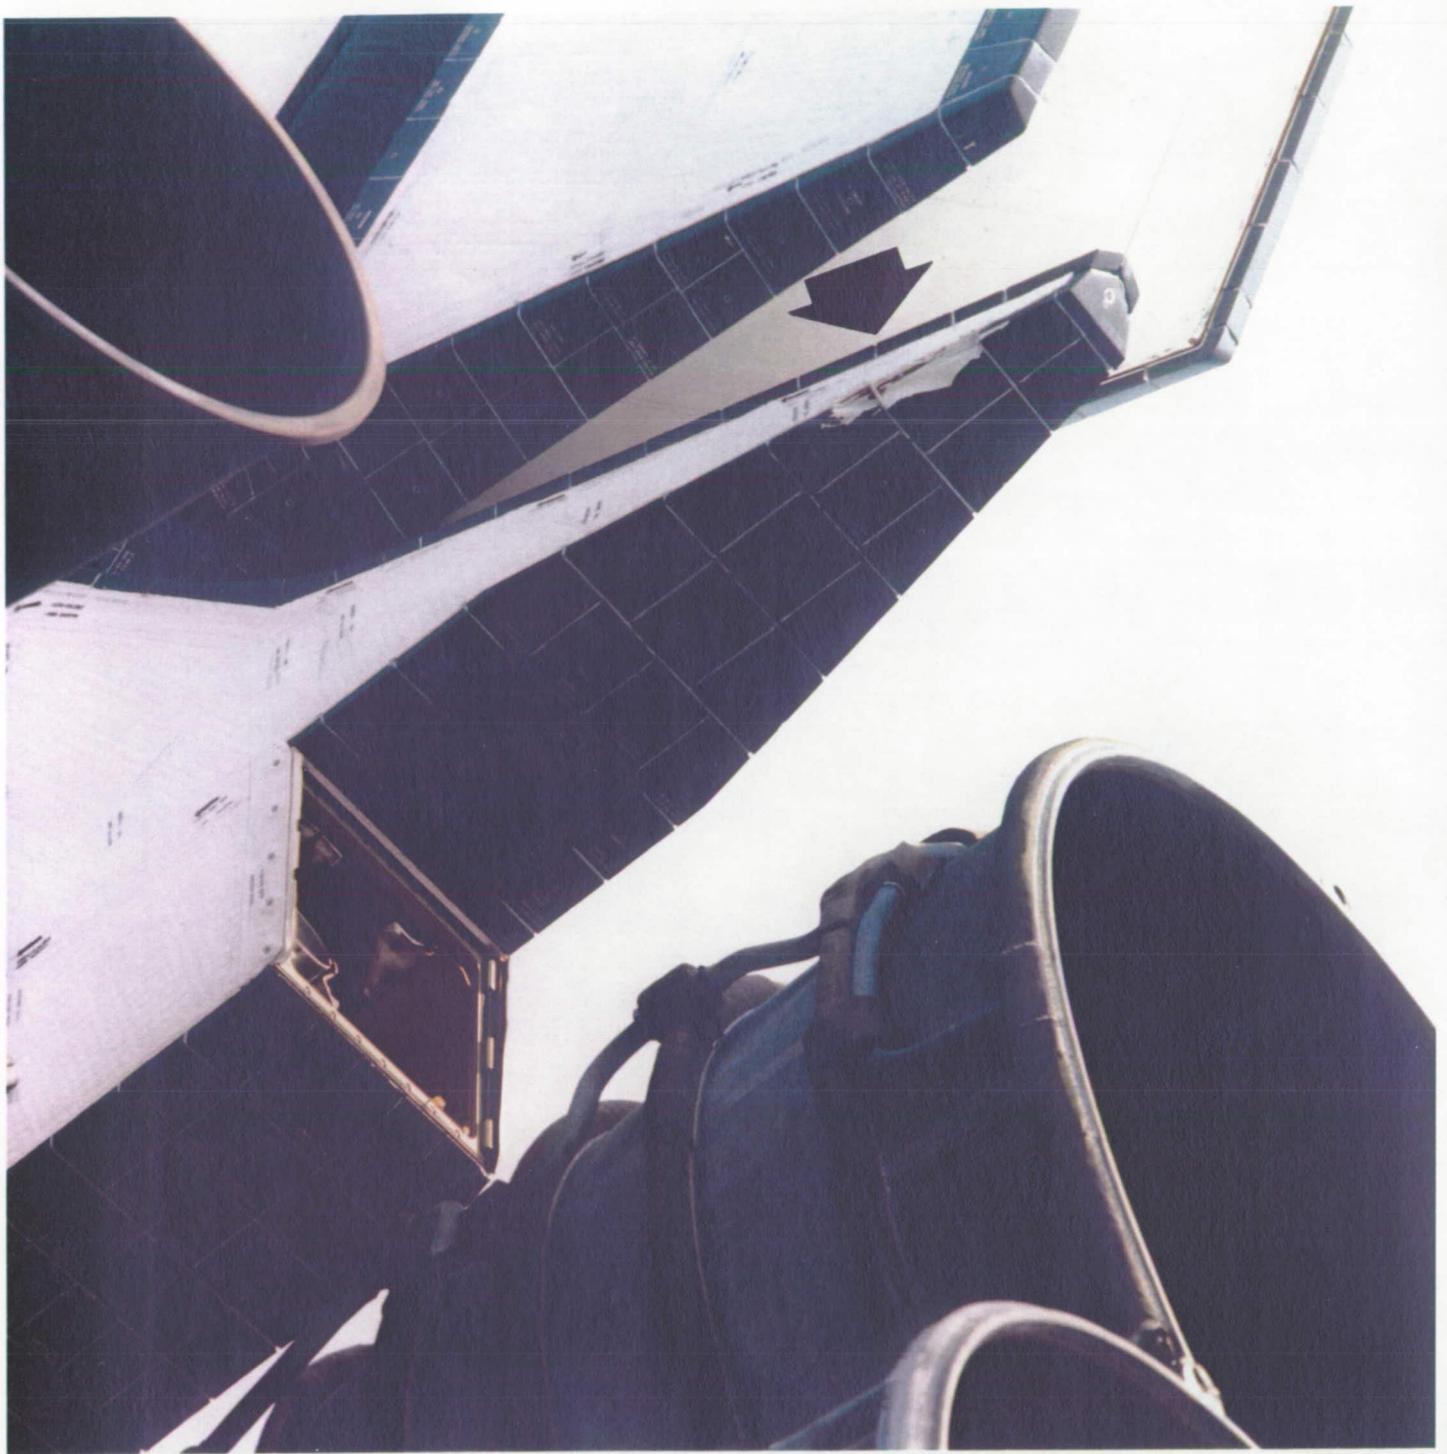
Three tiles on the left edge of the vertical stabilizer "stinger" sustained significant damage/material loss due to contact with the riser lines during chute deployment.

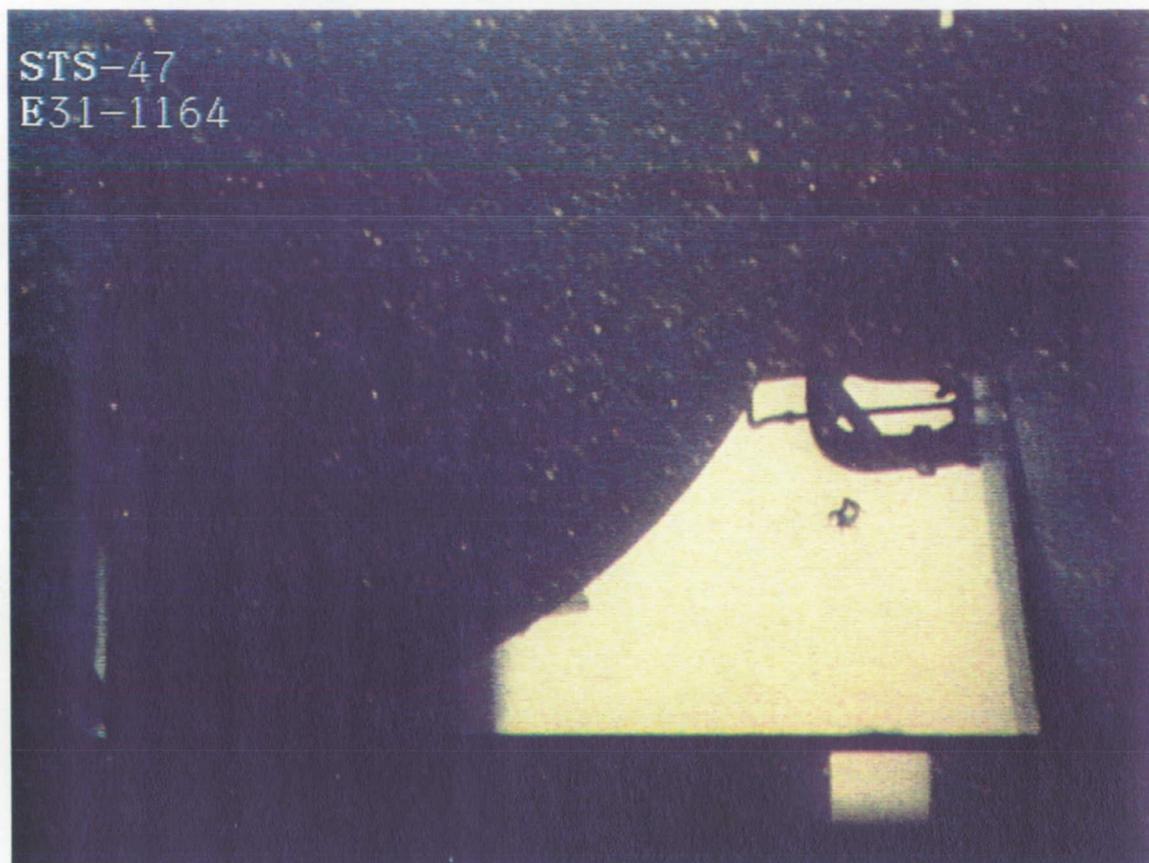
### 2.1.2.3 Large Dark Debris near Left SRB (Camera E-31)

**Figure 2.1.2.3 Large Dark Debris near Left SRB at .20 Seconds MET**

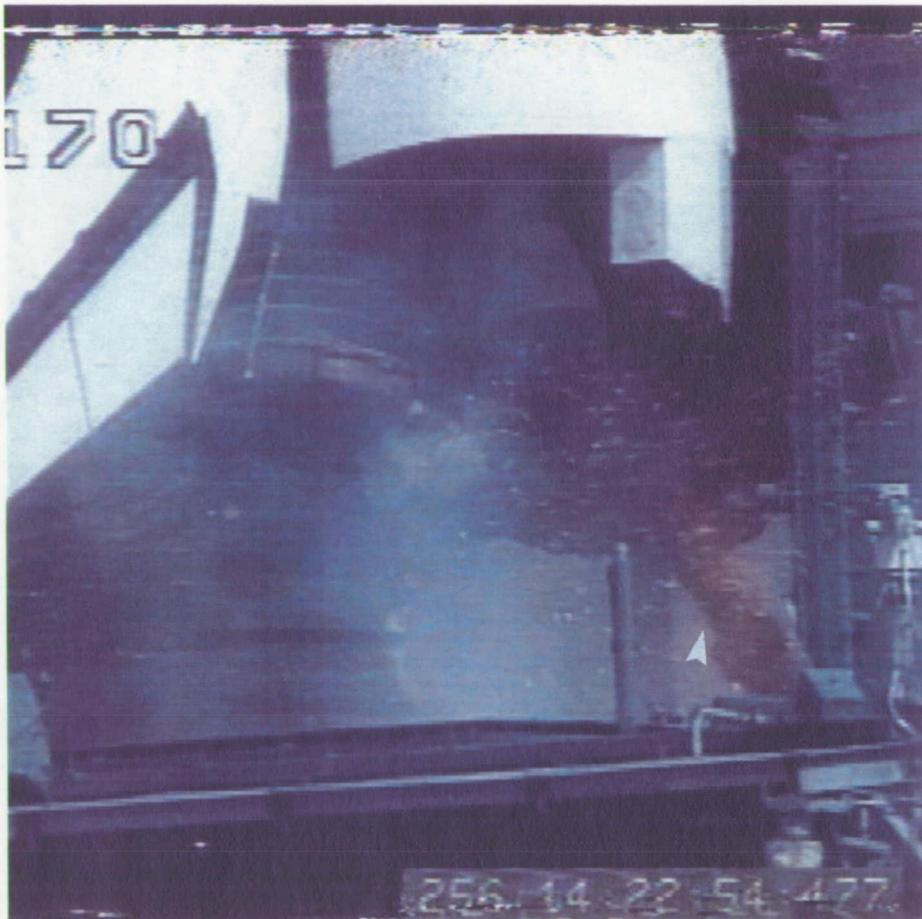
#### 2.2.1 Orange Vapor (Cameras E-19, E-76, OTV-170)

**Figure 2.2.1 Orange Vapor (Possibly Free-Burning Hydrogen) Noted under the SSME Bells just prior to SSME Ignition**

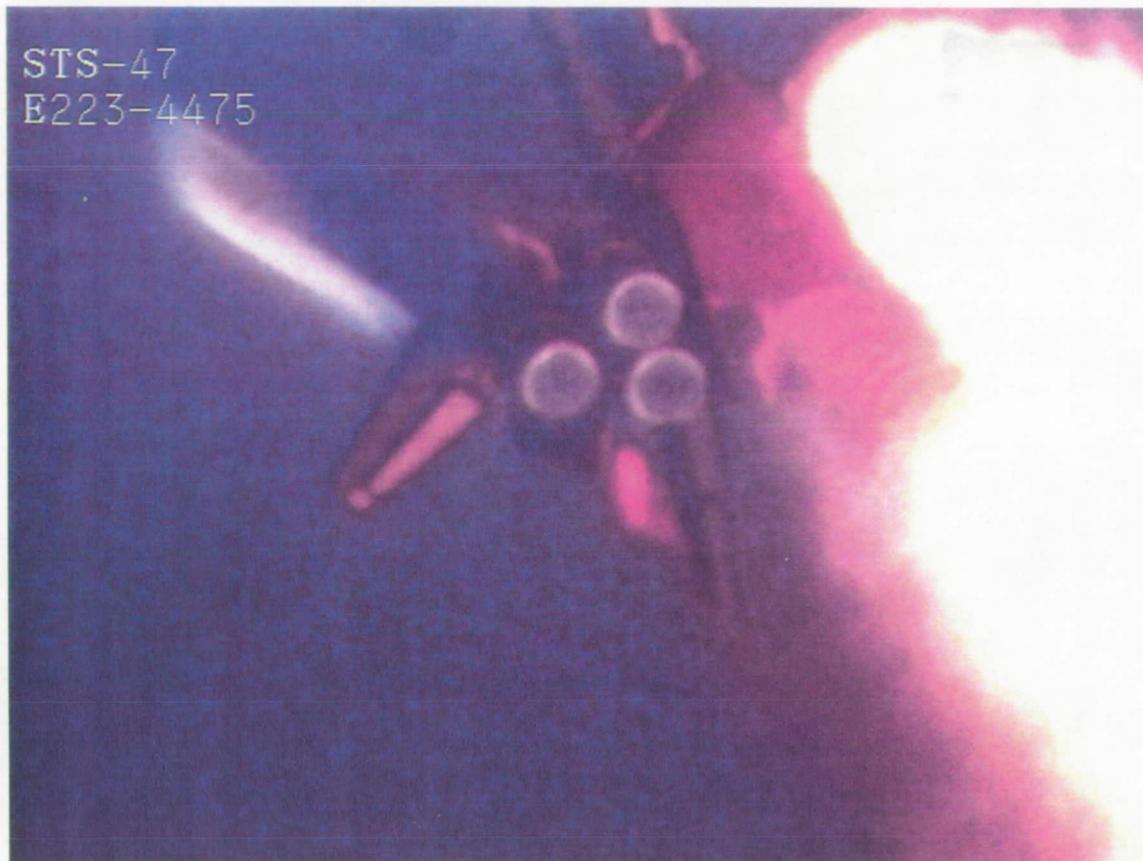
#### 2.3.1 Flares in SSME Exhaust Plume (Cameras E-54, E-207, E-222, E-223, KTV-4B)

**Figure 2.3.1 Flare in SSME Exhaust Plume at 48.7 Seconds MET**

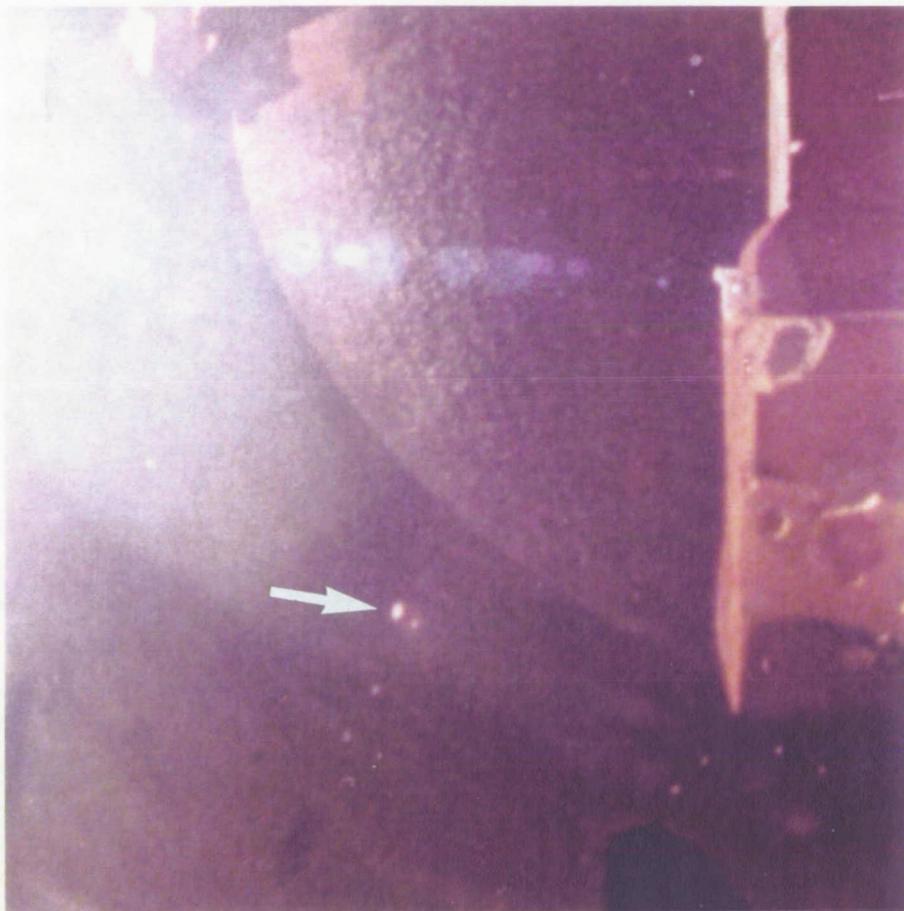
### 2.4.1.2 Metallic Appearing Object just prior to ET Separation (16mm Umbilical Well Camera with 5 mm lens)

**Figure 2.4.1.2 Metallic Appearing Object seen just prior to ET Separation**
