# Debris/Ice/TPS Assessment And Integrated Photographic Analysis For Shuttle Mission STS-47

November 1992

**Gregory N. Katnik**  
**NASA/Kennedy Space Center**

DEBRIS/ICE/TPS ASSESSMENT  
AND  
PHOTOGRAPHIC ANALYSIS  
OF  
SHUTTLE MISSION STS-47

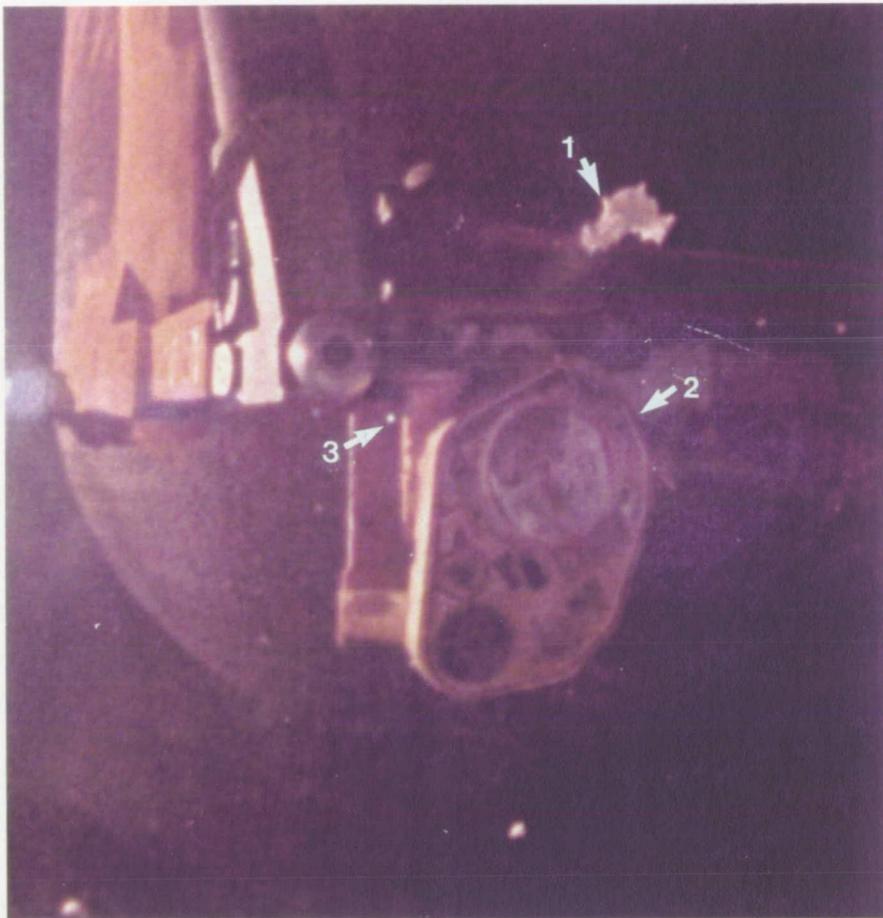
### 2.4.1.3 Debris/Ice/TPS Blistering Seen in the ET Separation Sequence (16mm Umbilical Well Camera with 5 mm lens)

**Figure 2.4.1.3 Debris/Ice/TPS Blistering Seen in the ET Separation Sequence**

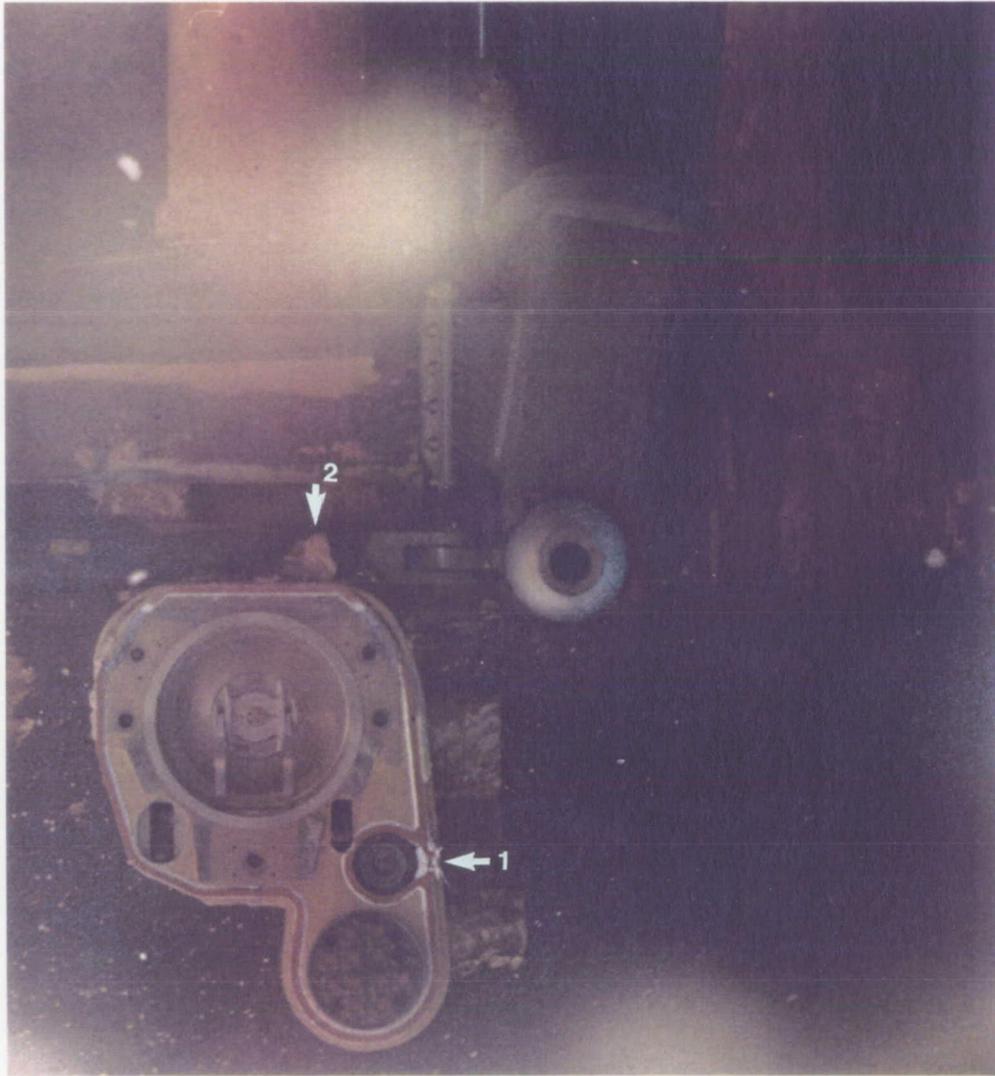
### 2.4.1.6 Marking near LO2 Umbilical Pressurization Line (Orifice) (35mm Umbilical Well Camera )

**Figure 2.4.1.6** Marking near LO2 Umbilical Pressurization Line (Orifice)  
(35mm Umbilical Well Camera with mm lens)

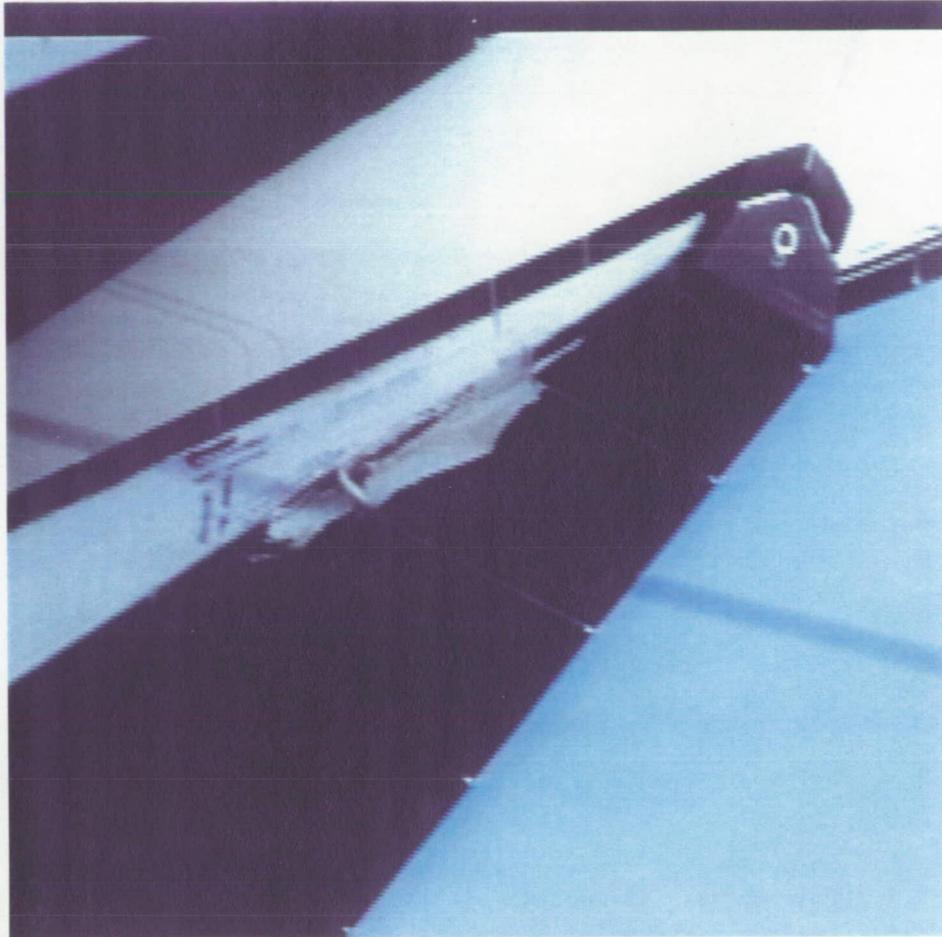
### 2.5.2 Damage to Base of Vertical Stabilizer

**Figure 2.5.2** Damage to Base of Vertical Stabilizer seen at Post Landing Inspection
