Debris/Ice/TPS Assessment And Integrated Photographic Analysis For Shuttle Mission STS-52

December 1992

DEBRIS/ICE/TPS ASSESSMENT
AND
PHOTOGRAPHIC ANALYSIS
OF
SHUTTLE MISSION STS-52

October 22, 1992

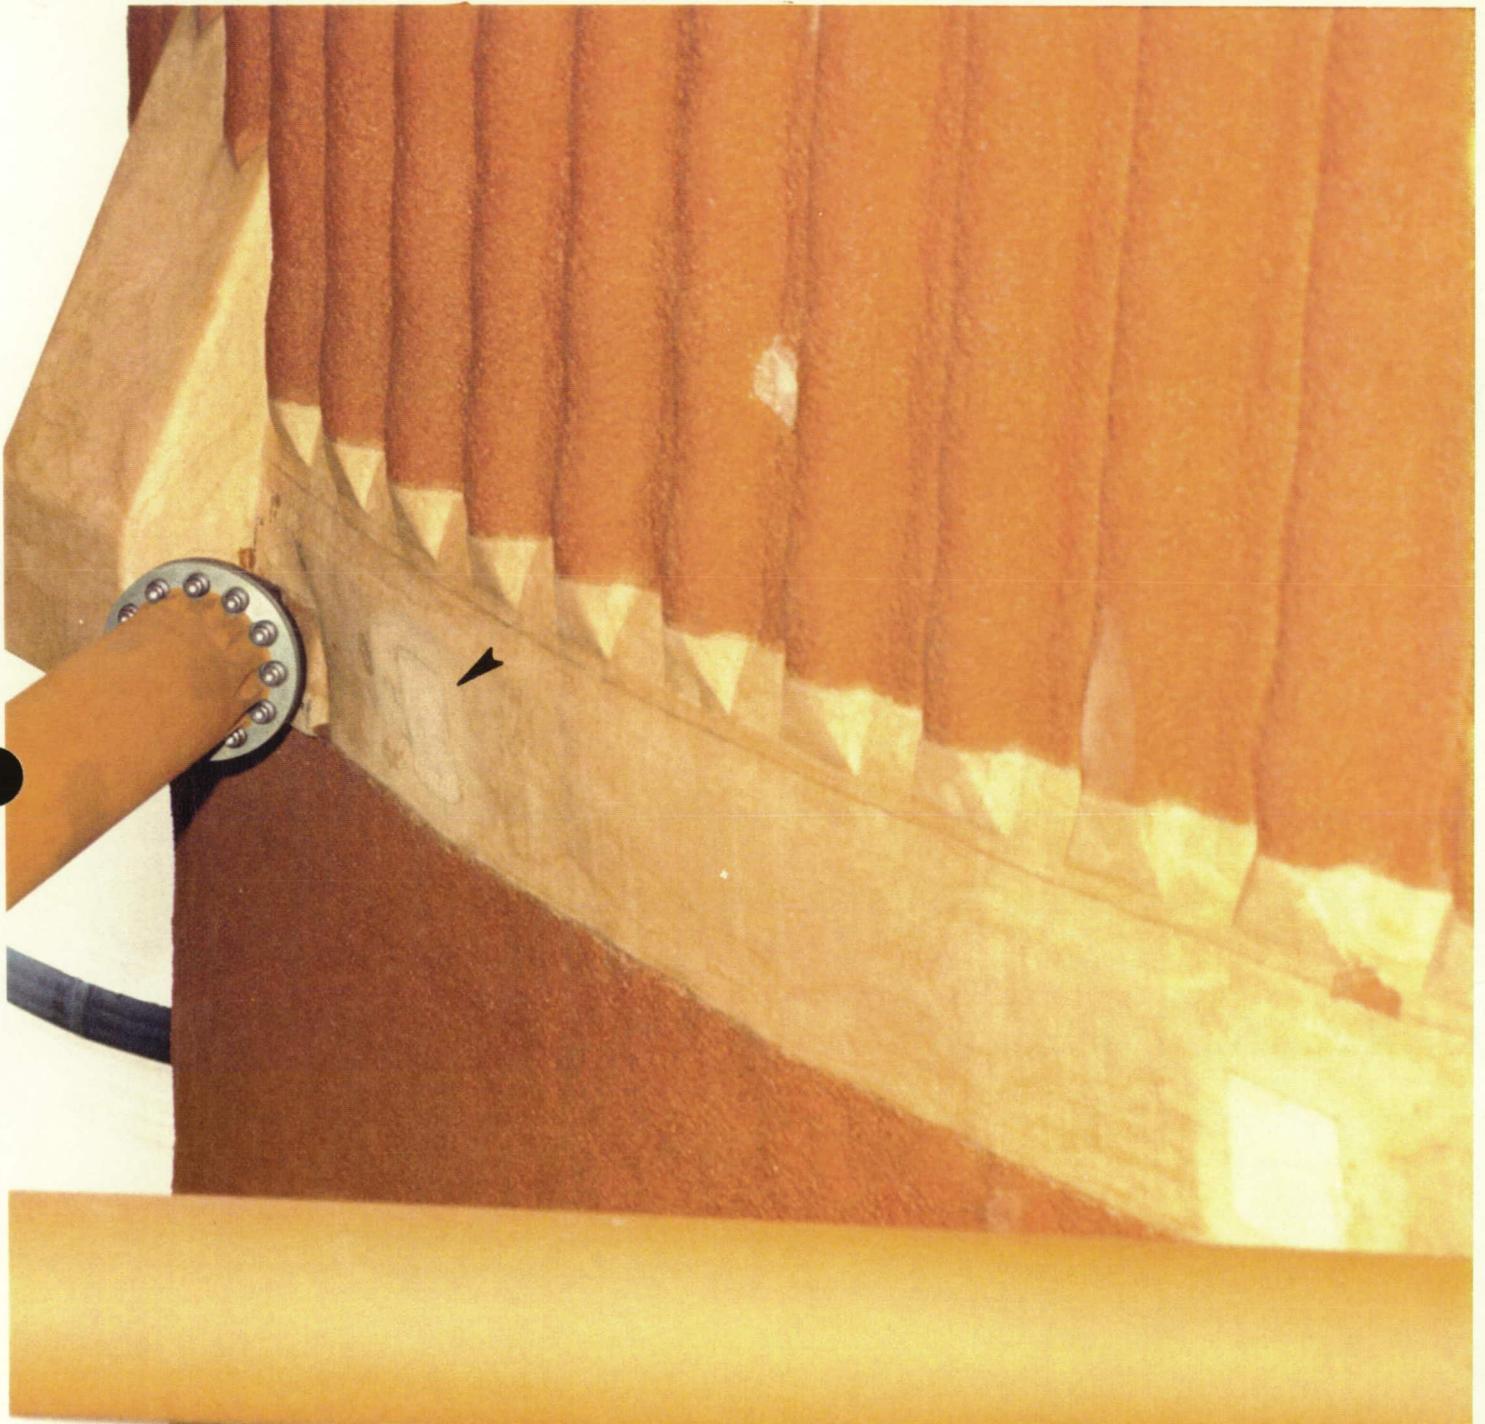
Pre-flight configuration of the bipod jack pad closeouts, the intertank TPS acreage, and the LH2 tank flange closeout. Post ET separation photography would reveal the loss of TPS from the intertank acreage and the LH bipod jack pad closeout.

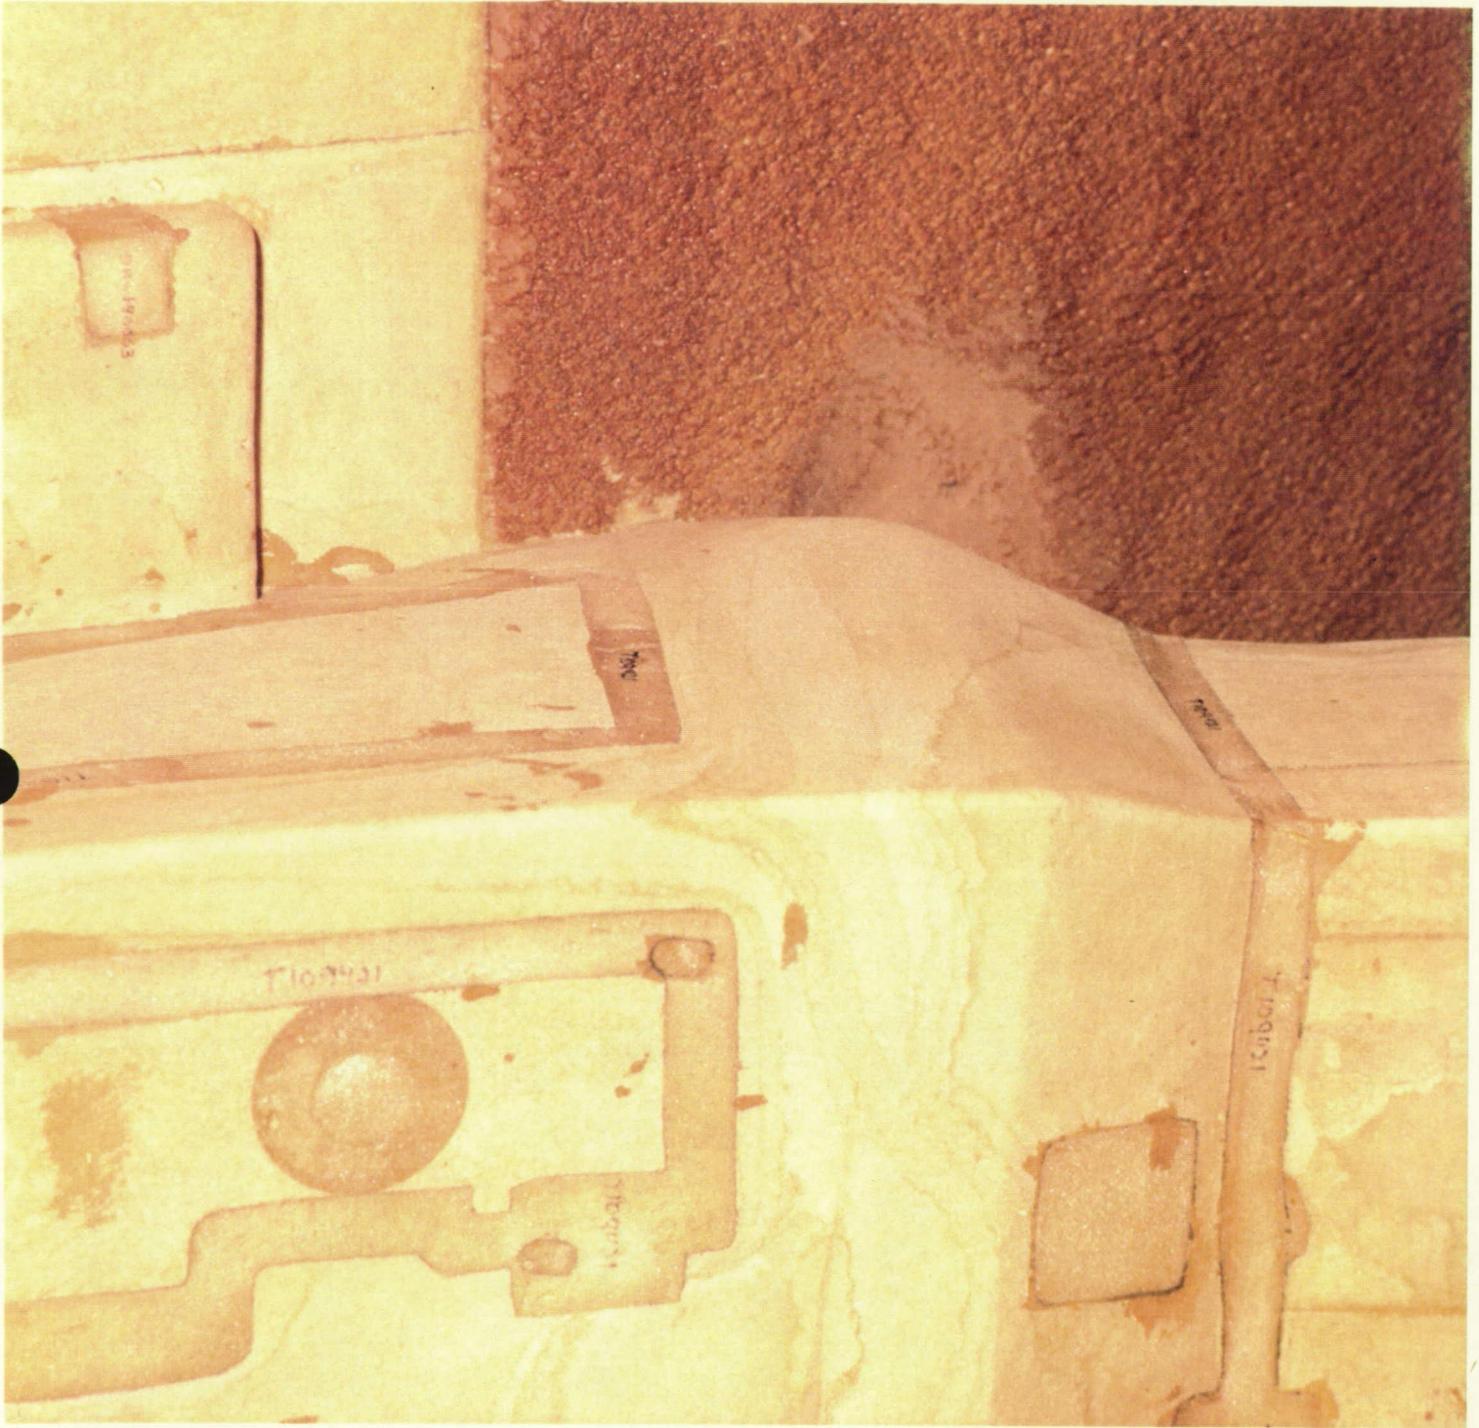
LH (-Y) vertical strut/cable tray TPS covering prior to cryogenic fuel loading. Cracks have appeared in this general area after cryoload due to the elimination of a stress relief gap as part of a manufacturing process enhancement change.

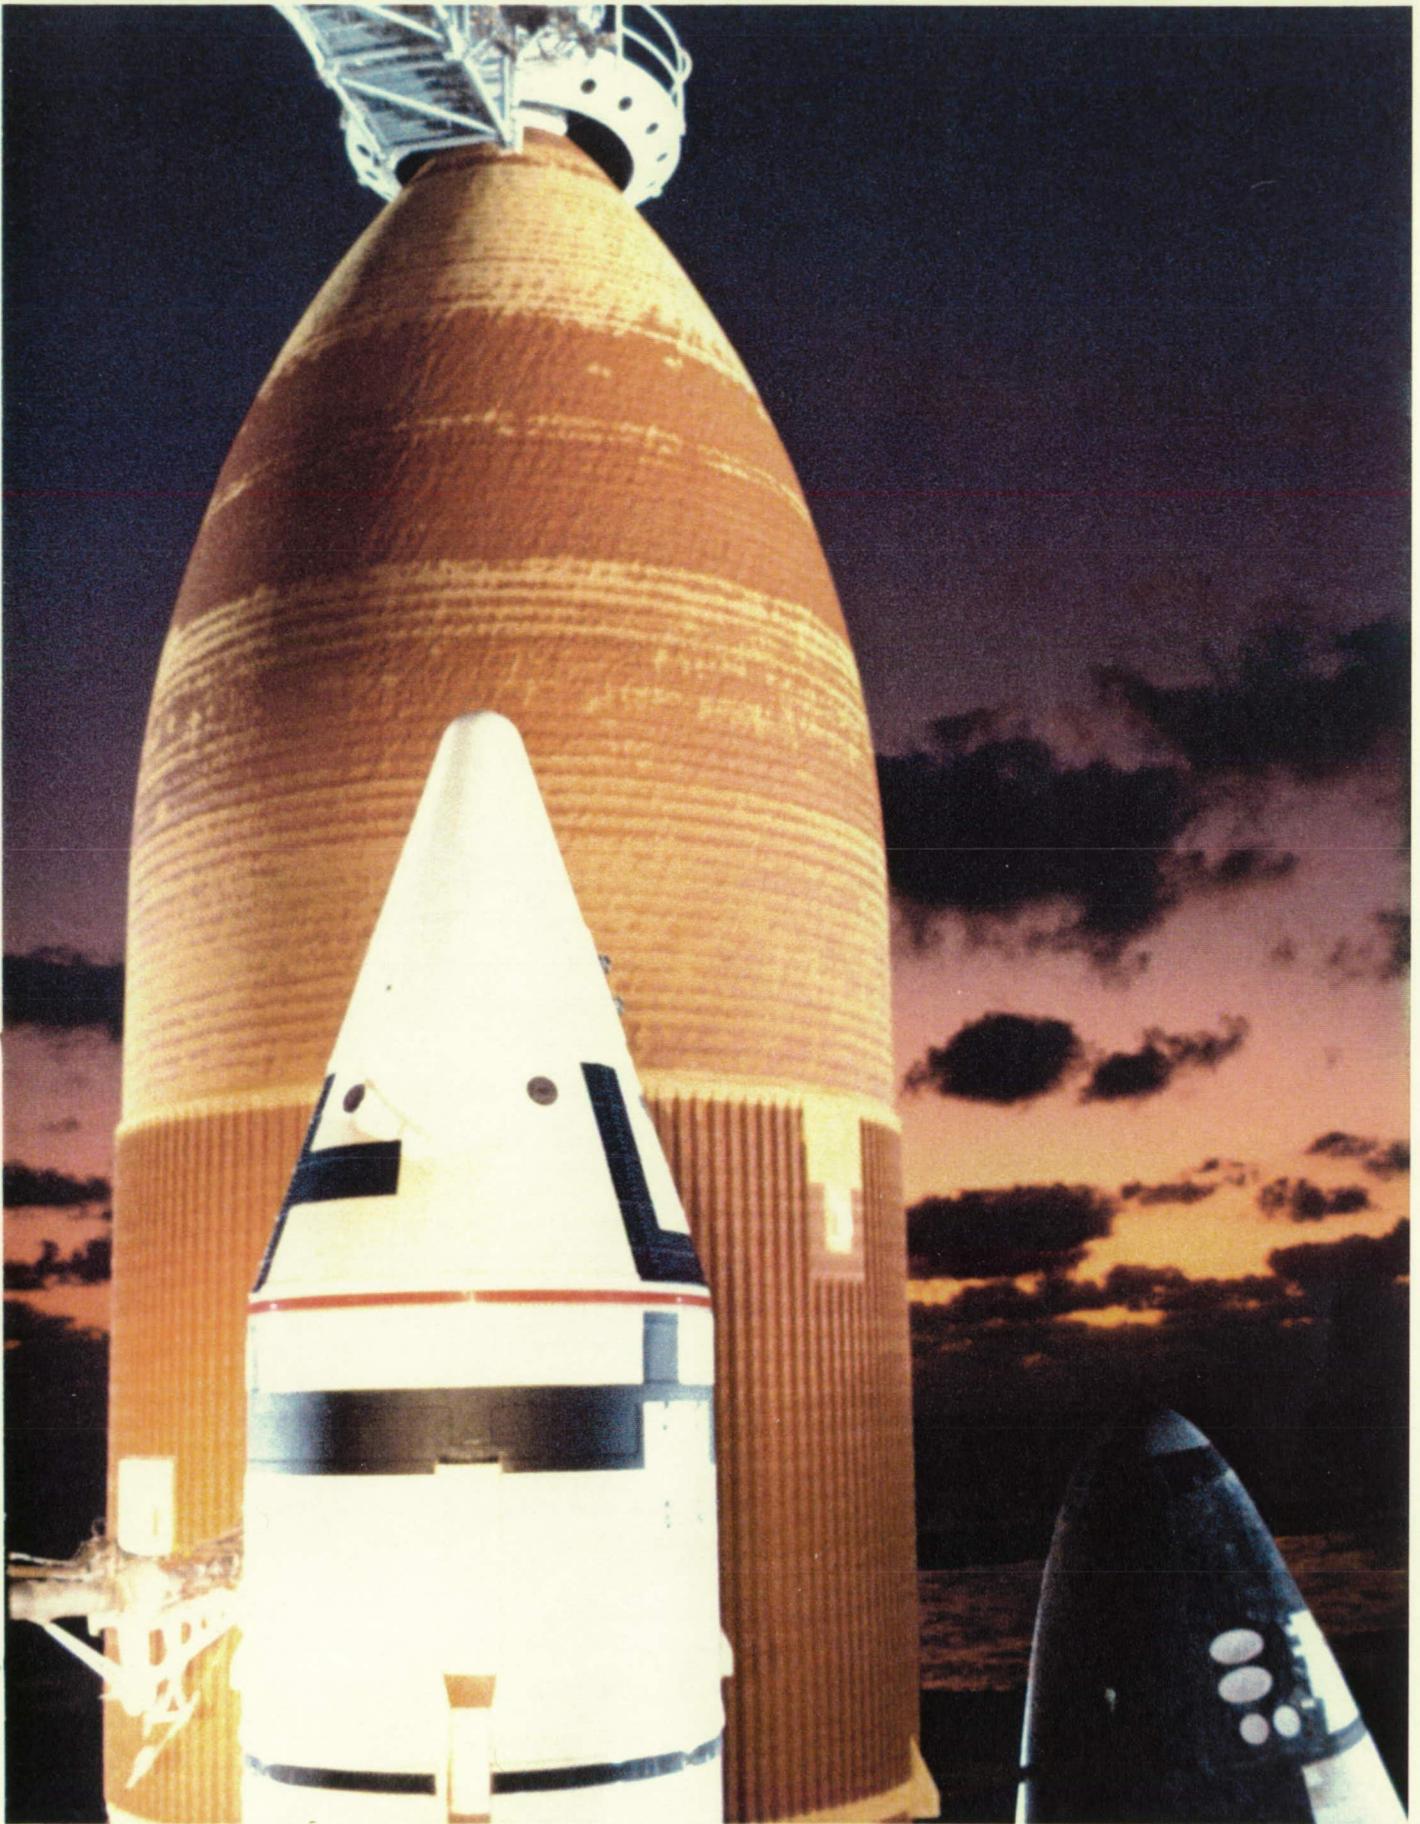
No condensate, ice, or frost accumulation was present on the
ET LO2 tank and intertank TPS acreage

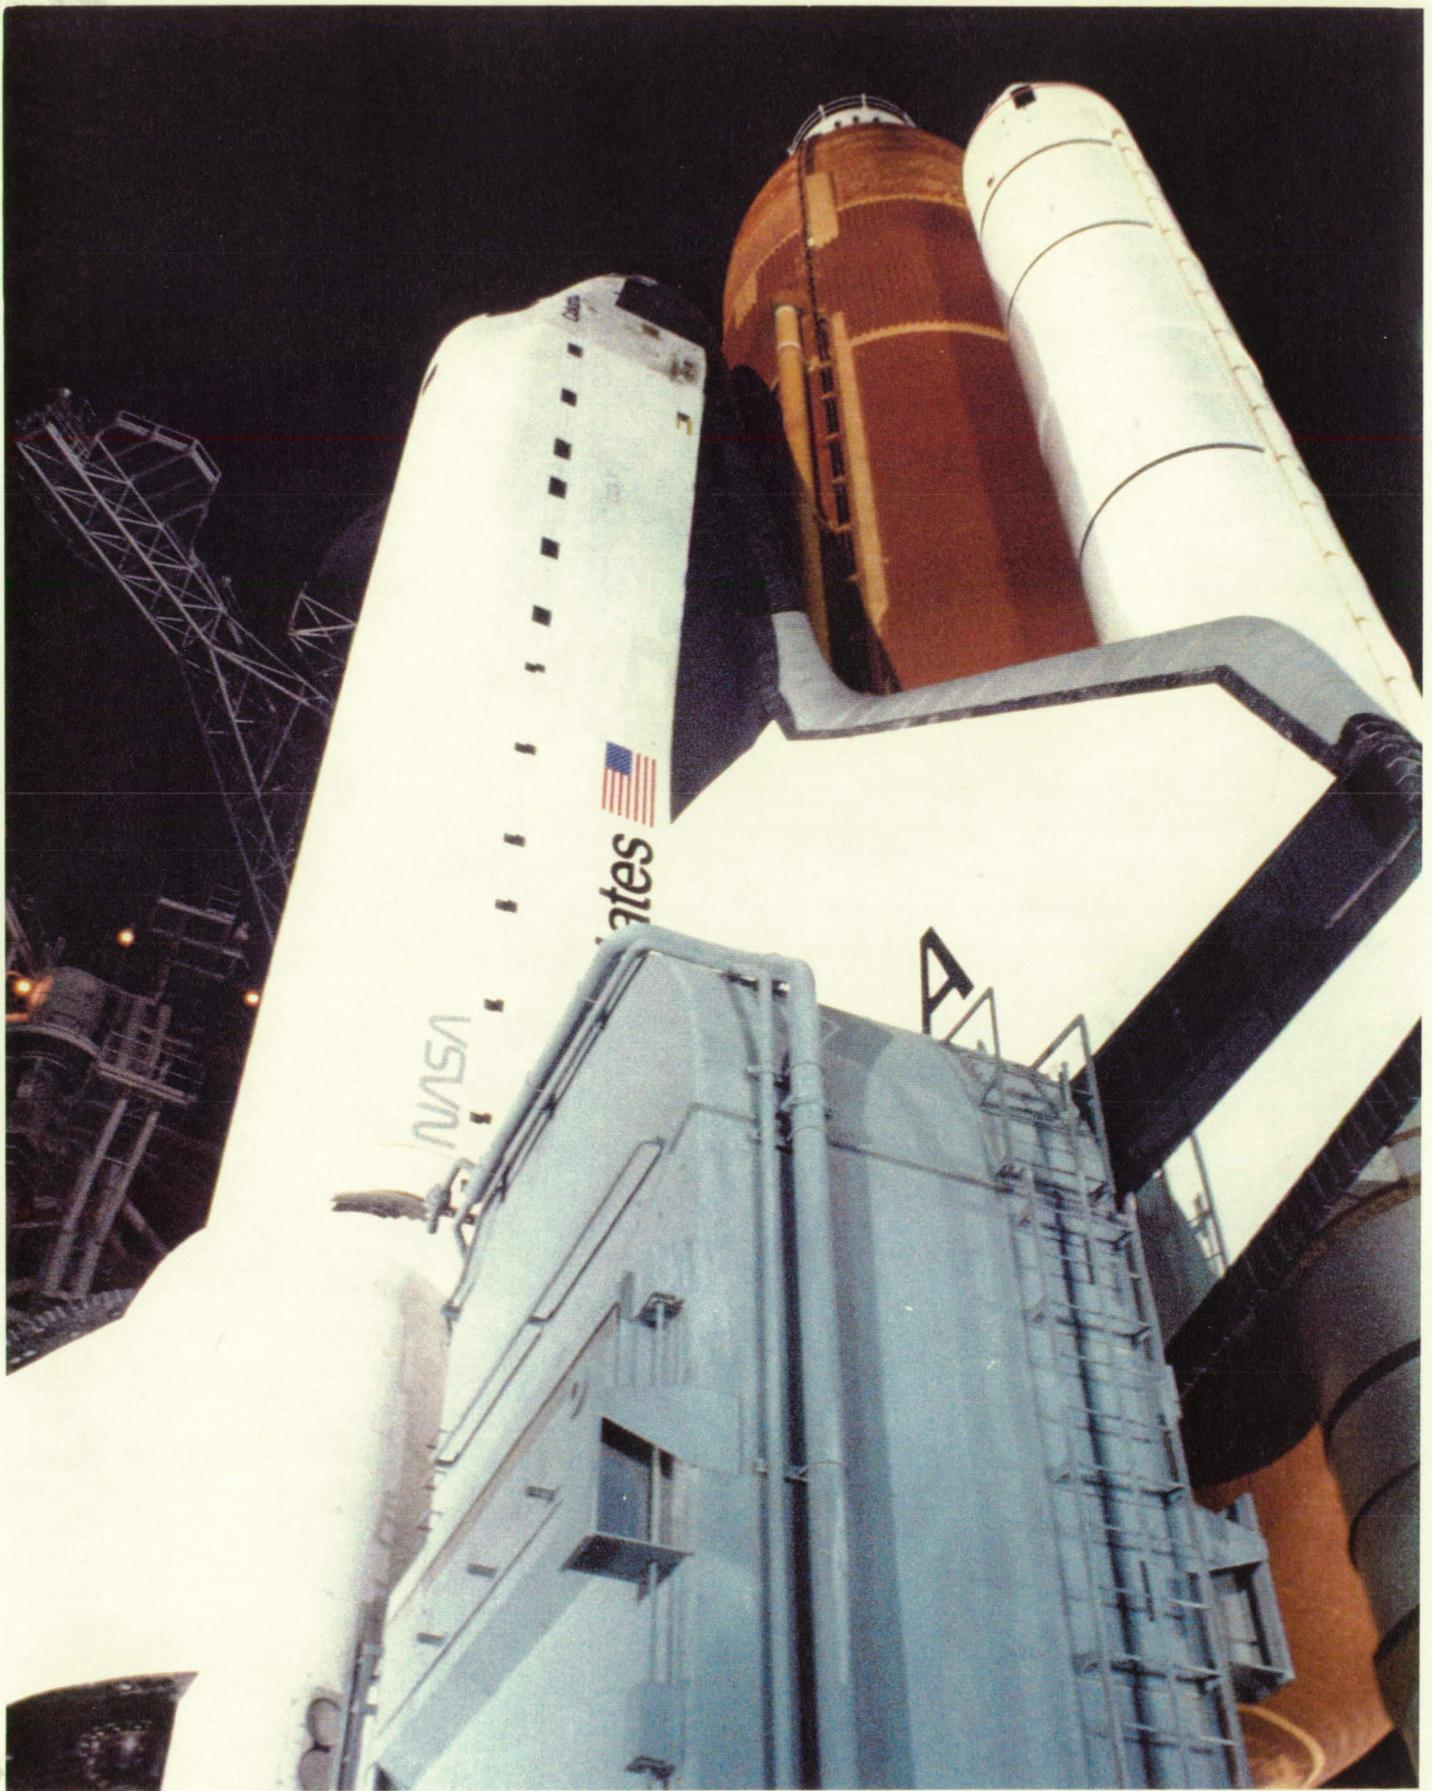
Light condensate, but no ice or frost accumulation, was present on the LH2 tank acreage and aft dome

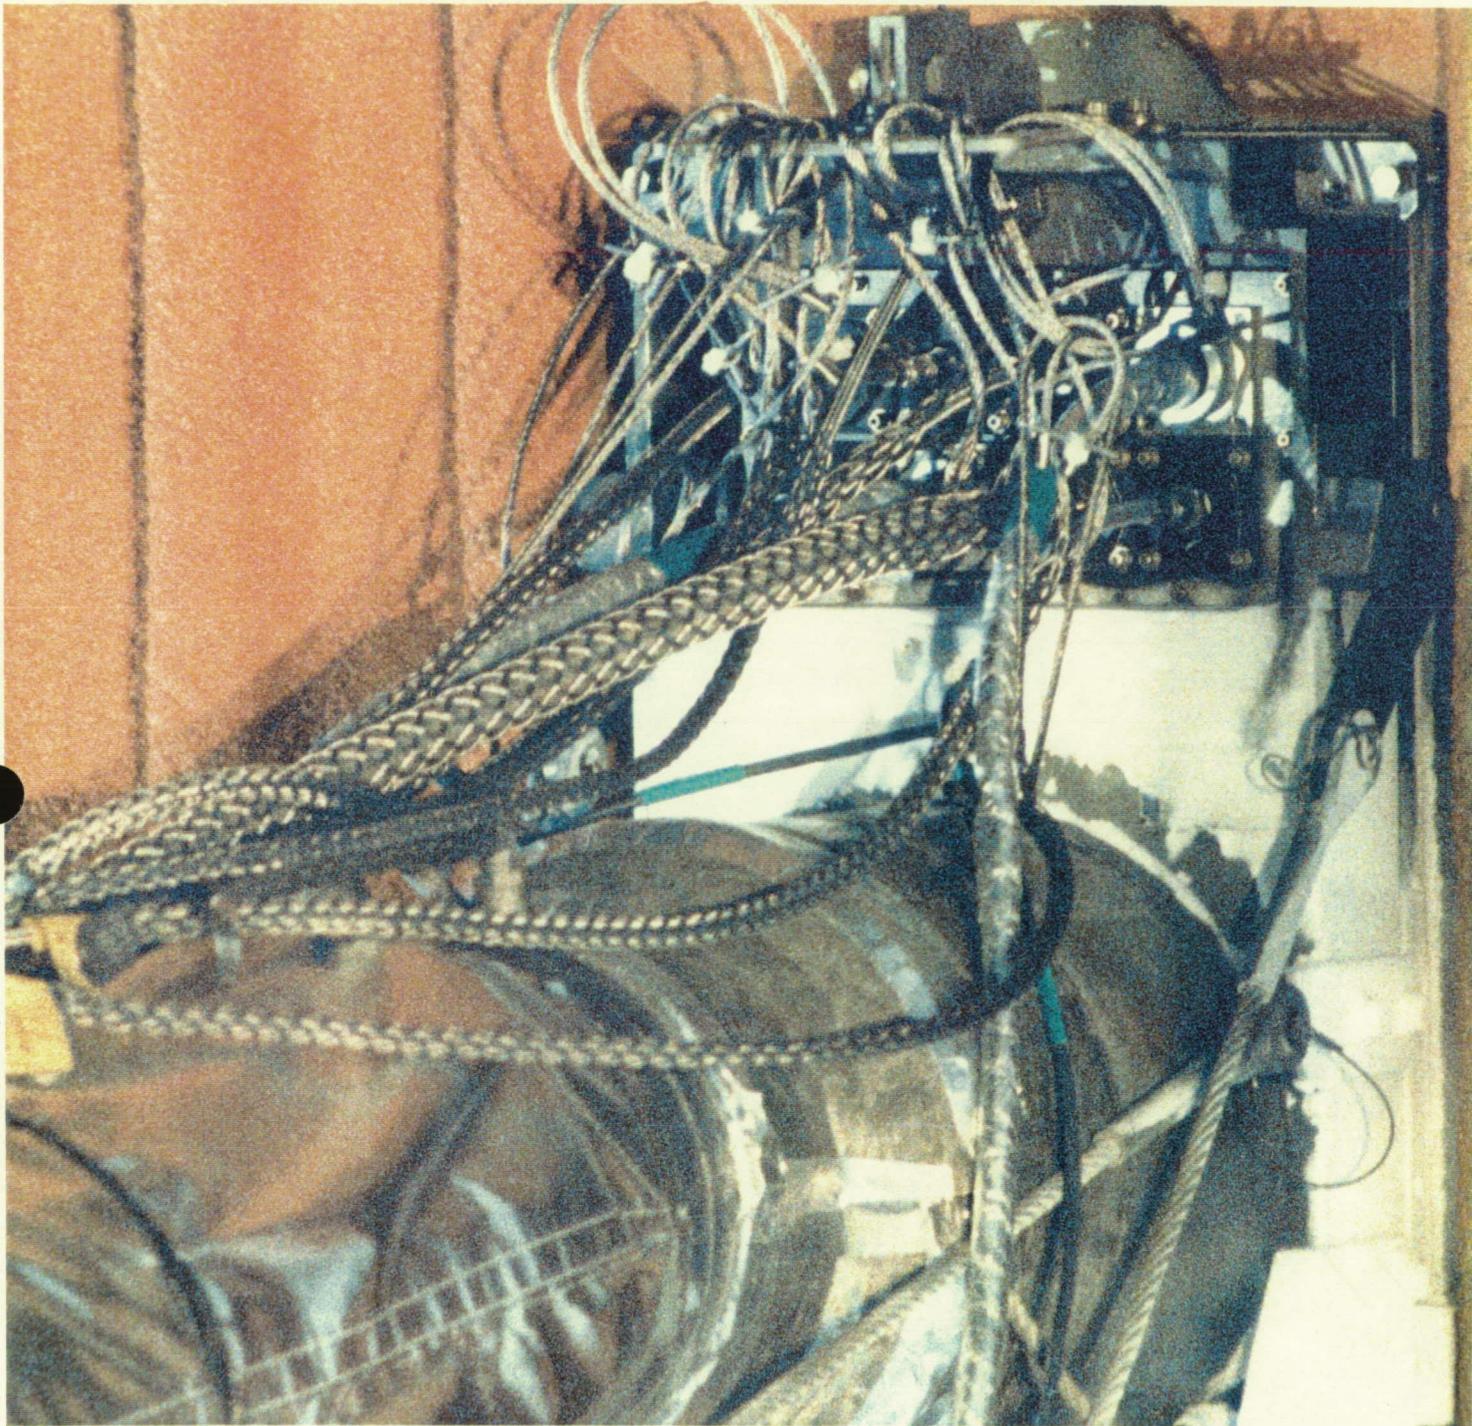
Leak detectors #23 and #25 located within the GUCP cavity indicated the presence of a hydrogen leak external to the vent line from cryogenic loading slow fill through stable replenish. Readings peaked during vent valve open cycles. The leak reached a maximum value of 44,000 ppm thirty minutes into topping then remained at 20-30,000 ppm during replenish. The suspected area of leakage was at the tank side teflon seal, which mates with the 7-inch GH2 vent quick disconnect probe. More than usual amounts of ice and frost covered the uninsulated areas of the GUCP around the 7-inch line. Post launch inspection and retest of the GSE hardware did not reveal any anomalies.

A hydrogen leak external to the vent line occurred from cryogenic loading slow fill through stable replenish. More than usual amounts of ice and frost covered the uninsulated areas of the GUCP around the 7-inch line. Post launch inspection and retest of the GSE hardware did not reveal any anomalies.

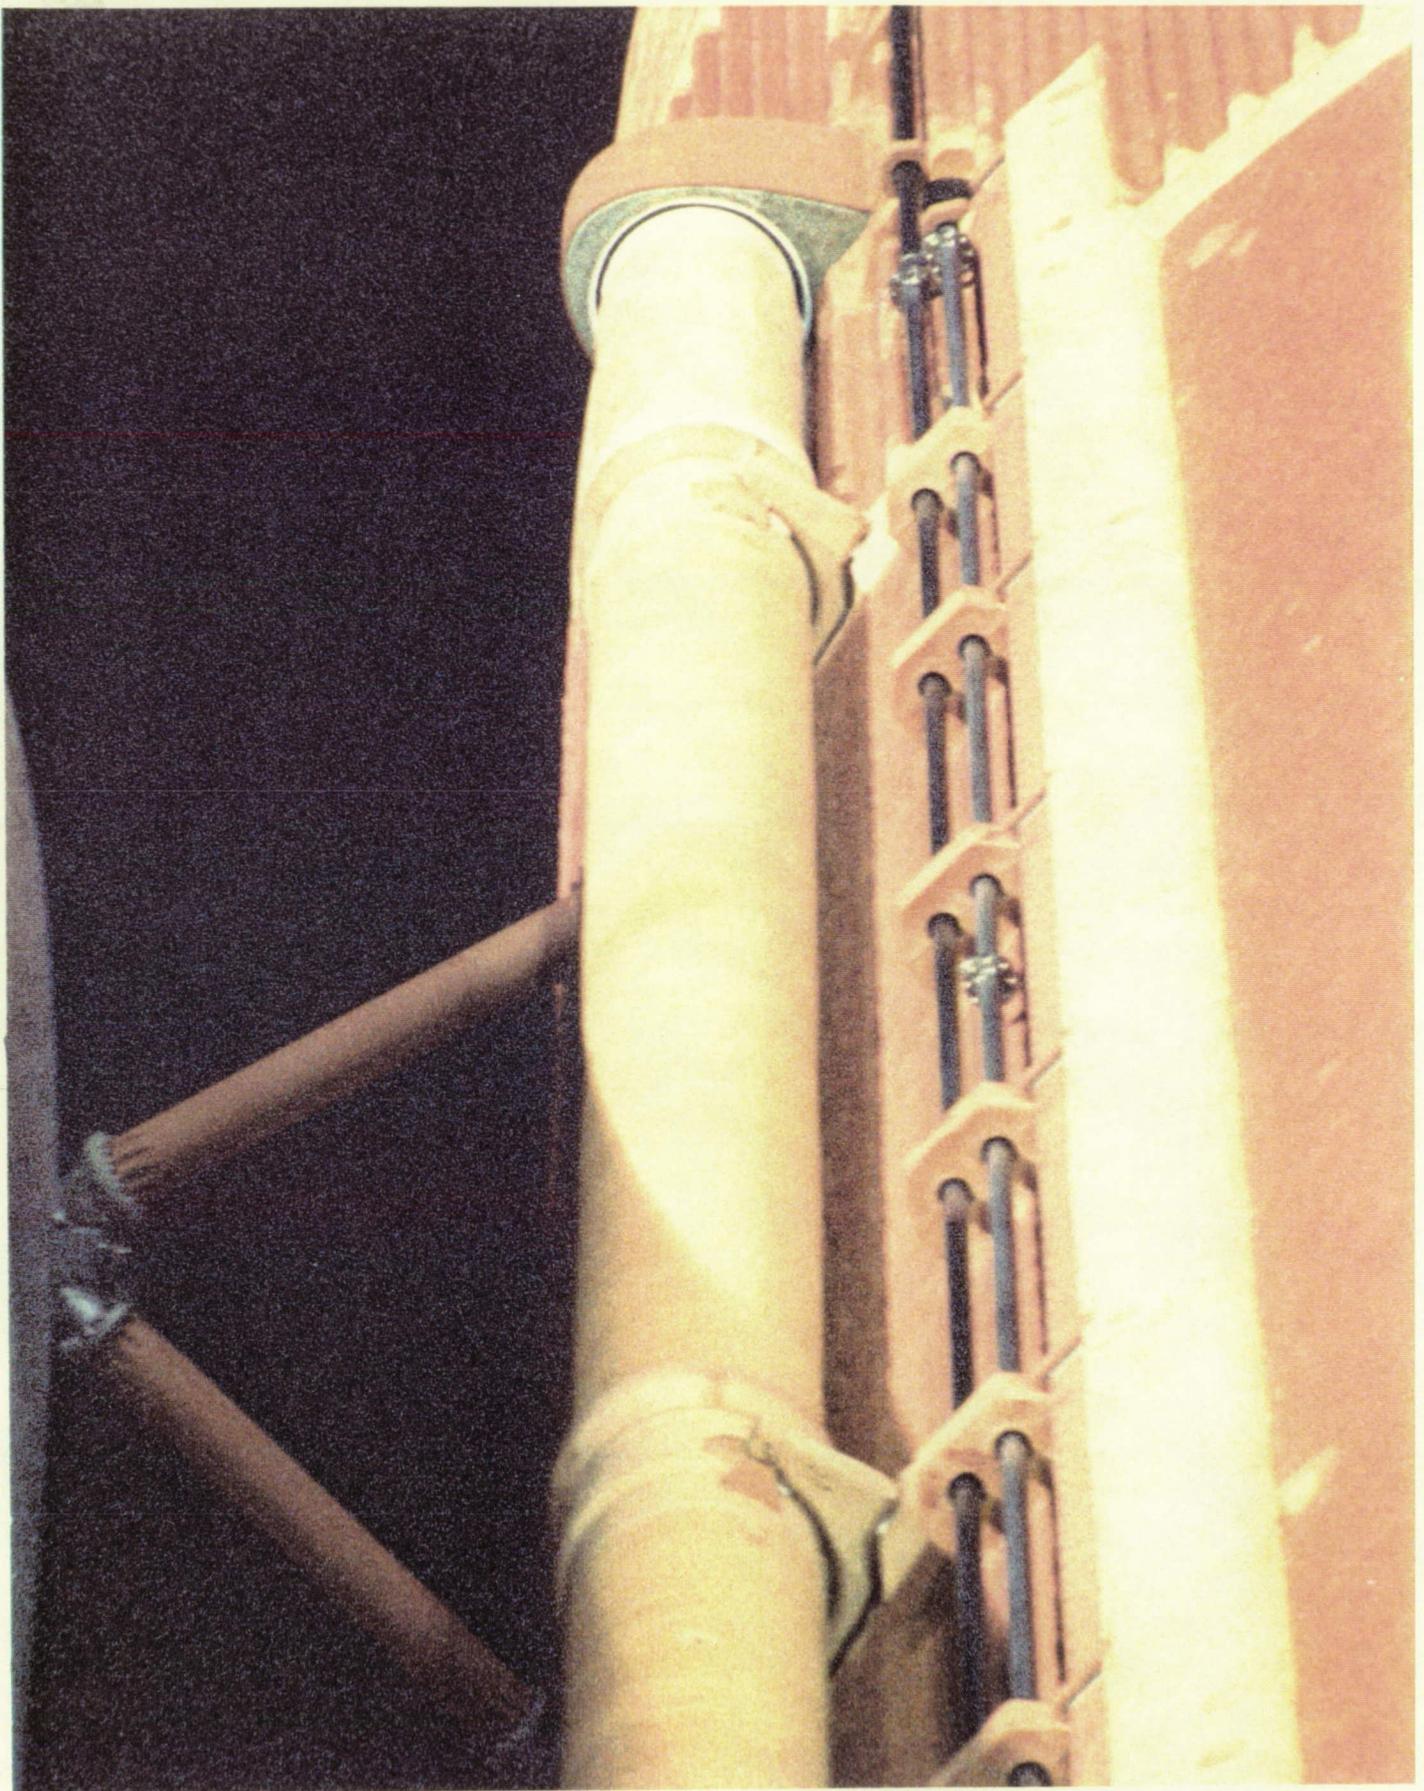
Anomaly 006 (documentation only) recorded ice/frost formations in the LO2 feedline bellows and support brackets. The ice/frost formations were acceptable per NSTS-08303.

Typical amounts of ice/frost had formed in the L2 feedline support bracket and upper bellows

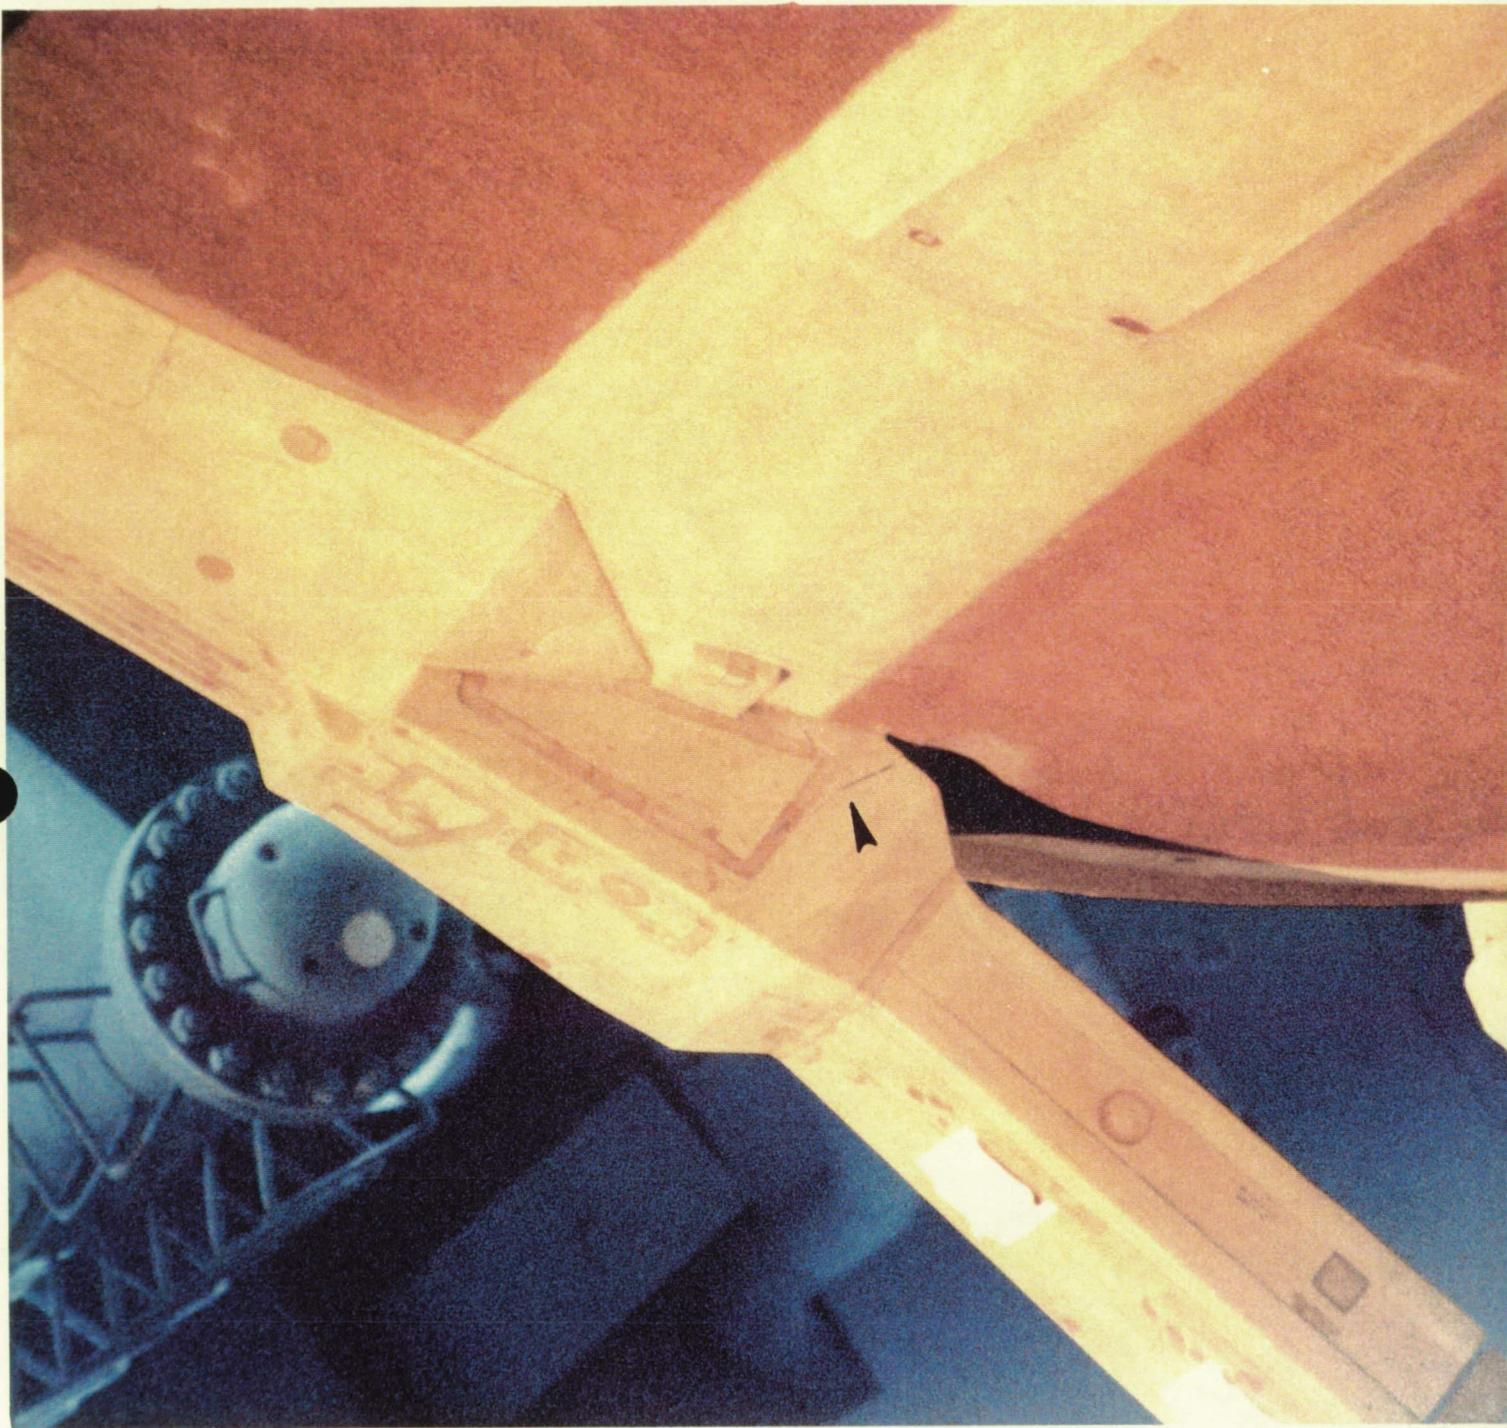
An 8-inch long dogleg crack was present in the forward surface TPS covering of the -Y vertical strut cable tray near the longeron closeout interface. The 3/8-inch wide crack exhibited no offset and was not filled with ice or frost. The appearance of the crack was expected due to the elimination of the stress relief gap at the factory.

Anomaly 003 documented an 8-inch dogleg crack in the forward surface TPS covering of the -Y vertical strut cable tray at the intersection to the ET/SRB cable tray transition fairing. The 3/8-inch wide crack exhibited no offset and was not filled with ice or frost. The condition was acceptable for launch per NSTS-08303 and CR S041254C.

An 8-inch long dogleg crack appeared in the LH (-Y) vertical strut/cable tray forward facing TPS covering near the longeron closeout interface. A stress relief cut in the TPS to allow for structural movement had been deleted by design. This condition was acceptable for flight per the NSTS-08303 criteria

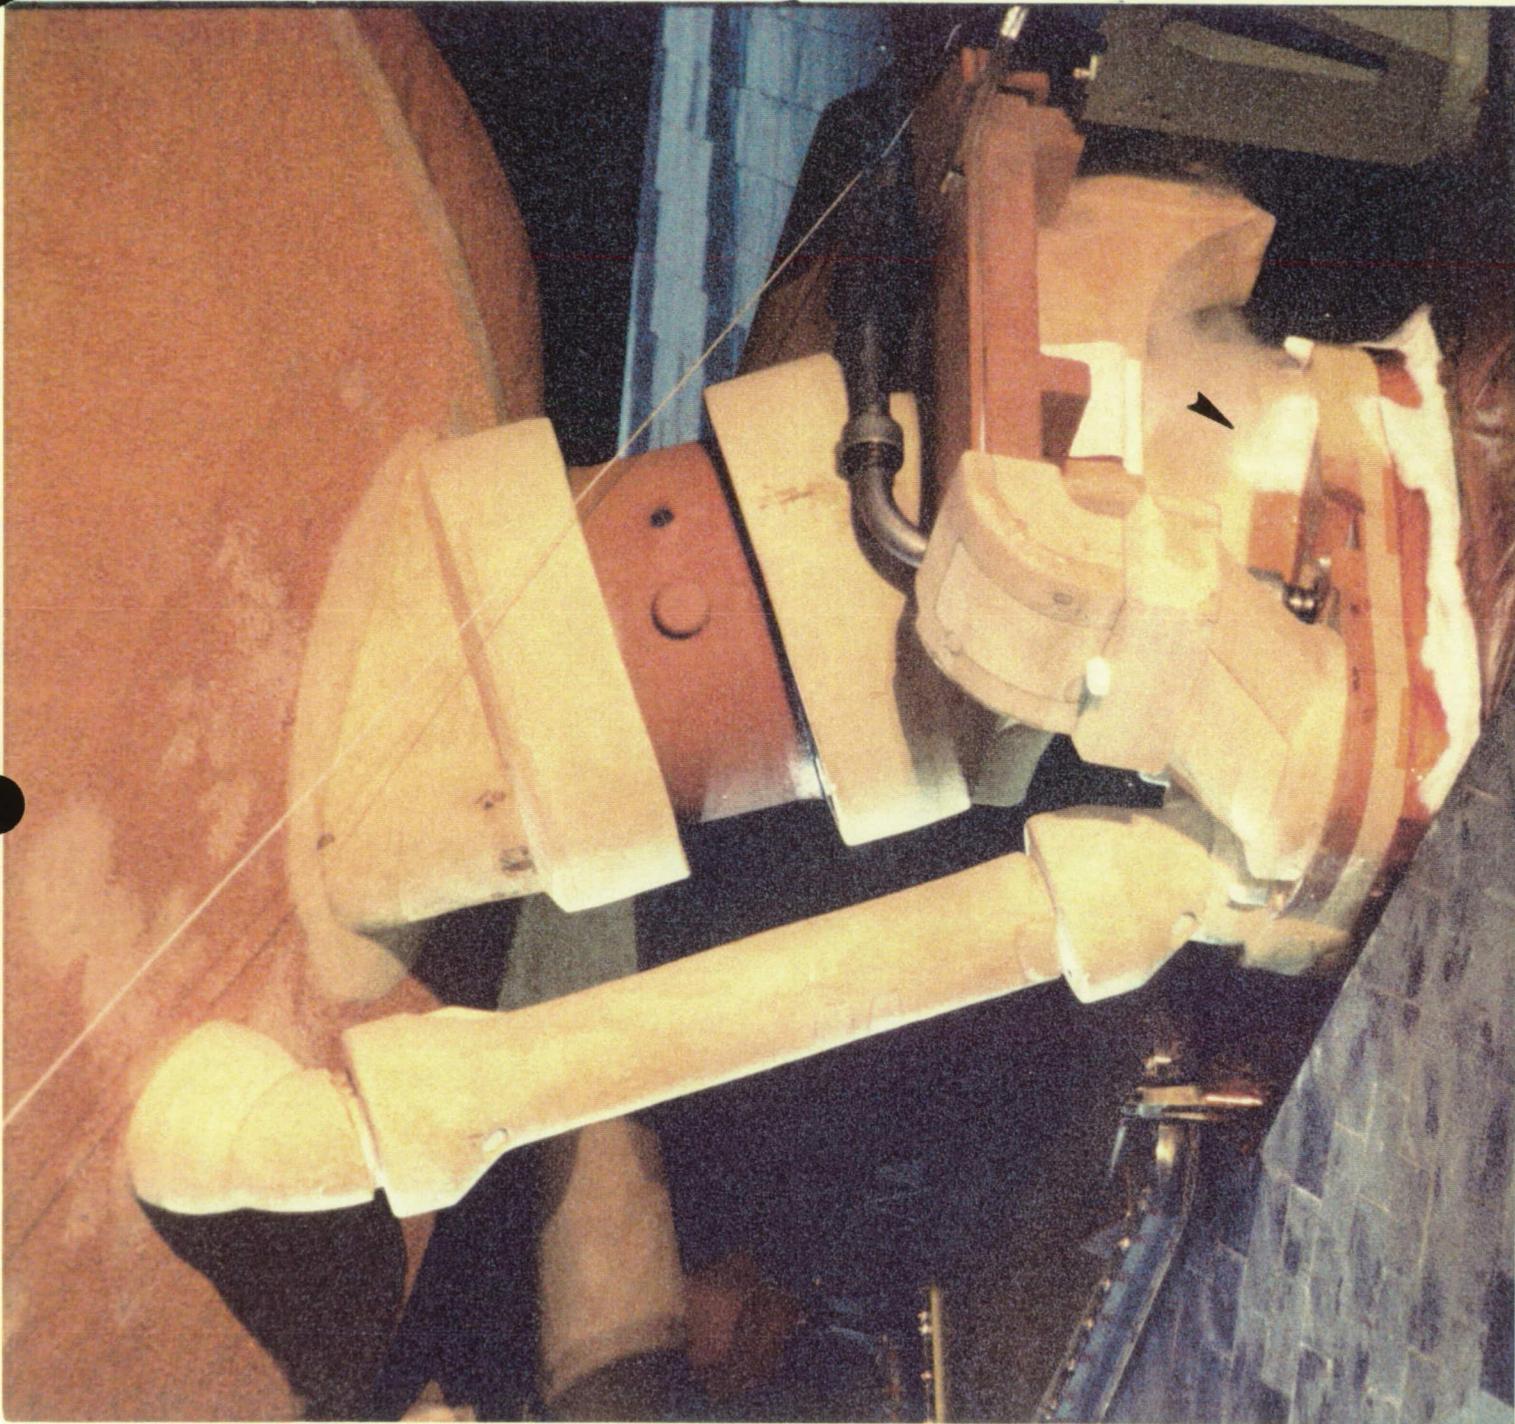
Typical amounts of ice/frost had formed on the top and outboard sides of the LH2 ET/ORB umbilical/purge barrier. Normal amounts of ice had accumulated on the plate gap and pyrotechnic canister purge vents, and the LH2 recirculation line bellows. Ice was present on the forward outboard pyrotechnic canister closeout bondline indicating a thermal short (arrow).

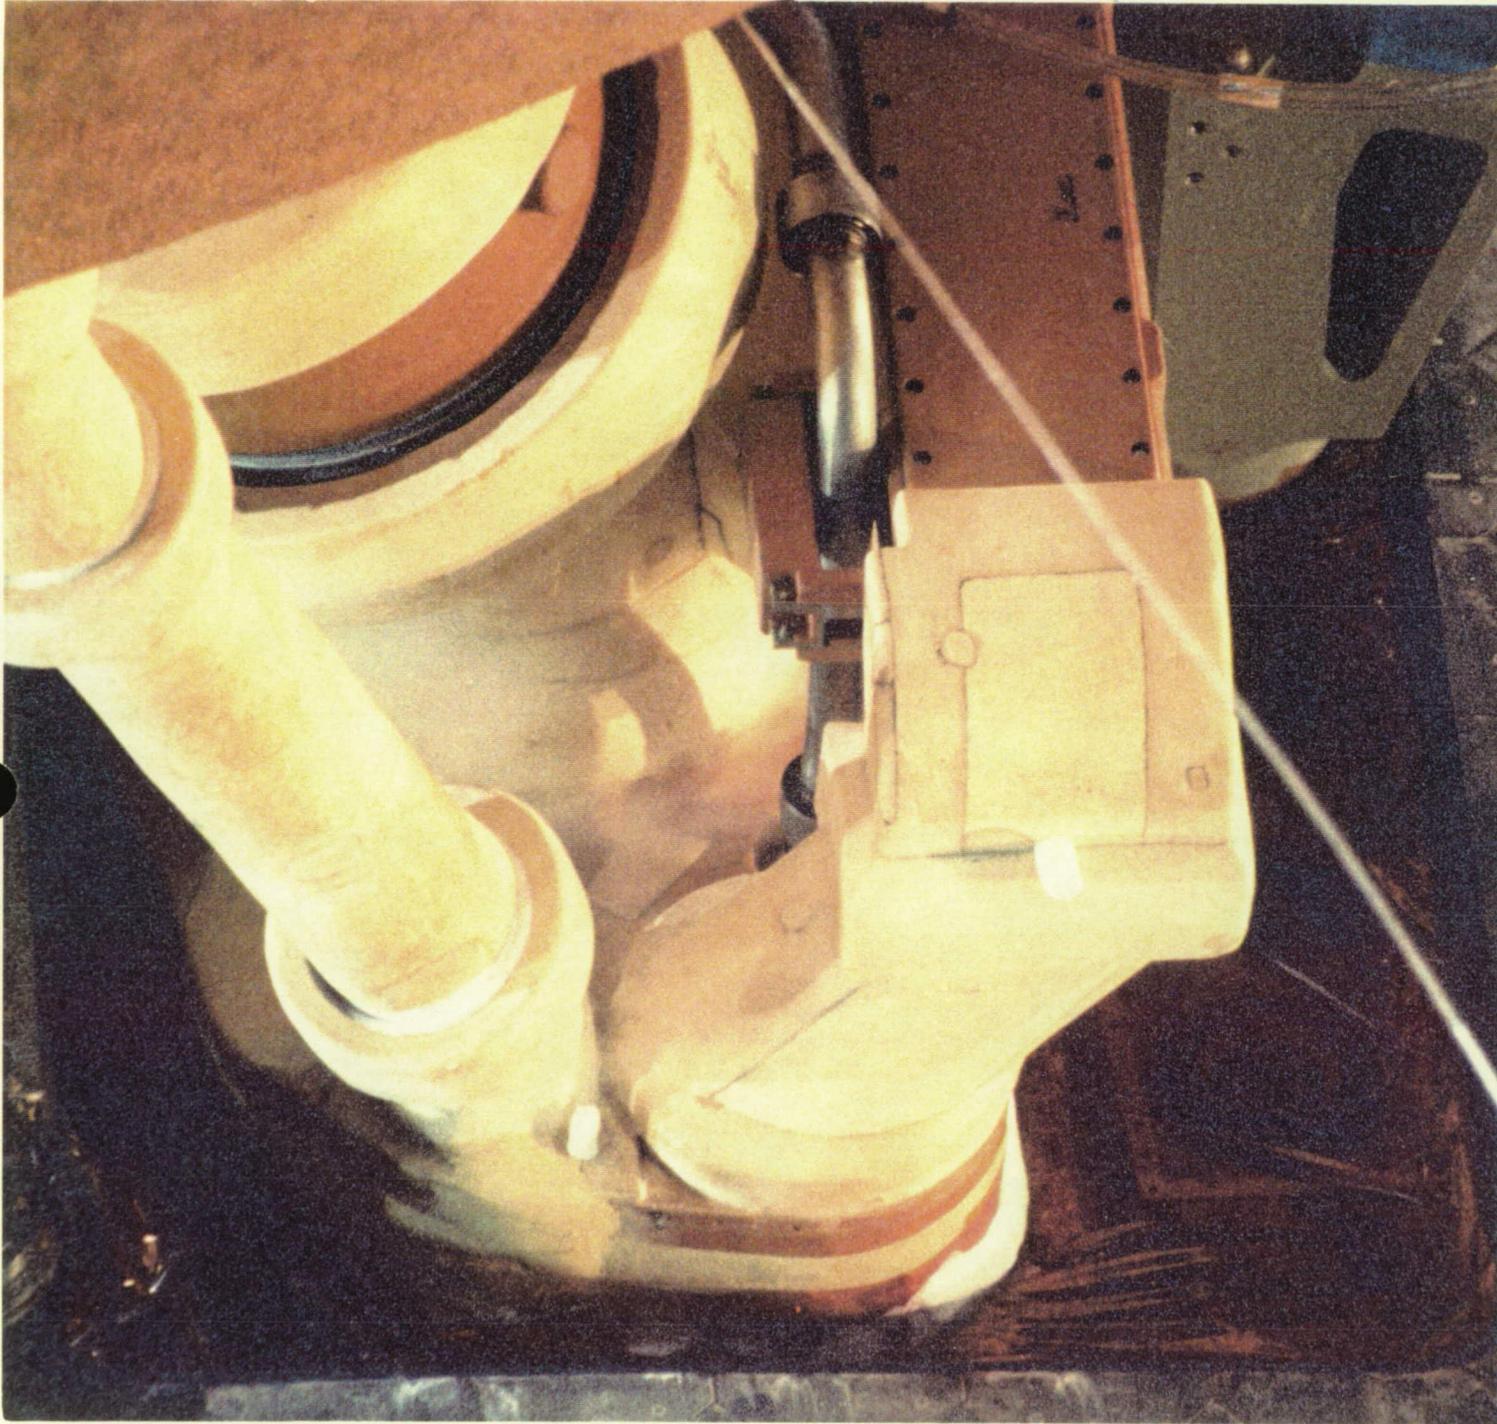
Typical in size, ice/frost fingers had formed on the aft plate gap purge vent and LH2 umbilical cable tray vent hole. The lack of ice or frost on the 17-inch flapper valve actuator access port foam plug closeout indicated a tight seal and nominal closeout.
