Debris/Ice/TPS Assessment And Integrated Photographic Analysis For Shuttle Mission STS-52

December 1992

DEBRIS/ICE/TPS ASSESSMENT
AND
PHOTOGRAPHIC ANALYSIS
OF
SHUTTLE MISSION STS-52

October 22, 1992

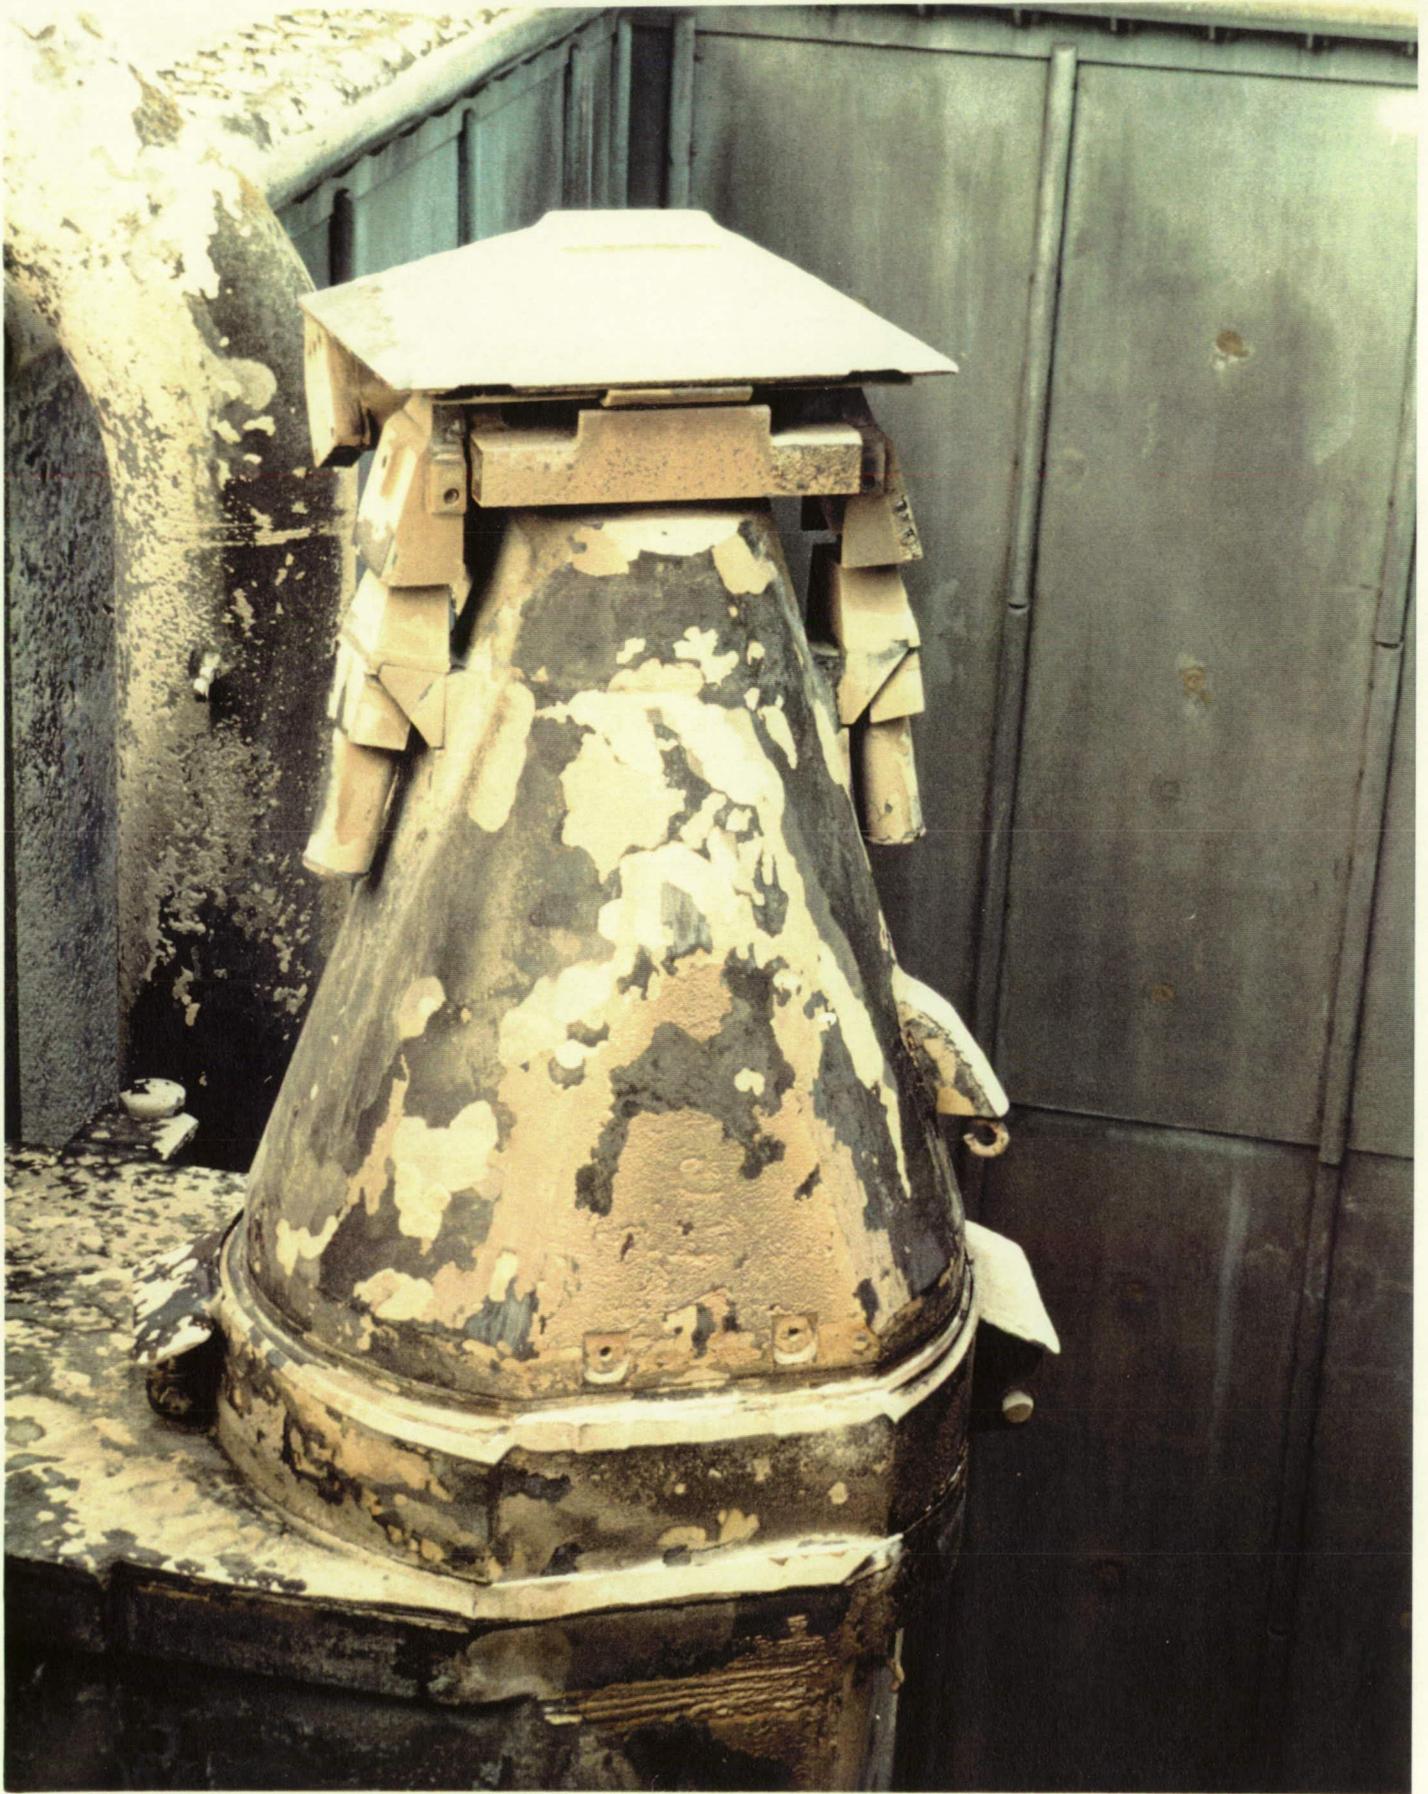
All of the north holddown post doghouse blast covers were in the closed position and showed typical plume erosion

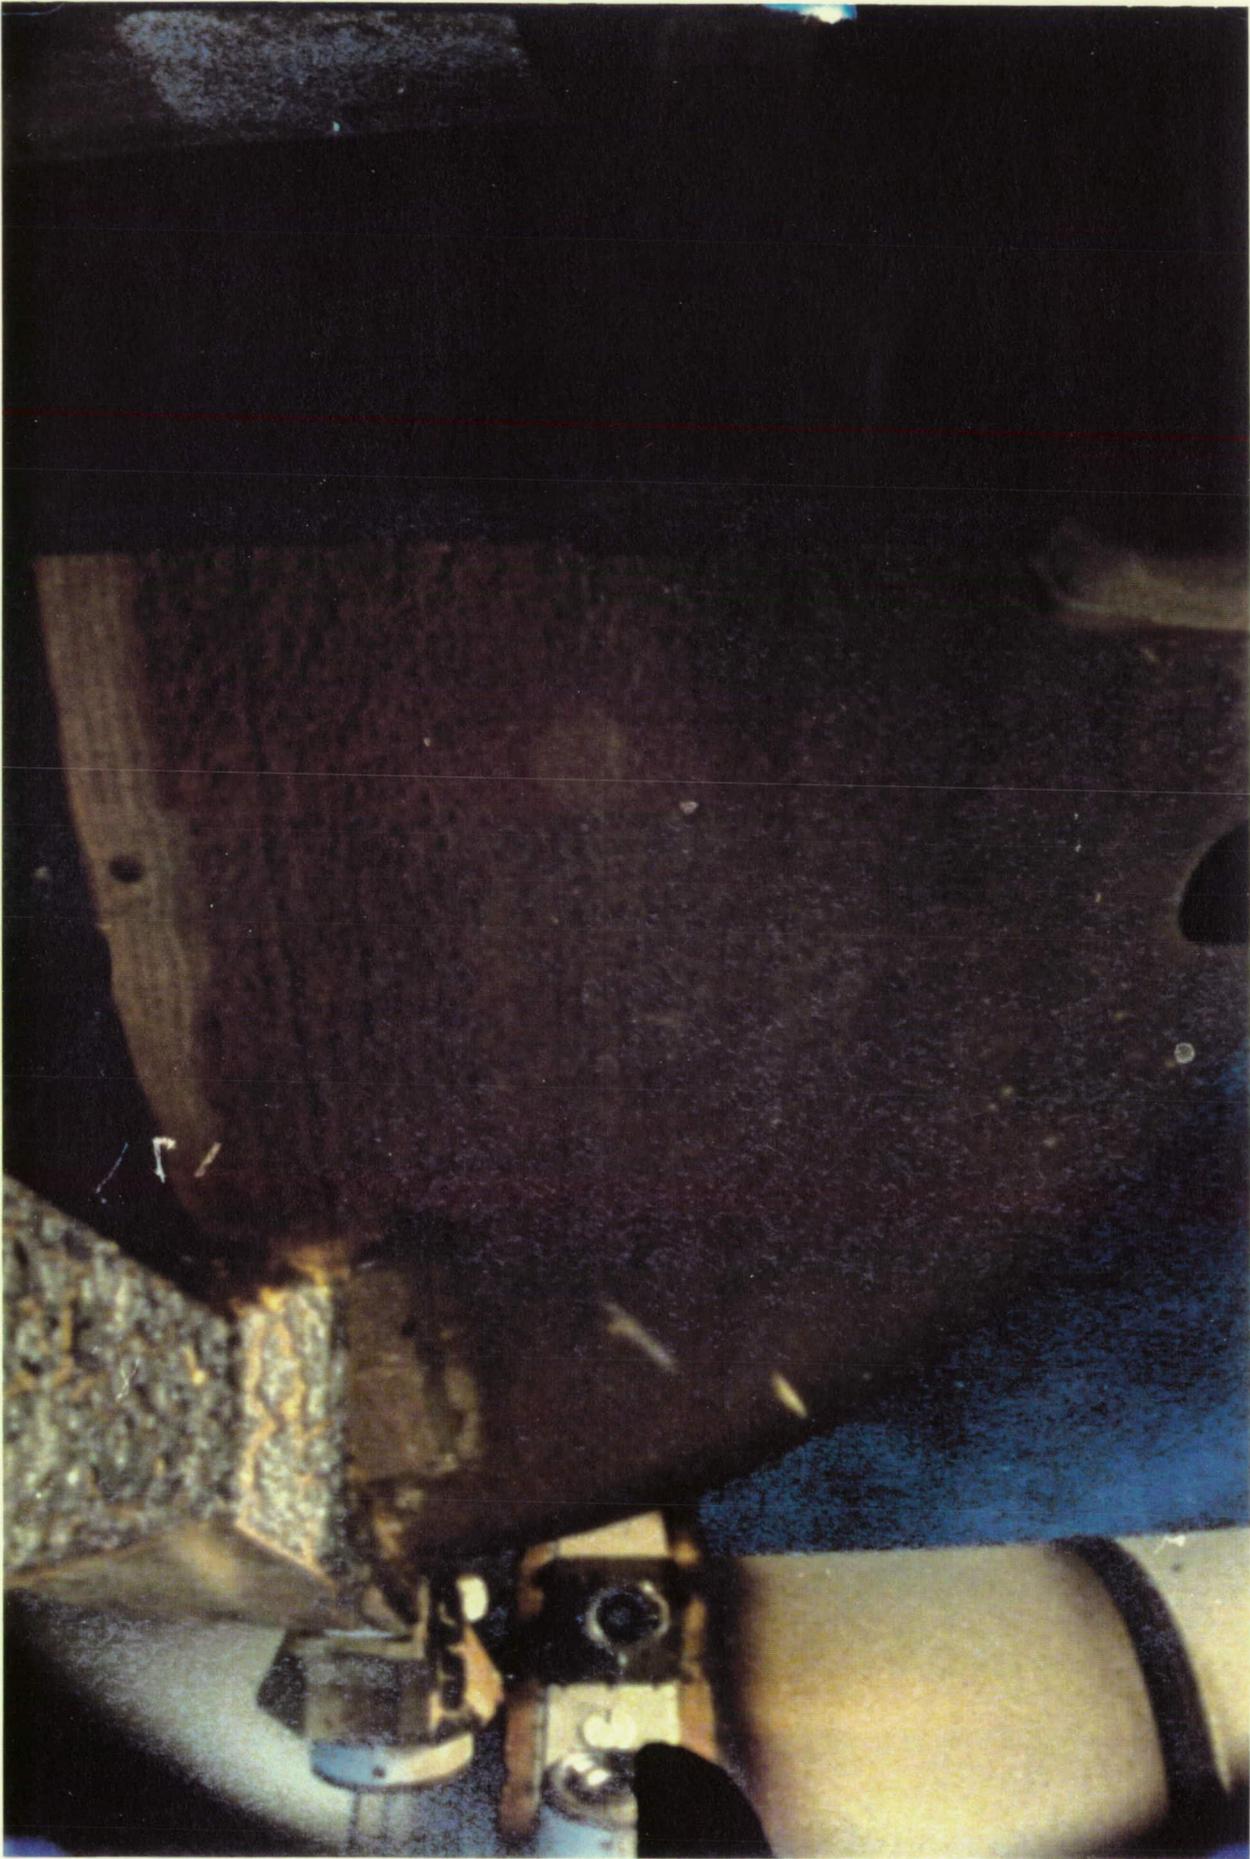
Wide angle view from a camera in the LH2 ET/ORB umbilical showed nominal separation of the LH SRB from the External Tank. Note erosion/loss of material from the TPS on the vertical strut/cable tray aft surface and the upper strut fairing.

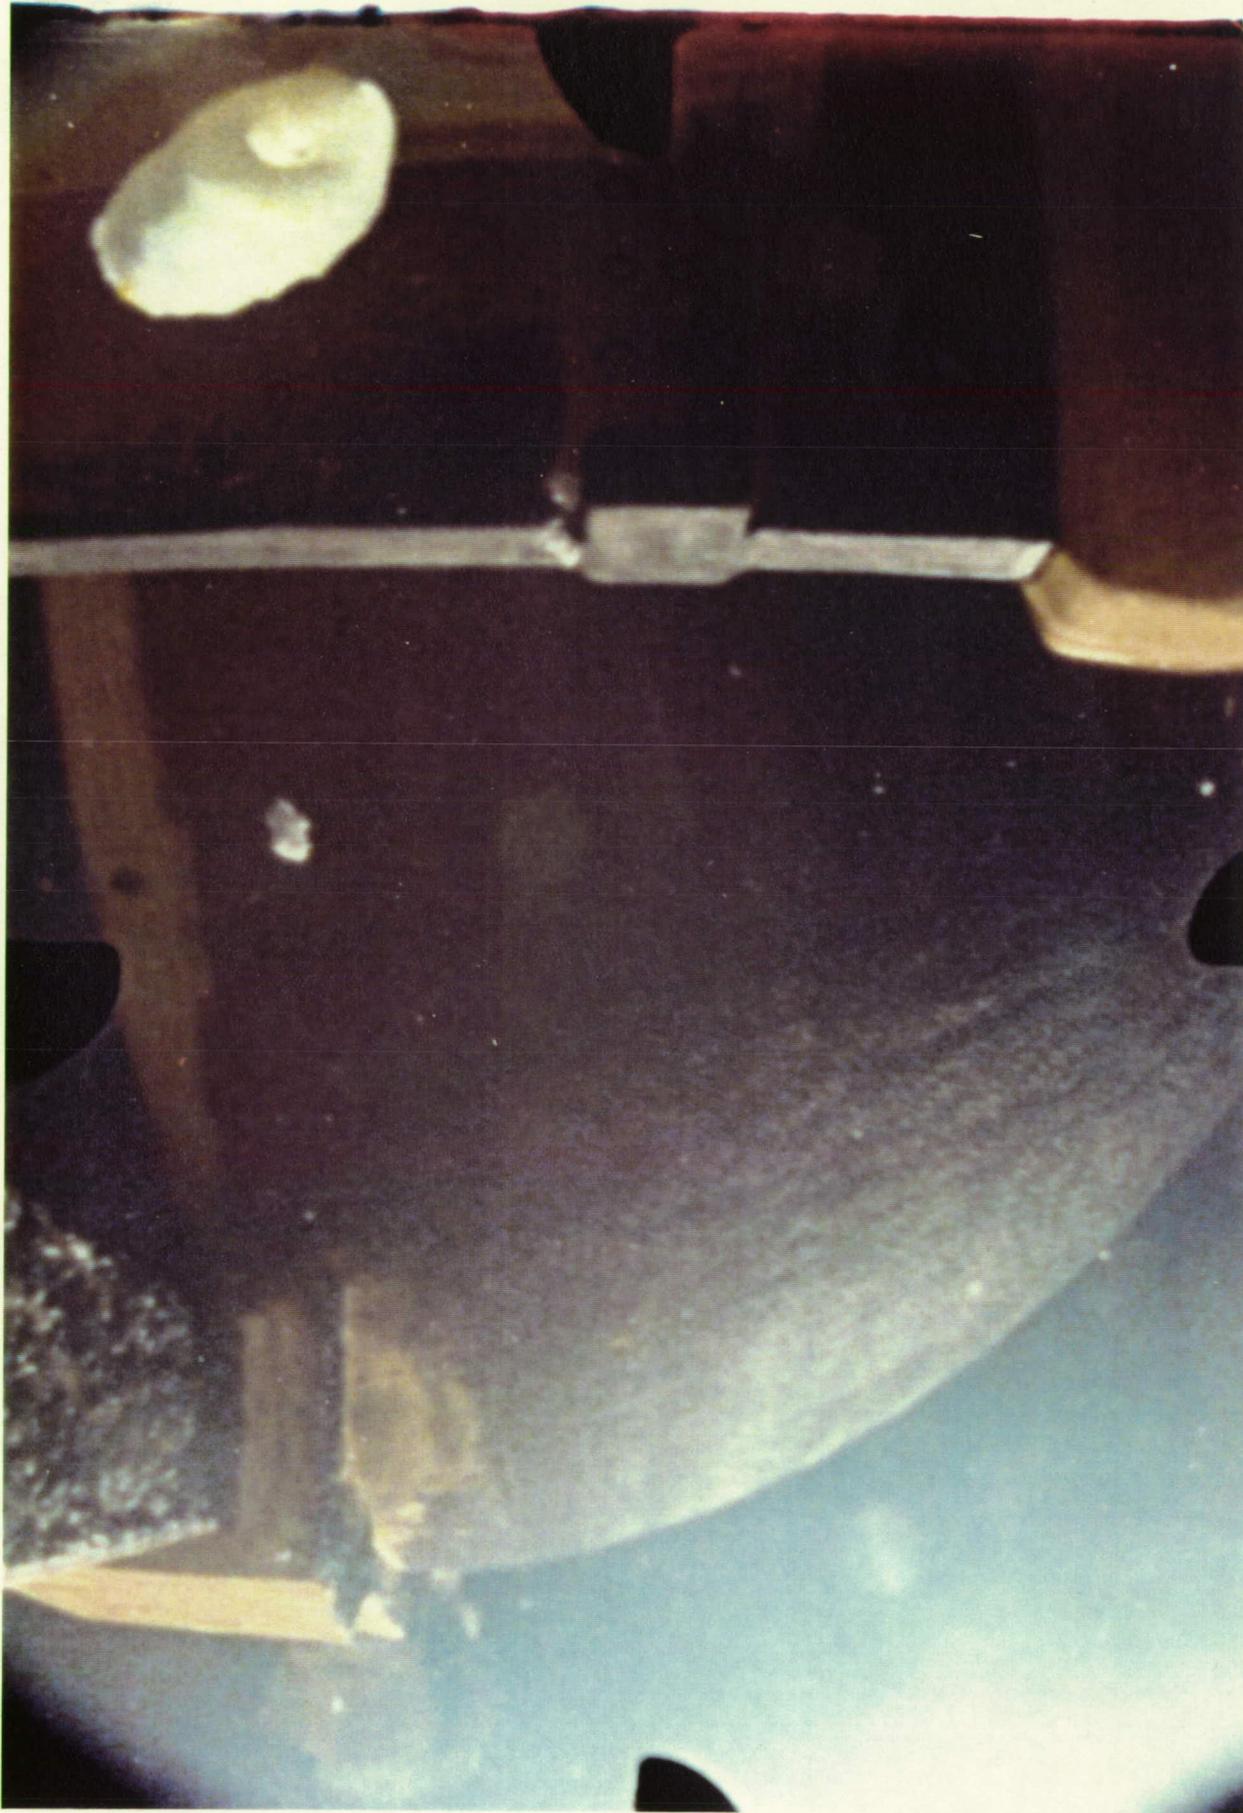
A white cylindrical rough-edged object drifted through the field of view and was most likely an ice finger from a forward purge vent tube inside the umbilical. Although not considered an anomaly, this type of ice formation had not been observed in umbilical separation films before.

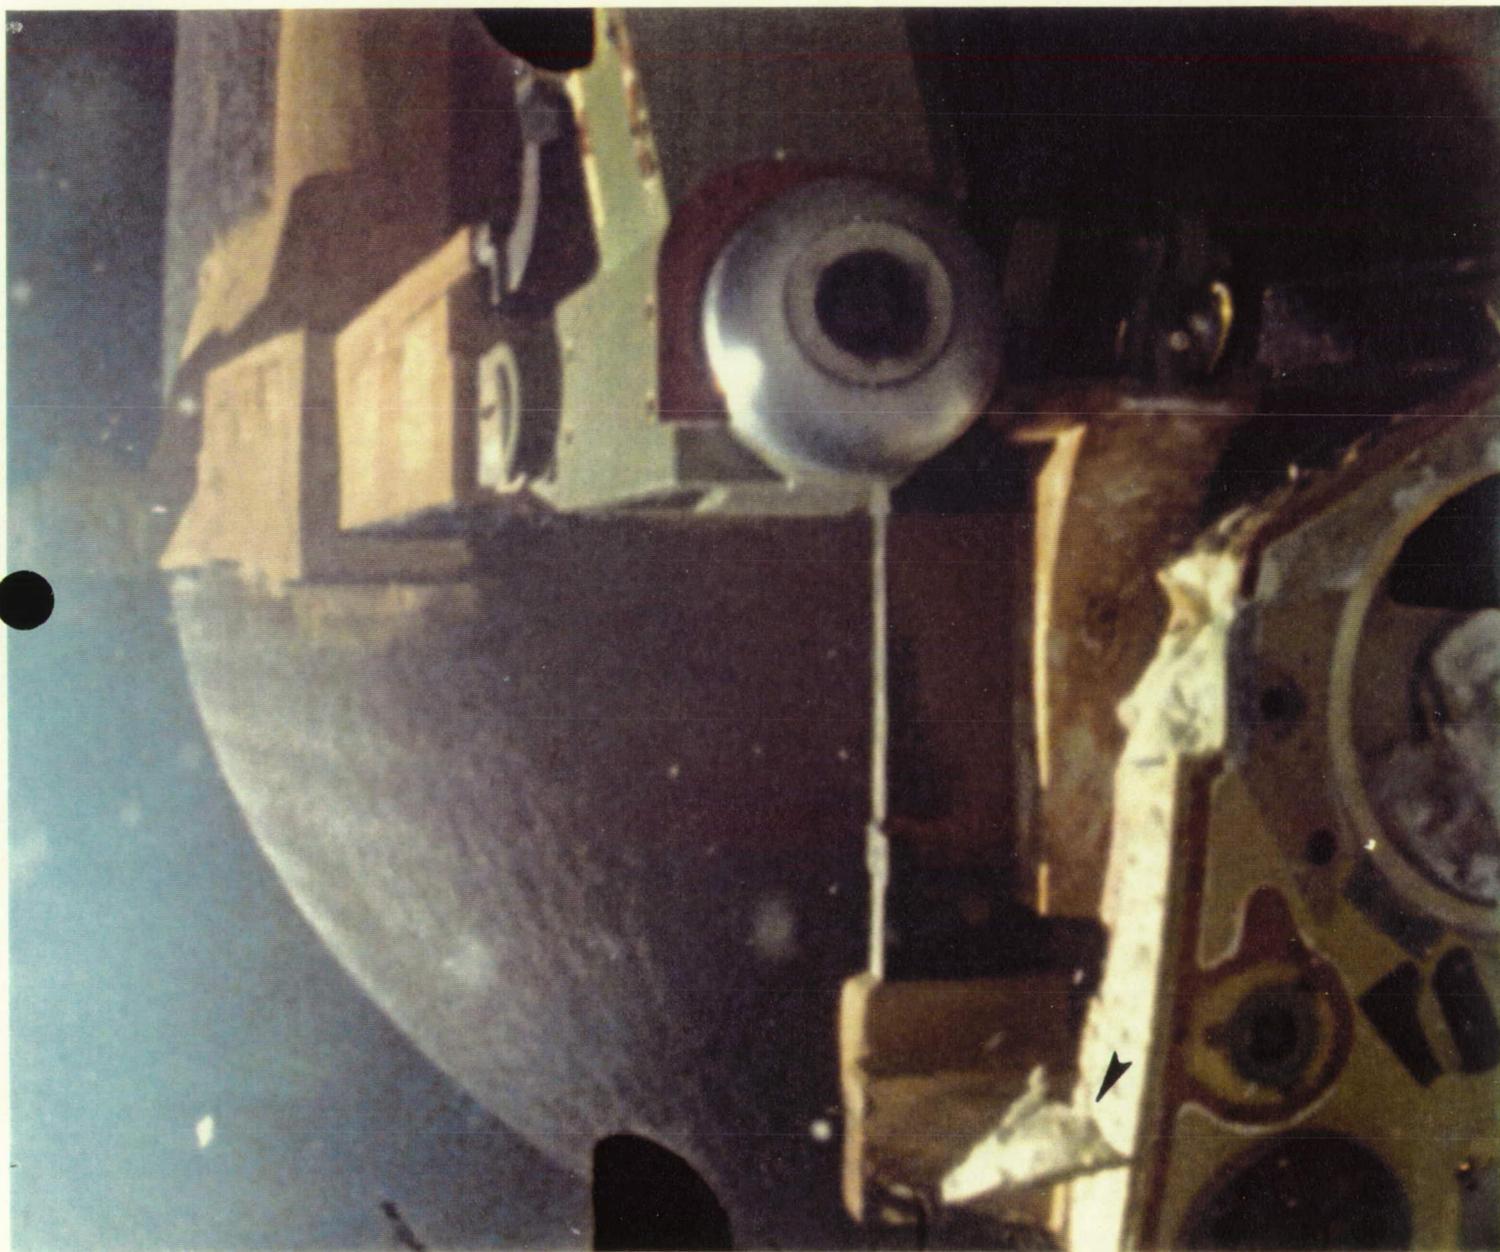
A small piece of foam with fire barrier material attached floated by the camera (arrow). It appeared to originate from the upper outboard side of the LH2 umbilical at the pyrotechnic canister closeout.

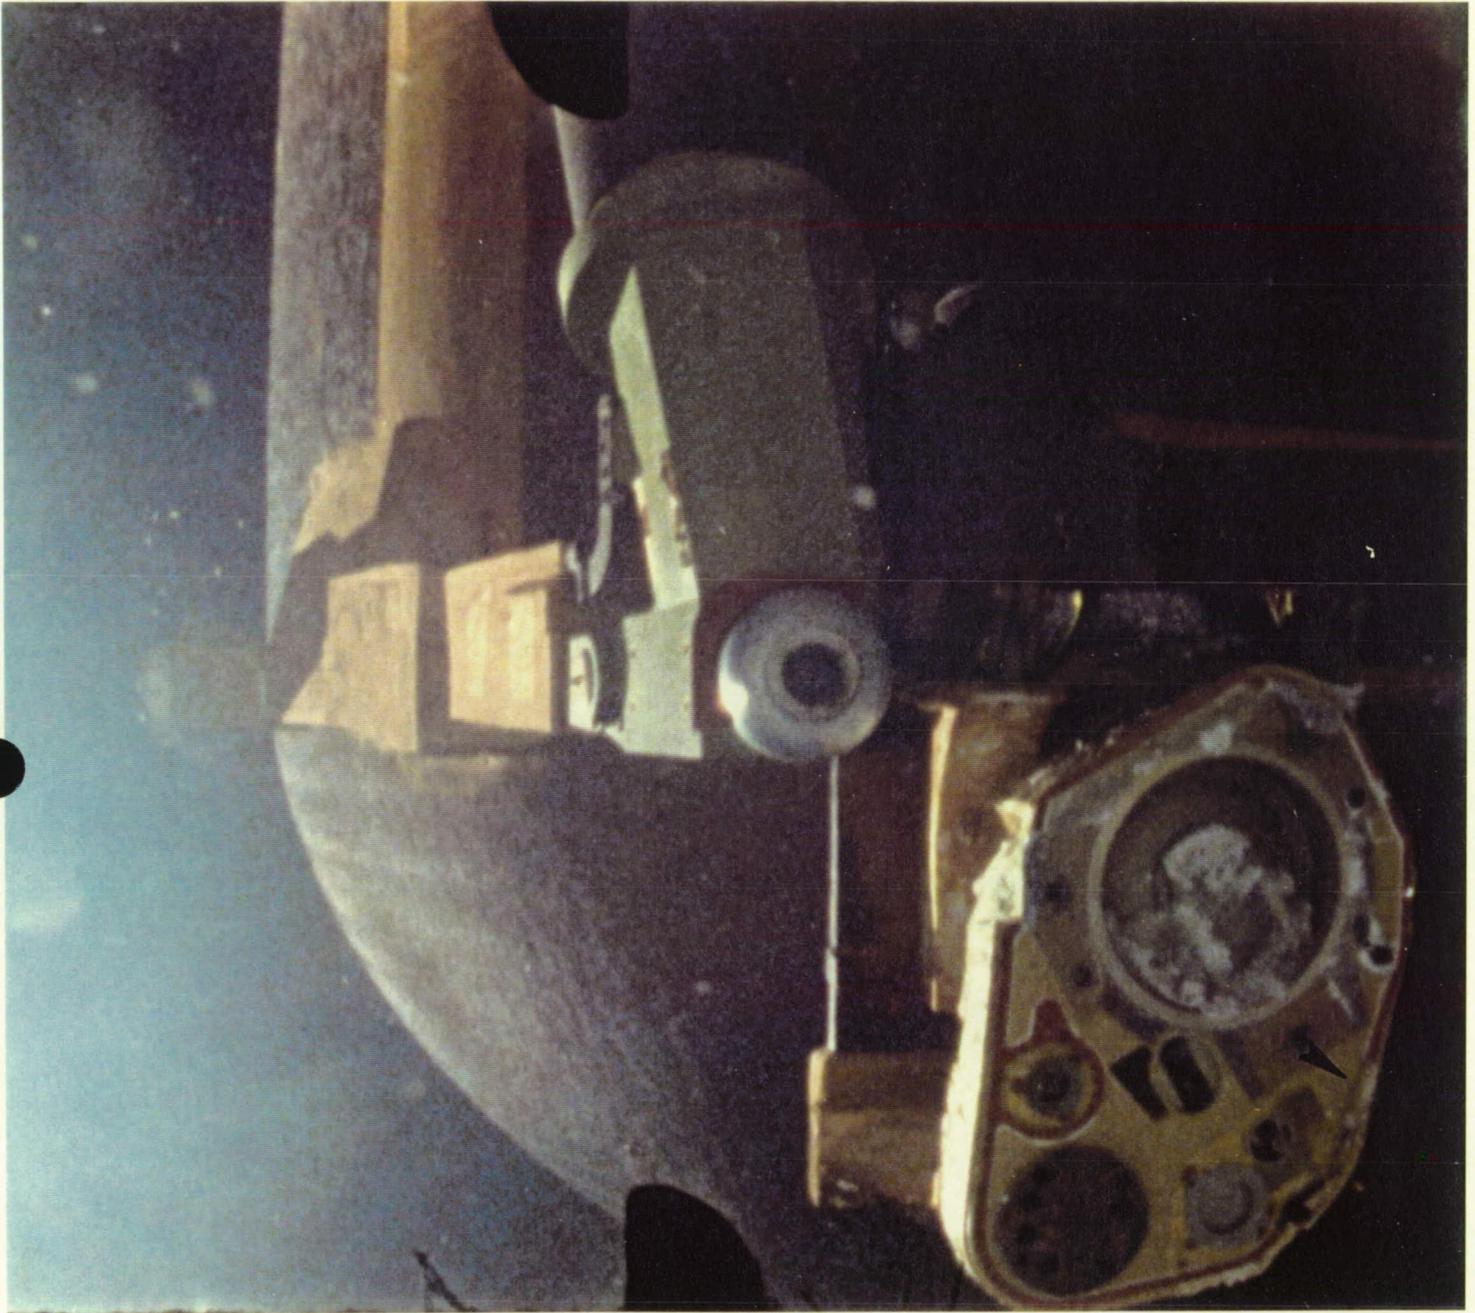
Structural separation of the LH2 ET/ORB umbilical appeared normal. Some TPS was lost from the upper outboard pyro canister closeout at separation. Rough appearance of the umbilical top and outboard sides was caused by blistering of the fire barrier material. A section of the red purge seal was missing from the aft inboard corner of the LH2 umbilical. This section of material adhered to the Orbiter side of the umbilical interface and was still attached after Orbiter landing.

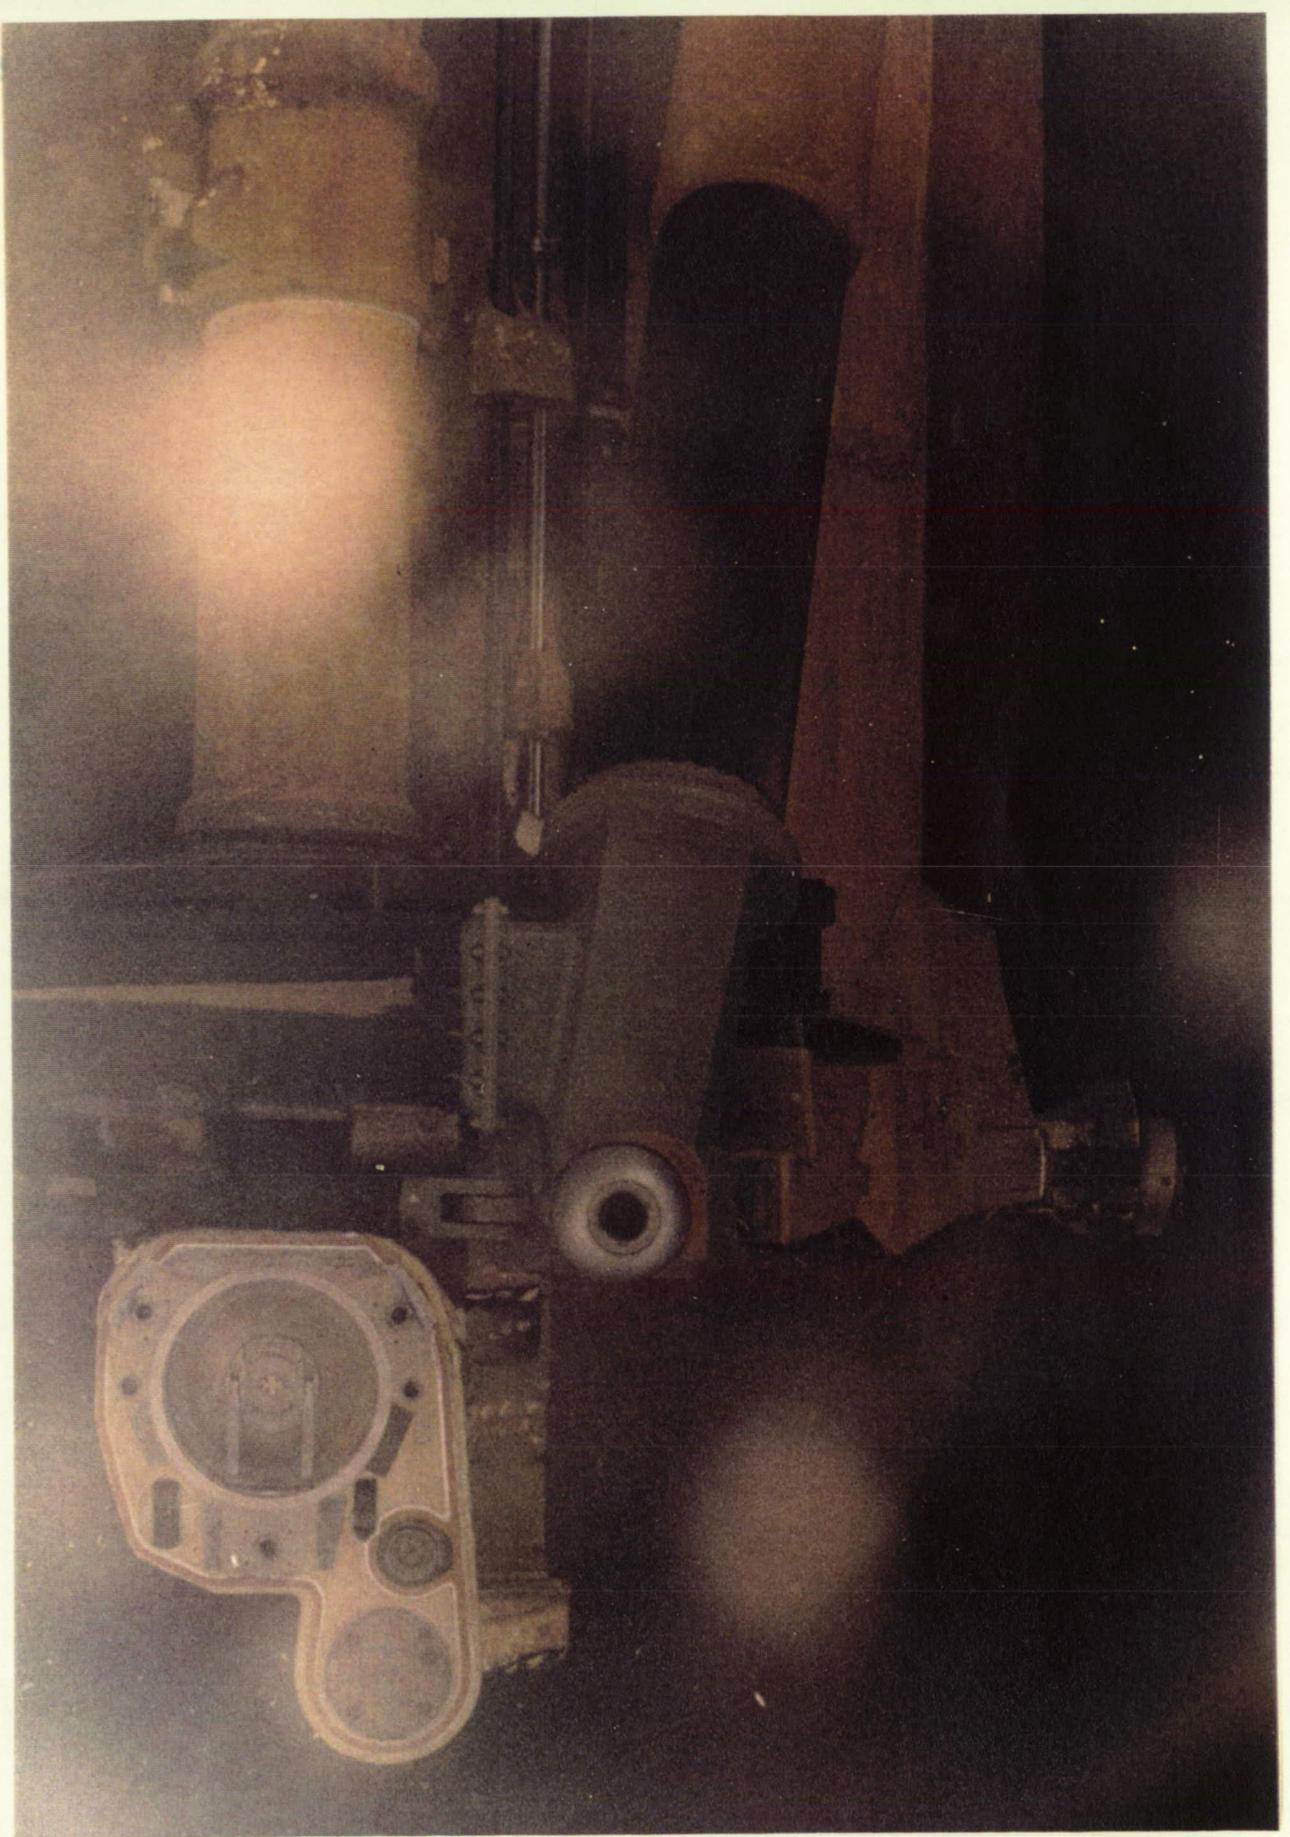
View from the L02 ET/ORB umbilical separation camera showed possible TPS damage at the forward inboard corner of the L02 umbilical. Pieces of TPS were missing from the vertical and horizontal sections of the umbilical cable tray.

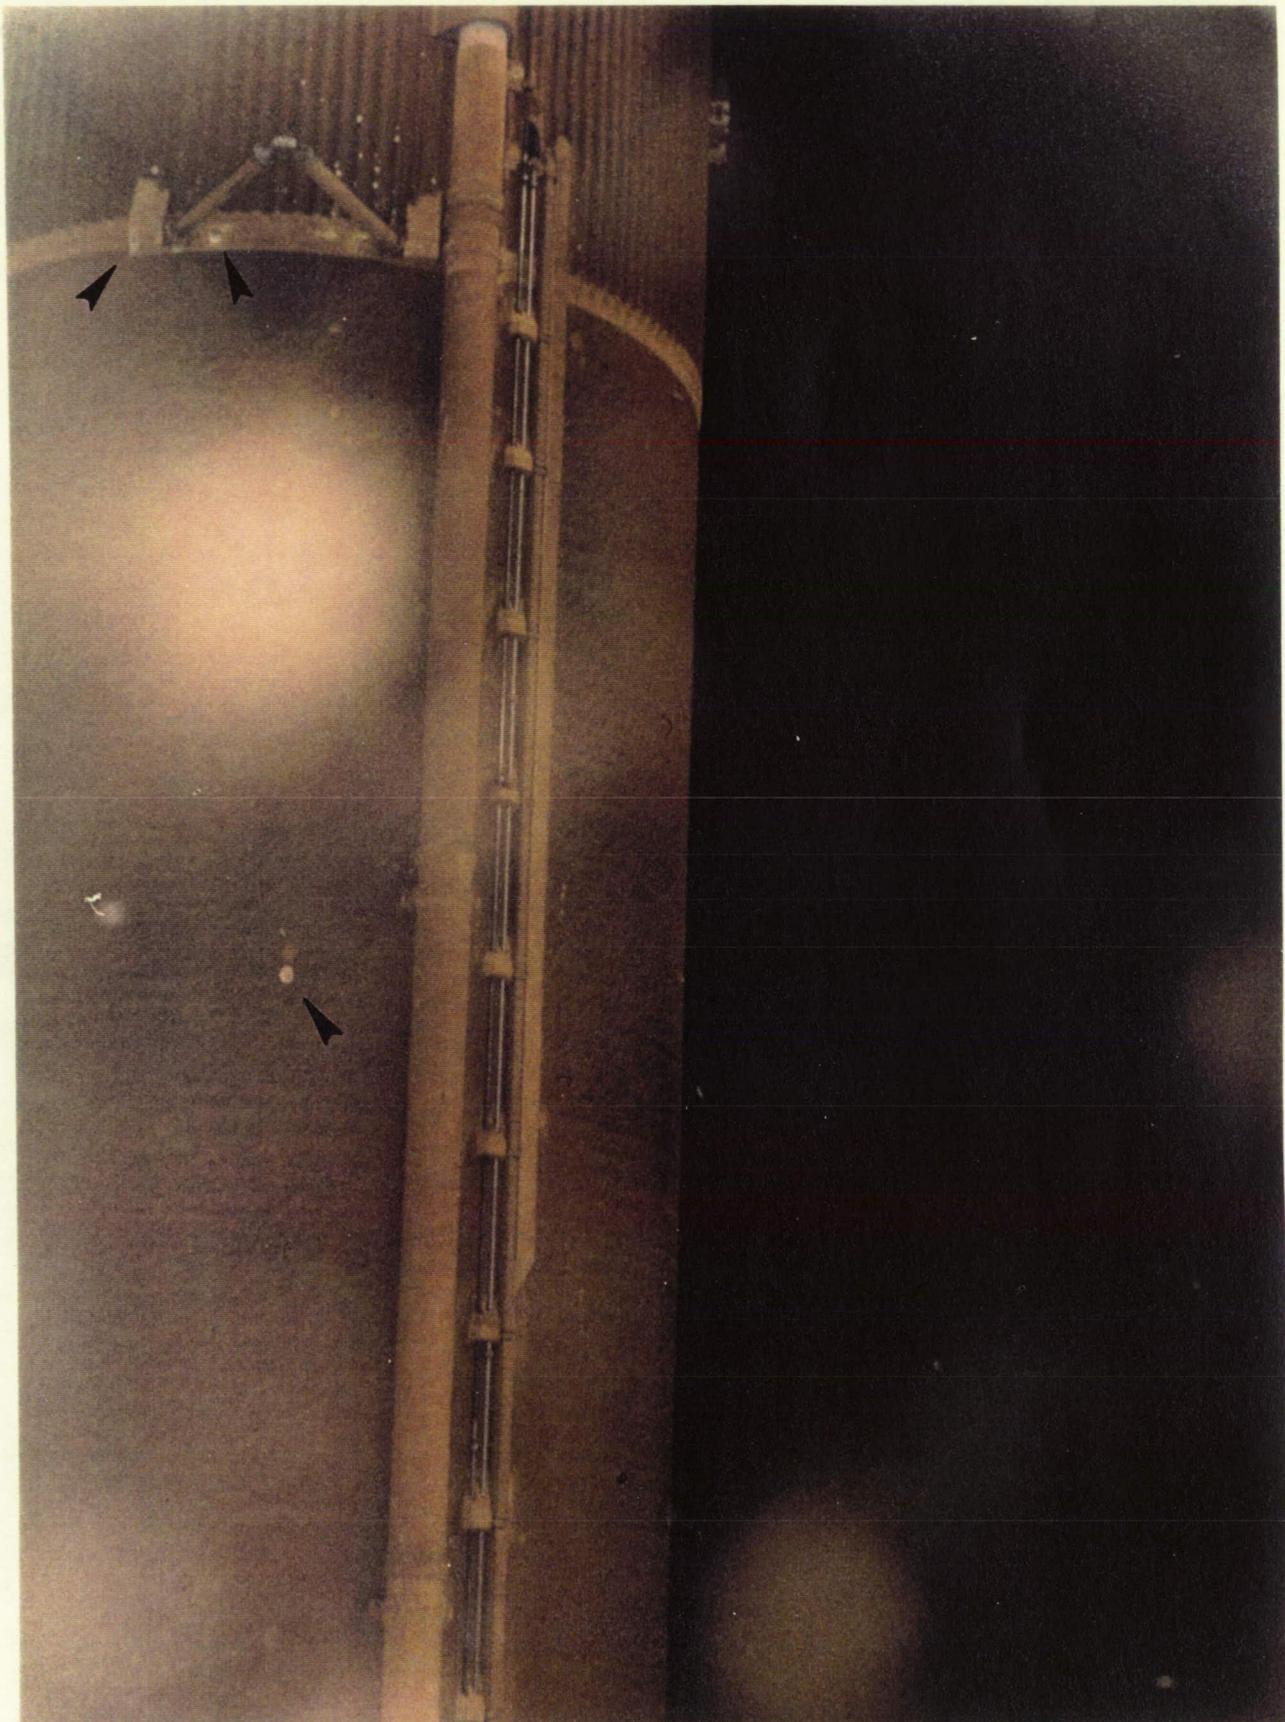
A 5-inch divot to substrate was present in the LH2 tank acreage at XT-1399 adjacent to a previously sanded area. Some of the left bipod jack pad closeout was missing. Foam was also missing from the aft outboard corner of the LH bipod ramp closeout.

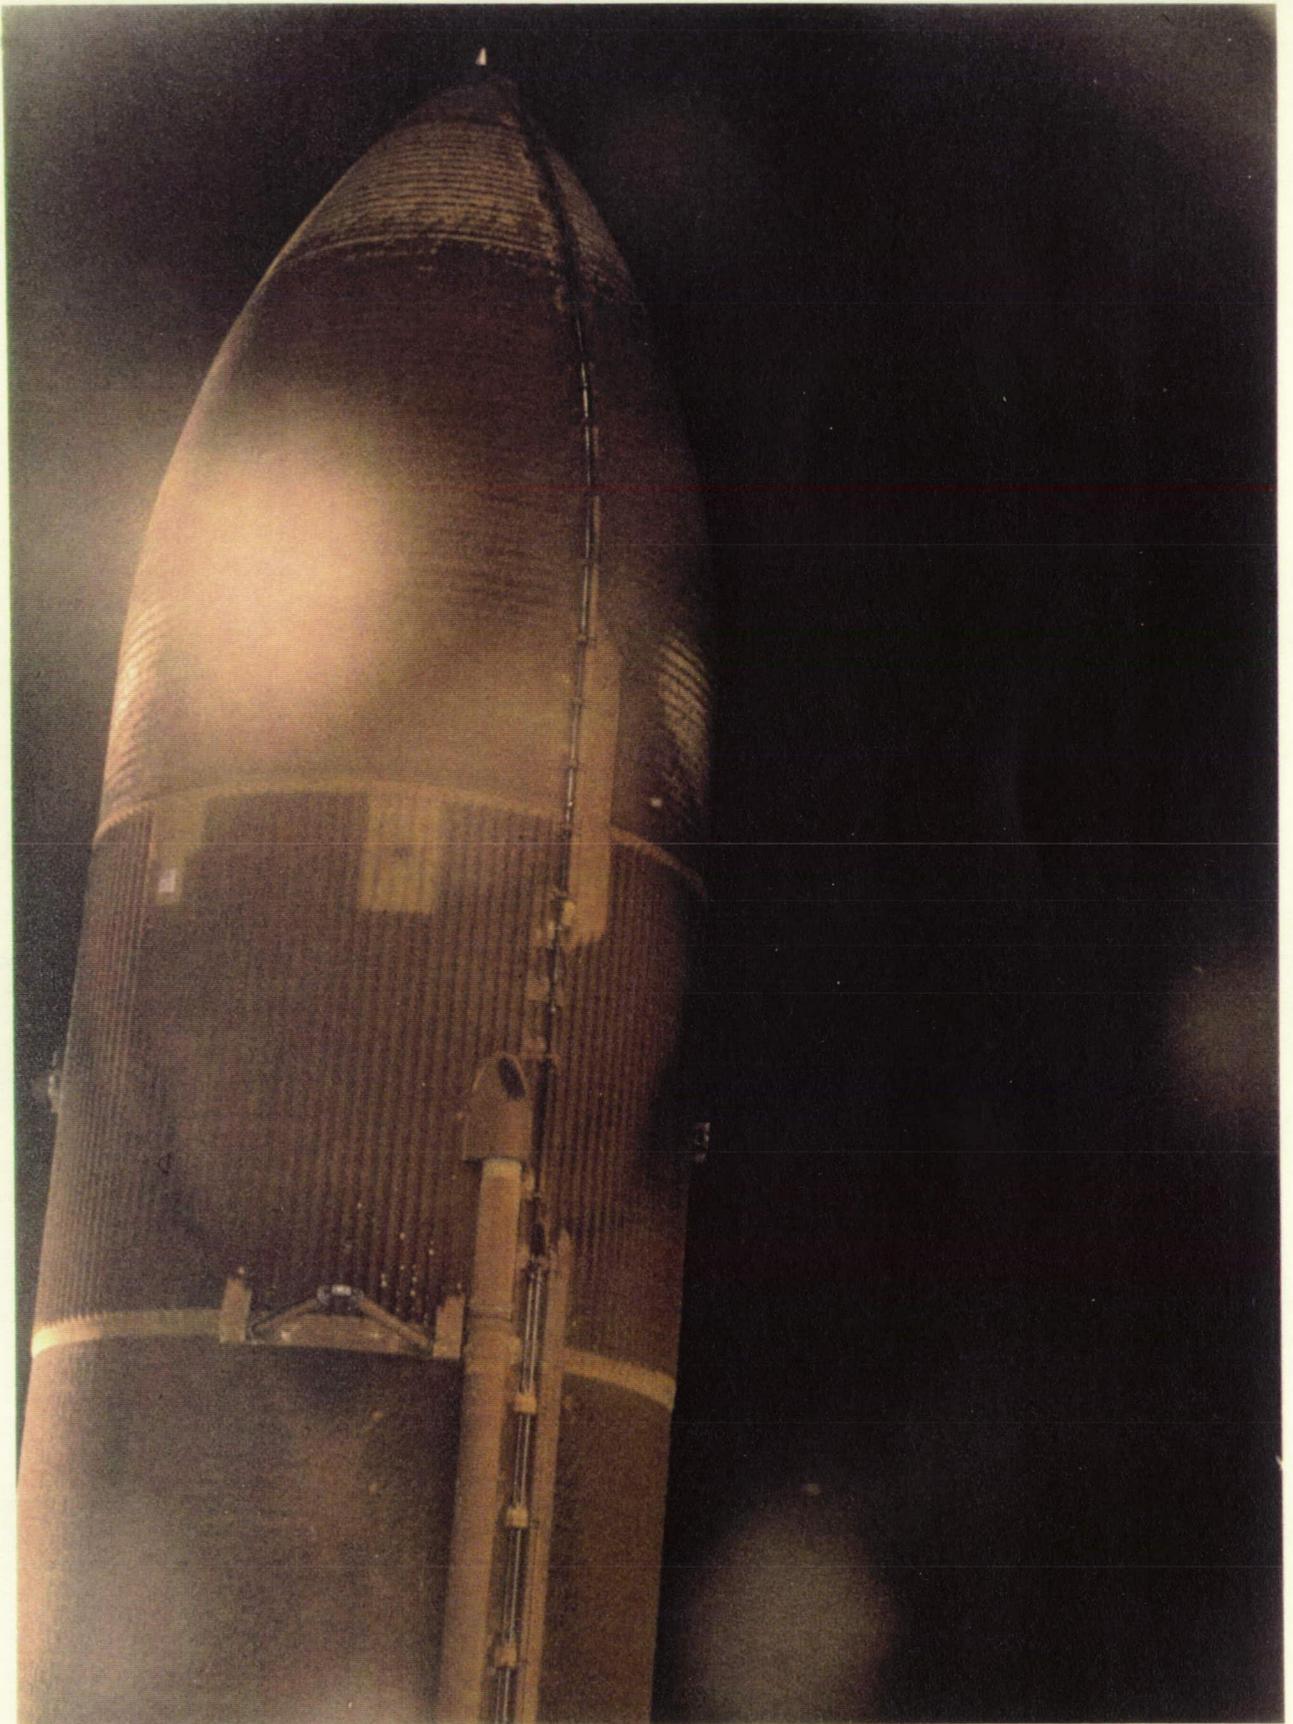
At least 20 small pieces of TPS were missing from intertank stringers forward of the LH2 tank-to-intertank flange/bipod area. No metal substrate or primer was visible. There were no divots in the flange closeout -Y+Z and +Y+Z quadrants. Post flight (ascent) condition of the LO2 tank/nosecone was nominal.

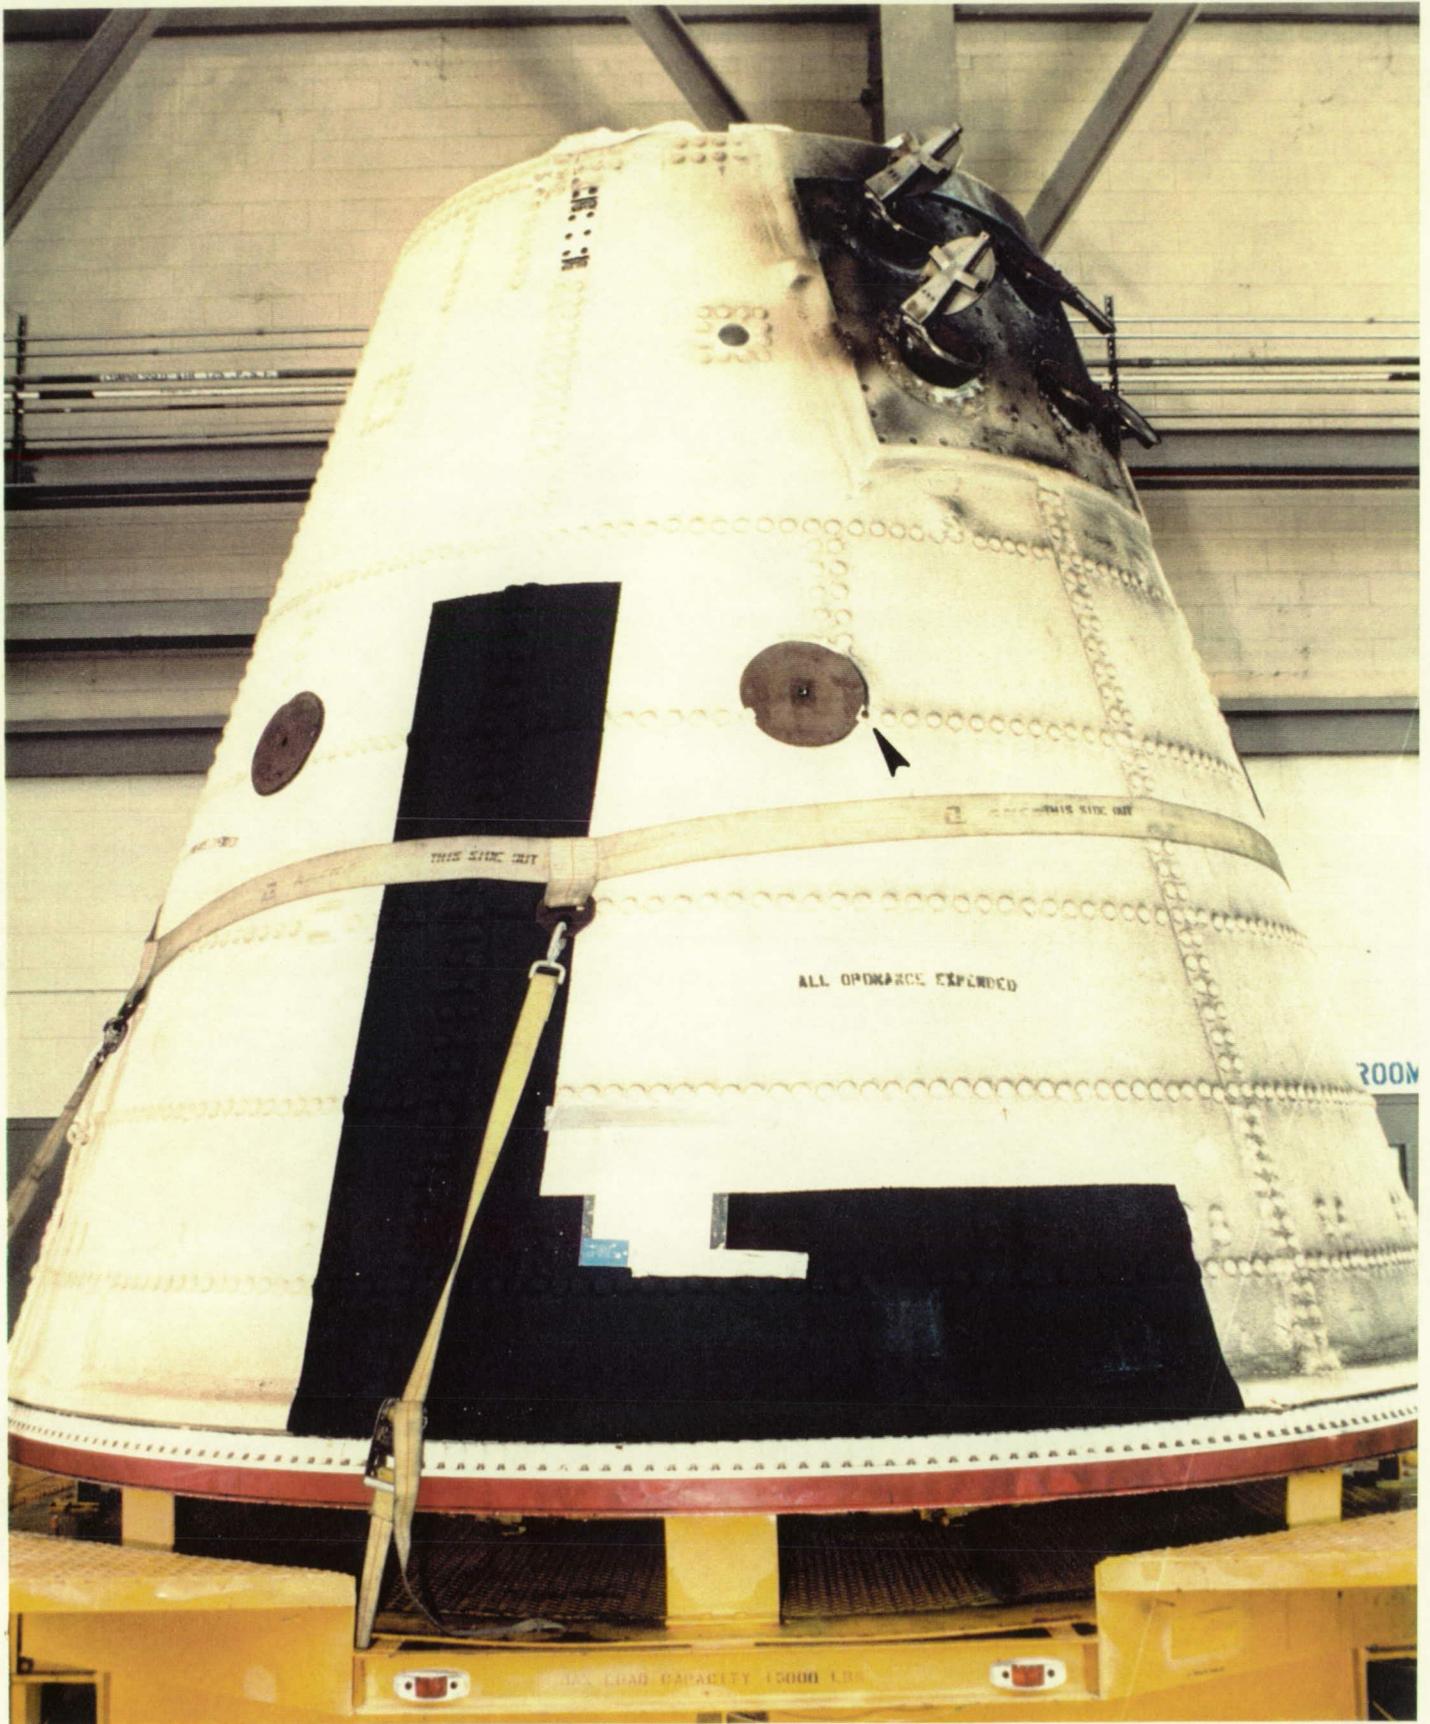
The RH frustum had 18 MSA-2 debonds over fasteners and one area of missing TPS near the pressure port (arrow). All BSM aero heat shield covers were locked in the fully opened position though the left two cover attach rings had been bent by parachute riser entanglement.

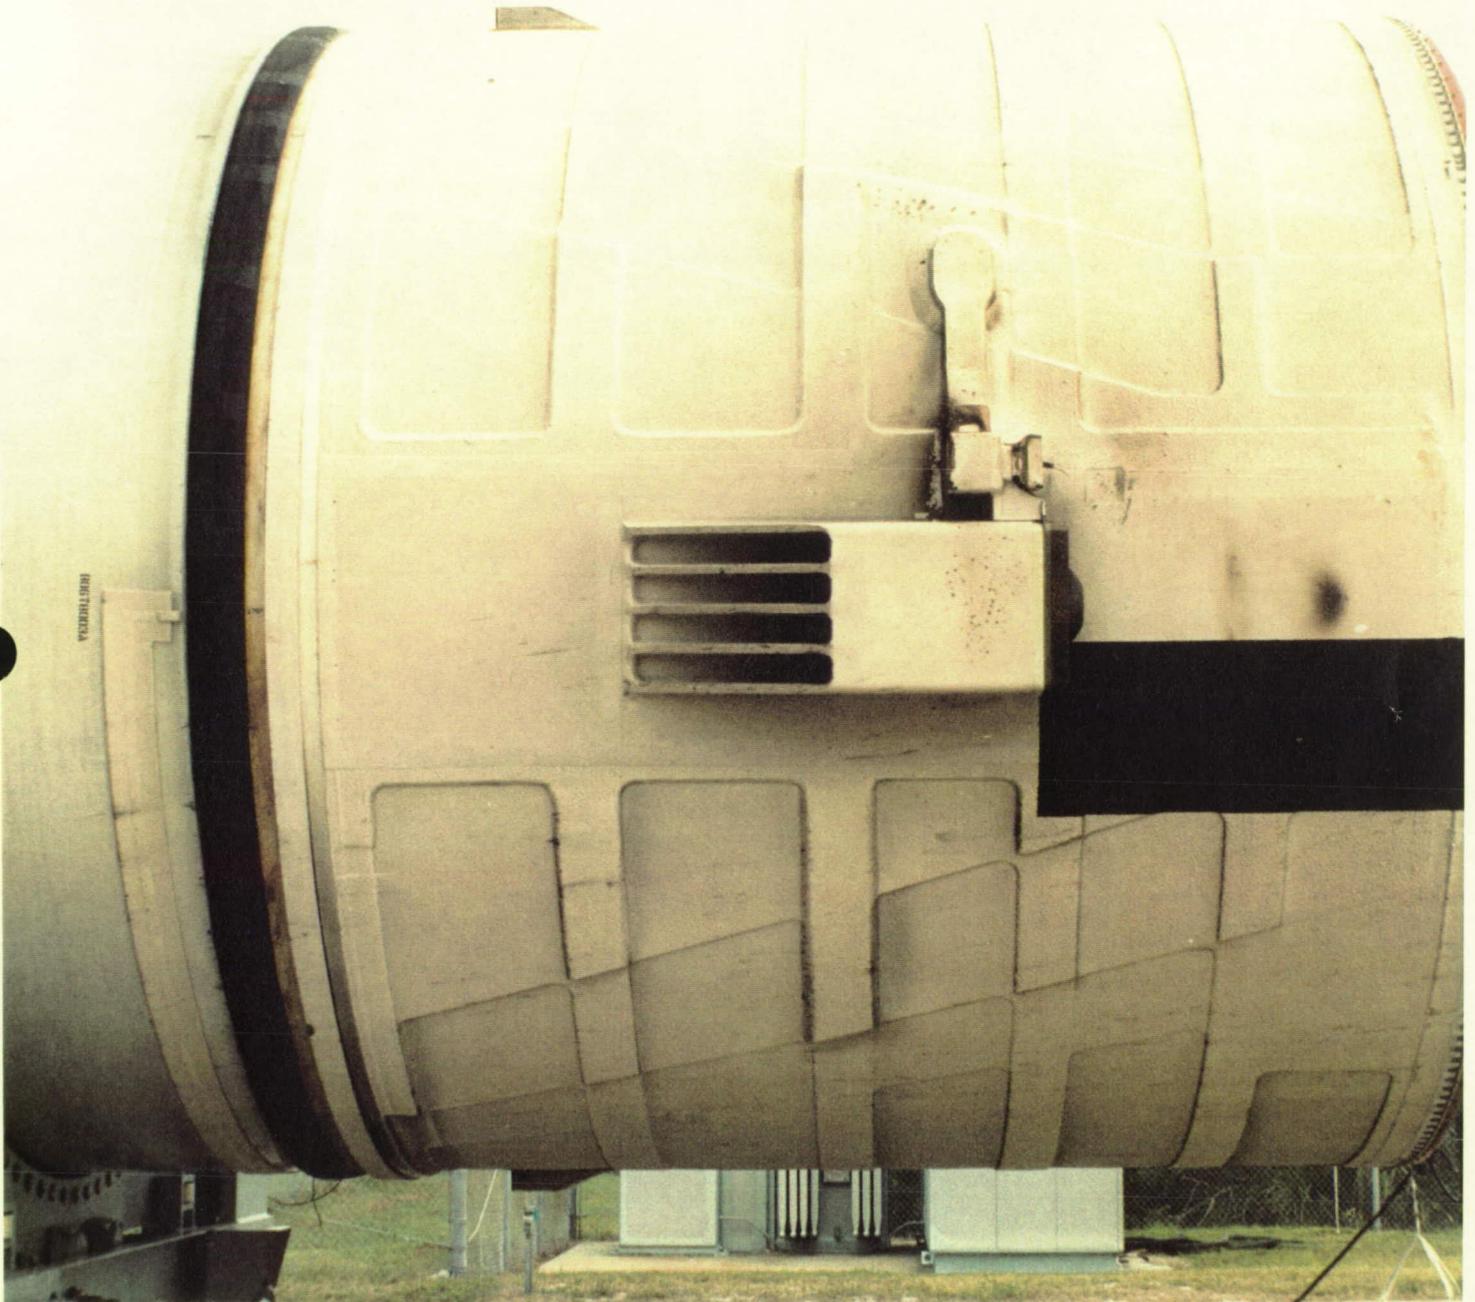
The RH forward skirt was missing no TPS, but did have two MSA-2 debonds. Minor blistering of the Hypalon paint occurred on the forward ET/SRB attach point. Both RSS antenna covers/TPS were intact and undamaged.
