Debris/Ice/TPS Assessment And Integrated Photographic Analysis For Shuttle Mission STS-52

December 1992

DEBRIS/ICE/TPS ASSESSMENT
AND
PHOTOGRAPHIC ANALYSIS
OF
SHUTTLE MISSION STS-52

October 22, 1992

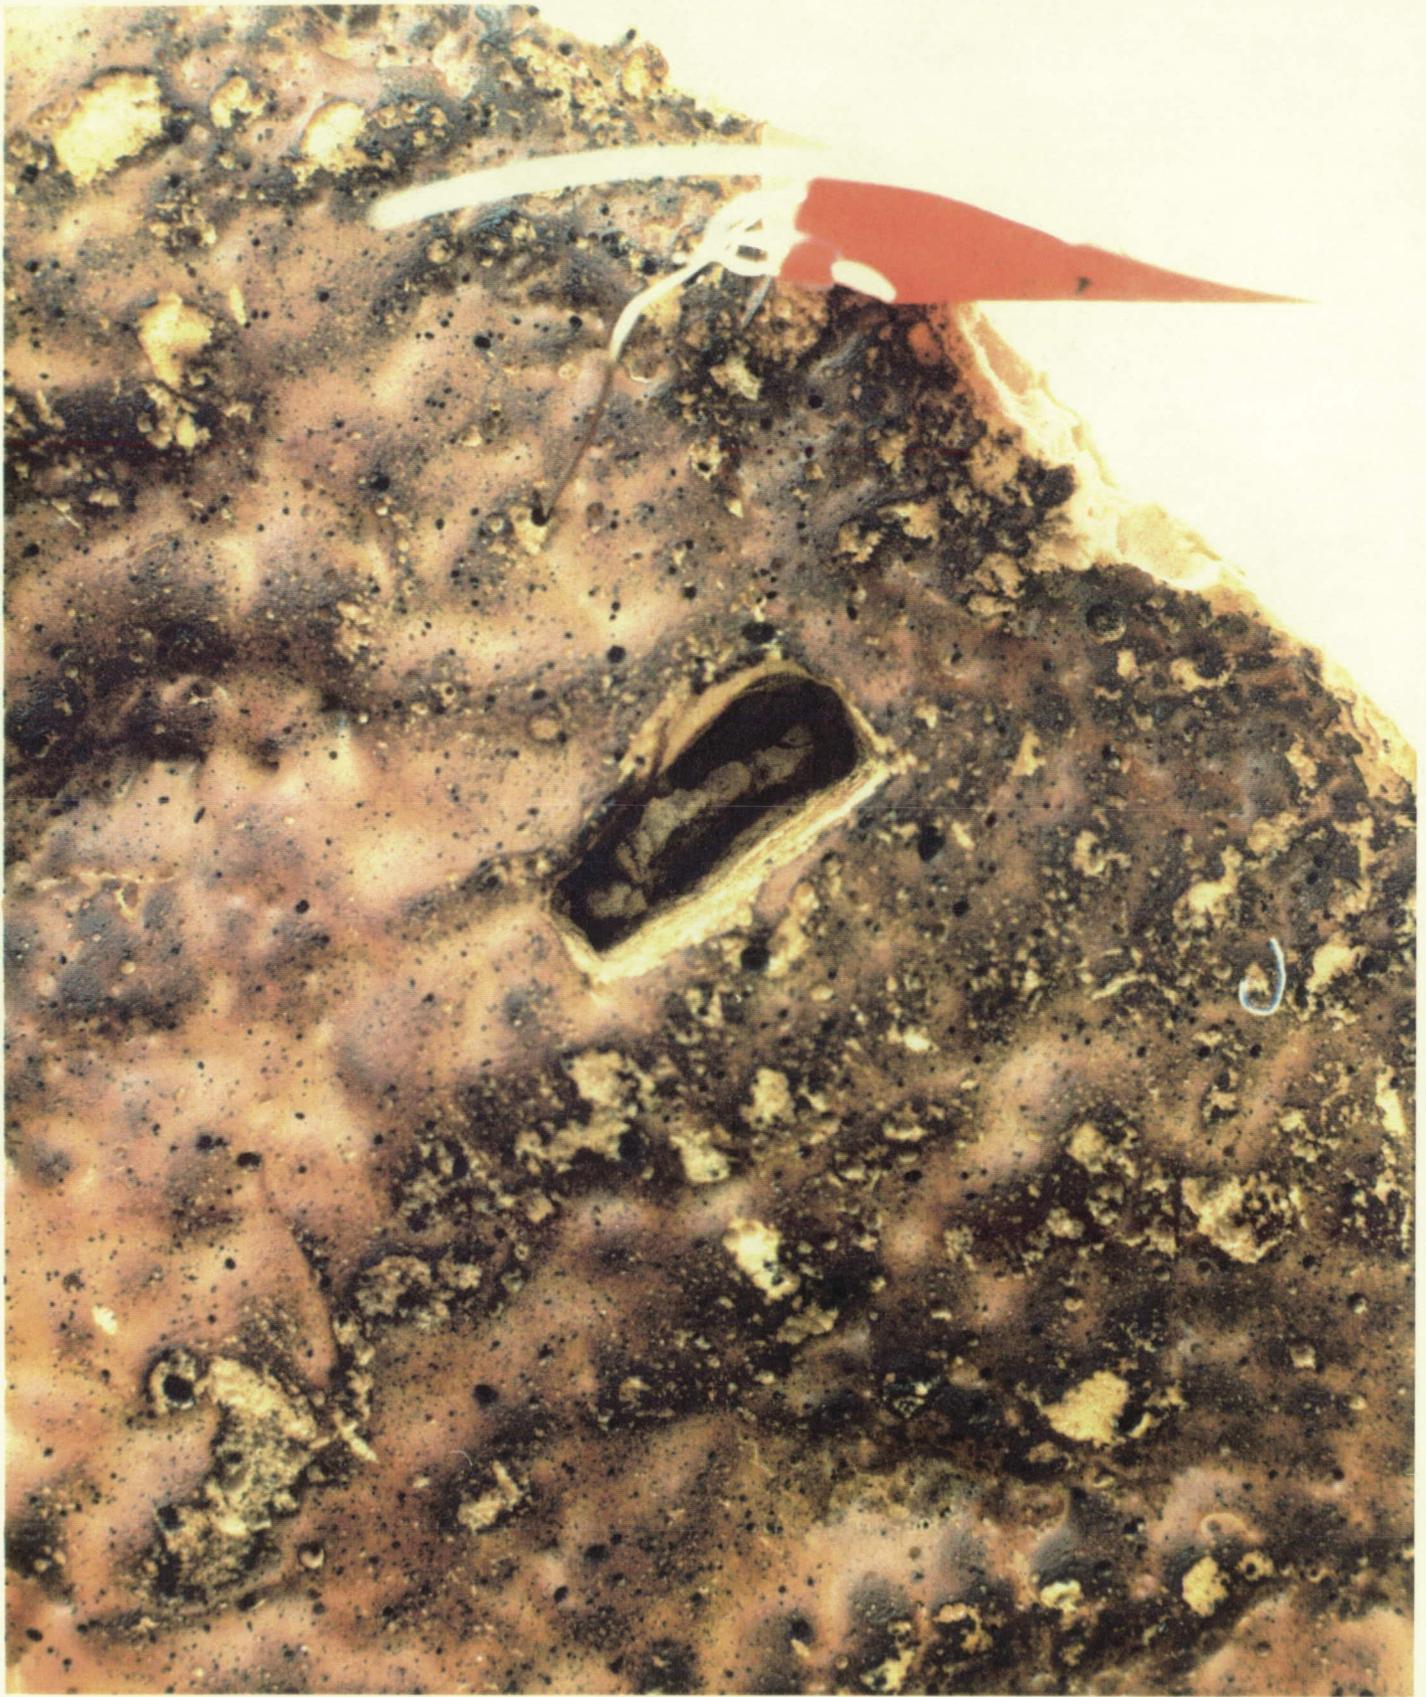
Two cavities were present in the forward-facing ETA ring TPS. Post flight analysis revealed no evidence of embedded debris or foreign material. The cavities had experienced a full ascent heat load and were most likely present prior to launch rather than an in-flight occurrence.

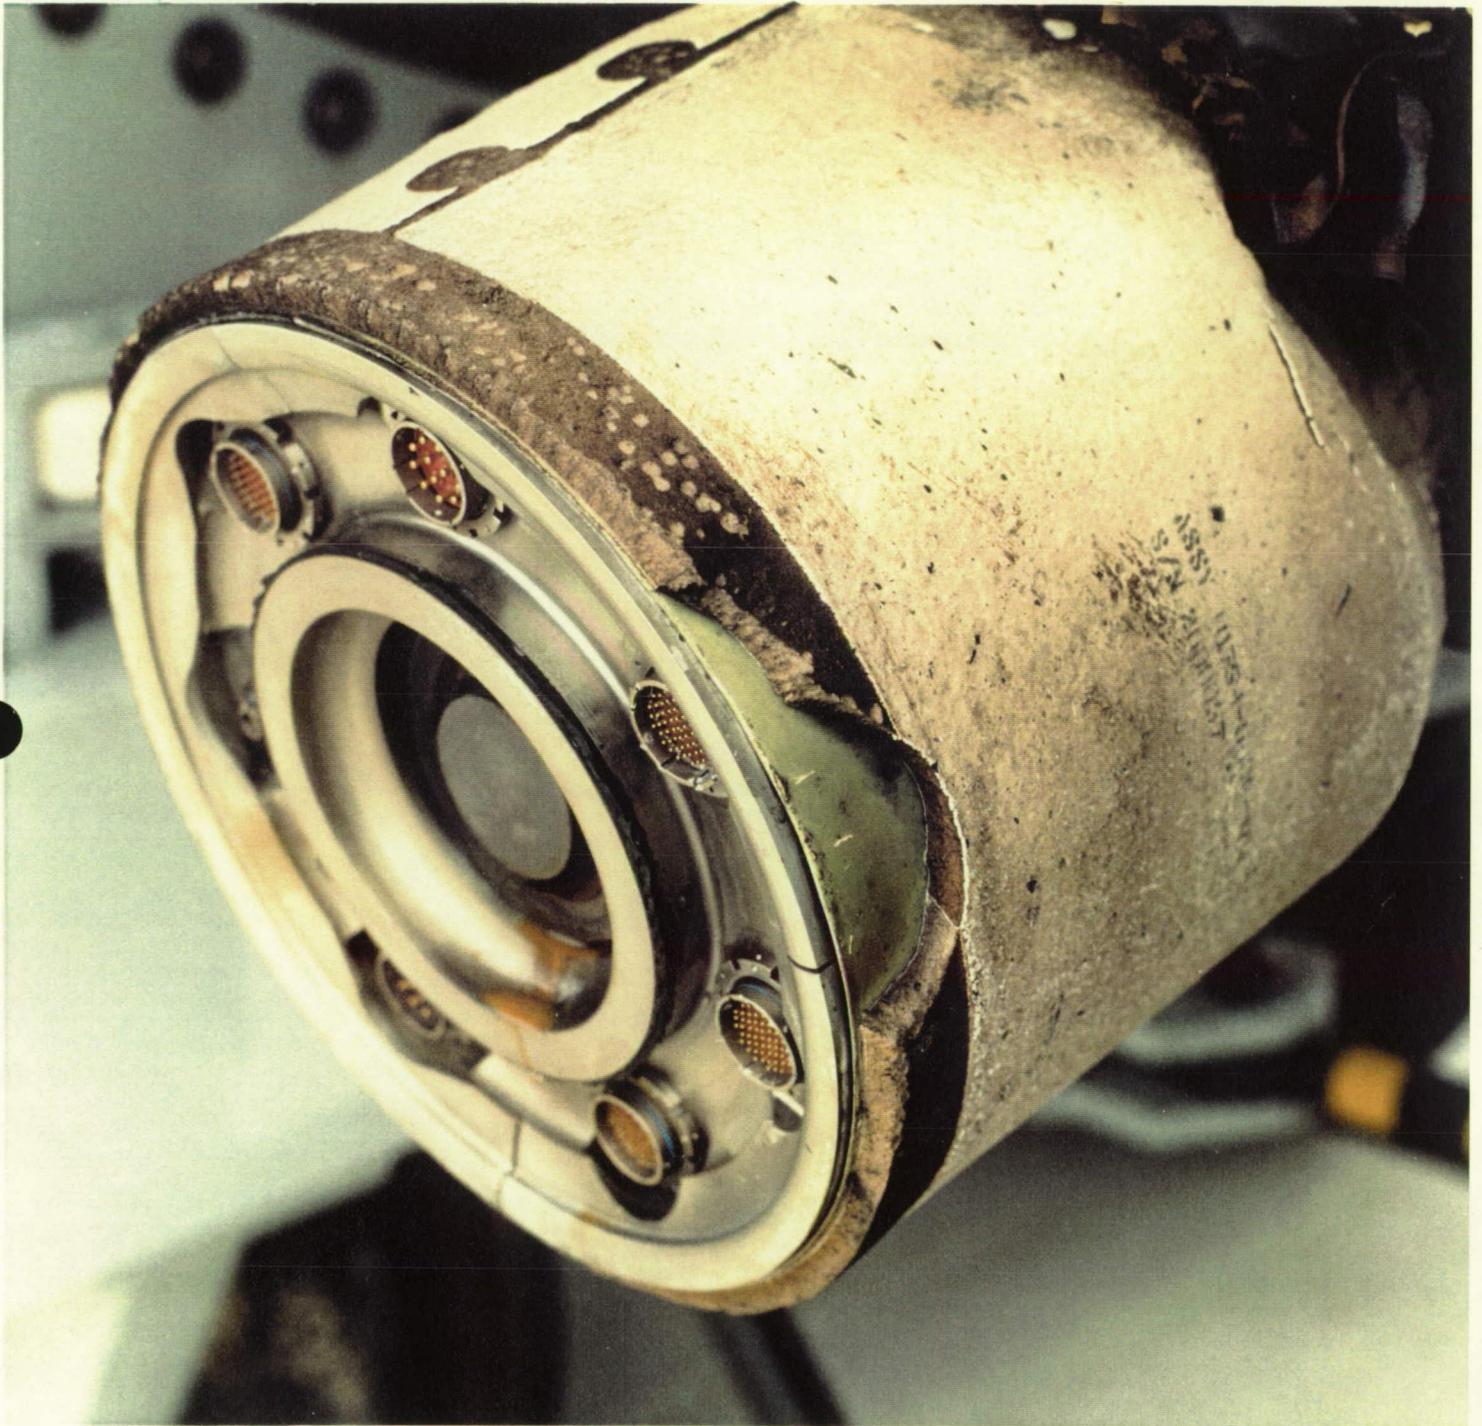
The upper strut fairing (milk can) was missing a 7" x 3" piece of K5NA. The substrate was charred.

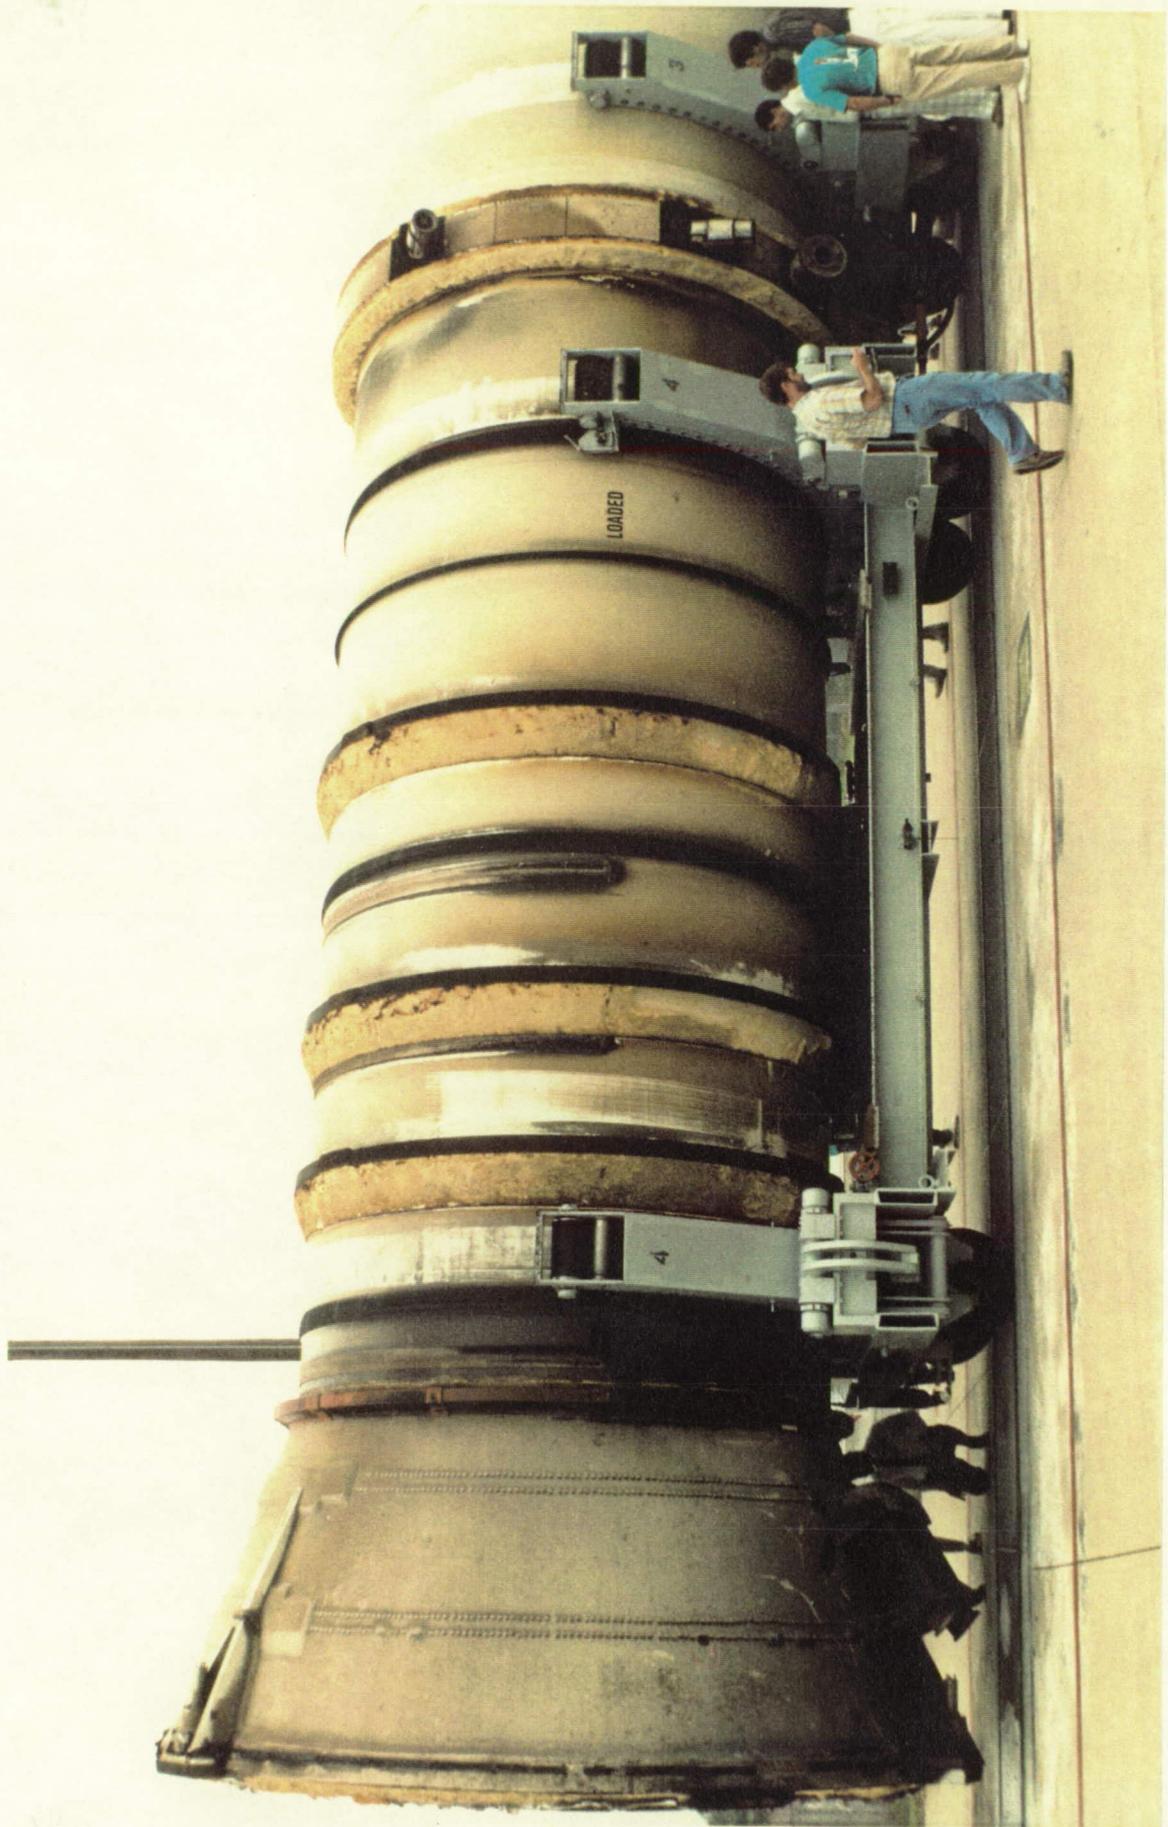
Post flight condition of the RH aft booster. Separation of the aft ET/SRB struts appeared normal. All three aft booster stiffener rings sustained water impact damage.

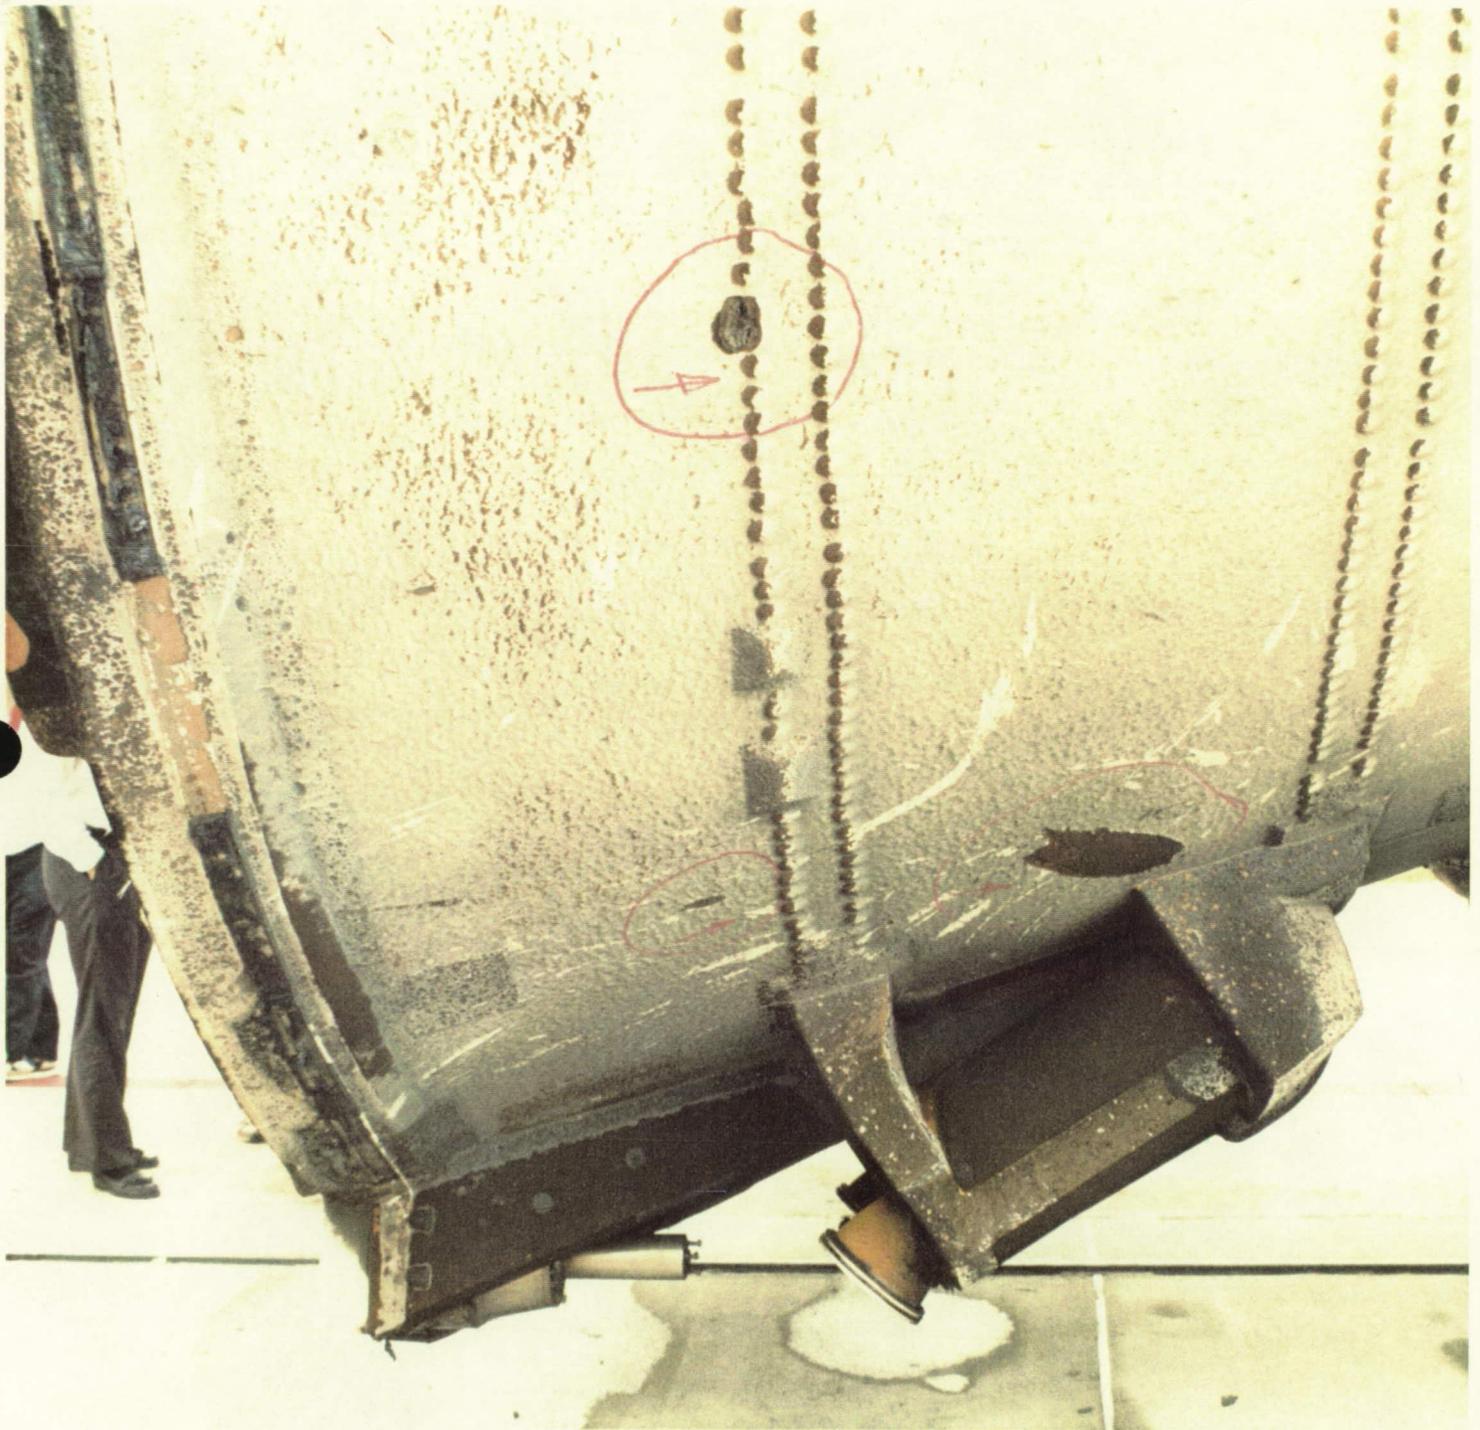
Three divots, one of which exposed two fastener head covers, occurred on the aft skirt acreage TPS near the location of the booster separation motors (BSM's).

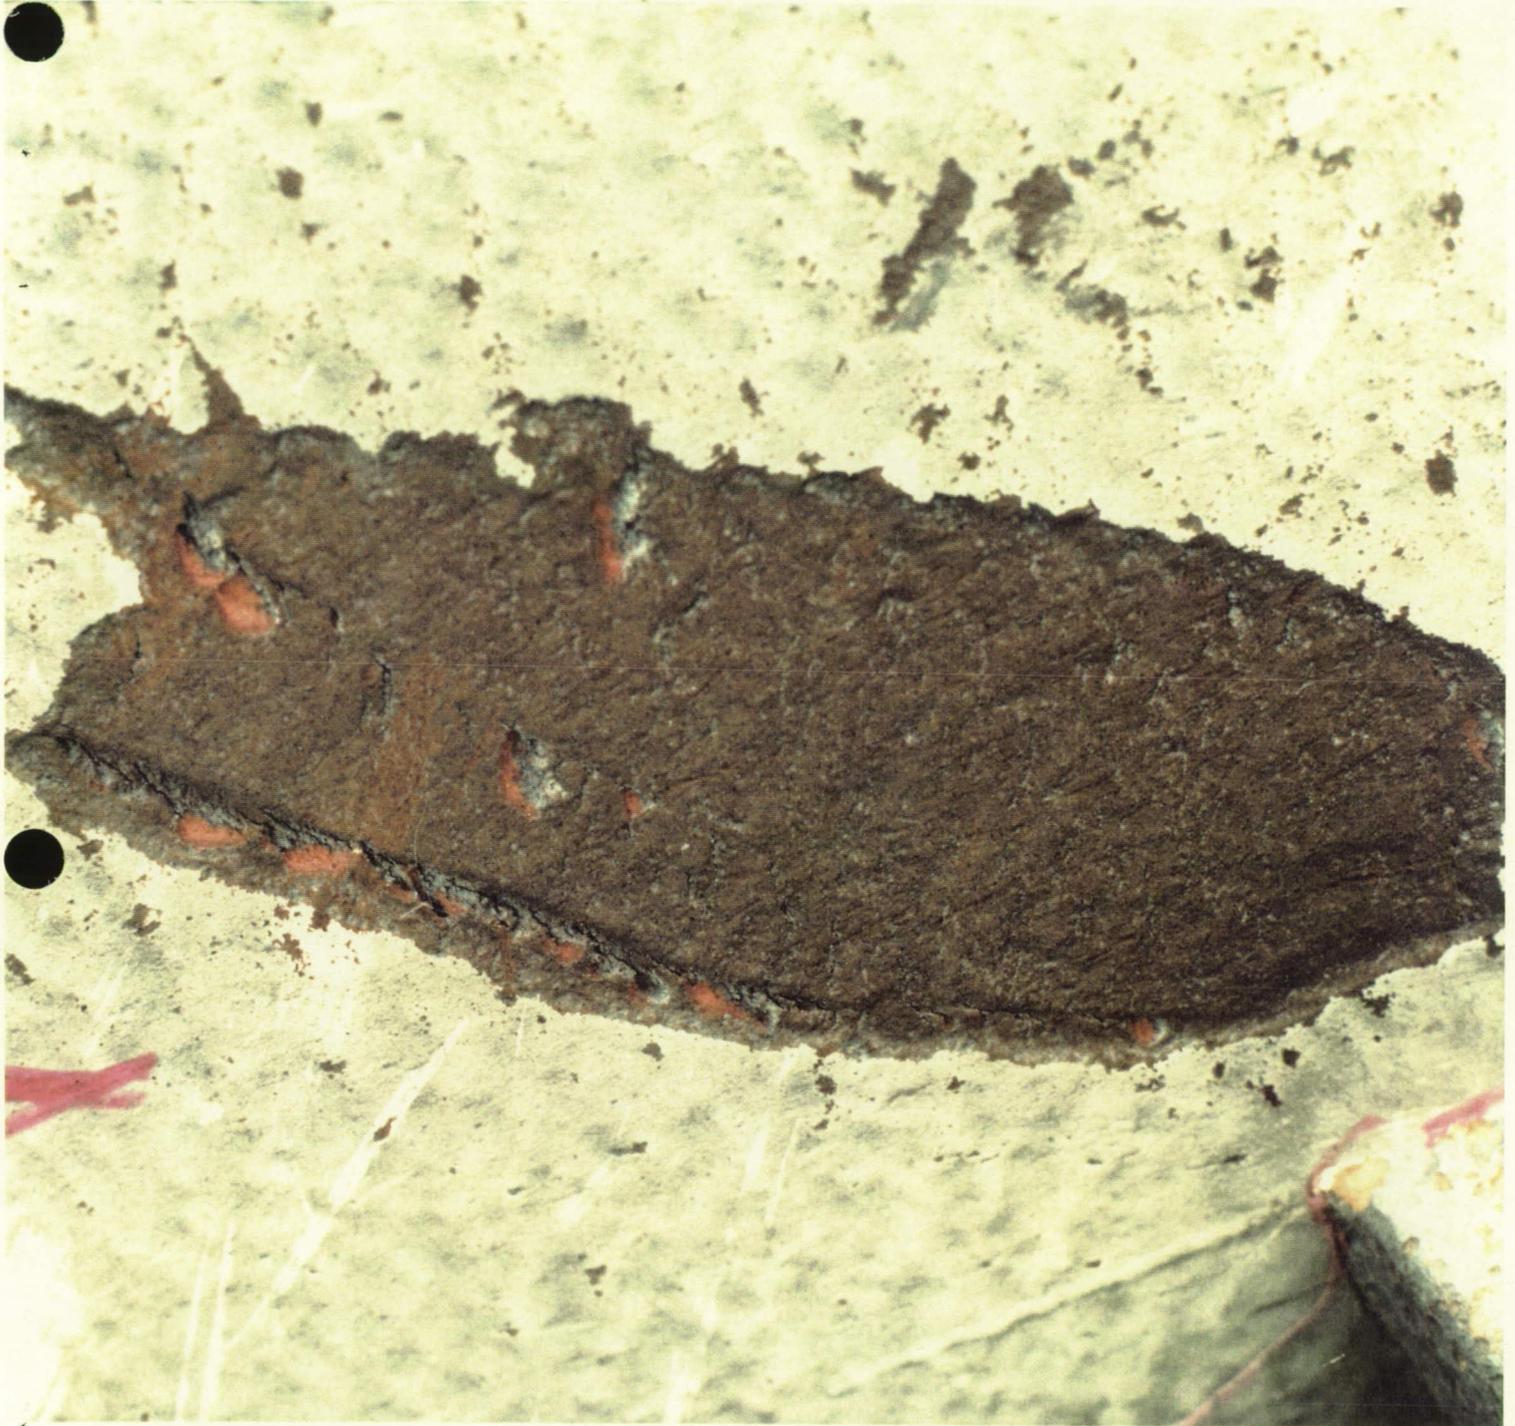
Close-up view of the 13" x 5" MSA-2 divot. Post flight analysis revealed a lack of high heat exposure, but did show signs of debris impacts followed by in-flight erosion. However, no foreign debris particles were detected in the remaining material. The divot most likely occurred during descent since areas of MSA-2 within the divot were peeled upward toward the nosecone and exhibited forward fracture sooting.

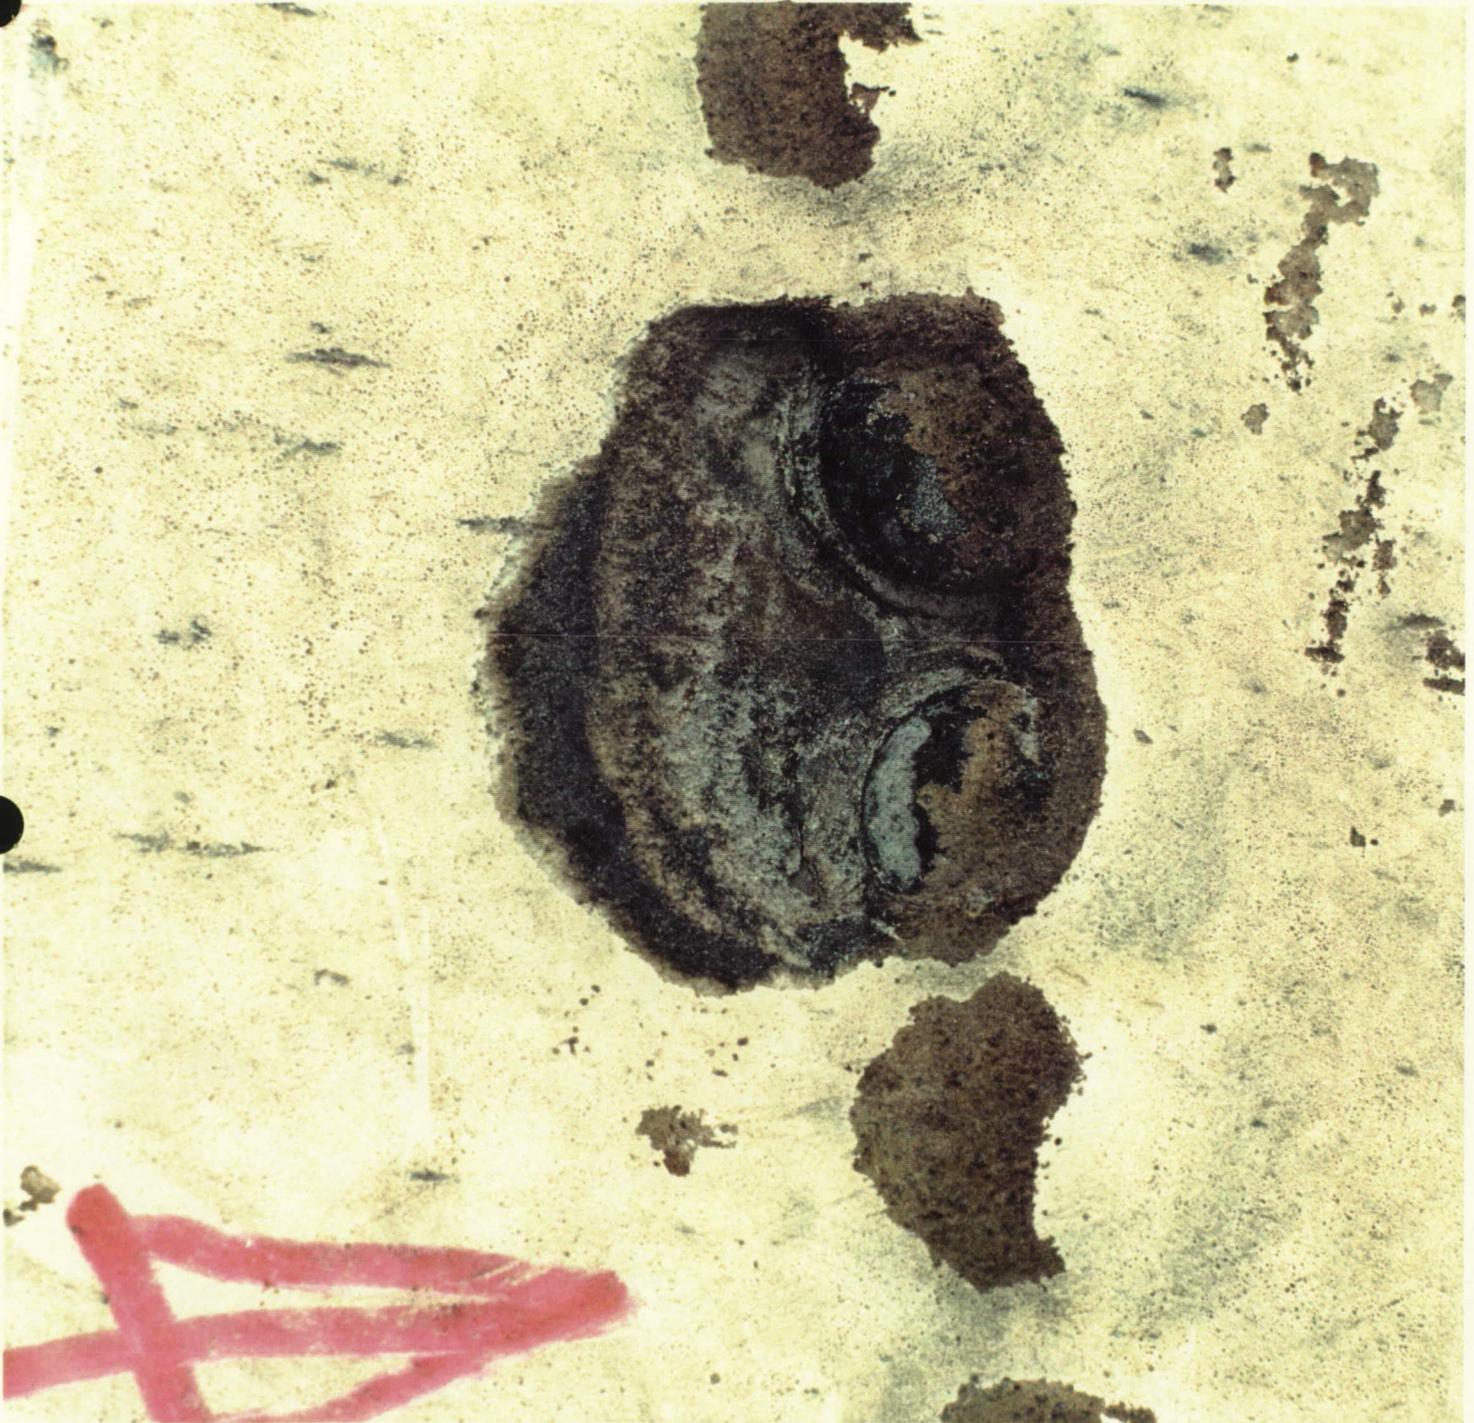
This divot exposed two fastener head covers and a small area of substrate. Post flight analysis revealed no foreign debris or high ascent heating effects. The divot was caused by a "smiley" starting aft of the fasteners during descent, which sooted the aft fracture surface before the MSA-2 broke loose.

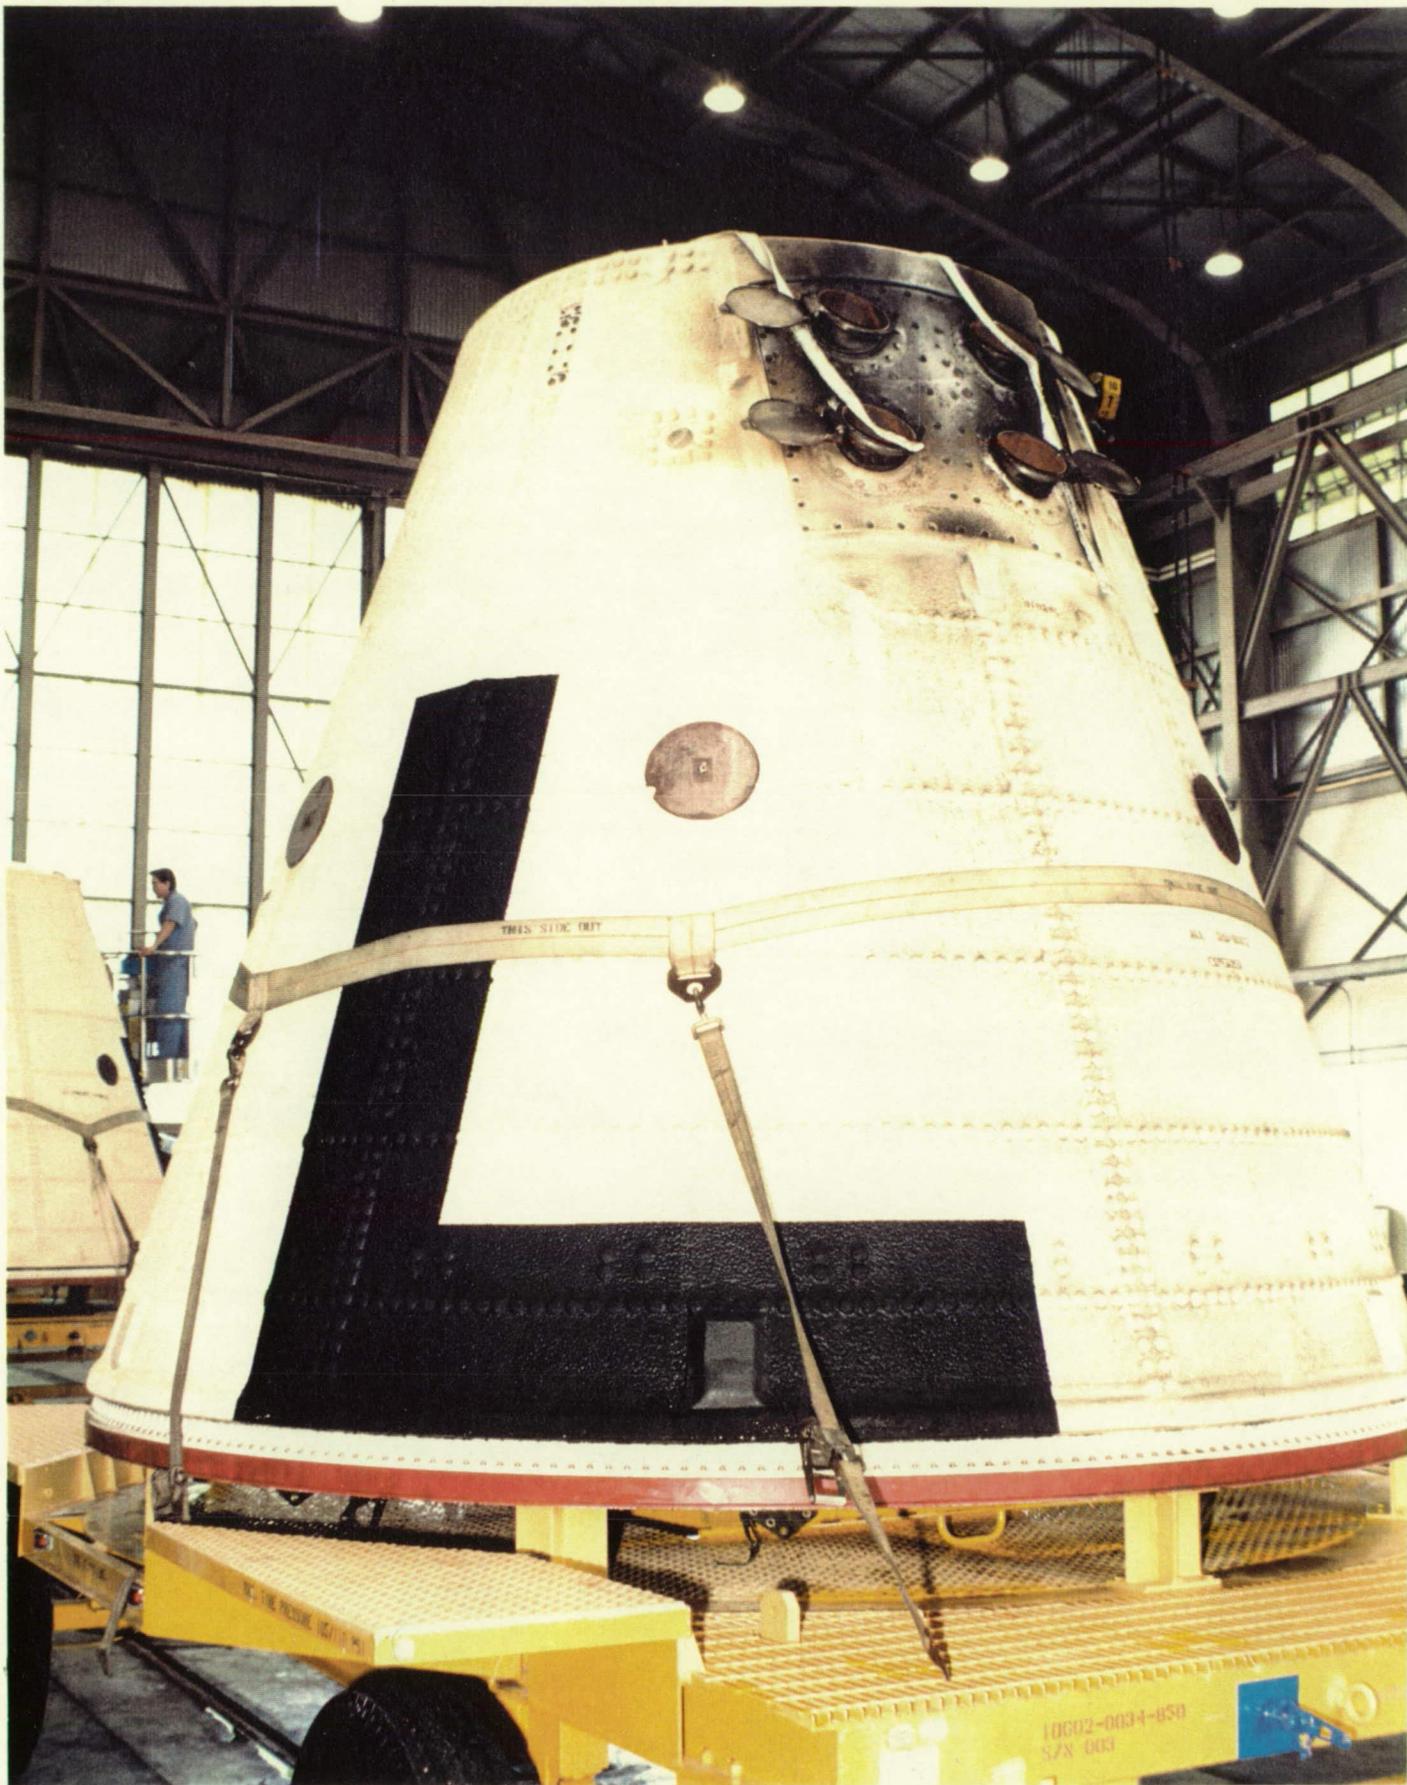
The LH frustum was missing no TPS, but had 27 MSA-2 debonds over fasteners. The BSM aero heat shield covers were locked in the fully opened position.

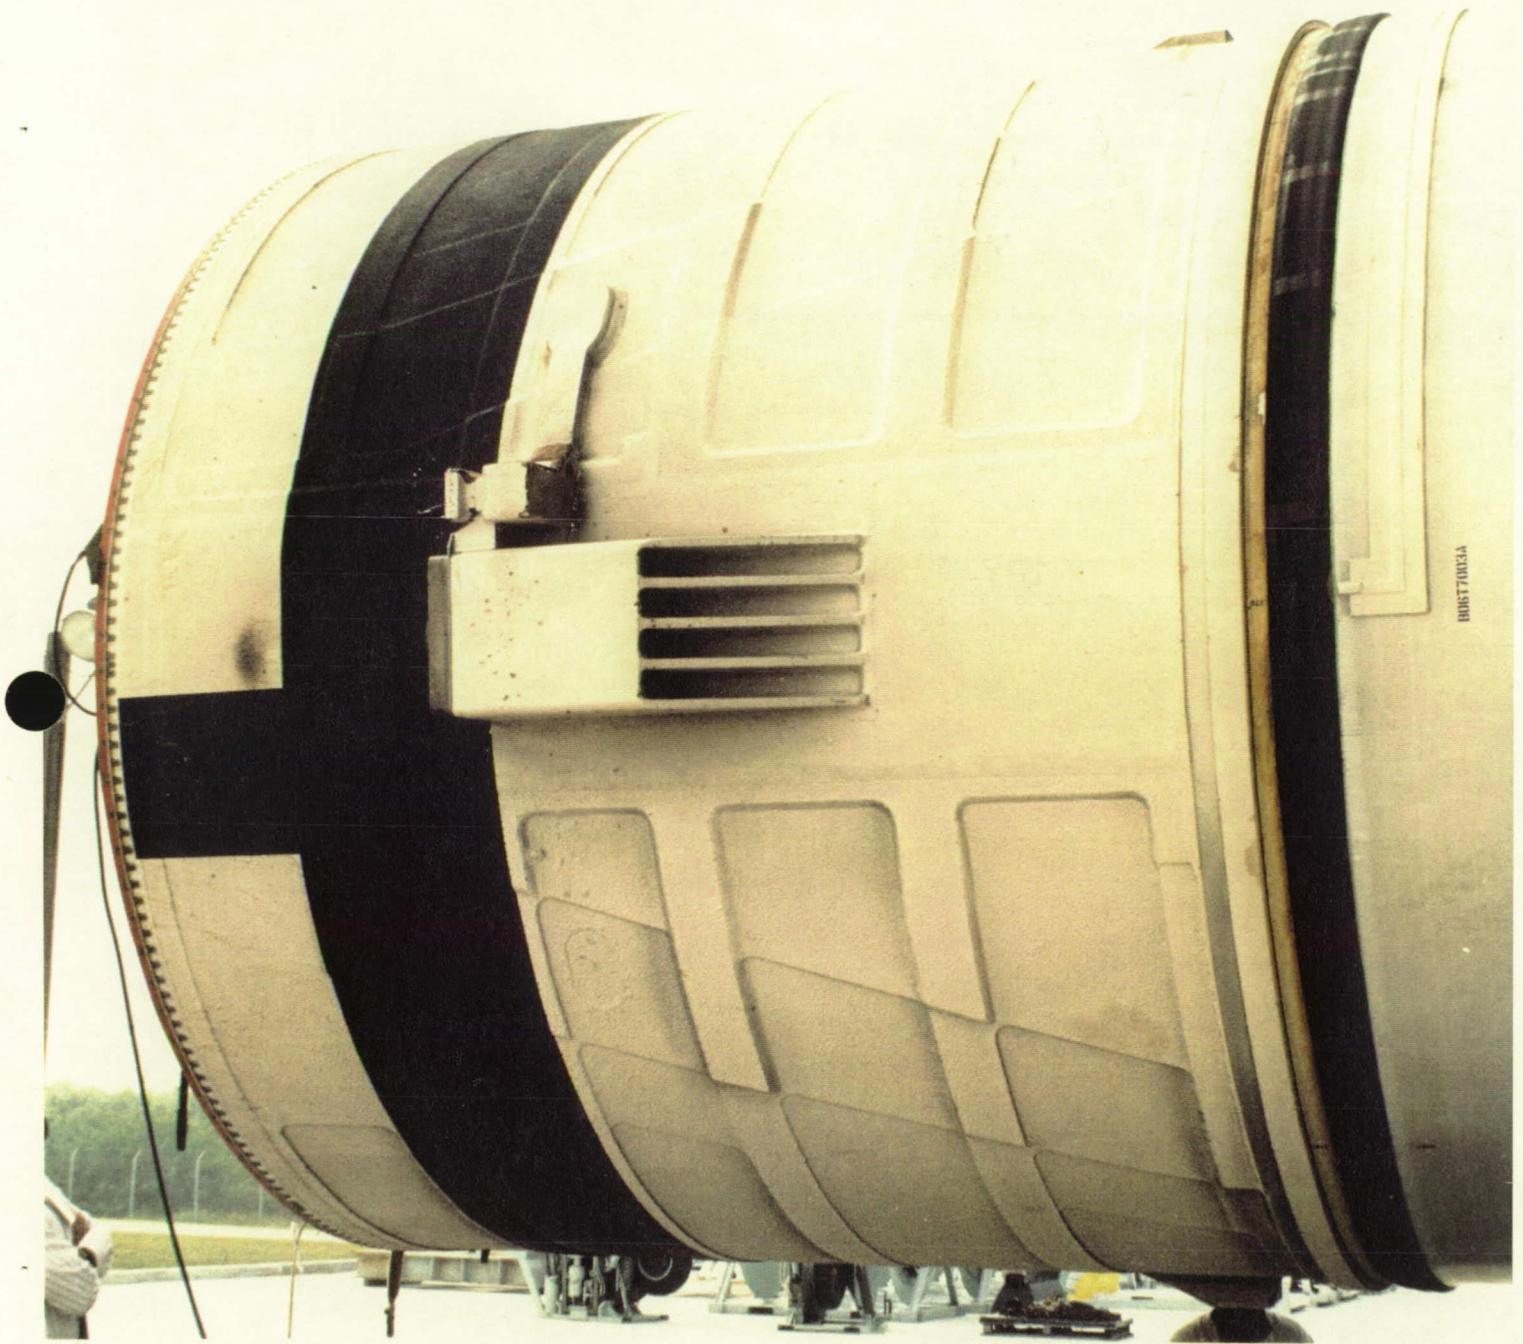
The LH forward skirt exhibited no debonds or missing TPS. Minor blistering of the Hypalon paint occurred in localized areas. Both RSS antenna covers/TPS were intact and undamaged.

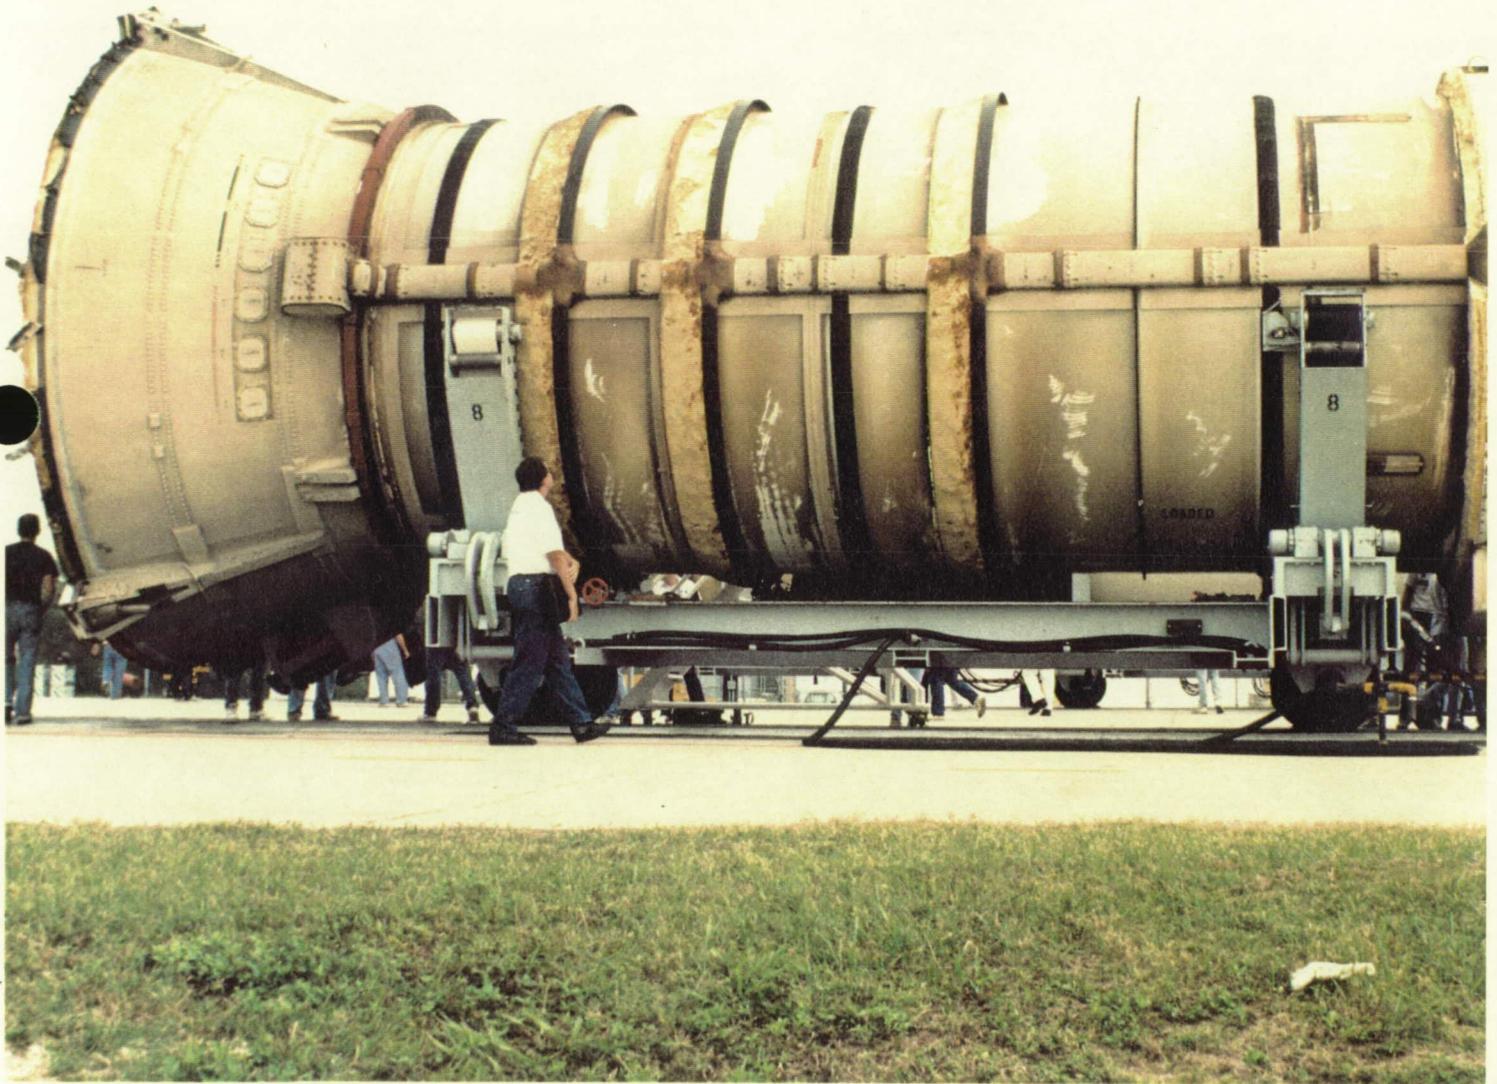
Post flight condition of the LH aft booster. The ET/SRB aft struts, ETA ring, IEA, and IEA covers appeared undamaged. All three aft booster stiffener rings sustained water impact damage

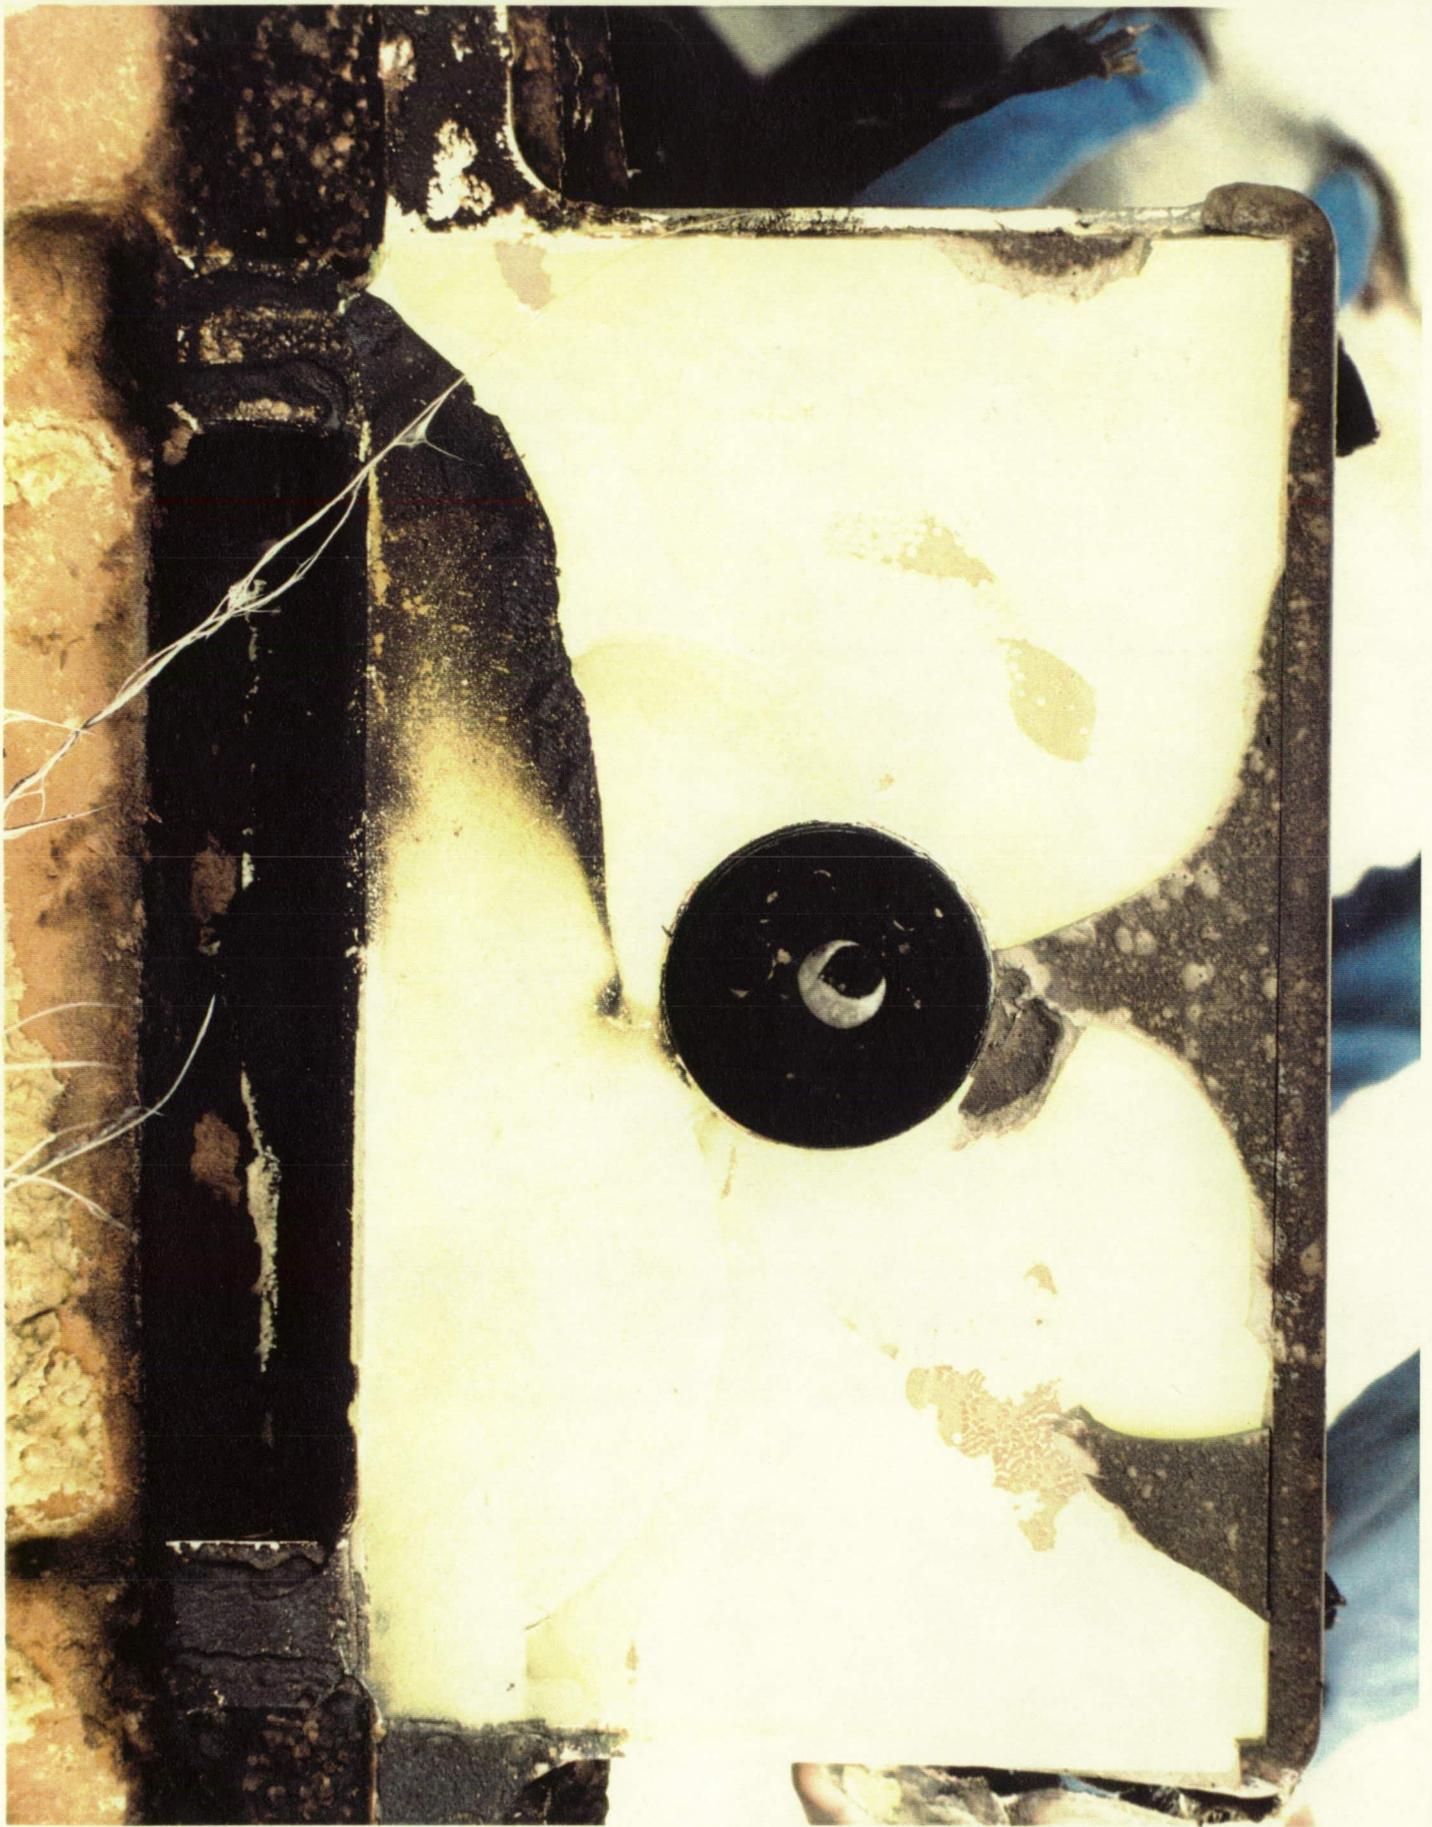
A piece of the HDP #8 EPON shim was missing prior to water impact (sooted/charred substrate).
