Debris/Ice/TPS Assessment And Integrated Photographic Analysis For Shuttle Mission STS-52

December 1992

DEBRIS/ICE/TPS ASSESSMENT
AND
PHOTOGRAPHIC ANALYSIS
OF
SHUTTLE MISSION STS-52

October 22, 1992

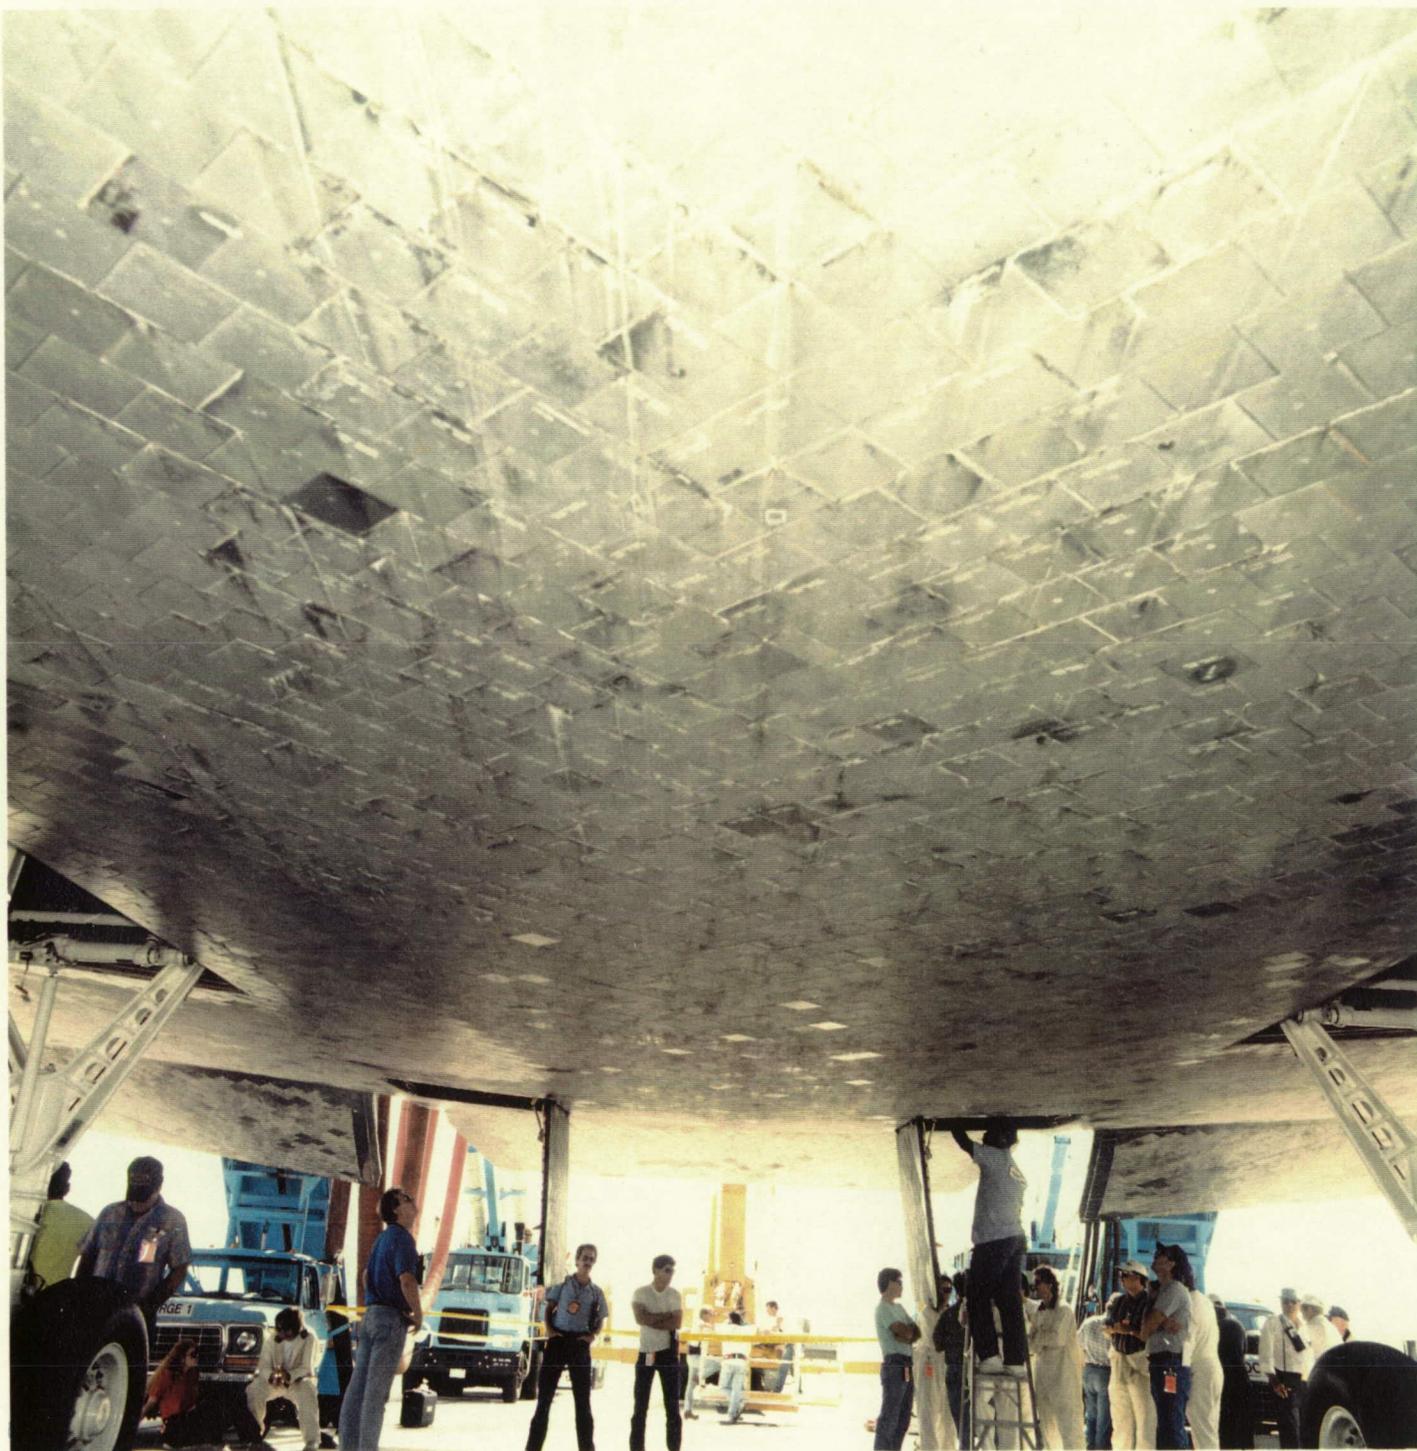
The Orbiter lower surface tiles sustained a total of 152 hits, of which six had a major dimension of 1-inch or greater. The distribution of tile damage hits does not suggest a single source of ascent debris, but indicates a shedding of ice and/or TPS debris from random sources.

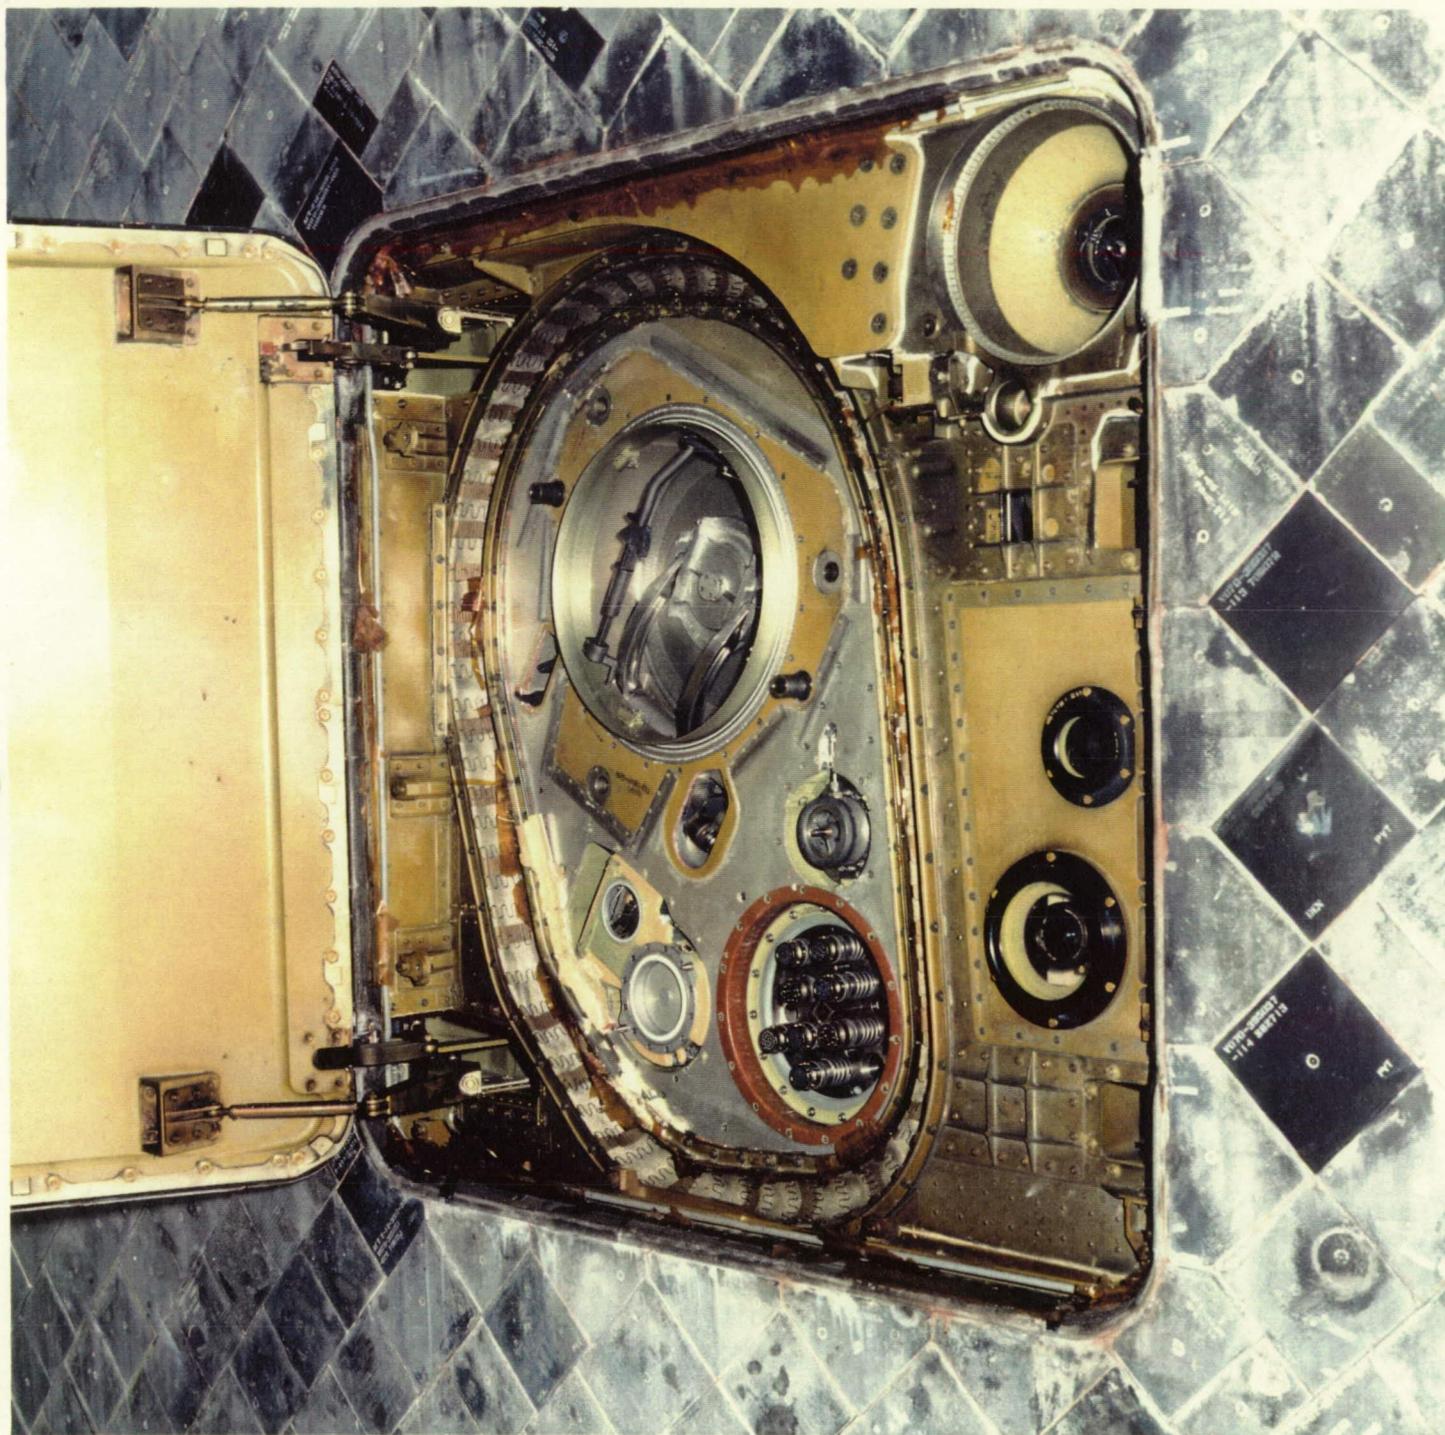
Overall view of the LH2 ET/ORB umbilical. All separation ordnance devices functioned properly. No flight hardware was found on the runway below the umbilical when the ET door was opened.

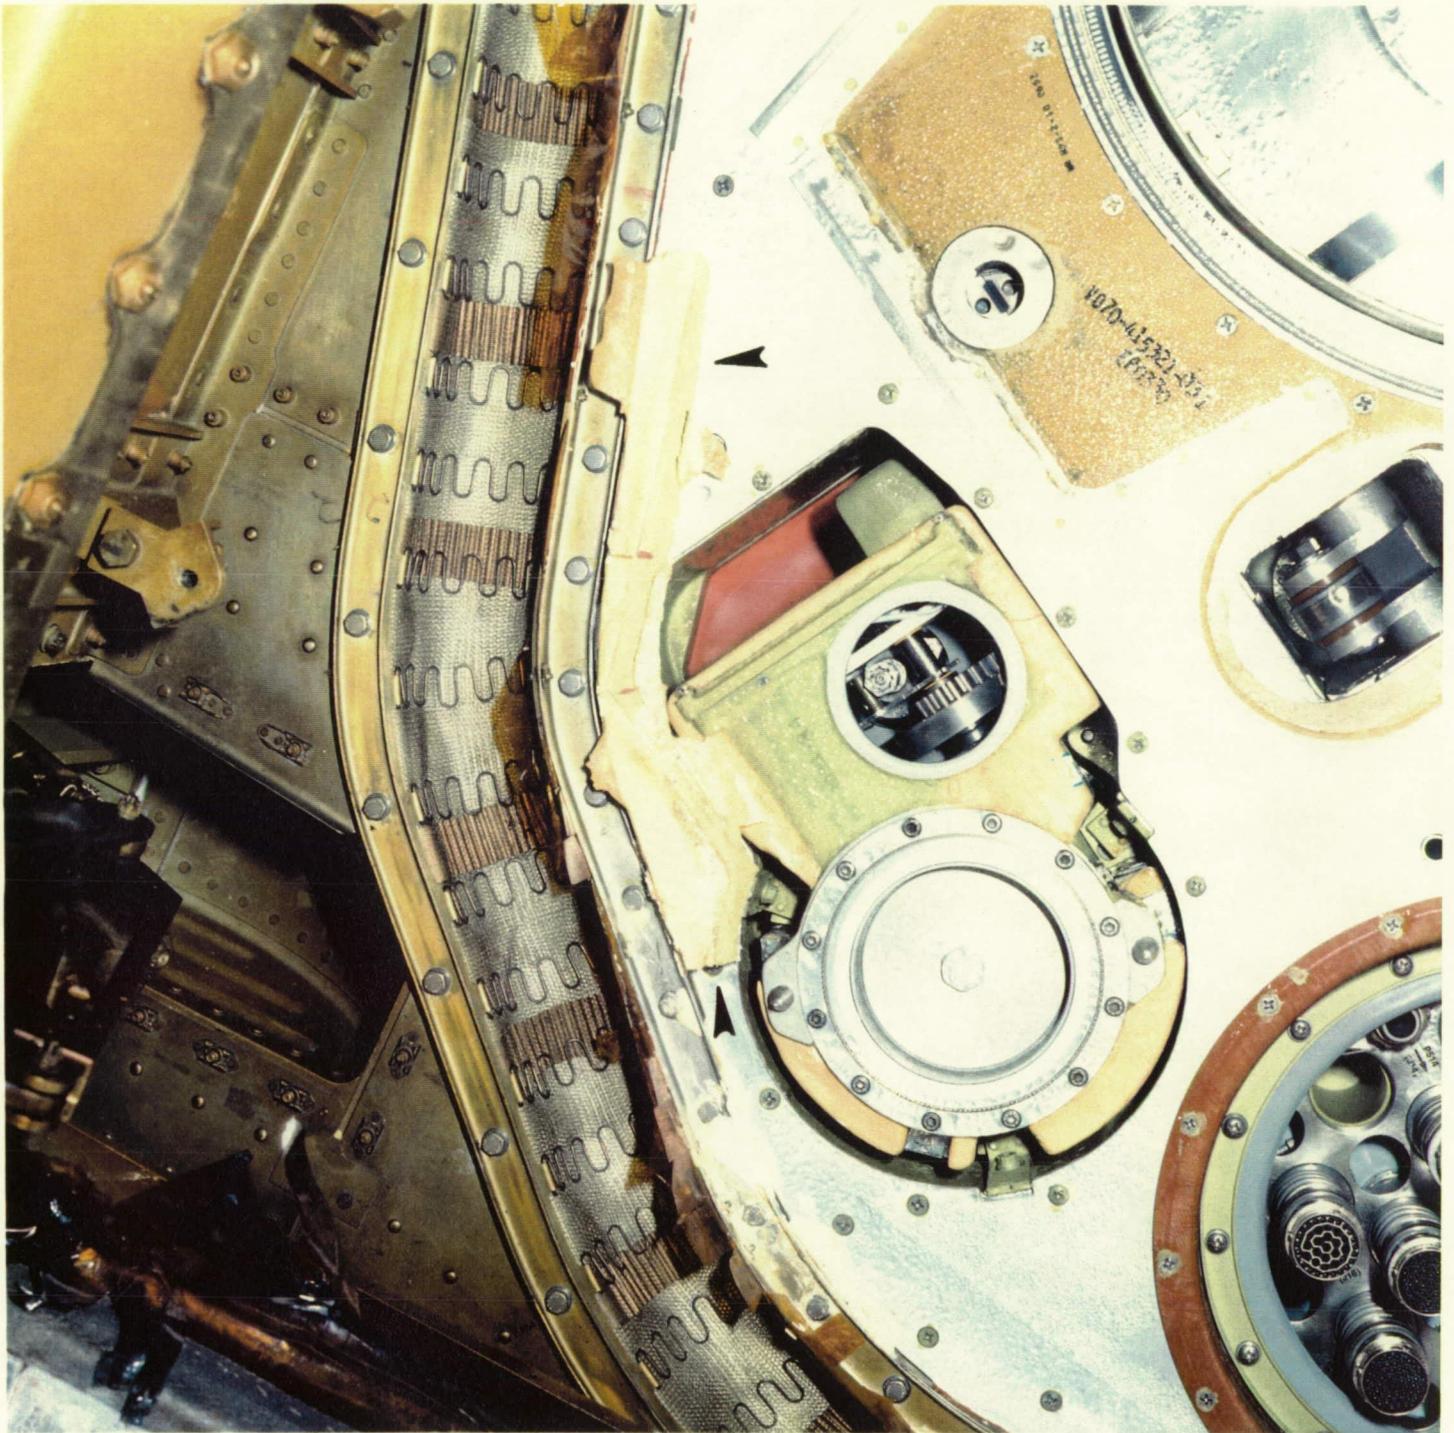
A section of the ET/ORB LH2 umbilical purge seal and closeout foam was still attached to the interface plate/disconnect. The missing section was visible in the separation camera films.

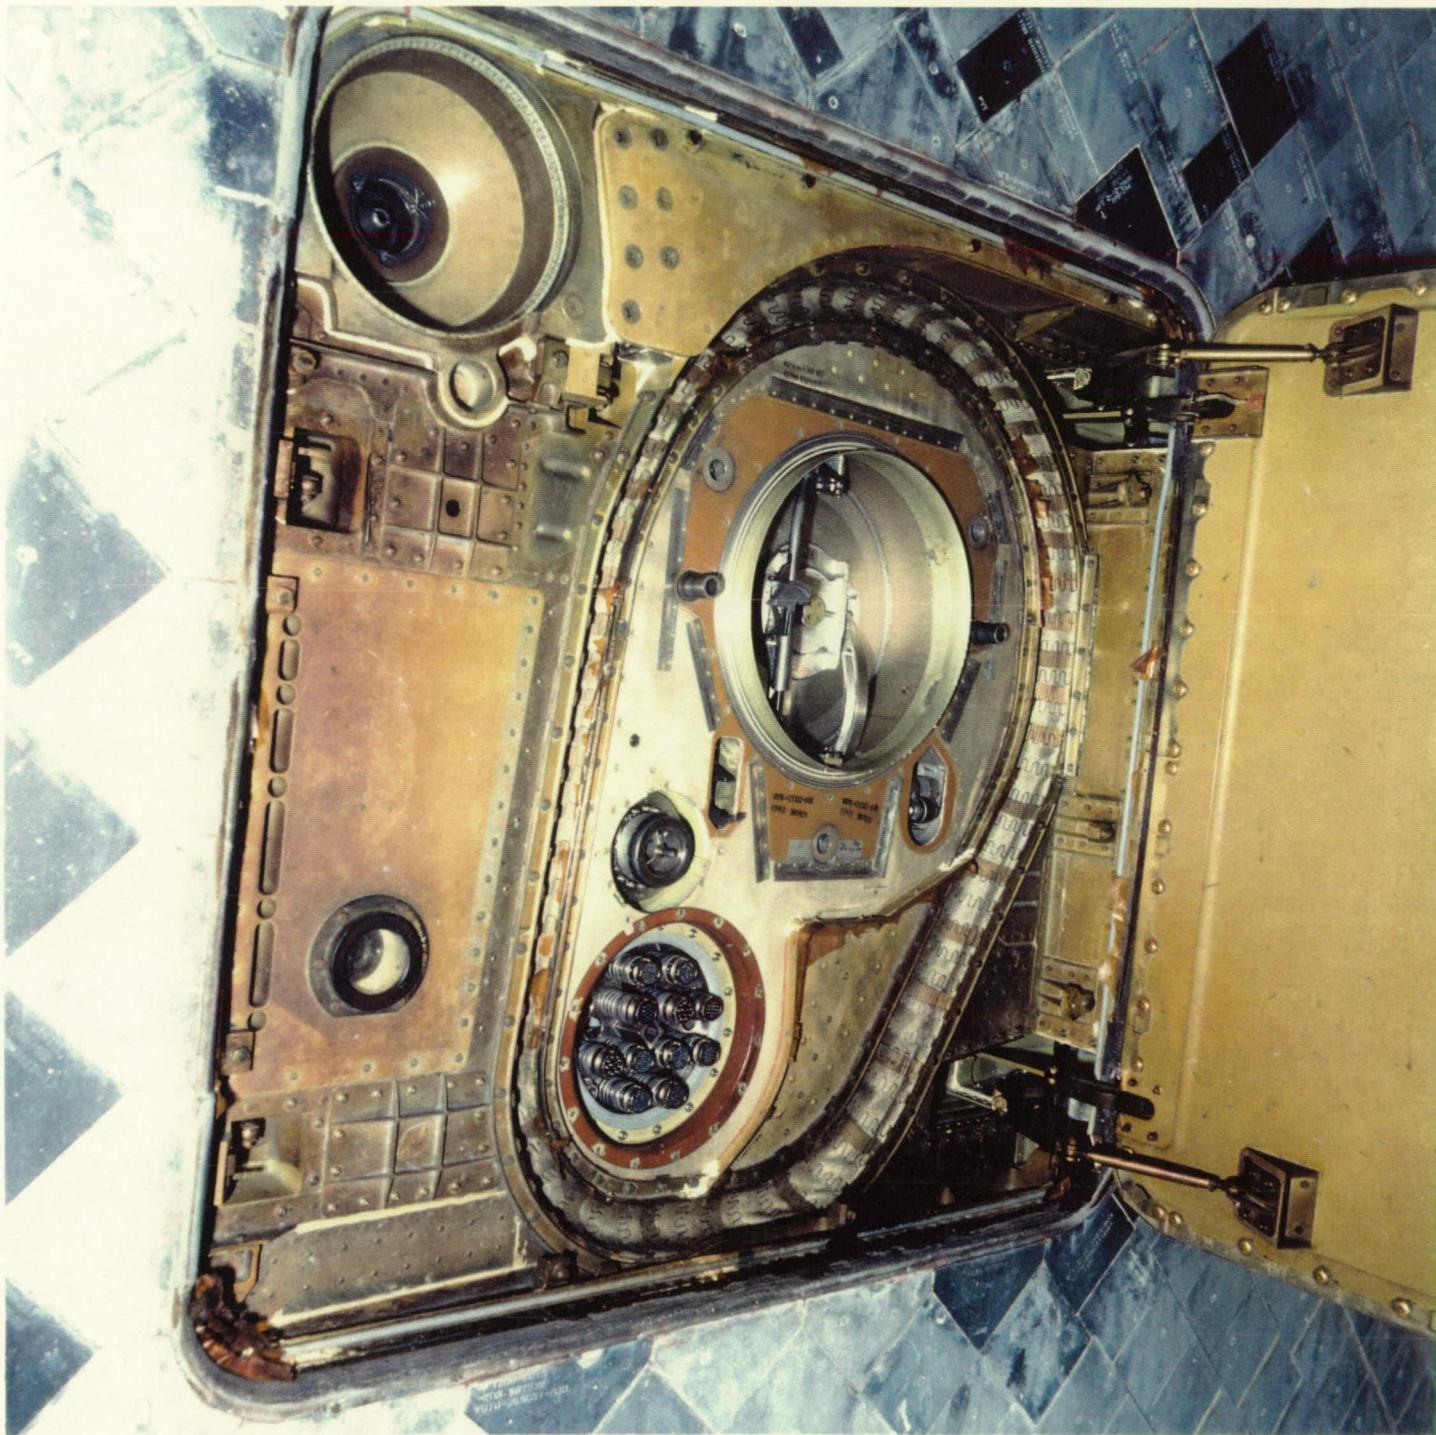
Overall view of the L02 ET/ORB umbilical. All separation ordnance devices functioned properly. No flight hardware was found on the runway below the umbilical when the ET door was opened.

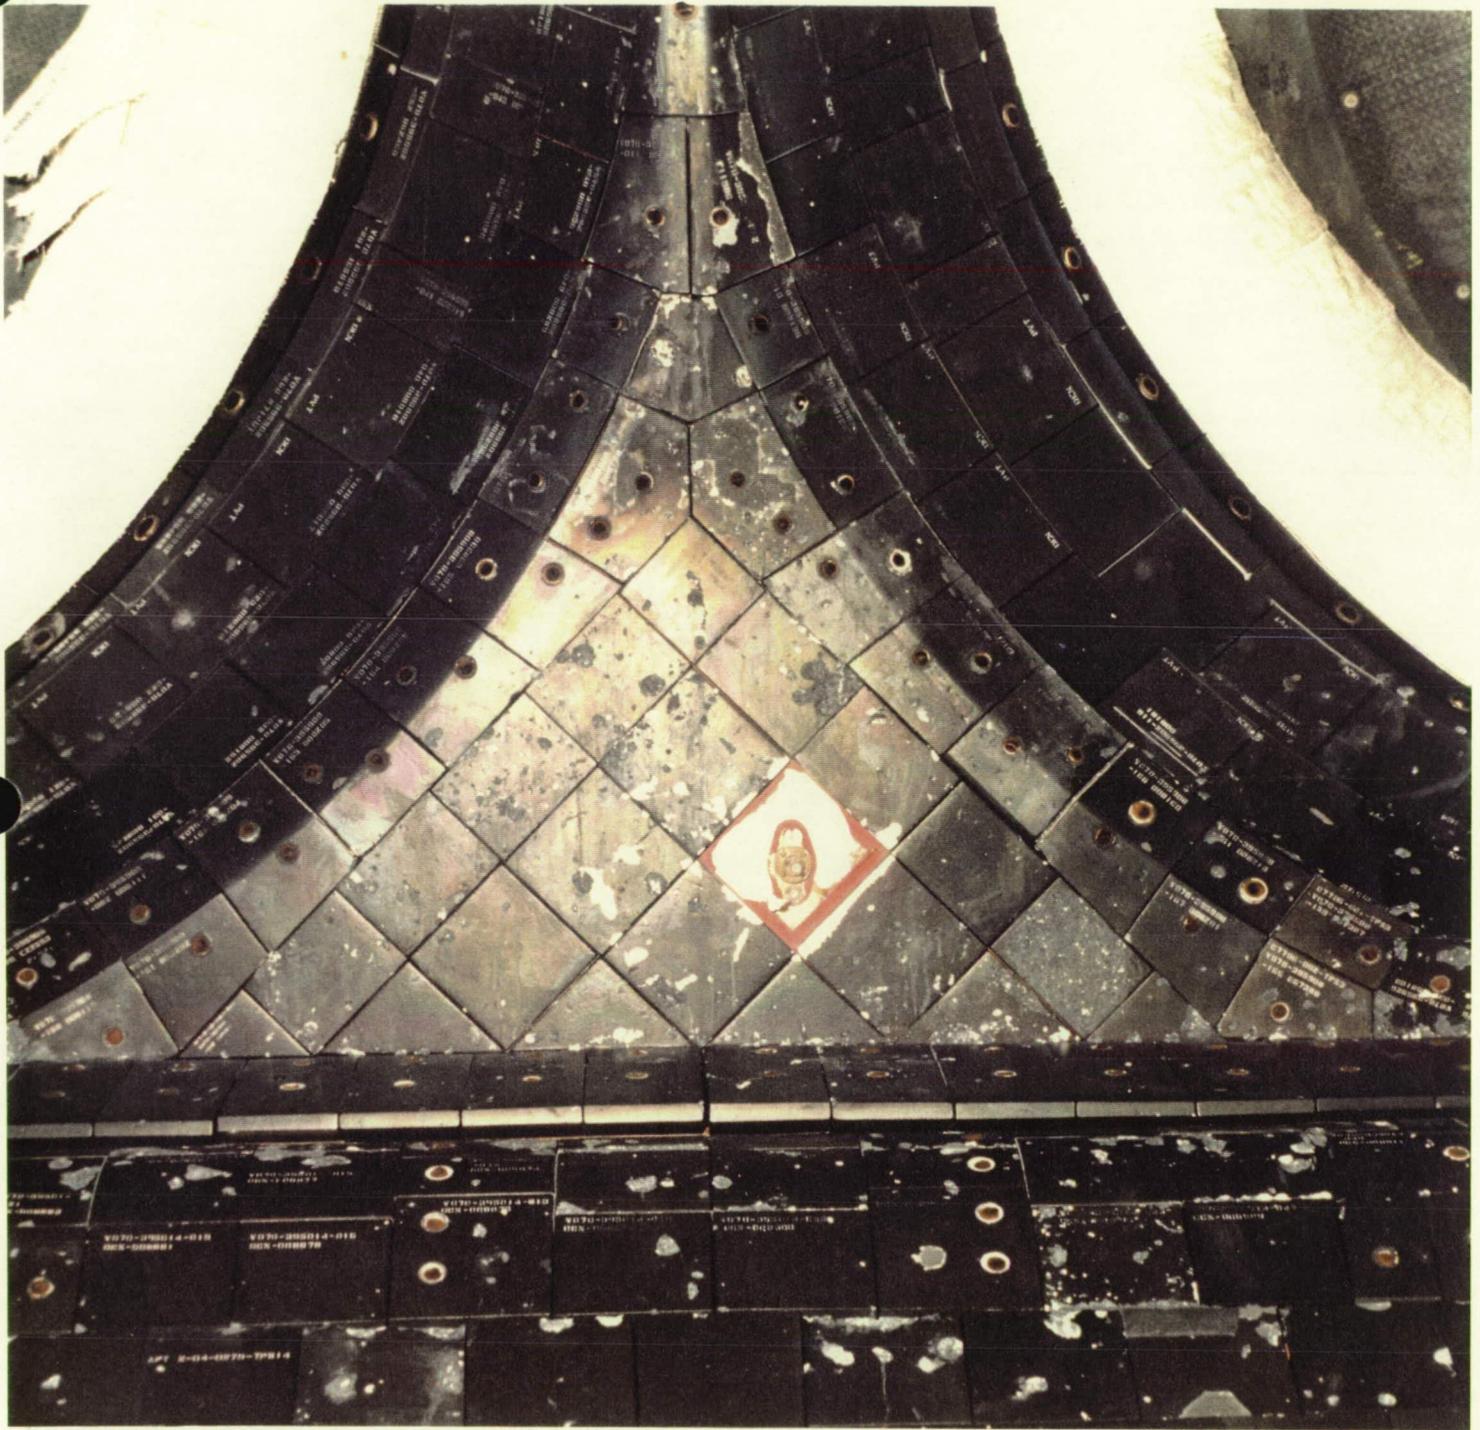
The majority of tile V070-395093-016 was missing from the base heat shield between SSME #2 and #3. This tile, which covers a calorimeter, sustained an in-plane failure, leaving the strain isolation pad and an attached layer (approximately 0.3 inches thick) of densified tile material in the cavity. An In-Flight Anomaly (IFA) was taken. In addition to the missing tile, an 8 by 6 by 0.5-inch tile damage site was present on the base heat shield adjacent to SSME #1 (at approximately the 7:00 o'clock position). This damage site appeared to have been caused by a dense object and may have been caused by the lost tile. This flight marked the fourth use of the Orbiter drag chute. The drag chute appeared to have functioned nominally. All drag chute hardware was recovered and showed no signs of abnormal operation. The only unexpected flight hardware found on the runway was a tile gap filler from the aft fuselage sidewall.

The majority of tile V070-395093-016 was missing from the base heat shield between SSME #2 and #3. This tile, which covered a calorimeter, sustained an in-plane failure leaving the strain isolation pad (SIP) and an attached layer of densified tile material in the cavity.

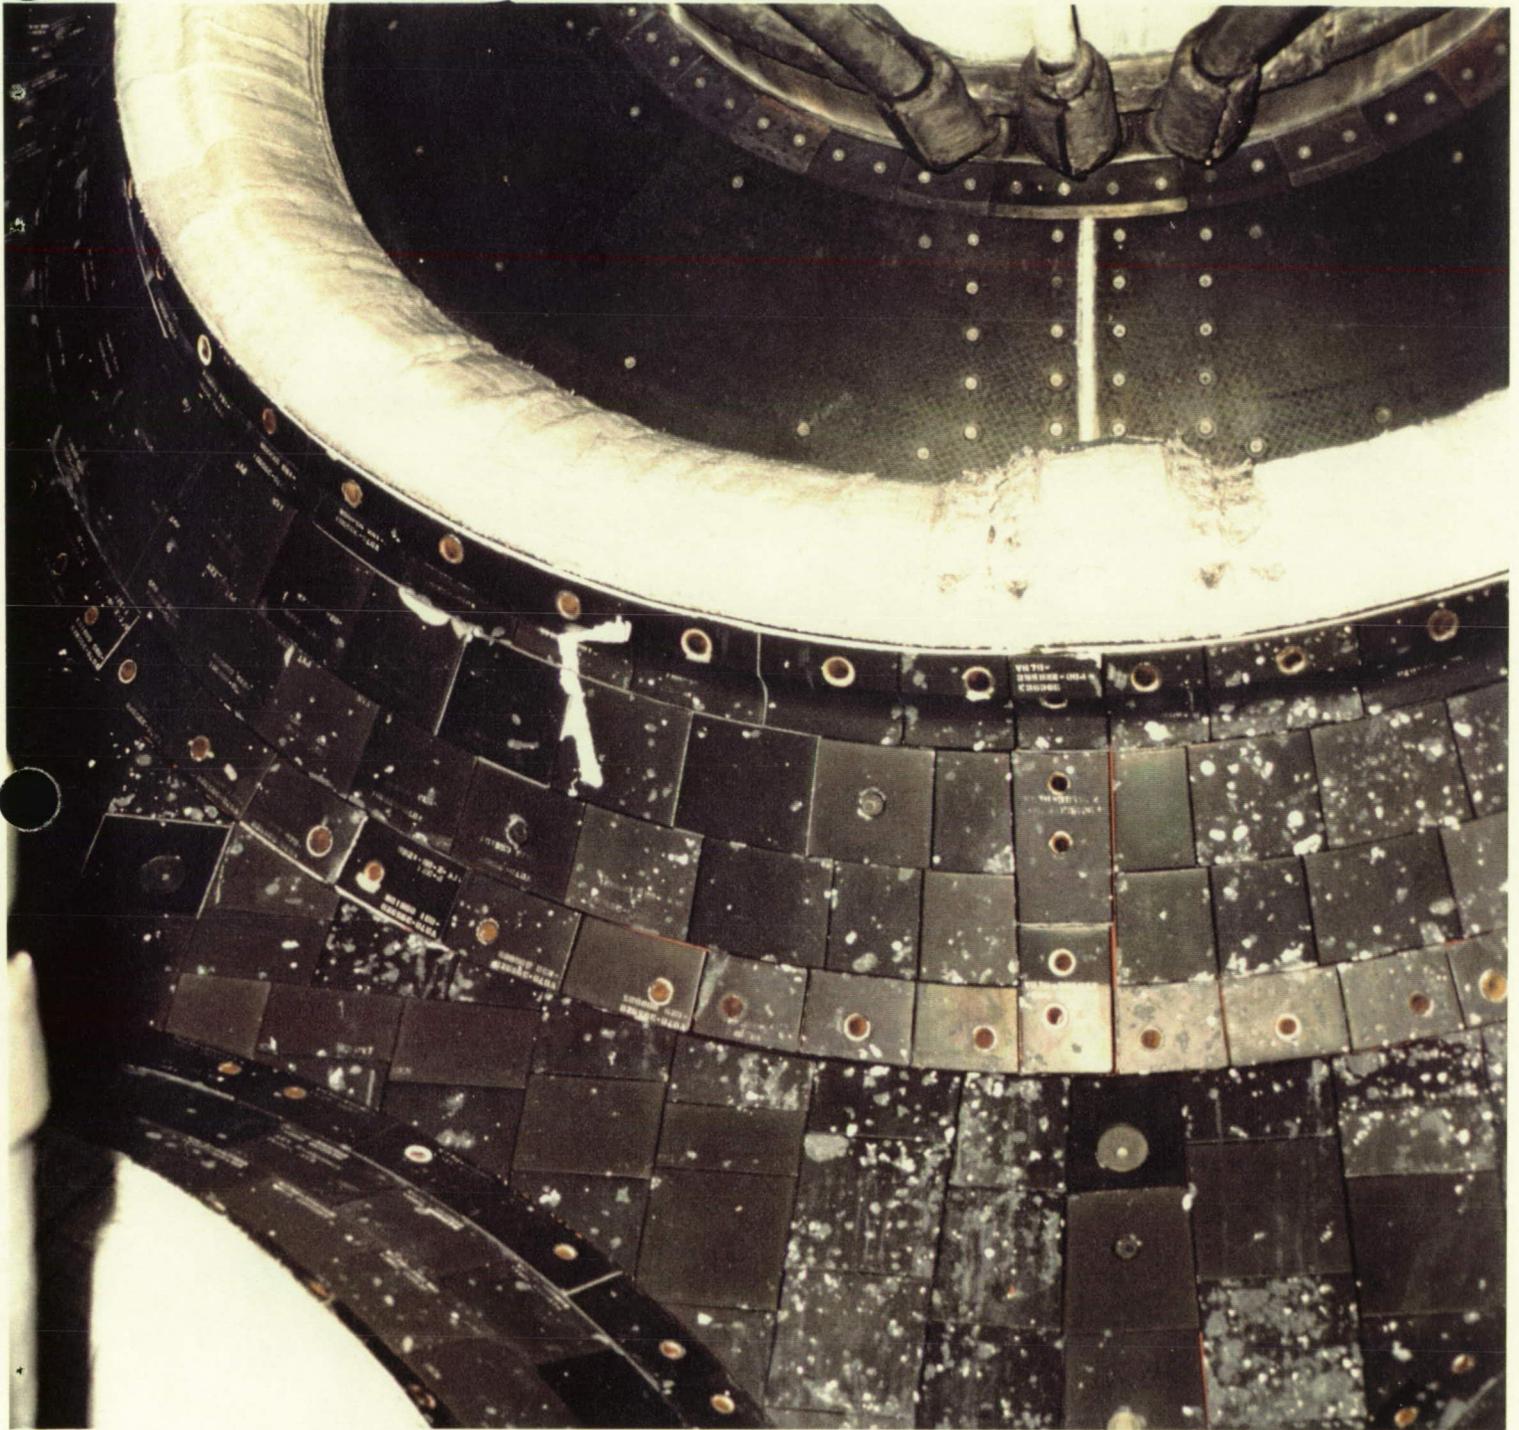
An 8" x 6" x 0.5" tile damage site was present on the base heat shield adjacent to SSME #1 (at approximately the 7:00 o'clock position). This damage site appeared to have been caused by a dense object and may have been hit by the lost tile between SSME #2 and #3.

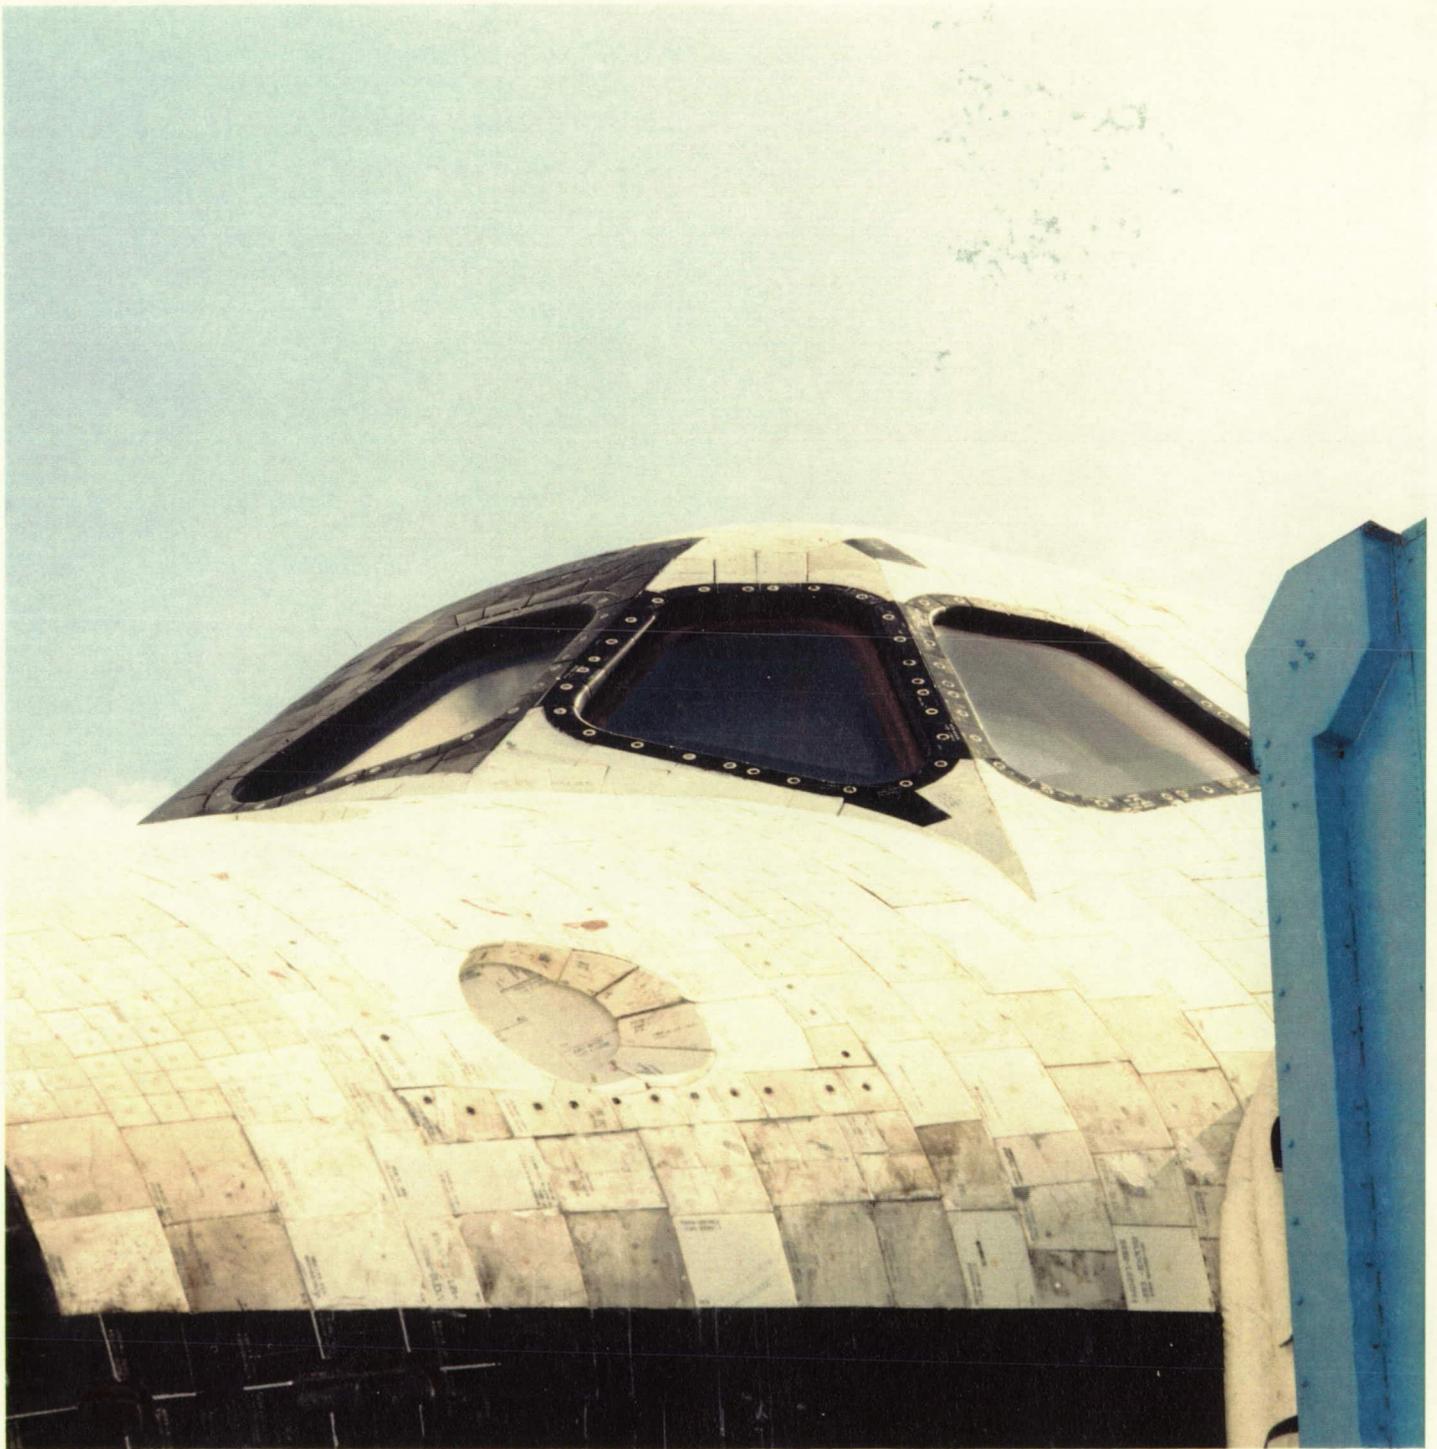
Hazing on the Orbiter windows was light and considered to be less than usual. A large number of tile impact sites (72 with 2 larger than 1-inch) occurred on the perimeter tiles around the forward facing windows. Most of the hits were small and shallow in depth.

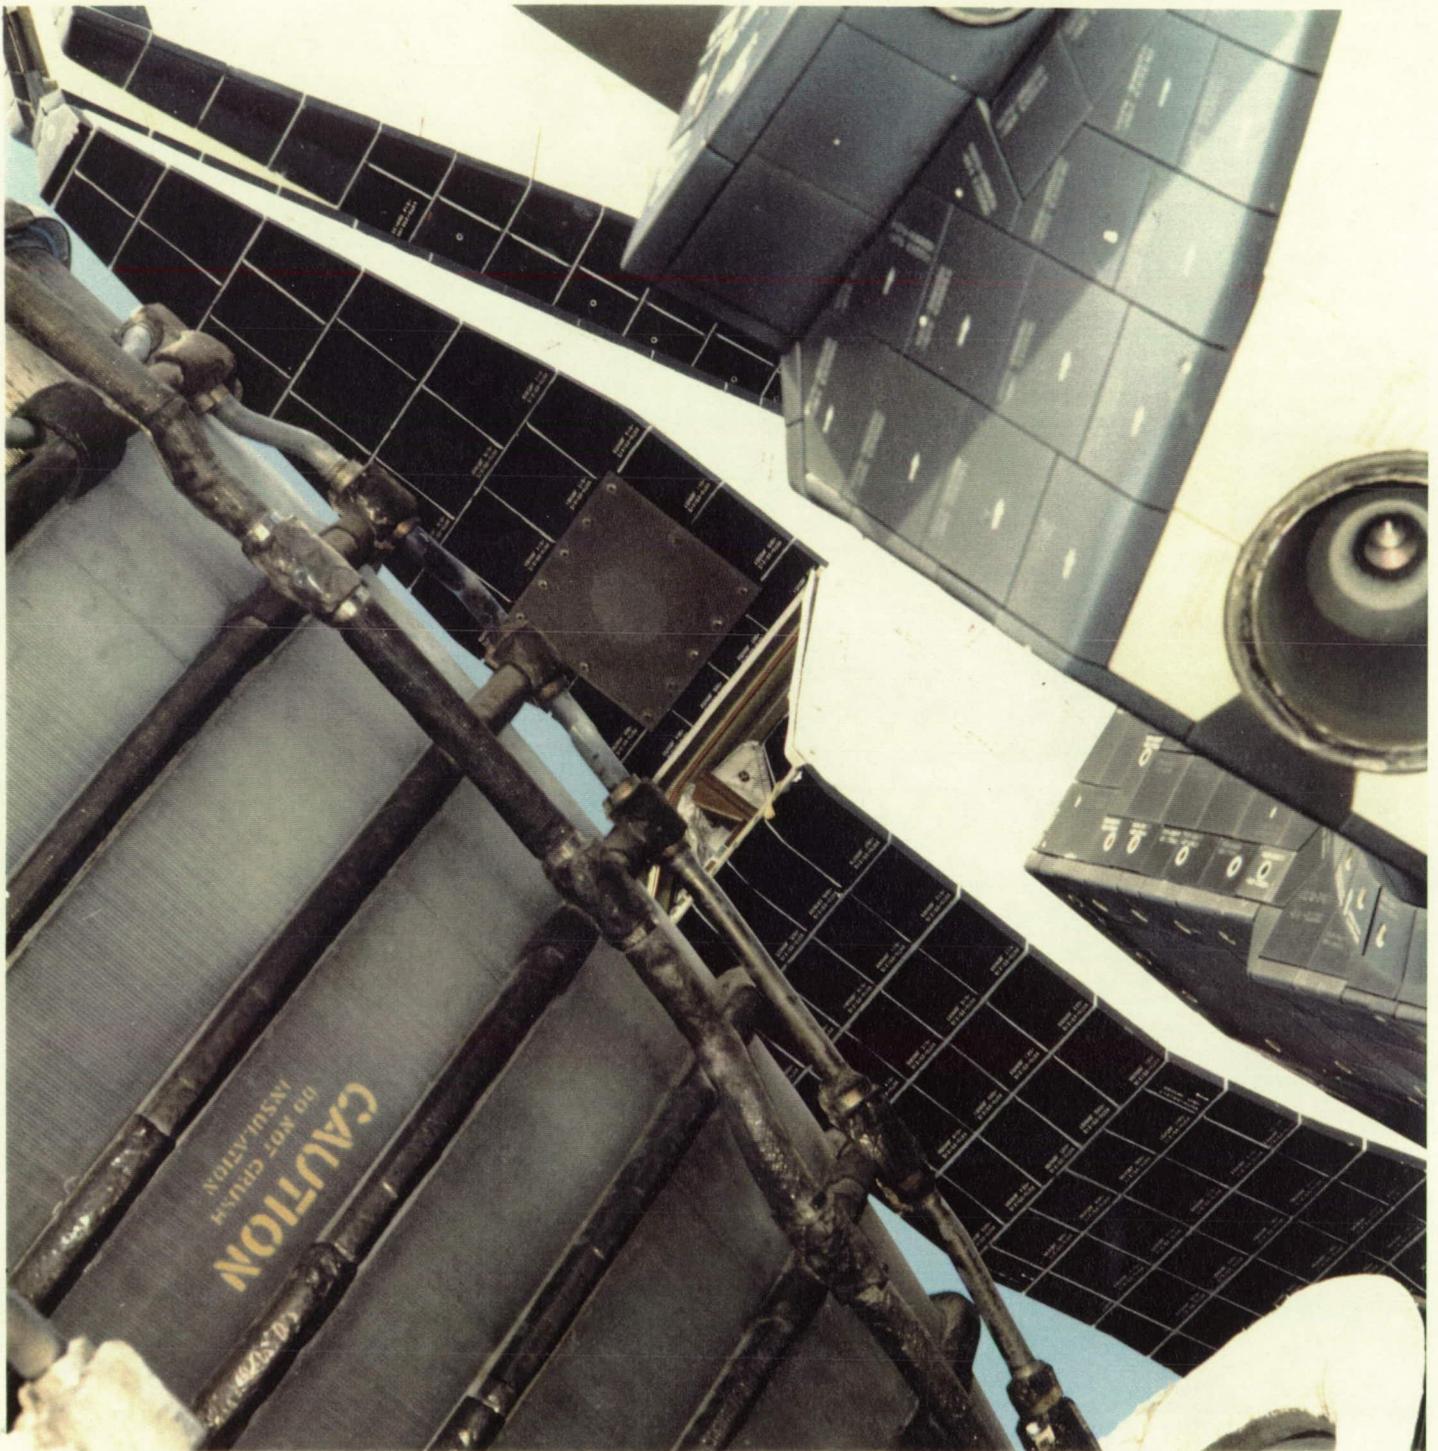
Fourth use of the Orbiter drag chute occurred normally. A tile on the lower (-Z) right edge of the drag chute compartment opening was slightly damaged by separation of the chute compartment door. Similar damage has been observed after every previous use of the drag chute.

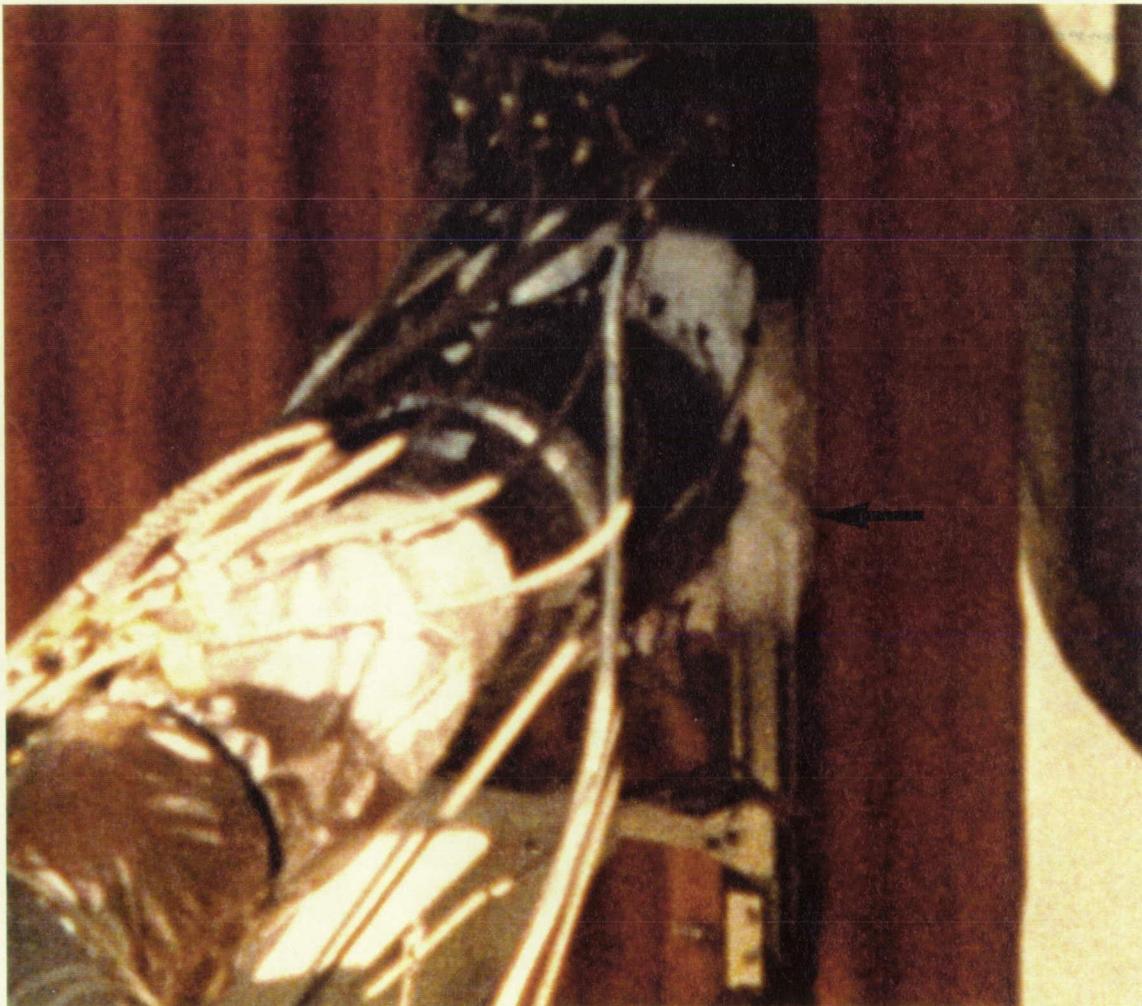
Ice was seen on the GH2 vent arm carrier plate disconnect. Multiple pieces of white debris (probably ice) were seen to fall from the GH2 vent arm during retraction. None of the ice debris appeared to strike the vehicle. No further analysis is expected.

Figure 2.1.2.3 Ice Noted on GH2 Vent Arm Carrier Plate

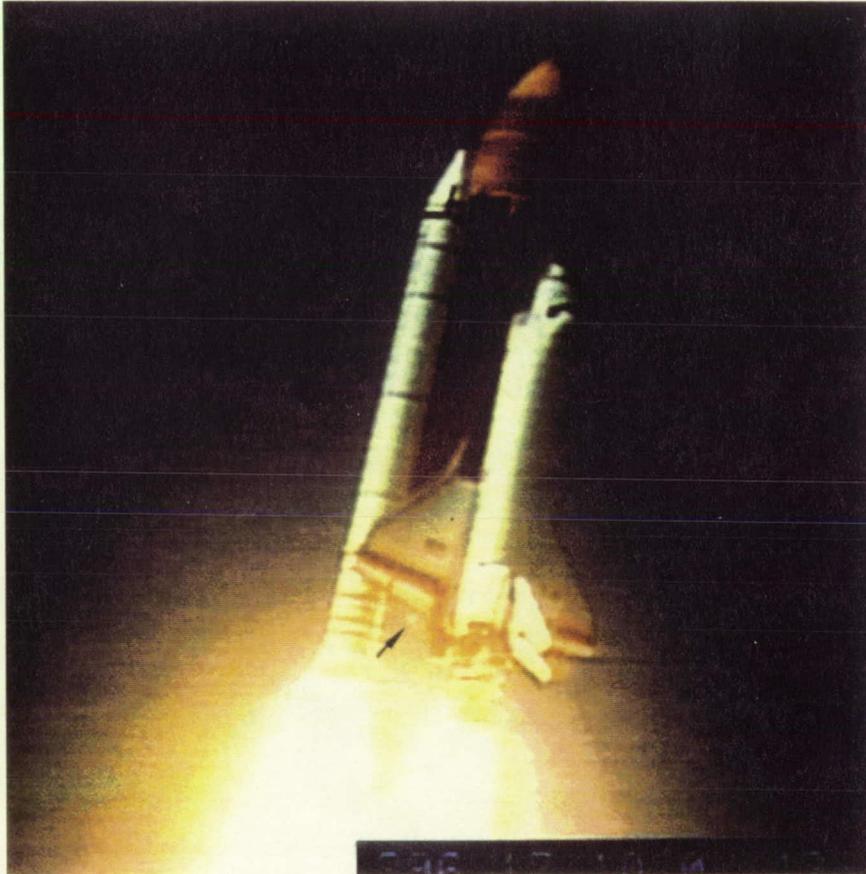
Figure 2.1.3.3 Large Piece of White Debris seen below Left Inboard Elevon after Roll Maneuver

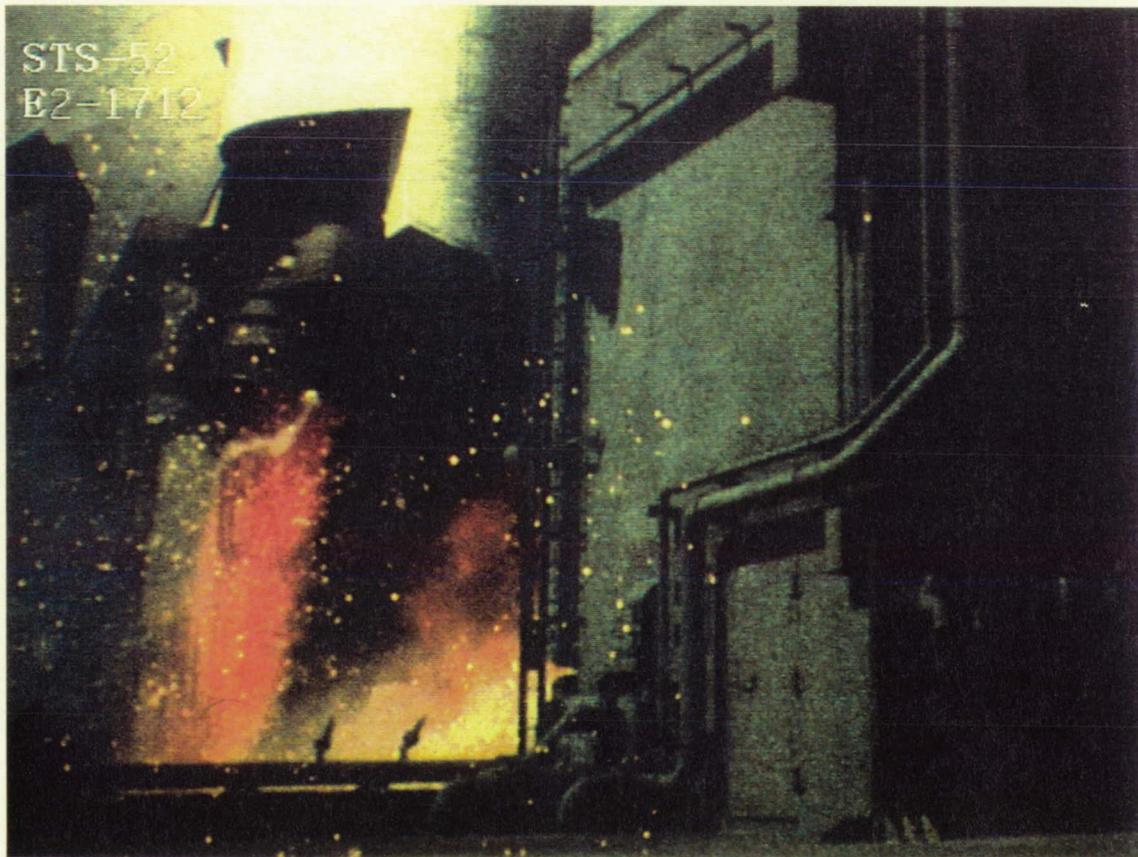
Orange vapor (possibly free-burning hydrogen) was noted beneath SSME #1 ~1.87 seconds prior to SSME #1 ignition (formation of mach diamond). (See Figure 2.2.1). Since free burning hydrogen is essentially colorless, engineers who reviewed films after the STS-38 mission believed that the orange cloud occurred due to impurities in the vapor. Similar events have been seen on twelve of the past nineteen missions. A comparison of this event with occurrences from earlier missions was performed. The amount and position of the vapor appeared similar to that seen on STS-35. See Appendix D Task #13 for analysis details.

Figure 2.2.1 Orange Vapor (Possibly Free-Burning Hydrogen) Noted under the SSME #1 Bell just prior to SSME Ignition

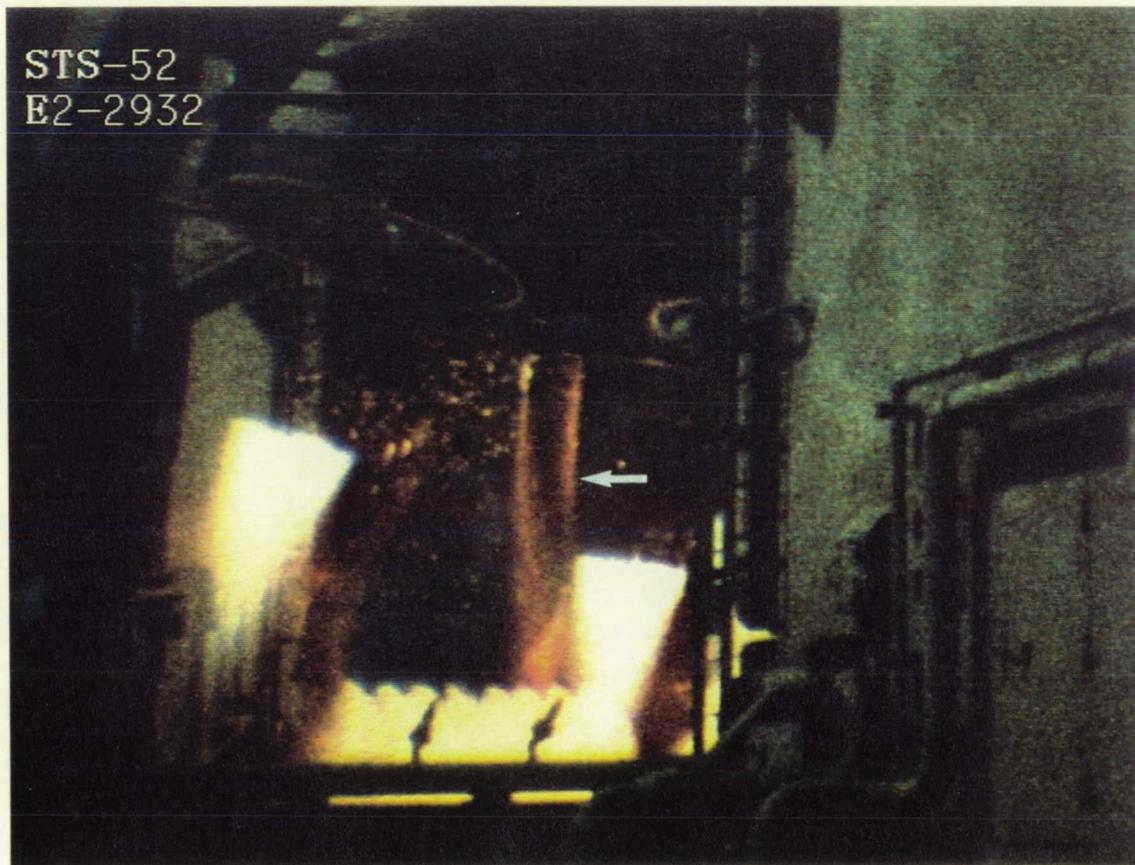
At least three orange/white flashes were noted in the SSME #1 and #2 plumes after ignition while the orbiter was still on the pad. The flashes in SSME #1 were timed at 296:17:09:36.356 UTC (T-2.658 seconds) and 296:17:09:39.252 UTC (T+0.238 seconds) as seen on Camera E-2. The flash in SSME #2 was timed at 296:17:09:37.128 UTC (T-1.886 seconds) on the same film. (See Figure 2.2.2). Flashes in the SSME plumes just after SSME ignition have been noted on ten of the past sixteen missions. While this event has not been considered anomalous in the past, future missions will be monitored for unusual occurrences or excessive numbers of flashes.

Figure 2.2.2 Flash in SSME #2 Plume 2 Seconds before Liftoff

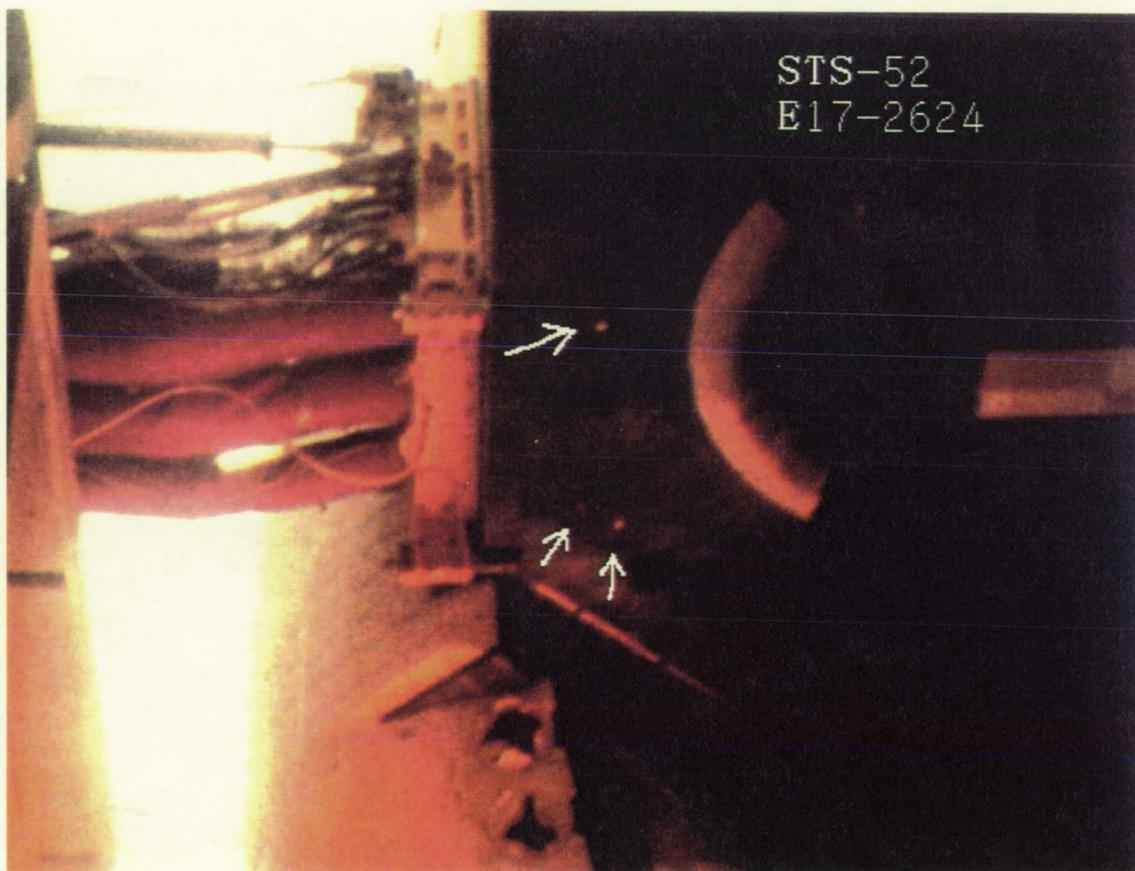
At least six occurrences of TPS erosion were noted at the base of SSME #2 and #3. (See Figure 2.2.3). Minor TPS erosion has been seen on nearly all previous missions. The erosion visible on this mission does not appear to be related to the tile damage noted at landing (see Section 2.5.2). No follow up action is expected.

Figure 2.2.3 TPS Erosion noted on Base Heat Shield
