Debris/Ice/TPS Assessment And Integrated Photographic Analysis For Shuttle Mission STS-52

December 1992

DEBRIS/ICE/TPS ASSESSMENT
AND
PHOTOGRAPHIC ANALYSIS
OF
SHUTTLE MISSION STS-52

October 22, 1992

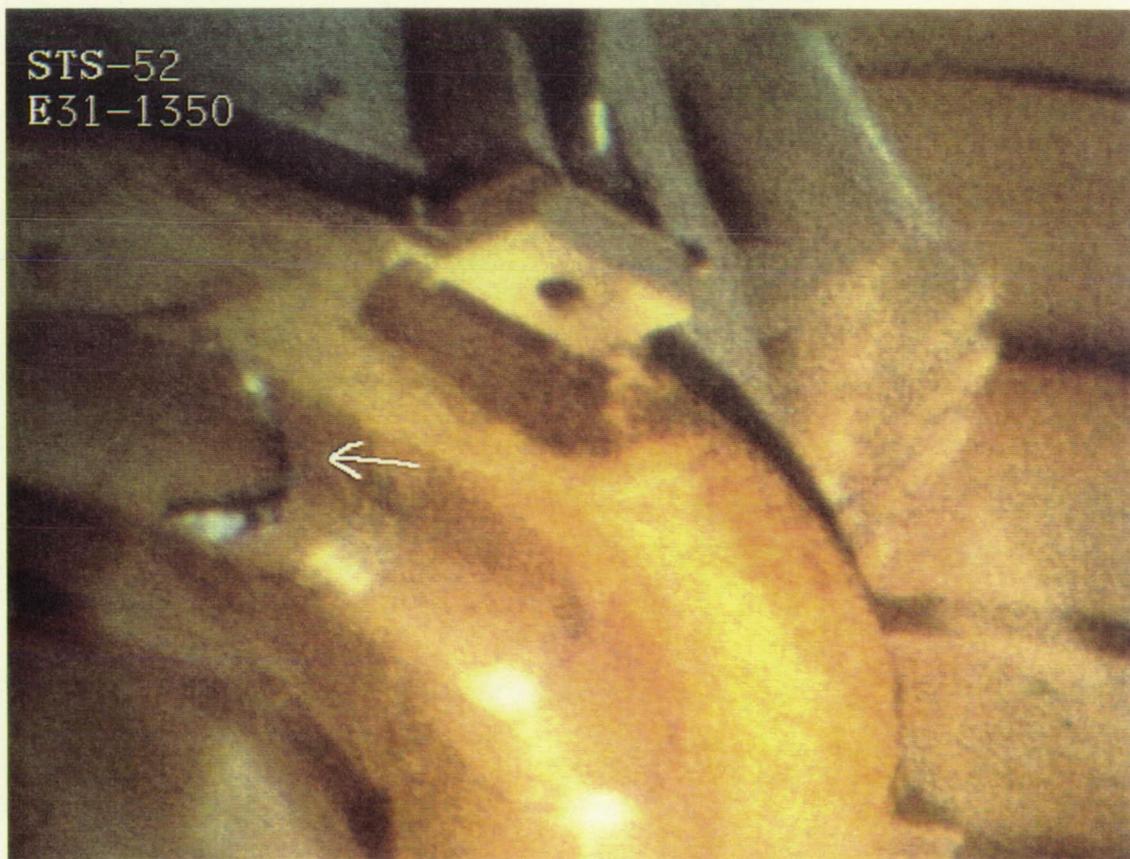
Loose tape was seen on both the LSRB and RSRB thermal curtains after liftoff. (See Figure 2.3.3). This event has now been seen on four missions since reflight. No further analysis is planned.

Figure 2.3.1 Loose Tape on LSRB Thermal Curtain

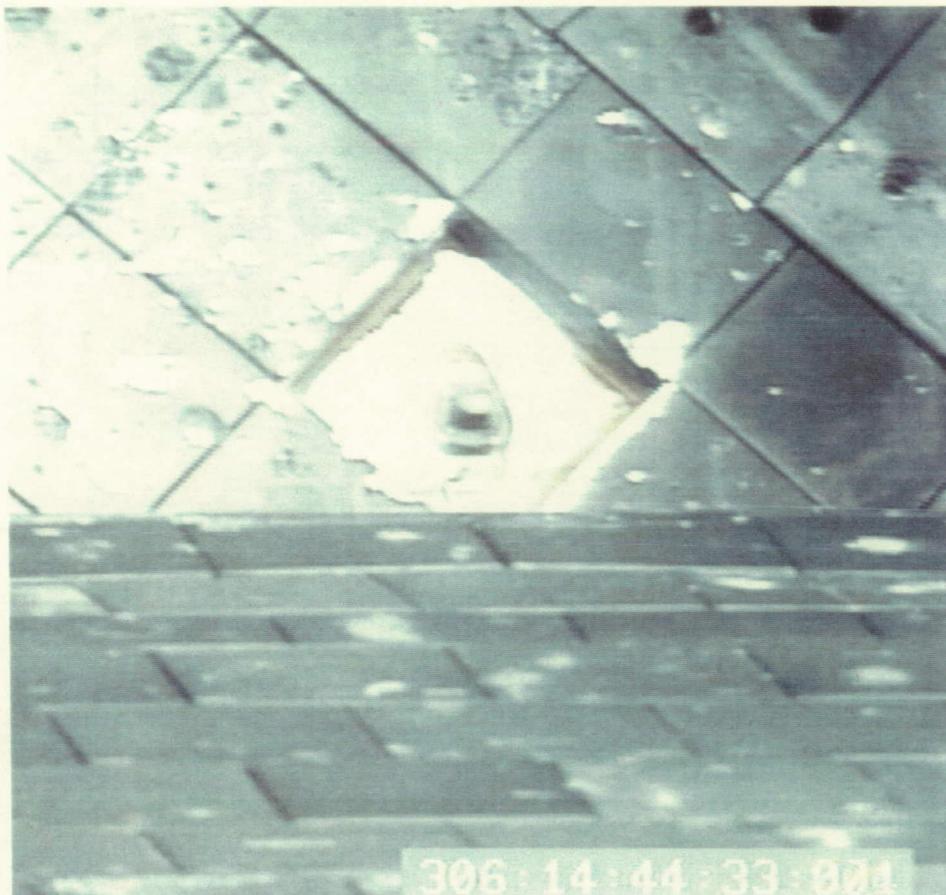
Figure 2.5.2 **Damage to Base Heat Shield Tile seen during Post Landing Inspection**

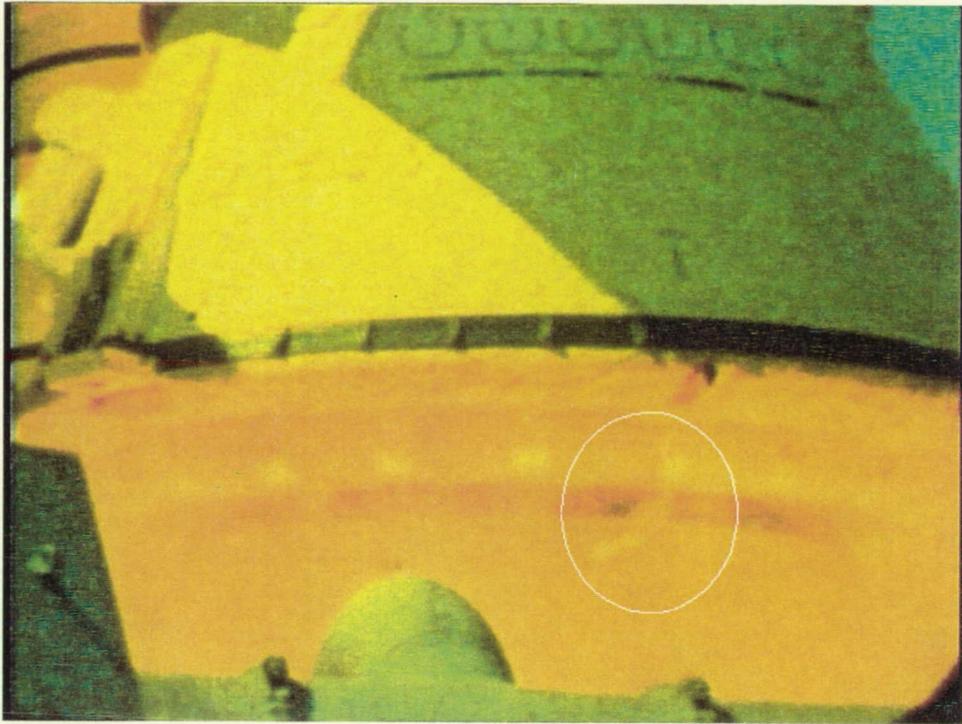
Figure 1

Loose Thermal Curtain Tape
