NASA-CR-192522

Final Report on the SRB Frustrum "Smiley" Cracking Phenomenon Study

February 6, 1993

Thomas A. Cruse, Ph.D.
401 Bowling Ave. #6
Nashville, TN 37205
(615) 343-8727; (615) 343-8730 (fax)

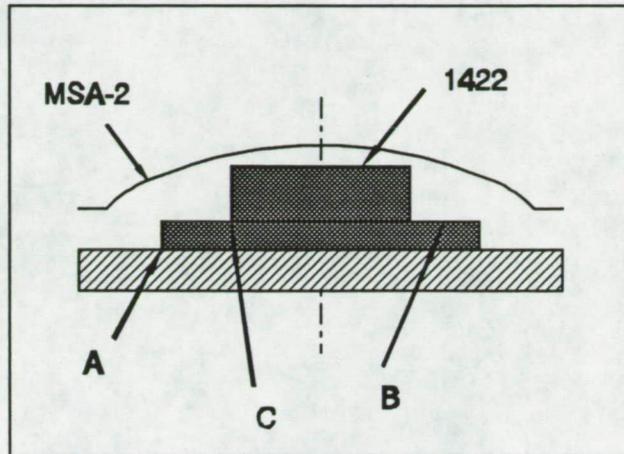
Figure 1: Representation of Material Configuration at Single Fastener

The figure indicates the essential features of the material arrangement in the area of a single fastener. Examination of all of the removed specimens containing various sizes, shapes, and orientations of cracks including the specimen with the divot indicated that each appeared to have common elements which are seen to be critical to understanding the "smiley" problem. Locations A, B, and C are all locations of an appearance of weak bonding between the MSA and substrate materials. Locations B and C have 1422 sealant as the substrate, while location A has base metal as the substrate material. Location C is the site of the undercut associated with the caps that are used for sealant application. The sealant between sites A and C is the overfill sealant from the application procedure and has variable thickness. In one case, the 1422 sealant was seen to extend beyond site A on the metal substrate but with very little apparent thickness. It would seem that the cleanup of the overfill resulted in a regularly-sized "smear" of 1422.

very low strength of the bond at site B in the figure, corresponding to the MSA-2 bond on the overfill bead of the 1422 sealant. The very low strength conclusion is based on the lack of adhesion of the MSA-2 to the 1422 indicated by MSA-2 "fuzz" which is clearly seen on other locations of the debond. Examination of the witness surface on the MSA-2 material I removed showed a consistent picture - the MSA-2 surface at location B was quite smooth and had the appearance of a mold of the 1422 sealant.

Examination of the six debonded regions also shows that the adherence of MSA-2 to the supporting material is weak at locations A and C. In no case did the weak bond of MSA-2 to base metal extend more than a few mils from the edge of the 1422, but the metal surface clearly showed a lack of retained MSA-2 over a significant arc length of the failed zone. The radial extent of the weak bond is consistent with the size of the "voids" noted in the report on STS-48 that I read. The MSA-2 fractures were all featured as conical failure surfaces at roughly 45° to the substrate. The small radial extent of the weak bonded surface indicated to me that this location was not primary, but secondary in the sequence of MSA-2 fracture.

The weak bond of MSA-2 and 1422 sealant is radially large compared to that at location A. The weakness may include both locations B and C. The undercut showed very little likelihood of good bonding between the two materials. However, the size of the weak region associated with the overfill surface (location B) appears to be large enough to allow fracture associated with the depressurization event near the point of separation, when the external pressure at the hypalon is at its lowest point. Such depressurization fractures of the MSA-2 material were shown in the USBI M&P test report, without the need for external heating. In removing the MSA-2 material from the selected sites, I qualitatively noted that the bond to the crown of the 1422 sealant in cases where the debond did not include this region, was quite strong in comparison to that strength I noted in peeling the material from location B.

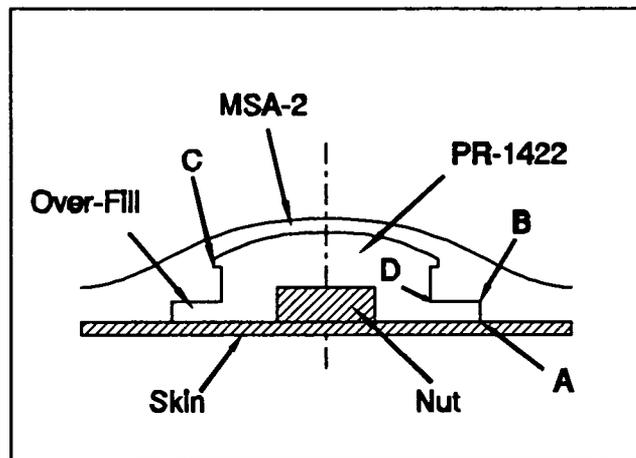
Figure 4: Schematic Showing Key Locations

The results of the stress analyses for all cases involving excess PR-1422 material show that the maximum effective stress occurs at location B, as indicated in Figure 4. The mechanical cause of the high stress at this location is the re-entrant corner formed by the MSA-2, and the fact that the MSA-2 material is much stiffer than the PR-1422 material. The load being carried by the MSA-2 material over the PR-1422 sealant must turn the corner at location B, and then flow to the substrate at location A. The high stress region focused at point B extends into the MSA-2 material, somewhat along the interface towards location A. Stress contour results for the various cases are given in the appendices to this report. The maximum stresses are not to be taken too literally, as they will increase as the size of the finite elements near location D is refined. All FEM model results are based on the same mesh refinement near the stress concentrations, in order to make the comparisons, at least, meaningful. The following table summarized the results for the FEM solutions involving geometries with excess PR-1422 material, shown above as the overfill region.

The FEM analysis therefore strongly suggests that the excess material should act to reduce the strength of the MSA-2/PR-1422 bond. Further, failure should occur from locations near the corner of the excess PR-1422 material (location B). The strength reduction due to the stress concentration is of the order of 30%, based on these results.

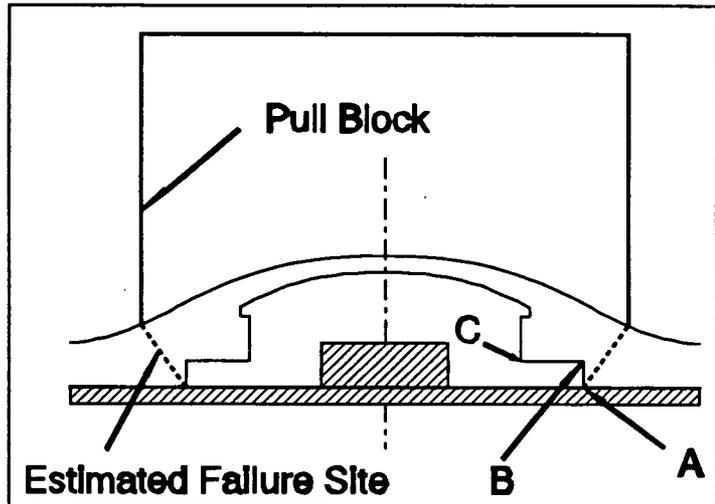
Figure 6: Schematic of Local Failure Region and Test Block

It was anticipated that failure of the locations with overfill will initiate at location B. Disbond will extend from B to locations A and C and beyond C toward the centerline, along the material interface. It was not known how suddenly the disbond along this path will be. At this time, I assume that the bond will remain intact up to some critical load level at which the disbond occurs. Following disbond, the load deflection curve is likely to be more compliant, indicating that there is softer support for resisting the pull bar. The break point is indicated in Figure 6 as point B. Final failure will likely occur as a separation along the path indicated as the estimated failure site.

The pull test for no overfill of the PR-1422 material will show less compliance than for the test with overfill. The reason is that there is more MSA-2 material between the pull bar and the aluminum panel, to resist the applied loading. At a critical load level, the MSA-2/aluminum bond will fail (indicated in Figure 3 as point A). The loading will shift more toward the MSA-2/PR-1422 interface centered over the simulated fastener location. This load path is much more flexible than the original load path prior to bond failure and the load deflection curve will likely show a significant increase in compliance. Failure at the indicated failure site in Figure 6 will likely occur at point A in the load history.

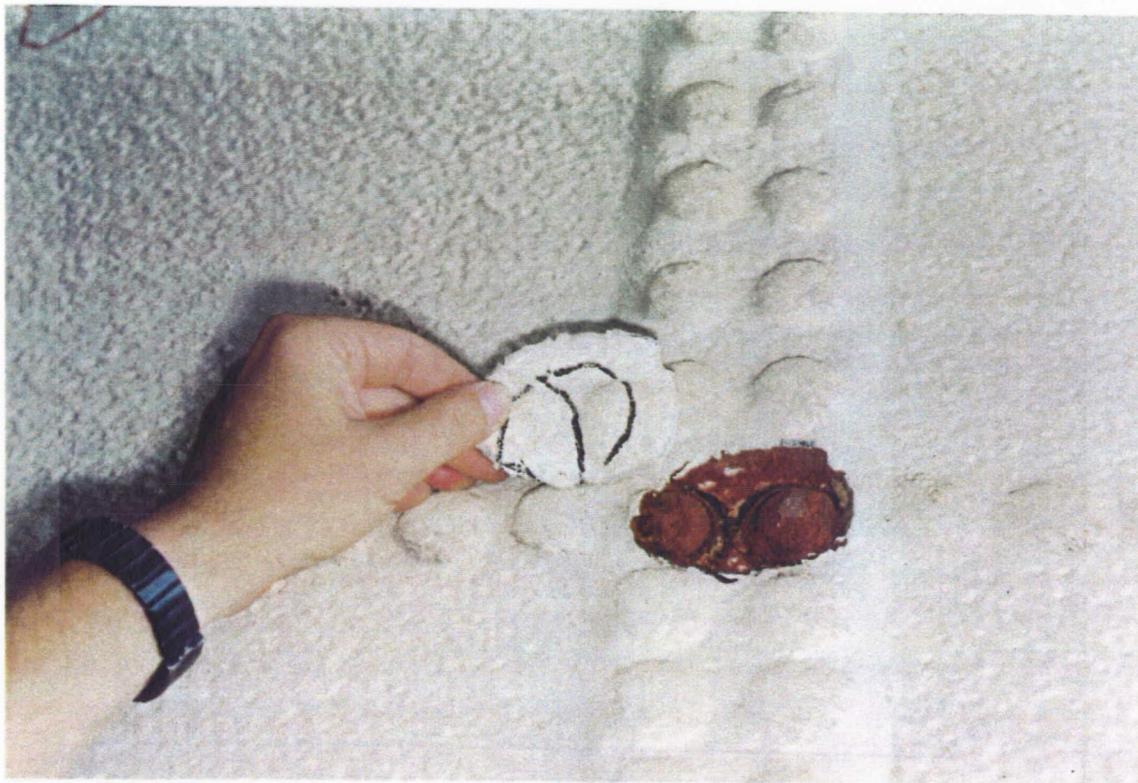
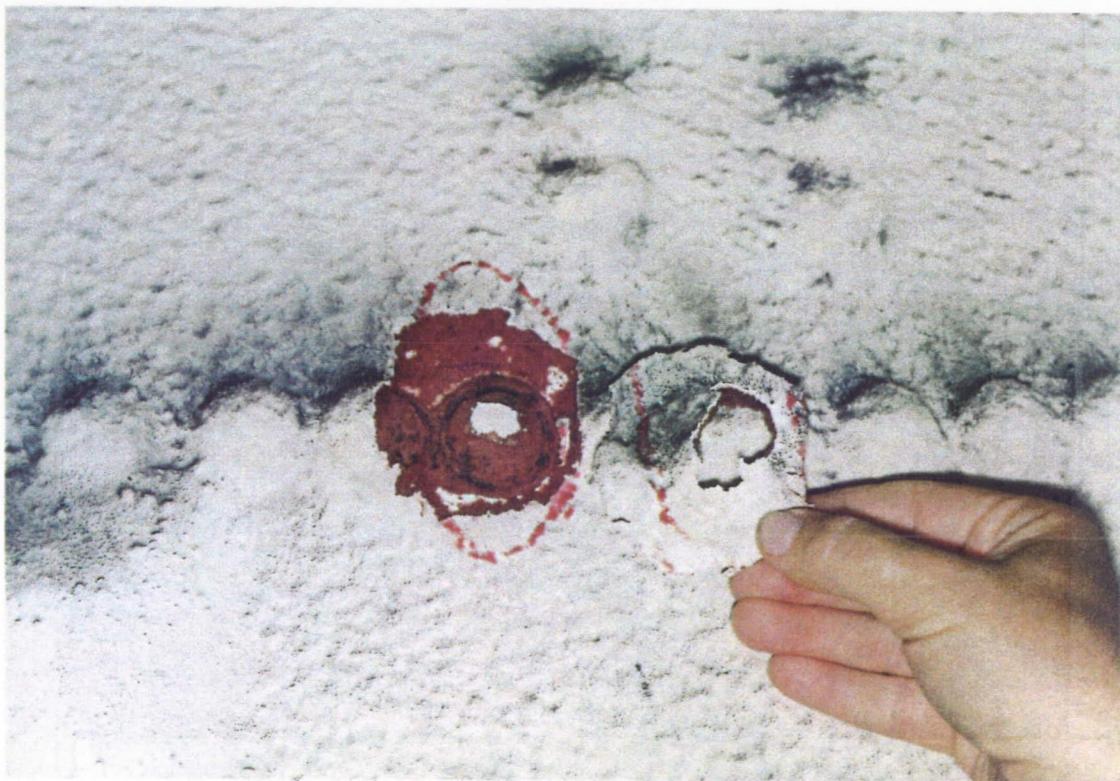
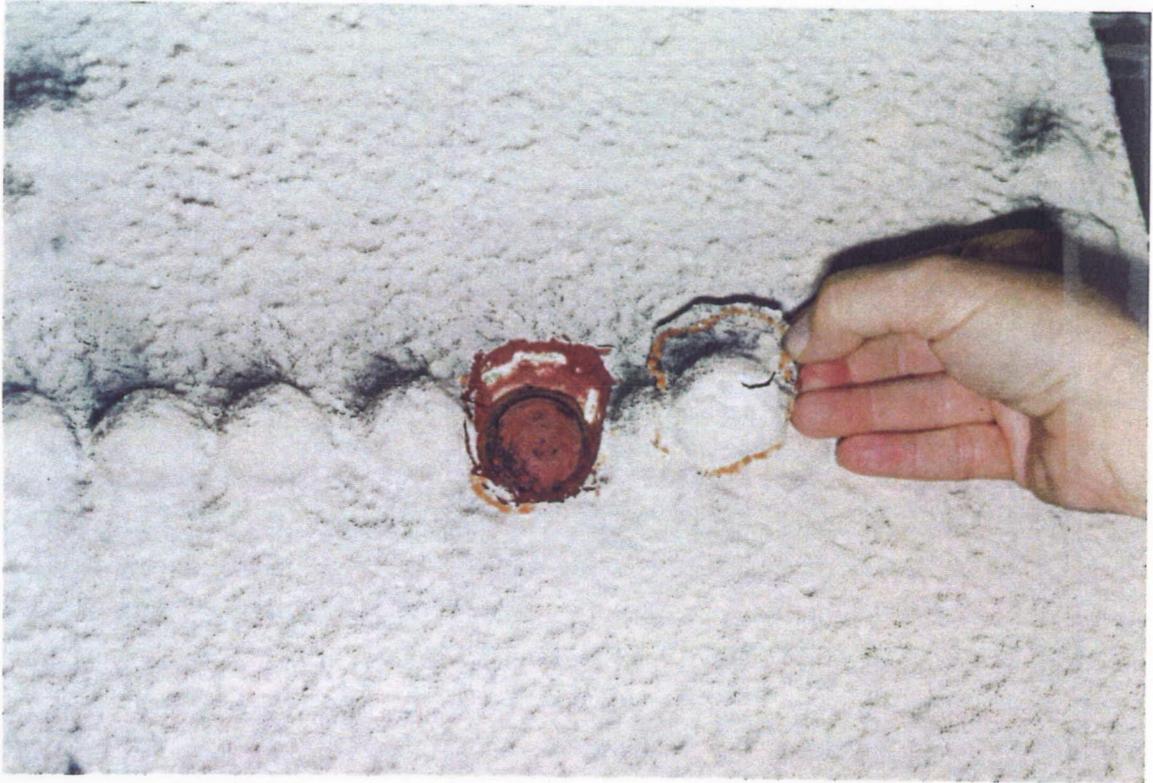
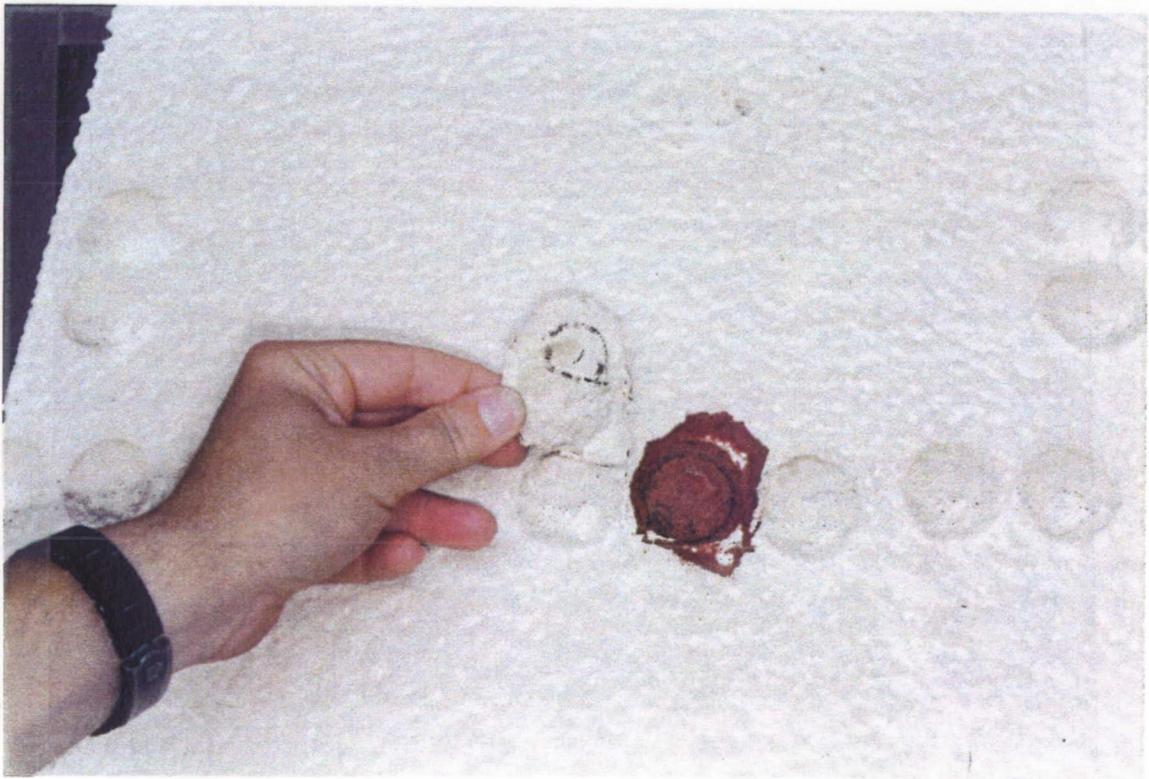
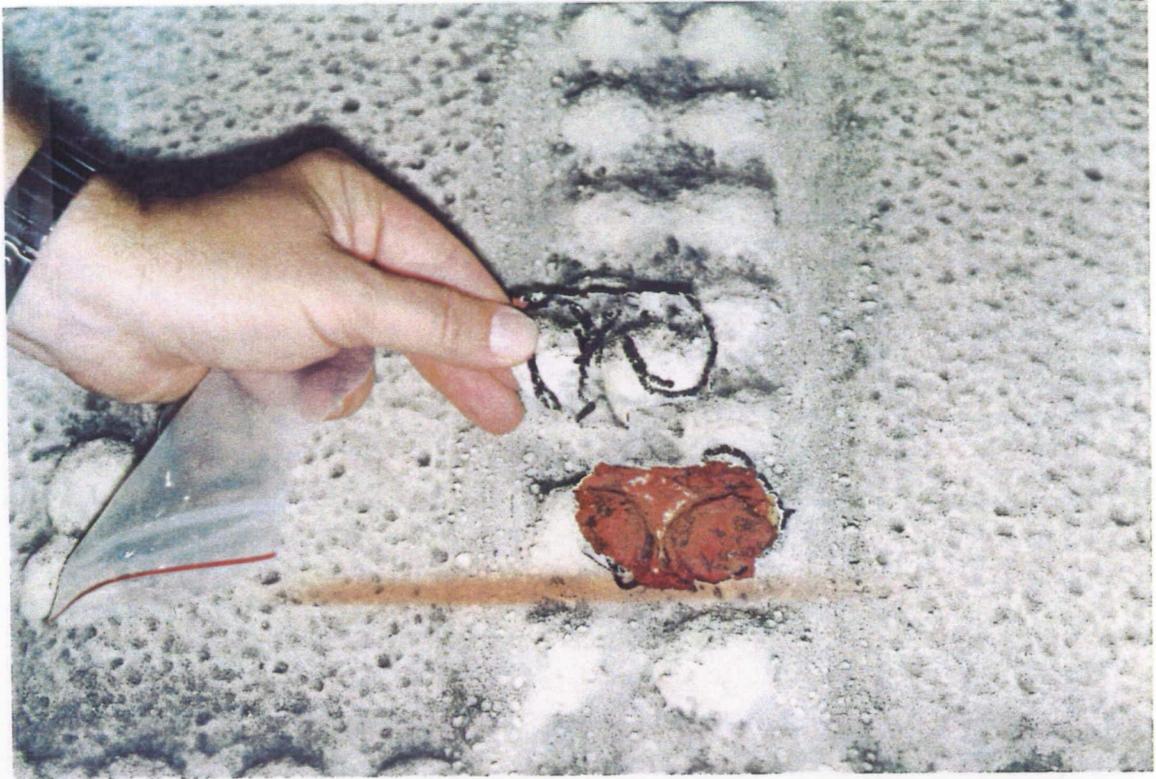
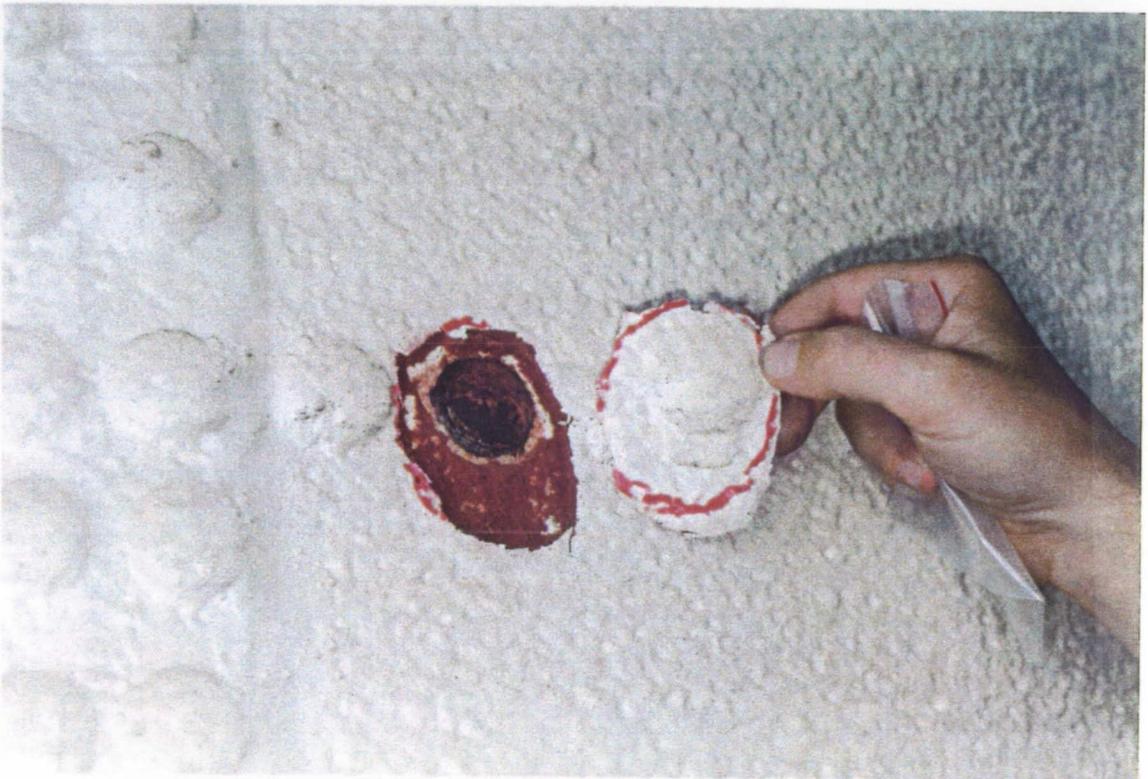
A. Photographs from post-flight inspection

I will begin with a summary of what I saw and what import I give to the observations. First, I think we need to generalize the definition of "smiley" cracks. There were numerous debonds of the MSA-2 over the fastener sealer. Many of these debonds had cracks of various sizes, orientations, and locations relative to the fasteners. According to those who report cracks, these are all "smileys" even though only some of them have the characteristic "smiley" shape and location. I observed a large number of these cracks and removed the MSA-2 material with crack at six locations. I have that material along with photos of the removed material and the frustrum site of the sample.

With only one major exception, all of the debond/cracking appeared to be on the up-wind side of the fastener (in the case of single-fastener row locations and some double-fastener row locations) or on the side of the double-fastener rows, or to cover the entire fastener. The exceptions included a noted site where the debond occurred on the downwind side of the fastener. That site is among those I selected for material removal. These are sites that can be expected to have higher heat flux during the ascent part of the flight. Based on USBI data subsequent to the PFA inspection, the frustrum sees its highest heat-loads during ascent, whereas the aft skirt sees its highest heat loads during reentry. All cracks are associated with debonds.

In all cases where I removed material containing a debond with a crack, the debond affected a larger region than the size of the crack - the physical appearance supports the hypothesis that the crack comes after the debond. I saw no exceptions to change this hypothesis. Further, and much more critically, the removed material at the debonds indicated quite clearly

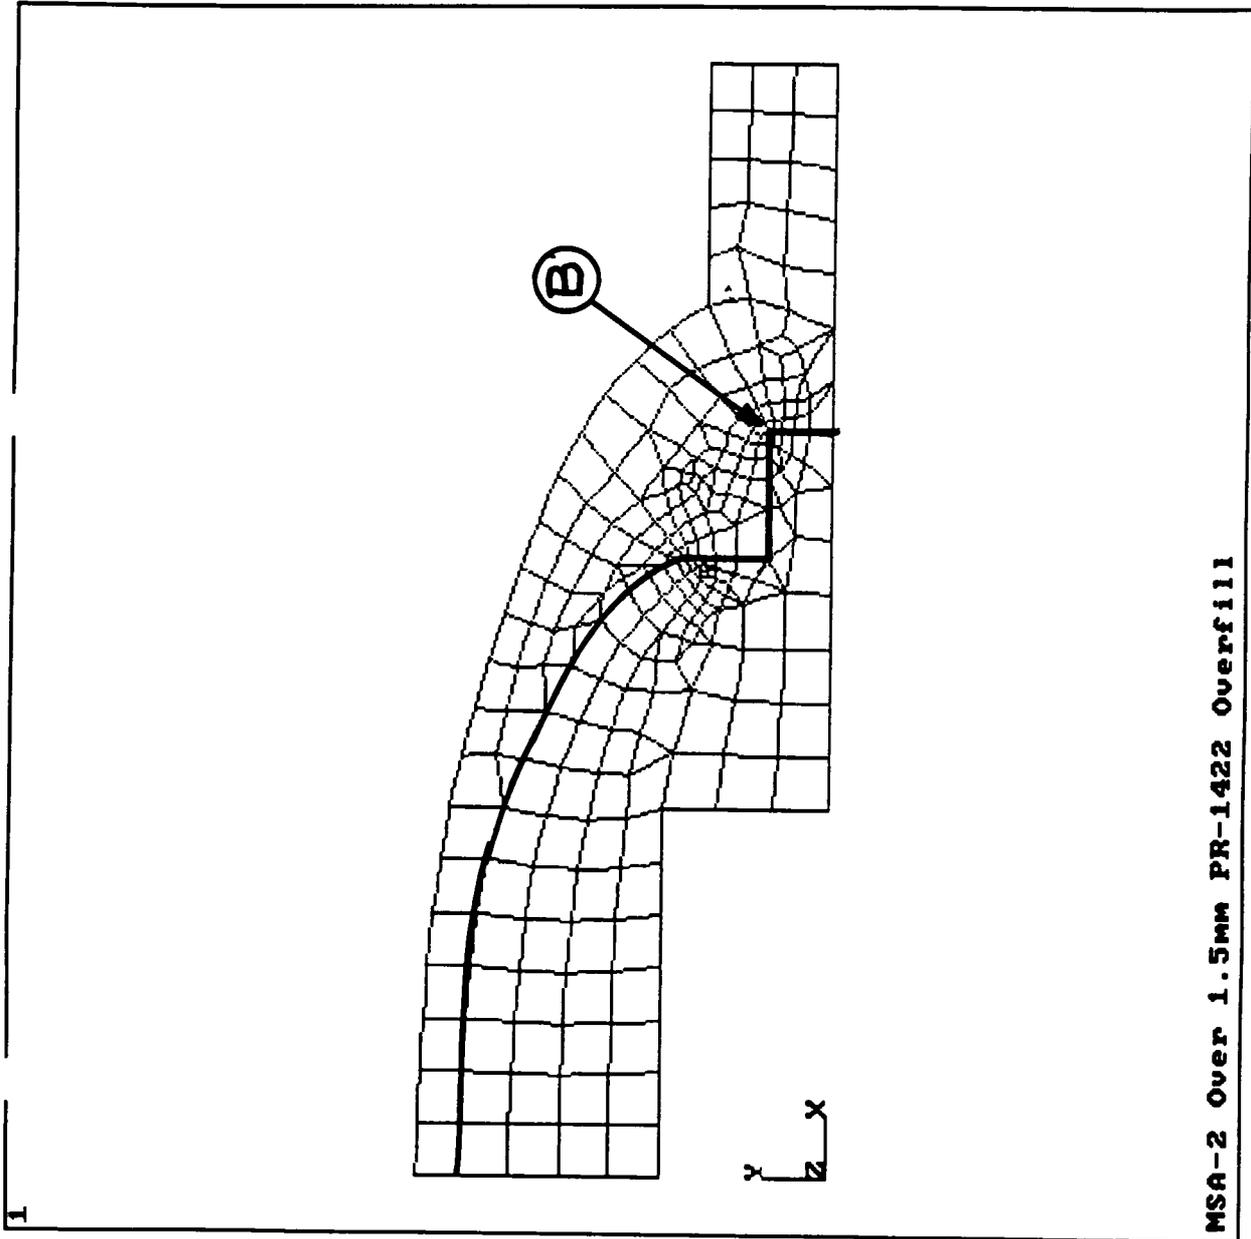
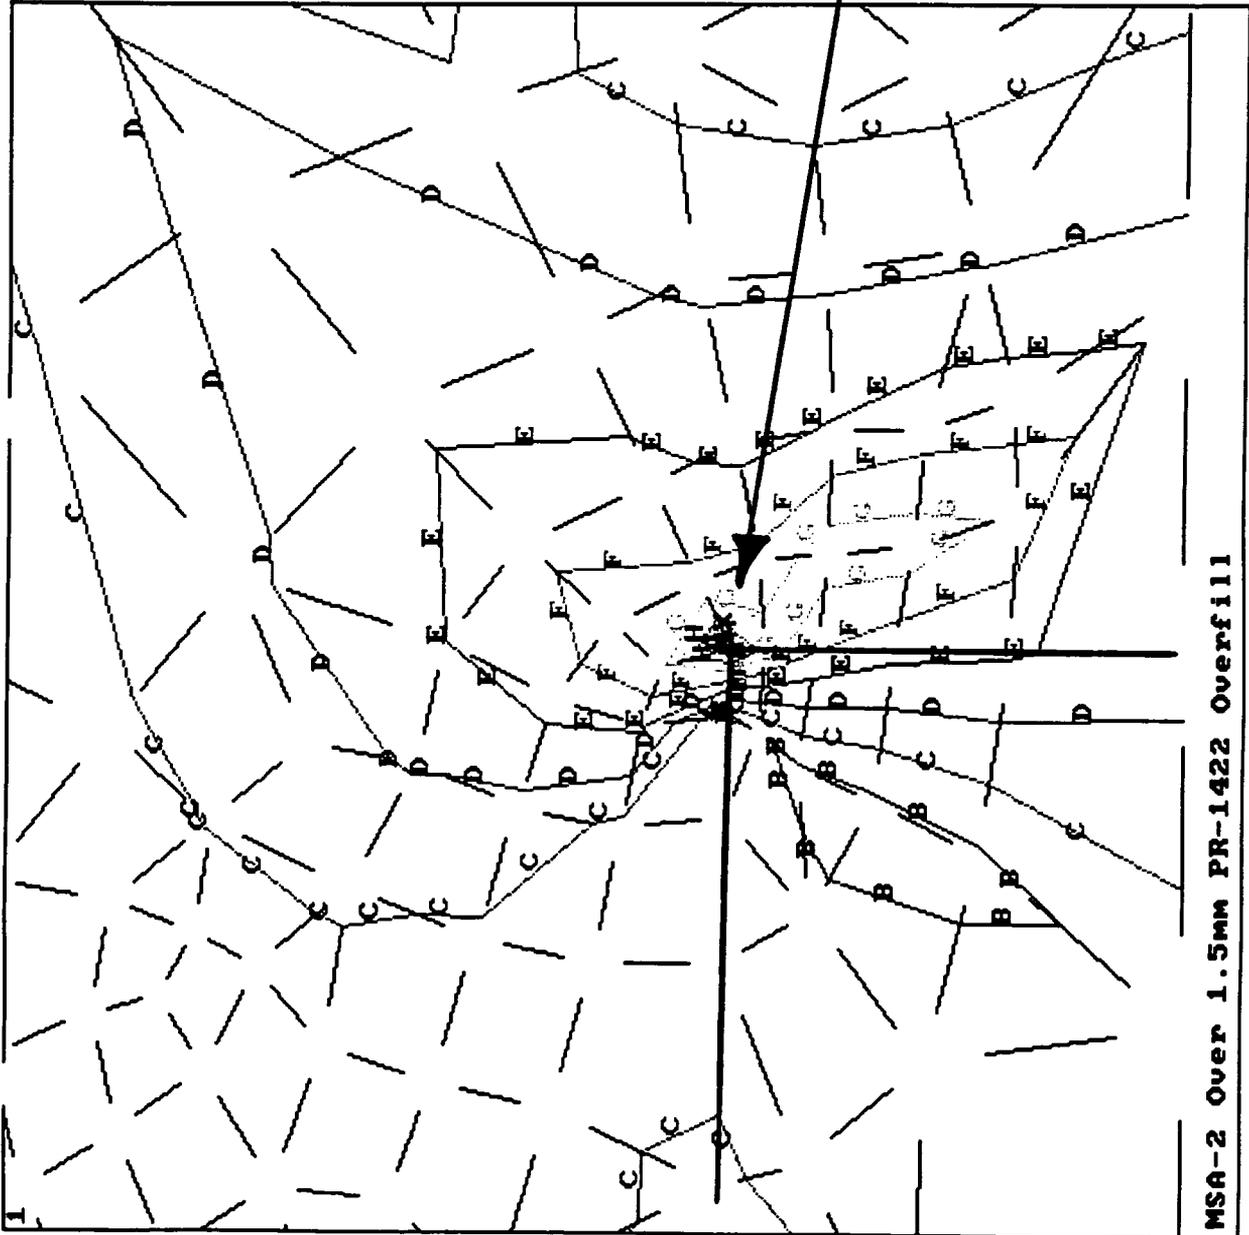
CASE 5

MSA-2 Over 1.5mm PR-1422 Overf111

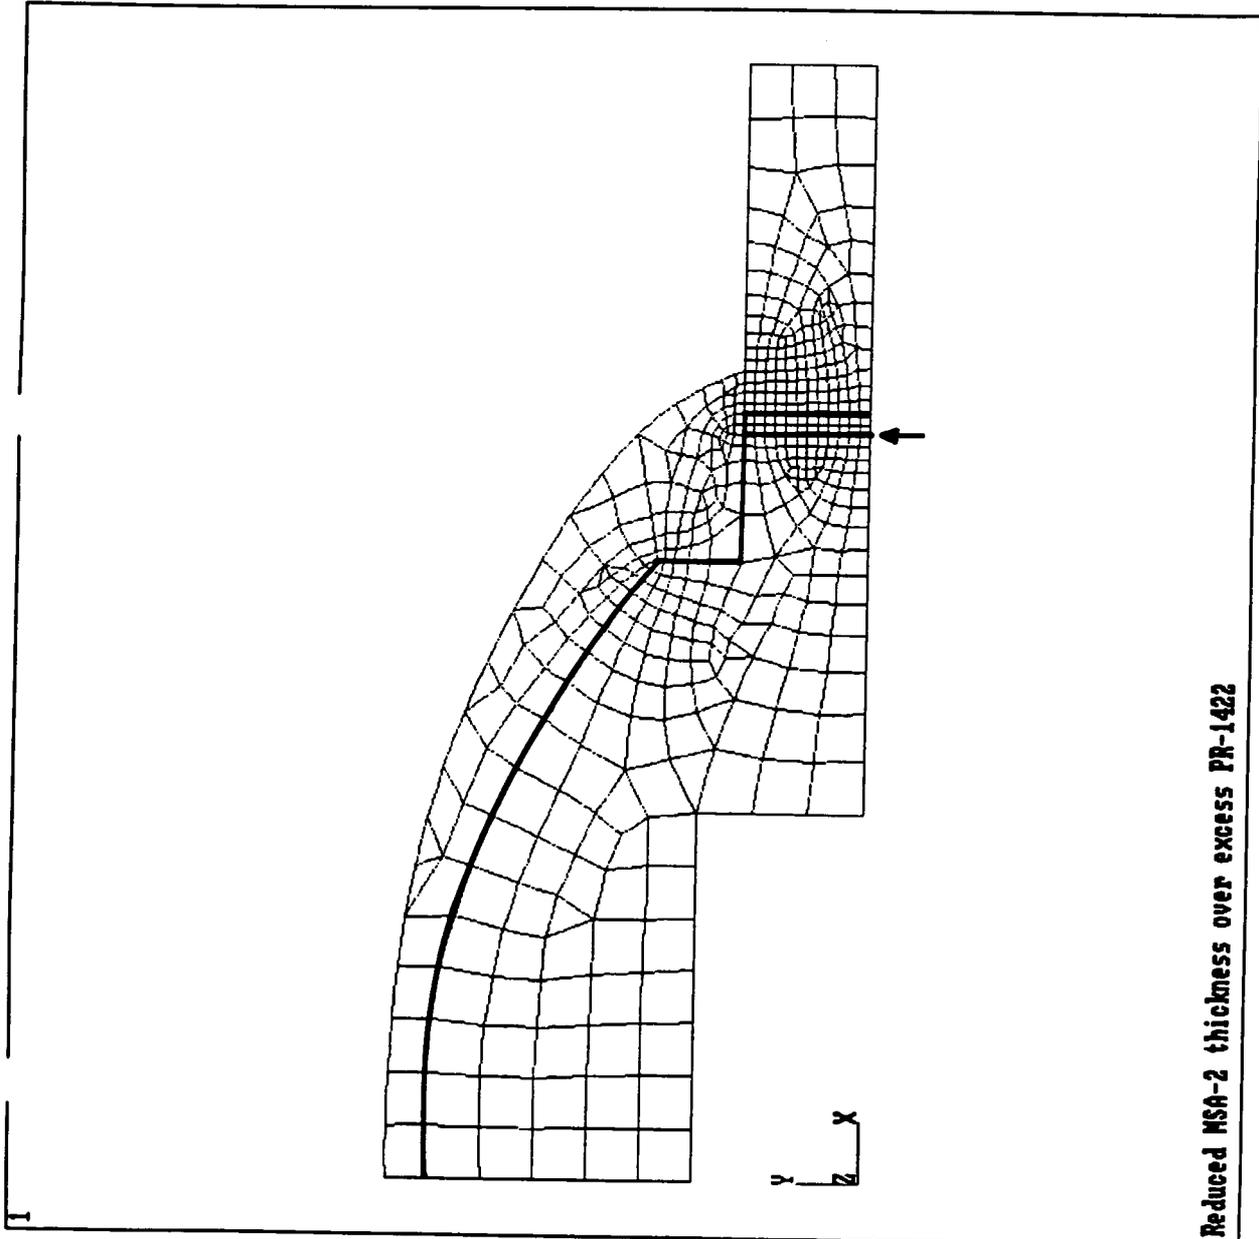
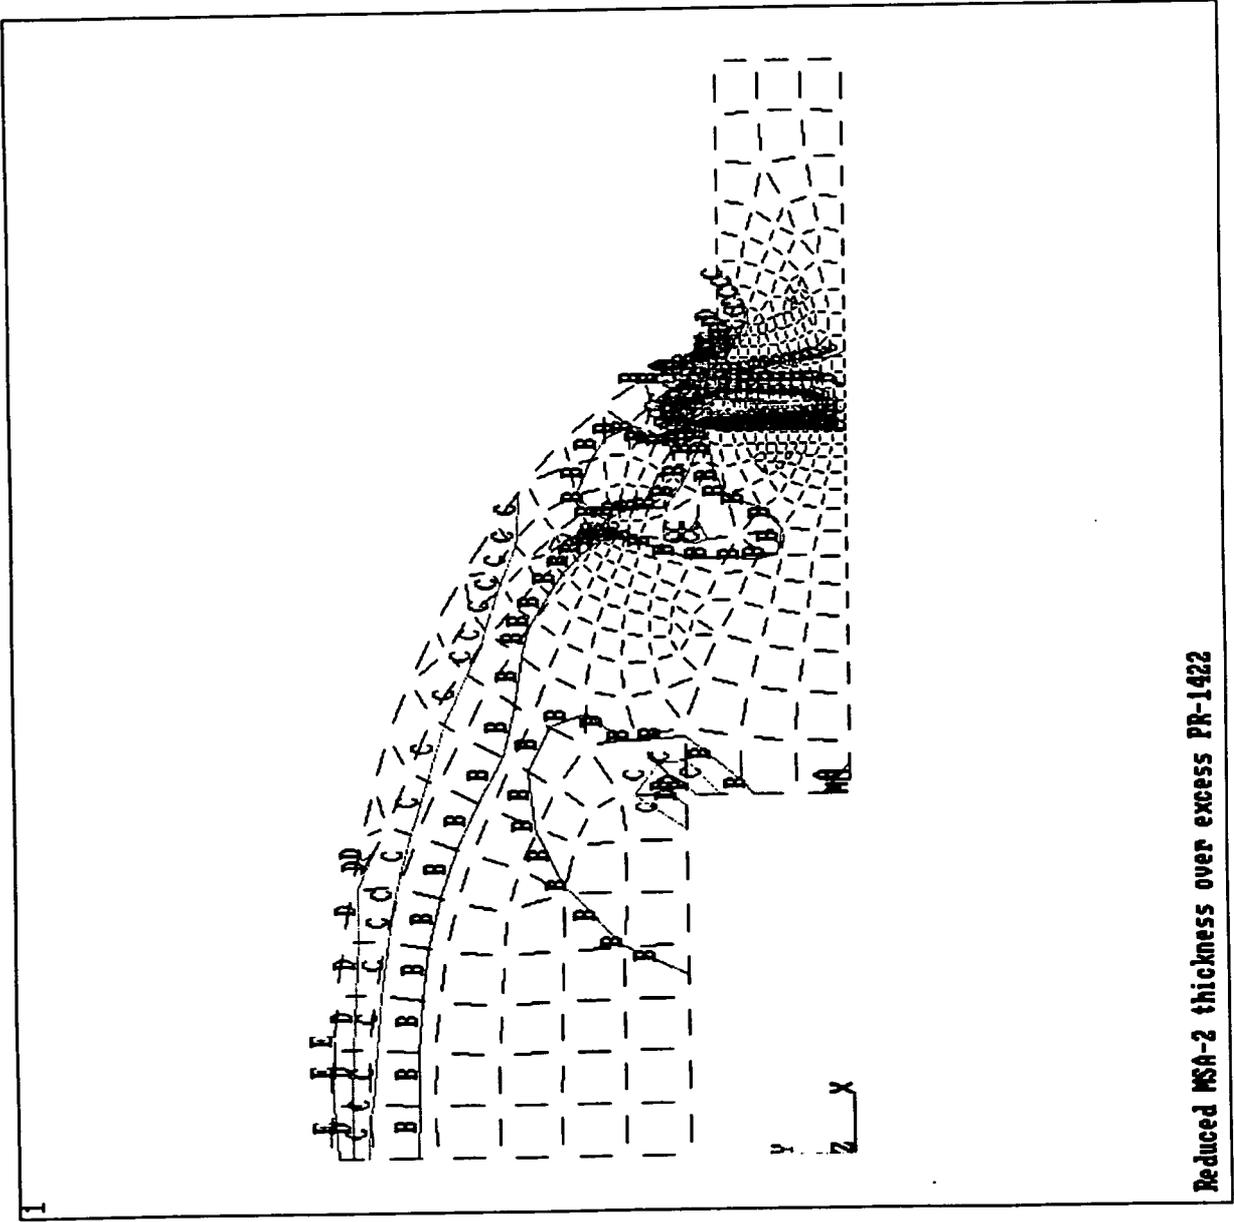
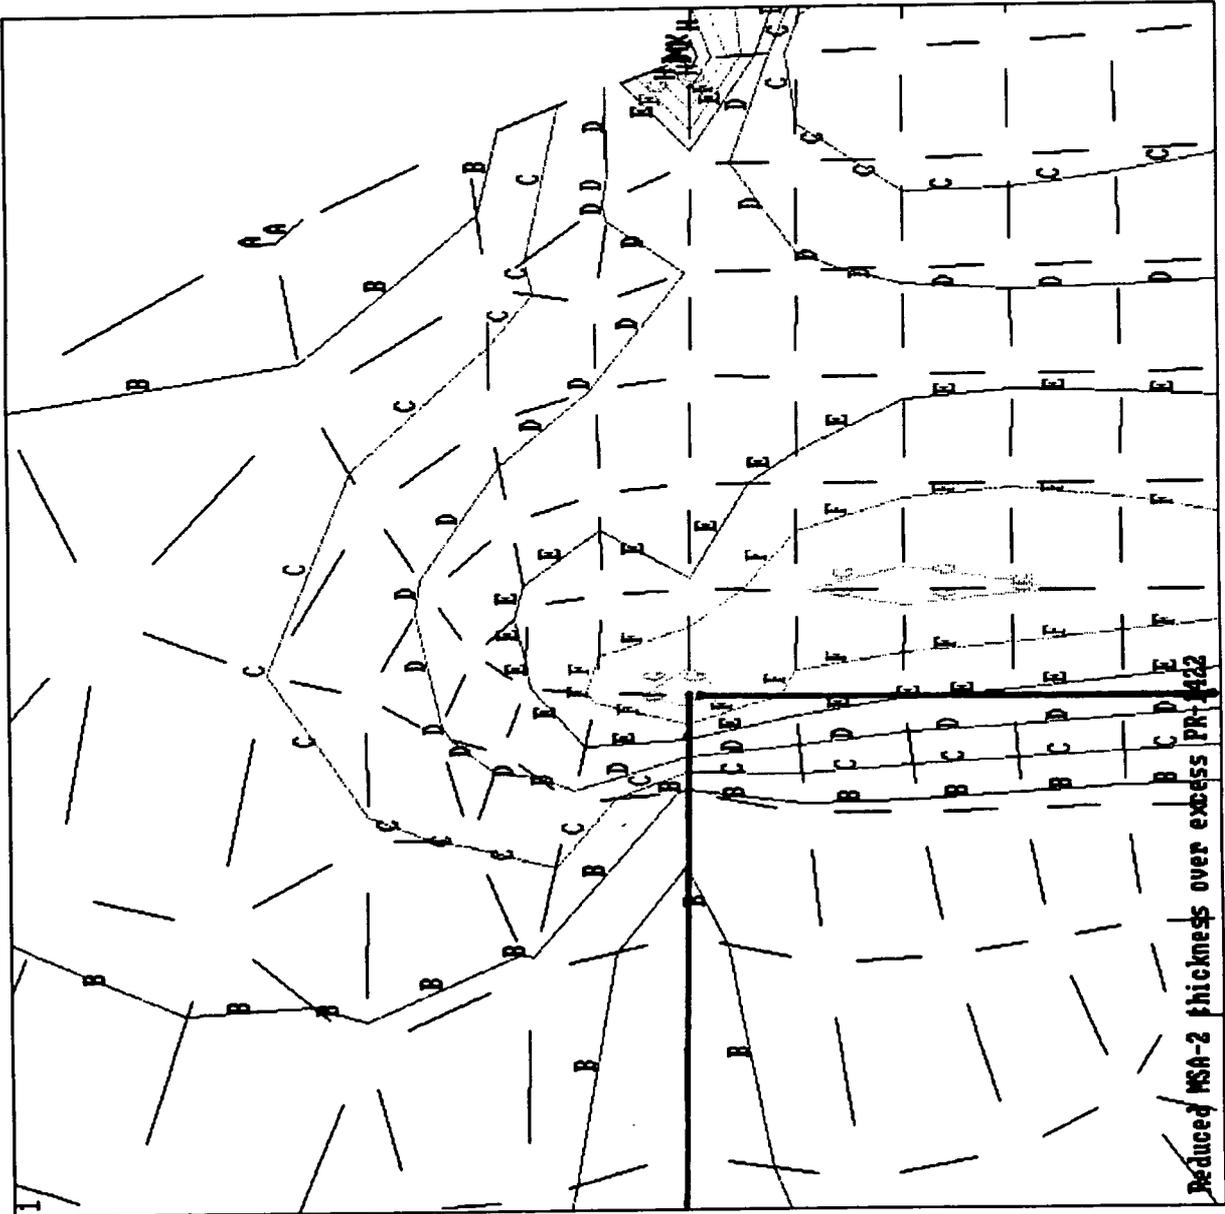
CASE-Y

Reduced MSA-2 thickness over excess PR-1422
