**NASA
Technical
Paper
3190**

**External Stress-Corrosion
Cracking of a
1.22-m-Diameter Type 316
Stainless Steel Air Valve**

Thomas J. Moore,
Jack Telesman,
Allan S. Moore,
Dereck F. Johnson,
and David E. Kuivinen

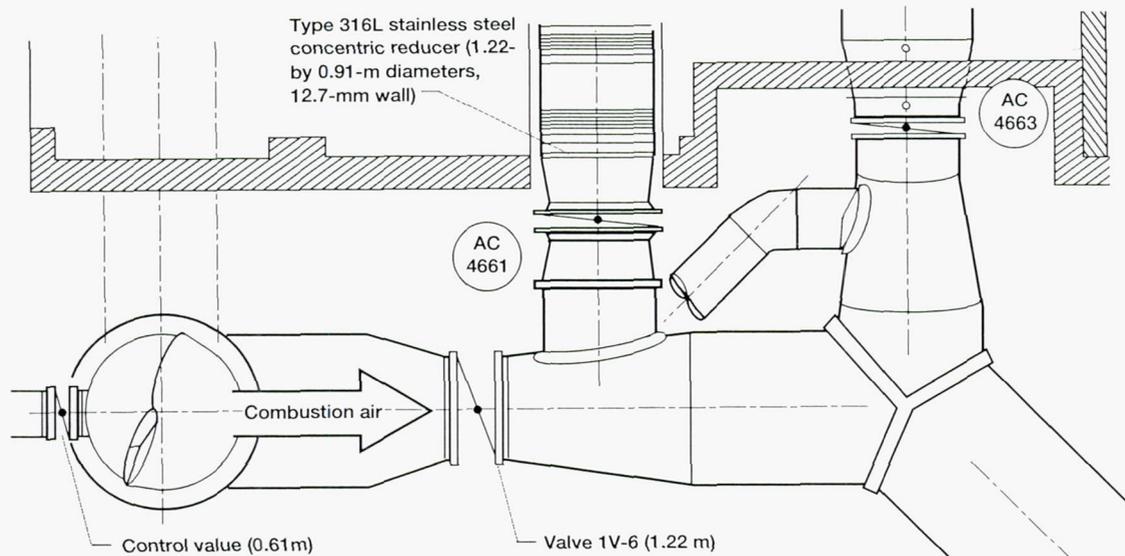
The outdoor pipeline immediately upstream and downstream from the failed 1V-6 valve is shown in figure 1. Valve 1V-6 is used in various modes to blend and divert combustion air to altitude test chambers in an adjacent building. These chambers are used in the testing of full-size aircraft turbine engines.

Figure 1.—A portion of the plan drawing of the outdoor air supply system. Cracking occurred at valve 1V-6.

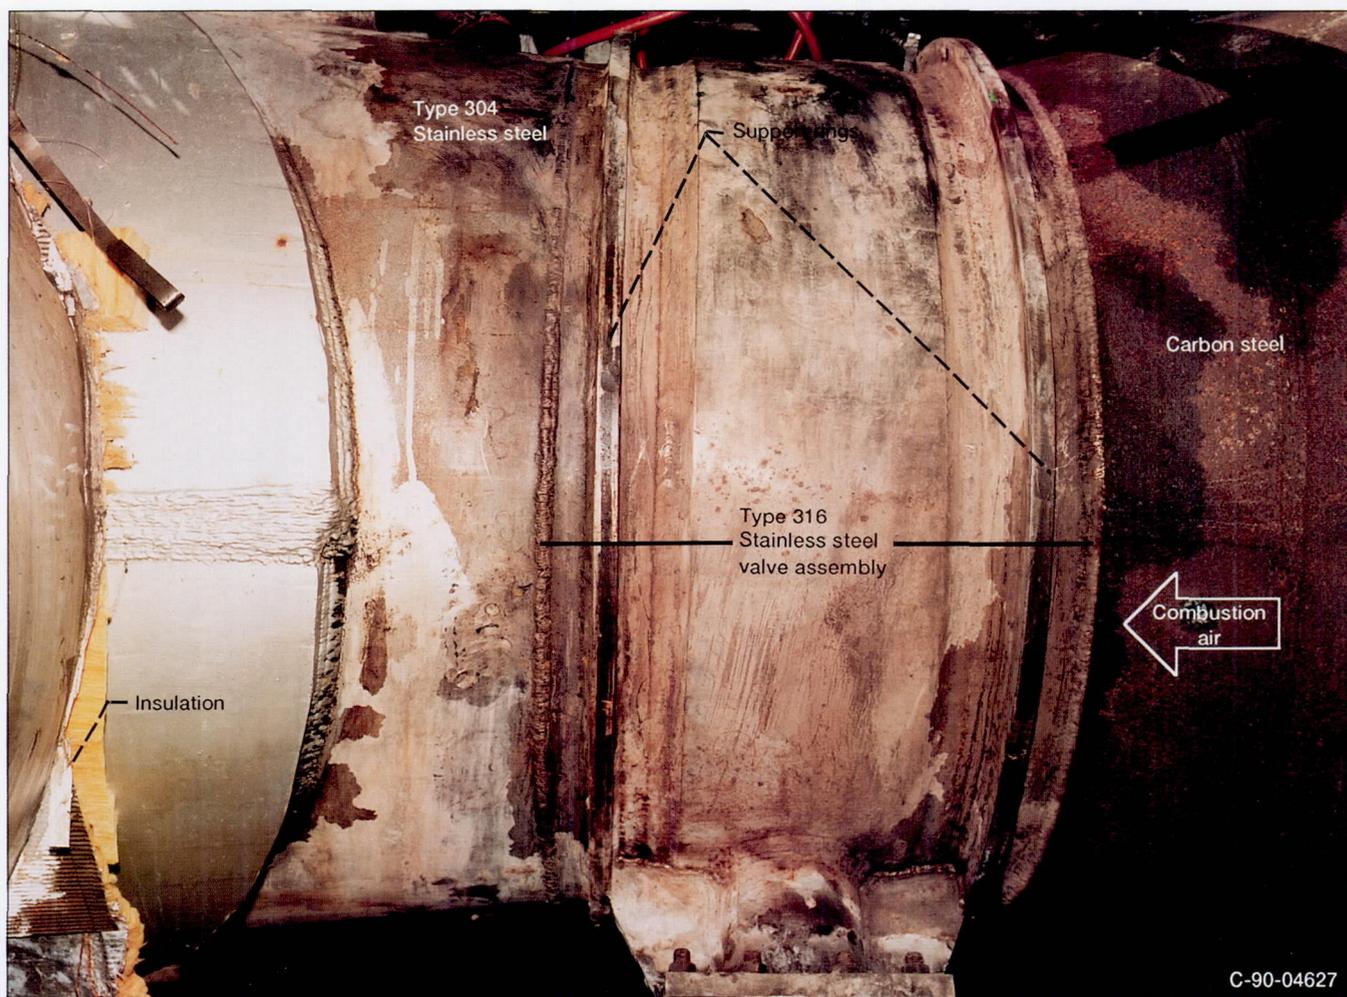
Figure 3.—Valve 1V-6 (1.22-m diam) with insulation removed showing dual support rings welded to the valve skirt.

The 1.22-m-diameter by 15-mm-wall Type 316 stainless steel valve 1V-6 is shown in figure 3 with the fiberglass insulation removed. The carbon steel air inlet pipe and the Type 304 stainless steel outlet pipe are also shown. Support rings (25.4 mm wide by 51 mm high) were welded to the skirt in T-joints on both the upstream and downstream sides of the butterfly valve. The metallographic failure investigation was concentrated primarily at the downstream side of the valve where dye penetrant inspection first revealed two through-the-wall cracks in the valve skirt. Later in the investigation, other cracks, including a through-the-wall crack, were discovered at the upstream side of the valve. Although these latter cracks were characterized, the photomicrographs are not presented herein.

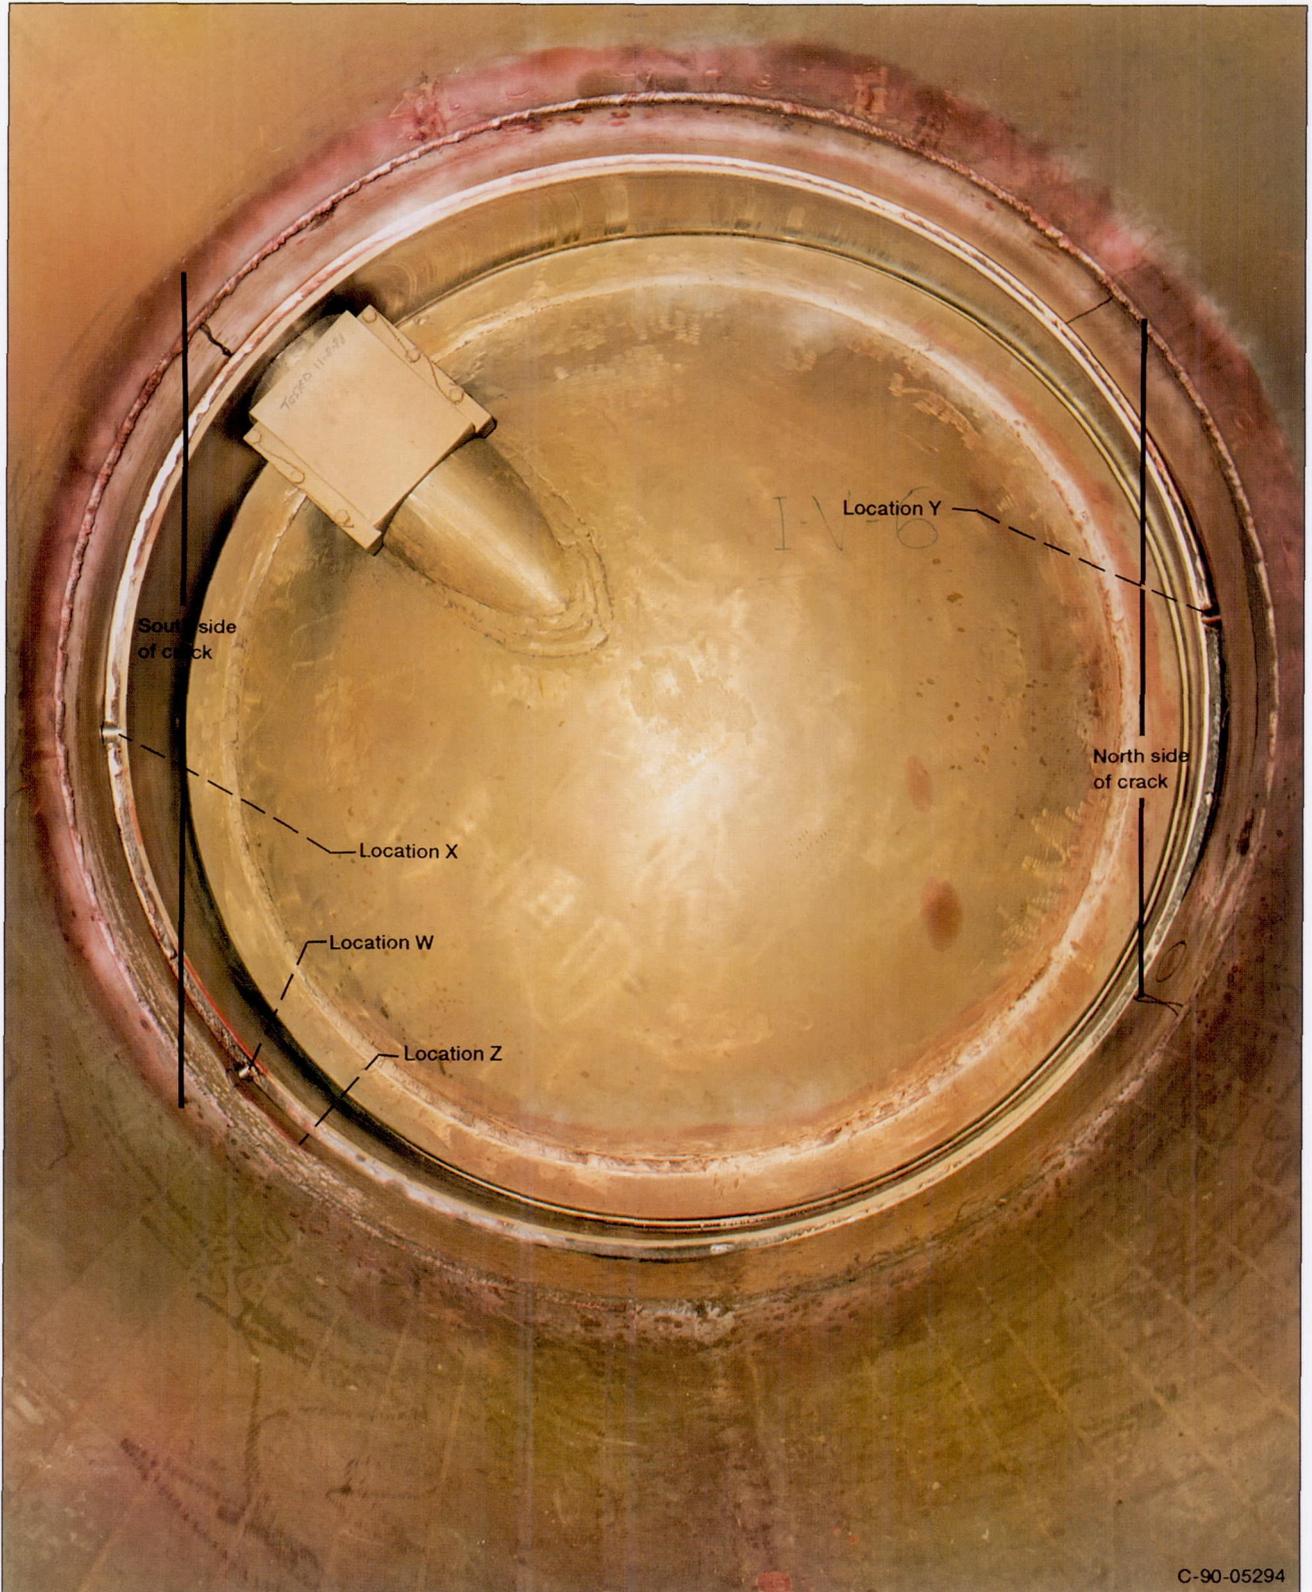
An internal view of the valve in the open position (looking upstream) is shown in figure 4. An identical view in the closed position is shown in figure 5. Through-the-wall cracking was present in the weld HAZ for about half the

circumference of the butt joint on the south and north sides. Figure 5 also shows the locations from which 21-mm-diameter metallographic plug samples W, X, and Y were taken from the butt joint and the region from which sample Z was taken from the T-joint. Figures 6 and 7 are external views showing the plug holes, which were centered at the butt joint cracks. The plugs included weld metal, HAZ, and unaffected base metal. Figure 6 also shows that the area of sample Z (which was cut out later) included a portion of the support ring. The internal view in figure 8 shows the plug holes of samples X and W and a portion of the through-the-wall toe crack from the external ring-to-skirt T-joint. This toe crack, which was evident along the inner circumference, was parallel to the circumferential butt joint crack. These cracks were only about 25 mm apart. Sample Z (shown in fig. 9), which contains the toe crack, was obtained by manual plasma arc cutting. The downstream support ring was included with a 10- by 26-cm portion of the skirt. Cross sections of sample Z were taken transverse to the support ring for both macro- and micro-examination.

Figure 5.—Internal view (looking upstream) of valve 1V-6 in the closed position. The locations from which samples W, X, Y, and Z were taken are indicated.

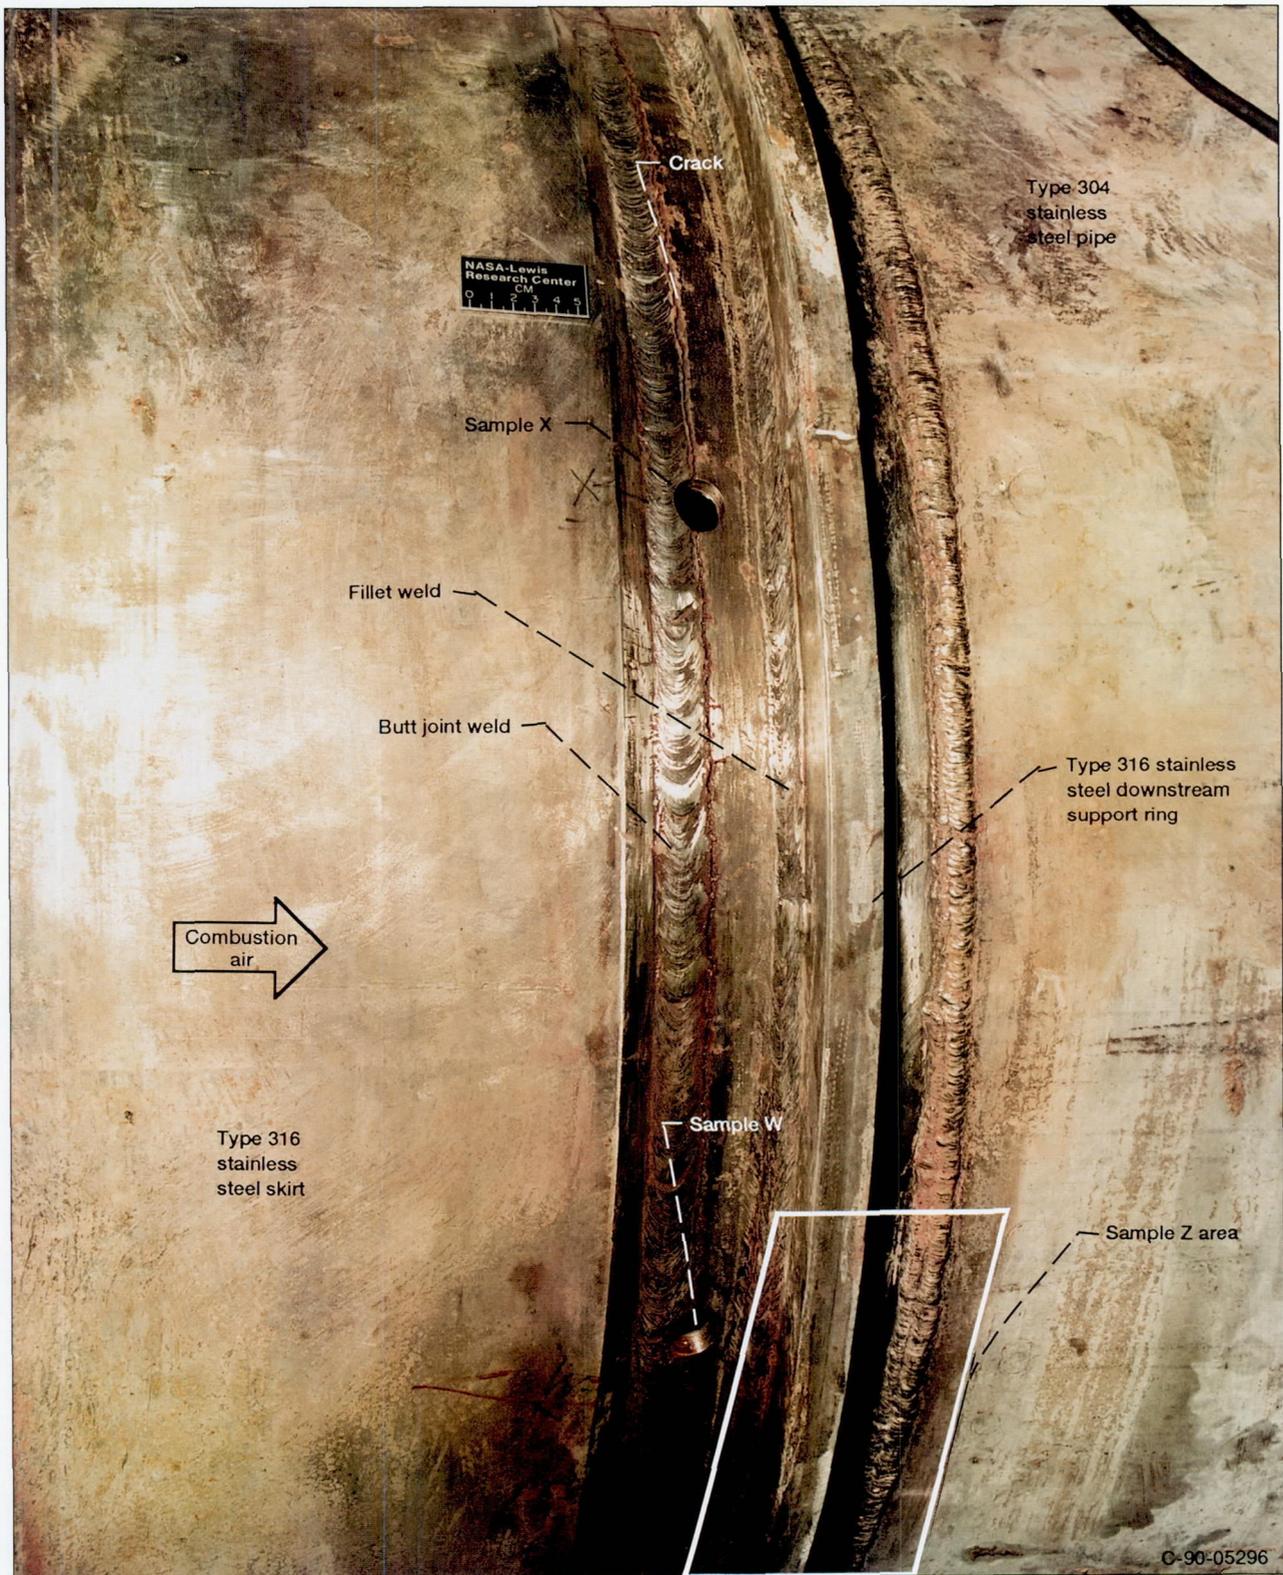
Figure 6.—External view from the south at the downstream side of valve 1V-6 showing plug holes for samples W and X and the area from which sample Z was taken.

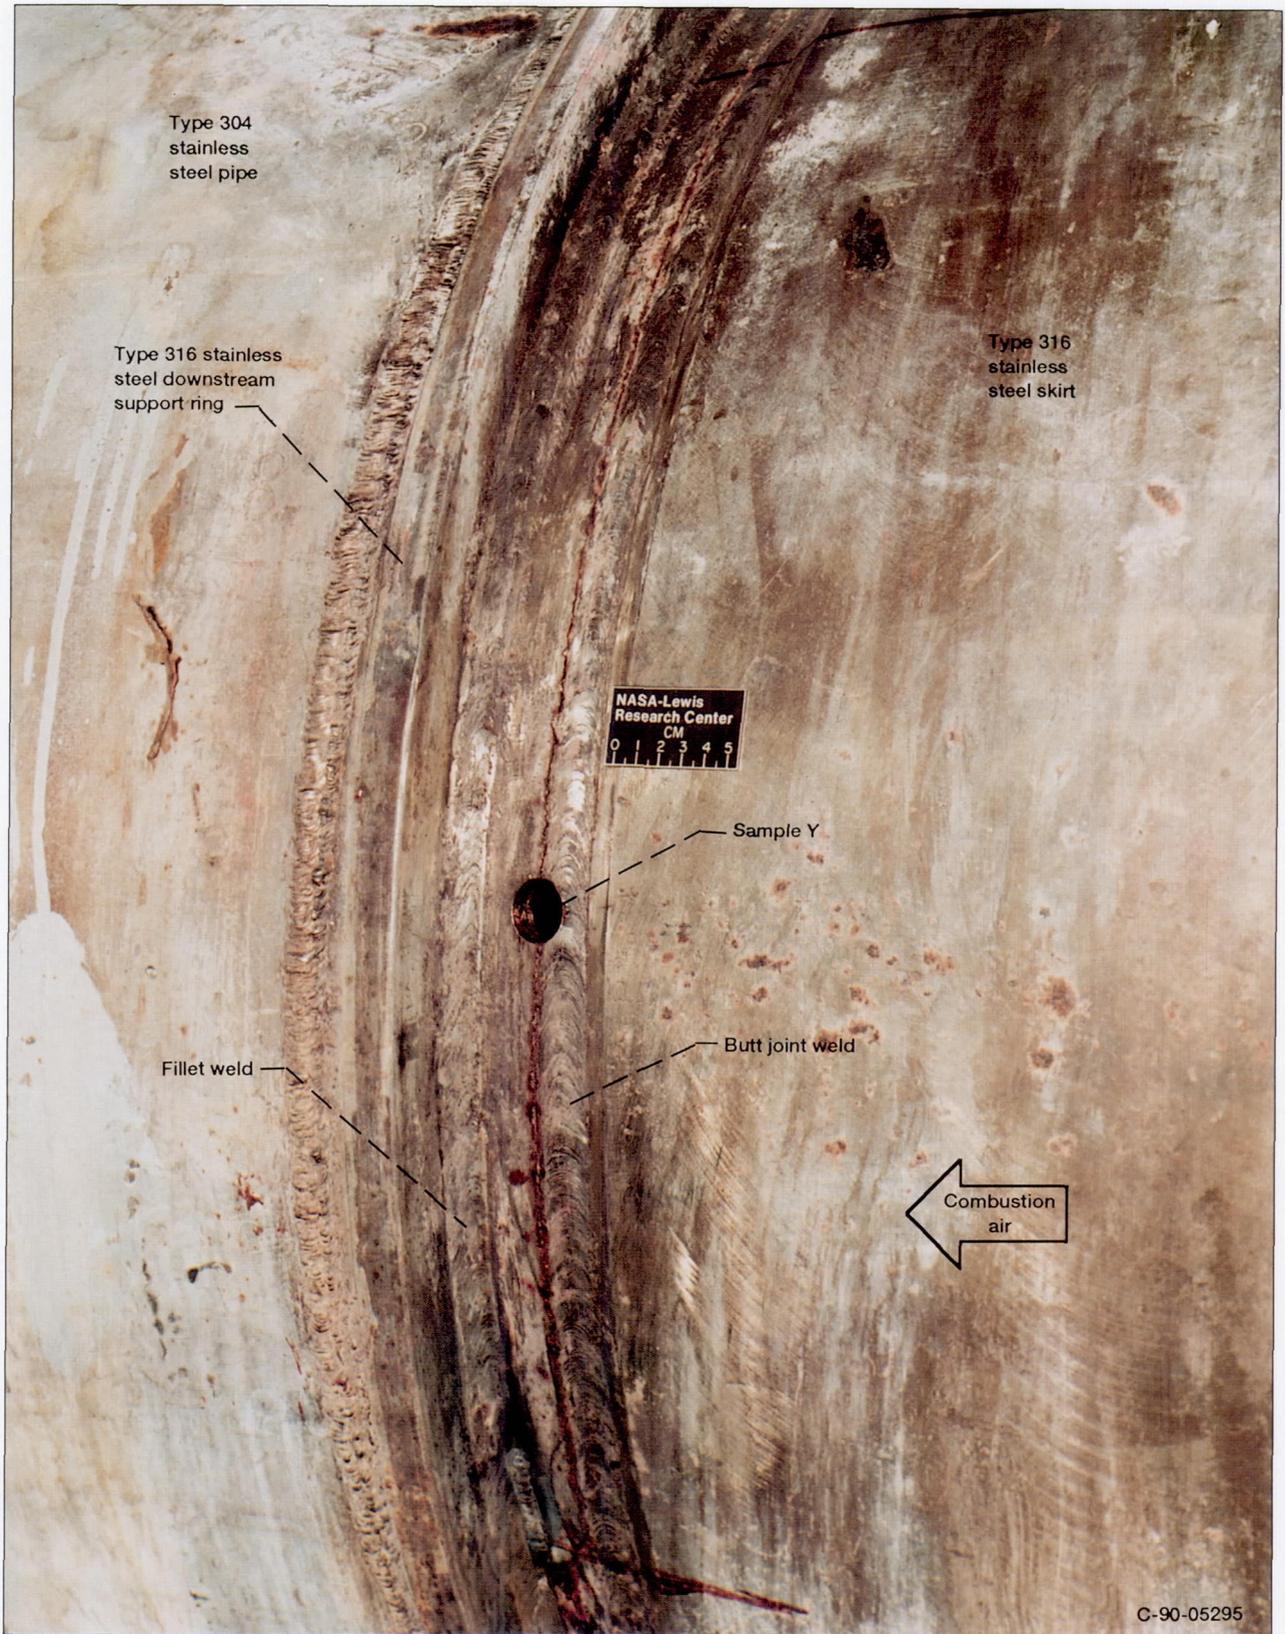
Figure 7.—External view from the north of valve 1V-6 at the downstream side showing plug hole for sample Y.

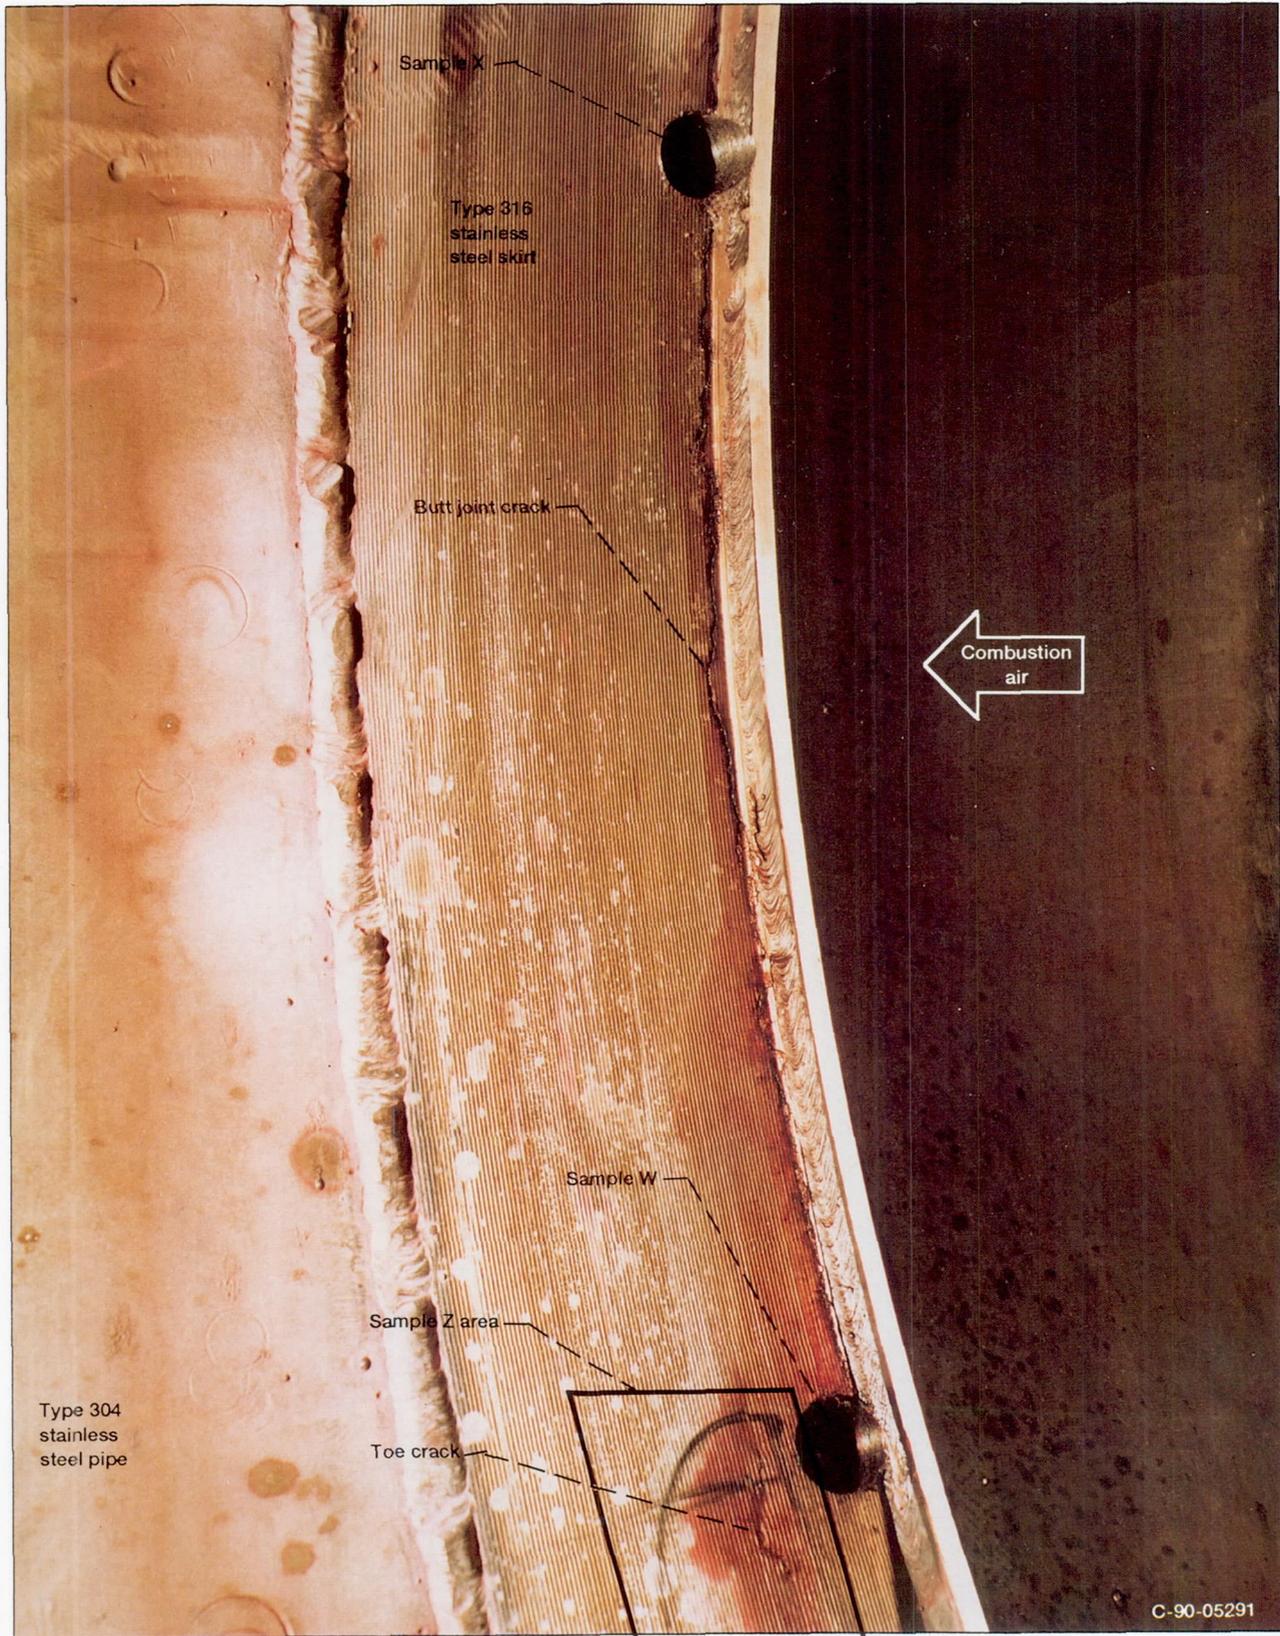
(a) View of the plug holes of samples W and X and a portion of the area from which sample Z was taken.

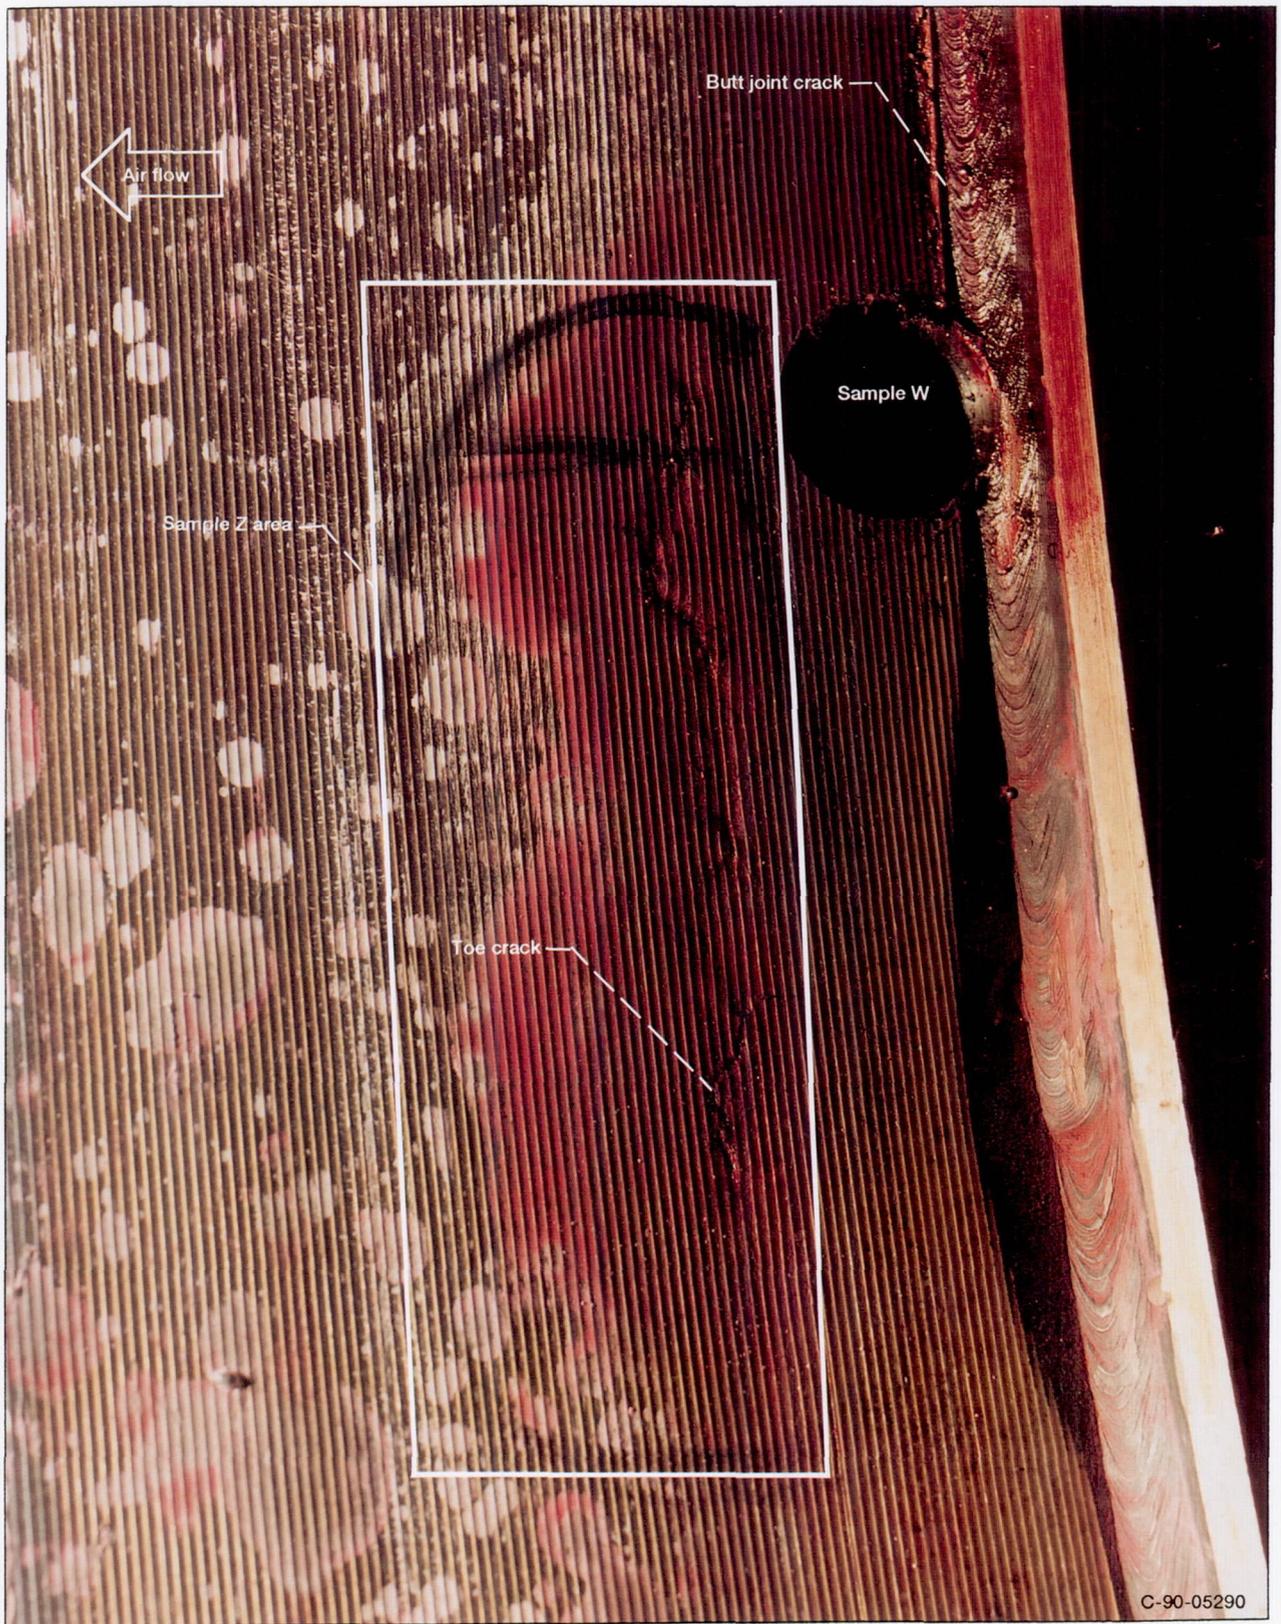
(b) Sample W plug hole and region from which sample Z was obtained.

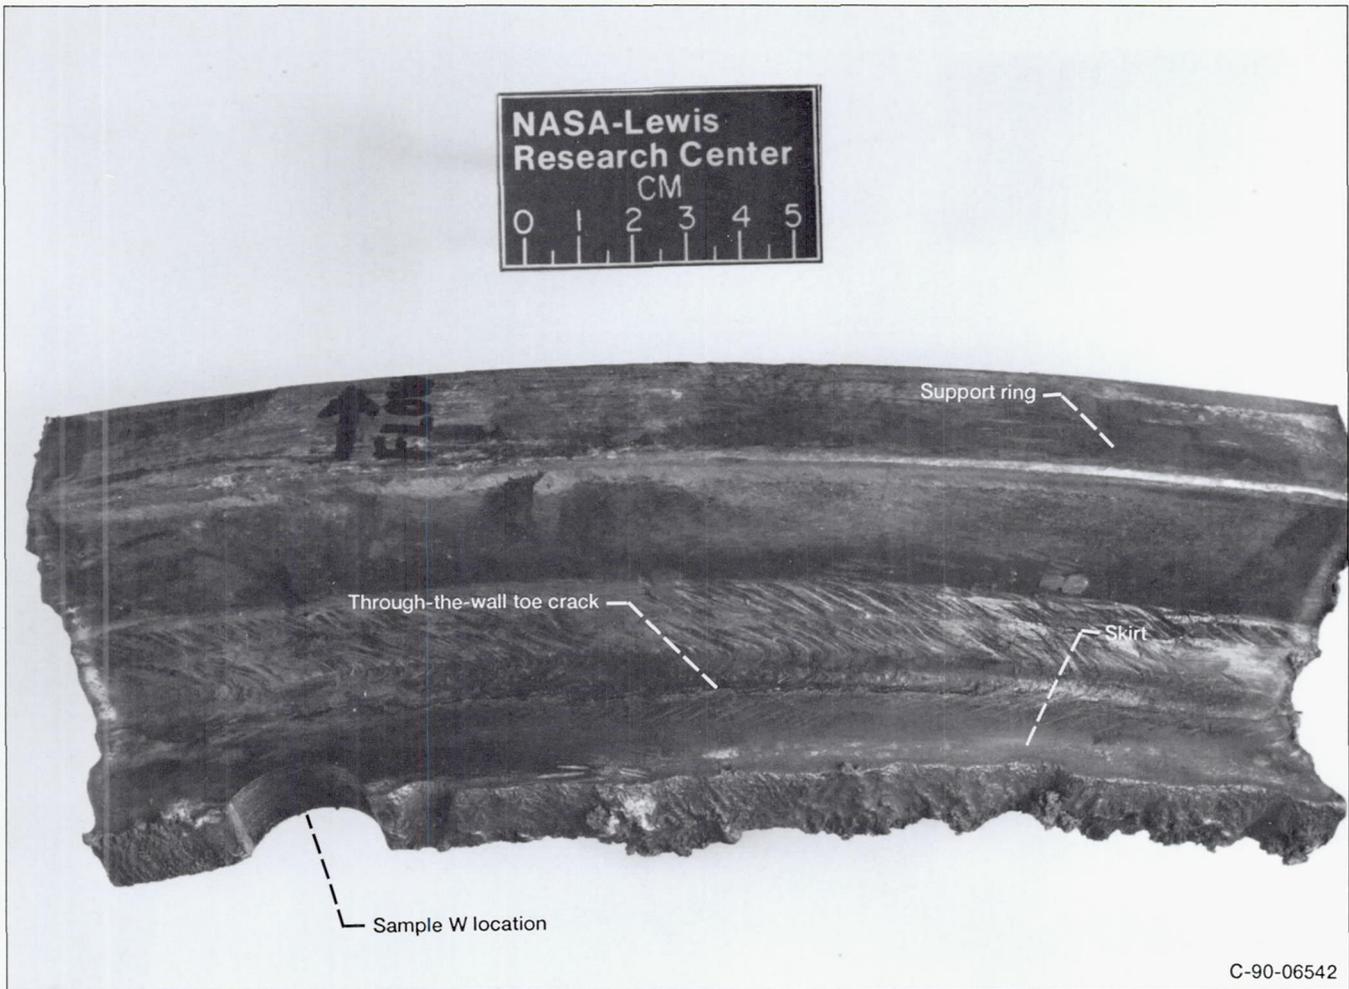
Figure 9.—Sample Z (a 10-cm by 26-cm section of the skirt), including a portion of the downstream support ring T-joint.

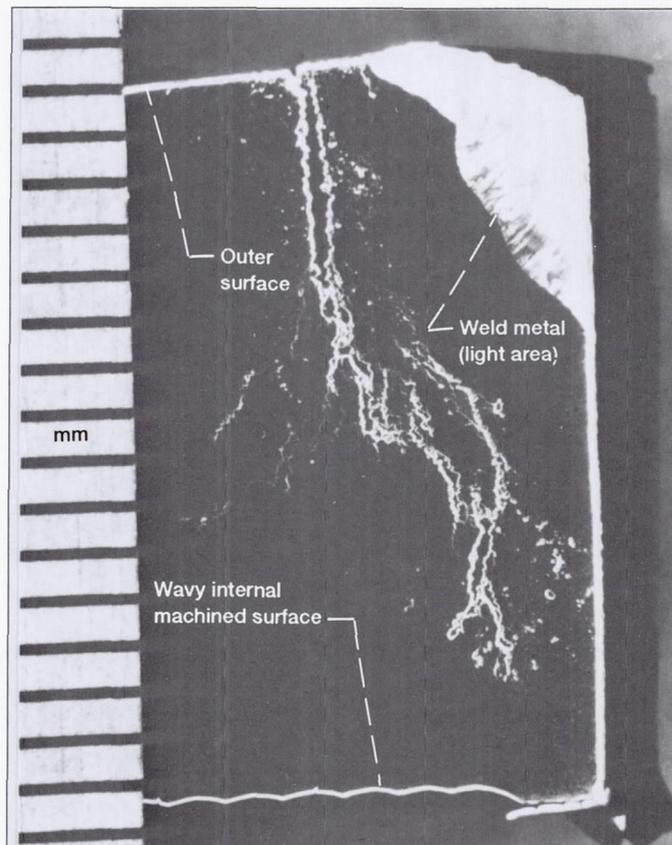
Figure 10.—Macrograph of stress-corrosion cracking in the heat-affected zone of a circumferential butt joint in Type 316 stainless steel (specimen W).

evident from the cracking pattern shown in figure 10 that the crack started at the outer surface of the skirt. Below the surface, it became branched. Figures 11(a) and (b) illustrate the intergranular nature of the cracking.

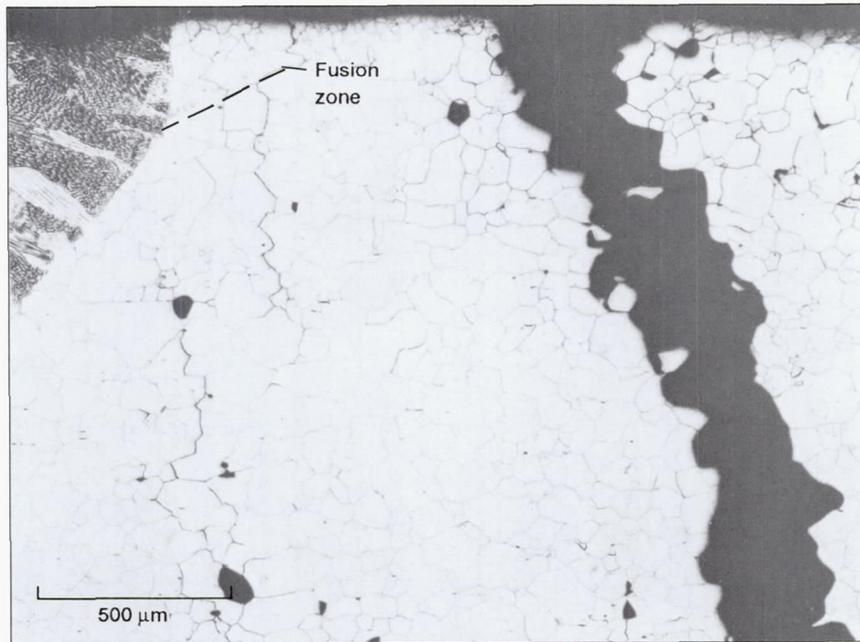
(a) Intergranular, heat-affected-zone crack at outside surface.

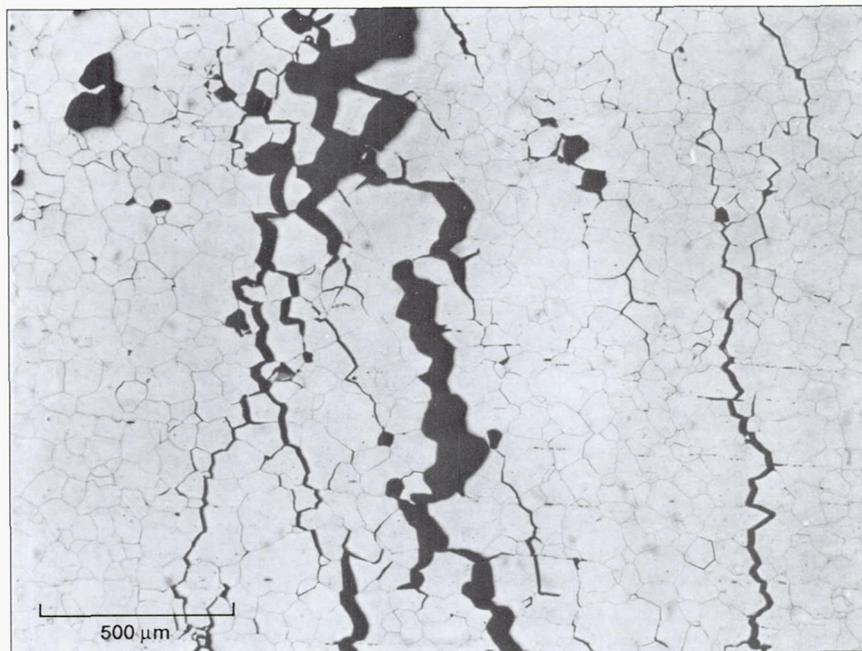
(b) Intergranular, base metal cracks at midthickness of the skirt. The cracks are oriented roughly parallel to the main fracture path.

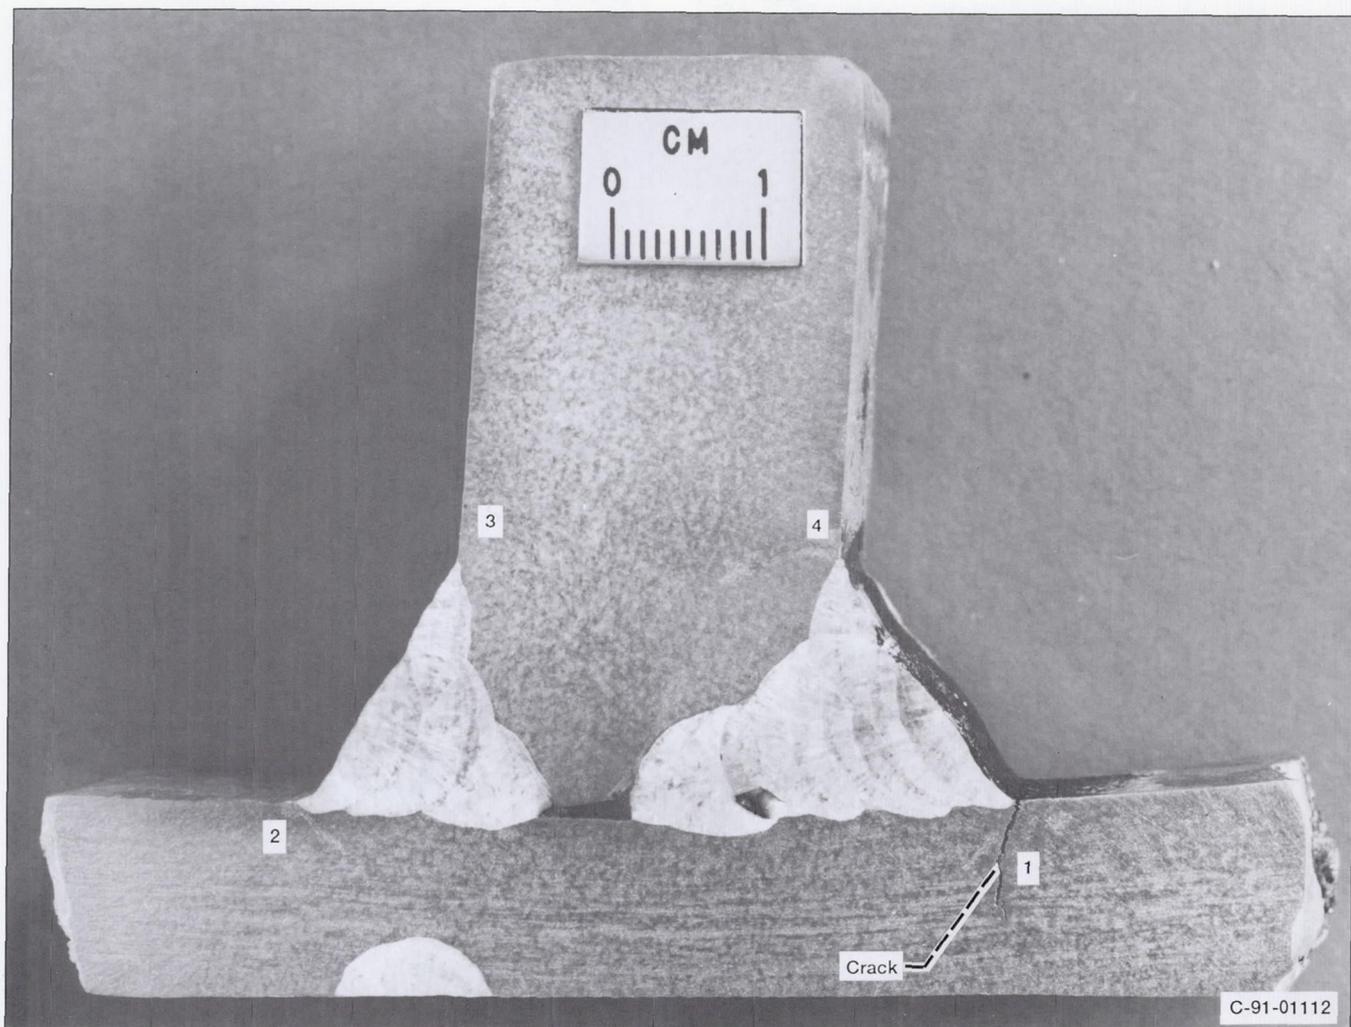
The cross section of sample Z from the valve skirt (fig. 12) shows a toe crack which extended more than half-way through the wall (location 1). Other cross sections of

Figure 12.—A cross section of sample Z T-joint showing a stress-corrosion toe crack in the Type 316 stainless steel valve skirt. Intergranular toe cracks (not evident in this photograph) are also present at locations 2, 3, and 4.

sample Z revealed that this crack had penetrated completely through the skirt for a distance of 18 cm along the circumference. Like the butt joint crack, it was narrow at the outer surface and branched as it proceeded towards the interior. The failure was intergranular, similar to that shown in figure 11. Tight, intergranular toe cracks not evident in figure 12 were present at locations 2, 3, and 4. These cracks were found only after sectioning and polishing. The cracking in the skirt at location 2 in figure 12 (shown in fig. 13(a)), extends to a depth of about 7 mm. At location 4 in figure 12, the cracking has progressed into the support ring to a depth of about 8 mm (see fig. 13(b)). At location 3 in figure 12, the cracking was only about 2 mm deep (not shown). The purpose of the autogenous gas tungsten arc weld pass at location 2 in figure 12, on the inner surface of the skirt, is not known.

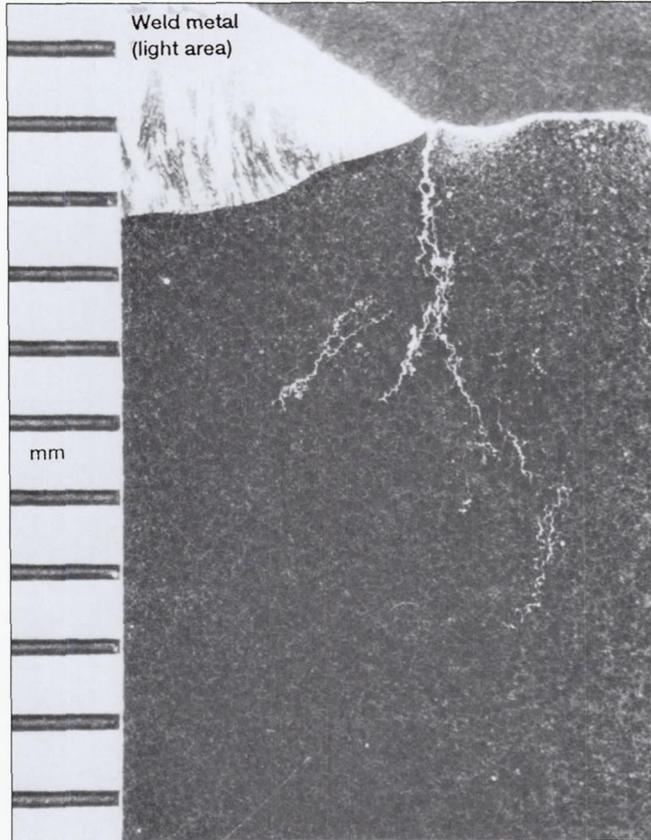
(a) Cracking in the valve skirt at location 2 in figure 12.

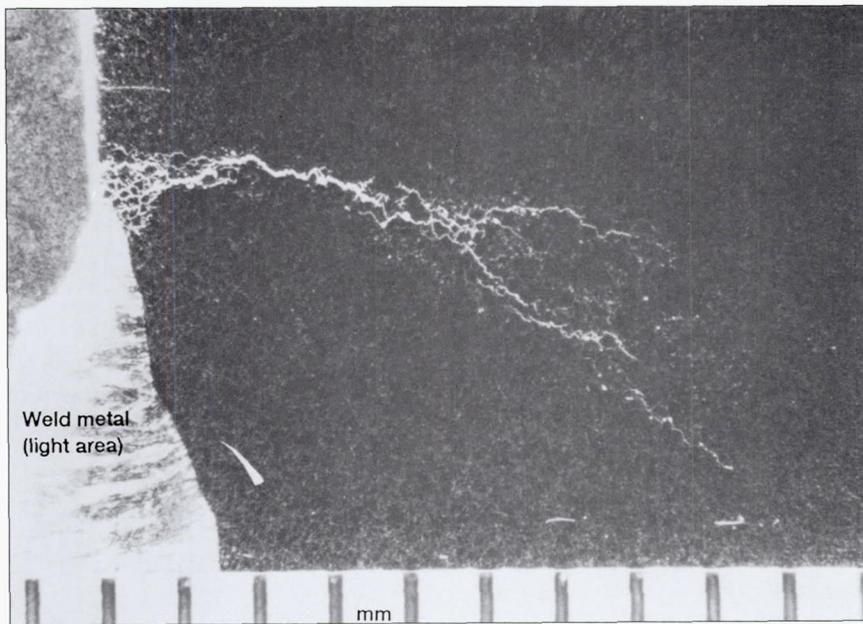
The support ring base metal toe crack at location 4 (fig. 13(b)) was the area examined. As shown in figure 14, two oxidelike layers were present at the outside surface, and a number of intergranular cracks extended from this surface into the support ring. The XEDS analysis was performed in three regions designated the outer layer, the inner layer, and the intergranular layer, respectively (fig. 14). XEDS analysis of the support ring was also conducted in a noncorroded area away from the crack.

(b) Cracking in the support ring at location 4 in figure 12.

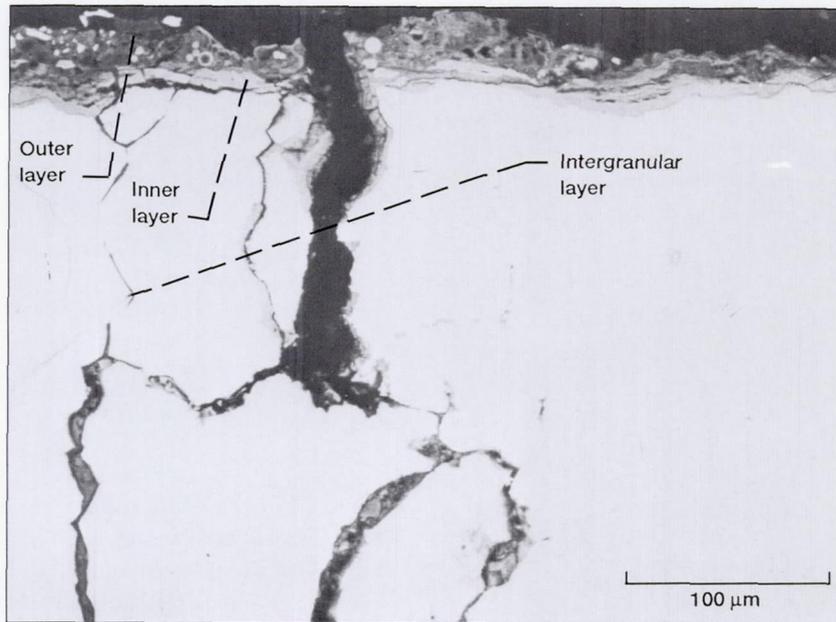
Figure 14.—Backscatter scanning electron microscope image showing intergranular, stress-corrosion cracking and the locations that were analyzed.

A major difference in composition between the outer layer (fig. 14) and the support ring can be noted in the XEDS analysis in table I. First, the relative levels of chromium (Cr) and nickel (Ni) in the outer layer are significantly lower. Second, the outer layer appears to contain substantial quantities of chlorine (Cl), Ca, Si, and phosphorus (P). The Ca and Si indications are probably a result of plastic mounting material infiltration. But the presence of Cl, P, and possibly K are believed to result from the environment in which the valve operated. Analysis of the inner layer (shown in table I) indicates that this material is essentially Type 316 stainless steel.

Perhaps the most important information was obtained from the analysis of the intergranular layer, 150 μm below the surface of the cracked ring (fig. 14). The profile for this spectra is shown in figure 16. These data are given in table I. A comparative XEDS analysis of the base metal and the intergranular layer showed increased quantities of Cr (18.5 to 31.1 percent), Cl (0.1 to 7.9 percent), and P (0.4 to 1.3 percent). The high Cr indicates the presence of chromium carbides at the grain boundaries (i.e., a sensitized condition). In this condition, the grain boundary regions adjacent to the

carbide particles are low in Cr and are thus susceptible to corrosive attack. The presence of a relatively large quantity of Cl is significant because of the key role this element plays in stress-corrosion cracking (SCC). The indicated increases in P and K may have resulted from the operational environment. Indications of higher Ca and Si are believed to be spurious, probably resulting from the plastic mounting material.
