# Debris/Ice/TPS Assessment and Integrated Photographic Analysis for Shuttle Mission STS-56

May 1993

DEBRIS/ICE/TPS ASSESSMENT  
AND  
PHOTOGRAPHIC ANALYSIS  
OF  
SHUTTLE MISSION STS-56

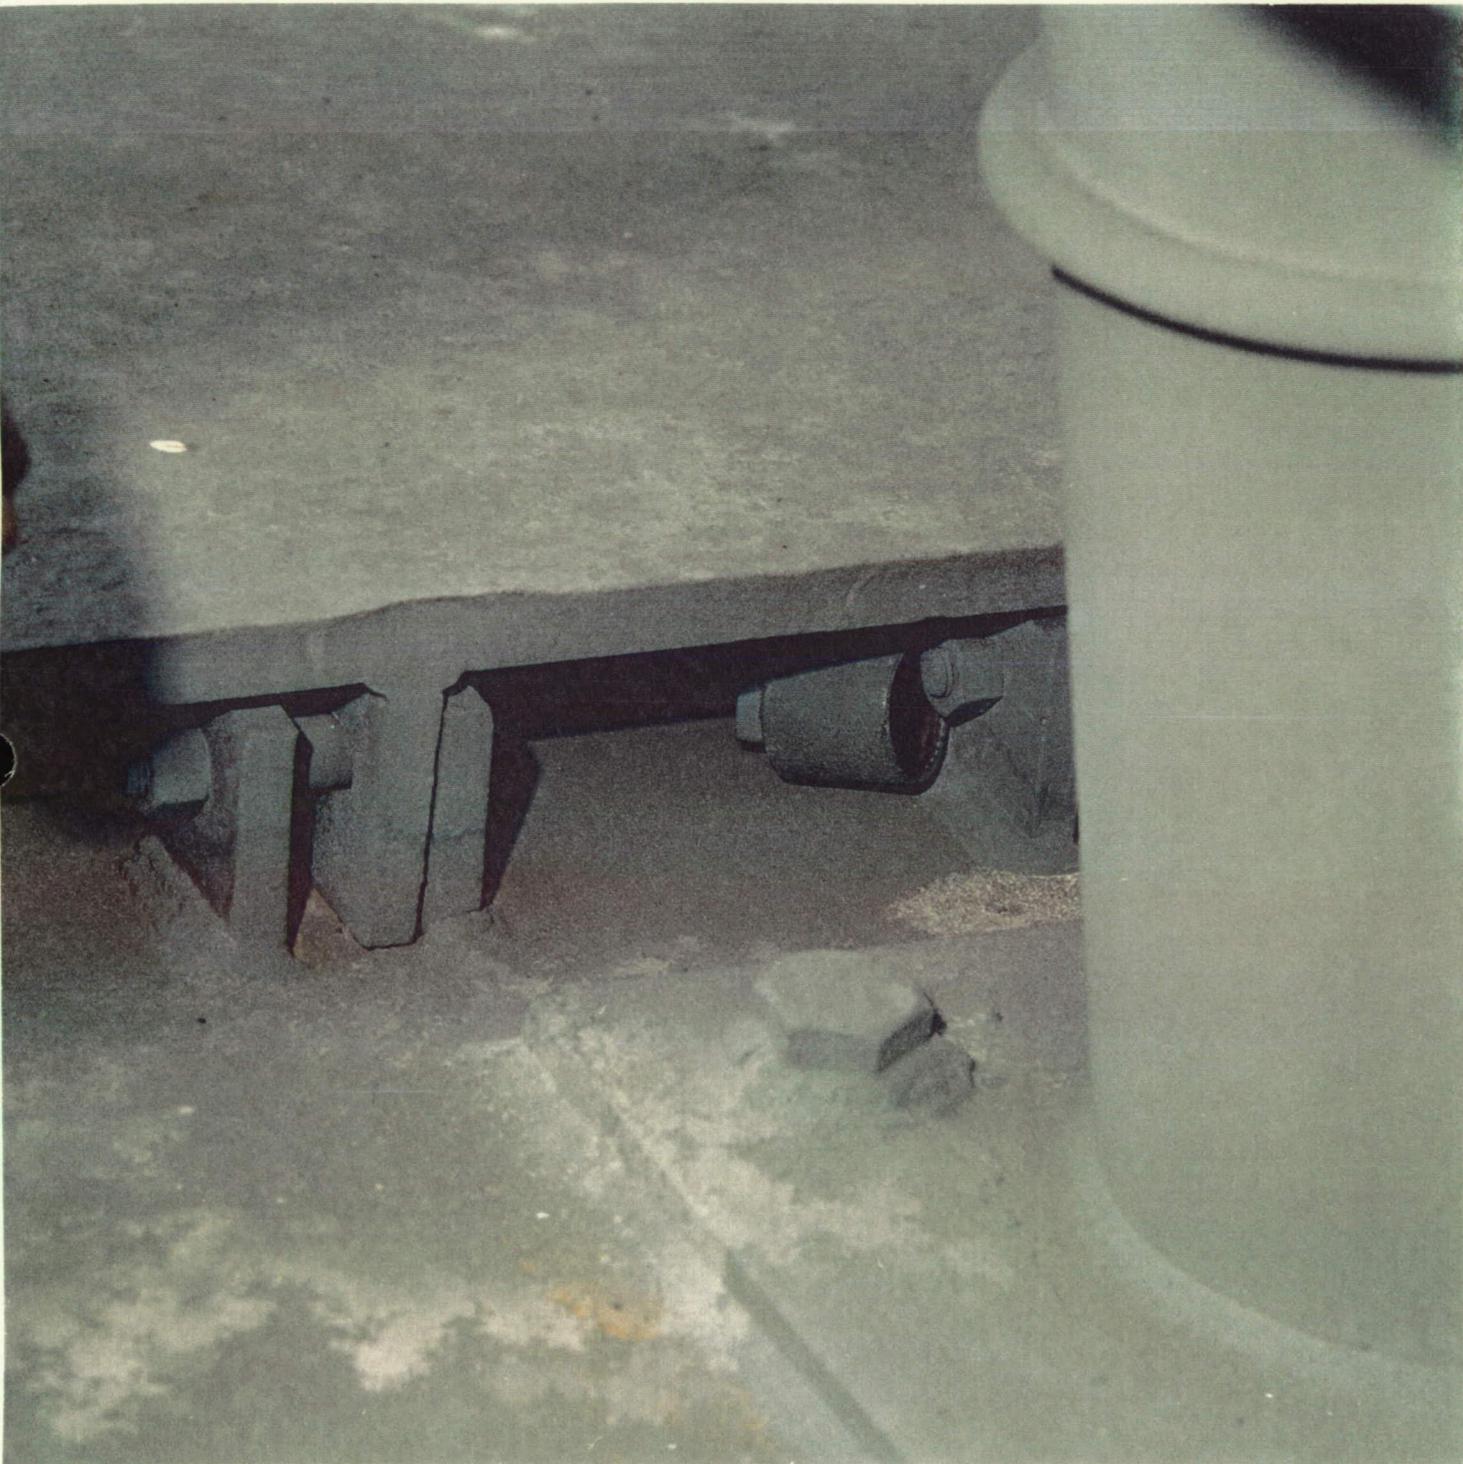
A conduit cap was found under the MLP raised deck during the pre-launch debris inspection

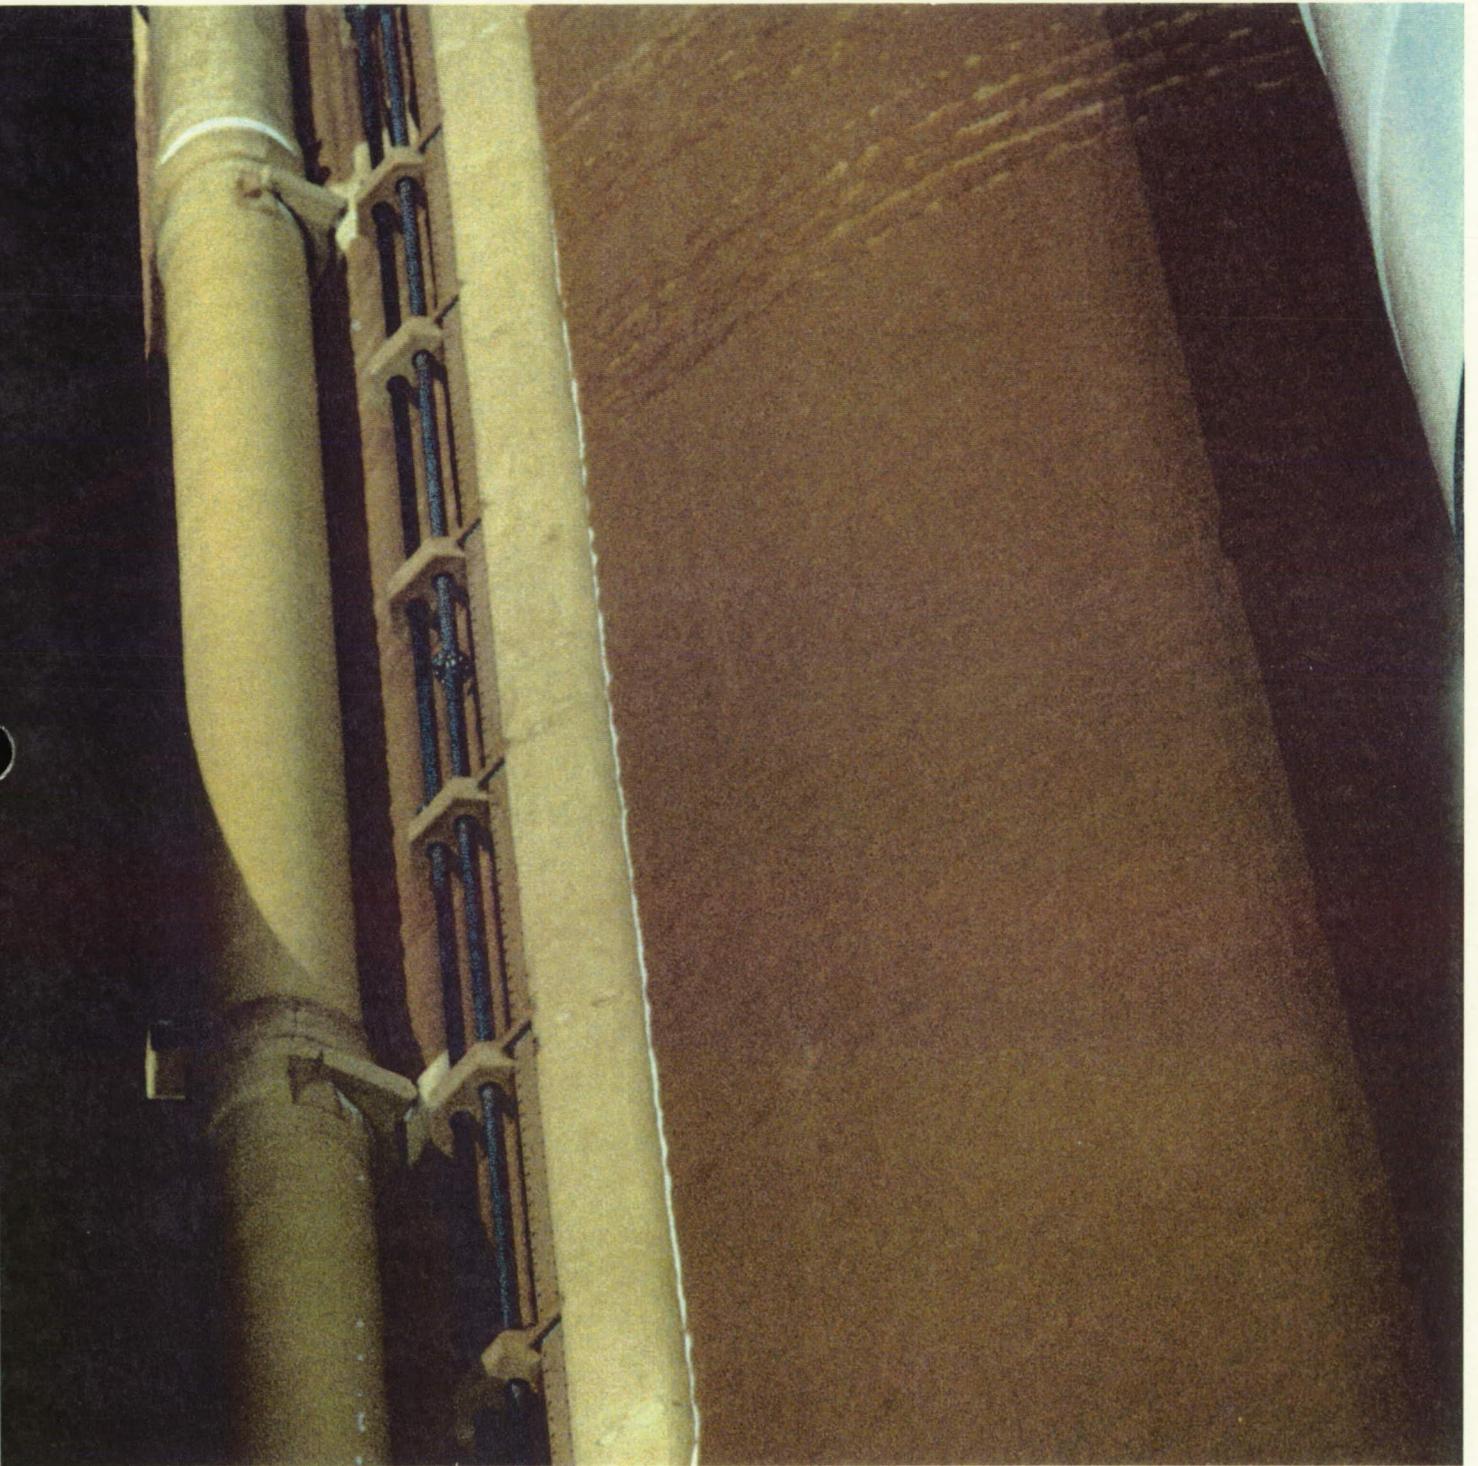
In spite of the warm ambient weather conditions, an ice/frost line formed along the edge of the LH2 tank PAL ramp. There was no ice or frost accumulation on the LH2 tank acreage TPS.

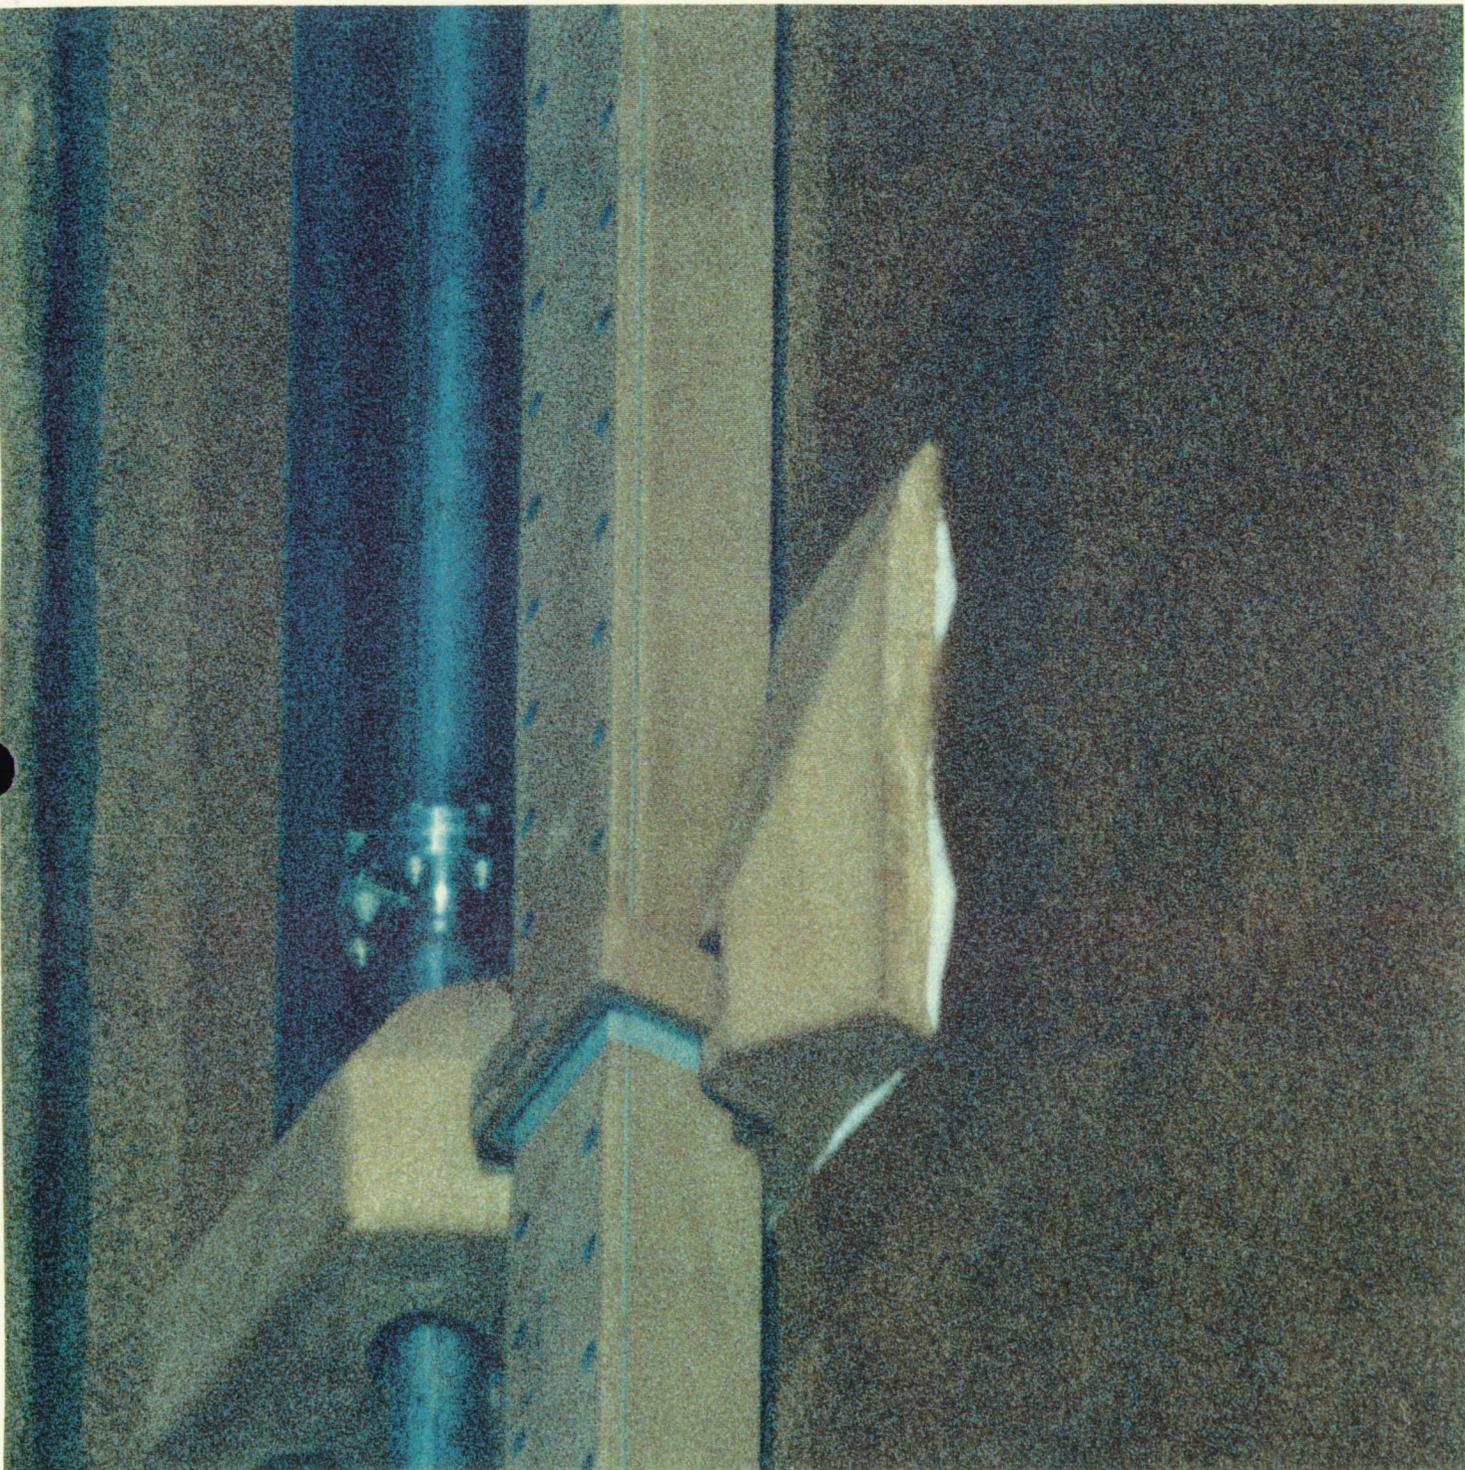
In spite of the warm ambient weather conditions, ice/frost had formed along the edges of three cable tray support ramps.

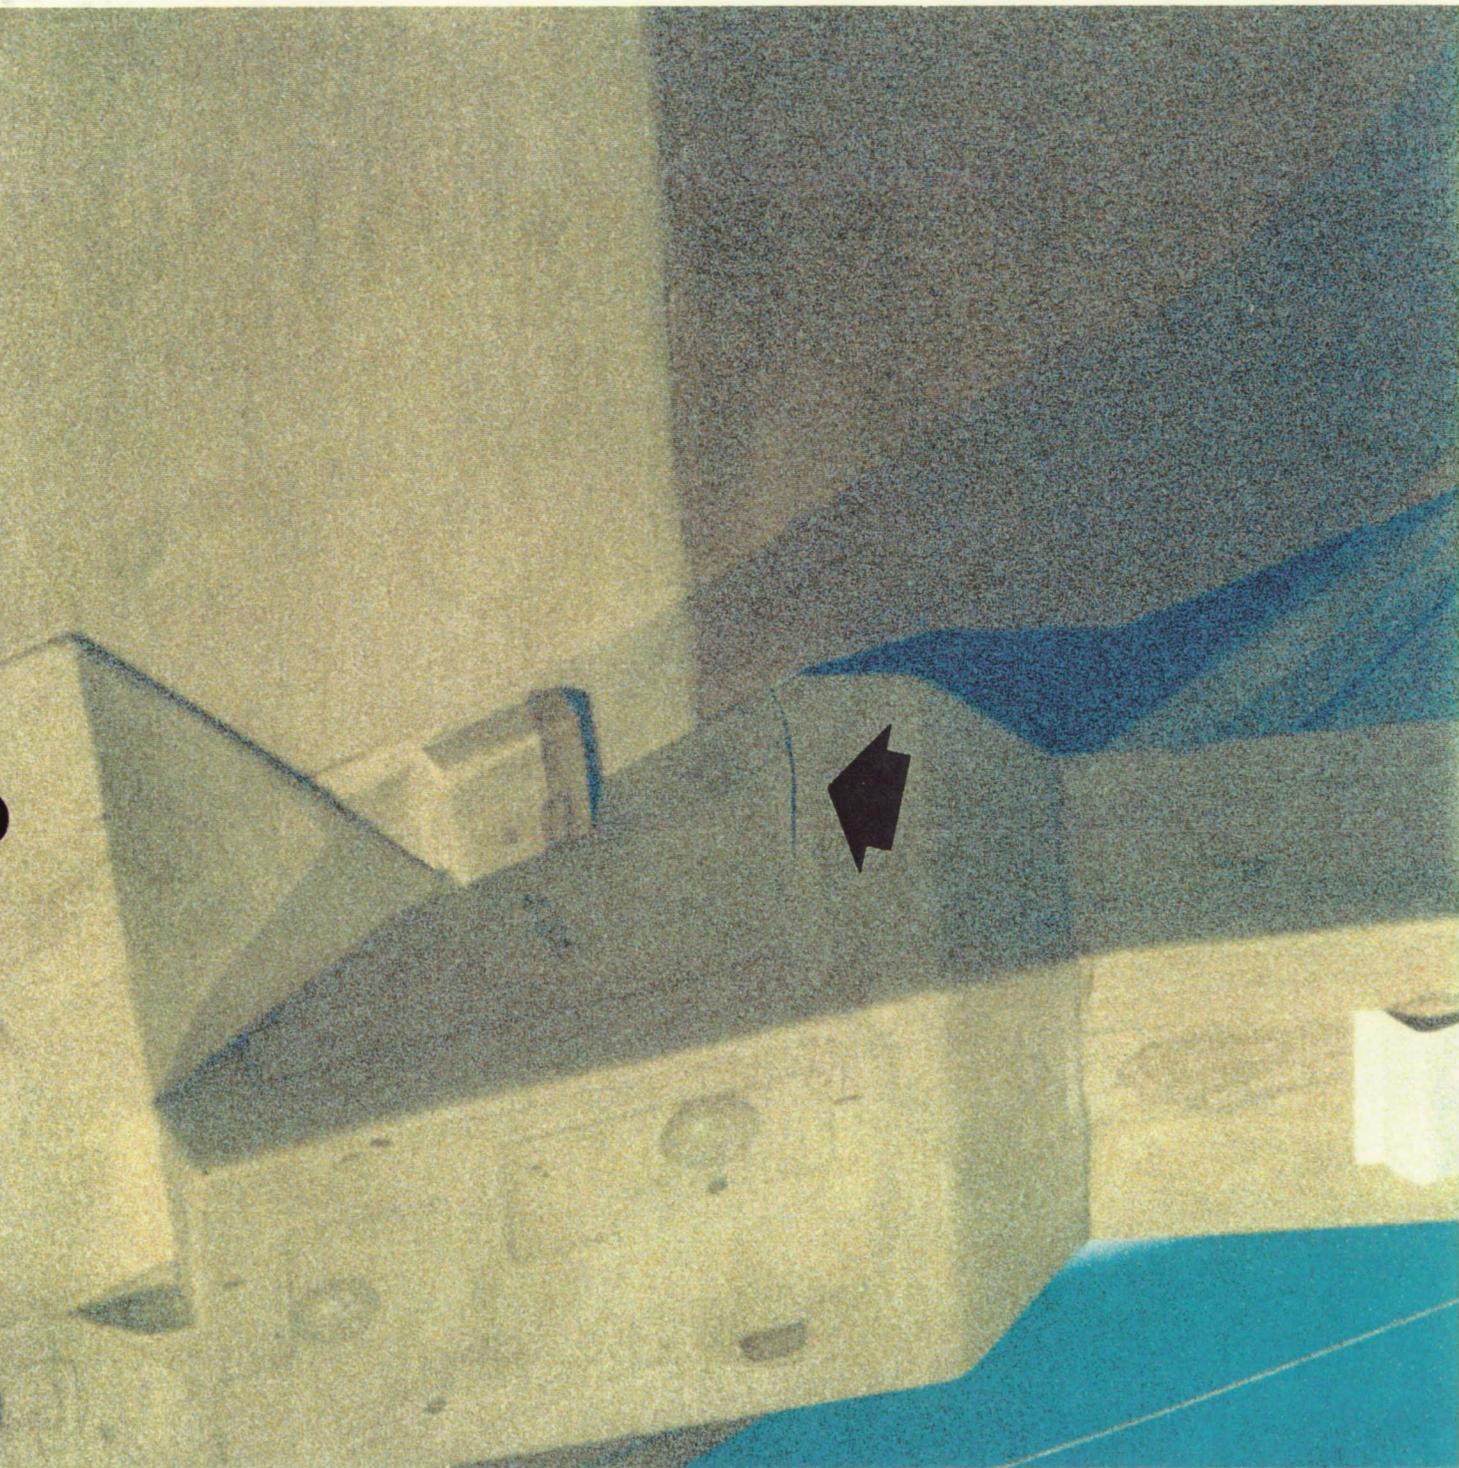
A 10-12 inch long crack occurred in the -Y vertical strut cable tray forward surface TPS near the longeron closeout interface. The 1/4-inch wide crack exhibited no offset and was not filled with ice or frost. The condition was acceptable for flight.

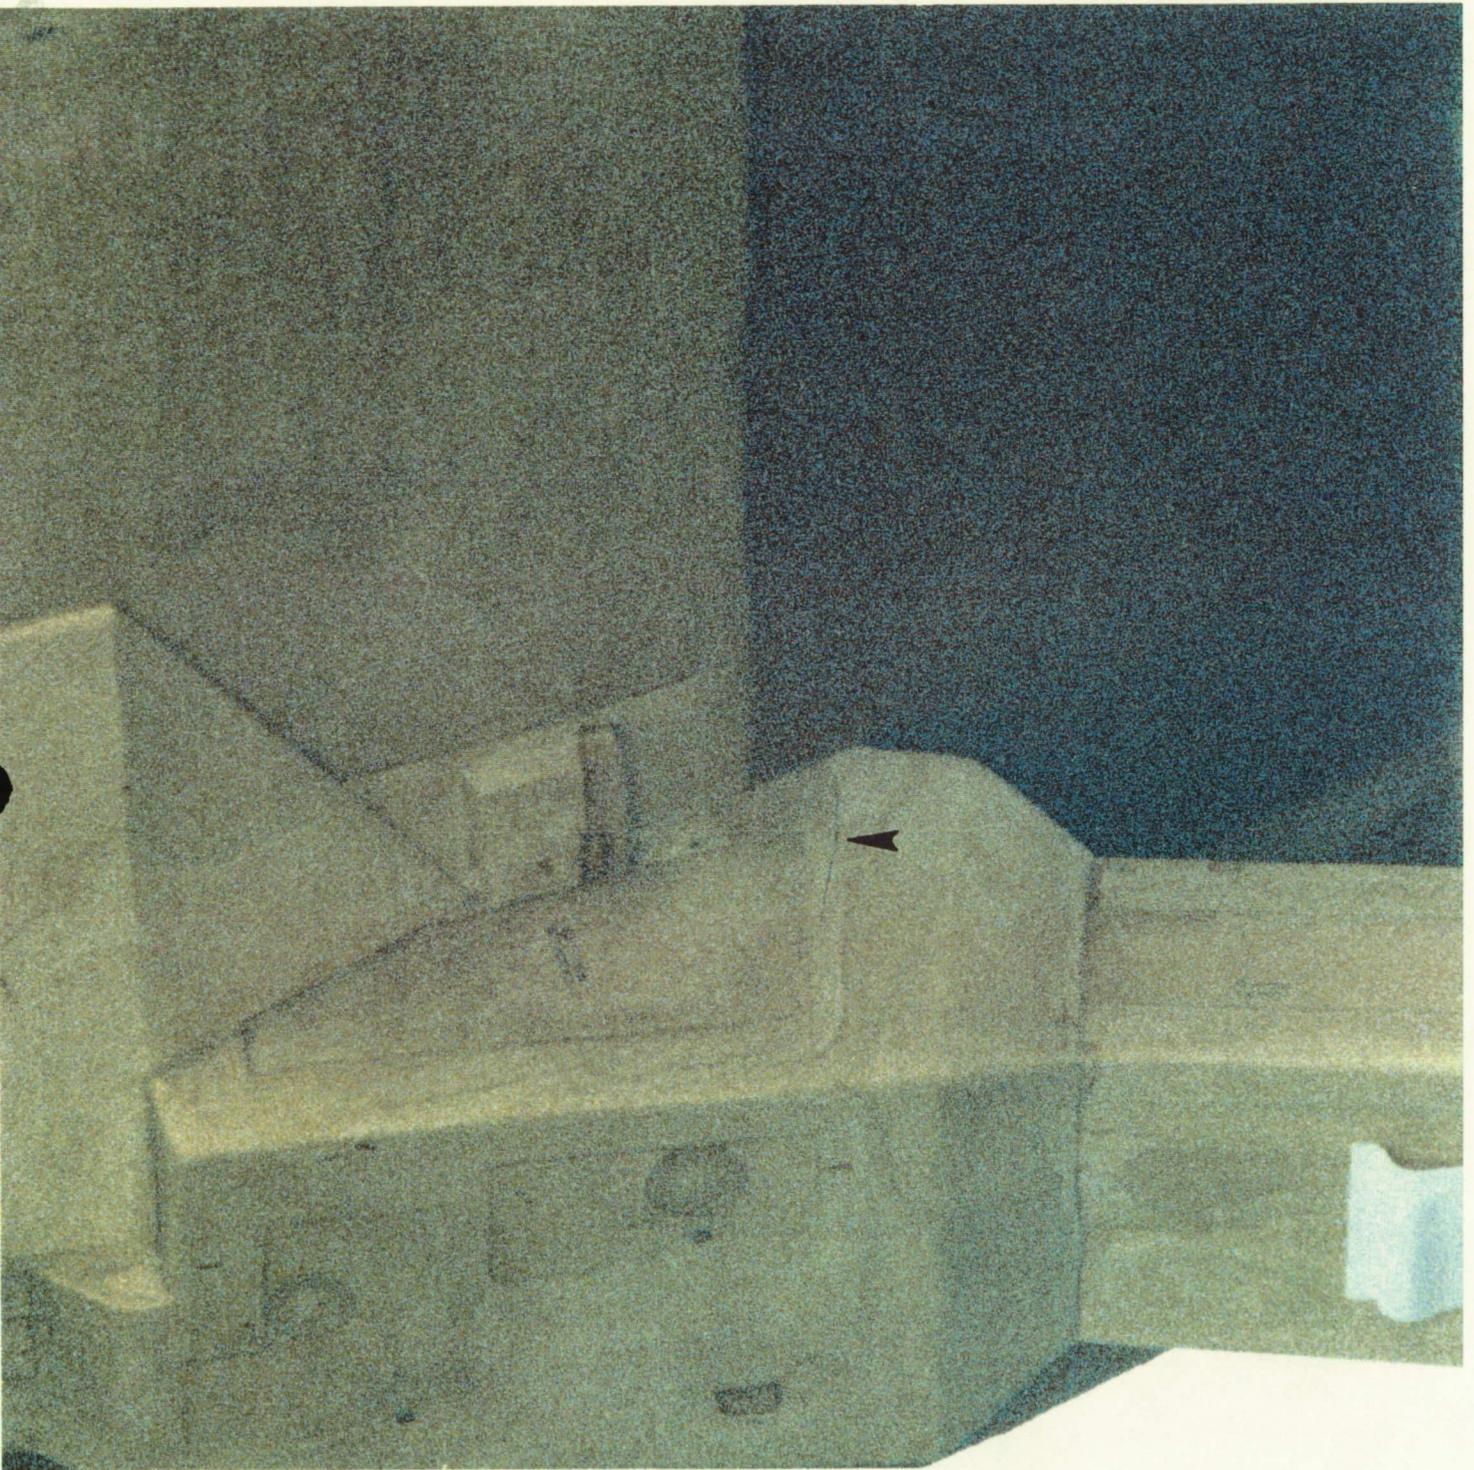
The 12-inch crack in the -Y vertical strut cable tray forward surface TPS was still visible after the tank had been drained.

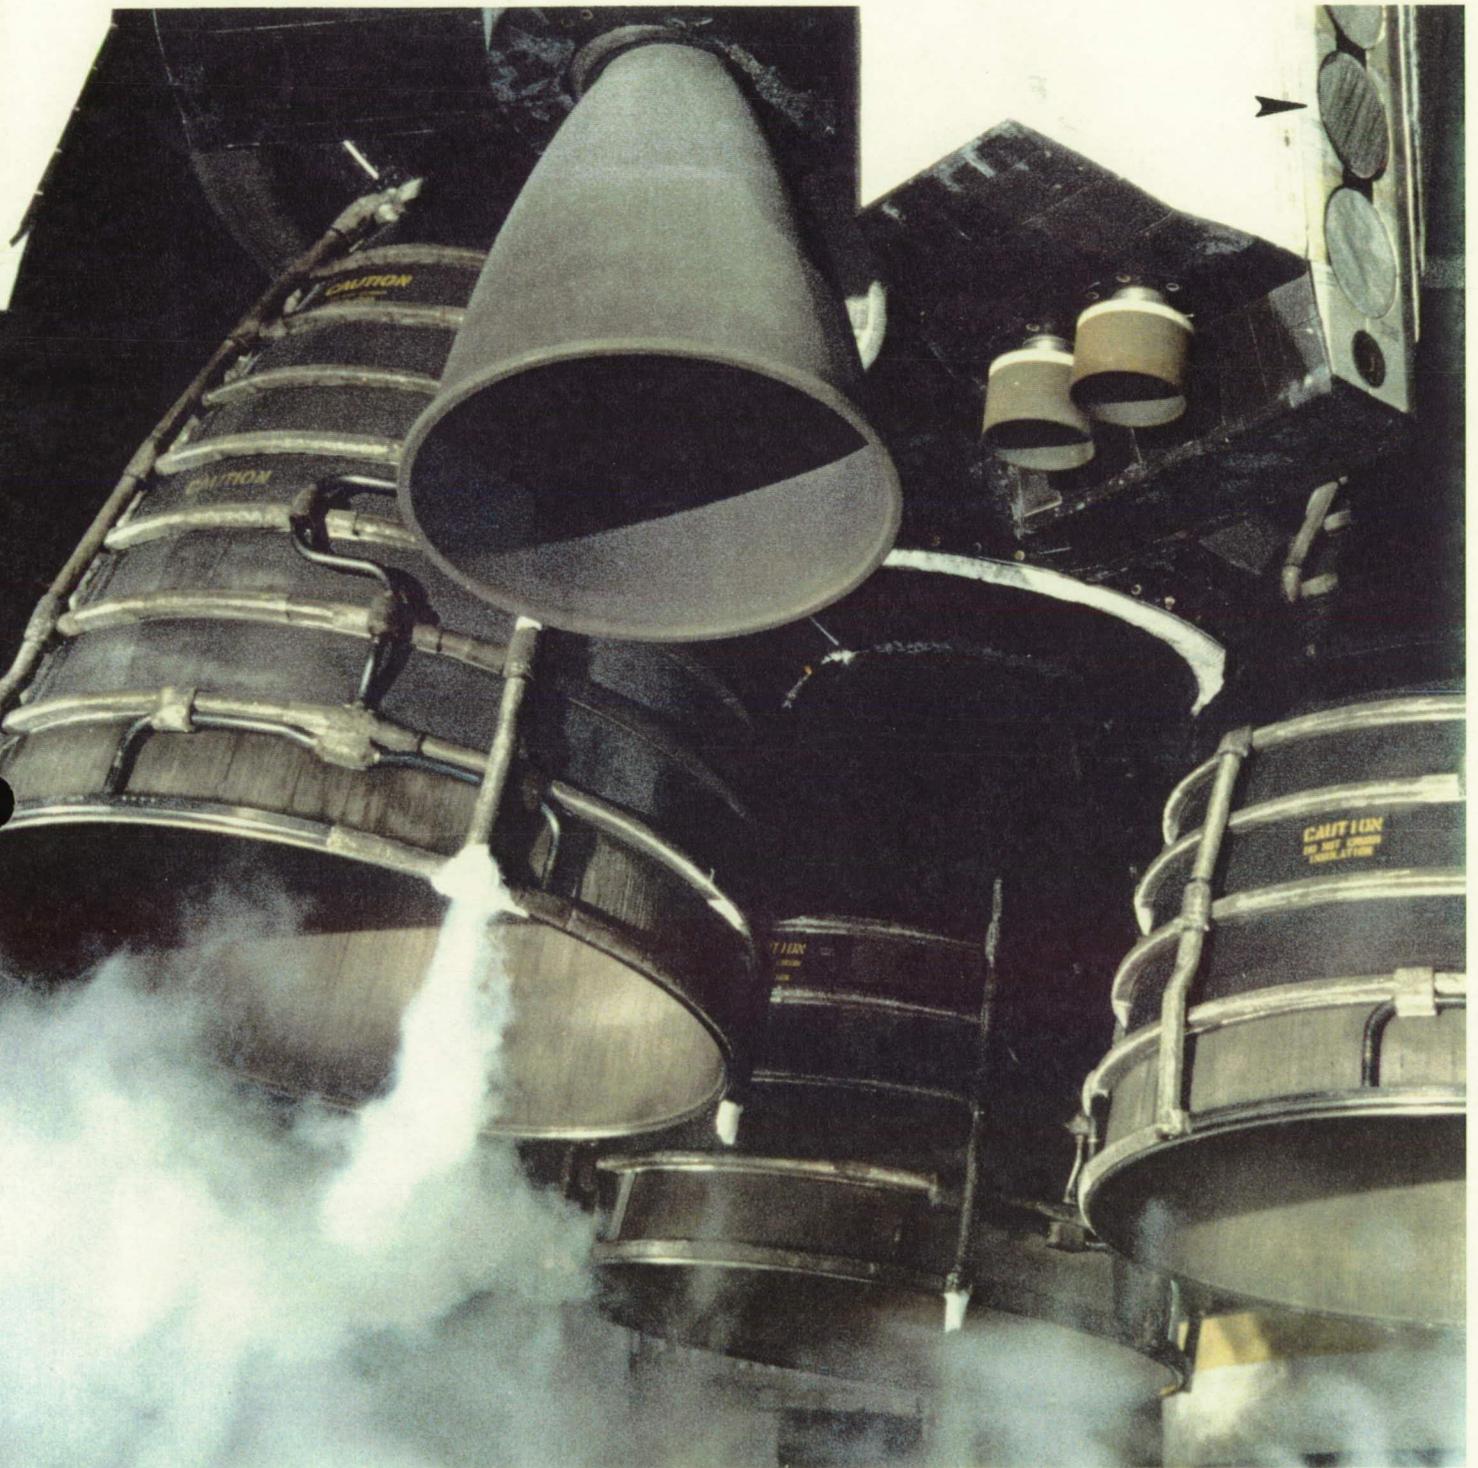
Typical ice/frost accumulations were present at the SSME #1 and #2 heat shield-to-nozzle interfaces. The R3R aft RCS thruster paper cover had been wetted by vapors.

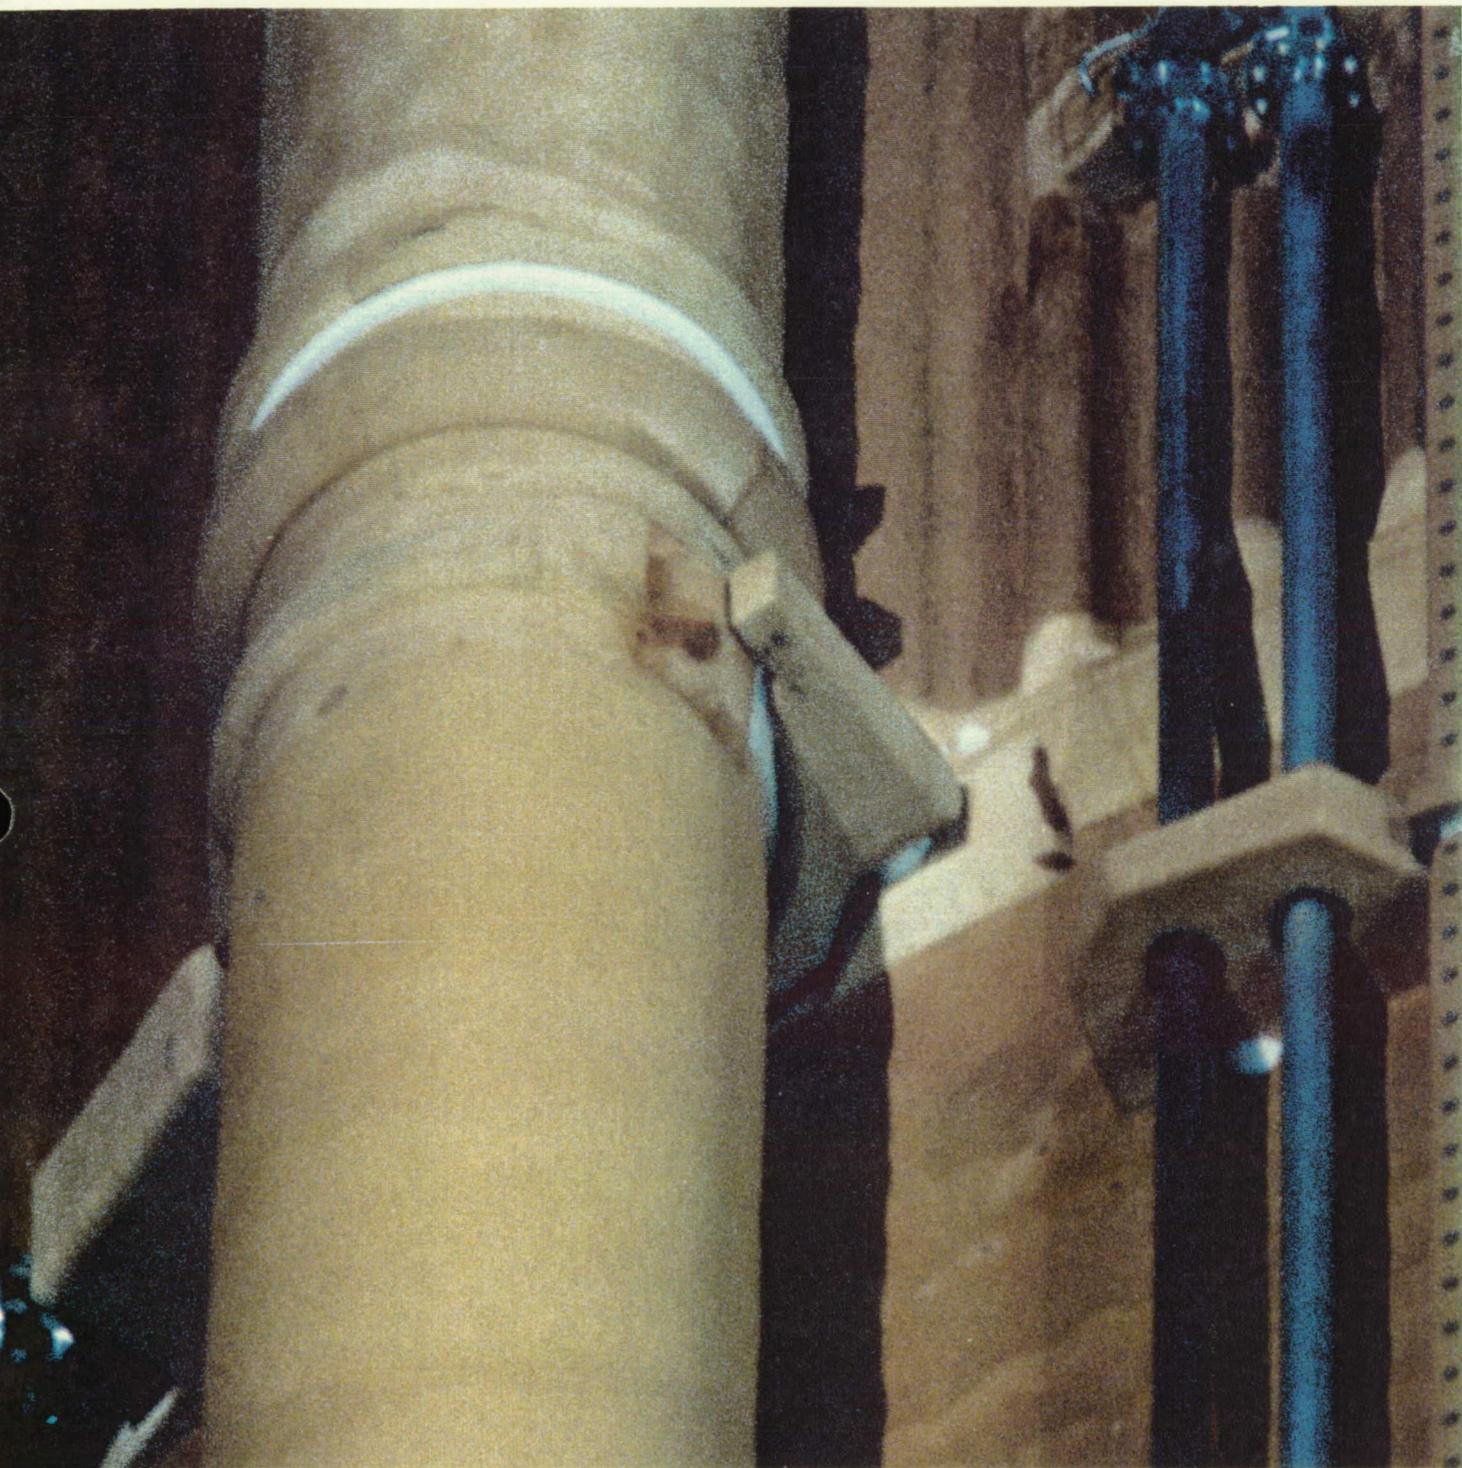
Typical amounts of ice/frost had formed in the LO2 feedline bellows and support brackets. Note ice/frost ball on aft edge of pressurization line support.

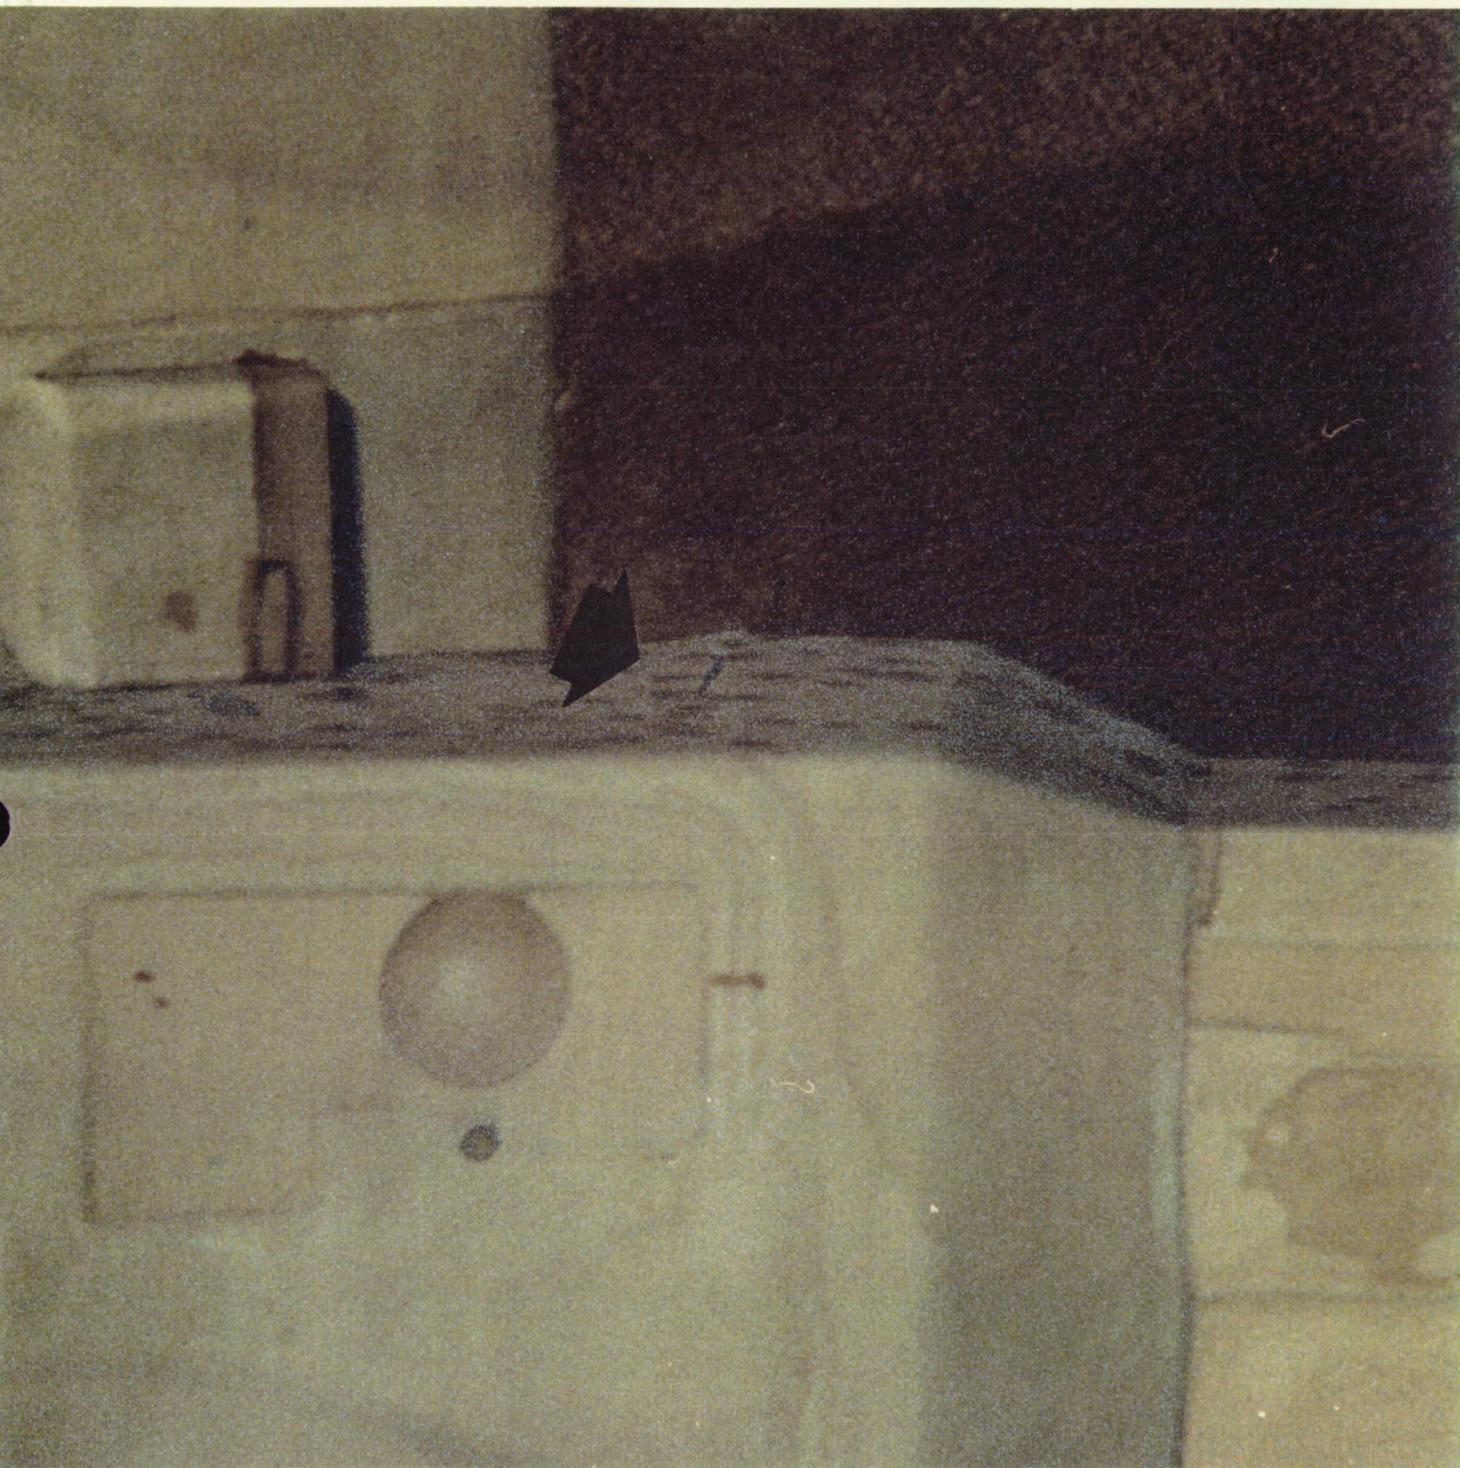
The 12-inch long crack in the LH (-Y) vertical strut cable tray forward surface TPS (previously observed during the first cryo load) had increased in length. The appearance of the crack was expected due to the elimination of the stress relief cut.

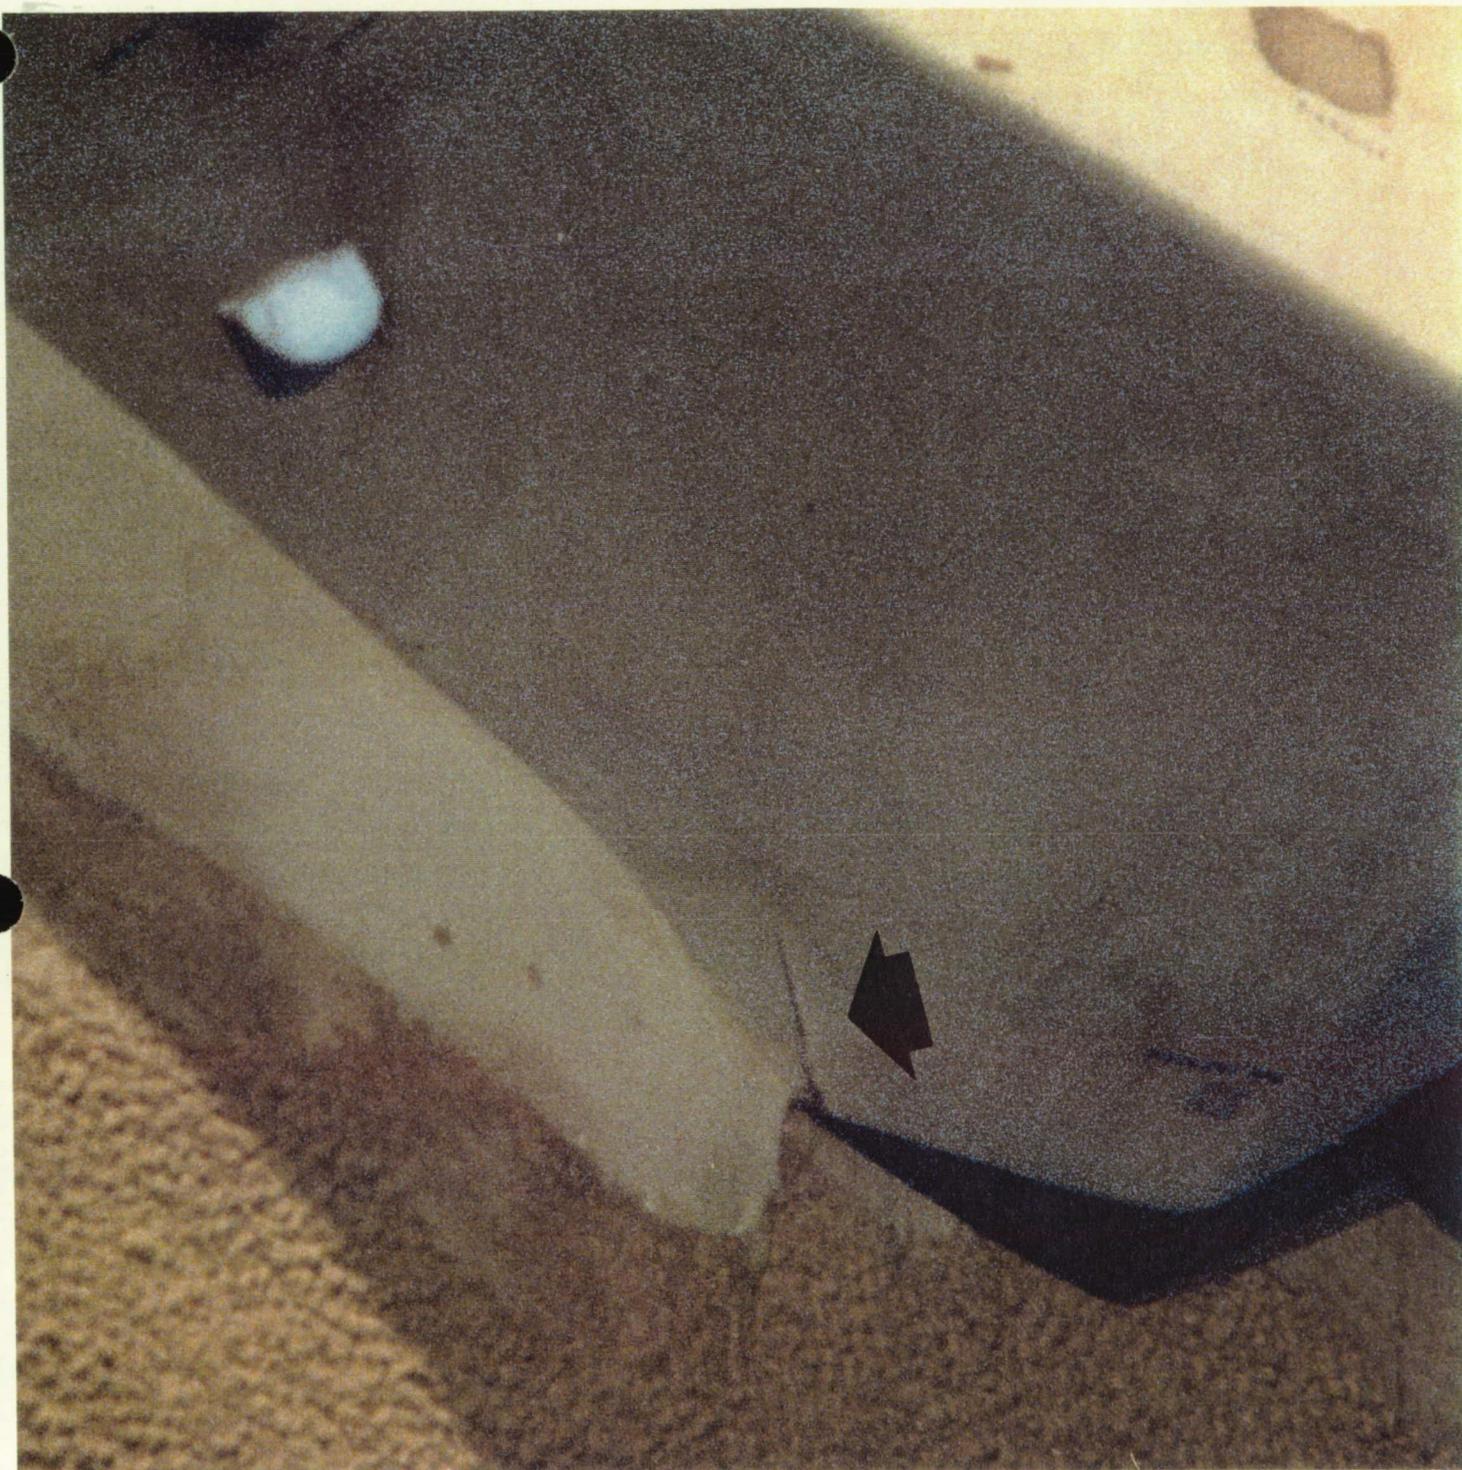
A 4-inch crack, propagating outboard from the ET interface, was most likely a continuation of the forward surface 12-inch crack along the inboard edge of the vertical strut/cable tray. The 4 inch crack exhibited some offset, which was caused by structural deflection rather than a TPS debond. Note ice formation over small TPS defect or thermal short on aft surface of strut TPS.

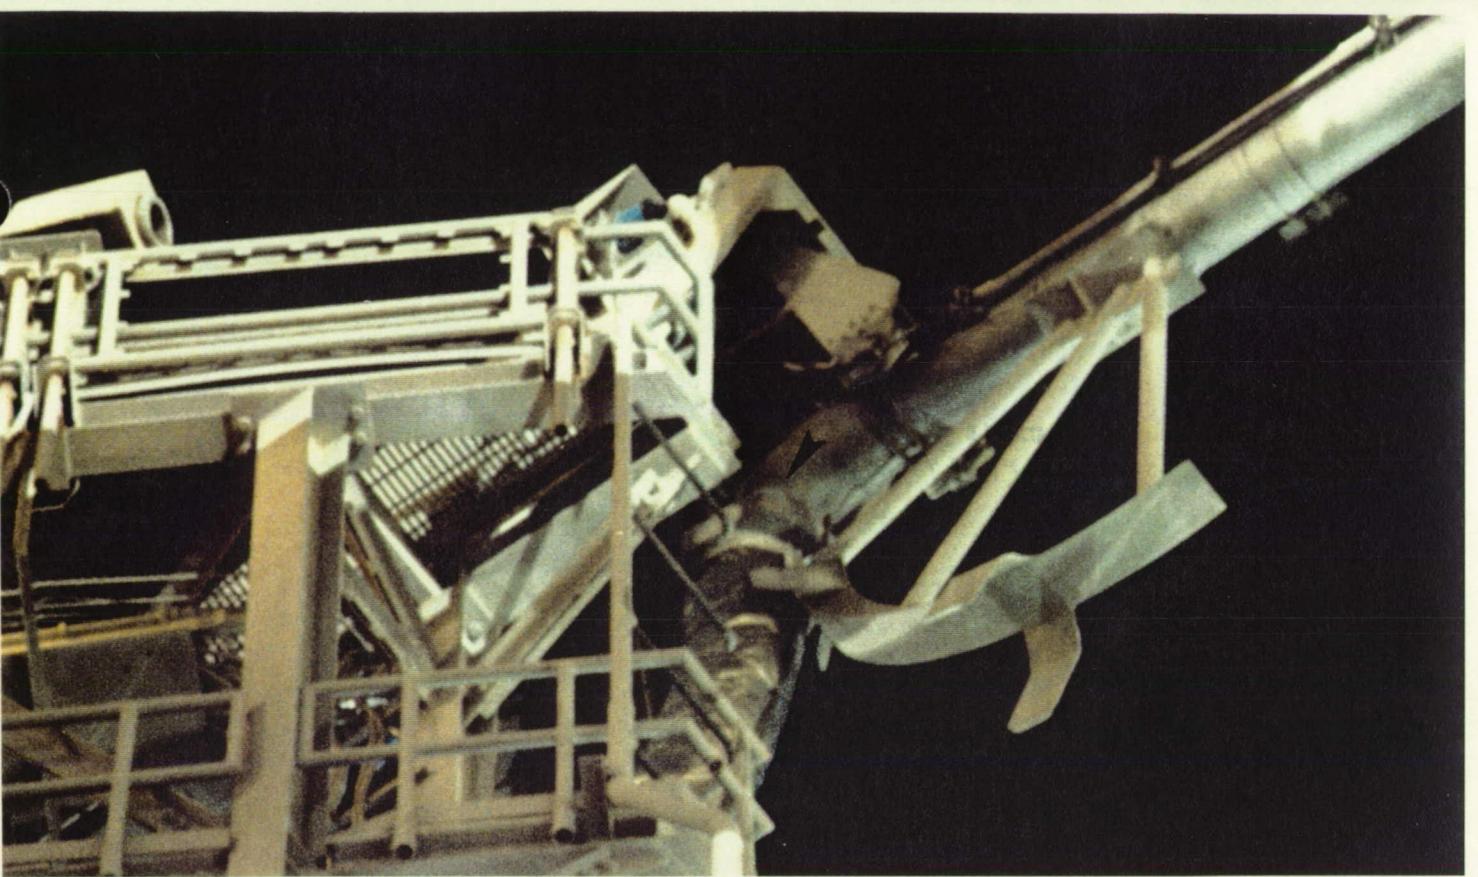
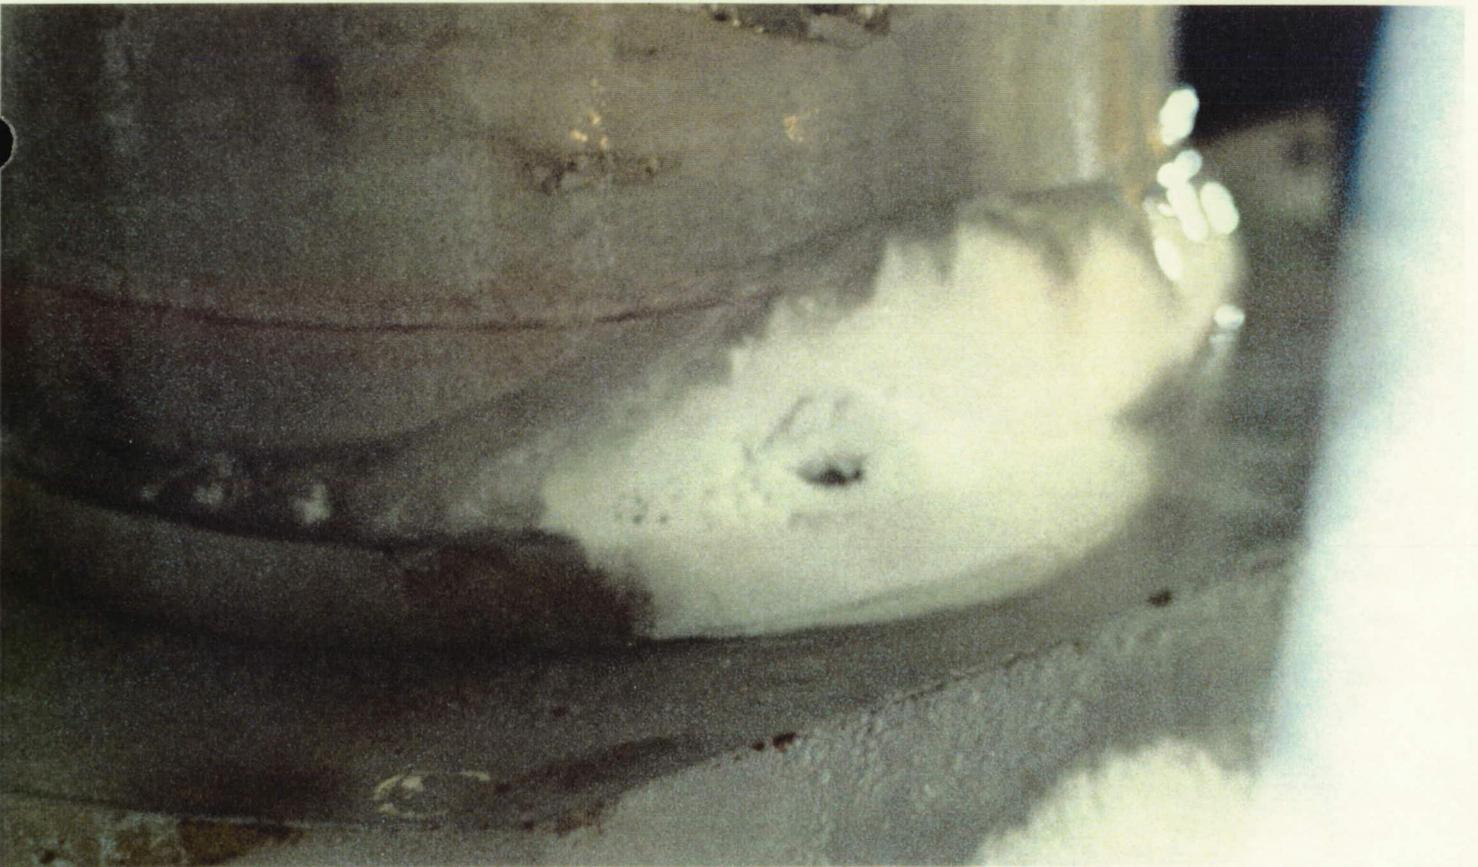
Venting vapors and an ice/frost buildup at the GH2 vent line 90 degree elbow/flex line flange (covered by an ice shroud) indicated the presence of a hydrogen leak, which was confirmed by a hydrogen detection meter. Since the leaking hydrogen was not driven by a pressurized GH2 vent line, and the line itself would be purged at T-90 seconds, the condition was not a constraint to launch. The ice buildup measured 10" x 4" x 3/8" thick and may have been a debris threat to Orbiter tiles. However, the easterly winds and the structurally enclosed area of the ice buildup would prevent large pieces of ice from falling toward the vehicle. Post launch disassembly of the elbow/flex line flange revealed the old Fluorogreen gasket, which was cracked, had not been removed prior to installation of the new Fluorogold gasket. In addition, the flange bolts had not been re-torqued after the last cryogenic loading cycle.

A hydrogen leak at the GH2 vent line elbow/flex line flange was detected by the on-pad Ice Team. The visual signs of venting vapors and ice/frost buildup showed the exit point from the ice shroud. The line was depressurized and purged prior to launch.
