# Debris/Ice/TPS Assessment and Integrated Photographic Analysis for Shuttle Mission STS-56

May 1993

DEBRIS/ICE/TPS ASSESSMENT  
AND  
PHOTOGRAPHIC ANALYSIS  
OF  
SHUTTLE MISSION STS-56

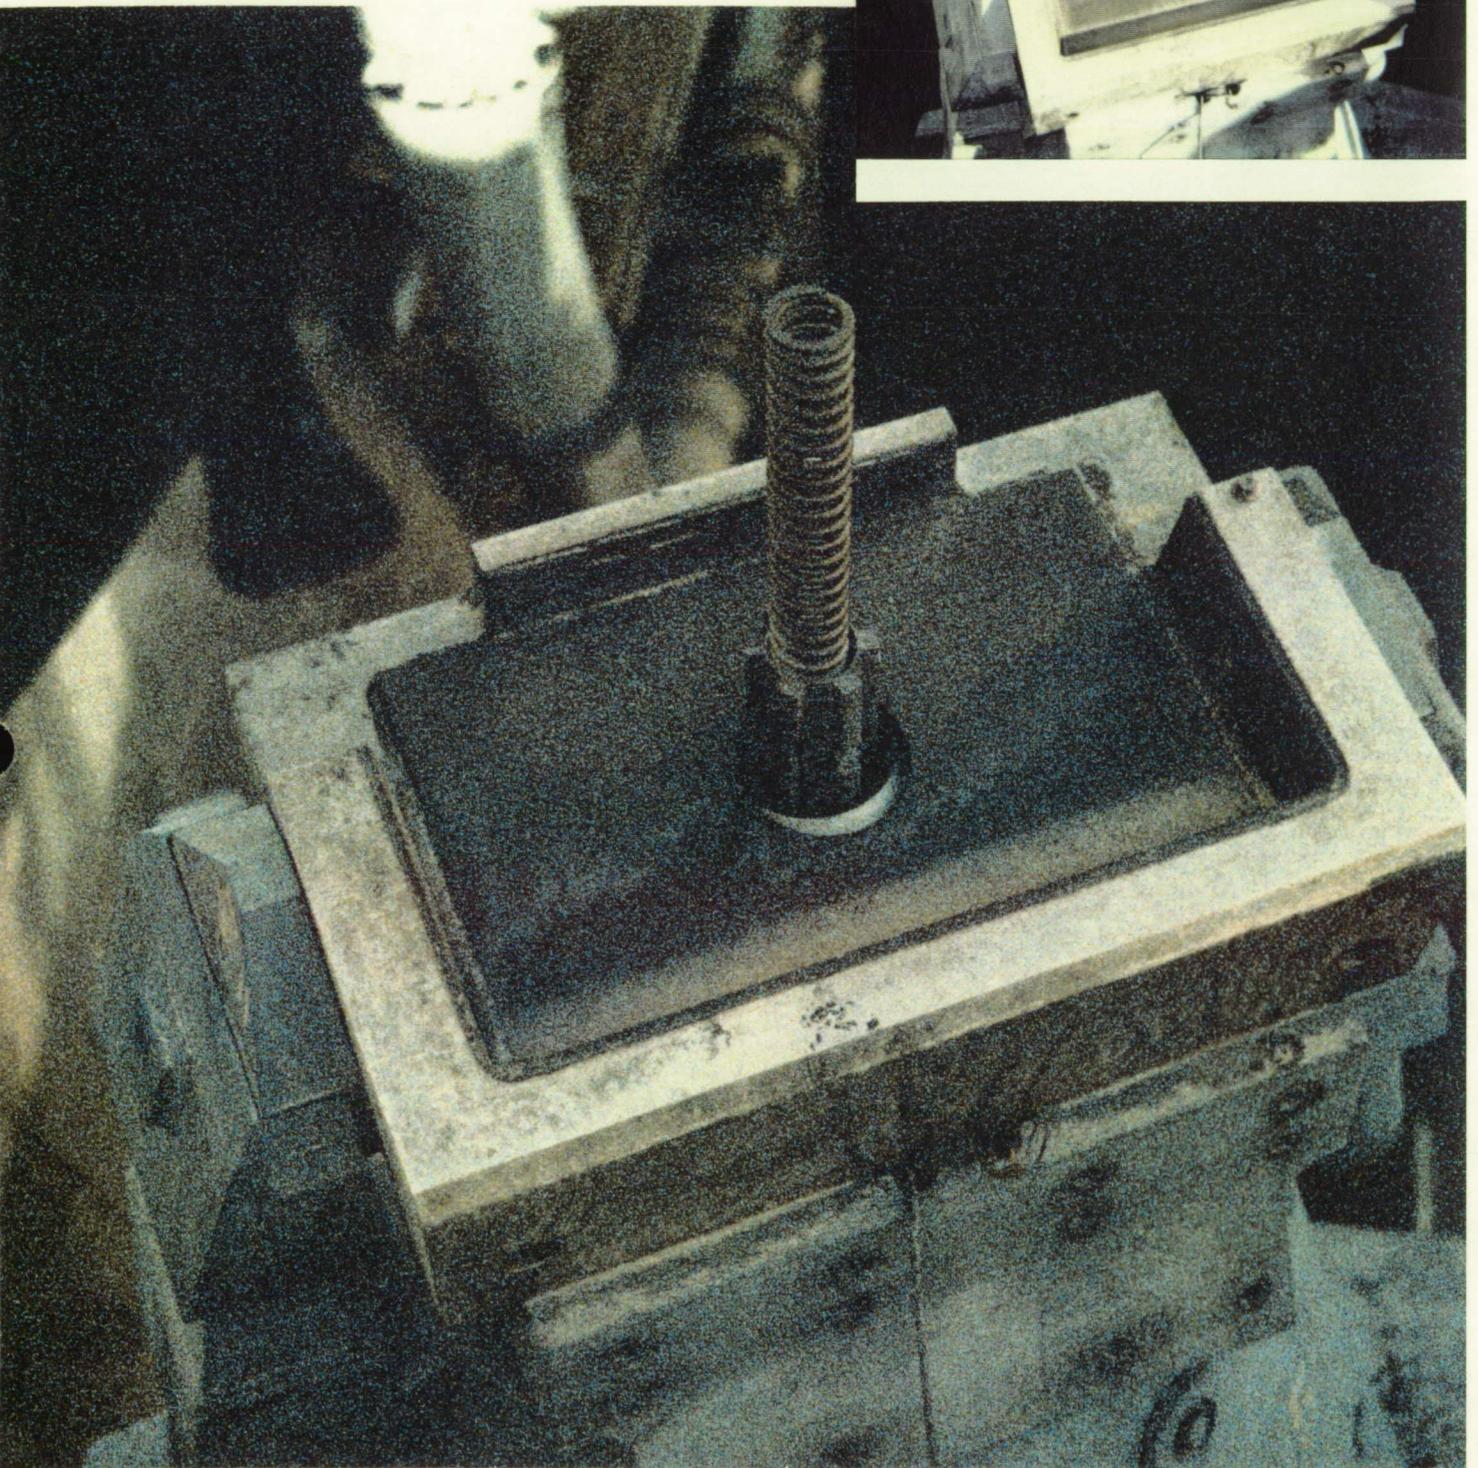
The HDP #5 DCS failure scenario suggests the frangible nut halves rebounded off the lead liner, symmetrically contacted the plunger assembly, and caused localized deformation to the plunger, which in turn allowed the plunger to pass through the stud hole. Once clear of the aft skirt/DCS housing, the plunger and spring became debris that could have been deflected by SRB plume impingement resulting in a potential threat to the vehicle. In this case, the frangible link connecting the plunger to the stud survived the launch environment.

A plunger, spring, and associated hardware from the Debris Containment System (DCS) was found on holddown post #5 still attached to the stud. This hardware is normally contained in the DCS housing and remains with the SRB aft skirt for flight.

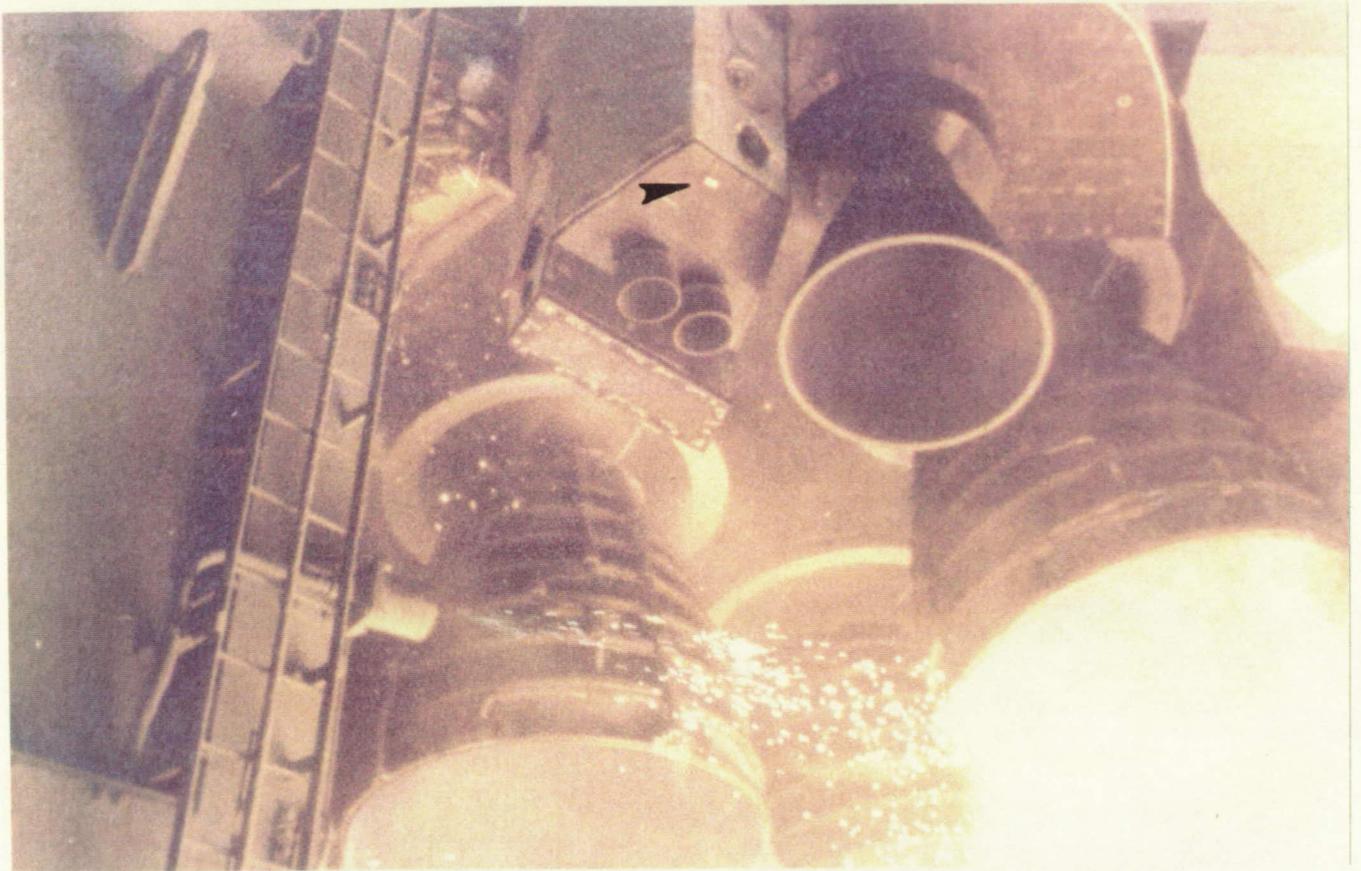
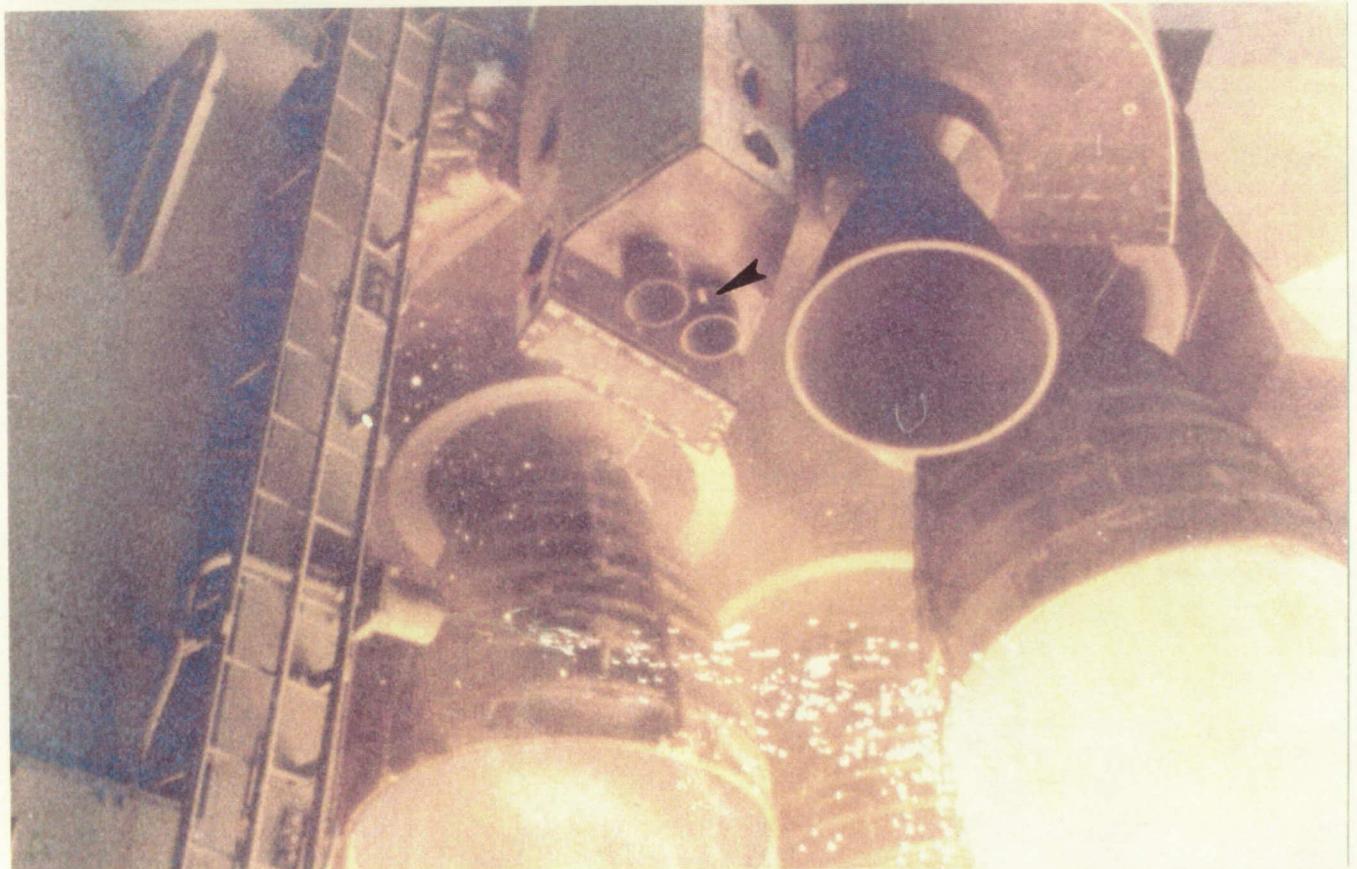
A thin, rectangular object, most likely a tile gap filler or GSE shim/spacer, originated from the left aft RCS stinger tiles (edge of the aft surface) fell during SSME ignition.

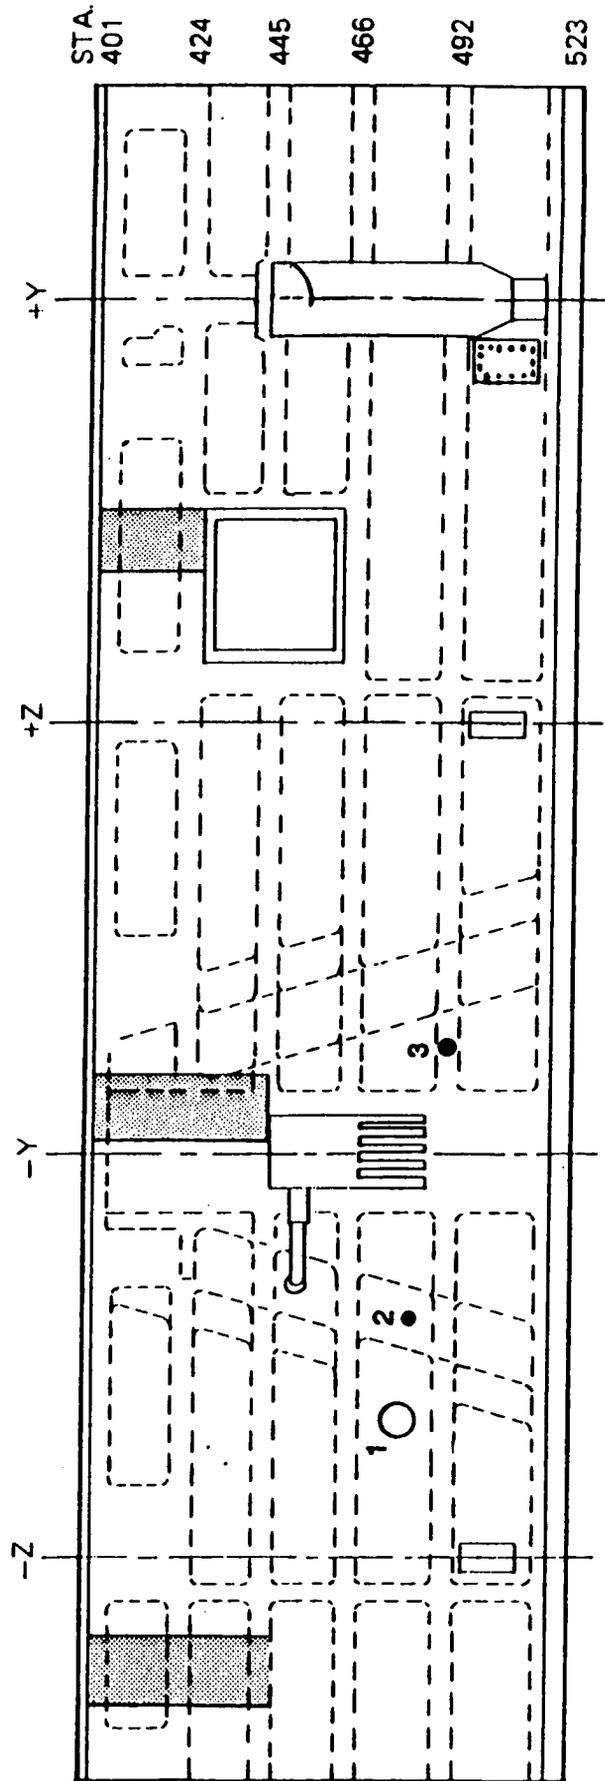
FIGURE 8. RIGHT SRB FWD SKIRT

TPS MISSING  
 1) 5' x 3'  
 (MAY BE  
 HANDLING  
 DAMAGE)

DEBONDS  
 2) 1.5" DIA  
 3) 3.0" DIA

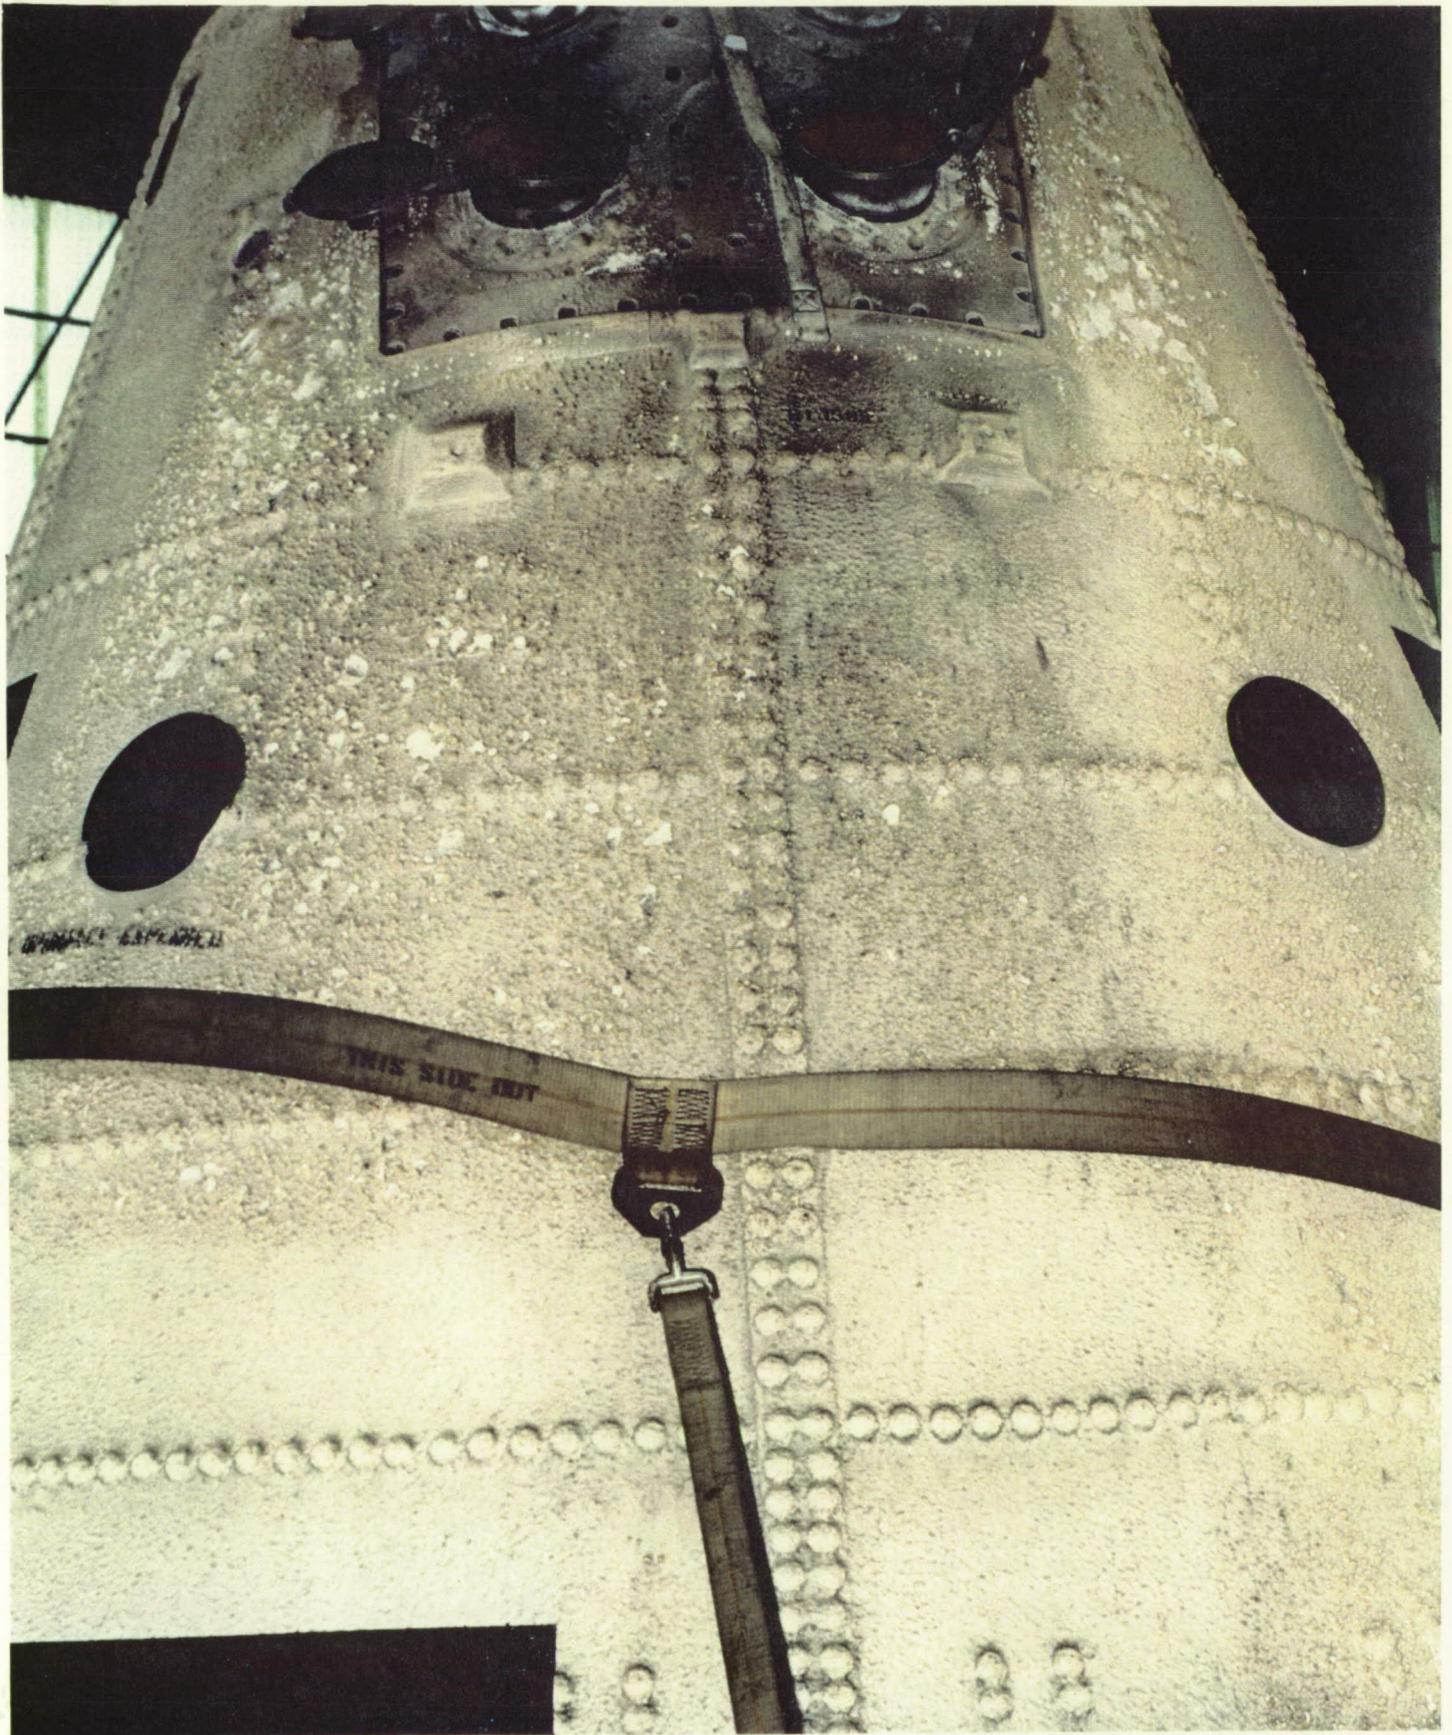
The RH frustum was missing no TPS, but had 11 MSA-2 debonds over fasteners. Significant blistering of the Hypalon paint top layer had occurred in an area around and aft of the BSM's.

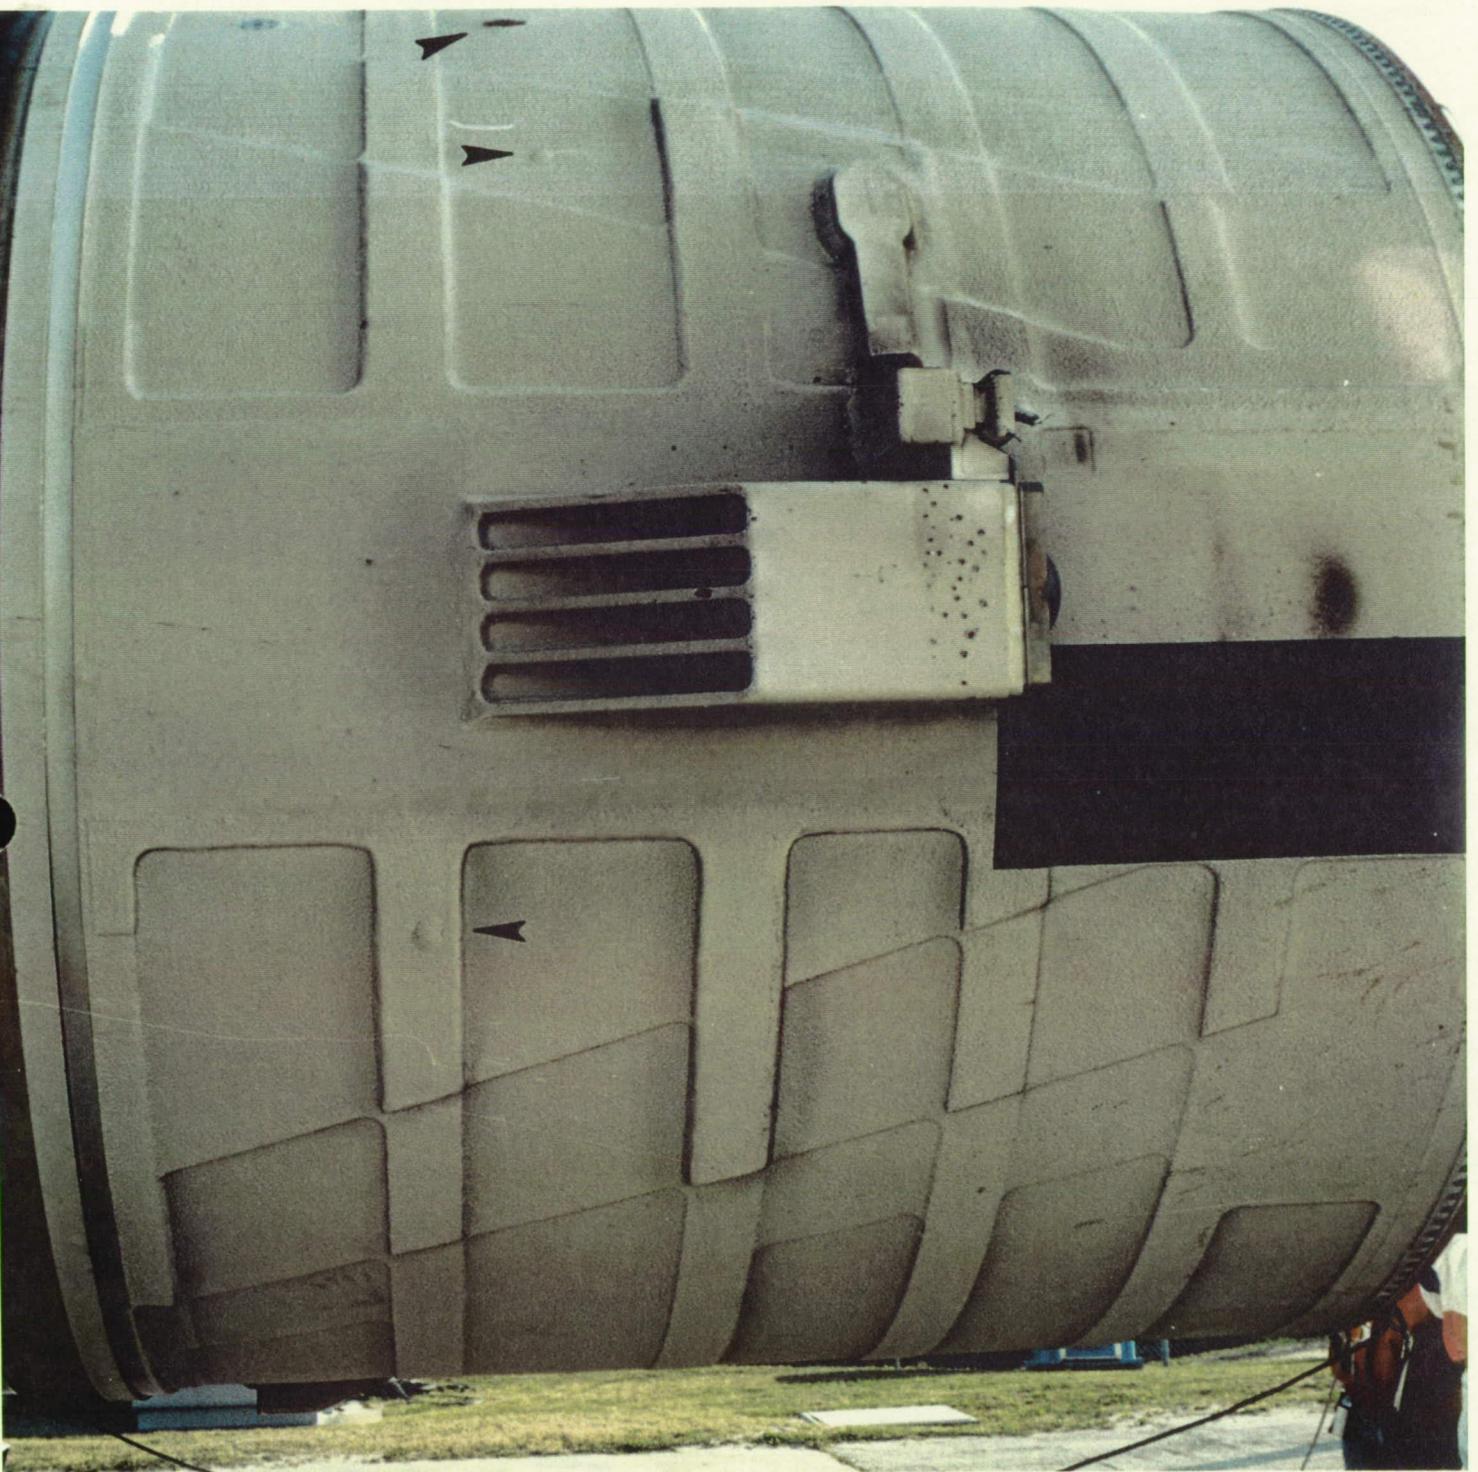
The RH forward skirt acreage MSA-2 exhibited two debonds near the ET/SRB attach fitting. A 5"x3" piece of MSA-2 was missing, but the substrate was not sooted. Both RSS antenna covers/TPS were intact.

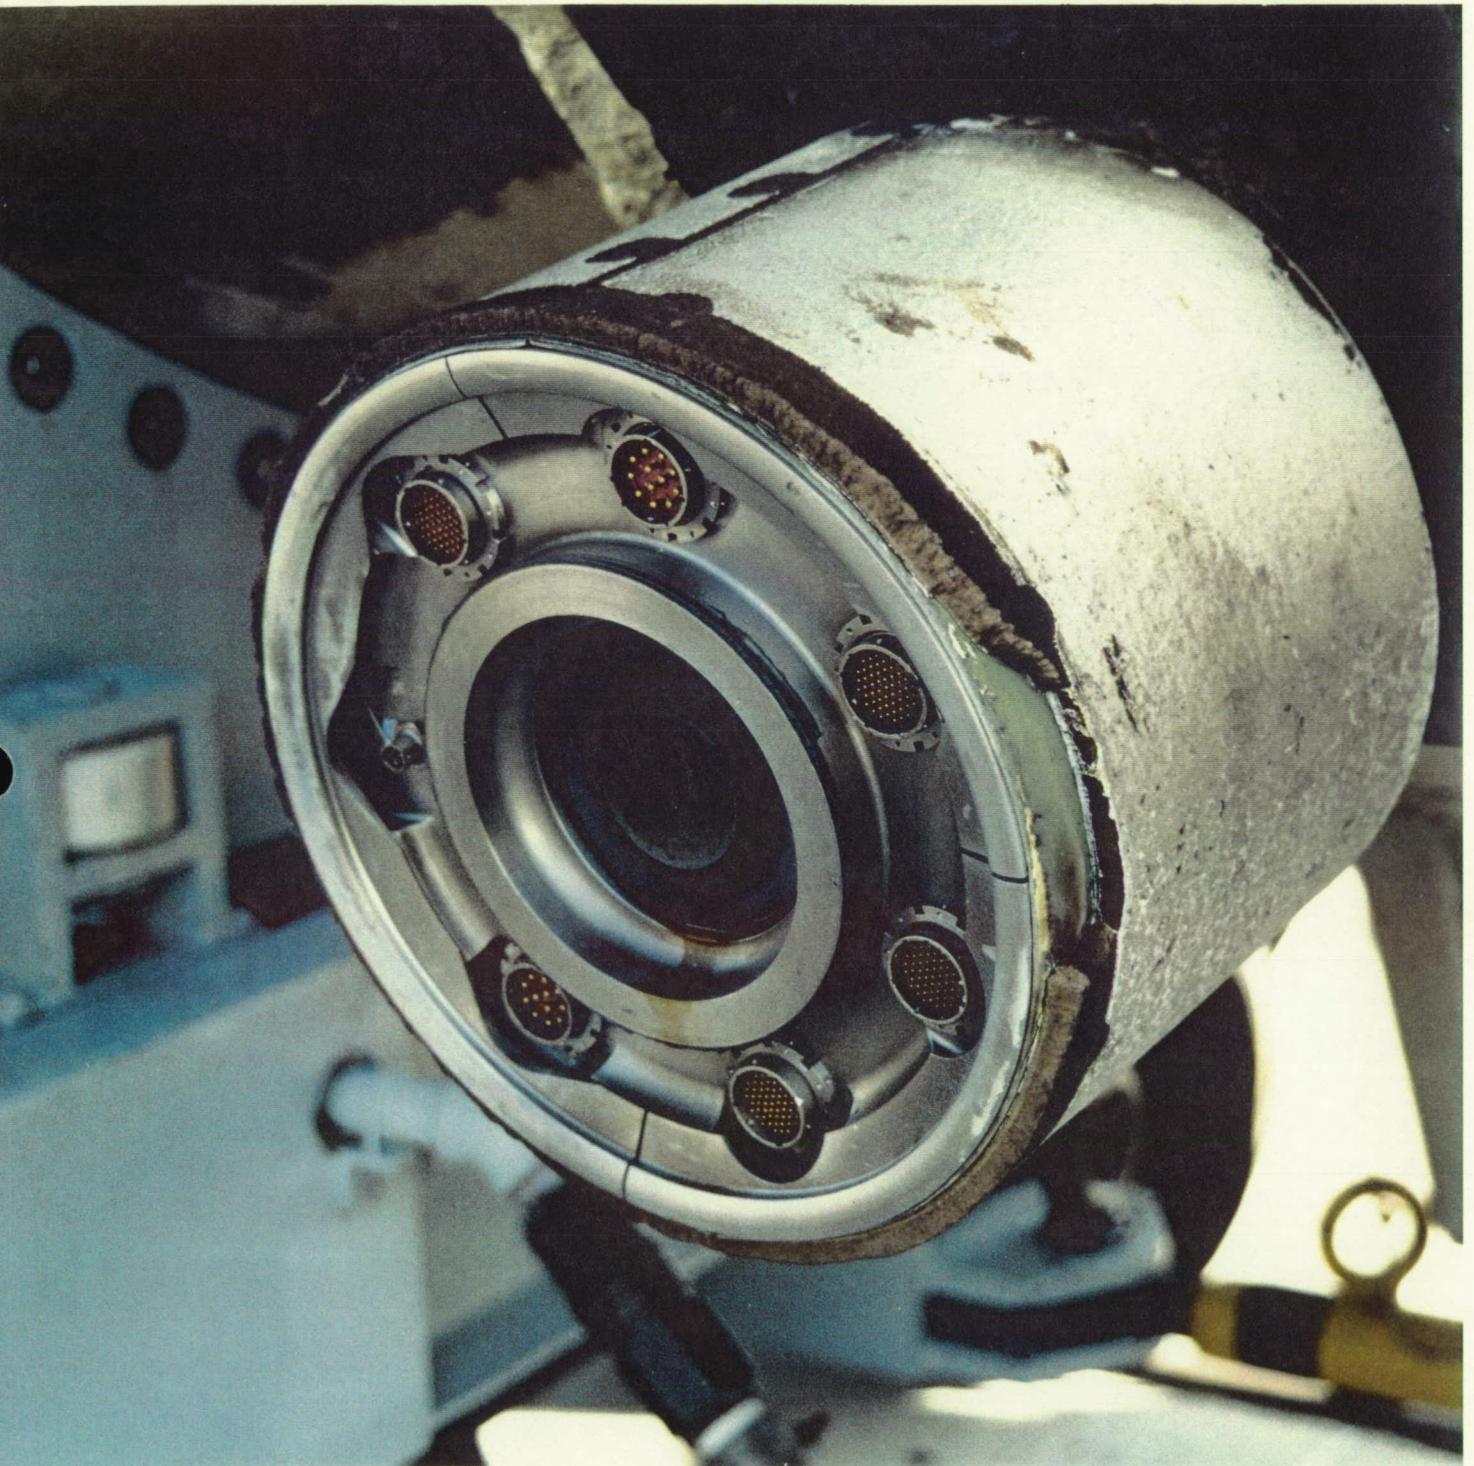
K5NA, 5"x1" in size, was missing from the upper strut fairing

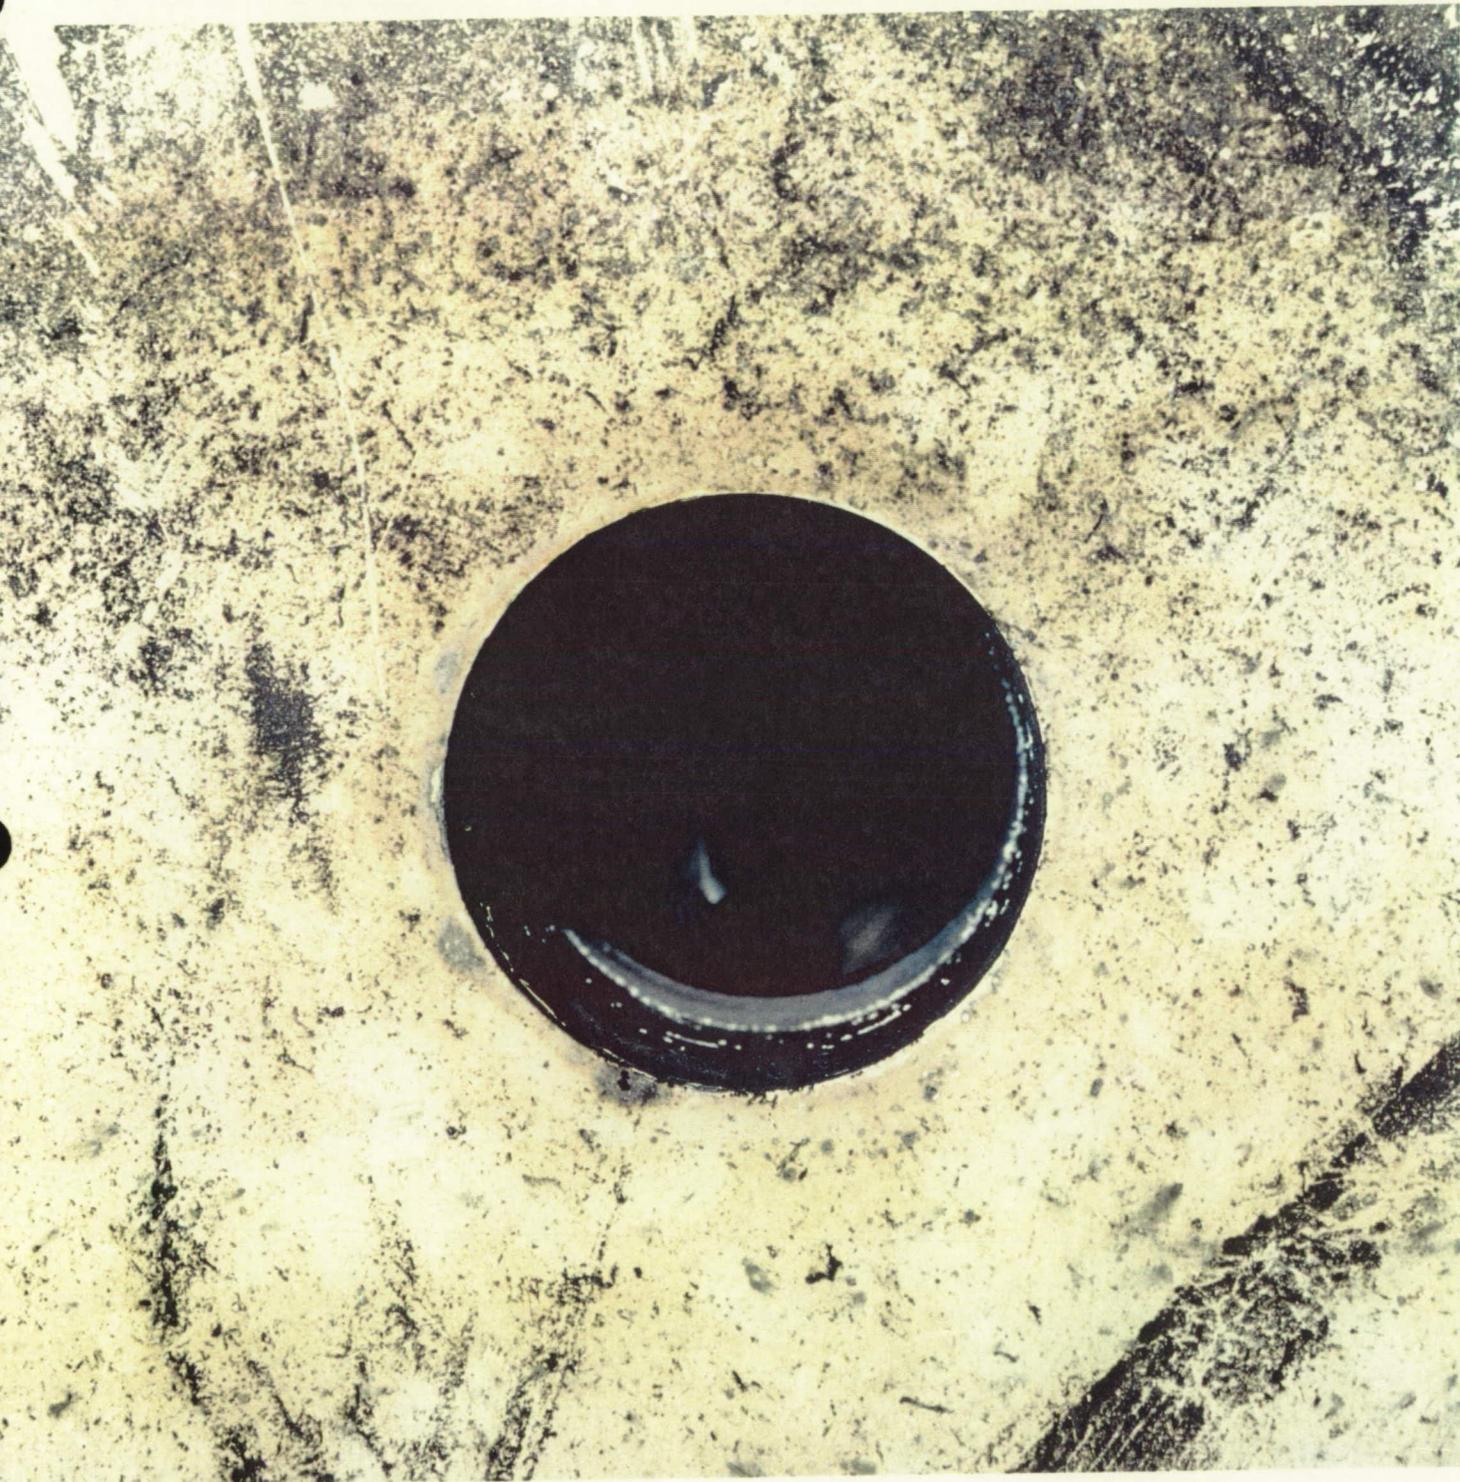
Examination of the HDP #5 stud hole revealed no obvious broaching or unusual abrasions due to the loss of the Debris Containment System (DCS) plunger/spring. The frangible nut halves were contained in the DCS housing.

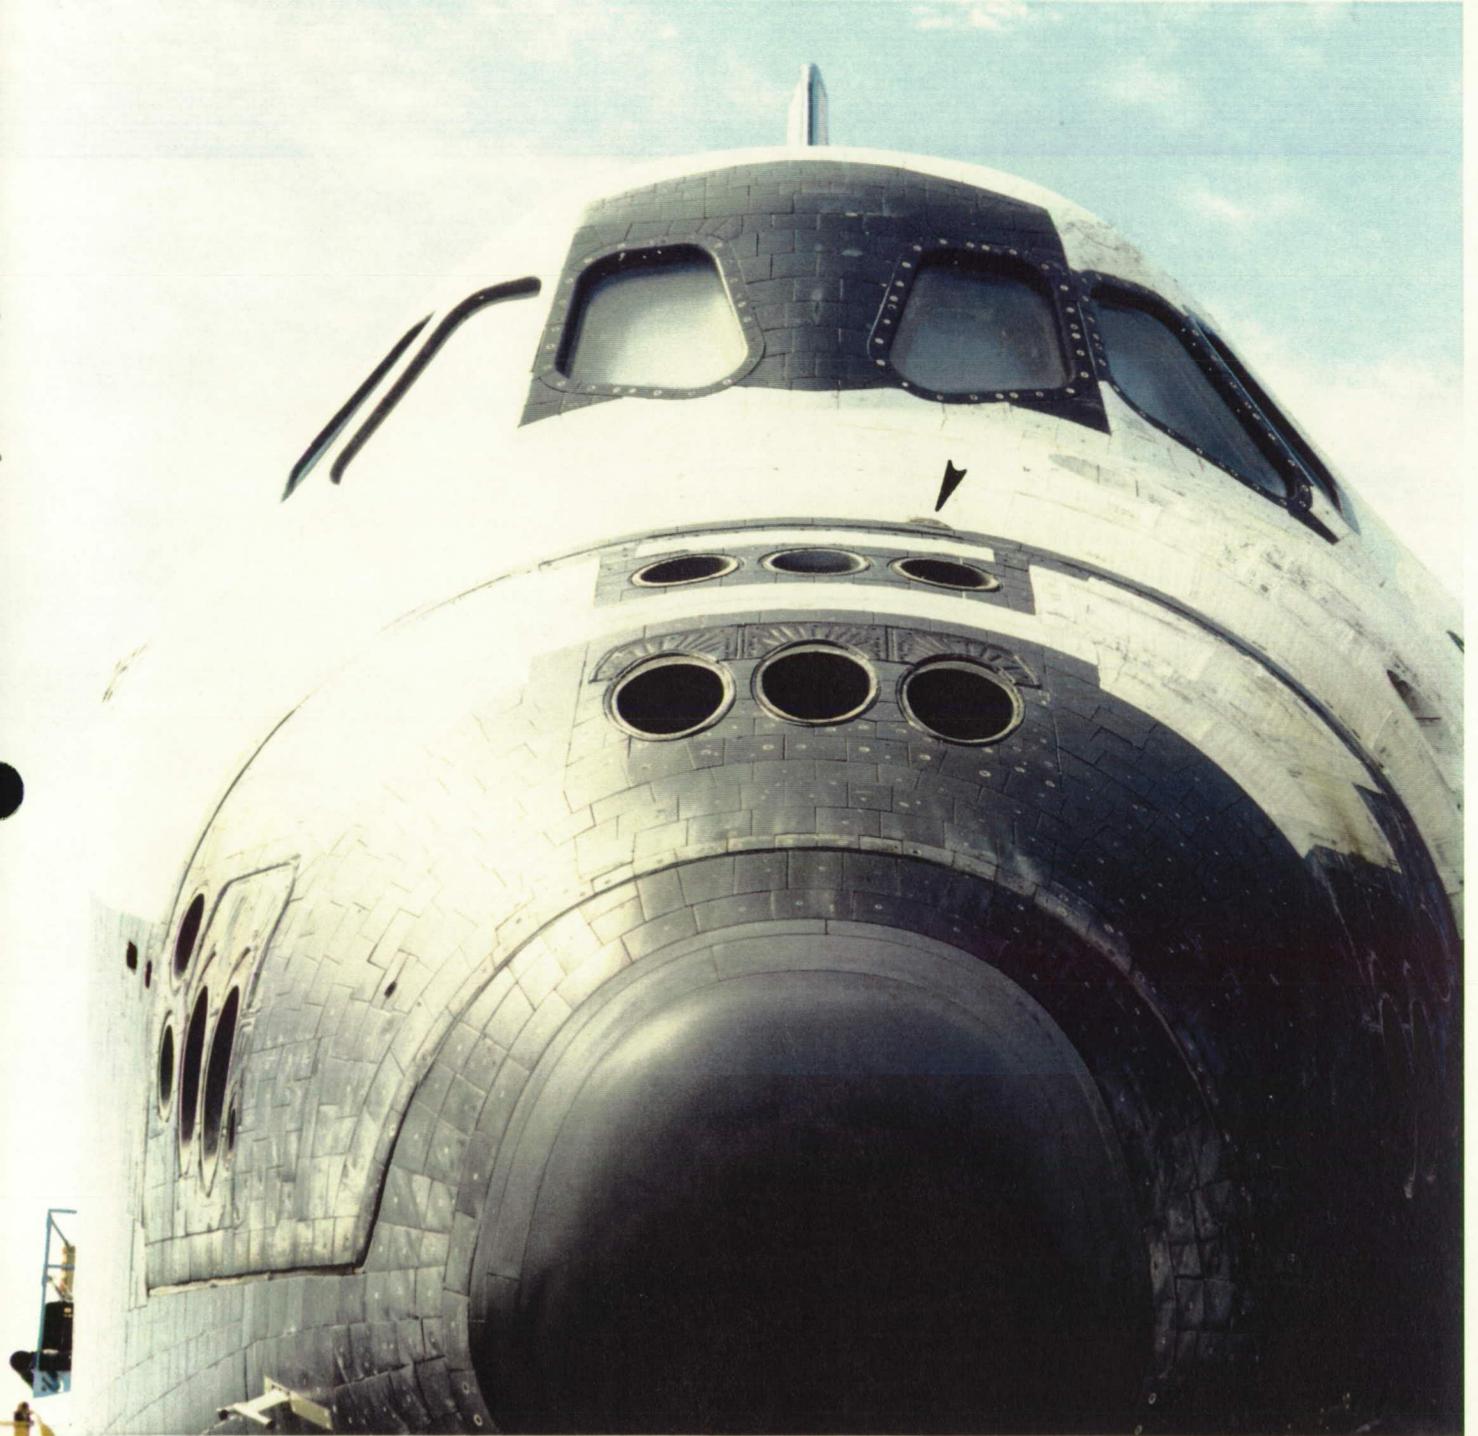
Overall view of Orbiter nose. Note moderate hazing of forward facing windows and small damage sites on window perimeter tiles. Part of a AFRSI panel is loose aft of FRCS thruster F1U.

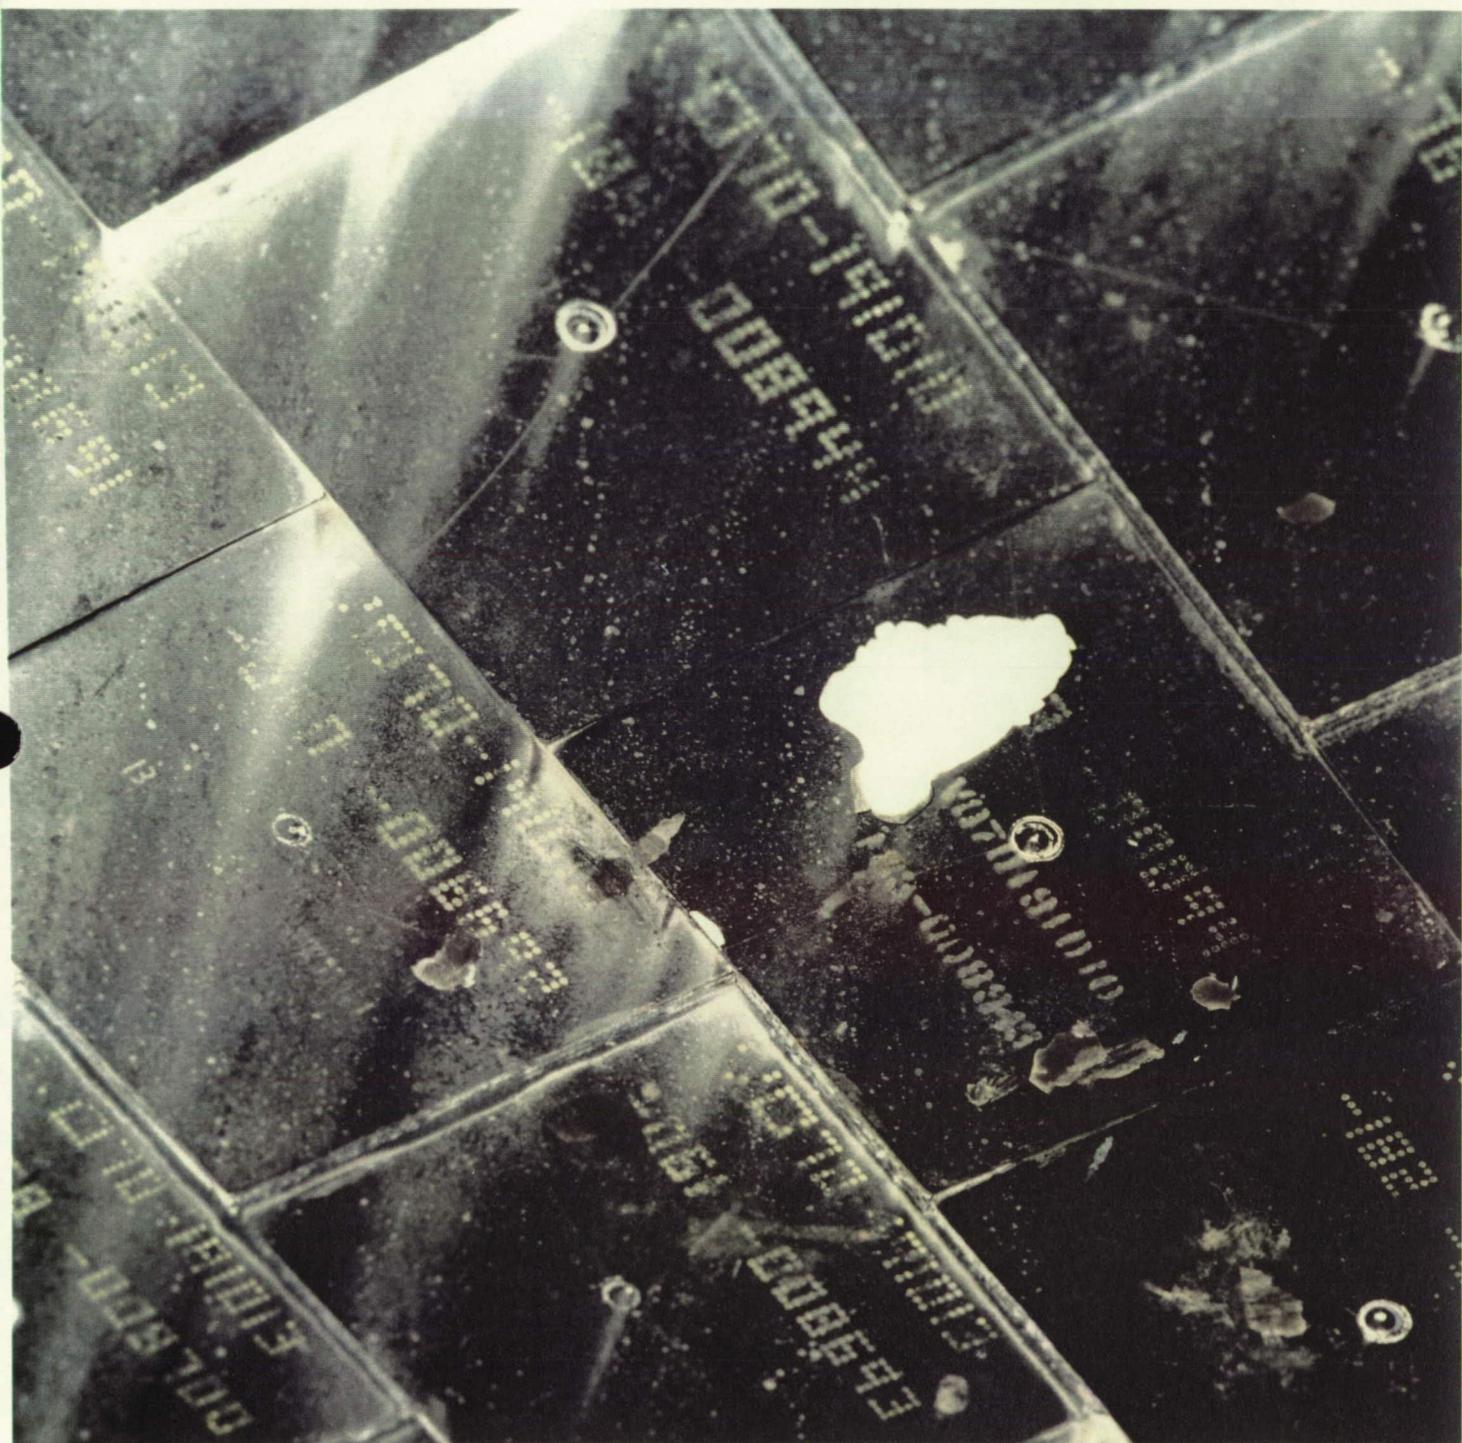
The Orbiter lower surface tiles sustained a total of 94 hits, of which 18 had a major dimension of 1-inch or greater.

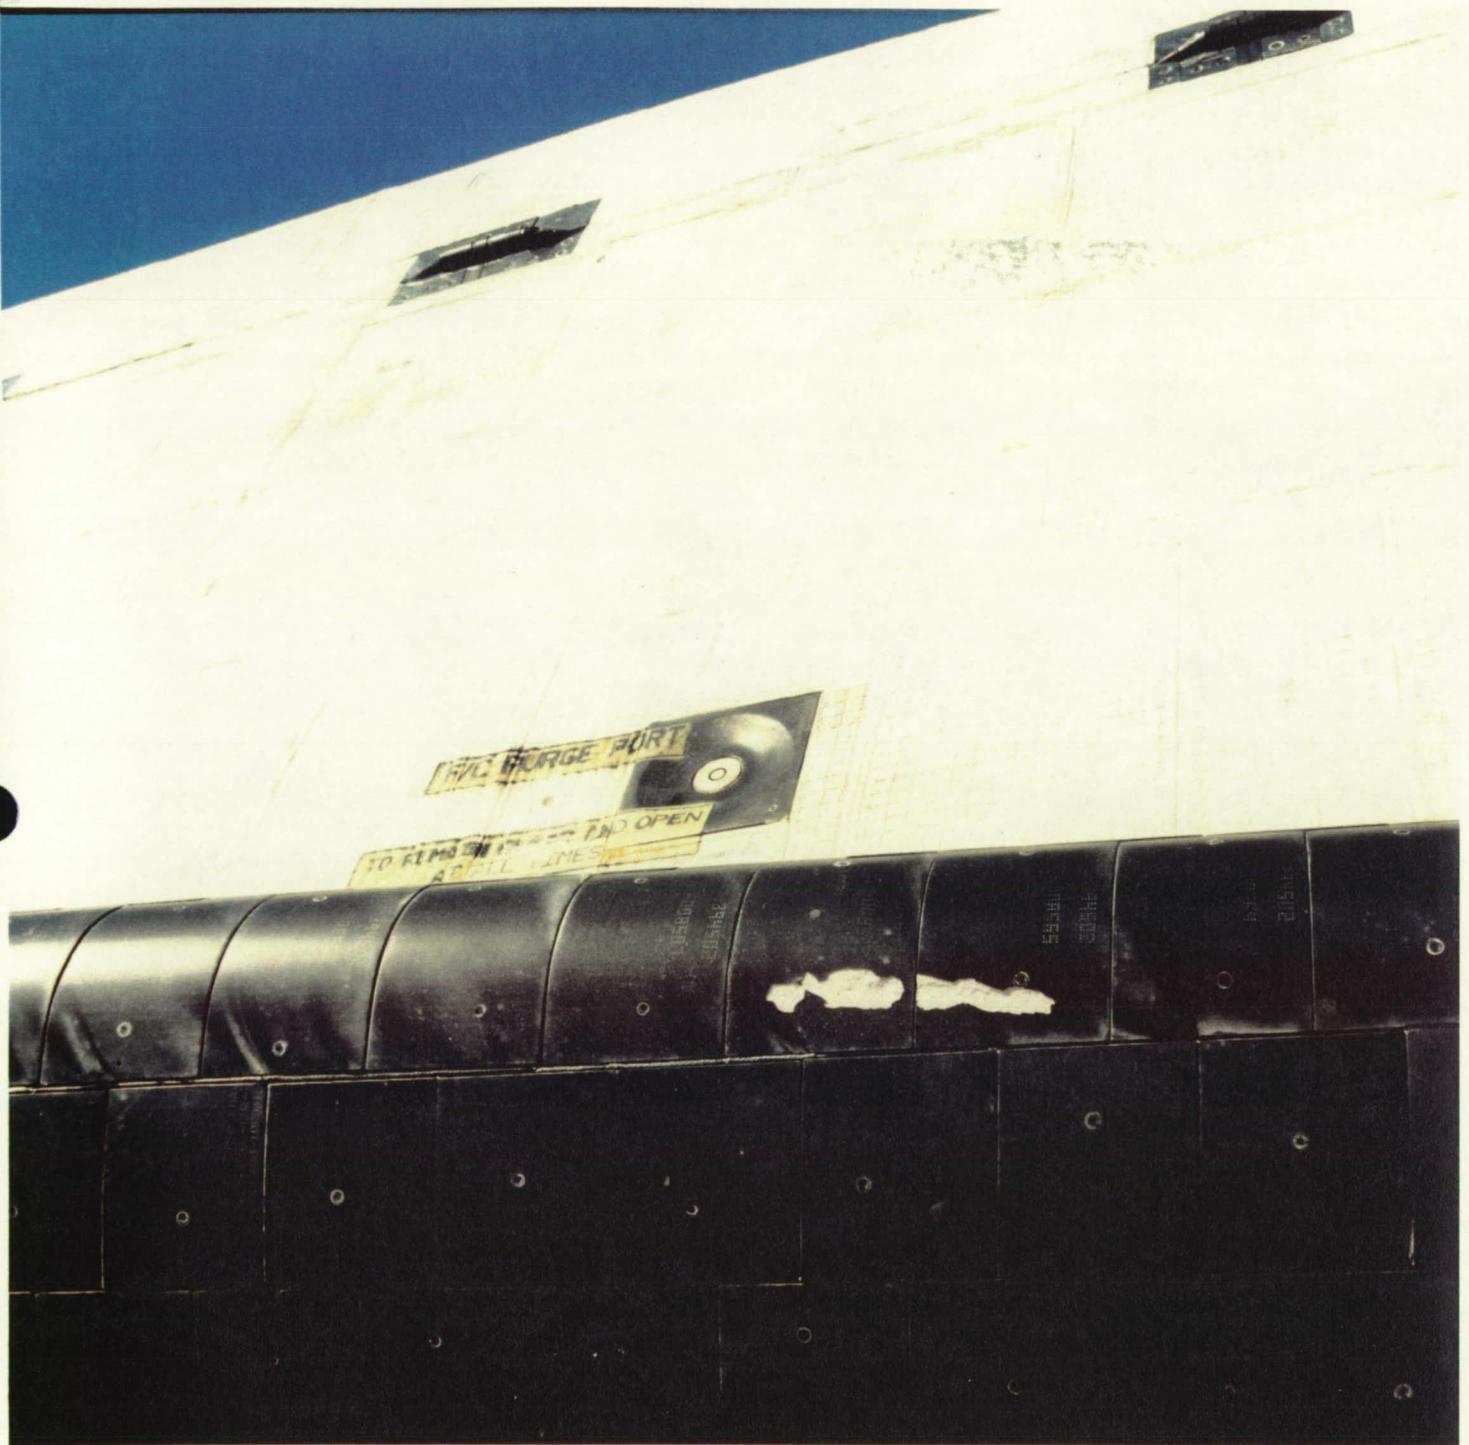
The largest tile damage site measured 9" x 2" x 0.2" and was located on the lower surface of the RH wing leading edge extension. The shallow depth is indicative of an impact by low density material.
