# Debris/Ice/TPS Assessment and Integrated Photographic Analysis for Shuttle Mission STS-56

May 1993

DEBRIS/ICE/TPS ASSESSMENT  
AND  
PHOTOGRAPHIC ANALYSIS  
OF  
SHUTTLE MISSION STS-56

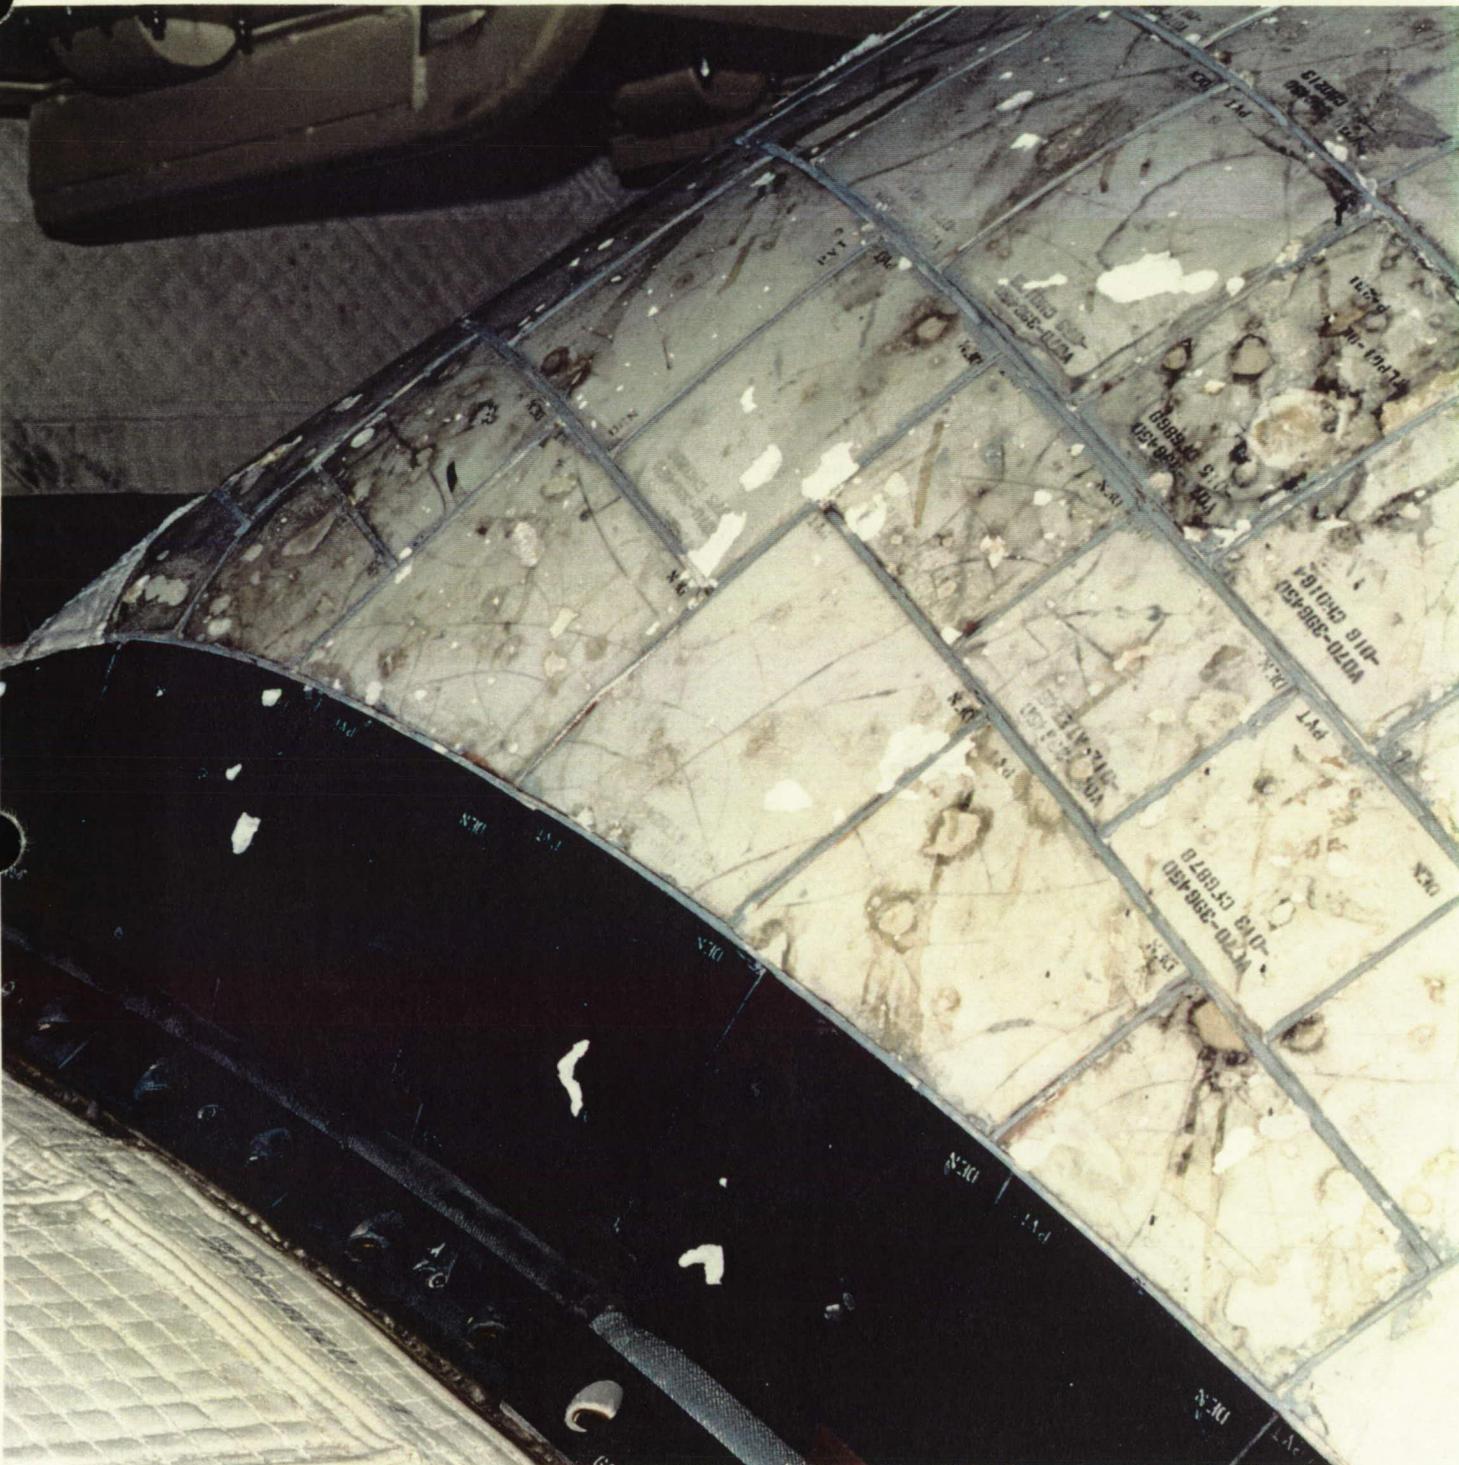
The tiles on the LH OMS pod leading edge sustained more damage than usual (at least 35 hits, of which 15 had a major dimension of 1 inch or greater). Several of the tile damage sites reached a depth ranging from 0.5 to approximately 1.3 inches. The cause of this damage is believed to be ice from the waste water dump nozzle near the crew hatch. All three ET/Orbiter separation devices (EO-1, 2, and 3) and all ET/ORB umbilical separation ordnance retention shutters functioned properly. No flight hardware was found on the runway below the umbilicals when the ET doors were opened.

Tiles on the LH OMS pod leading edge sustained more damage than usual (35 hits, of which 15 had a major dimension of 1-inch or greater). Several of the damage sites reached a depth of 1.25 inches. The cause of this damage is believed to be ice from the waste water dump nozzle near the crew hatch.

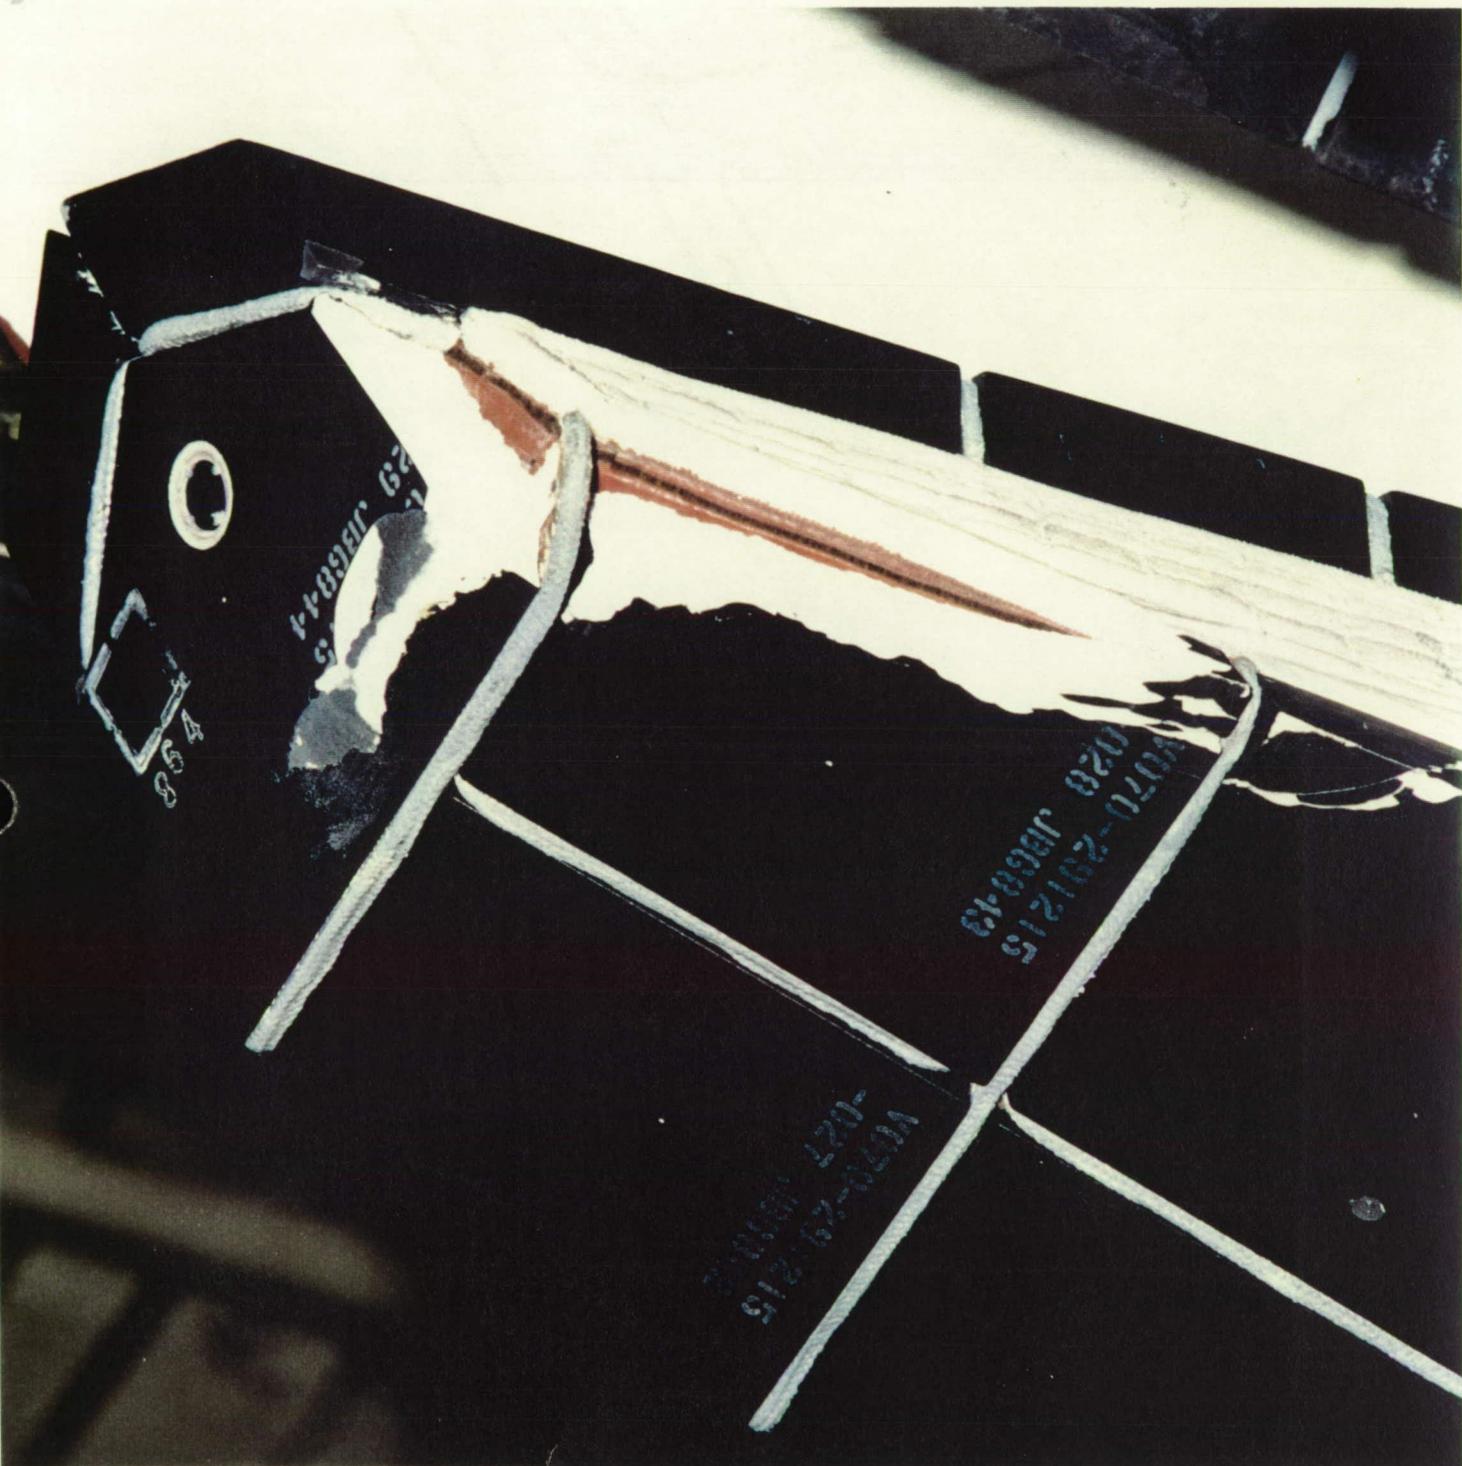
Eight tile fragments found on the runway originated from the vertical stabilizer "stinger" and had been dislodged by contact with the drag chute riser lines during deployment.

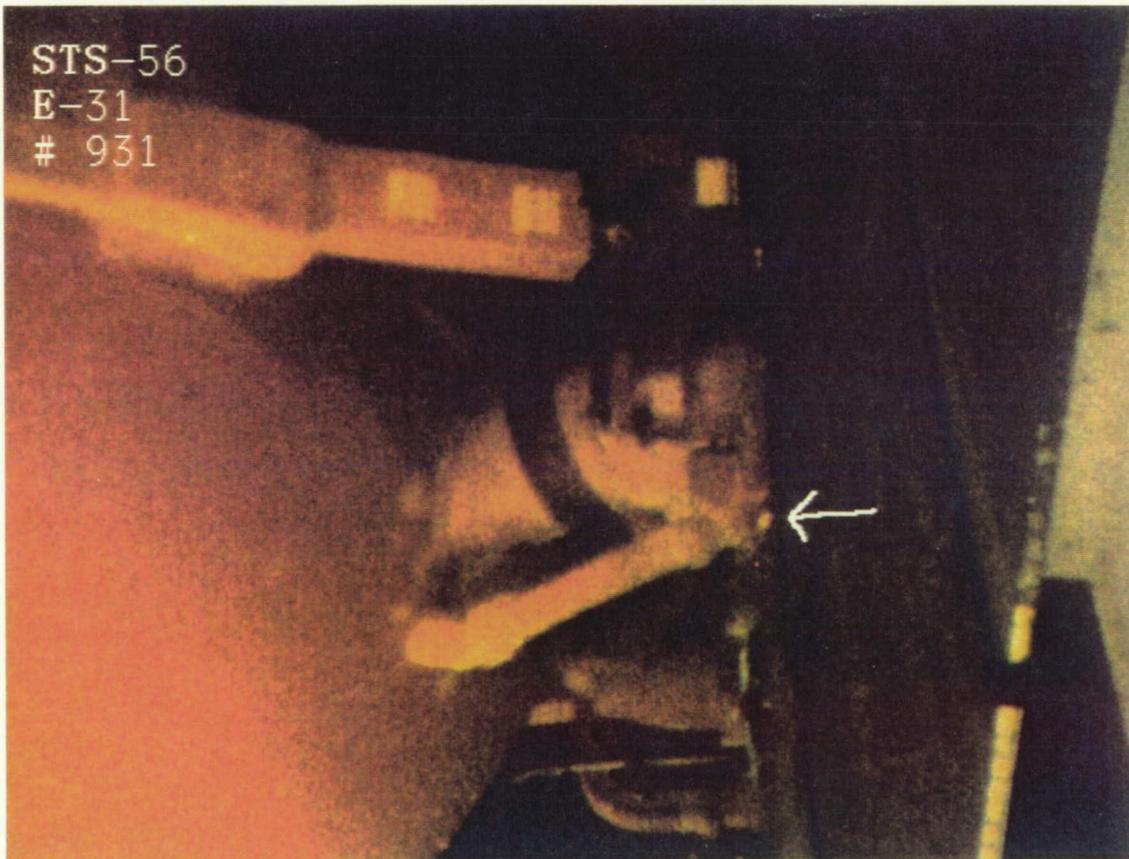
**Figure 2.1.1.1 Debris Strike to the Lower Side of the Orbiter**

At least one piece of white debris, appeared to strike the underside of the Orbiter near the LH2 umbilical well during SSME startup (05:28:57.575 UTC). The white debris appeared to be frost/ice from the ET/Orbiter LH2 umbilical. No damage to the vehicle was observed.

The arrow points to a white piece of debris as it struck below the LH2 umbilical well sill during SSME ignition.

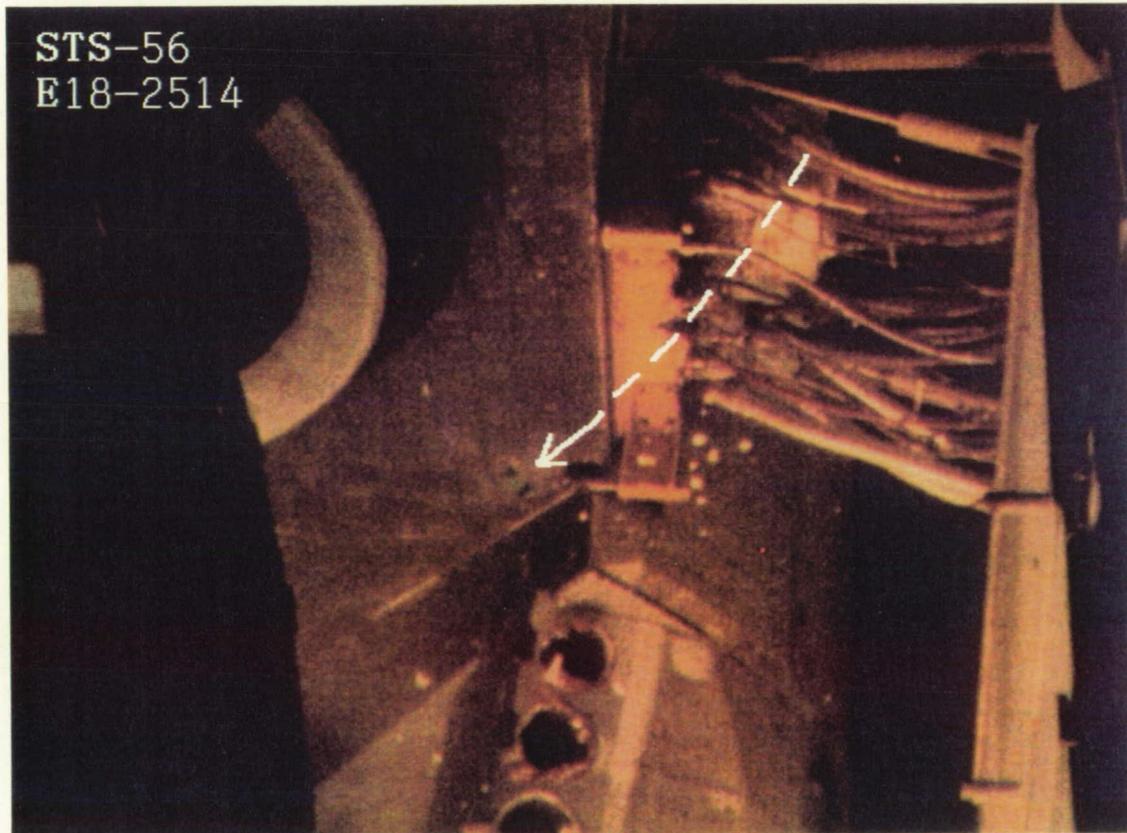
**Figure 2.1.1.2** Dark Debris from LH2 TSM Umbilical

A single dark piece of debris (arrow), possibly a piece of tape, originated from the LH2 T-0 TSM umbilical and fell aft at SSME startup (05:28:56.938 UTC).
