LONG DURATION EXPOSURE FACILITY (LDEF) EXPERIMENT M0003
METEOROID AND DEBRIS SURVEY

M. J. Meshishnek, S. R. Gyetvay, K. W. Paschen, and J. M. Coggi
Mechanics and Materials Technology Center
The Aerospace Corporation
El Segundo, CA 90245-4691
Phone: 310/336-8760, Fax: 310/336-1636

A survey of the meteoroid and space debris impacts on LDEF experiment M0003 has been performed. The purpose of this survey was to document significant impact phenomenology and to obtain impact crater data for comparison to current space debris and micrometeoroid models. The survey consists of photomicrographs of significant impacts in a variety of material types; accurate measurements of impact crater coordinates and dimensions for selected experiment surfaces, and databasing of the crater data for reduction, manipulation, and comparison to models. Large area surfaces that were studied include the experiment power and data system (EPDS) sunshields, environment exposure control canister (EECC) sunshields, and the M0003 signal conditioning unit (SCU) covers. Crater diameters down to 25 microns were measured and catalogued. Both leading (D8) and trailing (D4) edge surfaces were studied and compared. The EPD

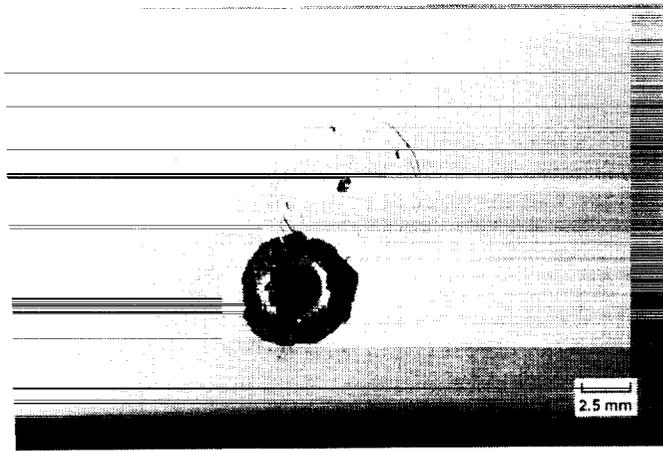
The D8 EPDS sunshield was an aluminum panel 42 by 93 cm having a thickness of 0.1 cm (40 mil), and was painted with a white thermal control paint (Chemglaze A-276) with an underlying primer coat to promote adhesion. The thickness of the paint was approximately 75 microns (3 mil). This paint consists of an inorganic titanium dioxide pigment in an organic polyurethane binder. After the exposure to the space environment, the paint binder at the surface of the paint layer had been eroded away by atomic oxygen, leaving a powdery coating of loose pigment particles. This surface was quite fragile and contained thousands of impact craters varying in size from below 0.001 to 0.093 in. in diameter. The largest crater penetrated through the aluminum. Surrounding most of the craters was an area of delaminated, or spalled paint or an area of roughened texture. The delamination occurred in intermediate layers of paint in which the top layer was folded over the outer edge of the delamination area, leaving a thin layer of paint still adhering to the aluminum substrate. An area of bare metal or melt zone was present between the crater and the delamination area on the larger craters of about 0.005 in. diameter and up. Most of these larger craters had raised rims surrounding the crater cavity, and, in some cases, patches of red or brown primer paint could be seen around the craters or on top of the raised rims. Most of the smallest craters were not visible through the 10X eyepiece, but the impacts were detected by the presence of the delamination zones, which were much larger in diameter than the actual crater by a factor of about 25. Delamination zones of 0.001 in. were observable. Figure V-1 shows photos of representative impacts in this sunshield.

About 2400 impacts were recorded with damage zones of 0.001 in. (25 micron) or greater in an area of the panel measuring 15 by 42 cm. Subsequently, the remainder of the panel was surveyed by counting only those craters with diameters of 0.001 in. or greater. A total of 701 impacts were counted, which corresponds to 1795 impacts/m² for craters 0.001 in. or greater. Most of the craters were circular; however, 26 of these were oblong, possibly indicating that the impacting particles were highly oblique. The delaminated paint surrounding many of the craters was lifted in large flakes just above the aluminum substrate surface. Some craters appeared dark inside, possibly because they were deeper or contained residue, and, in some cases, a dark spot could be seen inside the crater. This may also be due to lighting artifacts. The largest impact was a 0.090 in. diameter hole through the aluminum panel with a 0.21 in. melt zone and a delamination area of about 1 in. In general, this panel was unique due to the absence of paint binder at the surface and revealed evidence of very small impacts, which were not detectable on other LDEF surfaces or samples.

Figure V-1. Representative impacts in the D8 EPDS sunshield.

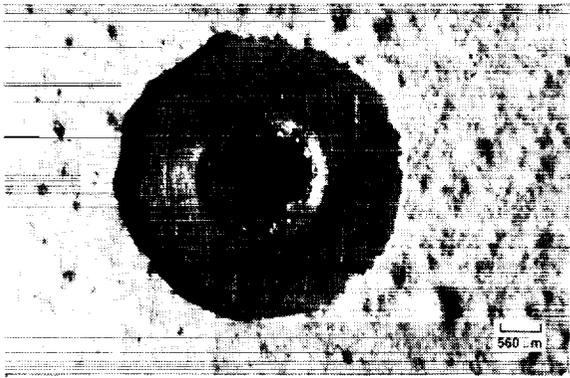
The D8 SCU cover was a box sunshield that fit over the signal conditioning unit on the D8 tray. It was constructed of aluminum sheet 0.086 cm (34 mils) thick and was double walled on the top surface, the surface scanned in this study. The aluminum was painted with a white thermal control paint, S13GLO, which is a zinc oxide pigment based paint that uses potassium silicate to encapsulate the pigment for UV stability. The binder for this paint is a methyl silicone material similar to GE RTV 602. The thickness of the paint was 230 microns (9 mils). This paint has significantly different mechanical properties than the Chemglaze A-276 paint used for the EPDS sunshields, primarily due to the elastomeric silicone binder, which imparts flexibility. The paint on the retrieved D8 SCU cover was crazed; however, it was still somewhat flexible and resilient, and the binder was still intact even after exposure to atomic oxygen. However, surface analysis using XPS indicated that a silicon dioxide coating had formed from the exposure. Moreover, the cover generally retained its white color in spite of the exposure to UV radiation. This was due to the interaction of atomic oxygen with the damaged material. The mechanism of this whitening process is still under investigation. The texture of the surface was quite rough as originally applied to the surface; the surface resembled, more than anything else, a stucco wall. This caused some difficulty in seeing and counting small impacts. In this material, the delaminated areas around the impacts were not folded back as on the D8 EPDS sunshield, but were simply eroded areas tapering down towards the craters. Bare metal between the crater and the delaminated area was observed on only three craters of the 59 that were counted in the diameter range of 0.001 in. and up giving a crater density of 434 craters/m². The largest crater was 0.075 in. in diameter with a 0.4 in. diameter area of bare metal surrounding the crater, with no apparent delamination of the paint beyond this melt zone. This impact would have punctured the aluminum if the surface had not been double thickness. The impact produced a deep crater in the material with a depth of 1.8 mm. This surface gave a lower crater density count than the other D8 panels, probably because the smaller impacts left no trace on the textured and resilient paint surface. Figure V-5 illustrates the response of this material to impacts.

Figure V-5. Representative impacts in the D8 SCU cover

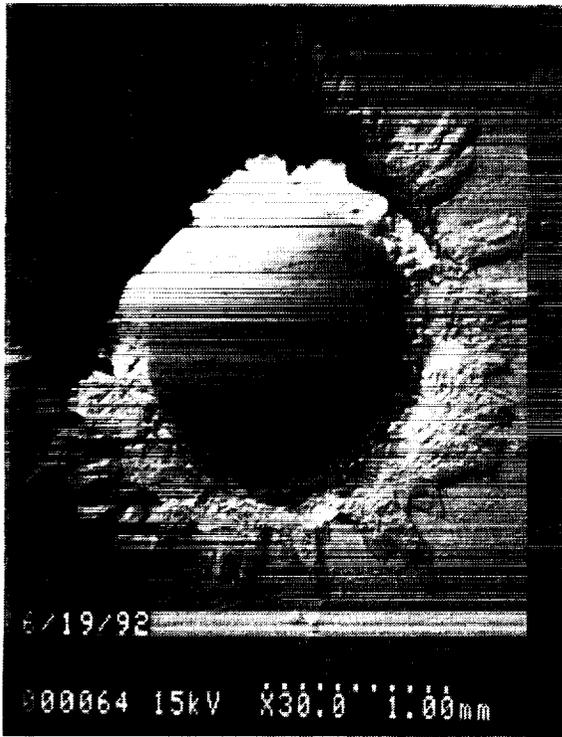
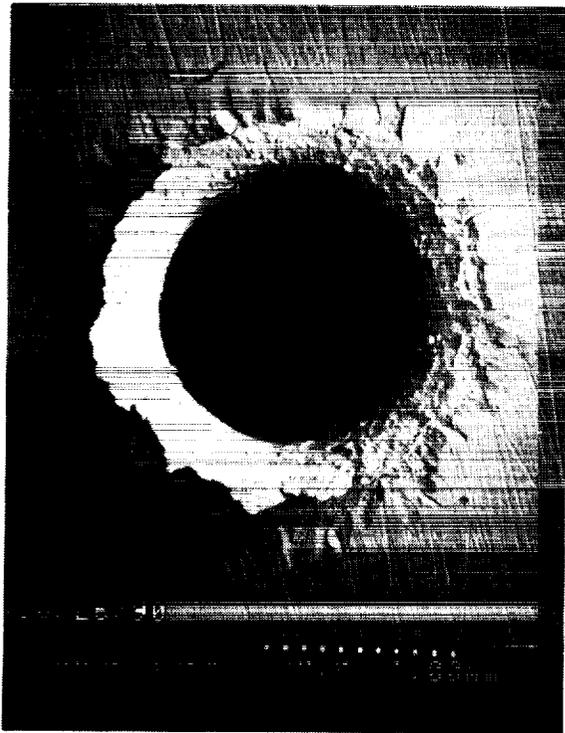
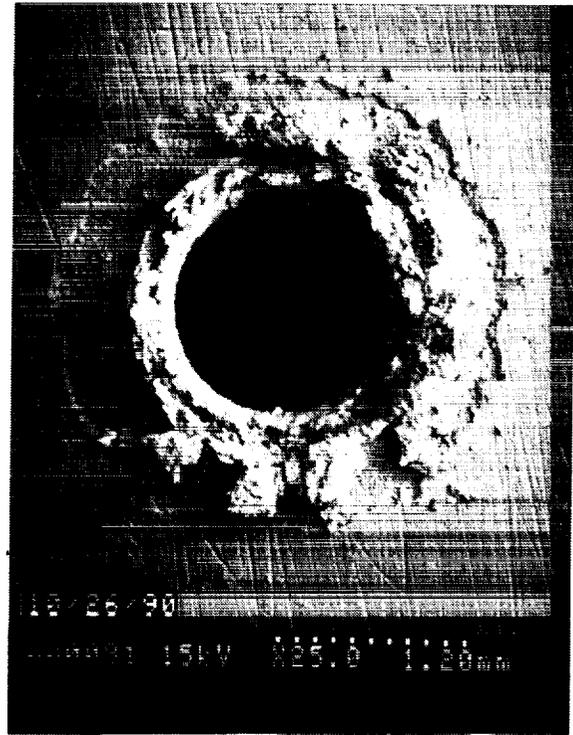
The response of the black anodized hardware is very similar to the sunshields. Impacts in the hardware are shown in Figure VI-1. In particular, this figure shows SEM photos of the entry and exit sides of a trailing edge (D3) perforation. All of these impacts display the classic raised lip structure, due largely to melt and hydrodynamic flow of the metal. The oxide layer has been shocked away.

Figure VI-1. Typical impacts in the black anodized aluminum MOO3 hardware.

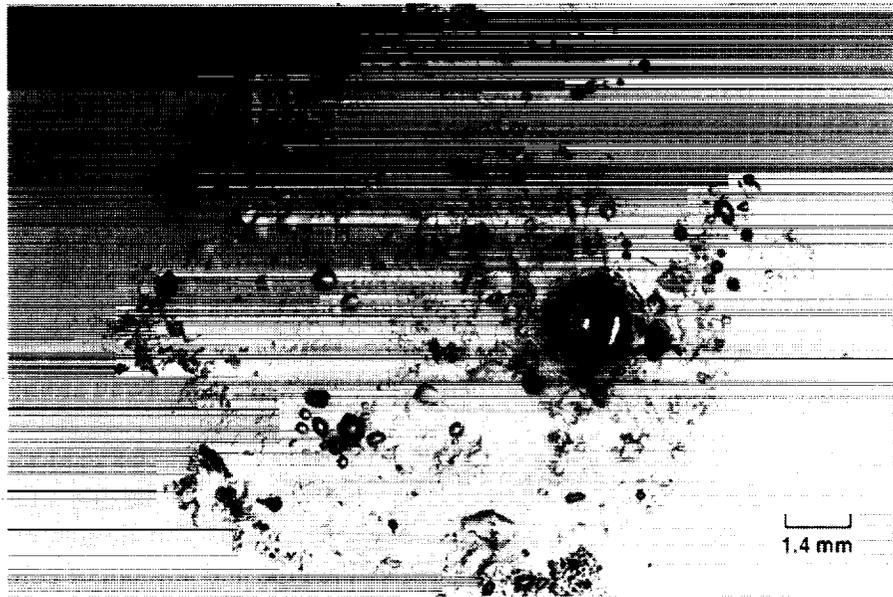
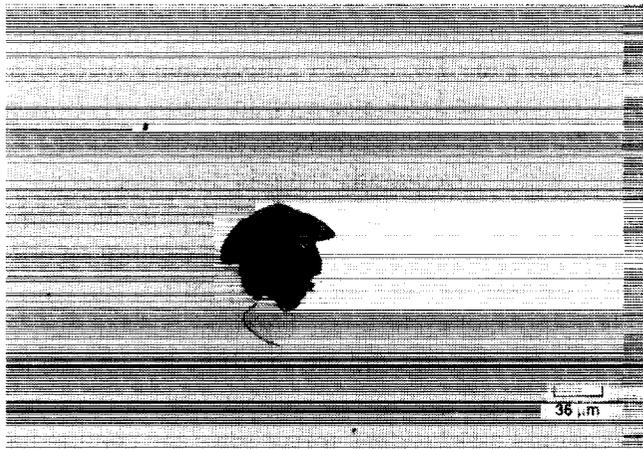
In contrast to the response of uncoated molybdenum substrates shown in Figure VI-2, the response of coated molybdenum can be quite different. Figure VI-3 graphically depicts the type of damage zone that can occur with hypervelocity impacts in some materials. In (a) we have a thorium fluoride-coated silver mirror on a molybdenum substrate with a 782- μm crater surrounded by a 1-cm blistered area. It would appear from the shape of the crater and the asymmetric damage zone that this impact occurred at a glancing angle. This type of damage was unusual (blistering without damage to the overlying layers), and its cause is not understood. Remarkably, the thorium fluoride coating was not cracked extensively, and no tarnishing of the silver layer was observed. There were other impacts in this sample, but they did not show the large damage zones observed around this impact. The cause of this difference is not known. It is hoped that further examination of these specimens will reveal more about material response and the effects of such impacts on performance. In (b), there is an impact in molybdenum coated with an aluminum oxide/silicon multilayer coating. Here, the brittle nature of the coating has caused it to crack and delaminate at the impact site. More damage to the sample could be anticipated as the coating flakes off. This sample was in the leading-edge

Figure VI-3. Impacts in coated molybdenum: (a) Thorium fluoride-coated silver mirror on molybdenum; (b) Alumina/Silicon multilayer coating on molybdenum; (c) ZnS/ThF₄ multilayer on molybdenum.

canister, and, therefore, only saw limited exposure to atomic oxygen. An interesting and unusual reaction zone around a ZnS/ThF₄ multilayer coating on molybdenum is shown in (c). The cause of this reaction zone is not known, but it is not due to a synergistic effect with atomic oxygen since this sample was mounted in the trailing edge canister.

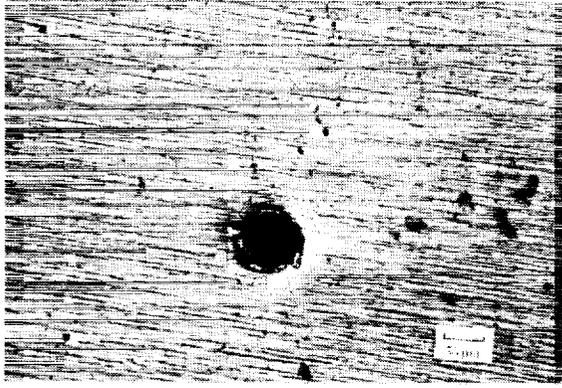
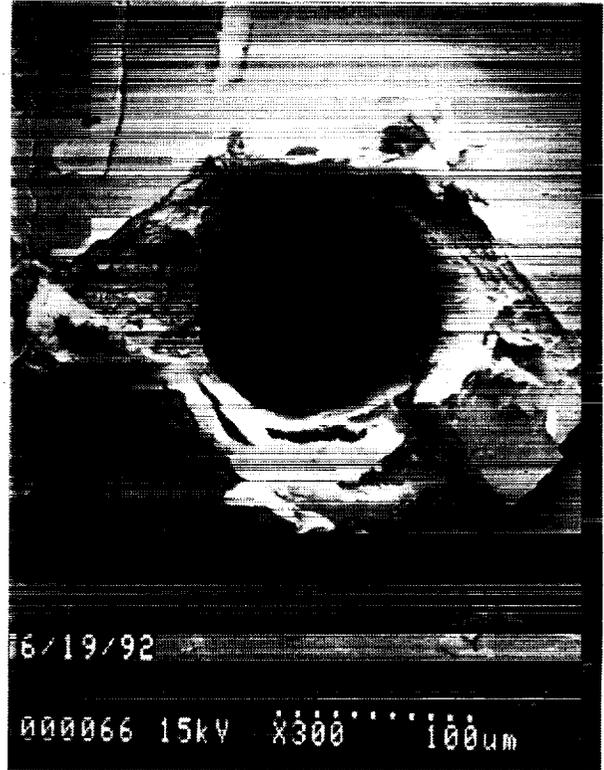
The response of unmounted molybdenum foils to impacts is shown in Figure VI-4. These are oxide-coated molybdenum foils approximately 2 mil thick. The sample shown in (a) has a SiO₂ coating while (b) is coated with a proprietary coating, P-273. The radial cracking of the silica layer is evident in (a); however, no such effect is seen in (b). The exit view shown in (c) indicates considerable spall of the metal. The sample shown in (d) is also oxide coated. The coating has also been shocked away around the impact site.

Figure VI-4. Impact perforations in coated molybdenum foils: a) Silica coated; b) P-238 coated; c) exit view of b); d) oxide coated Molybdenum.

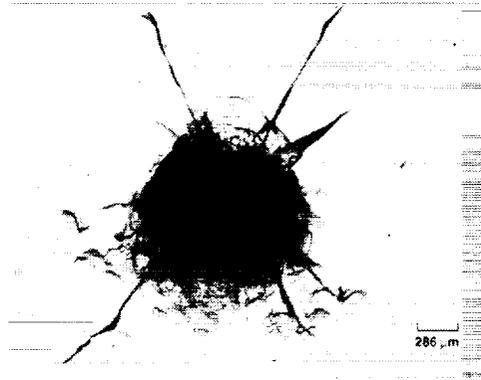
Figure VI-6 illustrates the response of uncoated 7940 fused silica to hypervelocity impacts. In most cases, the damage is localized; however, radial cracking does occur to a limited extent. Contrary to expectations, the cracks did not propagate a great distance from the impact site. The effect of this damage on optical performance and its long-term effects are largely unknown. Coated fused silica as seen in Figure VI-7 often displays crazing or cracking of the coating in addition to chonchoidal substrate cracking; however, sometimes unusual and extensive propagation of cracks is observed, while infrequently there is only localized damage. In Figure VI-8, more impacts to coated fused silica are shown. For example, (a) depicts the damage to magnesium fluoride coatings on fused silica, consisting of chonchoidal cracking. The coating on all magnesium fluoride-coated fused silica samples was crazed, regardless of the location on LDEF. The laboratory control was crazed as well, indicating that this effect is not related to the space environment but may be due to aging, and/or to processing conditions. The crazing of the coatings did not result in an increase in damage area around the craters. Large damage sites surround two small impacts in another sample (b) composed of a sodium fluoride coating on fused silica. This is no doubt a synergistic effect since the coating has been damaged by exposure to UV and/or atomic oxygen, and it is this damaged layer that has been lost or removed around the impact site.

Figure VI-6. Representative impacts in 7940 fused silica substrates.

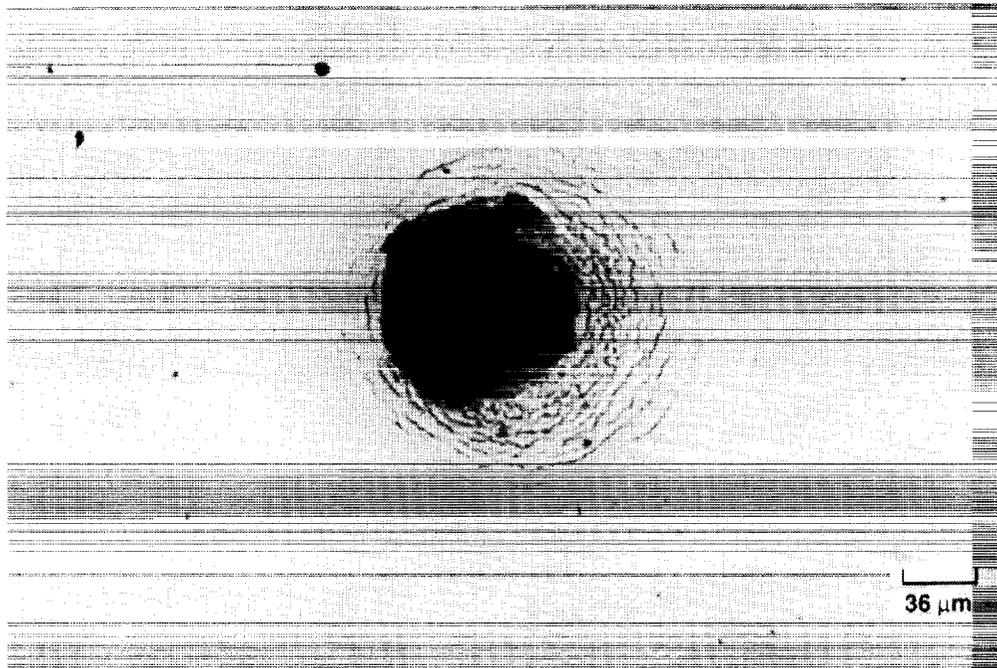
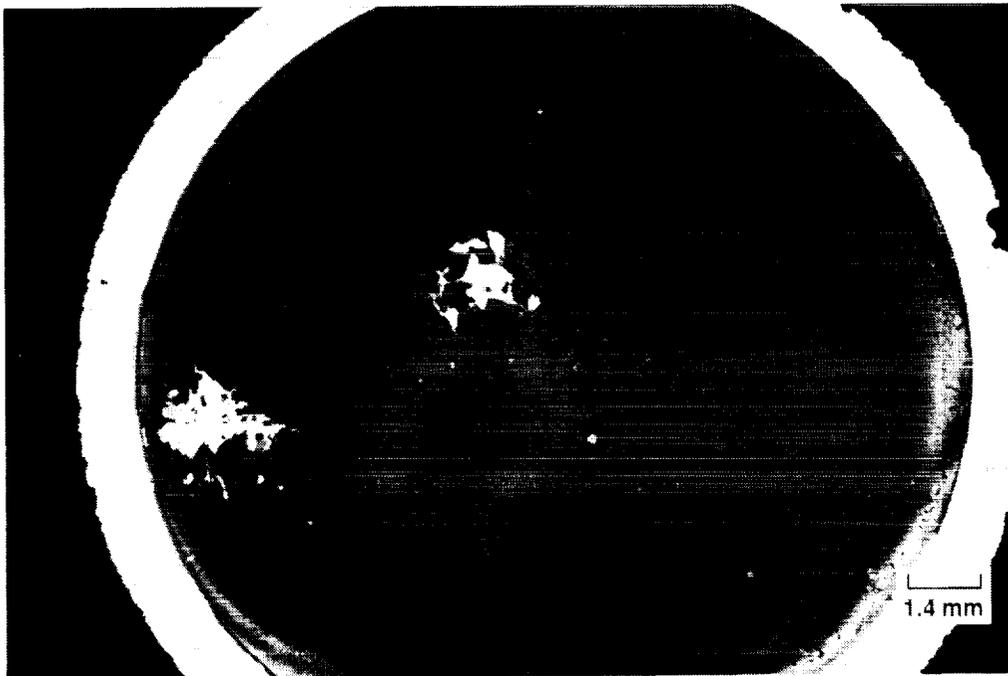
Figure VI-8. Impact damage to coated fused silica. (a) Magnesium fluoride coating; (b) Sodium fluoride coating.

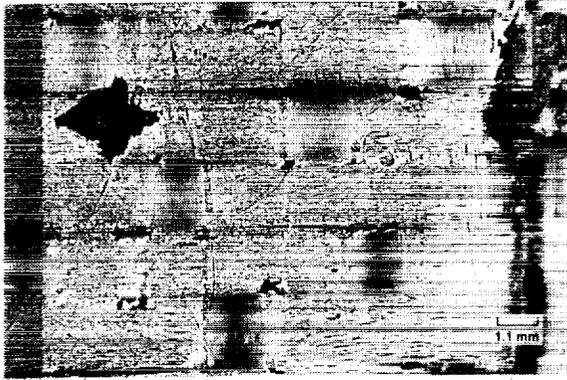
The response of organic matrix composites, primarily graphite epoxy, to hypervelocity impacts is represented by Figure VI-10. The damage to such materials is generally localized, with some chipping of the matrix in the outer layers of the composite at the crater site. In all cases examined, no perforations were observed. This may be a result of chance or the result of many layers of the composite acting as bumpers to slow down and vaporize the impactor. Metal matrix composites, such as graphite/aluminum, respond differently than the organic matrix composites, and behave much the same as metals to impact phenomenology as shown in Figure VI-11.

Figure VI-10. Representative impacts in organic matrix composites

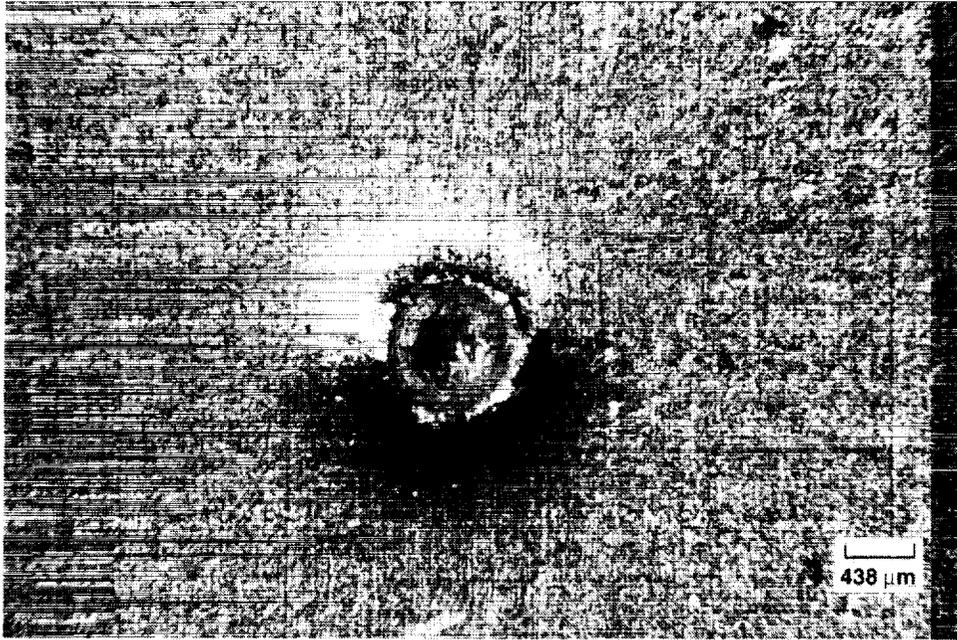
Figure VI-11. Representative impacts in metal matrix composites
