TECHNICAL NOTE 4263

EFFECT OF PRIOR AIR FORCE OVERTEMPERATURE  
OPERATION ON LIFE OF J47 BUCKETS EVALUATED  
IN A SEA-LEVEL CYCLIC ENGINE TEST

By Robert A. Signorelli, James R. Johnston, and Floyd B. Garrett

Lewis Flight Propulsion Laboratory  
Cleveland, Ohio

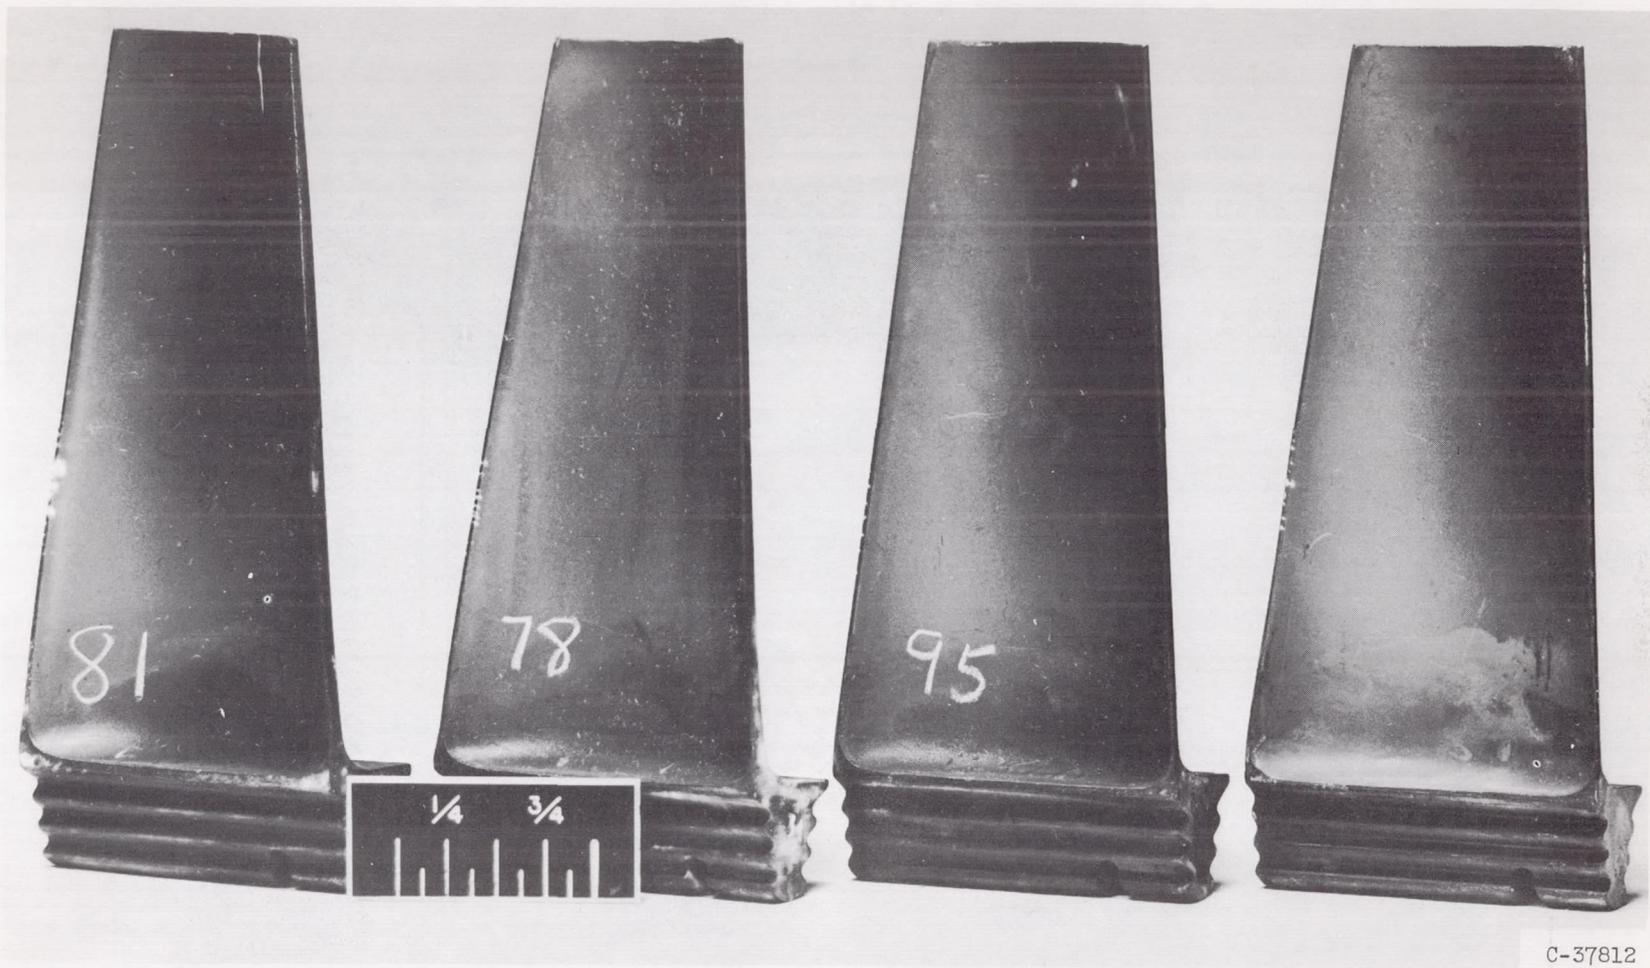
(a) Inspection, 198 hours.

Buckets ran for long periods of time without fracture after the inception of cracks. The one bucket that fractured ran 572 hours from the time cracks were first noted until it fractured. Photos of some of the buckets showing the progression of cracks during the course of the test are presented in figure 4. The depth of cracks did not increase very rapidly, as shown in figures 4(a) and (b), which illustrate the cracks after 198 and 500 hours of operation, respectively. After 500 hours, the largest leading-edge crack in bucket 81 elongated more rapidly (figs. 4(c) and (d)) and the bucket fractured in 652 hours (fig. 4(e)). The cracks in the other three buckets shown are relatively short after 660 hours, when the test was concluded (fig. 4(f)).

Figure 4. - Progression of cracks in representative buckets.

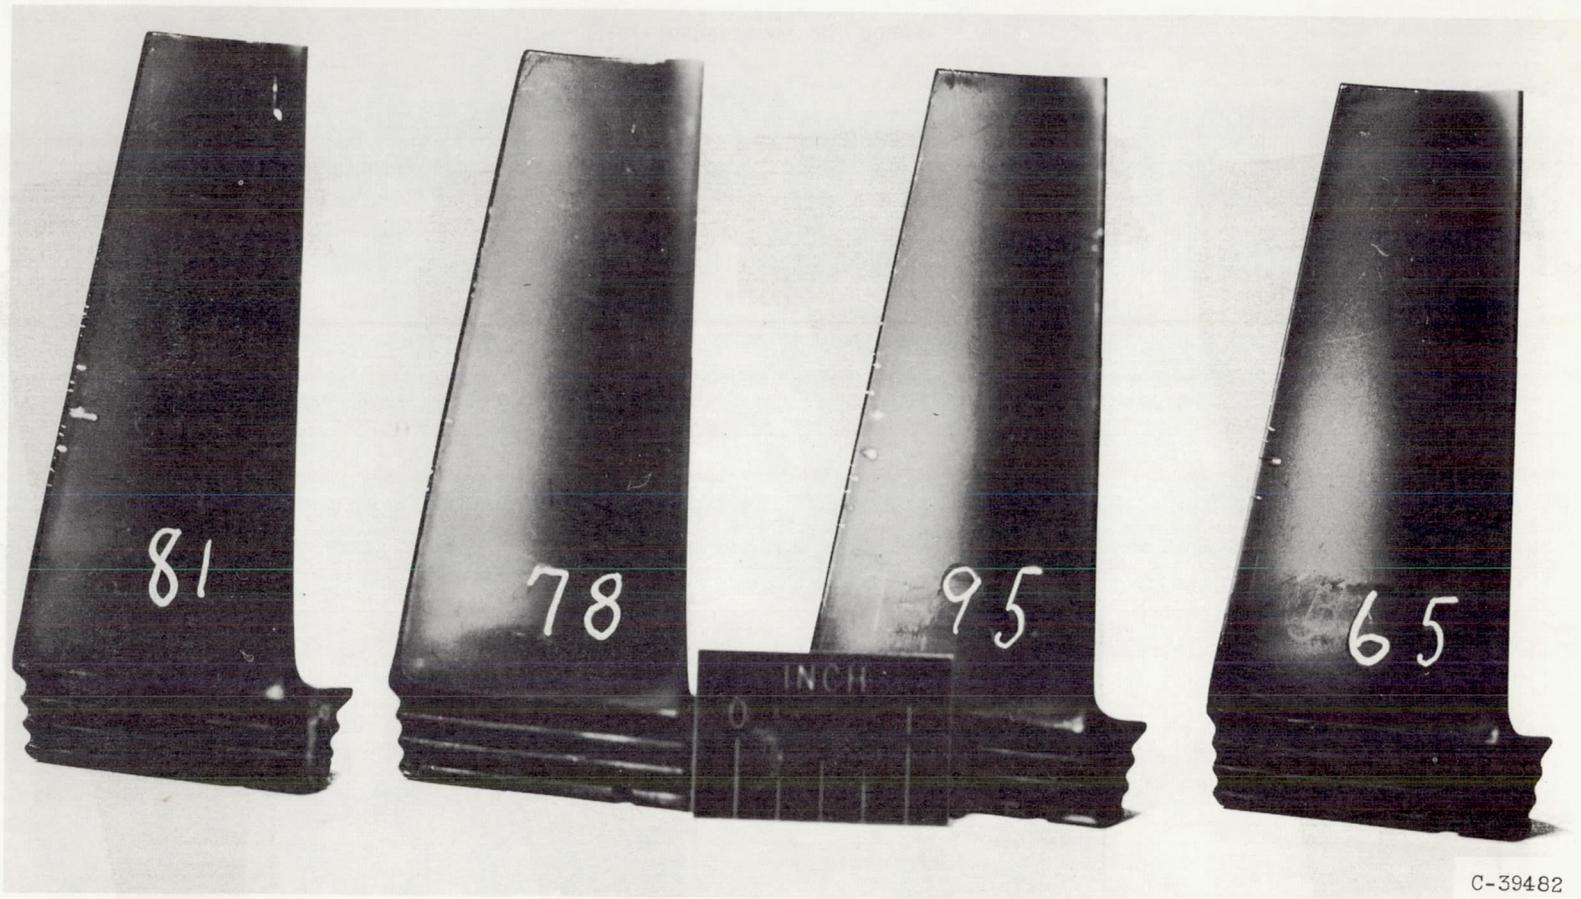
(b) Inspection, 500 hours.

Figure 4. - Continued. Progression of cracks in representative buckets.

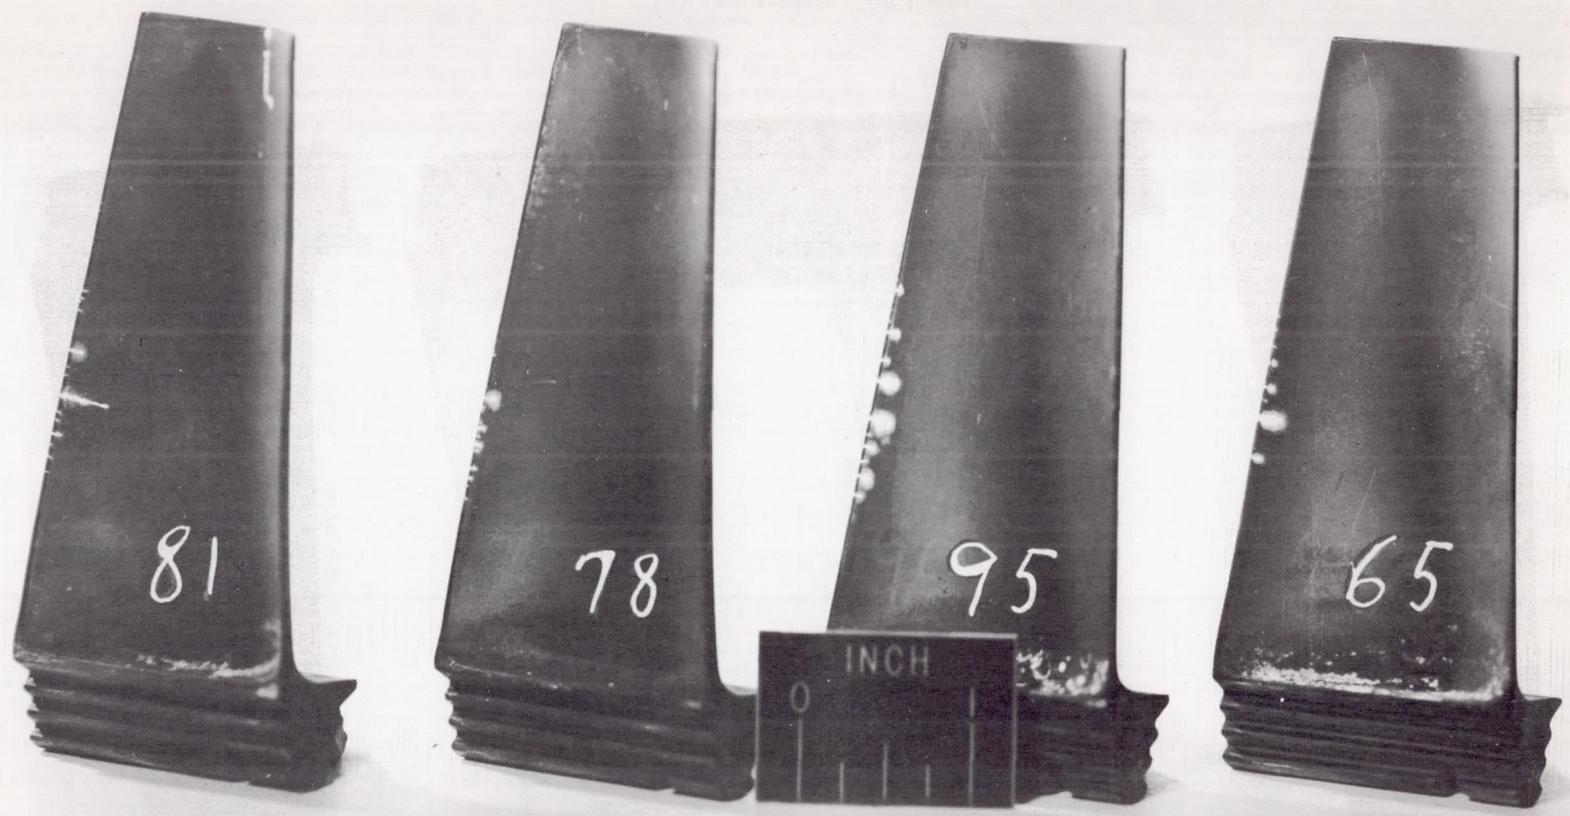
(c) Inspection, 580 hours.

Figure 4. - Continued. Progression of cracks in representative buckets.

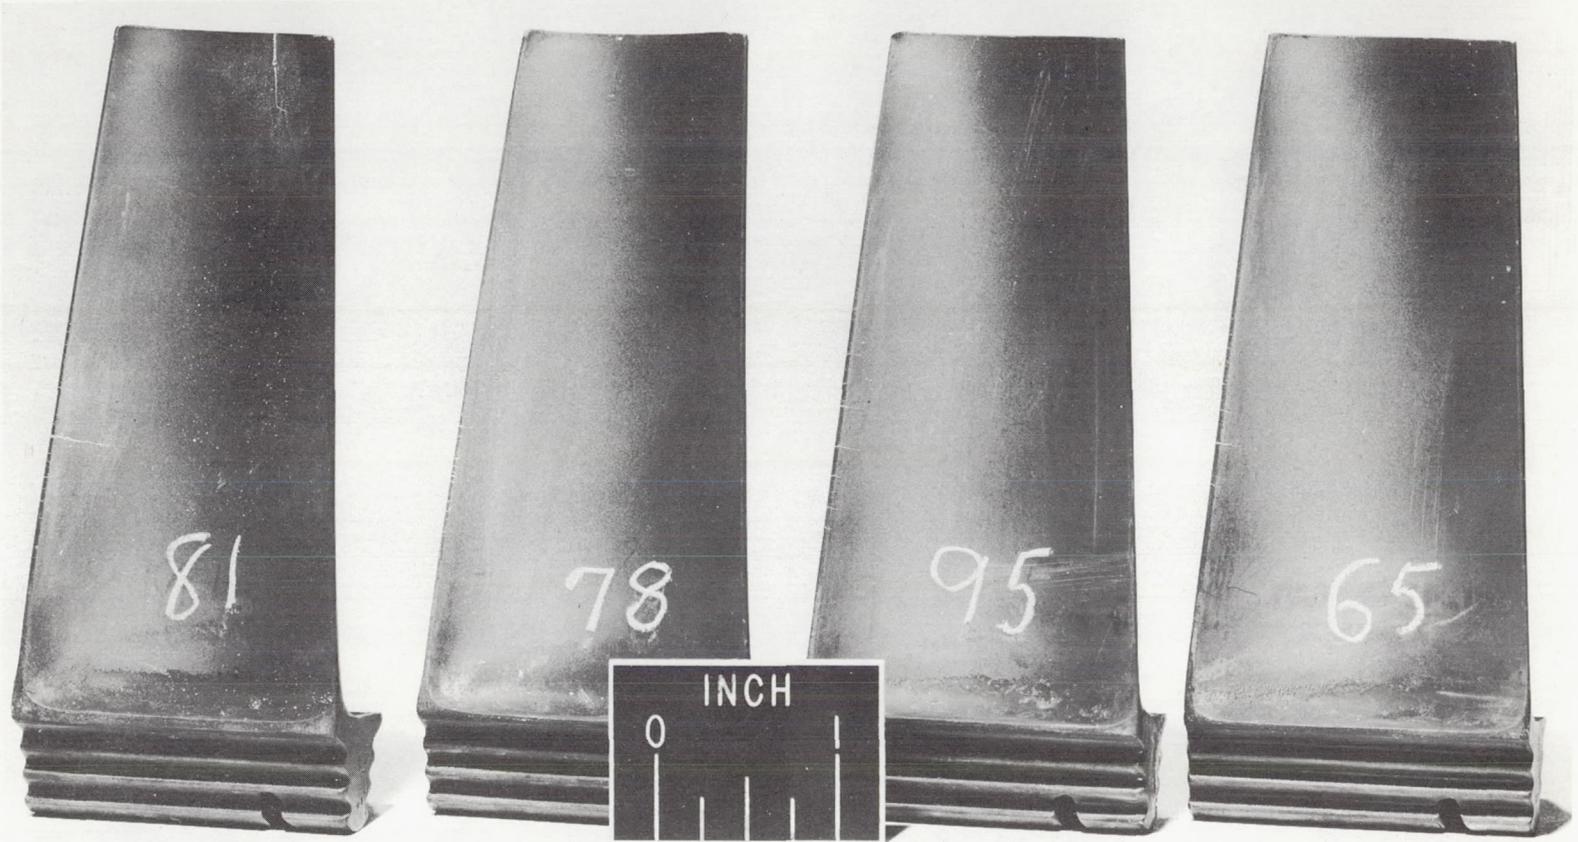
(d) Inspection, 620 hours.

Figure 4. - Continued. Progression of cracks in representative buckets.

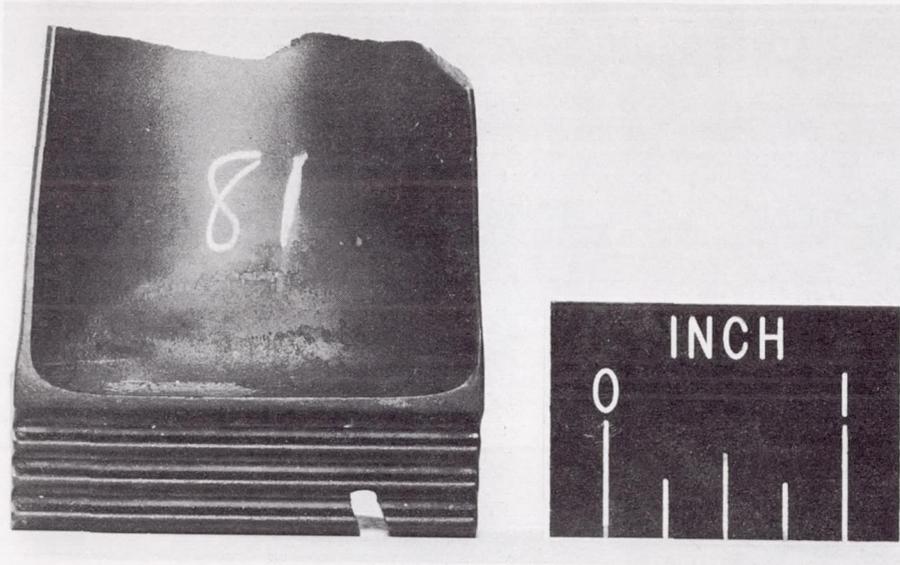
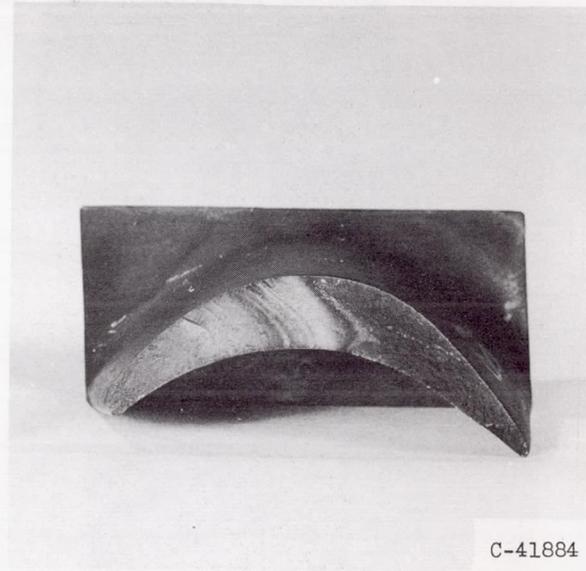
Bucket failures. - Only one bucket had fractured when the test was discontinued after 660 hours at rated speed. The fracture occurred in an overtemperated and reaged bucket (group 3) after 652 hours of operation. However, 81 buckets (84 percent) were cracked at the conclusion of the test after 660 hours (table III). Cracked buckets were first detected in the second zyglo inspection, which was performed after 80 hours. With the exception of the three buckets with trailing-edge tip cracks, all buckets were reinserted in the engine after zyglo inspection, and the test was continued to determine the rate of crack propagation.

The fracture surface of the one bucket that fractured in this investigation is shown in figure 10. The fracture surface is near the leading edge where failure began and at a point near the center of the chord length. The fracture appears intergranular near the leading edge and transgranular near midchord. The failure was propagated by fatigue from a leading-edge crack until the load-carrying area was reduced sufficiently to cause tensile failure.

(e) Bucket fracture from a leading-edge crack after 652 hours of operation.

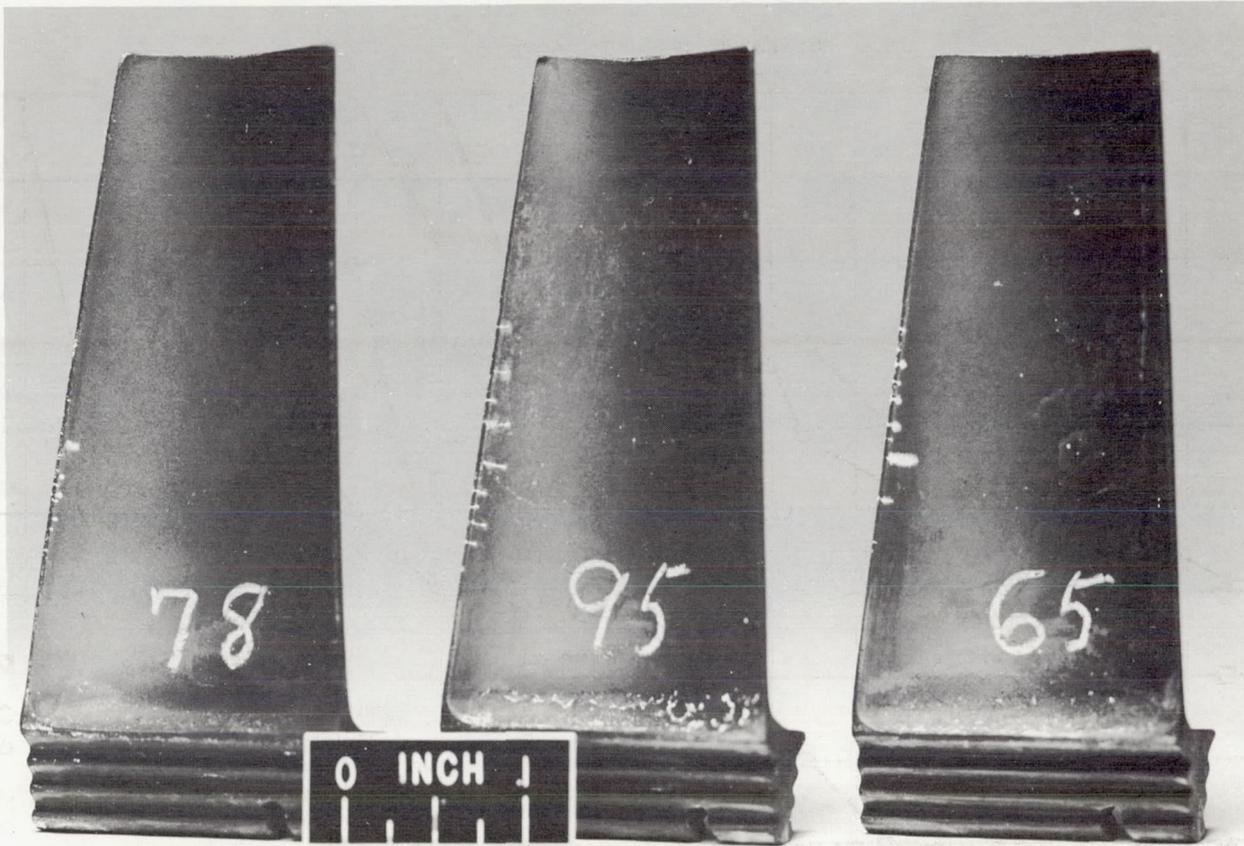
(f) Conclusion of test, 660 hours.

Figure 4. - Concluded. Progression of cracks in representative buckets.

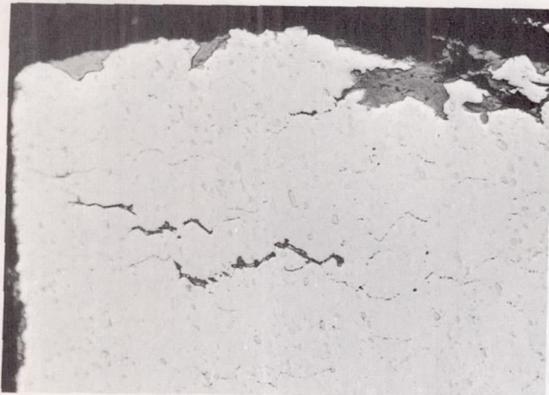
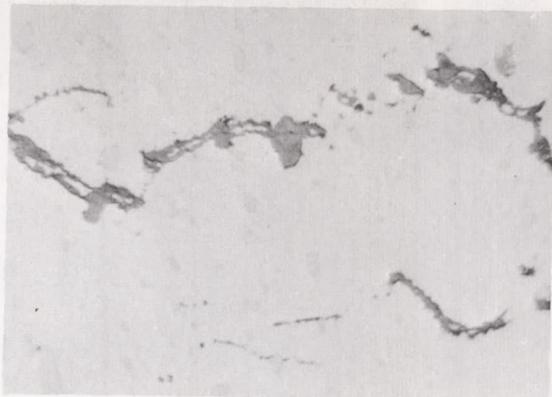
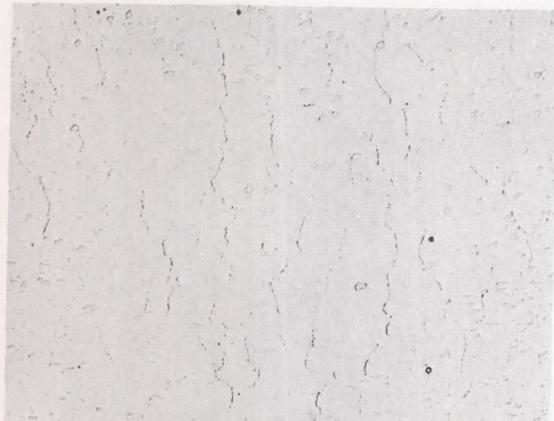
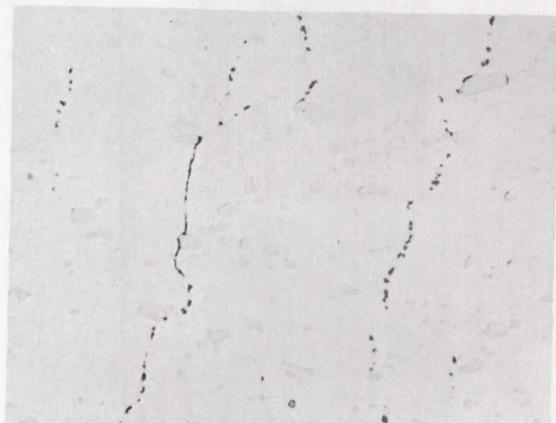
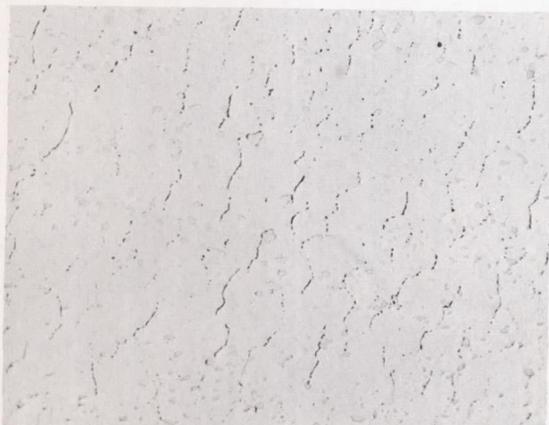
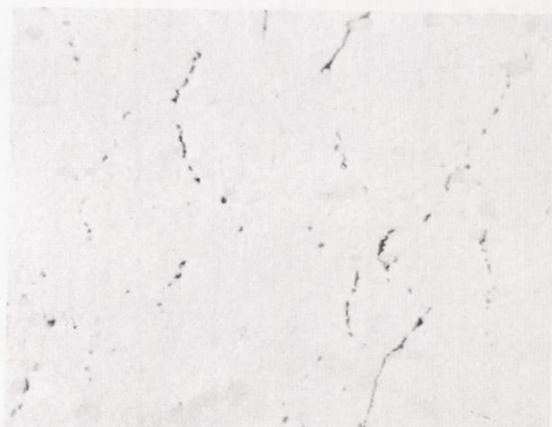
In addition to the continuous cracks near the leading edge, there were clusters of voids present in the grain boundaries of buckets. The voids were found in buckets from every group, but only specimens from the as-overtempered and the standard groups are shown in figure 9. The voids are in the grain boundaries transverse to the direction of centrifugal stress in the airfoil. They are found near, but not at, the leading edge and extend inward for a distance of about 0.2 inch.

As indicated in the results, clusters of voids were observed in the examination of microstructures after engine testing (fig. 10). The voids do not appear to be intergranular oxidation or rupture tears may be evidence supporting a theory that intergranular failure of metals at higher temperatures is caused by migration and collection of interstitial gases or vacant lattice sites, as suggested by Parker in 1944 (ref. 7) and others more recently (ref. 8). These voids have been seen in rupture specimens by others (refs. 9 and 10) and may be associated with the failure mechanism of leading-edge cracks.

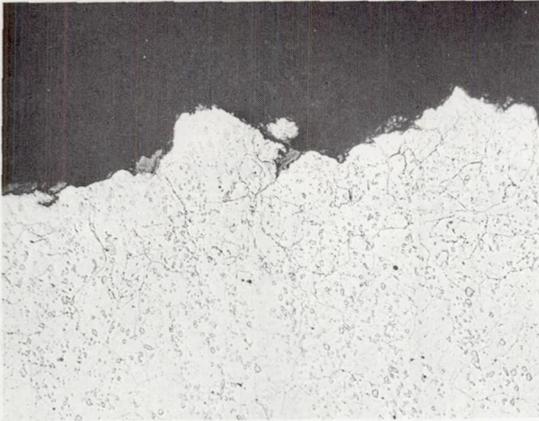
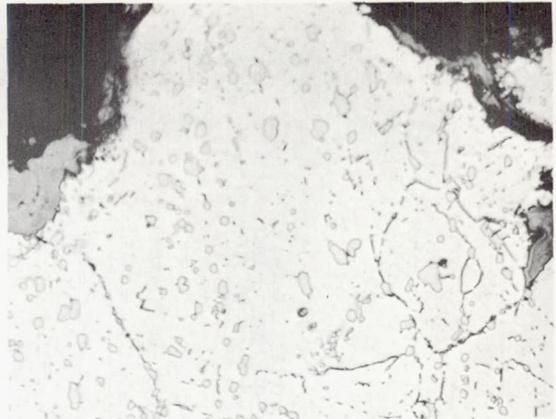
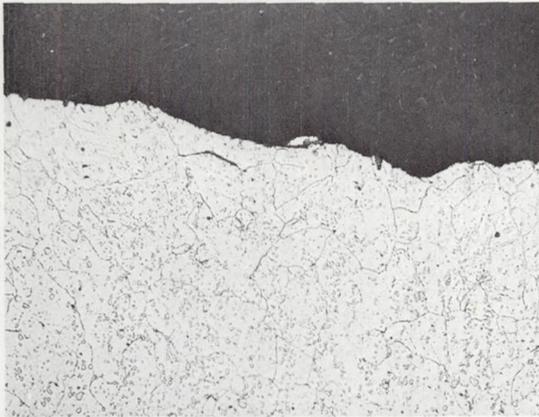
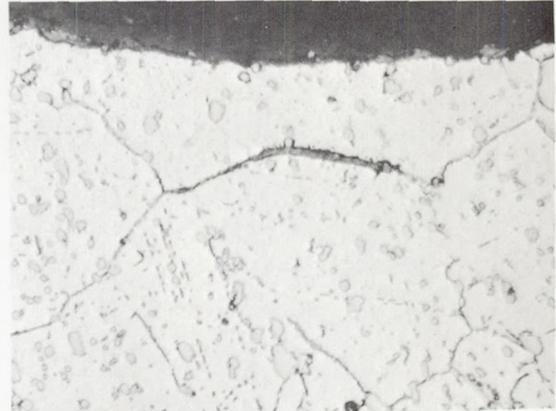
Intergranular near leading edge of bucket

Transgranular portion of fracture surface following above  
(a) Bucket failure progressing from leading-edge crack.

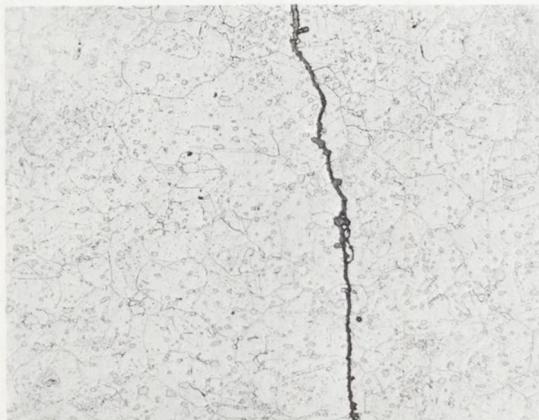
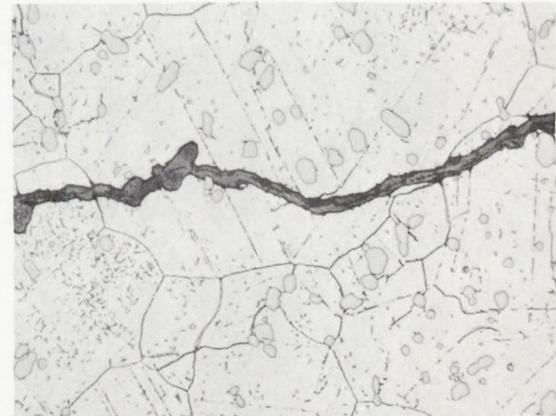
(b) Radial tip crack.

A typical radial-tip crack shown in figure 10 is a transgranular fatigue failure. Buckets ran for 500 hours with such radial-tip cracks and did not fracture.
