RESEARCH MEMORANDUM

PRELIMINARY INVESTIGATION OF SEVERAL ROOT DESIGNS FOR
CERMET TURBINE BLADES IN TURBOJET ENGINE

III - CURVED-ROOT DESIGN

December 28, 1955

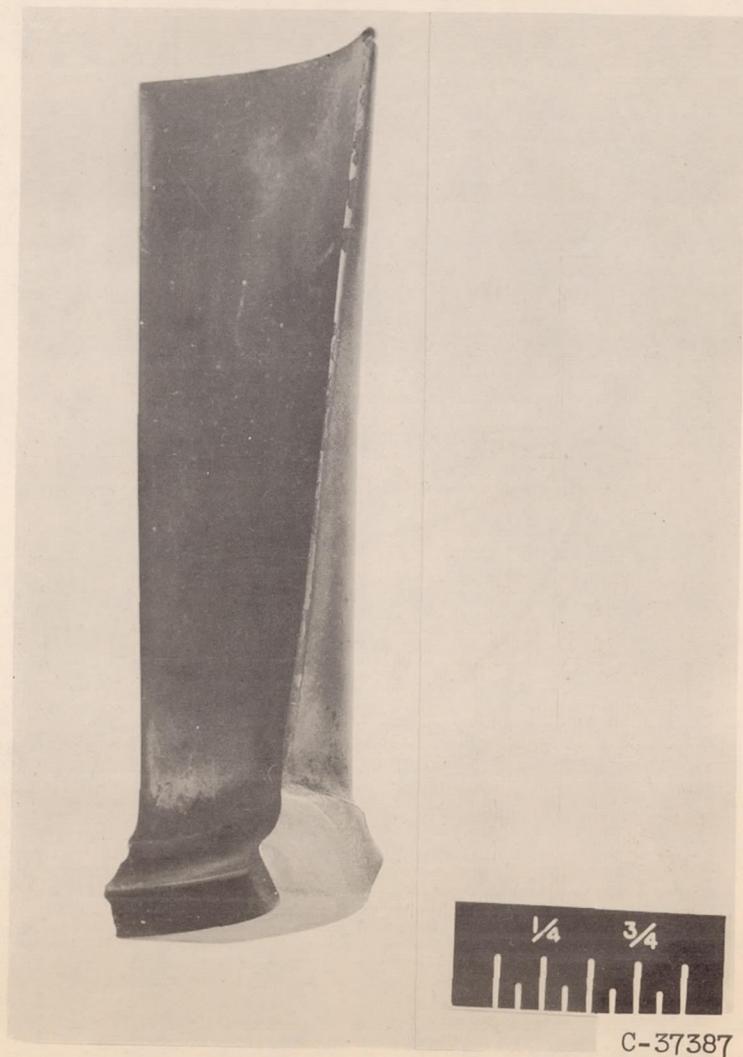
Run 1. - The curved-root blades of run 1 successfully completed 150 hours. One of them is shown in figure 3. Except for a discoloration of the surface, no change in the blade during operation was detected. During the course of this run the engine was shut down 19 times.

Figure 3. - Cermet turbine blade after 150 hours of operation. Run 1.

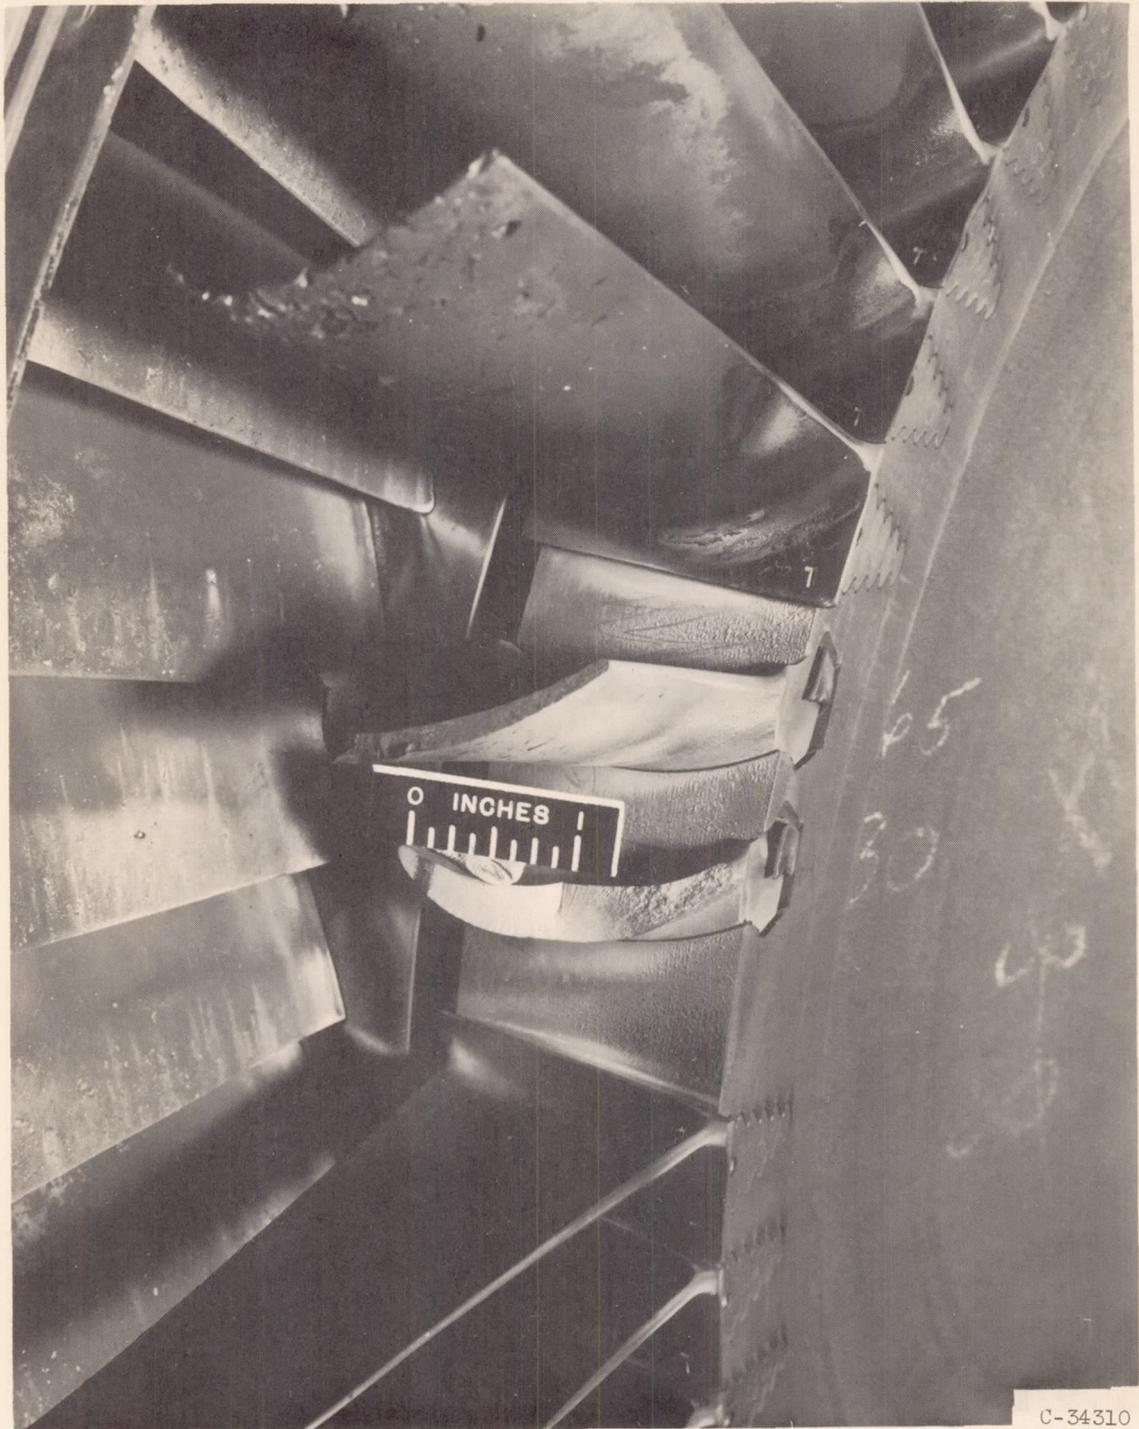
Run 2. - The second set of curved-root blades had accumulated 77 hours and 4 minutes at rated speed when an airfoil failed, as shown in figure 4(a), and damaged the other cermet blades (fig. 4(b)). While no definite cause for the failure was established, the blades were severely corroded along the leading edge. The enlarged view of the leading edge of the failed blade (fig. 5) is typical of the appearance of the leading edges of all the cermet blades in this run. X-ray diffraction of flakes chipped from the edges of the blades did not indicate the presence of foreign material; only the constituents or their oxides were detected. Since this corrosion was not evident in the many previous engine runs with this composition, it is not considered characteristic of either the nominal composition or the normal operating environment.

(a) Originally failed blades.

Figure 4. - Failure of curved-root cermet turbine blades after 77 hours and 44 minutes at rated speed. Run 2.

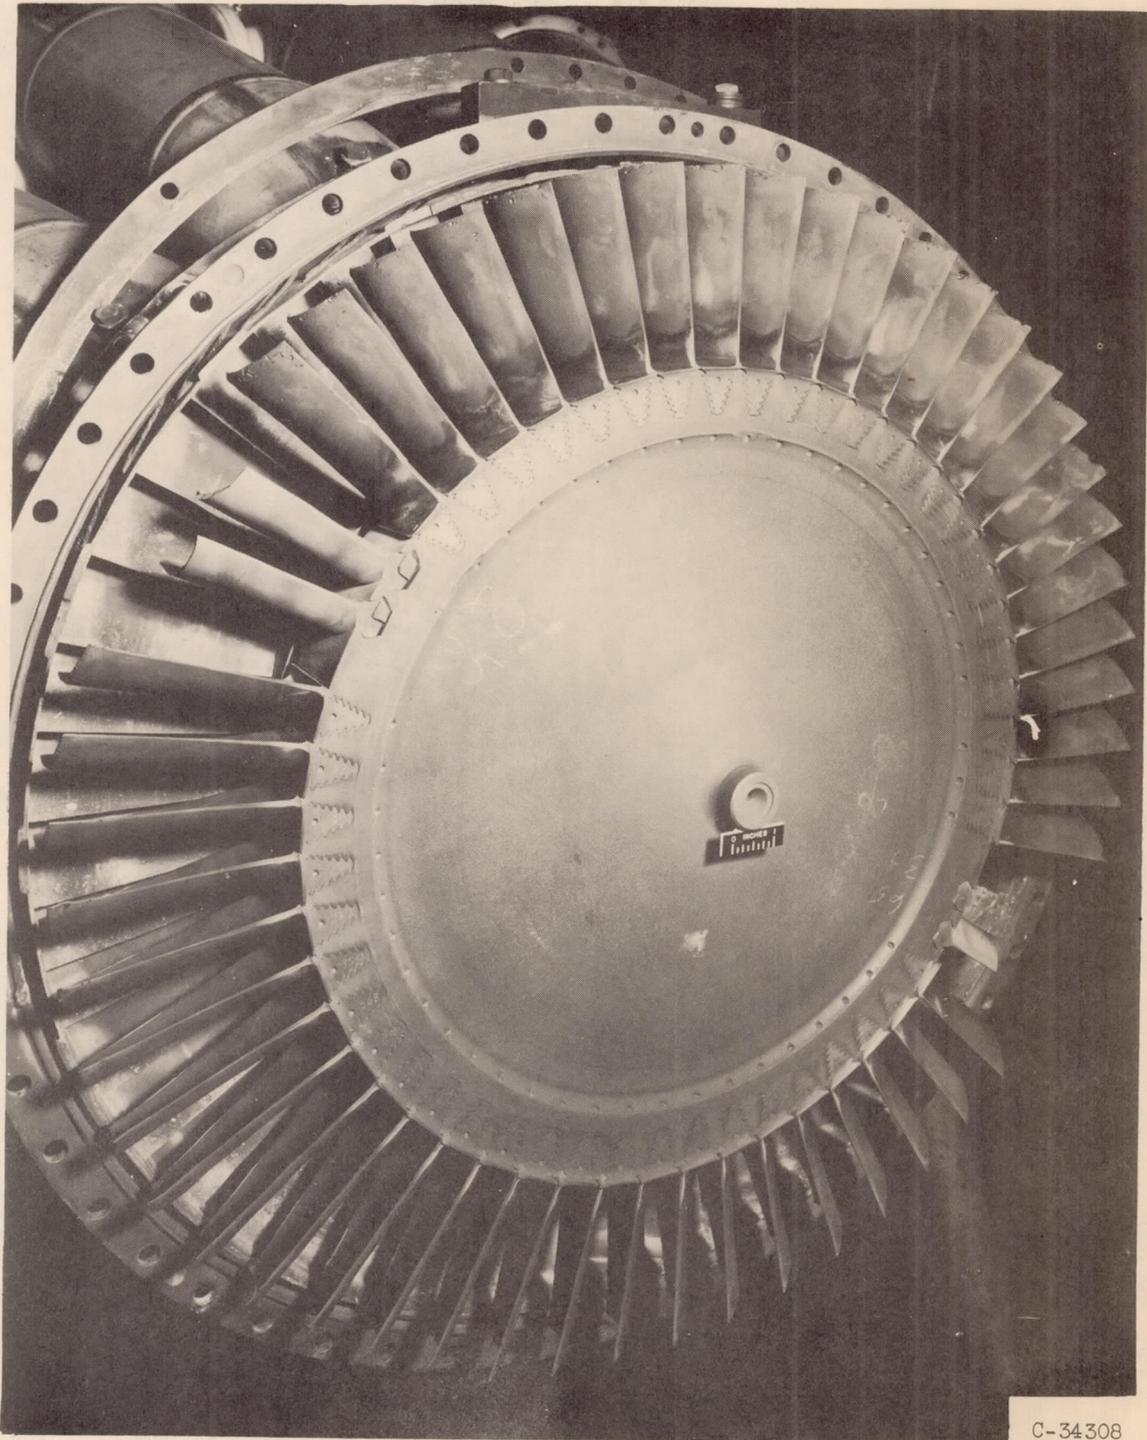
C-34308

(b) Damage to entire wheel.

Figure 4. - Concluded. Failure of curved-root cermet turbine blades after 77 hours and 44 minutes at rated speed. Run 2.

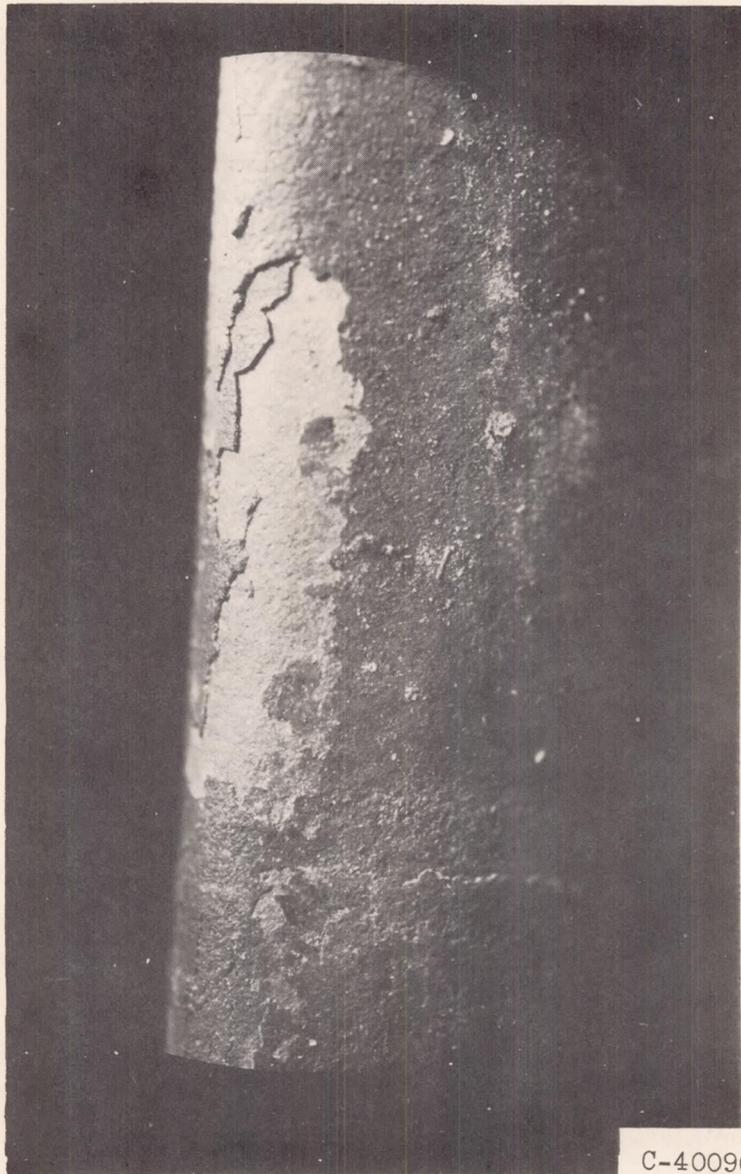
Figure 5. - Enlarged view (X15) of failed curved-root cermet turbine blade showing corrosion along leading edge. Run 2.

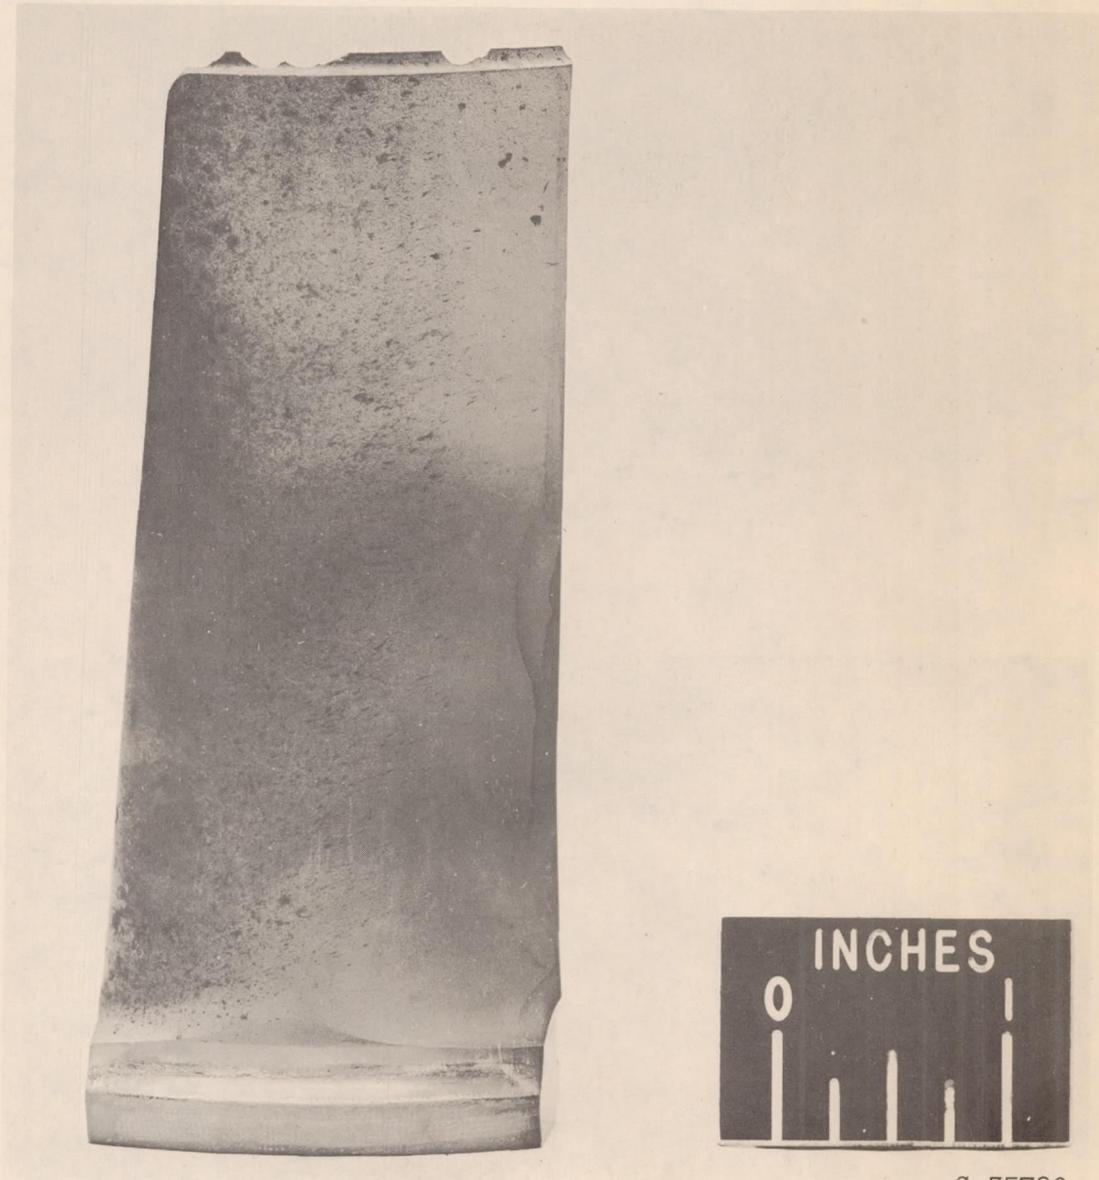
C-35790

Run 3. - In run 3, a curved-root blade failed at the base of the airfoil after 132 hours and 15 minutes at rated speed. A black powdery substance spotted the suction surfaces of all blades, particularly near the leading edges (fig. 6). X-ray diffraction patterns of scrapings of this powder indicated only carbon. Since the formation of carbon is unusual in this engine, the deposit indicates that the engine was malfunctioning. The deposit itself was tightly adherent; it was not removed when the blade was held against a linen buffing wheel. The tight adherence of the deposit as well as the presence of carbon near the origin of the fracture (fig. 7(a)) suggests that a chemical reaction may have occurred between the carbon and the blade material. Malfunction of the engine may have propagated the stress raiser formed by such a reaction. To investigate this possibility, carbon was collected from deposits in the combustion chambers of several engines and compacted into pellets. These were heated to 1500° F in a furnace, in contact with the surface of an unfailed curved-root blade. The carbon soon burned away, but the blade was left in the furnace to react with whatever ash or residue may have resulted. No reaction was detected after 200 hours at 1500° F. Although the fracture is located in an area of low vibratory stress, appearance of the fracture (fig. 7(b)) suggests a fatigue mechanism.

Figure 6. - Carbon deposits on curved-root cermet turbine blade after 132 hours and 15 minutes at rated speed. Run 3.

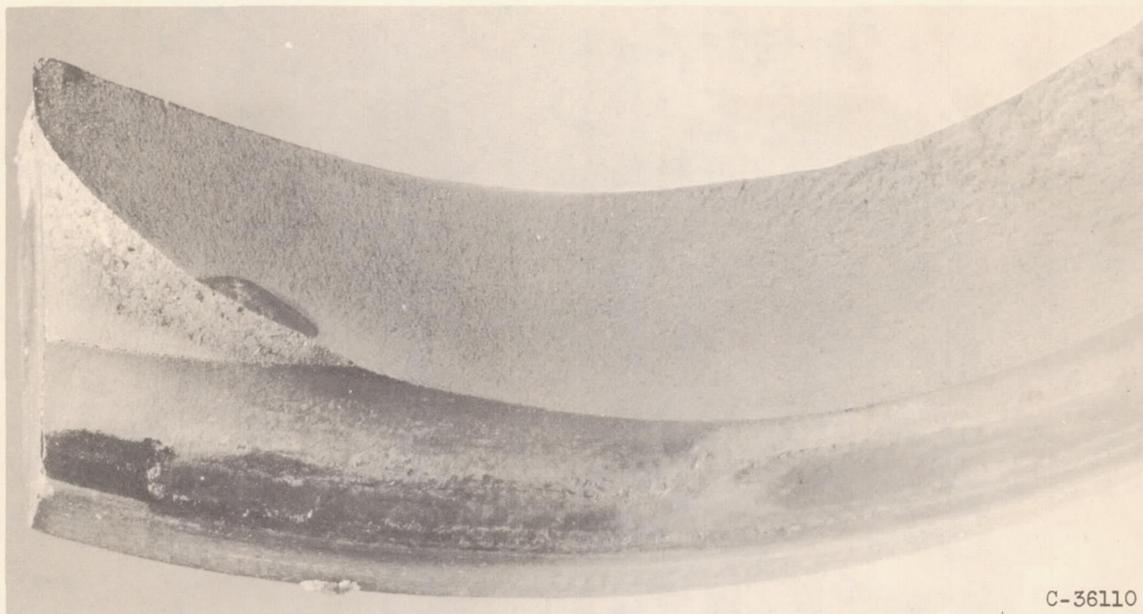
(a) Failure location; base of airfoil.

Figure 7. - Failure of curved-root cermet turbine blade after 132 hours and 15 minutes at rated speed. Run 3.

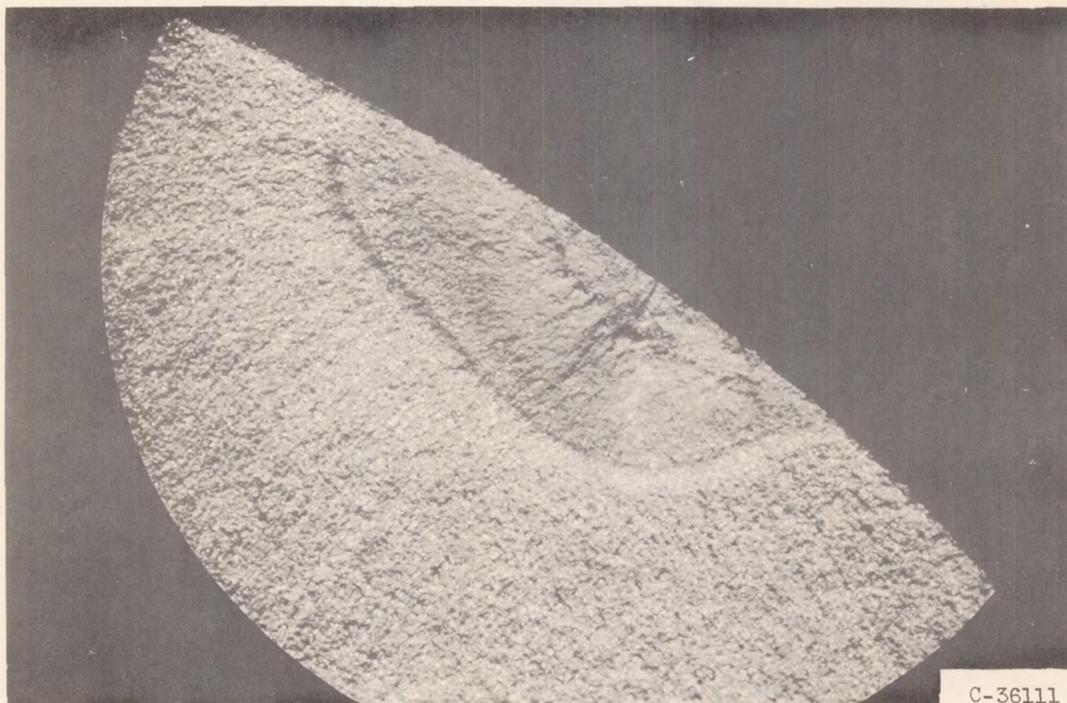
(b) Origin of failure. X15.

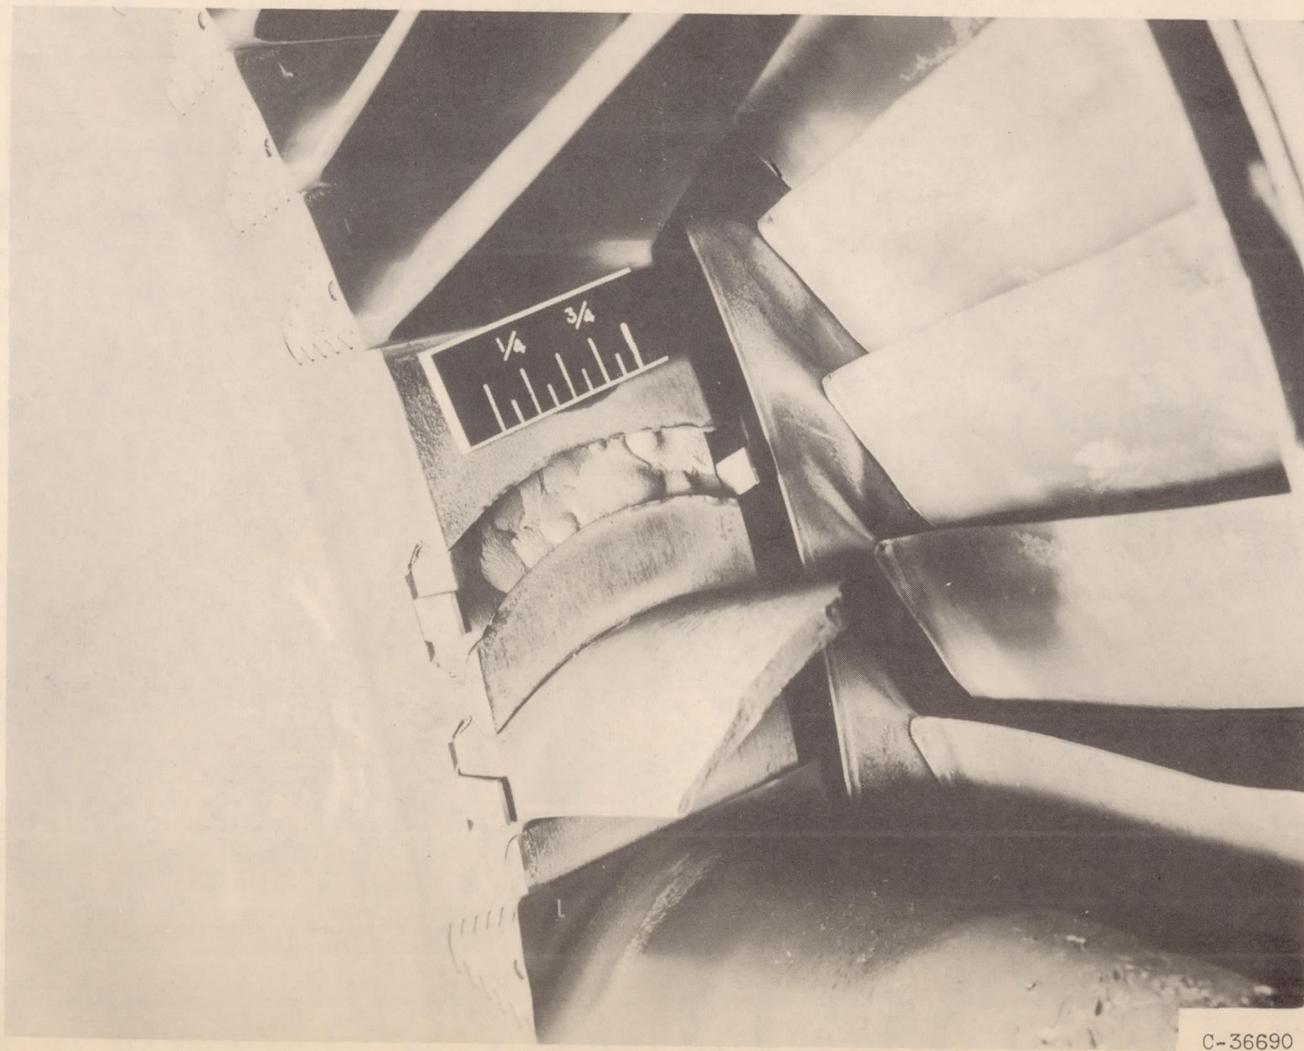
Run 4. - A curved-root blade (fig. 8(a)) failed in the root after 142 hours and 58 minutes at rated speed, damaging the adjacent cermet blade but inflicting only minor damage to the opposing pair of blades (fig. 8(b)). The failure has the spalled appearance that has previously been attributed (ref. 4) to the presence of high compressive stresses,

particularly those resulting from the progressive pinching action of the turbine wheel during engine operation that involves many engine stoppages. During run 4, the engine was stopped and started 25 times. Reference 4 states also that the root radius used in this study is superior to the larger radii used previously from consideration of the build-up of these compressive stresses.

(a) Root failure showing spalled appearance characteristic of compressive stressing.

Figure 8. - Failure of curved-root cermet blades after 142 hours and 58 minutes at rated speed. Run 4.

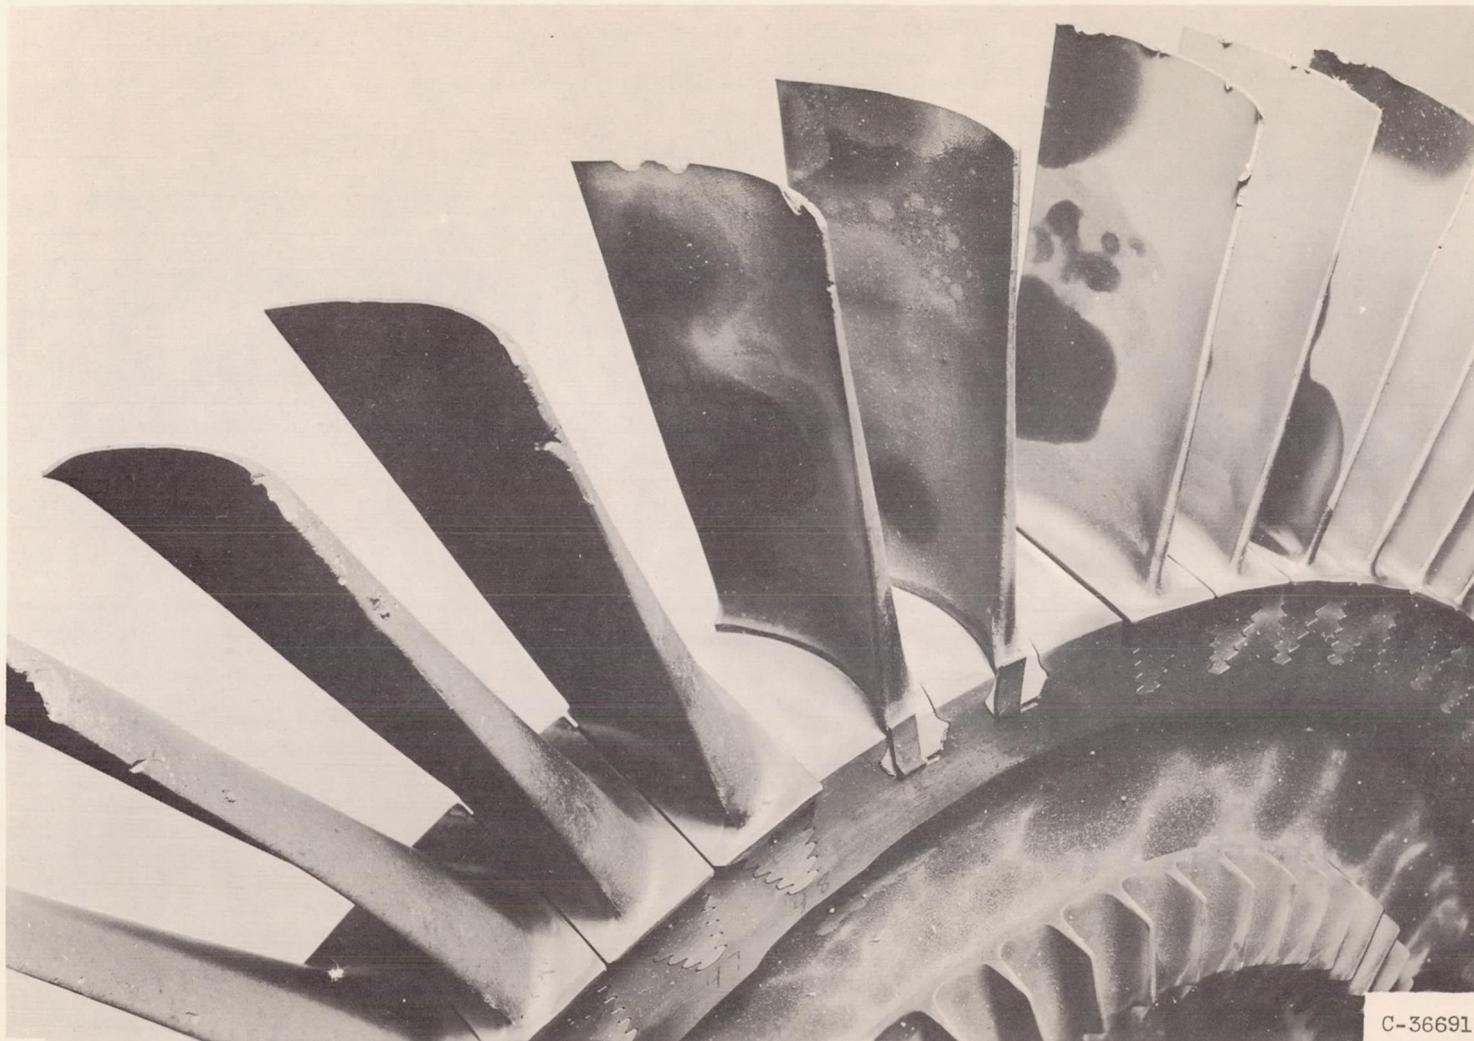
C-36691

(b) Blades damaged by diametrically opposite blade with root failure.

Figure 8. - Concluded. Failure of curved-root cermet blades after 142 hours and 58 minutes at rated speed. Run 4.

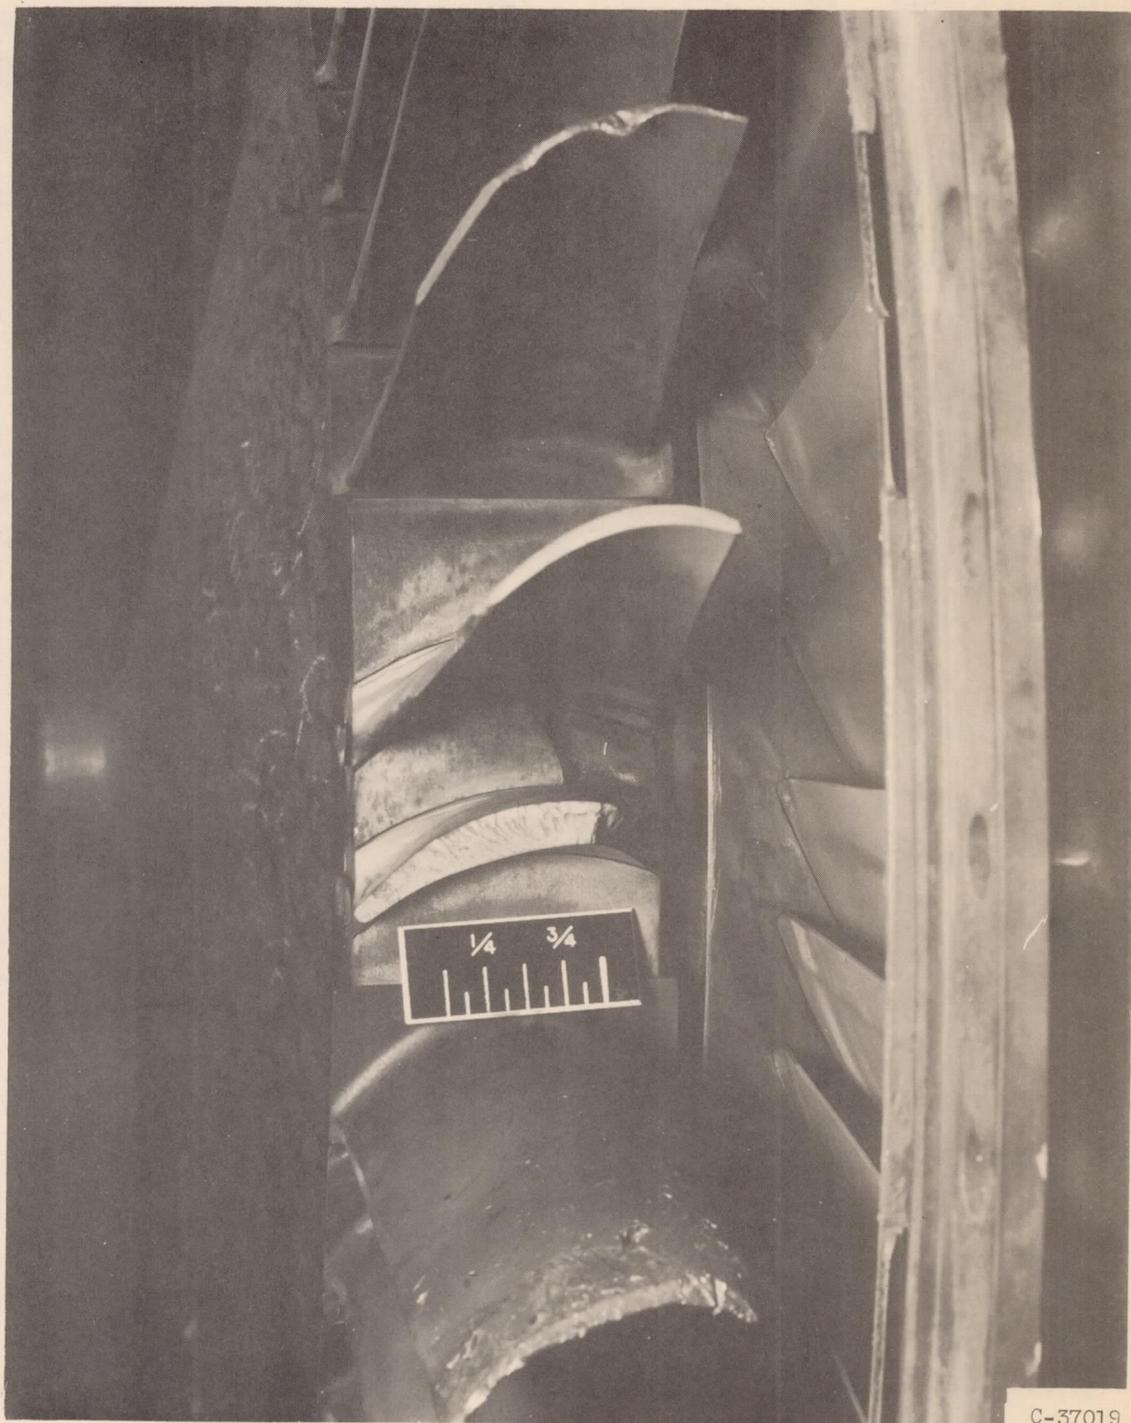
C-37019

Run 5. - After 102 hours at rated-speed during run 5, the wheel failed in the serration area between two cermet turbine blades (fig. 9), damaging the cermet turbine blades and terminating the run. The wheel had been used for all the runs discussed in this report, accumulating more than 600 hours of rated-speed operation, and had been subjected to 98 starts and stops. As indicated in table I, wheel stress is considerably less with the curved root than with the root forms previously investigated (refs. 3 and 4). The expected stress-rupture life of the rotor alloy had not been attained at the time of failure, and the appearance of the fractured face is not characteristic of a stress-rupture mechanism. Cause of the failure was not determined.

Figure 9. - Failure of turbine wheel containing curved-root cermet turbine blades after 102 hours at rated speed. Run 5.
