NACA RM E55L06

RESEARCH MEMORANDUM

EFFECTS OF A STRAIGHTENING OPERATION ON PERFORMANCE
OF INCONEL 550 BUCKETS

WASHINGTON
February 29, 1956

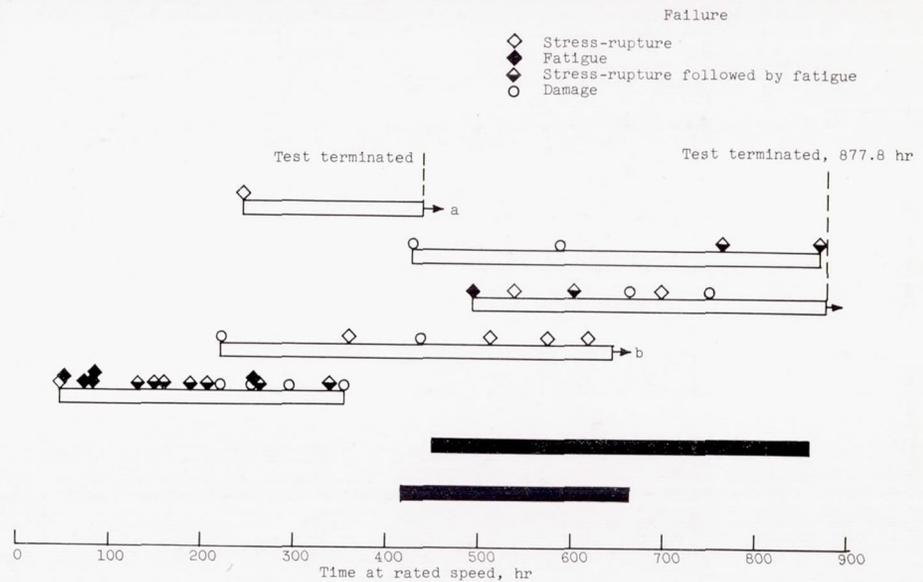
Figure 4. - Effect of straightening on bucket life of Inconel 550 in J33-9 engine at bucket temperature of 1500° F.

Engine life of the different groups of buckets is listed in table II and shown in figure 4. The straightened buckets (group 1), which were placed in the engine after 438 hours had been accumulated on the other groups of buckets, had a first failure after 248 hours. No other failure occurred in this group of buckets for the remainder of the investigation. The total accumulated time on these straightened buckets was 439 hours.

The buckets that were straightened and re-solution-treated prior to aging (group 2 buckets) had an excellent engine life. The first two failures of this group were damage-induced failures occurring at 428 and 586 hours. One unfailed bucket was removed from the engine at 618 hours to permit balancing of the turbine wheel. The first true failure occurred at 765 hours, and the other failure (last bucket of group 2) occurred at 872 hours at rated speed.

The engine life of the best-performing group of reference 1 (group 3 herein) ranged from 493 hours to the termination of the test at 878 hours. One bucket in this group did not fail.

The performance of group 4 buckets herein (second-best-performing group of ref. 1) ranged from 361 to 645 hours, when the last bucket of this group was removed to permit balancing of the turbine wheel. A damage-induced failure occurred in this group at 222 hours of rated-speed operation.

The results also show that reproducibility of performance was obtained for the two groups of Inconel 550 (groups 3 and 4) which were common to both this investigation and the previous one (see fig. 4).

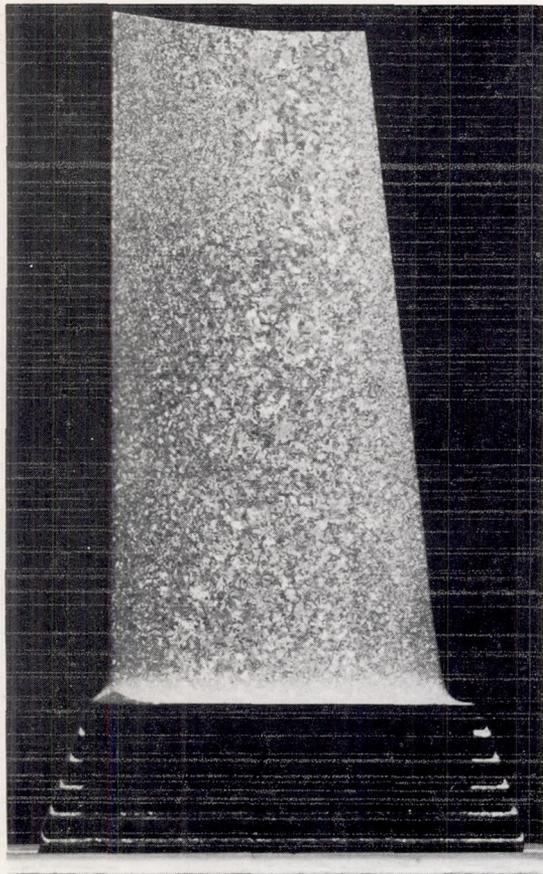
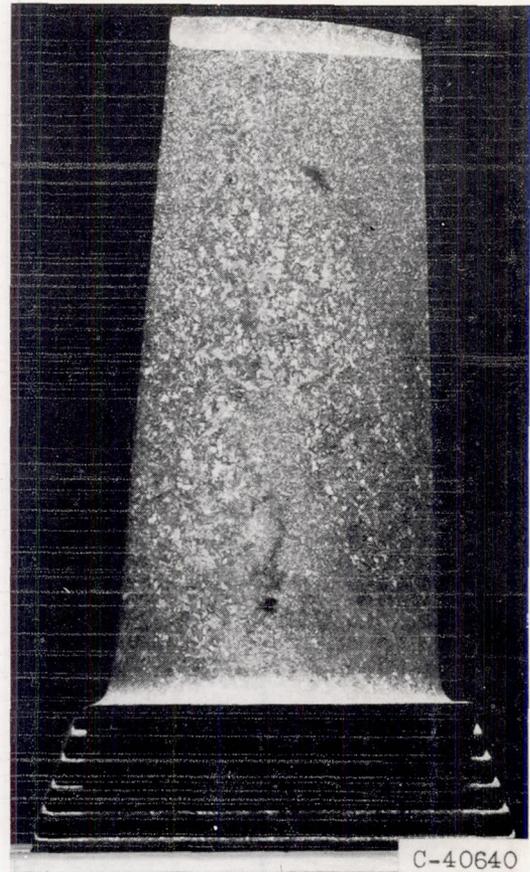
(a) Group 1.

Macro- and microexaminations. - Photographs of macroetched buckets are shown in figure 5. Grain sizes within each group were relatively uniform, and the grain sizes of the different groups were somewhat similar. The largest grain size was noted in buckets of groups 1 and 2. Both fine and coarse grains were found in most of the groups of buckets, but no germinated ("elephant") grains were observed.

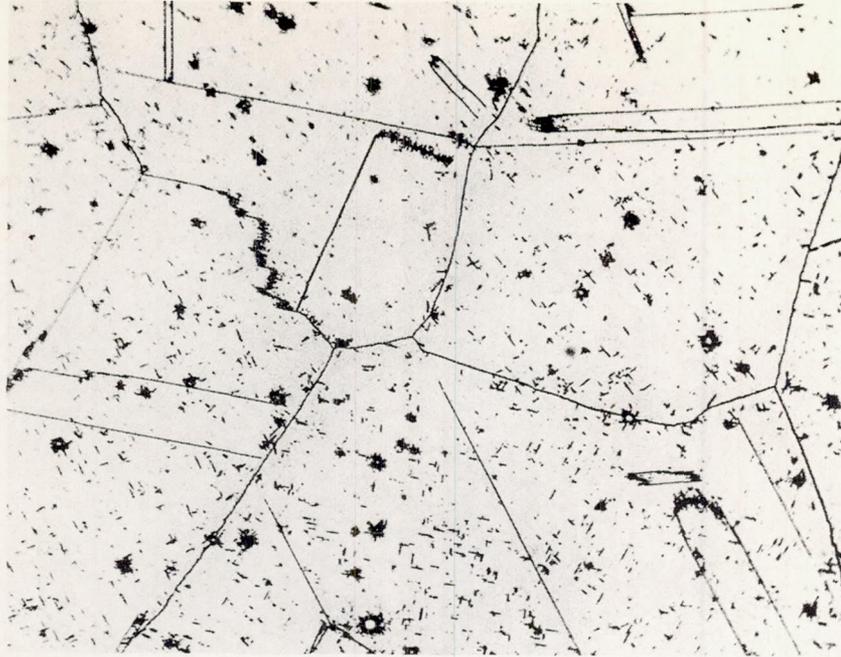
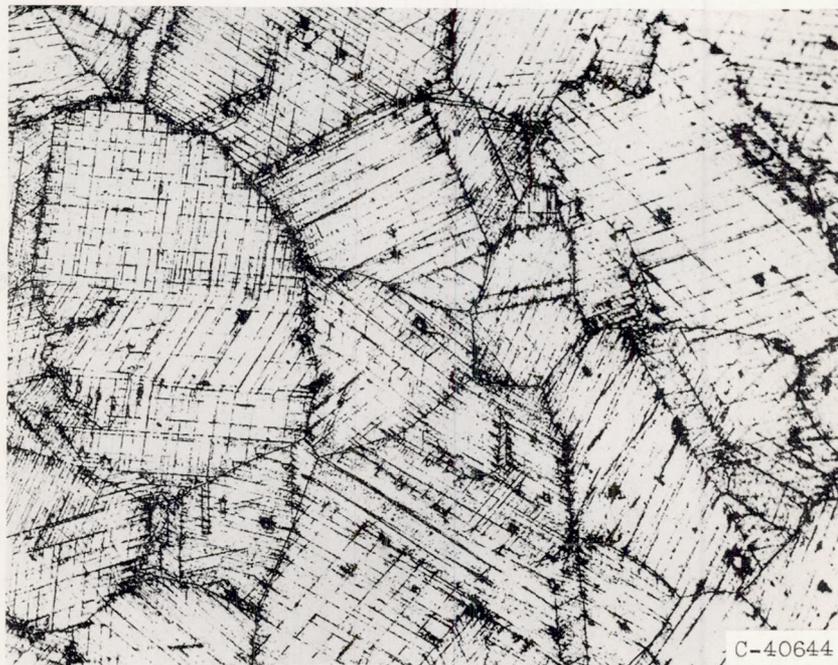
(a) Group 1 (straightened after solution treatment).

Microstructures representative of the different bucket groups, prior to operation in the engine, are shown in figure 6. The Inconel 550 buckets that were straightened (restruck) after solution treatment, prior to aging (group 1), show considerable evidence of working (fig. 6(a)). This is revealed by precipitation in slip lines and by Widmanstätten structures that formed during subsequent aging. Re-solution-treatment after the straightening operation has eliminated most of this evidence of cold work (fig. 6(b)); and the structure appears similar to that of groups 3 and 4, which have not been given the straightening treatment (figs. 6(c) and (d)).

In the present investigation, the stress-rupture life of straightened buckets (group 1), which contained Widmanstätten structure and slip-line precipitates, was approximately 1/4 of the stress-rupture life at 20,000 psi of the unstraightened buckets (group 3). The stress-rupture life of the straightened and flash-solution-treated buckets of group 2 (which was devoid of Widmanstätten structure and relatively free of slip-line precipitation) was equal to that of the group 3 buckets. These significant facts strongly indicate that a flash solution treatment after straightening would be desirable.

Under certain conditions, as was the case of this investigation, it may be possible to compensate for damage to properties by a re-solution-treatment. It would seem advisable to avoid straightening wherever possible; however, when it cannot be avoided, careful consideration should be given to the possible detrimental effects.

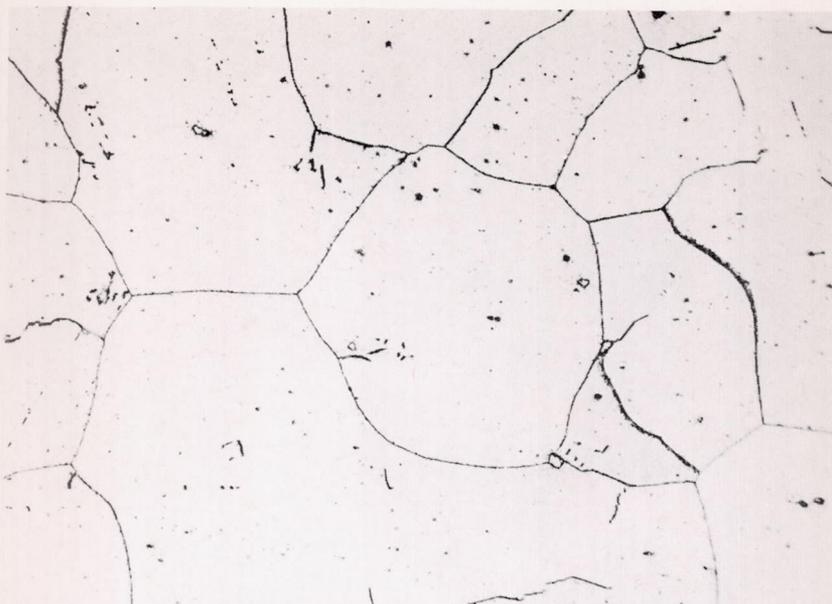
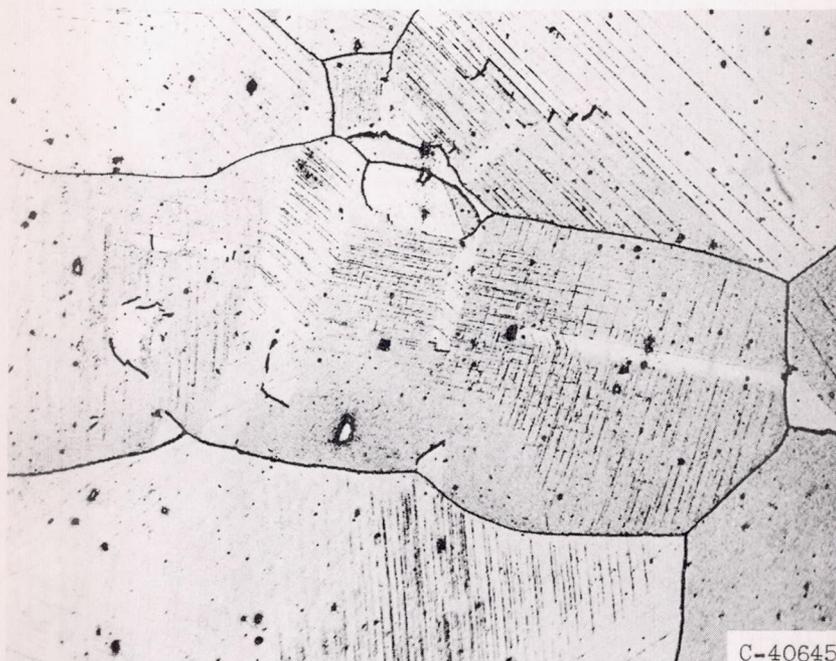
(b) Group 2 (straightened and flash-solution-treated).

It can be noted in figures 7, 6(a), and 6(b), respectively, that the interposed flash solution treatment affected both the stress-rupture life and the precipitation mechanisms of the restruck buckets. The effects of various precipitation phenomena on the physical properties of high-temperature alloys are not definitely known, but a past investigation (ref. 2) showed that the stress-rupture life of a cobalt-base alloy was structure-sensitive. It was found that a Widmanstätten structure was associated with low stress-rupture life and that salt-and-pepper precipitation (general precipitation) was beneficial.

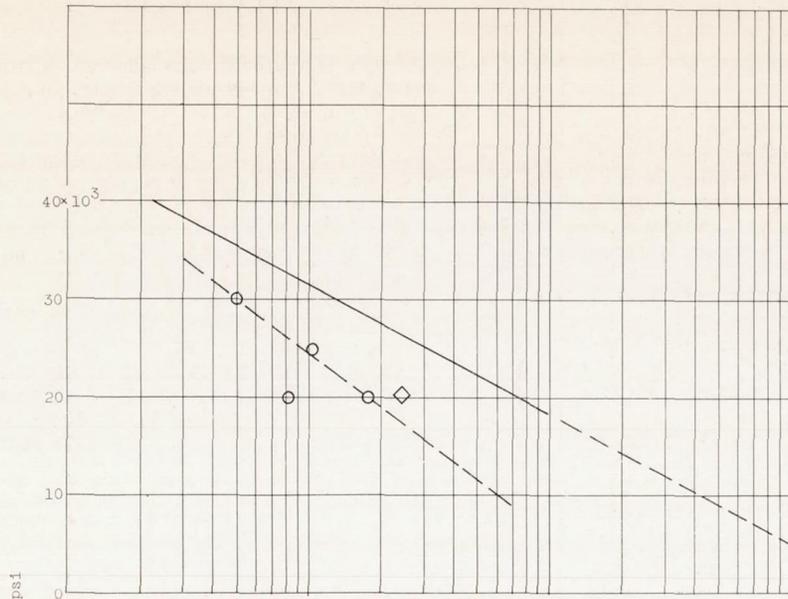
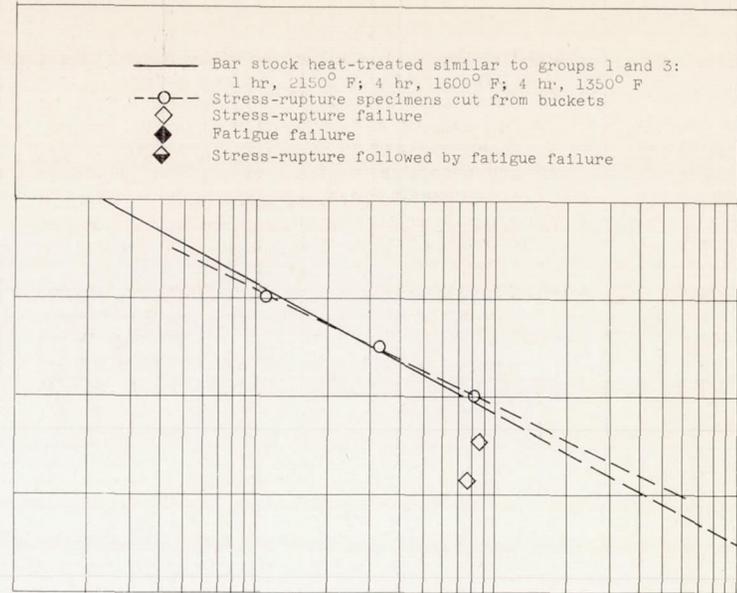
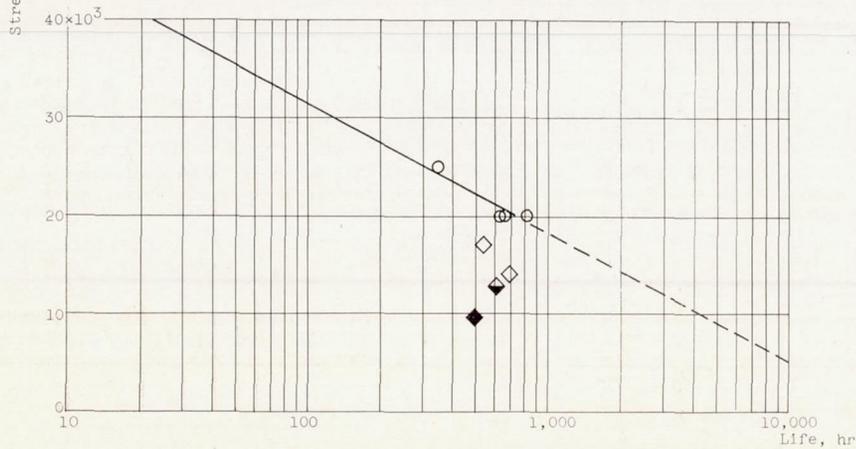
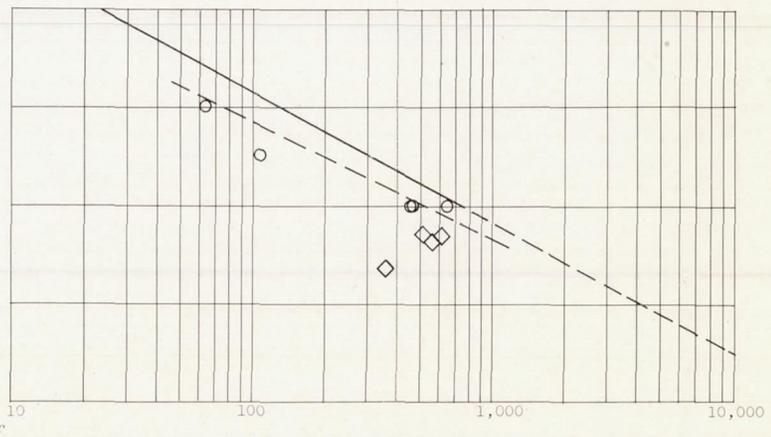
Figure 7. - Comparison of bucket life and stress-rupture life of bar stock and specimens cut from buckets at 1500° F test temperature. (Bucket life is plotted at stress level obtaining at origin of failure.)

The results of the stress-rupture tests of specimens cut from bucket airfoils are given in table III and figure 7. The stress-rupture properties of the specimens cut from the straightened buckets (group 1) were the poorest obtained. The stress-rupture lives of the specimens from the group of buckets given the flash-solution-treatment after the straightening operation (group 2) equal or exceed the stress-rupture lives of specimens cut from the group 3 buckets that performed best in reference 1 (see group 3 herein). The life of the buckets from group 4 herein (the second-best group of ref. 1) duplicated the results obtained in reference 1.

In the preceding study (ref. 1) and in almost all engine studies made at this laboratory, it has been found that bucket life is less than or equal to life of stress-rupture specimens cut from bucket airfoils for comparable stresses and temperatures. In the present investigation this was true for groups 2, 3, and 4 but not for the straightened buckets of group 1. The group 1 bucket life was considerably longer than the life predictable from stress-rupture properties. This may be seen in figure 7, where bucket life for the different groups is plotted (as in ref. 1) at the stress levels occurring at the failure origins.

Attempts have been made to explain this anomaly by various means. Metallographic studies revealed that the microstructures of the stress-rupture bars cut from central portions of buckets differed from structures at or near the leading and trailing edges. In general, more slip-line precipitation, finer grains, and less Widmanstätten structure occurred at or near the edges than occurred in the interior portions of the airfoils. The strength of the material in the leading- and trailing-edge regions may have been greater than that of the central portion tested in stress-rupture. However, it was not feasible to determine the stress-rupture strength of the leading- and trailing-edge material, because it is most difficult to obtain satisfactory test specimens from these areas.
