RESEARCH MEMORANDUM

AN EXPERIMENTAL EVALUATION OF SEVERAL DESIGN
VARIATIONS OF HOLLOW TURBINE BLADES FOR
EXPENDABLE ENGINE APPLICATION

By W. C. Morgan and R. H. Kemp

February 23, 1955

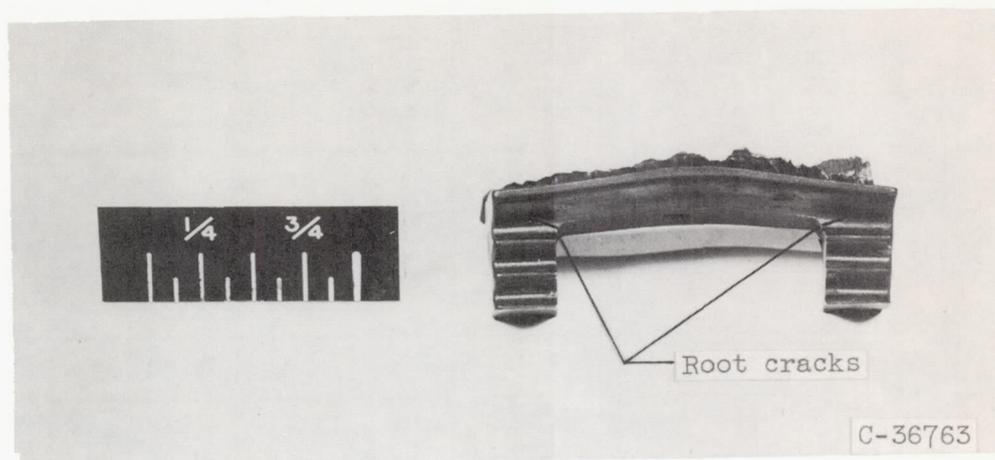
Group 1. - (L-605, 0.030-in. wall, all-welded, fig. 3, base D.) All of the six specimen blades failed in less than 10 hours. The immediate cause of failure was deformation in the base. Figure 9 shows the type of failure. It was noted also that the weld penetration was not uniform

in the base attachment. The results indicated that this type of base is of insufficient strength and that the relative disparity in mass between the airfoil and the base is unfavorable for welding.

Figure 9. - Failure of Group 1 sheet-metal blade showing the excessive base deformation and location of root cracks.

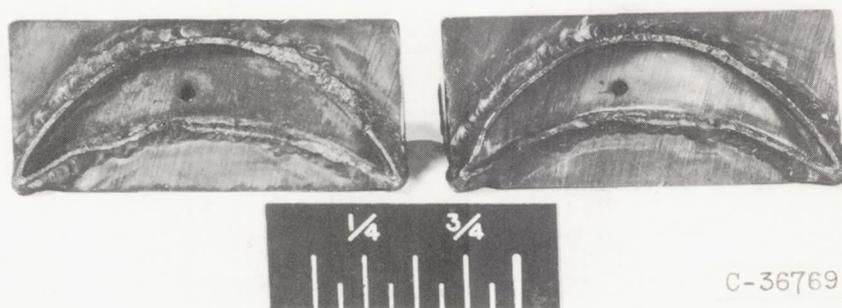
Group 2. - (L-605, 0.030-in. wall, all welded, fig. 3, base C.) In this group of blades the importance of sound welding was exemplified. All six blades failed because of imperfect weld penetration; four blades failed in less than five hours. Figure 10 shows typical failed specimens. Automatic machine weld might prove to be more effective in making joints of this type.

Figure 10. - Two failures of Group 2 sheet-metal blades showing the imperfect weld penetration.

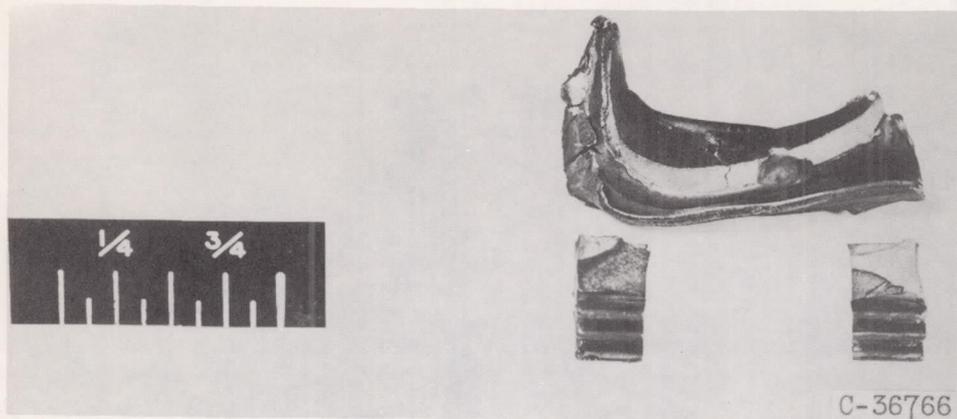
Group 3. - (L-605, 0.030-in. wall, welded airfoil brazed to stub, fig. 3, base B.) The failure of three blades was attributed to improper fabrication. Excessive clearance between the pressure side of the airfoil and the stub resulted in an inadequate braze. Another blade failed because of a crack that originated in the trailing edge. Two blades were operated for about 18 hours before failure occurred due to base deformation. The failures were similar to those that were characteristic of the group 1 tests. The stub section did not provide sufficient stiffness to the modified base. Location of the root supports at points nearer the center of the blade platform would result in a more favorable stress distribution. One of the base failures is shown in figure 11.

Figure 11. - Complete root failure produced by deformation of Group 3 sheet-metal blade.

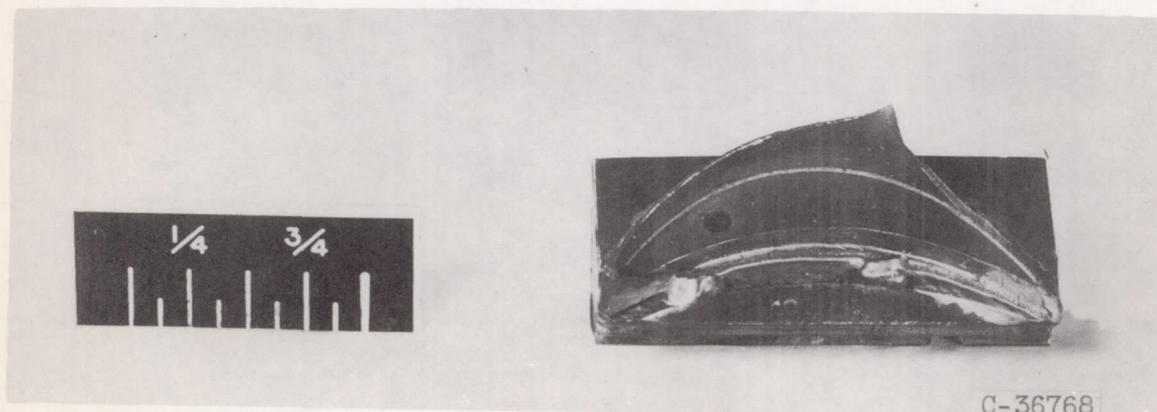
Group 4. - (L-605, 0.030-in. wall, brazed tip cap, welded airfoil brazed to stub, fig. 3, base A.) Two blades of this group failed because of improper fabrication. The remaining four specimen blades completed 30 hours. The failure presented in figure 12 shows a typical example of excessive clearance, approximately 0.060 inch between surfaces. Clearance should be 0.001-0.004 inch for best results. The results indicate that attachment of a tip cap by brazing is feasible. The failures caused by excessive clearance between brazing surfaces are not of great significance; in subsequent fabrication the technique was changed and there was only one recurrence.

Figure 12. - Premature failure of Group 4 sheet-metal blade caused by excessive clearance between surfaces to be brazed.

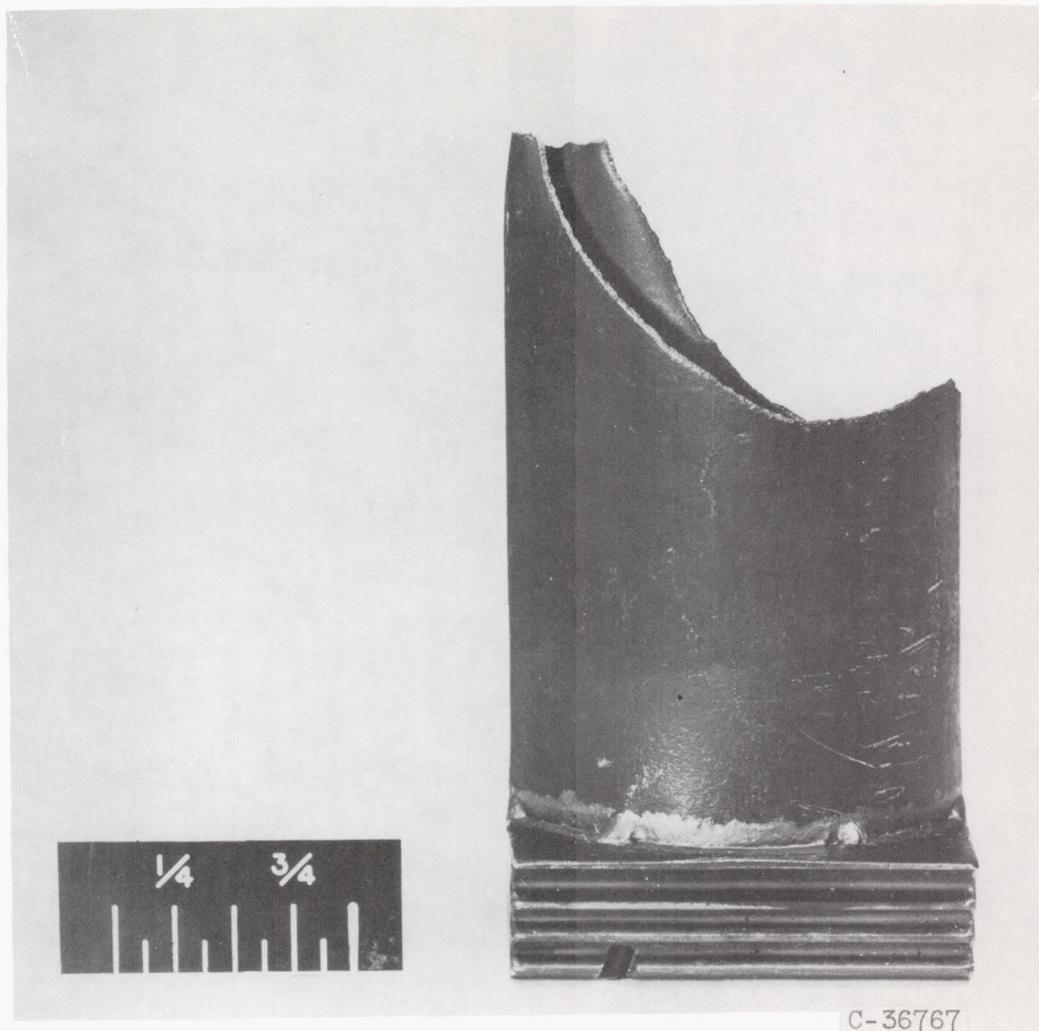
Group 5. - (L-605, 0.025-in. wall, welded airfoil brazed to stub, fig. 3, base A.) One blade failed as a result of excessive clearance in the brazed attachment. Three blades were removed from testing because of failure in the airfoil at the midsection. Two blades were still intact after 30 hours of operation. The failures appeared to be the result of fatigue. Figure 13 shows a representative failure in the airfoil midsection.

Figure 13. - Mid-section airfoil failure in Group 5 sheet-metal blade suspected to have been caused by fatigue.

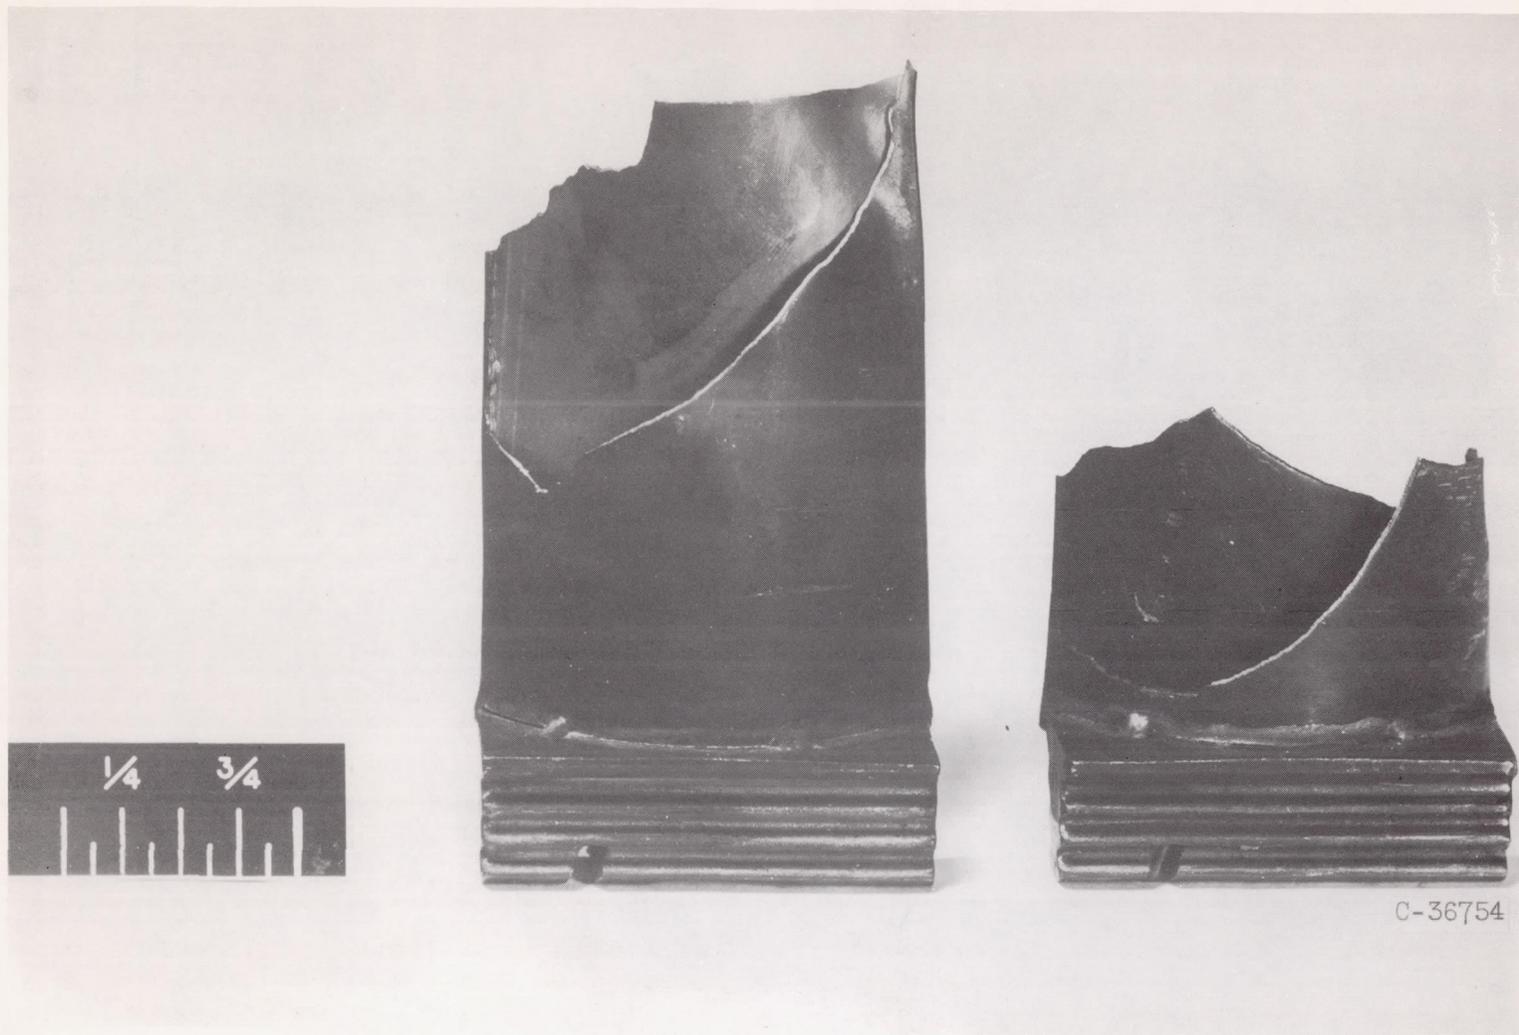
Group 6. - (L-605, 0.022-in. wall, welded airfoil brazed to stub, fig. 3, base A.) Failure occurred in less than 10 hours of operation for the six blades of this group. Serious cracking or actual rupture in the airfoils occurred near the base, the midsection, and the tip. Figure 14 presents typical failures. It is probable that the decrease in structural rigidity caused by the relatively thin airfoil wall made this type of blade particularly susceptible to vibration.

Figure 14. - Typical failures of Group 6 sheet-metal blades suspected to have been caused by fatigue.

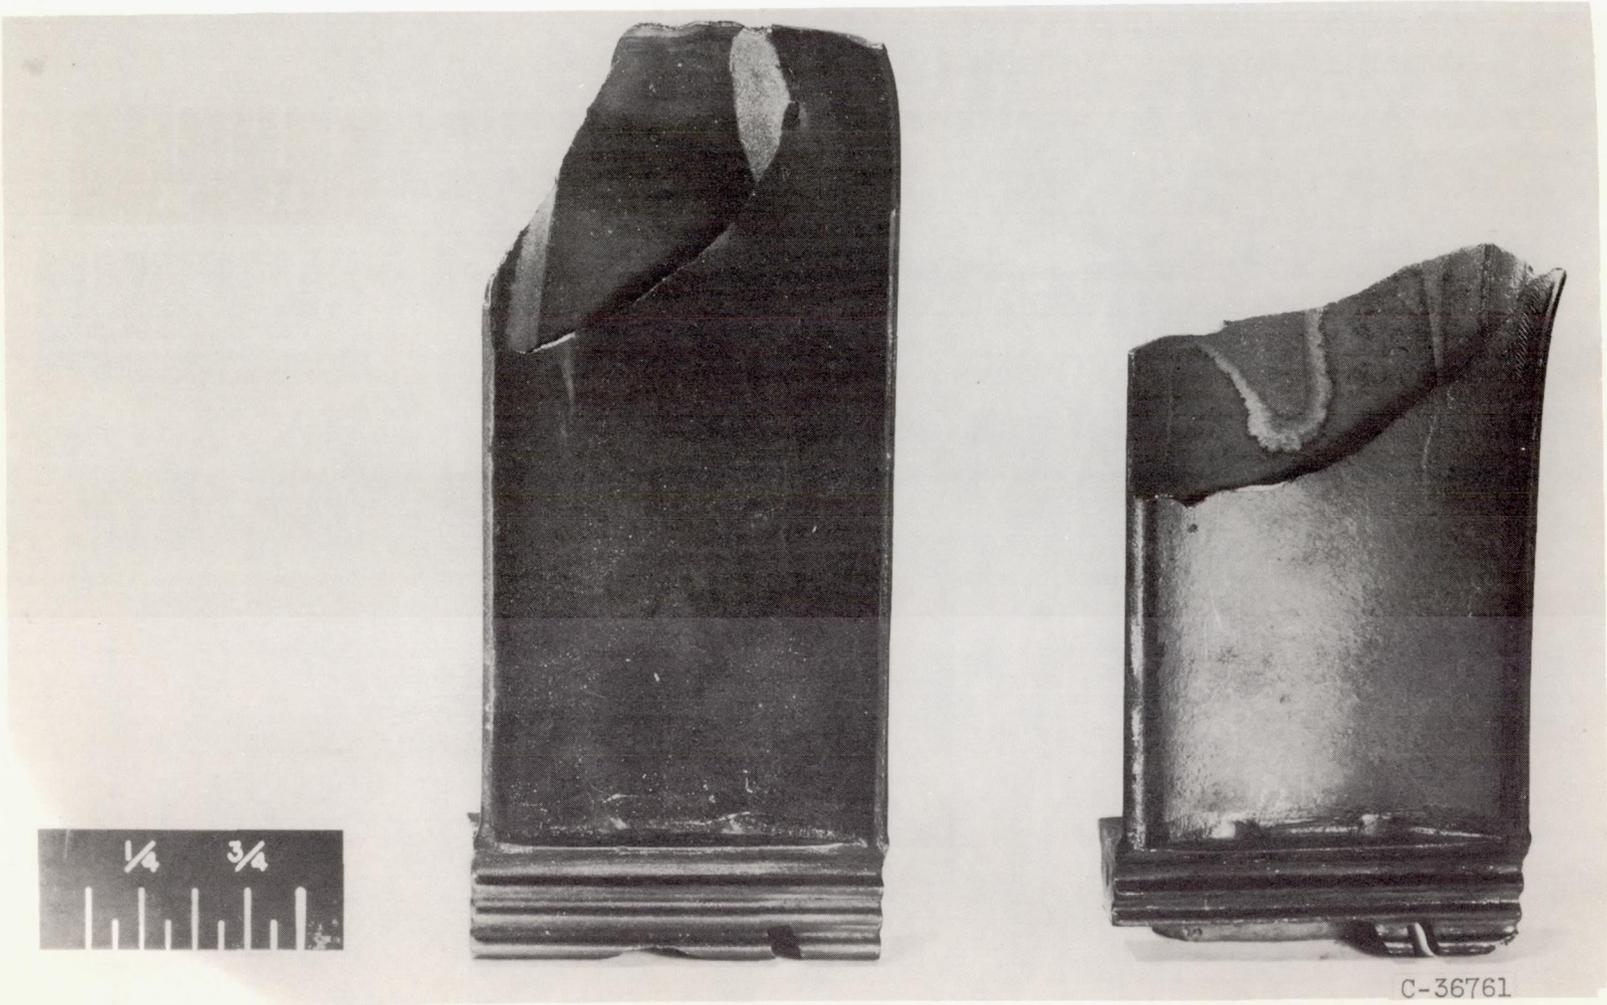
Group 8. - (L-605, 0.030-in. wall, airfoil formed from tubular stock brazed to stub, fig. 3, base A.) Five of the blades tested were undamaged after 30 hours of operation. Seven were withdrawn from the test after sustaining tip failure. Two blades failed near the base, and another blade received excessive impact damage. The majority of the failures originated in the leading or trailing edge, probably as a result of severe bending during fabrication or of inadequate trailing-edge brazing. Two of the failures are shown in figure 15.

Figure 15. - Airfoil failures of Group 8 sheet-metal blades attributed to cracking caused by the forming operation and to imperfect edge brazing.

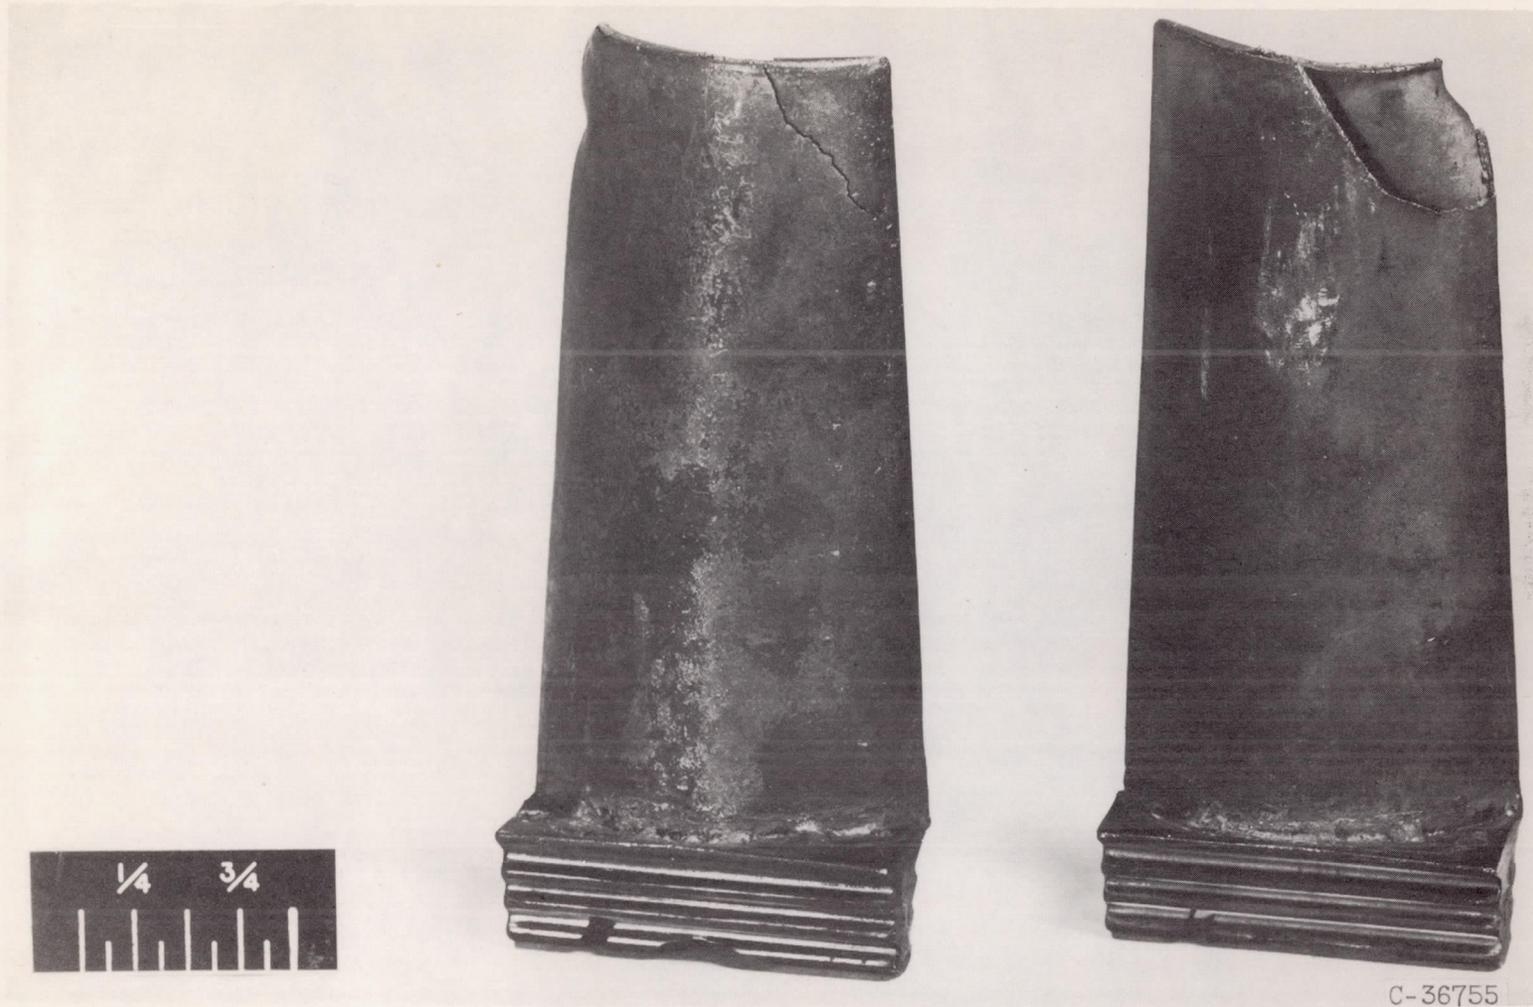
Group 10. - (A-286, 0.030-in. wall, welded airfoil salt-bath brazed to stub, fig. 3, base A.) One blade survived 29 hours of operation before removal from the test because of cracks in the airfoil tip. Three other blades sustained similar failure in shorter operation times. One blade failed in the base as a result of defective brazing. The clearance between parts was correct but the braze material had not filled the joint. The results show that A-286 blades are relatively susceptible to tip fatigue. In addition, it is probable that special welding and brazing techniques are required. The salt-bath brazing was not entirely satisfactory. Figure 16 shows typical failures.

Figure 16. - Tip failure in Group 10 sheet-metal blades showing fatigue cracks.

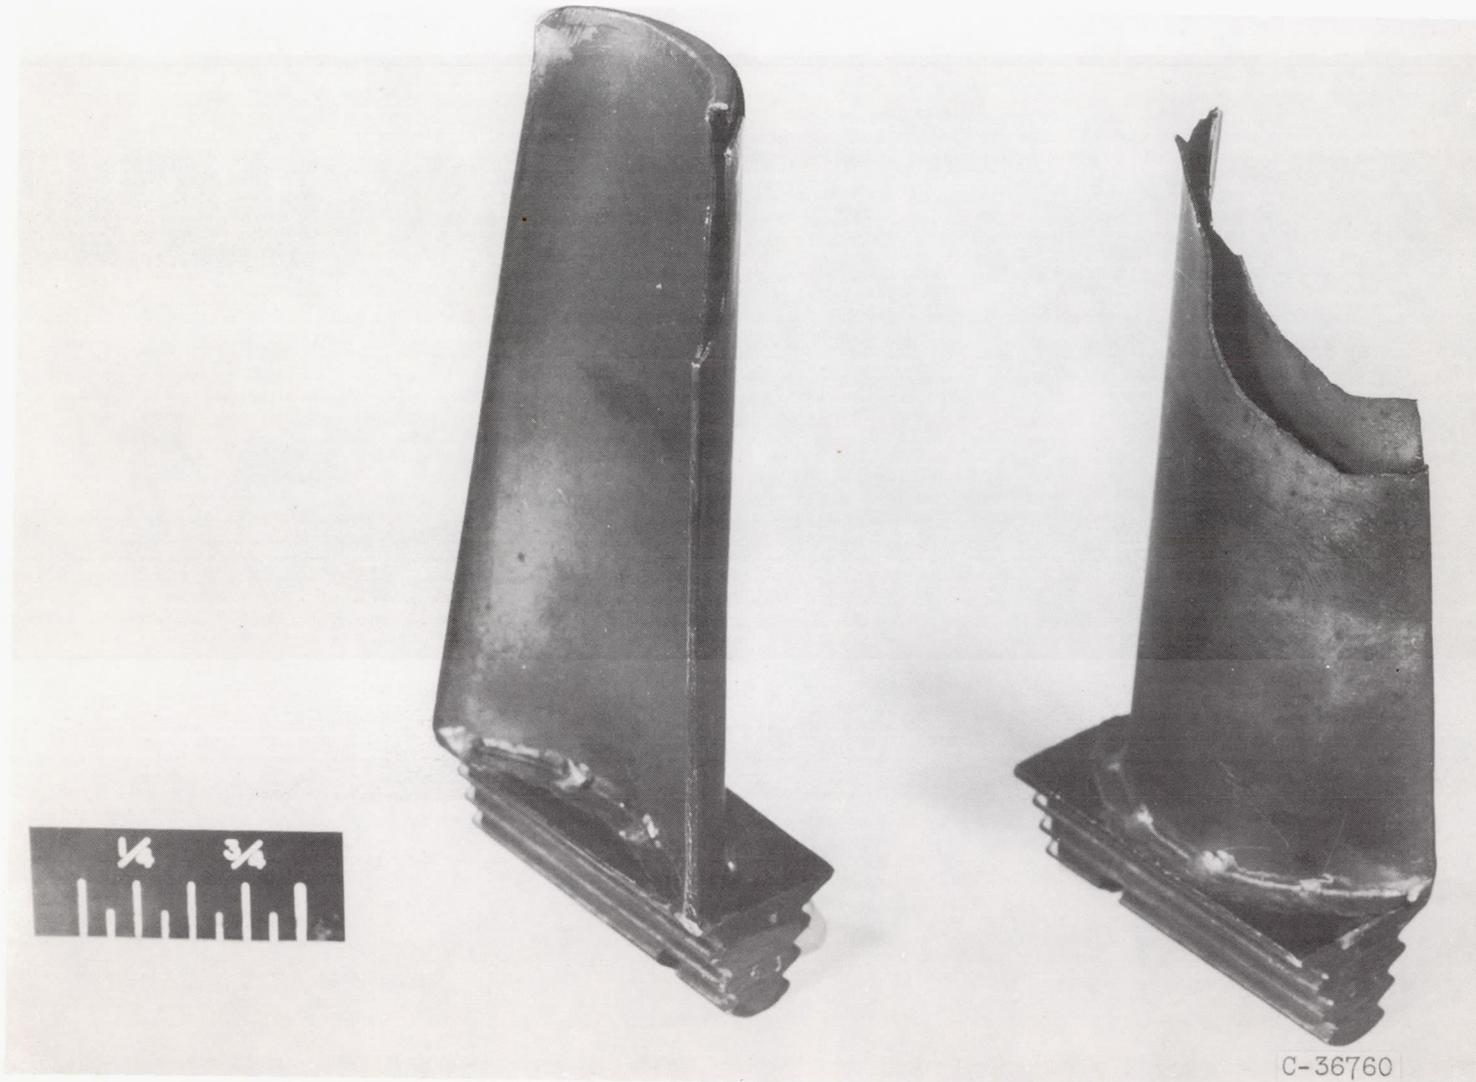
Group 11. - (L-605, 0.030 to 0.020 in. tapered wall, welded airfoil brazed to stub, fig. 3, base A.) Cracking in fatigue after short engine life characterized the failures of the six sample blades. Typical examples are shown in figure 17. The failures occurred at several locations along the airfoil. It appeared that the tapered wall was of insufficient thickness to resist vibration.

Figure 17. - Fatigue failures in Group 11 tapered-wall sheet-metal blades. (0.030-.020-in wall)

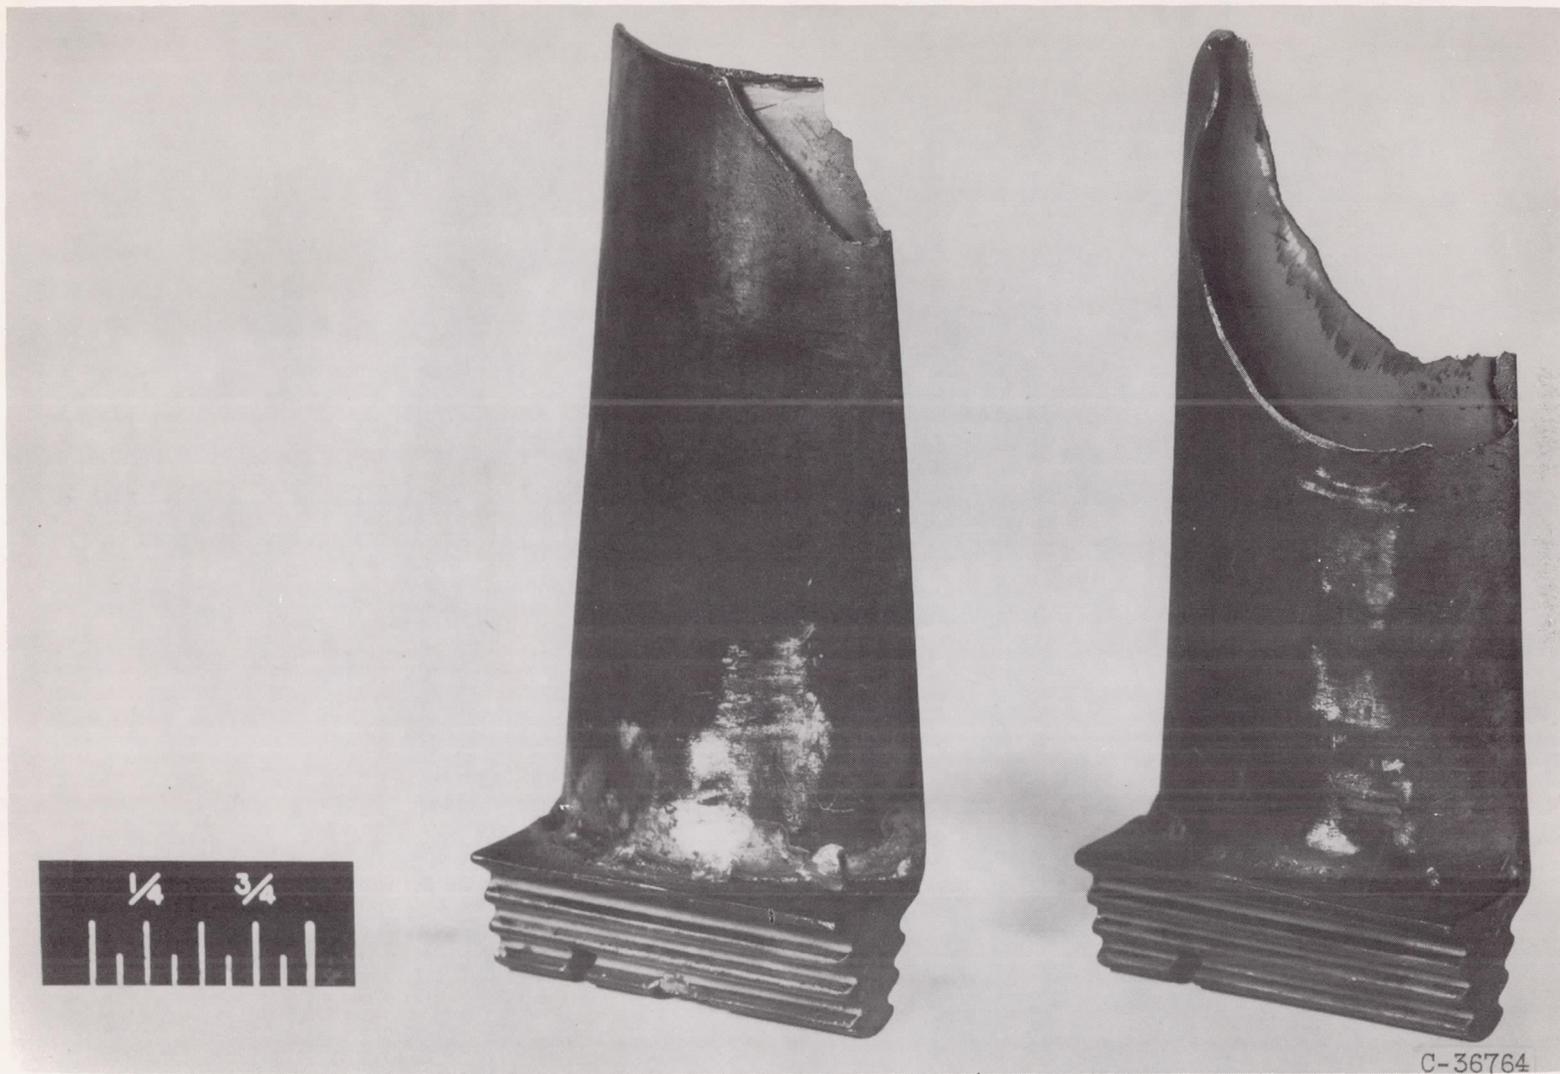
Group 12. - (L-605, 0.035 to 0.020 in. tapered wall, welded airfoil brazed to stub, fig. 3, base A.) Three blades of this group failed in less than 10 hours of operation. The failures were all in the tip region, and were attributed to fatigue. It is possible that a welding problem exists where it is necessary to join comparatively thin sheet. On the other hand, slight variations in the machined taper may have been a critical factor. Figure 18 shows the type of failure encountered in

operation. The other three blades were still in good condition at the end of 30 hours in the engine. On the basis of these results it appeared that the wall thickness in the tip is an important factor in a design that employs tapered airfoil walls.

Figure 18. - Failures in Group 12 tapered-wall sheet-metal blades attributed to fatigue. (0.035-.025-in wall)

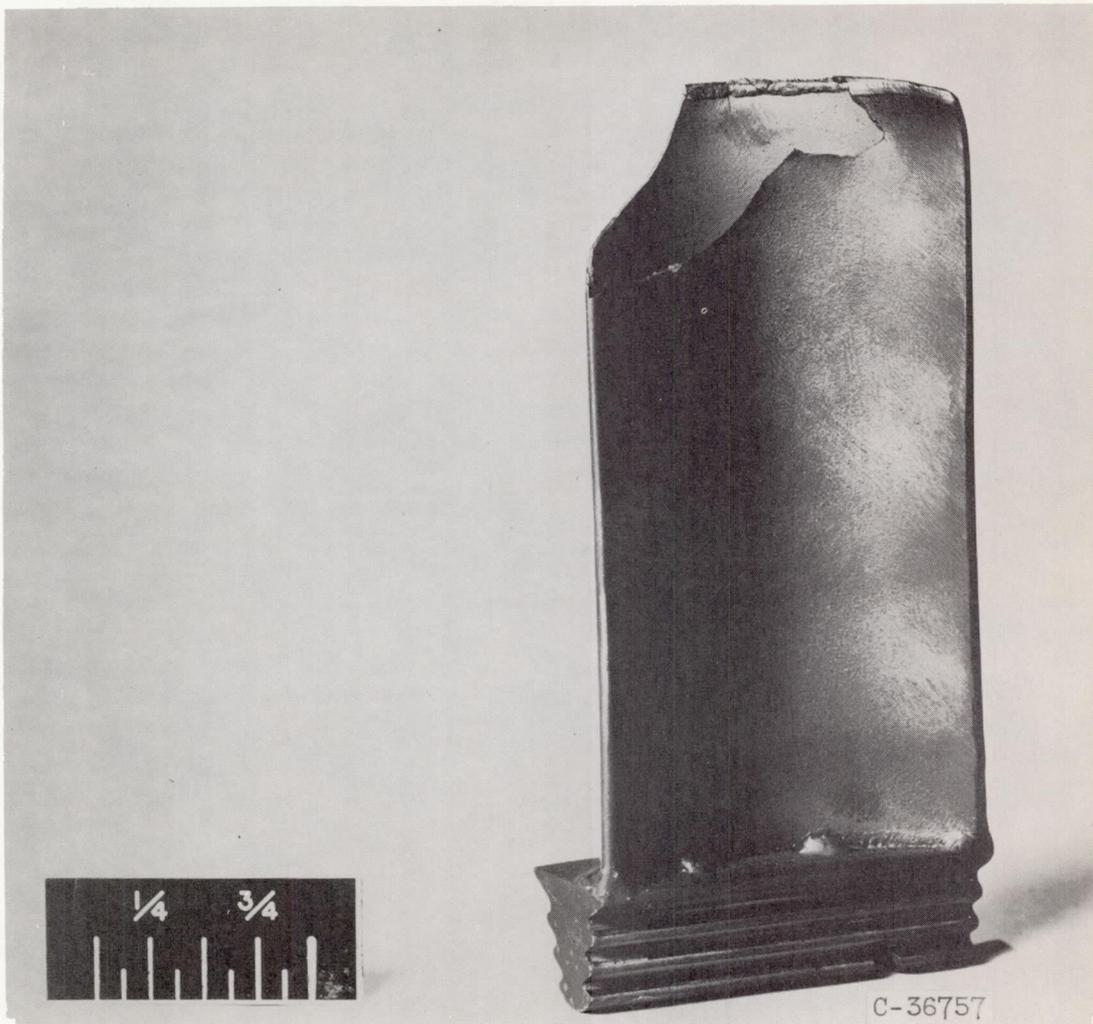
Group 13. - (L-605, 0.040 to 0.020 in. tapered wall, welded airfoil brazed to stub, fig. 3, base A.) There were five blades in this sample group; only one blade failed within the 30-hour test period. This failure occurred in the tip region after more than 29 hours and appears in figure 19. From the appearance of the failure it appeared that the crack originated in the weld. The results indicate that the proper design of tapered airfoil walls may produce satisfactory turbine blades.

Figure 19. - Group 13 tapered-wall sheet-metal blade failure attributed to fatigue.
(0.040-.020-in wall)

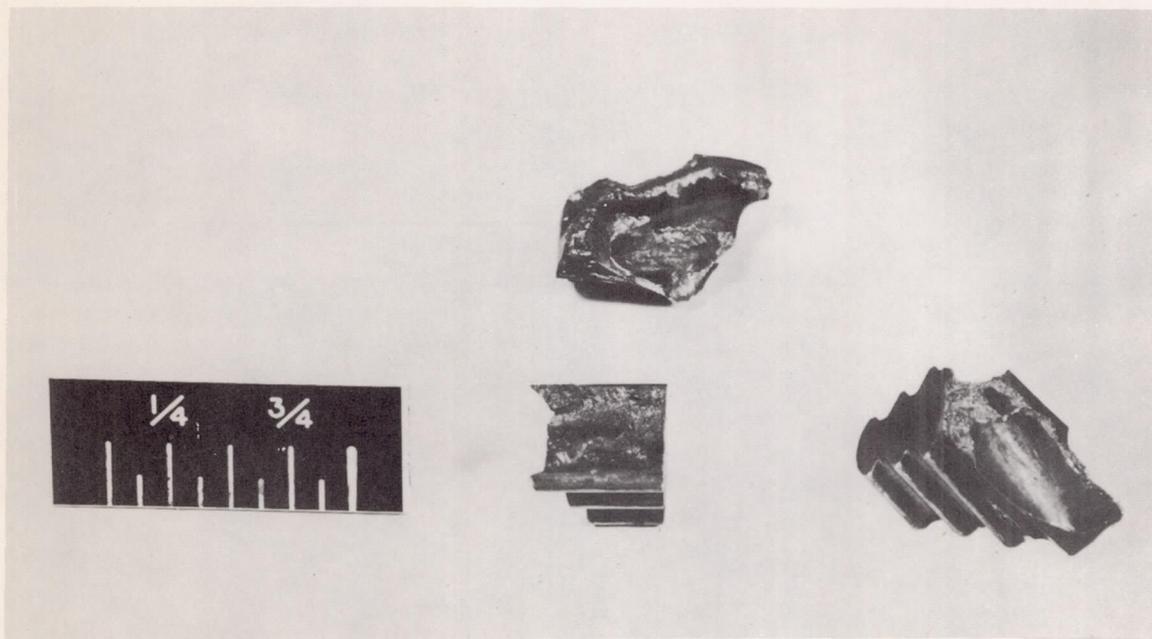
Group 15. - (X-40, 0.055 to 0.030 in. tapered wall, cast, modified base.) The six blades of this group were removed after 9 hours. One blade had failed in the root serration and three others showed serious cracking in this region. The two remaining blades had developed cracks in the airfoil as well as in the root. The evidence indicated that the blades of this group were subject to fatigue failure. Figure 20 shows the root-serration failure.

Figure 20. - Root serration failure in a Group 15 hollow X-40 cast blade with a modified root.

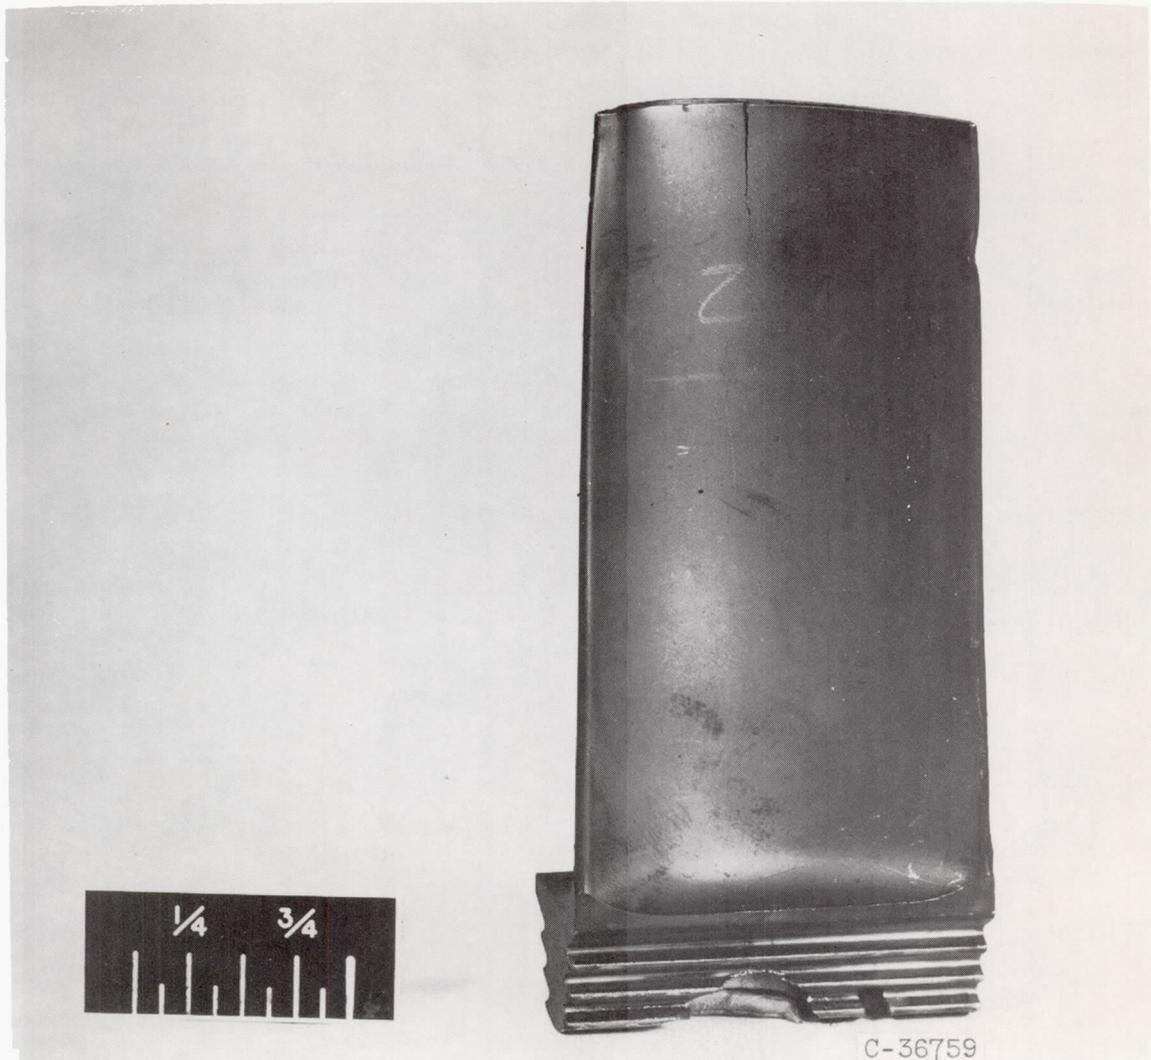
Group 16. - (X-40, 0.055 to 0.030 in. tapered wall, cast, standard base.) At the end of 20 hours of engine life the sample of four blades was removed. Three of the blades had developed fatigue cracks in the tips; the fourth blade also appeared to be cracked by vibration, but may have been damaged by impact. Typical failure is shown in figure 21. The X-40 blades in the as-cast condition are susceptible to fatigue.

Figure 21. - Fatigue crack in a Group 16 hollow X-40 cast blade.

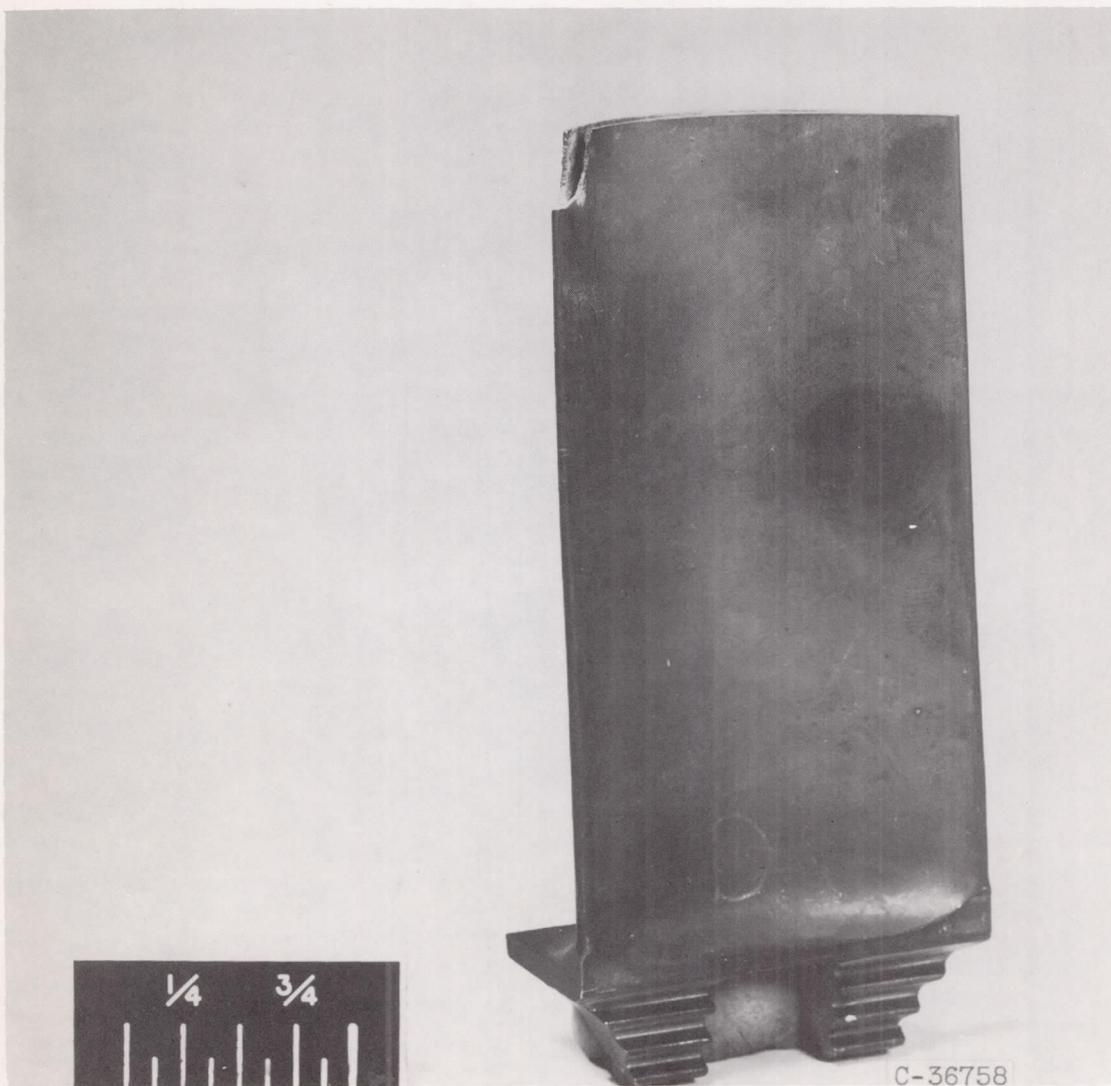
Group 17. - (X-40, 0.055 to 0.030 in. tapered wall, cast, heat-treated, shot-peened modified base.) After 24 hours of operation four of the eight sample blades were removed. These blades had fatigue cracks in the tips. The remaining four blades survived 30 hours of operation, although inspection of the bases revealed evidence of cracking in the root serrations. Figure 22 shows one of the failures. A comparison of these results with those obtained from the group 15 tests indicates that considerable improvement in the quality of X-40 cast blades can be obtained by proper heat-treatment and work-hardening of the root. There was less tendency toward tip failure by fatigue, and root-cracking was reduced.

Figure 22. - Fatigue failure in the tip of a Group 17 hollow X-40 cast blade that had been heat treated and shot-peened in the root section.
