NATIONAL ADVISORY COMMITTEE FOR AERONAUTICS

FLIGHT MEASUREMENTS OF HORIZONTAL TAIL LOADS ON A
TYPICAL PROPELLER-DRIVEN PURSUIT AIRPLANE DURING
STALLED PULL-OUTS AT HIGH SPEED

MEMORANDUM REPORT

Materiel Command, U.S. Army Air Forces

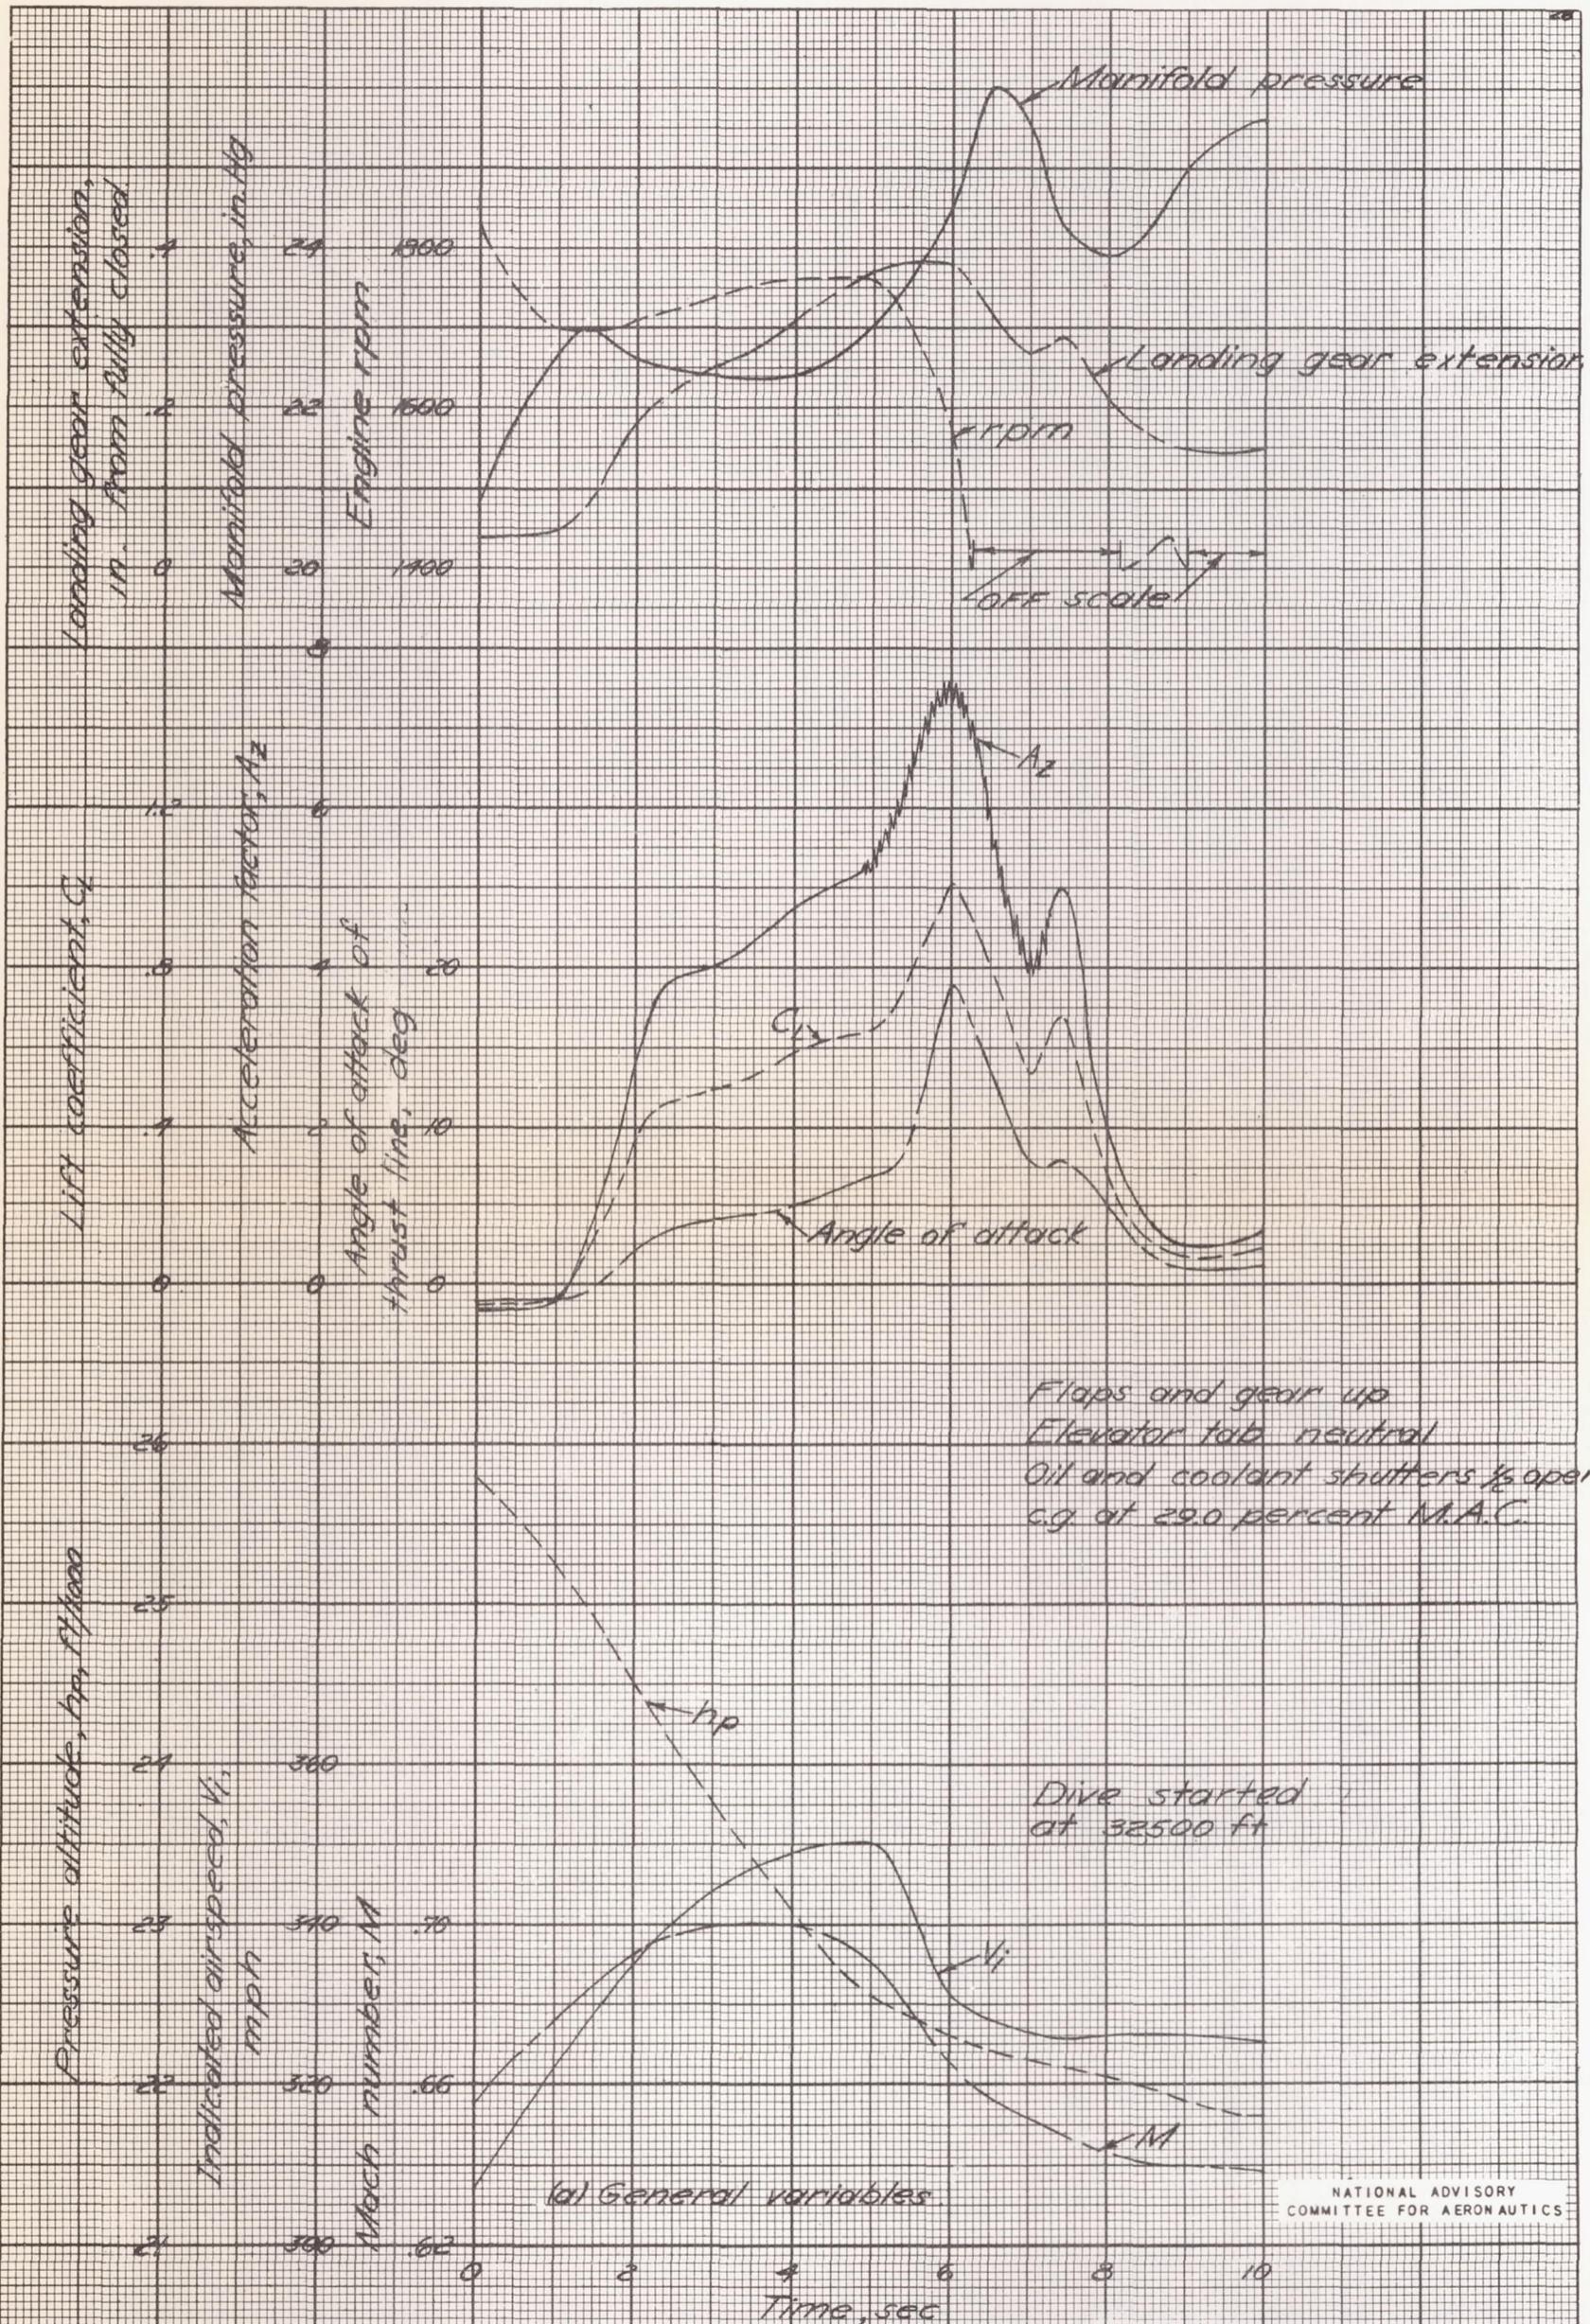
In figures 13, 14, and 15 it is seen that the airplane was pulled in until a very violent stall occurred at a lift coefficient of 1.01 and a Mach number of 0.67. The maximum acceleration factor reached was 7.5 at an angle of attack of 19° . The maximum elevator angle used was 11.5° up. The buffeting was apparently about the same on both sides of the tail in this run. Rapid fluctuations of pressure of 300 to 400 pounds per square foot occurred at the leading edge of the stabilizer during the buffeting. The maximum recorded pressures and unit span loads in this run are listed in the following table:

During this run structural failure of the horizontal tail occurred. Since the airplane was operating within maneuvering limits which were considered safe by design specifications in use at the time the airplane was designed, it is of interest to examine the nature of the tail failure in relation to the loads measured, and in relation to the necessity for revision of air load requirements and the manner of specifying safe maneuverability limits to a pilot.

loads caused much more severe structural strain than the same loads would have caused if applied under static conditions. In the last pull-out, in which the structural failure occurred (figs. 13, 14, and 15), the buffeting was more severe than in any previous maneuver. In this pull-out an attempt had been made to insure absolutely that the maximum acceleration factor possible to attain had been obtained. A strong pull force was exerted on the stick even after heavy buffeting had set in. A slightly greater elevator angle was used than in the previous pull-outs. It should be realized, too, that the loads which were measured during the buffeting condition may actually have been somewhat greater than those recorded, due to lag in the pressure lines.

Figure 13 - Time history of a power-off dive pull-out at $M \approx 0.67$ in which partial failure of the reinforced horizontal tail structure occurred.

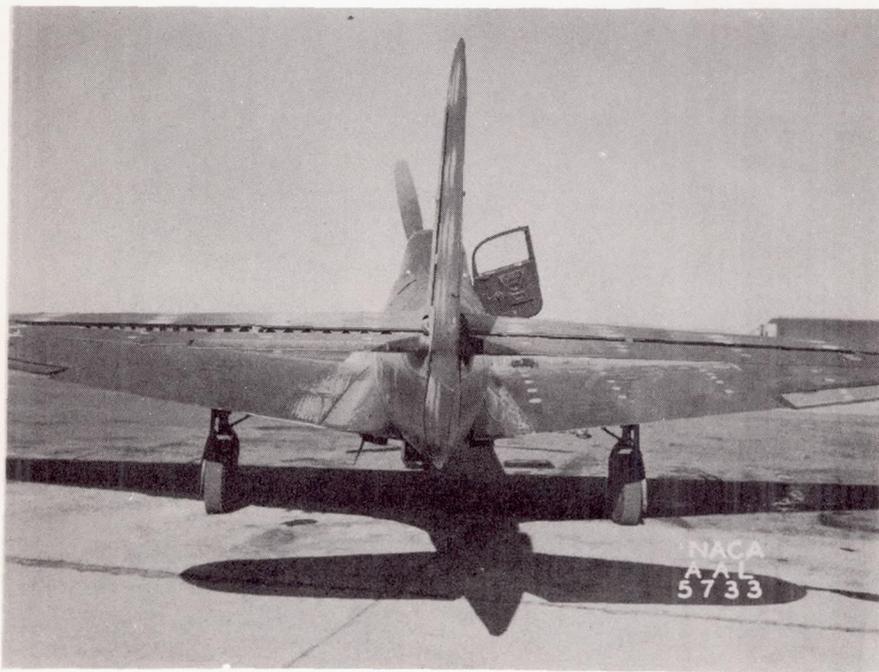
The principal failures were on the left side of the tail, although failure had also started on the right side. A rear view of the airplane with undamaged tail is shown in figure 16, and views of the principal failures are presented in figures 17 to 23. The left elevator had buckled downward at about the third outboard row of orifices (figs. 17, 18, and 19), cracking the elevator spar (fig. 20). The elevator nose balance had been forced downward severely enough to break the elevator nose rib on each side of the tail just inside the outboard hinge fitting (figs. 21 and 22). The left stabilizer rear beam was cracked at the inboard hinge bracket, and the two top bolts holding the bracket to the stabilizer rear beam had been sheared completely (fig. 23). Other miscellaneous failures of various degrees of severity occurred to both the stabilizer and elevator structure in the immediate vicinity of all the hinge brackets.

Figure 17.- Rear view showing damaged horizontal tail surfaces.

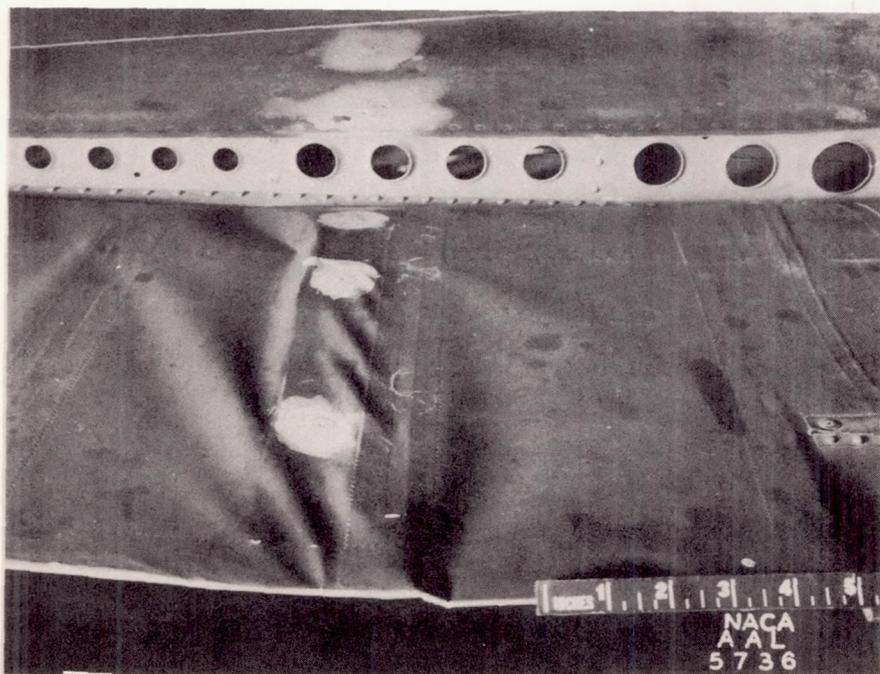
Figure 18.- Rear view of the buckled left elevator.

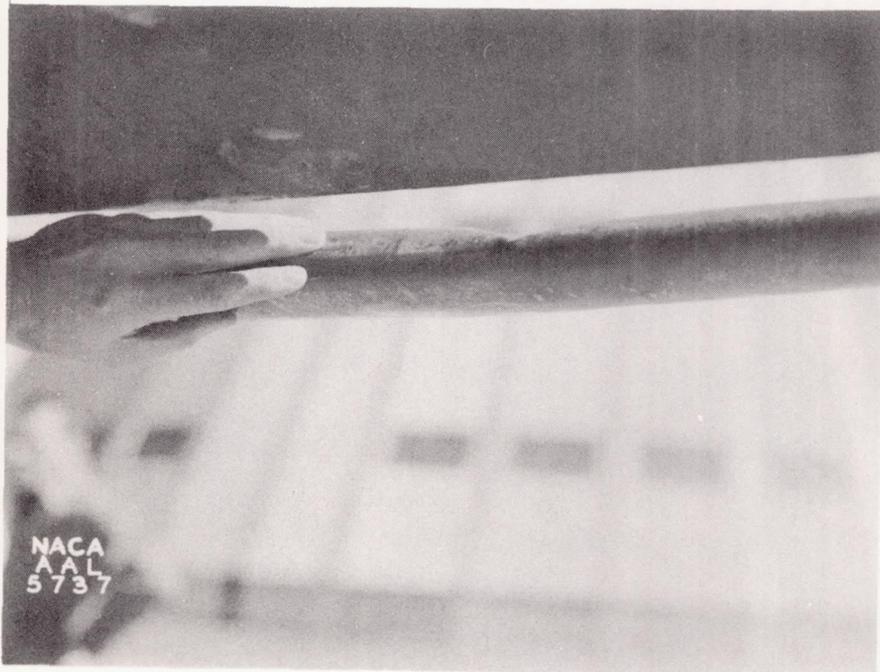
Figure 19.- Lower front view of the buckled left elevator.

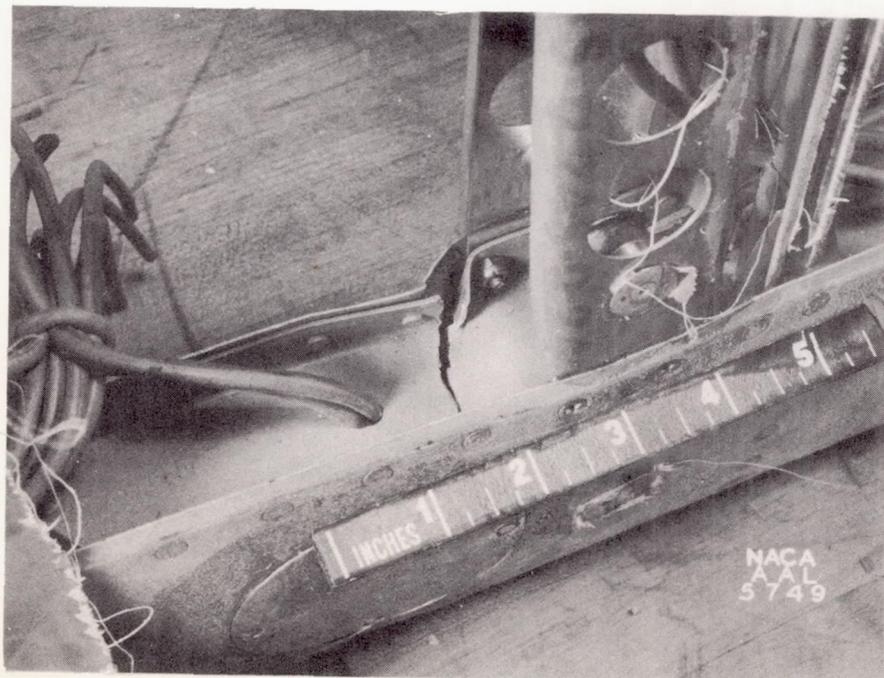
Figure 20.- Detail of cracked elevator spar.

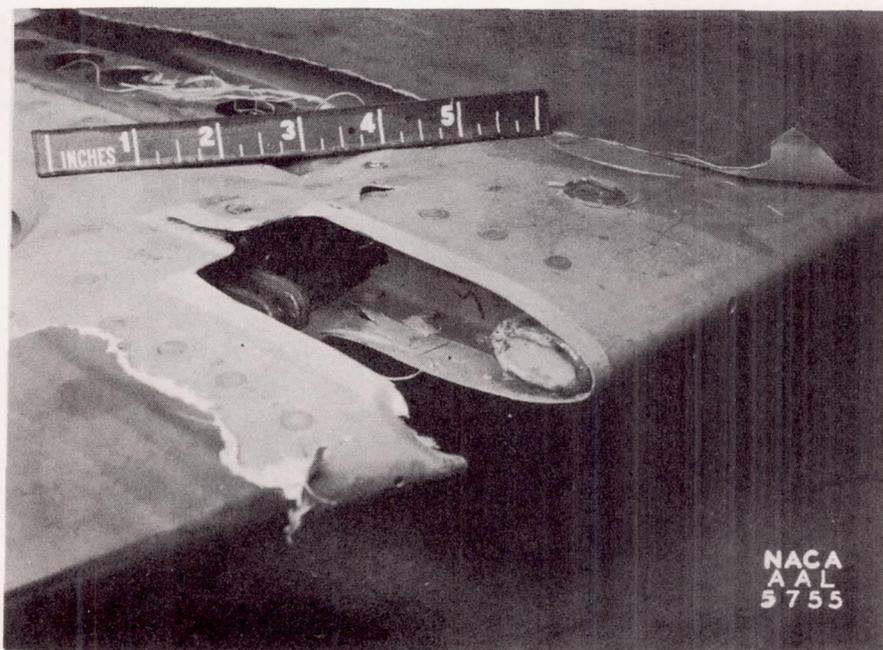
A minor, but perhaps not negligible, additional load which may have contributed to the failure was that caused by a bar weighing about 2.4 pounds per foot which extended along the leading edge of the elevator between the two hinge brackets. This bar was used as a mass balance for the elevator. The acceleration reached in the last run increased the effective weight of the bar to about 18 pounds per foot. Under the dynamic conditions accompanying heavy buffeting this weight may have added appreciably to the stresses set up in the nose structure.

Figure 21.- Lower surface of left elevator showing failure of elevator nose rib at left outboard hinge fitting.

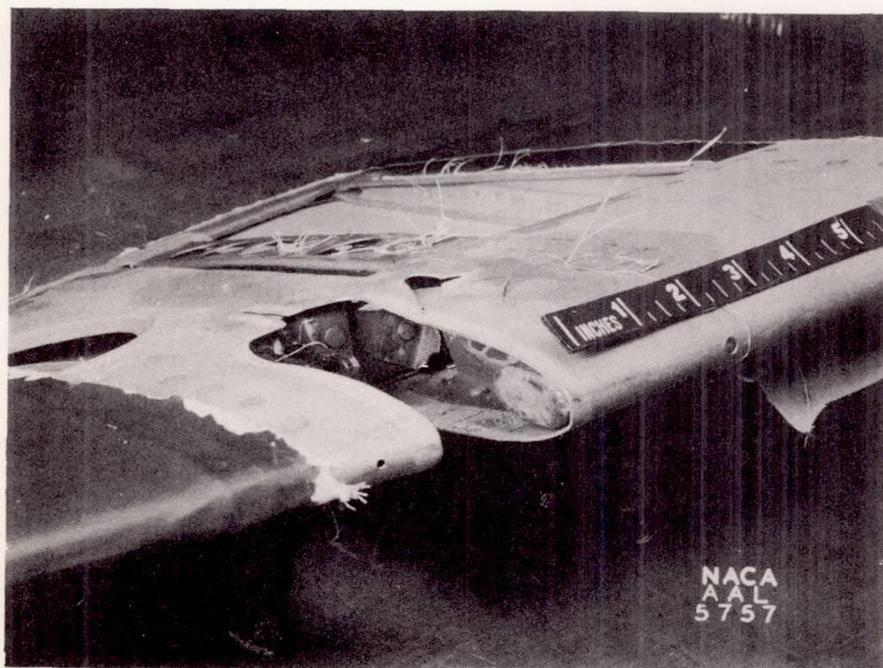
Figure 22.- Upper surface of right elevator showing failure of elevator nose rib at right outboard hinge fitting.

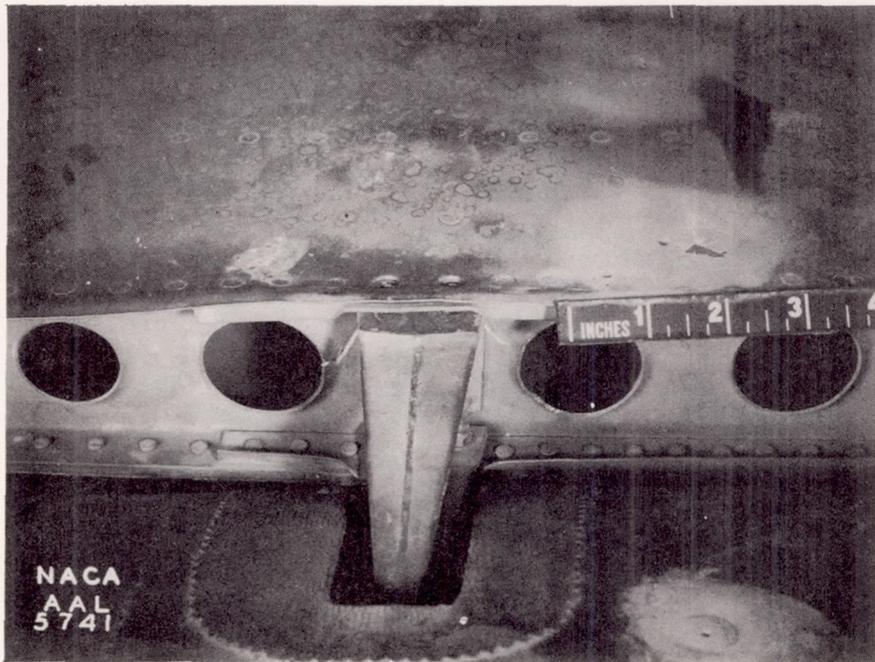
Figure 23.- Detail of cracked stabilizer rear spar at left inboard elevator hinge bracket.

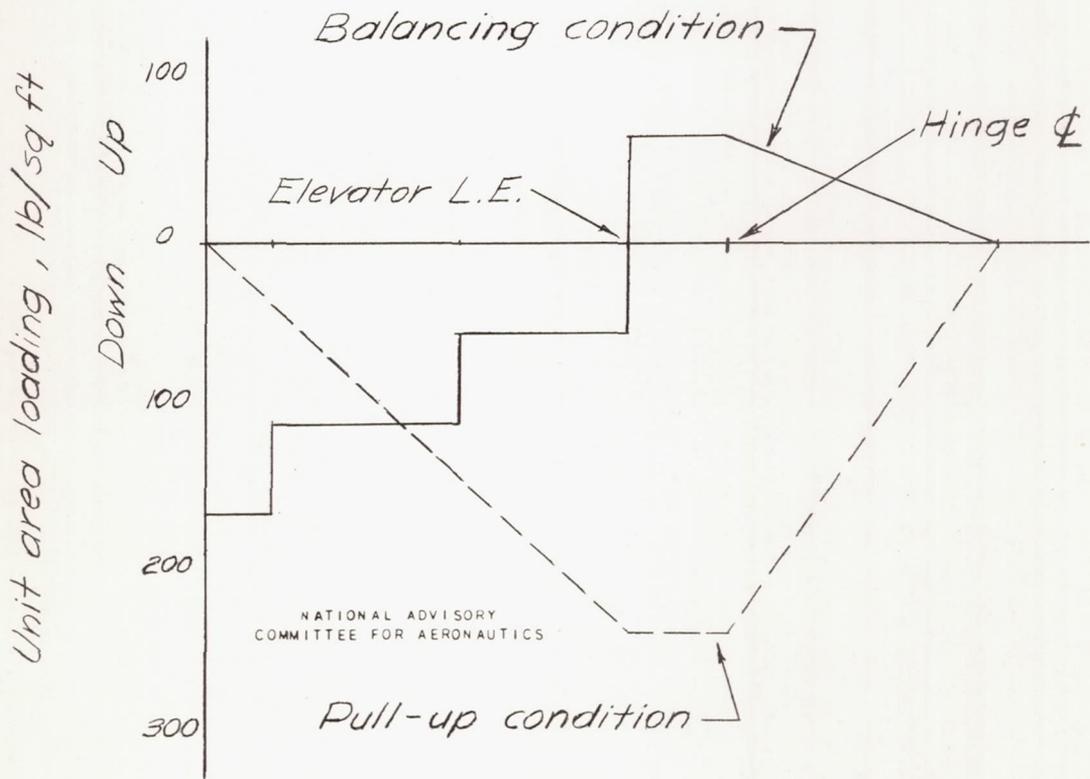
Figure 24 shows the loading conditions for which the horizontal tail surface was designed. Comparison of this figure with the actual flight measurements (figs. 5, 8, 11, and 14) shows that in many instances the unit loads actually measured on the stabilizer in flight were not only considerably in excess of the design unit loads, but that they occurred in a direction opposite to the design loads. At the leading edge of the elevator, the design unit loads were not exceeded in the pull-outs, at least not at the particular spanwise stations at which measurements were made. However, it was the elevator and a fitting supporting the elevator that failed and not the stabilizer.

Figure 24 . - Horizontal tail design load conditions.

Revision of the tail-load design requirements and of the manner of specifying safe maneuverability limits to pilots appears necessary.
