NATIONAL ADVISORY COMMITTEE FOR AERONAUTICS

February 1945 as
Advance Restricted Report E5B07

EFFECT OF PROGRESSIVE RING FAILURE ON PISTON DESTRUCTION

By Max J. Tauschek and Lester C. Corrington

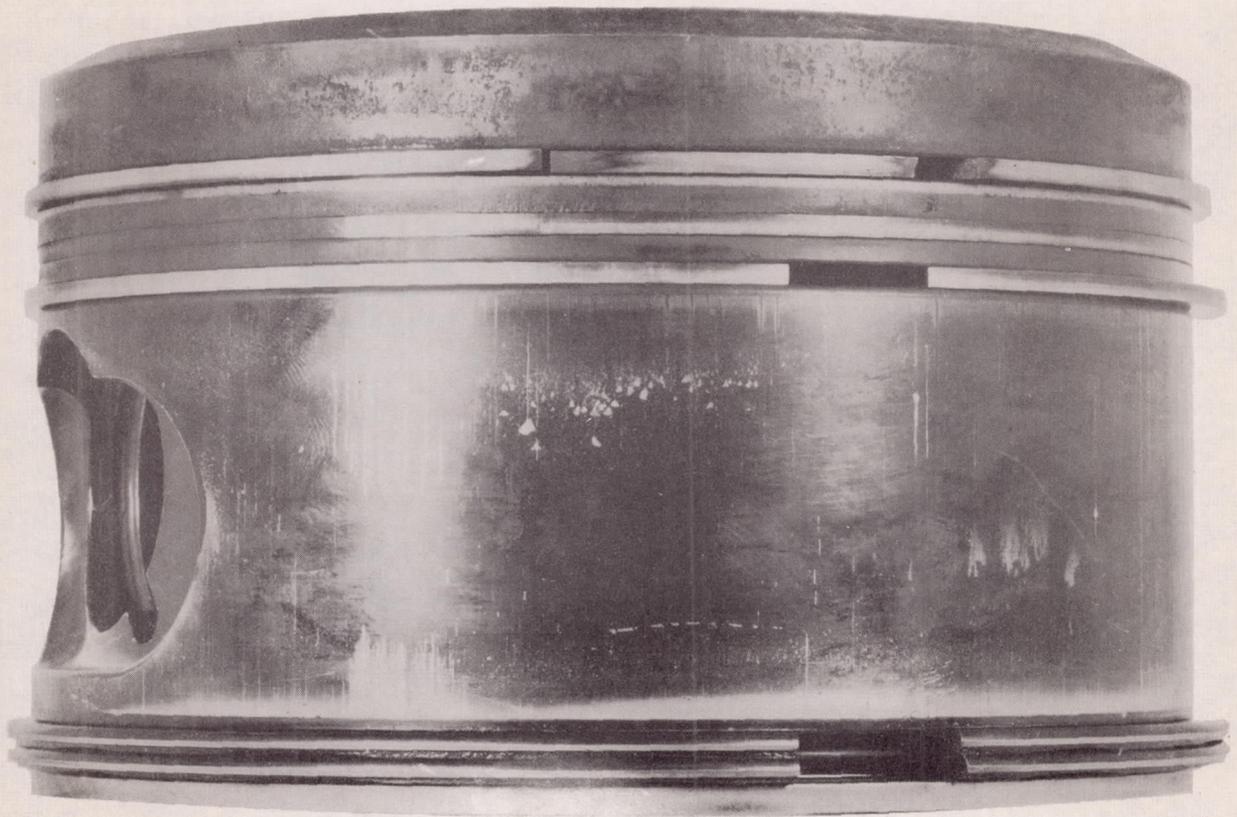
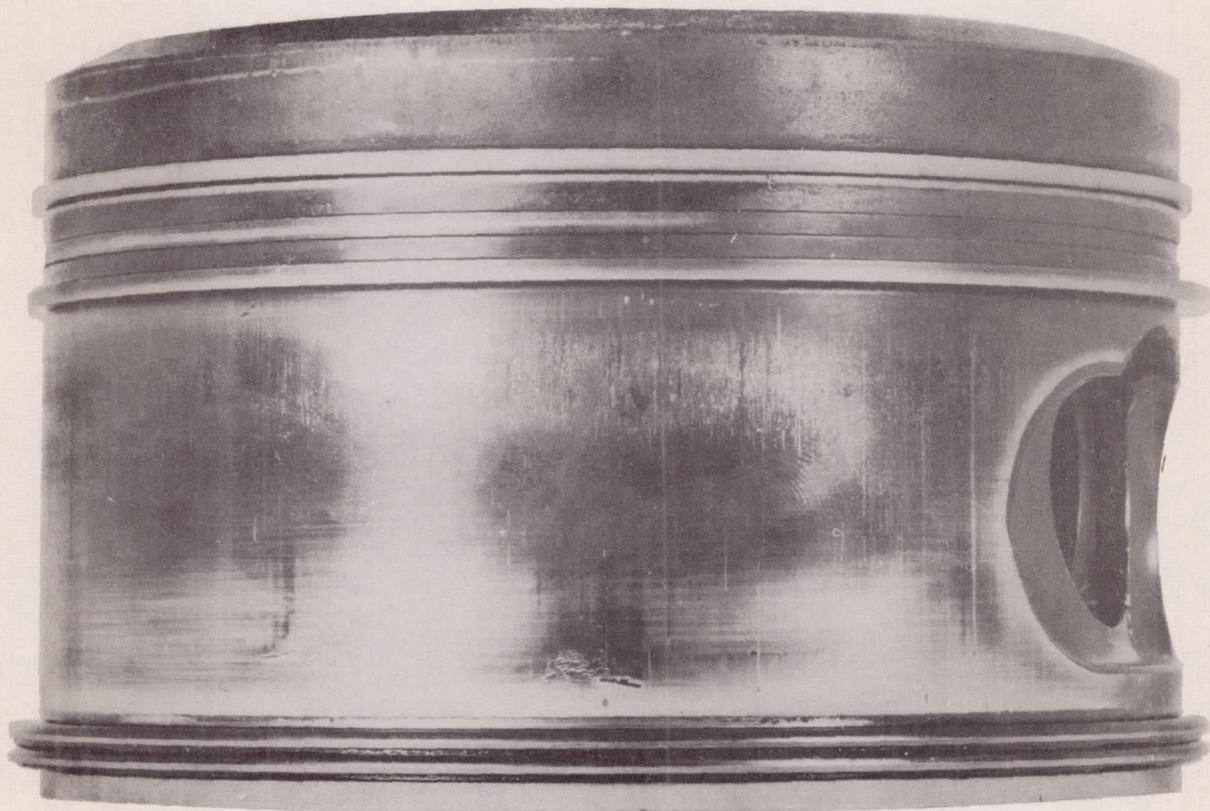
The piston used in the first test had previously been used to obtain preignition data in connection with another project. These tests comprised about 15 hours running time. The severe operating conditions encountered in the preignition tests resulted in breaking of the top ring and sticking of the second ring. Figure 1 shows the piston prior to installation in the cylinder at the beginning of the endurance test. A clean used piston equipped with new piston rings was used for the second test.

Figure 1. - Piston and ring assembly just before the first endurance test. Failure of top and second rings has taken place.

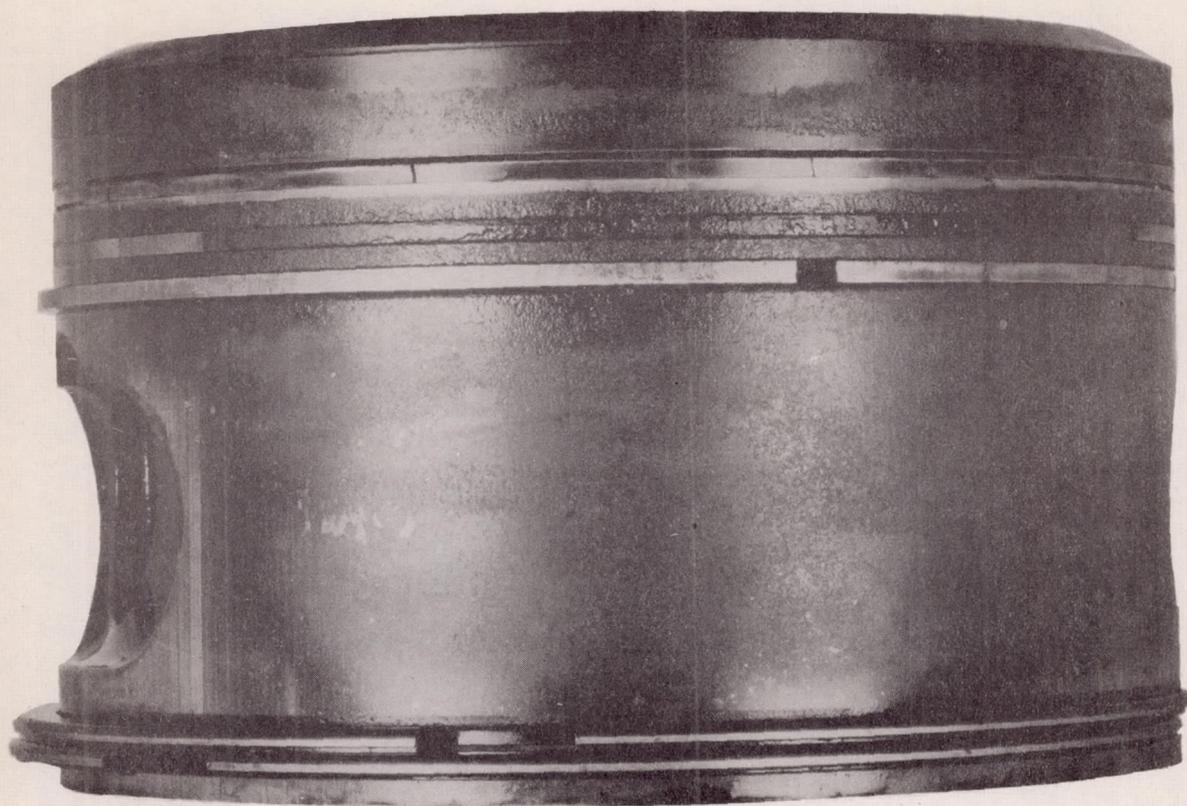
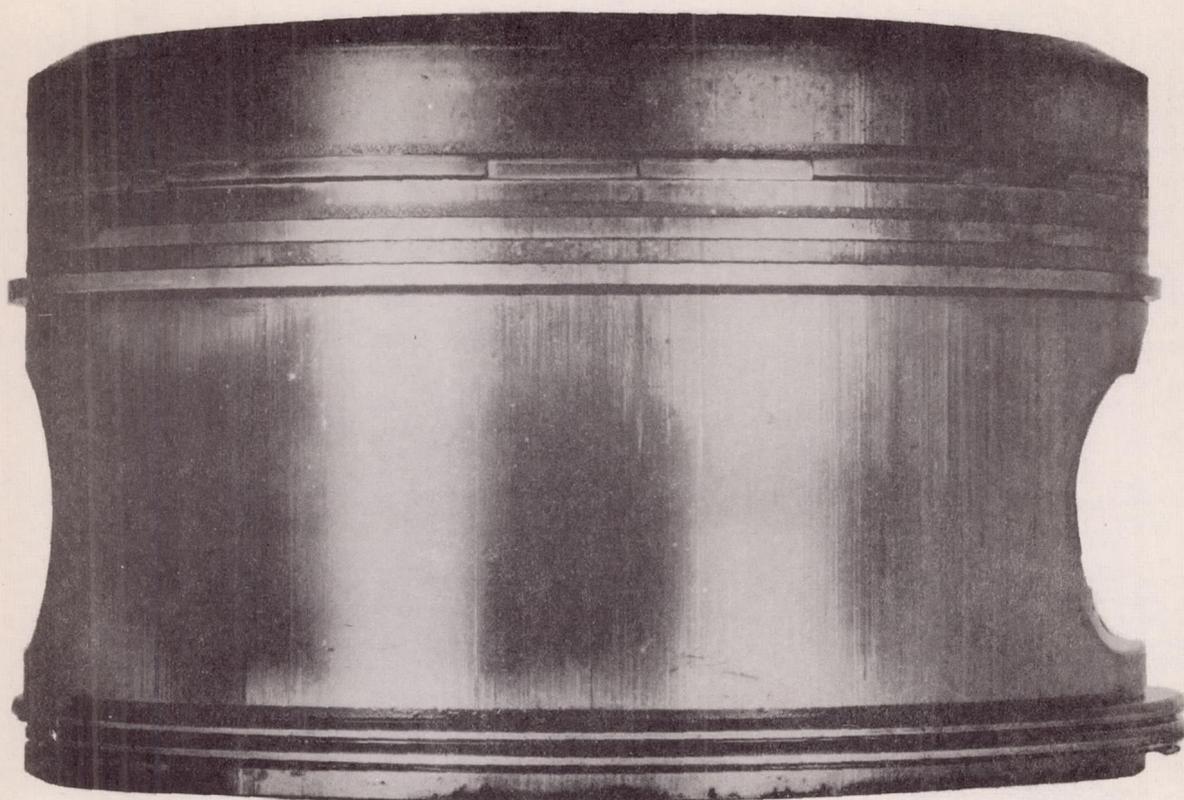
At the end of 7.5 hours the piston was removed for inspection. By this time complete failure of the compression rings had taken place but the oil rings were still in reasonably good condition (fig. 2). The piston and ring assembly was reinstalled and the test continued. After an additional 10.6 hours, the inlet-air pressure was increased to determine the power level at which immediate and complete piston failure would take place. This failure occurred at an inlet-air pressure of 68 inches of mercury absolute with the results shown in figure 3. The total test time was 33.1 hours including the preignition tests conducted previous to the endurance run.

time of the inspection when all the compression rings had failed (fig. 2), which suggests that the oil-control rings had a considerable effect in sealing the combustion chamber.

Figure 2. - Piston and ring assembly after 7.5 hours of first endurance test. All compression rings have failed.

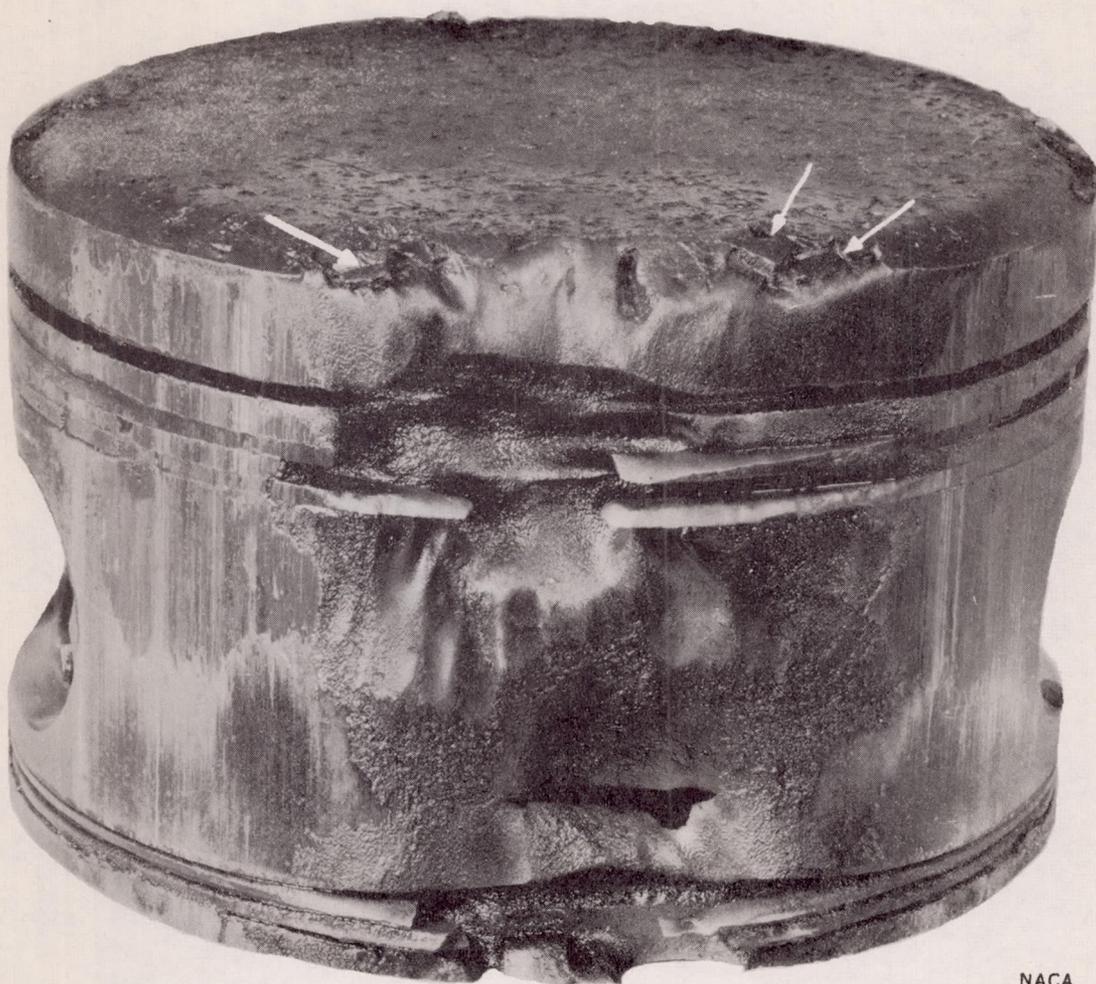
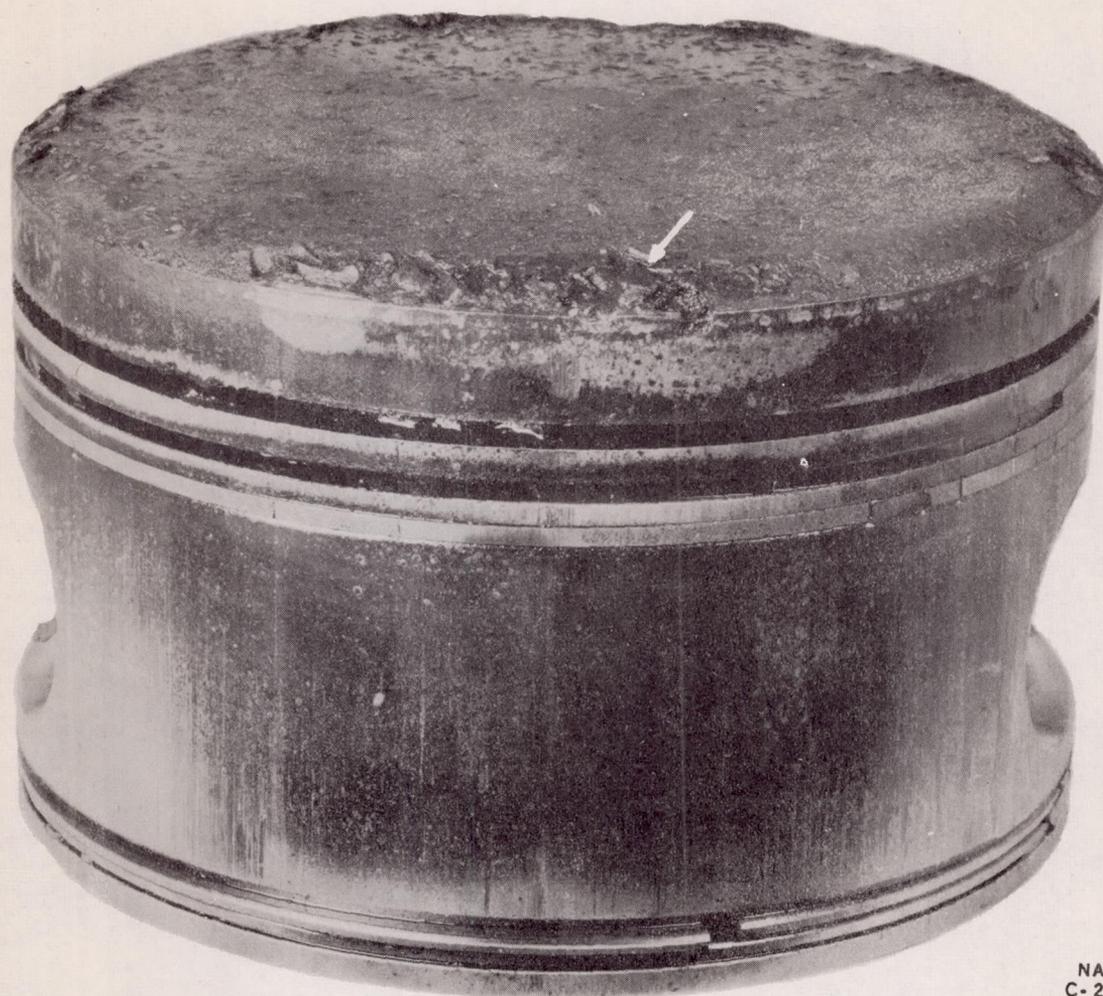
Analysis of failed piston. - Figure 3 shows the piston and ring assembly after the final failure of the first test. A wide deep channel has been burned down the entire length of the piston and a hole has been made through the piston skirt above the oil rings. This damage was confined to the minor thrust face of the piston; the major thrust face remained comparatively unharmed.

The ultimate failure was most likely caused by the action of high-temperature gases against the side of the piston, probably taking place over a relatively long period of time. Figure 7 shows the ring belt of a piston that had been operated under severe conditions in another test program. The large flow of high-temperature gases resulting from compression-ring failure has begun an erosion of one of the ring lands, which probably would have resulted in a large channel similar to figure 3 if operation had been continued long enough. These high-temperature gases are not necessarily all blow-by gases. A portion of these gases leaks by all the rings as blow-by gases, whereas part of them travel down and back up past the ineffective rings as the pressure in the combustion chamber is alternately increased and decreased. The net result is a scouring action, which in all probability causes the erosion shown in figures 3 and 7.

Further evidence that this channeling took place over a prolonged period of time is found in the fact that the entire top ring and parts of the second ring are missing from the piston in figure 3. The channel in the face of the piston provides the only escape path for these ring pieces. Because the broken rings were partly stuck in the grooves, the time required for them to work their way along the grooves to the channel would probably be quite appreciable. The pieces of rings imbedded in the top of the piston at the end of the test (shown by arrows in fig. 3) were covered with a coating of carbon, indicating their presence on the top of the piston for a considerable length of time. The preignition in the engine previously mentioned may have been caused by these ring pieces in the combustion chamber or by the ends of the compression rings left exposed by the formation of the channel down the side of the piston. The fact that particles of aluminum alloy were found lodged in the oil-ring groove, displaced as much as 90° from the channel in the face of the piston, lends further support to the supposition that the channeling of the piston took place over an extended period of time.

The final destruction of the piston occurred without any forewarning other than the high blow-by rates and did not extend beyond a few engine cycles. The piston skirt had been weakened by the channeling and by the increased temperature and the full pressure of the combustion chamber was acting on the sides of the channel.

The stresses in the aluminum became so great and the temperature so high that the skirt collapsed and permitted the free flow of burning gases into the crankcase.

Figure 3. - Piston and ring assembly at end of first endurance test. Total test time 33.1 hours. Arrows indicate pieces of piston rings imbedded in piston.

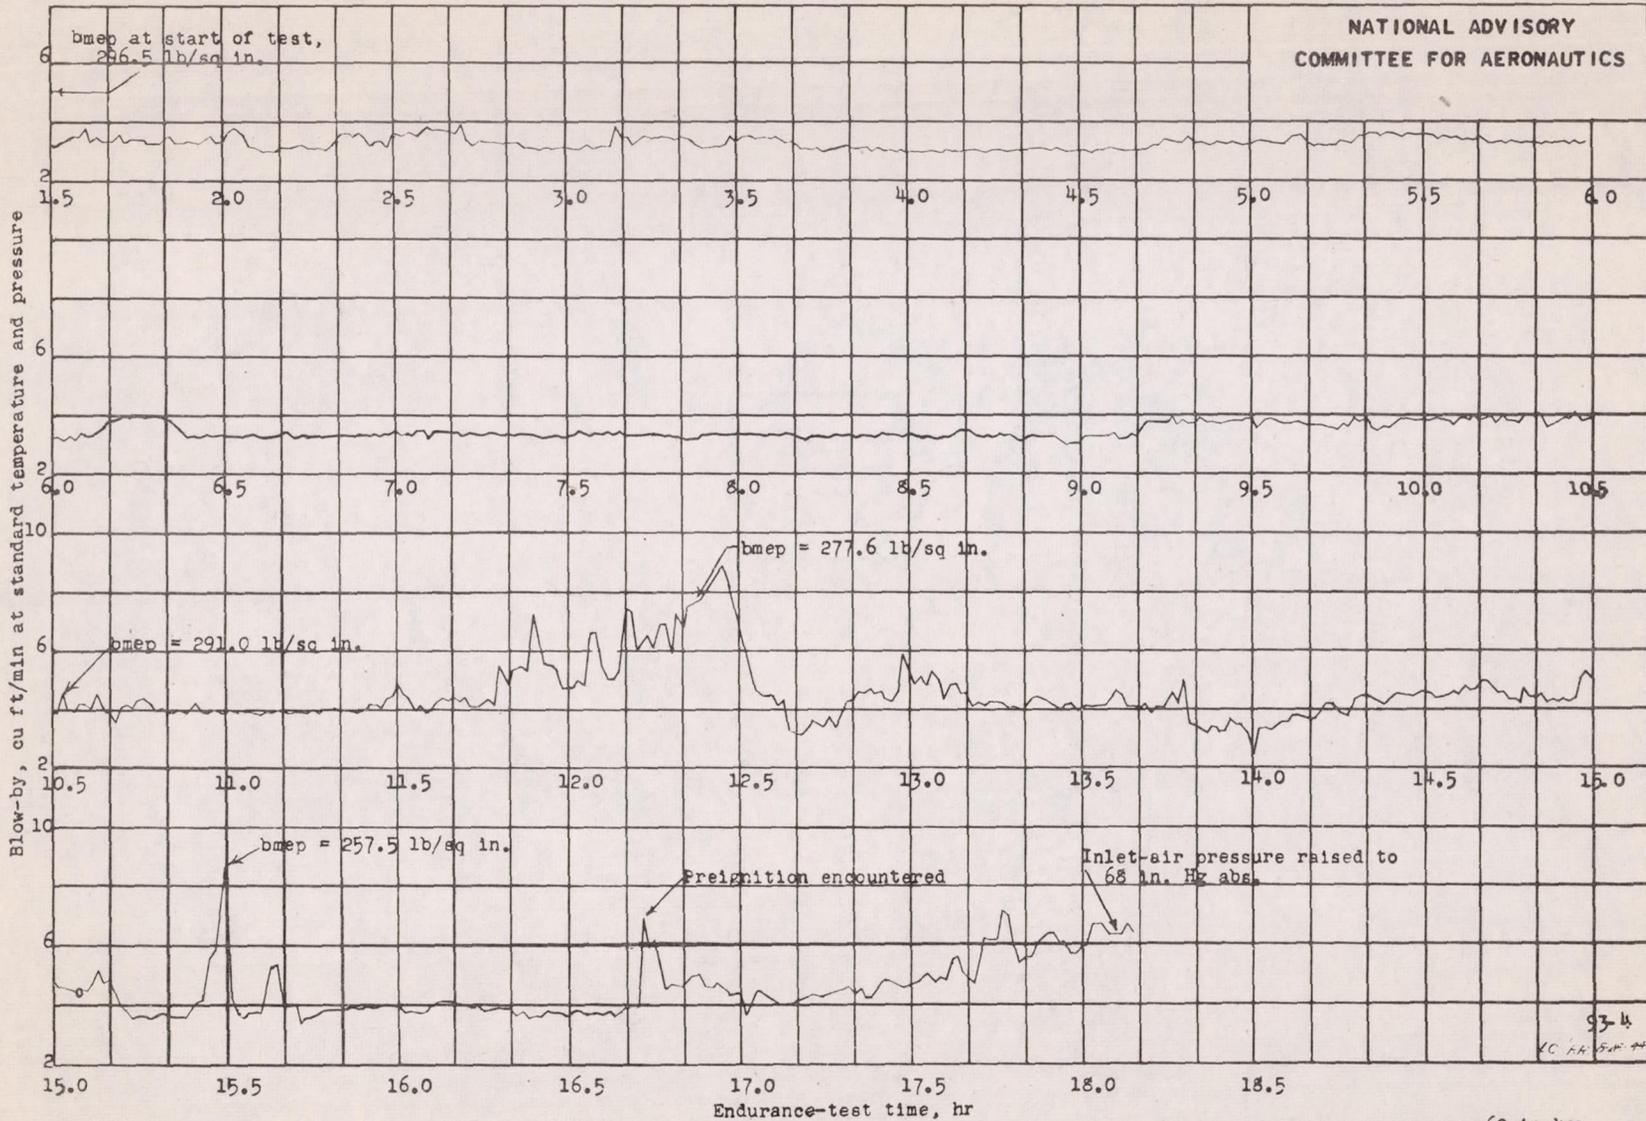
Figures 4 and 5 indicate that, after failure of the top and second rings had taken place (beginning of endurance test), an increasing degree of failure of the compression rings did not affect the sealing qualities of the piston and ring assembly to any marked extent. The rate of blow-by and the crankcase pressure at the beginning of the test were approximately the same as those values at the

A marked rise in the rate of blow-by is evident after 11.5 hours of operation. Immediately after these values reached a maximum, the engine was shut down. When the test was continued on the next day, the blow-by rate was found to have dropped to a relatively low value. Upon examination of the piston at the end of the test, small particles of aluminum alloy were found lodged in the oil-ring groove. These aluminum-alloy particles suggested that the marked rise in the rate of blow-by may have been caused by similar particles which served to partly stick the oil-control rings and which were later displaced upon idling the engine to a stop or during the subsequent starting and warming-up operations on the following day. The fact that these deposits were found in the oil-ring groove and displaced as much as 90° from the point of final failure indicates that considerable time was required for their formation and that they were not a result of melted aluminum alloy finding its way into the groove at the time of final failure. The irregularities in the rate of blow-by throughout the rest of the test further substantiate the occasional partial sticking of the oil-control rings.

Figure 4. - Effect of running time on rate of blow-by for first endurance test. Engine speed, 2600 rpm; inlet-air pressure, 60 inches of mercury absolute (except as noted); inlet-air temperature, 100° F; fuel-air ratio, 0.095; oil flow to piston, 2.0 pounds per minute.

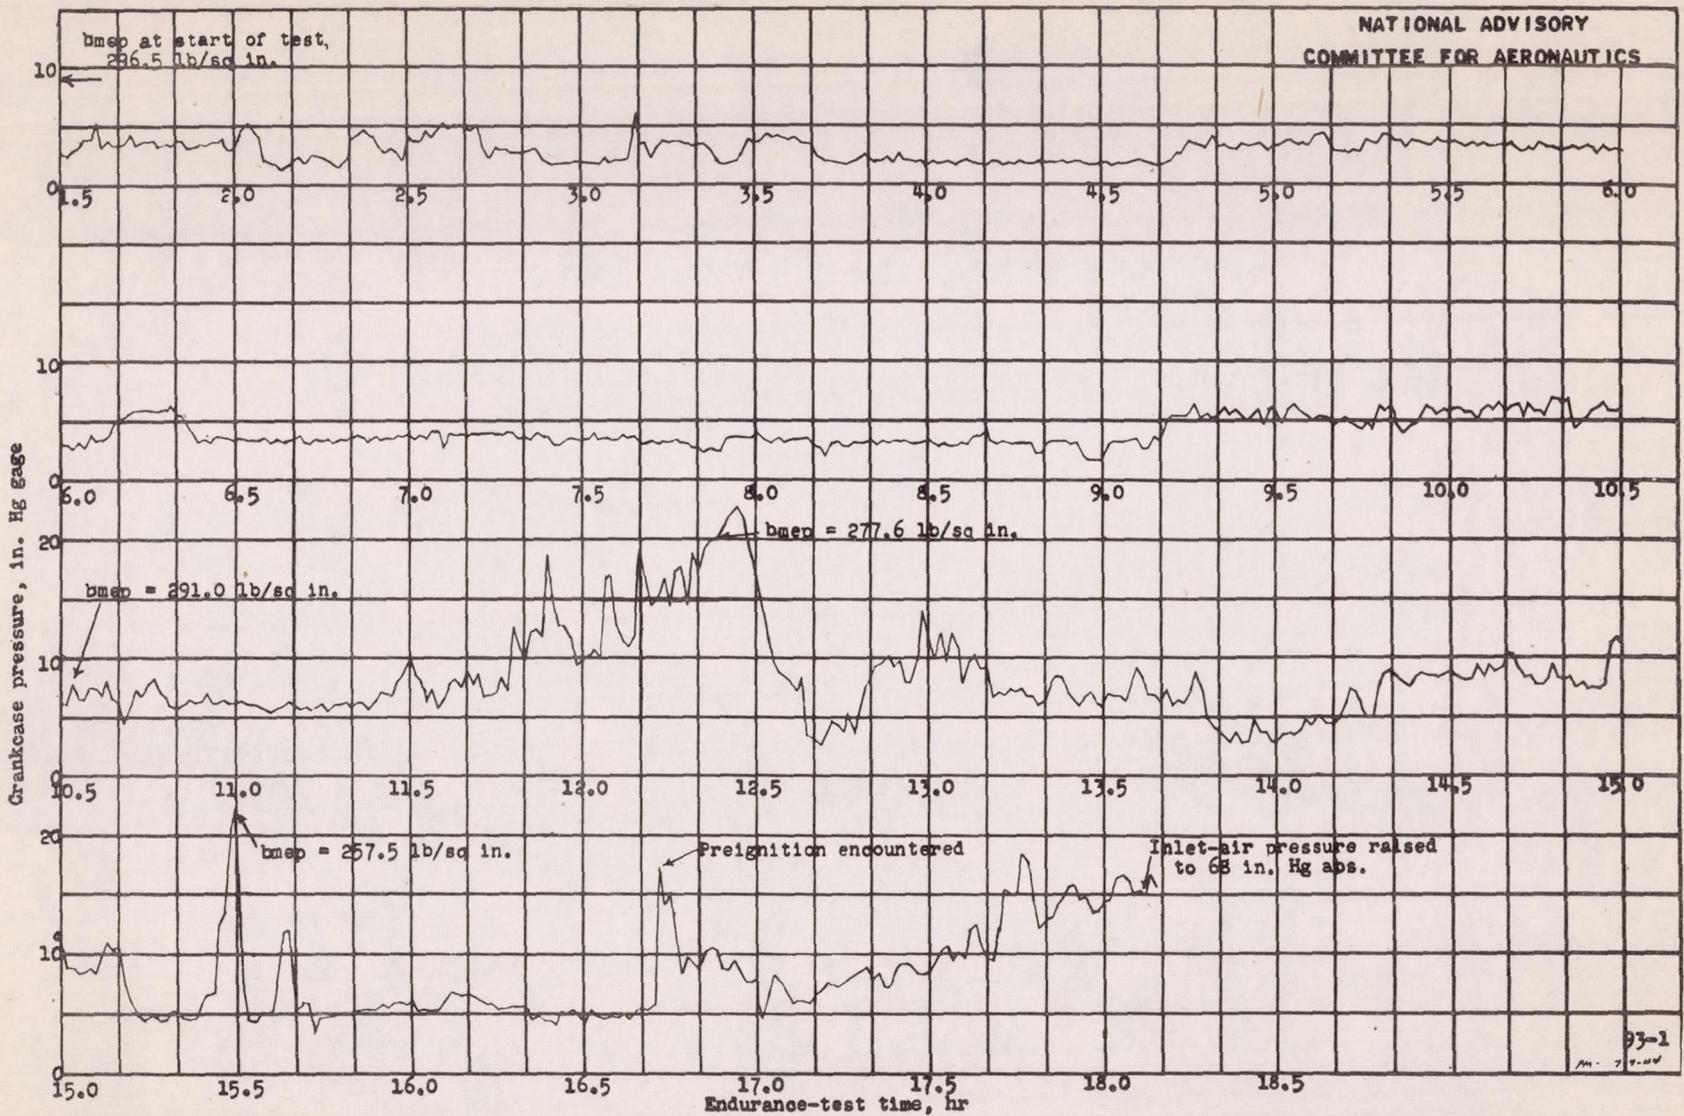
Blow-by and crankcase pressure. - The curves of the rate of blow-by and the crankcase pressure are shown in figures 4 and 5. Because the crankcase pressure is directly related to the blow-by rate, these curves are similar. It must be borne in mind, in the interpretation of the results of the crankcase-pressure curve, that the magnitudes of the crankcase-pressure values are entirely dependent upon the system used for the removal of the blow-by gases from the crankcase; a system having many restrictions, such as small piping, a flowmeter, and numerous valves, will result in high pressures, whereas a system having fewer obstructions to the gas flow will result in low pressures. The actual pressure in the crankcase was somewhat higher than the values measured because the manometer was connected to the blow-by line some distance from the crankcase.

Figure 5. - Effect of running time on crankcase pressure for first endurance test. Engine speed, 2600 rpm; inlet-air pressure, 60 inches of mercury absolute (except as noted); inlet-air temperature, 100° F; fuel-air ratio, 0.095; oil flow to piston, 2.0 pounds per minute.

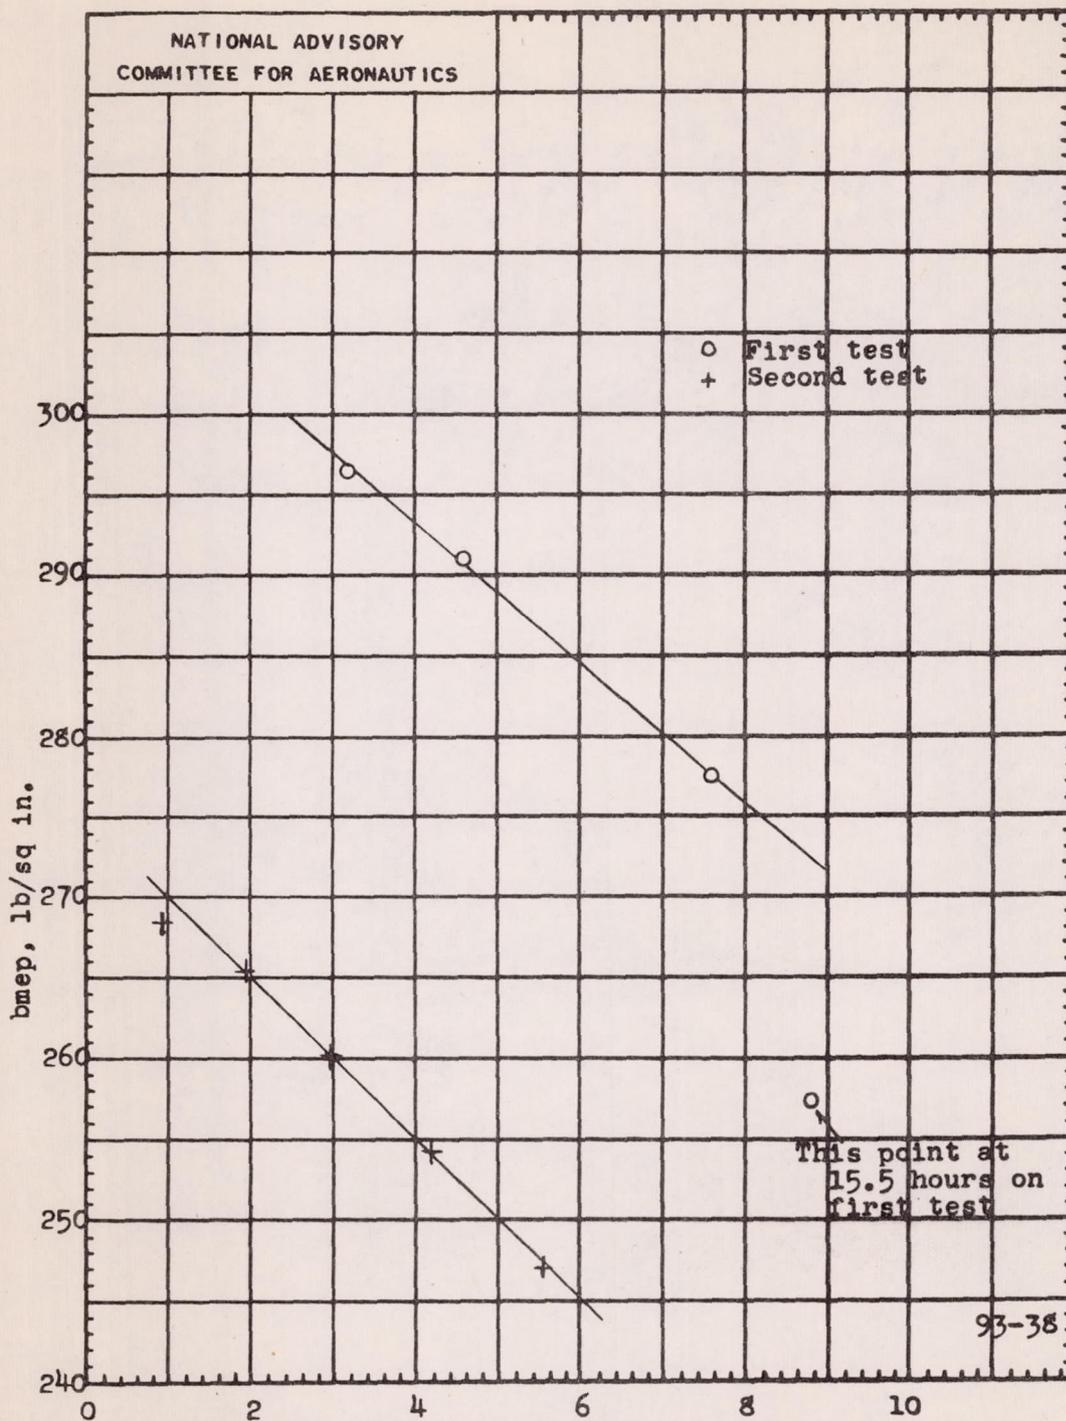
The two curves of figure 6 are straight lines and are roughly parallel. Calculations based on the slopes of these curves indicate that the power loss for a given rate of blow-by is about three times what would be expected if the weight of blow-by gases were considered as an equivalent weight loss of fresh charge. An Orsat analysis of the blow-by gases showed an oxygen content of about 15 percent, and unpublished data taken at this laboratory confirm this value for the

blow-by gases of another engine. The blow-by gases therefore probably consisted of about two-thirds unburned charge and one-third burned charge and the rates of blow-by shown in figure 6 should account for somewhat less than one-third of the power loss on the basis of gas leakage alone. The rest of the power loss can be accounted for only by possible increases in piston and ring friction and by pumping losses caused by the high crankcase pressure.

Blow-by, cu ft/min at standard temperature and pressure
 Figure 6. - Effect of rate of blow-by on brake mean effective pressure. Engine speed, 2600 rpm; inlet-air temperature, 100° F for first test, 200° F for second test; fuel-air ratio, 0.095 for first test, 0.085 for second test; oil flow to piston, 2.0 pounds per minute for first test, 0.5 pound per minute for second test.

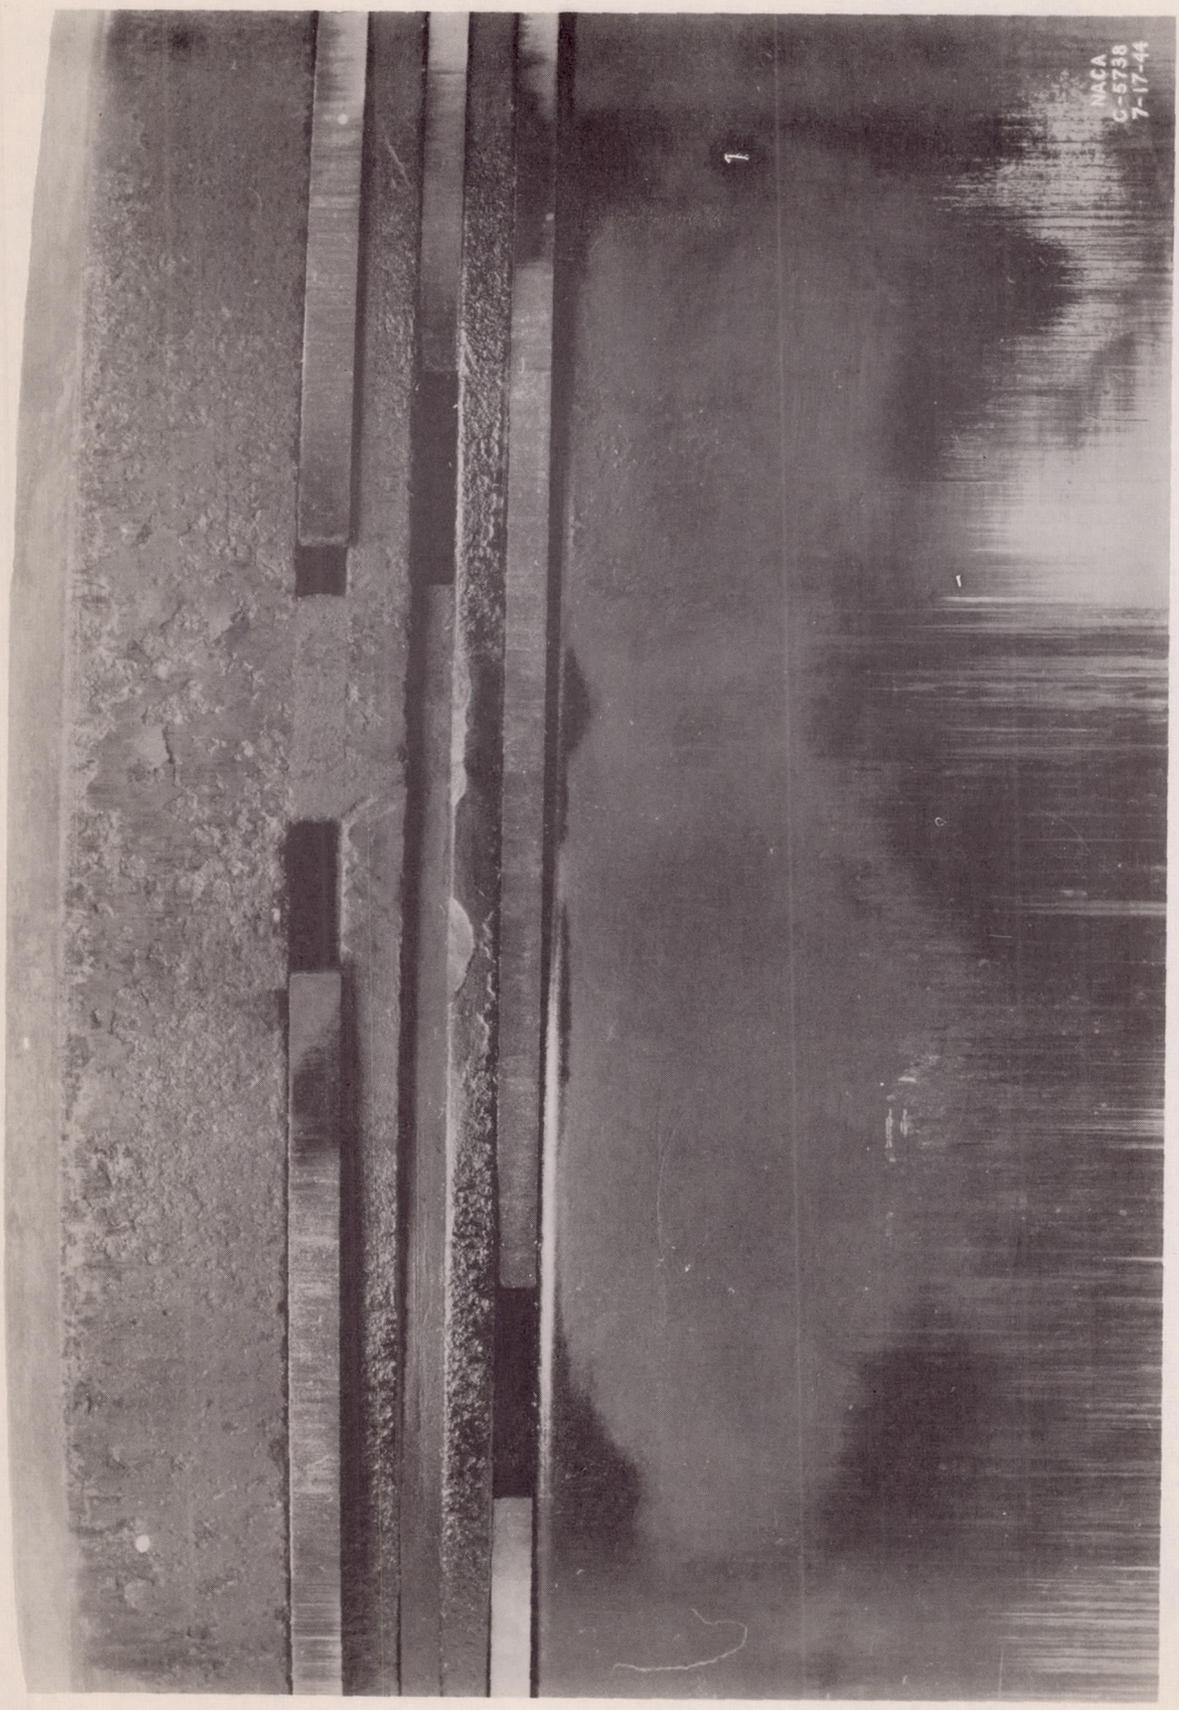
Figure 7. - Beginning of piston erosion as caused by high rate of gas flow past piston rings from another test program.

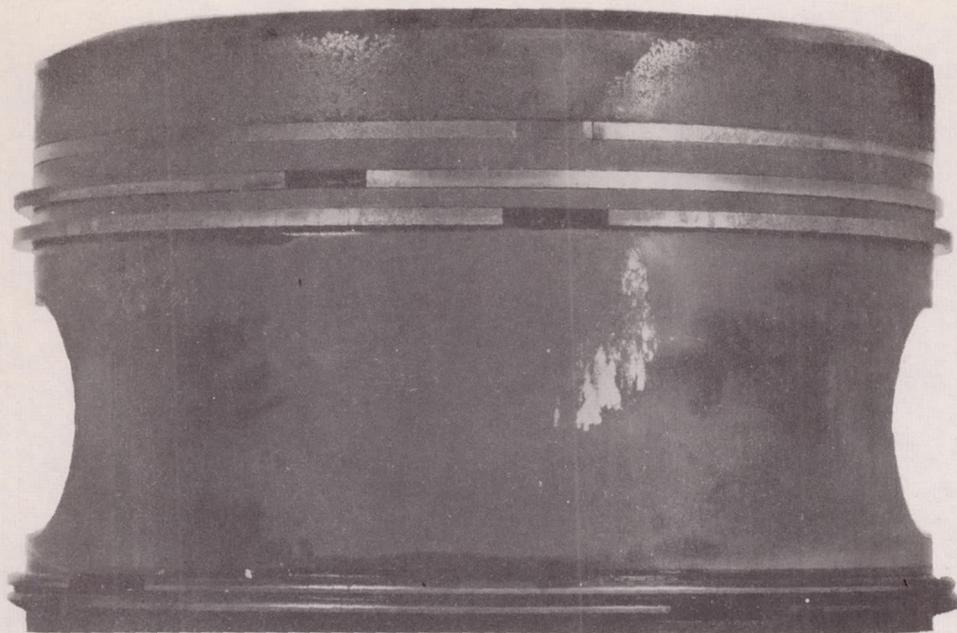
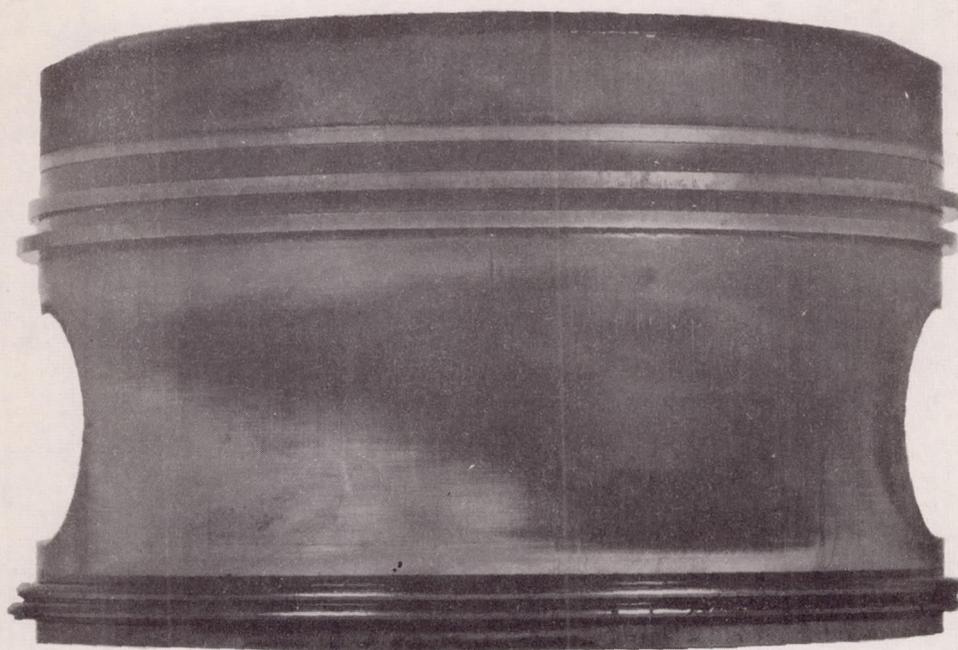
After 12.5 hours of operation the rings were examined. (See fig. 8.) The top ring was stuck and broken a short distance from the gap; the second ring was stuck for a part of its length. All the rings were considerably worn and had an etched appearance. After 42.0 additional hours of running the cylinder was again removed and a visual inspection showed all the compression rings to be broken. Upon reassembly the inlet-air pressure was raised to 56 inches of mercury absolute and the test was continued until complete piston failure occurred at a total running time of 84.25 hours (fig. 9).

From the time the top ring became stuck until the first inspection, the rate of blow-by showed a gradual upward trend, probably indicating the rapid rate of deterioration to the condition shown in figure 8. Between the first and the second inspections the rate of blow-by was quite irregular but, after the second inspection, began an upward climb continuing almost to the end of the test. A similar upward climb, which may be associated with the gradual channeling of the piston, occurred during the last 1.5 hours of the first test. Such channeling would provide a more unrestricted path for the blow-by gases past the broken compression rings.

Figure 8. - Piston and ring assembly after 12.5 hours of second endurance test. Top ring broken and stuck; second ring partly stuck.

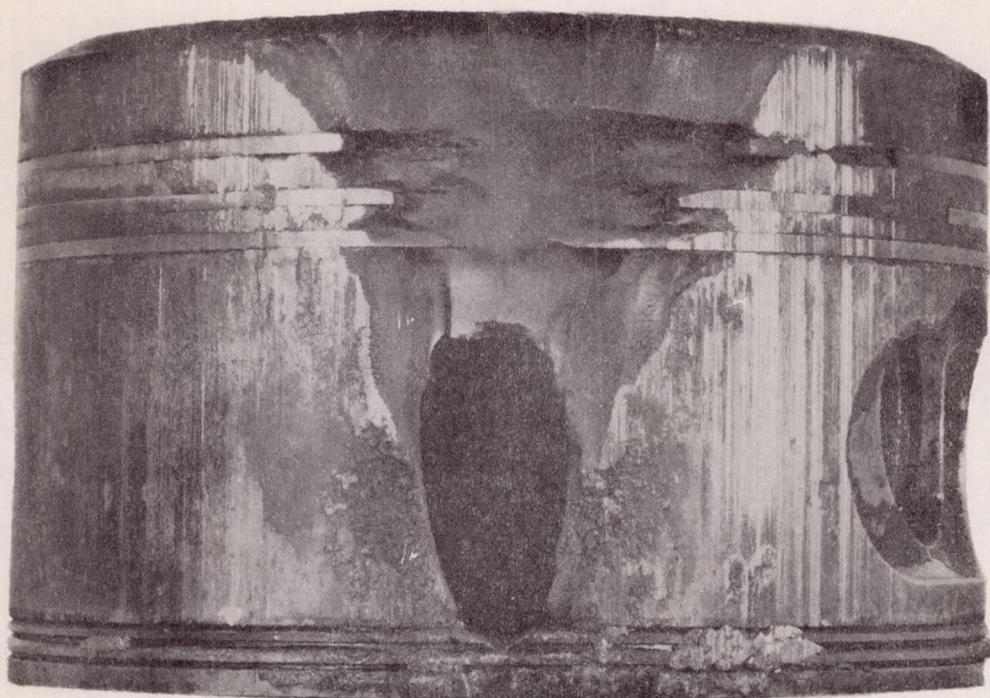
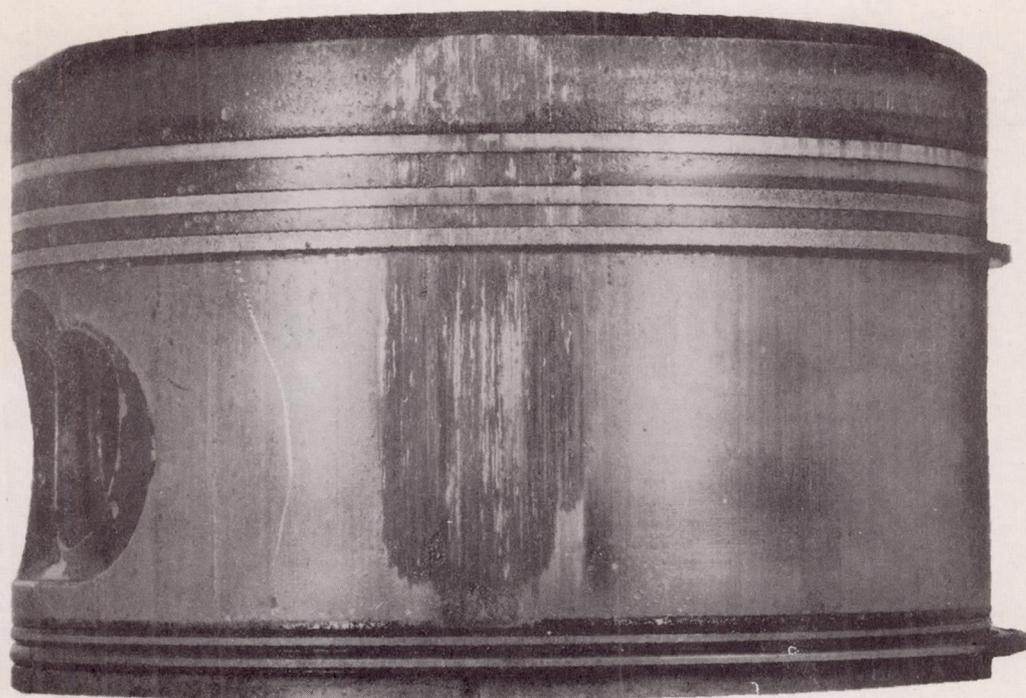
Analysis of failed piston. - Figure 9 shows the piston at the end of the second test. The failure was quite similar to that of the first test. In this case, however, much of the top two compression rings was still in the ring grooves, probably caused by the rings' being more severely stuck than in the first test and therefore not so free to rotate in the grooves.

Particles of aluminum alloy were found in the oil-ring groove displaced a considerable distance from the point of failure. Here again is evidence that the channeling of the piston took place over an appreciable period of time. It appears unlikely that these aluminum particles could have moved so far along the groove at the instant of final failure.

Figure 9. - Piston and ring assembly at end of second endurance test. Total test time, 84.25 hours.

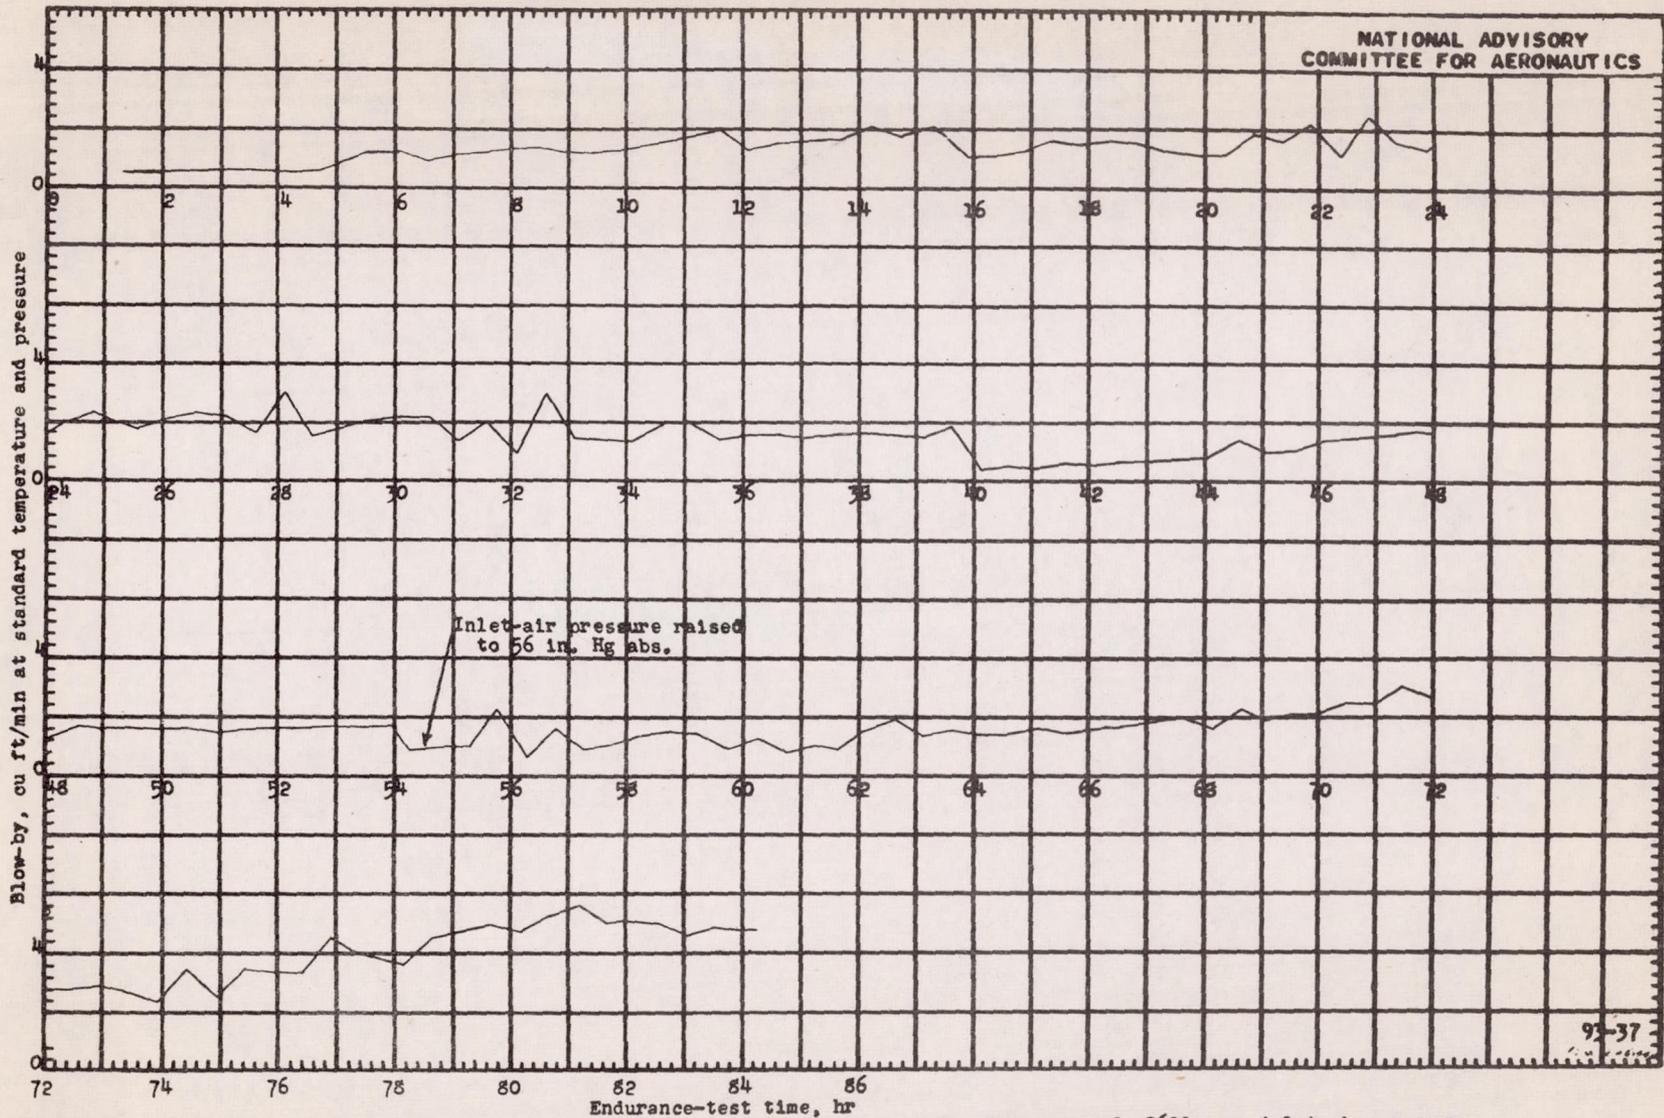
Blow-by and crankcase pressure. - The curves of rate of blow-by and crankcase pressure for the second test are shown in figures 10 and 11. These curves show a marked increase in the blow-by rate and the crankcase pressure after the first 4.5 hours of running, which indicates the beginning of compression-ring failure probably by sticking of the top ring. Unpublished data taken on this engine have shown that 0.5 cubic foot per minute is an average value for the rate of blow-by with a new piston and ring assembly when operating

Figure 10. - Effect of running time on rate of blow-by for second endurance test. Engine speed, 2600 rpm; inlet-air pressure, 50 inches of mercury absolute (except as noted); inlet-air temperature, 200° F; fuel-air ratio, 0.085; oil flow to piston, 0.5 pound per minute.
